BUILDING RAPID EVALUATION SAFETY ASSESSMENT FORM

Inspection Number-(1700-SUPER-006-2007-1)

<u>Building Description:</u>	<u>Overall Rating:</u>
<p>Name: Pier 70 Building #6</p> <p>Address/Location:</p> <p>Facility Code 1700 Lease No.</p> <p>No. of Stories: 1</p> <p>Construction: Wood <input type="checkbox"/> Concrete <input type="checkbox"/> Steel Masonry</p> <p style="margin-left: 40px;"><input type="checkbox"/> Combination</p> <p>Support: <input checked="" type="checkbox"/> Over Water <input type="checkbox"/> On Land</p> <p>Occupancy: Commercial Office Industrial</p> <p>Assembly Residential Emergency Serv. <input type="checkbox"/> Other</p>	<p>Green:</p> <p>Yellow:</p> <p><input checked="" type="checkbox"/> Red:</p>

PORT OF SAN FRANCISCO · PIER 70 · BUILDING 6
SEISMIC REVIEW

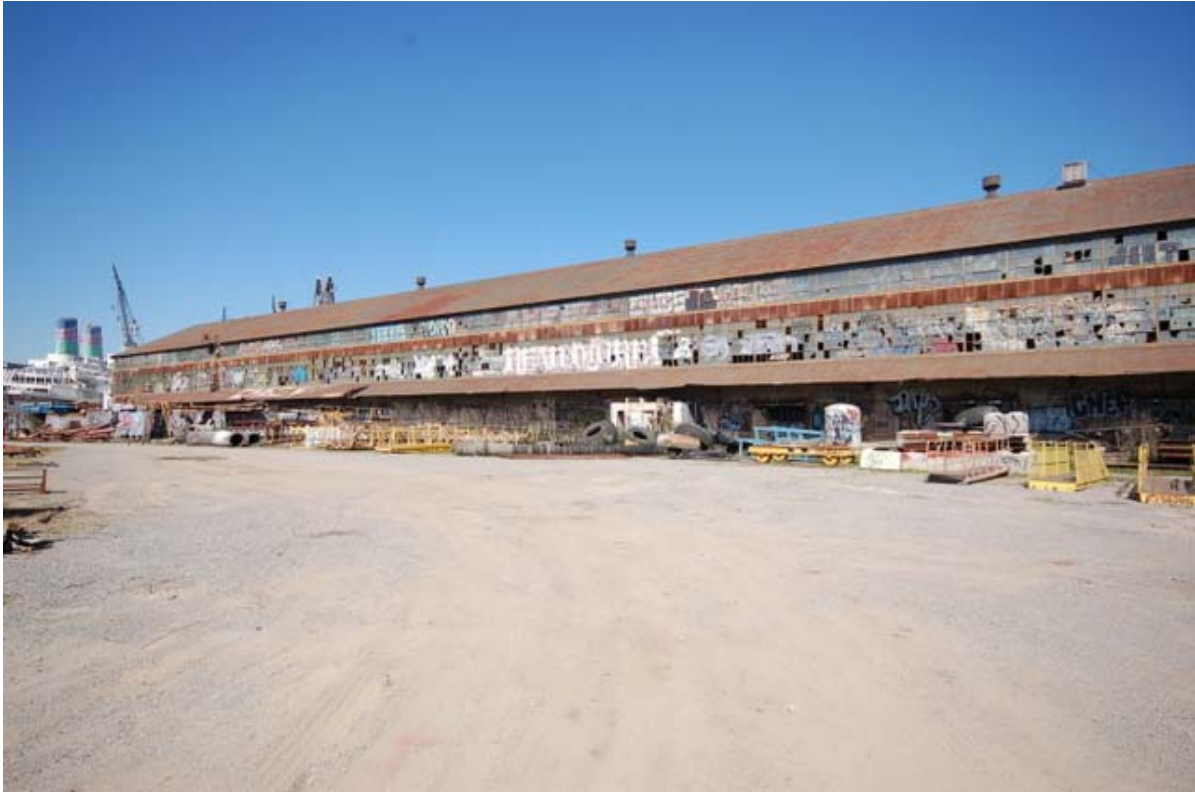
Figure 1: Partial south elevation

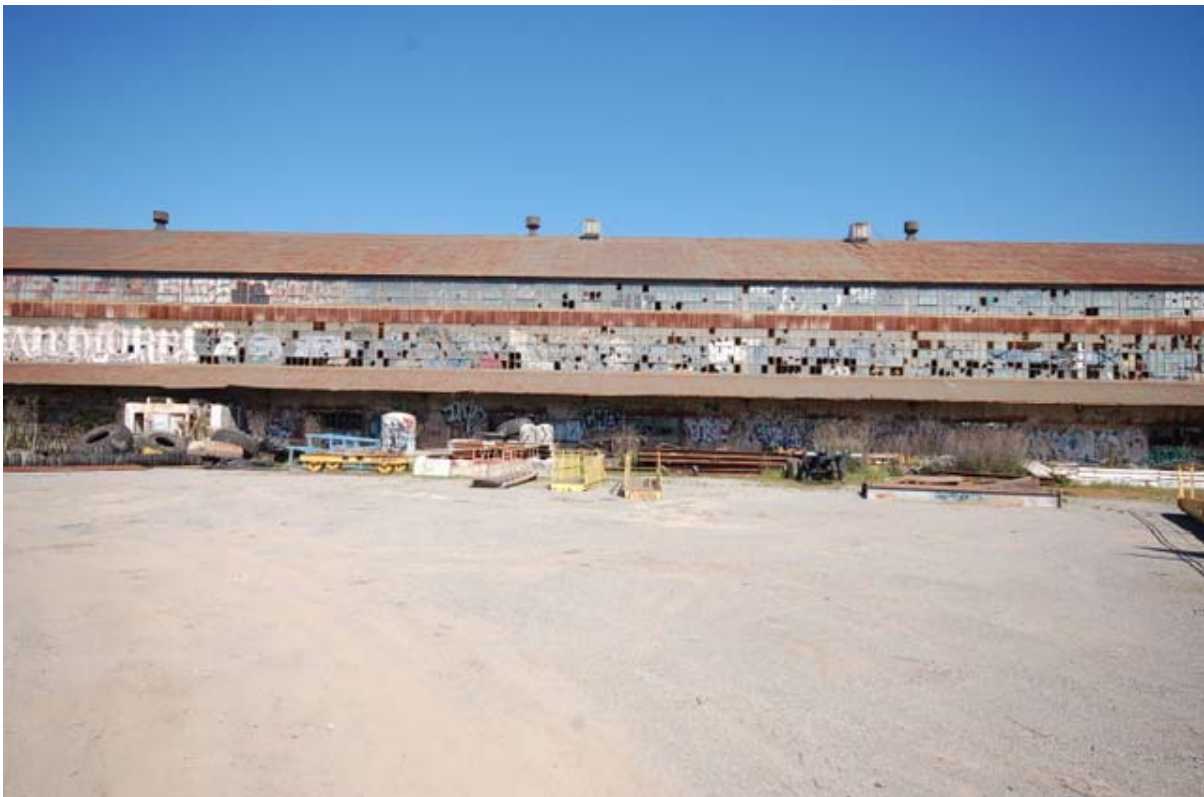
Figure 2: Partial south elevation

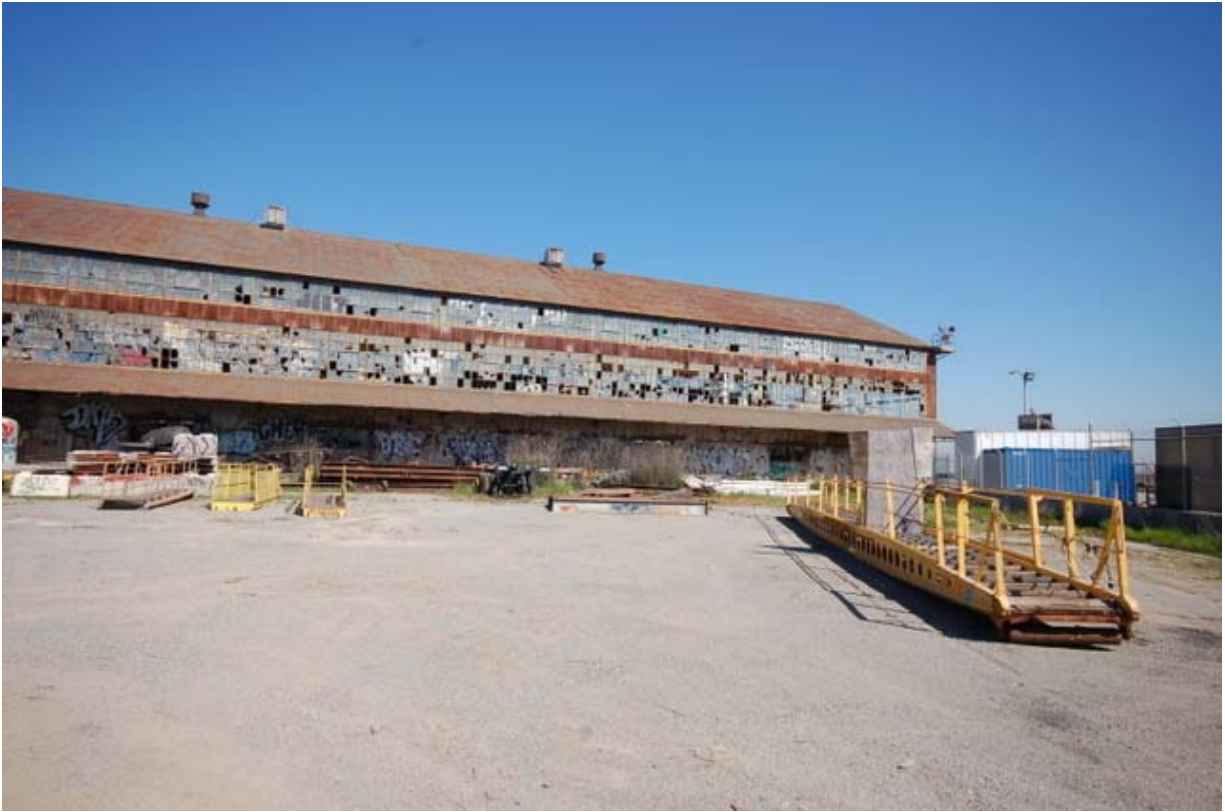
Figure 3: Partial south elevation

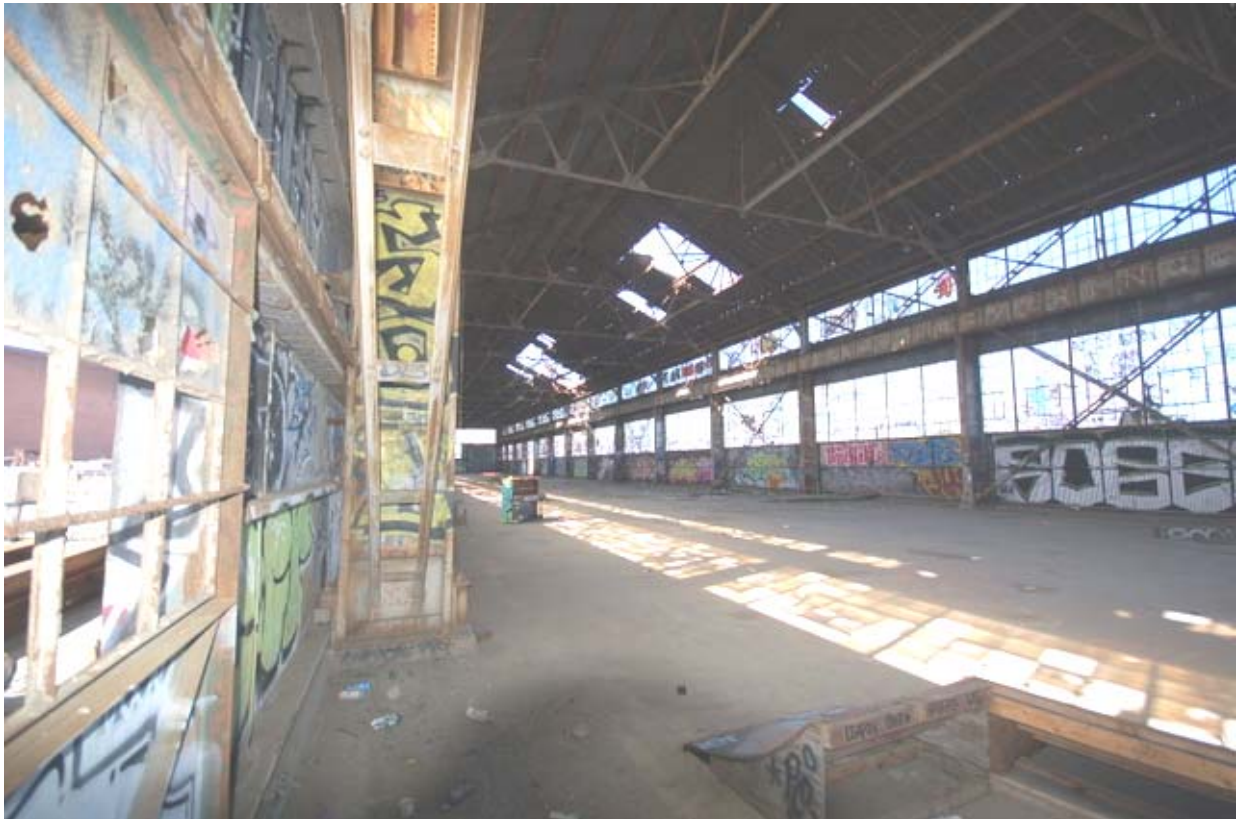
Figure 4: Interior, looking west

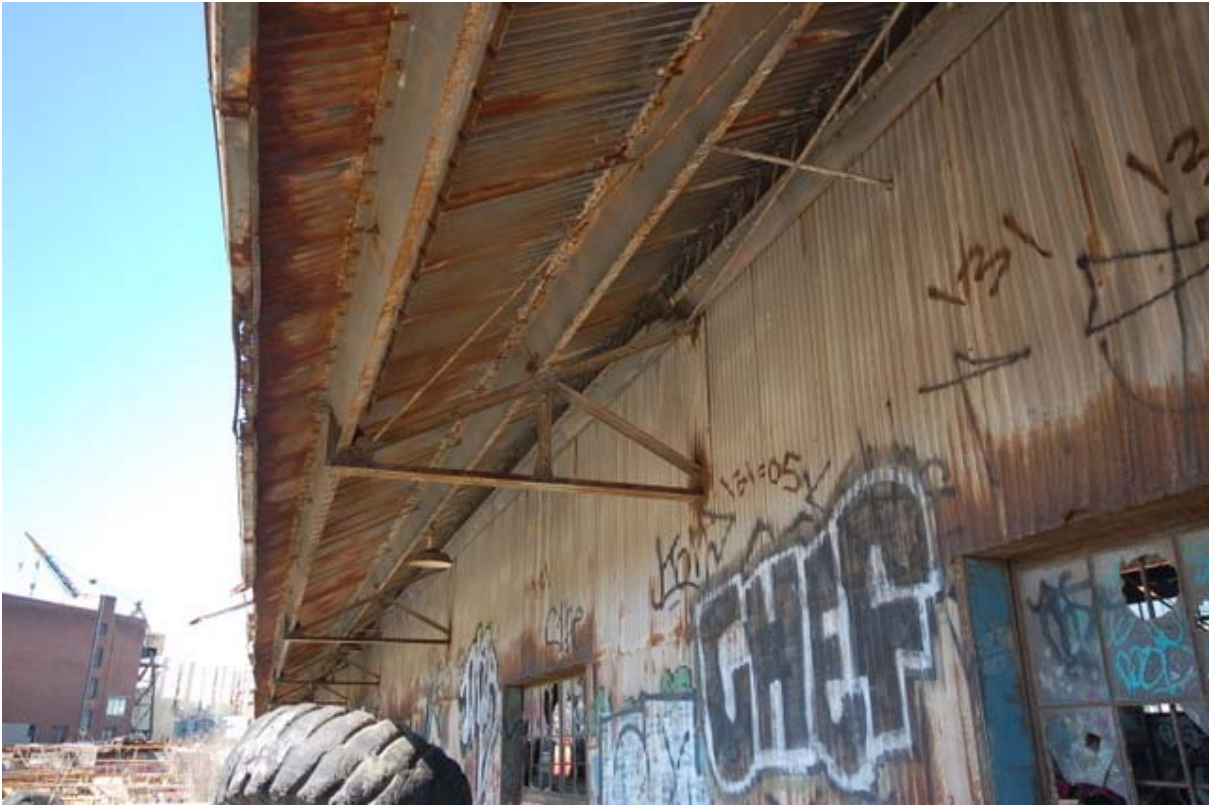
Figure 5: South wall, overhang

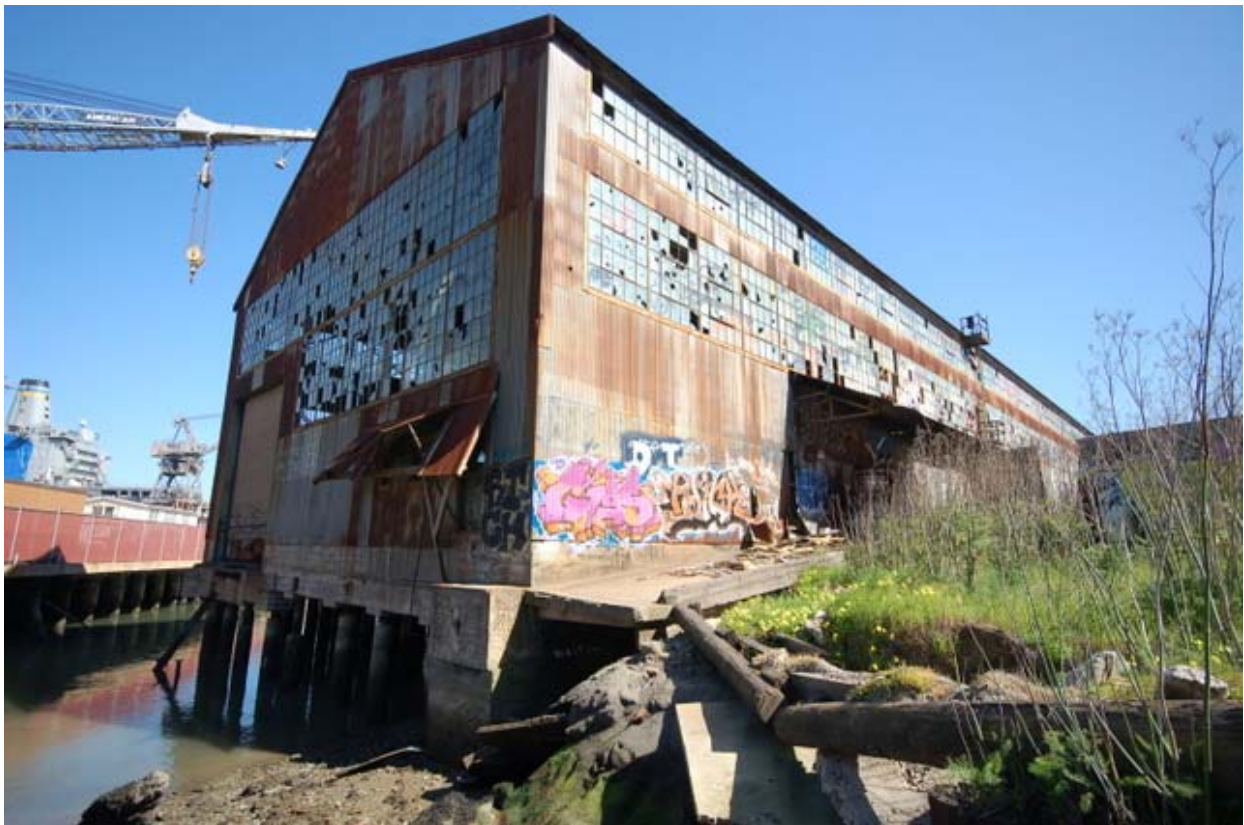
Figure 6: Southwest corner

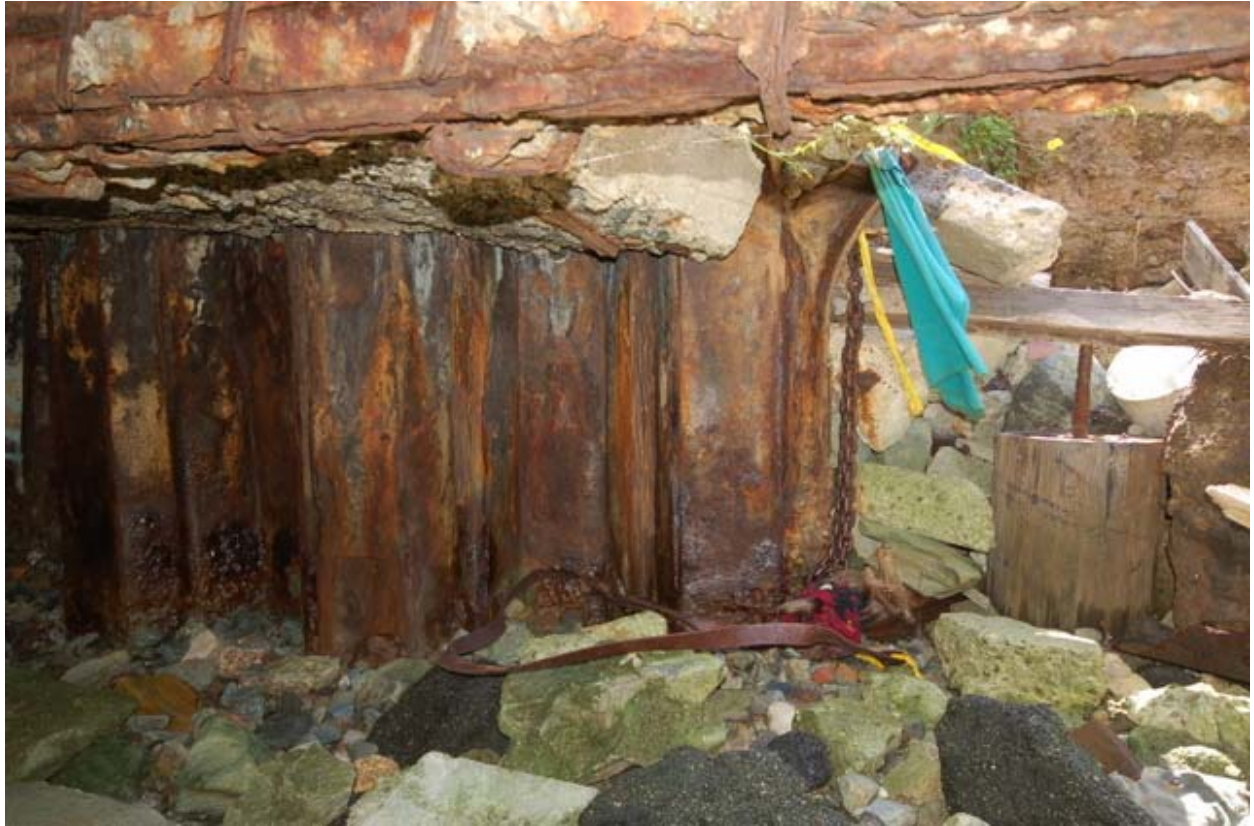
- 1) Broken glass and debris present
- 2) West side wall open to water
- 3) Large steel and concrete debris blocking south side of building
- 4) Most windows are broken
- 5) Sea wall at foundation appears to be in poor condition

Figure 7: Damaged seawall

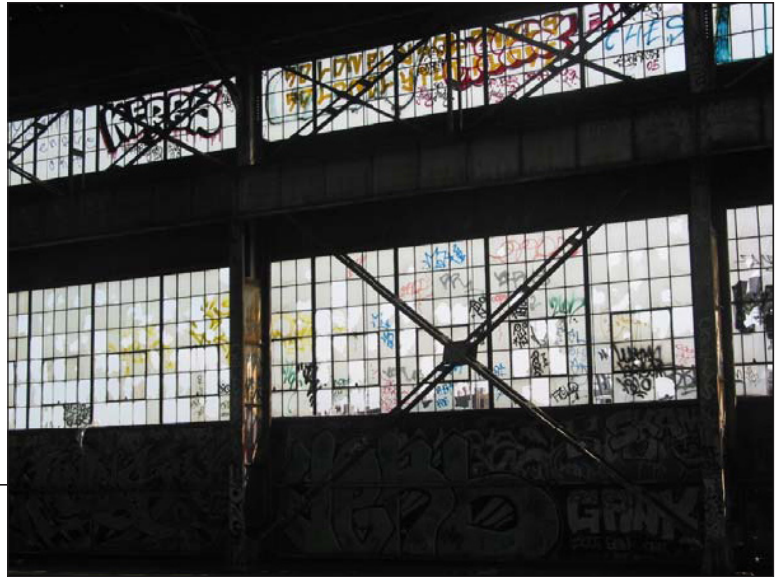
The lateral force resisting system of the building consists of roof metal deck diaphragm and steel brace frames that occur in only the longitudinal direction of the building as seen in Photo 2 and 3. In the transverse direction of the building, there are no apparent seismic lateral resisting elements except for weak axis column bending. The existing lateral force resisting system appears to have many seismic deficiencies. The existing roof diaphragm appears inadequate for code seismic lateral forces. Clerestories walls between high and low roofs prevent the roof diaphragm from behaving as a single continuous diaphragm, resulting in inadequate transfer of lateral forces. The braced frames consisting of steel double angle braces do not appear to be adequate for seismic loading and connections. The connections at the column base are not constructed to perform in a ductile manner, and can fail suddenly.

Photo 2 Above:
Brace Frame at South Side

- Add steel braces in the clerestory between the high roof and low roof where the roof diaphragm is discontinuous.
 - Add new steel braced frames to resist seismic forces in both transverse and longitudinal directions.

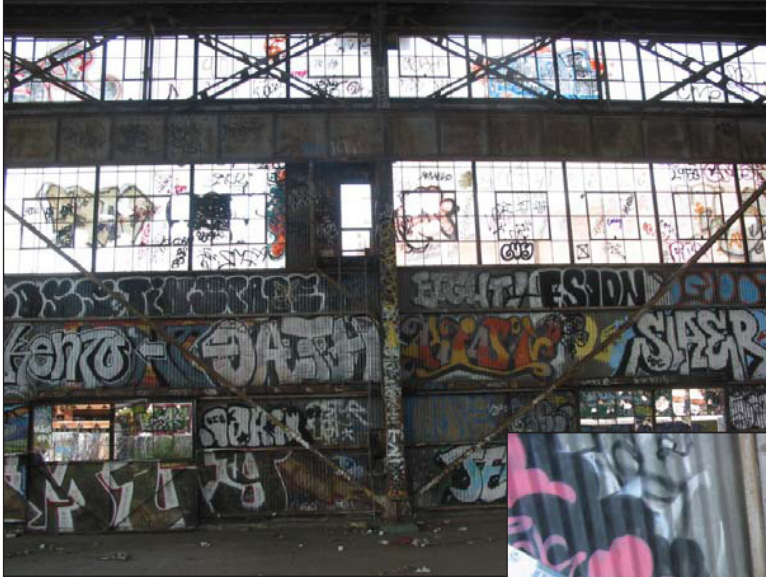
Photo 3 Above:
Brace Frame at North Side

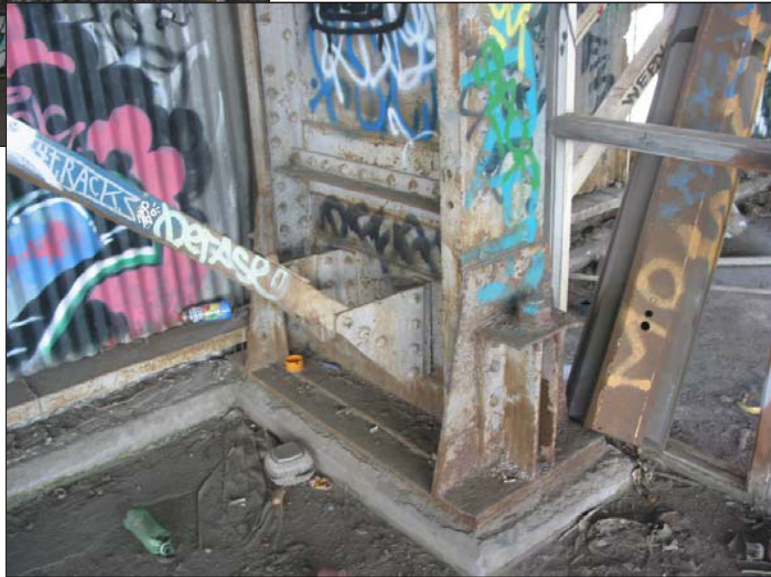
Photo 4 Below:
Brace Connection at
Column Base

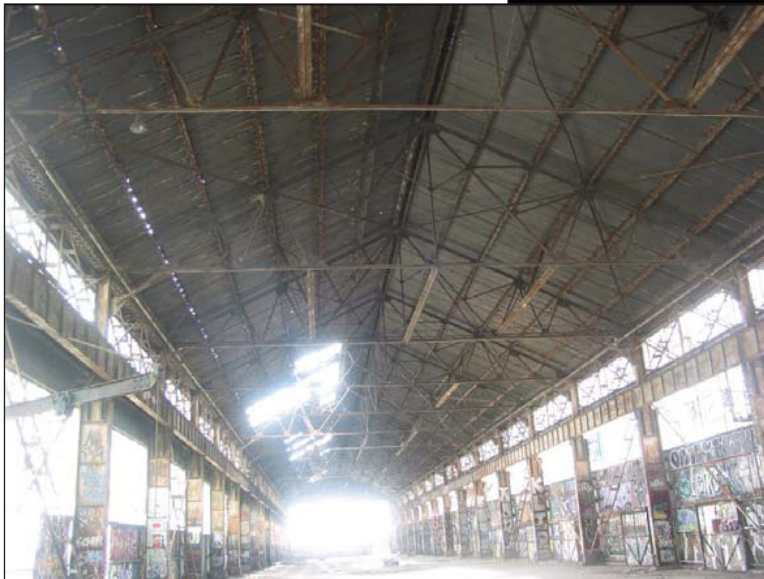
The vertical load carrying system of the building consists of light gage roof metal deck spanning between purlins made of steel channels. The purlins are supported on steel trusses, which in turn are supported on steel built-up columns at the perimeter of the building. Most of roof metal deck and steel trusses show signs of corrosion. Portions of the roof have completely deteriorated. There are large openings in the roof at multiple places.

Photo 5 Above:
Deteriorated Roof Framing

3. For preliminary planning and cost-estimating purpose, the seismic strengthening may consist of:
 - Add new metal deck to replace existing roof metal deck and increase strength of connections of roof diaphragm to seismic force resisting elements.
