701 Sutter St., 4th Floor, San Francisco, CA 94109

Tel: (415) 882-9449

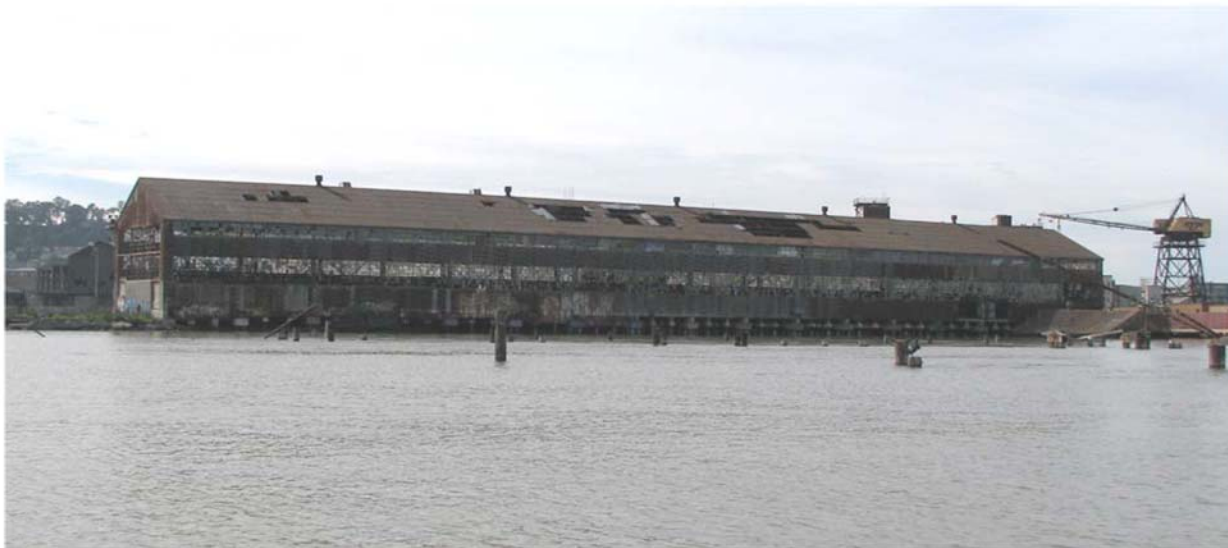
Figure 1 Pier 70 Building 6 as seen from the water looking west.

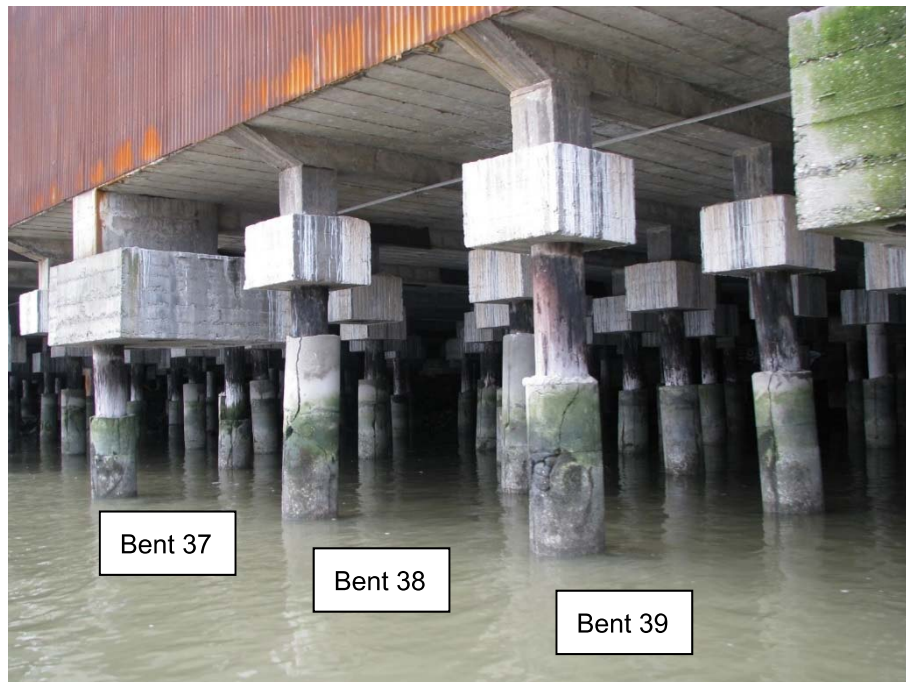
Figure 2 Photo showing bents 37 to 39, the first row of piles is row 1, cracked concrete sleeves are seen on the majority of the timber piles and the four pile cluster at I-37 is missing three piles.

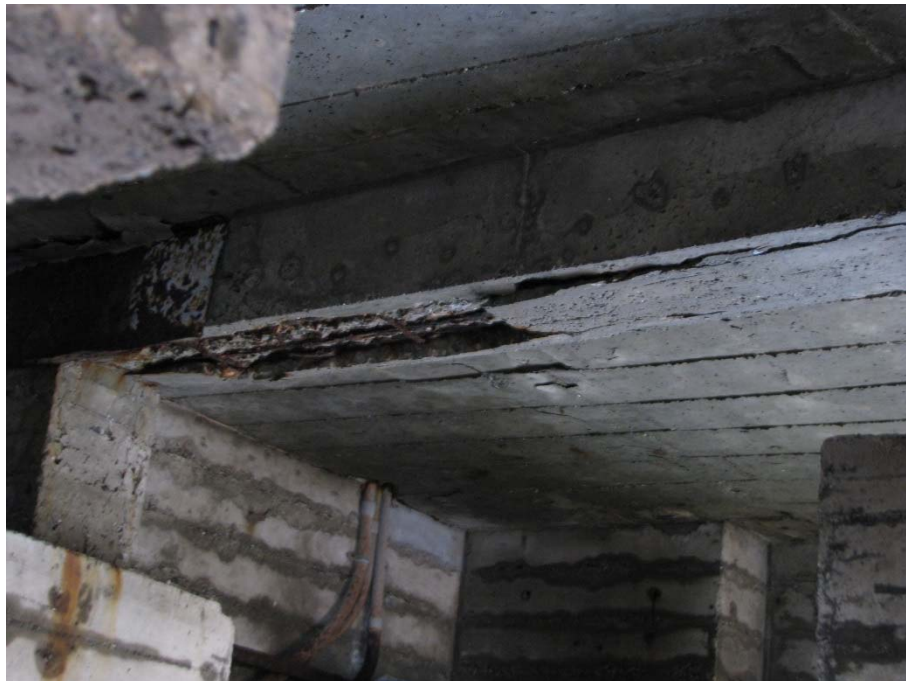
Figure 3 Photo showing spall damage with corroded rebar to cap beam at row 51 A-B

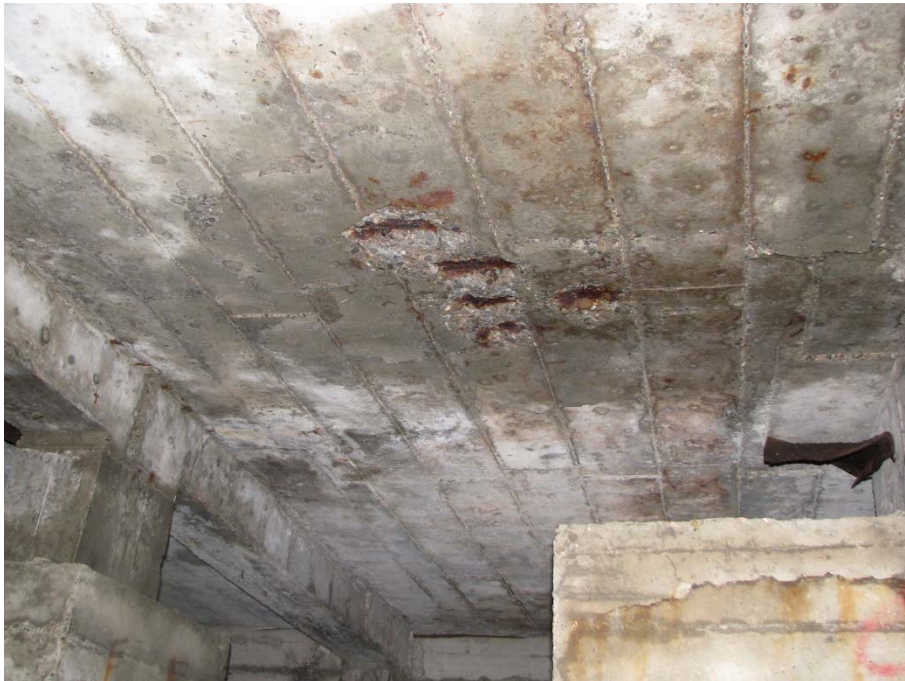
Figure 4 Photo showing typical soffit spall damage with corroded rebar between bents 45-46 row A

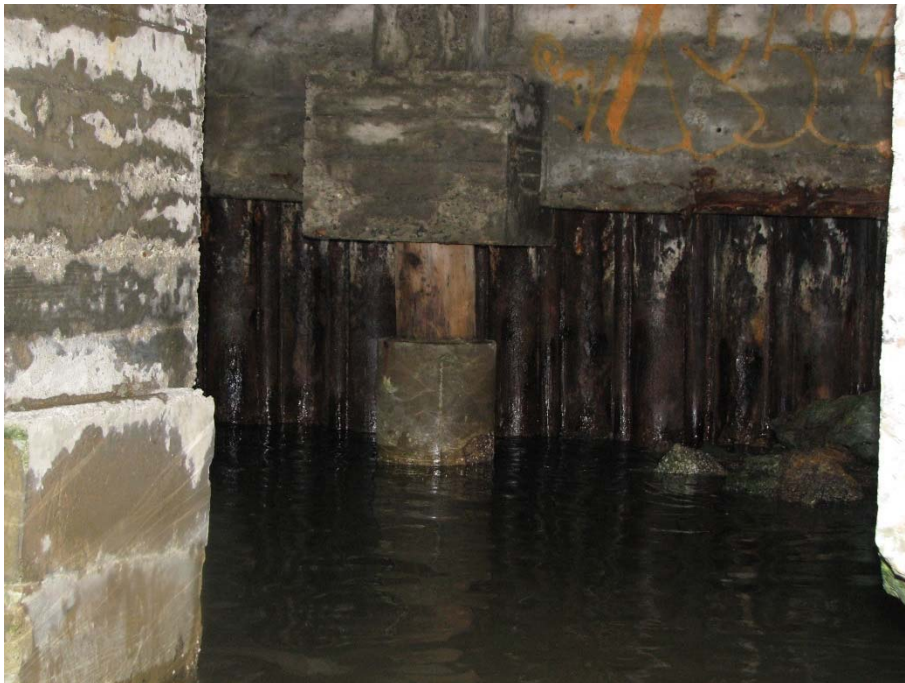
Figure 5 Steel sheet pile at row BB with timber pile at bent 45 row AA shown in front.

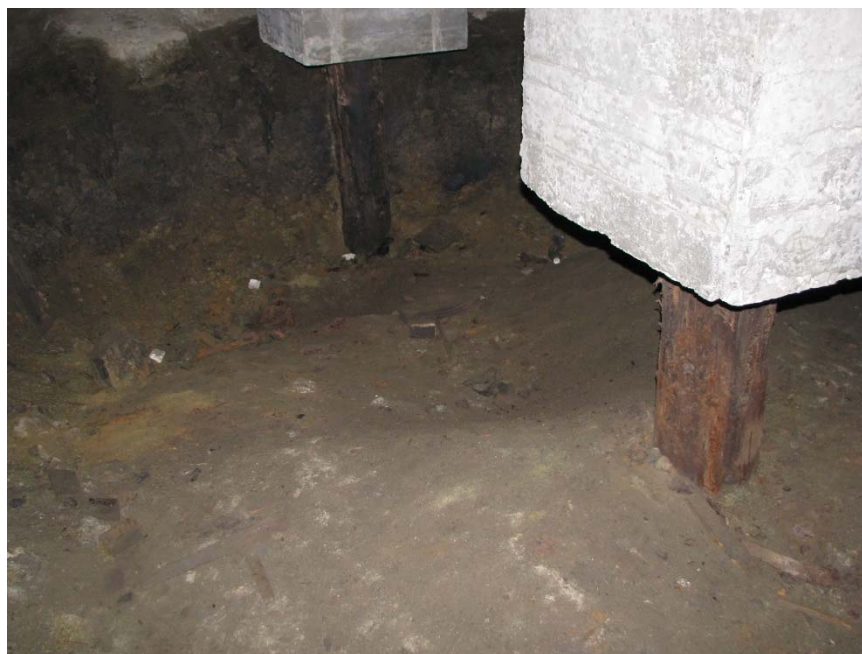
Figure 9 Piles at 19 B and C, Surface damage due to borers, erosion, or both. Soil is

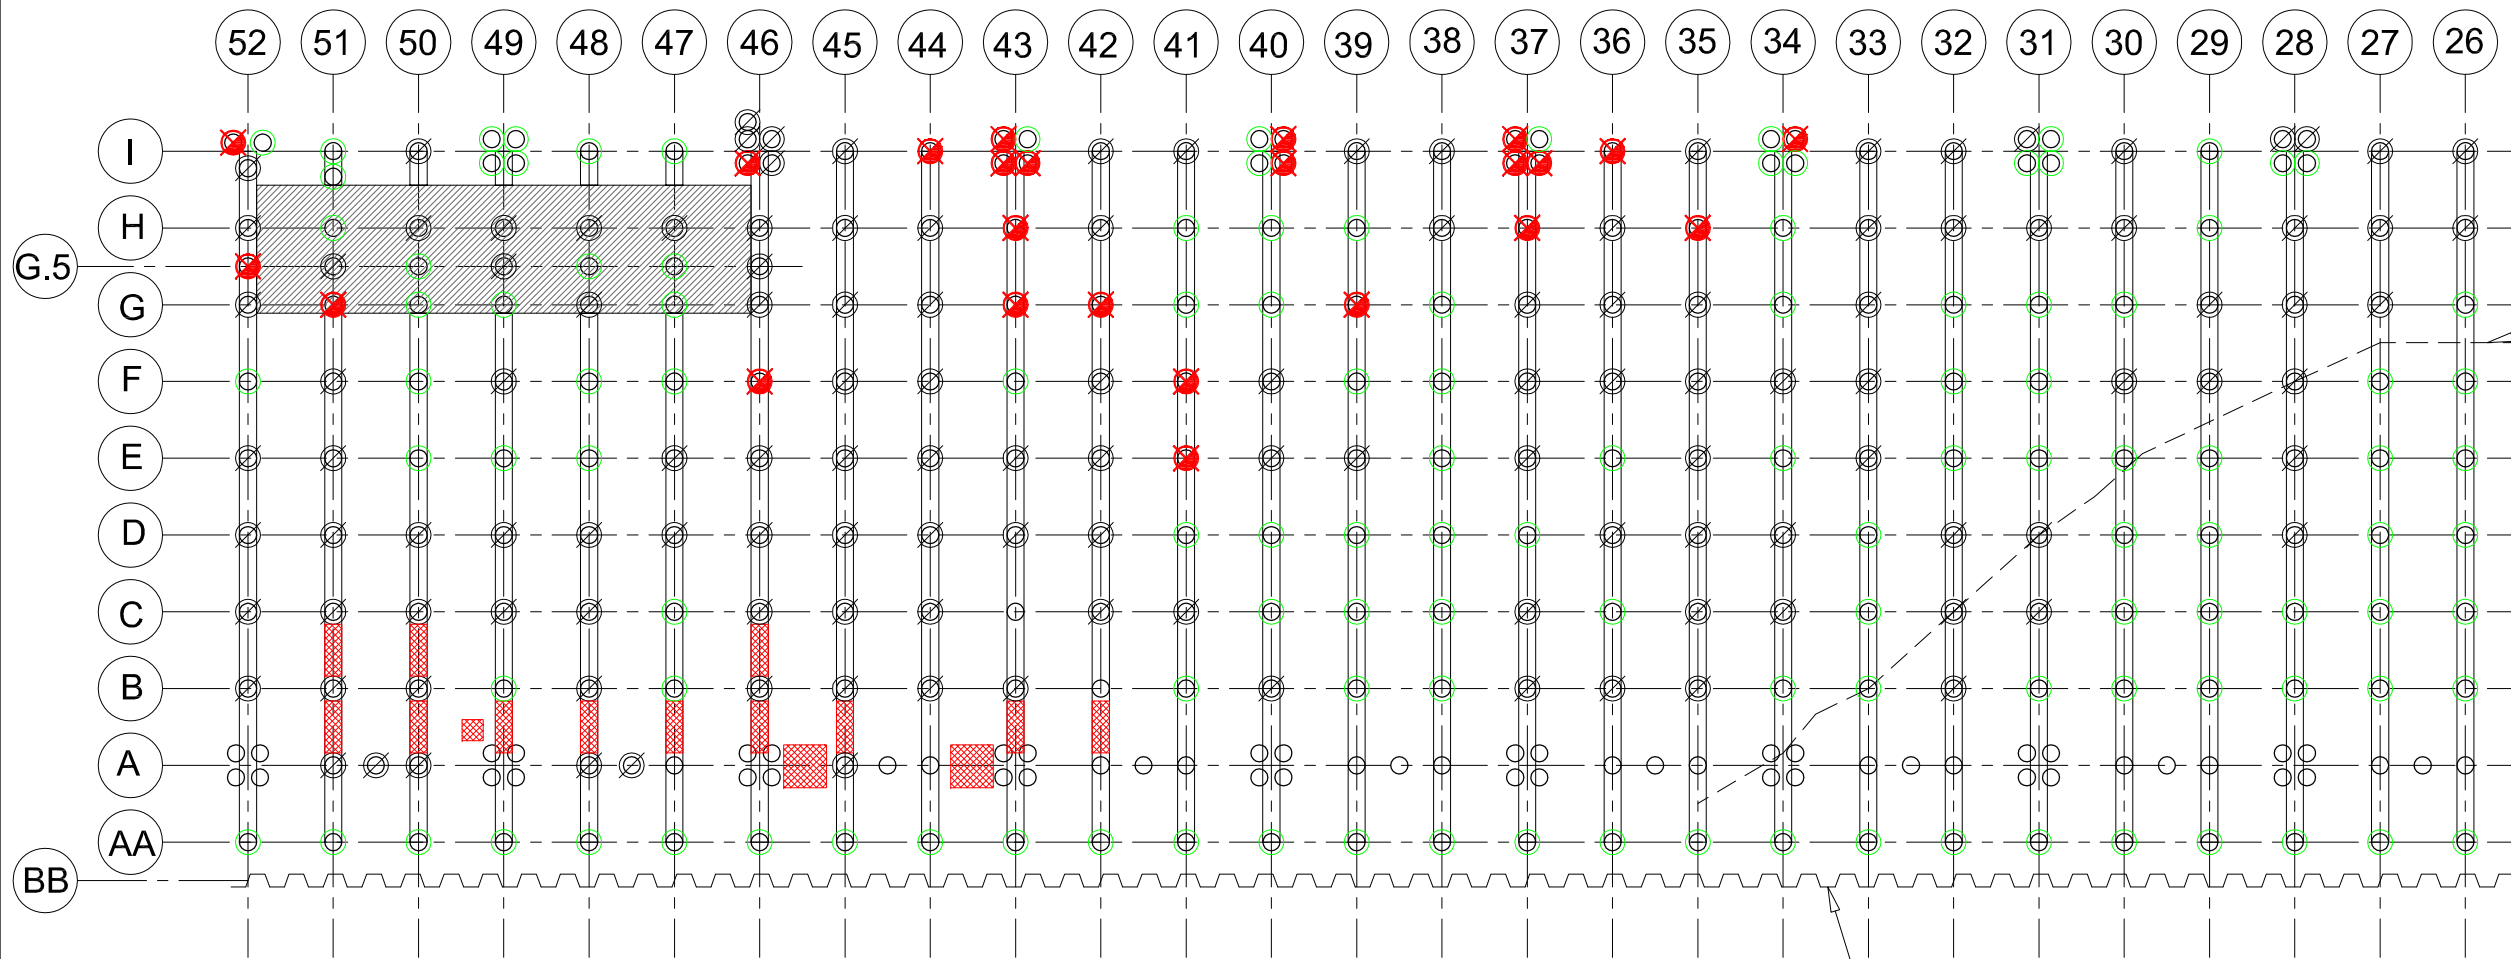
APPROXIMATE SHORE LINE AT +5.5 FT MLLW

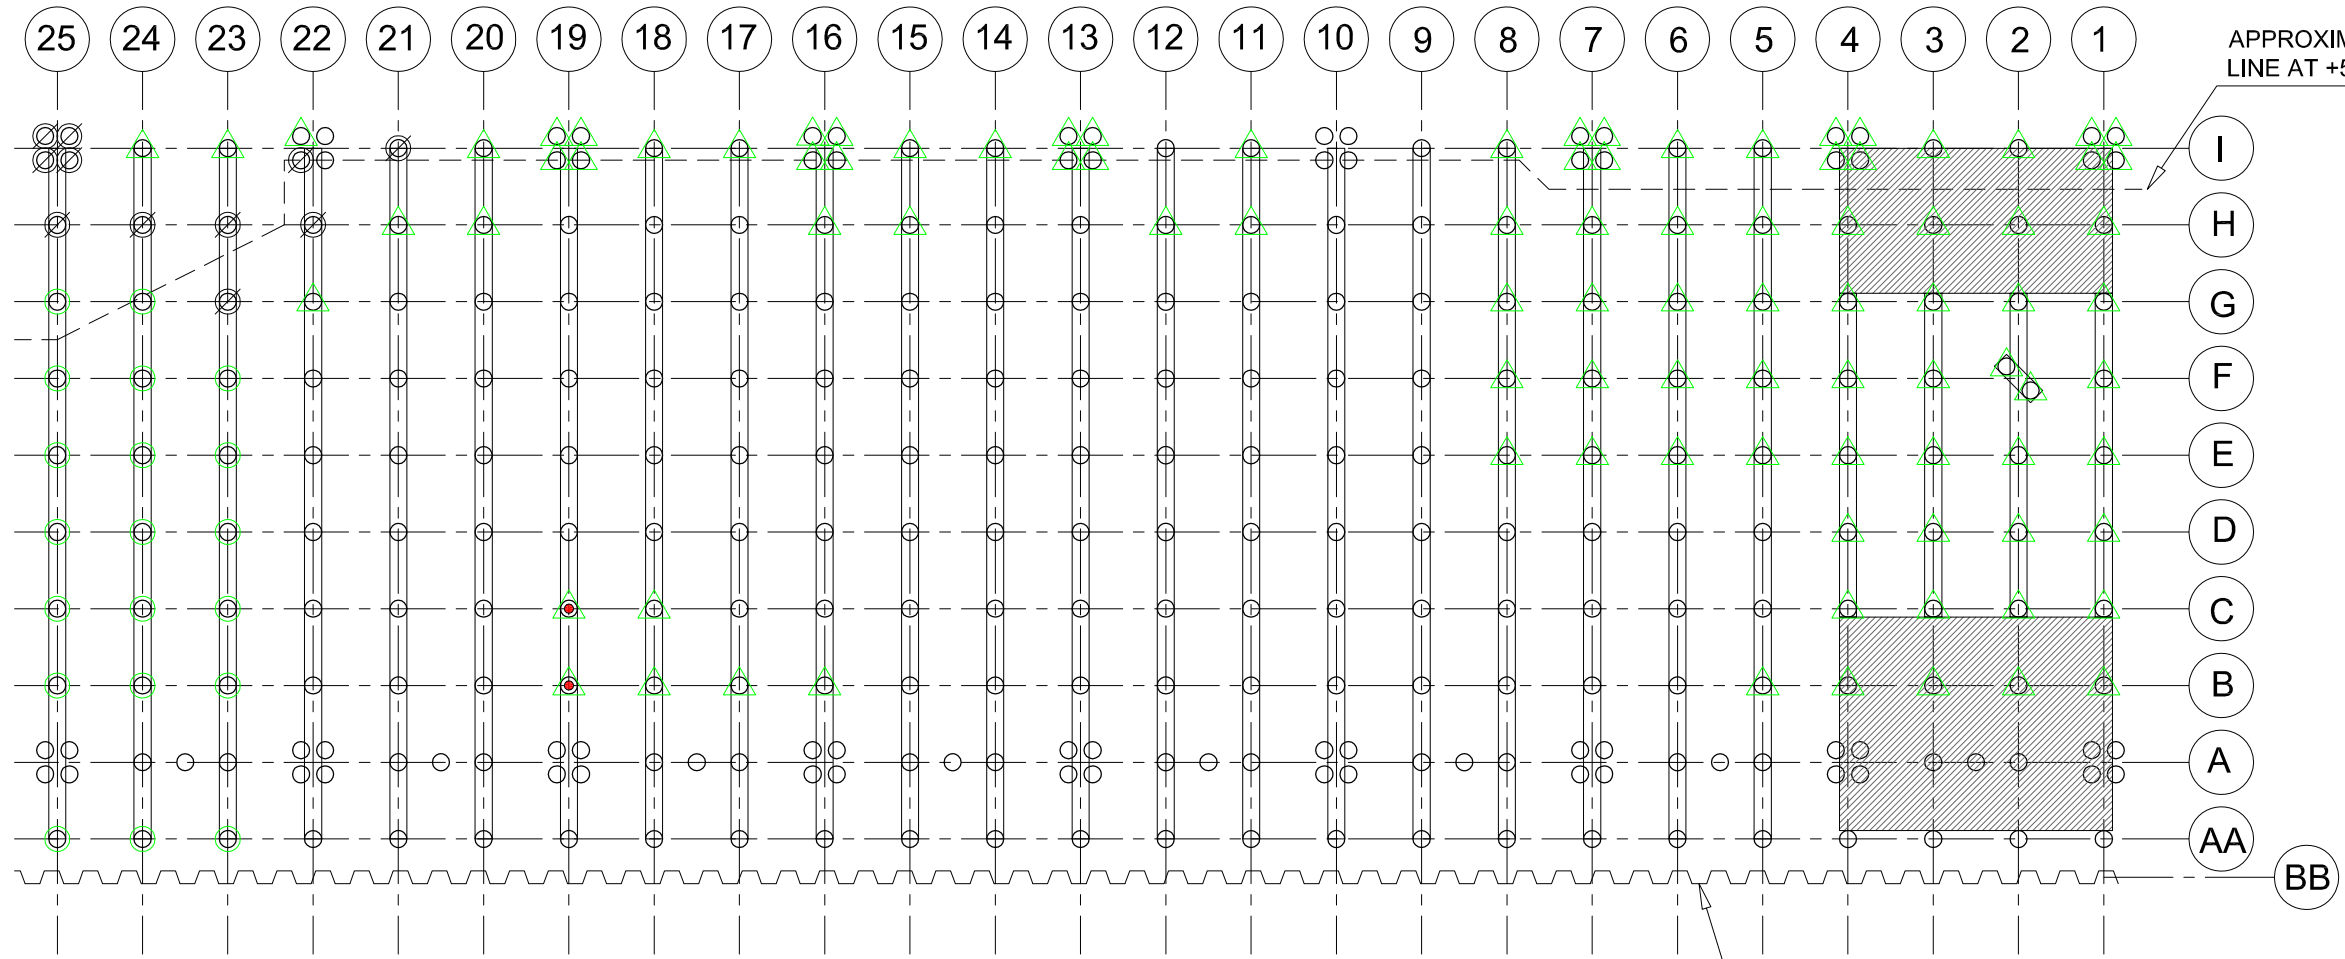
- LEGEND:**
- AREA WITH LOWERED SOFFIT
 - SPALLED CONCRETE CAP OR SOFFIT
 - EXPOSED TIMBER PILE WITHOUT CONCRETE SLEEVE
 - CRACKED OR BROKEN CONCRETE SLEEVE
 - MISSING PILE
 - PILE WITH CONCRETE SLEEVE
 - TIMBER PILE W/ LOSS OF SECTION
 - TIMBER PILE

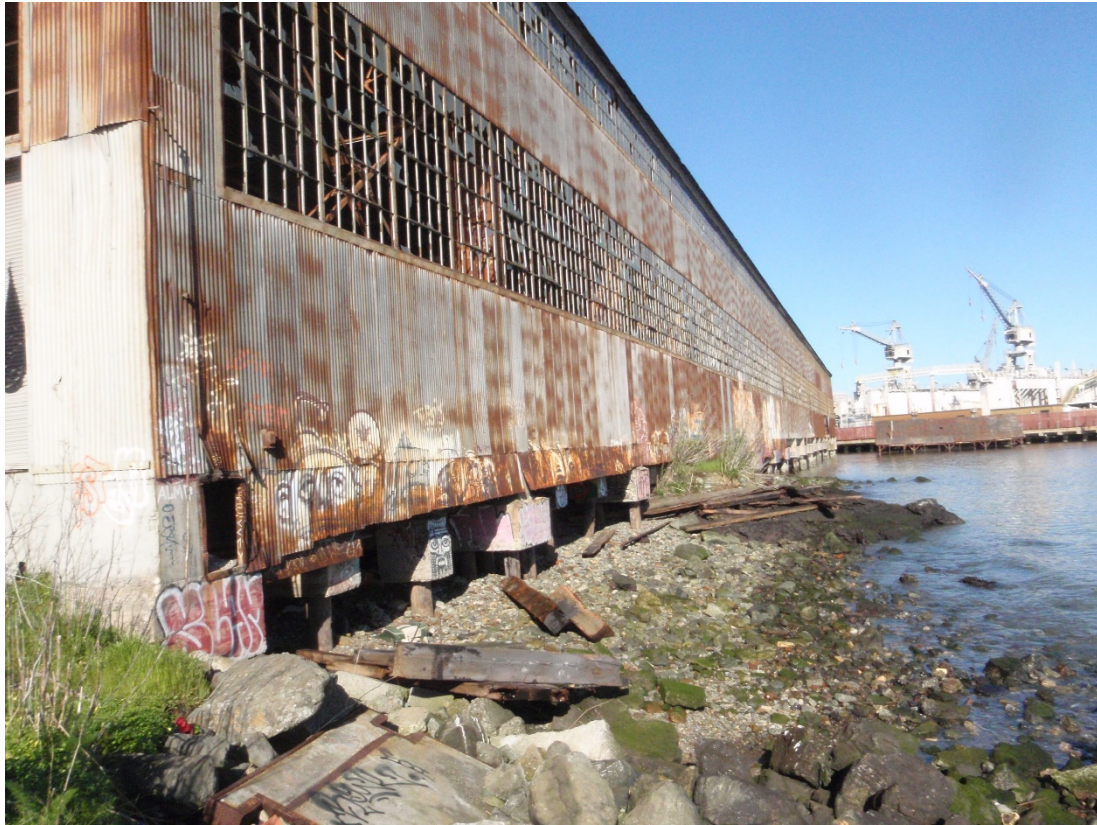
Subsurface Conditions. Our understanding of the subsurface conditions is based on a review of the preliminary geotechnical investigation report for Pier 70 (Treadwell & Rollo, 2012) and geologic maps (CDMG, 1969; Schlocker, 1974; USGS, 2000), and by a site reconnaissance performed on February 27, 2017. No additional subsurface investigation was performed for this limited geotechnical assessment. Based on this review, the site is underlain by artificial fill and young bay mud which overlies Franciscan Complex bedrock.

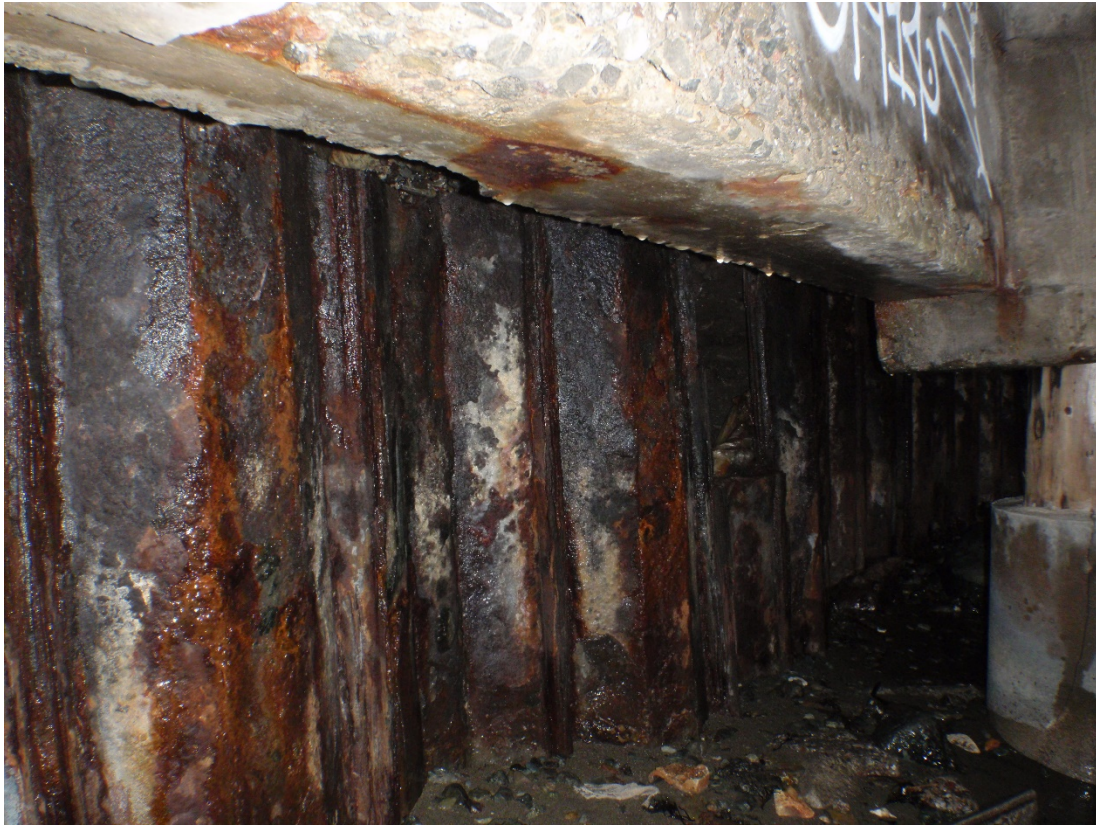
Limitations. The findings, discussion and conclusions presented herein are professional opinions based on geotechnical and geologic data and the project as described. The conclusions are based on limited geotechnical subsurface information. Additional geotechnical exploration should be performed during design of improvements to better assess liquefaction and lateral spread potential and geotechnical parameters for foundation design.
