BUILDING 58 – Power Substation No. 4

ARCHITECTURAL DESCRIPTION*PHYSICAL DESCRIPTION*

BUILDING 68 – Power Substation No. 7

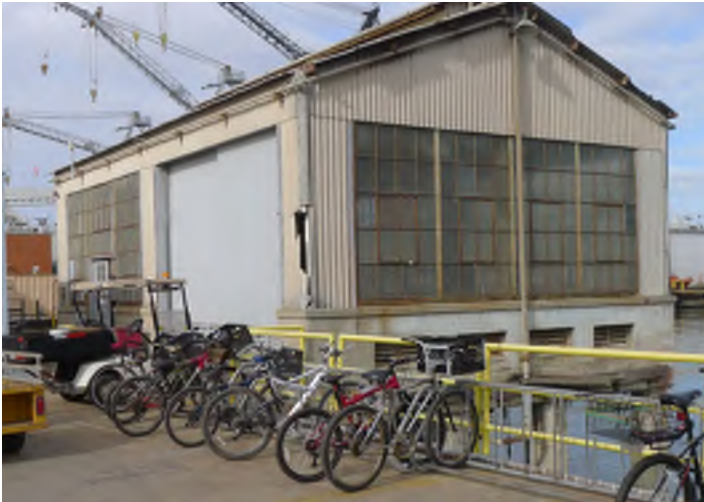
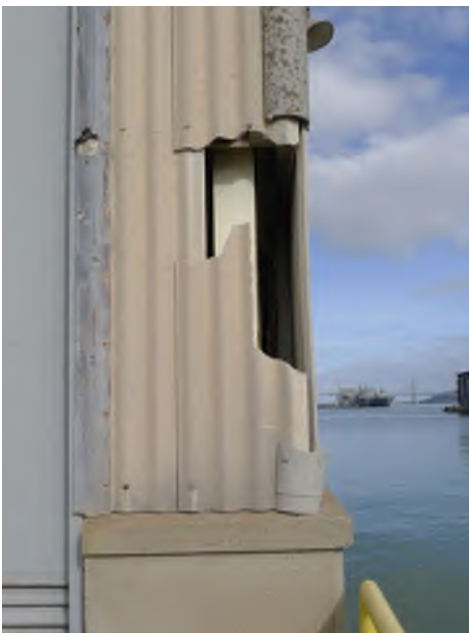
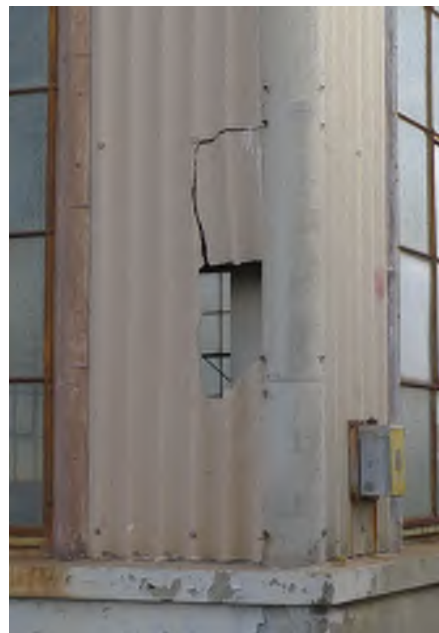
Corrugated transite panels (CTP) above concrete stem walls. Condition: Fair-Poor (figures 2 - 4)

Most of the CTP is sound; however, the southeast and southwest corners of the CTP cladding are shattered, opening the building to rain, and vermin. In addition, the leading edges of the overhanging panels at the gable ends and eaves are damaged (figures 2 – 4).

Figure 3 – Southeast corner, CTP damage

Figure 4 – Southwest corner, CTP damage

- Repair southeast and southwest corner CTP .
 1. Replace shattered and missing corner panels with galvanized corrugated metal panels. Note that CTP is considered a hazardous material.
 2. Install sealant at all conduit and pipe penetrations. Scrape, prime and paint rusted conduit or pipe.

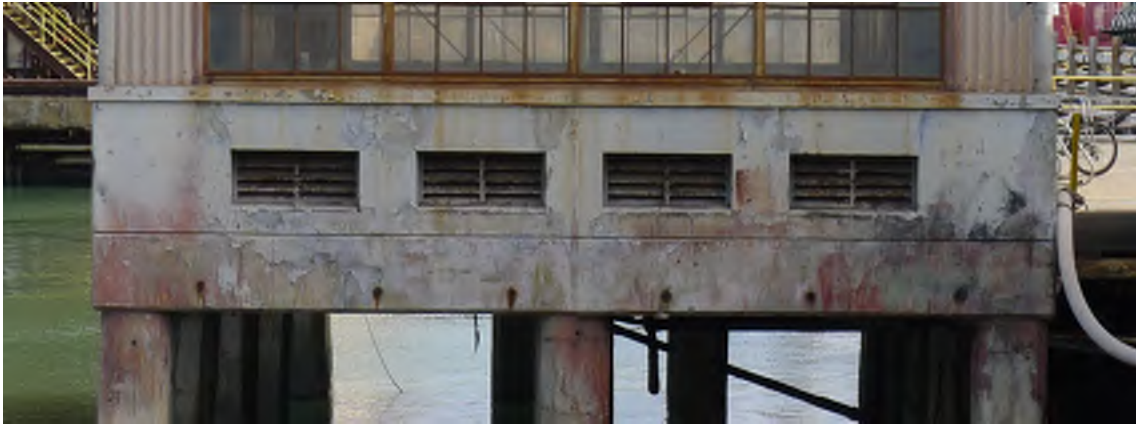
Concrete stem wall. Condition: Good (figure 5)

The concrete stem wall has very few spalls and is fundamentally sound.

Figure 5 – Concrete stem wall showing penetrations with ventilation louvers

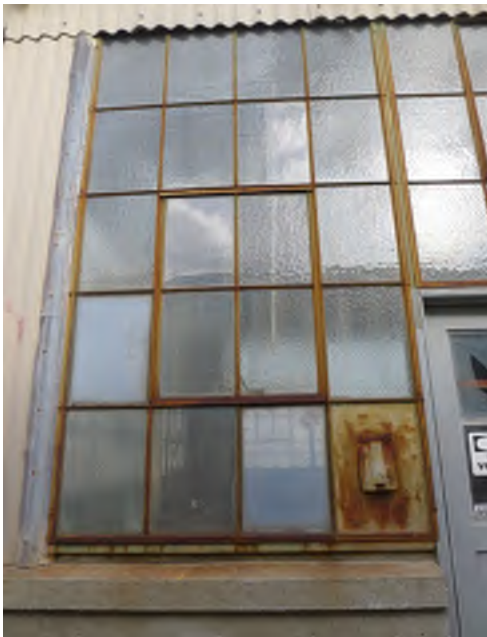
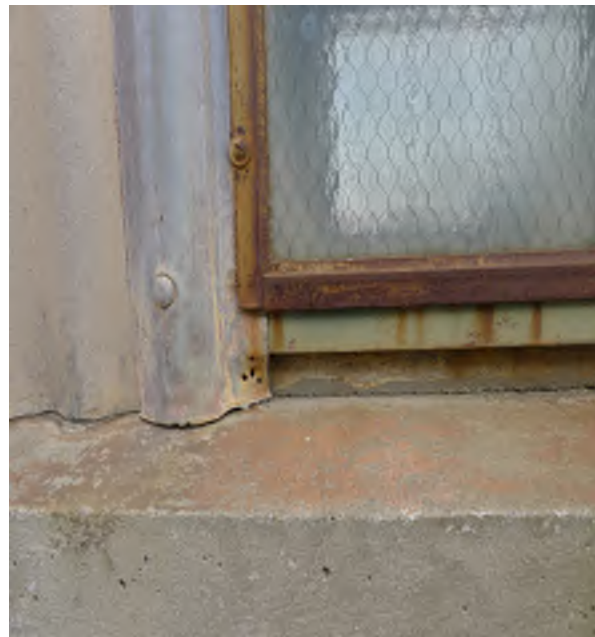
Steel sash windows. Condition: Fair (figures 6 and 7)

Steel sash multi-lite, fixed in frame with operable portions typical. Frame, mullions, and muntins are in fair condition. Window damage and broken/cracked panes have been dealt with by gluing sheet plastic panels at cracked or broken lites. Approximately Twenty three (23) 14”x20” panes are open and need to be replaced.

- Replace ten (10) 14"x20" window panes
- Repaint 100% of steel sash window components: frame, mullion and muntins.
 1. Remove all dirt and deteriorated glazing putty.
 2. Wire brush steel elements to remove rust.
 3. Install new glazing putty.
 4. Install new glazing where required to match existing original glazing.
 5. Prepare steel surfaces, prime with rust inhibitive primer and paint with two top coats.
 6. Seal all joints where sash meets adjacent elements
 7. Install plywood impact protection on south elevation

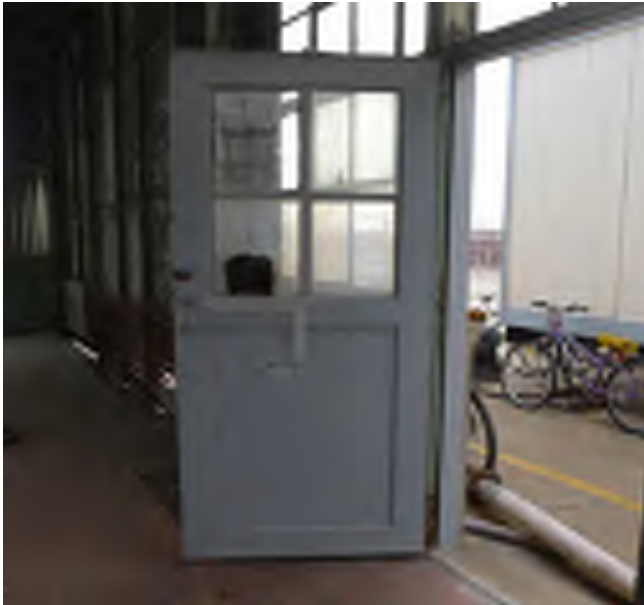
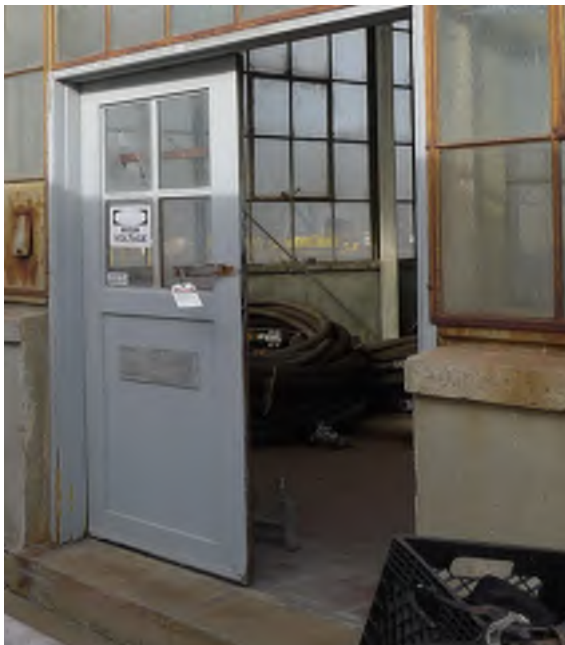
South personnel doors. Condition: Good (figures 8 and 9).

The original exterior door knob and spindle is in place but the interior knob is missing. The doors are currently secured with a hasp and padlock.

- Repair south elevation, metal double personnel doors
 1. Survey existing condition of doors.
 2. Replace missing hardware and components.
 3. Replace broken glass pane.
 4. Prepare surfaces, prime and paint with two top coats.
- Repair south elevation, metal double sliding door and frame.
 1. Survey existing condition and operation of doors.
 2. Replace missing hardware and components.
 3. Prepare surfaces, prime and paint with two top coats.

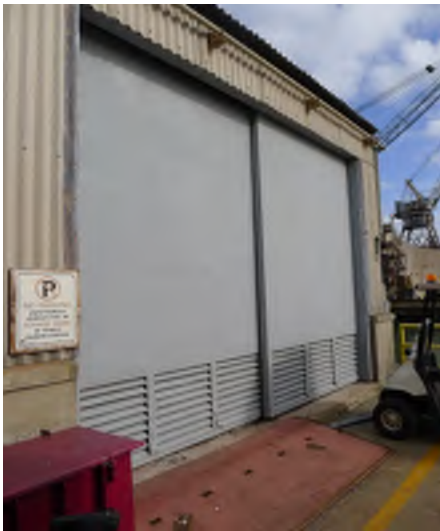
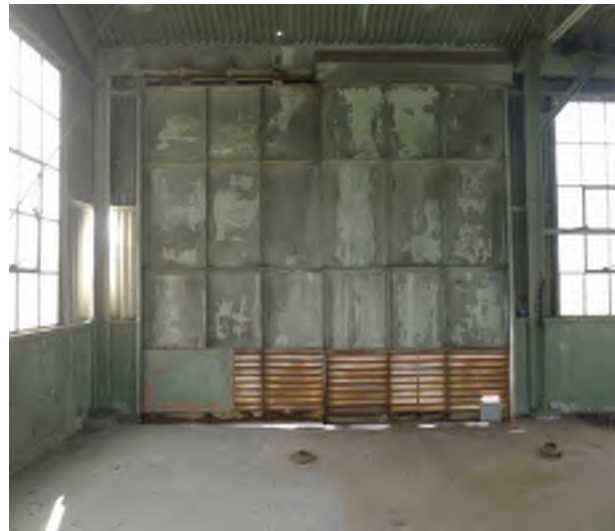
Double steel sliding doors. Condition: Good

The doors are stiff but operable (figures 11 and 12)

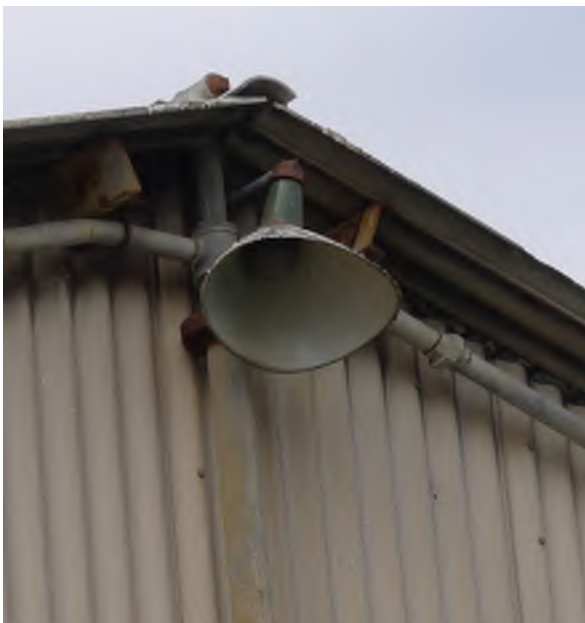
Metal lamp. Condition: rusted (figure 12)

Figure 12 - Lamp at ridge, east elevation

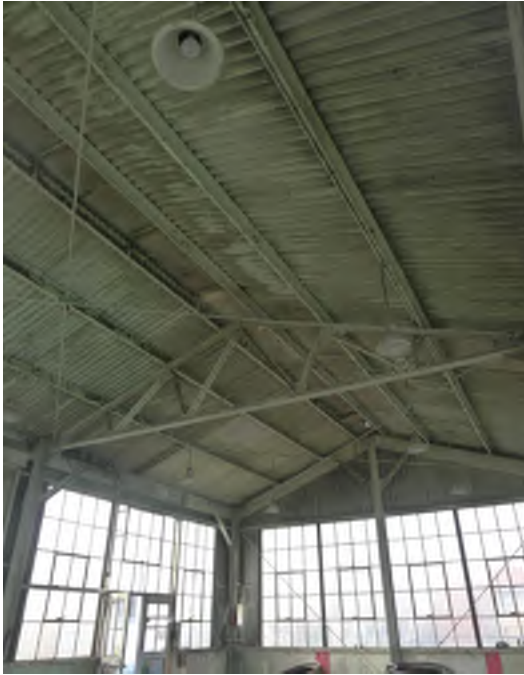
CTP. Condition: Good-fair (figure 13)

- No recommendation. Structural engineering report recommends 100% replacement.

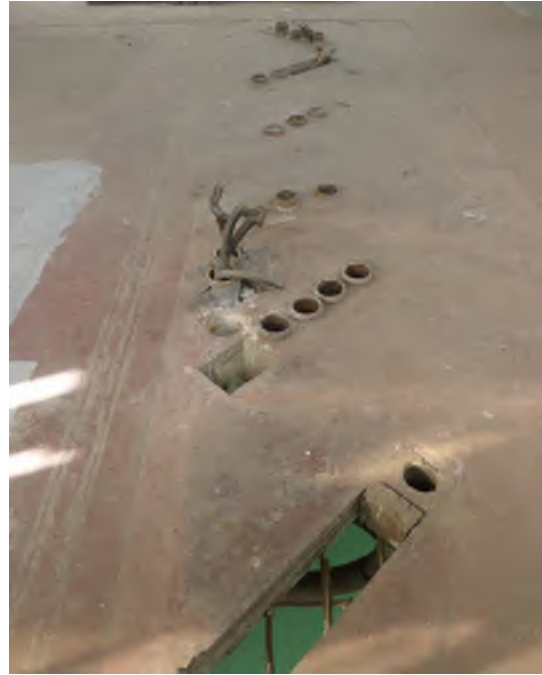
Figure. 14 - Interior view floor with penetrations

Tile and concrete. Condition: Good to Fair (figure 14)

- Close floor penetrations.
 1. Use plywood as a temporary cover or plug holes in the slab with concrete as a permanent repair

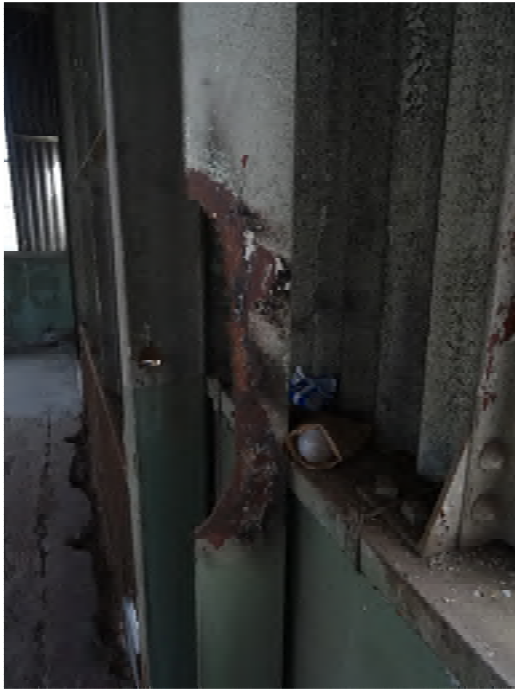
- The corrugated transite panel roof decking, which is a hazardous material, shows significant deterioration.
- The steel framing shows signs of mild to moderate corrosion.
- There were cut holes present in the suspended slab that has several exposed reinforcing bars to the elements.
- One column on the south side of the building was severely damaged.

Figure 1 – Building 58 column damage

- The column on the south side is recommended to be patched with steel plate approximately two feet by eight inches.
- Clean existing rusted steel framing to remove rust and paint, assess its condition, and re-coat with a rust-inhibiting primer and paint. There is a potential for the presence of lead or other hazardous materials in the existing coating.
- Holes in concrete slab should be patched. Approximately twelve holes were observed consisting of various sizes.
- Replace 100% of CTP roof deck with CMP to match appearance of existing roof.

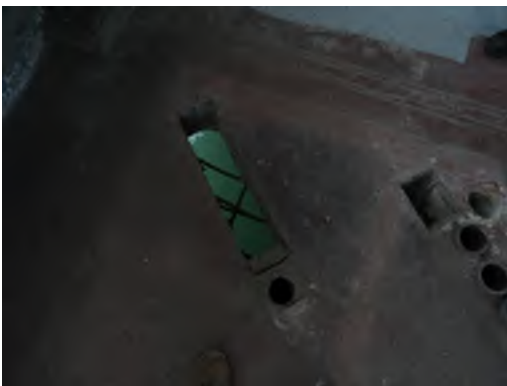
Figure 2 – Building 58 cut holes in slab

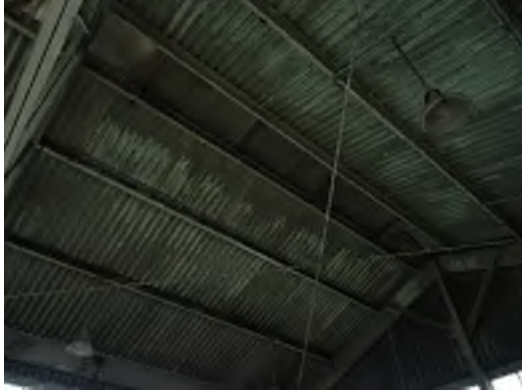
Figure 3 – Building 58 CMP degradation

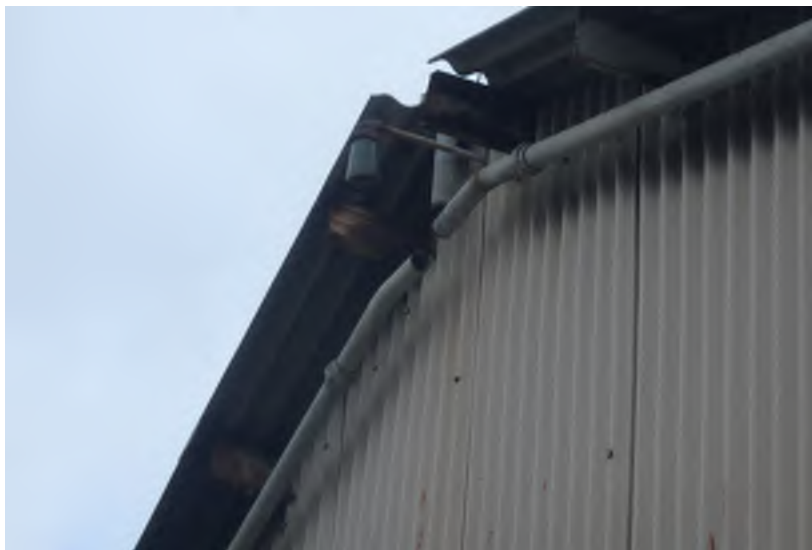
- Building appears to have a fire sprinkler connection, but the pipe is broken at several points (see fig. 58-2) and abandoned.
- No other Plumbing service observed.

Figure 58-2 – Broken Fire Sprinkler Pipe

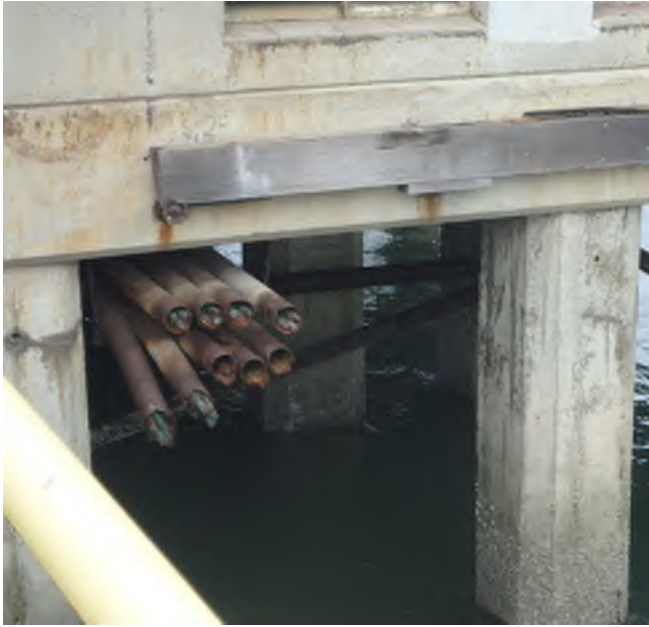
- The transformers and electrical equipment noted on previous reports has been removed and the station is currently used for general storage.
- Outdoor lights are equipped with photo sensors.
- Numerous conduits feeding from the building are disconnected and abandoned (see fig. 58-3).

Figure 58-3 – Abandoned Conduit beneath Building

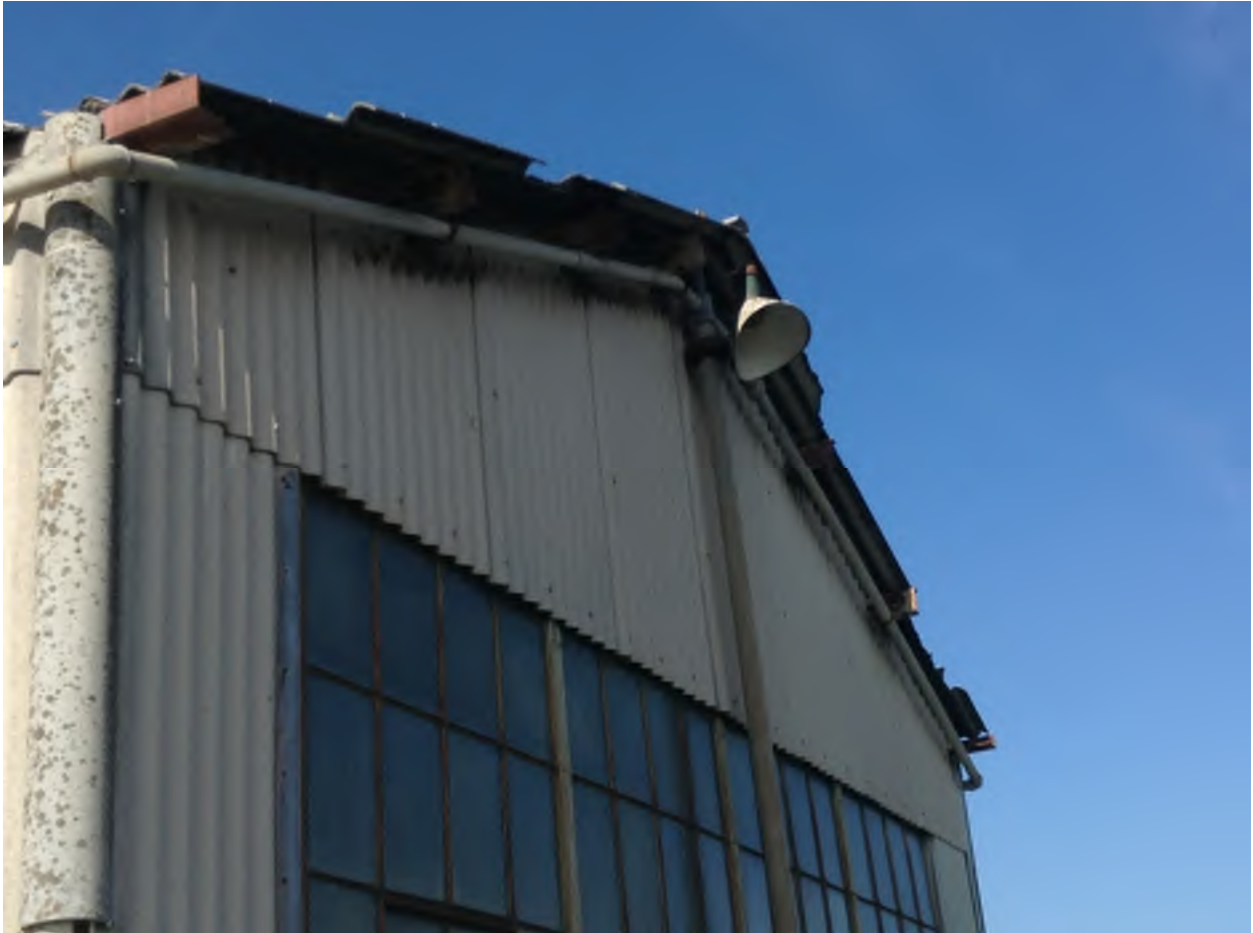
Fig. 1 - Building 58 view from ground at S. E. corner

GENERAL NOTES: When viewing this building from the ground, this building appears to have damaged corrugated sheathing at the eaves and possibly throughout the entire roof.

- Install temporary roofing patch at all holes, penetrations.

- Replace the entire corrugated roof with a new roof.

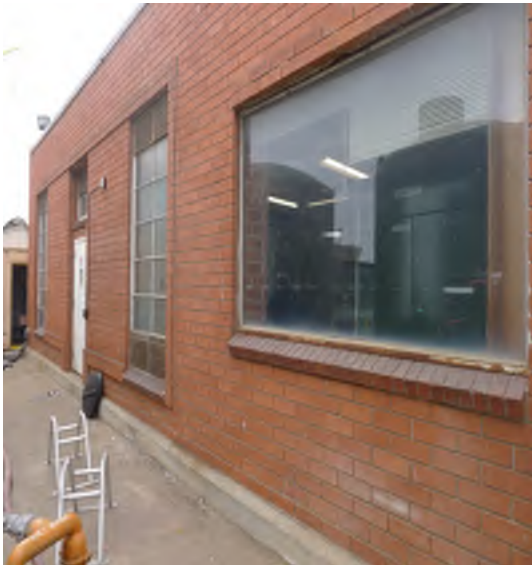
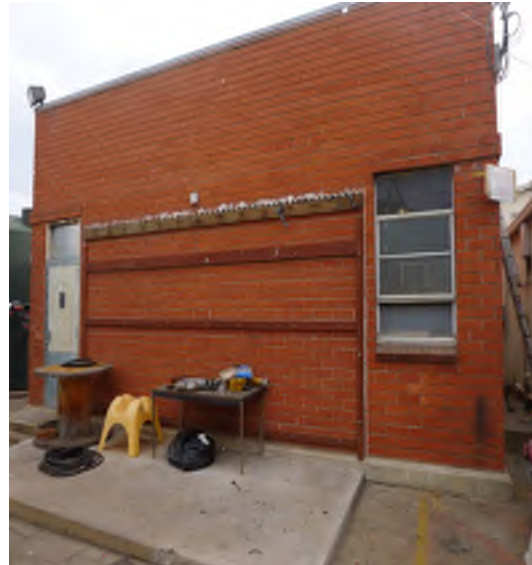
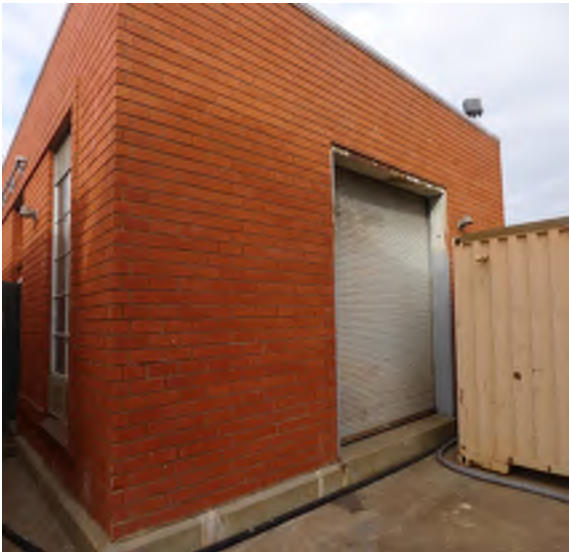
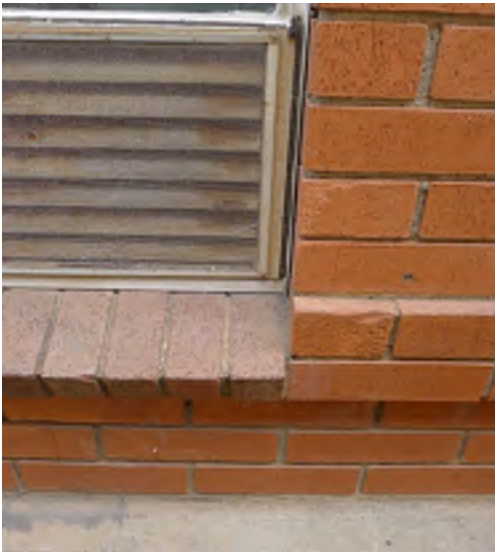
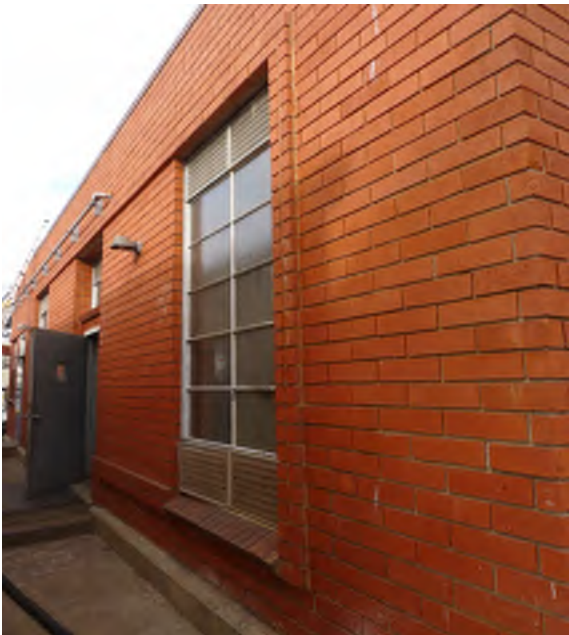
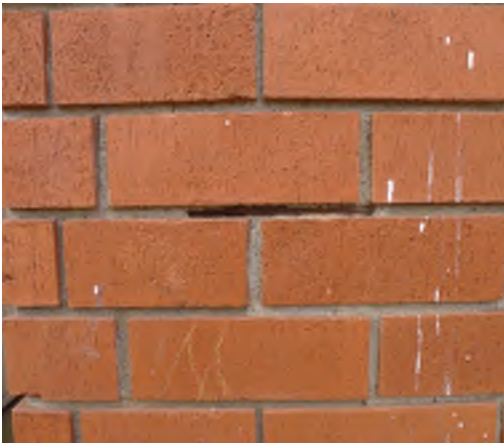
Brick. Condition: Good (figures 2 - 7)

The brick and mortar joints are generally sound with only a few locations requiring repointing.

Figure 7 - Masonry joint with exposed rebar

- Repair Masonry joints.
 1. Conduct a survey of the masonry joints for mortar failure
 2. Paint exposed reinforcing rod with rust inhibitive paint.
 3. Re-point approximately 50 linear feet of the masonry joints where rebar is exposed and mortar is missing with matching mortar.
 4. Install sealant at all conduit and pipe penetrations. Scrape, prime and paint rusted conduit or pipe.

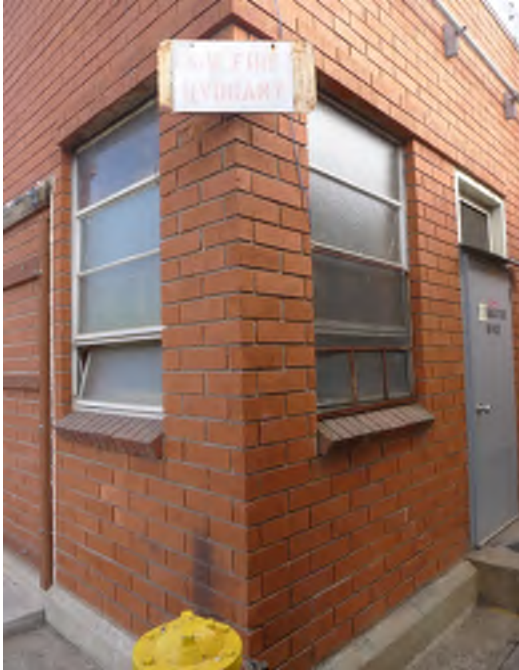
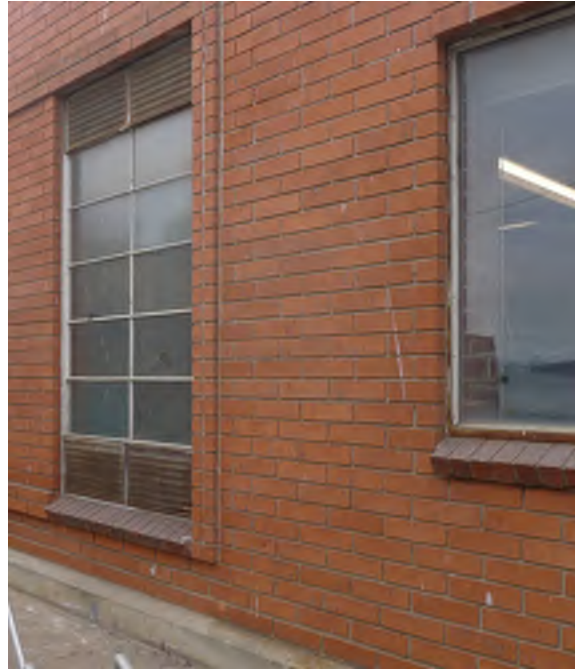
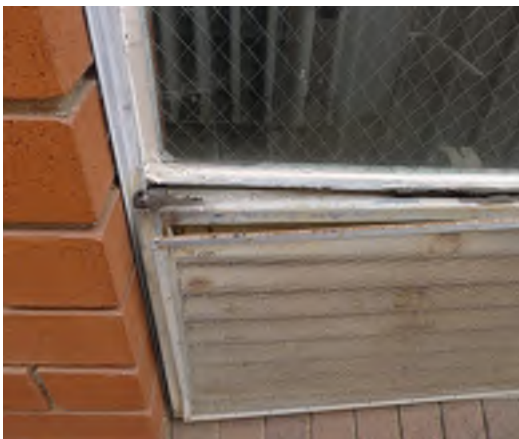
Steel and aluminum sash windows. Condition: Good-Fair (figures 8 - 10)

Steel sash and aluminum sash multi-lite, fixed in frame with operable portions and integral ventilation louvers are typical. Mottled obscure wire glazing is typical. There is one large clear, fixed plate glass window on the west elevation. There is only one cracked pane, and all other glazing is sound. There are open joints at the perimeter of the window and several louvers need to be reset into the sash.

Figure 10 - damaged louver

- Replace 1 window pane
- Repaint 100% of steel and aluminum sash window components: frame, mullion and muntins.
 1. Remove all dirt and deteriorated glazing putty.
 2. Wire brush metal elements to remove rust or corrosion.
 3. Install new glazing putty.
 4. Install new glazing where required to match existing original glazing.
 5. Prepare metal surfaces, prime with rust inhibitive primer and paint with two top coats.
 6. Apply sealant at metal frame to brick joints

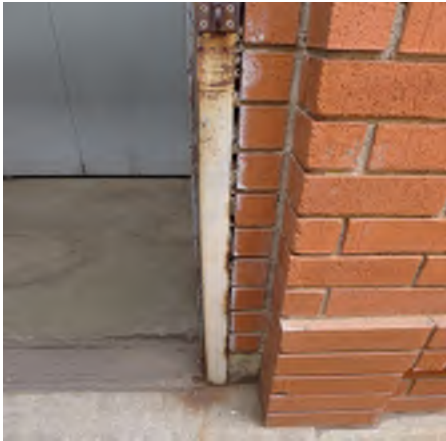
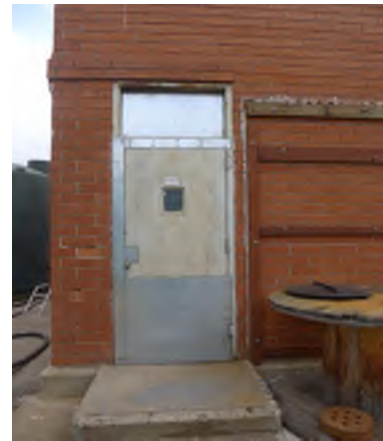
Personnel doors. Condition: Fair (figure 11 and 12)

There are three 3'x7' steel personnel doors in the building – one each on the north, west and south elevations. The door on the west elevation has intentionally been closed and sealed. The hardware on the operating doors is deficient. In general, the joints between the steel frame and brick are open. The doors and frames are lightly rusted.

Figure 11 - Sealant failure in door frames

Figure 12 - sealed personnel door

- Repair and rehabilitate doors
 1. Survey existing condition of all doors
 2. Replace missing hardware and components.
 3. Repaint all metal doors and frames. Prepare surfaces, prime and paint with two top coats.
 4. Apply sealant at metal frame to brick joints.

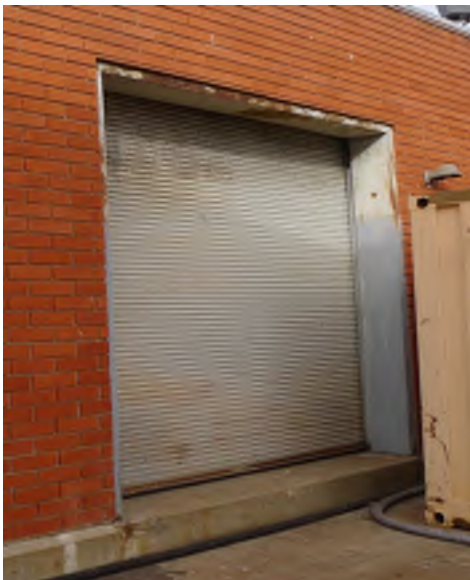
Roll-up door. Condition: Good (figure 13)

The roll-up door is on the north side of the west elevation and is in sound condition. The steel channel frame is moderately rusted. The door exterior is lightly rusted.

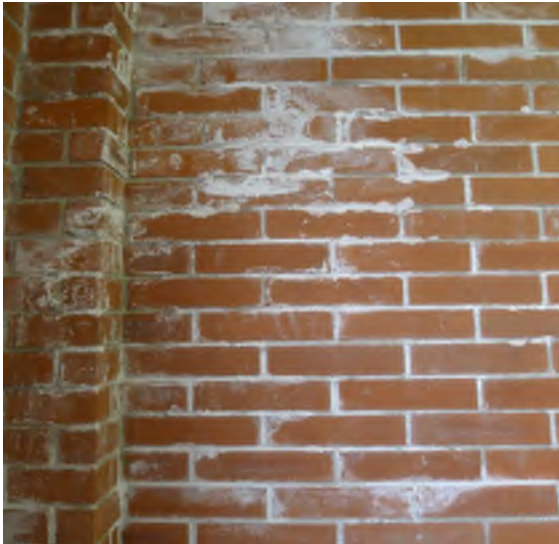
Brick. Condition: Good-Fair (figure 16)

There is substantial efflorescence on all interior walls suggesting water intrusion from the back side of the parapet.

Figure. 16 - Interior efflorescence on brick

- Brick.
 1. Identify and repair the sources of water intrusion on the roof.
 2. Clean wall of efflorescence by brushing.

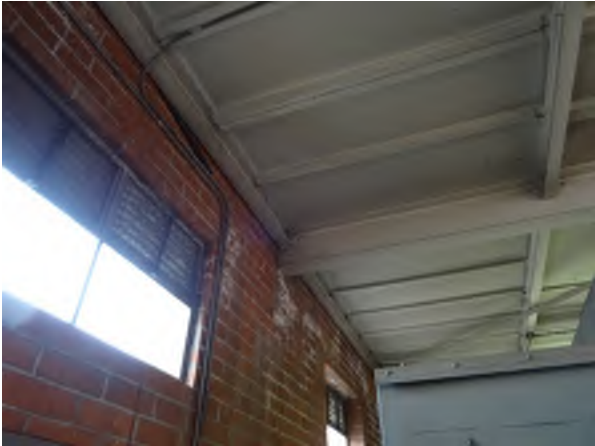
- Some minor cracks in the precast concrete panel were observed
- An interior partition wall has been removed, exposing some reinforcing bars in the wall.

Figure 1 – Concrete precast panels with minor cracking

- Monitor the cracks in the concrete roof panels for further damage.

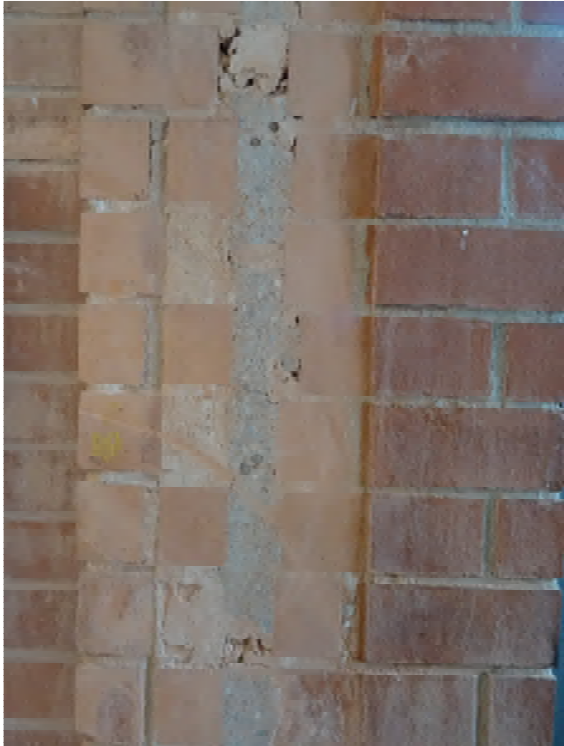
Figure 2 – Cut masonry partition wall with exposed rebar

- Paint the exposed wall rebar with rust inhibiting paint.

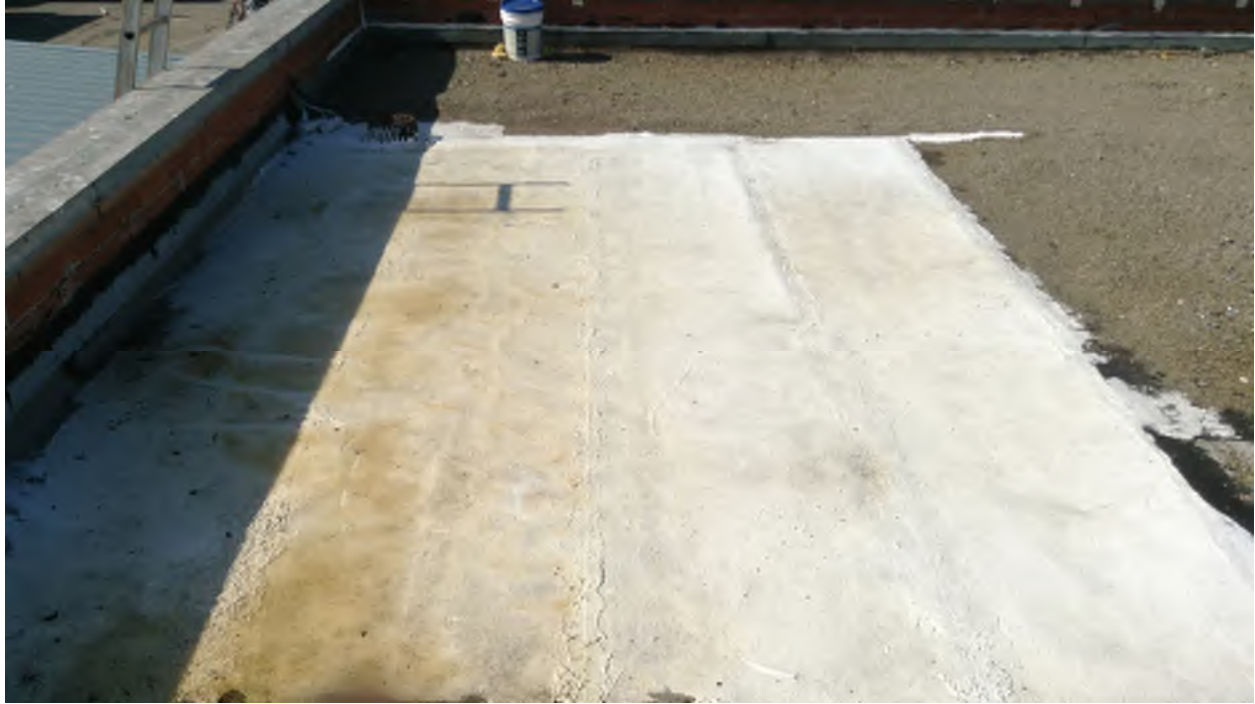
Fig. 1 - Building 68 view from roof top

GENERAL NOTES: This building has a tar and gravel roof with recent patch work. There is heavy ponding directly over a recently patched roof area.

- Re-work the semi patched roof area to prevent or eliminate the potential for ponding.

- Tear off and replace with all new roofing materials.

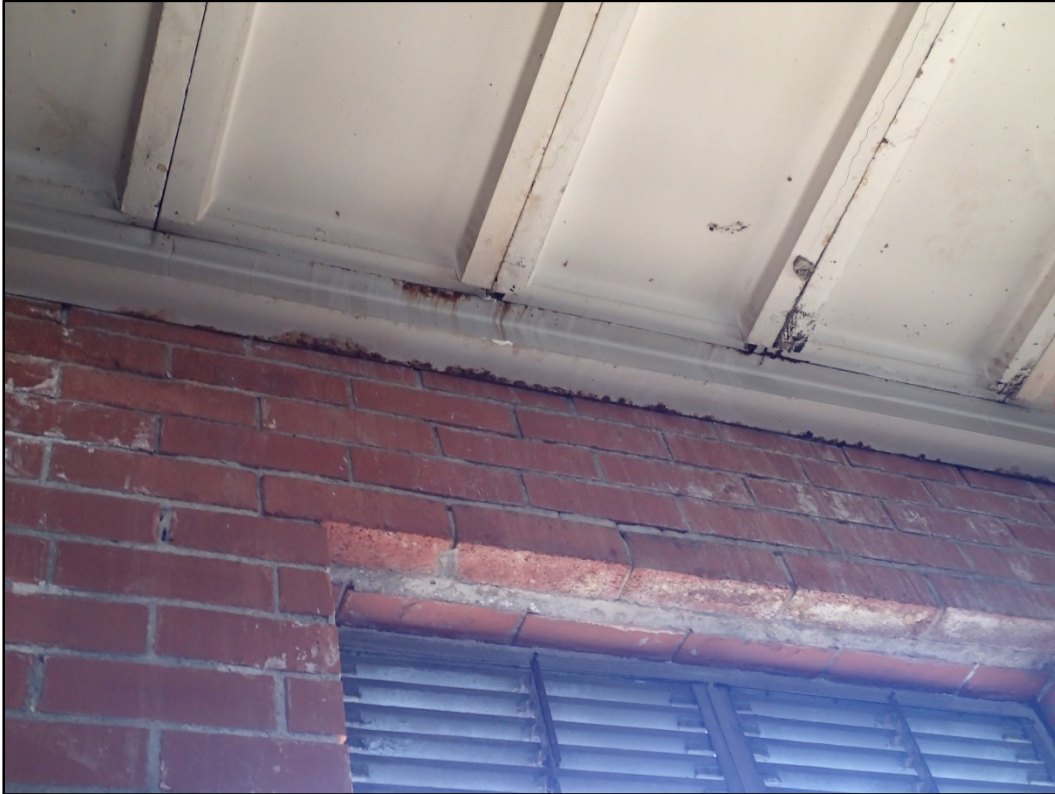
Figure 68-7 – View of localized minor surface corrosion on the ledger along Building 68 south wall.
