BUILDING 103 - Steam Powerhouse No. 2

ARCHITECTURAL DESCRIPTION

CONDITIONS

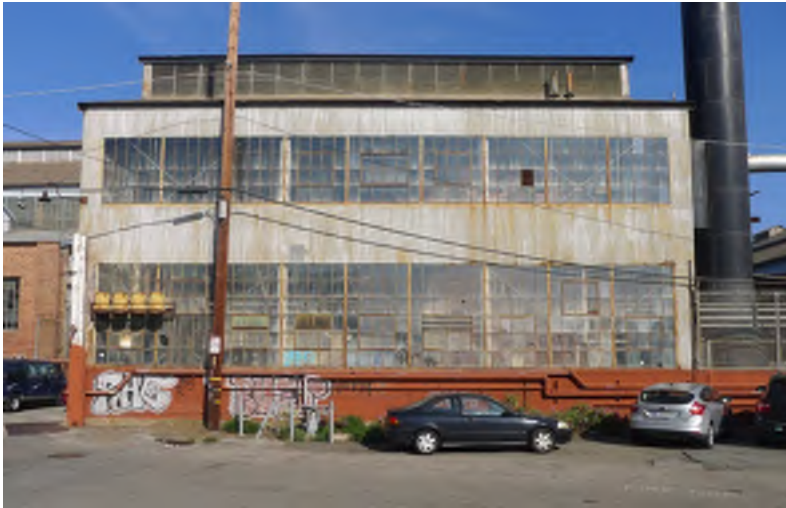
Figure 2 - Building 103: South Elevation

WALLS - CMP (corrugated metal panels) above brick base on concrete curb (figures 2-4).

CMP. Condition: Fair

Mild rust observed throughout the CMP, heaviest at the eaves and where the panels meet the brick base. The panels exhibit multiple penetrations where I-beams, metal conduit, pipes and other appurtenances exit the building.

- Repair 10% CMP panels.
 1. Replace dented and damaged components in kind to match original.
 2. Install sealant at all conduit and pipe penetrations. Scrape, prime and paint rusted conduit or pipe.

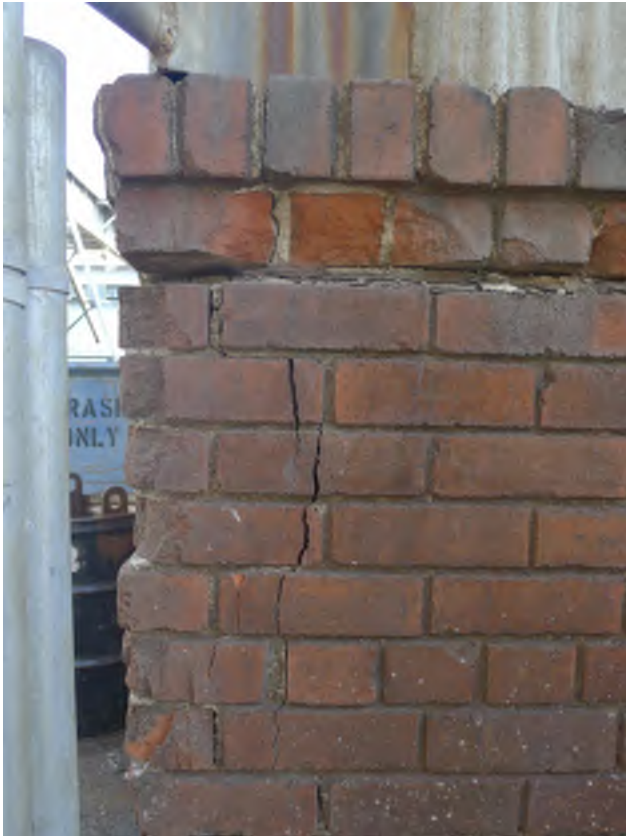
Brick on concrete curb. Condition: Poor (figures 5 and 6)

Cracked and broken brick were observed on all wall areas. Horizontal steel reinforcing is rusted and expanding forcing mortar out of the joints and contributing to brick cracking, spalling and displacement. Diagonal cracks were observed at the north doorway and at the NE, NW and SW corners.

Figure 5 - Building. 103: Brick crack at NW corner.

- Perform two (1sf) exploratory probes at locations of rusting steel in the brick wall. **Probes and repair/reconstruction work shall be specified and monitored by a qualified historical architect. Work shall be performed by a qualified historic masonry contractor.**

- Repair option 1 (preferred): Install new brick at locations of spalls and cracks. Approx. 25%.
 1. Survey existing condition of all brick.
 2. Rake out mortar at existing deteriorated joints.

3. Remove flaking rust where accessible.
 4. Paint remaining reinforcing rod with rust inhibitive paint.
 5. Install new face brick to match sound existing brick in size, color, texture and strength. Allow for three rounds of brick and mortar submittals/mock-ups.

6. Repoint brick joints with matching mortar. Match historic joint profile.
 7. Repaint walls at areas of graffiti.
- Repair option 2 (if repair is not possible): Reconstruct entire wall to faithfully reproduce existing as described below.

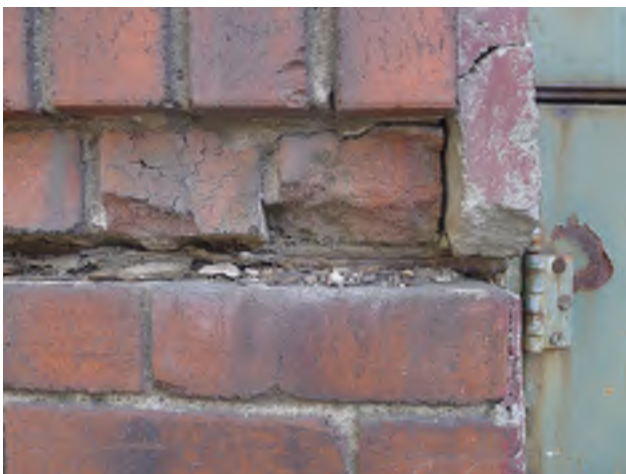
Figure 6 - Building. 103: Brick spall/crack at fire door. Note exposed rebar below header course.

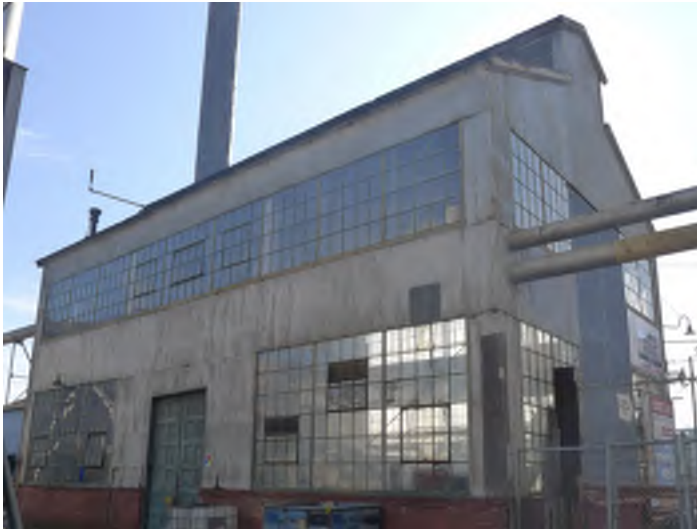
Steel sash windows. Condition: Fair (figures 7 and 8)

Steel sash multi-lite, fixed in frame with operable portions typical. Frame, mullions, and muntins are in fair condition. Window damage and broken/cracked panes have been dealt with by glueing sheet plastic panels at cracked or broken lites. Approximately 10% of the window lites are cracked or broken.

Figure 7 - Building 103: Windows at north & west elevations

- Replace 10% window panes
- Repaint 100% of steel sash window components: frame, mullion and muntins.
 1. Remove all dirt and deteriorated glazing putty.
 2. Wire brush steel elements to remove rust.
 3. Install new glazing putty.
 4. Install new glazing where required to match existing original glazing.
 5. Prepare steel surfaces, prime with rust inhibitive primer and paint with two top coats.

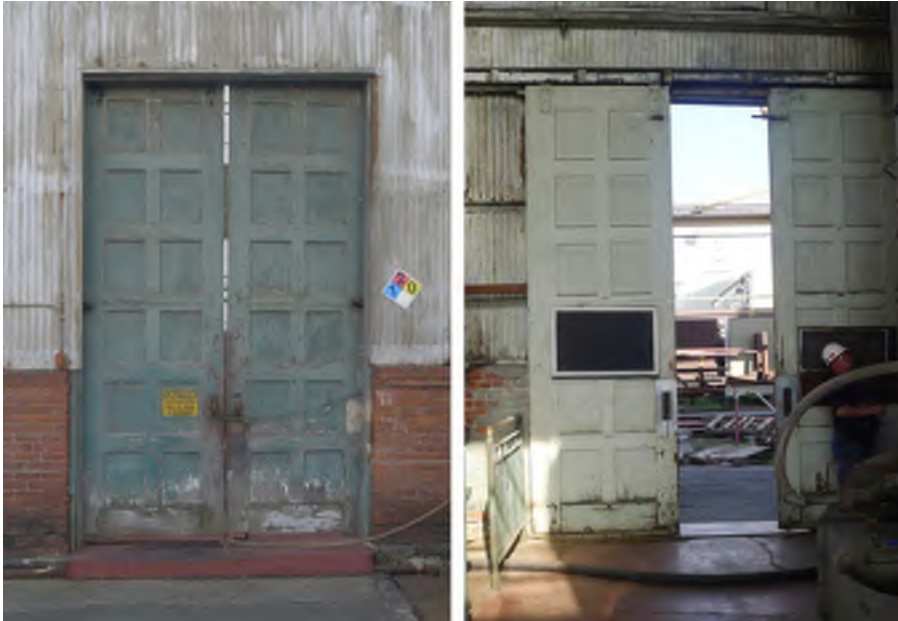
North entry doors. Condition: Fair (figure 9)

One wood 12-panel rolling double door on a metal track. The flat bars attached to both sides of the bottom edge of the door are rusted. One flat bar is missing from the bottom of the door. The paint on the door is in poor condition. The two lowermost panels at each door are in very poor condition. Molding at the panels is missing in some locations.

Figure 9 - Building 103: Rolling door at north elevation

- Repair north elevation wood rolling doors
 1. Survey existing condition of rolling doors.
 2. Replace missing hardware and components.
 3. Prepare surfaces, prime and paint with two top coats.
- Repaint hollow metal fire door and frame.

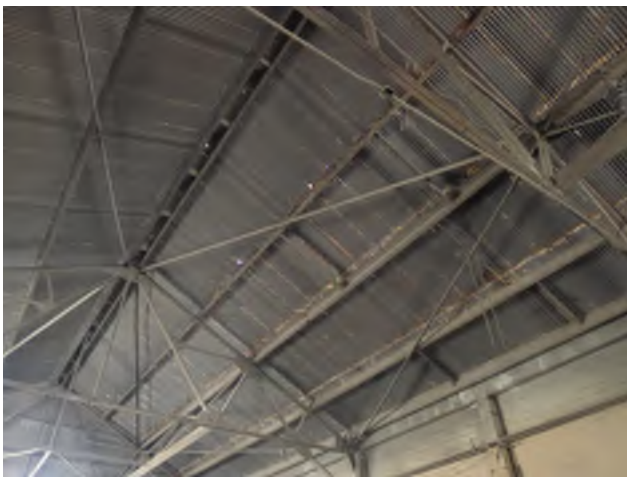
CMP. Condition: Poor (figure 13)

CMP panels are corroded, especially at seams. There are multiple holes throughout ceiling.

Figure 13 - Building 103: View of interior ceiling.

- Repaint CMP ceiling
 1. Prepare steel surfaces, prime with rust inhibitive primer and paint with two top coats.

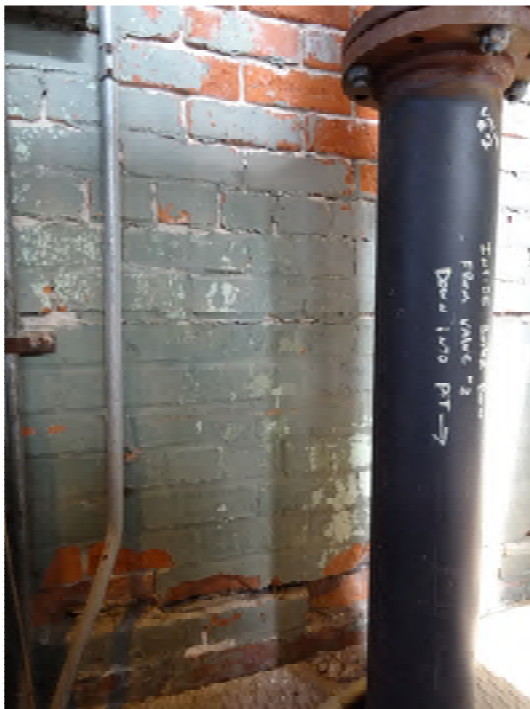
- The smokestack and boilers' structural components appear to be in good condition.
- The trusses and columns appear to be in good condition
- The brick masonry wall is in poor condition. It appears water has infiltrated and resulted in rusting of the embedded steel plate, thus causing the mortar to spall out. Reinforcing is exposed at the exterior and interior in several locations and is exhibiting significant corrosion.
- The suspended ground floor slab has some significant cracking.
- One of the vertical "x" tension rod braces is missing at the south wall.

Figure 1 – Partial height masonry wall damage

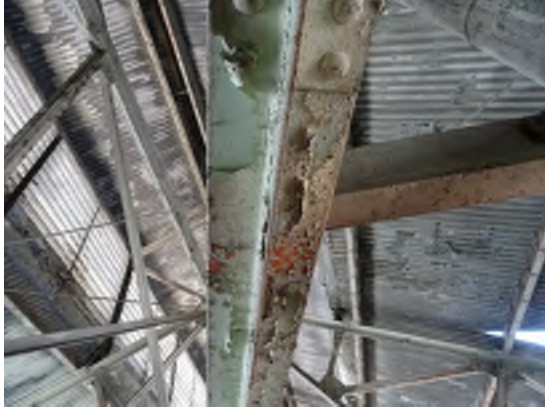
Figure 2 – Typical corrosion on steel framing and CMP

- Clean existing steel framing and corrugated steel roof decking to remove peeling paint, assess its condition, and re-coat. There is a potential for the presence of lead or other hazardous materials in the existing coating.
- Repair the damaged brick wall: remove brick and mortar to access the embedded steel plates, clean the plates of all rust and coat with a rust-inhibiting epoxy, replace the brick and mortar and repoint all joints. Follow the historical preservation guidelines noted in the architectural report.

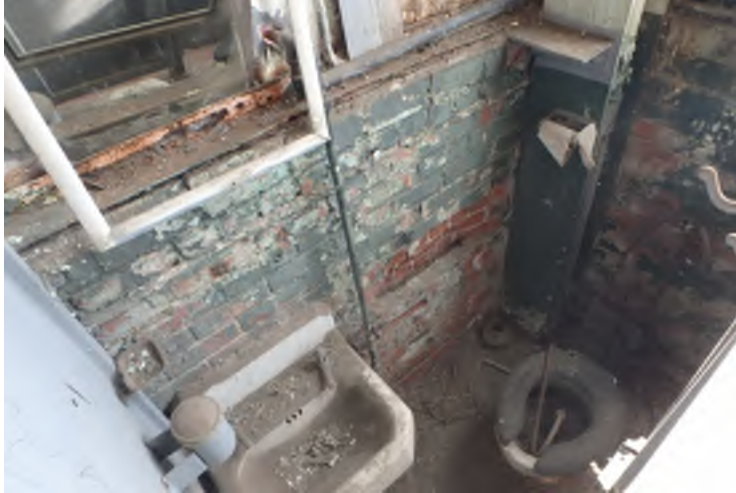
Figure 103-1 – Non-operational Restroom.

- Clean & repair existing restroom plumbing systems for a usable restroom facility.

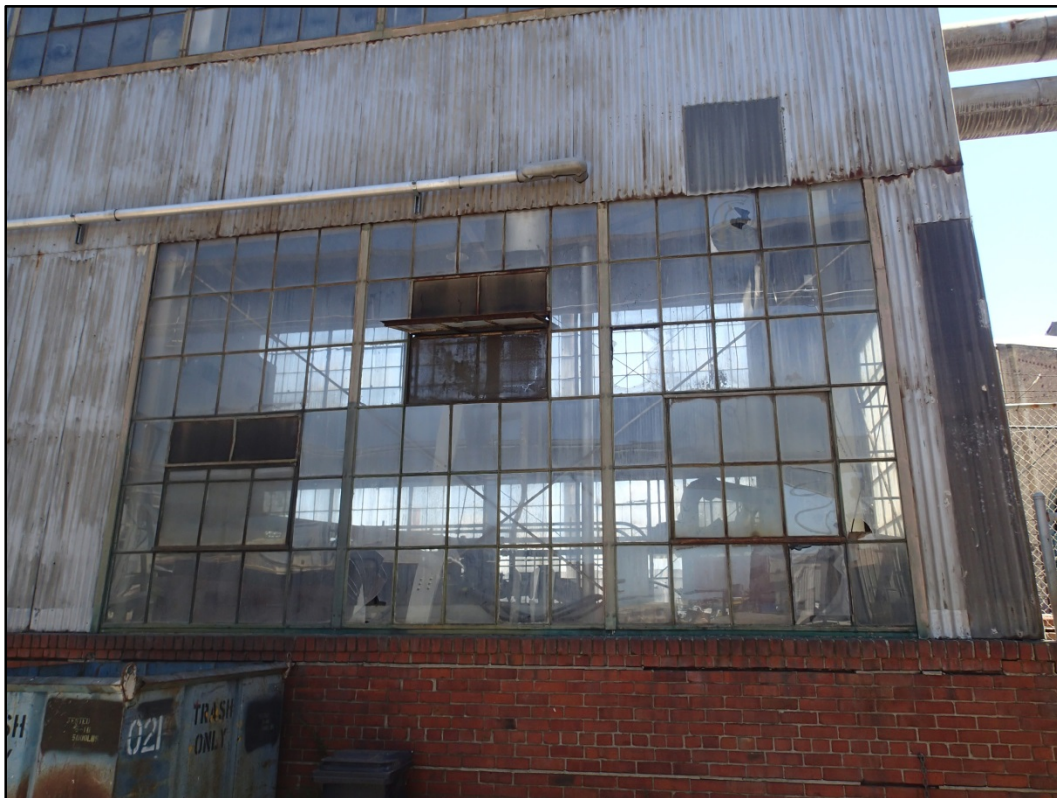
Figure 103-3 - View of Building 103 typical exterior window condition.

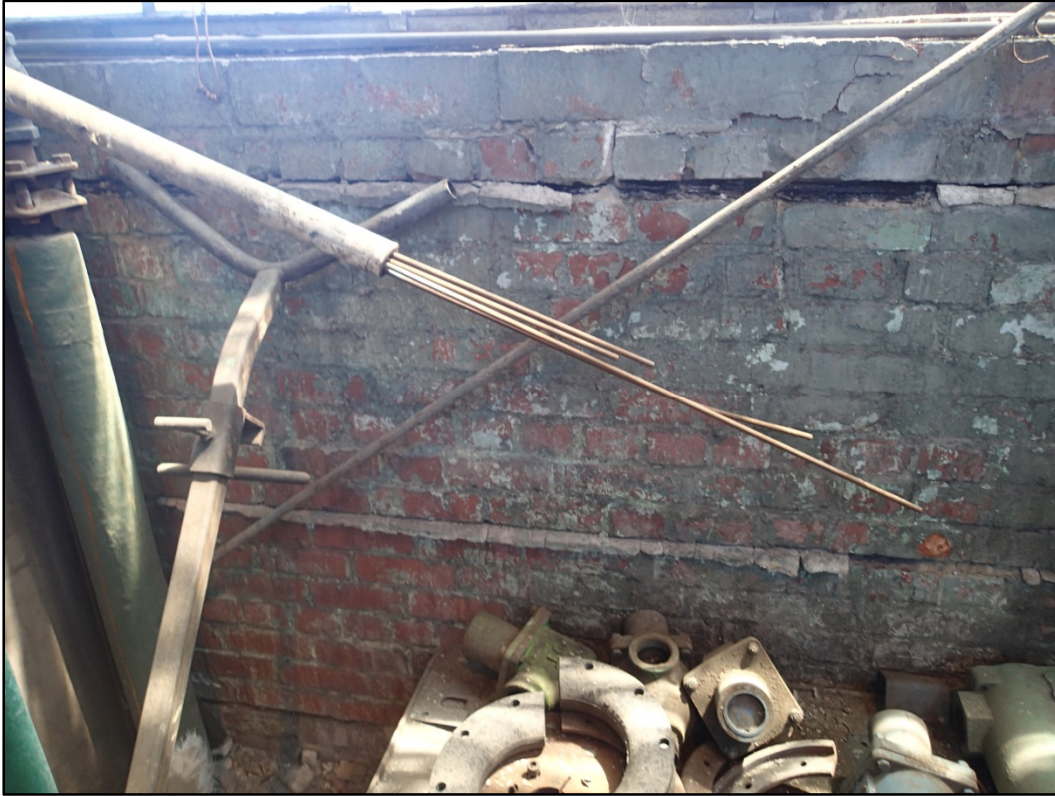
Figure 103-7 – View of the typical Building 103 deteriorated interior brick mortar joints.

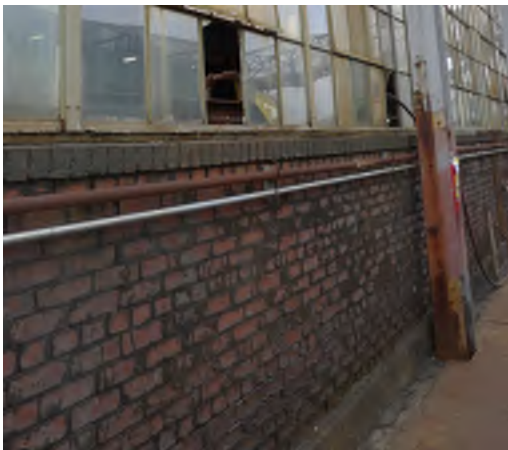
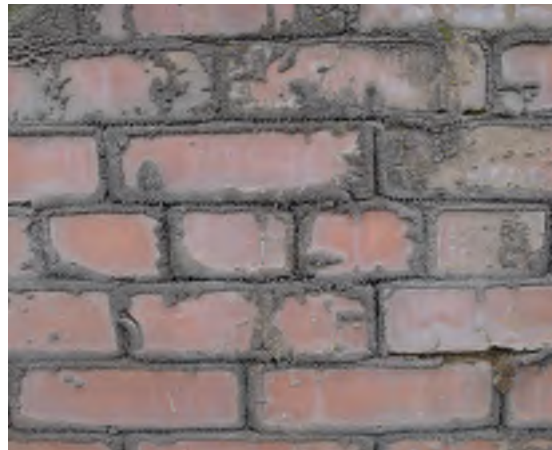
Brick base on Concrete Curb, west, south and east elevations. Condition: Fair (figures 6 - 8)

The brick is generally sound with minor localized areas of displacement. The mortar is deteriorated, particularly at the east end of the north wall, with evidence of water intrusion causing moss and mold in the joints.

Figure 6 - North wall showing moss in joints

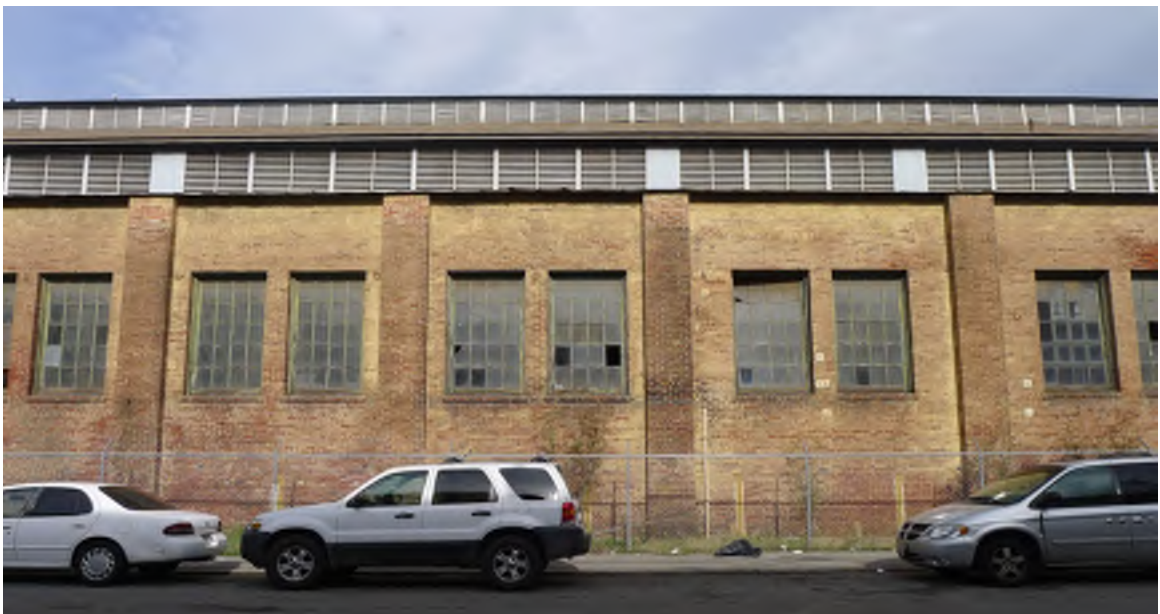
Brick, south wall, Condition: Poor (figures 9 - 12).

The one story, brick, southern wall is a remnant of an earlier late nineteenth century building which was incorporated into the 1937 construction of Building 105. The masonry in this wall is roughly contemporary with that of Building 113 across 20th Street to the south. A high percentage of the mortar joints have failed, and the fabric of the brick shows signs of severe deterioration from water intrusion, primarily from wicking ground water below. We believe the foundation of this wall is brick. In addition there is severe cracking, likely caused by seismic activity and settlement over time.

Figure 9 - South wall, typical view of bays.

- At South Wall: Install new brick at locations of spalls and cracks and moisture deterioration. Approx. 30% of the total masonry wall area.
 1. Survey existing condition of all brick.

2. Rake out mortar at existing deteriorated joints.
 3. Remove flaking rust where accessible.
 4. Paint remaining reinforcing rod with rust inhibitive paint.

5. Install new face brick to match sound existing brick.
 6. Repoint approximately 80% of the brick joints with matching mortar.
- At Partial Height Masonry Wall: Perform two (1sf) exploratory probes at locations of rusting steel in the brick wall. **Probes and repair/reconstruction work shall be specified and monitored by a qualified historical architect. Work shall be performed by a qualified historic masonry contractor.**

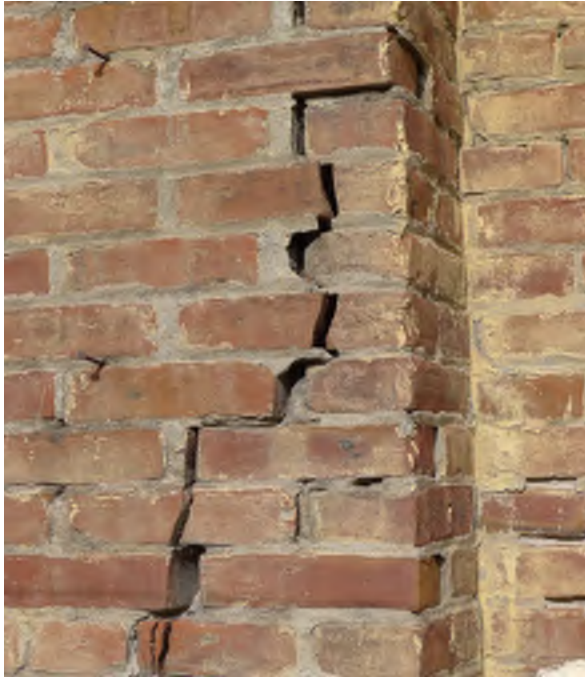
Figure 10 - South wall, cracking at pilasters.

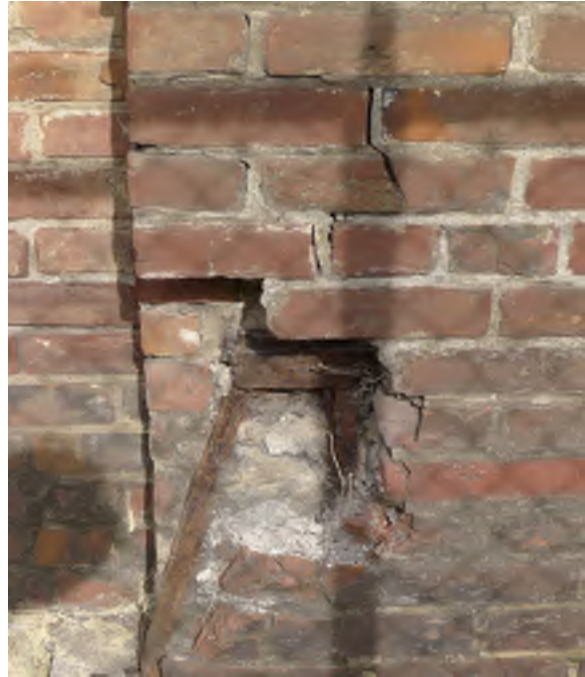
Figure 11 - South wall, displaced masonry at column base.

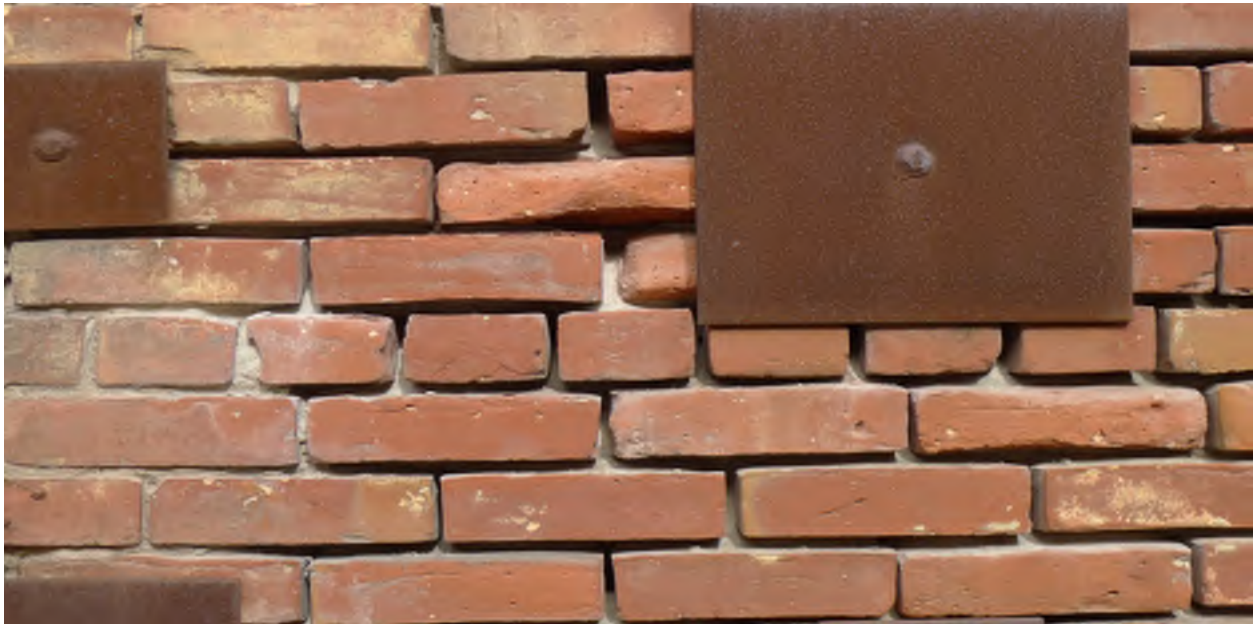
Figure 12 - South wall, deteriorated mortar from water intrusion. Reinforcing plates installed at an unknown date.

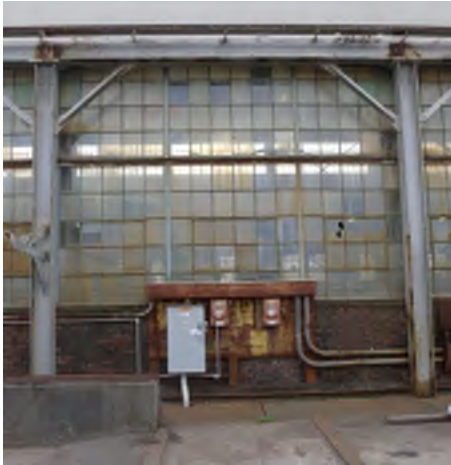
Steel Sash Windows. Condition: Good - Fair (figures 13 and 14).

Steel sash multi-lite, fixed in frame with operable portions are typical. Frame, mullions, and muntins are in fair condition with light to moderate rust. Window damage and broken/cracked panes have been dealt with by gluing sheet plastic panels at cracked or broken panes. Approximately 35 of the window panes are currently cracked or broken. All sealant joints have failed where the steel windows meet the brick wall base (figures 13 and 14).

Figure 13 – North wall, typical bay

- Steel Windows - Replace approximately (35) 14"x20" window panes
- Repaint 100% of steel sash window components: frame, mullion and muntins.
 1. Remove all dirt and deteriorated glazing putty.

2. Wire brush steel elements to remove rust.
 3. Install new glazing putty.
 4. Install new glazing where required to match existing original glazing.
 5. Prepare steel surfaces, and prime with rust inhibitive primer and paint with two top coats.

6. Flash and seal to adjacent CMP and brick sills.
- Wood Windows - Replace (12) 14"x20" window panes.
- Repair all wood frames and moveable sash (hopper operation).

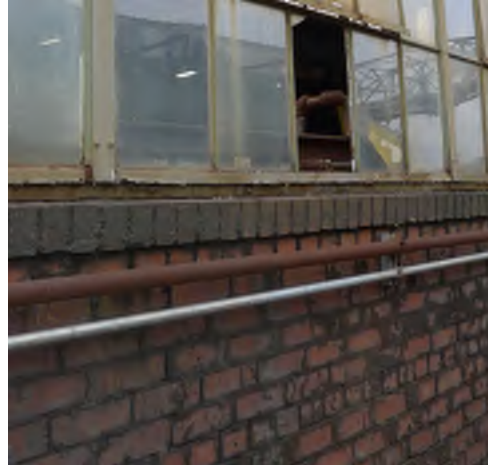
Figure 14 – North wall, joint sealant failure

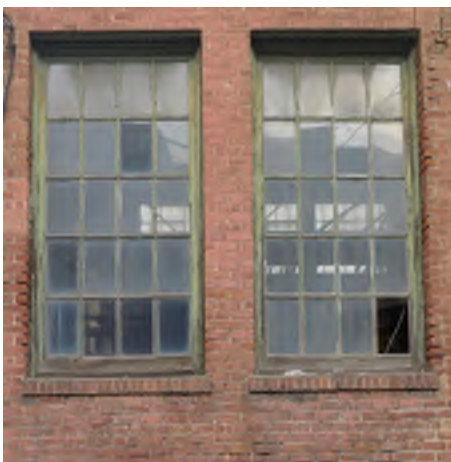
Wood Sash Windows. Condition: Good - Fair – Poor (figures 15 and 16).

There are (24) wood sash, (20) lite windows found on the south elevation. All windows operate as in swinging hoppers hinged at the bottom. The jambs, heads, sills, sash, and muntins are in fair condition. All of the paint is severely deteriorated. Approximately 15 of the window panes are currently cracked or broken. All sealant joints have failed where the wood window heads and jambs and sills meet the brick (figures 15 and 16).

Figure 15 –South wall, typical bay

1. Remove all moveable sashes for epoxy consolidation in a shop.
 2. Salvage and repair the hardware for re-use. Replace missing or deteriorated pieces.

3. Retain the sound glass, replace broken glass and install new glazing putty in all windows.
 4. Repair and replace missing wood frame elements and epoxy consolidate, and patch the wood in situ.

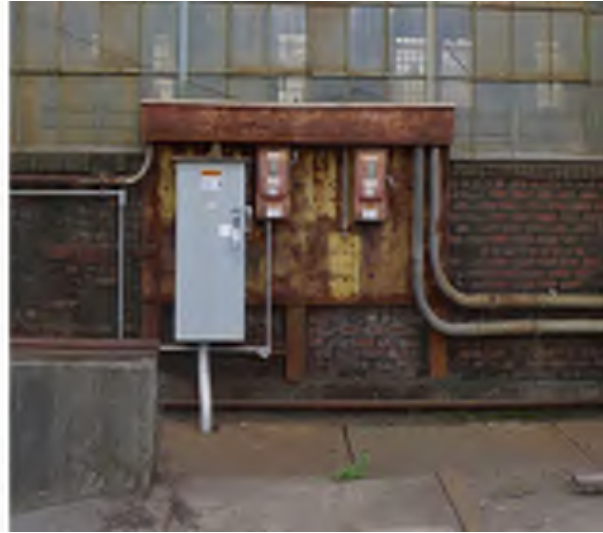
Figure 18 – North elevation, electrical equipment

Electrical components- Condition: functional, rusted (figure 18)

There are numerous flood lights, and loud-speakers attached to the building, none of which are historic. There are electrical conduit runs along the north face of the building mounted to the brick base. A three box circuit breaker panel is also mounted to the brick base on a severely rusted steel plate.

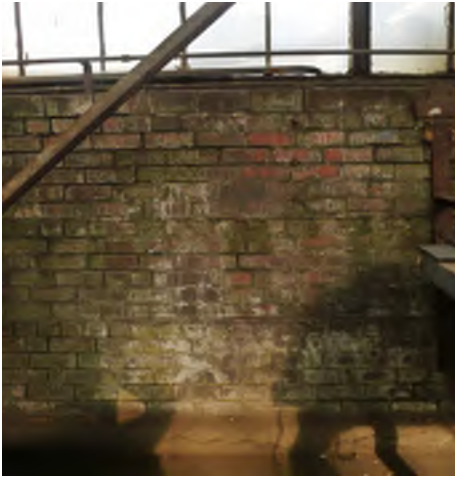
Brick and mortar joint Condition: Fair to Poor (figure 25).

Similar to the exterior, the fabric of the brick is sound, but water intrusion has degraded the mortar joints

Figure. 25 - North main shed brick base wall.

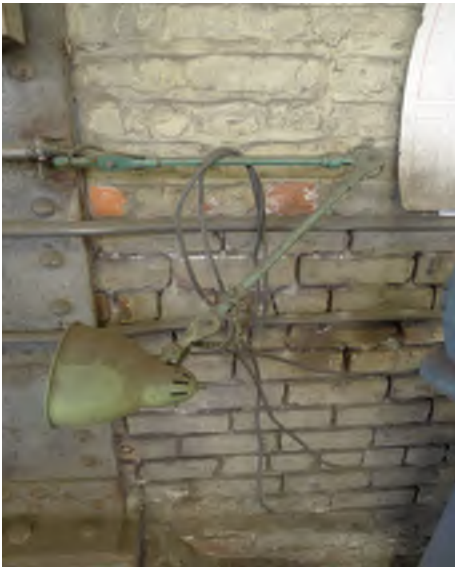
Brick and mortar joint Condition: Poor (figure 26).

Similar to the exterior, the fabric of the brick has deteriorated, and water intrusion has degraded the mortar joints. The wall is cracked in numerous locations. In addition sections of the wall have been painted, likely with lead based paint and the paint adhesion is failing.

Figure. 26 – South shed brick wall.

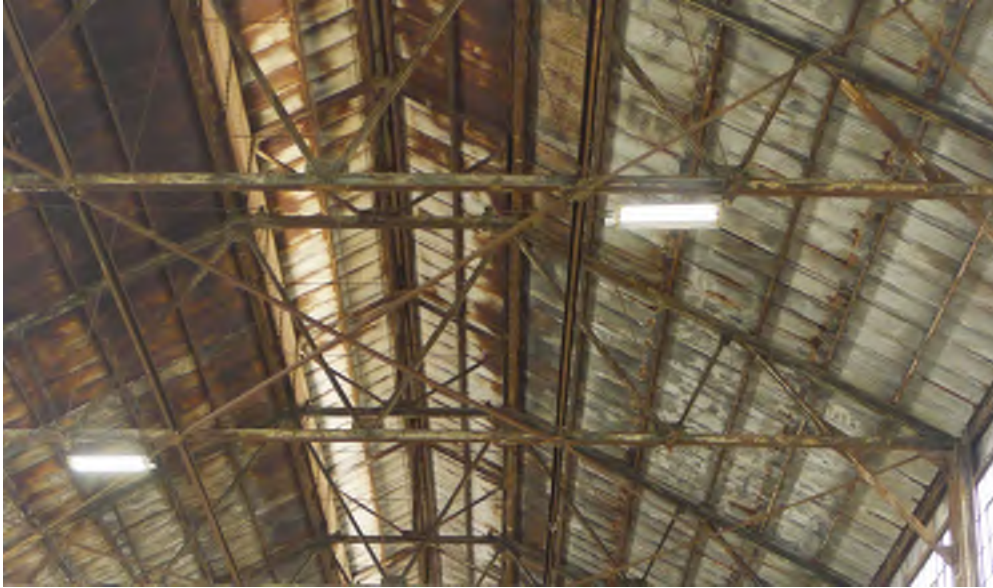
Condition: Fair to Poor, (figure 27)

CMP panels are heavily rusted on the south side with rusting at the seams on the north side.

Figure 27 - Interior main shed ceiling looking west.

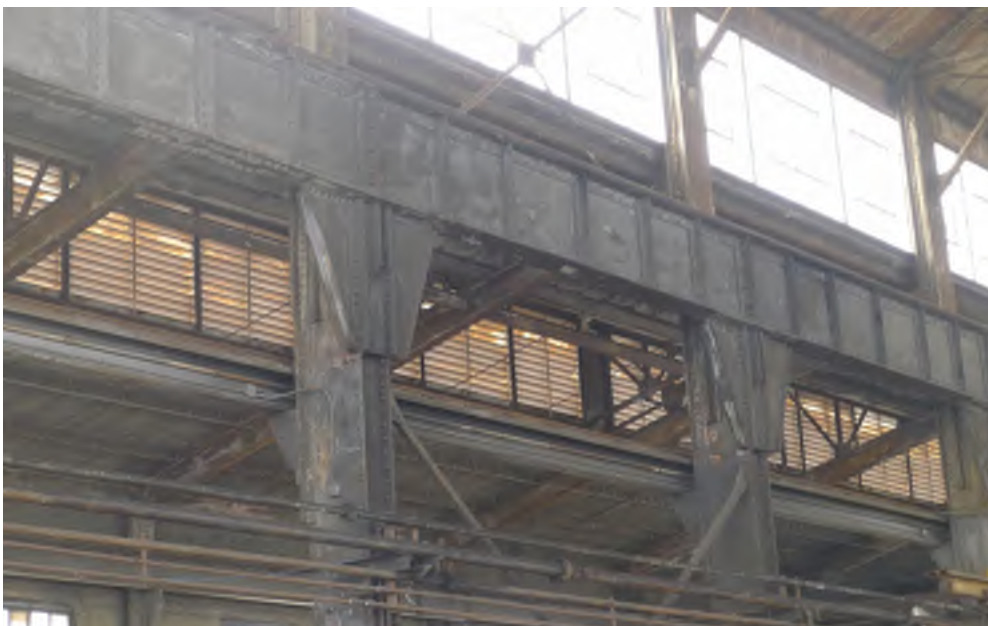
Condition – Good to fair (figure 30)

The structural members were all originally primed and / or painted with lead based paint. The paint is failing throughout the building, and there is moderate rusting visible in all members.

Figure 30 - Structure of main shed looking into south shed

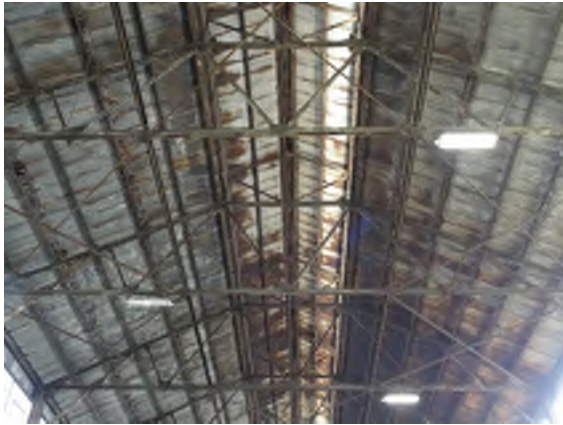
Figure 1 – Typical roof framing and CMP corrosion

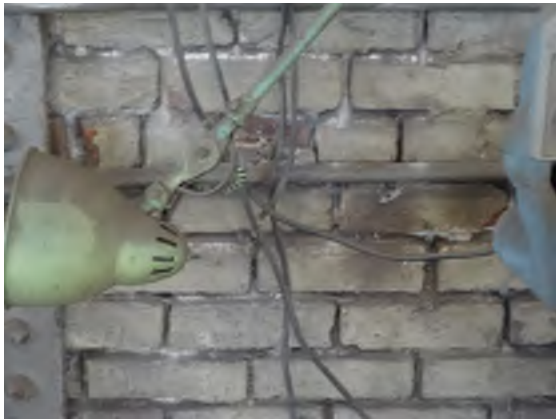
Figure 2 – Typical full height wall masonry damage

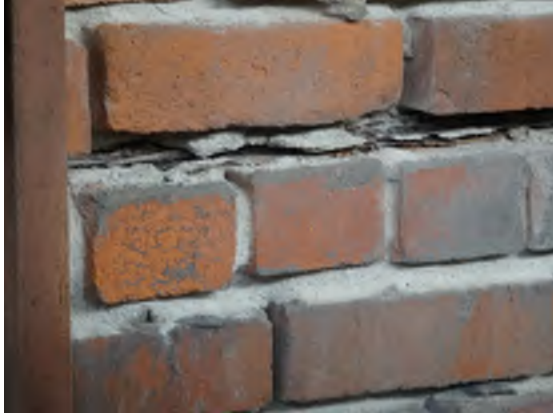
Figure 3 – Typical partial height wall masonry damage

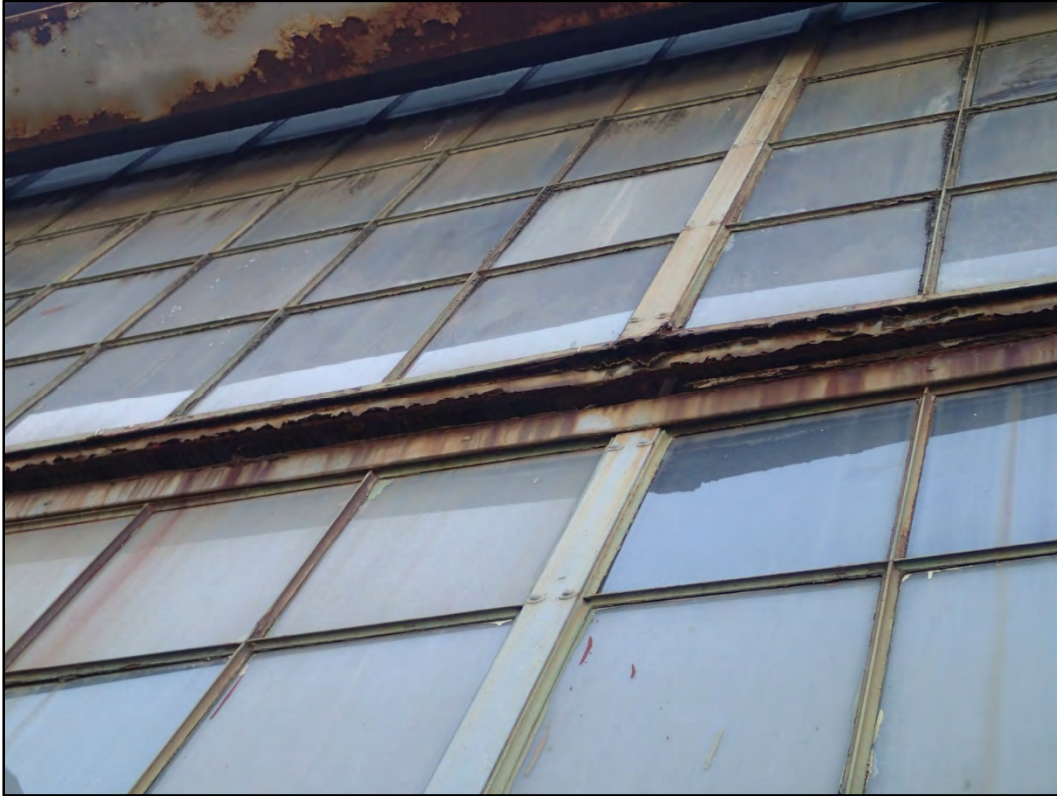
Figure 105-4 –View of the top row of windows that is bulging out towards the exterior.

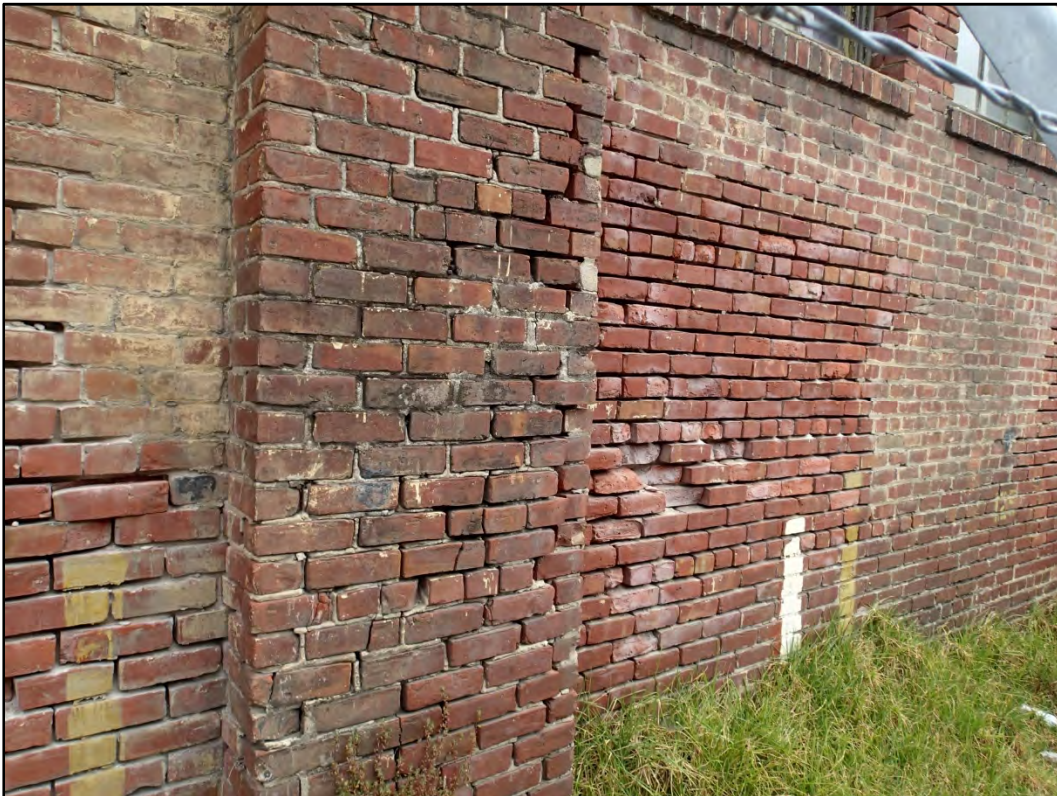
Figure 105-5 - View of Building 105 typical exterior brick mortar joint deterioration.

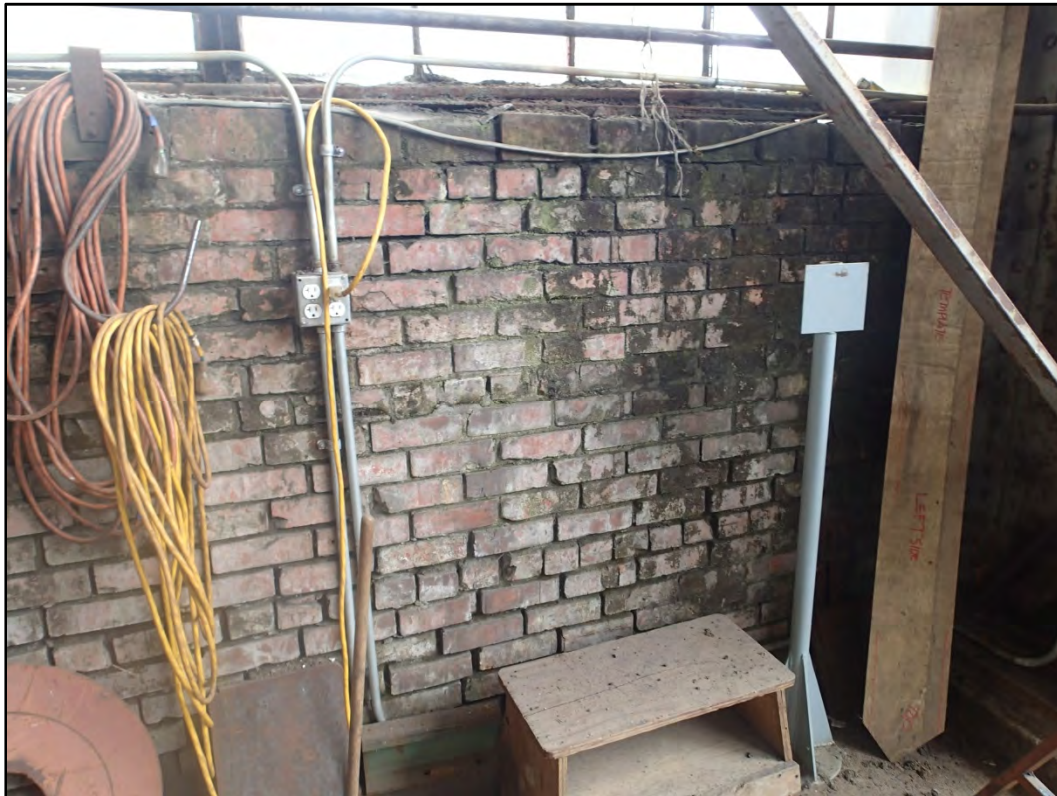
Figure 105-7 – View of the typical Building 105 deteriorated interior brick mortar joints.

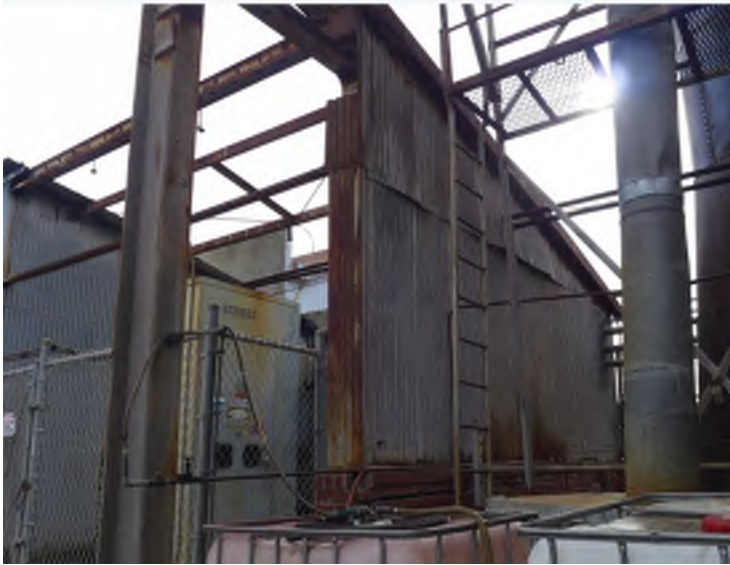
The CMP is painted on the north elevations that face the yard. The west (figure 2) and visible portions of the south elevation are unpainted and in somewhat poorer condition with corrosion and open seams especially where the panels meet the brick base. Most of the south wall was inaccessible for inspection. The narrow space between building 107 and the north wall of building 19 was boarded up with plywood. The east wall of building 107 abuts the interior of building 108.

Figure 2 - Building 107: West Elevation

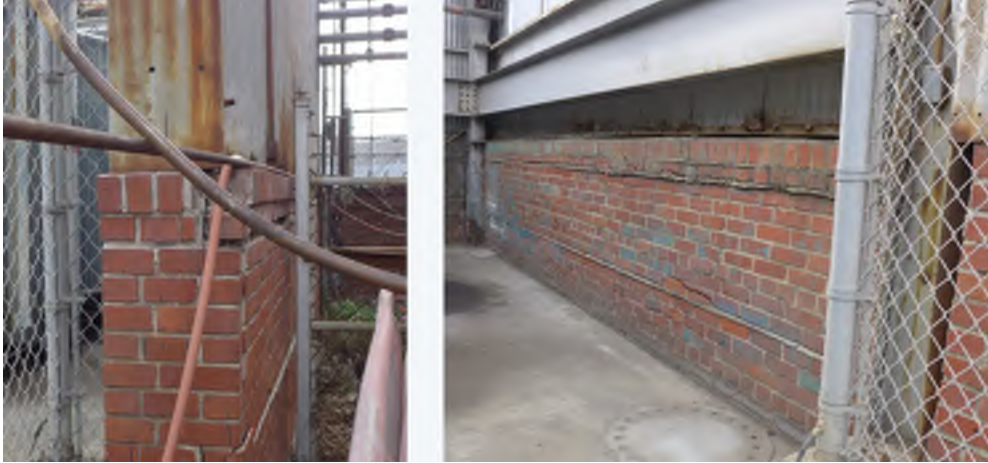
Brick. Condition: Poor (figure 3 and 4)

Cracked and broken brick were observed on all wall areas. Horizontal steel reinforcing is rusted and expanding forcing mortar out of the joints and contributing to brick cracking, spalling and displacement. Diagonal cracks were observed at the north doorway and at the NE, NW and SW corners.

Figure 3 - Building 107: Brick at west wall. Figure 4 - Building 107: Brick at south wall.

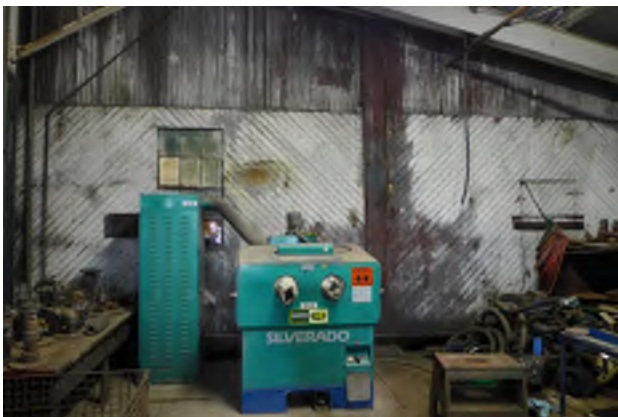
Deteriorated paint. (figure 5)

Figure 5 - Building 107: Interior wood wall.

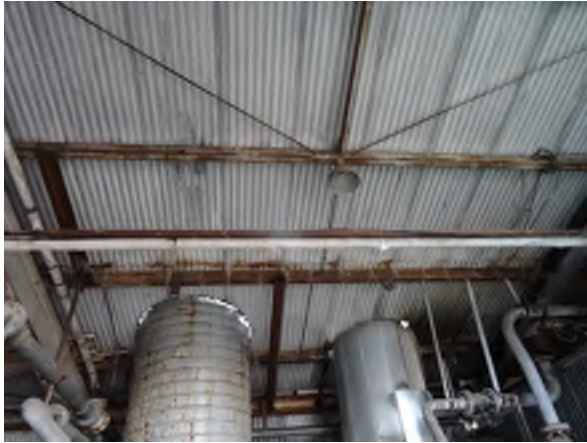
Figure 1 – CMP corrosion at cooling units

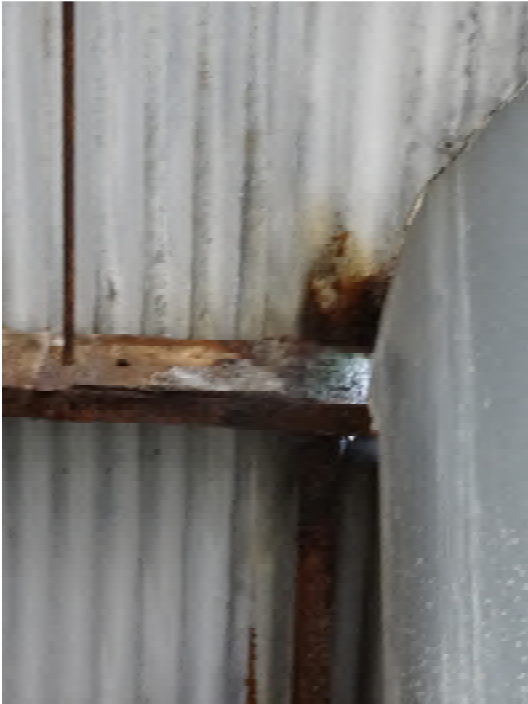
Figure 2 – CMP and purlin corrosion at cooling units

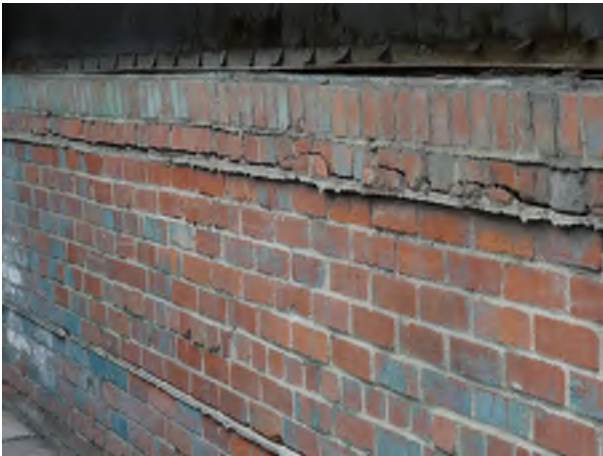
Figure 3 – Partial height masonry wall damage

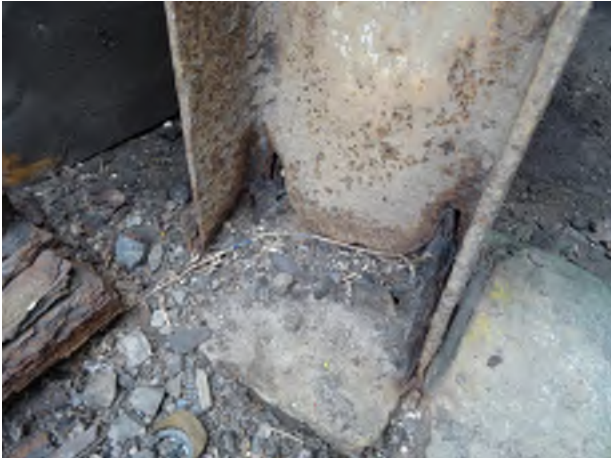
Figure 4 – Column damage at north end

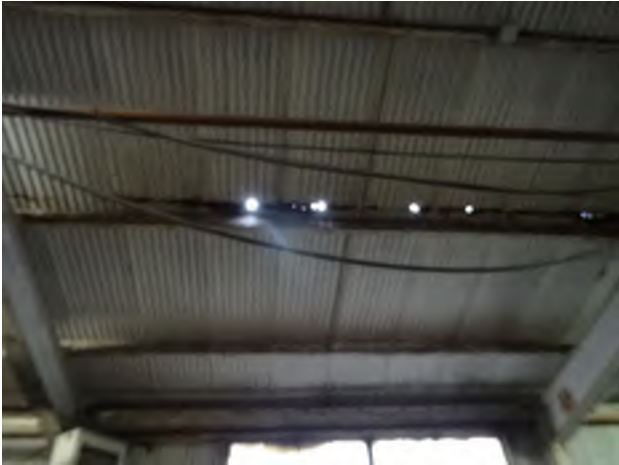
Figure 5 – Typical CMP corrosion with rust holes

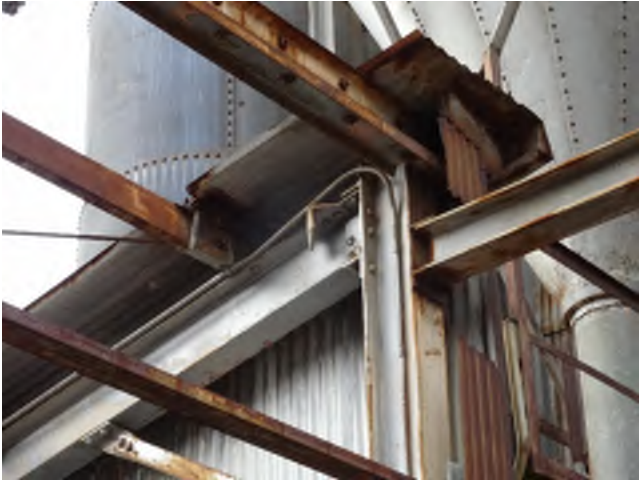
Figure 6 – Typical corrosion to steel framing members in open area

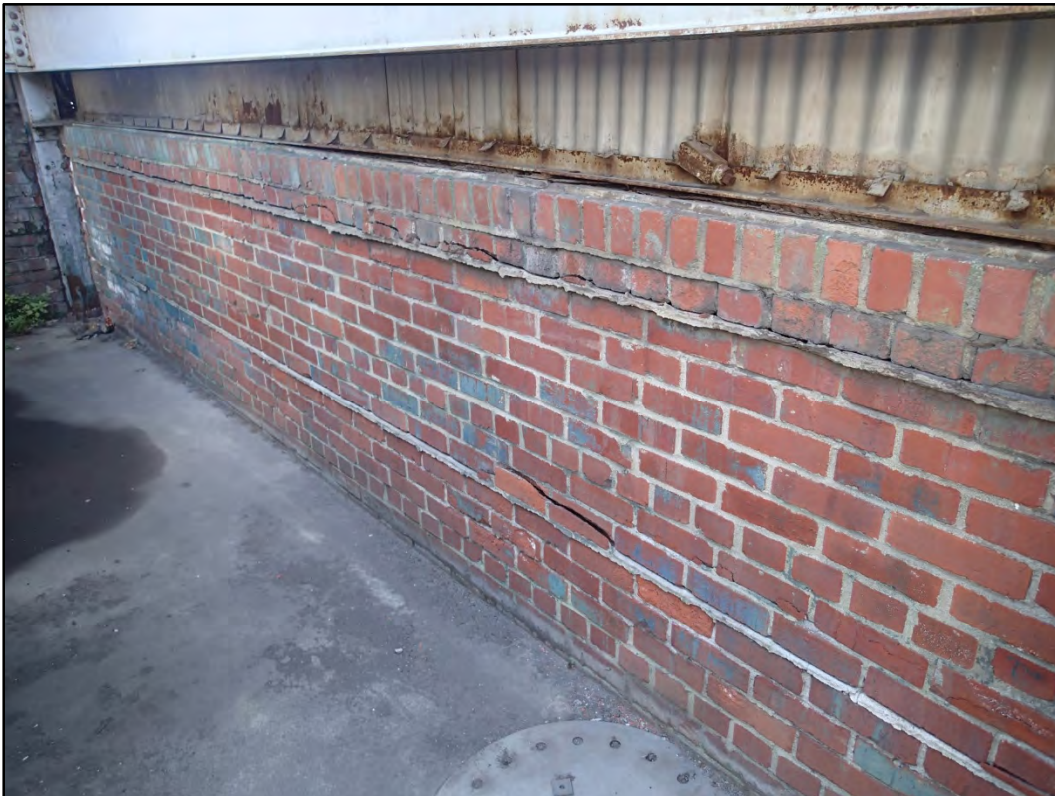
Figure 107-3 - View of Building 107 typical exterior brick mortar joint deterioration.

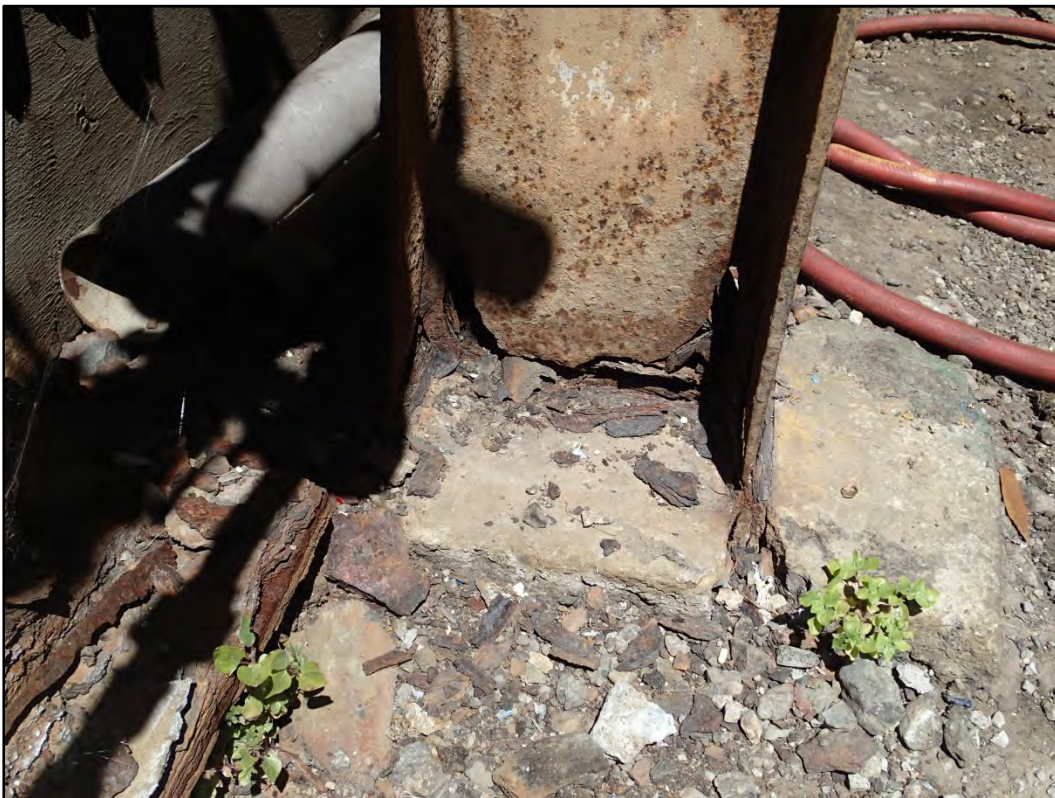
Figure 107-7 – View of the heavily corroded column base at north side of Building 107.
