BUILDING 108 –Carpenter’s Shop

ARCHITECTURAL DESCRIPTION

BUILDING 108 – Carpentry Shop & Storage

A condition assessment of Building 108 was performed by AGS Inc. on June 27th, 2017 based on the 2015 Pier 70 Building Condition Assessment Report by DCI+SDE Engineers. The purpose of the condition assessment and this addendum is to provide an update and field verification of the architectural and structural deficiencies found at Building 108, which was described in the aforementioned report by DCI+SDE Engineers. The condition assessment was based on a general visual observation of the exposed portions of the building from the ground level. No assessment was performed in areas that were not easily and/or safely accessible.

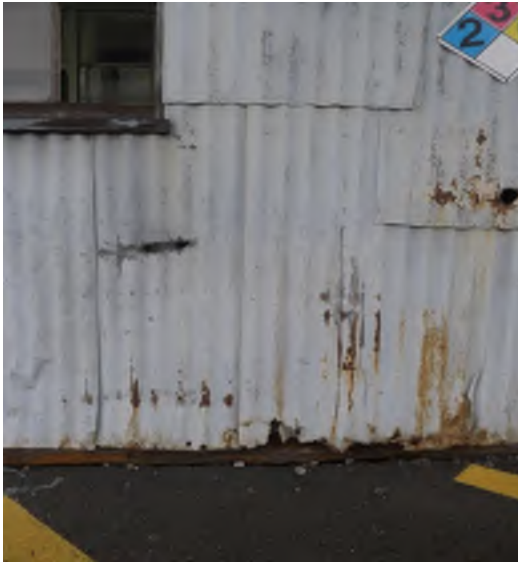
CMP. Condition: Fair to poor (figures 9 - 12)

The CMP has suffered from impact damage in the first course of panels above grade as well as impact damage around openings. There is significant rust deterioration at grade. The upper levels of CMP are in sound condition.

Figure 9 - Deteriorated CMP at grade

- Retain and rehabilitate historic fixtures mentioned in this report.
- Patch holes throughout the building.
- Seal CMP at all conduit and pipe penetrations.
- Replace deformed and deteriorated CMP with new galvanized corrugated steel to match the existing panels. Replace the panels from grade to the next panel above on the north, east and south elevations. Replace the deformed panels above the western loading doors. Prime and paint the new panels.
- Re-paint all existing CMP

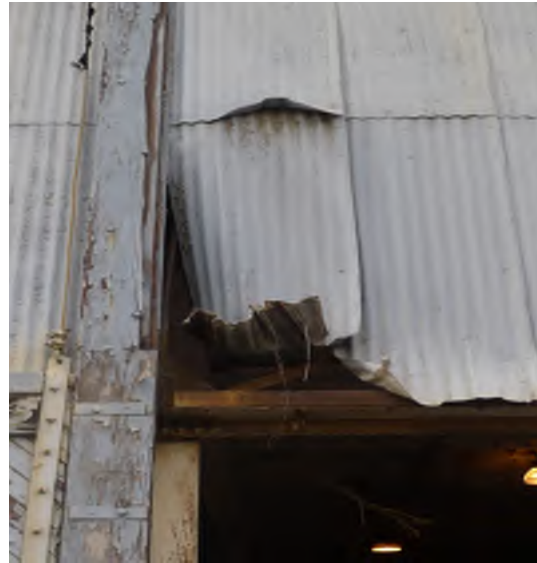
Figure 10 - Impact damage to CMP, west elevation

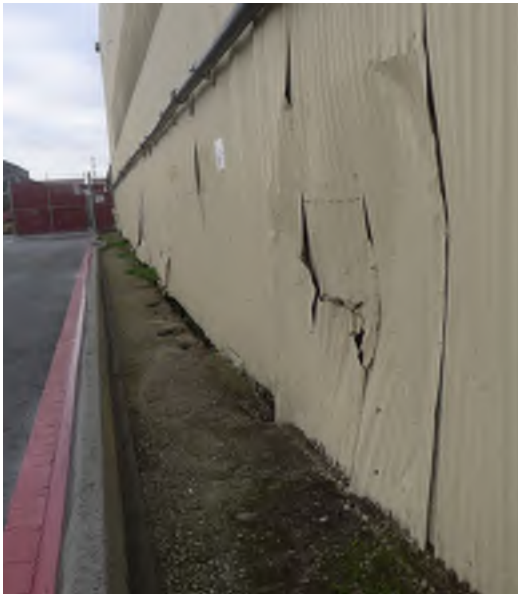
Figure 11 - Impact damage to CMP, east elevation.

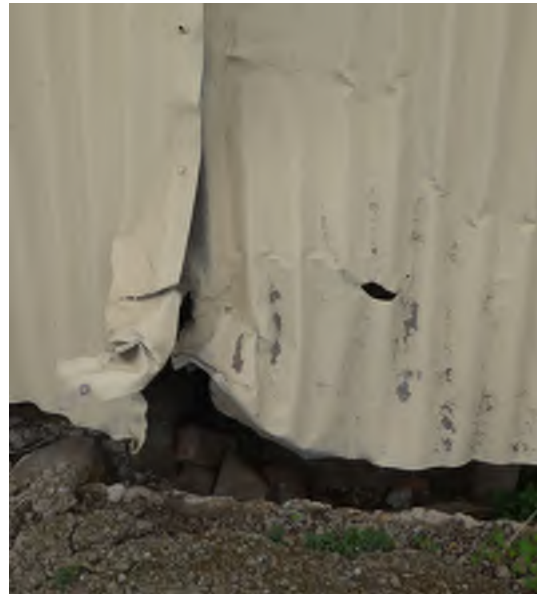
Figure 12 - Impact damage to CMP at grade, west elevation.

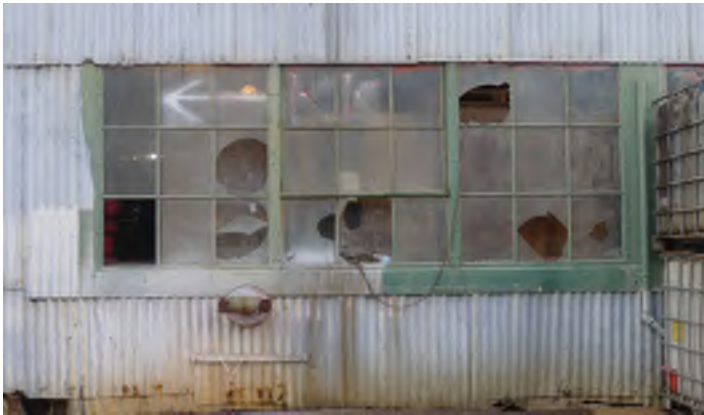
Figure 13 - view from the northwest

Steel Sash Windows. Condition: Good - Fair (figure 13).

Steel sash multi-lite, fixed in frame with operable portions are typical. They are located in the western half of the building. The frame, mullions, and muntins are in fair condition with light to moderate rust. Window damage and broken/cracked panes have been dealt with by gluing sheet plastic panels at cracked or broken panes. There are 70 steel windows, and approximately 40 of the window panes are currently cracked or broken. The steel windows flash into the CMP and the flashings appear to be sound.

- Steel Windows - Replace approximately fifty (50) 14"x 20" window panes
- Repaint 100% of steel sash window components: frame, mullion and muntins.
 1. Remove all dirt and deteriorated glazing putty.

2. Wire brush steel elements to remove rust.
 3. Install new glazing putty.
 4. Install new glazing where required to match existing original glazing.
 5. Repair bent steel sash and operating components.

6. Prepare steel surfaces, and prime with rust inhibitive primer and paint with two top coats.
 7. Flash and seal to adjacent CMP.
- Repair leaking skylights, similar to repairs listed above for steel sash windows.

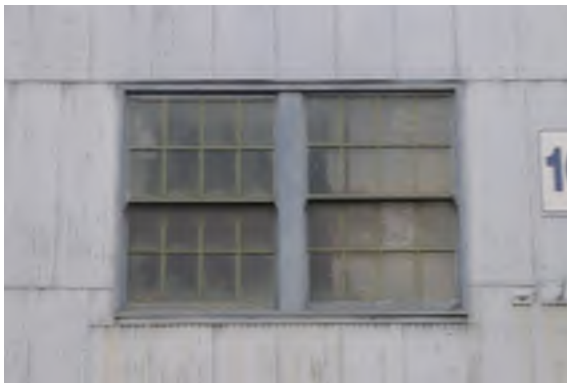
Wood Sash Windows. Condition: Fair - Poor (figure 14).

There are (30) wood sash, (16) lite windows found primarily on the north and south elevations of the eastern half of the building. All windows are double hung. Most of the windows on the south side have been covered in plywood, and at the first floor a pipe traverses the window openings. The jambs, heads, sills, sash, and muntins are in fair condition. All of the paint is severely deteriorated. Approximately 25 of the window panes are currently cracked or broken. All sealant joints have failed where the wood window heads and jambs and sills meet the CMP (figures 15). The south elevation contains two aluminum replacement windows.

Figure 14 –South wall, typical bay

- Wood Windows - Replace (20) 14"x20" window panes.
- Repair all wood frames and moveable sash.
 1. Remove all moveable sashes for epoxy consolidation in a shop.

2. Salvage and repair the hardware for re-use. Replace missing or deteriorated pieces.
 3. Retain the sound glass, replace broken glass and install new glazing putty in all windows.

4. Repair and replace missing wood frame elements and epoxy consolidate, and patch the wood in situ.
 5. Install moveable sash into restored frames and install new sash chords. Ensure that all moveable sash operates.

6. Prepare the wood surfaces, and prime and paint with two top coats.
 7. Flash and seal to the adjacent CMP

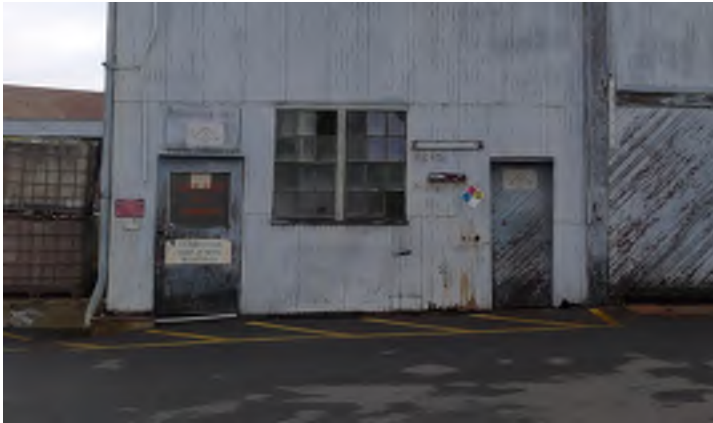
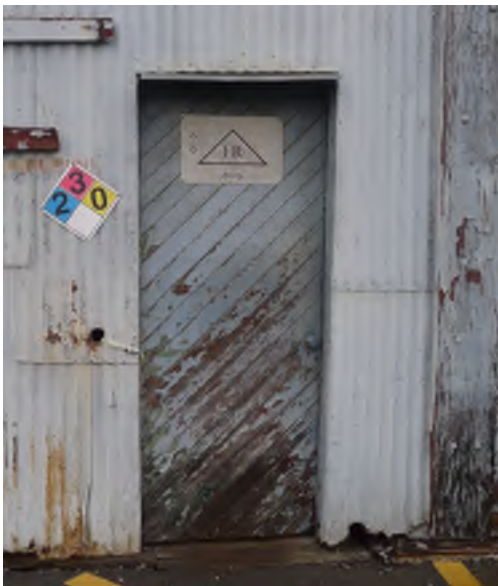
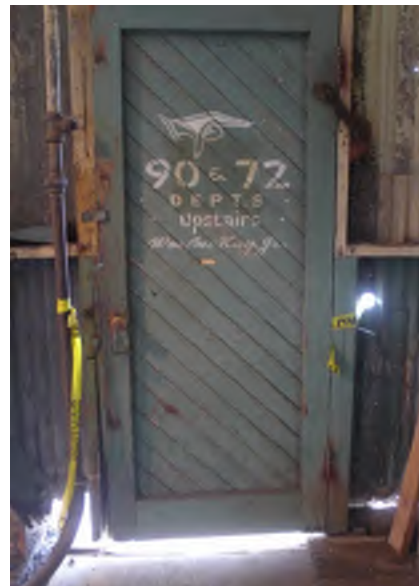
Personnel Doors. Condition: Fair (figures 15 -17).

There (4) personnel doors in the building. One, leading to a balcony on the north elevation, second floor was not accessible, but it appears to be plywood or a plywood cover over the opening. There is an angle iron and steel hinged door leading to an electrical room at the south end which is in good condition. The other two are side by side on the northern corner of the west elevation. The wood door with a single glazed lite is fixed closed. The adjacent door to the south is constructed of wood tongue and groove material that diagonally sheathes a supporting frame. Its construction is similar to that of the large loading doors along the west elevation. The inside of the door contains skillfully hand painted signage that is likely historic. The exterior paint on these doors is flaking exposing the wood to the elements. The hardware on this door is original and is completely in-tact.

Figure 15 –Wood personnel doors, west elevation

Figure 16 - Personnel door, west elevation

Figure 17 - Interior of same personnel door

- Replace deteriorated wood personnel doors at the northern most end of the west elevation and at the second floor of the north elevation with new steel doors.
- Repair the second personnel door to the south on the west elevation.

1. Remove door to a shop for the work
 2. Clean and repair all original hardware.
 3. Remove flaking paint from diagonal tongue and groove wood cladding. Seal tongue and groove joints. Prime and repaint the exterior surface only with two top coats.

4. Lightly clean the inside surface of the door preserving the painted signage. Apply a clear sealer to the inside surface.
 5. Replace the original wood jambs and head. Re-hang the door ensuring proper operation.

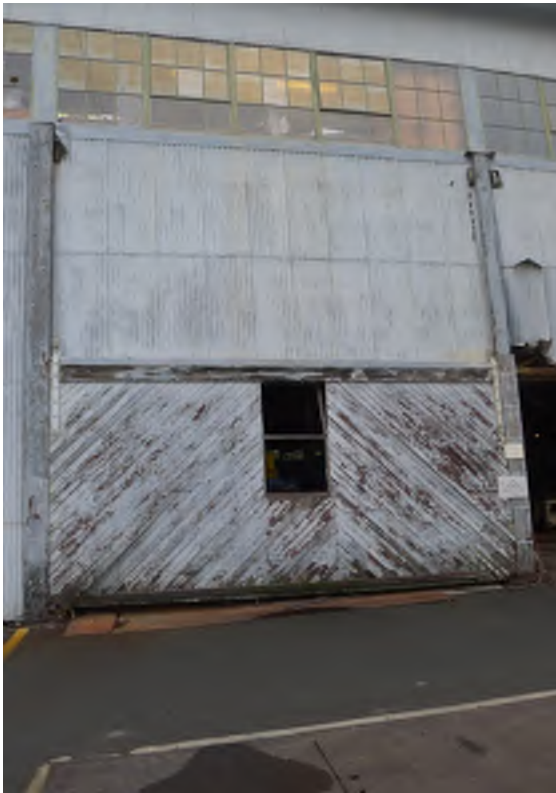
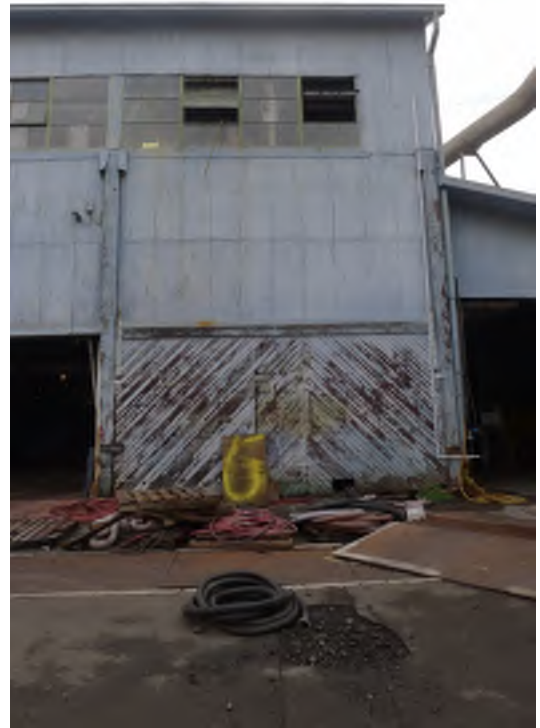
Vertical lift wood loading doors. Condition: Fair - poor (figures 18 and 19).

There are two (2) surviving, vertical lift “guillotine” type loading doors on the west elevation, which appear to be unique to Pier 70. There were originally five (5) doors on this elevation. They are 9’-8” high by 19’ wide, and are constructed of wood tongue and groove material that diagonally sheathes a supporting frame. Its construction is similar to that of the personnel door described above. The exterior paint on these doors is flaking, exposing the wood to the elements. The hardware on the doors is original and is completely intact, but is not operable. The hardware includes sheaves mounted at the second floor, cable, wood lifting guides and metal straps for the cable attachment. Both doors appear to be fixed in the down position. The northernmost door contains a deteriorated window without glazing, and the southern door contains a personnel door.

Figure 18 – West elevation, north loading door.

Figure 19 – West elevation, south door

- Repair two wood loading doors on the west elevation.
 1. Repair the doors in-situ.
 2. Survey the existing condition of the door.
 3. Remove flaking paint from diagonal tongue and groove wood cladding. Seal tongue and groove joints. Prime and repaint the exterior and interior surface with two top coats.

4. Create a 4" curb to lift the doors out of standing water.
 5. Repair all hardware and components.
 6. Flash the tops of the doors into the CMP.
 7. Repair and repaint the wooden lifting guides.

8. Fix doors in the closed position

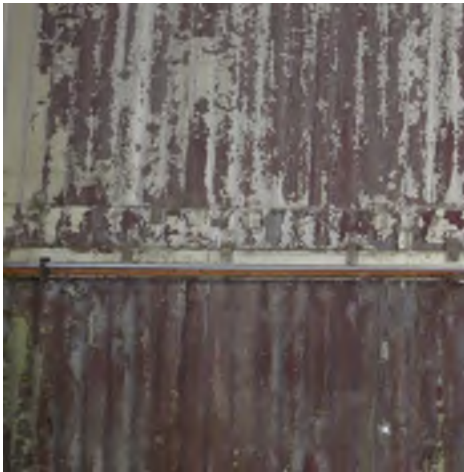
CMP. Condition: Fair to poor (figure 27).

CMP. The panels have generally been painted, and the paint is peeling. The panels are lightly to moderately corroded.

Figure. 27 – Interior side CMP, second floor.

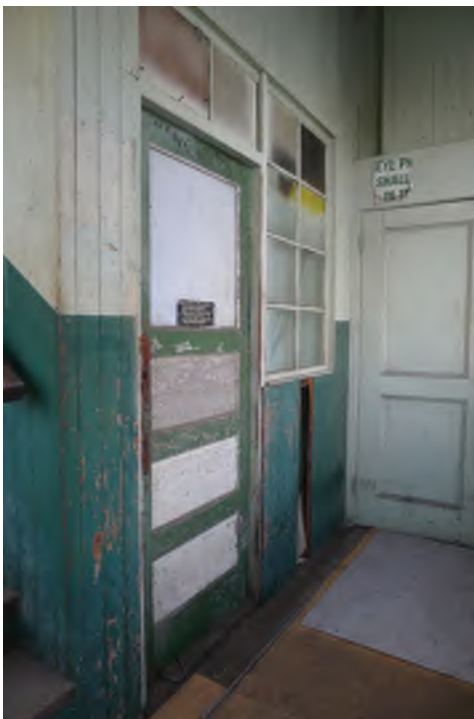
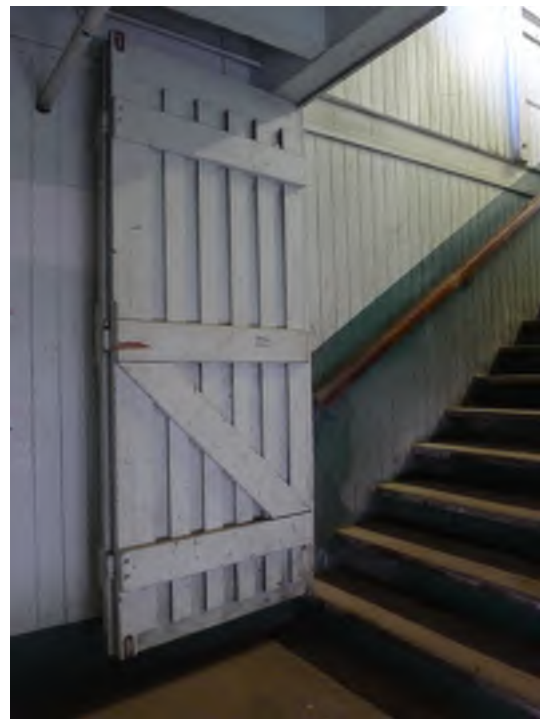
In the first floor entry foyer and stair and in the second floor office and employee area in the north end of the west portion of the building, there are (5) historic wood doors. Condition: Fair, (figures 31 and 32).

All doors have been painted, and the paint is peeling. The painted surfaces are worn and grimy. Most original hardware is missing.

Figure. 31 – Personnel doors, first floor entry.

Figure. 32 – Unique, bi-fold door to second floor.

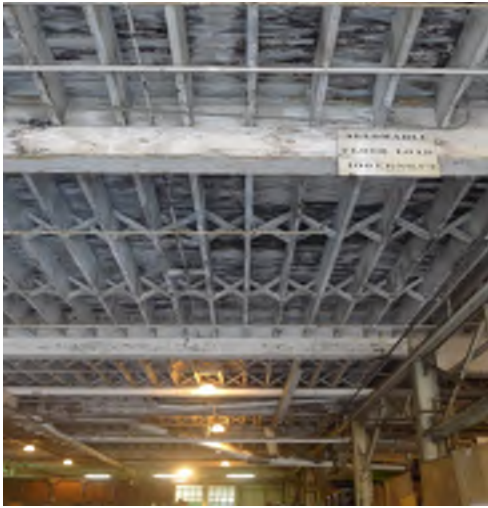
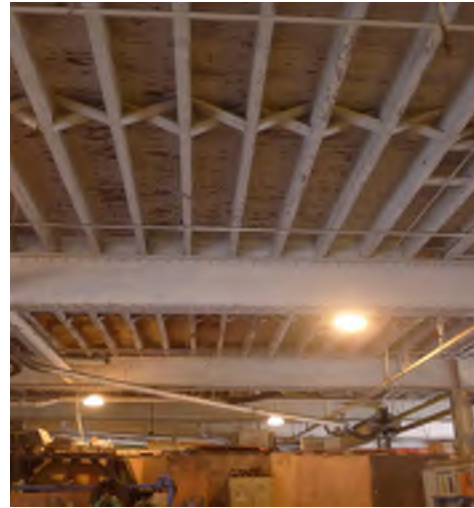
Condition: Fair, (figures 33 and 34)

The wood ceilings in both the west and east sections of the building appear to be sound. They were likely painted with lead based paint and it is severely deteriorated.

Figure 33 – Ceiling, east side looking south.

Figure 34 – Ceiling, west side looking south...

- Repaint exposed wood joists, bridging and underside of the tongue and groove second floor surface.
 1. Verify that existing surfaces do not contain lead based paint.
 2. If lead based paints are suspected on the project, all removal must be done in accordance with the EPA Renovation, Repair and Painting rule and all applicable state and local regulations.
 3. Prepare wood surfaces, prime and paint with two top coats.

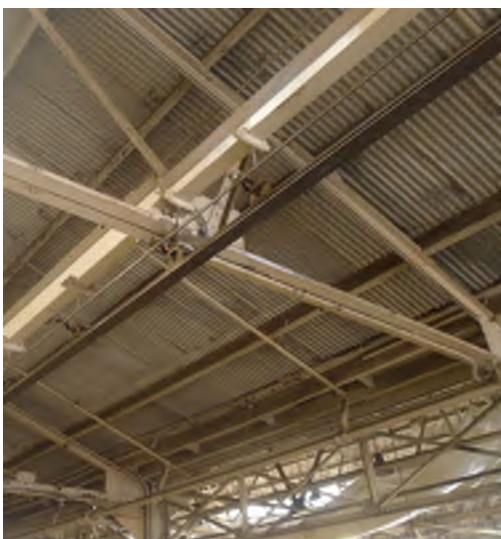
Condition: Good, (figure 35).

CMP panels are only lightly rusted at the seams with the planar areas clear of rust.

Figure 35 – CMP ceiling looking southwest.

- Repaint CMP ceiling on second floor
 1. Verify that existing surfaces do not contain lead based paint.
 2. If lead based paints are suspected on the project, all removal must be done in accordance with the EPA Renovation, Repair and Painting rule and all applicable state and local regulations.
 3. Prepare steel surfaces, prime with rust inhibitive primer and paint with two top coats.

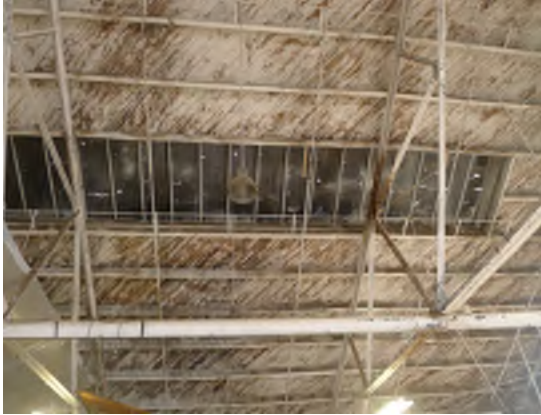
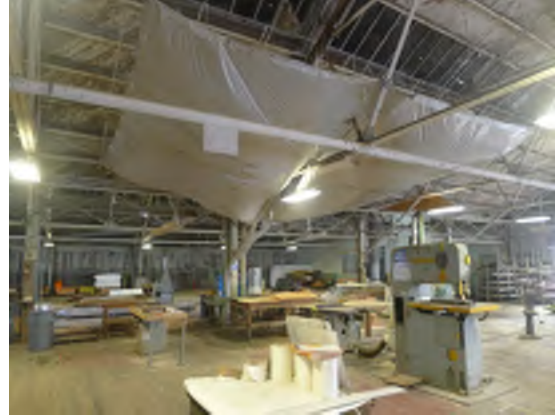
Condition: Fair - poor, (figure 36 and 37).

The wood T&G diagonal sheathing was likely painted with lead based paint and it is severely deteriorated. The soundness of the wood is unknown. The roof sheathing and skylights are leaking.

Figure 36 - Wood ceiling, east side.

Figure 37 - BAE staff built roof leak containment.

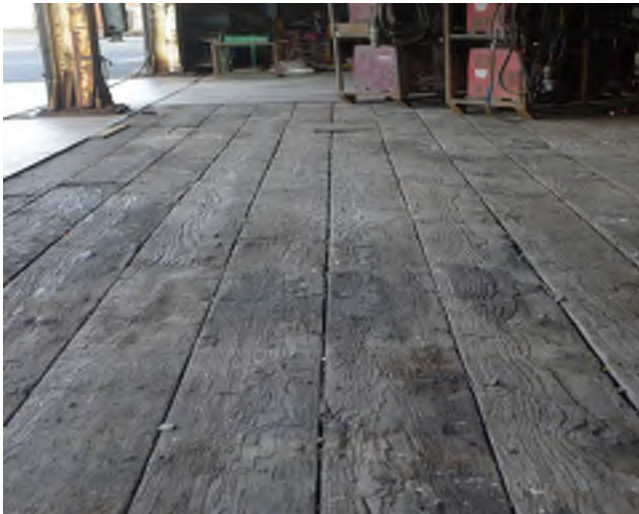
Condition: Fair to Poor (figure 38)

The first floor material is heavily worn but still serviceable. A total assessment of the floor is not possible because of equipment coverage. Numerous locations are clad in a plywood overlayment.

Figure 38 – Wood floor, west side at loading bays.

- Patch areas of deteriorated wood.
 1. Survey the existing condition of the floor.
 2. Replace deteriorated wood in-kind.

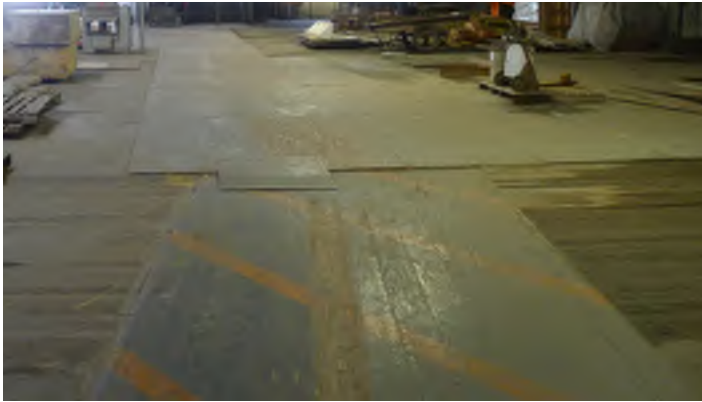
Condition: Fair (figure 39)

The floor material is generally worn with damage from water intrusion. A large quantity of the floor is over laid with plywood.

Figure 39- Typical second floor, floor with plywood over-lay.

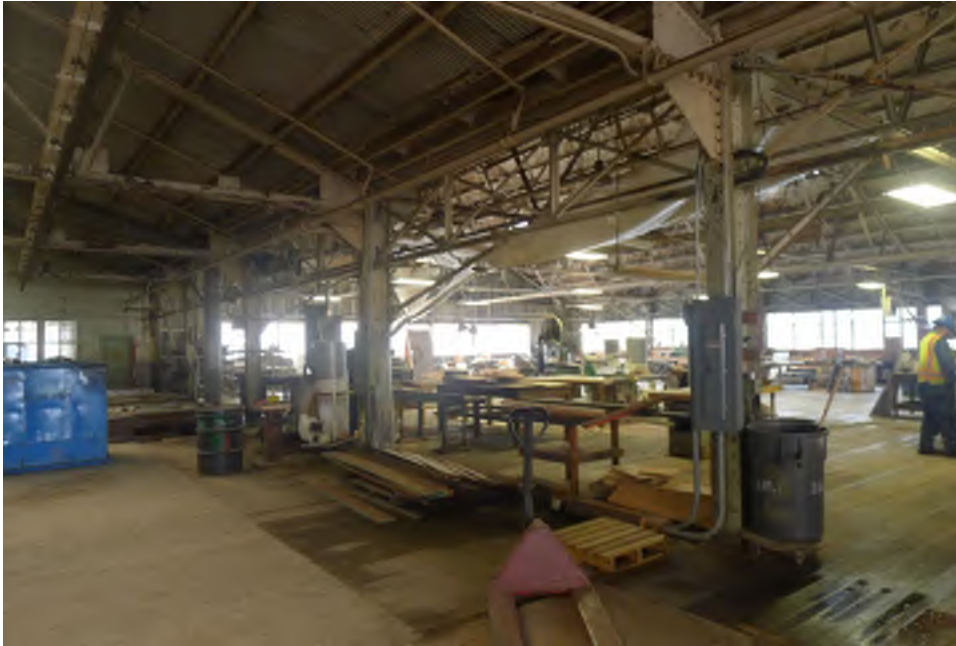
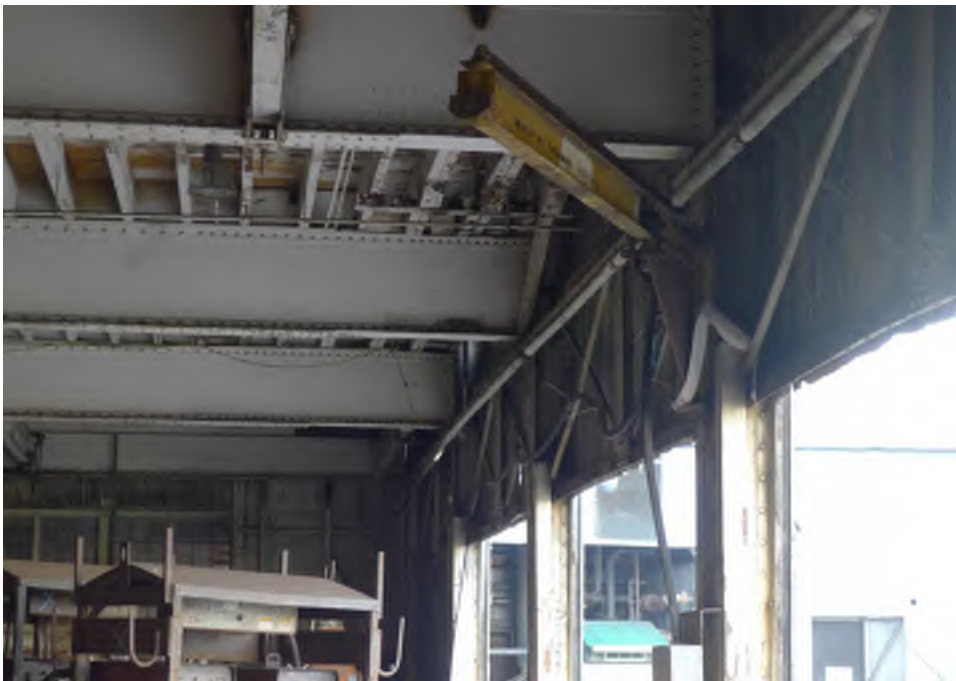
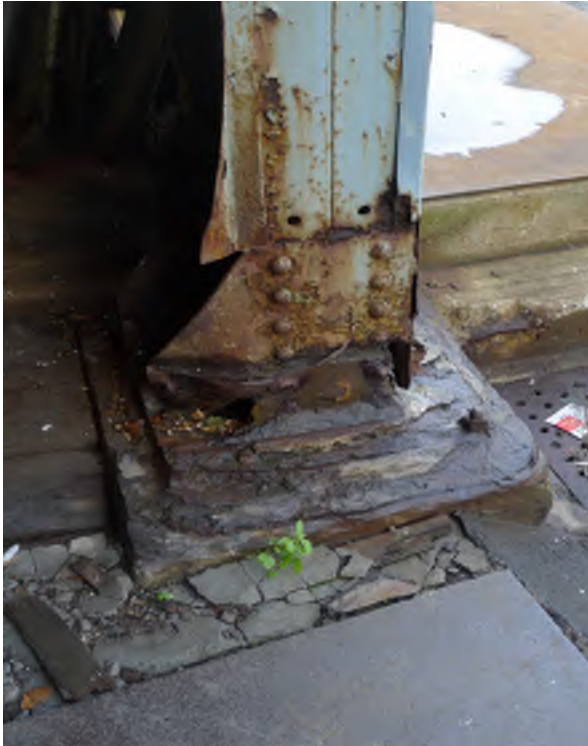
Condition – Good to Poor (figures 40 - 42)

The structural members were all originally primed and / or painted with lead based paint. The paint is failing throughout the building, and there is moderate rusting visible in all members. The second floor roof trusses and purlins are generally in sound condition with light to moderate rusting. The first floor built-up spanning steel beams carrying the wood joists are also generally in good condition with only light to moderate rusting. Steel columns at the periphery of the first floor are deteriorated because of breaches in the CMP, and exposure to the elements.

Figure 40 - Steel structure in east side, looking southwest.

Figure 41 - Built-up steel beams in the west side at loading doors, looking south.

Figure 42 – Deteriorated structural column base, north elevation.

- Repaint steel columns and trusses.
 1. Verify that existing surfaces do not contain lead based paint.
 2. If lead based paints are suspected on the project, all removal must be done in accordance with the EPA Renovation, Repair and Painting rule and all applicable state and local regulations.
 3. Prepare steel surfaces, prime with rust inhibitive primer and paint with two top coats.

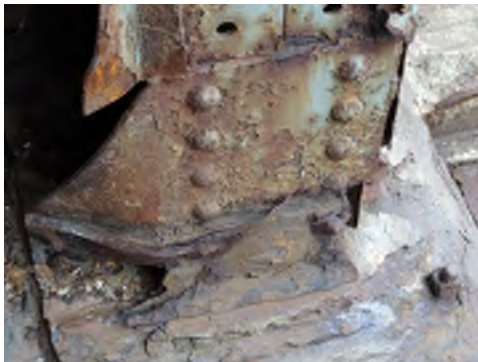
- Steel roof deck is generally in good condition but with approximately 10-15% damaged due to rust.
- Steel framing is generally in good condition but about 20% show corrosion of peeling of paint.
- Wood purlins at roof level show significant sagging.
- Wood diagonal sheathing shows severe water damage and dry rot.
- At 2nd level there is some significant corrosion on the trusses on the west half.
- There are several removed “x” braces in the building on the east elevation and along the centerline.
- There is moderate corrosion to the 2nd floor wood framing
- There is moderate to severe corrosion at column bases along the exterior and some interior conditions.

Figure 1 – Typical base plate and column damage

- Approximately 20%-30% of structural steel truss members need to be replaced in kind.
- At approximately 20-30% of columns, replace the bottom one foot of the column including the baseplate. The approximate size is W12x30.

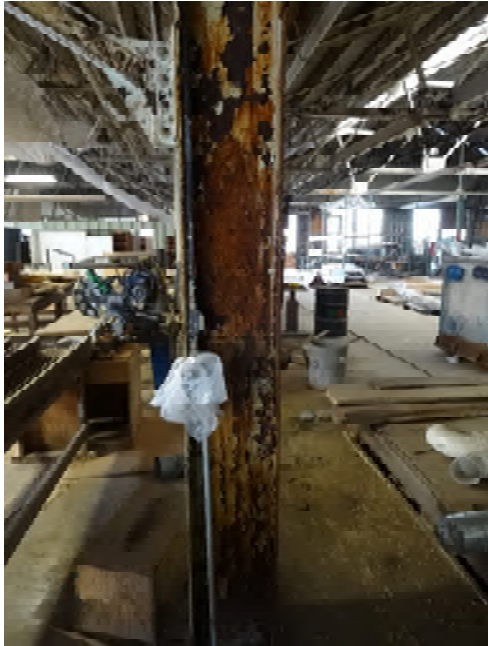
Figure 2 – Typical column corrosion

- Clean existing rusted steel framing to remove rust and paint, assess its condition, and re-coat with a rust-inhibiting primer and paint. There is a potential for the presence of lead or other hazardous materials in the existing coating.

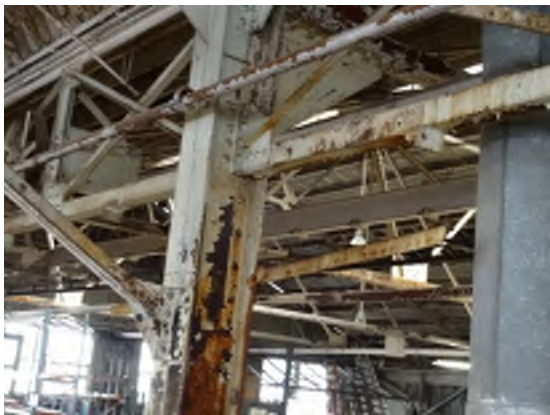
Figure 3 – Removed/Damaged brace

- Removed “x” braces along the interior and east side need to be replaced. Approximately four locations.
- Patch or replace steel roof deck where rusting has created rust holes. Approximately 10-15% of the area.

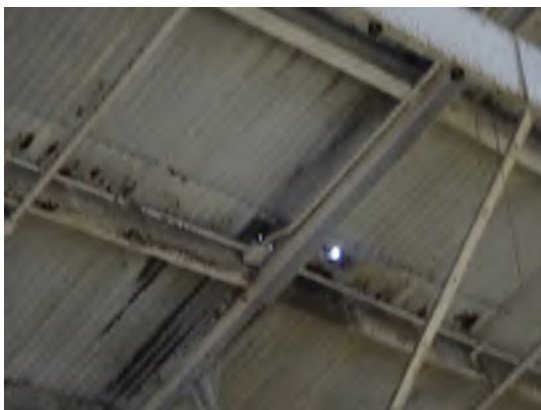
Figure 4 – Typical CMP roof damage

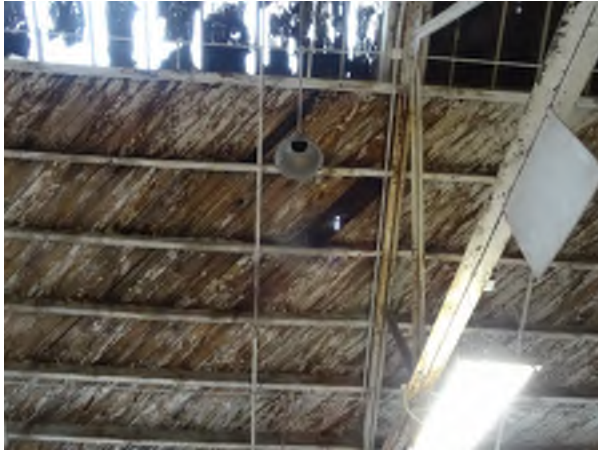
Figure 5 – Typical wood roof damage

- Replace approximately 30% of 1x diagonal wood roof sheathing in kind.
- Replace purlins at roof framing that show significant sagging, approximately 20%.

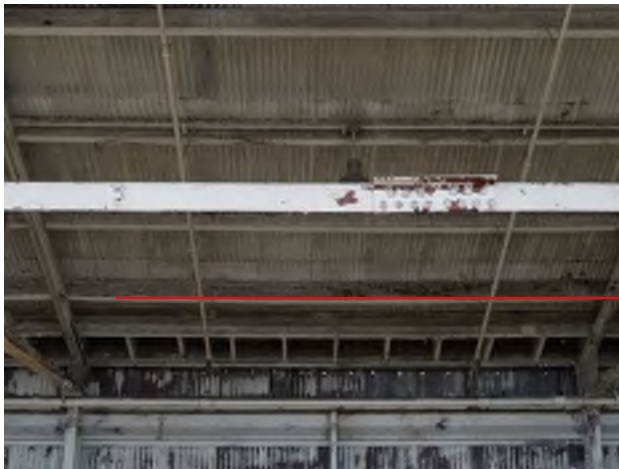
Figure 6 – Typical wood purlin sagging (redline drawn for clarity)

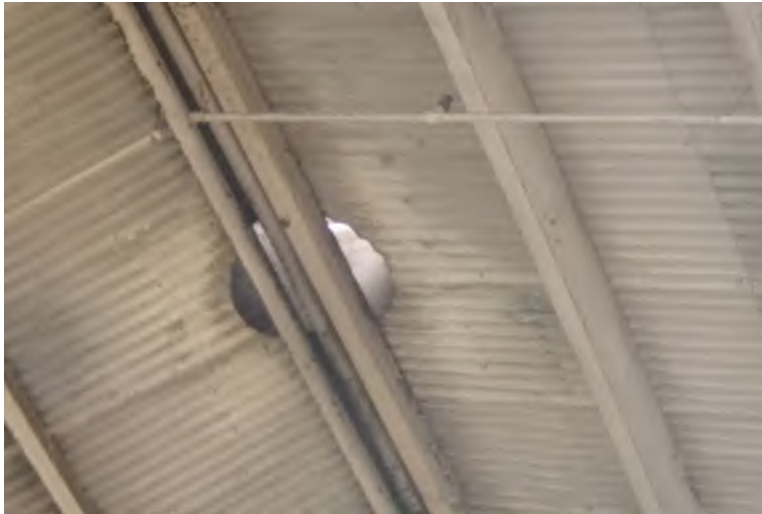
- 1st and 2nd floor shop area have no mechanical ventilation system. 2nd floor has gravity vents at peak of roof (See fig. 108-1).
- Small unit heaters provide heating. Appear abandoned with no current gas connection.
- Space is equipped with a process exhaust fan for sawdust collection. Numerous openings in the ductwork were observed.

Figure 108-1 – Gravity Vents in ceiling.

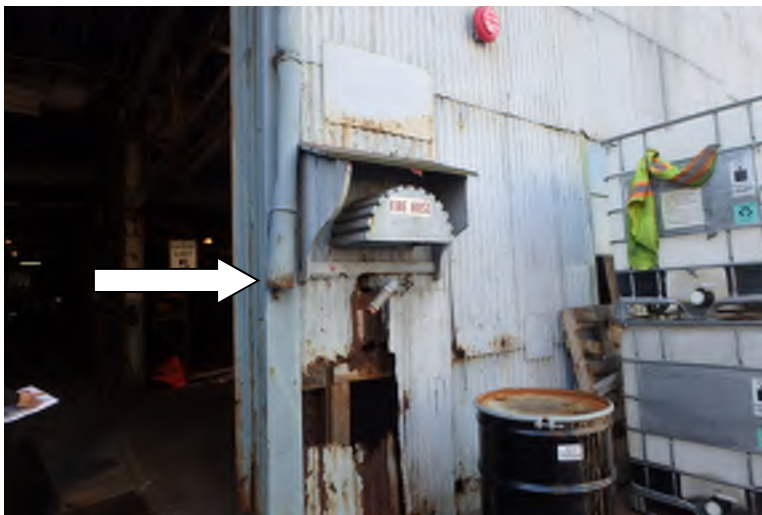
- Building is fully sprinklered with fire hoses available at the 2nd floor.
- Rainwater leaders from roof observed to be broken (See fig. 108-2).
- Building is equipped with a restroom at the 2nd floor w/ water closet, urinal, and hand sink available. Facility is currently labeled “out of service.”
- Waste connection from 2nd floor restroom run outside of building and observed equipped with non plumbing transition connections. Appear to be 90-degree conduit connections. (See fig. 108-3)

Figure 108-2 – Broken Rainwater Leader.

- Repair building plumbing service to restroom.
- Replace existing non-plumbing transitions with correct plumbing fittings.
- Repair existing rainwater leaders and route to terminate at floor drains.

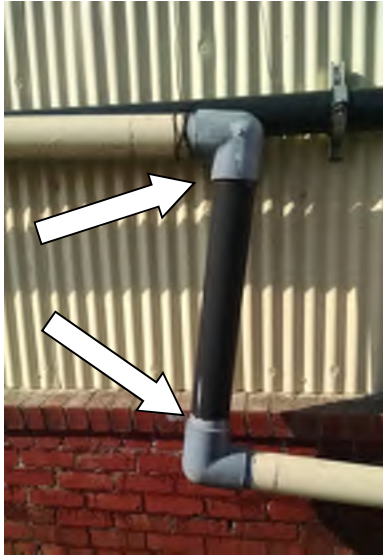
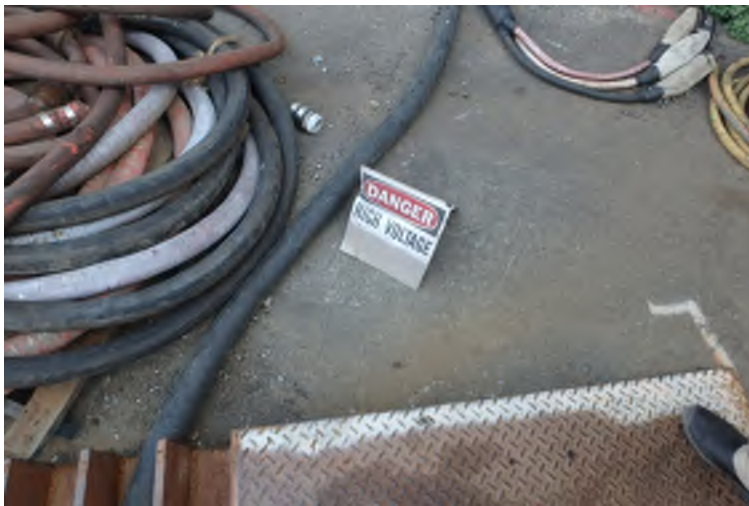
Figure 108-3 – Non-waste fitting on plumbing waste pipe.

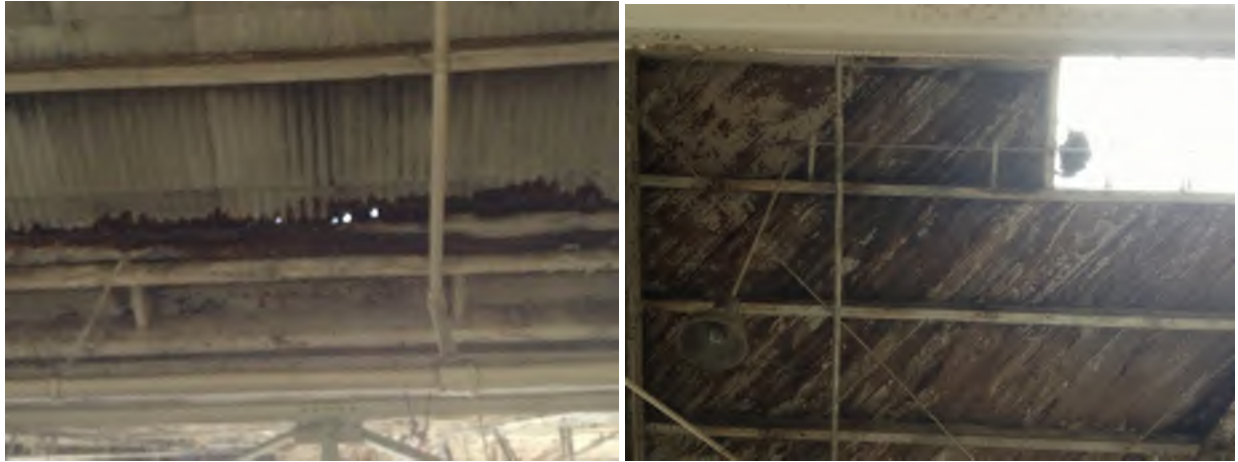
Fig. 1 - Building 108 metal roof from interior on left and wood roof from interior on right

GENERAL NOTES: The corrugated roof has multiple holes in multiple locations, throughout the entire area all of which are visible from the building's interior.

GENERAL NOTES: The built up roof has multiple leaks in multiple locations, moisture damage roof sheathing 2xs and framing members, this occurs in multiple locations; all areas are visible from the building interior.

- Temporary roofing patch or caulking of all holes and penetrations is recommended.

- Replace all moisture damaged lumber and framing materials and patch all holes and penetrations is recommended

- Replacement of the entire roof is recommended as a long term solution

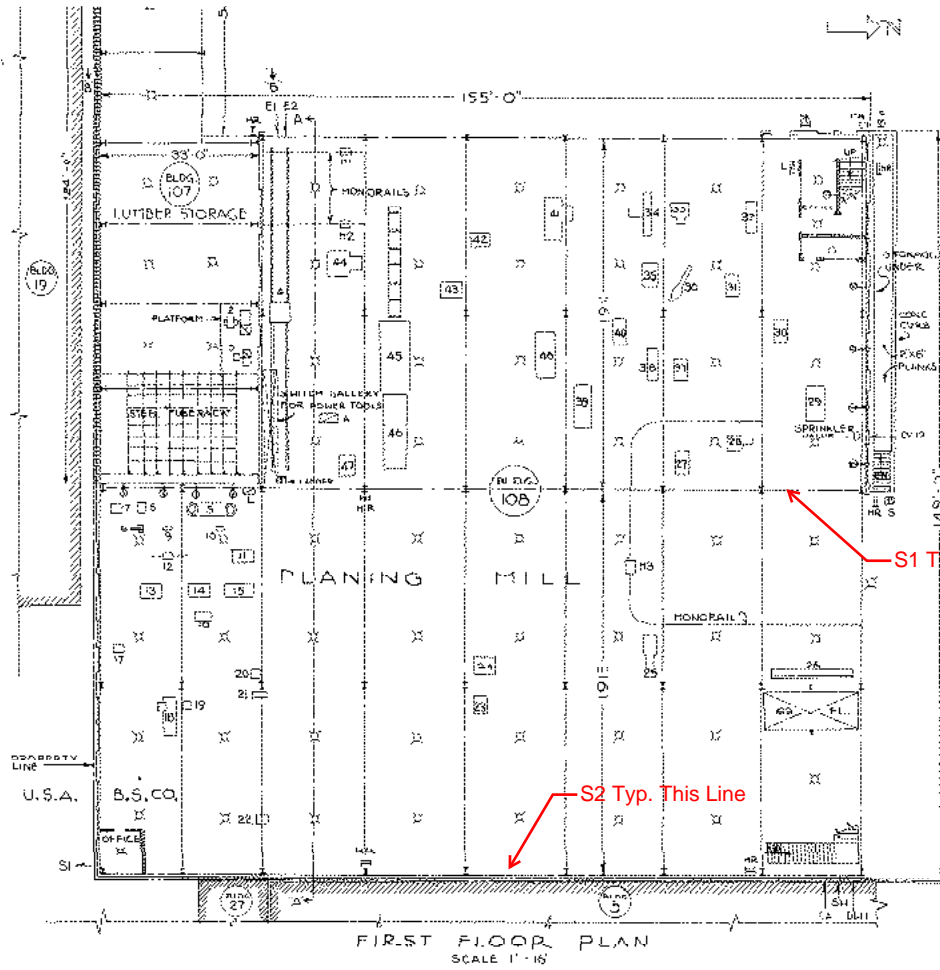
S1: Steel truss to be repaired per report.

S2: Steel braces to be repaired per report.
