**BUILDING 109****Tool Room/Paint Booth/Sheet Metal & Non-UV Covered Storage**

**BUILDING 109 Tool Room**

## BUILDING 109

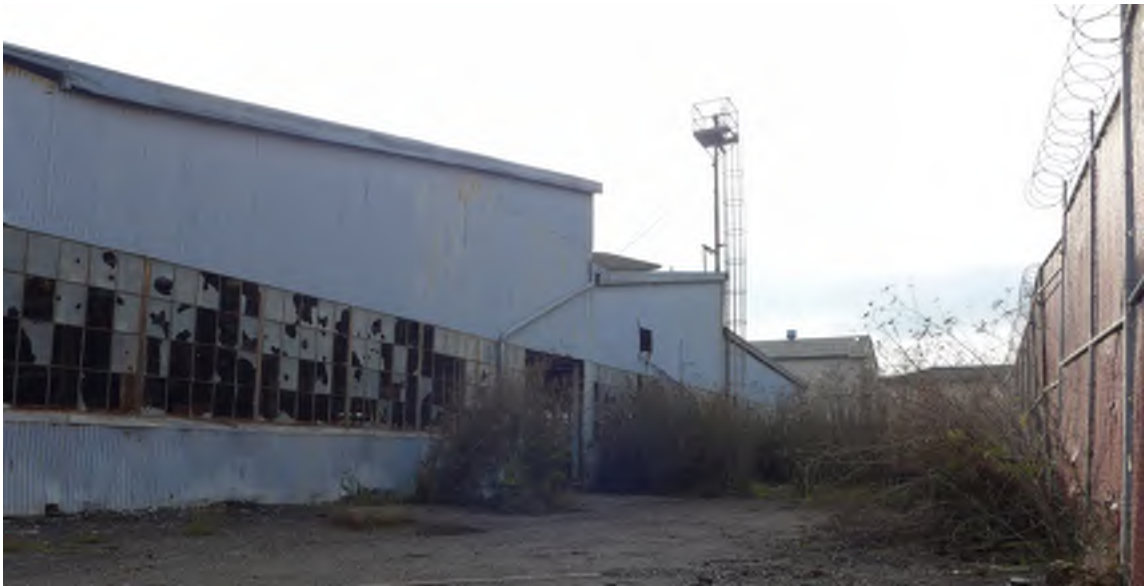
CMP (corrugated metal panels). Condition: Poor

The CMP at this western section of the building is painted on the exterior. It is heavily dented at the ground level. Plant growth at the perimeter is abundant on the west and south side of the building. There is a 3 square foot cut out above the windows on the west wall. The panels are torn at the northeast corner.

Figure 2 - Building 109, western section of building, view from northwest

- Repair 5% CMP panels.
  1. Replace deformed and deteriorated CMP with new galvanized corrugated steel to match the existing panels.
  2. Replace the panels from grade to the window sill level on the Non-UV Covered Storage portion of the building.
  3. Prime and paint the new panels.

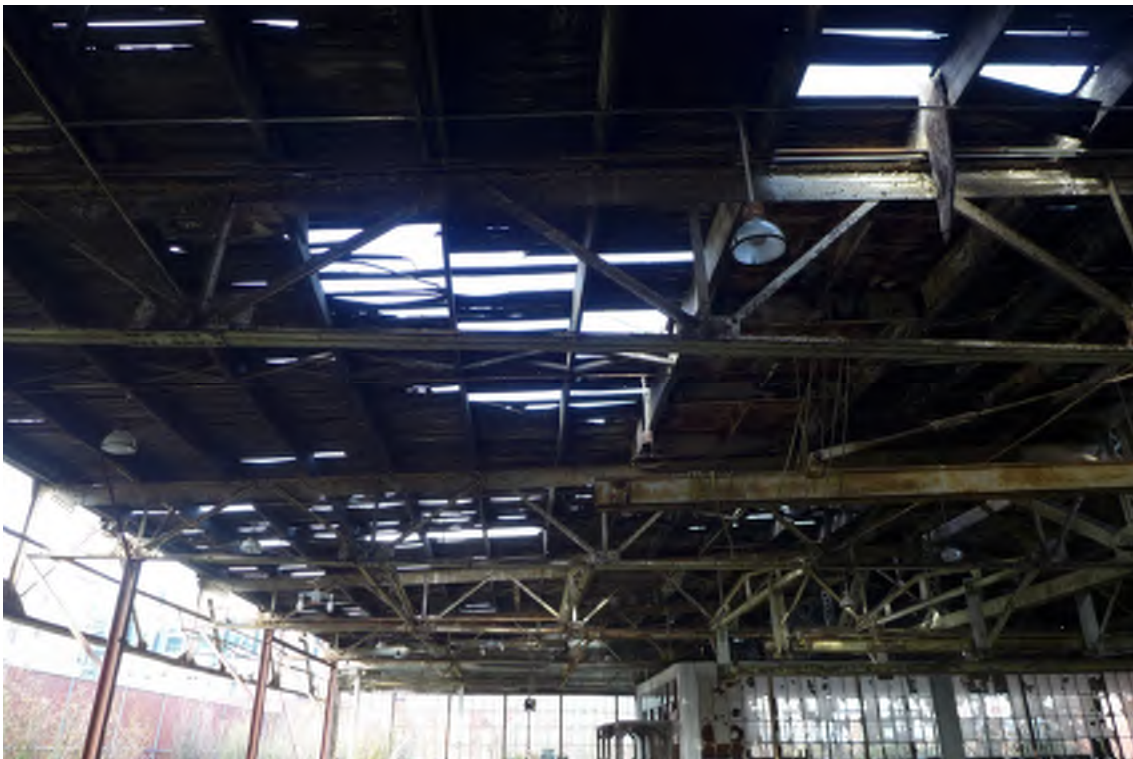
Tongue and groove wood planking. Condition: Poor

The wood is severely rotted. Large areas of ceiling are open to the sky.

Figure 6 - Building 109, western section of building, looking west. Note missing wood T&G ceiling.

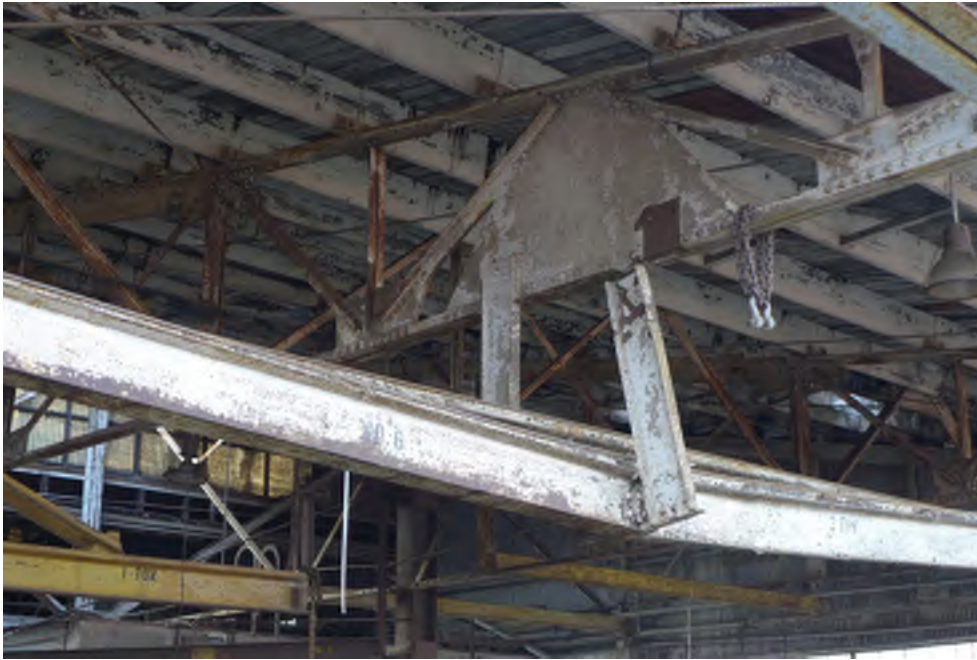
Steel trusses on wide flange steel columns. Condition: Poor

The steel structure at the portion of the building is severely rusted. A partially collapsed beam was observed.

Figure 7 - Building 109, western section of building. Note collapsed steel beam.

- Replace the damaged suspended platform.
- Approximately 20% of punch-out CMP roof should be replaced in kind.
- Approximately 20% of punch-out wood floor is rotted due to water damage and should be replaced in kind.
- Re-tension the “x” braces.
- Due to the significant level of damage observed at the western portion of the structure, further investigation of this region is recommended to determine the potential for collapse under service conditions. Potential partial or total demolition may be required.

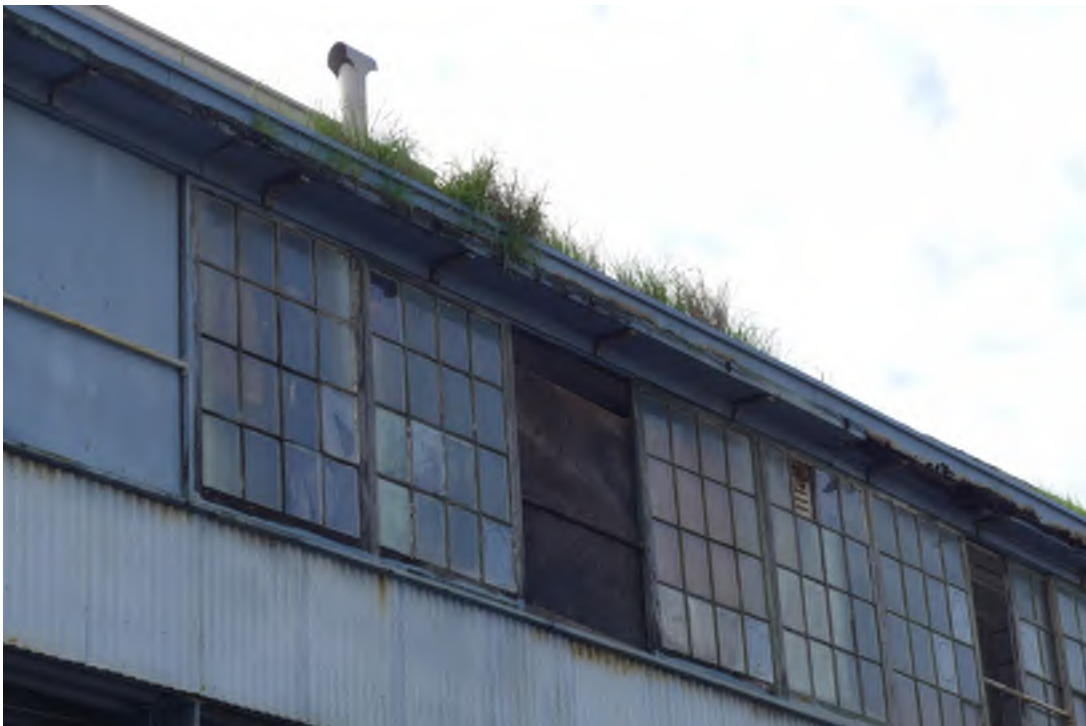
Wood Sash Multi-Lite Windows. Condition: Poor

The window sash at the Mold Loft are fixed and sliding unit. The wood at the windows is in very poor condition. Paint is missing from much of the surface of the wood. The sliding units are inoperable. Approximately 10% of the glass panes are missing or broken. The gutters above the windows are severely clogged with plant growth causing serious damage to the interior.

Figure 22 - Building 109, Mold loft windows, north elevation. Note gutter condition.

- Replace 15% of window panes at the 2nd floor of the Non-UV Covered Storage portion of the building.
- Replace 5% of window panes at the Paint Shop/Plate Shop/Rigging-Break Room/Tool Room
- Replace 10% of window panes at the Mold Loft
- Repaint 100% of all wood frames and sash.
- Repaint 100% of all steel window sash.

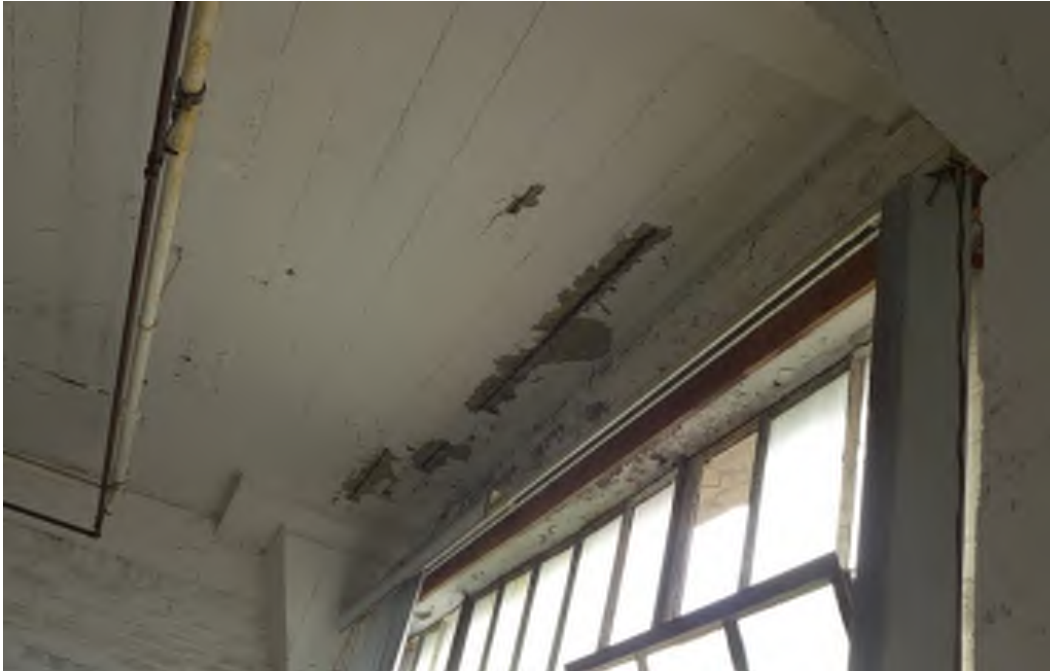
Localized areas of moisture damage with biological growth, cracking, spalling and exposed, rusting rebar.

Figure 35 - Building 111, third floor ceiling

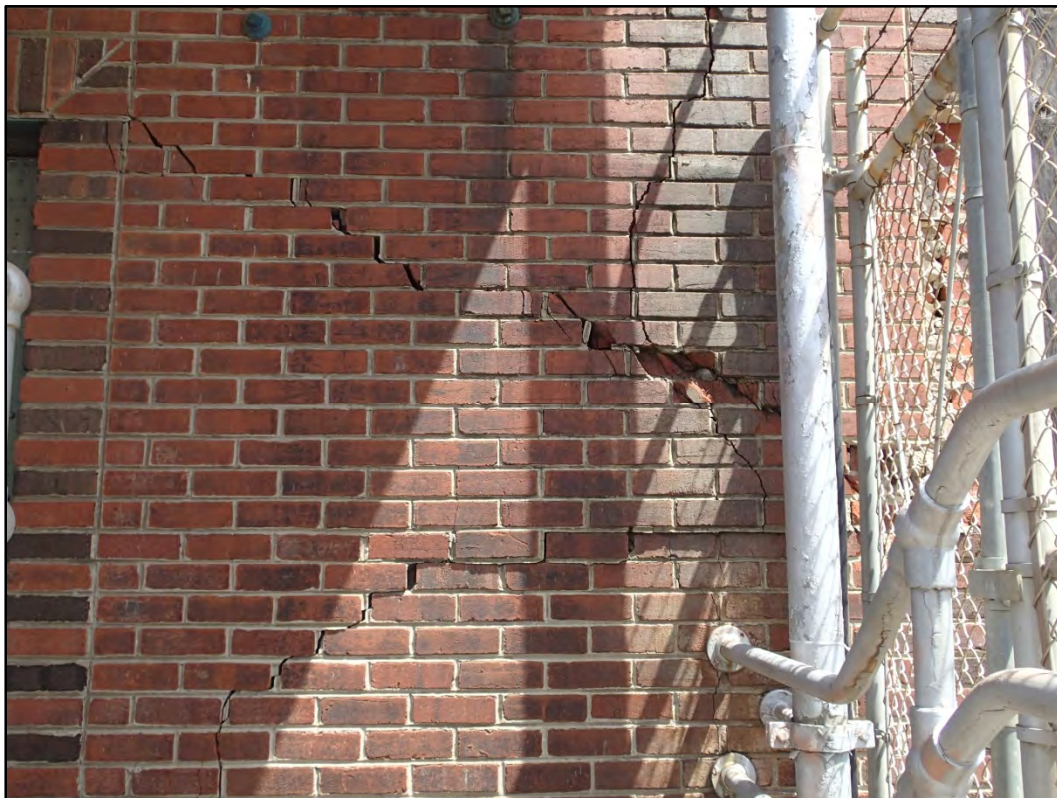
Figure 111-8 – View of the typical cracking on the exterior brick of Building 111.

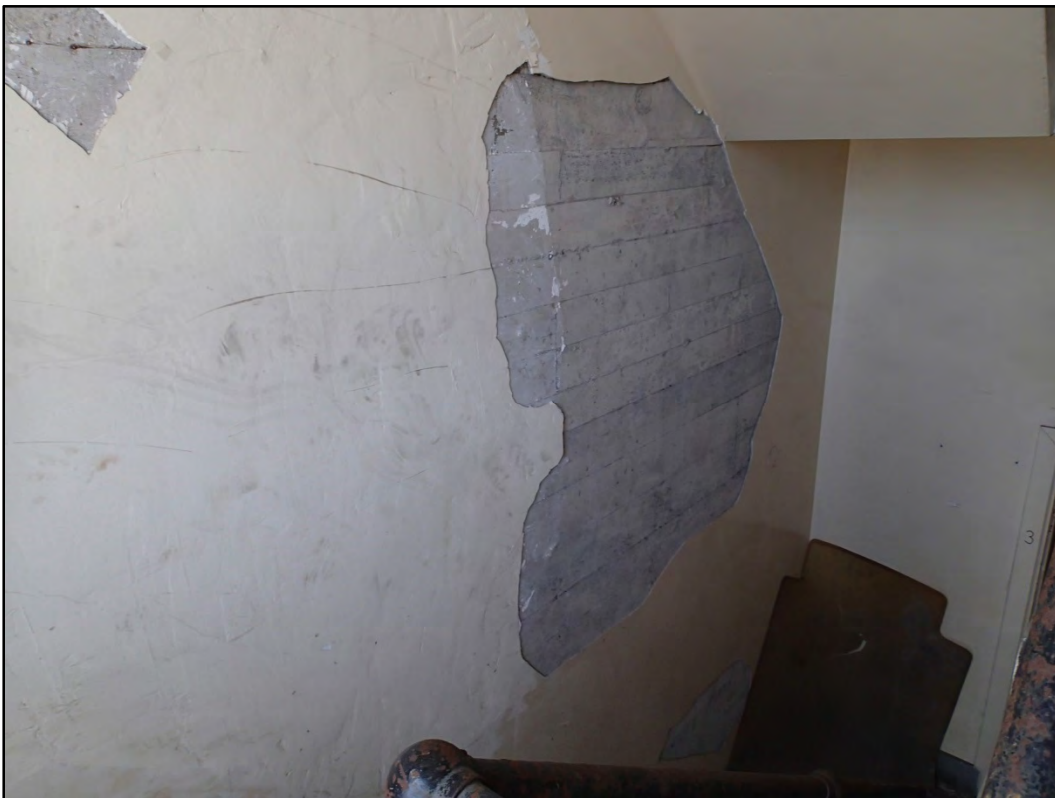
Figure 111-12 – View of typical interior plaster damage in Building 111.

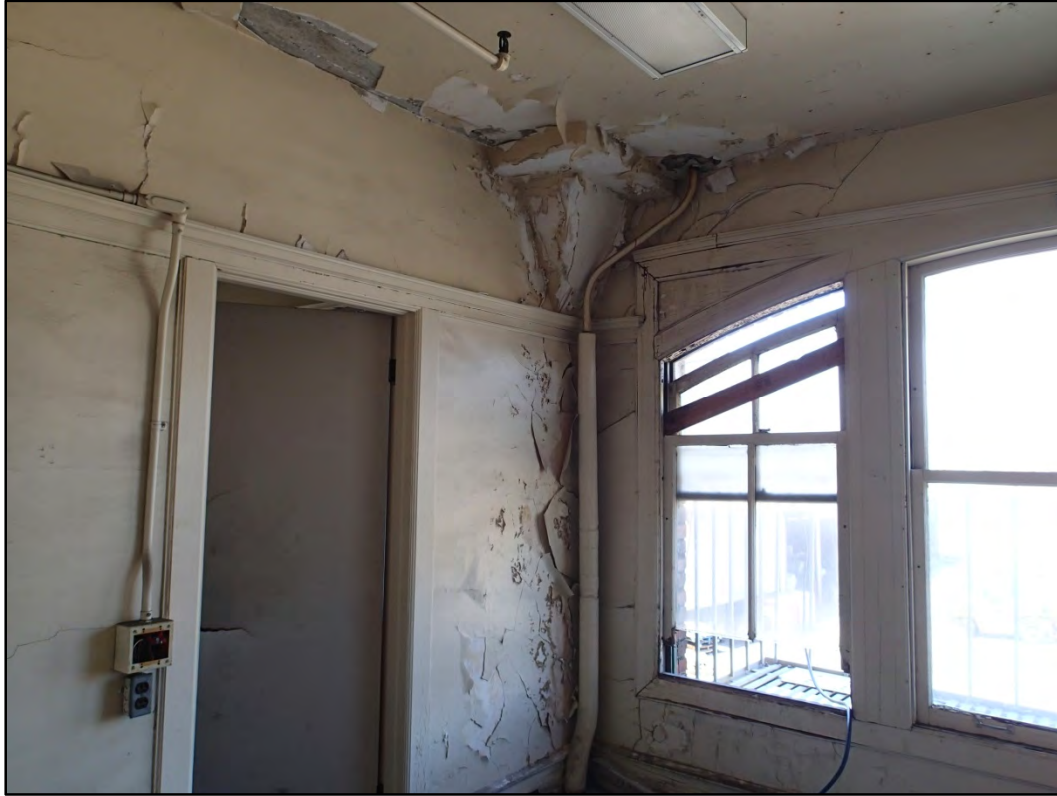
Figure 111-13 – View of typical interior paint deterioration in Building 111

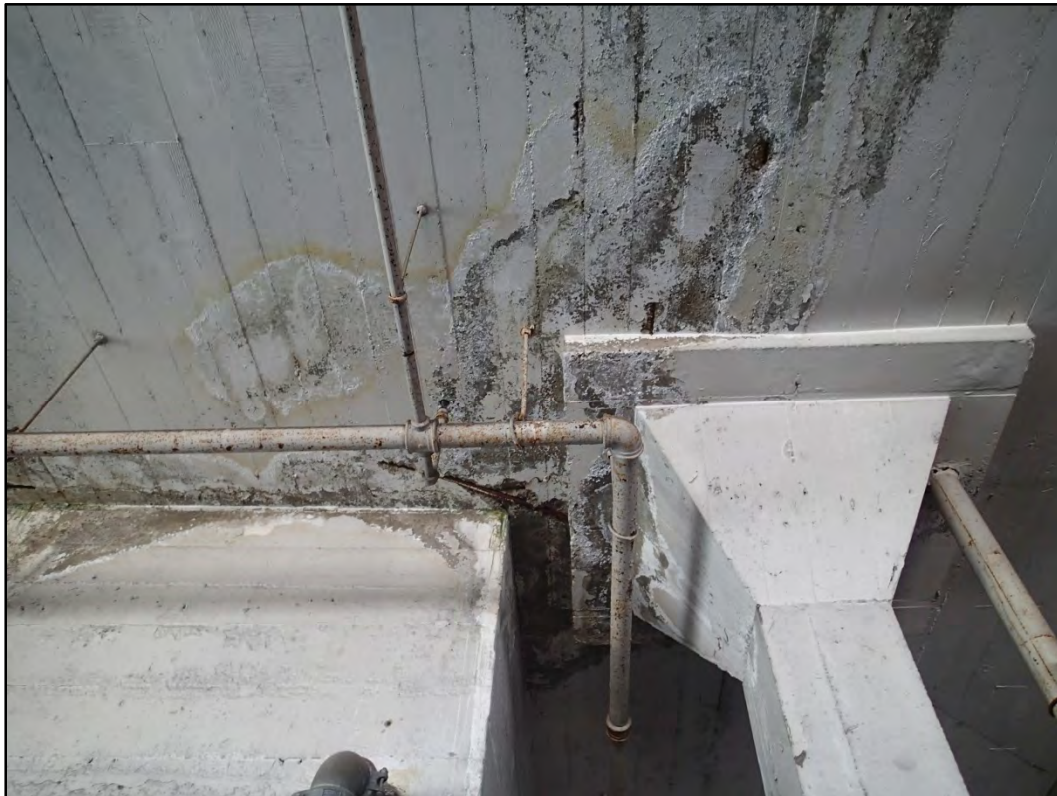
Figure 111-14 – View of fifth floor interior ceiling efflorescence in Building 111.

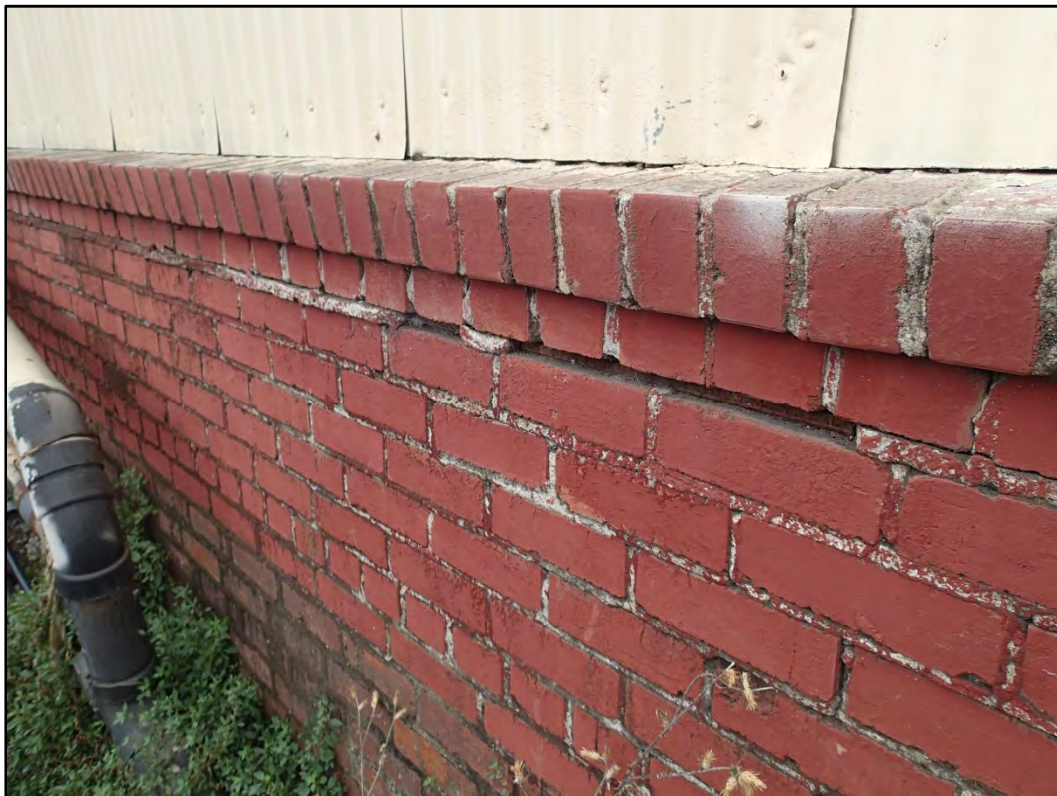
Figure 120-3 –View of deterioration in the exterior mortar joint at Building 120.

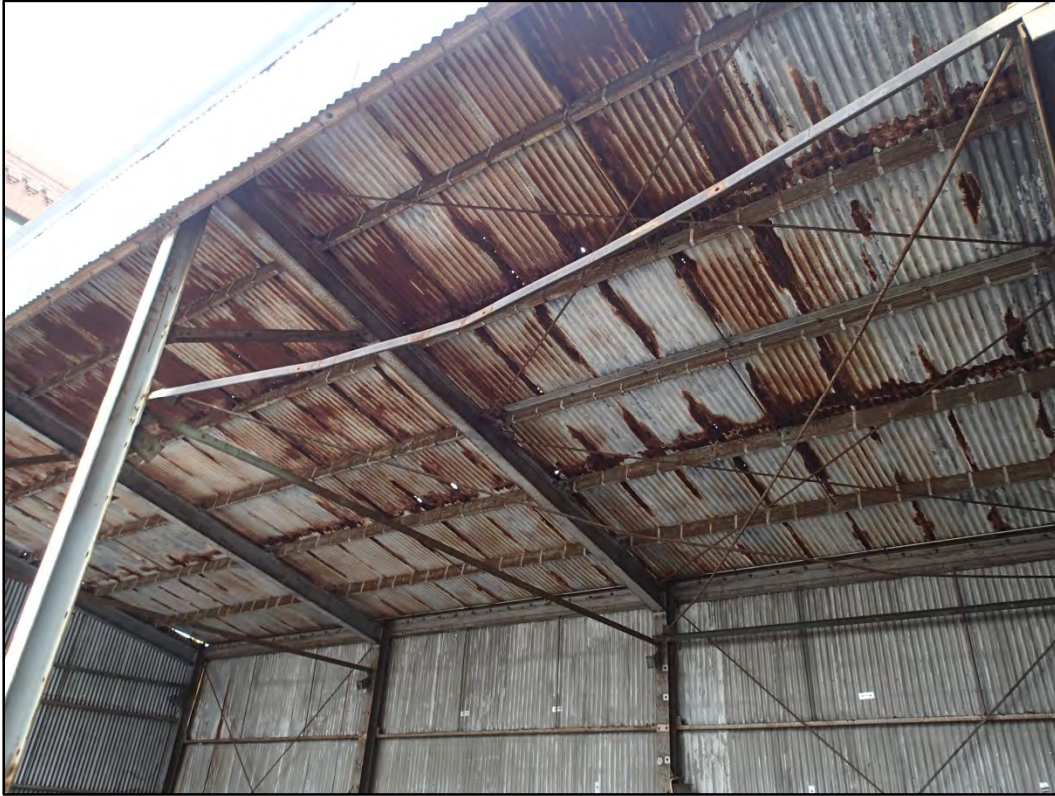
Figure 120-4 – View of the typical interior roof corrosion in Building 120.

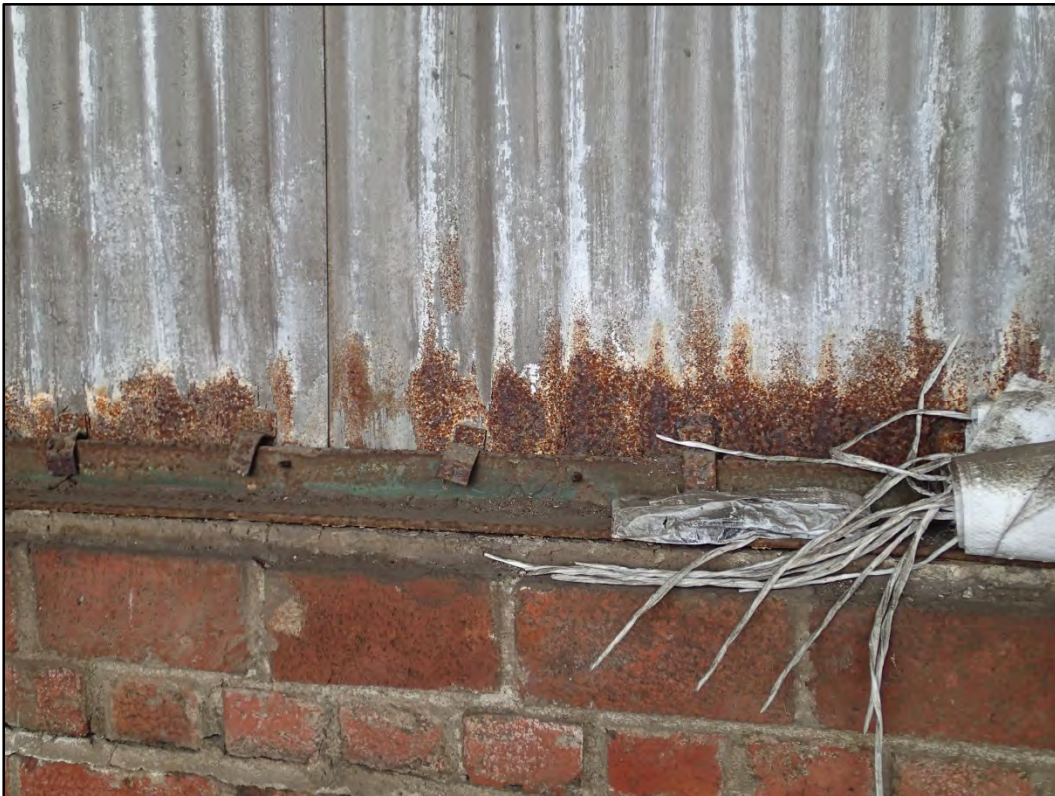
Figure 120-5 – View of the corrosion along the bottom edge of the interior corrugated metal wall panels.

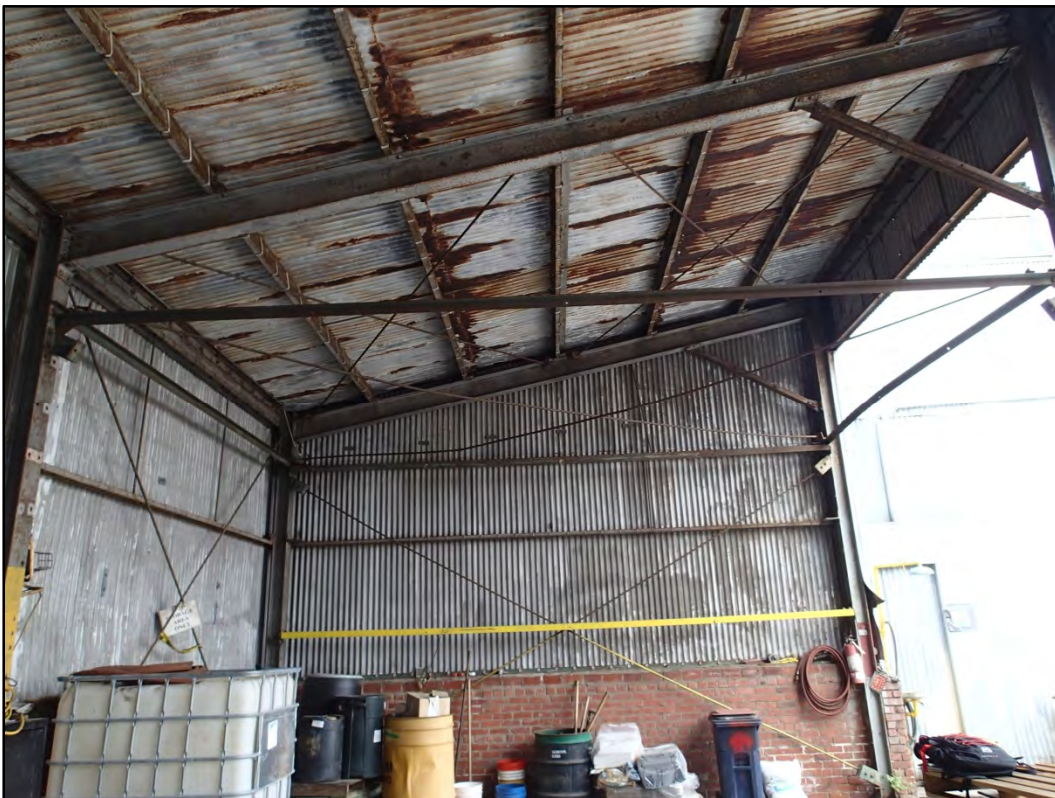
Figure 120-7 – View of the typical loose steel braces in Building 120.

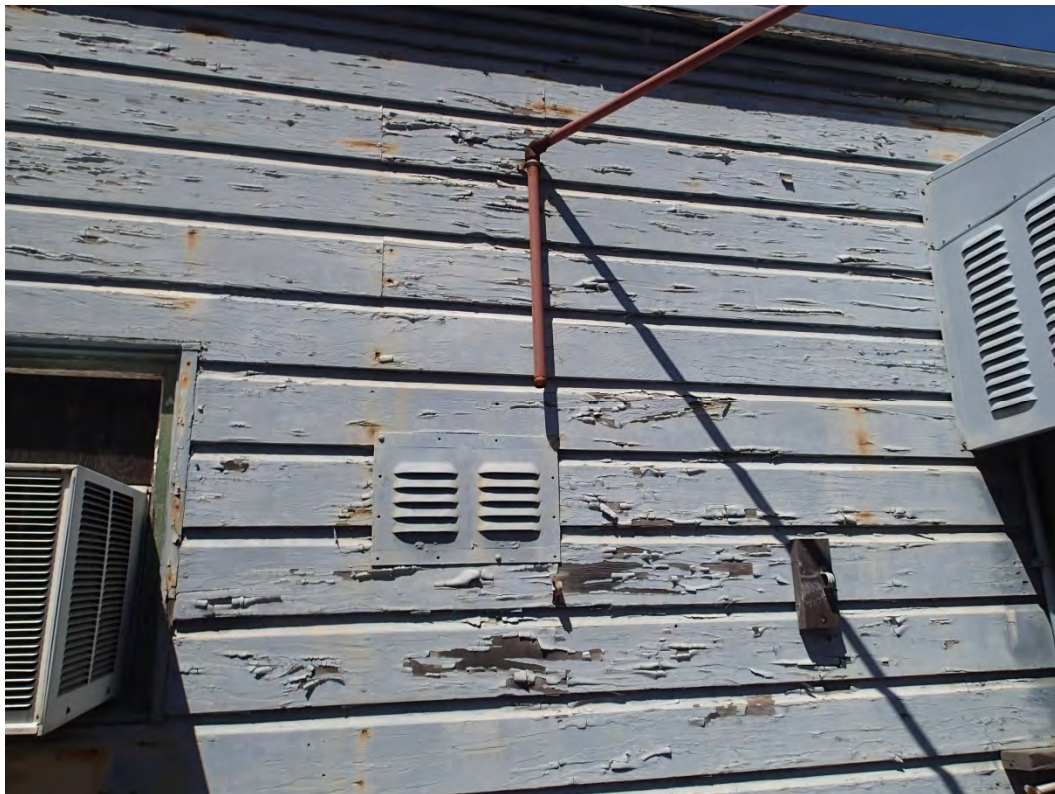
Figure 121-6 – View of the typical paint deterioration on the exterior of Building 121.

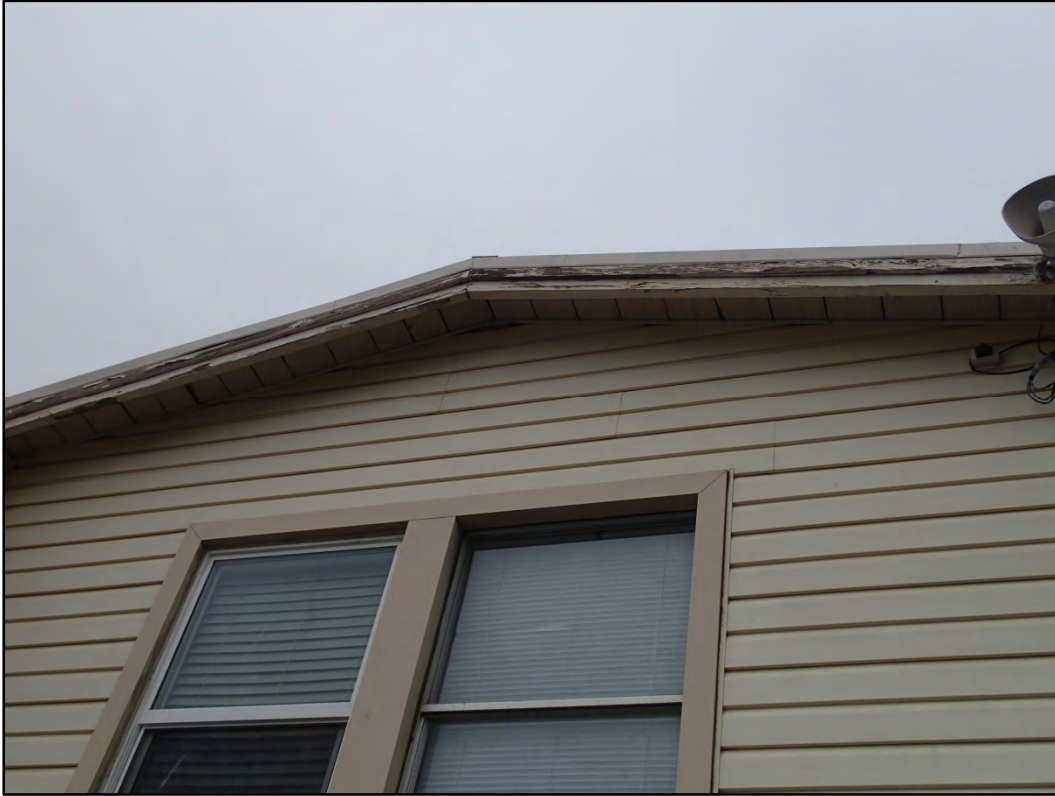
Figure 127-5 – View of the existing paint deterioration on the fascia and eaves at Building 127.

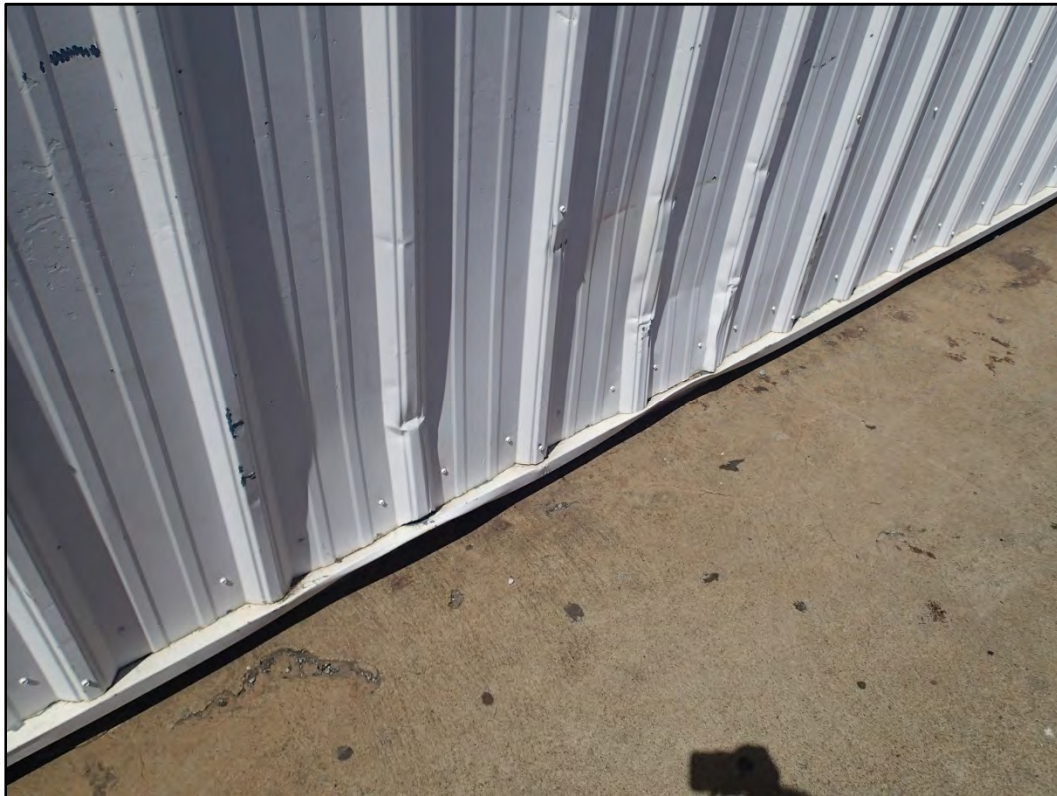
Figure 143-3 – View of previous damage to corrugated metal wall panel at Building 143.

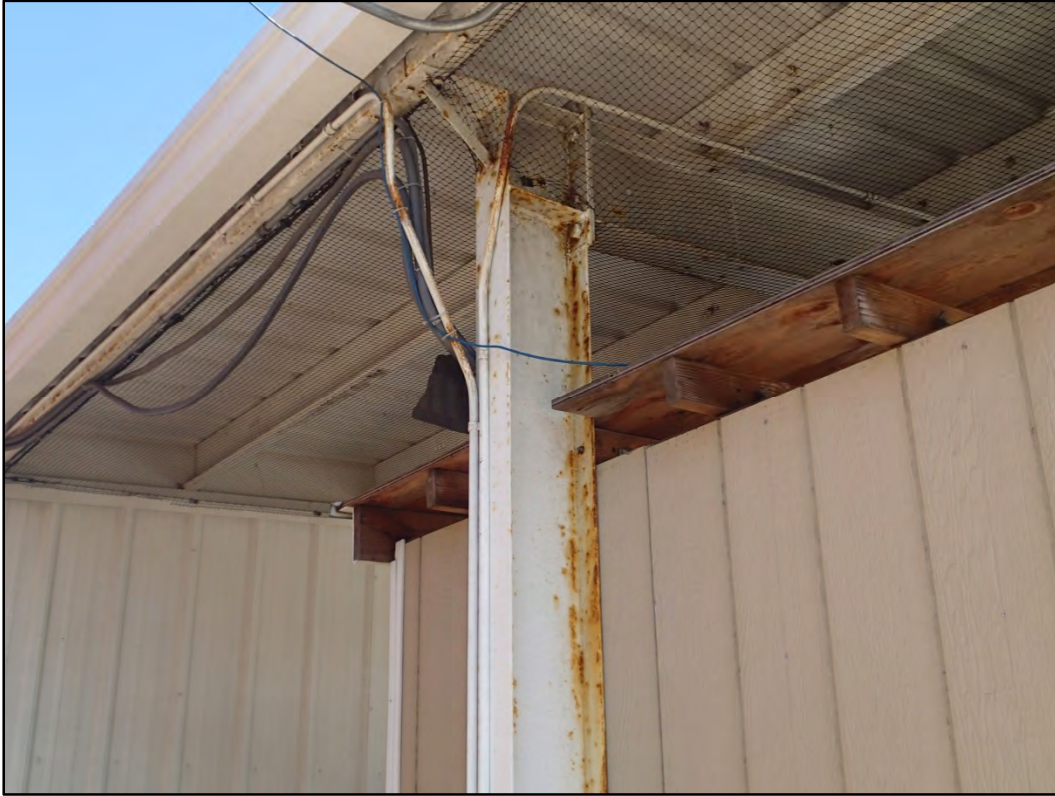
Figure 143-4 – View of the minor surface corrosion on the structural steel members at Building 143.

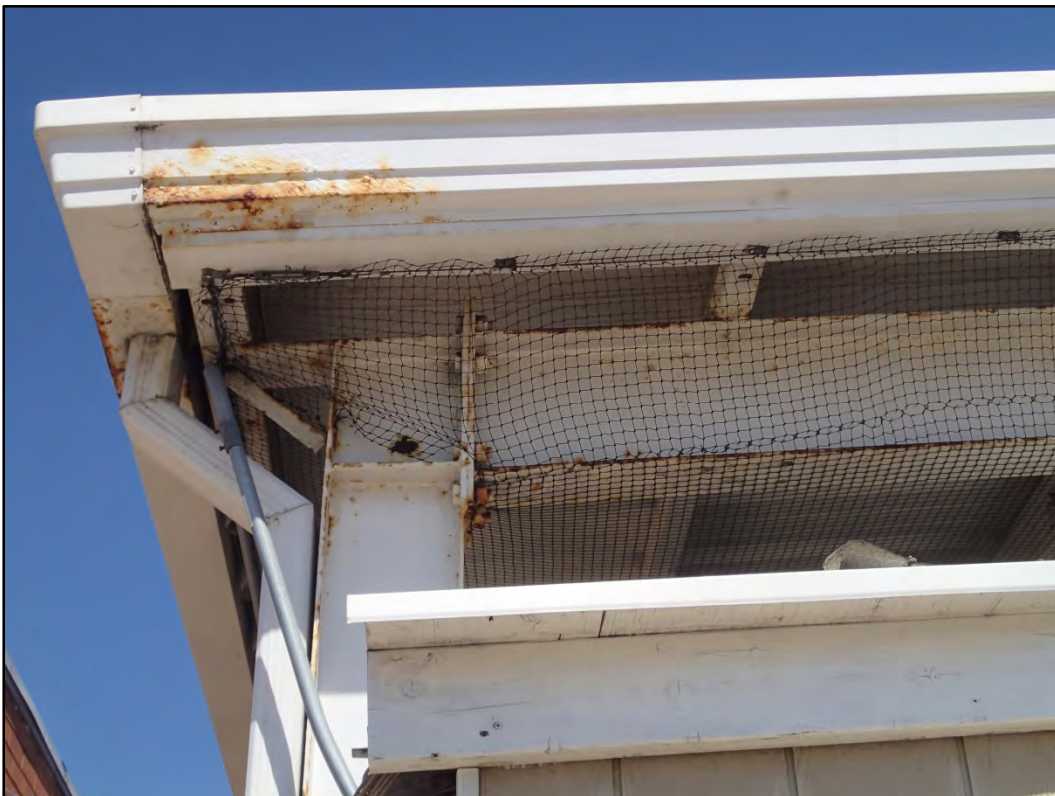
Figure 143-5 - View of the surface corrosion on the structural members and gutters at Building 143.

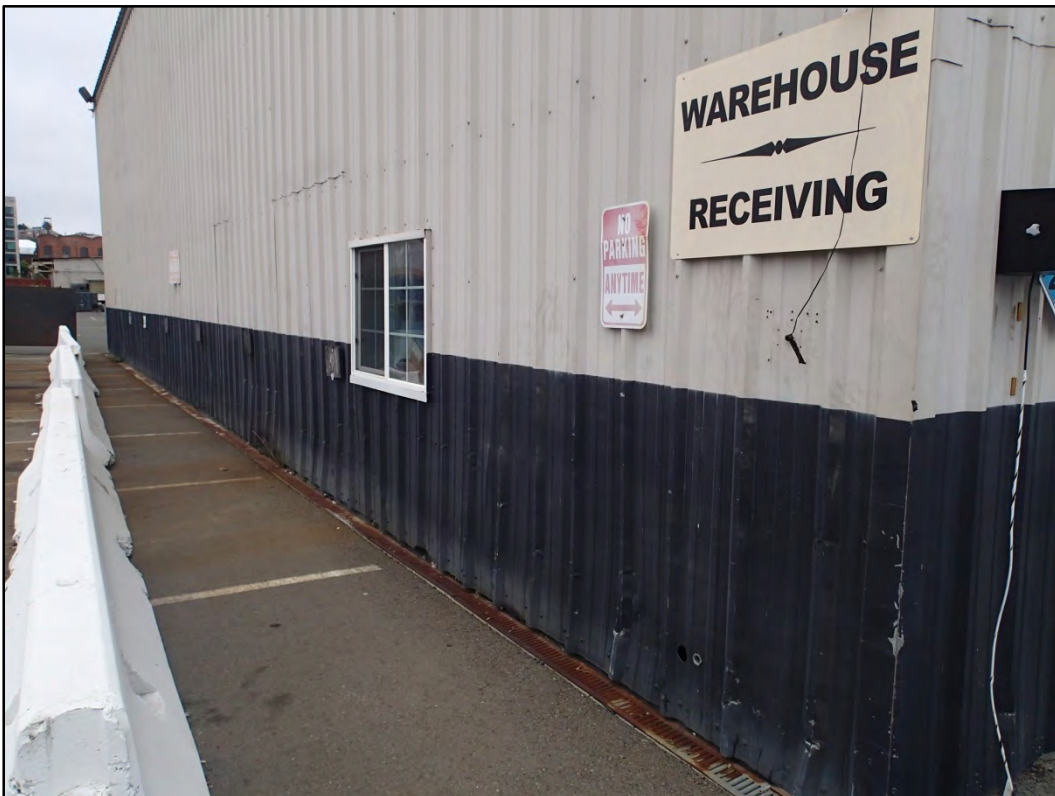
Figure 250-3 – View of the typical condition of the corrugated metal panels at Building 250.

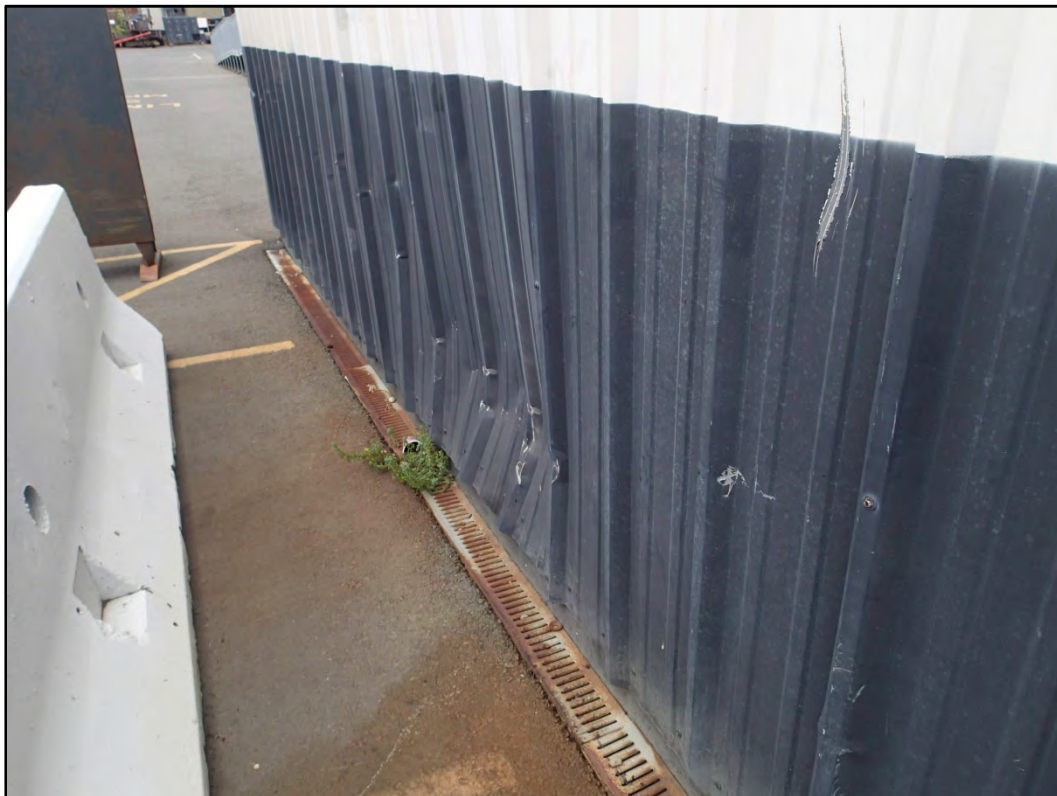
Figure 250-5 – View of the existing impact damage to the south wall at Building 250.

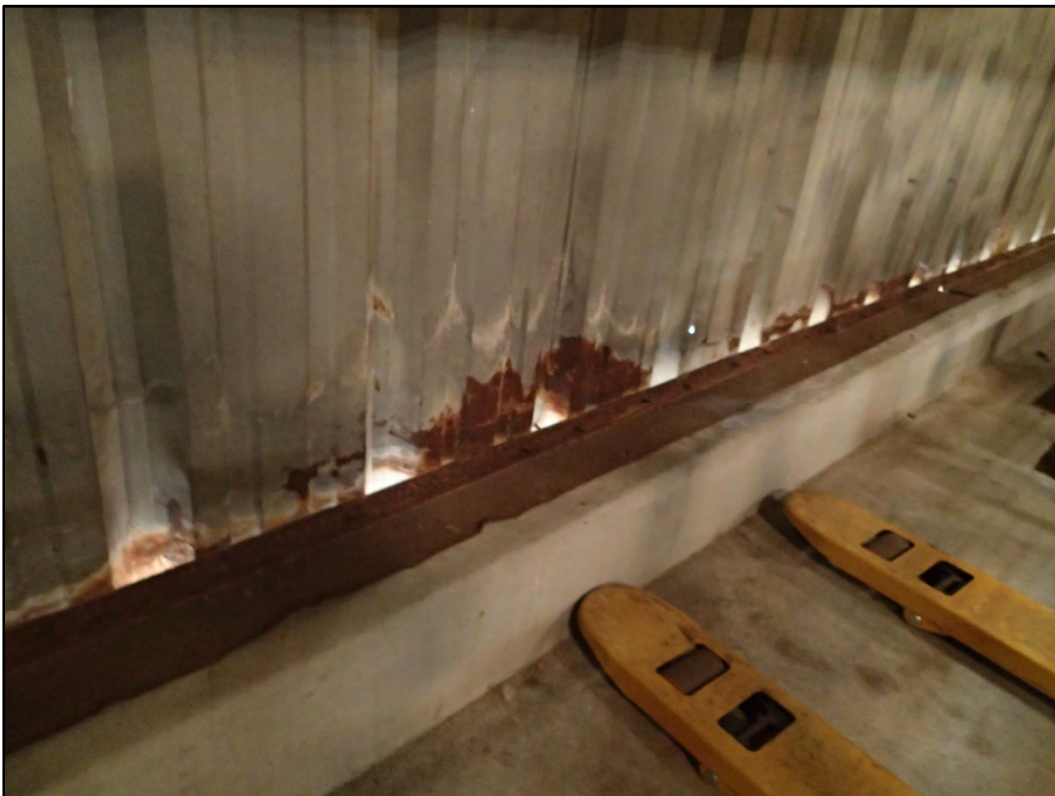
Figure 250-9 – View of the minor to moderate corrosion along the bottom of the corrugated metal panels.
