Pier 68-70 Shipyard Facility Condition Survey Civil Site Utilities Report

2185 North California Blvd, Suite 500
Walnut Creek, CA 94596
July 21, 2017
Job: 9590-06

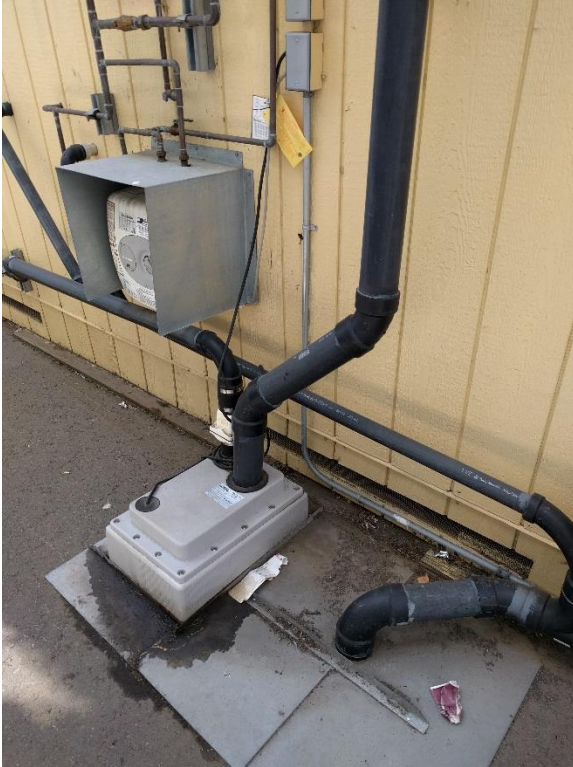
Figure 2. Medical Trailer Sewer Pump

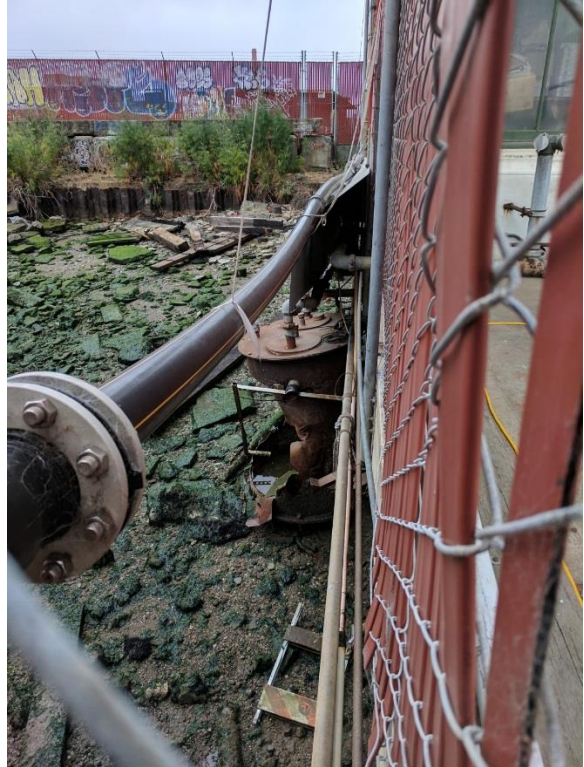
The existing sanitary sewer service for Building 111 is currently inactive. Building 111 was structurally condemned following the 1989 Loma Prieta Earthquake, and is currently utilized only for storage on the ground floor. Building 111 was serviced by a building pump and holding tank, but the tank had been damaged and the pump turned off.

The existing sanitary sewer service for Building 108 is also currently inactive. Building 108 was also serviced by the sewer pump and damaged holding tank next to Building 111.

Figure 3. Bldg 111 Damaged Holding Tank and Inactive Pump

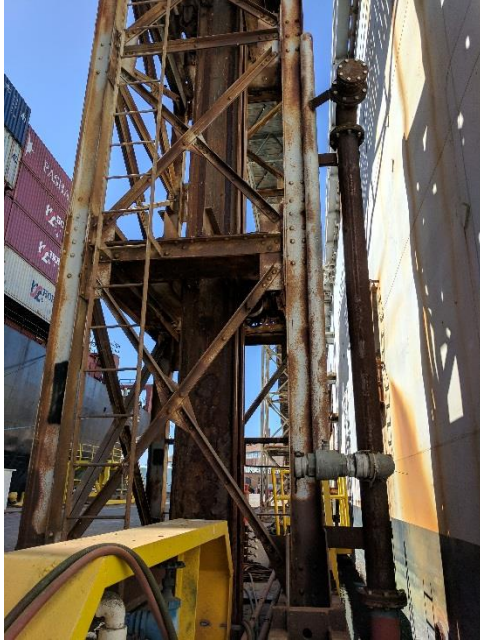
Figure 4. Sewer Ship Connection Pier 4 West

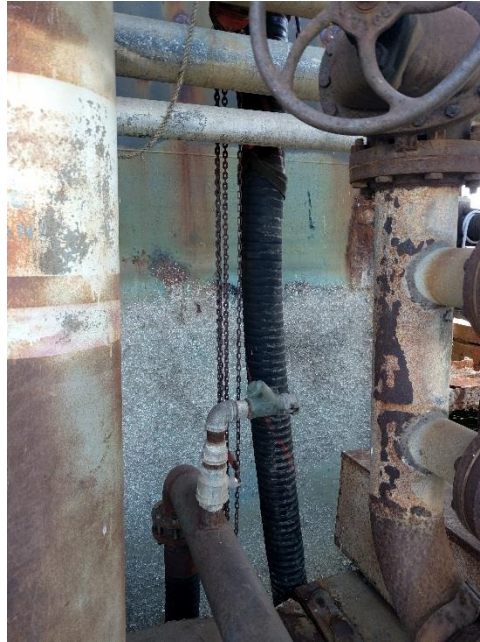
Figure 5. Highwater Platform Sewer Connection Drydock #2

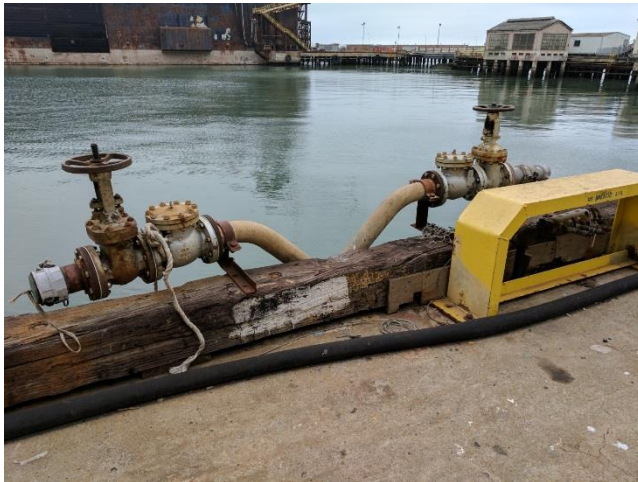
Figure 6. Sewer Ship Connection Pier 4 East

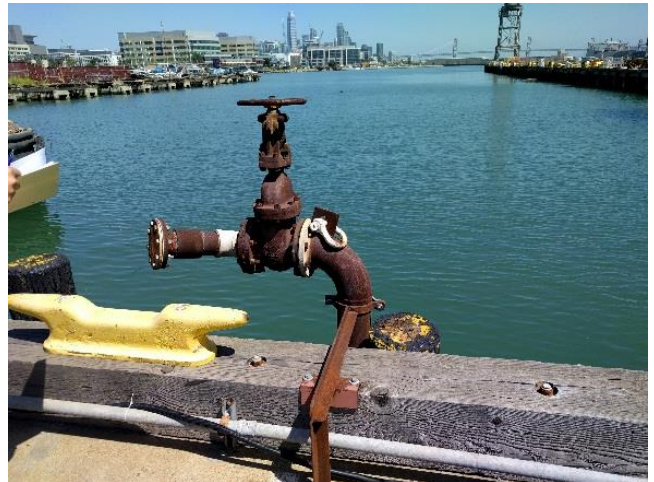
Figure 7. Sewer Ship Connection West of Pier 3

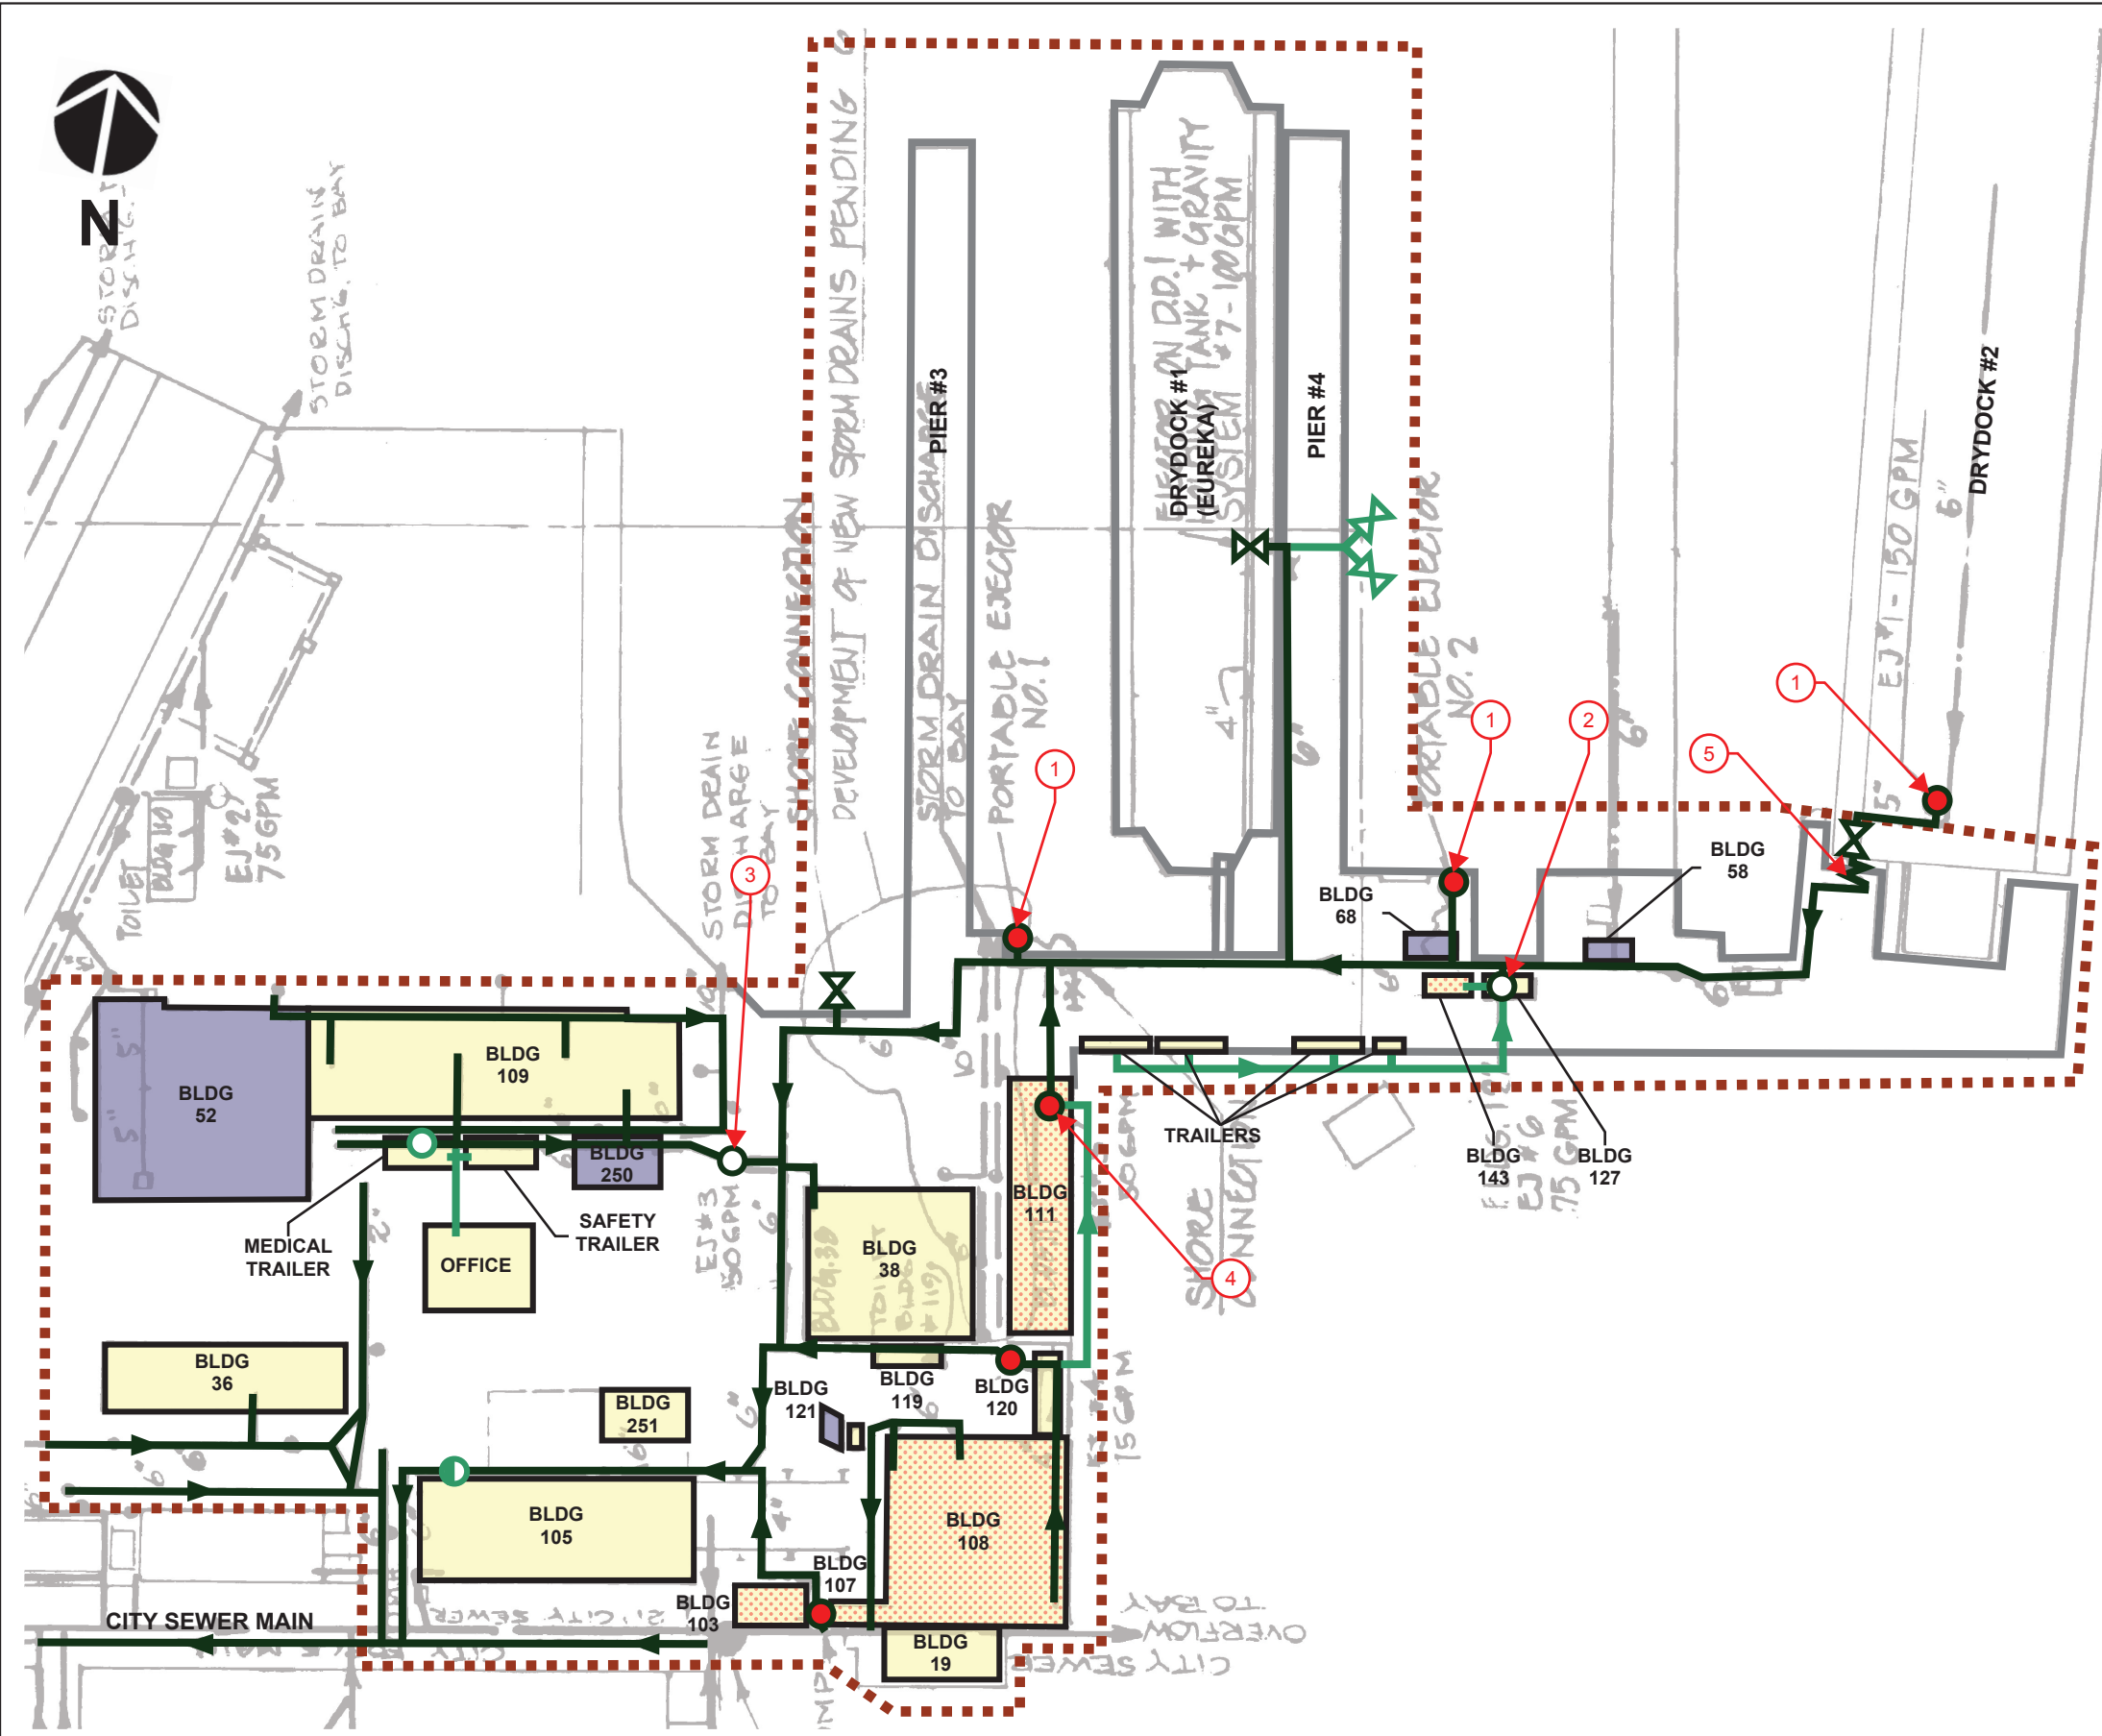
- 1 PORTABLE EJECTOR PUMPS WERE REMOVED.
- 2 ELECTRIC PUMP.
- 3 ONE OF THE TWO ELECTRIC PUMPS IS INACTIVE.
- 4 HOLDING TANK CONNECTED TO INACTIVE PUMP IS DAMAGED.
- 5 6" FLEXIBLE SEWER PIPE

It is our recommendation that existing building services be restored where feasible or where desired. The existing sanitary sewer pipes located under the High Water Platform should be repaired or replaced to restore service to Building 143 at a rough order of magnitude cost of about \$15,000. The building sewer pumps located by Building 103, 108, and 120 should be repaired, replaced at a rough order of magnitude cost of about \$15,000, or removed. It is also our recommendation to upgrade or repair the existing CHT pumps so that they are more reliable; assessment of the CHT pumps can be found in Section E. Pumps. Additionally, due to the age of the sewer system, it is also our recommendation that a thorough television inspection of the existing pipes be performed to better assess the condition of the existing underground pipes. The television inspection has a rough order of magnitude cost of about \$15,000.

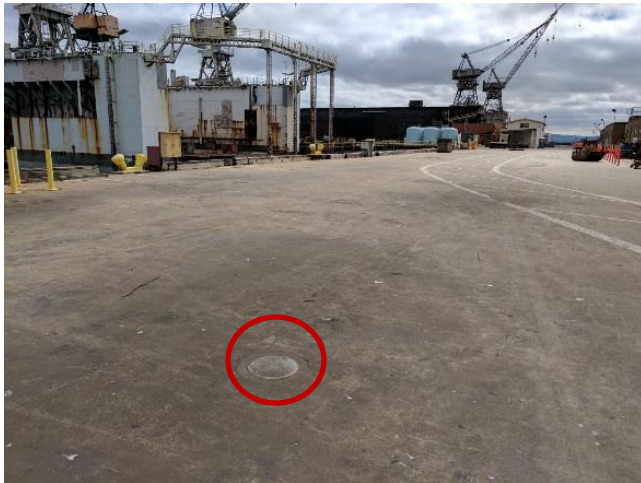
In order to comply with the SWPPP requirements, and to also reduce the number of water quality sampling points and point discharges into the bay, many of the existing drain inlets along the High Water Platform and piers have been deliberately plugged. Since drain inlets are often located at low-spots, plugging existing drain inlets have led to numerous locations of ponding water following storm events. The ponding water creates both a nuisance for staff and have contributed to the deterioration of the wharf top decking.

Figure 8. Wharf-side Plugged Drain

Regarding the plugged inlets along the Wharf, it is difficult for AGS to make a recommendation without understanding the cost savings associated with the reduced sampling, we feel this situation would best be addressed by SFPort or by the future operator, the following options could be considered:

1. Unplug the existing drain inlets along the Wharf that were previously plugged, for a rough order of magnitude cost of about \$35,000. The unplugging of drain inlets will lead to an increase in sampling points, and associated sampling costs, to meet SWPPP requirements;
2. Unplug the existing drain inlets along the Wharf that were previously plugged, provide storm drain piping beneath the wharf to collect groupings of drain inlets to minimize sampling points to meet SWPPP requirements; OR
3. Leave as is, tolerate the localized ponding around some plugged drain inlets, and accept an increase in maintenance costs associated with more frequent repairs to the wharf deck.

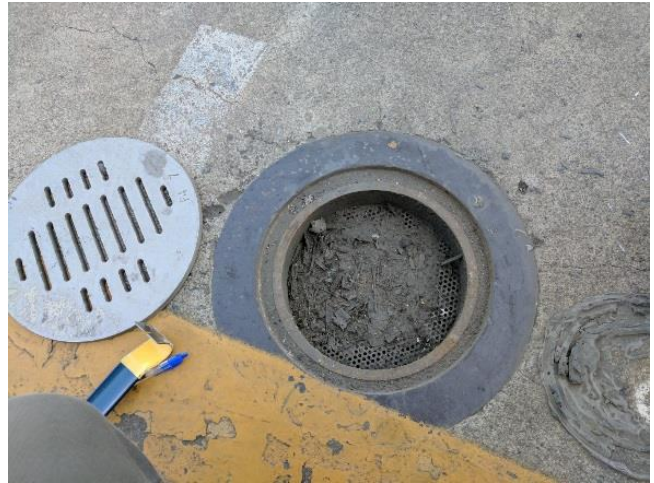
Figure 9. Wharf-side Drain Inlet with Screen

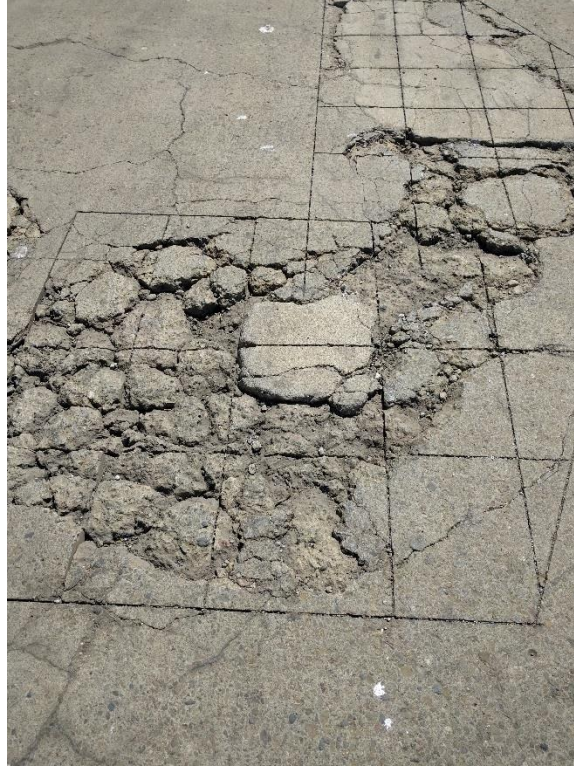
Figure 10. Wharf-side Concrete Deck Damage

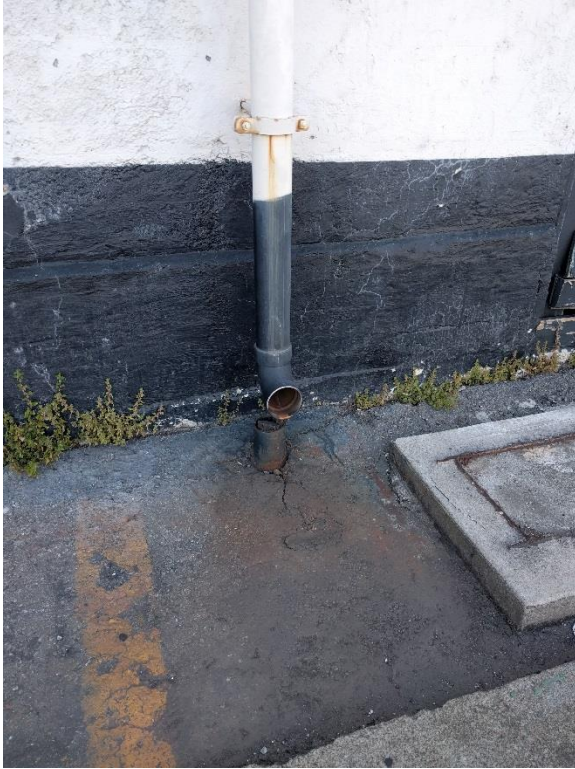
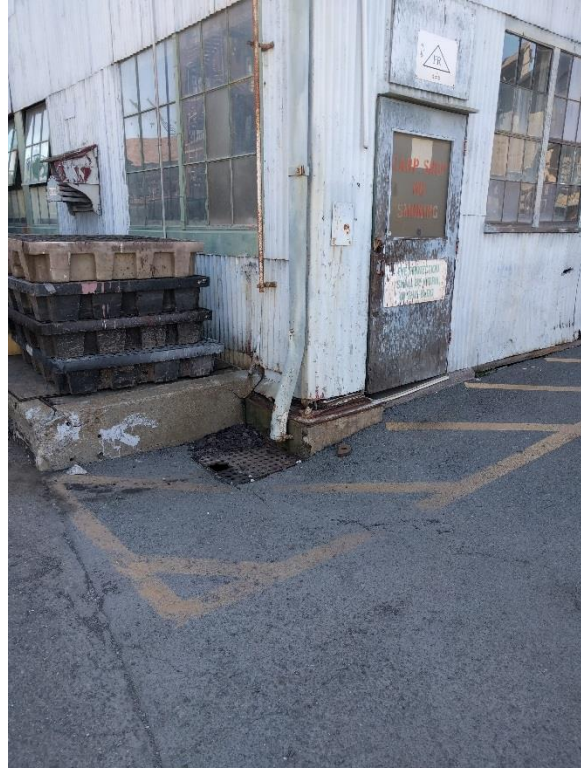
Figure 11. Disconnected Roof Downspout w/ Plugged Inlet Figure 12. Disconnected Roof Downspout

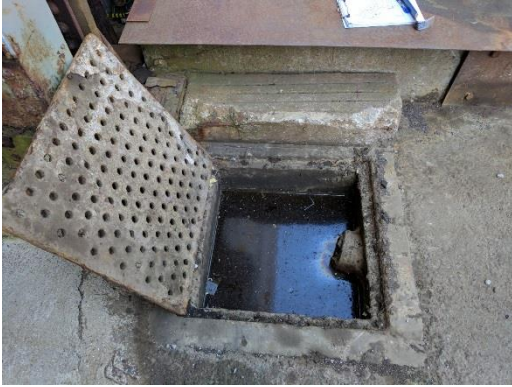
Figure 13. SD-13 Drain Inlet with Brackish Standing Water

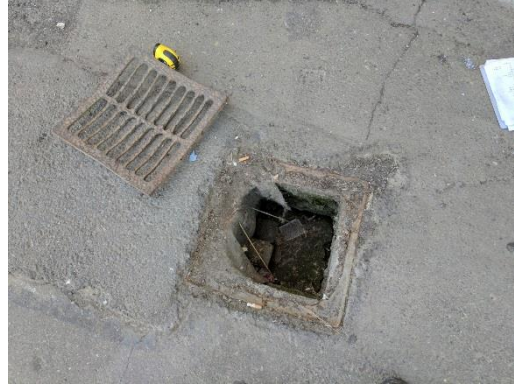
Figure 14. SD-20 Drain Inlet with Debris/Dirt

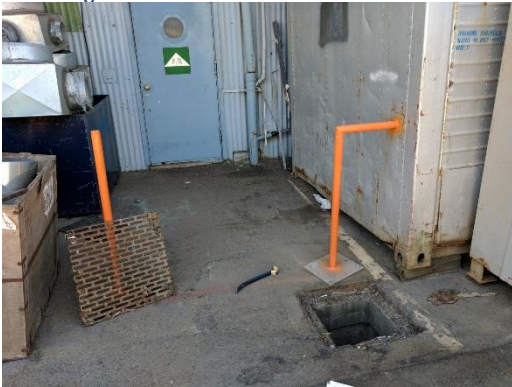
Figure 15. SD-13 Drain Inlet with Brackish Standing Water

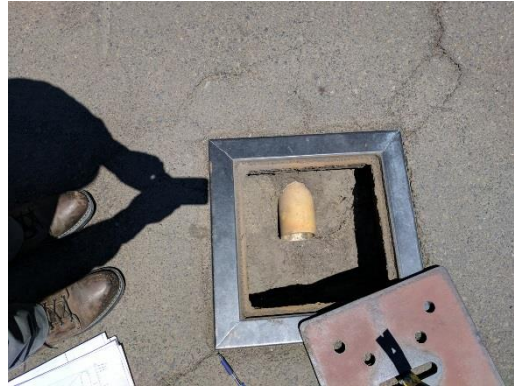
Figure 16. SD-20 Drain Inlet with Debris/Dirt and Plastic Pipe

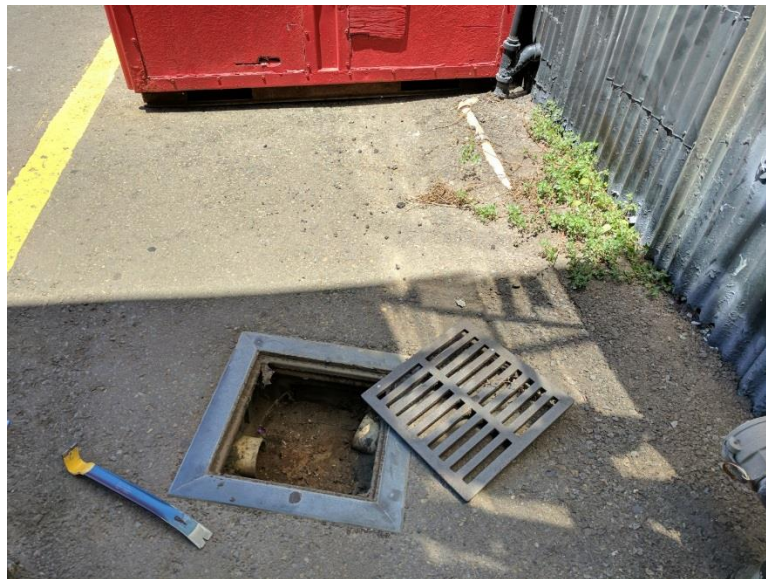
Figure 17. SD-27 Drain Inlet with Plastic Pipe

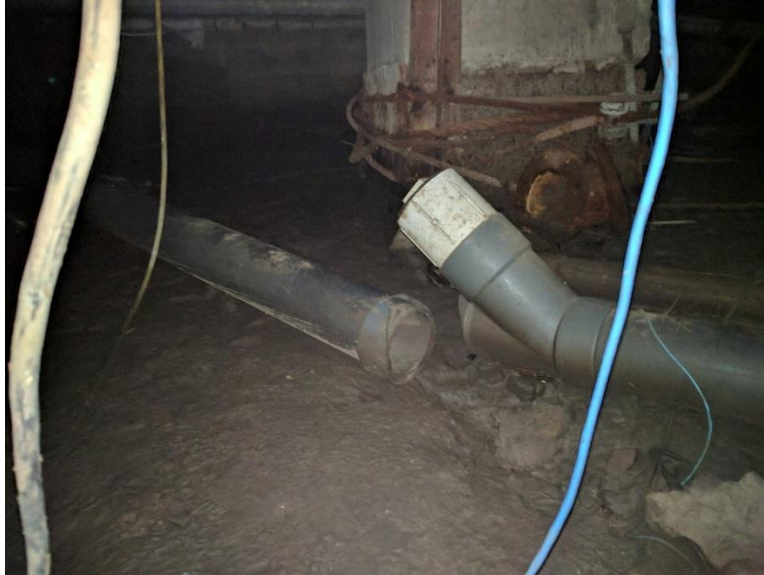
A portion of the landside storm drain system surrounding Building 111 connects to the inactive sanitary sewer pump with the damaged holding tank [Exhibit 3]. Based on interviews with Shipyard staff, the Building 111 system currently

appears to discharge directly to the basement level of Building 111, flooding the basement during storm events and eventually infiltrating through the ground.

Figure 18. Storm Drain Outfall Bldg 111

The storm drain system appears to be operational to the best extent practical and should continue to service the needs of the Shipyard. The separate storm drain system adjacent to Building 111 should be rerouted to connect to the existing landside storm drain system that discharges into the combined sanitary sewer and storm drain system, at a rough order of magnitude cost of about \$5,000. It is also recommended that the existing storm drain inlets be cleaned out to the sump at regular intervals as part of a comprehensive site maintenance program, at a rough order magnitude annual cost of about \$10,000. Additionally, due to the age of the storm drain system, it is also recommended to perform a television inspection of the existing pipes to better assess the existing condition of the pipes, see recommendations for sanitary sewer system television inspection in previous section.

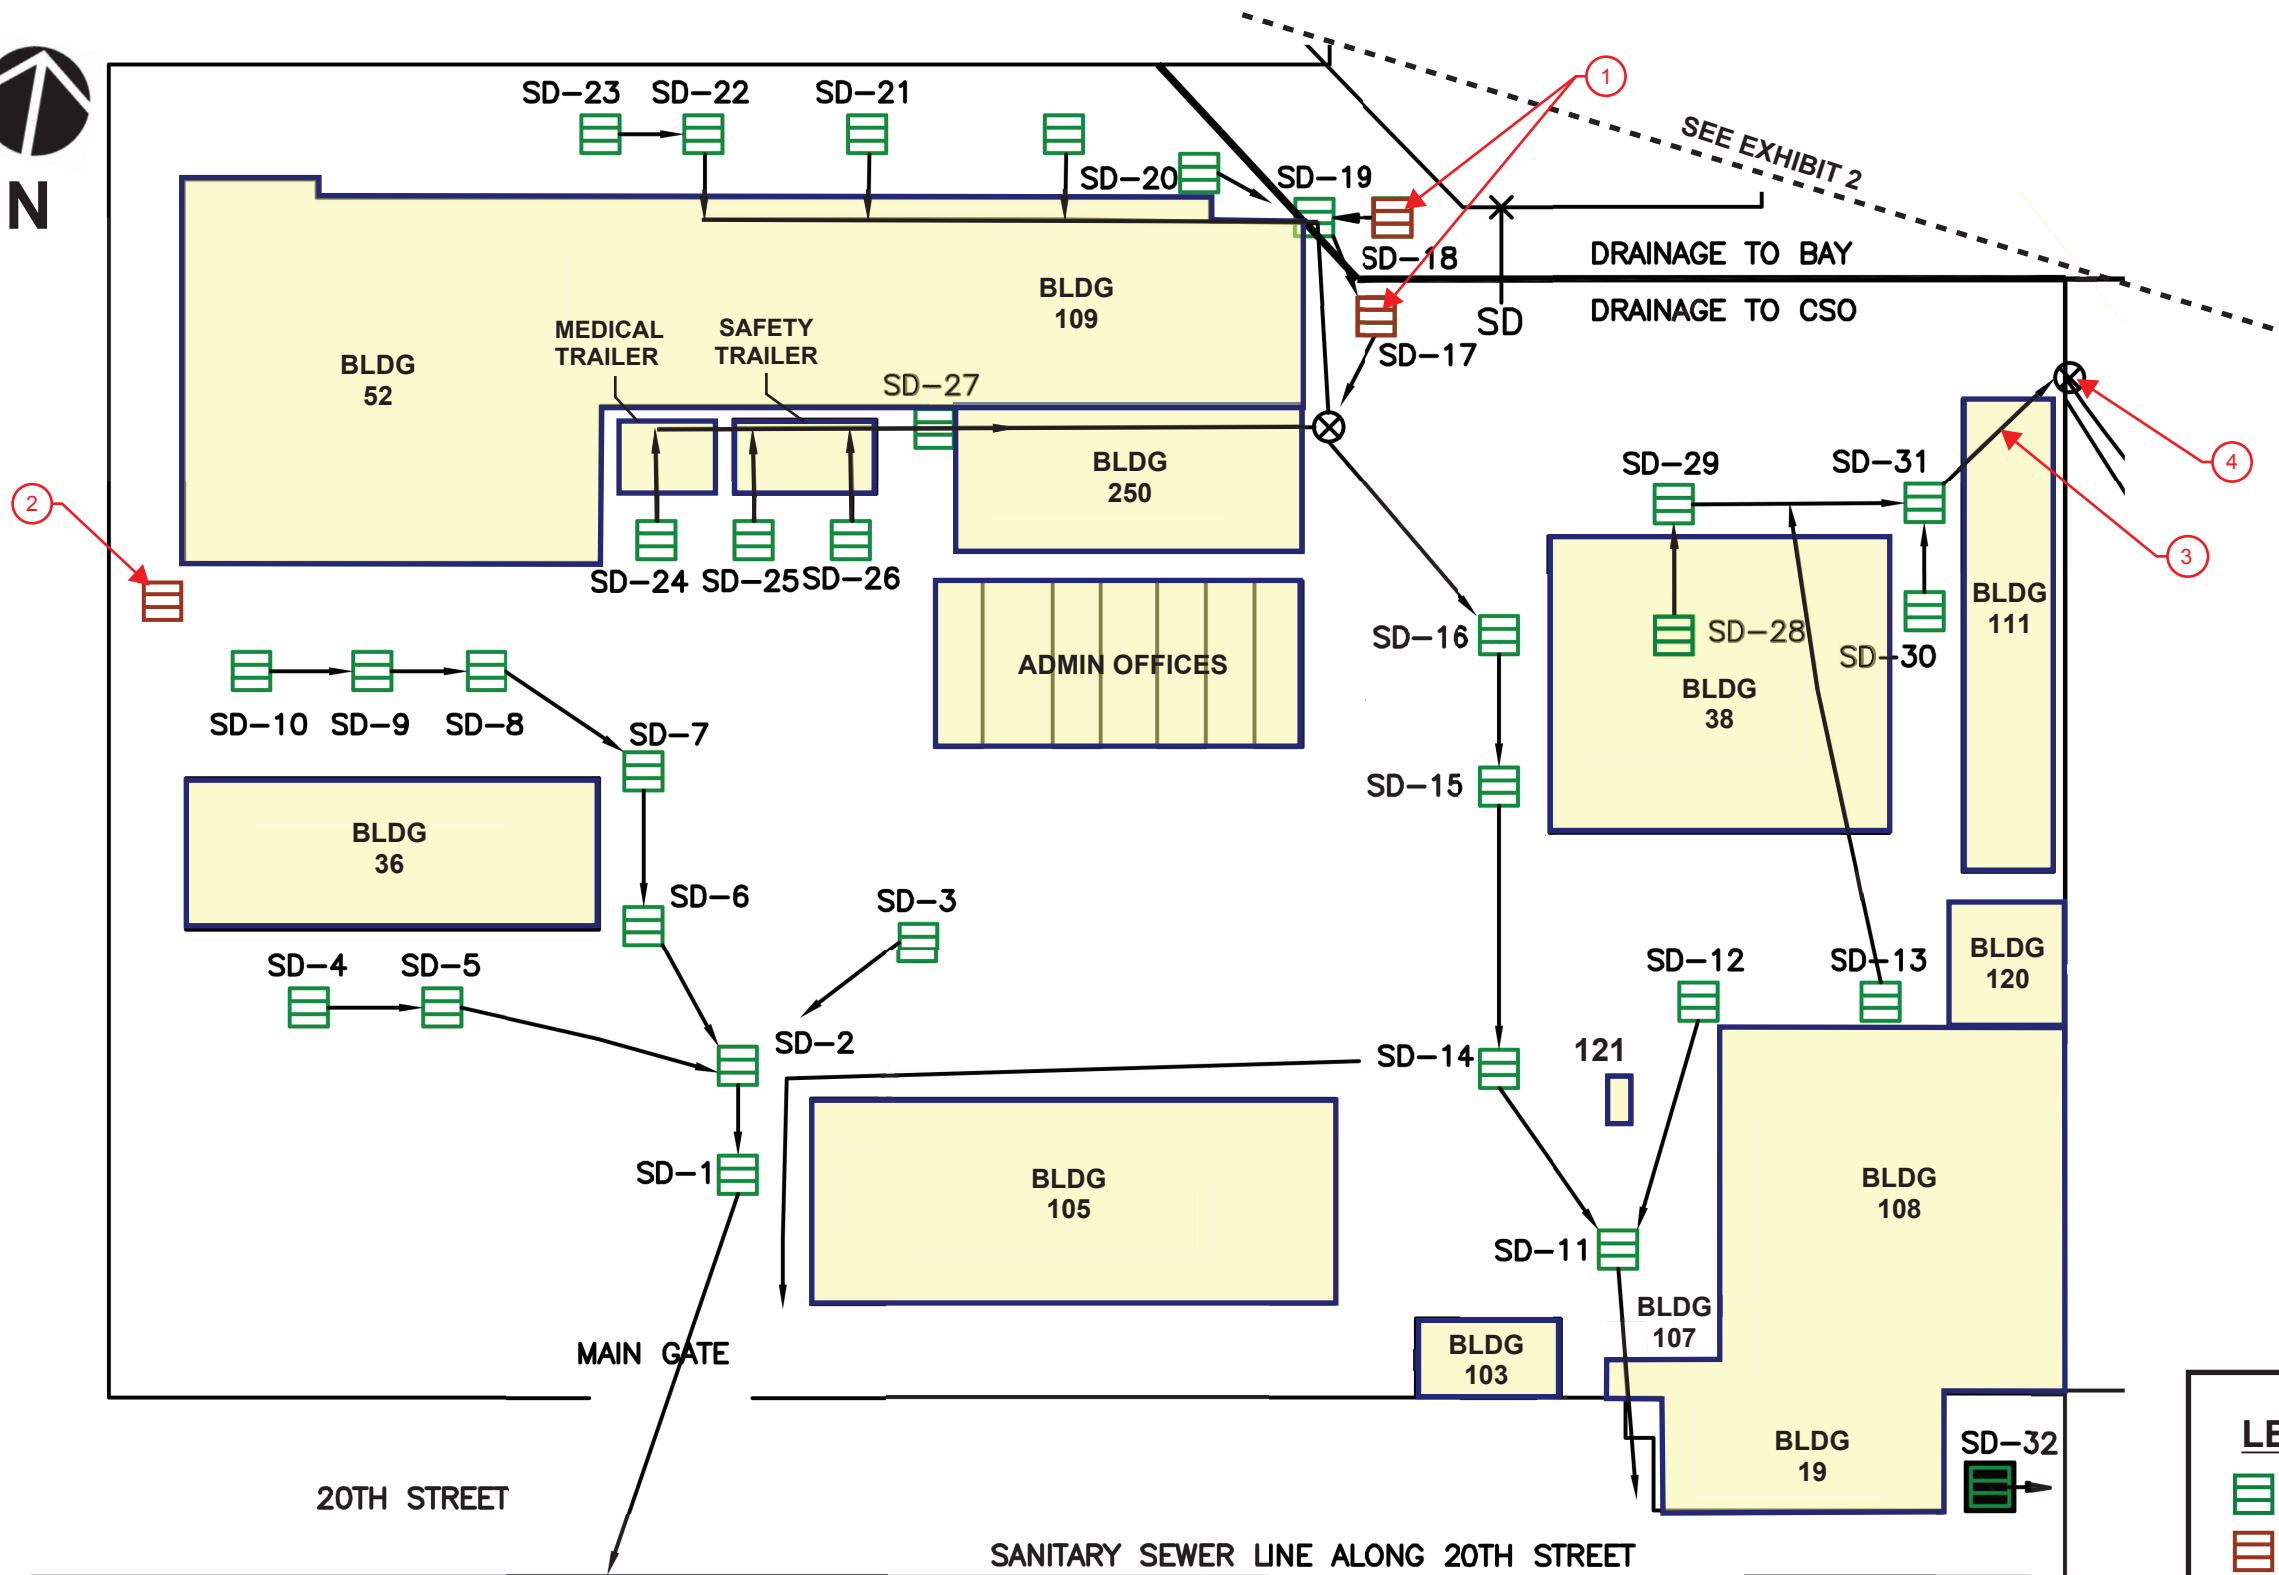
- ① CATCH BASIN NOT FOUND
- ② CATCH BASIN PLUGGED
- ③ BROKEN/DISCONNECTED STORM PIPE
- ④ INACTIVE SEWER PUMP

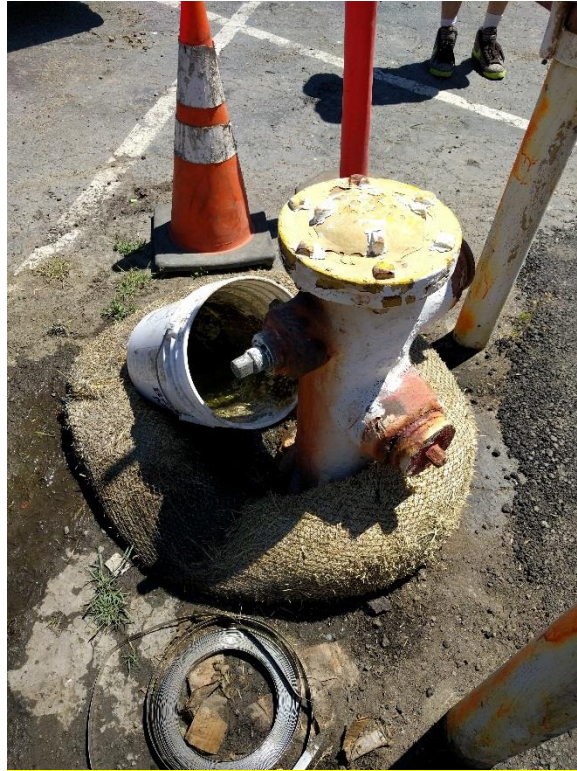
- Fire hydrant located by Building 36 is leaking at the valve stem.
- Riser to fire hydrant in utility trench west of Building 3 is leaking.
- Two leaks along main in utility trench east of Building 105 where trench tees.

Figure 19. Leaking Fire Hydrant Building 36

Due to the age of the system and supported by water meter readings, site investigation, and interviews with Shipyard staff, it is our determination that there exists significant leaks in the existing on-site fresh water system. It is our recommendation that the fresh water system be evaluated in more depth and detail to determine the cost-benefit analysis of replacing the system in whole or in part. It is our strong recommendation that the DDCV at the water meter should never be closed and bypassed. The DDCV should be in operation at all times. Ship repair and Auxiliary Ship Repair activities along with the condition of the on-site fresh water system impose serious contamination risks to the public municipal water system. It is also our recommendation that the exposed fresh water pipe and appurtenances beneath the wharf, showing serious rusting should be replaced in segments or in its entirety, for a rough order of magnitude cost of about \$450,000. Service lines to Building 36, Building 38, and Building 107 should be restored where feasible and desirable.

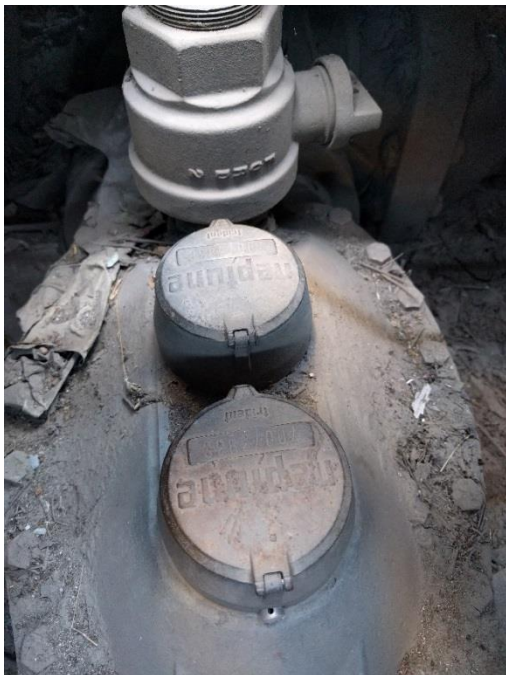
Based on the above water meter readings, 2,169 cubic feet (16,225 gallons) of water flowed through the meter from Thursday June 22, 2017 to Monday June 26, 2017. Since the Shipyard is currently inactive, in a status of non-operation, there appears to be significant losses in the existing fresh water system.

Figure 21. 6" Neptune Water Meter

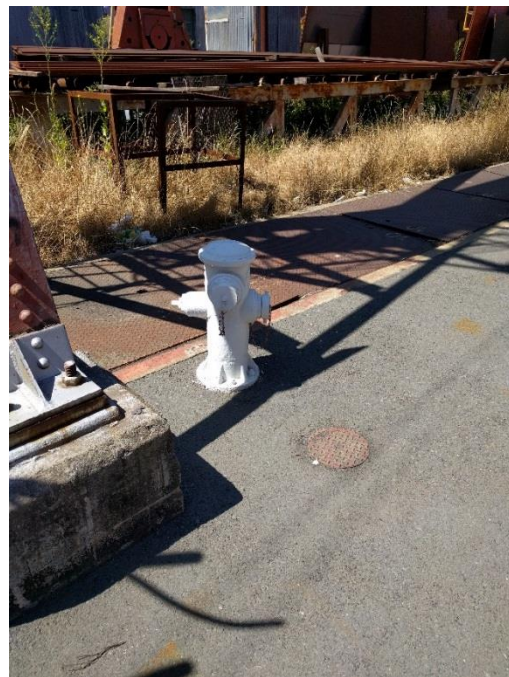
Figure 20. Typical Fresh Water Fire Hydrant

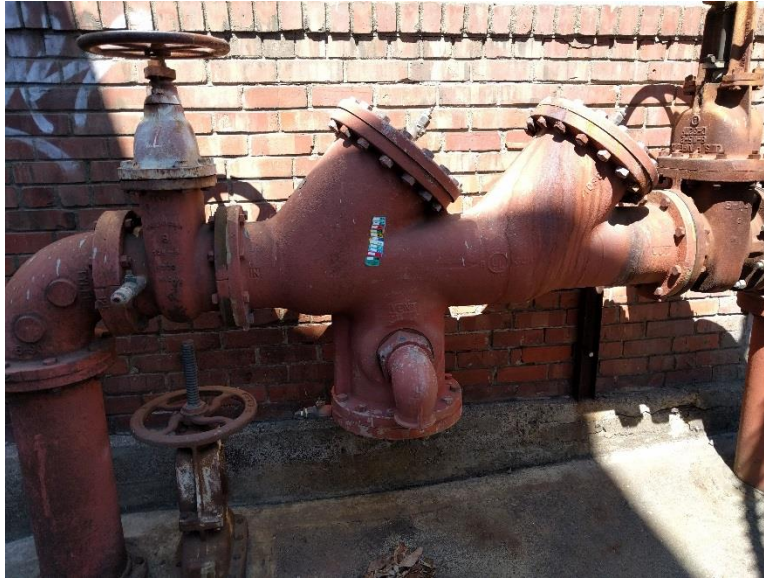
Figure 22. Main Double Detector Check Valve

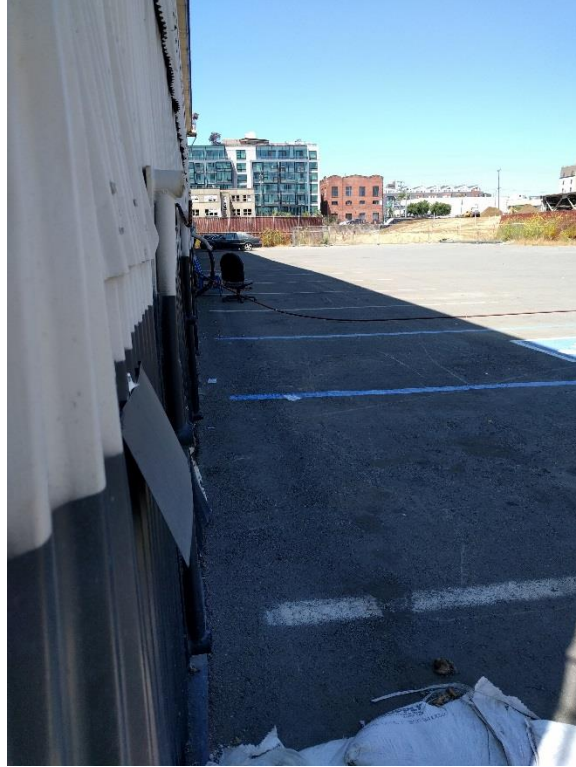
The service lateral to Building 36 is currently inactive due to leaks. Service to Building 36 is currently provided using an above ground rubber hose bypass.

Figure 23. Building 36 Hose Connection

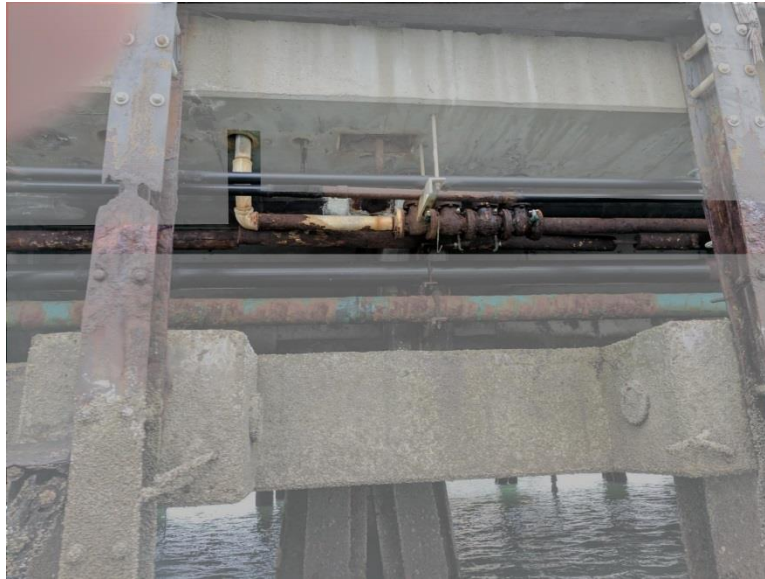
Figure 24. Fresh Water Pipe w/ DDCV at Pier 4

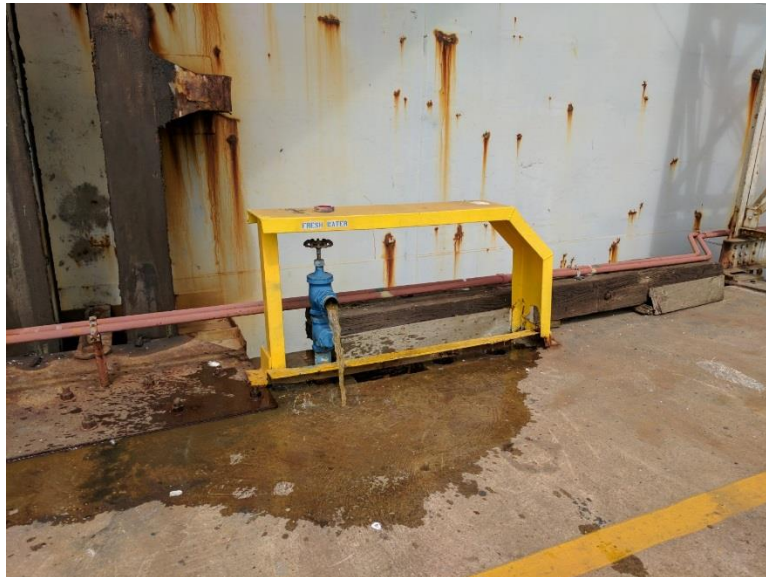
Figure 25. Opened Fresh Water Riser Pier 4

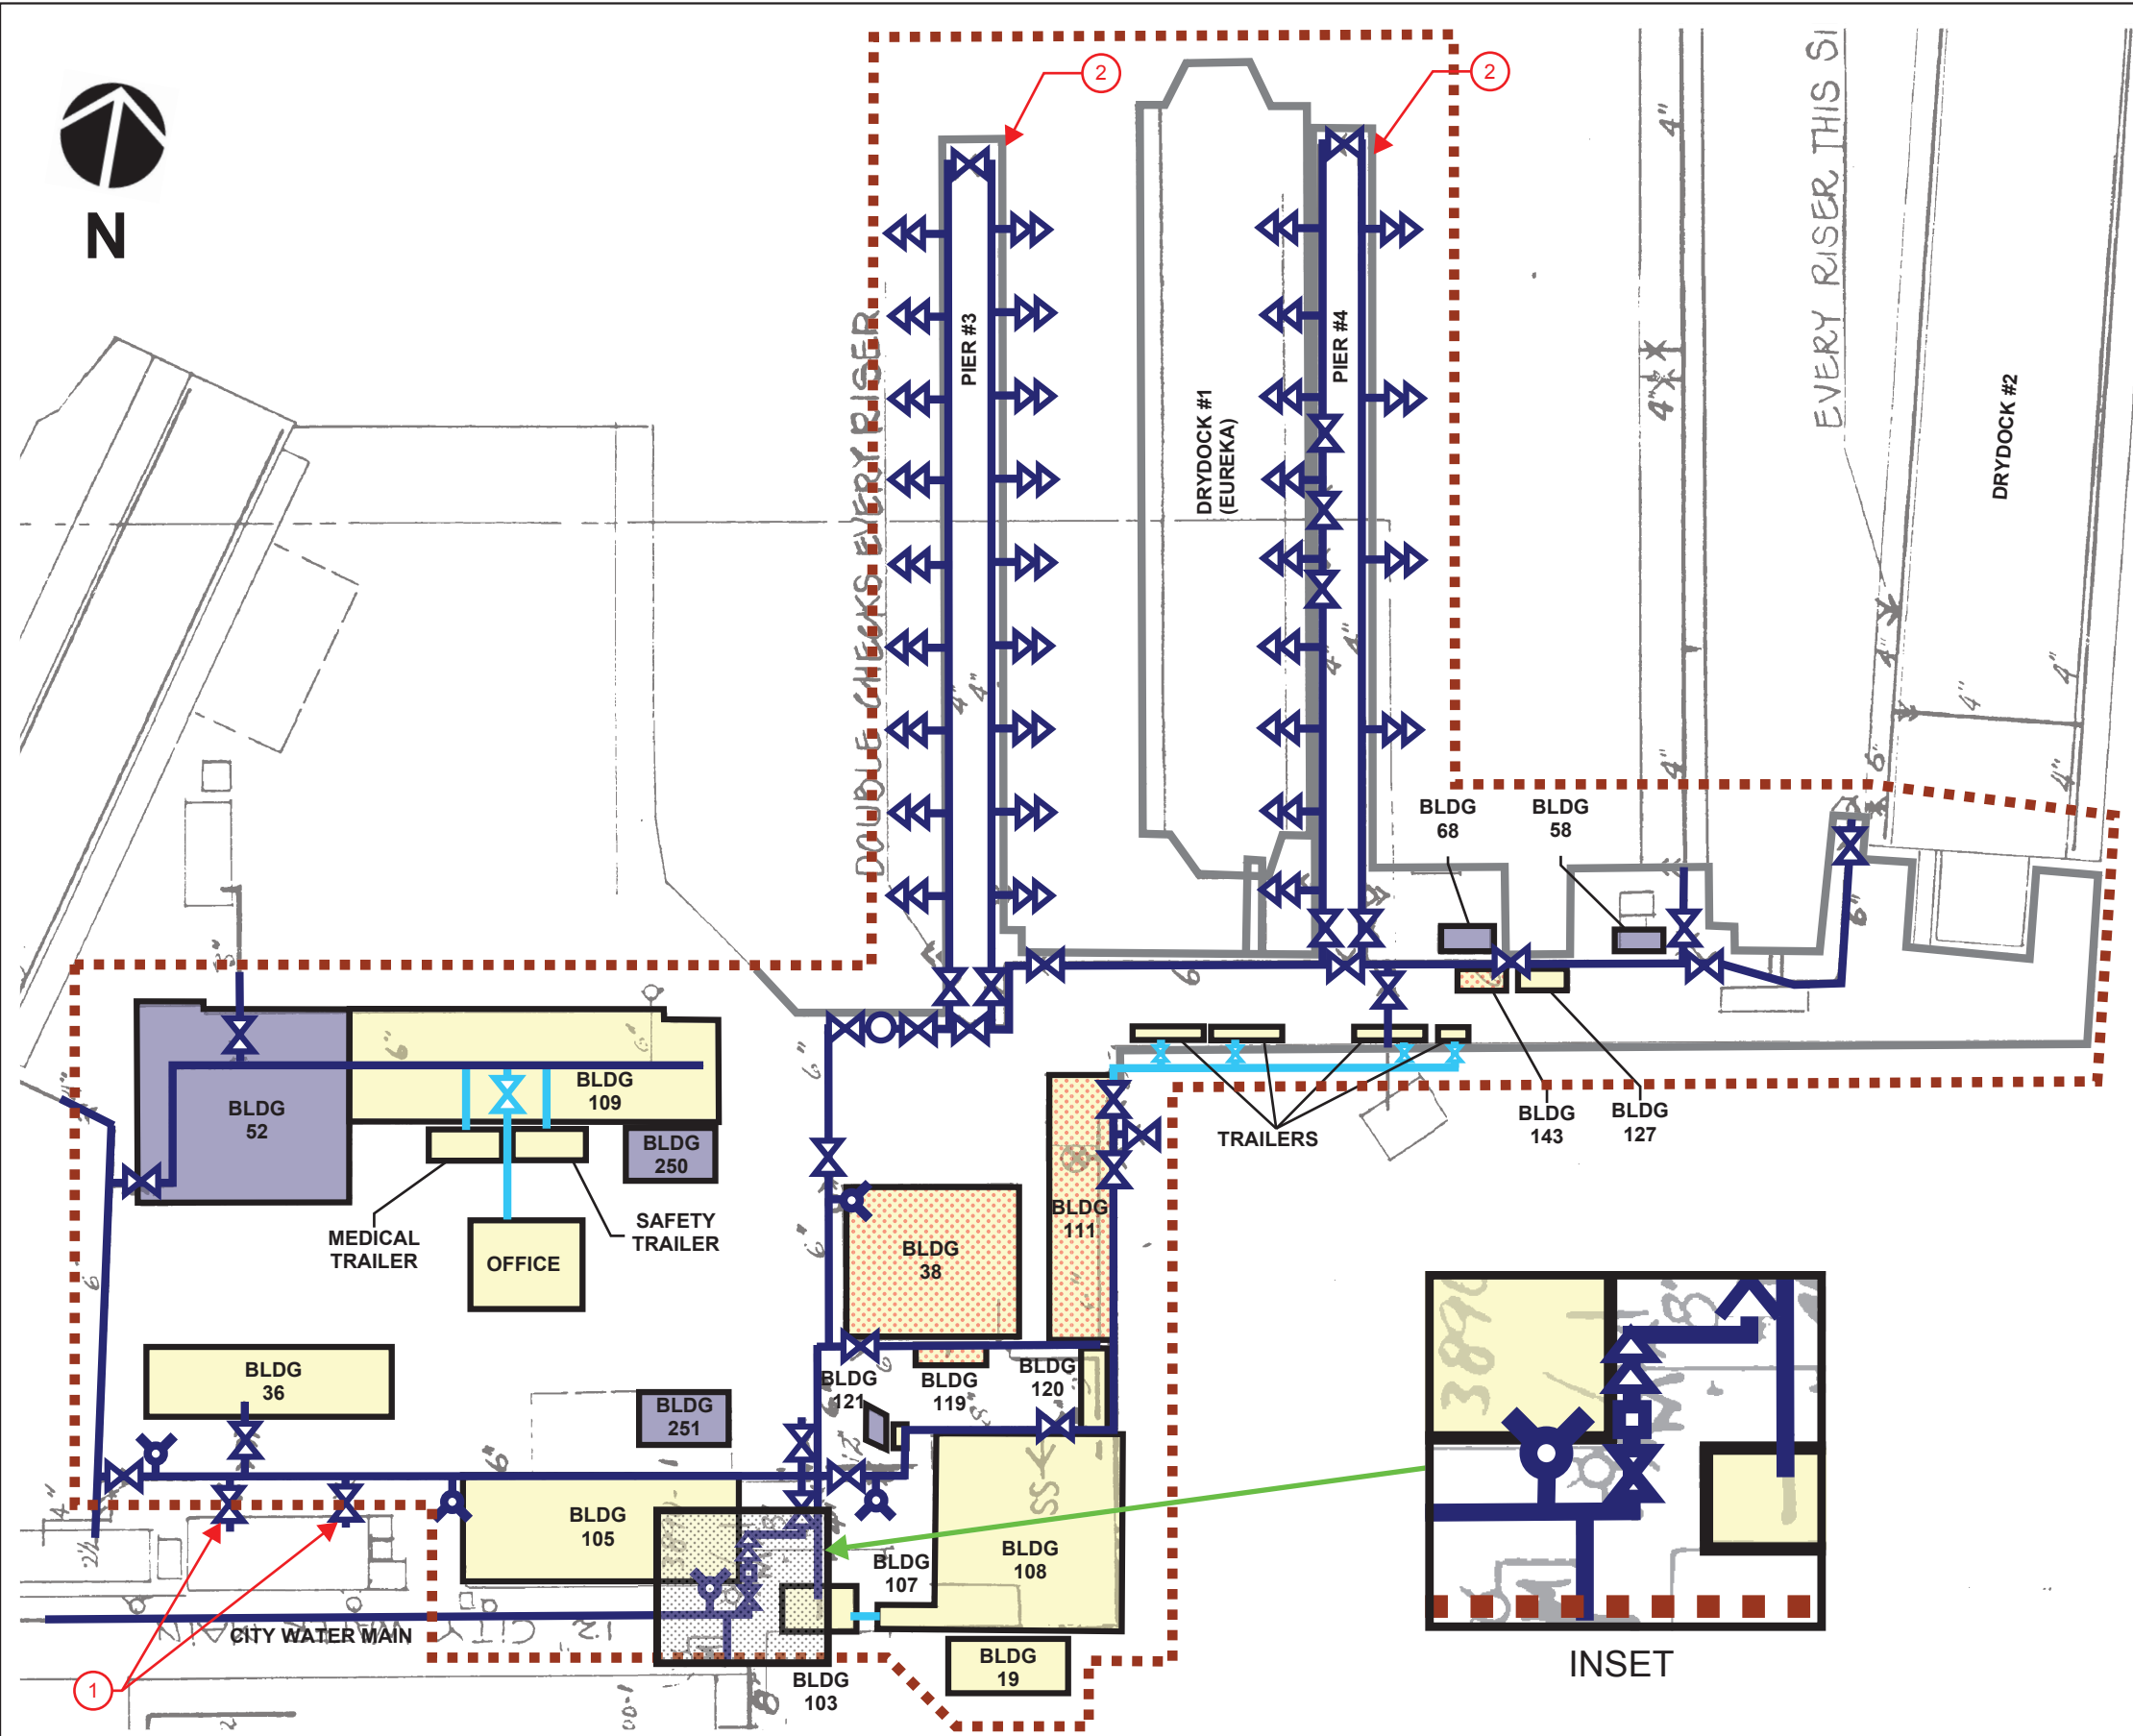
- ① VALVES WERE REMOVED AND CAPPED
- ② BALL VALVES AT EVERY RISER FROM DDCV ALONG THE PIER FOR PIER SERVICES

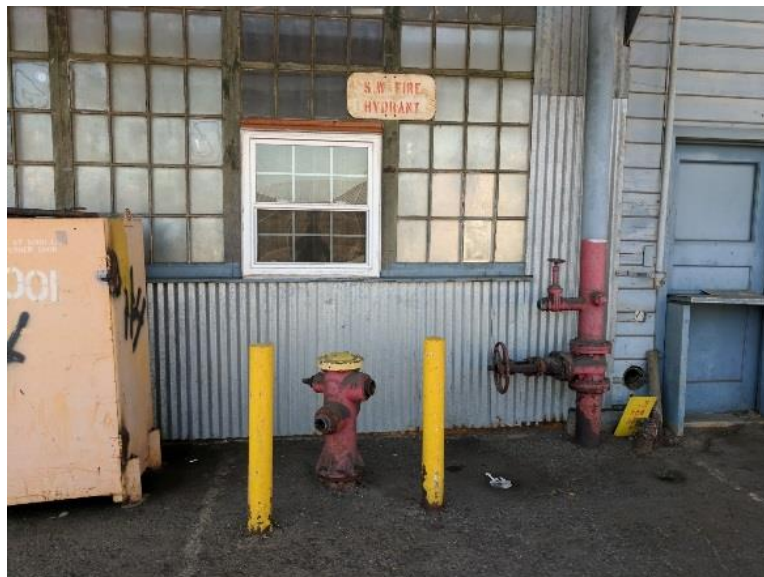
Figure 27. Salt Water Fire Hydrant
