Pier 68-70 Shipyard Facility Condition Survey Civil Site Utilities Report

2185 North California Blvd, Suite 500
Walnut Creek, CA 94596
July 21, 2017
Job: 9590-06

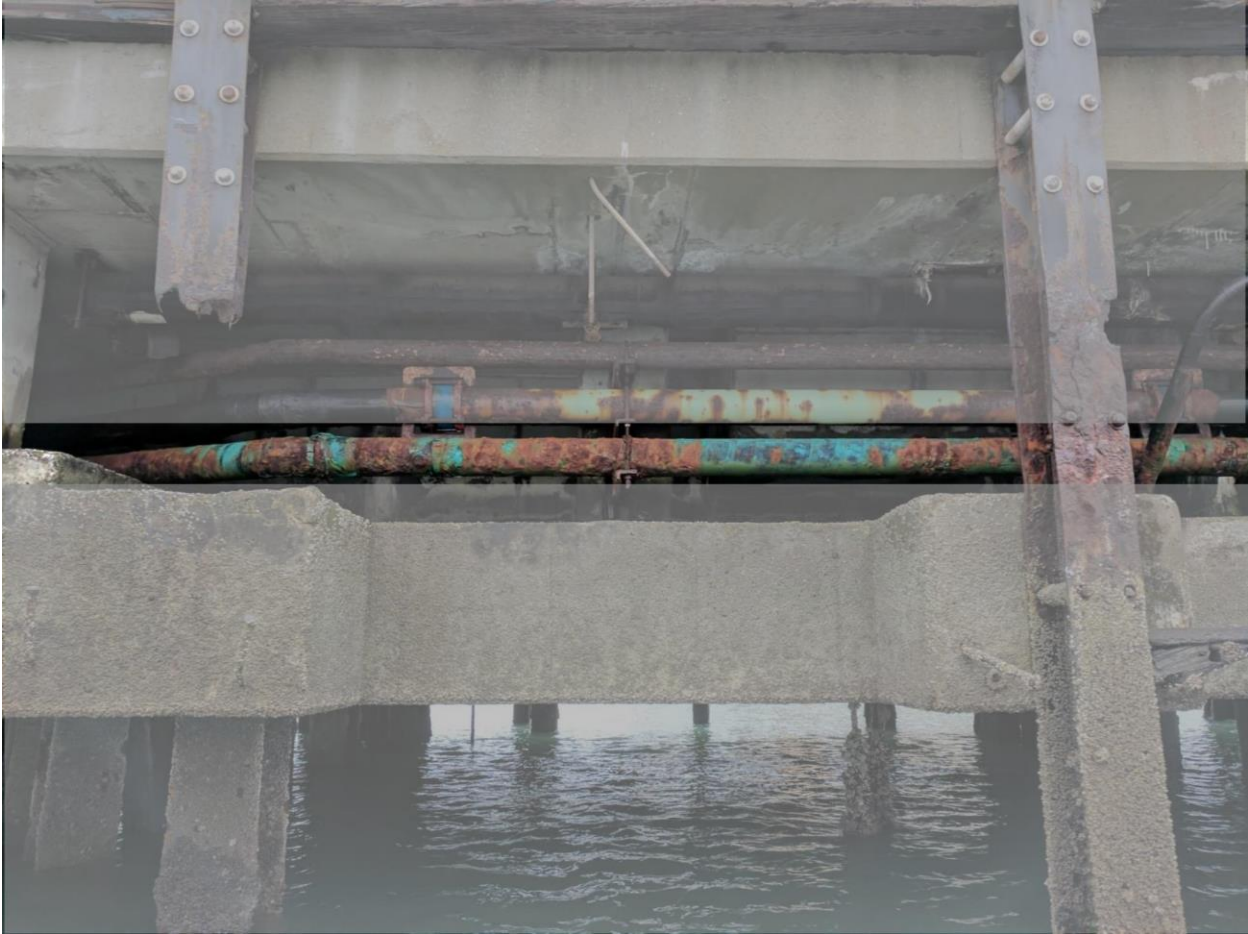
The salt water system servicing the piers and the drydocks are attached to the underside of the High Water Platform and piers with individual riser connections rising above deck. The salt water pipes, appurtenances, and hangers underneath the High Water Platform and piers appeared to be showing slight to severe rusting.

Figure 28. Salt Water Fire Protection Pipe beneath Pier

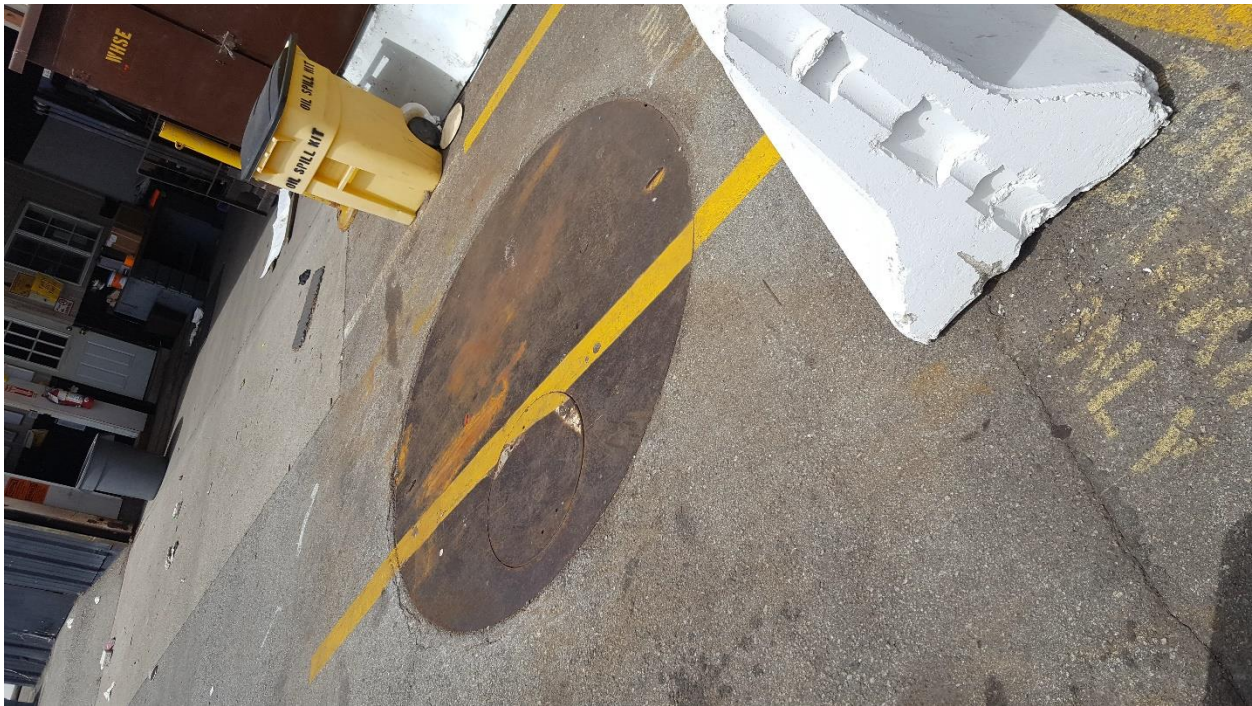
1. CHT Pump #1 (CHTP1) Southeast of Bldg 109 - Two pumps, one pump works well, the other requires service. (Located underneath the wharf. HRA was unable to gain access to and inspect this pump)
2. CHT Pump #2 (CHTP2) underneath wharf at Bldg 127 – (Located underneath the wharf. HRA was unable to gain access to and inspect this pump)

Figure 29. Sewer System CHT Pump Located Underneath the Wharf
