August 30, 2016

REF: 16LET019

Subject: Dry Dock No. 2 Dolphin & Stair Tower Inspection

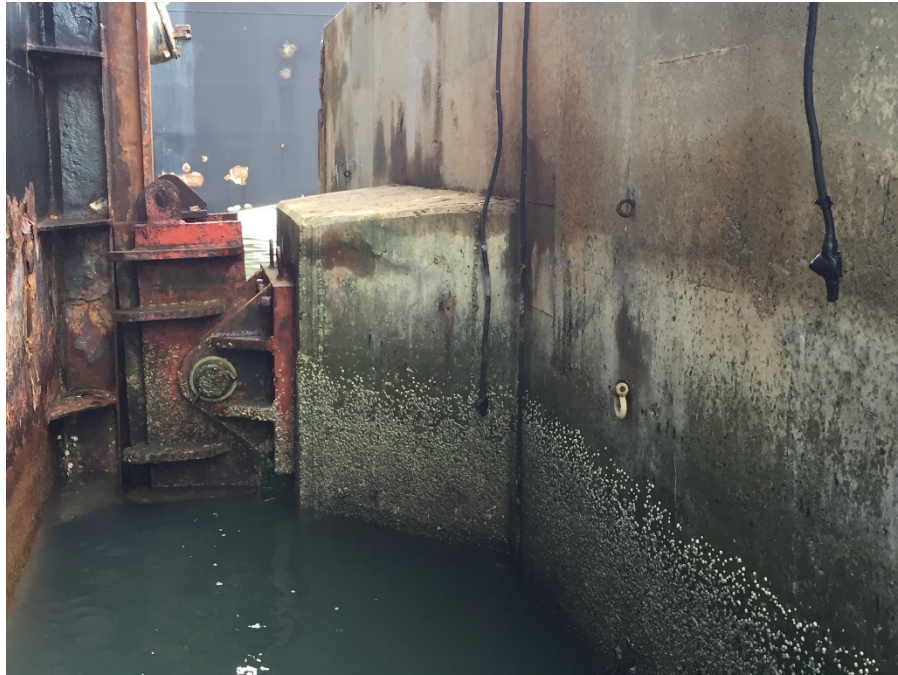
Figure 1 – General view of dry dock gripper assembly mounted at concrete extension at face of concrete dolphin (D4).

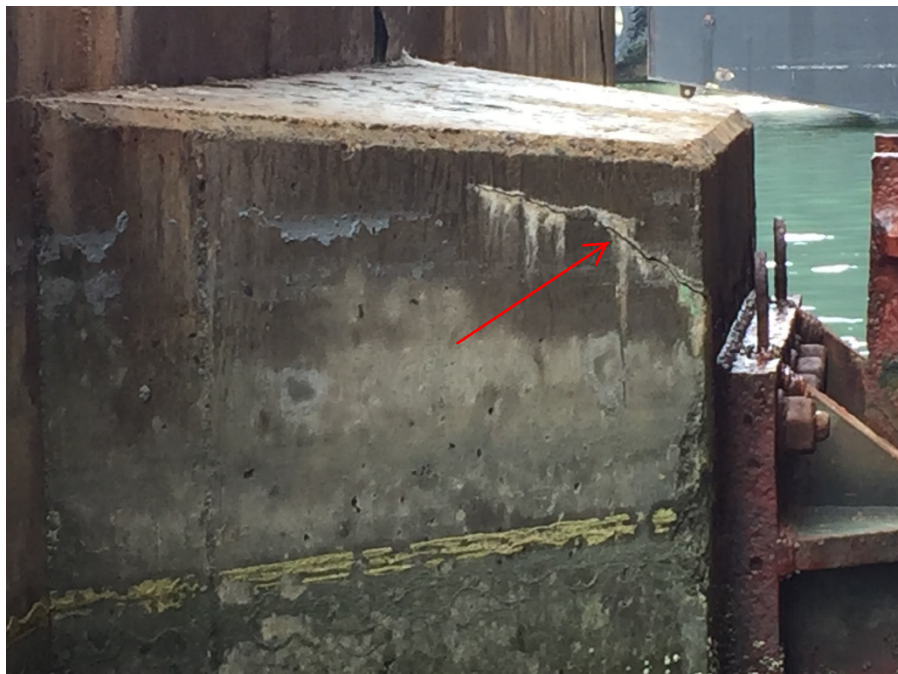
have grown since previous inspections with delaminated surface areas failing at certain locations (Figures 5 through 8). Cracks found to occur at the face of concrete extensions at edge of each gripper base plate which extend upward to flat portions of the concrete extensions appear to be unchanged (Figures 2 through 4). More specifically, the following was observed the following:

Dolphin D2: Closed corrosion spalls exist along the east face of deck structure, above and to each side of the gripper extension. Cracks occur at the top edge of the gripper steel mounting plate extending upwards to the horizontal surface. A horizontal crack occurs at the extension alongside a closed corrosion spall on the flat surface. Remaining concrete regions outside of observed spalls determined to be sound.

Figure 2 – Close-up view of crack extending from top corner of gripper plate to side face and upwards at dolphin (D2).

The integrity of the gripper base plates and surrounding concrete appears to remain intact. Spalled regions of dockside face of all four of the dry dock dolphin structures should be considered for repair in the next 2 to 3 years as the deterioration in these regions continues to grow and extend towards the gripper plates.

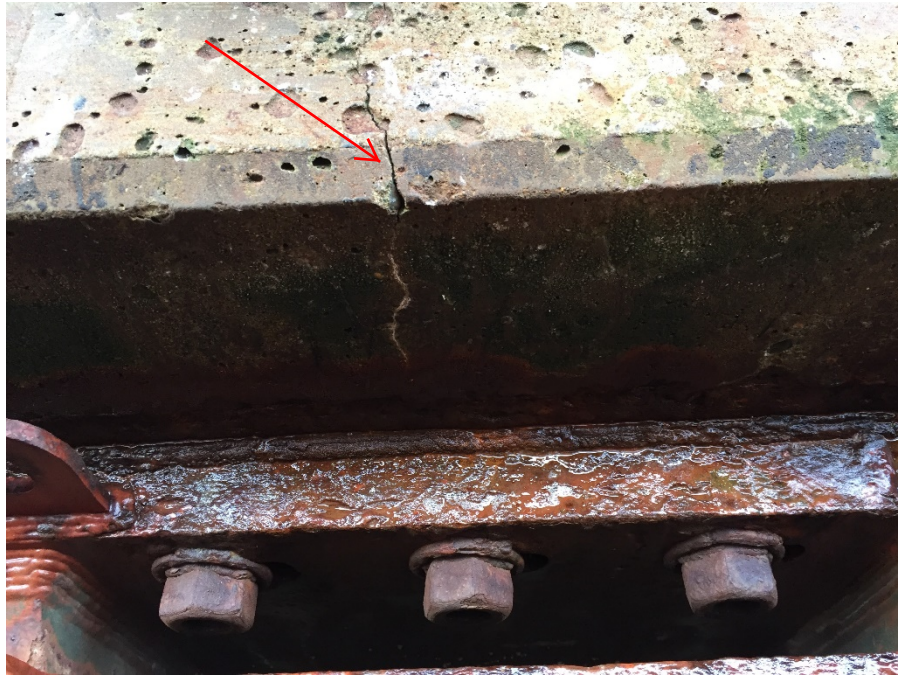
Figure 3 – View of typical crack in concrete extending from gripper plate at dolphin (D2).

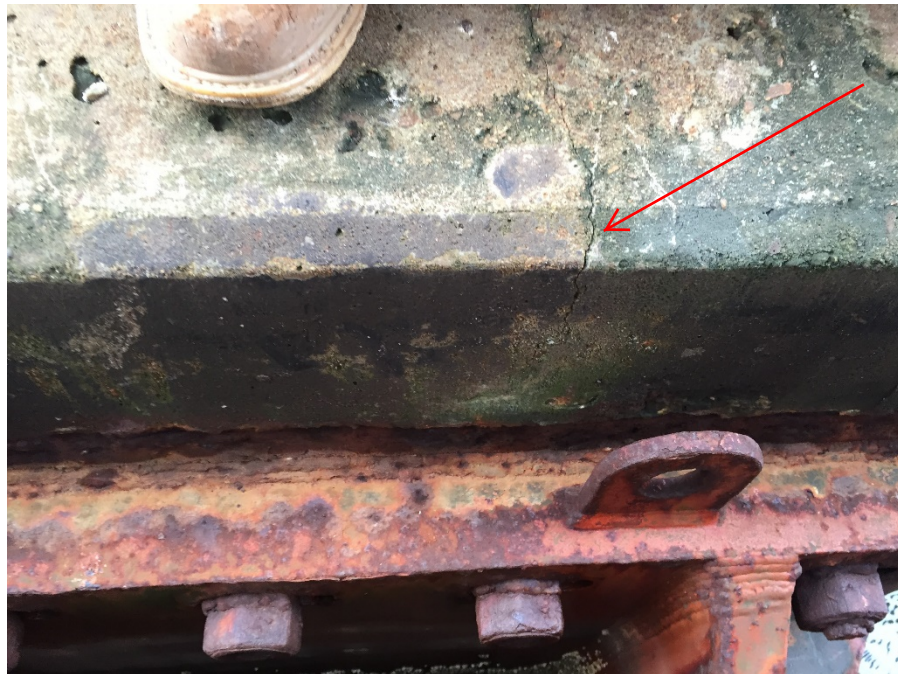
Dolphin D3: Several open and closed corrosion spall exist along the east face of deck structure, directly above the gripper extension mount. A crack occurs at the south edge of the gripper steel mounting plate, originating from the top corner and extending upwards. Except for dockside face (east) concrete is sound.

Figure 4 - View of typical crack in concrete extending from gripper plate at dolphin (D3).

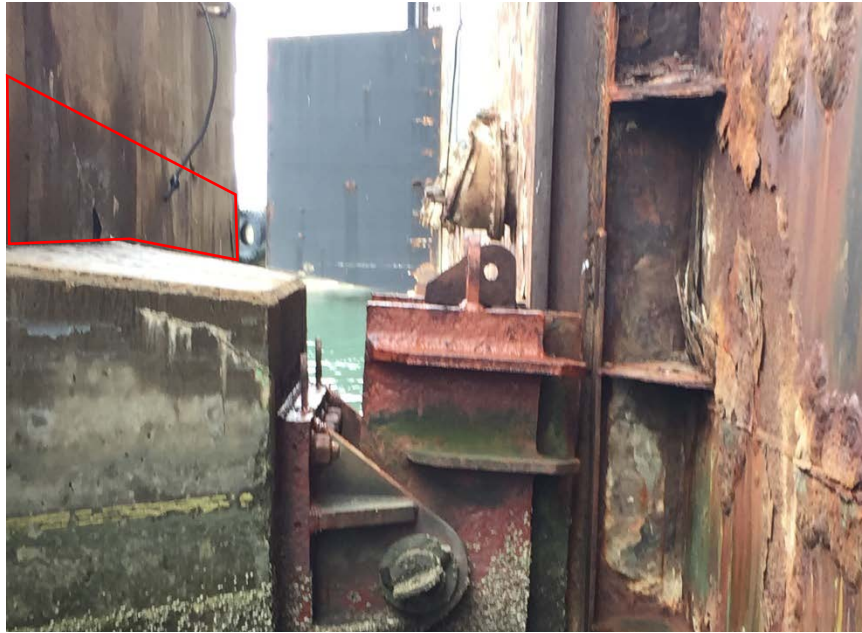
Figure 5 – Location of concrete spalls at east face of dolphin (D2).

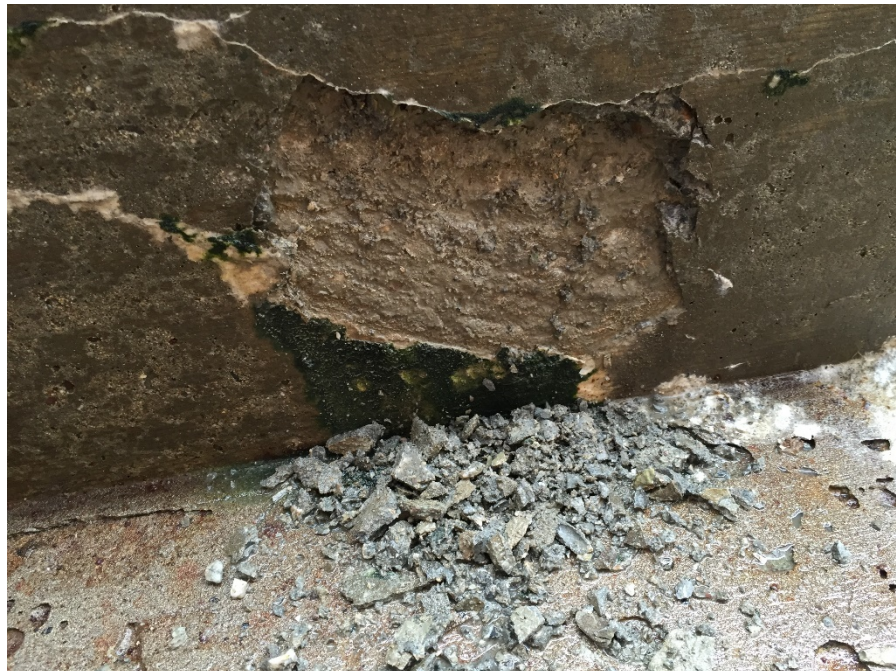
Figure 6 – Close-up view of spalling and soft concrete observed at east face of dolphin (D2).

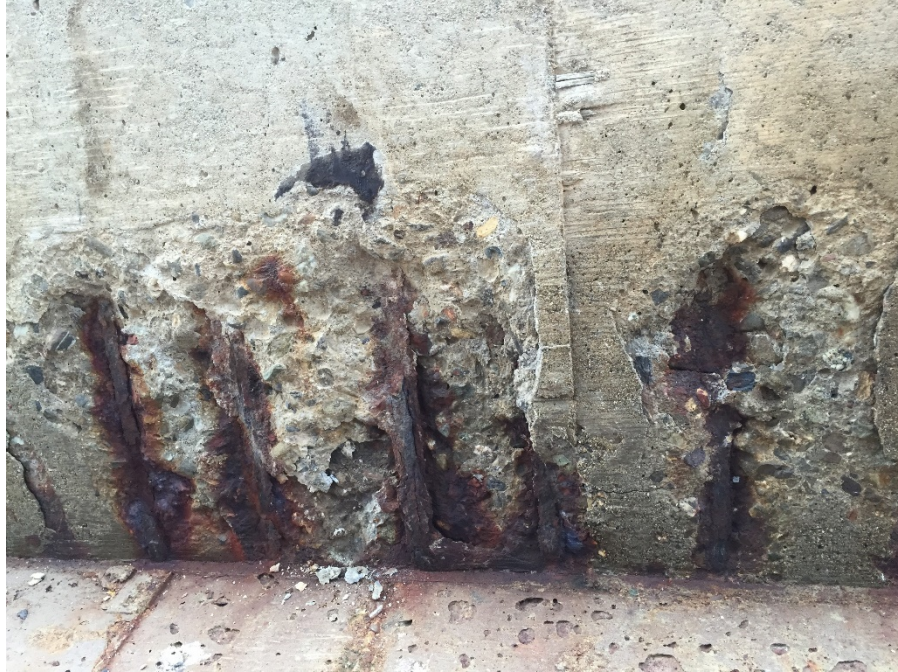
Figure 7 – Close-up view of open corrosion spall at east face of dolphin (D3). Note exposed steel reinforcing.

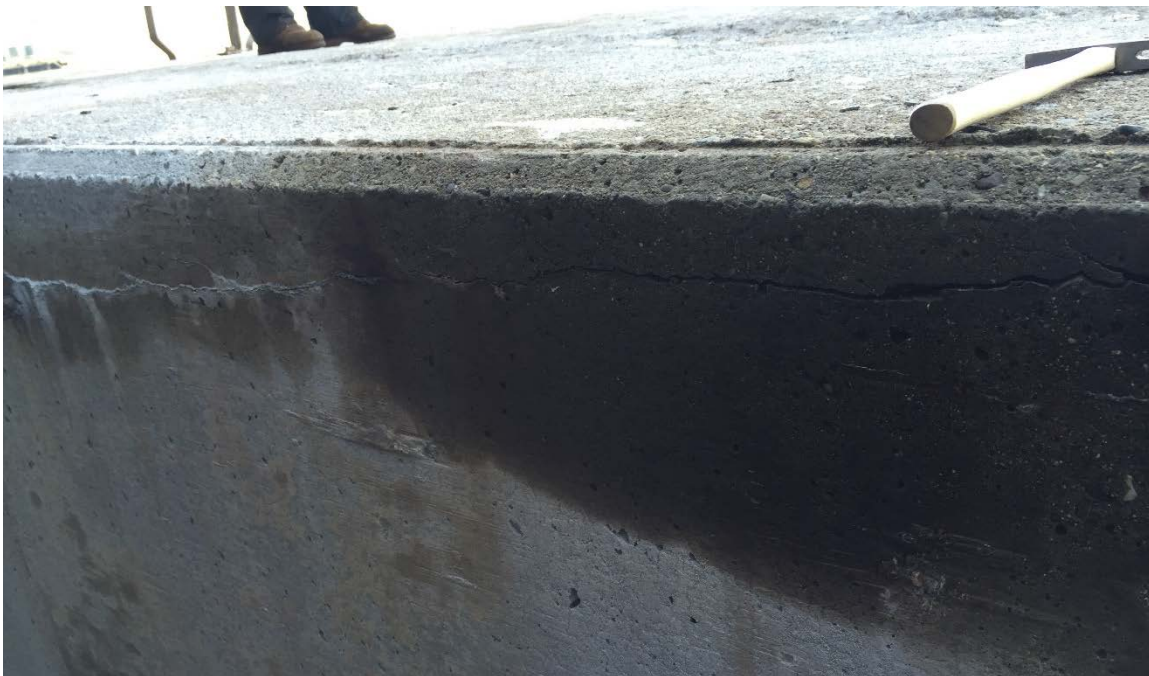
Dolphin D4: A closed corrosion spall and horizontal crack exists at the east face near the top corner of deck. Cracks occur at both edges of the concrete extension, originating from gripper plate and extending. Concrete outside region of spall determined to be sound.

Figure 8 – Close-up view of horizontal crack near top corner of dolphin deck structure (D4).

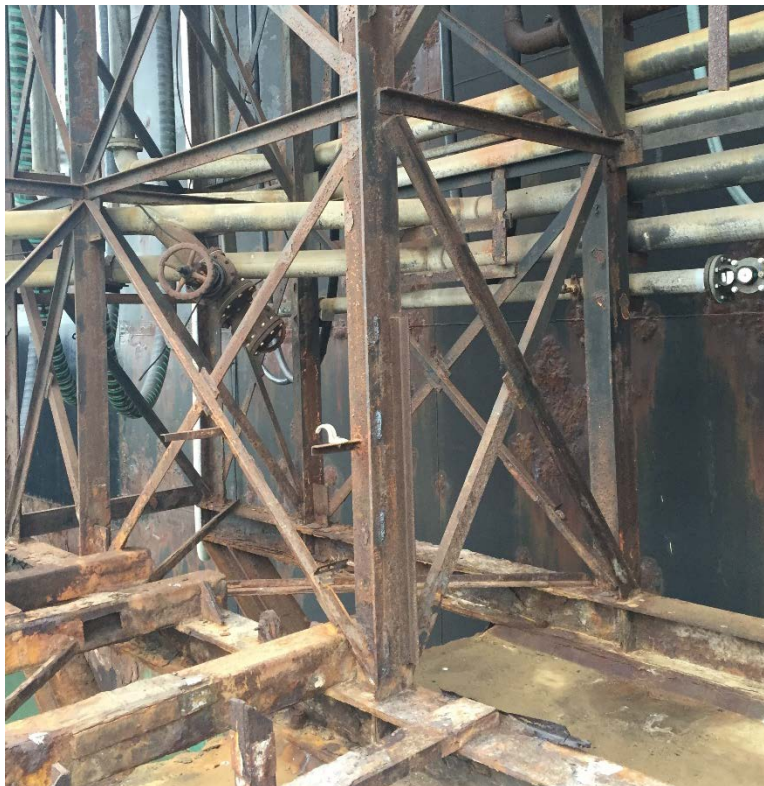
The upper regions of framing of the stair tower appear in good condition (Figures 14 through 16). Lower portions of the frame nearer to the deck surface of the wharf and dolphin structure are heavily scaled due to corrosion and in poor condition (Figure 13).

Figure 13 – View of heavily corroded base region of steel frame.

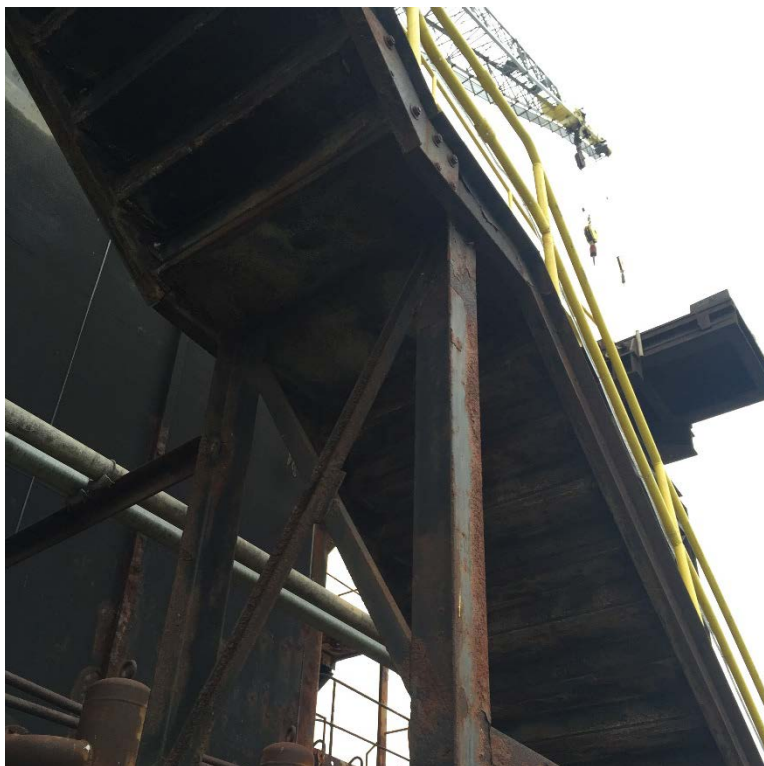
Figure 14 – View of intermediate stair landing steel frame support.

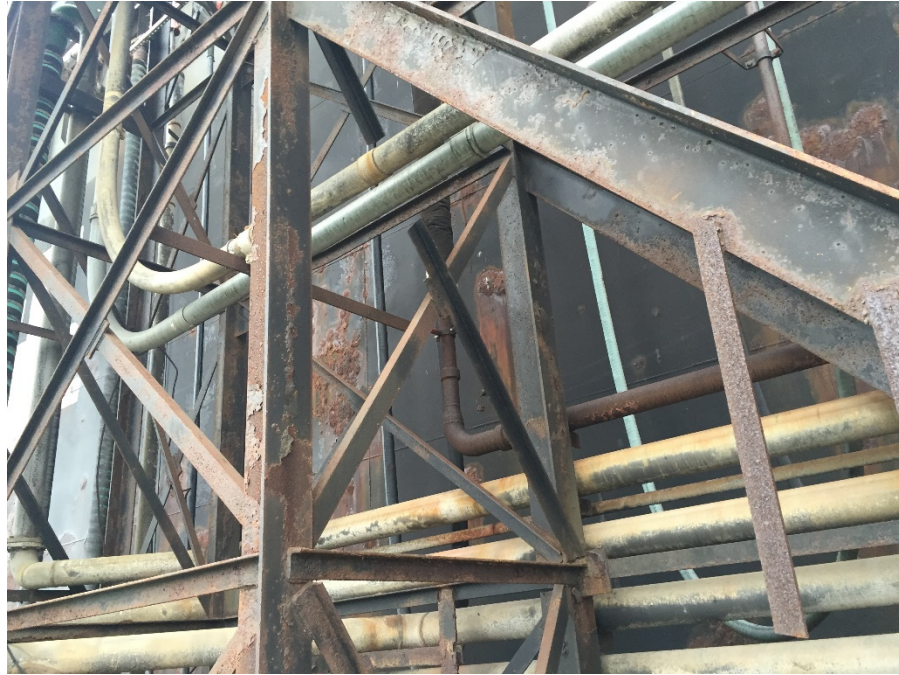
Figure 15 – View of upper portions of steel frame in good condition.

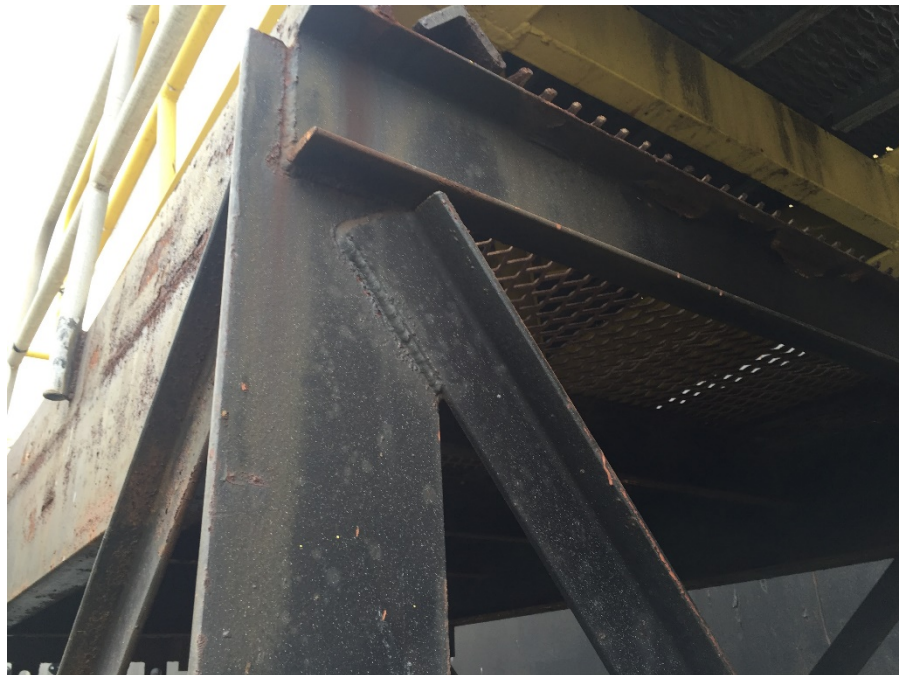
Figure 16 – Upper region of tower frame in excellent condition. Paint coating remains in good condition.

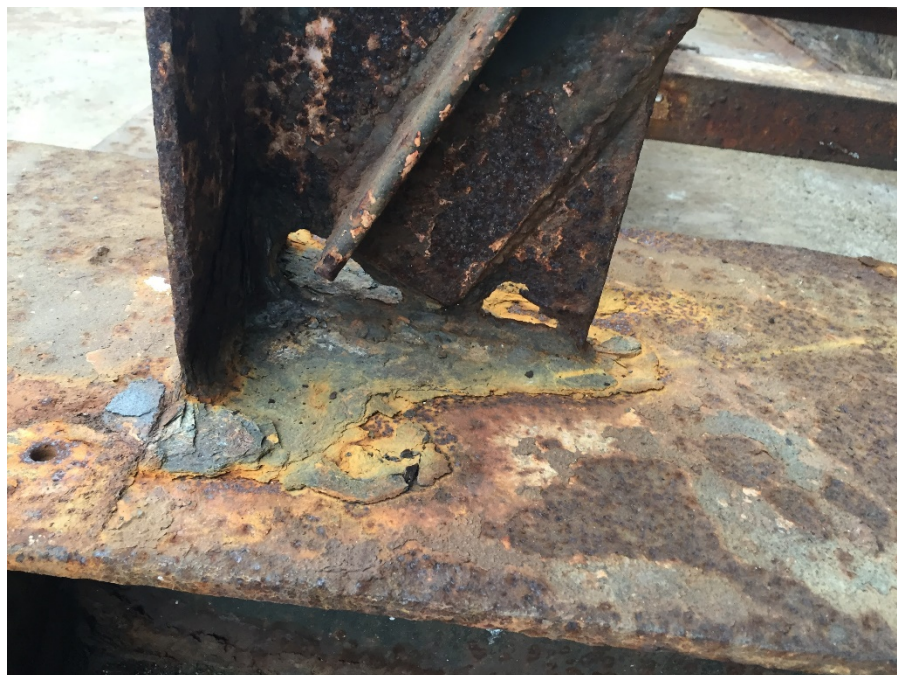
Connections (approximately 8 locations) between columns, diagonal and horizontal brace connections have undergone significant deterioration leaving little or no original cross section remaining (Figures 17 – 22). These connections are susceptible to failure.

Figure 17 – Deteriorated base connection at braced column.

The failed connections (8 ea.) require immediate attention to reinstate their original design strength. The tower in its current condition is susceptible to base failure under a significant seismic event or wind load.

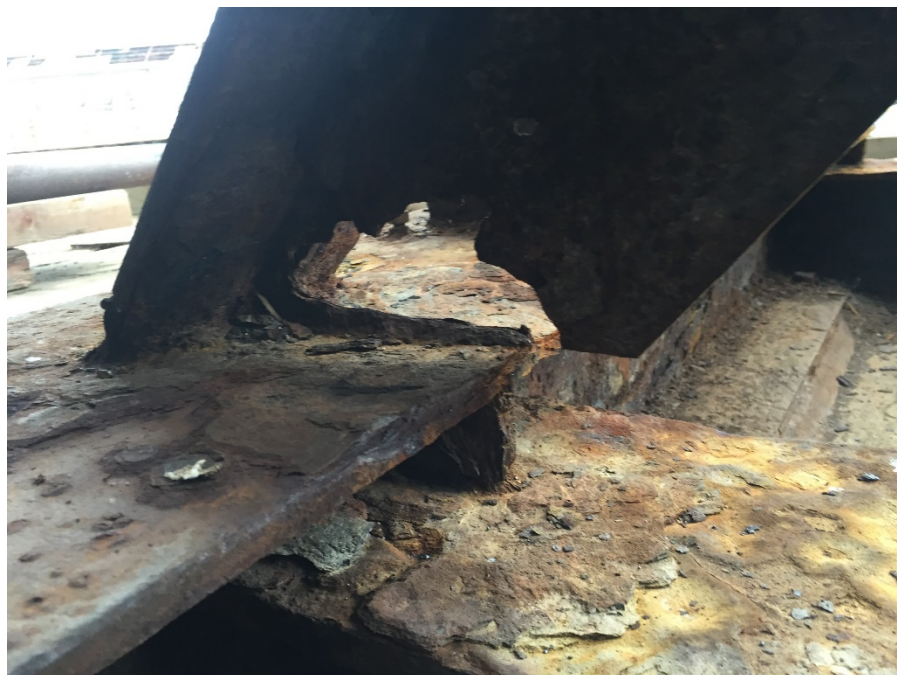
Figure 18 – Complete loss of cross section at angled brace support.

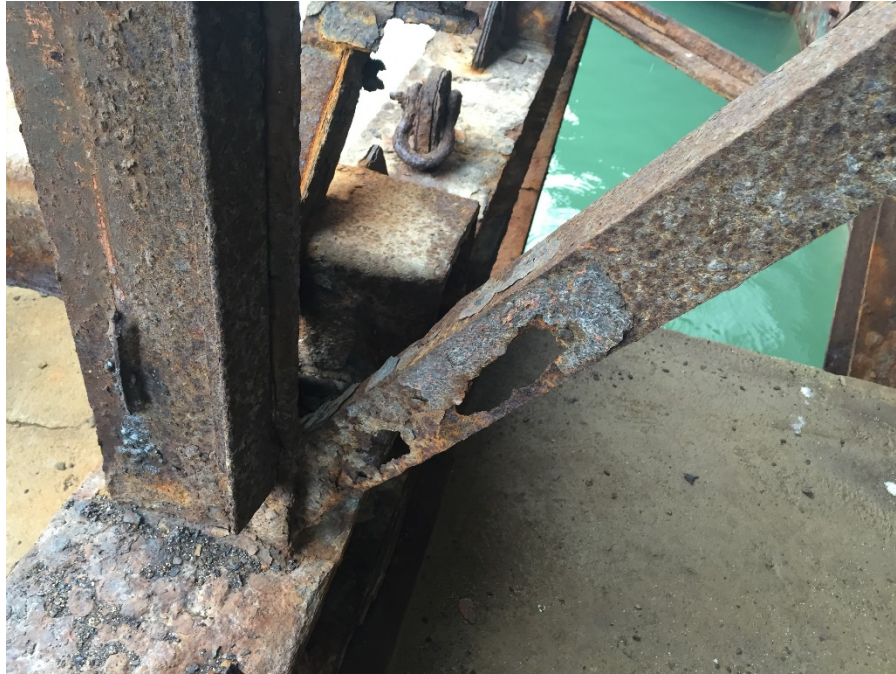
Figure 19 – Complete loss of section at diagonal brace.

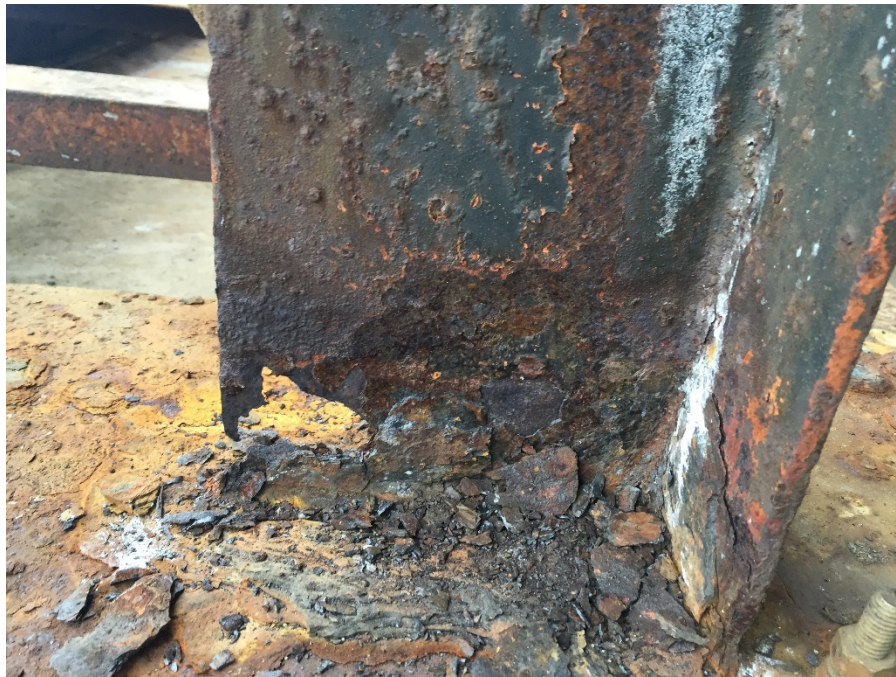
Figure 20 – Deteriorated base connection at corner column.

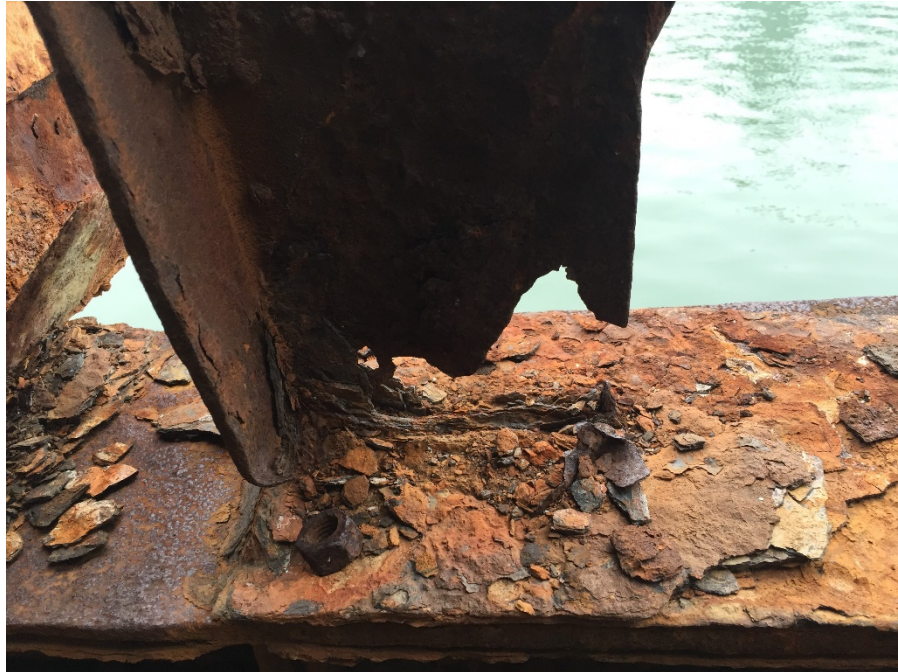
Figure 21- Complete loss of cross section due to corrosion at corner column base connection.

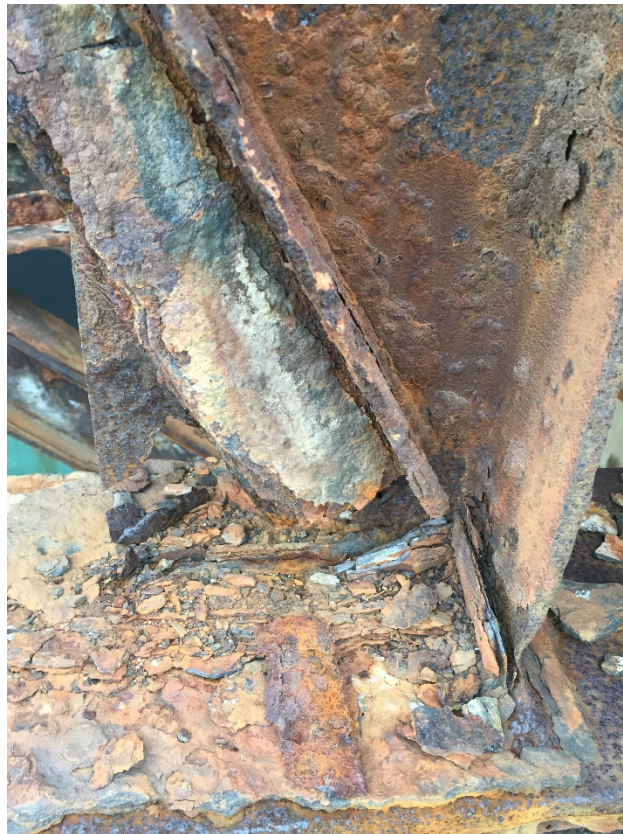
Figure 22 - Heavily scaled connection at braced column connection.

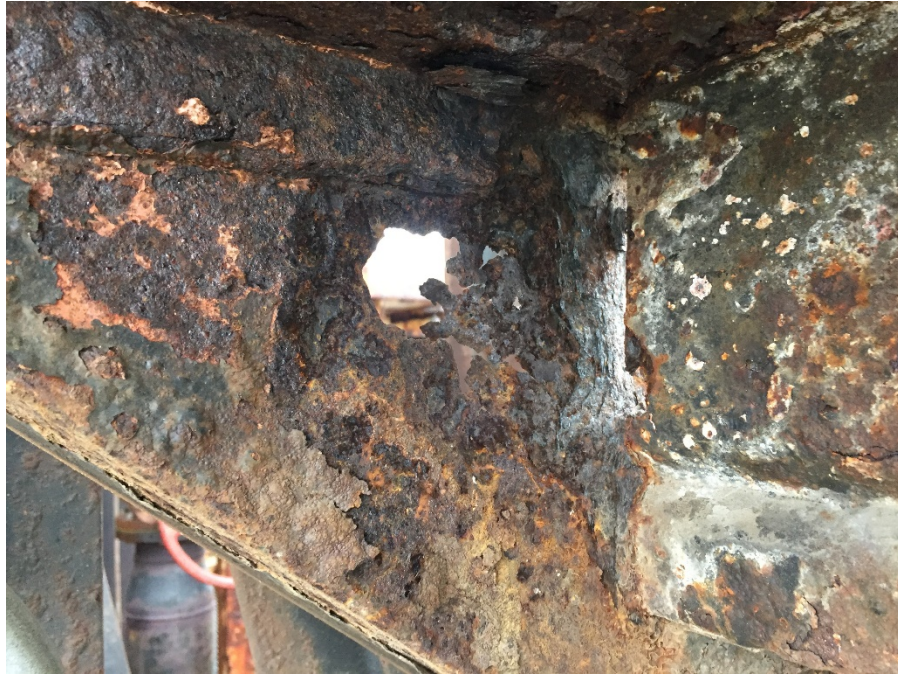
The lower regions of the steel stringers located at each side of the stairs were observed to be heavily corroded leaving webs at the 12" channels with considerable reduction in thickness and shear tab connections between sheet metal treads and steel channel stringers susceptible to failure (Figures 23 & 24). Several tread connections near the base have been previously repaired.

Figure 23 – Complete loss of cross section at web of stair stringer.

Numerous connections between stair treads and stringers were observed to have been previously repaired at lower regions of the stairs. Other connections will continue to fail above this region and will require similar repair as this occur.

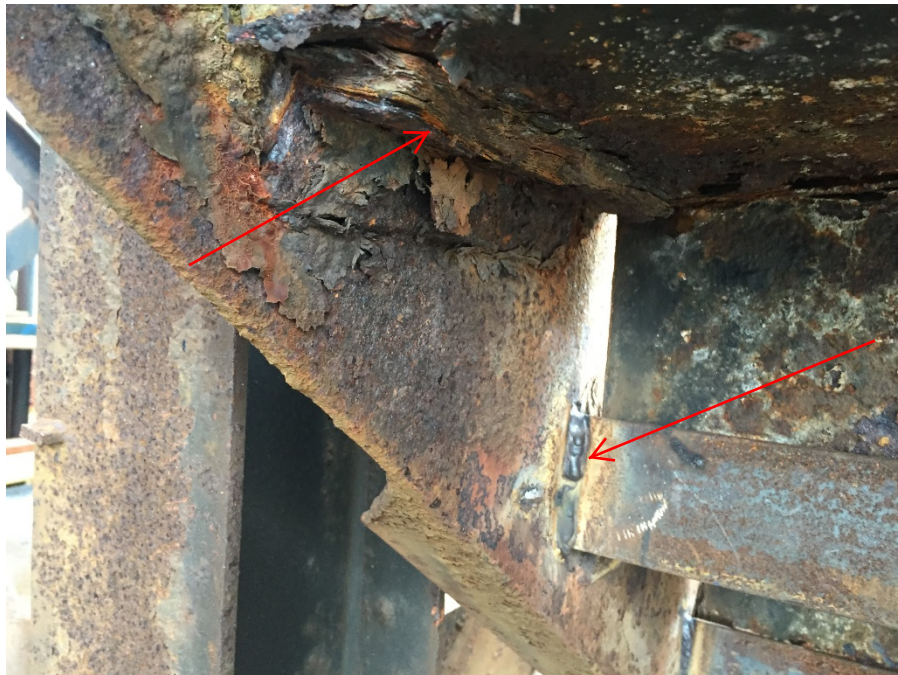
Figure 24 – View of deterioration at shear tab support between stringer and stair tread (upper). Repaired stair tread connection (bottom right).

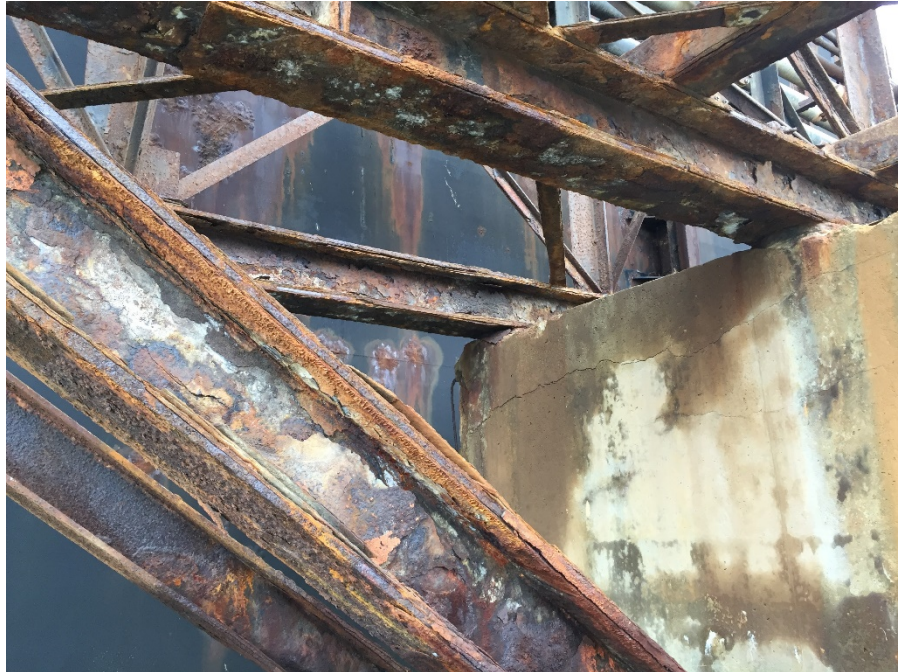
sections at beam and strut locations are heavily scaled (Figure 25). Measurements made on site following removal of scale reveal approximately 0.375" thickness remaining on an original 0.680" thick section (or approx. 55% of original section remains).

Figure 25 – Heavily corroded base horizontal beams and diagonal struts. Approximately 50% to 60% of original cross section remains.

The heavily corroded beams and struts which support the tower at the concrete deck have lost nearly half of their original cross section and will require replacement in the next 2 to 3 years.

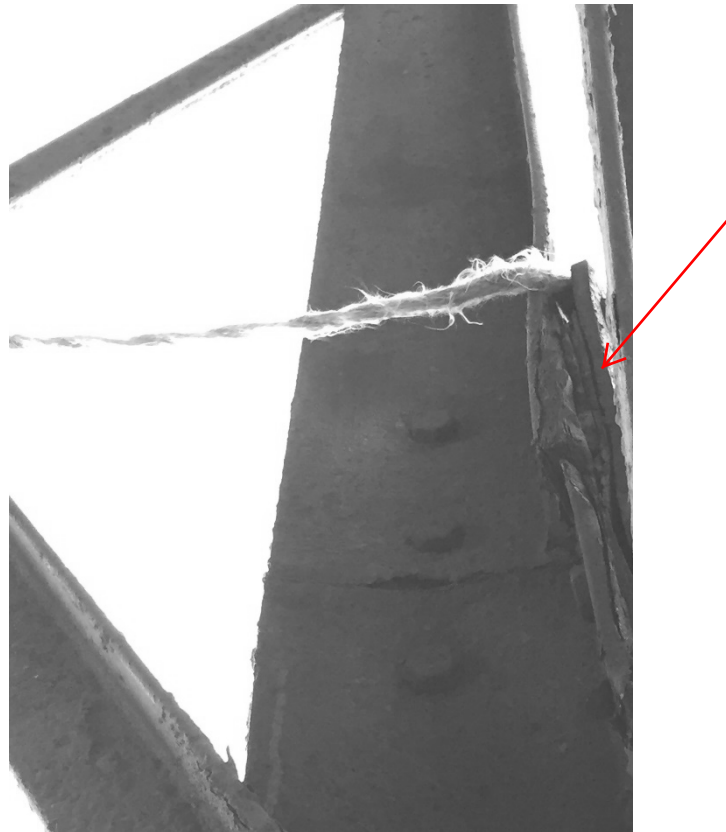
Two columns (waterside) at the tower frame were observed to have been previously repaired with splice plates (Figure 26). The spliced connections appear sound, although some deterioration of the splice plates has occurred. Similar regions further up the frame appear buckled, likely from impact. These areas have not been repaired.

Figure 26 – View of condition of splice plates at previously repaired column damage.
