Port of San Francisco Dry Dock EUREKA Structural Assessment Report

June 2017

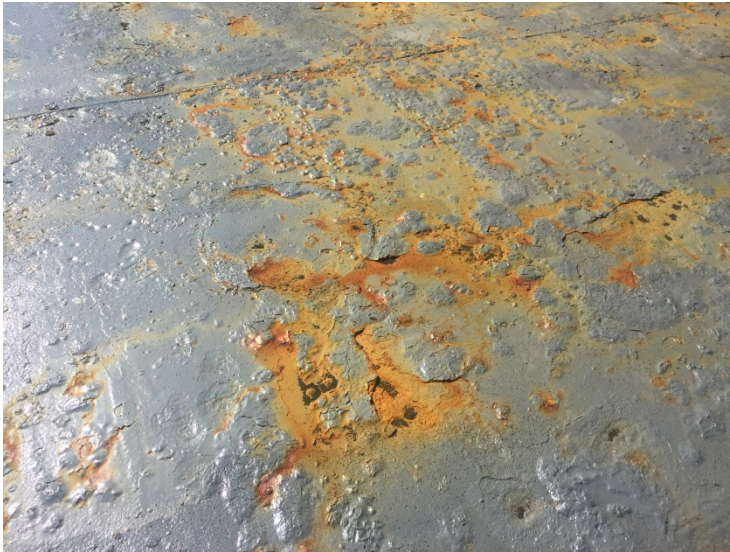
Figure 4: Typical Pontoon Deck Corrosion

GHD-TECI engineers observed that the top surface of the pontoon deck exhibits numerous locations of failed coating and loss of steel. A typical photo is shown as Figure 4 below.

GHD-TECI obtained ultrasonic thickness gauge measurements at several pontoon deck locations to confirm the findings of the 2015 UT survey. Results of GHD-TECI's confirmation survey showed plate thicknesses ranging from 0.45 inch to 0.24 inch. This represents a loss from the original steel thickness of up to 50%. These readings are similar to those taken in the 2015 survey.

The EUREKA's deteriorating pontoon deck structure presents two issues. The pontoon deck plate is experiencing significant diminution in material thickness. The deck plate is typically a floating dry dock's most susceptible region to metal loss as the pontoon deck experiences the highest amount of wear due to work performed on the docked vessels, vehicular traffic and high exposure to weathering effects such as rain and sun. These factors ultimately cause accelerated coating failure and corrosion of the deck plating. The diminution of the pontoon deck is of particular concern as it acts as one of the critical structural components in supporting a ship load during a lifting operation on a floating dry dock. The loss of plate thickness on a longitudinally strengthened pontoon deck, such as EUREKA's, exponentially decreases the compressive buckling strength of the pontoon deck. Prior ultrasonic thickness surveys and confirmed by GHD-TECI showed a significant number of readings (nearly half of all readings) with corrosion in the range of 25% - 50% on the original 7/16-inch pontoon deck plating. The corroded plate in its current condition drastically reduces the transverse strength of the dock.

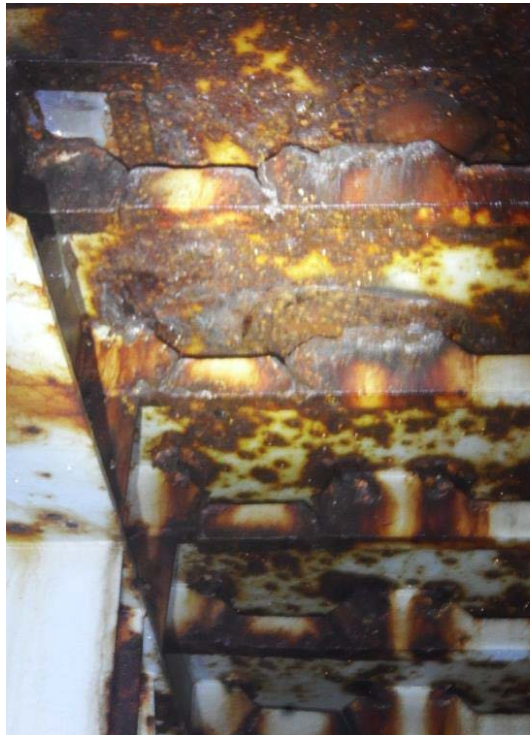
Figure 5: Pontoon Deck Stiffener Damage Example

In the 2015 inspection, it was noted the pontoon deck's serrated channels were beginning to fracture. In response, an in-depth visual survey mapping out the extent of the deck stiffener fractures was performed in May 2015. A pontoon deck repair plan was outlined in the previous inspection reports. By the time of the 2017 dock inspection, it was observed that no repairs had been made to the fractured stiffeners and the failures had become more widespread bringing uncertainty to the dock's ability to resist head pressure and vehicular traffic loads.

An example of heavy corrosion damage to the channel stiffeners is shown in Figure 5 below, compared against an undamaged stiffener shown in Figure 6.

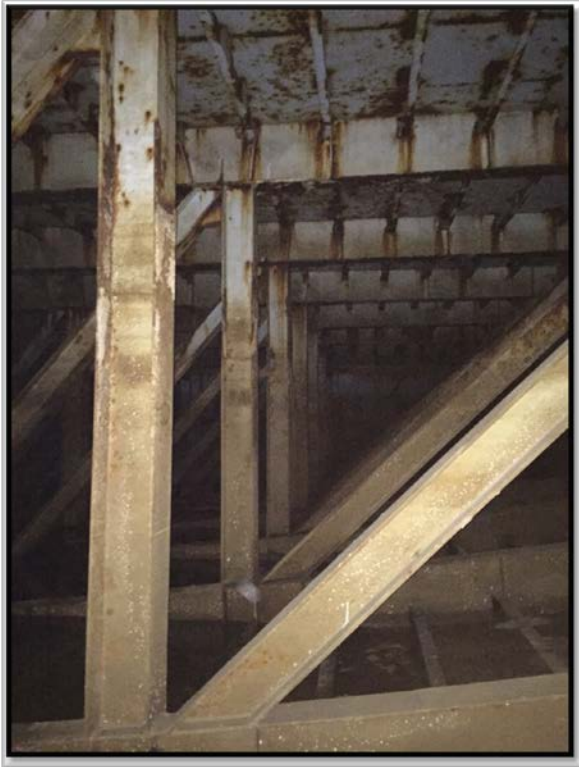
Figure 7: Typical Observations on Transverse Framing

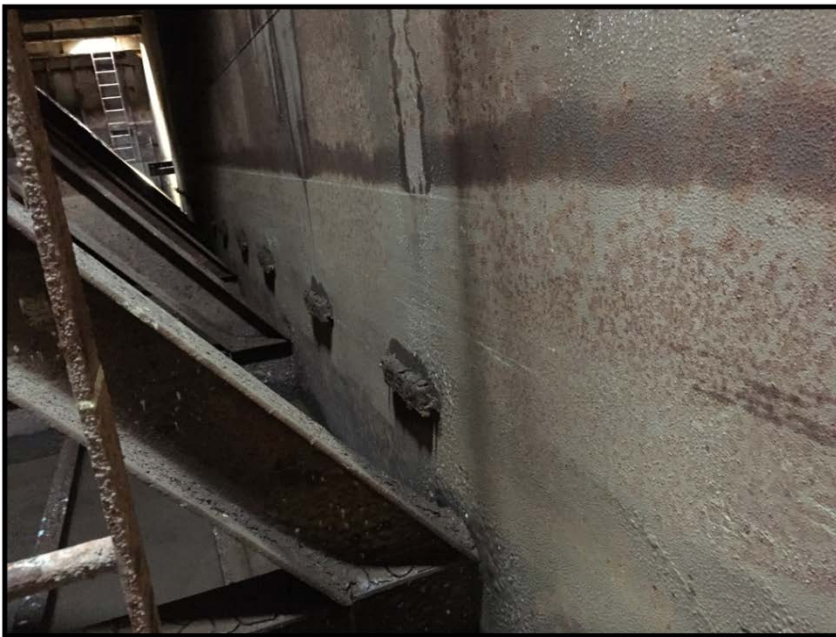
Figure 8: Interior Shell Plates and Anodes

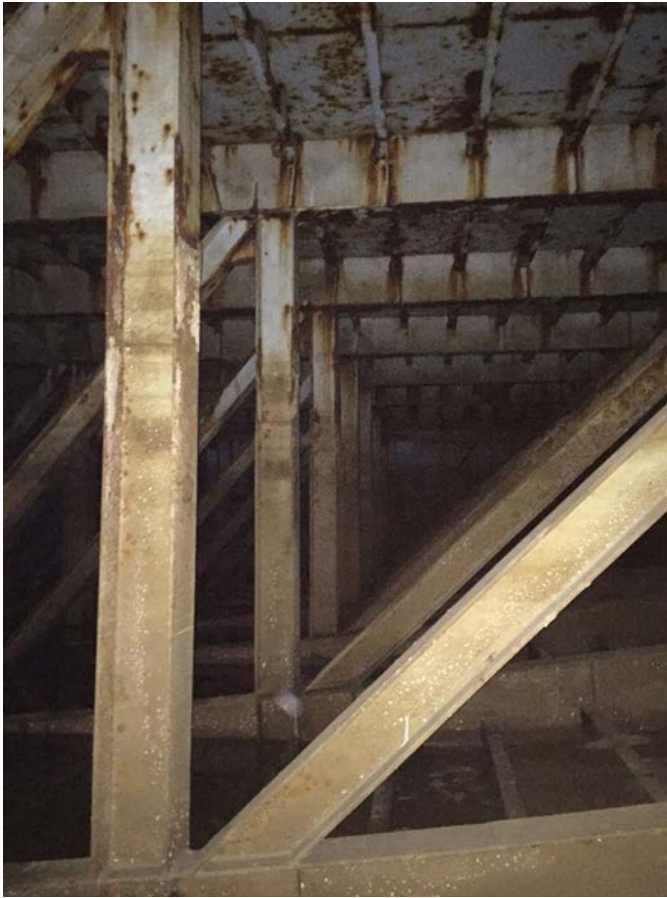
Member	Thickness (in)
Diagonal	0.67
Post	0.69
Bottom Chord	0.52

Figure 17: Tank 5 Corroded Members

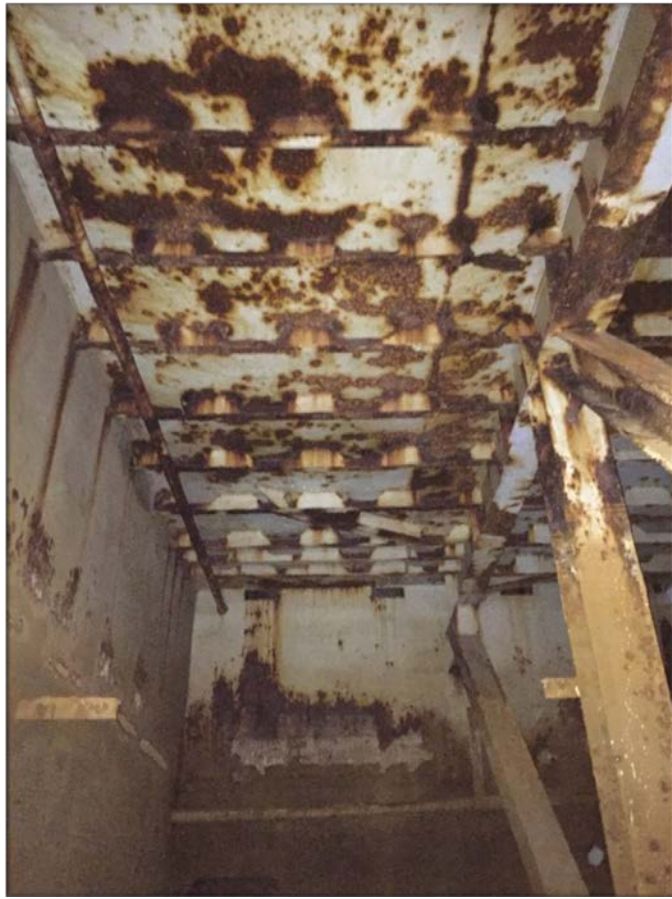
Member	Thickness (in)
Diagonal	0.58
Post	0.63
Bottom Chord	0.53

Figure 18: Typical Corrosion at Roof of Tank 6A

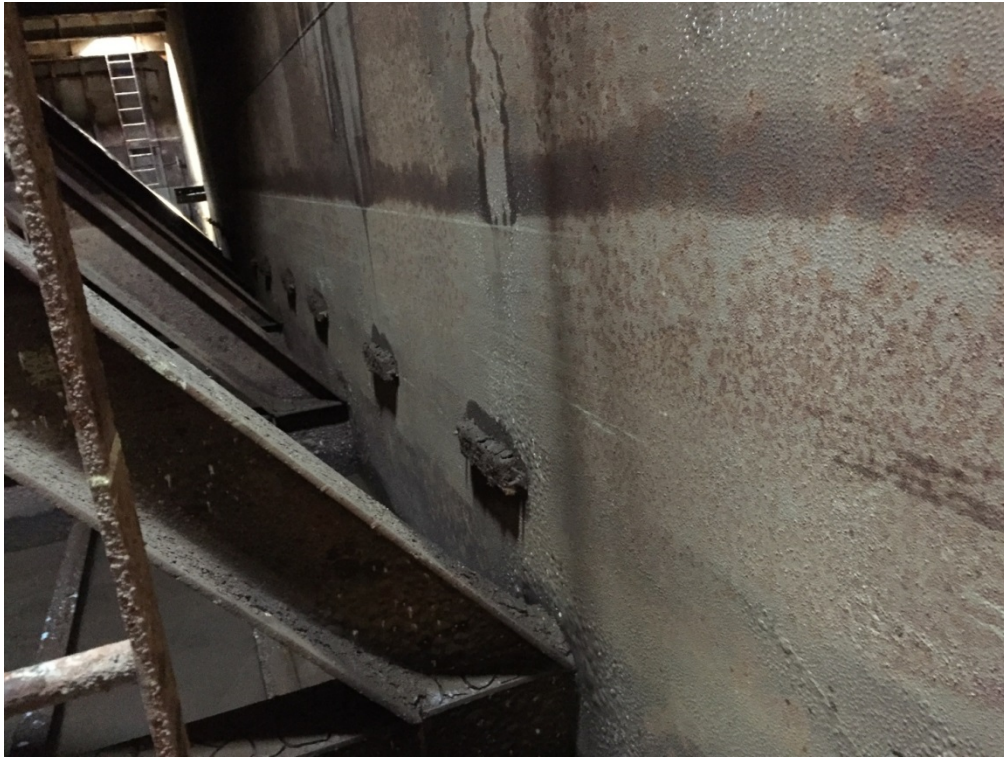
Figure 19: Tank 9 Wall

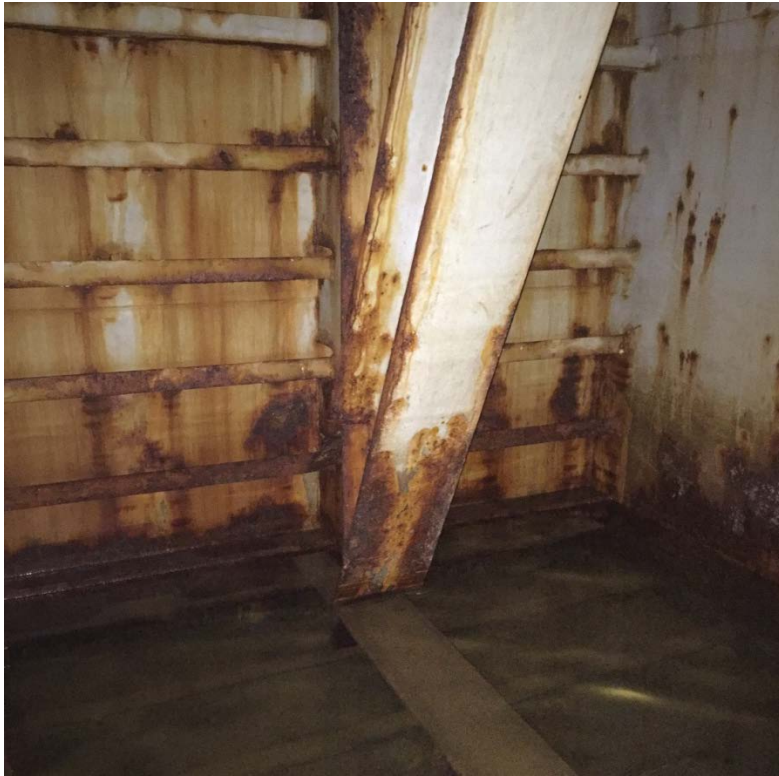
Figure 20: Tank 20A Side Wall and Diagonal

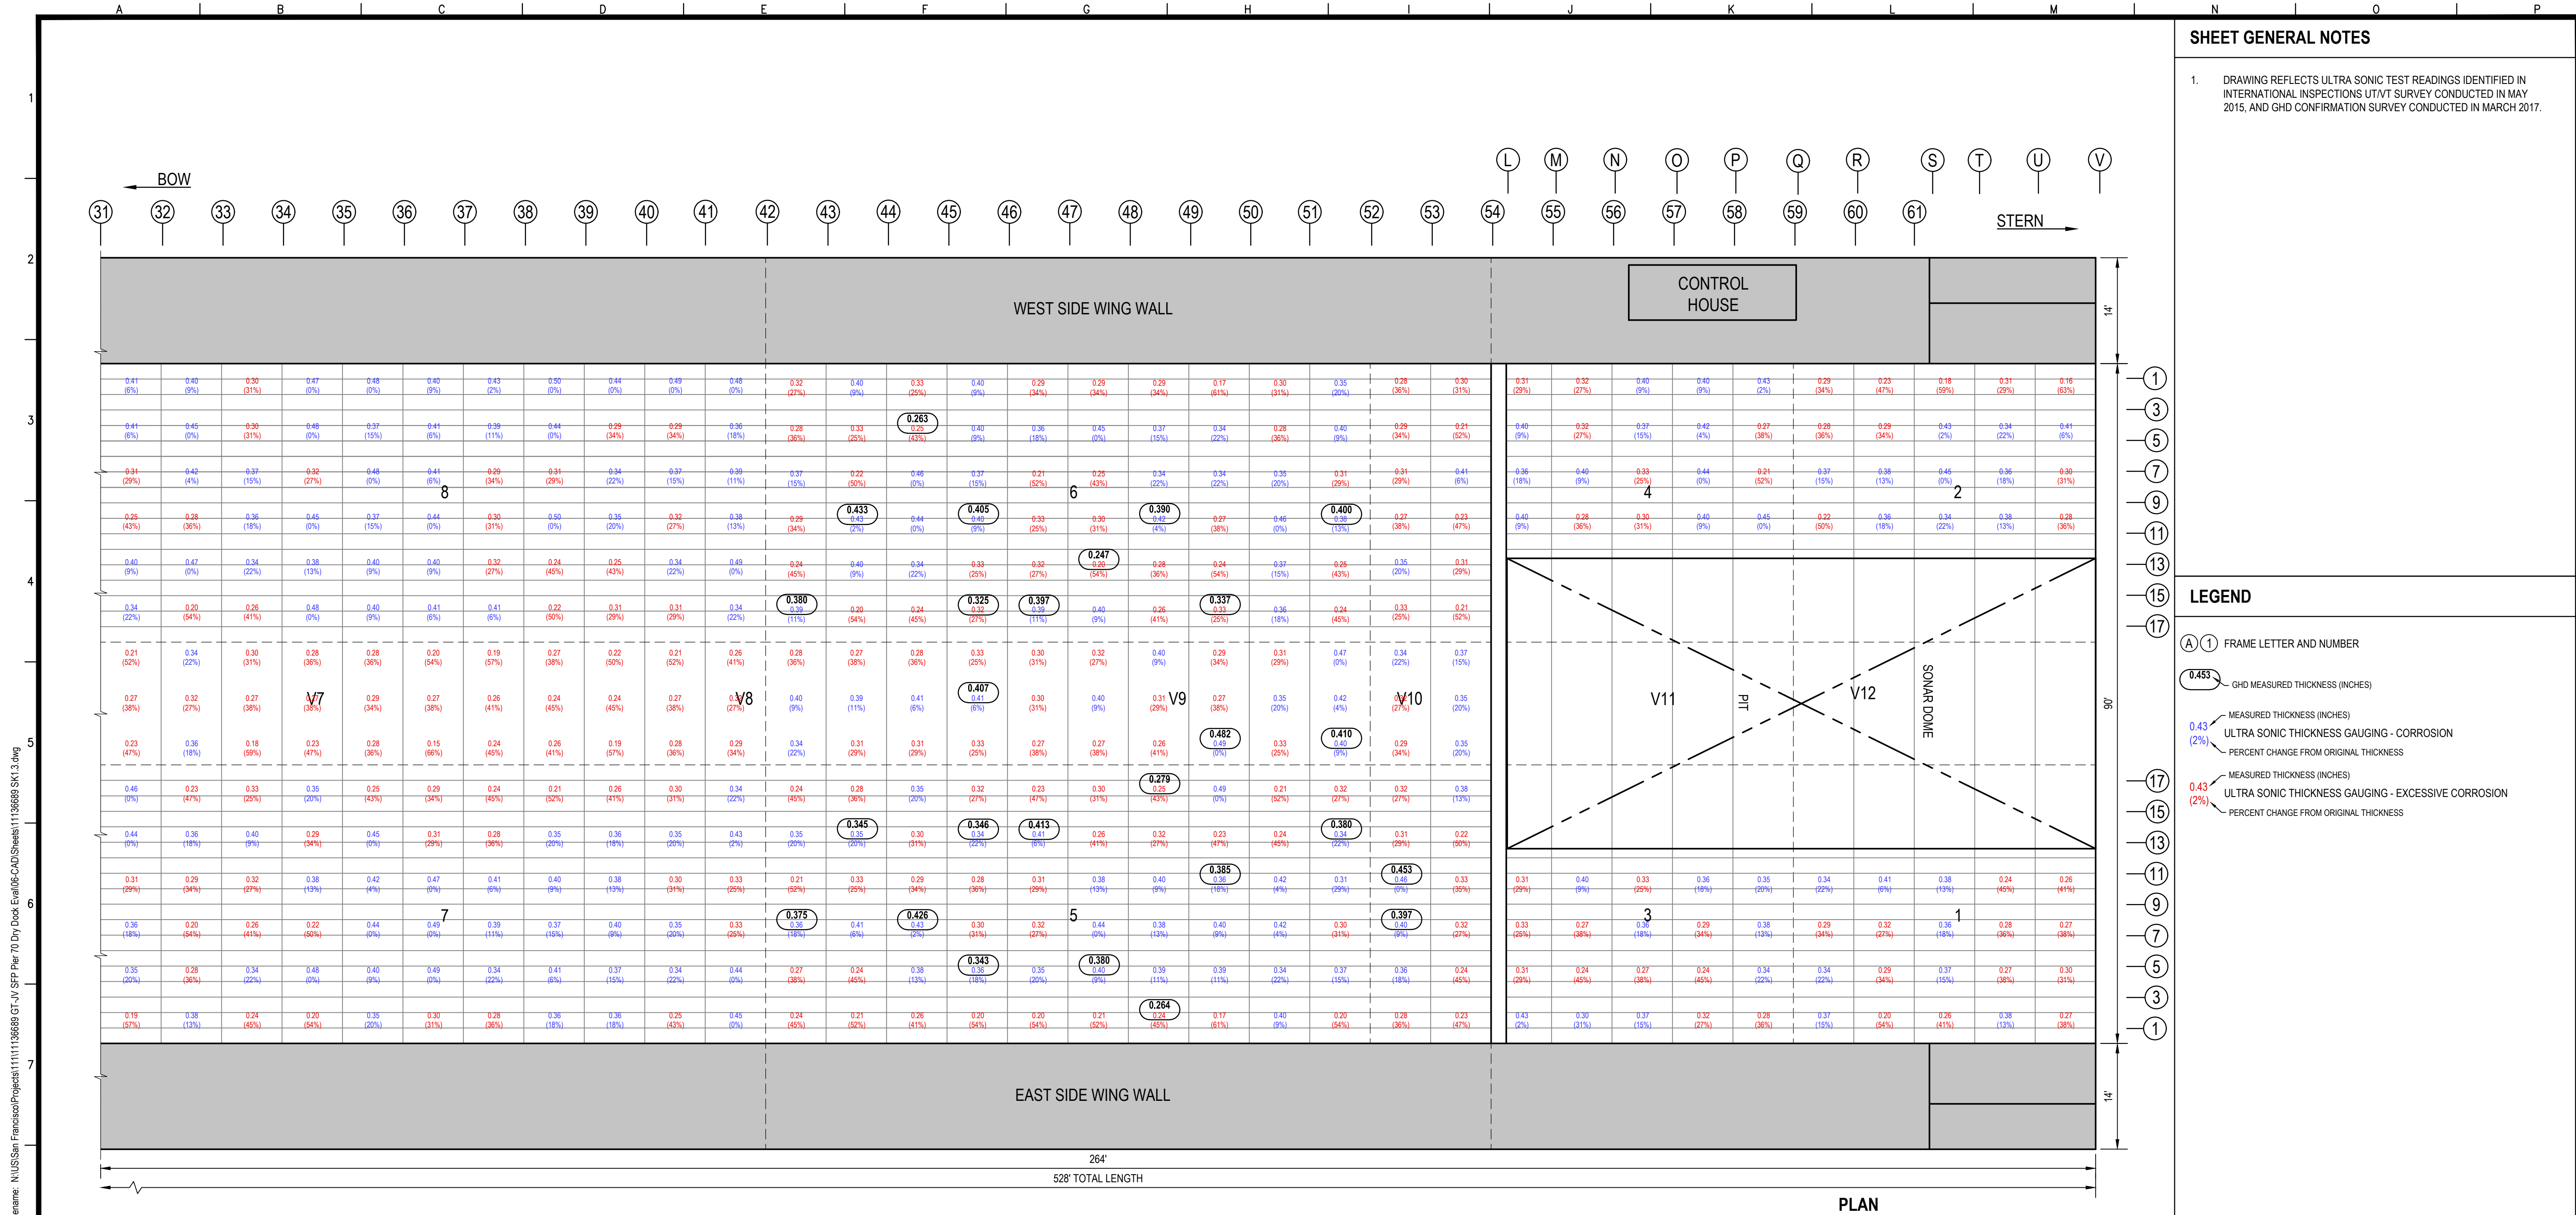
EUREKA DECK PLATE THICKNESS CONFIRMATION SURVEY

- (A 1) FRAME LETTER AND NUMBER
- 0.453 GHD MEASURED THICKNESS (INCHES)
- 0.43 (2%) MEASURED THICKNESS (INCHES)
ULTRA SONIC THICKNESS GAUGING - CORROSION
PERCENT CHANGE FROM ORIGINAL THICKNESS
- 0.43 (2%) MEASURED THICKNESS (INCHES)
ULTRA SONIC THICKNESS GAUGING - EXCESSIVE CORROSION
PERCENT CHANGE FROM ORIGINAL THICKNESS

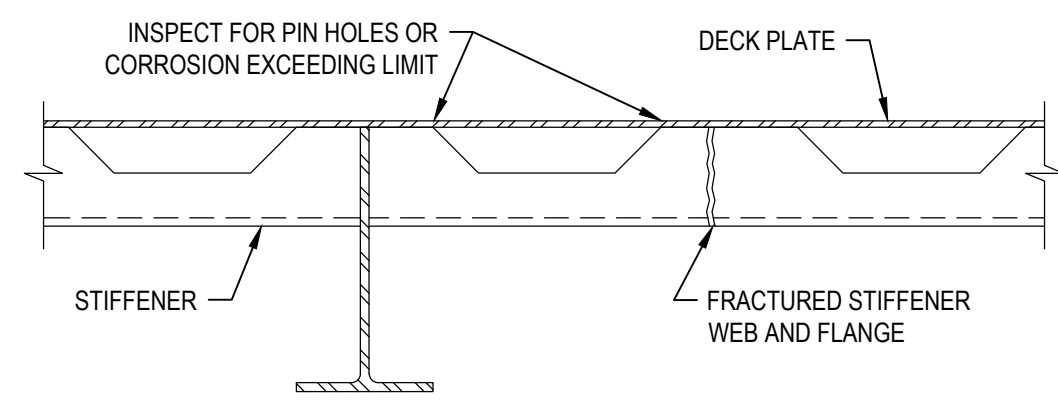
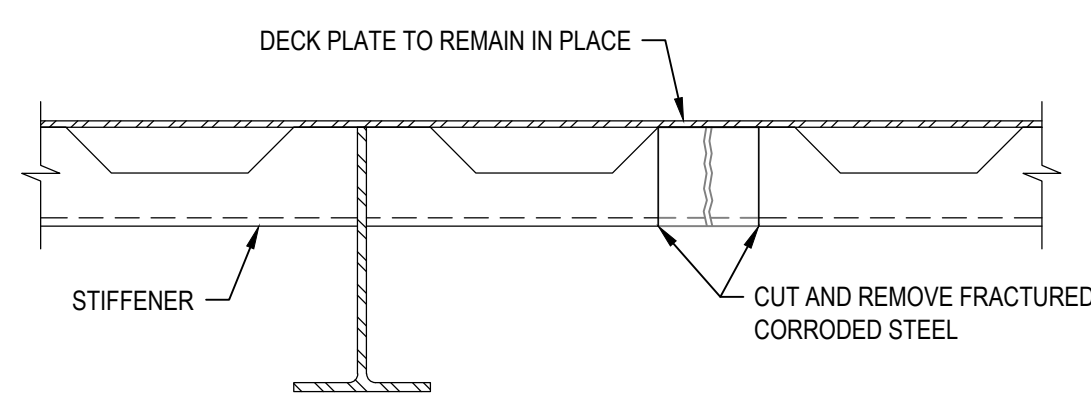
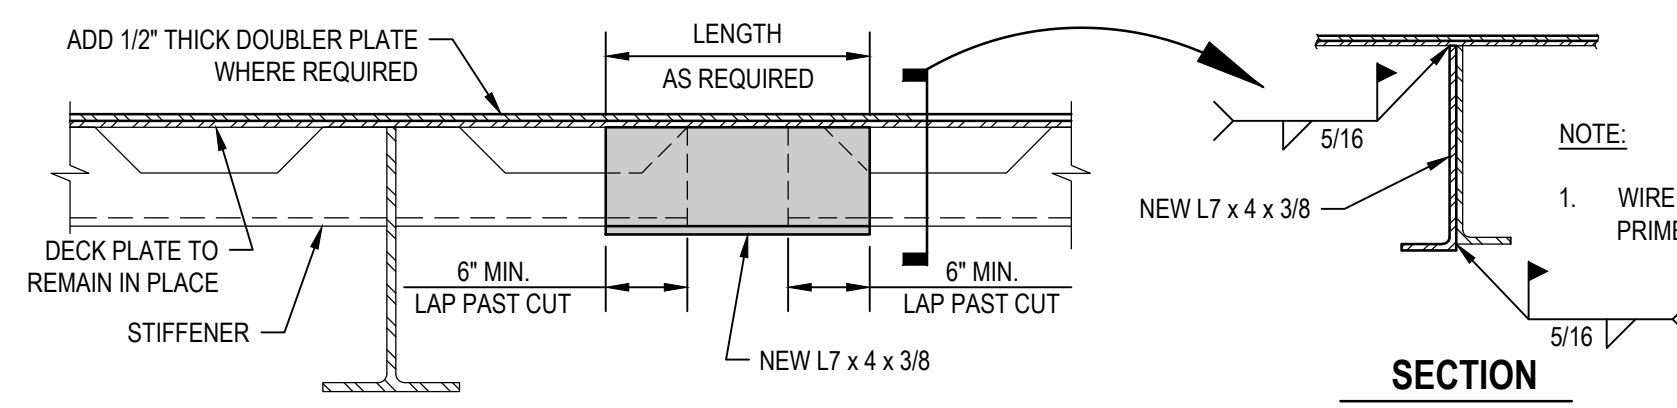
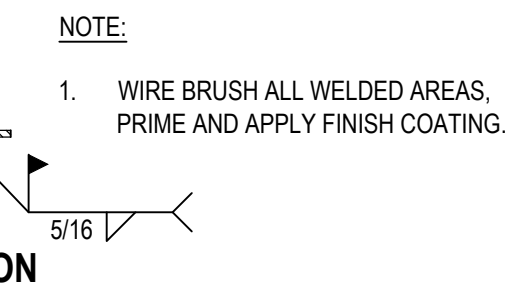
1 STIFFENER WEB AND FLANGE REPAIR DETAIL (SHORT TERM)
NOT TO SCALE

ORIGINAL DAMAGED AREA

STEP 1 OF REPAIR

STEP 2 OF REPAIR

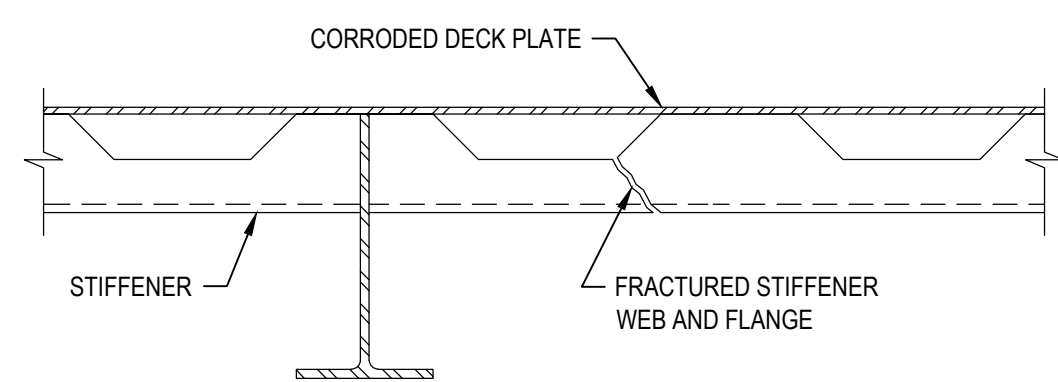
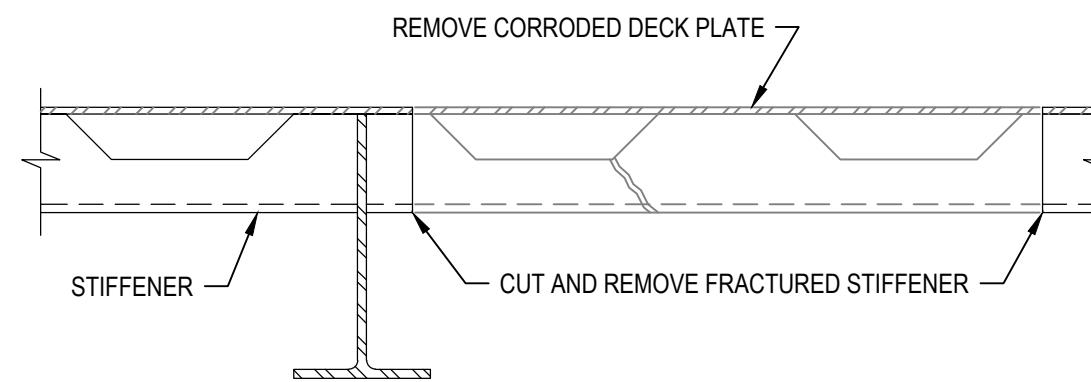
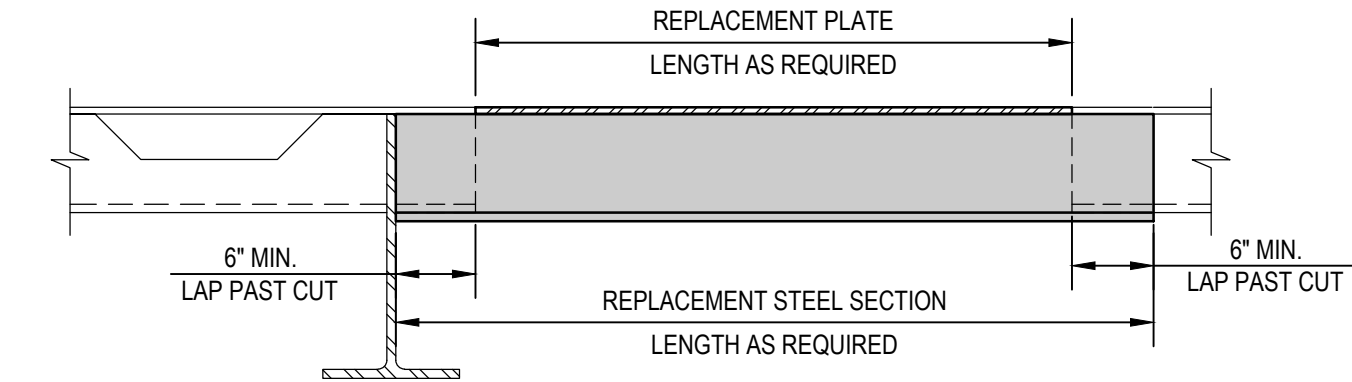
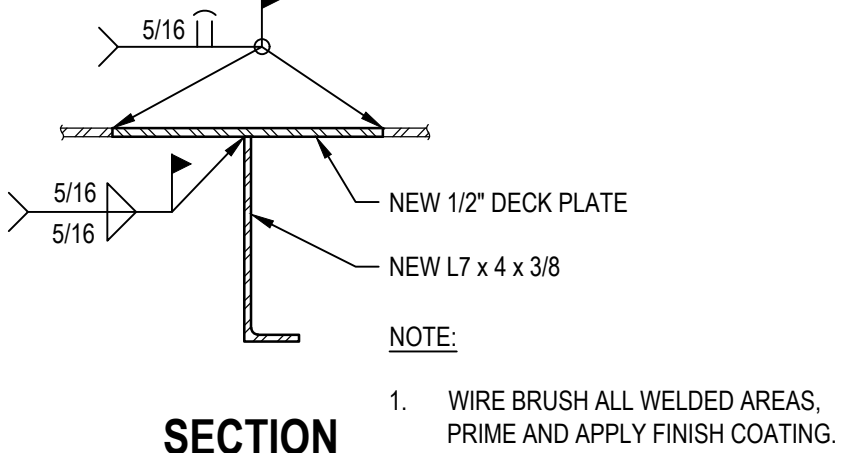
2 PLATE AND STIFFENER REPAIR DETAIL (LONG TERM)
NOT TO SCALE

ORIGINAL DAMAGED AREA

Long term repairs should also include repair and patching of upper deck plating and wing wall plating where section loss has occurred.

STEP 1 OF REPAIR

STEP 2 OF REPAIR

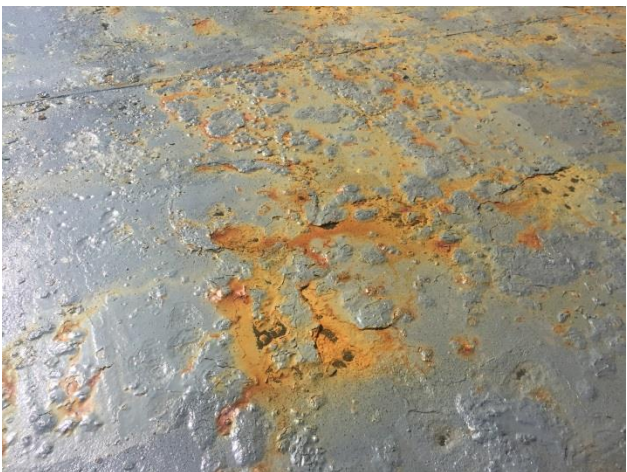
5. Close up of pontoon deck corrosion

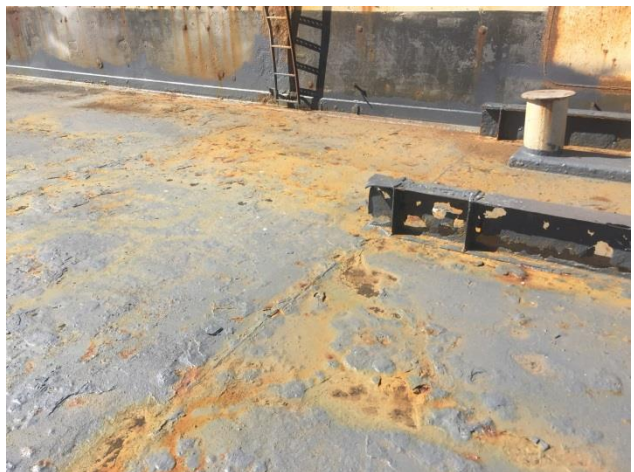
6. Wide view of pontoon deck corrosion

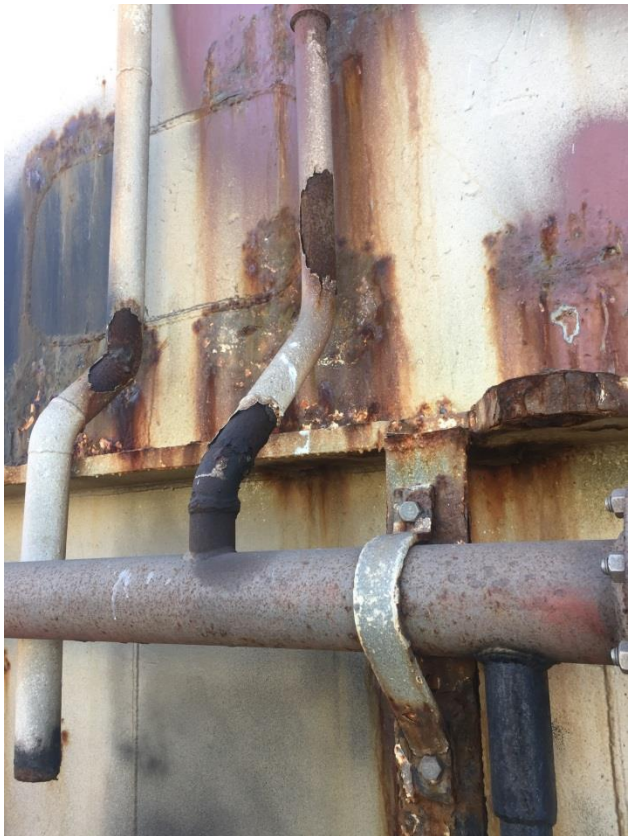
9. Typical pipe and steel corrosion at wing wall

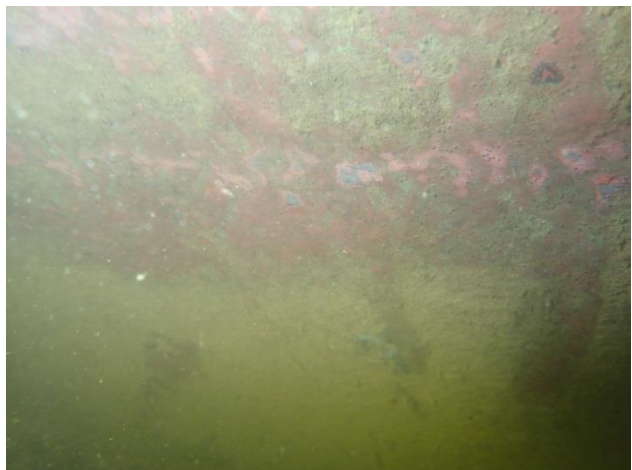
24. Typical hull deterioration after removal of marine growth

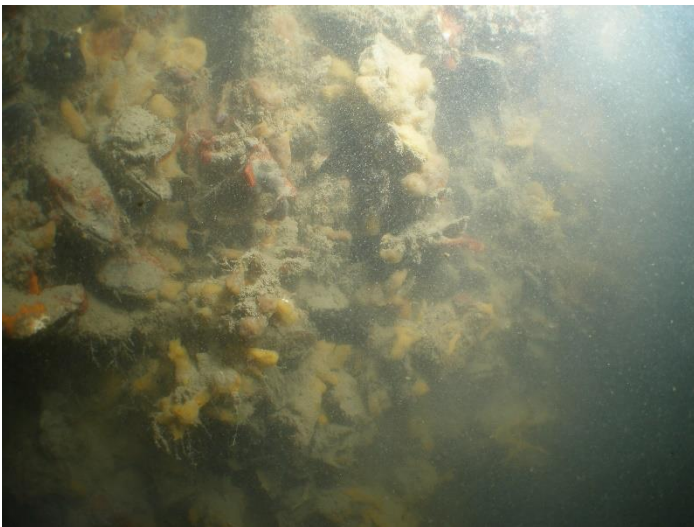
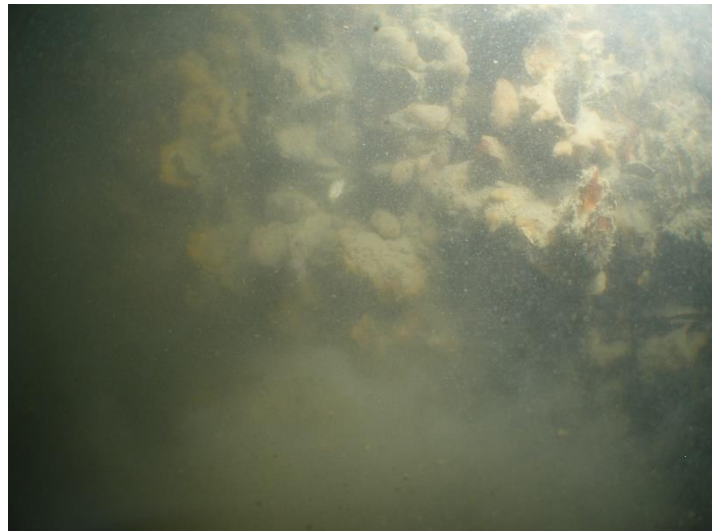
The dive crew cleaned the screens. The screens had mostly hard growth and were clogged up to 90%. All the screens were pressure washed and the marine growth was removed.

Typical condition of a screen (90% clogged with marine growth)

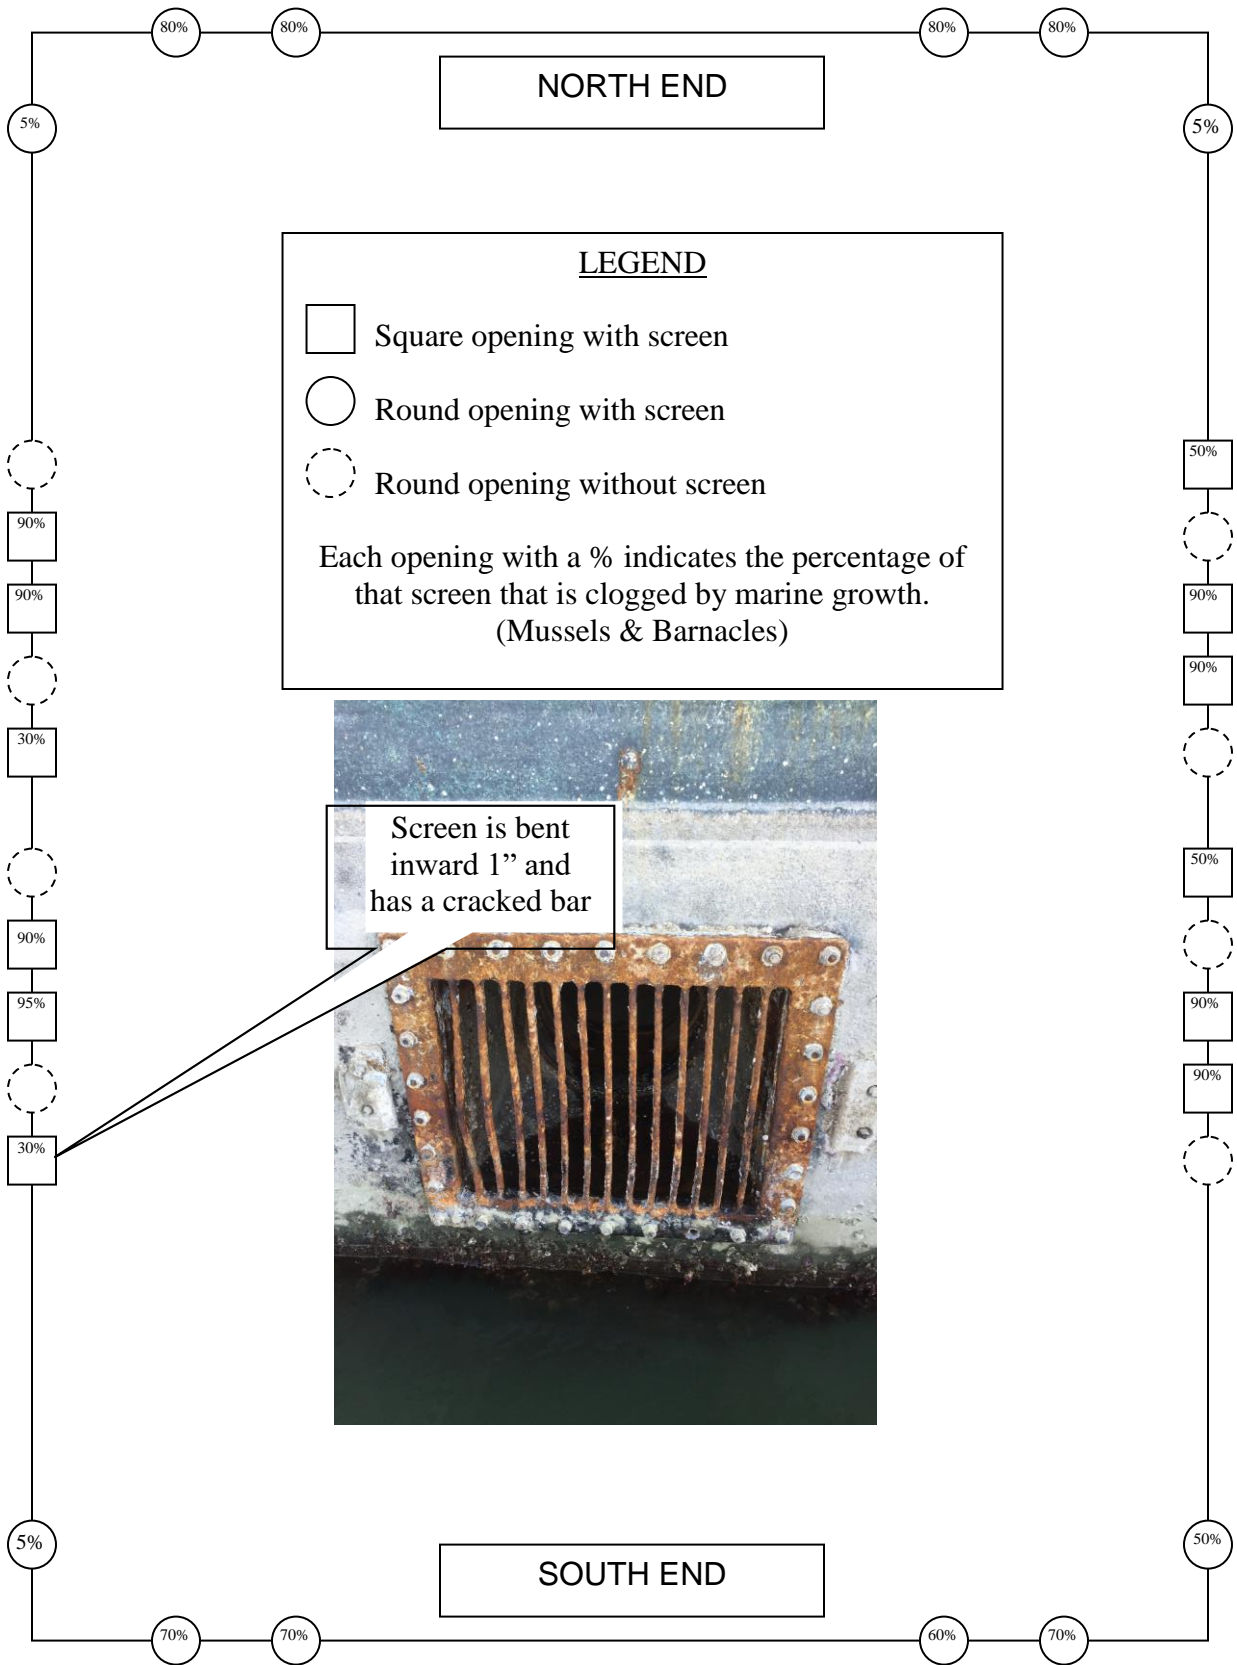
DRAWING B % of marine growth on each screen

Diver checked each screen again after cleaning and found one screen that has a bent bar which is identified in ***Drawing B***. All other screens are securely fastened to dry dock and in good condition. Below are pictures of a few screens which are typical of all screens after cleaning.

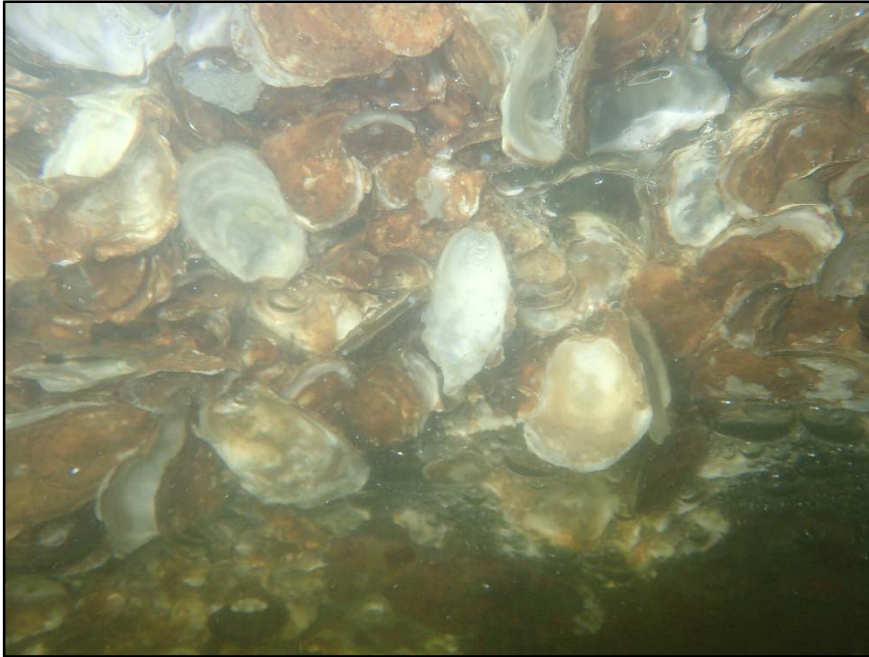
Photograph 3 : Underwater view of typical marine growth located along outer hull perimeter.

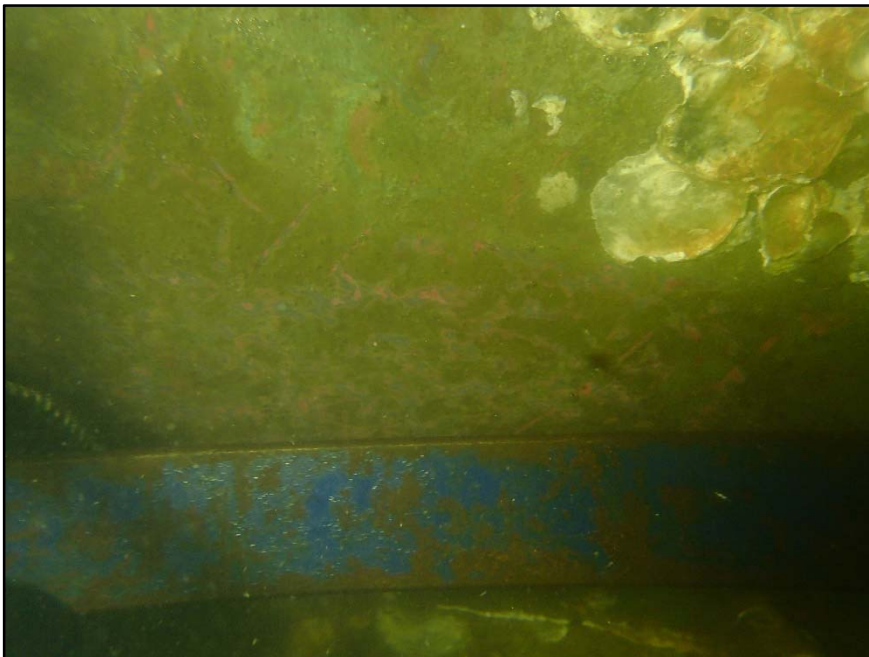
Photograph 4 : Underwater view of typical marine growth towards hull keel.

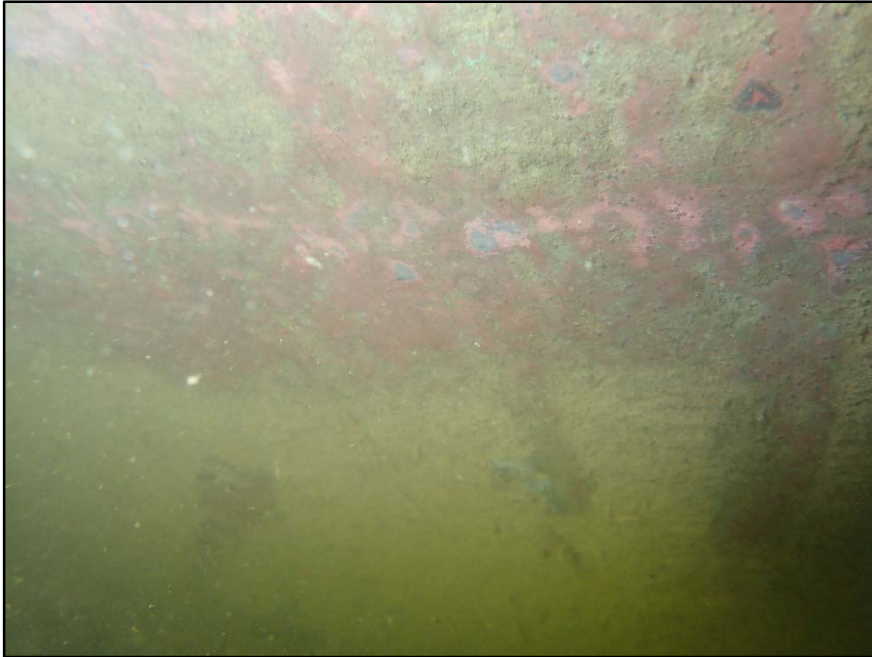
Photograph 5 : Underwater view of typical hull coating presentation with red coloring.

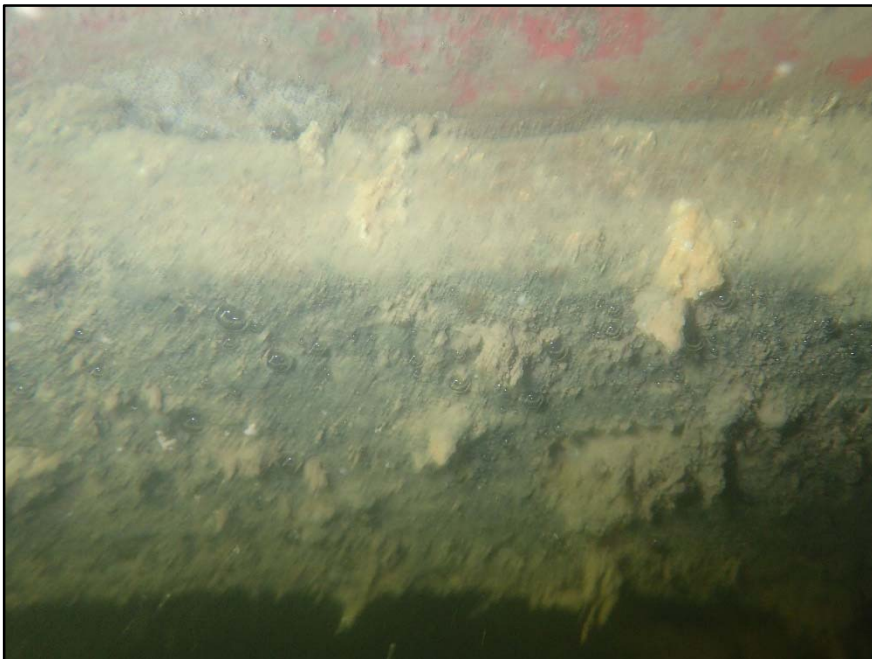
Photograph 6 : Underwater view of typical sacrificial anode condition.
