RAPID STRUCTURAL ASSESSMENT REPORT

Structure Type:	SUPERSTRUCTURE	Work Order:	5540
Facility Name:	Pier 68 Warehouse Building- Bldg. # 36	FIN:	1680036
Asset Number:	1680-BLDG36	Facility Code:	3490
Asset Activity:	STRUCTURE TWO YR INSPECTION	Port Engineer:	Duncan, Mr. Sherban A.
Inspection Number:	1680-BLDG36-1-2013	Inspected By:	AGS - Jasper Chau
Inspection Start Date:	2013/05/29 11:23:24	Inspection End Date:	2013/05/29 11:23:24
Purpose Of Inspection:	Periodic Inspection	Lease Number:	M-13828
Address:			
Year Built:

Name of Facility: Pier 68 Warehouse Building- Bldg. # 36

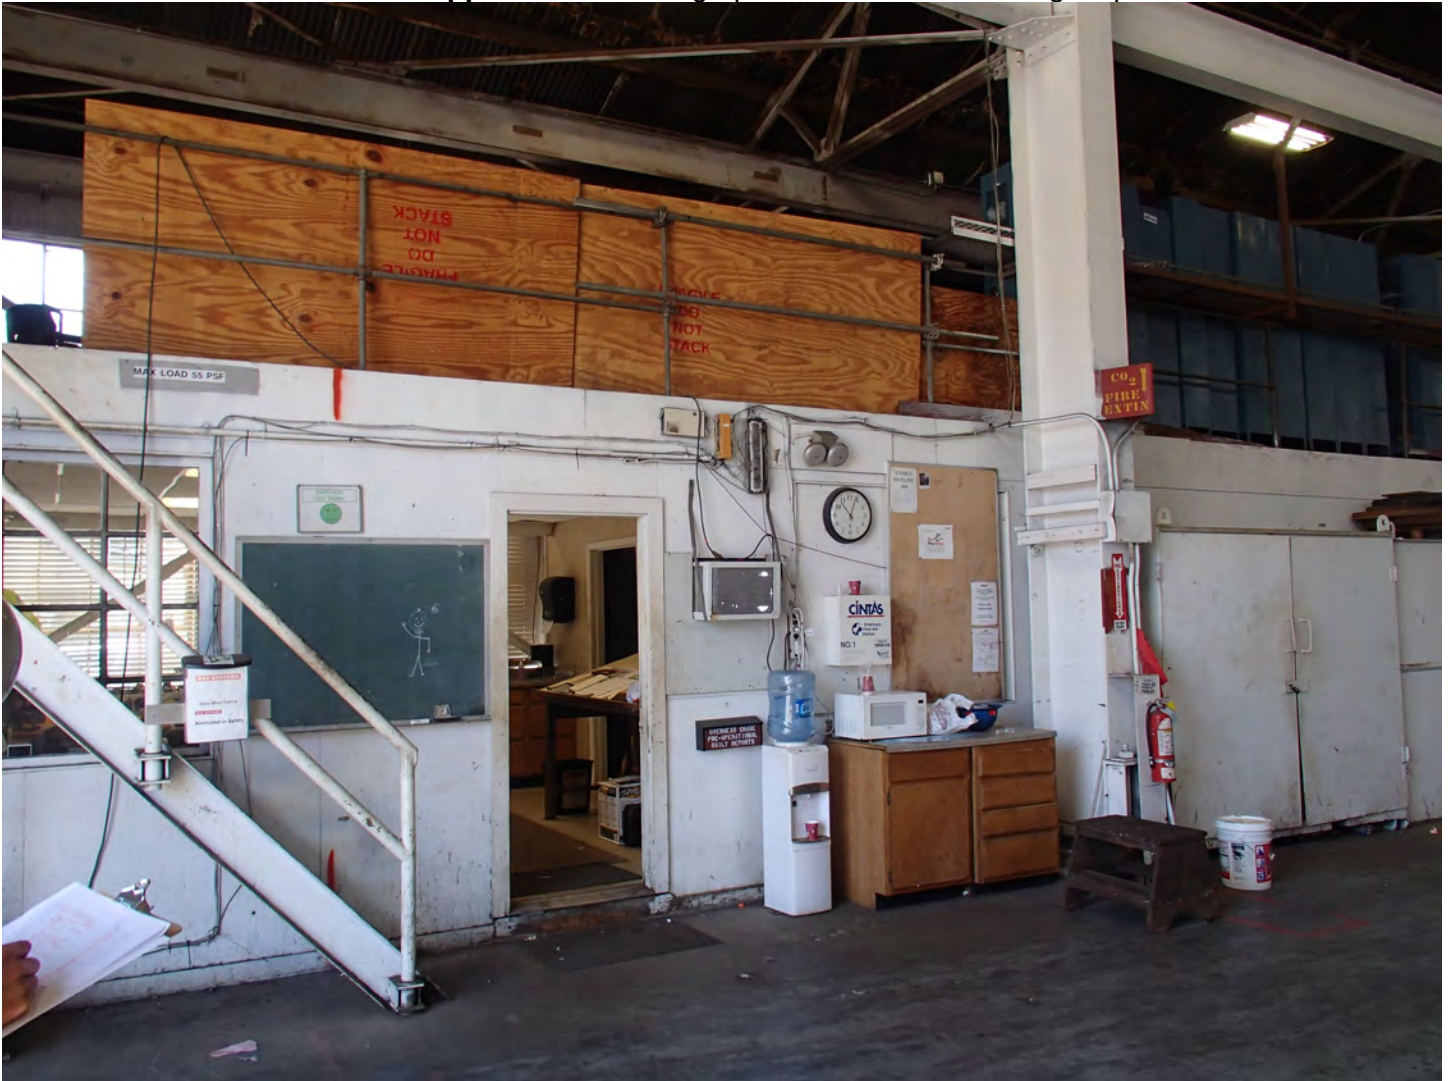
Photo 1. View of the interior office spaces

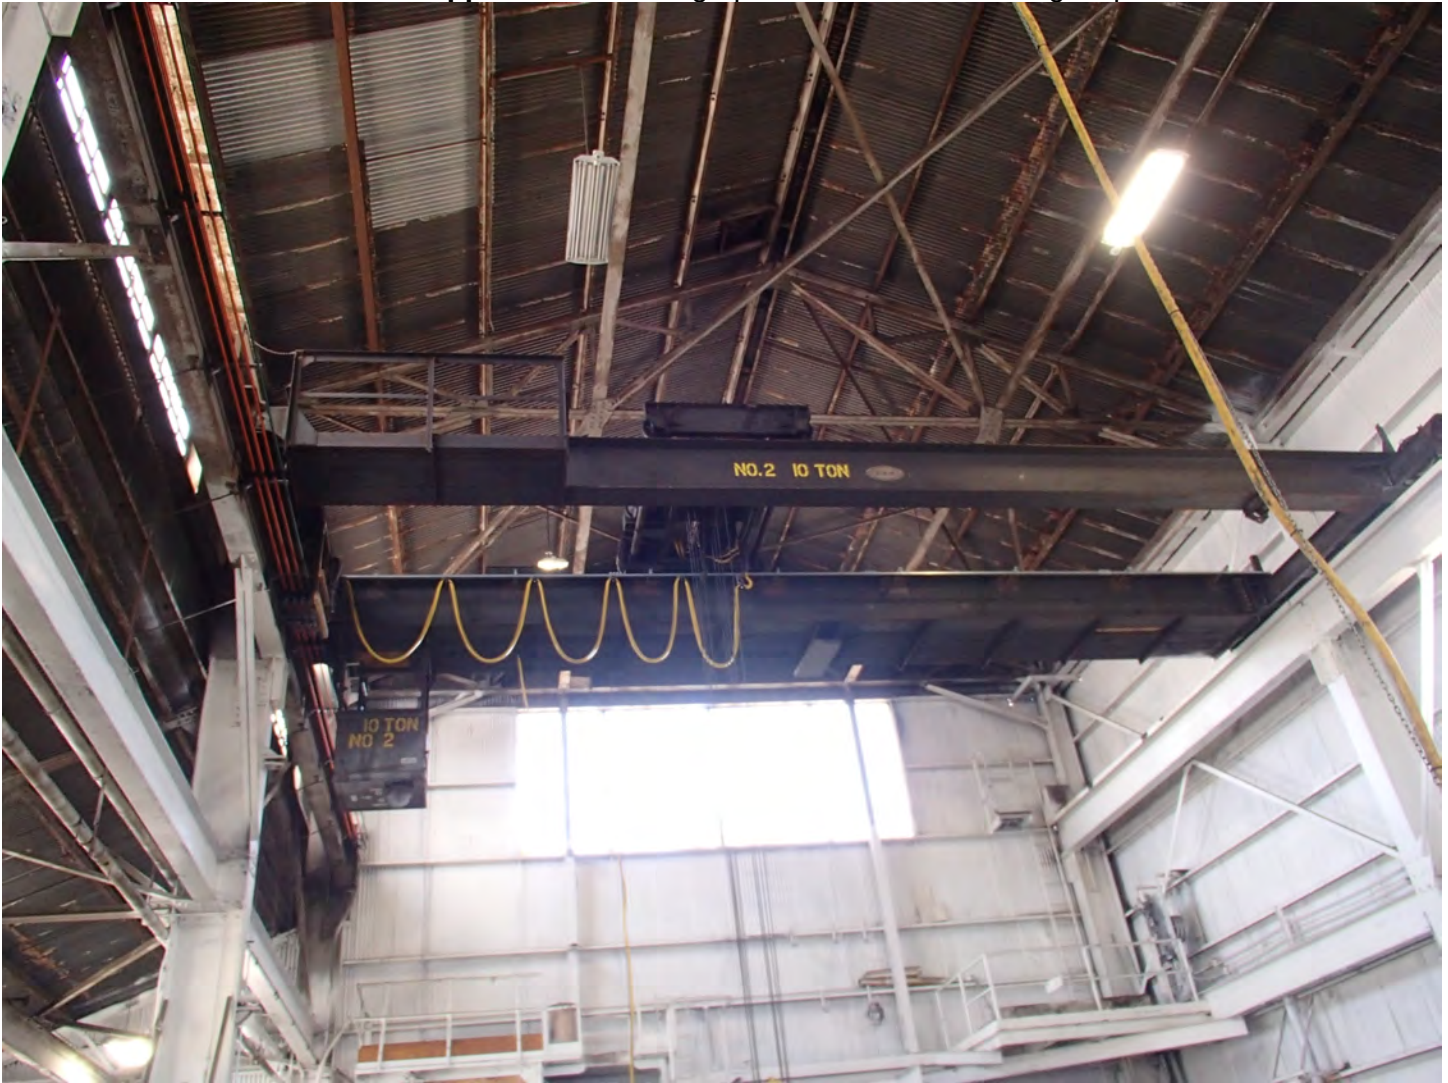
Photo 2. View of the 10-ton cranes

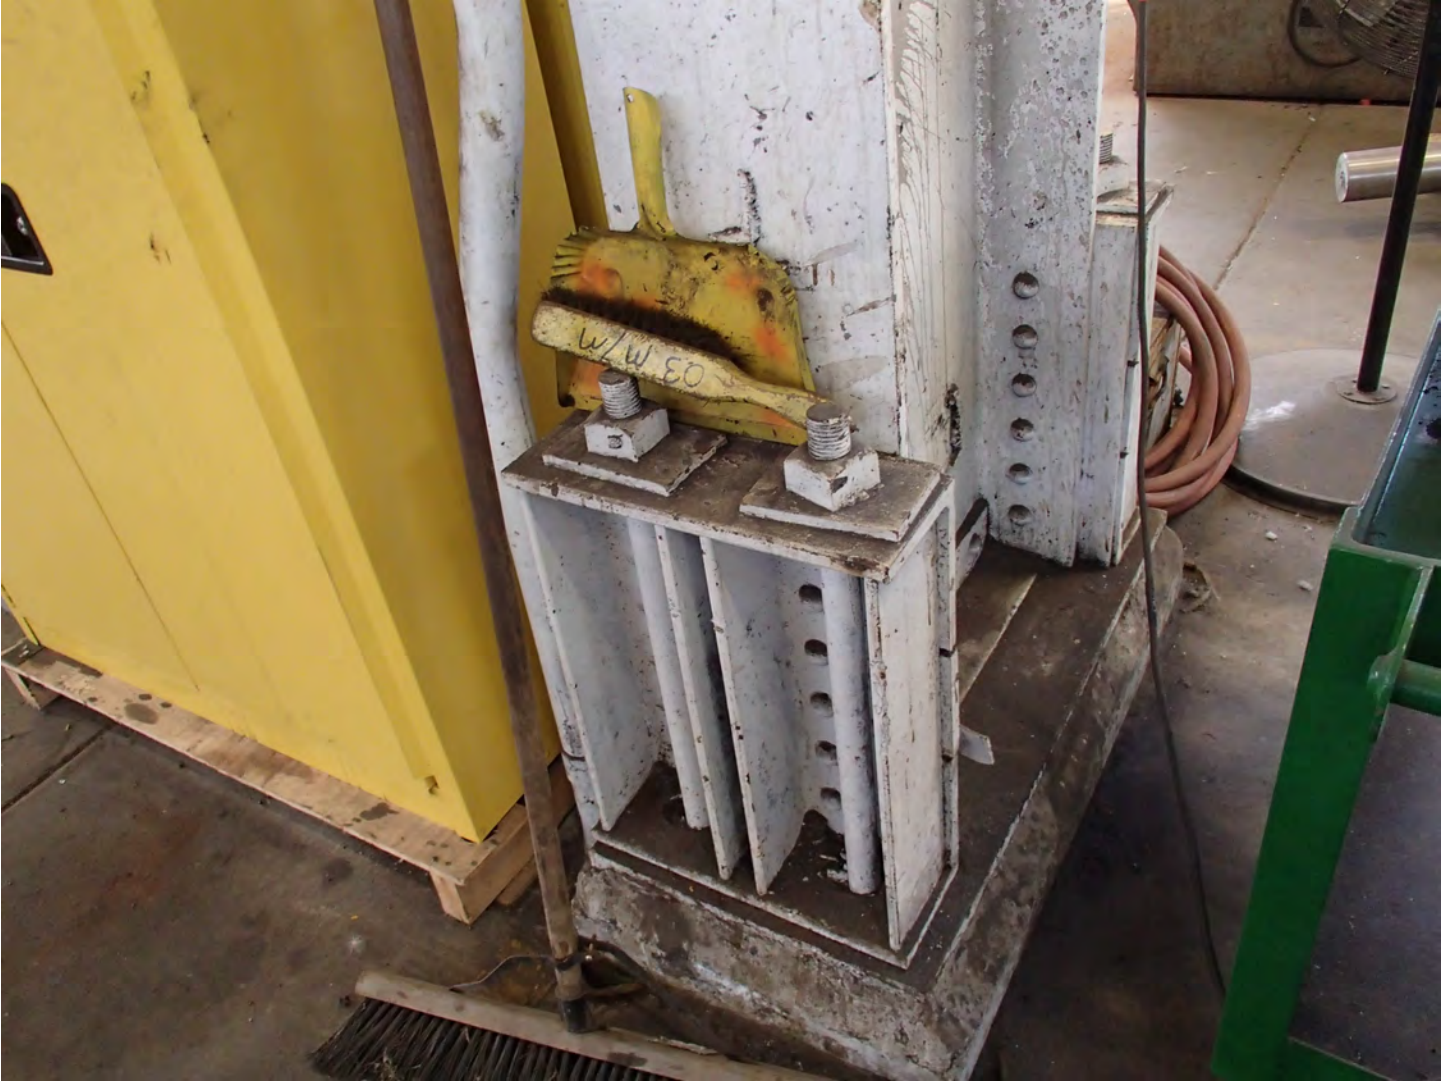
Photo 3. View of the interior steel column base connection

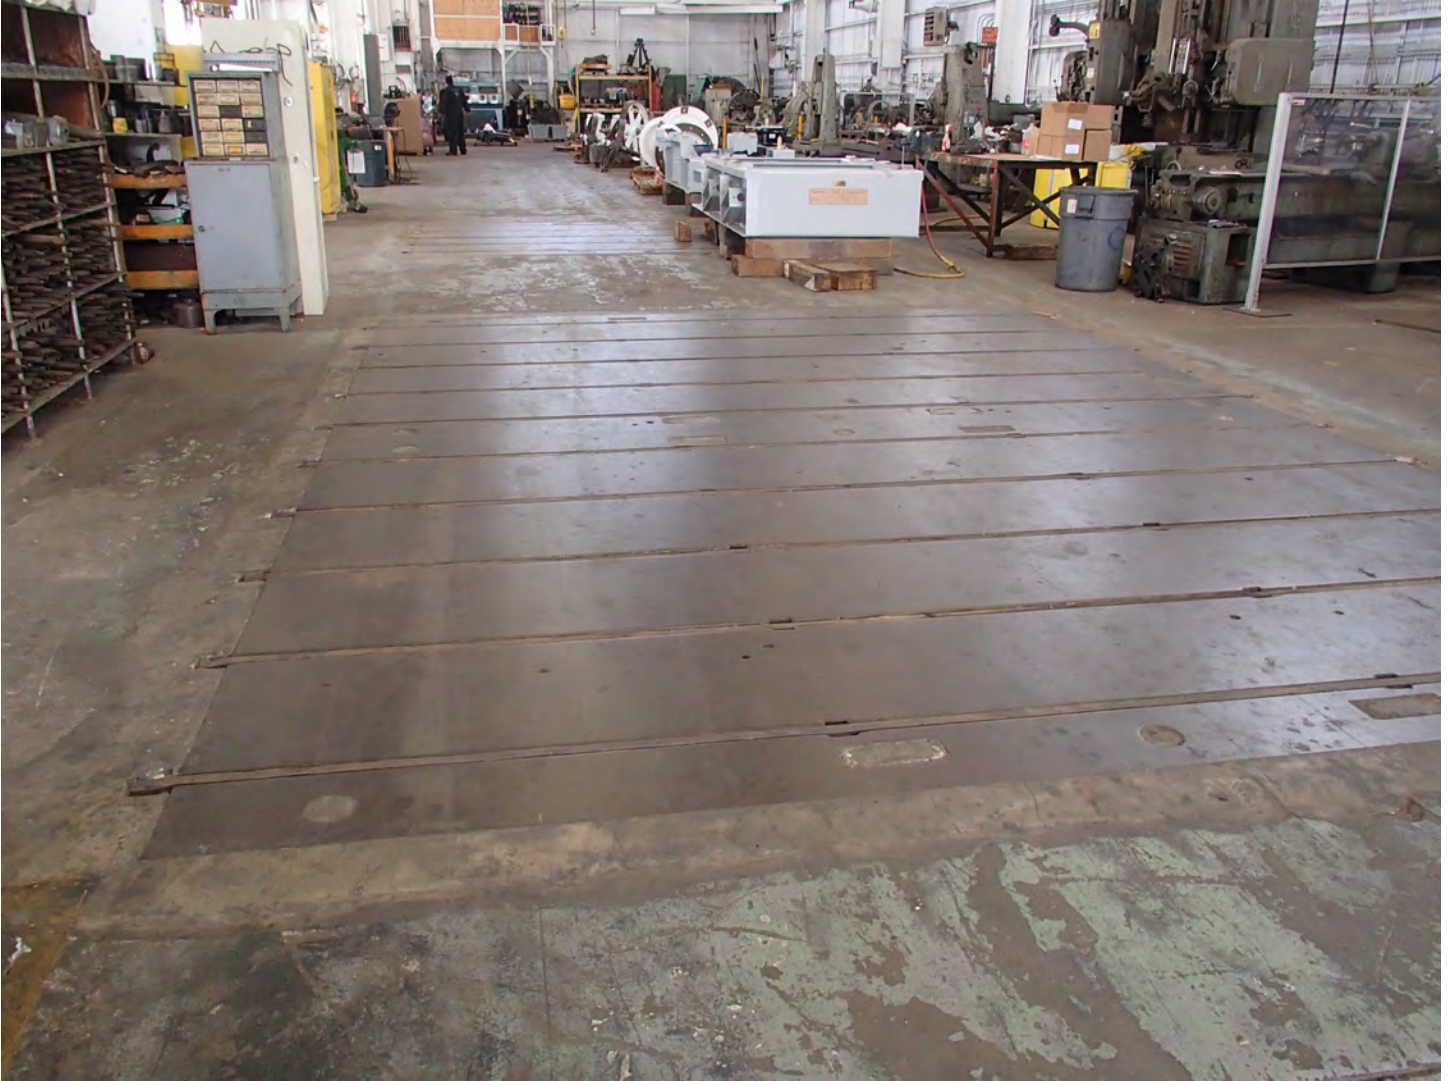
Photo 4. View of the interior floor slab

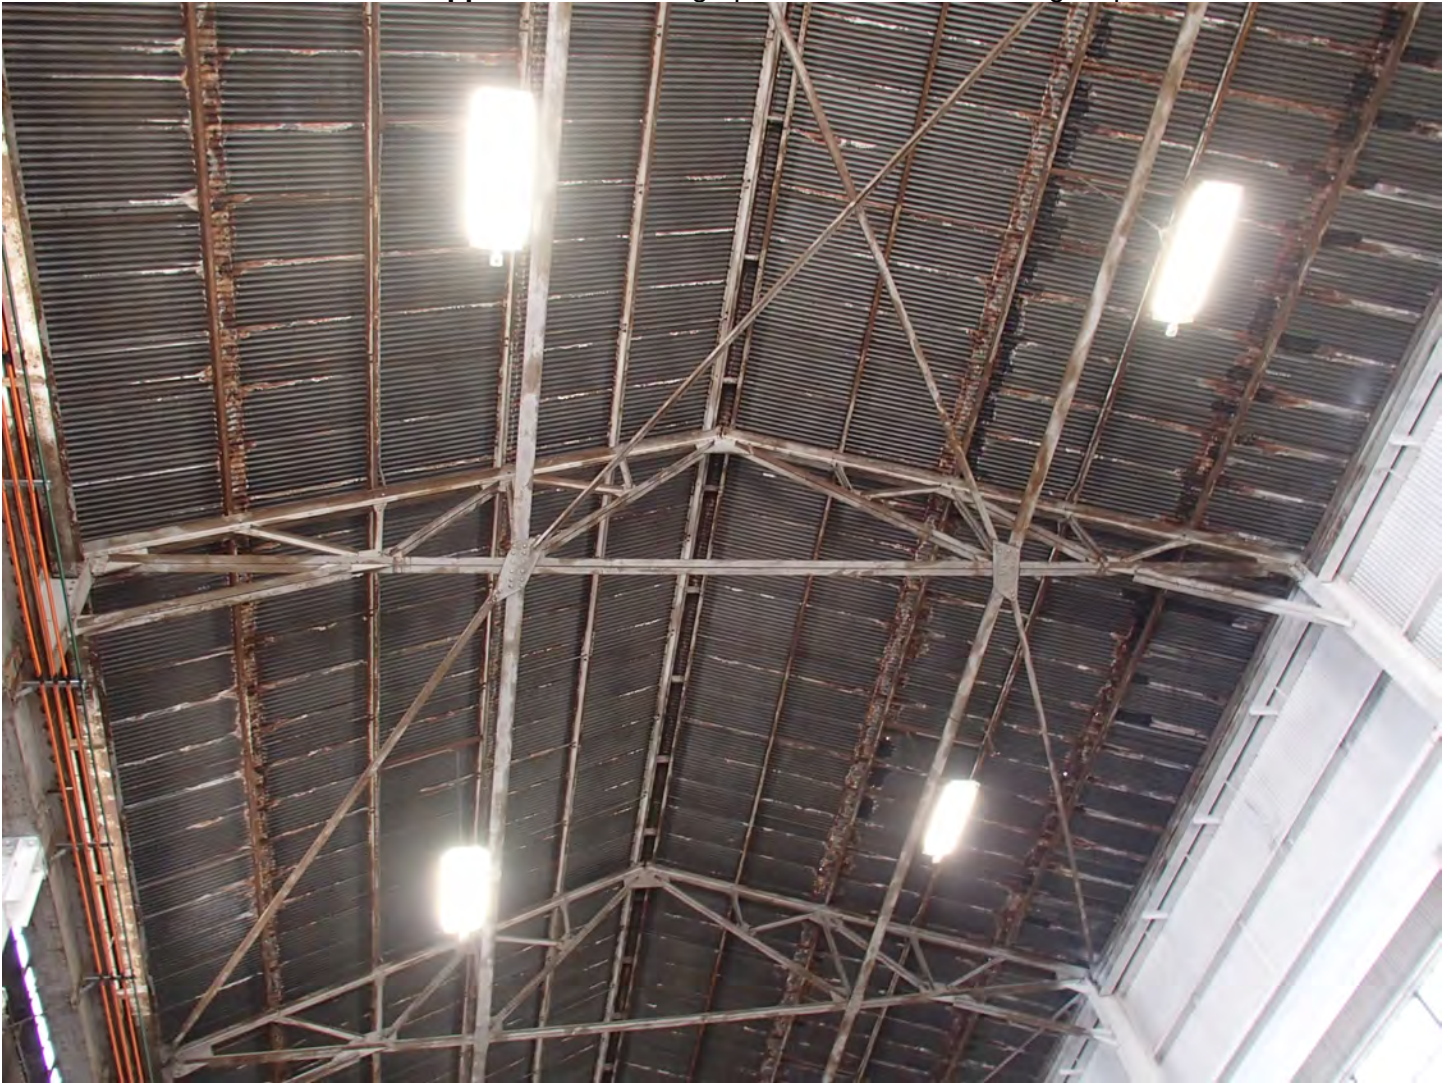
Comment - There minor damage to the building's metal siding. The corrugated roof metal decks exhibited rust due to water intrusion.

Photo 5. View of the steel roof truss and underside of the metal deck

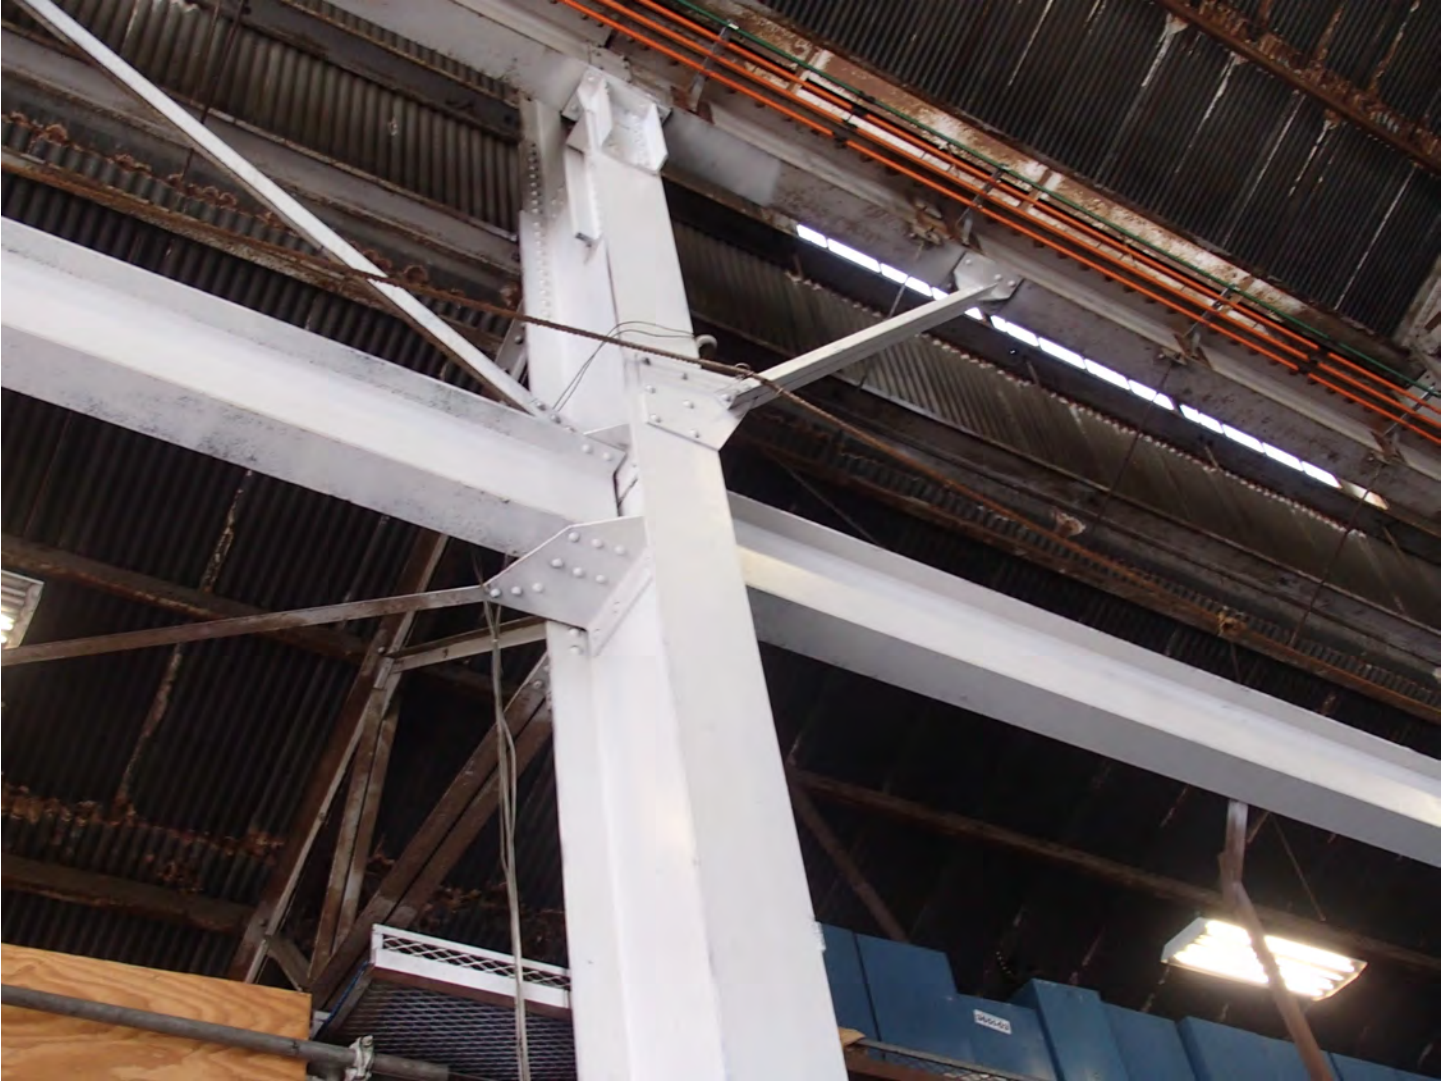
Photo 6. View of the interior steel column

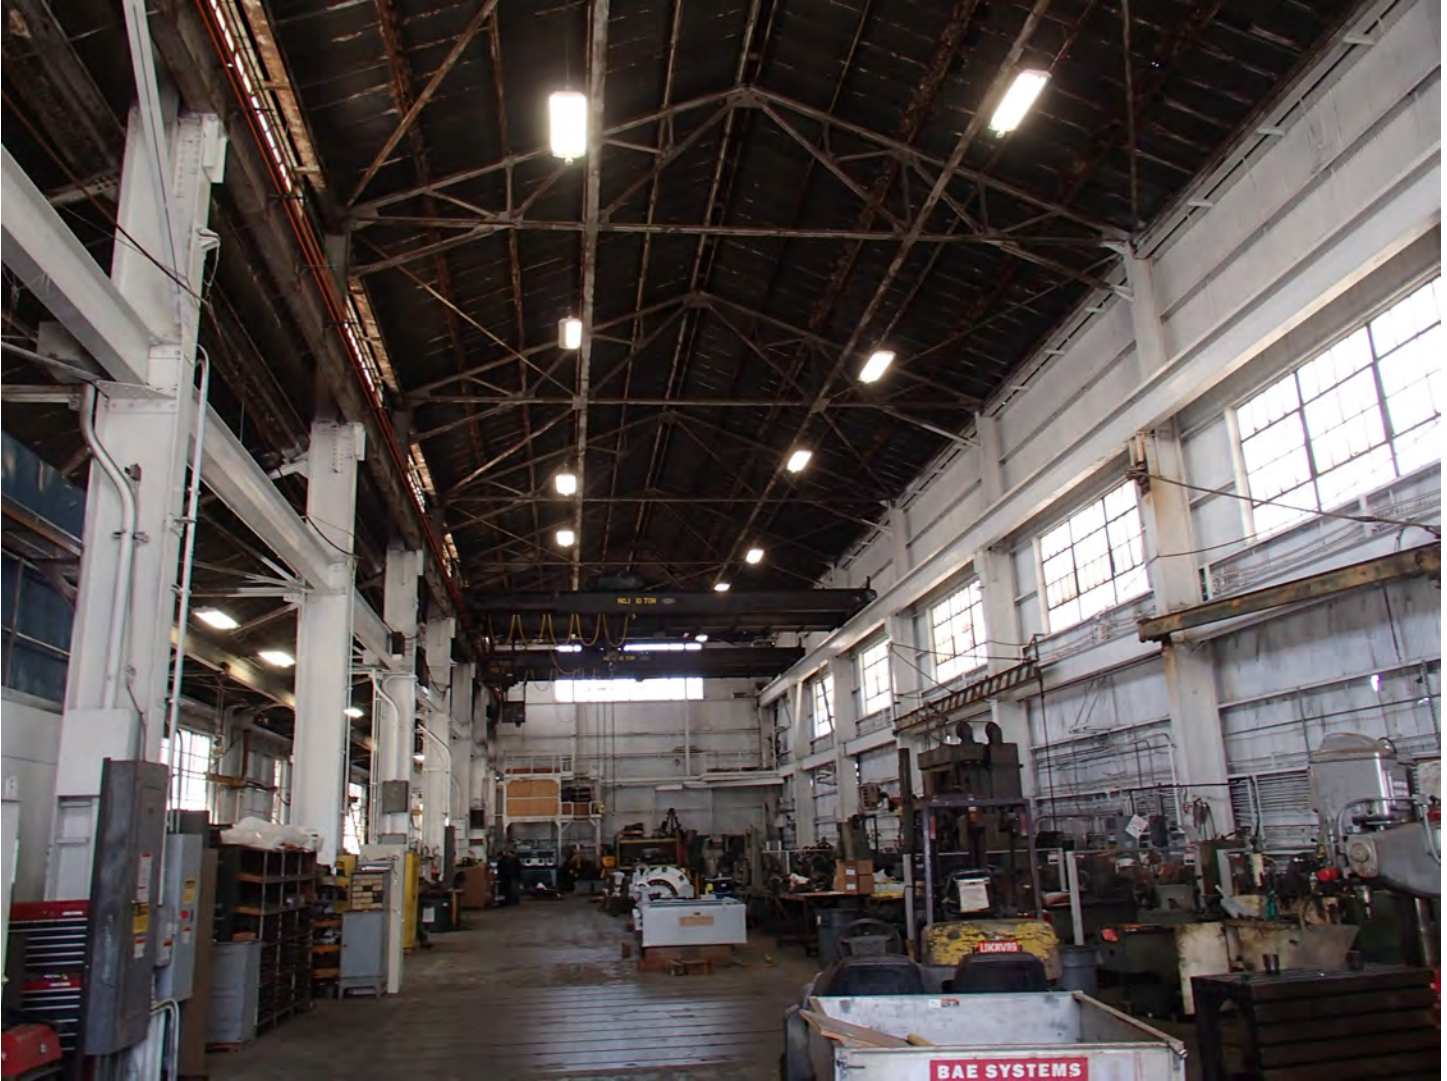
Photo 7. View of the machine shop, looking west

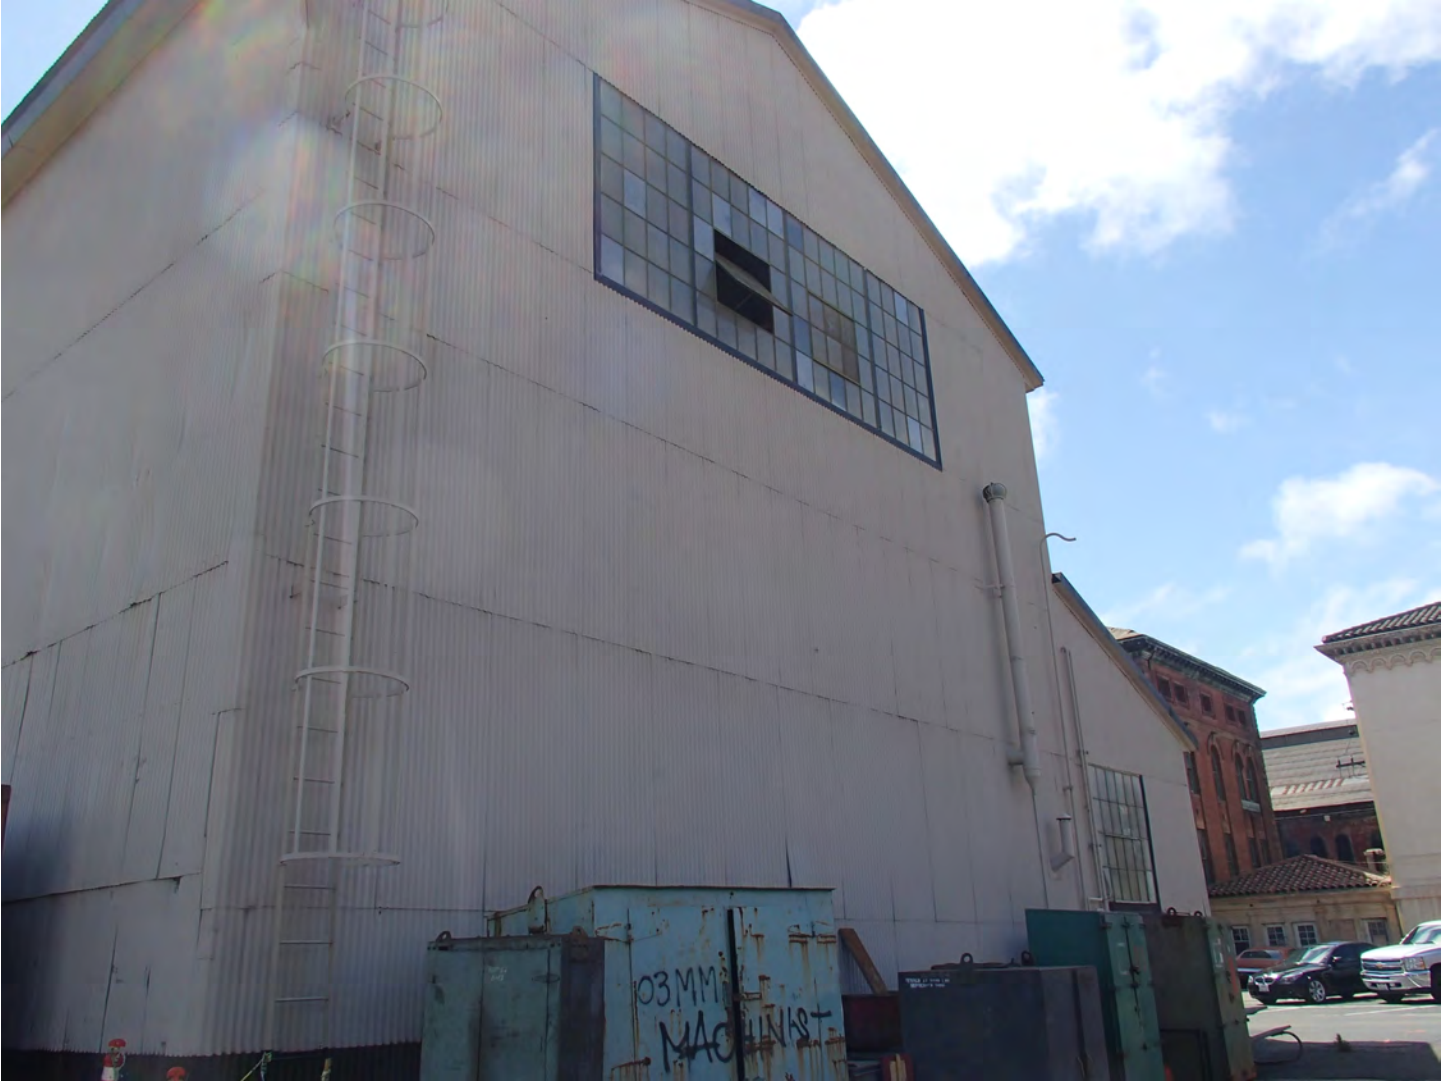
Photo 8. View of the west elevation

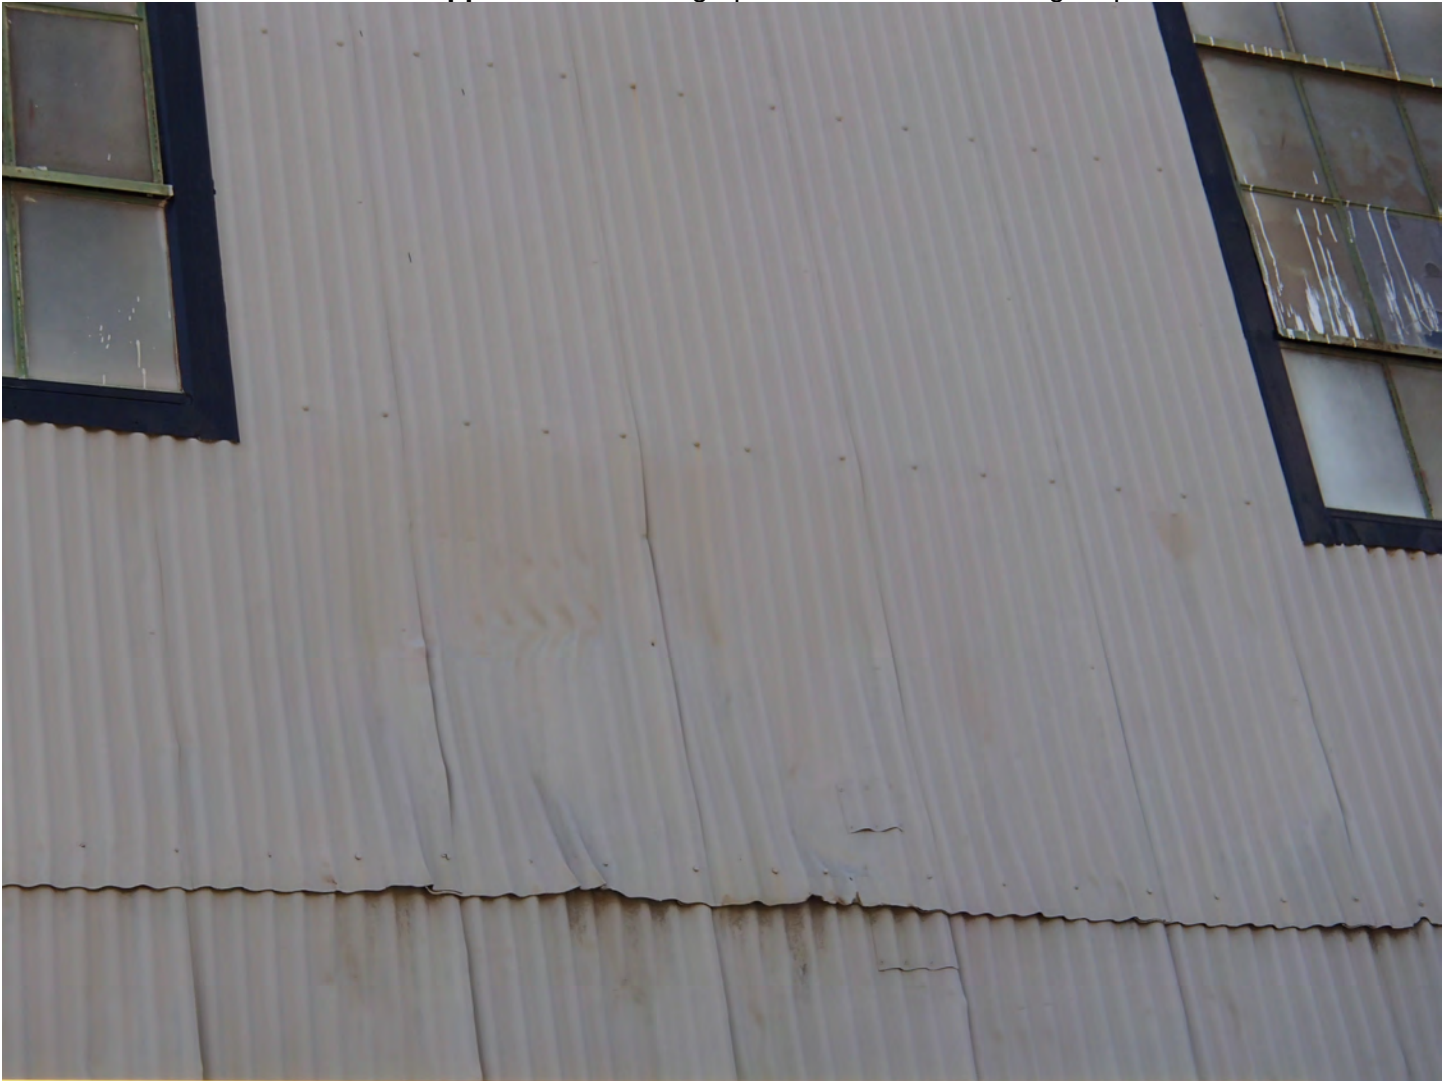
Photo 9. View of the typical impact damage in the metal siding

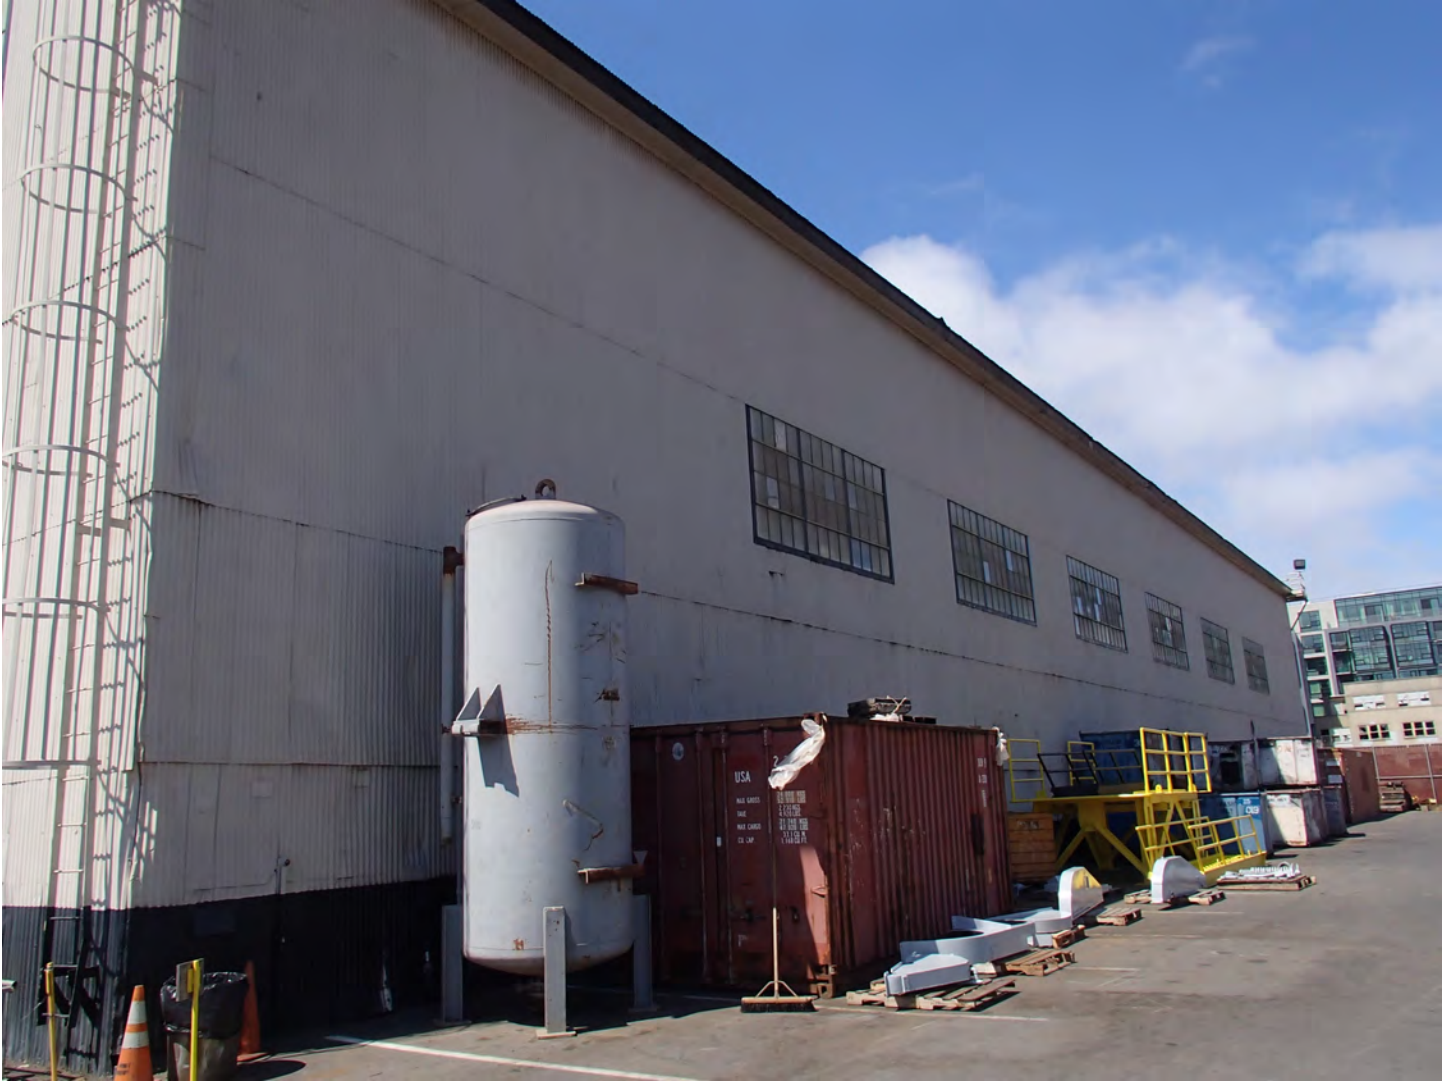
Photo 10. View of the north elevation

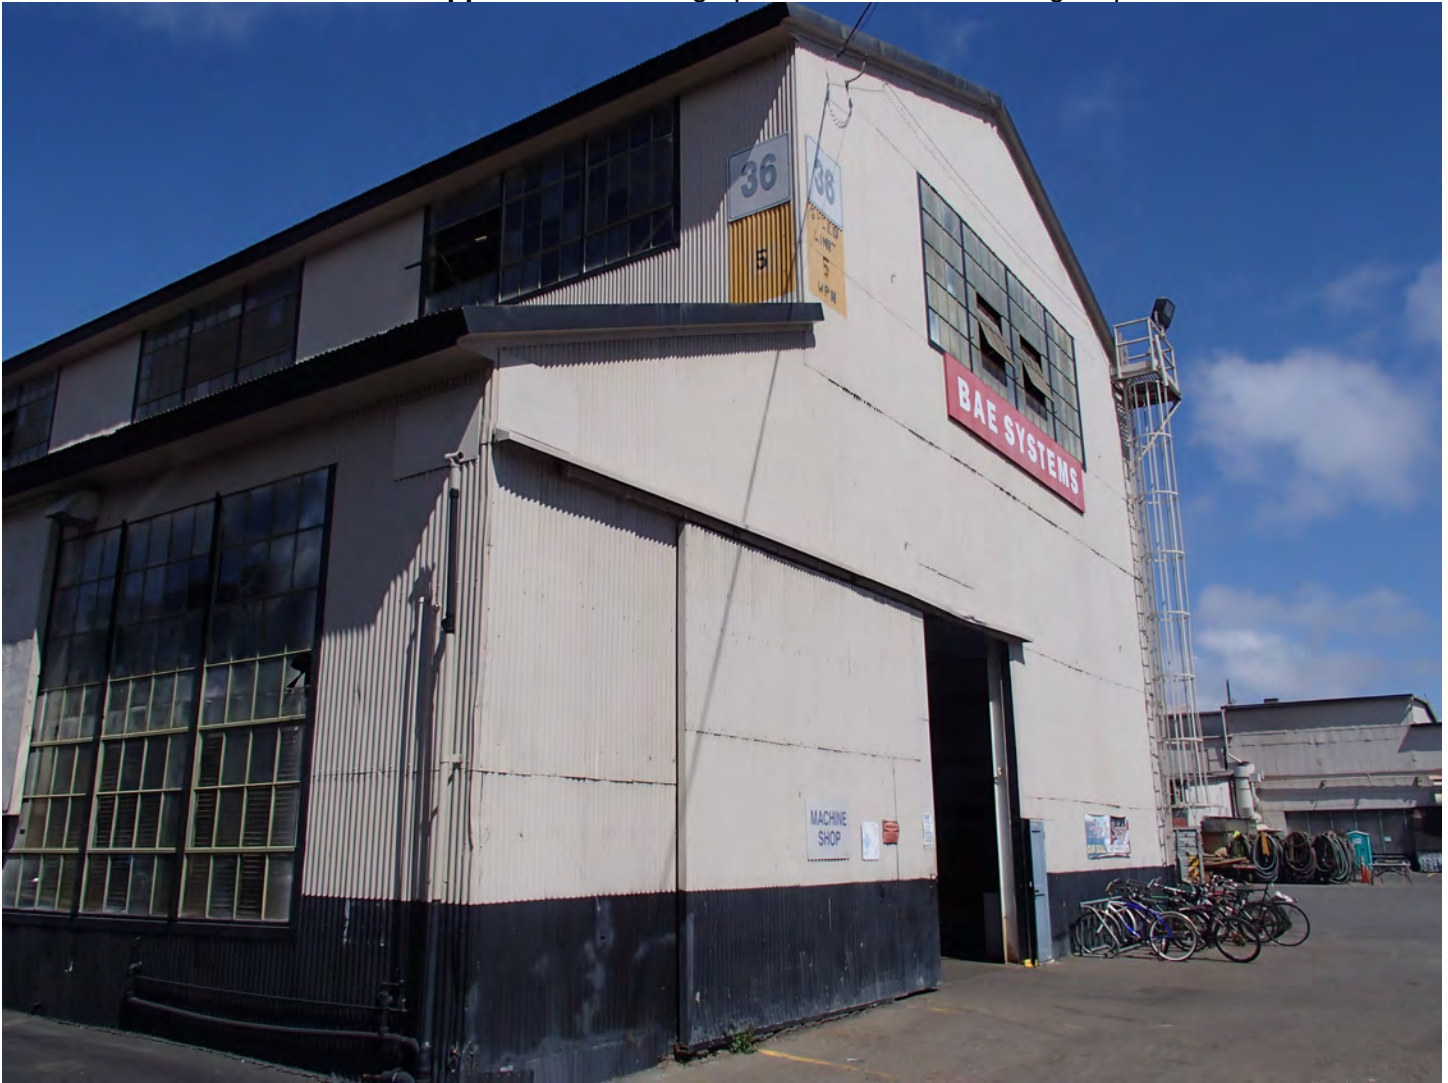
Photo 11. View of the east elevation

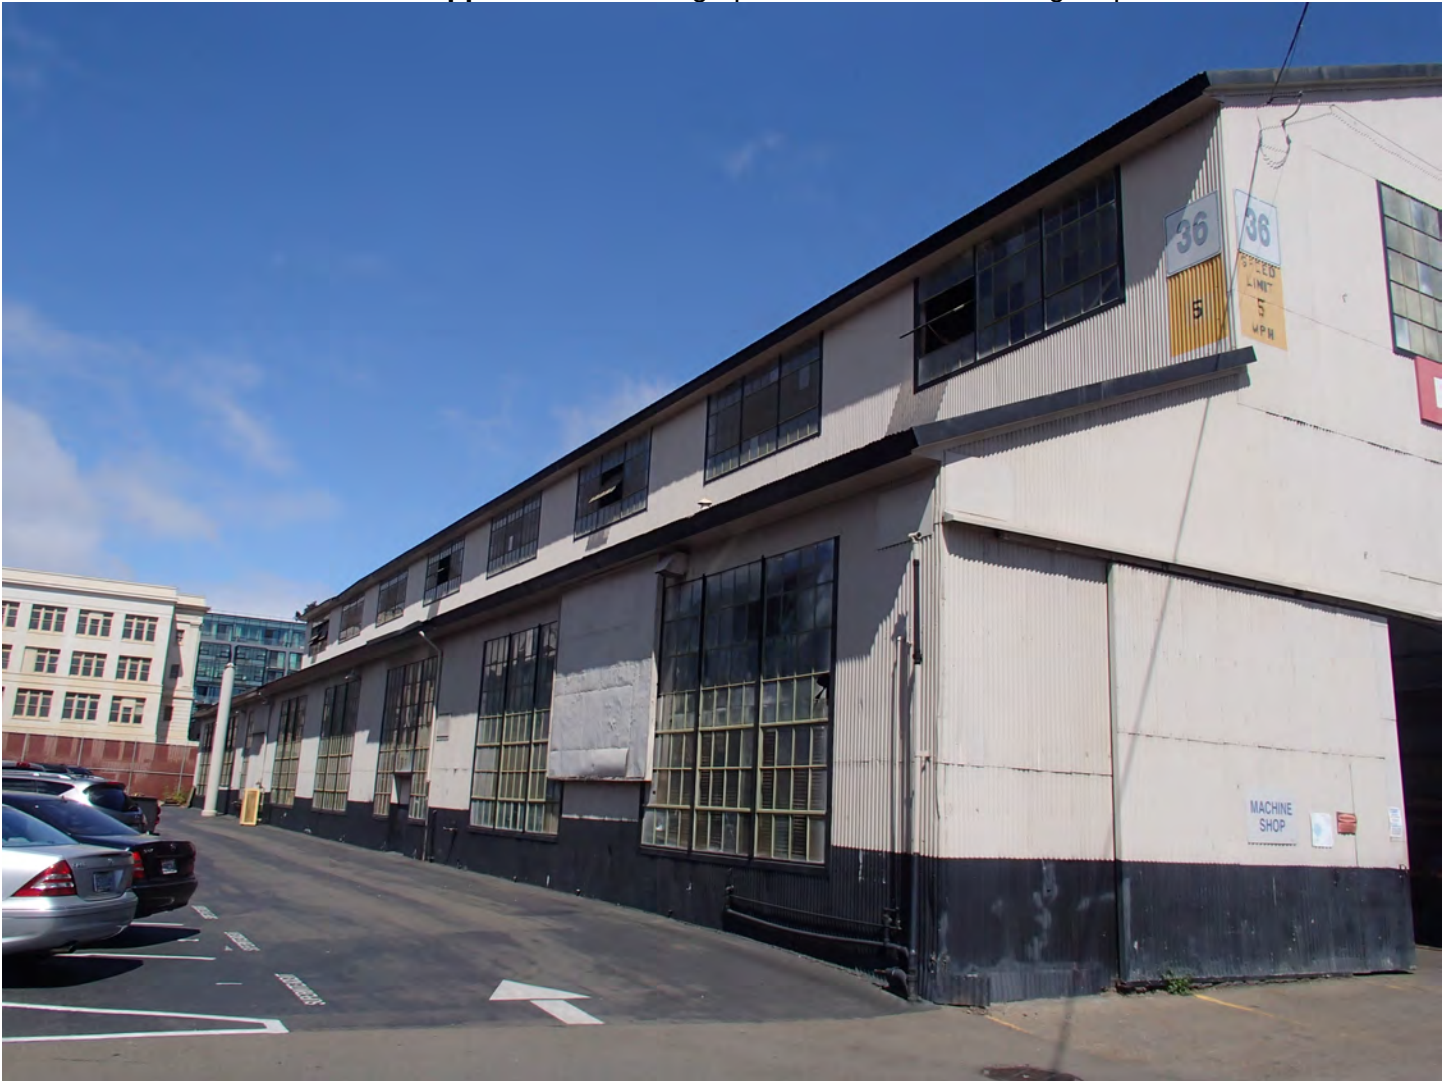
Photo 12. View of the south elevation

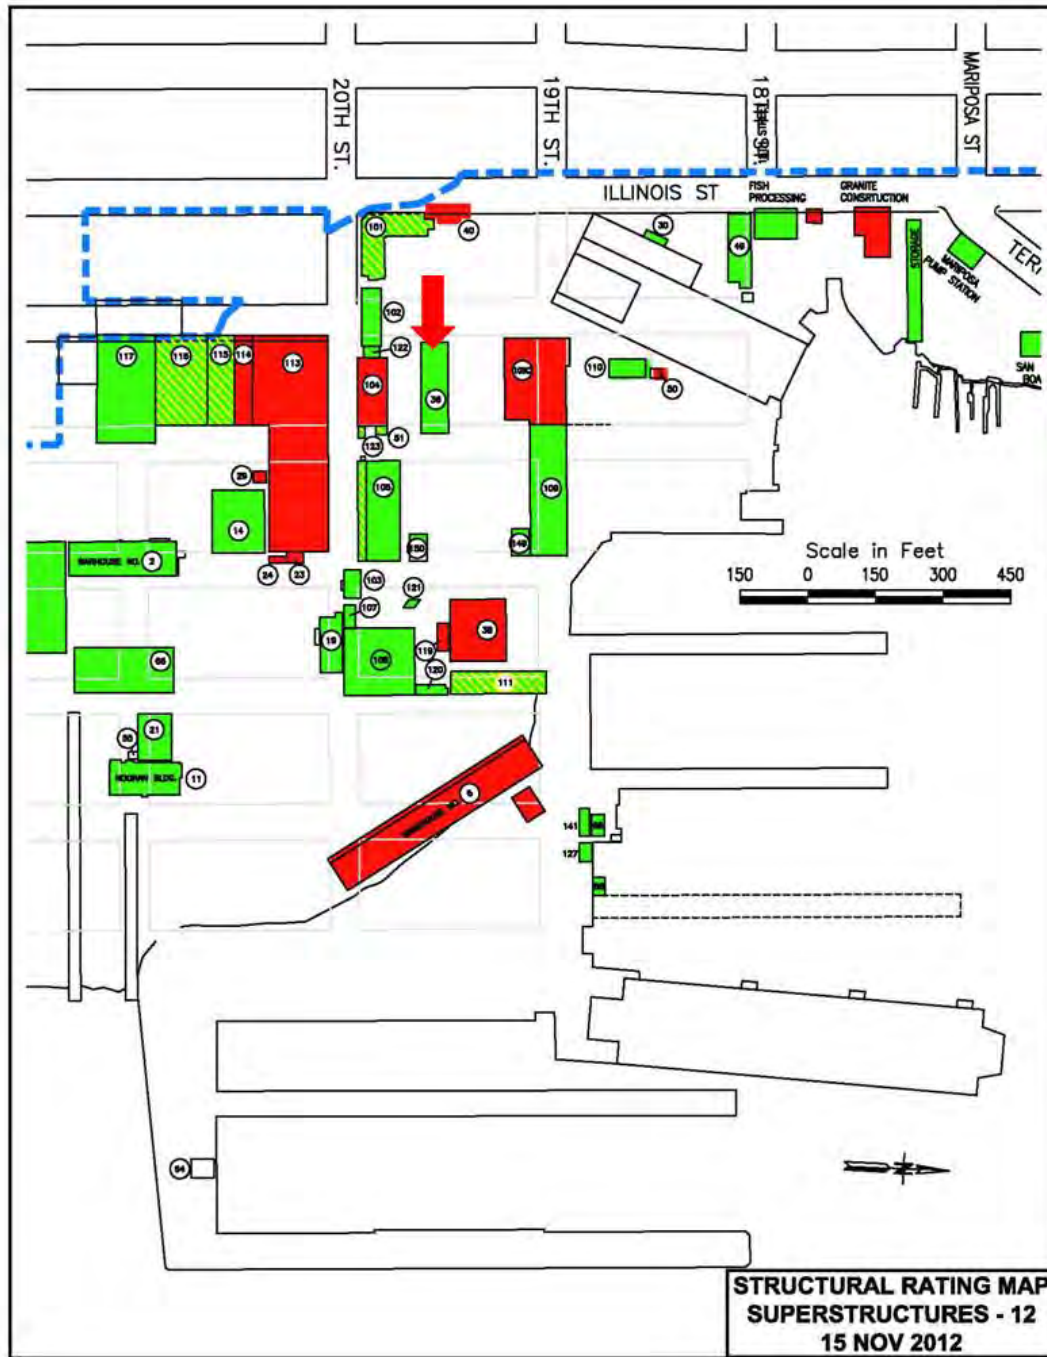
Photo 13. Structural rating map

Overall Rating: **Green**
