Pier 68-70 Shipyard Facility Condition Survey Marine Structures

Pier 68-70 Shipyard Facility Condition Survey
 Marine Structures - July 2017
 (This drawing is a reproduction of available
 record drawing marked up to indicate the
 findings of the 2017 survey)

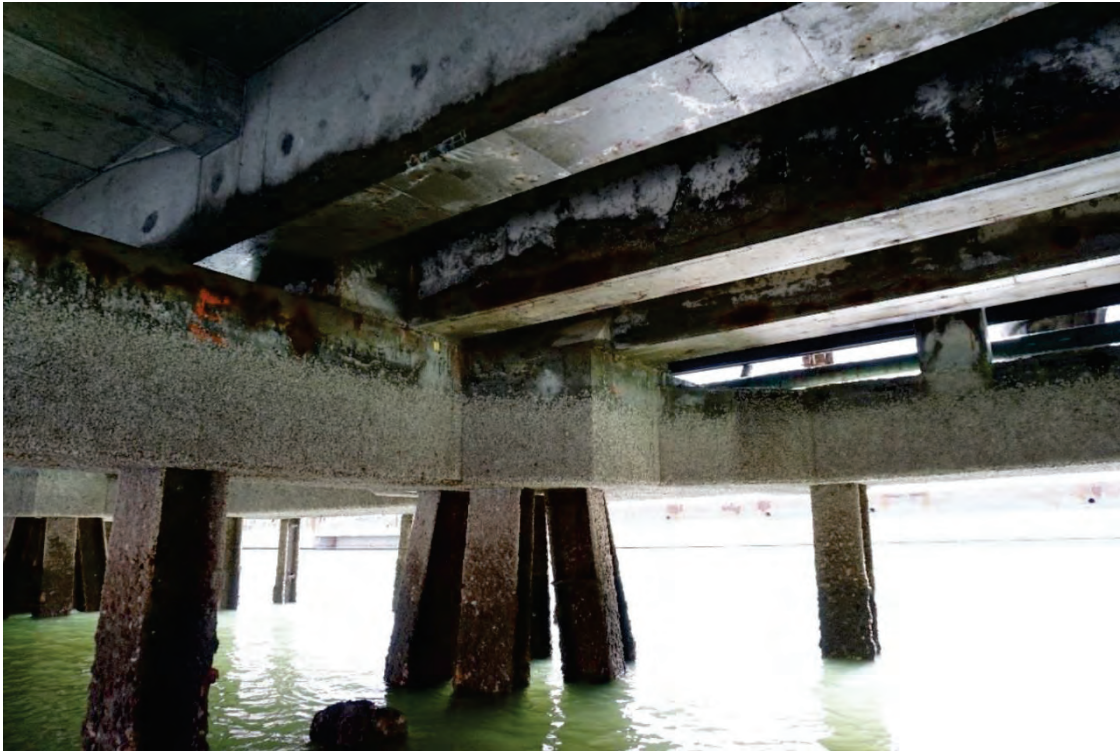
Figure 3 - Typical Condition Pile, Pile cap, Beam

Nearly all of Wharf 3 Steel piles and pile caps are in satisfactory condition, as shown in Figure 3. There is moderate marine growth visible on the piles. Very minor corrosion stains can be seen on a small percentage of the piles rendering that the protective coating is in good condition.

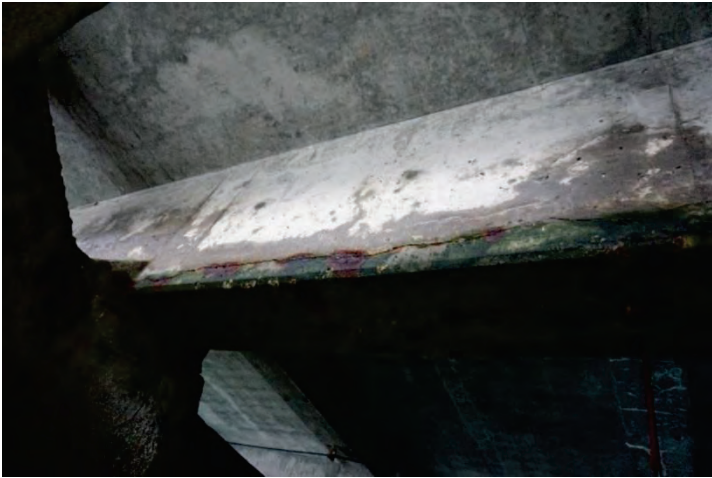
The longitudinal girders which are steel I beams encased in concrete are in fair condition. There are minor to moderate cracks along with rust with minor rust bleeds visible on 60% of the longitudinal girders, Figure 3 & Figure 4. These cracks were previously documented in the 2017- RSA report.

Figure 4 – Crack in Protective Concrete Over Steel Girder, Indicating Corrosion

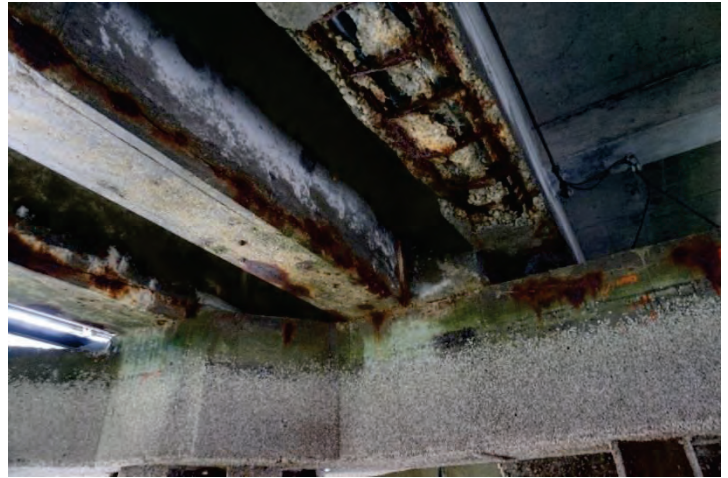
The duct bank extends longitudinally along the length of the pier and has major to severe spalling along 80% of its length. At approximately 15-20% locations along the beam there is substantial loss of section with reinforcing bars and conduit exposed, as shown in Figure 5.

Figure 5 - Spalled Duct Bank and Exposed Conduit

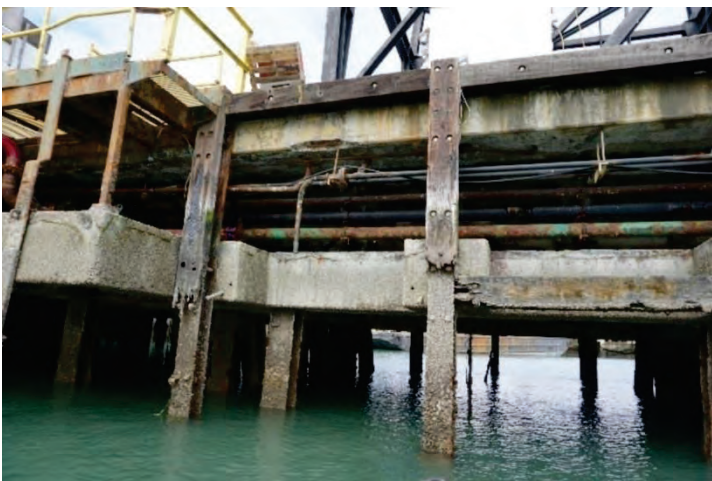
The concrete deck is generally in satisfactory condition. The majority of the deck has minor cracks and isolated spalls along the edges, as shown in Figure 6. A few major to severe spalls were also identified along the edges of the structure, as shown in Figure 7.

Figure 6 – Typical Deck Condition

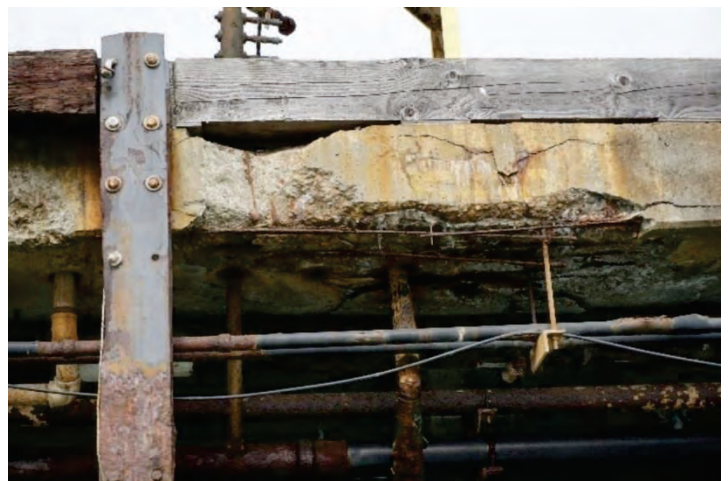
Figure 7 – Spall on Deck Edges

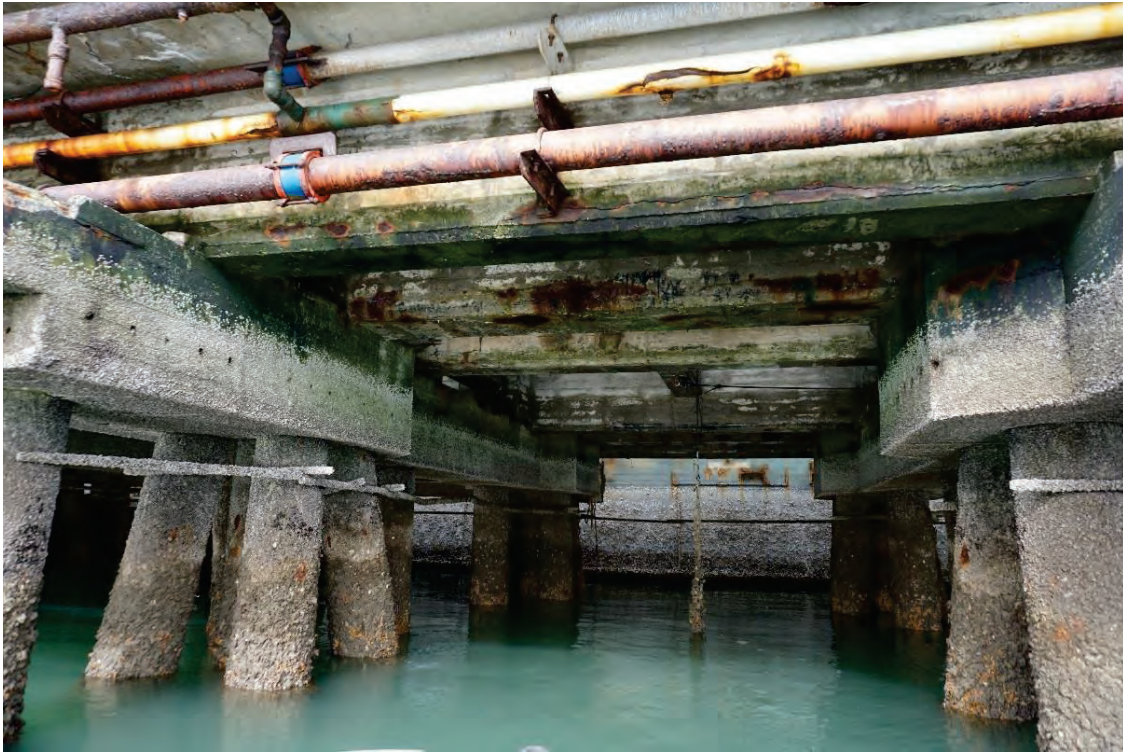
Figure 8 - Typical Conditions Beams, Piles, Pile caps

Nearly all of the steel Piles are in satisfactory condition as shown in Figure 8. There are major spalls and cracks (Figure 9) visible on approximately 5-10% of pile caps. There are moderate marine growths visible on the piles and minor rust stains can be seen. The protective shotcrete coating of the piles is in generally good condition with minor vertical cracks visible on approximately 5% of piles.

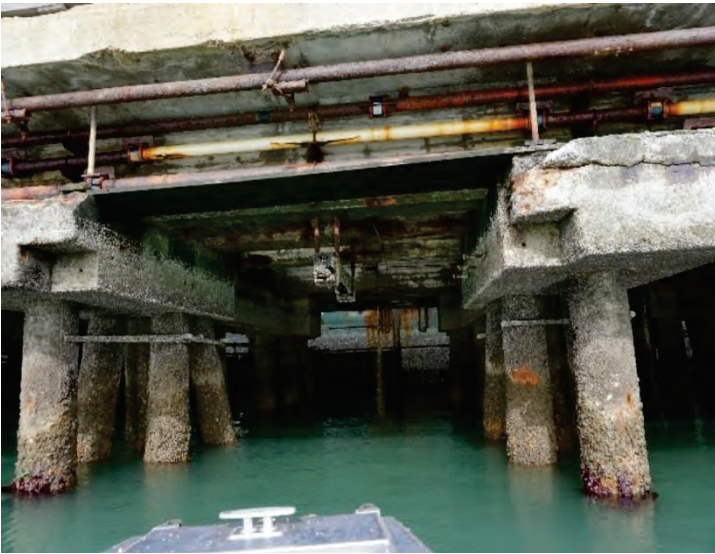
Figure 9 - Crack on Pile Cap

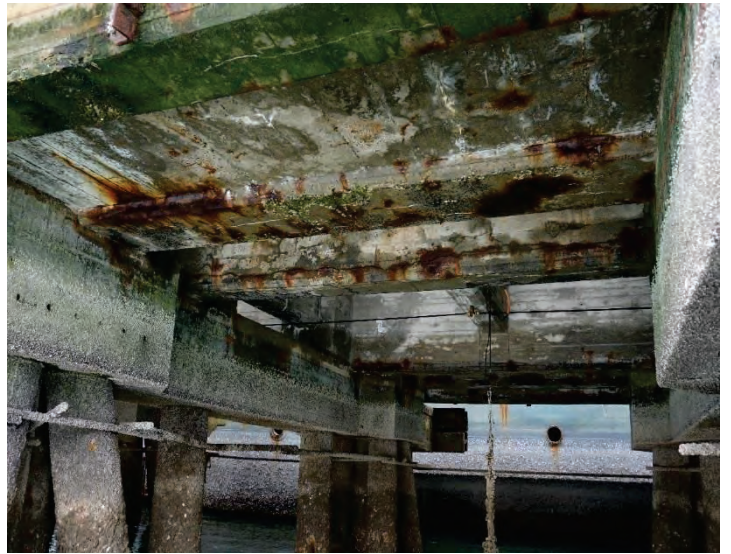
The longitudinal steel I beams encased in concrete are in fair condition. The crane rail girders have minor to moderate cracks with corrosion stains visible along approximately 80-90% of the wharfs length. The cracks and corrosion stains are shown in Figure 10 and Figure 11. These cracks are documented in the 2017- RSA report.

Figure 10 - Cracks and Corrosion on Beams

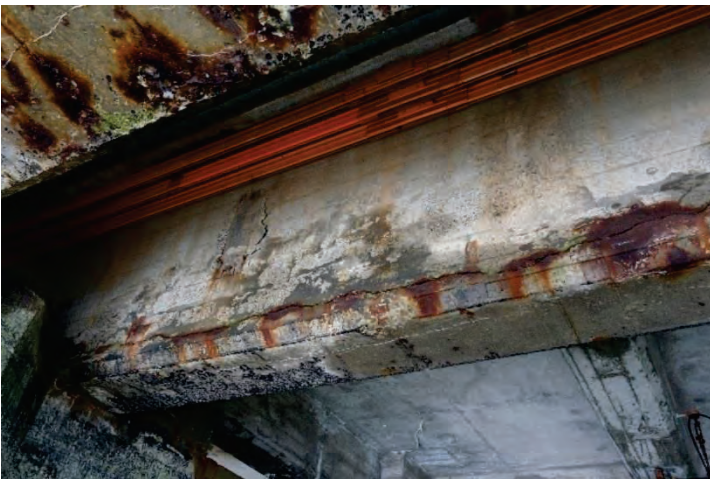
Figure 11 - Cracks on Beam

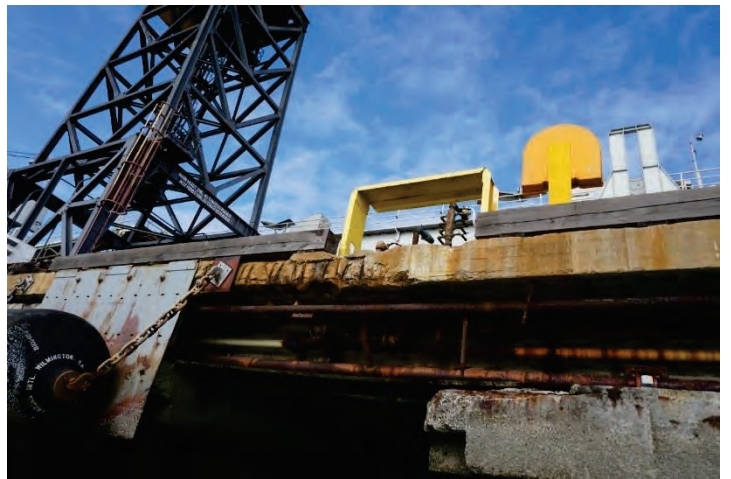
The concrete deck is generally in satisfactory condition. There are moderate to major spalls visible at the east side of the wharf deck, as shown in Figure 12. The west side of the deck could not be inspected due to the positioning of the dry dock Eureka on the west side of the pier.

Figure 12 - Spall on Deck Edge

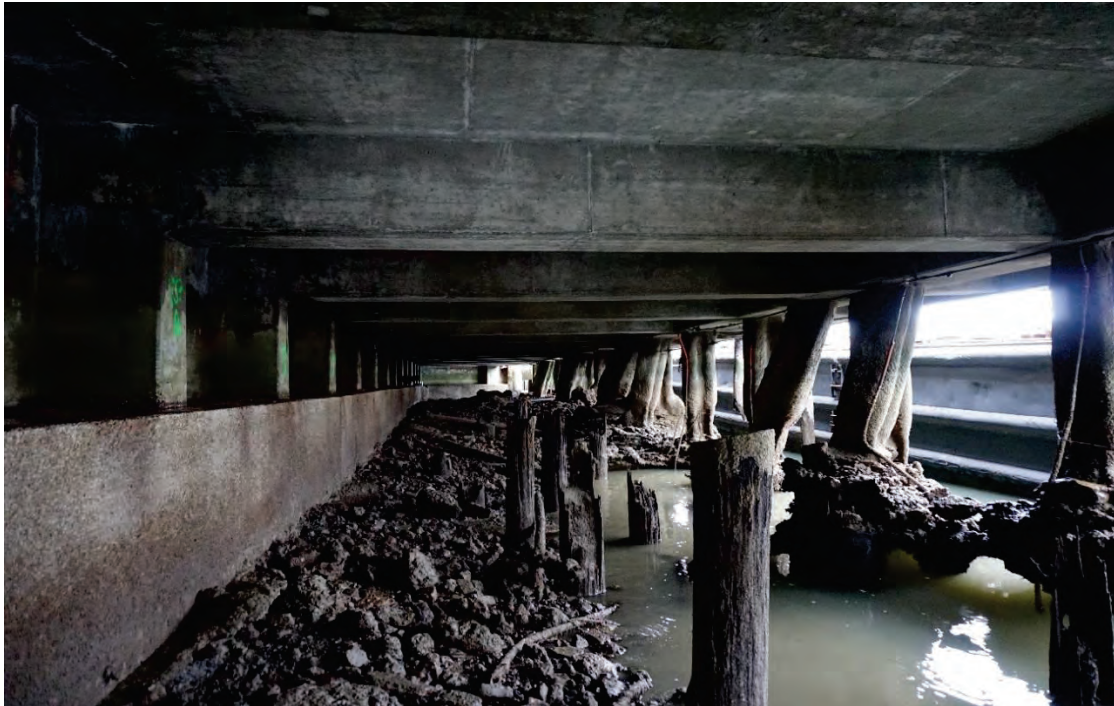
Figure 13 - Typical Condition of Beams and Piles

Area 1 is generally in fair condition, as shown in Figure 13. Majority of the steel piles have protective shotcrete coating in satisfactory to fair condition. Approximately 20 - 40% of the steel piles have deteriorated coating, exposed steel and visible corrosion stains at the base as shown in Figure 14. The inspection of this area was done by foot.

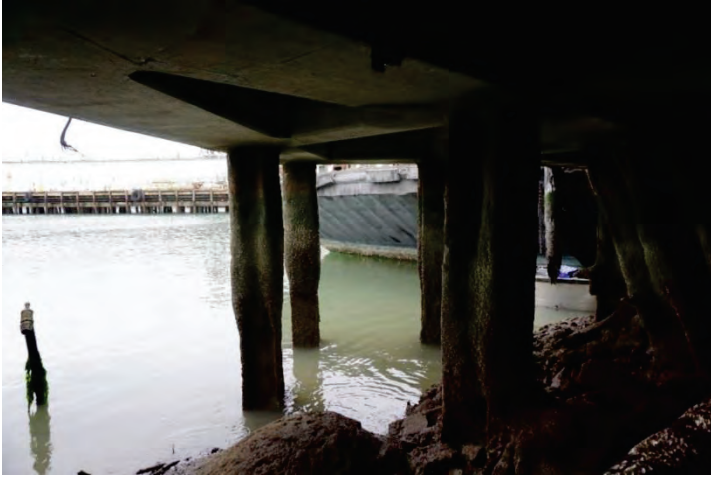
Figure 14 – Exposed Steel Pile and Corrosion

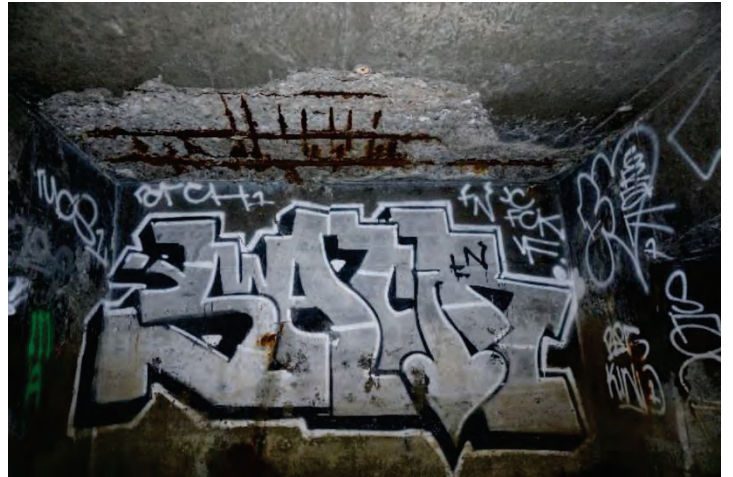
The bulkhead on the land side and the underside of the deck above the wall are in poor condition with severe spalling and exposed reinforcing bars through approximately 90% of the length of the structure, as shown in Figure 15 & Figure 16. The rest of the deck spanning between the two rows of piles is in satisfactory condition with no damage to minor deteriorations visible.

Figure 15 – Spall on Overhead Deck

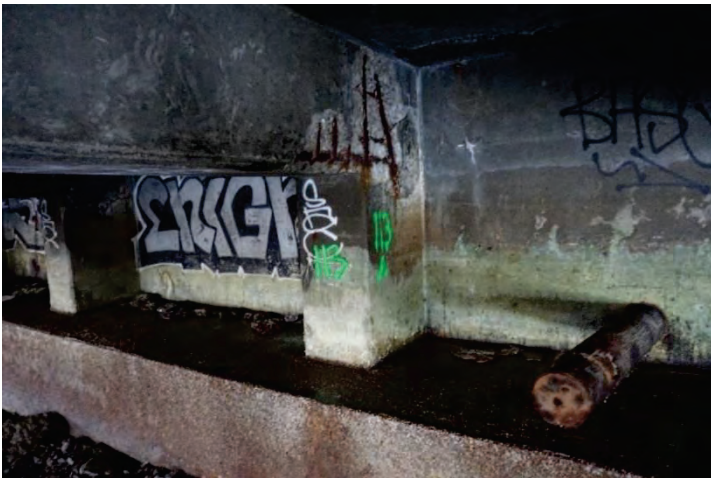
Figure 16 – Spall on Bulkhead Column and Beam

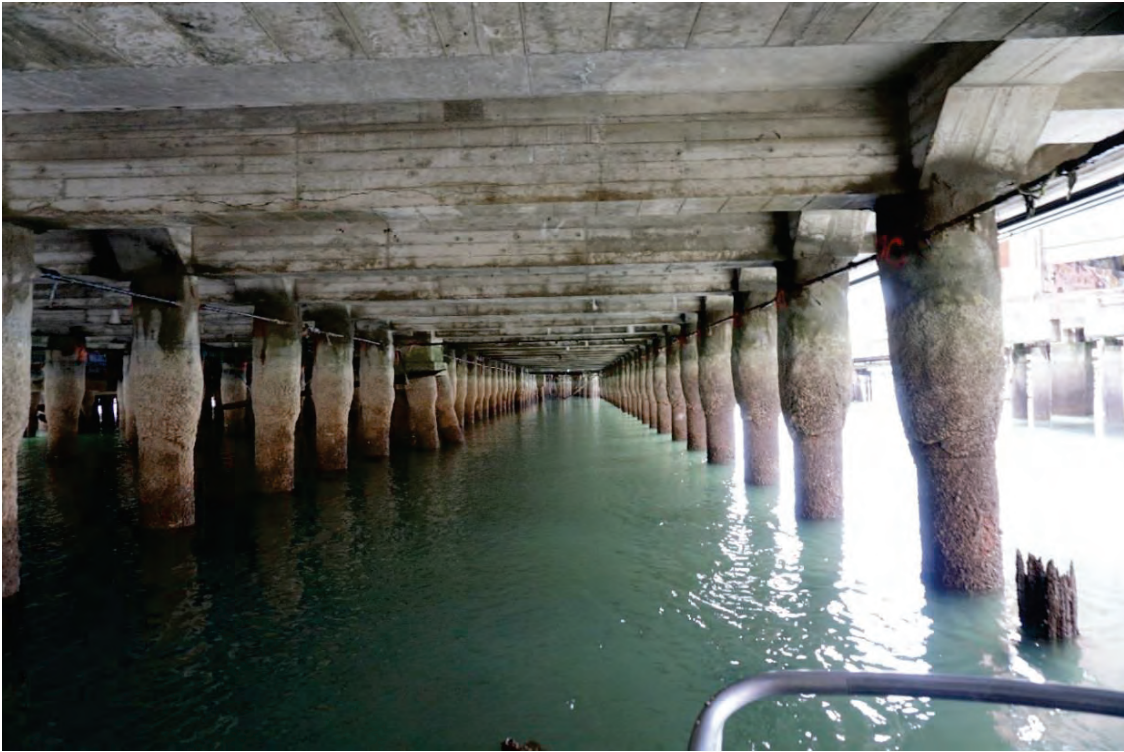
Figure 17 - Typical Condition of Beams and Piles

Area 2 is in generally satisfactory condition. Almost all of the steel pipe piles are in good condition with minimal visible deterioration as shown in Figure 17. Several pile caps have minor to moderate cracks (Figure 18).

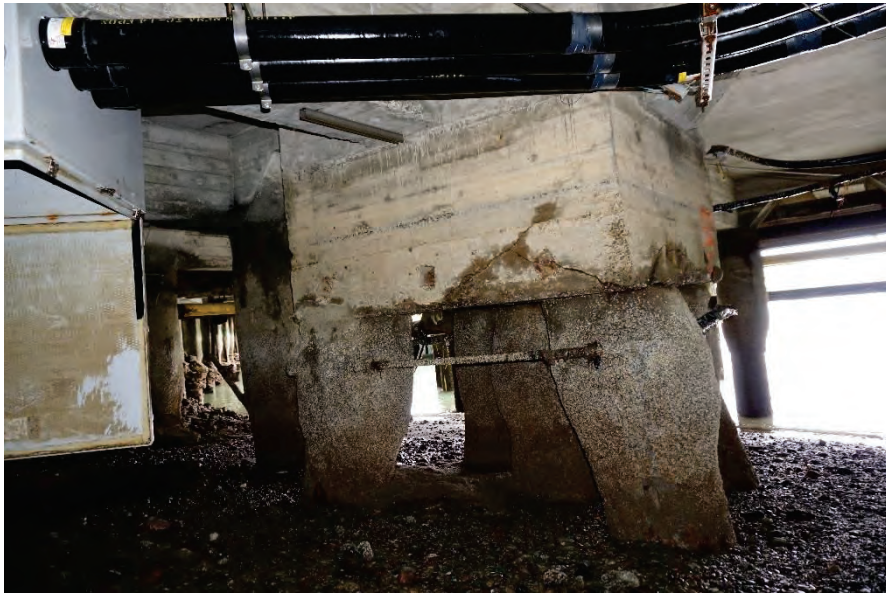
Figure 18 – Cracked Pile Cap

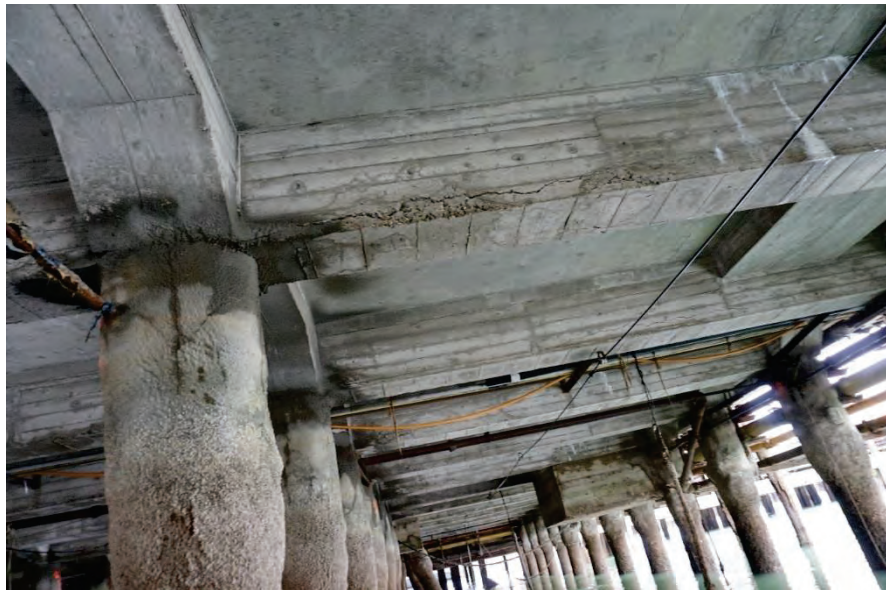
The reinforced concrete beams spanning between the pile caps are in satisfactory condition. However, approximately 10-15% of the beams have moderate to major cracks extending their full length, as shown in Figure 19.

Figure 19 – crack on Beams

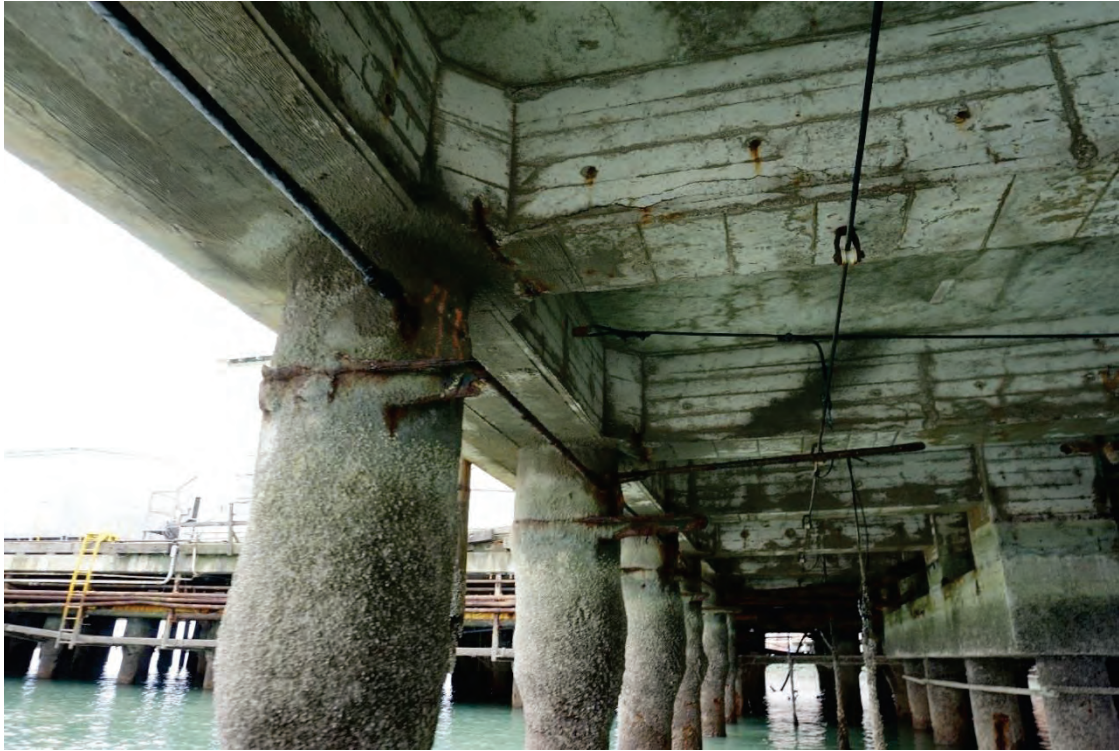
Figure 20 – Typical Beams and Pile Condition

Almost all of the steel pipe piles are in satisfactory condition with minimal visible deterioration as shown in Figure 20. Pile caps are in satisfactory condition with minor cracks visible at few isolated locations.

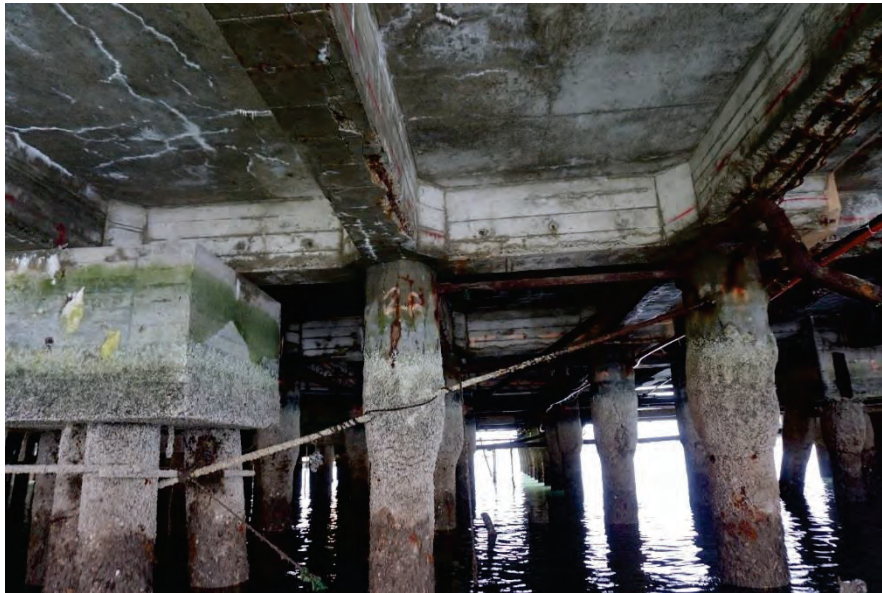
The reinforced concrete beams spanning between the pile caps are in fair condition. Approximately 25-30% of the beams in Area 6 have severe spalls spanning the full length of the beams along with moderate to major cracks. As shown in Figure 21, many of the beams have substantial section loss with exposed reinforcing bars.

Figure 21 – Spall and Crack on Beams

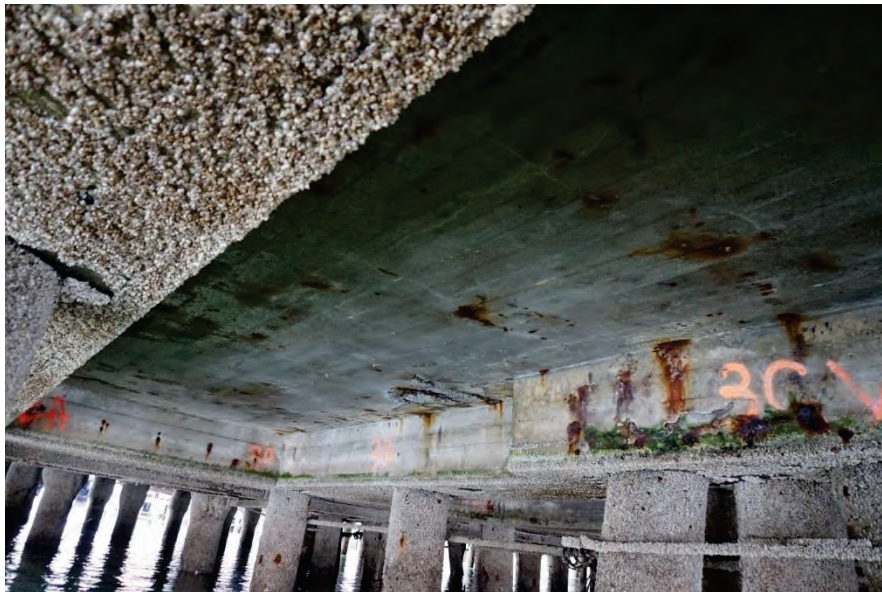
The reinforced concrete deck in Area 5 also has isolated minor to moderate spalls at a few locations, the spalls spread approximately 10-15% of the slab areas, as shown in Figure 22

Figure 22 – Spall on Deck & Corrosion Stains

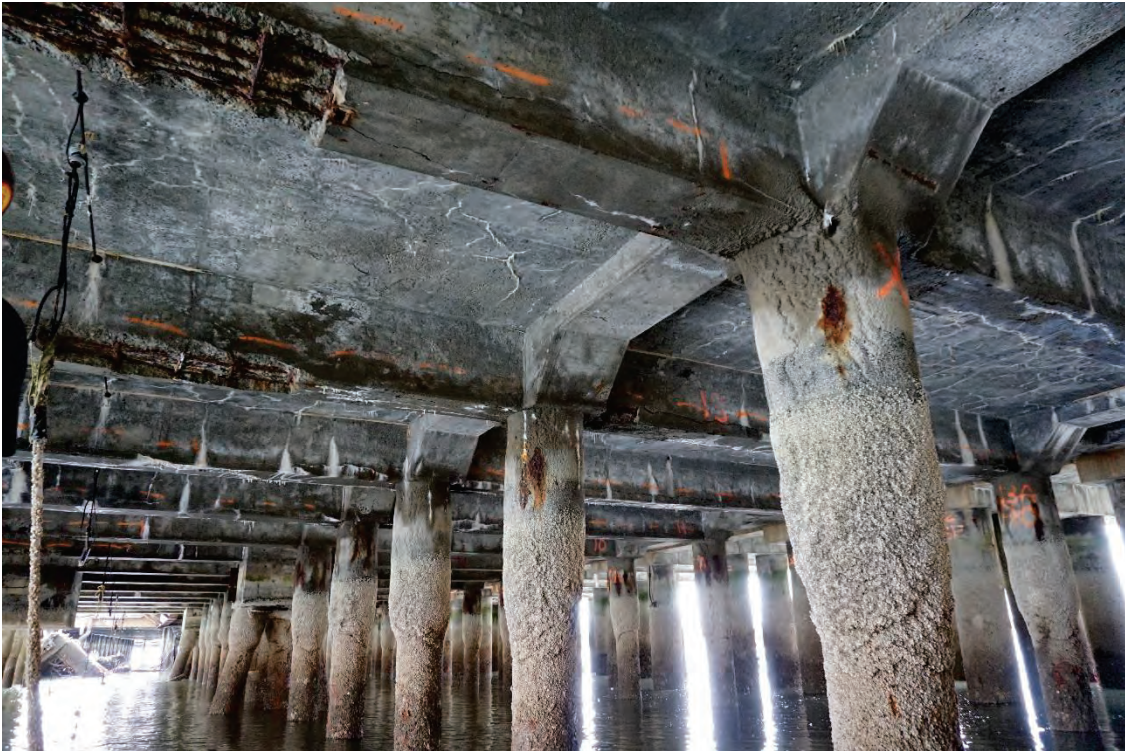
Figure 23 – Typical Condition of Piles, Pile Caps, Beams & Deck

Area 7 has major deterioration throughout the structure and is in poor condition as shown in Figure 23.

Area 7 is an essential access way to Area 9 and Dry Dock No. 2. Due to its level of deterioration and its significance in keeping the pier operational, urgent repairs are recommended for this area, particularly the beams and the deck slabs.

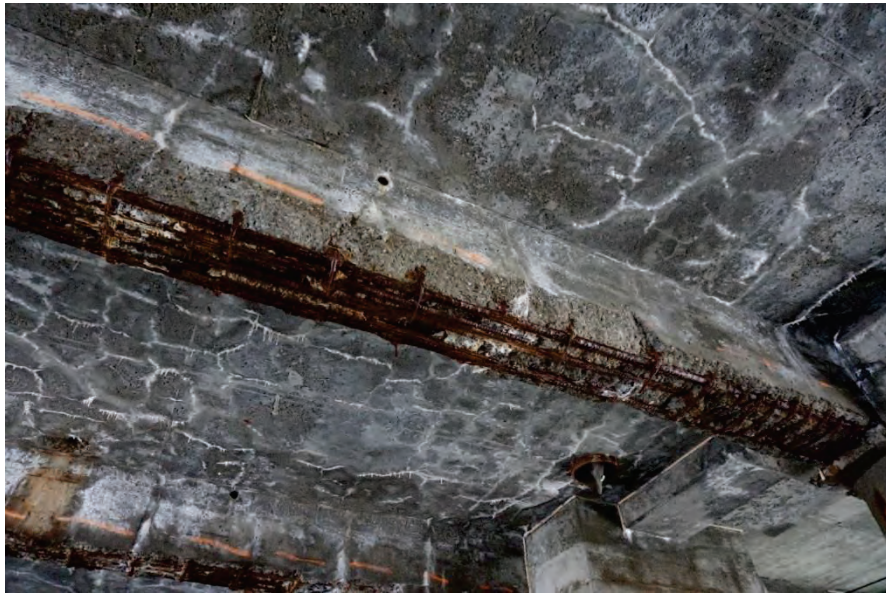
There are numerous moderate cracks in the concrete deck distributed approximately throughout 40-70% of the area.

Figure 24 – crack on deck

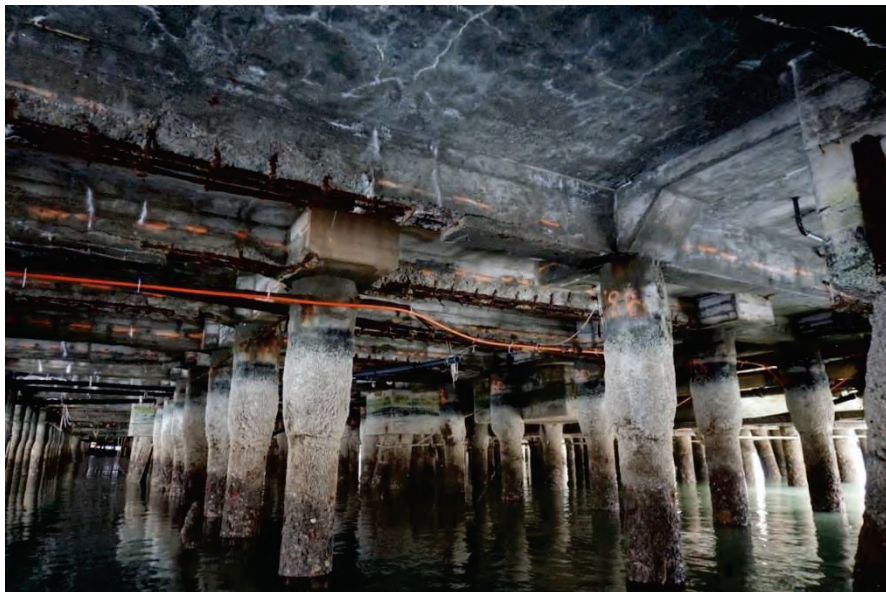
The beams in Area 7 are in poor condition. Approximately 60-80% of the reinforced concrete beams within this subarea have major to severe spalling and cracks. As shown in f Figure 24 and Figure 25 there is substantial loss of section and exposed reinforcing bars extending to almost the full length of the beams.

Figure 25 – beam spall and section loss

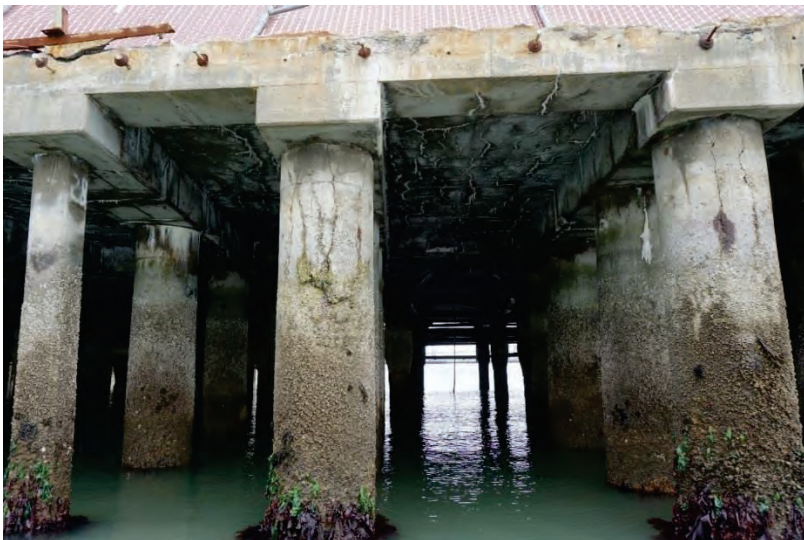
Figure 26 - Typical Pile and Deck Condition

Area 8 has been red tagged for many years due to excessive settlement of the caissons. The majority of the concrete caisson and caps have major cracks as shown in Figure 26. The girder has also suffered major deterioration due to the settlement. Level of settlement compared to the adjacent area 6 can be viewed in Figure 27.

This area has foundation problems and to repair would mean complete rebuild of the structure. The area could be simply demolished and not rebuilt – since there seems to be no use for the area, and access to the Drydock #2 is still provided by the steel bridge. The estimated cost to demolish Area 8 is approximately \$630,000. This cost includes the removal of the concrete deck and the caisson caps. The caissons could be left in-place.

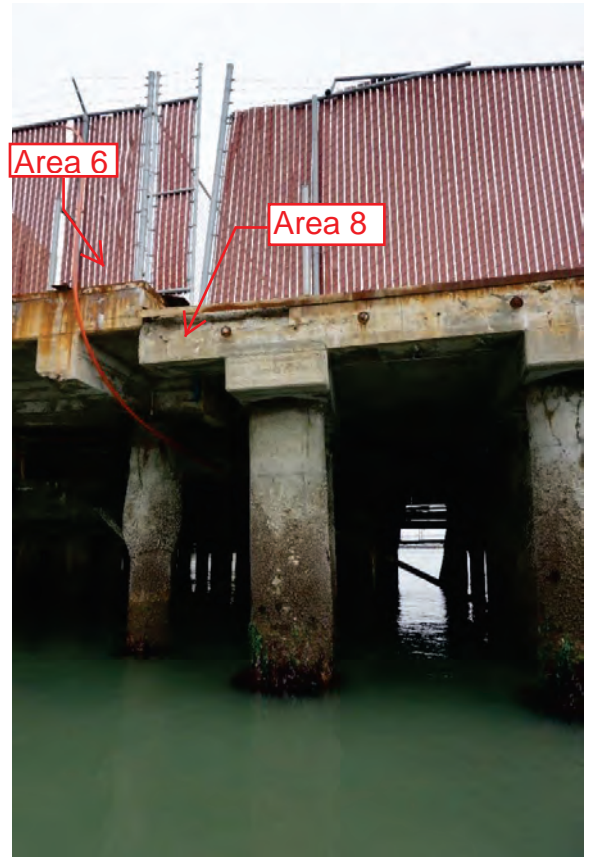
Figure 27 - Settlement of Piles

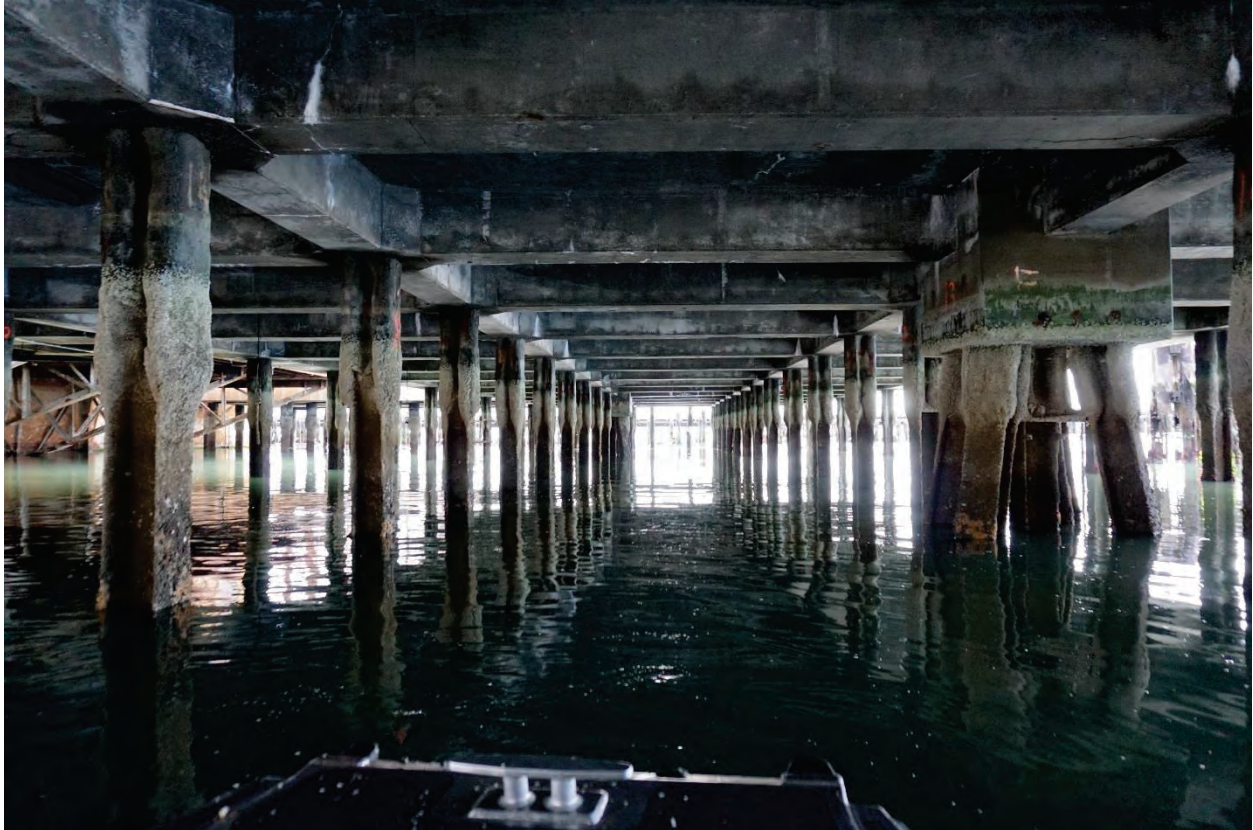
Figure 28 – Typical Condition of Piles , Beams & Deck

Area 9 is in satisfactory condition. Nearly all the Steel piles are in satisfactory condition with protective coating intact with minor corrosion stains and minor cracks on approximately 10-20% of the piles, Figure 28. Nearly all pile caps are in satisfactory / Fair condition however approximately 15-20 % of pile caps have moderate cracks and spalls as shown in Figure 29 and Figure 30.

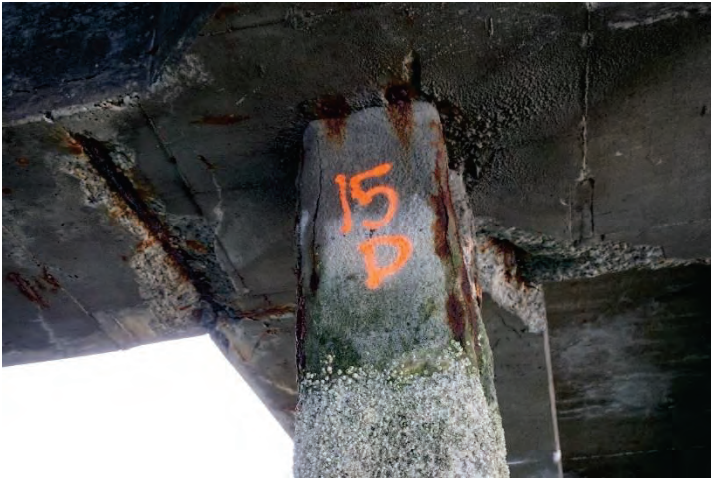
Figure 29 – Spall on Beam and Pile Cap

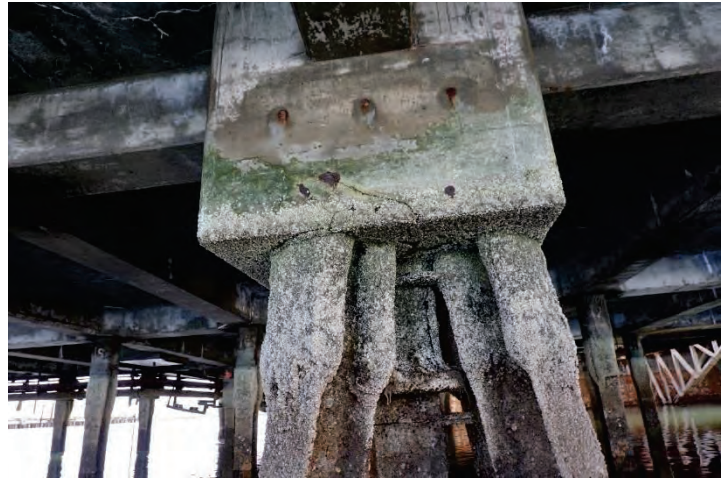
Figure 30 – Crack on Pile Cap

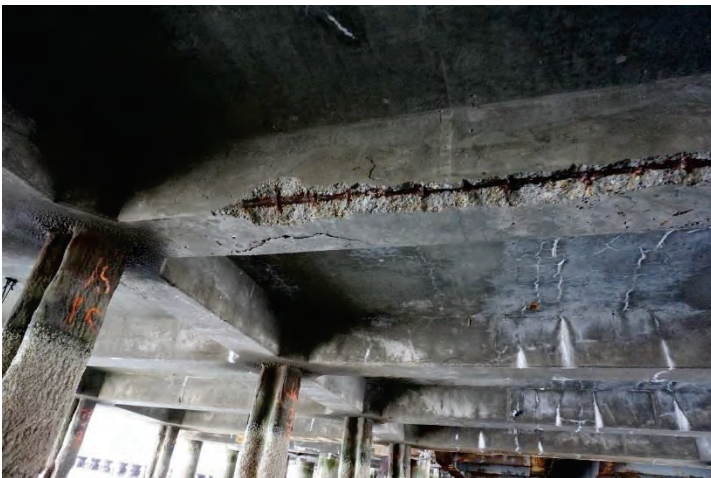
The Beams are in satisfactory / fair condition. Approximately 15-20% of the beams have moderate cracks. Few isolated spalls were also observed on few beams. As shown in Figure 31 some beams have exposed reinforcing bars and deteriorating reinforcements

Figure 31 – Spall on Beam

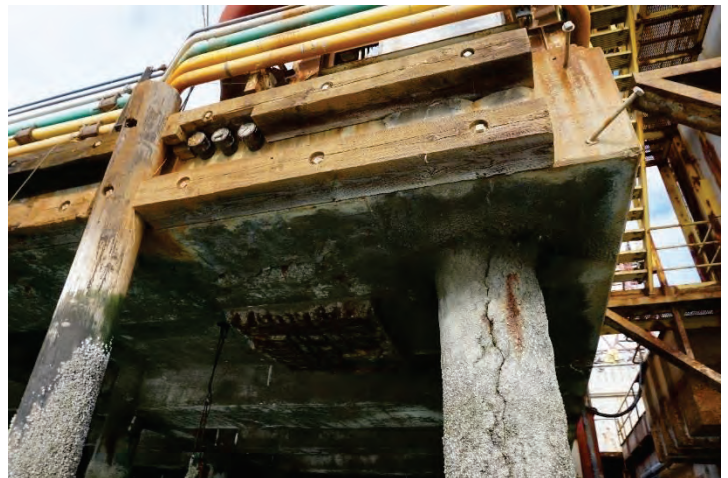
The concrete deck is in satisfactory condition throughout. Two spalls occurring on rectangular section of the deck have severe deterioration and exposed reinforcements as shown in Figure 32.

Figure 32 – Spall on Deck

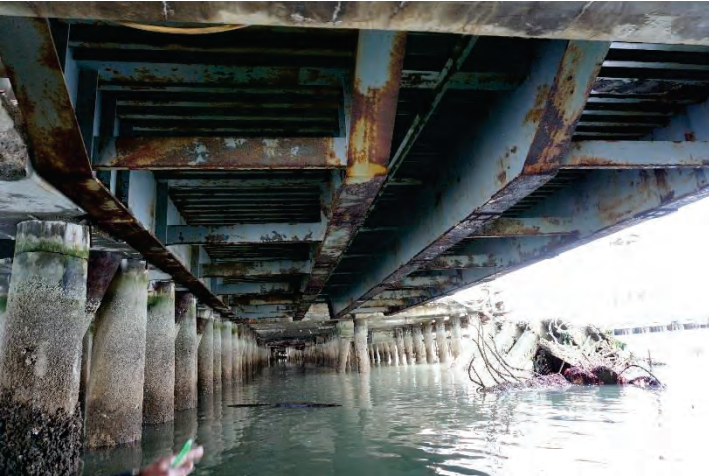
The steel Bridge spanning over the collapsed area between area 7 and 9 is in satisfactory condition. Based on available information the steel bridge was installed in 1999. As shown in the figures below, there are multiple areas where the protective coating has deteriorated and minor corrosion is visible. The pile caps adjacent to the steel bridge as shown in Figure 34 and Figure 35 have major spalls and corroded reinforcing bars.

Figure 33 - Typical Condition of Steel Bridge Underside

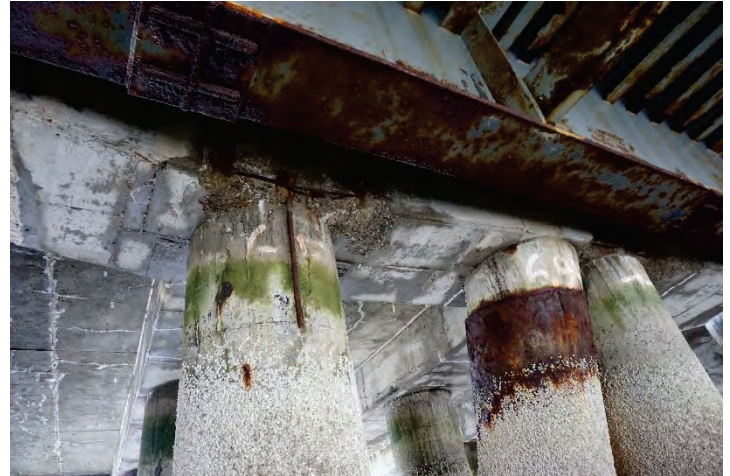
Figure 34 - Loss of Protective Coating on Bridge, Spalled Pile Cap

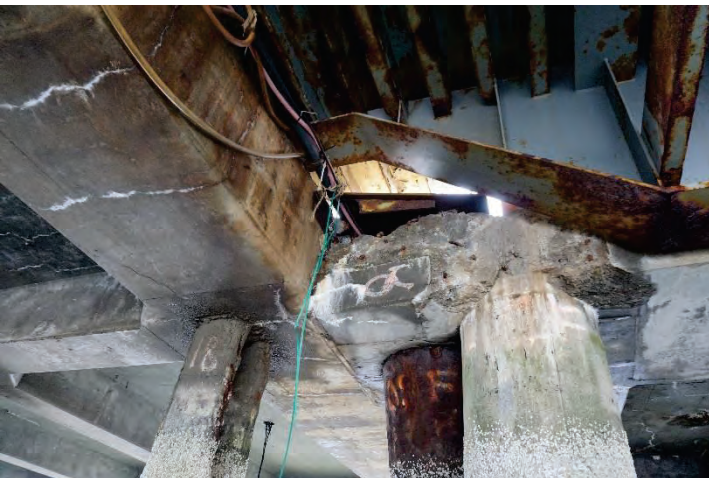
Figure 35 - Minor Corrosion and Loss of Protective Coating

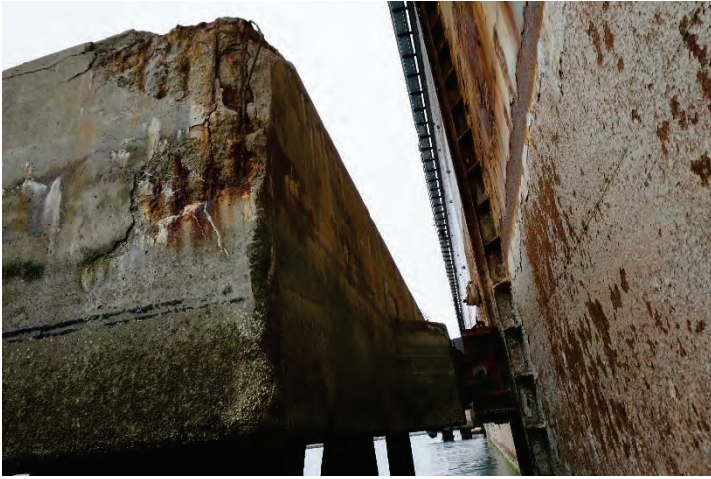
The Mooring Dolphins are in generally satisfactory conditions. However, spalls were observed at few edges of the pile caps, as shown in Figure 37 and Figure 38. Moderate cracks as shown in Figure 39 were also observed on all the dolphins.

Figure 37 - Spall on Edge of Pile Cap

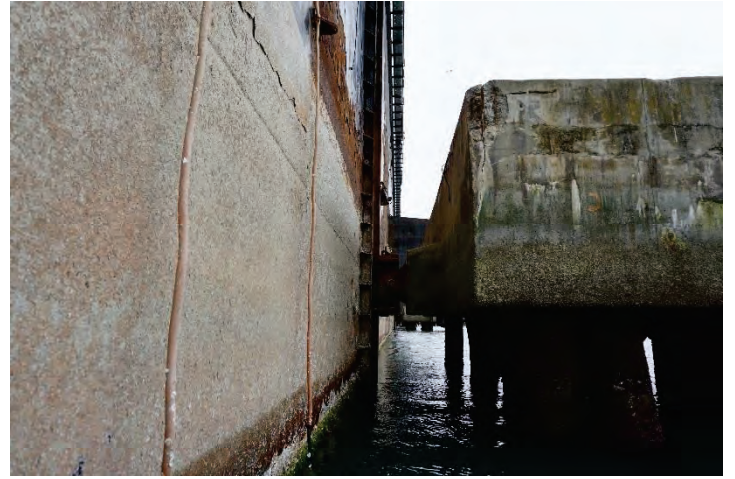
Figure 38 - Crack and spall on Pile Cap Corner

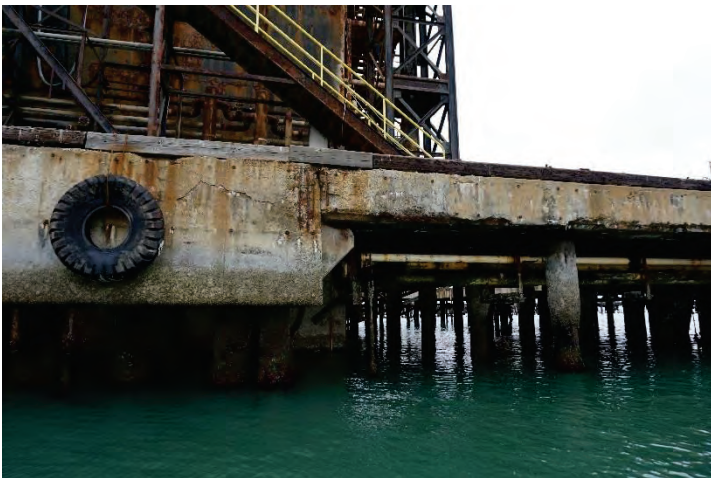
Figure 39 - Crack and Spalling on Dolphin

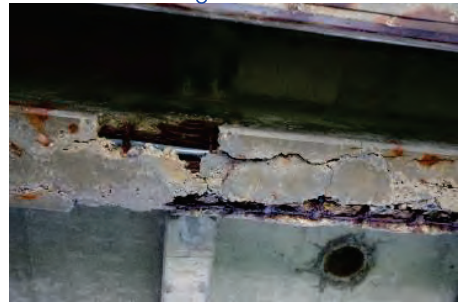
Spalled Duct Bank

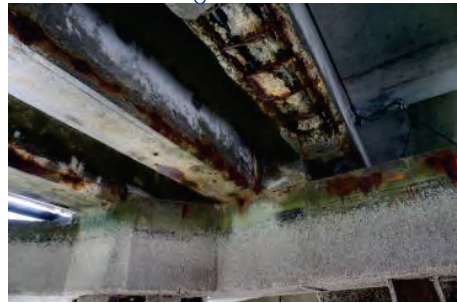
Spalled Duct Bank & Exposed Conduit

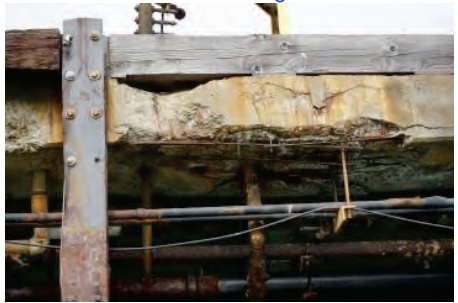
Spalled Deck

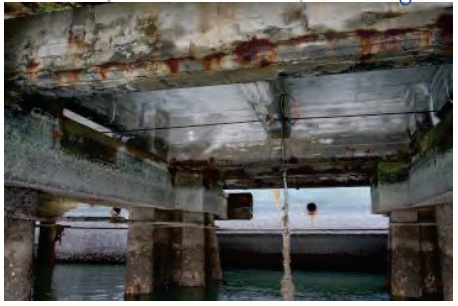
Cracks on Beams

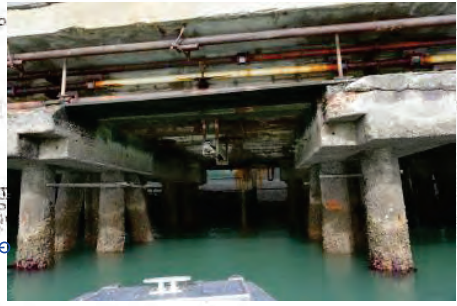
Spalled Pile Cap

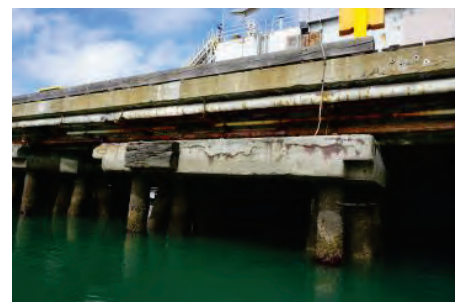
Major Crack on Pile Cap

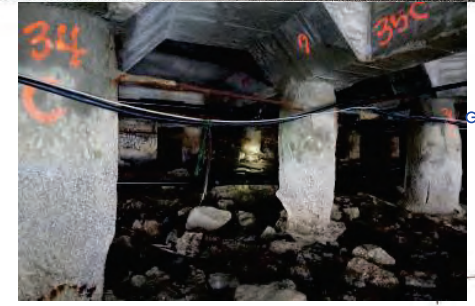
Exposed Piles

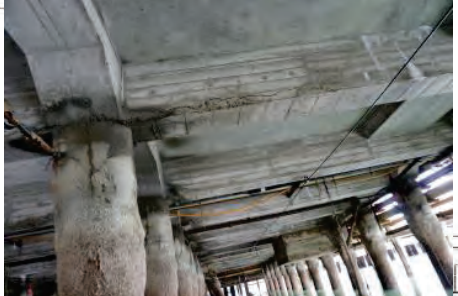
Crack on Beam

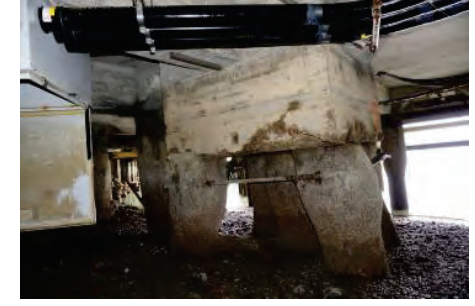
Major Crack on Pile Cap

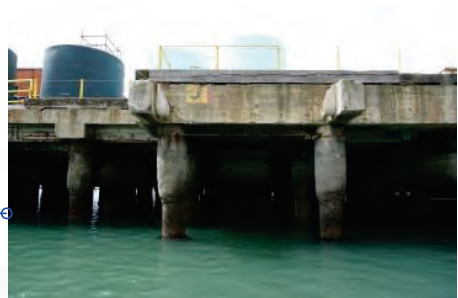
Cracked Pile Cap

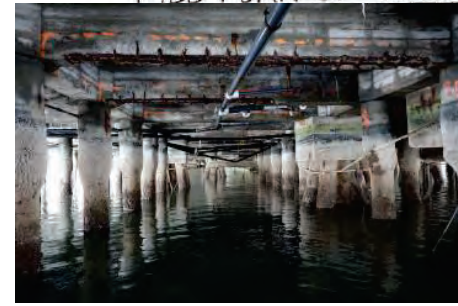
Sever Spalled Beams

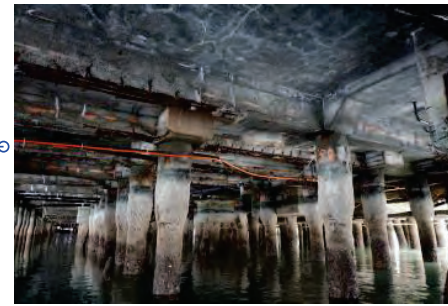
Spalled Beams

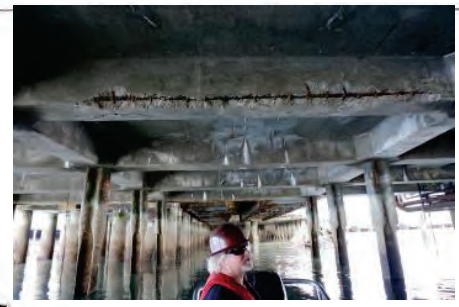
Severe Spall on Beam

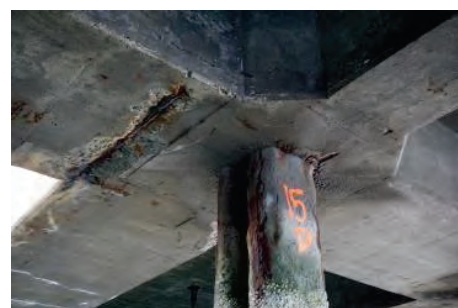
Spalled Beam & Pile Cap
