MEMORANDUM

To: Matthew Bell
Contract: Port of San Francisco As-Needed Engineering & Related Professional Services
Parsons/Lotus Water JV (PL 05)
Date: September 6, 2017
From: Paul Osmundson, Premier Structures
Eric Zickler, Lotus Water
RE: Pier 33.5 Restaurant Lease Condition Assessment

PIER 33.5 RESTAURANT LEASE ASSESSMENT

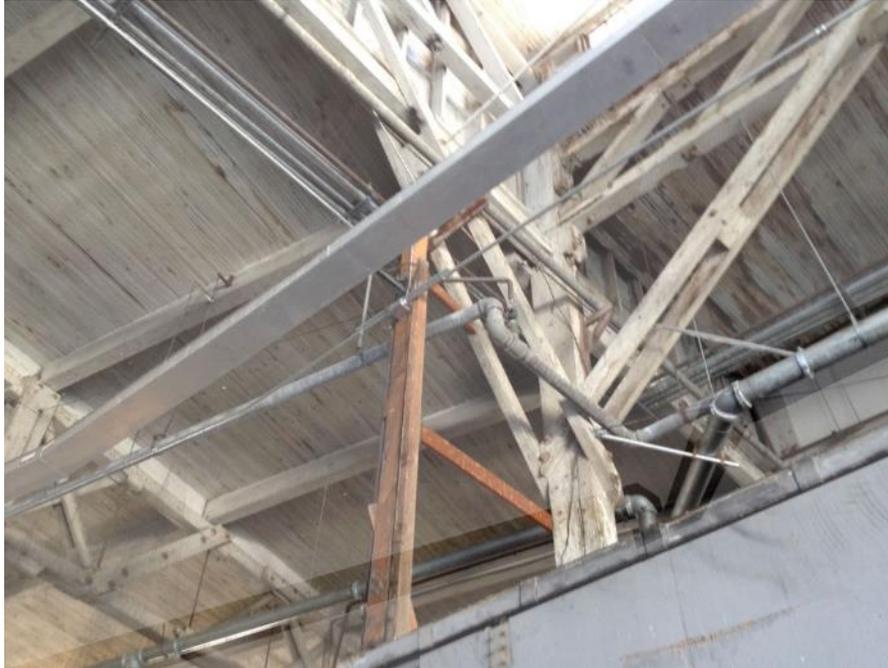
- b. There is a Port-maintained main fire riser assembly for the Pier 33 shed on the south side across the driveway in the shed (Figure 1). The new tenant's fire sprinkler system could be fed from here. Testing and certification of the tenants system would likely need to be perform simultaneously with the rest of the Port-owned system.

Figure 1: Existing fire water riser in Pier 33 shed, across the driveway from the restaurant back entrance (galvanized pipe in un-faded portion of photo).

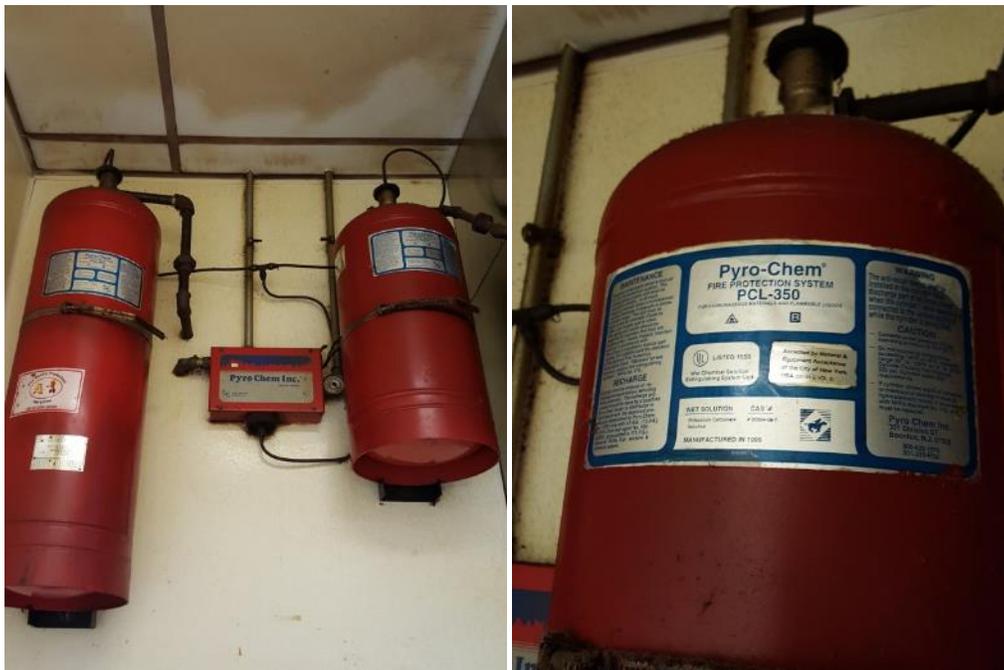
- a. The existing system is a Pyro-Chem wet chemical agent system with a 5.5 gallon cylinder serving the front kitchen hoods and a 3.5 gallon cylinder serving the back kitchen hood (Figure 2). The cylinders were manufactured in 1997 and the entire system was likely installed as part of the 1997 Samos Restaurant Remodel permit set.

Figure 2: Pyro-Chem wet chemical fire suppression system.

- c. The kitchen fire suppression system is set up for the previous kitchen equipment layout. Nozzles are directed at burners that are no longer in place. It is recommended that the entire system be replaced if the kitchen layout is modified.

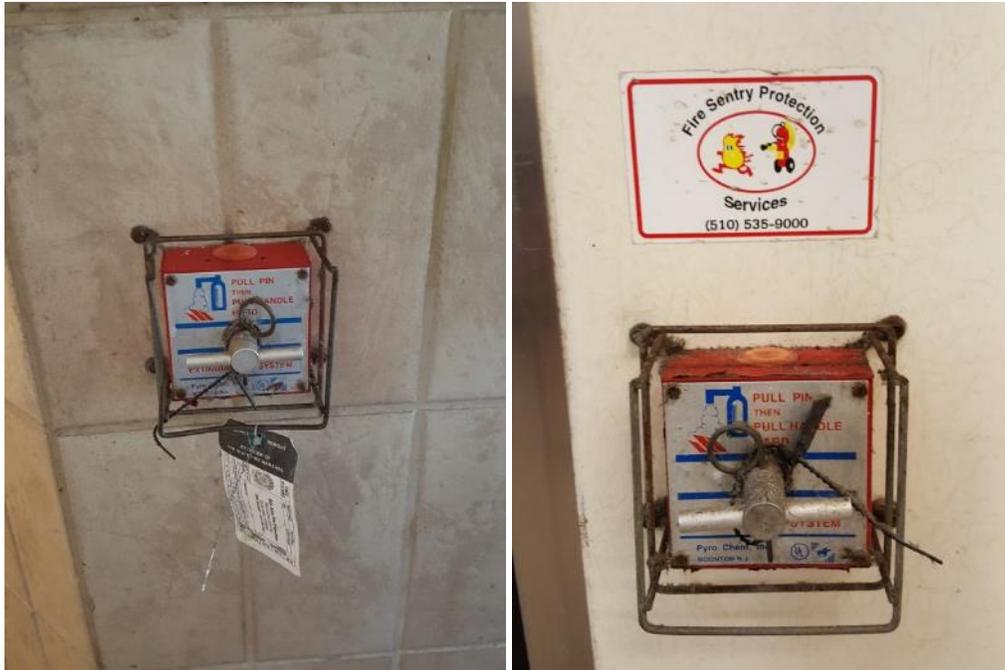
- b. There are two manual pull stations adjacent to the front and back kitchens (Figure 3). Automatic fire detection is provided by fusible links along a tensioned line in the hoods. Fusible links were not field verified.

Figure 3: Manual pull stations for kitchen fire suppression system.

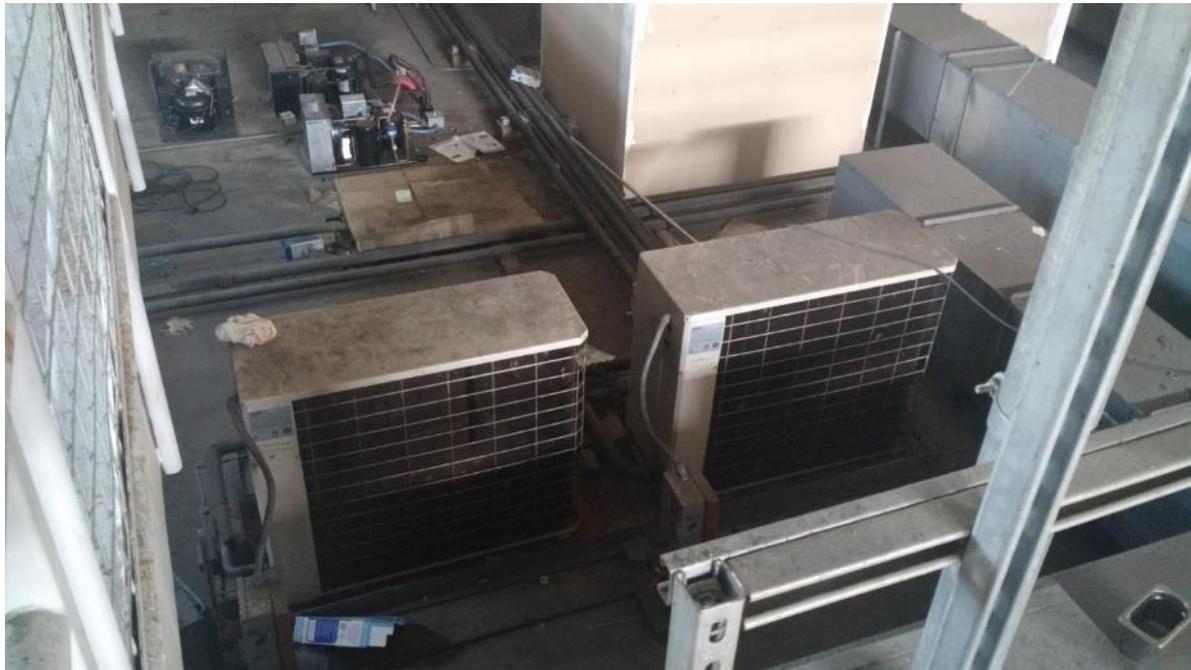
- a. There are two split-system heat pump units that serve the space. The two fan coil units and two condensing units (heat pumps) are located on a mechanical penthouse above the space in the shed of Pier 33 (Figure 4) and the associated ductwork is running exposed with sidewall grilles. Each has four-ton capacity, which differs from the specified capacities on the 1997 plans but match the total capacity of the two specified (one at 3-tons and the other at 5-tons). It could not be determined if these units were operational, but with an approximate age of 20 years, it is recommended to replace them with higher efficiency units that would meet current Title-24 energy efficiency requirements. The ductwork and grilles appear serviceable but should be cleaned.

Figure 4: Heat pumps at mechanical mezzanine.

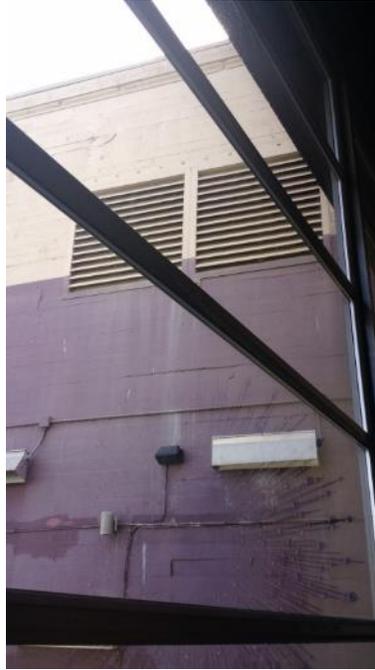
- b. Outdoor air to the space is provided by outdoor air ducts connected to the intake/return air plenum on the fan coil units. The ducts are routed to an outdoor air louver located at the pier deck area (Figure 5). These all appear serviceable but should be cleaned.

Figure 5: Outdoor air louver above restaurant's outdoor area on the Pier 33 apron.

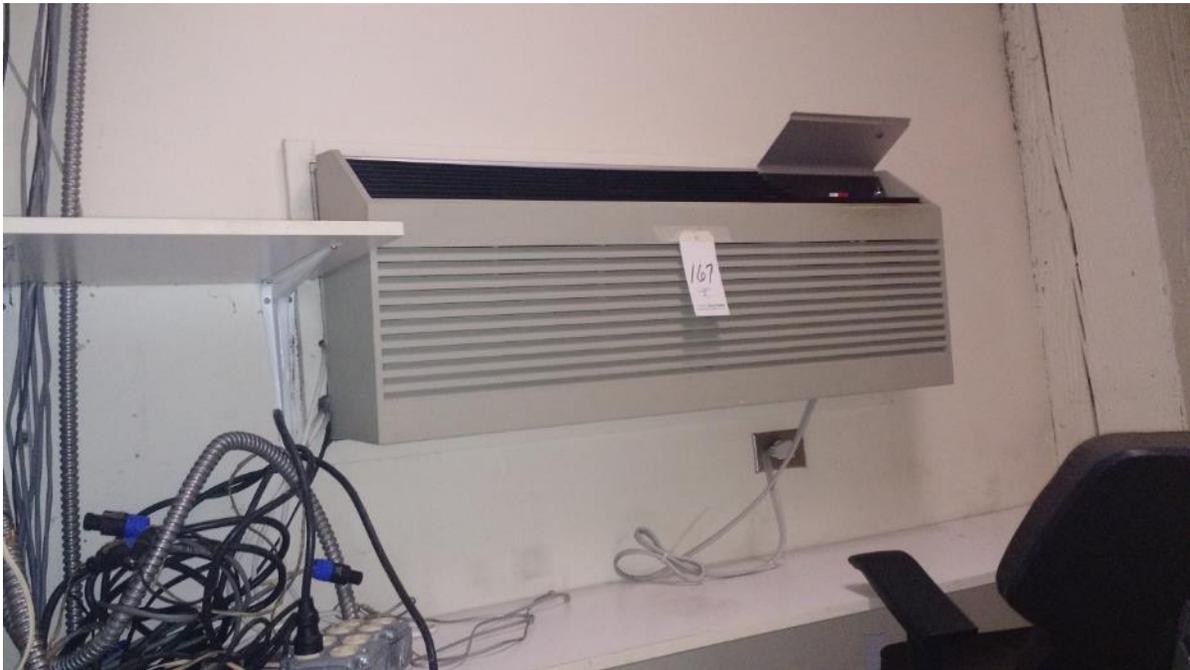
- c. There is a packaged terminal air conditioner (PTAC) for the back office (Figure 6). The unit is installed through the wall at the pier deck area. This unit appears serviceable. If the unit is replaced, makeup air calculations should be performed to provide sufficient outside air per current code requirements.

Figure 6: Office PTAC unit.

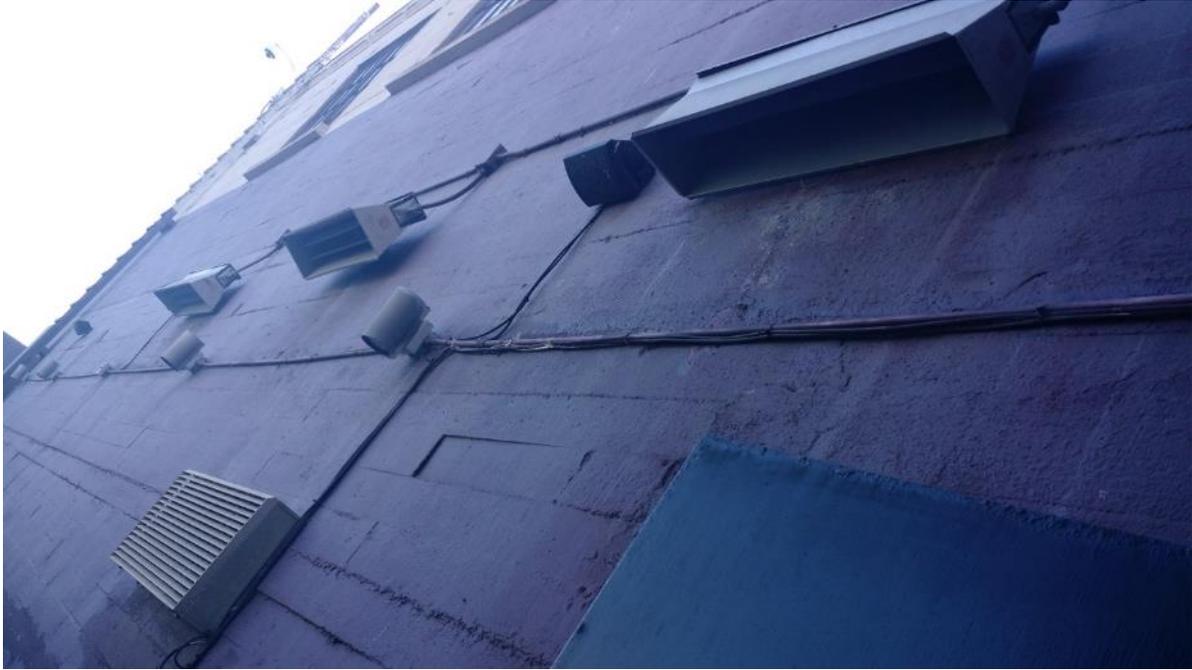
- d. The outdoor deck area is heated by three infrared radiant heaters (Figure 7). It could not be determined if these were operational, but they appear serviceable. The heaters were added as part of the 1999 tenant improvement plans.

Figure 7: Radiant heaters for outdoor area. Intake for PTAC unit is at lower left.

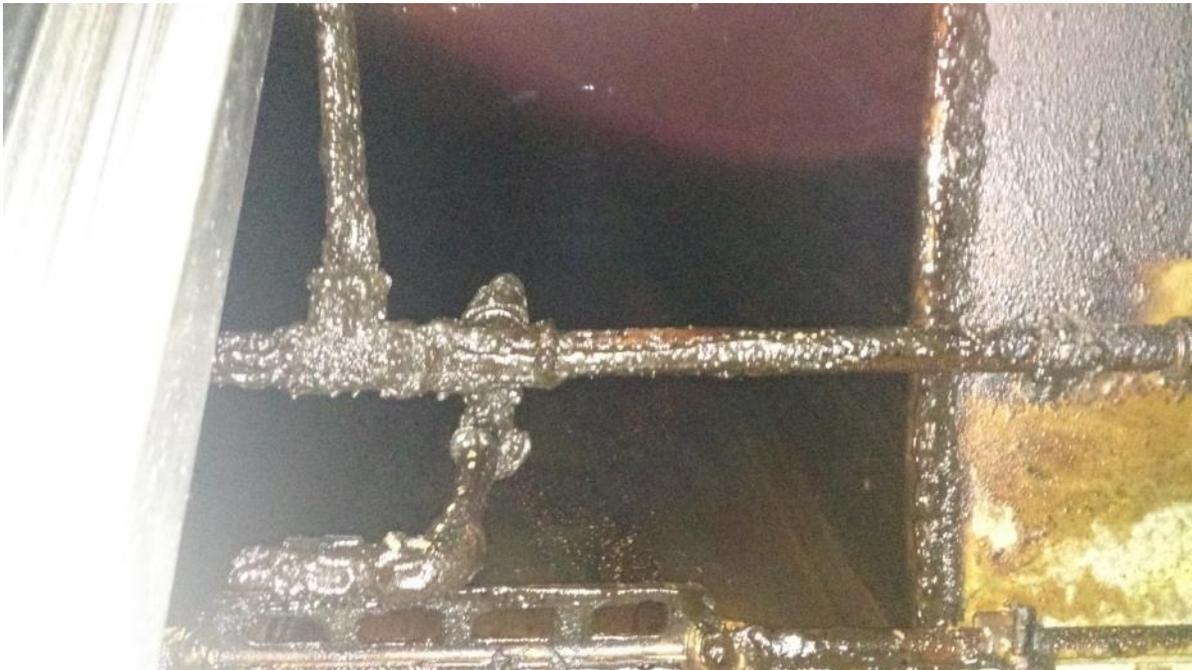
Figure 8: Hood duct and fire suppression nozzles covered in built up grease.

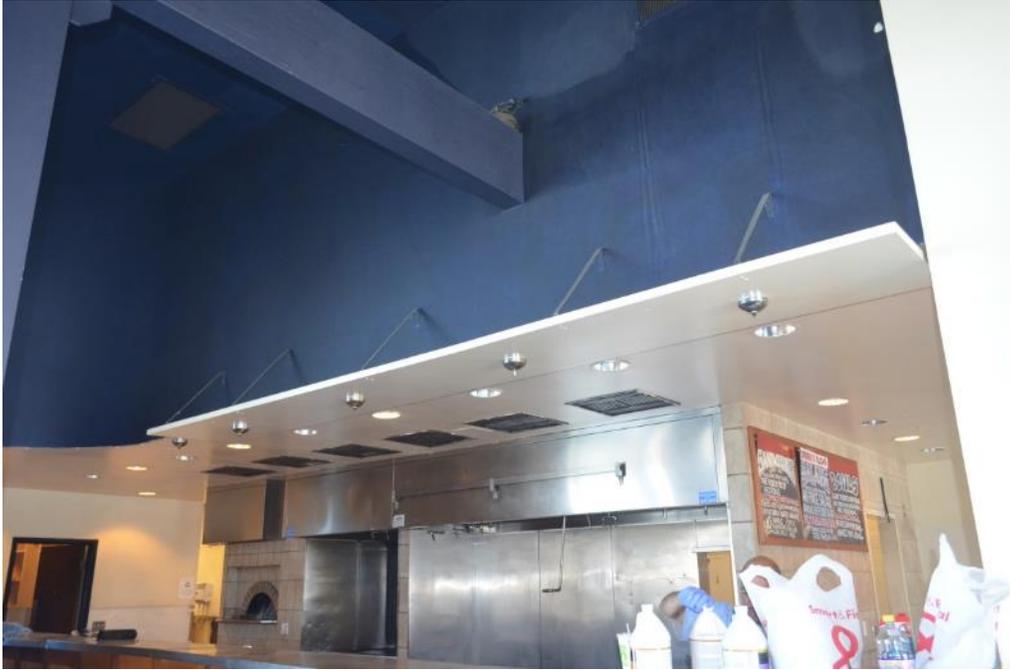
- a. There are four Type I commercial hoods. The CFM capacity should be sufficient for new kitchen equipment but this will depend on the type of equipment the new operator uses. One, roughly 10 feet long, is the main hood facing the dining space, and it is served by a roof-mounted utility fan labeled as EF-1 on the 1997 plans and rated at 3,750 CFM. The second hood, on the back of the main hood and roughly 6 feet long, is served by a roof-mounted utility fan labeled as EF-2 on the 1997 plans and rated at 3,400 CFM. The third and fourth hoods are back-to-back and are roughly 4 feet long. They are served by a common duct and roof-mounted utility fan labeled as EF-3 on the 1997 plans and rated at 3,690 CFM. The outlets of all three fans are upwards with duct meeting the code requirement of minimum 40 inches from the roof surface. The terminations meet the code requirement of 10 feet horizontal clearance from property lines and air intakes. All three fans have grease traps as required per code. However, they do not have vibration isolators. It could not be determined if all these fans were operational. There are grease cleanouts at the roof. Upon visual inspection of the duct collars in two of the hoods (Figure 8), it is recommended that a thorough cleaning of all the grease ducts via the cleanouts on the roof be conducted. See Figure 9 for kitchen hoods and Figure 10 for roof-mounted fans.

Figure 9: Front kitchen hoods.

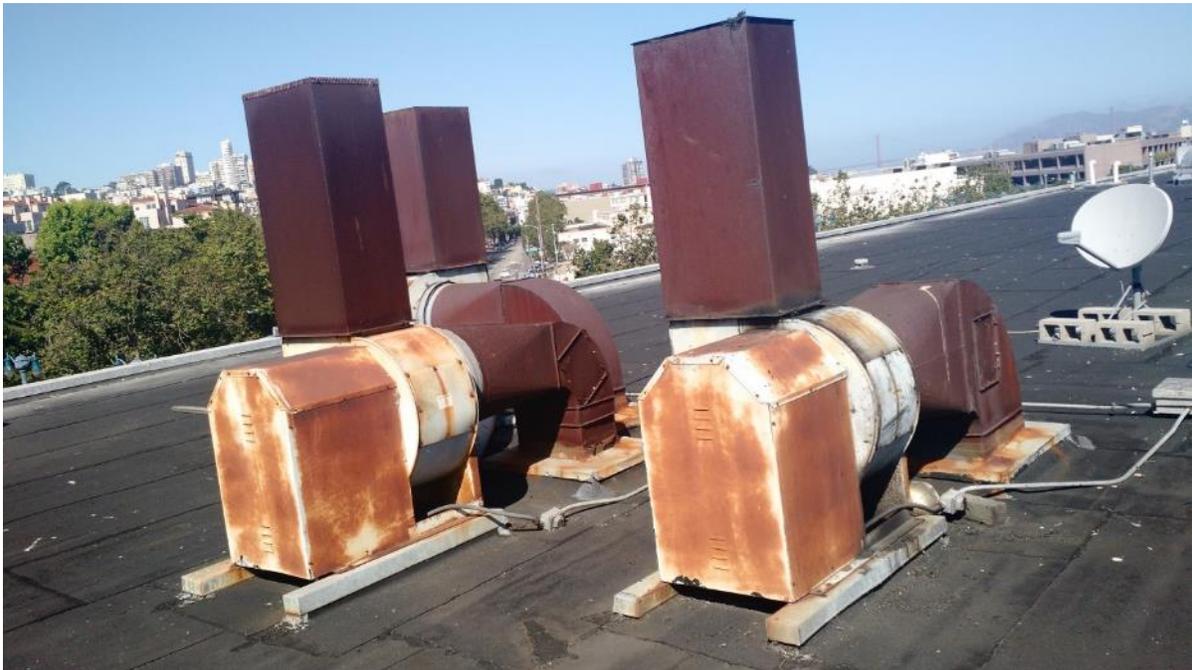
Figure 10: Roof mounted hood fans.

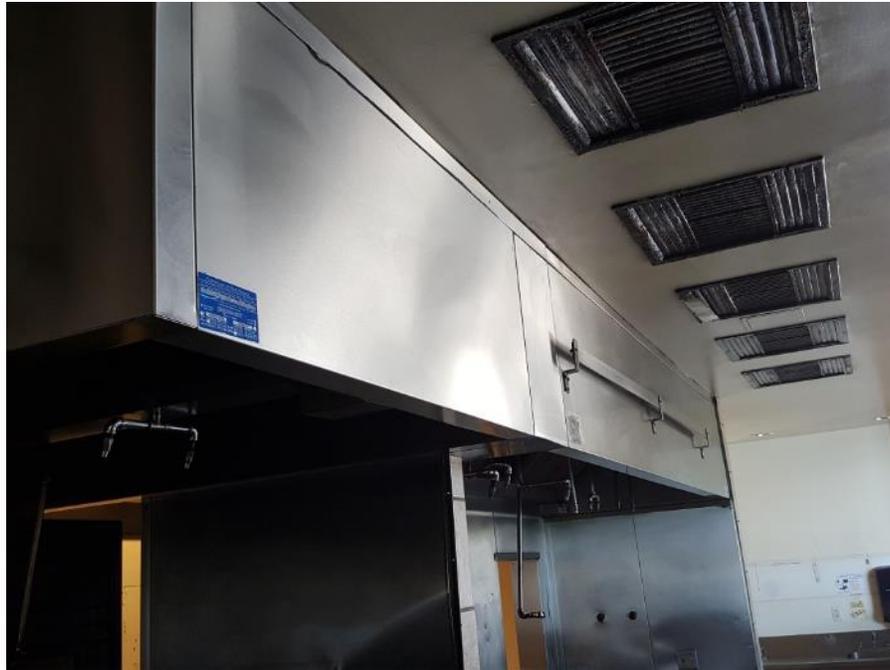
- b. Makeup air is provided by three air handlers located on top of the plywood deck above the space and through ceiling supply diffusers lining the front of the hoods (Figure 11). The air is drawn from the same outdoor air louver mentioned above that is used for the outdoor air into the dining space. Air handler, labeled AH-1 on the 1997 plans, is rated at 3,750 CFM and appears to be interlocked with EF-1. Air handler AH-2 is rated at 3,400 CFM and appears to be interlocked with EF-2. Air handler AH-3 is rated at 3,688 and appears to be interlocked with EF-3. All the makeup air diffusers appear to be serviceable but require thorough cleaning. It could not be determined if these air handlers are operational. See Figure 12 for air handlers located at the mechanical mezzanine and Figure 13 for the interlocked pushbutton starters.

Figure 11: Makeup air diffusers at the front kitchen.

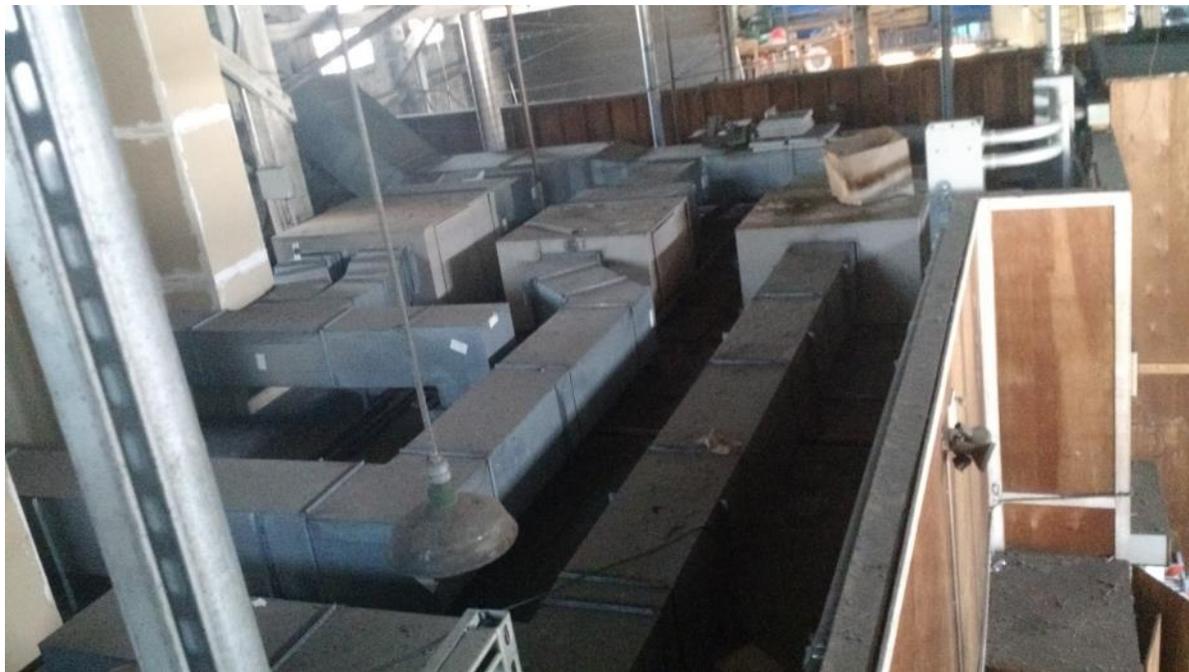
Figure 12: Air handling units AH-1, AH-2 and AH-3 located on the mechanical mezzanine.

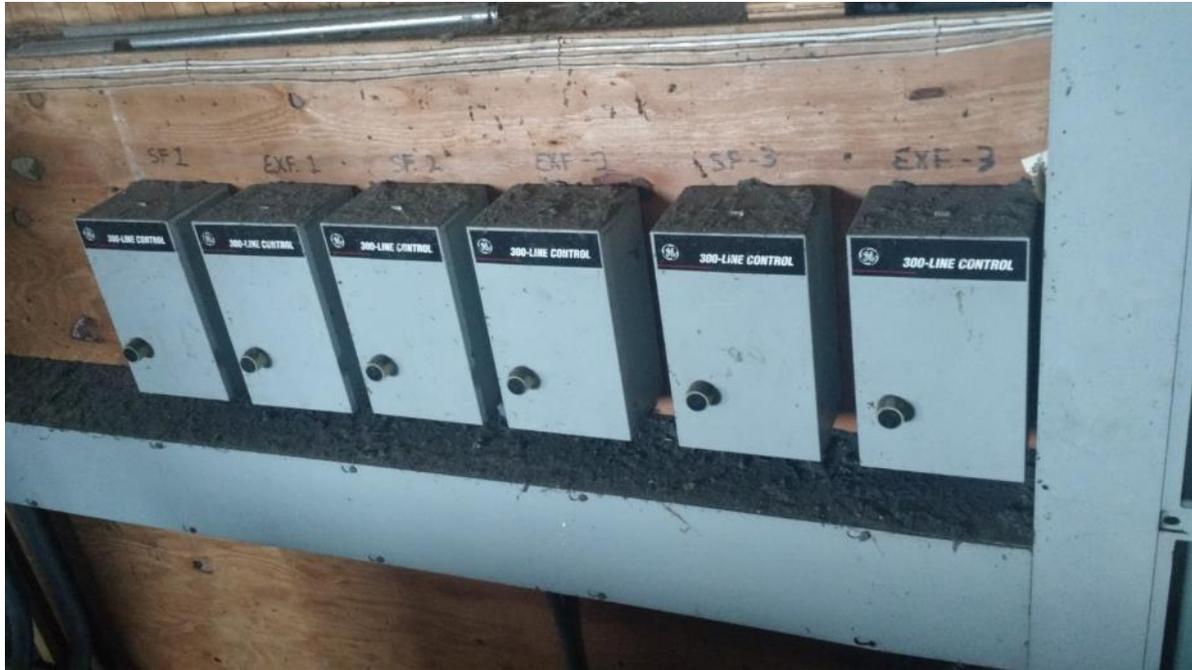
Figure 13: Exhaust fan and makeup air handler pushbutton starters, appear to be interlocked.

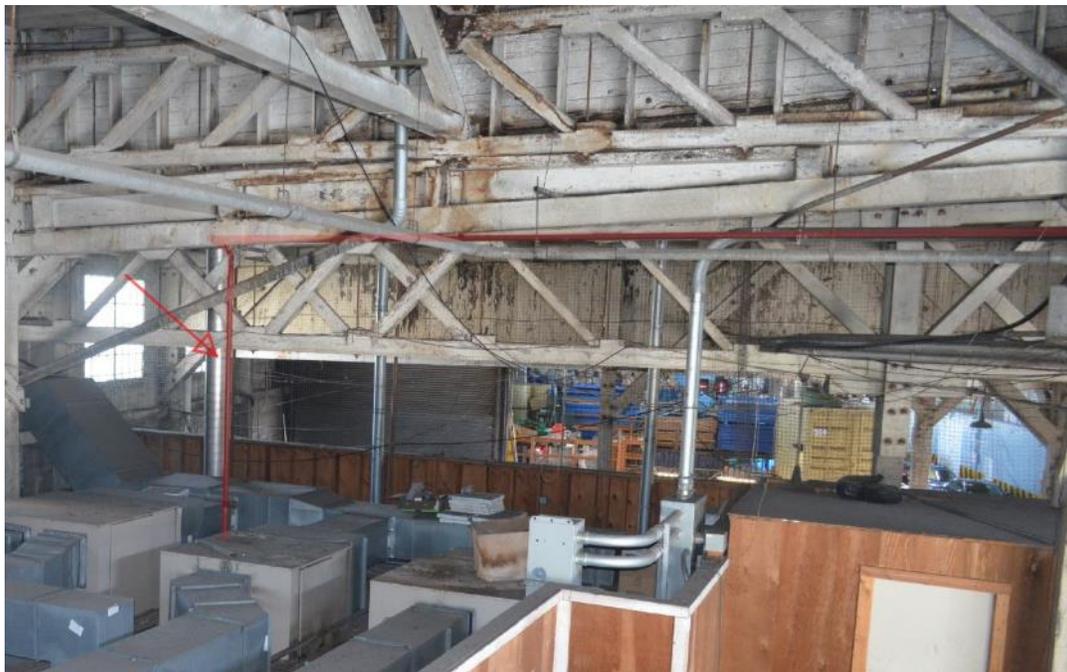
- a. The existing water meter is located in the south side of Pier 33 across the driveway in a utility room within the shed. The water line is two inches, which appears to be properly sized for the load in the previous restaurant. See Figure 14 for a photo of the water line where it enters the restaurant.
- b. Existing water service is a deduct service which is connected to the water main serving the Pier 33. See Figure 15 for a photo of the existing deduct meter. The Pier 33 main is owned and maintained by the Port of San Francisco. The restaurant operator has the option of obtaining and installing their own water main directly from the SFPUC.

Figure 14: 2 inch copper water line entering the restaurant from the Pier 33 shed (highlighted in red).

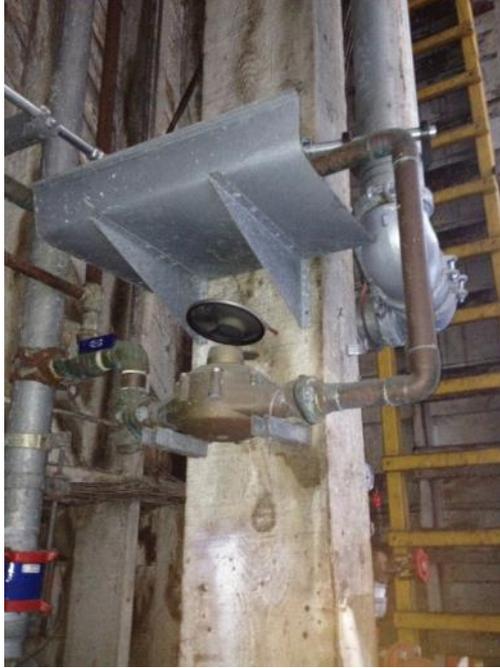
Figure 15: Deduct water meter for the restaurant located in the Pier 33 bulkhead utility room.

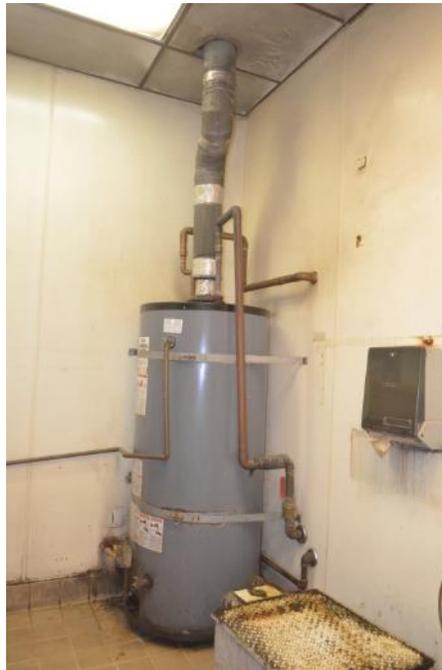
- a. There is a gas water heater for the kitchen, and it is a 100-gallon Rheem model G100-80N, input rating of 76,000 Btuh/hr, 73.7 recovery gal/hr (Figure 16). The base of the water heater where the burner is located is blackened with soot and/or debris and may indicate issues with the burner. If the heater is replaced, a new hot water demand calculation will need to be performed for the kitchen to confirm rating and capacity of the new heater.

Figure 16: 100 gallon Rheem water heater located in the kitchen.

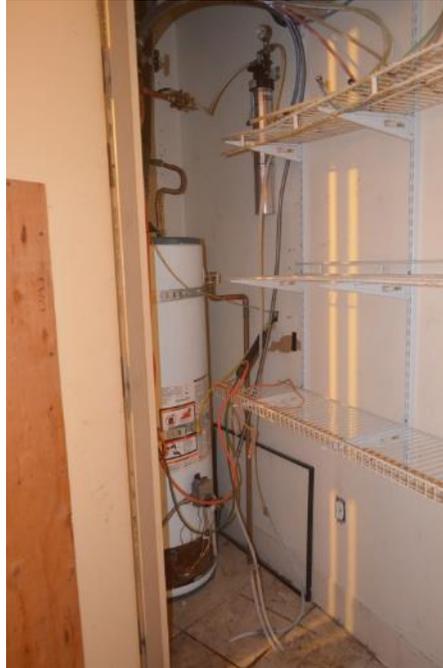
- b. There is a second gas water heater for the restrooms and bar area, and it is a 48-gallon Rheem model 22V50FN, input rating of 40,000 Btuh/hr (Figure 17). This water heater appears serviceable, but a new hot water demand calculation will need to be performed with the future bar equipment and any new lavatories added to the restrooms to determine adequate sizing.

Figure 17: 48 gallon Rheem water heater located in the bar and restroom area

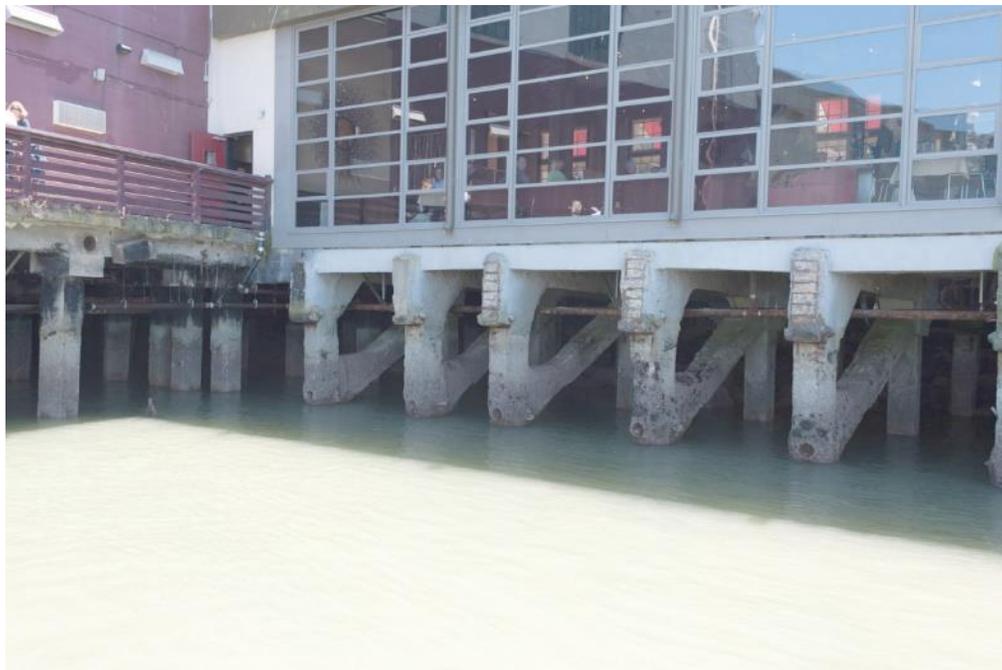
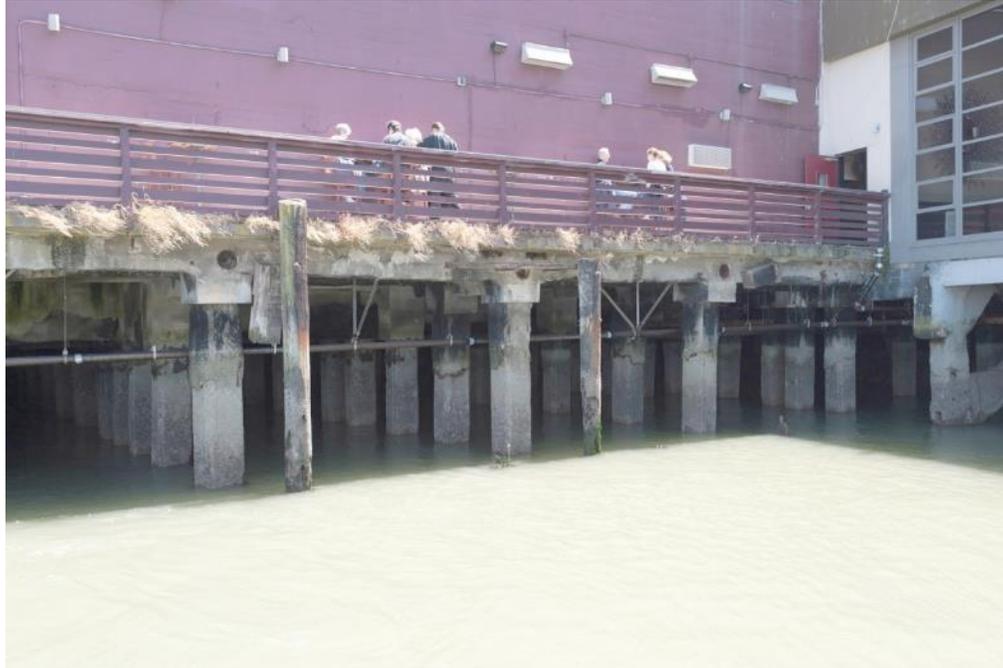
- a. The existing waste and plumbing lines are all routed under the pier deck and are exposed to sea water, wave action and occasional floating debris, as is typical with most existing plumbing at Port facilities built over water. See Figure 18 and Figure 19 for photos of the under-pier plumbing taken by the Port in 2011.

Figure 18: Under-pier plumbing lines (Record photo from Port taken in 2011).

Figure 19: Under-pier plumbing lines (Record photo from Port taken in 2011).

- c. For improved reliability, it is recommended that the waste lines be rerouted to discharge directly to the sewer transport storage box in the Embarcadero. This will require trenching on the Embarcadero to install a gravity sewer line. The new waste lines will still be exposed under the pier, but a shorter run of pipe will be less susceptible to damage, and will not be affected by potential issues with the pump station.

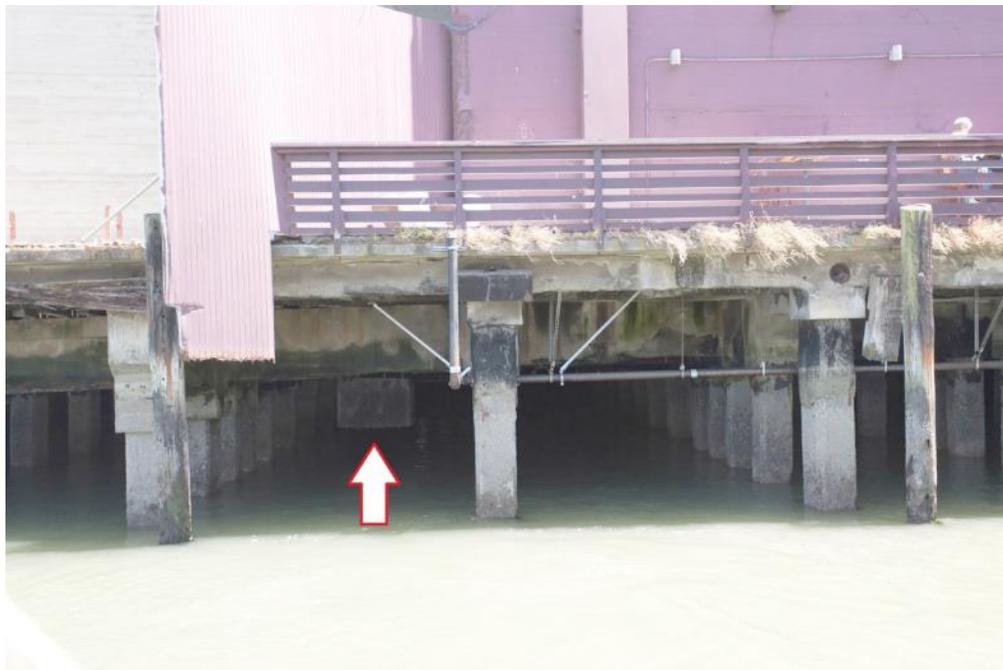
- b. The existing waste plumbing discharges into a sewer pump station serving all of Pier 33, located approximately 80-90 ft from the edge of the lease boundary via under-pier plumbing. The main line to the pump station is 4 inch and sizes of the branch lines are shown on the 1997 plans. Regular maintenance of this sewer pump station by the Port will likely cause downtime. See Figure 20 for a photo of the pump station sump taken by the Port in 2011.

Figure 20: Location of pump station sump that currently serves the restaurant's plumbing system (Record photo from Port taken in 2011).

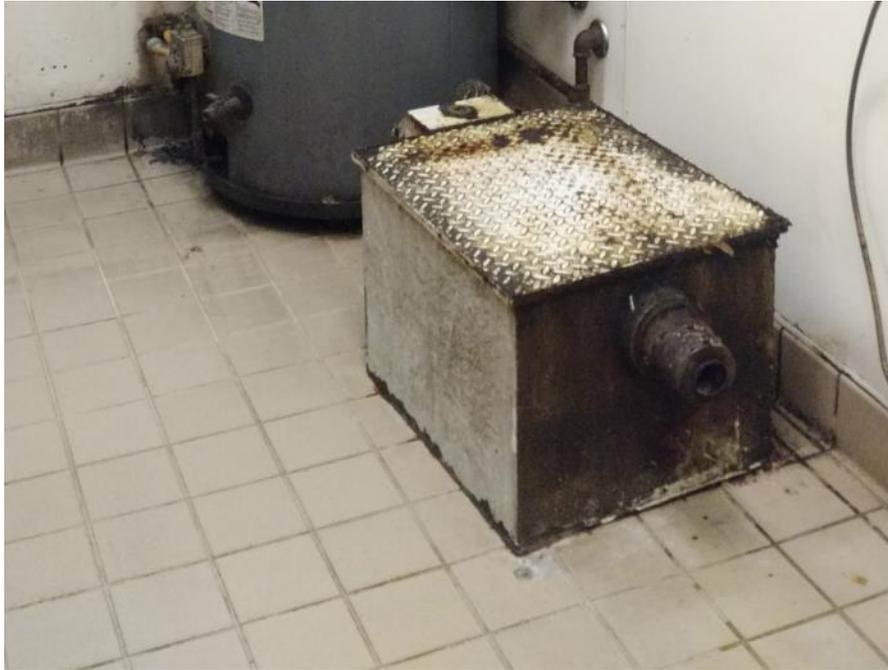
- a. There is a floor-mounted grease trap in the back preparation area, which appears to have served a previous 3-compartment sink, no longer in place (Figure 21). It is recommended that this be replaced with a new grease removal device under a future 3-compartment sink that complies with the FOG Ordinance as a Class 1 Facility, as approved by the SFPUC.

Figure 21: Existing grease trap.

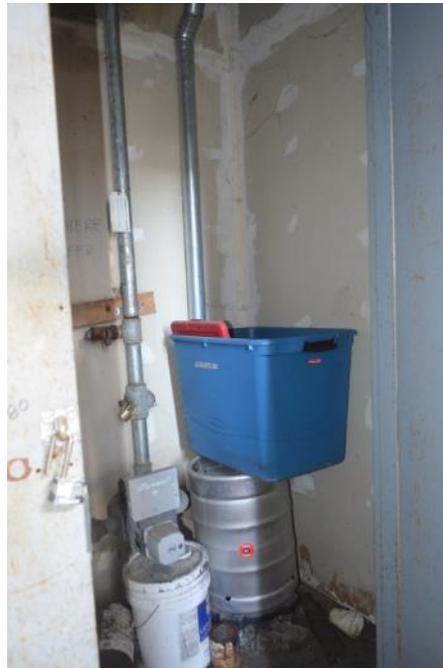
- a. The gas meter is in a closet on the south side by the driveway and it is a Dresser Roots Rotary meter model 1.5M125, with 1500 CFH rated maximum capacity (Figure 22). Actual maximum gas flowrate should be confirmed with PG&E prior to specifying new gas-fired equipment. The gas meter closet/enclosure does not meet current PG&E standards, and will need to be updated to meet PG&E manual J-16 if any modifications are made (either by the tenant or mandated by PG&E). A new mechanical ventilation system for the closet will need to be provided. The existing gas meter closet should not be used for storage.

Figure 22: Gas meter located in utility closet. Gas meter closet should not be used for storage.

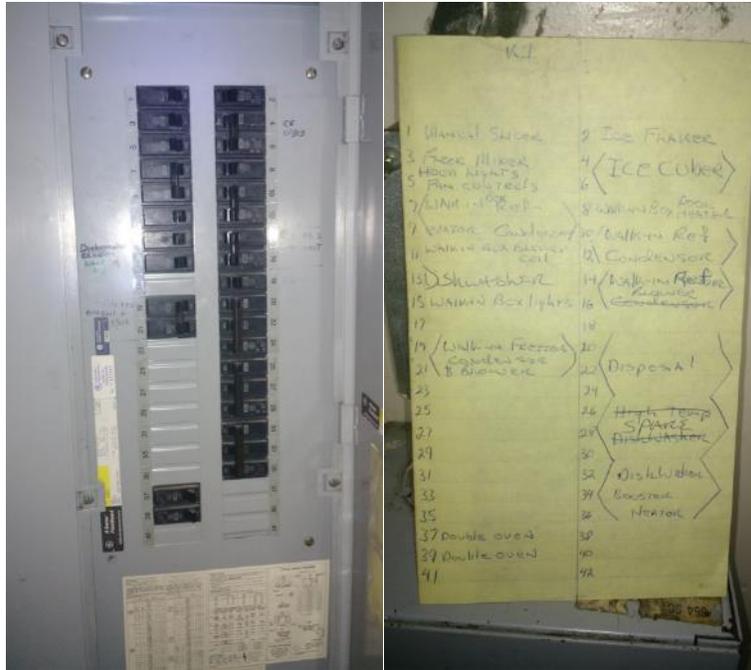
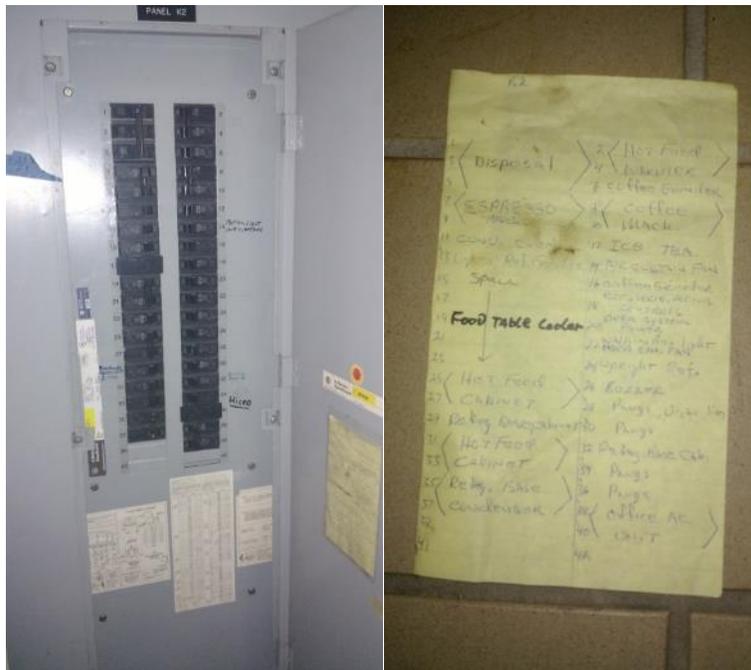
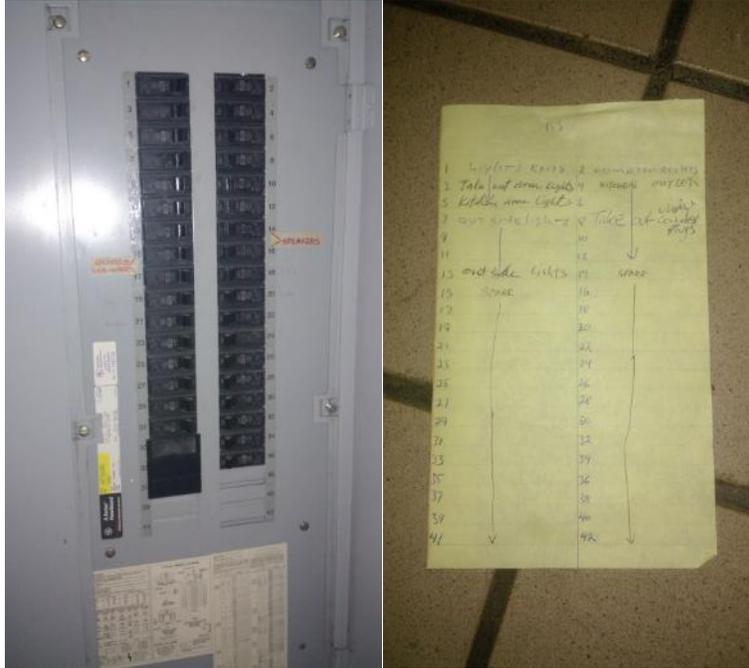
- c. There are five subpanels:
 - i. K1, K2 and K3 which are located by the staff restroom (Figures 23, 24 and 25). These feed kitchen equipment, outlets, light fixtures and other miscellaneous items.

Figure 23: Panel EF-1 located in the kitchen.

Figure 24: Panel EF-2 located in the kitchen.

Figure 25: Panel EF-3 located in the kitchen.

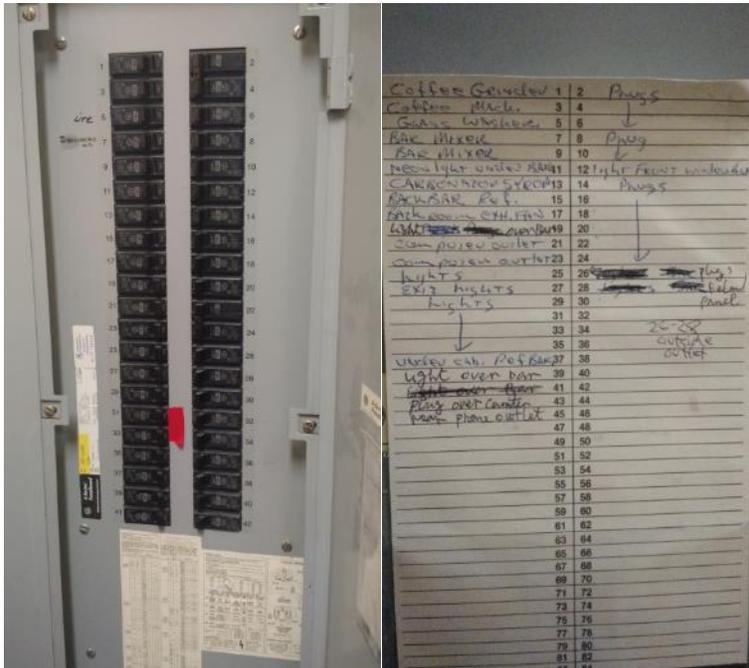
- ii. B1 which is located in the janitor room by the back bar area (Figure 26). This feeds bar equipment, outlets, light fixtures and other miscellaneous items.

Figure 26: Panel B-1 located in the janitor closet near the bar and restrooms.

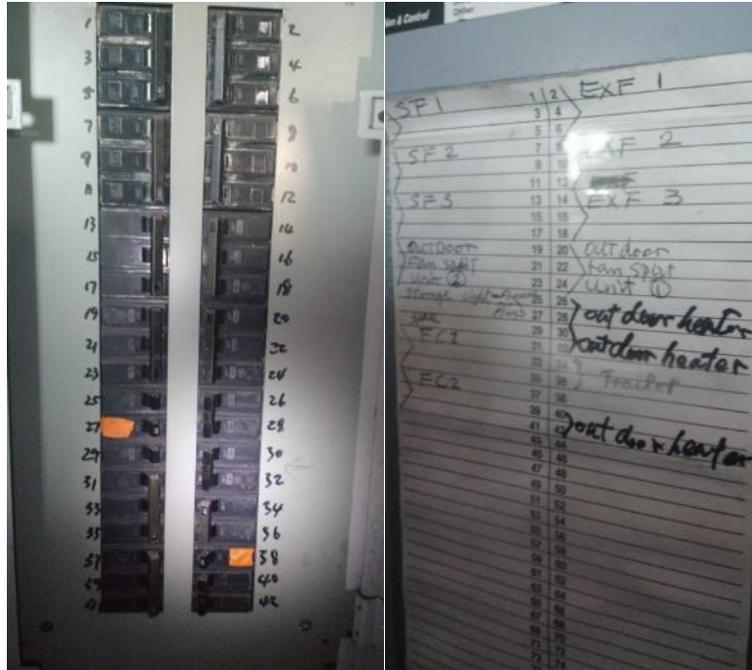
- iii. A subpanel is located on the plywood deck above the space. This serves all the mechanical equipment. (Figure 27)All subpanels appear to be serviceable.

Figure 27: Subpanel located on the mechanical mezzanine.

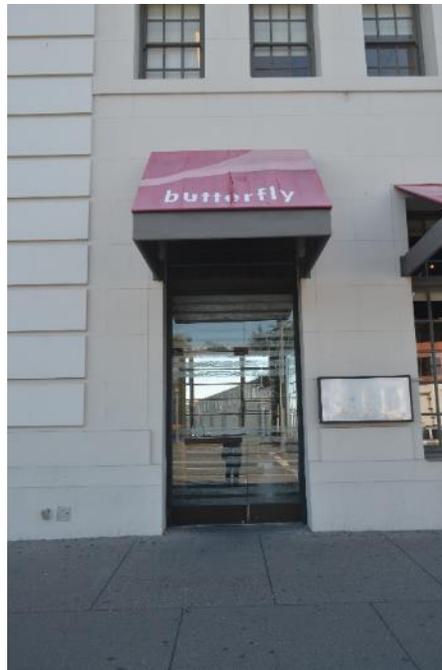
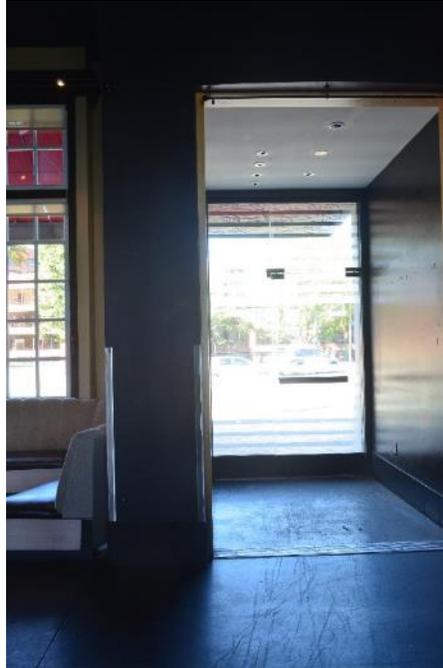
The path of travel at the existing main entry is in general conformance with accessibility requirements with the exception of the door pull. The existing horizontal pull on the glass door is mounted over 44" above the finish floor which exceeds the required 34" minimum to 44" maximum range for the operable parts of door hardware and will need to be revised or replaced. The main entry door is recessed greater than 8 inches and has sufficient latch side clearance at the exterior pull side and level landings on the interior and exterior. The existing glass door bottom rail provides a 10" smooth surface at the push side. The existing threshold appears to be compliant. The existing main entry door does not have an automatic operator or door closer installed. If the existing door hinges provide self-closing action, their closing speed and operating force could not be confirmed as part of this survey.

Figure 28: Existing main entry door exterior

Figure 29: Existing main entry door interior

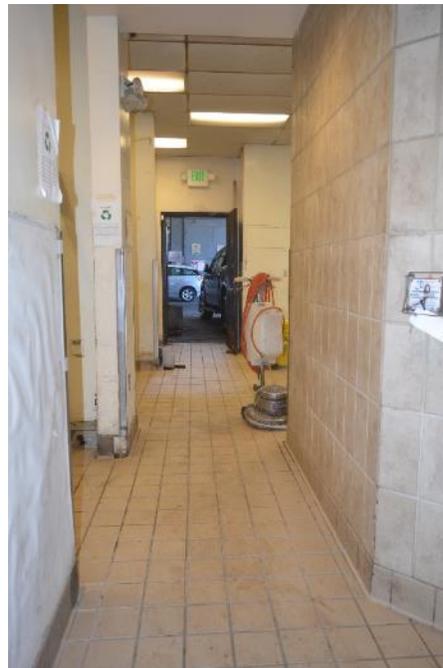
There is an illuminated exit sign installed above the door that leads from the kitchen to the shed however this door does not swing in the direction of egress and is not compliant as an exit (Figure 30).

Figure 30: Exit from restaurant to shed

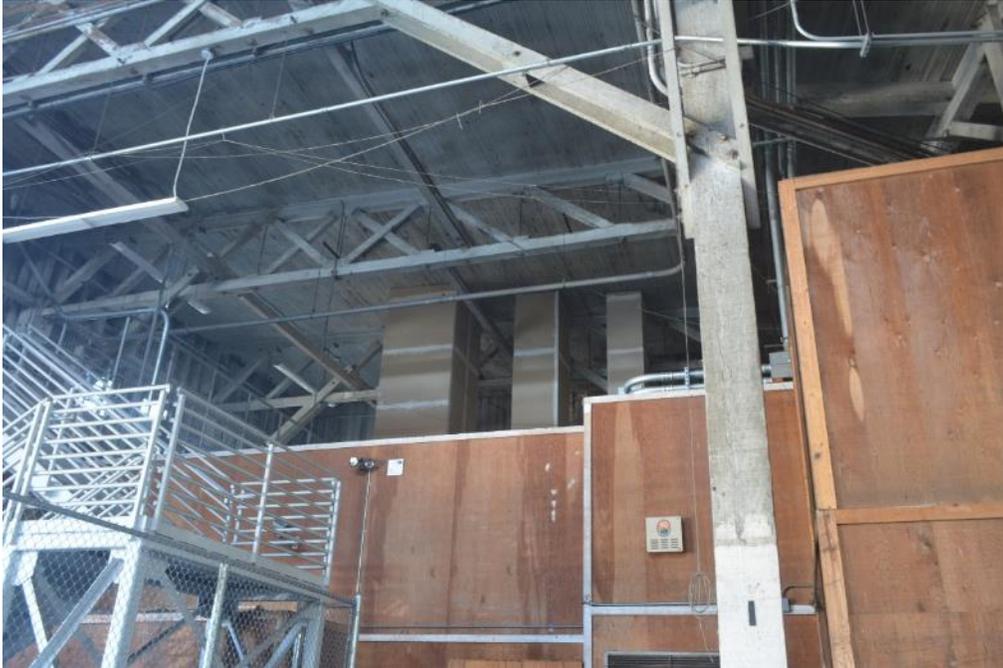
Figure 31: Existing finish on the shed side of these exterior perimeter walls

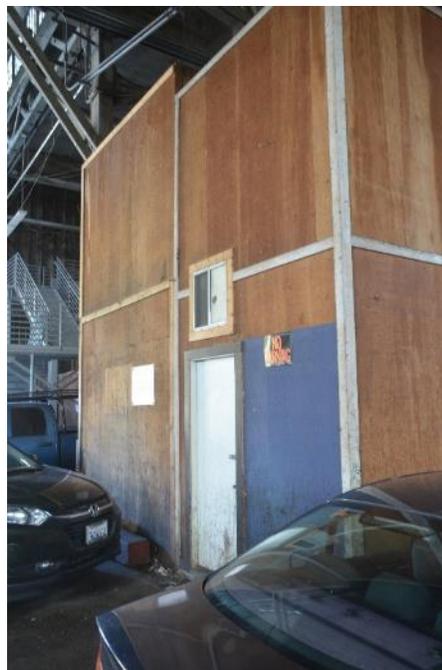
There are several rated doors and frames at the envelope between the kitchen and the shed but their locations and ratings are inconsistent or cannot be verified. The door between the kitchen and the shed has labels but are painted over or rusted to a degree that makes it illegible. Other doors have a rated label on the frame but not the door. These doors and frames would need to be inspected and relabeled or replaced. A new unrated door and frame opening and a small residential window was added at a later date, in what was previously called the wood storage room, both reducing the amount of perimeter shear wall and interrupting the rated wall construction indicated in the 1997 set, see Figure 32. The mechanical penthouse is accessed by a ladder and hatch opening in the penthouse floor assembly in this same room. This opening would also need to be provided with the rating hatch to maintain a rated horizontal assembly.

Figure 32: Unrated door and frame opening and a small residential window

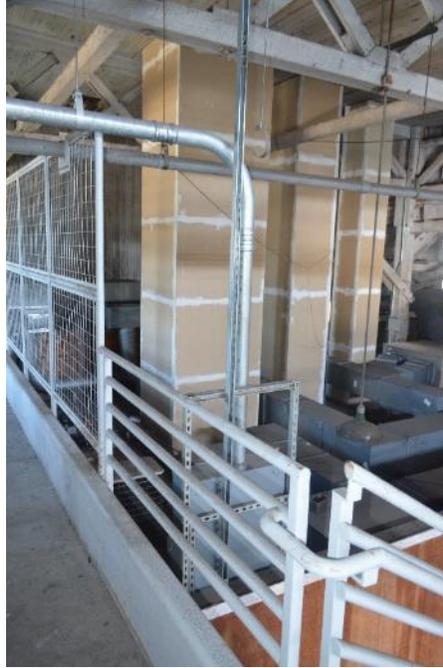
There are three major mechanical shaft walls extending from the top of the plywood deck of the mechanical penthouse to the underside of the wooden roof deck of the shed for the exhaust ducts from the kitchen equipment (Figure 33). There are two details on the 1997 set that address the construction of the mechanical shafts but the information shown conflicts with each other. The canopy hood detail 5/A13 calls for a one hour rated shaft and the observed construction appears to generally conform to this detail. The Exhaust Shaft/Duct Reference Specification Detail 3/A13 shows the shaft construction extending above the roof. There is no specific UL or GA rated shaft assembly indicated in the documents. The outside face of the gypsum board stops at the bottom of the wood roof deck. The mechanical units would need to be removed to confirm if the gypsum board shaft construction was continuous on the inside of the shaft to above the roof. The existing shaft construction appears inconsistent and somewhat incomplete. They are not fully taped and floated on the exterior and what appears to be existing fire caulking at joints between floor and roof assemblies is minimal with potential gaps and appears to be missing at one location.

The condition of this mechanical shaft is a significant concern and requires further investigation, including destructive testing, removal of the units, and a visual survey following this effort.

Figure 33: Three mechanical shaft walls
