MEMORANDUM

To: Matthew Bell
Contract: Port of San Francisco As-Needed Engineering & Related Professional Services
Parsons/Lotus Water JV (PL 05)
Date: September 6, 2017
From: Paul Osmundson, Premier Structures
Eric Zickler, Lotus Water
RE: Pier 33.5 Restaurant Lease Condition Assessment

PIER 33.5 RESTAURANT LEASE ASSESSMENT

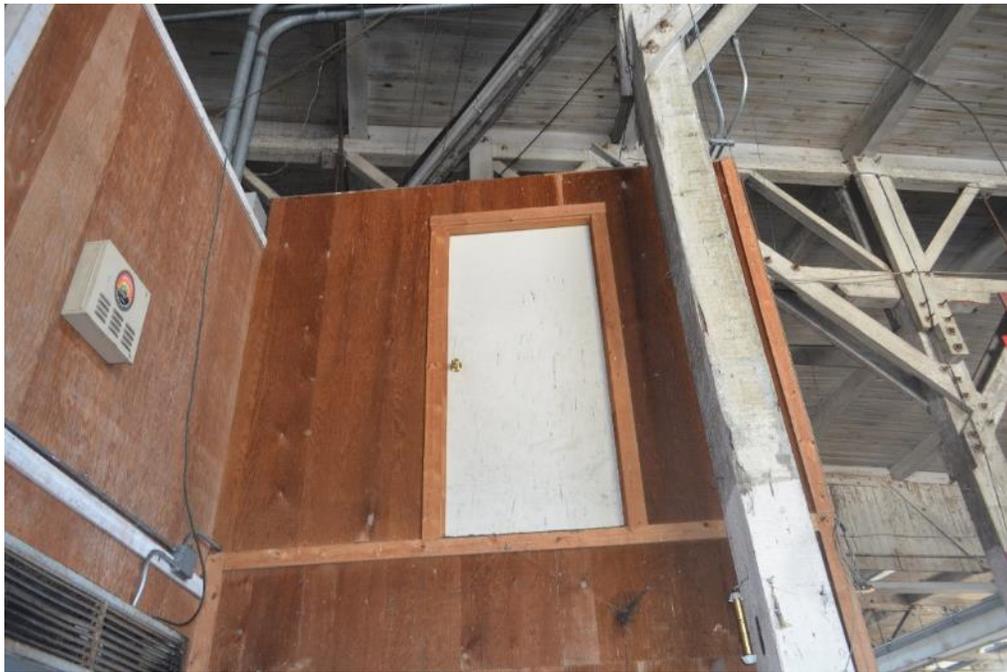
On the shed side of the perimeter wall there is an existing two-story addition of storage rooms and a single story storage room constructed at a later time (Figure 34). The construction appears to be separate and from visual observation does not appear to impact the 1997 restaurant construction of the potentially rated perimeter wall. There were no existing drawings available of these later additions to review as part of this assessment and these spaces have been excluded as part of the restaurant square footage. It is not known if these are permitted construction from the information available.

Figure 34: Existing two-story addition of storage rooms

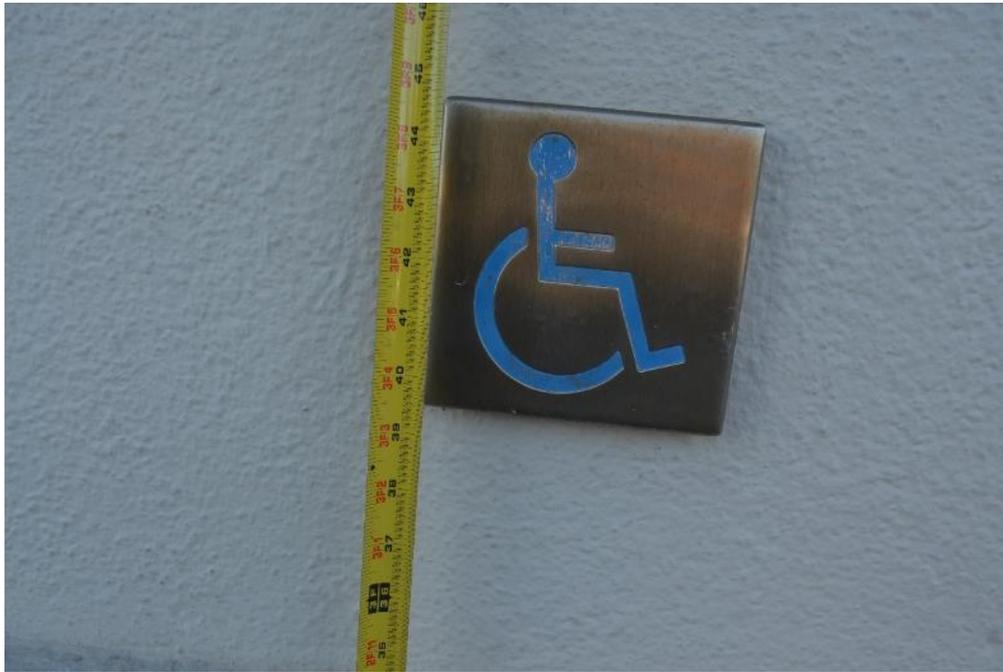
Figure 35: Existing compliant push plate

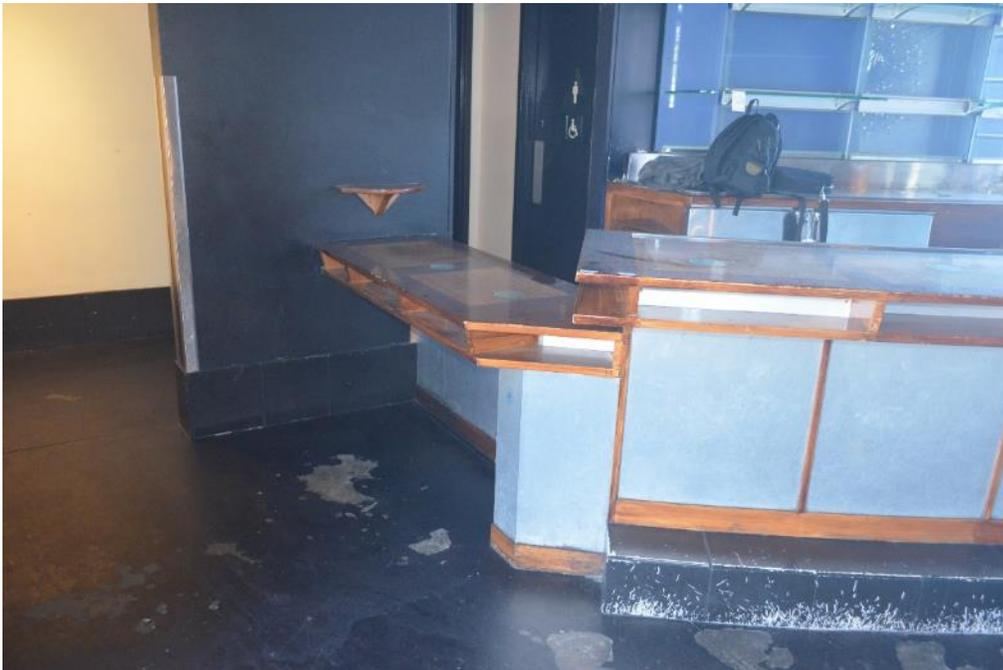
There is a section of the existing bar with a counter height and knee clearance designed to accommodate a single front approach wheelchair clear floor area space and it is in general conformance with current accessible requirements (Figure 36). The take-out counter is also designed to a 34" maximum height with sufficient space for a wheelchair side approach and a 5'-0" turning radius.

Figure 36: counter height and knee clearance designed to accommodate a single front approach wheelchair
