HEGER DRY DOCK, INC

December 7, 2016

Re: Request for HEGER Certification of Dry Dock No. 2 located in BAE San Francisco, CA

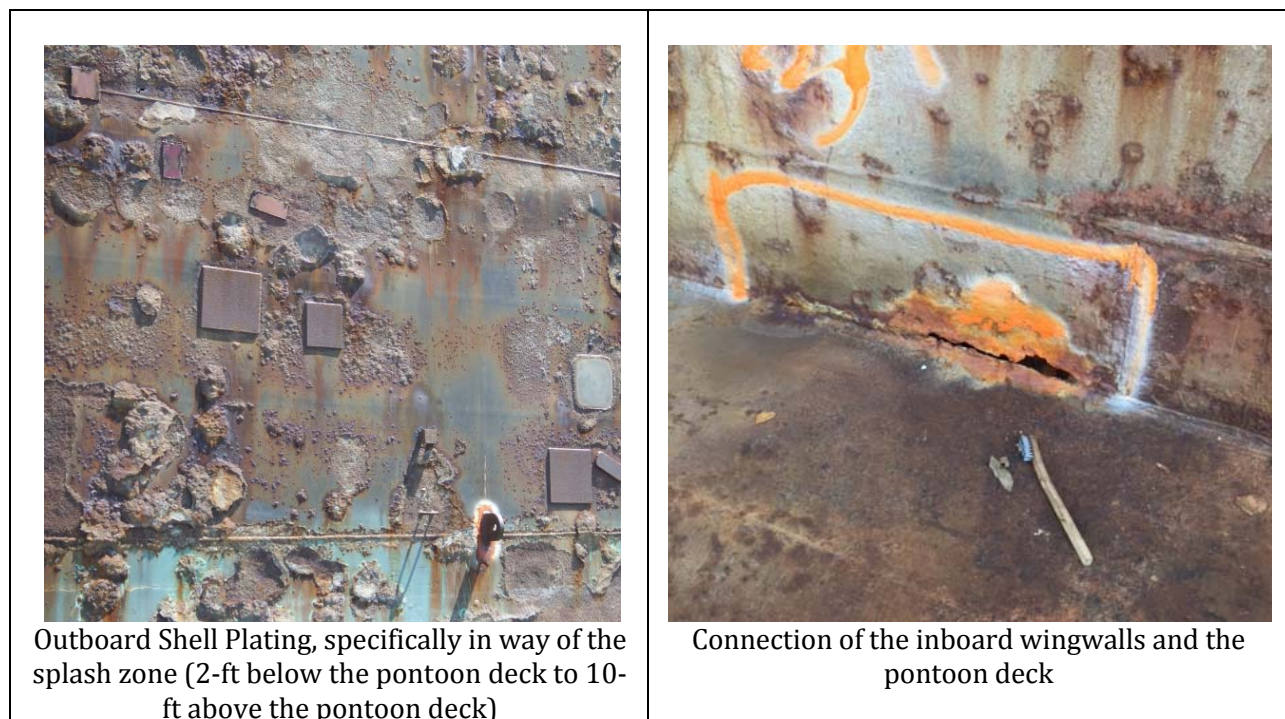
The UT survey results of the dock's external shell plating indicate areas of significant metal thickness loss. Areas of extensive corrosion were confirmed by HEGER's August 2016 visual inspection with numerous observed holes in the plating.

The most notable areas of corrosion are:

There have been ongoing repair efforts to the dock's original external plating to fix areas of extensive corrosion and holed-through plating. Some locations have been repaired by installing doubler plates over localized holes. Other areas of the external shell have been repaired by cropping and replacing 40-ft x 10-ft stiffened plate panels. The thickness of the new plate panels has been increased to 1/2" from the original 7/16".

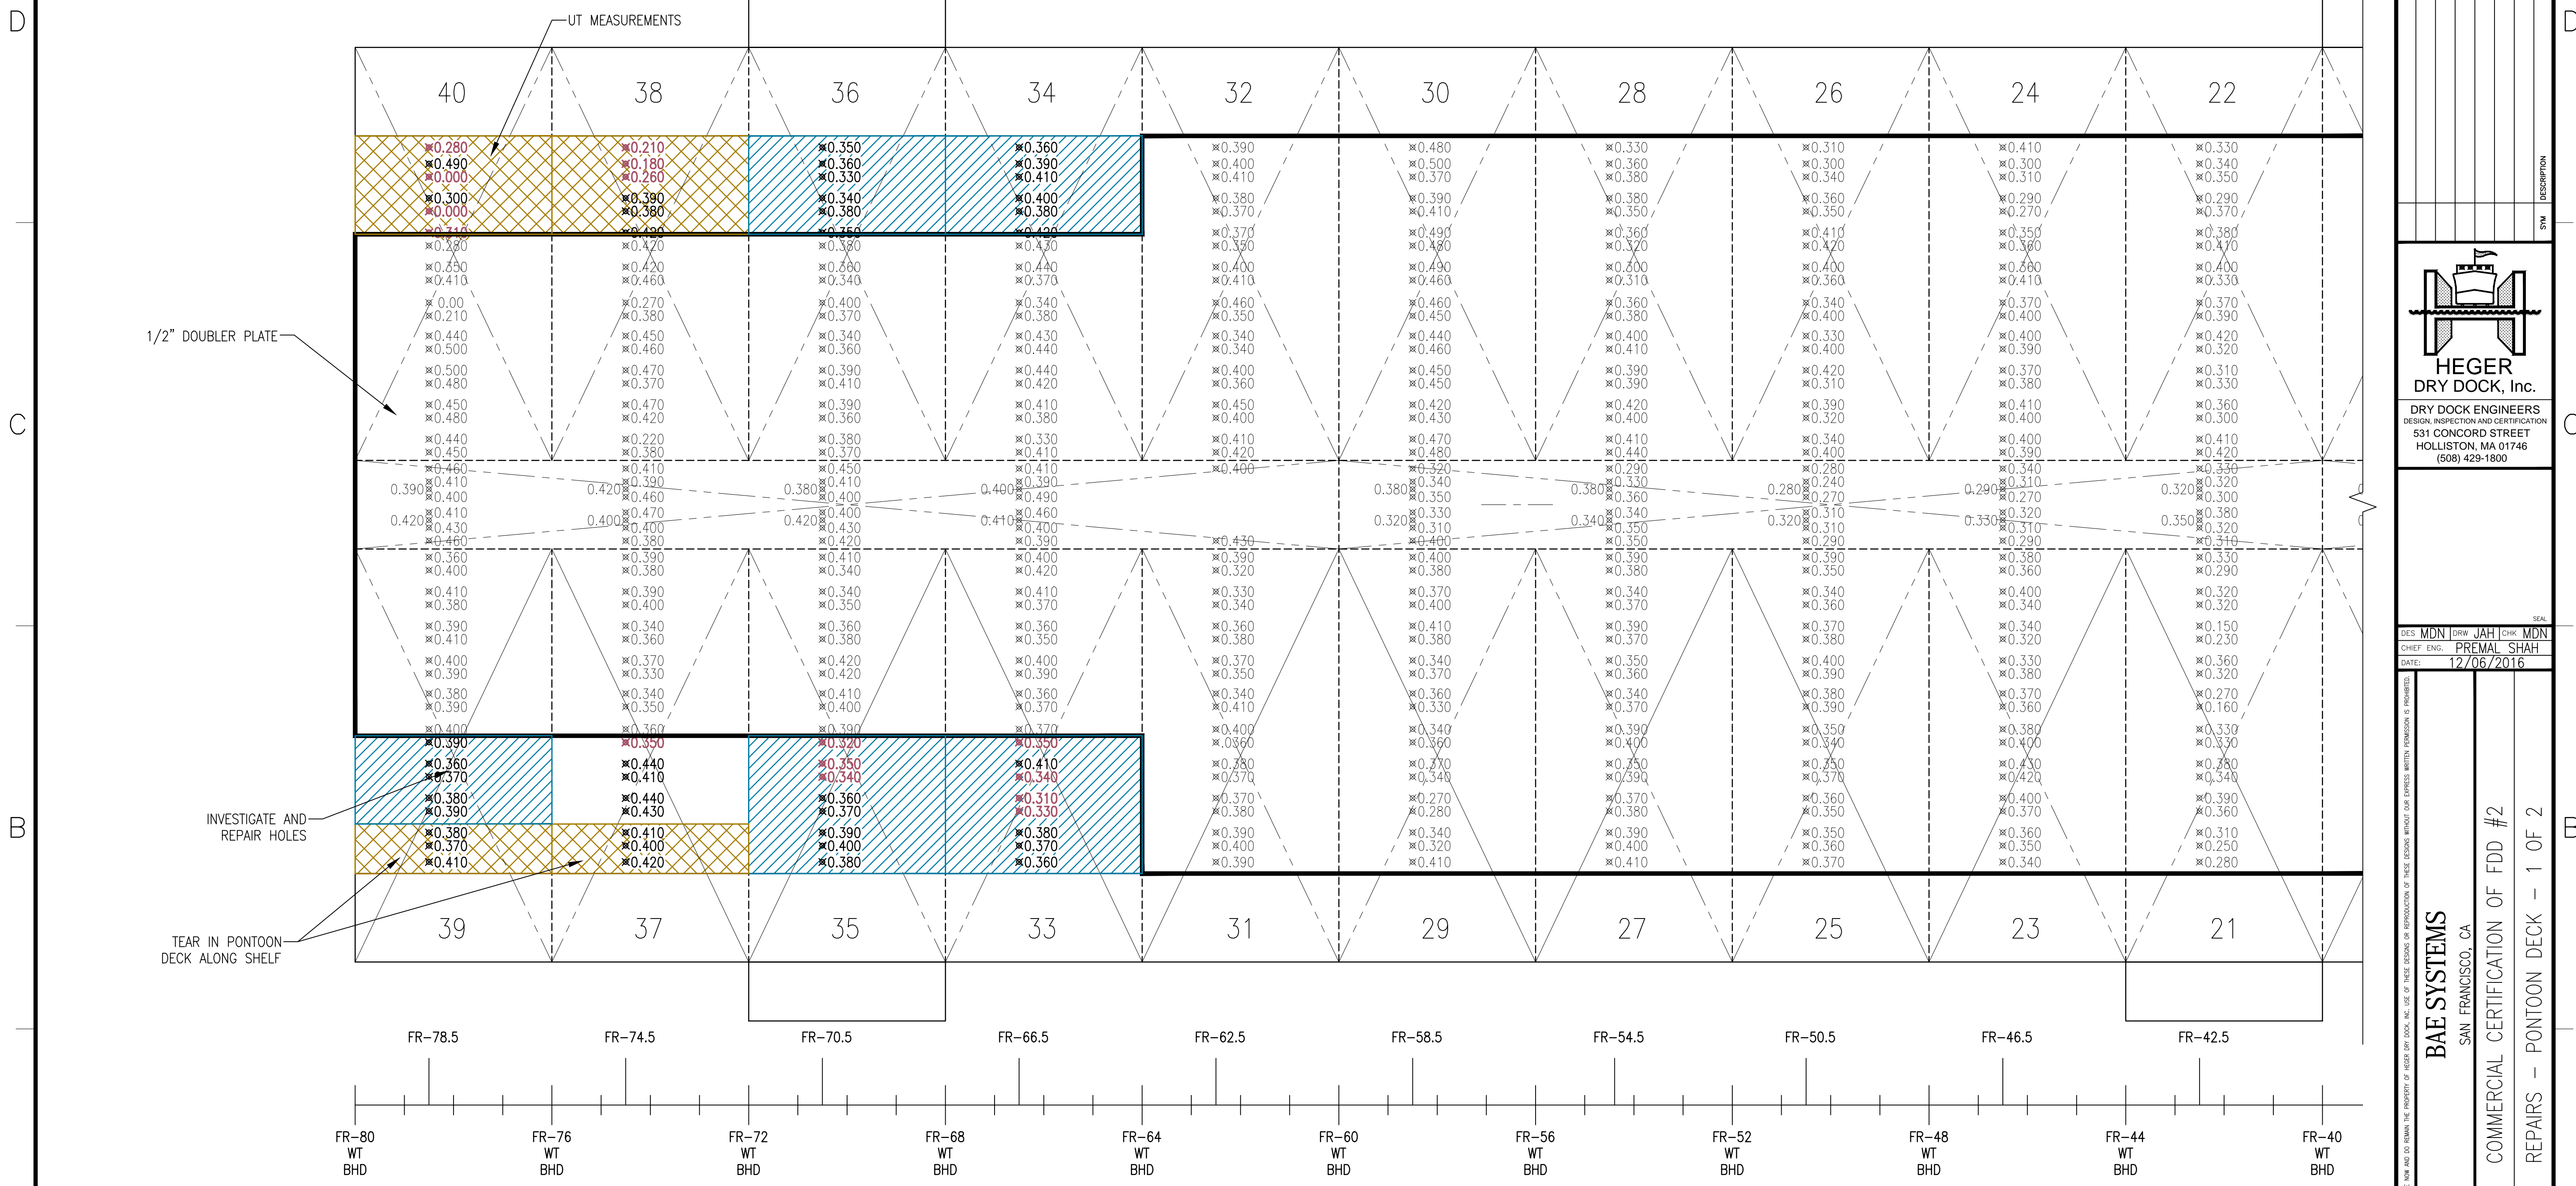
PLAN - PONTOON DECK - UT MEASUREMENTS
SCALE: 1/16"=1'-0" **A1**

The dock's original pontoon deck is severely corroded as reflected in the most recent ultrasonic thickness (UT) measurements surveyed by International Inspection in January 2016 (see Reference 2). UT measurements were taken internally and measured the thickness of the original deck plate only.

Doubler plates have been installed on the topside of the dry dock's original pontoon deck plate over about 65% of the surface with a concentration towards the dock's centerline. The doubler plates are 1/2" in thickness and are connected to the dock's original pontoon deck plate via 2" x 6" slot welds located along transverse and longitudinal structure. These slots welds are considered essential as they provide the doubler plates with required buckling capacity. The half-inch doubler plates were installed to fortify the original deck plate as an alternative to removing and replacing the corroded plating and stiffeners.

Based on HEGER's knowledge of the dock's design review, visual condition survey, and most recent UT survey, areas of the dock's structural deficiencies have been mapped out on the inboard and outboard wing shells and the pontoon deck in the drawings listed below. HEGER has assigned a Priority 1 or 2 to the areas of most structural concern.

Priority 1 areas will need to be repaired prior to HEGER certification. These areas are either heavily corroded as indicated by the dock's UT survey or contain holes or other deficiencies noted in the 2016 control inspection.

Priority 2 areas will need to be repaired before the subsequent HEGER re-certification. These areas also show signs of significant corrosion. Until the priority 2 areas are repaired, there will need to be operational restrictions regarding allowed head pressure in these areas.

The majority of the pontoon deck has been covered with a 1/2" doubler plate. This is not a viable long term solution for the dock. HEGER recommends a maintenance plan be developed to properly replace the corroded deck panels with insert plates. Note that the dock was originally designed with 1/2" high strength steel (yield point of 50 ksi). HEGER recommends any pontoon deck replacements be 3/4" high strength steel. Note that this may correspond to a small reduction in the lift capacity of the dock due to an increase in dock weight, but will build in additional corrosion allowance.

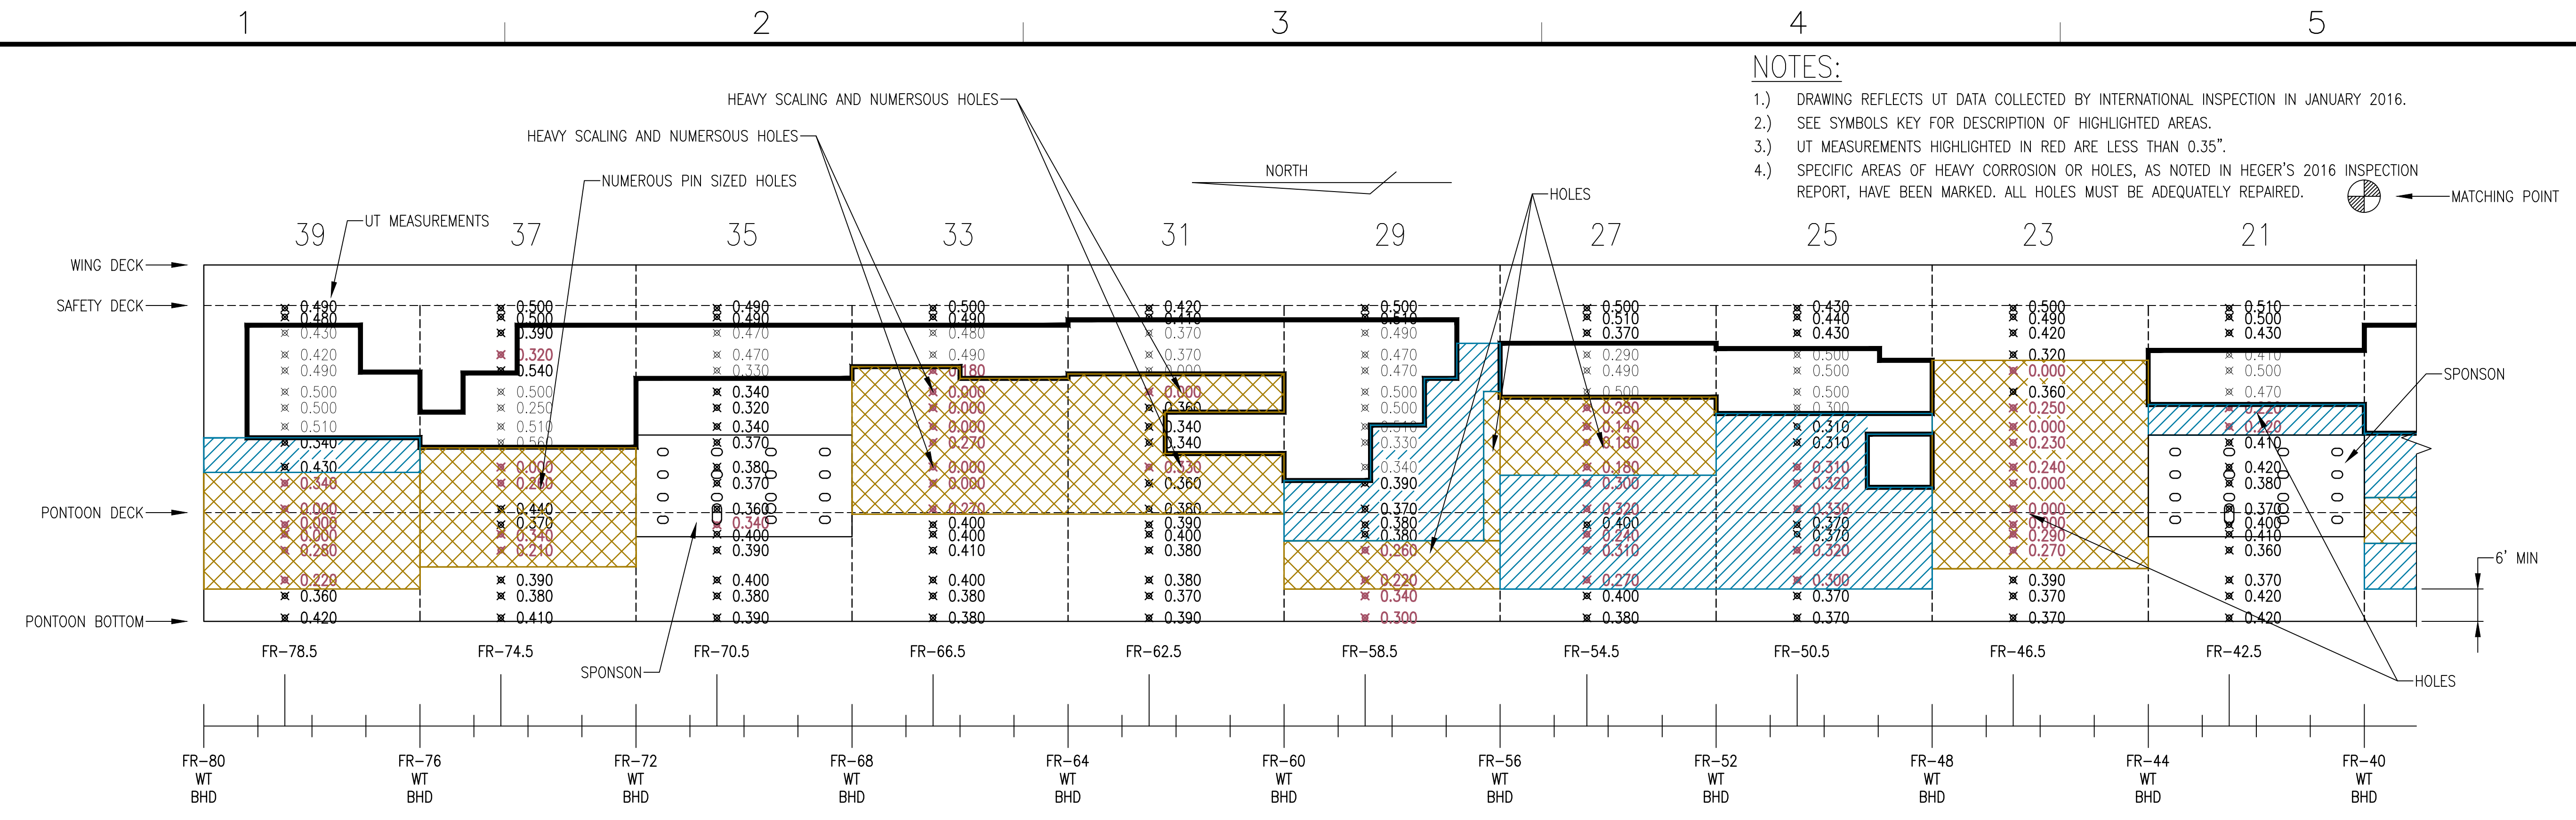
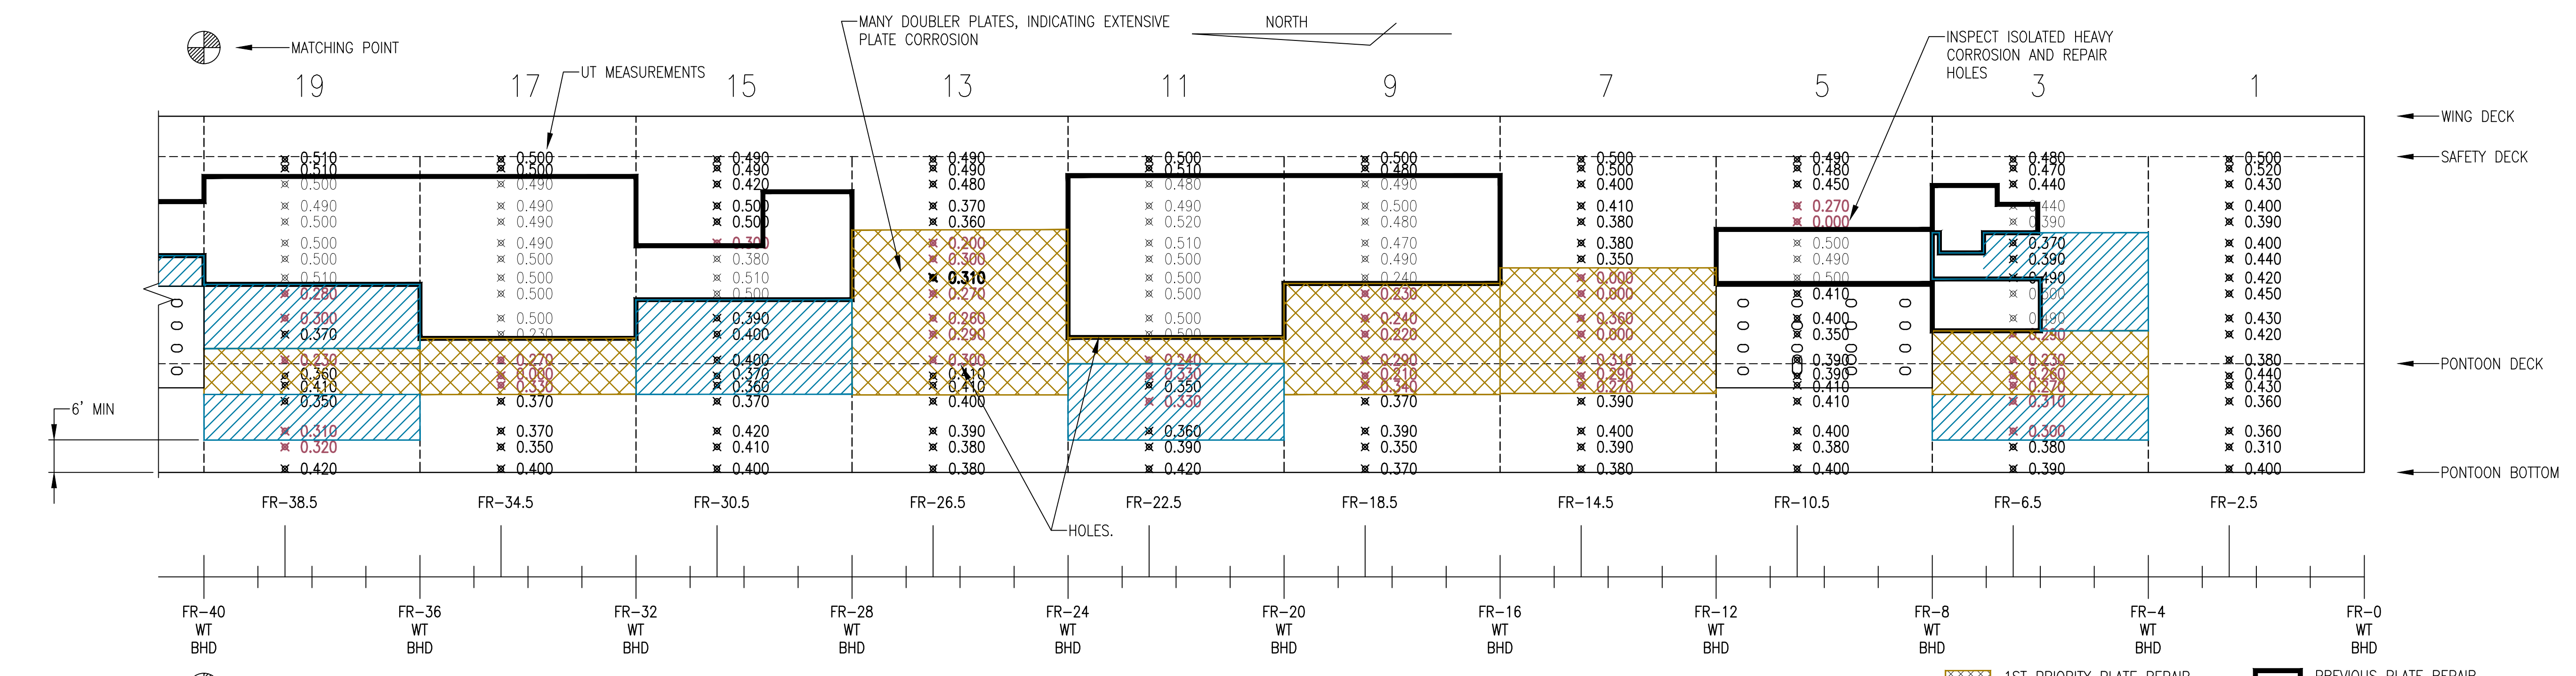
REPAIRS - WEST OUTBOARD WINGWALL

- NOTES:**
- 1.) DRAWING REFLECTS UT DATA COLLECTED BY INTERNATIONAL INSPECTION IN JANUARY 2016.
 - 2.) SEE SYMBOLS KEY FOR DESCRIPTION OF HIGHLIGHTED AREAS.
 - 3.) UT MEASUREMENTS HIGHLIGHTED IN RED ARE LESS THAN 0.35".
 - 4.) SPECIFIC AREAS OF HEAVY CORROSION OR HOLES, AS NOTED IN HEGER'S 2016 INSPECTION REPORT, HAVE BEEN MARKED. ALL HOLES MUST BE ADEQUATELY REPAIRED.

In the drawings listed below, all areas are generally mapped out on a tank by tank basis. It is recommended the external shell in these areas be cropped out and replaced with a fabricated insert plate to properly repair the area. In the event of small isolated holes, a doubler plate may be installed as a temporary fix.

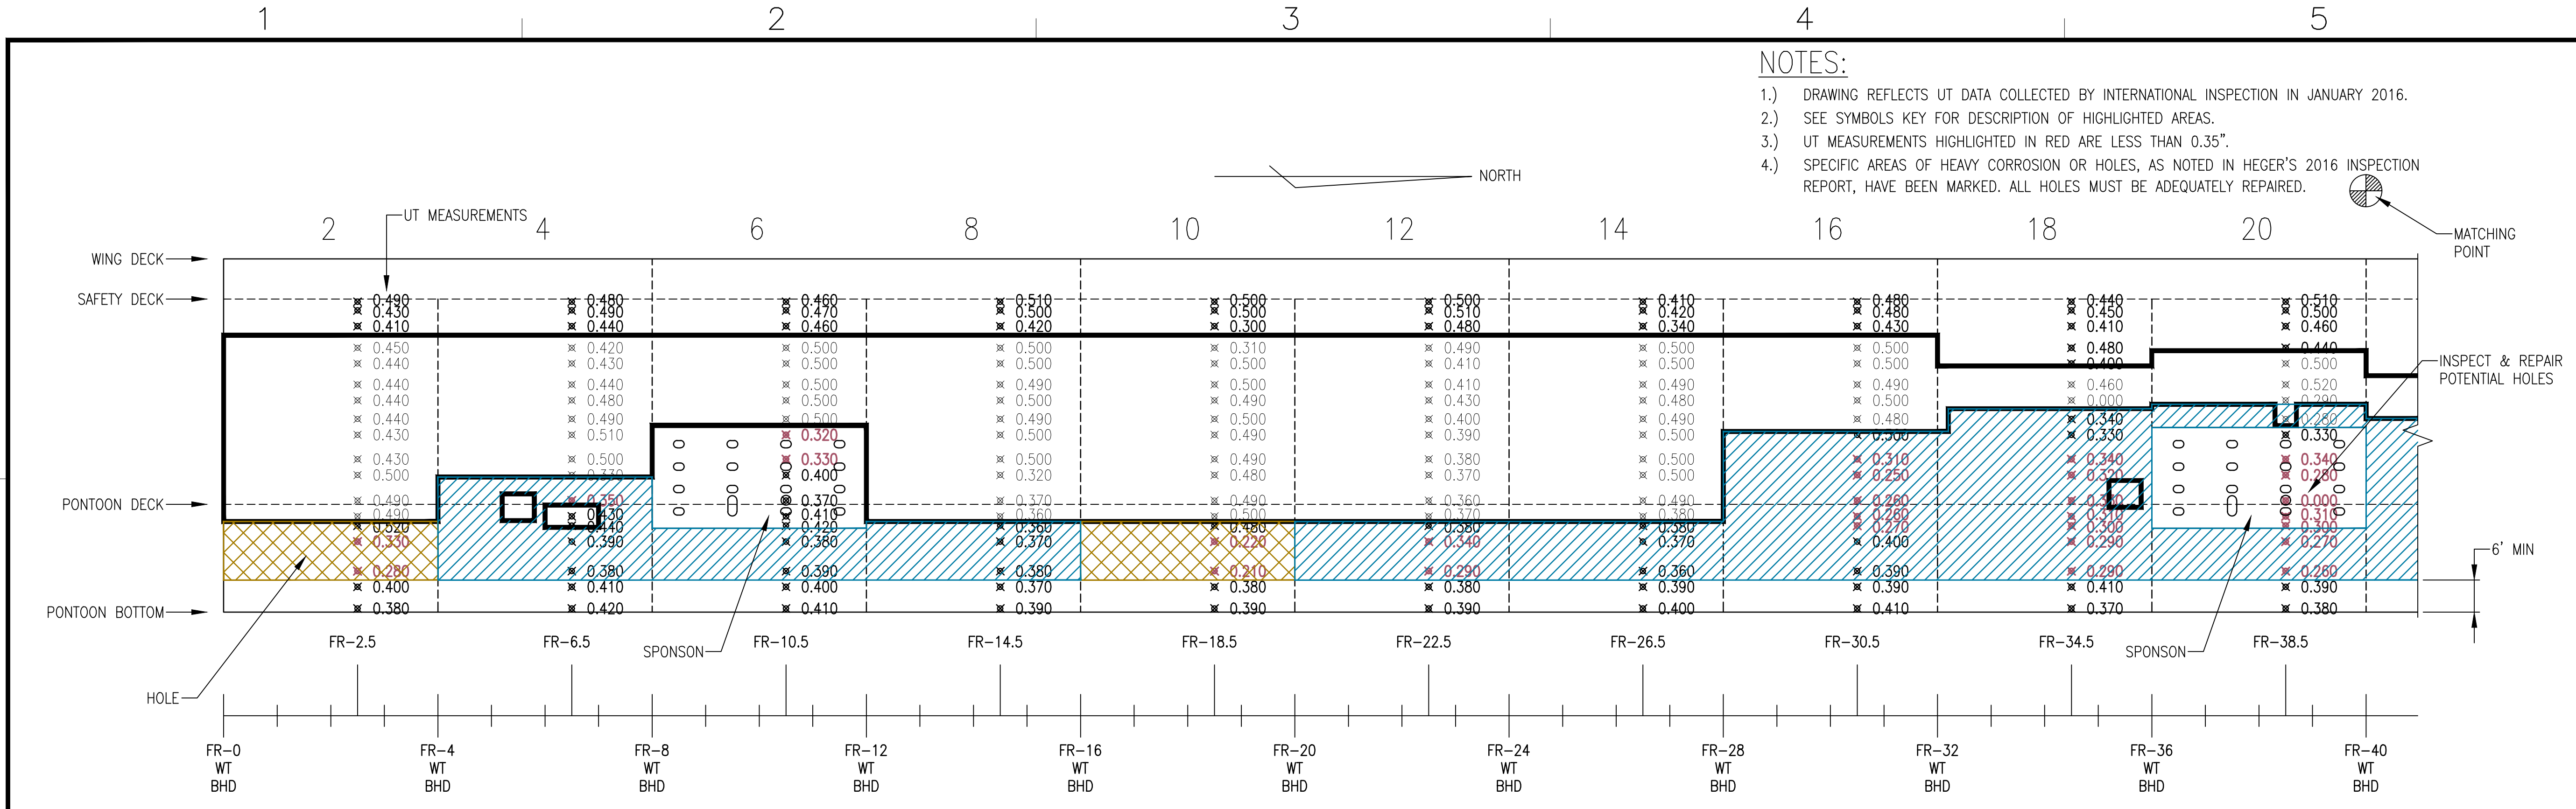
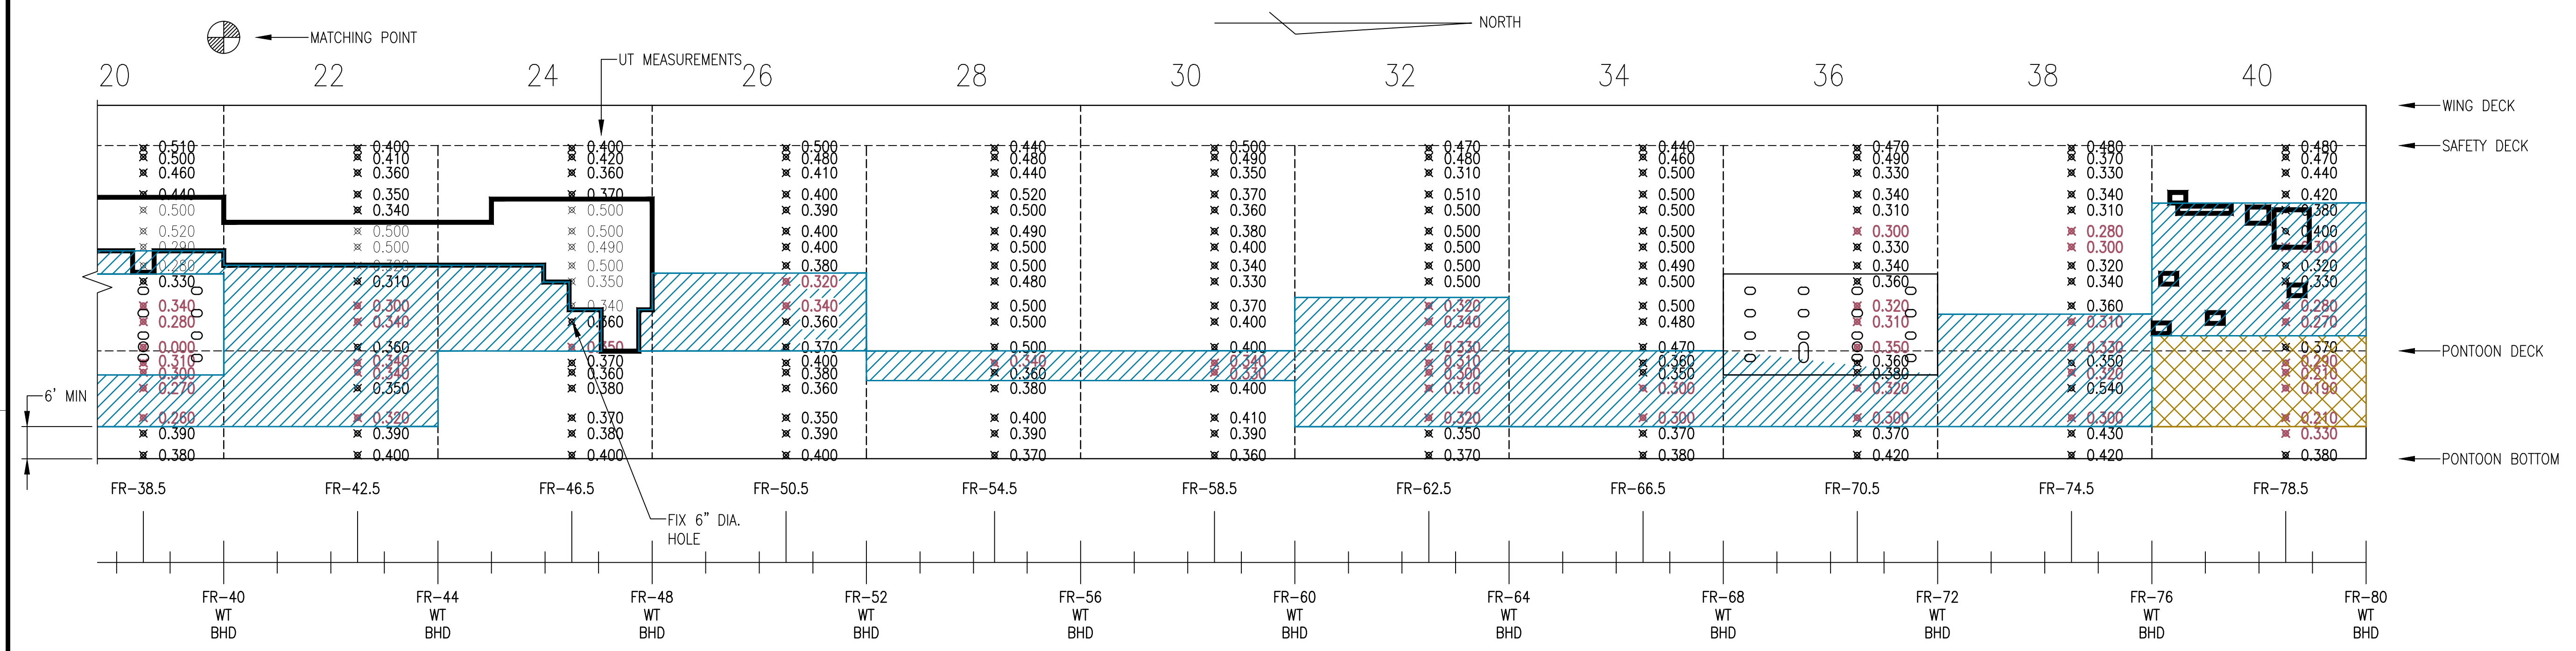
BAE SYSTEMS SAN FRANCISCO, CA	COMMERCIAL CERTIFICATION OF FDD #2
REPAIRS - EAST OUTBOARD WINGWALL

- NOTES:**
- 1.) DRAWING REFLECTS UT DATA COLLECTED BY INTERNATIONAL INSPECTION IN JANUARY 2016.
 - 2.) SEE SYMBOLS KEY FOR DESCRIPTION OF HIGHLIGHTED AREAS.
 - 3.) UT MEASUREMENTS HIGHLIGHTED IN RED ARE LESS THAN 0.35".
 - 4.) SPECIFIC AREAS OF HEAVY CORROSION OR HOLES, AS NOTED IN HEGER'S 2016 INSPECTION REPORT, HAVE BEEN MARKED. ALL HOLES MUST BE ADEQUATELY REPAIRED.

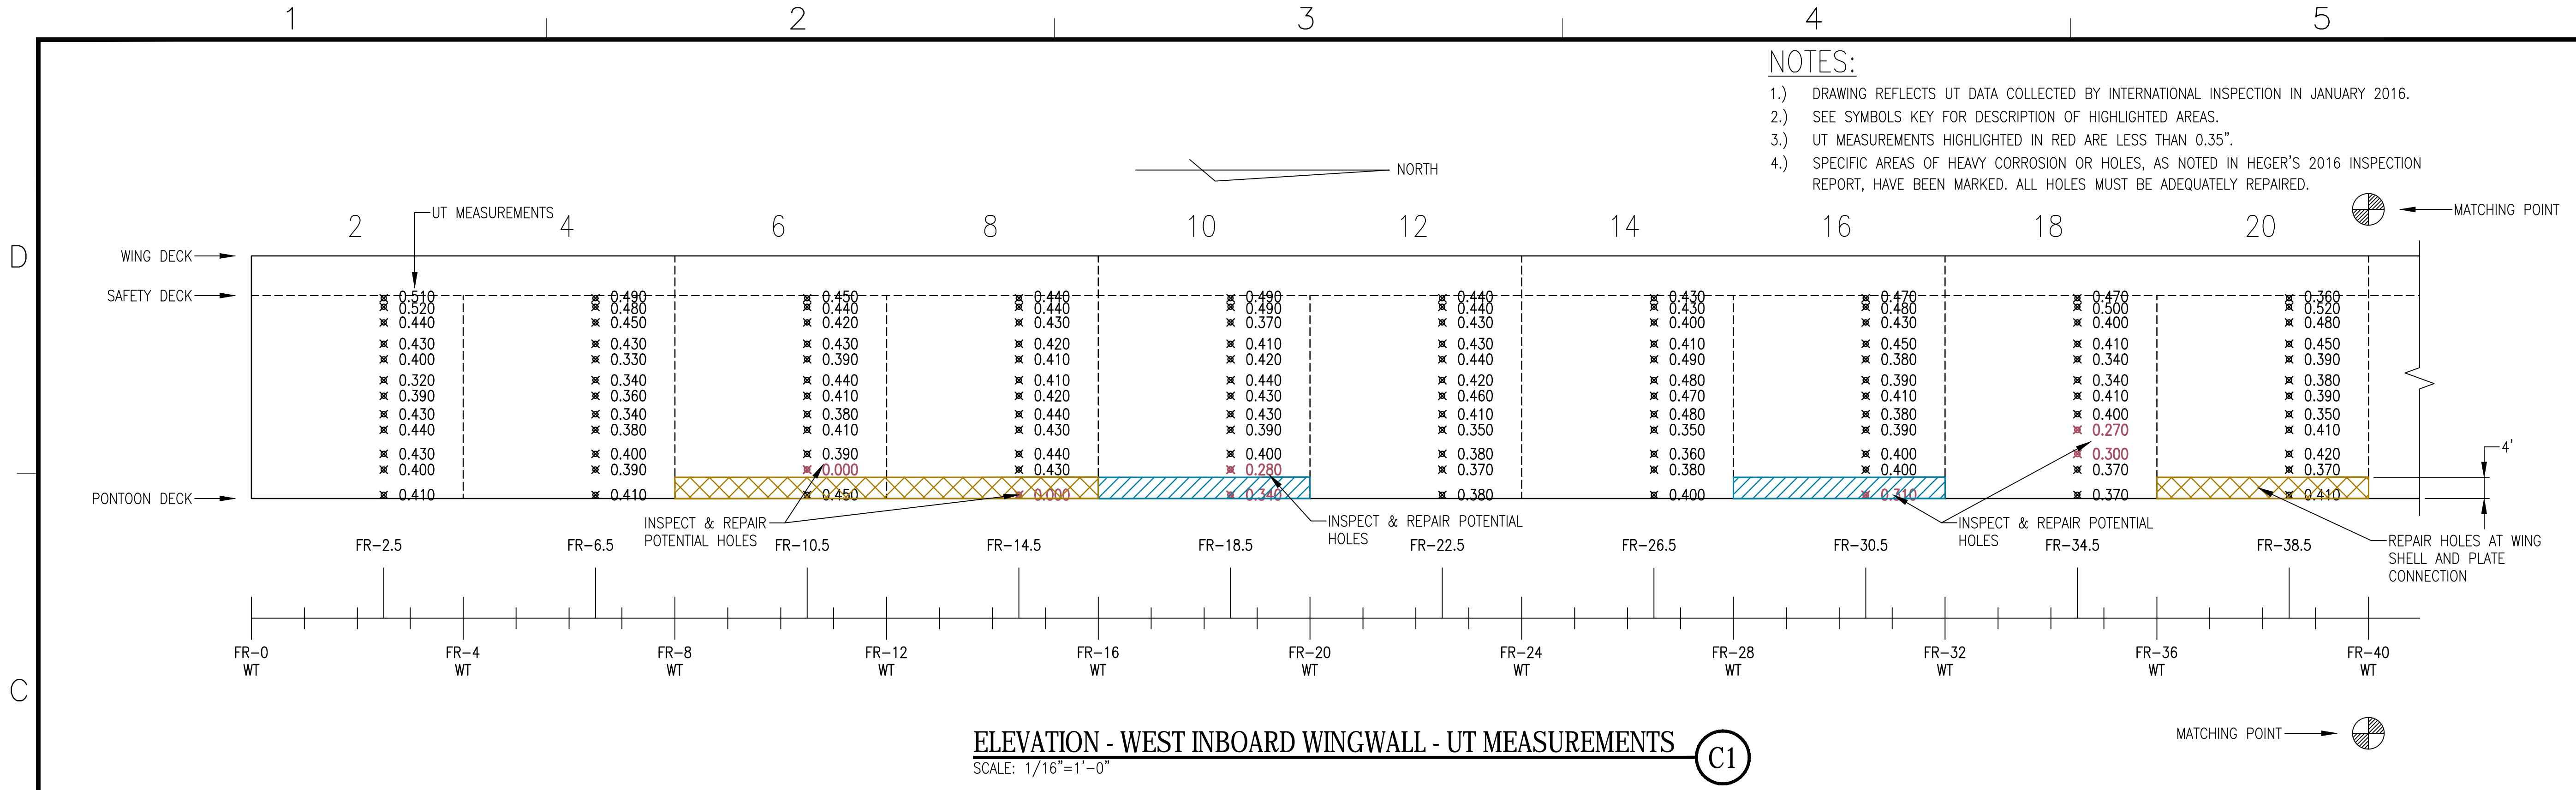
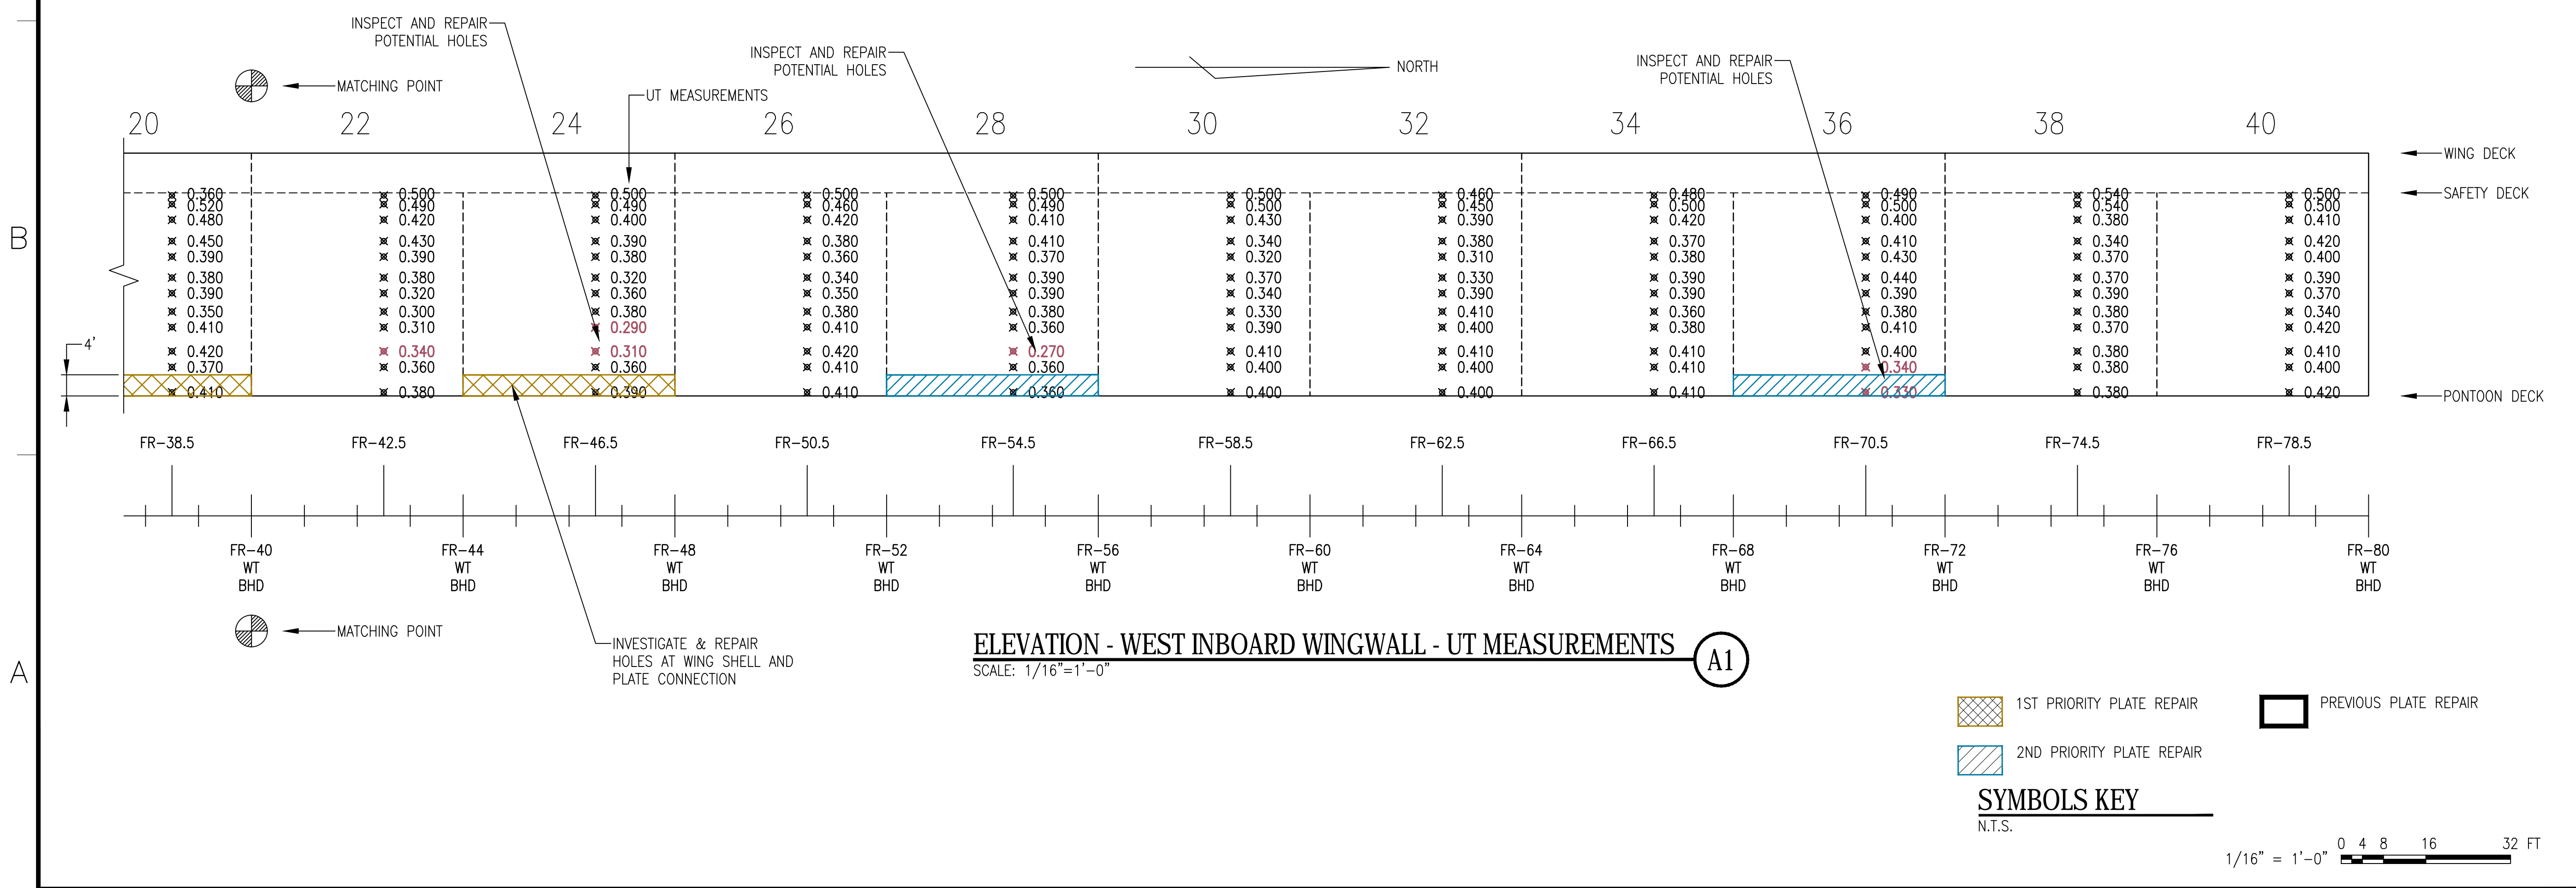
BAE SYSTEMS
 SAN FRANCISCO, CA
COMMERCIAL CERTIFICATION OF FDD #2
 REPAIRS - WEST INBOARD WINGWALL

- 1.) DRAWING REFLECTS UT DATA COLLECTED BY INTERNATIONAL INSPECTION IN JANUARY 2016.
- 2.) SEE SYMBOLS KEY FOR DESCRIPTION OF HIGHLIGHTED AREAS.
- 3.) UT MEASUREMENTS HIGHLIGHTED IN RED ARE LESS THAN 0.35".
- 4.) SPECIFIC AREAS OF HEAVY CORROSION OR HOLES, AS NOTED IN HEGER'S 2016 INSPECTION REPORT, HAVE BEEN MARKED. ALL HOLES MUST BE ADEQUATELY REPAIRED.

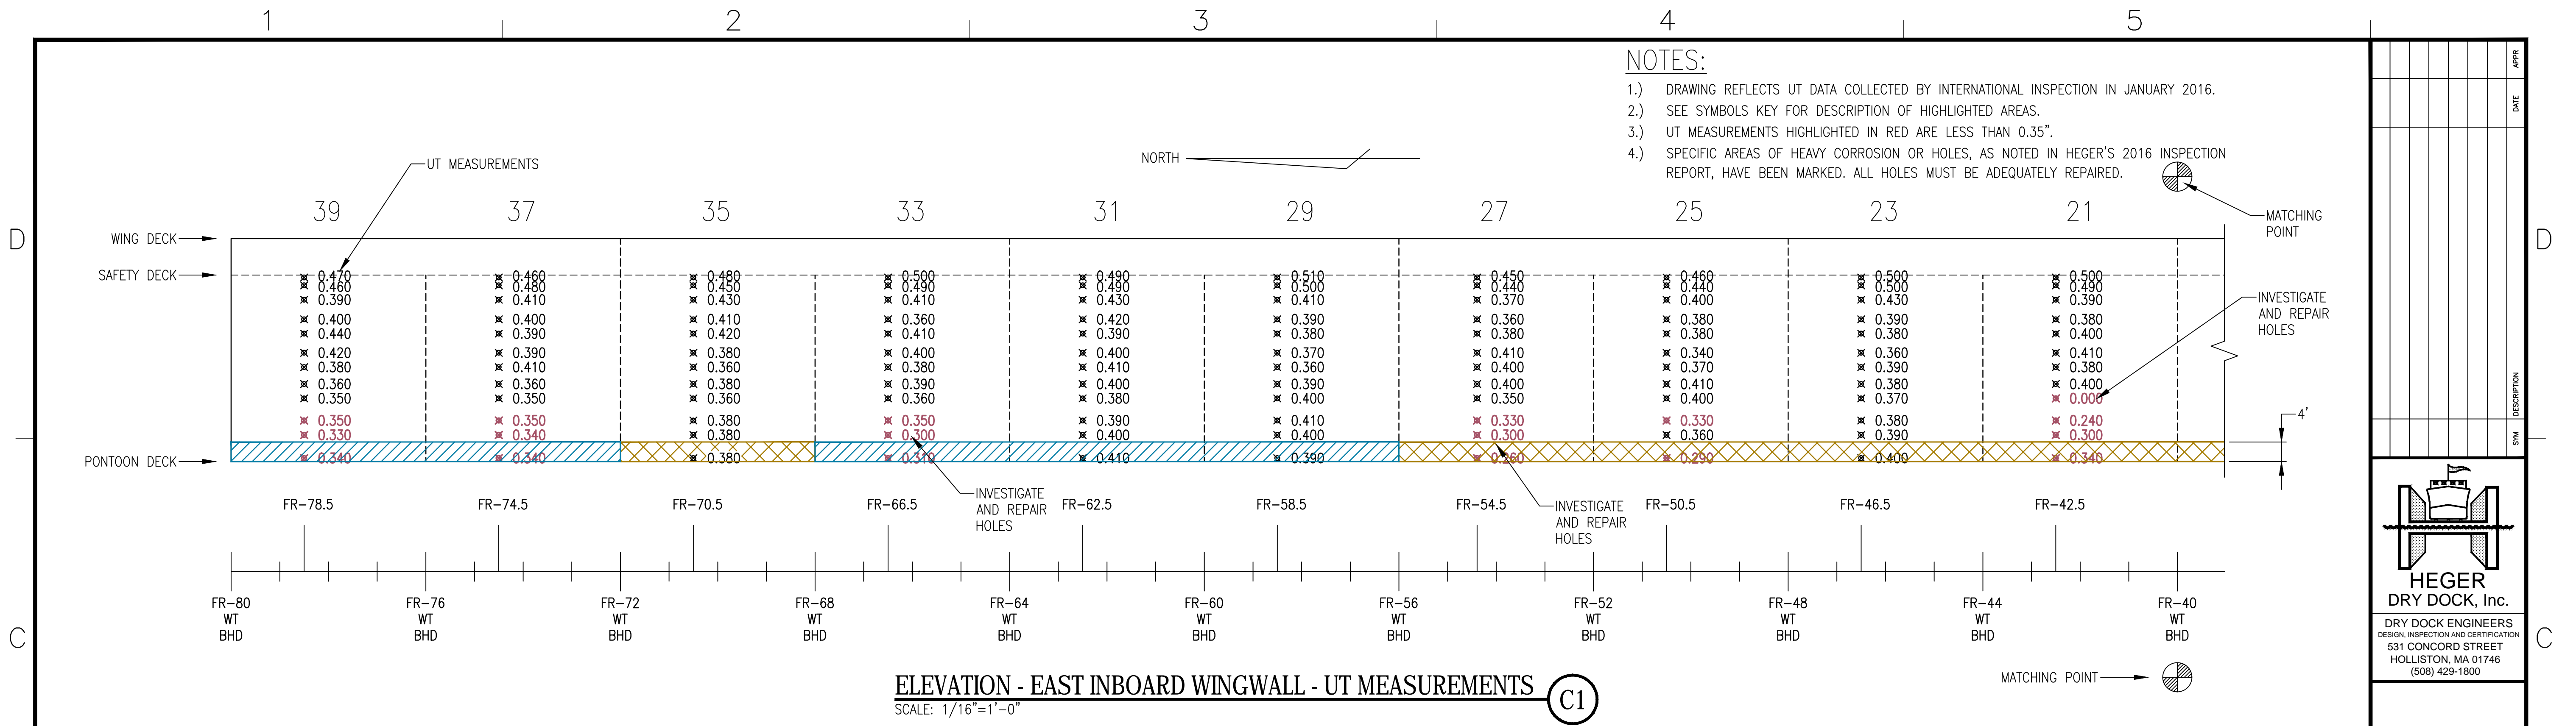
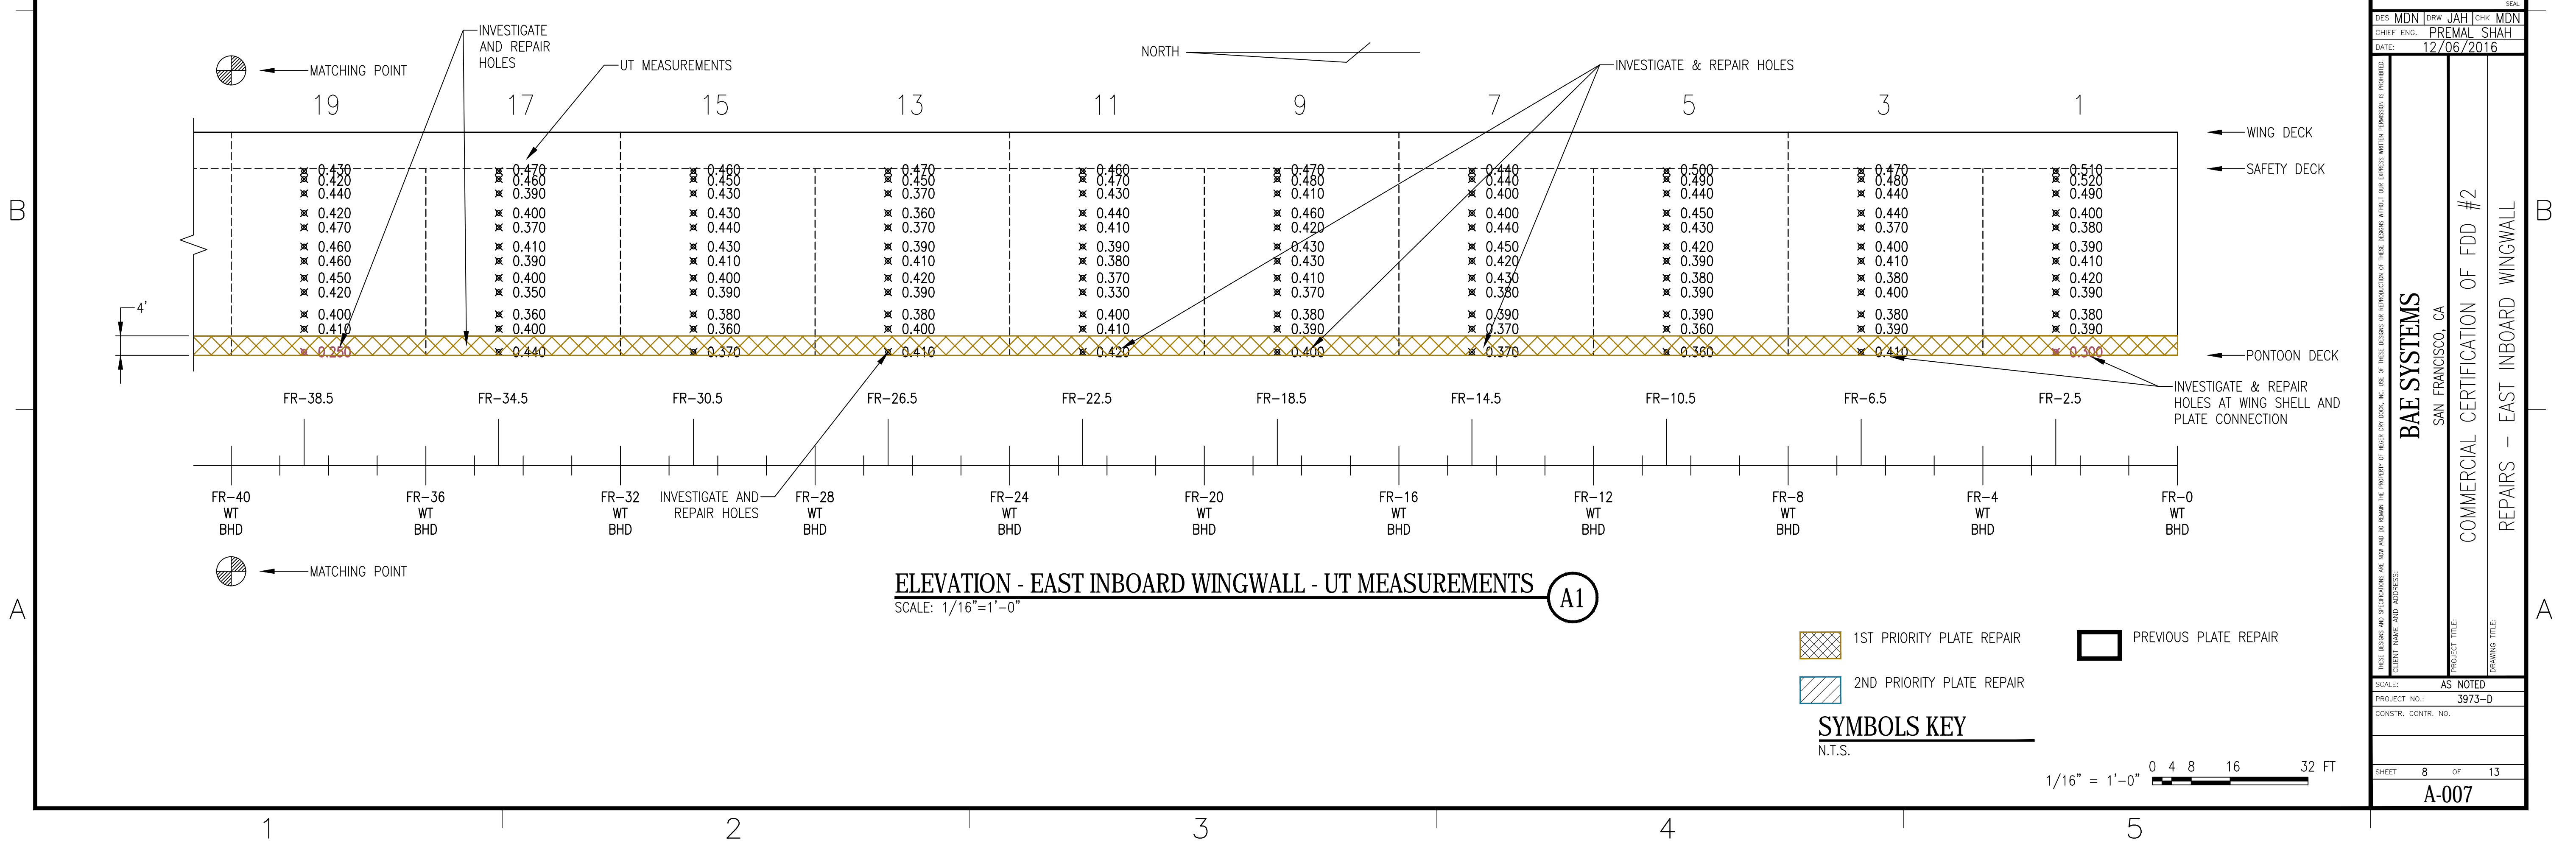
- 1.) DRAWING REFLECTS UT DATA COLLECTED BY INTERNATIONAL INSPECTION IN JANUARY 2016.
- 2.) SEE SYMBOLS KEY FOR DESCRIPTION OF HIGHLIGHTED AREAS.
- 3.) UT MEASUREMENTS HIGHLIGHTED IN RED ARE LESS THAN 0.35".
- 4.) SPECIFIC AREAS OF HEAVY CORROSION OR HOLES, AS NOTED IN HEGER'S 2016 INSPECTION REPORT, HAVE BEEN MARKED. ALL HOLES MUST BE ADEQUATELY REPAIRED.
