Port of San Francisco

Dry Dock #2

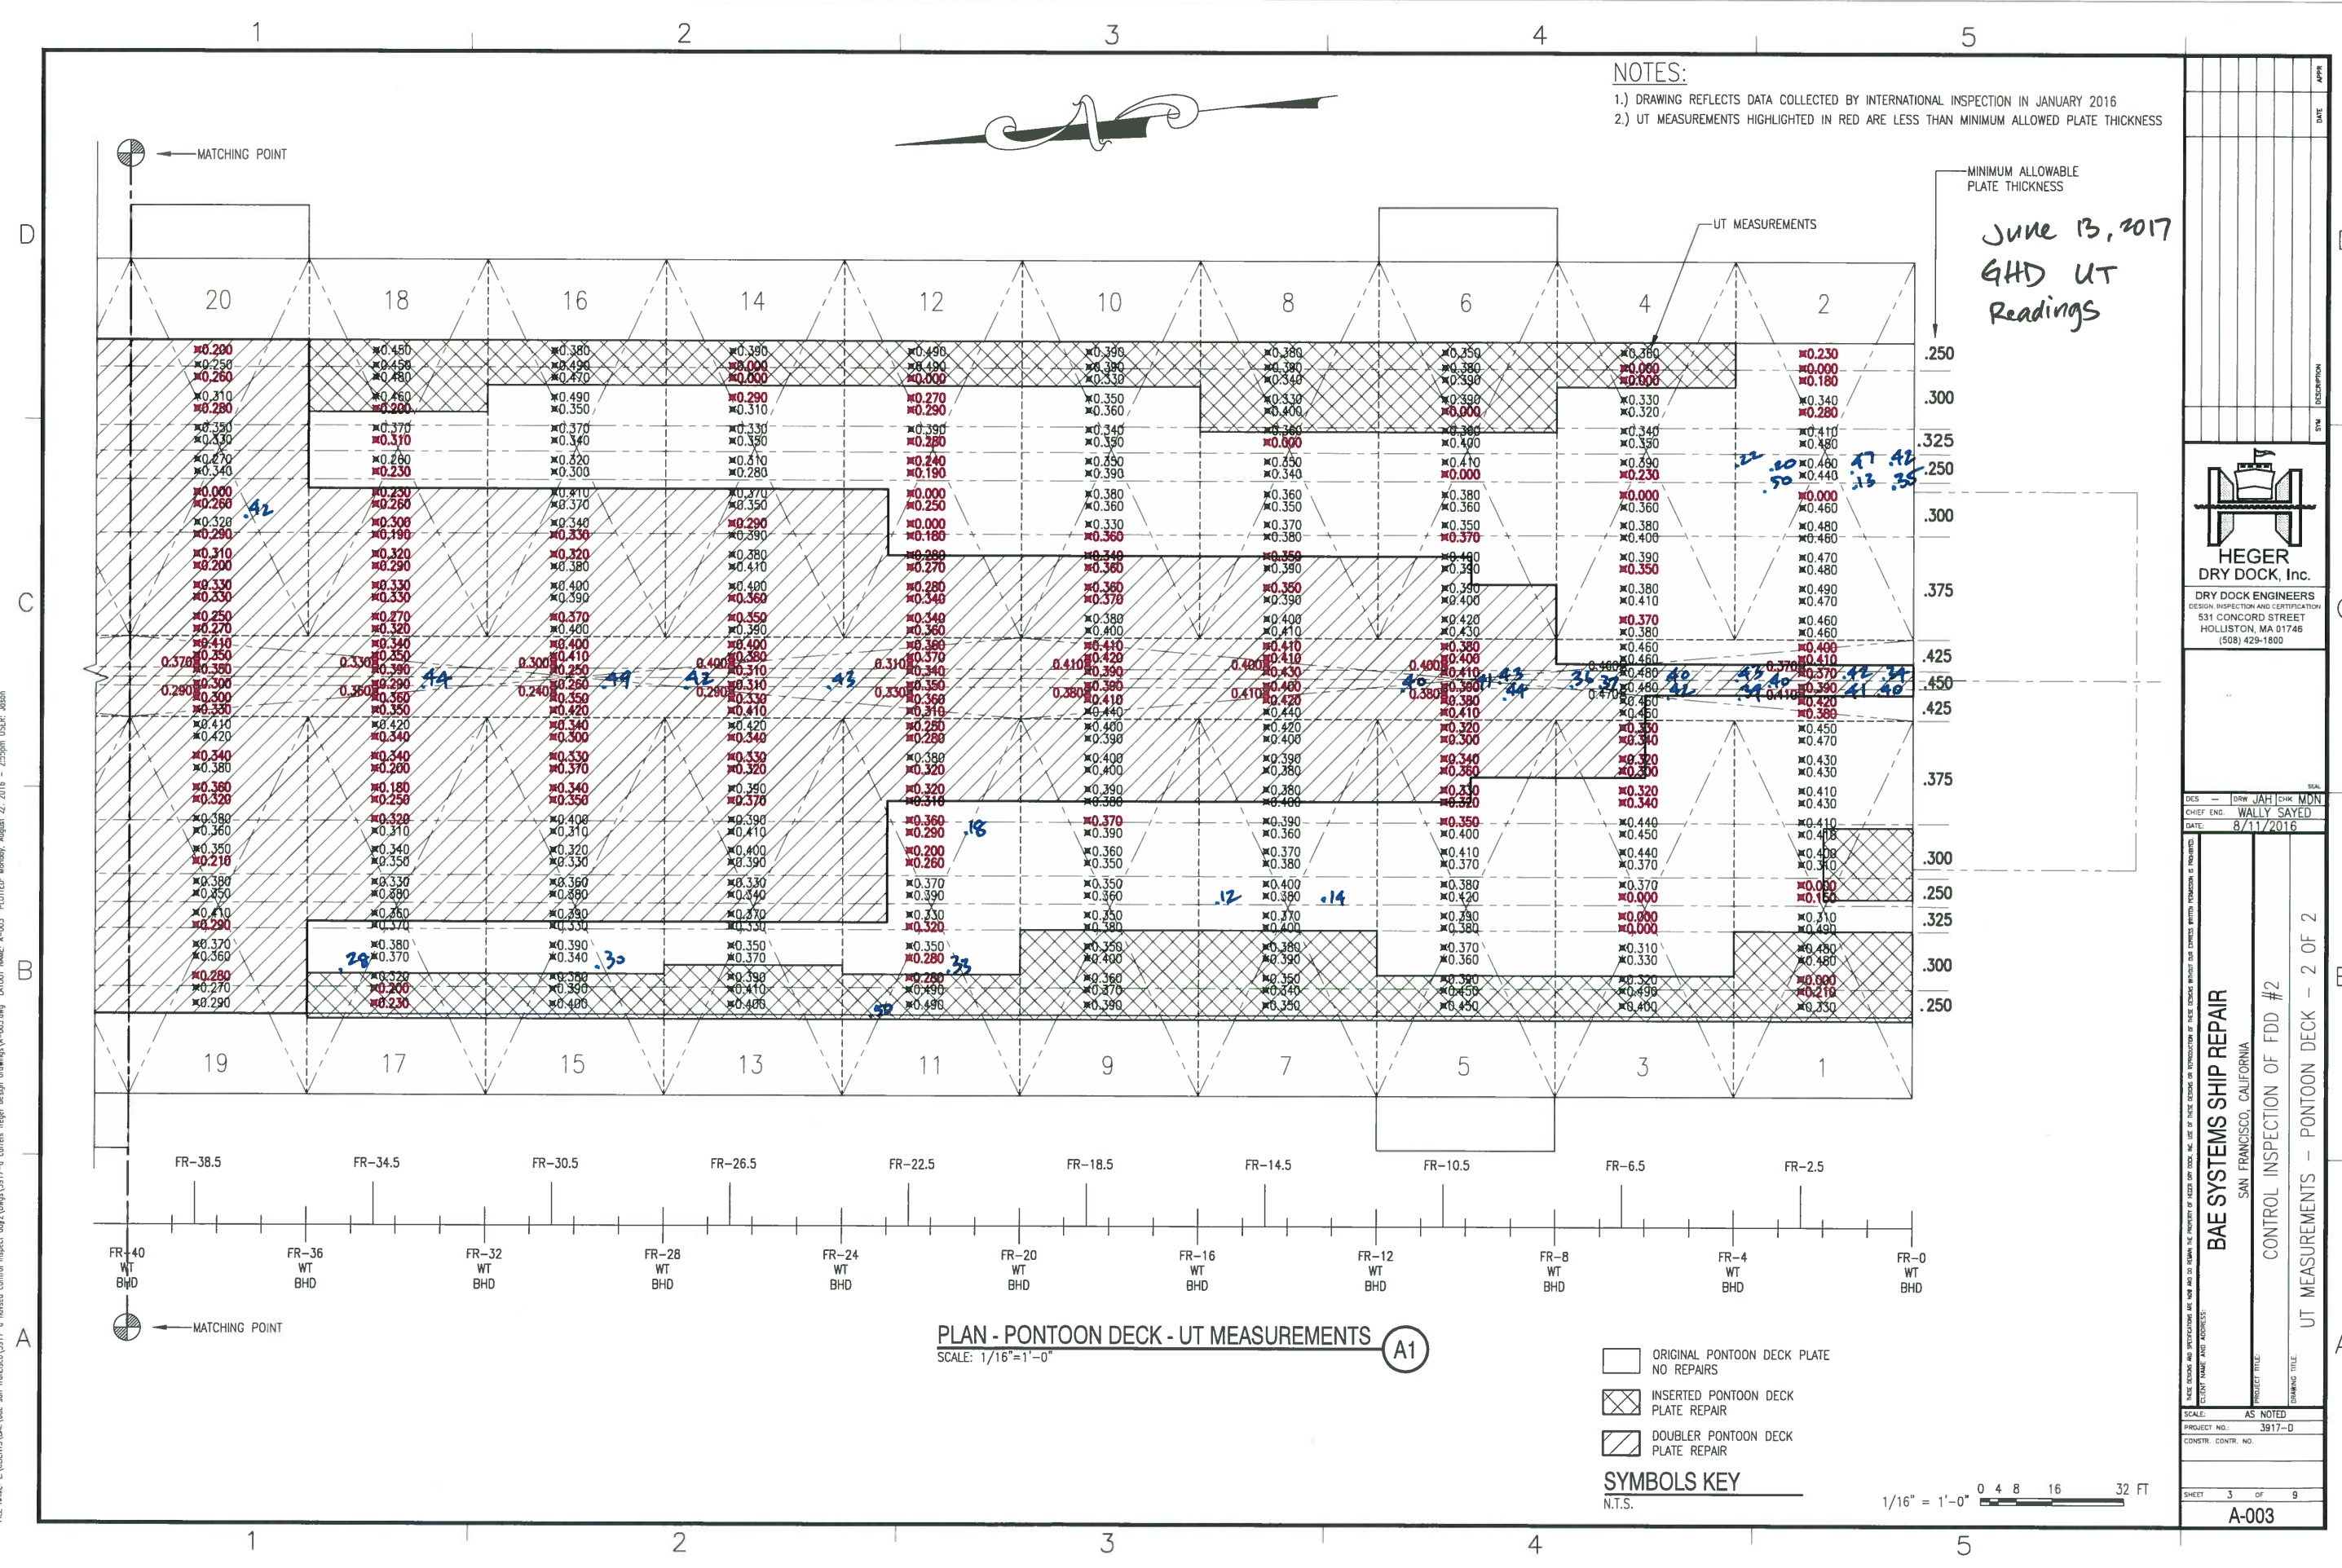
PLAN - PONTOON DECK - UT MEASUREMENTS (A1)
SCALE: 1/16"=1'-0"

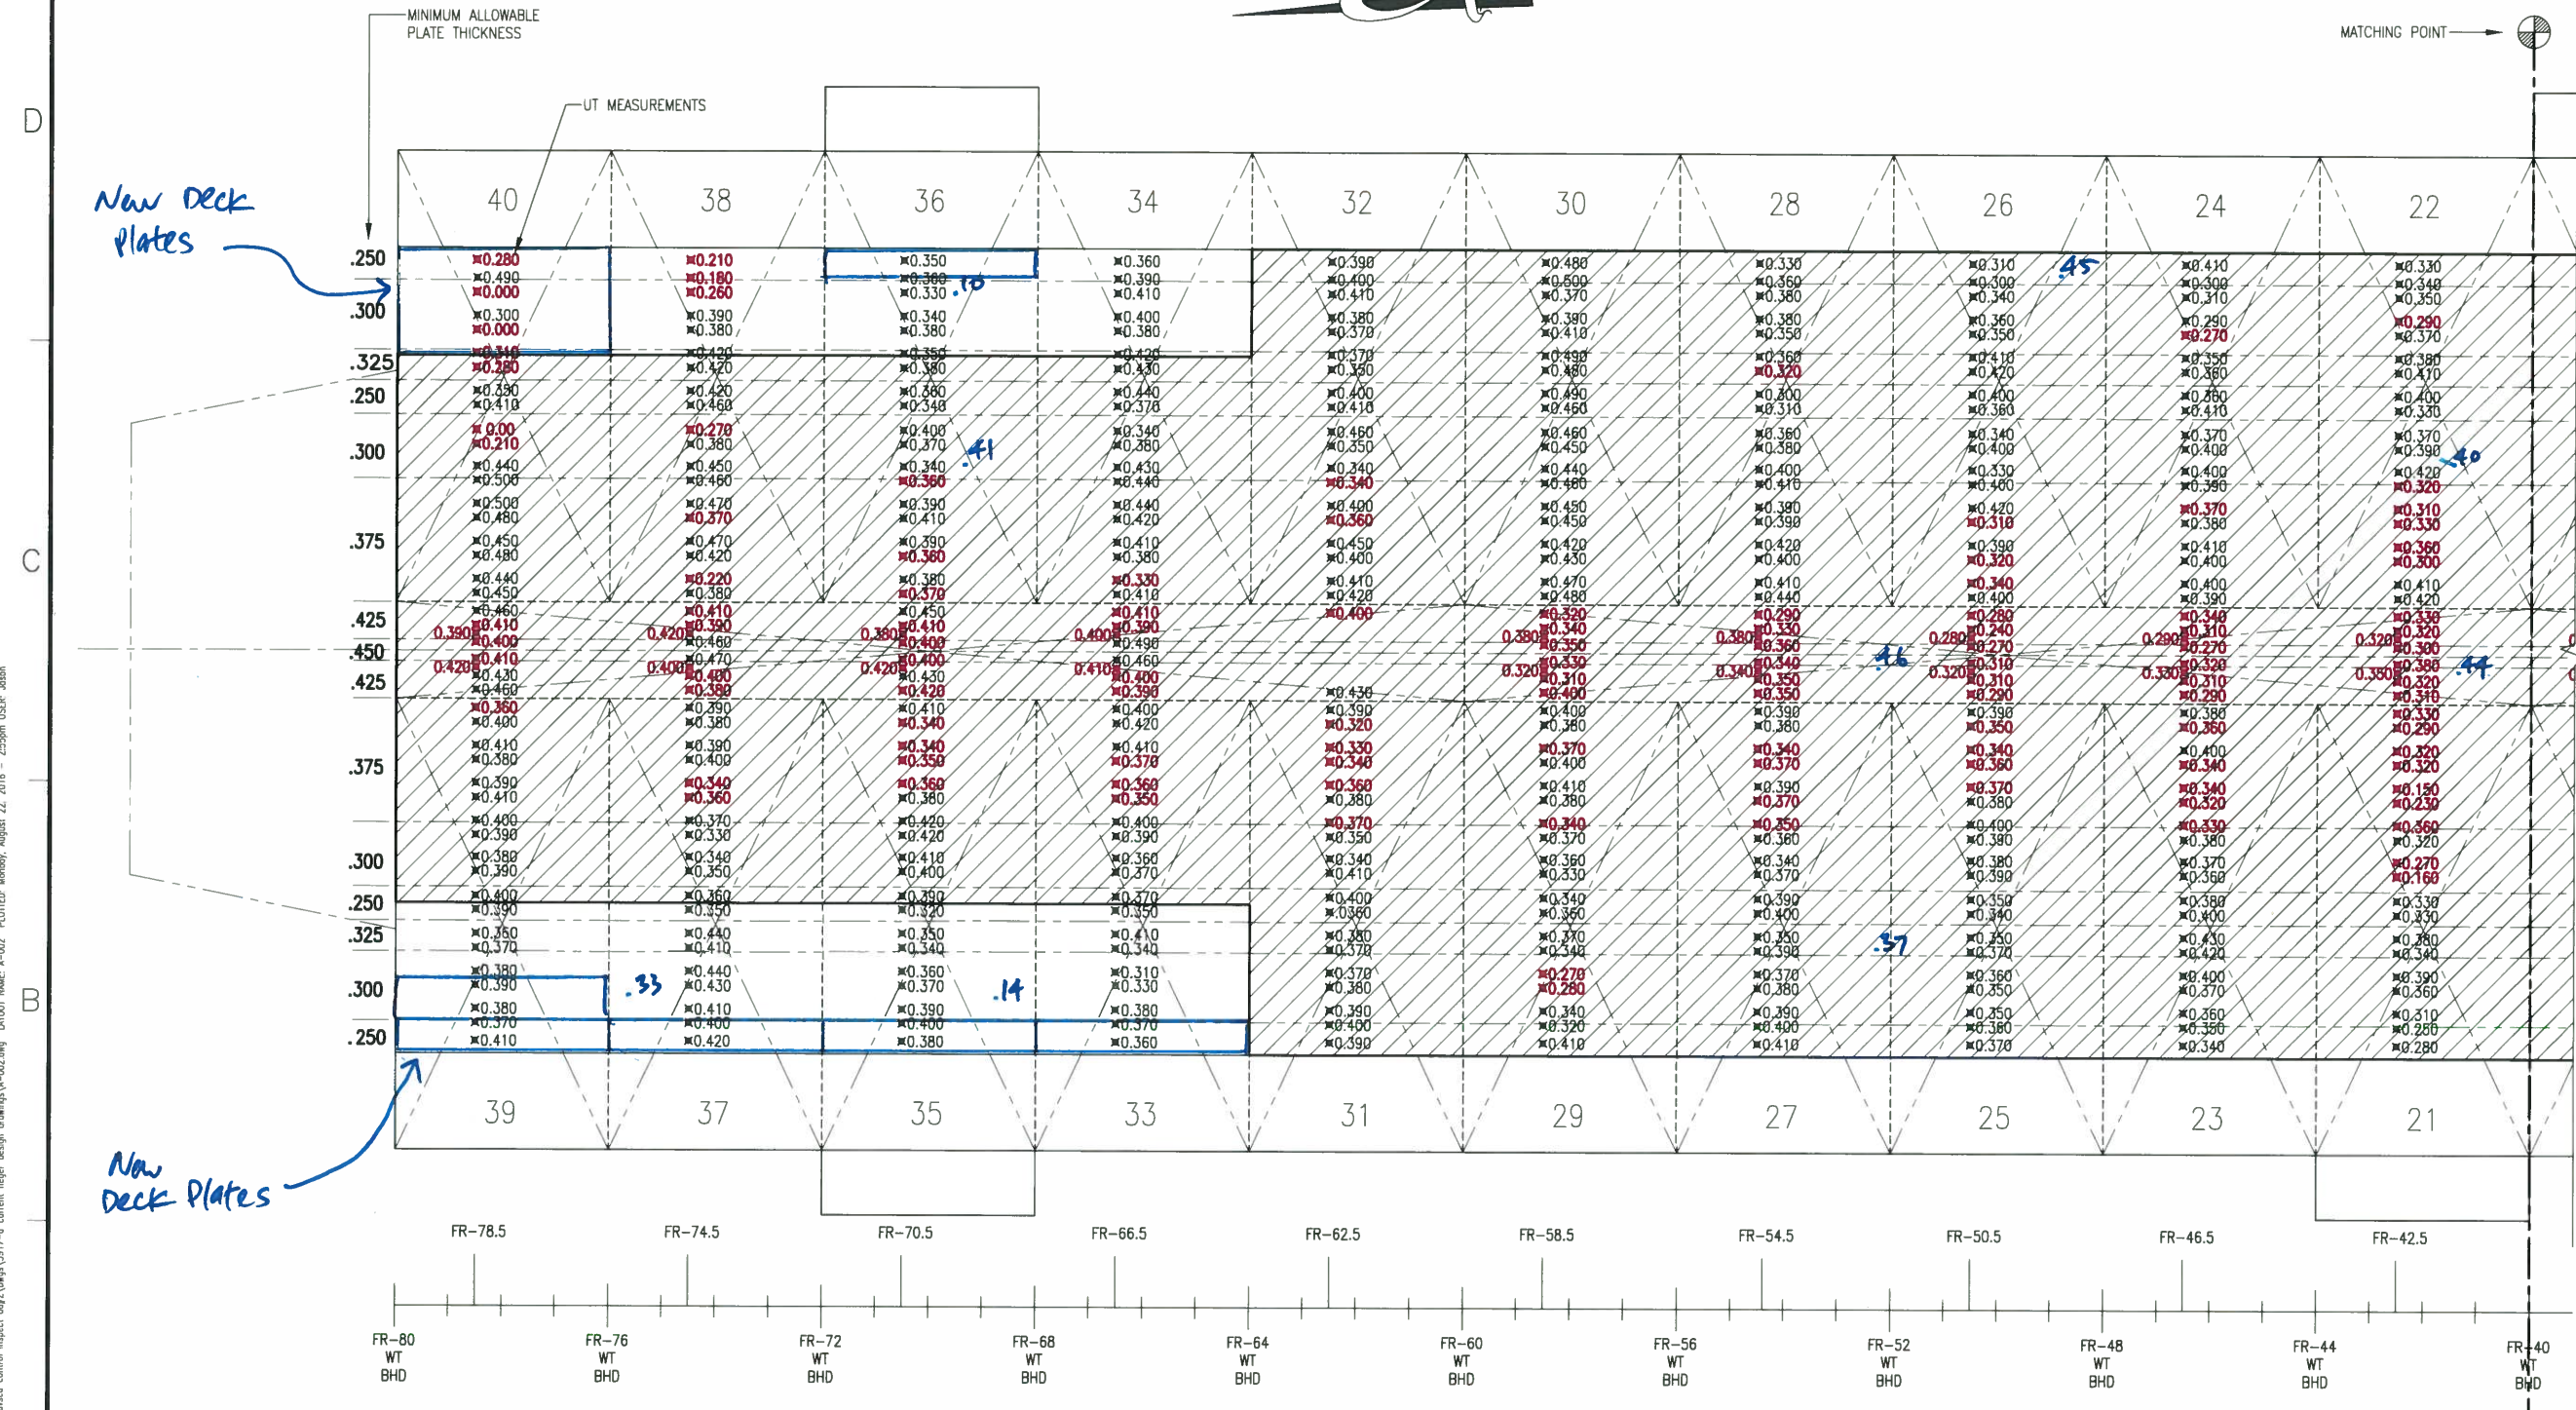
PLAN - PONTOON DECK - UT MEASUREMENTS (A1)
 SCALE: 1/16" = 1'-0"
