FINAL REPORT
JUN 5, 2017

Port of San Francisco
Dry Dock EUREKA
Structural Assessment Report

June 2017

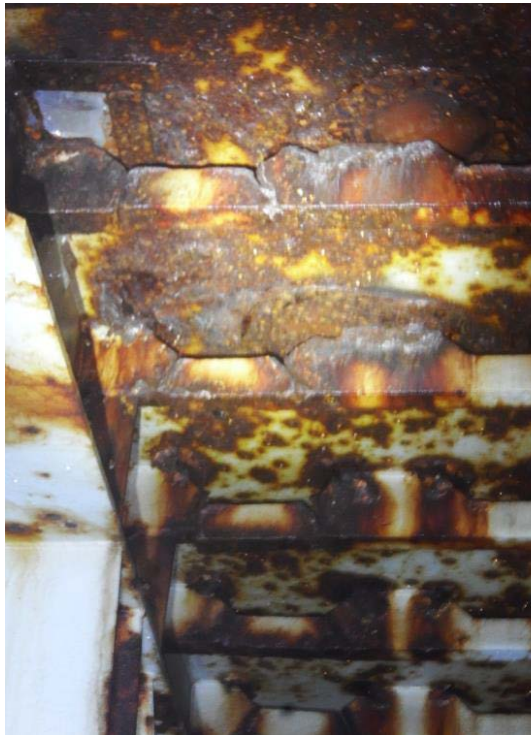
Figure 5: Pontoon Deck Stiffener Damage Example

In the 2015 inspection, it was noted the pontoon deck's serrated channels were beginning to fracture. In response, an in-depth visual survey mapping out the extent of the deck stiffener fractures was performed in May 2015. A pontoon deck repair plan was outlined in the previous inspection reports. By the time of the 2017 dock inspection, it was observed that no repairs had been made to the fractured stiffeners and the failures had become more widespread bringing uncertainty to the dock's ability to resist head pressure and vehicular traffic loads.

An example of heavy corrosion damage to the channel stiffeners is shown in Figure 5 below, compared against an undamaged stiffener shown in Figure 6.

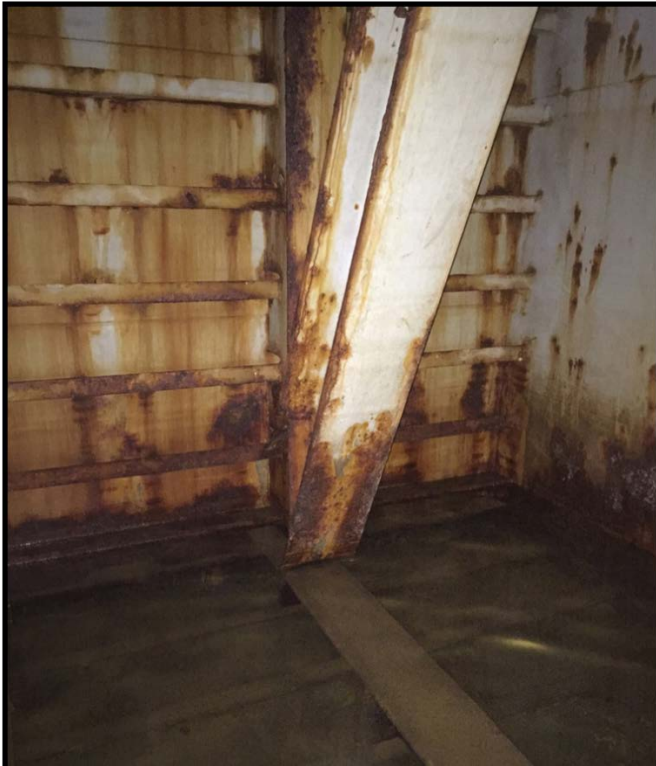
Figure 9: Corrosion Observed on Framing at Keel

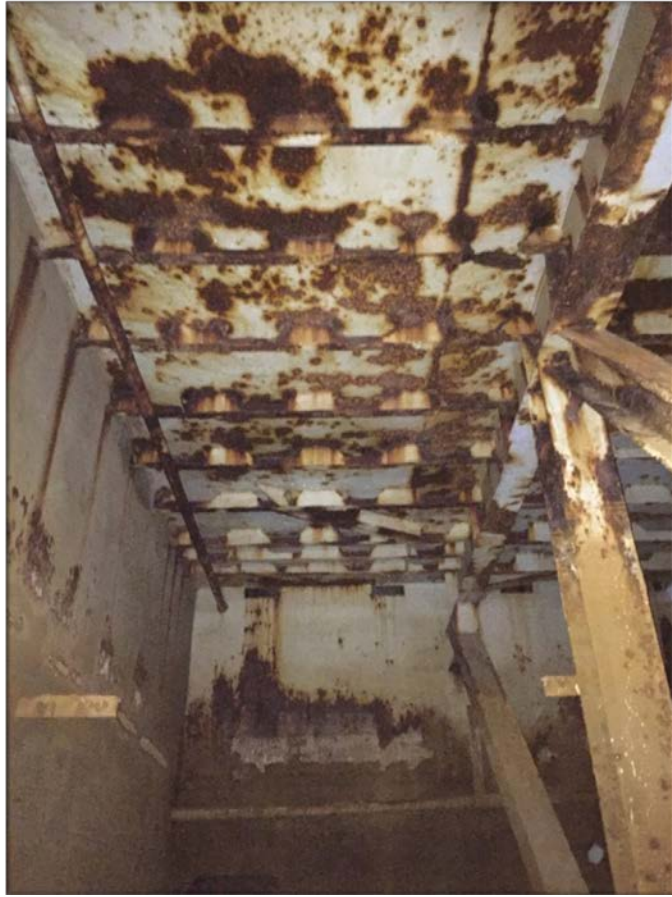
Member	Thickness (in)
Diagonal	0.58
Post	0.63
Bottom Chord	0.53

Figure 18: Typical Corrosion at Roof of Tank 6A

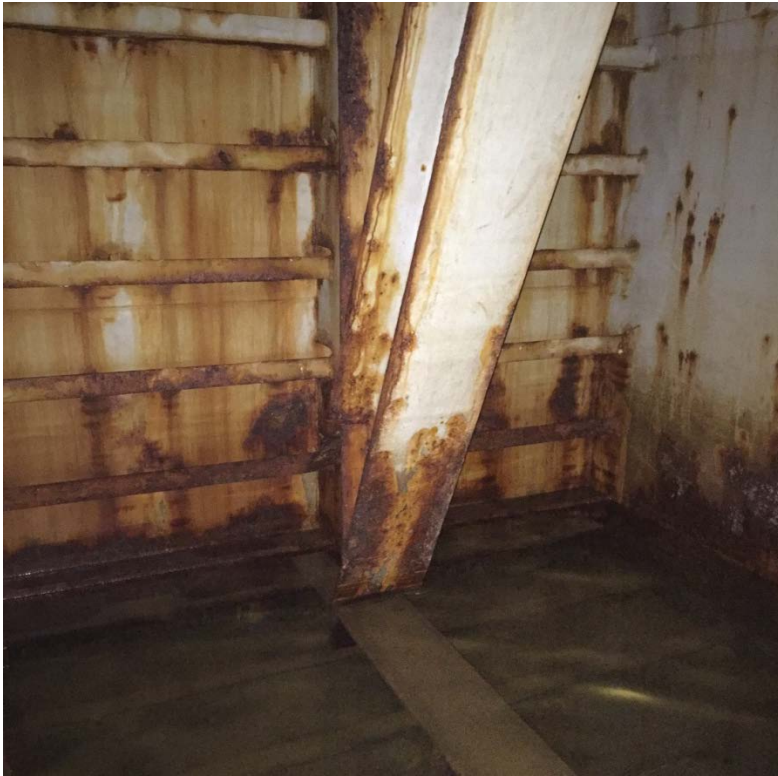
Figure 20: Tank 20A Side Wall and Diagonal

Member	Thickness (in)
Diagonal	0.57
Post	0.53
Bottom Chord	-

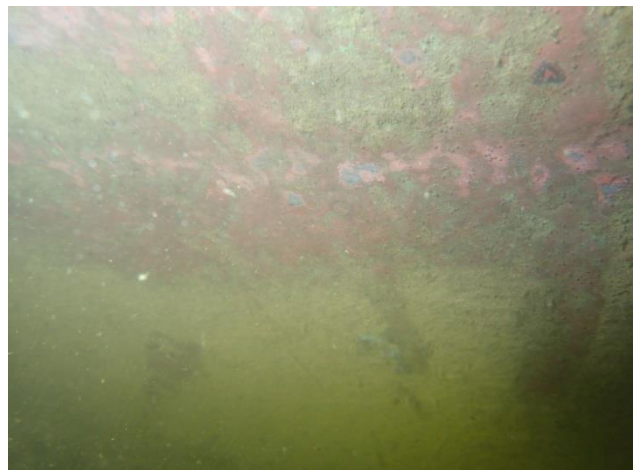
24. Typical hull deterioration after removal of marine growth

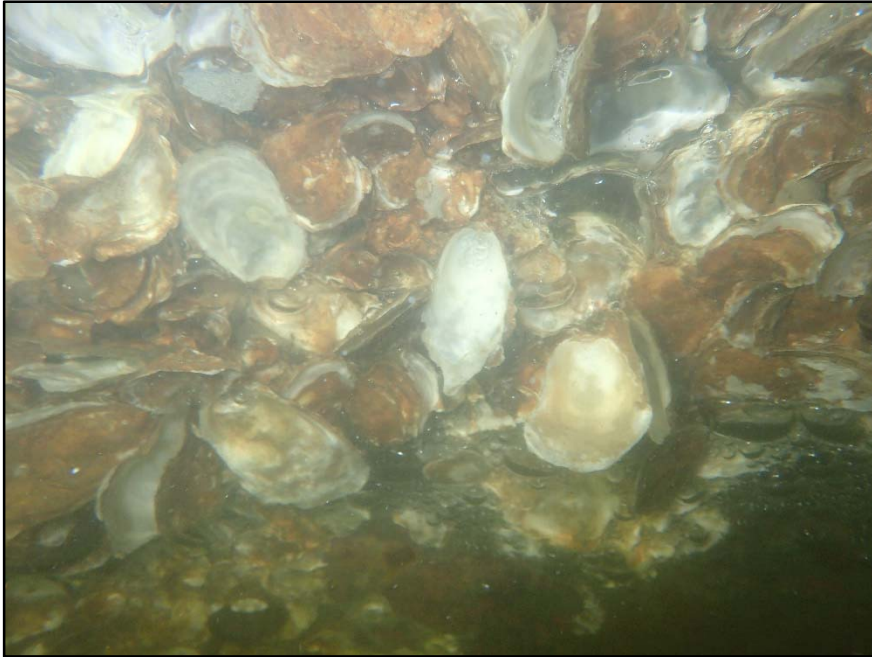
Photograph 3 : Underwater view of typical marine growth located along outer hull perimeter.

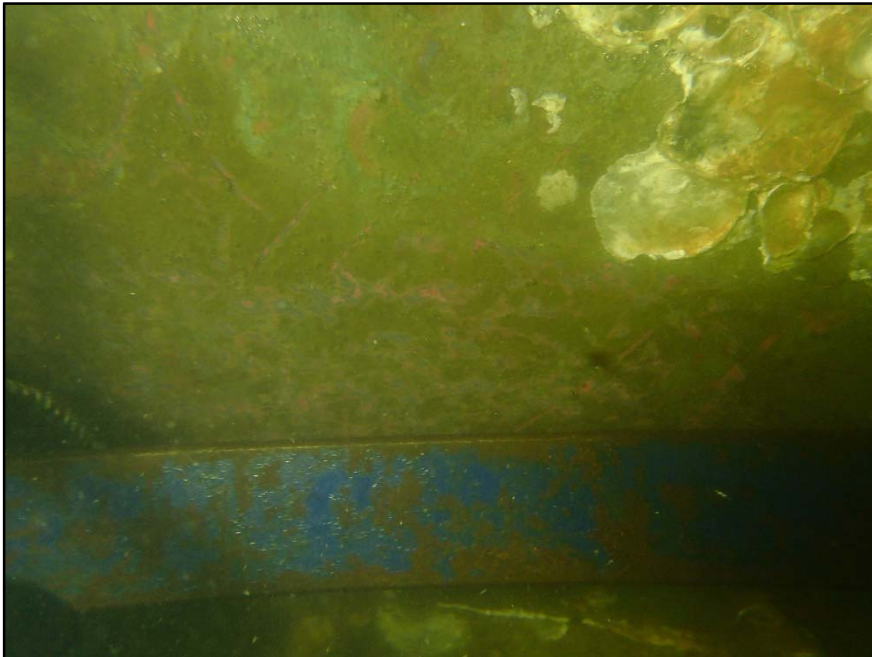
Photograph 4 : Underwater view of typical marine growth towards hull keel.
