## EUREKA DRY DOCK UT /VT SURVEY MAY 2015

Ultrasonic thickness measurements and a visual survey was performed for BAE Systems of San Francisco on the Eureka Dry Dock located at BAE Shipyard in San Francisco, CA. The owners were represented by Mr. Justin Gleaton. The survey was performed by International Inspection personnel.

## EUREKA DRY DOCK VISUAL SURVEY TABLE OF CONTENTS

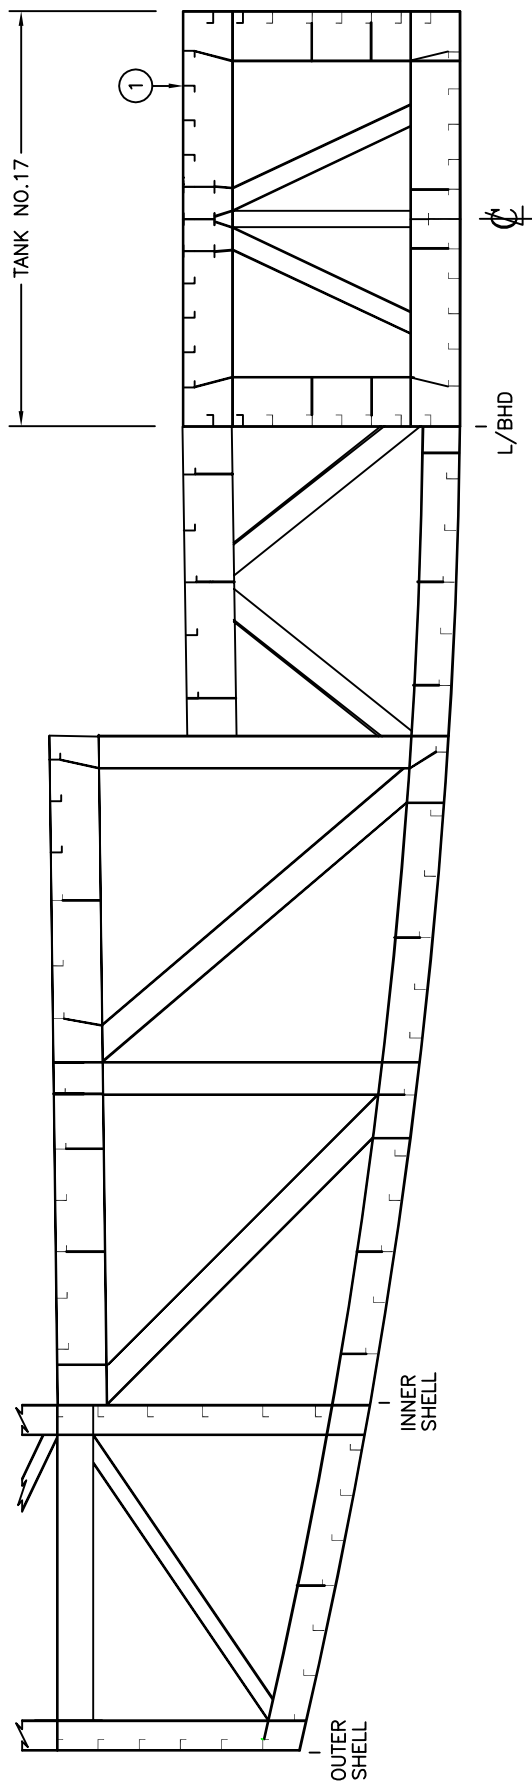
- 1.) 2 ½" Fracture in flange of longitudinal in way of channel cut-out, 21" north of frame.

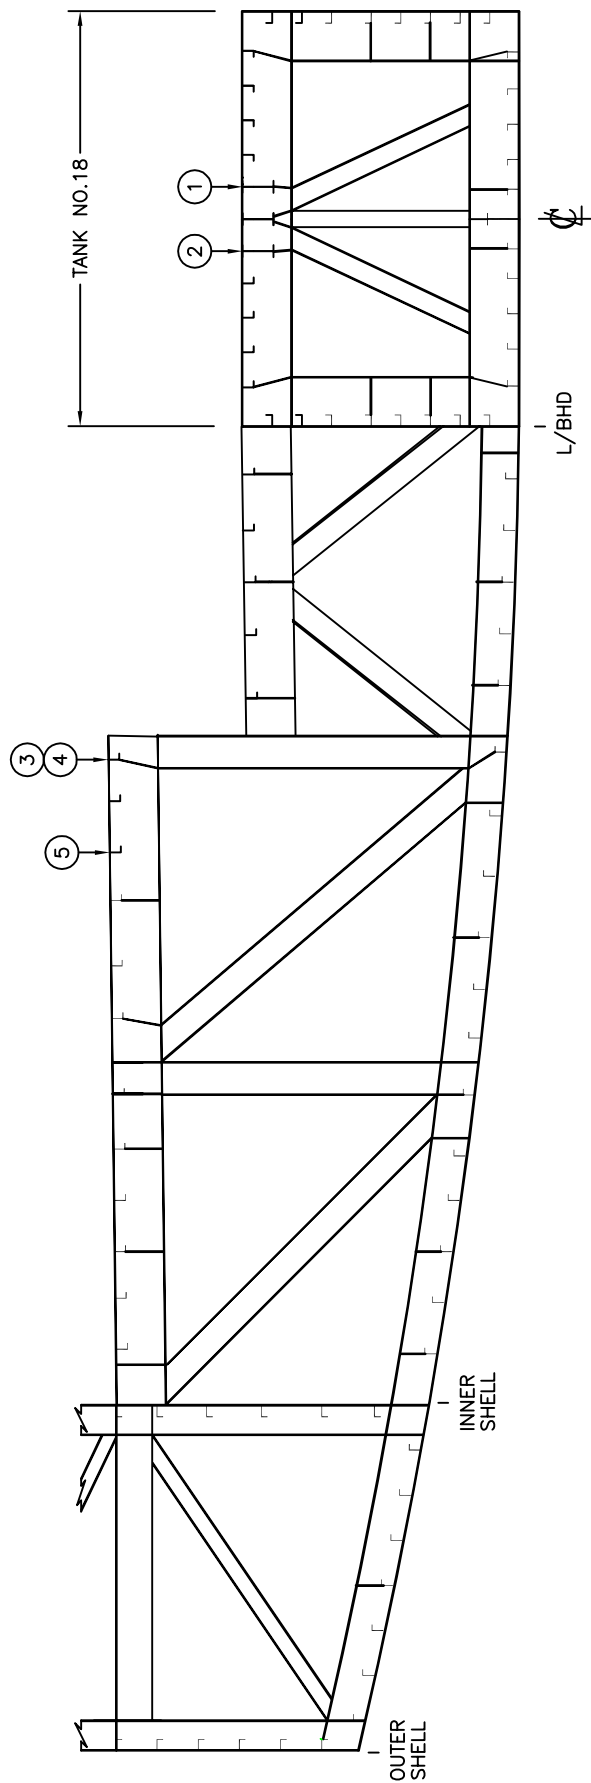
- 1.) 10" Fracture in attachment weld of longitudinal starting 40" north of frame.
- 2.) 10" Fracture in attachment weld of longitudinal starting 20" north of frame.
- 3.) 1" Fracture in web of longitudinal in way of channel cut-out, 17" north of frame.
- 4.) ½" Fracture in web of longitudinal in way of channel cut-out, 17" south of frame.
- 5.) 1 ½" Fracture in web of longitudinal in way of channel cut-out, 17" north of frame.

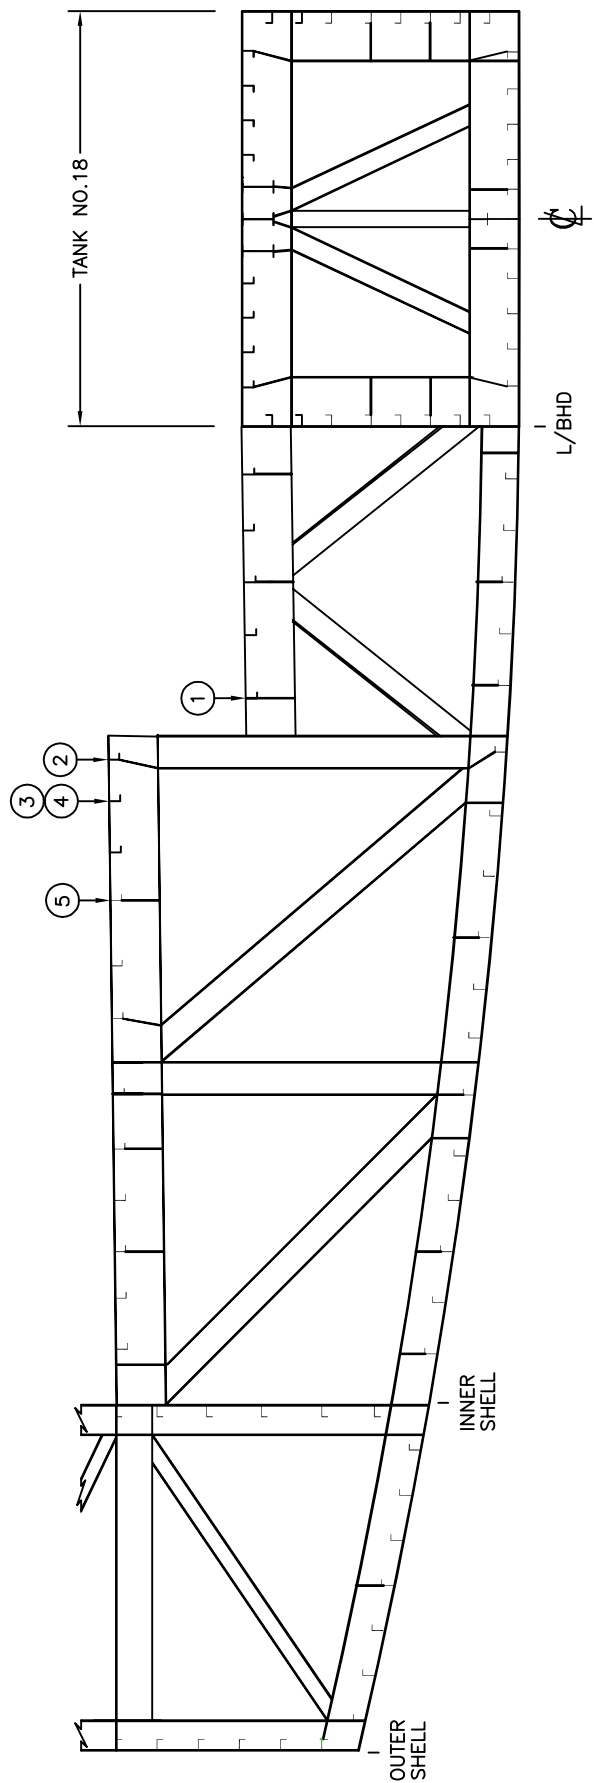
- 1.) 1" Fracture in web of longitudinal in way of channel cut-out, 17" north of frame.
- 2.) 2" Fracture in web of longitudinal in way of channel cut-out, 17" north of frame.
- 3.) 2" Fracture in web of longitudinal in way of channel cut-out, 17" north of frame.
- 4.) 1" Fracture in web of longitudinal in way of channel cut-out, 17" south of frame.
- 5.) 1" Fracture in web of longitudinal in way of channel cut-out, 17" north of frame.

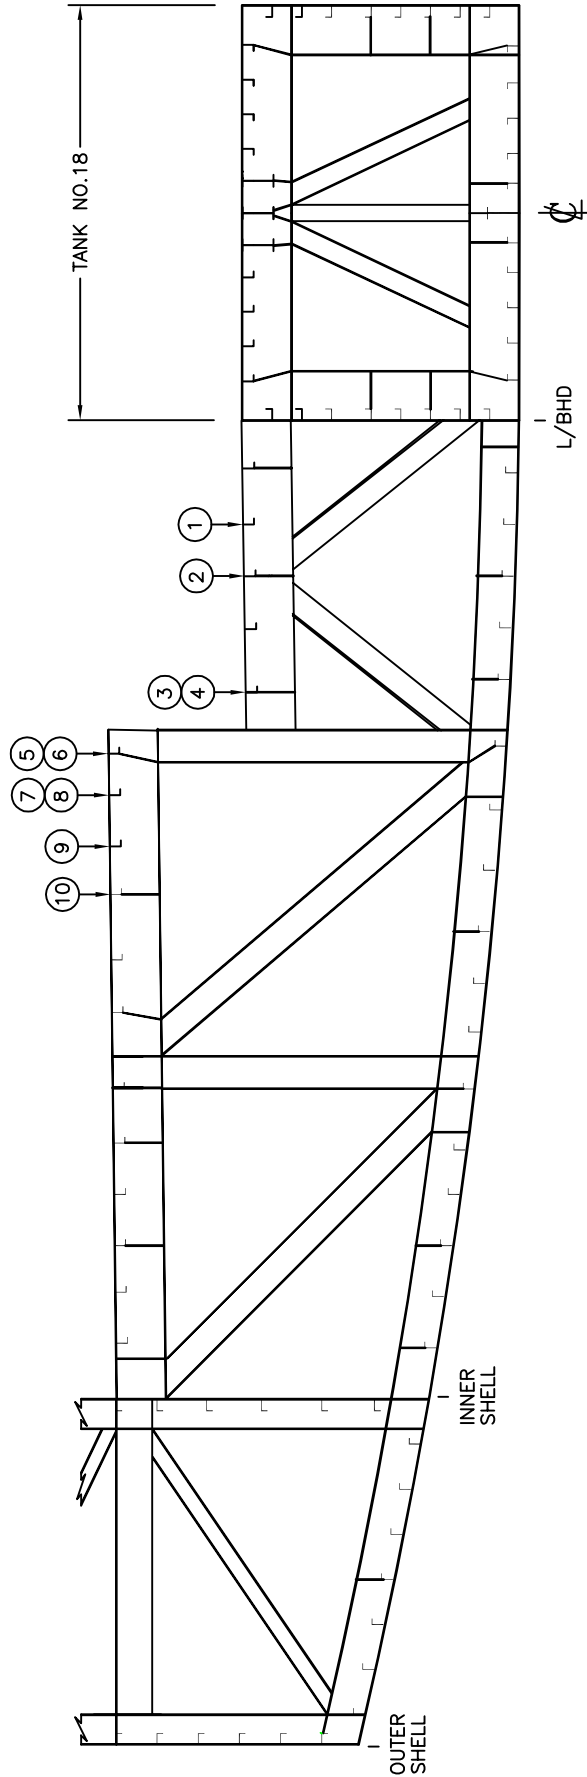
- 1.) 1" Fracture in web of longitudinal in way of channel cut-out, 17" south of frame.
- 2.) 1" Fracture in web of longitudinal in way of channel cut-out, 17" south of frame.
- 3.) 1" Fracture in web of longitudinal in way of channel cut-out, 17" north of frame.
- 4.) 1" Fracture in web of longitudinal in way of channel cut-out, 17" south of frame.
- 5.) 2" Fracture in web of longitudinal in way of channel cut-out, 17" north of frame.
- 6.) 3" Fracture in web of longitudinal in way of channel cut-out, 17" south of frame.
- 7.) 1 ½" Fracture in web of longitudinal in way of channel cut-out, 17" north of frame.
- 8.) 1" Fracture in web of longitudinal in way of channel cut-out, 17" south of frame.
- 9.) 2" Fracture in web of longitudinal in way of channel cut-out, 17" south of frame.
- 10.) 1" Fracture in web of longitudinal in way of channel cut-out, 17" south of frame.

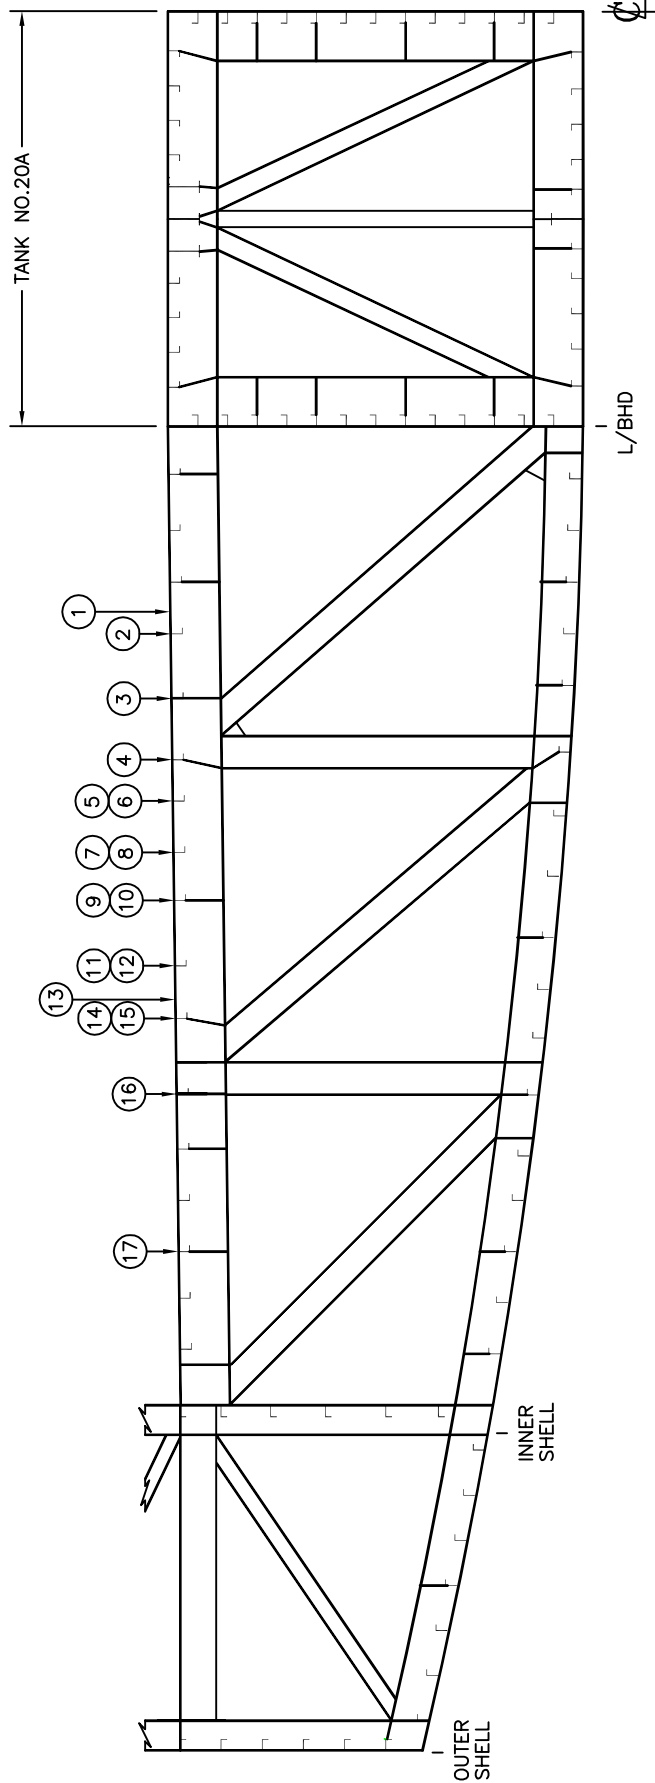
- 1.) Pin hole in deck plating, 5" north of frame.
- 2.) 1" Fracture in web of longitudinal in way of channel cut-out, 17" south of frame
- 3.) 4" Fracture in web of longitudinal in way of channel cut-out, 17" south of frame.

- 4.) Longitudinal web and flange fractured 100%, 8" south of frame.
- 5.) Longitudinal web and flange fractured 100%, 8" south of frame.
- 6.) Longitudinal web and flange fractured 100%, 17" south of frame.

- 7.) Longitudinal web and flange fractured 100%, 8" south of frame.
- 8.) Longitudinal web and flange fractured 100%, 17" south of frame.
- 9.) Longitudinal web and flange fractured 100%, 8" south of frame.

- 10.) Longitudinal web and flange fractured 100%, 17" south of frame.
- 11.) Longitudinal web and flange fractured 100%, 8" south of frame.
- 12.) Longitudinal web and flange fractured 100%, 17" south of frame.

- 13.) ½"Ø hole in deck plating, 20" south of frame.
- 14.) Longitudinal web and flange fractured 100%, 8" south of frame.
- 15.) Longitudinal web and flange fractured 100%, 17" south of frame.

- 16.) 3" Fracture in web of longitudinal in way of channel cut-out, 17" south of frame.
- 17.) 2" Fracture in web of longitudinal in way of channel cut-out, 17" south of frame.

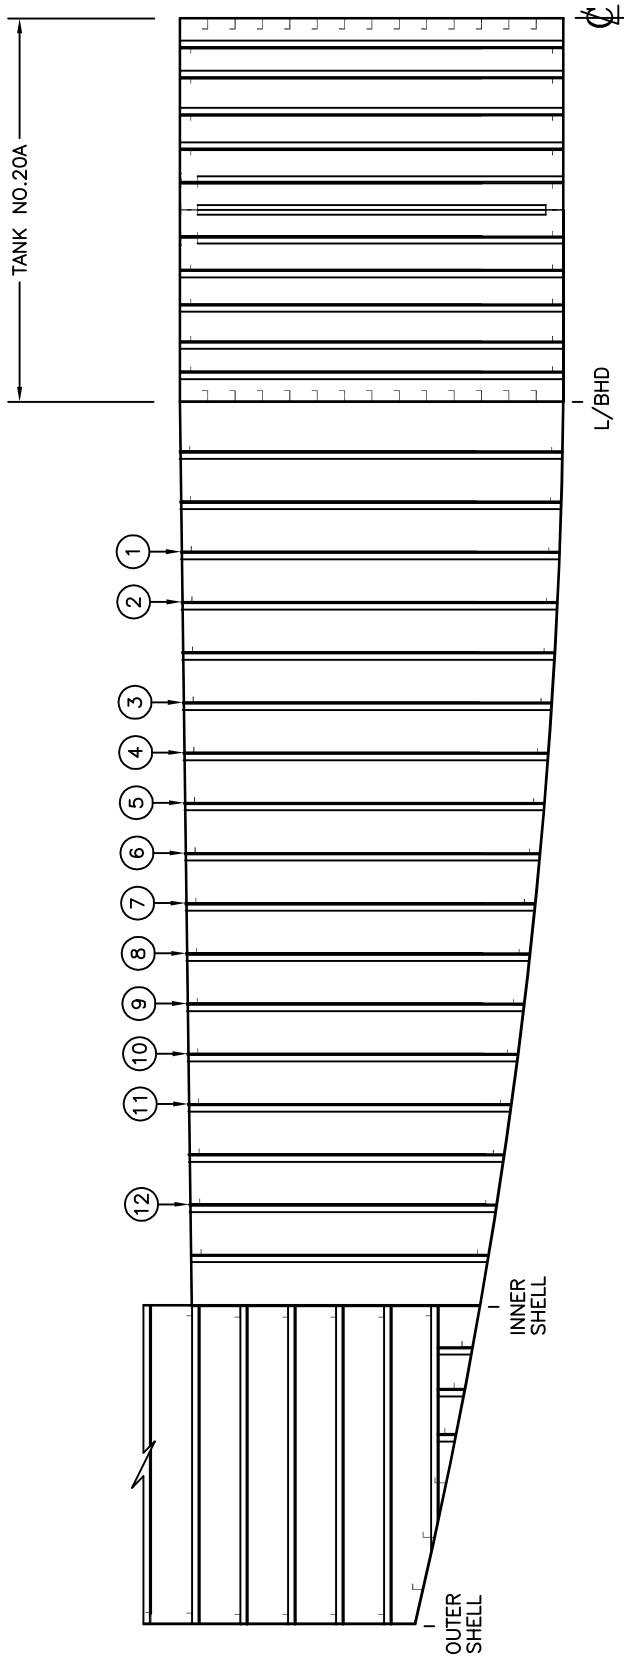
- 1.) 6" Fracture in web of longitudinal in way of channel cut-out, 17" north of bulkhead.
- 2.) 6" Fracture in web of longitudinal in way of channel cut-out, 17" north of bulkhead.

- 3.) 6" Fracture in web of longitudinal in way of channel cut-out, 17" north of bulkhead.
- 4.) 6" Fracture in web of longitudinal in way of channel cut-out, 17" north of bulkhead.

- 5.) 6" Fracture in web of longitudinal in way of channel cut-out, 17" north of bulkhead.
- 6.) 6" Fracture in web of longitudinal in way of channel cut-out, 17" north of bulkhead.

- 7.) 6" Fracture in web of longitudinal in way of channel cut-out, 17" north of bulkhead.
- 8.) Longitudinal web and flange fractured 100%, 17" north of bulkhead.

- 9.) Longitudinal web and flange fractured 100%, 17" north of bulkhead.
- 10.) 4" Fracture in web of longitudinal in way of channel cut-out, 17" north of bulkhead.

- 11.) 2" Fracture in web of longitudinal in way of channel cut-out, 17" north of bulkhead.

12.) 1" Fracture in web of longitudinal in way of channel cut-out, 17" north of bulkhead.

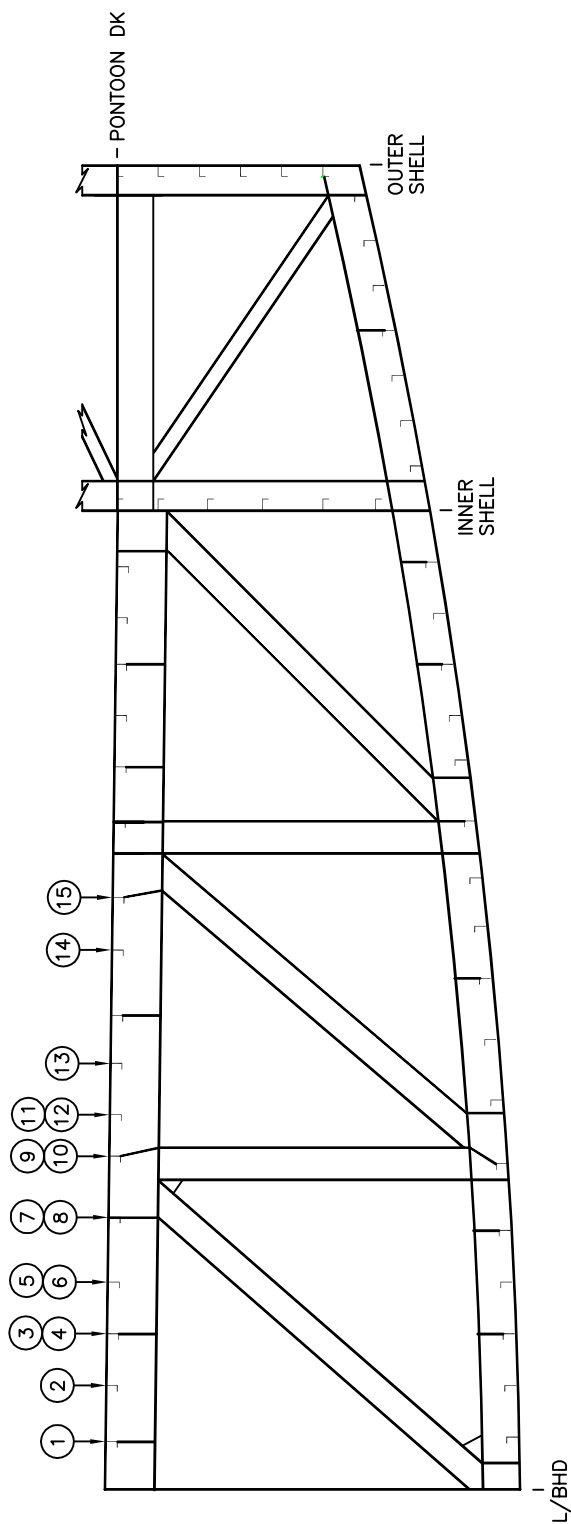
- 1.) 2" Fracture in web of longitudinal in way of channel cut-out, 17" south of frame.
- 2.) 2" Fracture in web of longitudinal in way of channel cut-out, 17" south of frame.

- 3.) 1" Fracture in web of longitudinal in way of channel cut-out, 17" south of frame.
- 4.) 2" Fracture in web of longitudinal in way of channel cut-out, 17" north of frame.

- 5.) 2" Fracture in web of longitudinal in way of channel cut-out, 17" south of frame.
- 6.) 2" Fracture in web of longitudinal in way of channel cut-out, 17" north of frame.

- 7.) 2" Fracture in web of longitudinal in way of channel cut-out, 17" south of frame.
- 8.) 1 ½" Fracture in web of longitudinal in way of channel cut-out, 17" north of frame.

- 9.) 2" Fracture in web of longitudinal in way of channel cut-out, 17" south of frame.
- 10.) 1" Fracture in web of longitudinal in way of channel cut-out, 17" north of frame.

- 11.) 1" Fracture in web of longitudinal in way of channel cut-out, 17" south of frame.
- 12.) 1" Fracture in web of longitudinal in way of channel cut-out, 17" north of frame.

- 13.) 2" Fracture in web of longitudinal in way of channel cut-out, 17" south of frame.
- 14.) 2" Fracture in web of longitudinal in way of channel cut-out, 17" north of frame.

15.) 2" Fracture in web of longitudinal in way of channel cut-out, 17" north of frame.

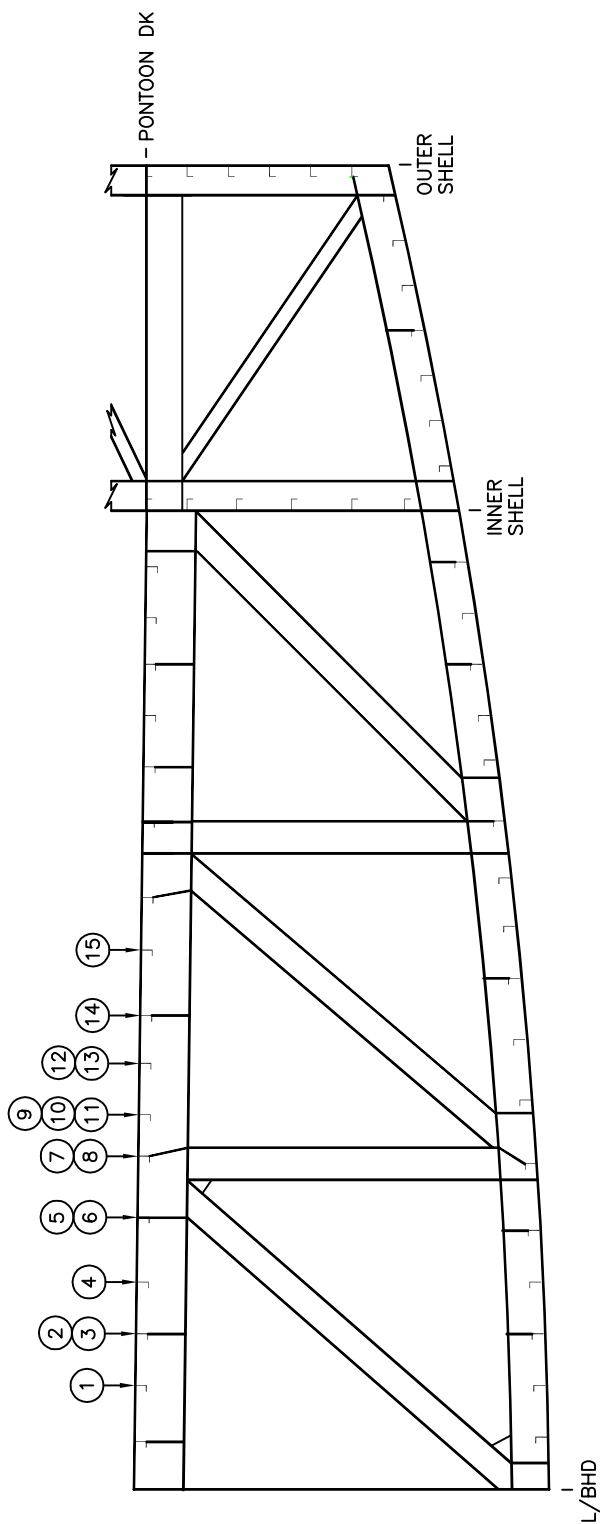
- 1.) 2" Fracture in web of longitudinal in way of channel cut-out, 17" north of frame.
- 2.) 2" Fracture in web of longitudinal in way of channel cut-out, 17" north of frame.

- 3.) 1" Fracture in web of longitudinal in way of channel cut-out, 17" south of frame.
- 4.) 2" Fracture in web of longitudinal in way of channel cut-out, 17" north of frame.

- 5.) 2" Fracture in web of longitudinal in way of channel cut-out, 17" north of frame.
- 6.) 2" Fracture in web of longitudinal in way of channel cut-out, 17" south of frame.

- 7.) 2" Fracture in web of longitudinal in way of channel cut-out, 17" north of frame.
- 8.) 2" Fracture in web of longitudinal in way of channel cut-out, 17" south of frame.

- 9.) 1" Fracture in web of longitudinal in way of channel cut-out, 17" north of frame.
- 10.) 2" Fracture in web of longitudinal in way of channel cut-out, 17" south of frame.

- 11.) 2" Fracture in longitudinal wrap weld deck attachment in way of channel cut-out, 18" south of frame.
- 12.) 2" Fracture in web of longitudinal in way of channel cut-out, 17" north of frame.

- 13.) 2" Fracture in web of longitudinal in way of channel cut-out, 17" south of frame.
- 14.) 2" Fracture in web of longitudinal in way of channel cut-out, 17" south of frame.

- 15.) 2" Fracture in longitudinal wrap weld deck attachment in way of channel cut-out, 17" south of frame. ½ diameter hole on deck in way of wrap weld.

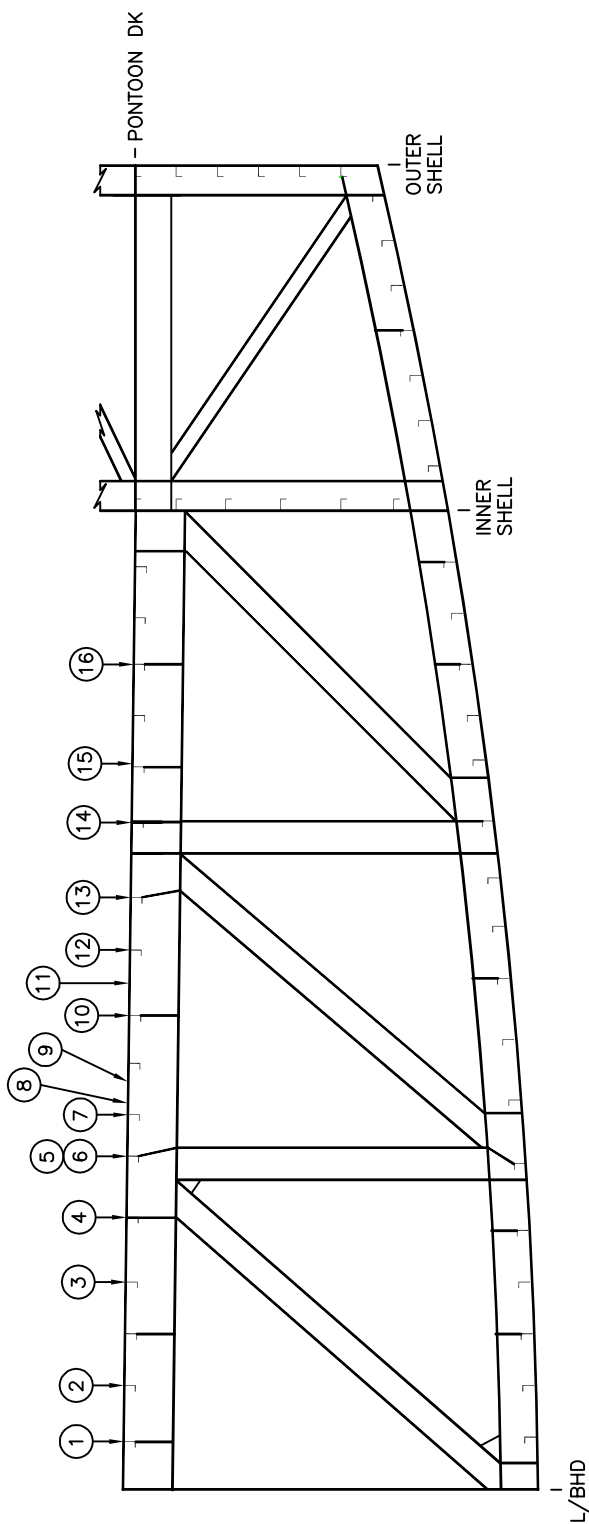
- 4.) 1" Fracture in web of longitudinal in way of channel cut-out, 17" south of frame.
- 5.) 1" Fracture in web of longitudinal in way of channel cut-out, 17" south of frame.

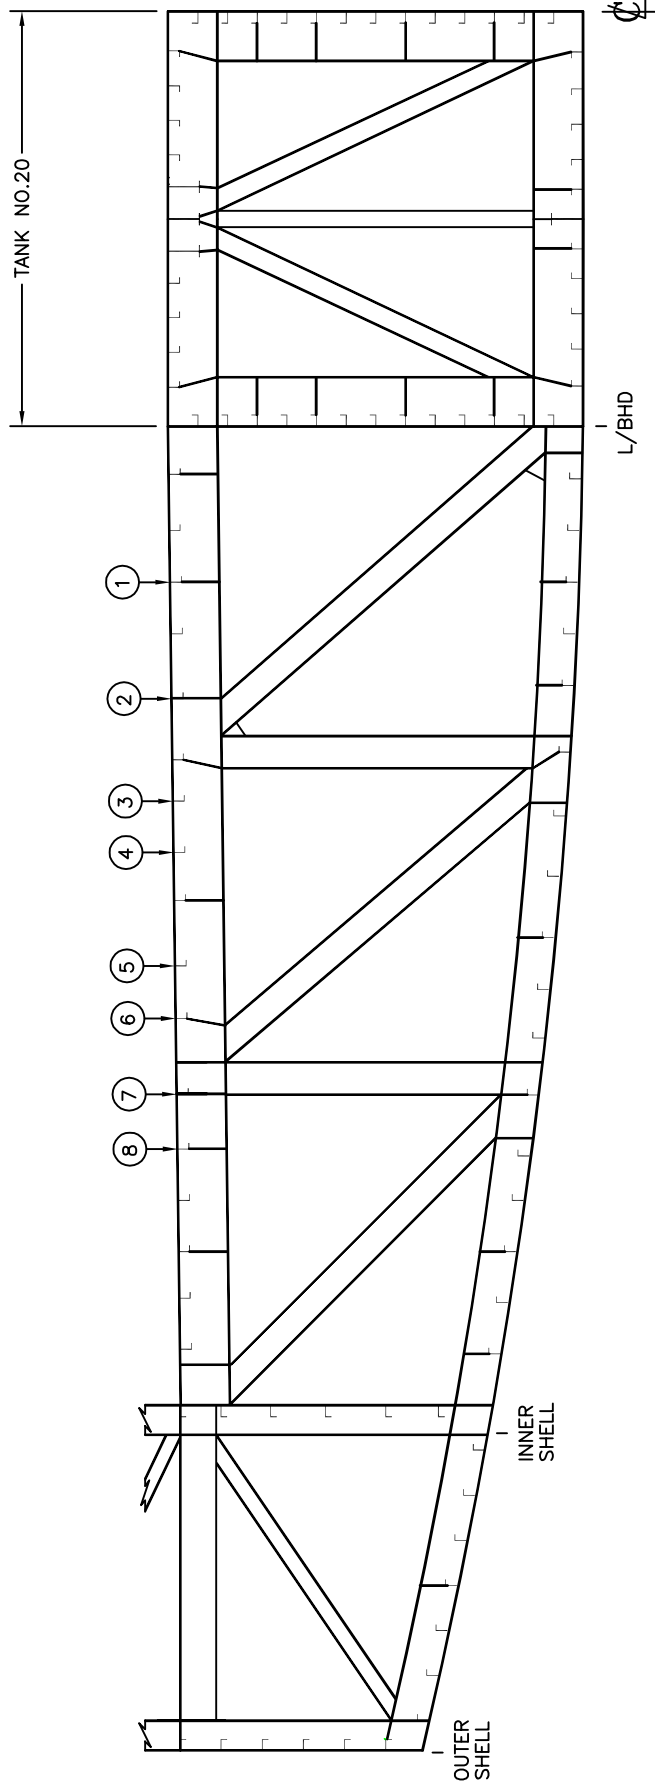
- 1.) 2" Fracture in web of longitudinal in way of channel cut-out, 17" south of frame.
- 2.) 2" Fracture in web of longitudinal in way of channel cut-out, 17" south of frame.
- 3.) 2" Fracture in web of longitudinal in way of channel cut-out, 17" south of frame.
- 4.) 2" Fracture in web of longitudinal in way of channel cut-out, 17" south of frame.
- 5.) 2" Fracture in web of longitudinal in way of channel cut-out, 17" south of frame.
- 6.) 2" Fracture in web of longitudinal in way of channel cut-out, 17" south of frame.
- 7.) 2" Fracture in web of longitudinal in way of channel cut-out, 17" south of frame.
- 8.) 2" Fracture in web of longitudinal in way of channel cut-out, 17" south of frame.

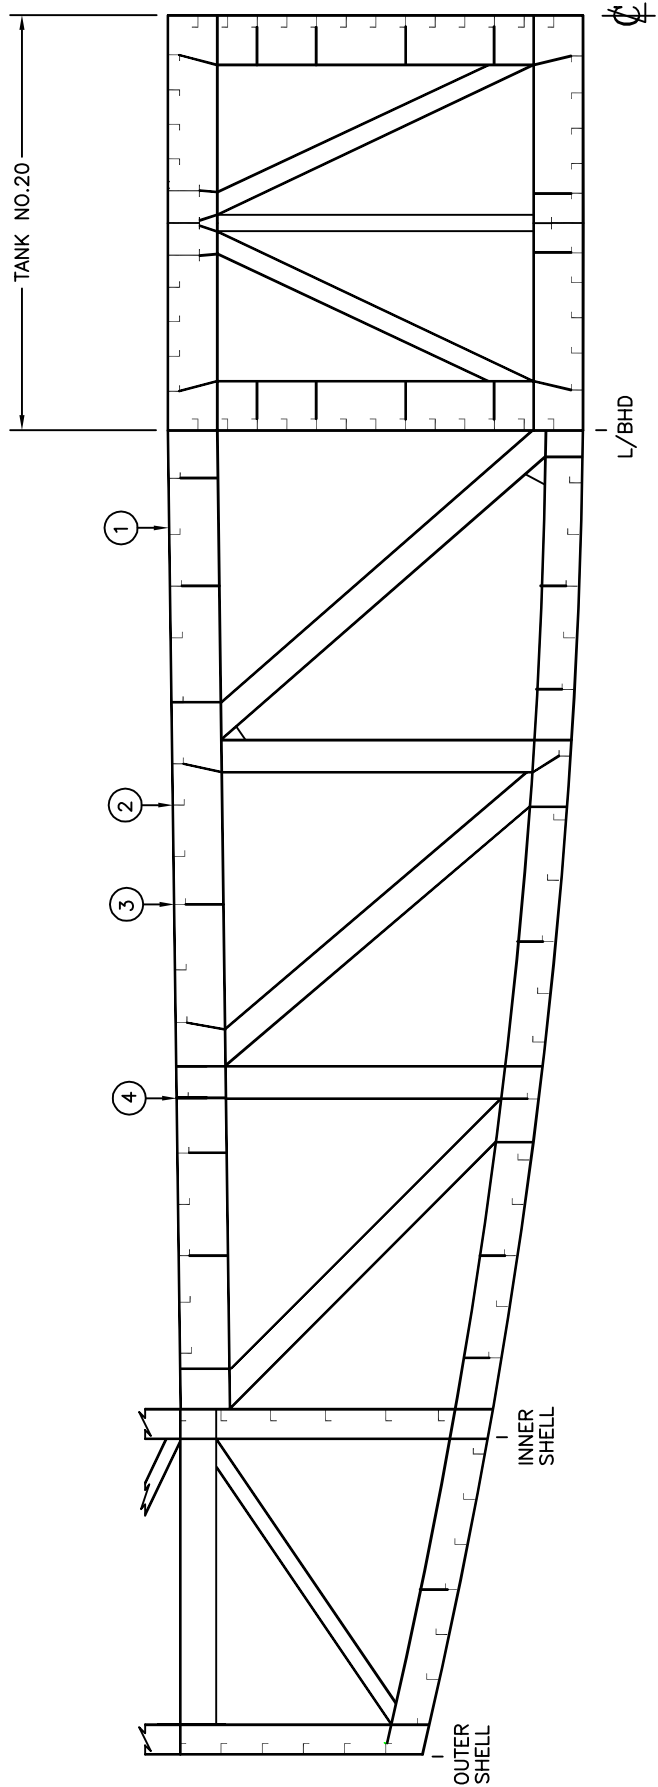
- 1.) 1"Ø hole in deck plating, 40" south of frame.
- 2.) 2" Fracture in web of longitudinal in way of channel cut-out, 17" north of frame.
- 3.) 2" Fracture in web of longitudinal in way of channel cut-out, 17" north of frame.
- 4.) 2" Fracture in web of longitudinal in way of channel cut-out, 17" north of frame.

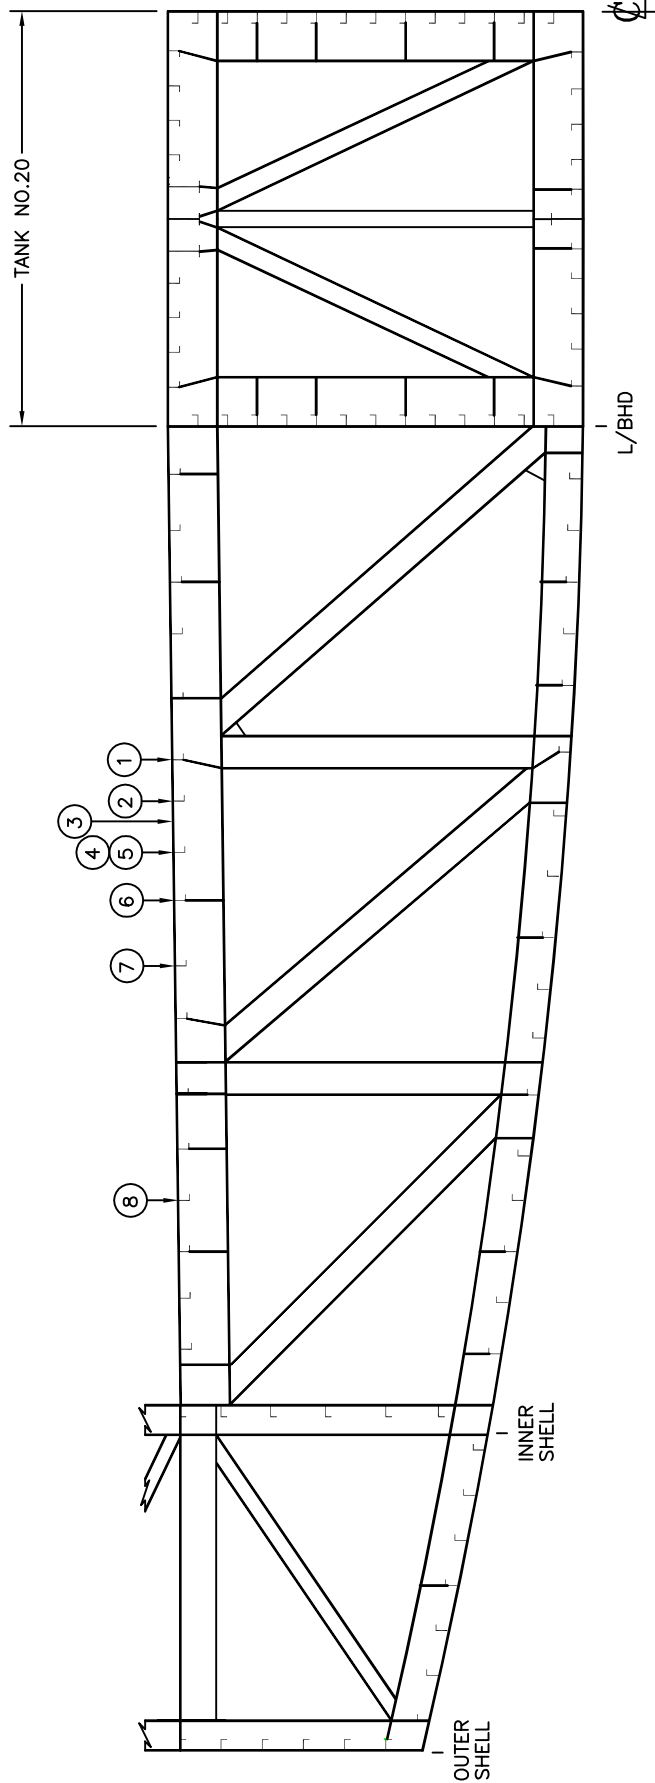
- 1.) 3” Fracture in web of longitudinal in way of channel cut-out, 17” north of frame.
- 2.) 3” Fracture in web of longitudinal in way of channel cut-out, 17” north of frame.
- 3.) 3” $\varnothing$  hole in deck plating, 2” south of frame.
- 4.) 3” Fracture in web of longitudinal in way of channel cut-out, 17” north of frame.
- 5.) 1” Fracture in web of longitudinal in way of channel cut-out, 17” south of frame.
- 6.) 3” Fracture in web of longitudinal in way of channel cut-out, 17” north of frame.
- 7.) 3” Fracture in web of longitudinal in way of channel cut-out, 17” north of frame.
- 8.) 1” Fracture in web of longitudinal in way of channel cut-out, 17” south of frame.

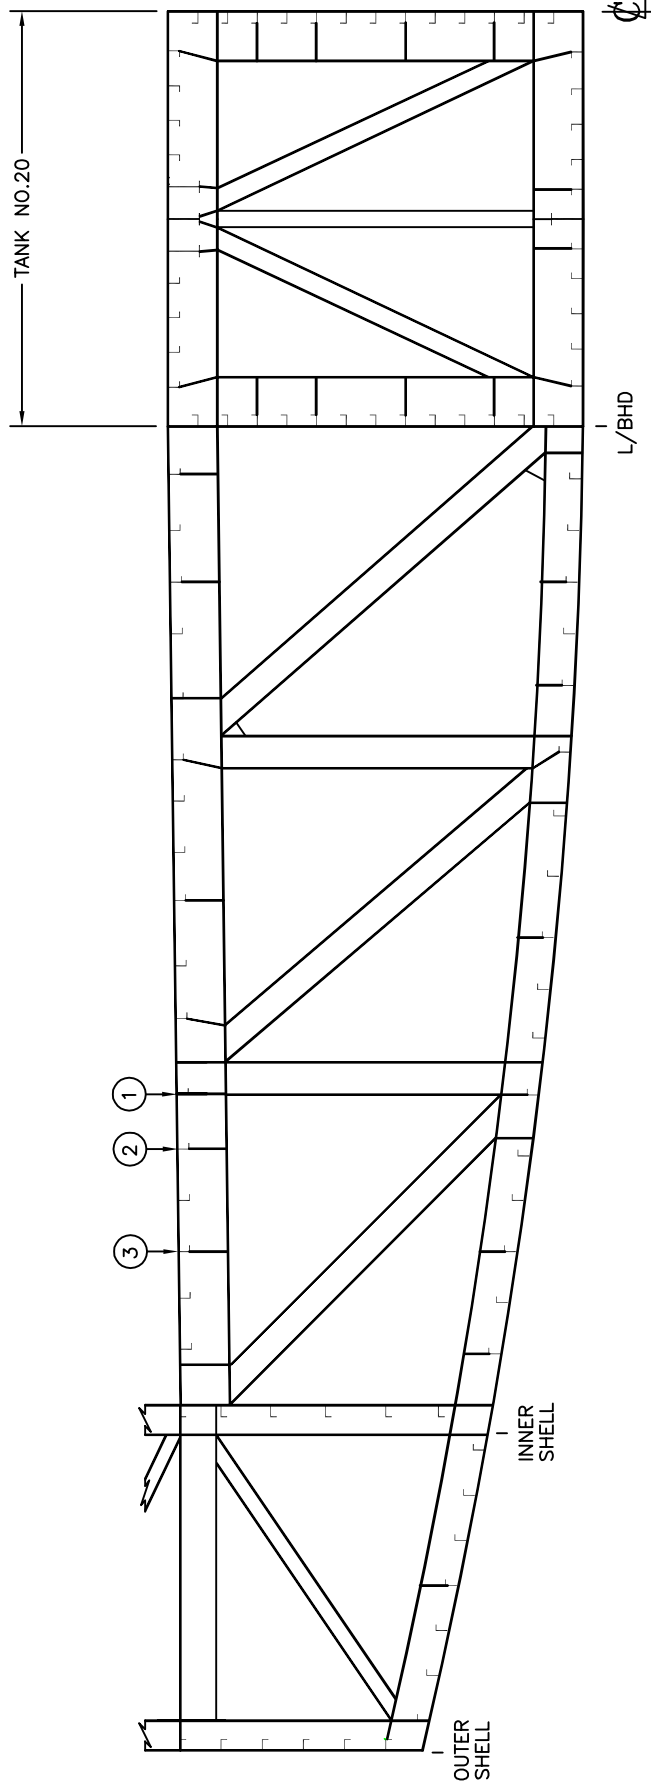
- 1.) 1" Fracture in web of longitudinal in way of channel cut-out, 17" north of frame.
- 2.) 1" Fracture in web of longitudinal in way of channel cut-out, 17" north of frame.
- 3.) 1" Fracture in web of longitudinal in way of channel cut-out, 17" north of frame.

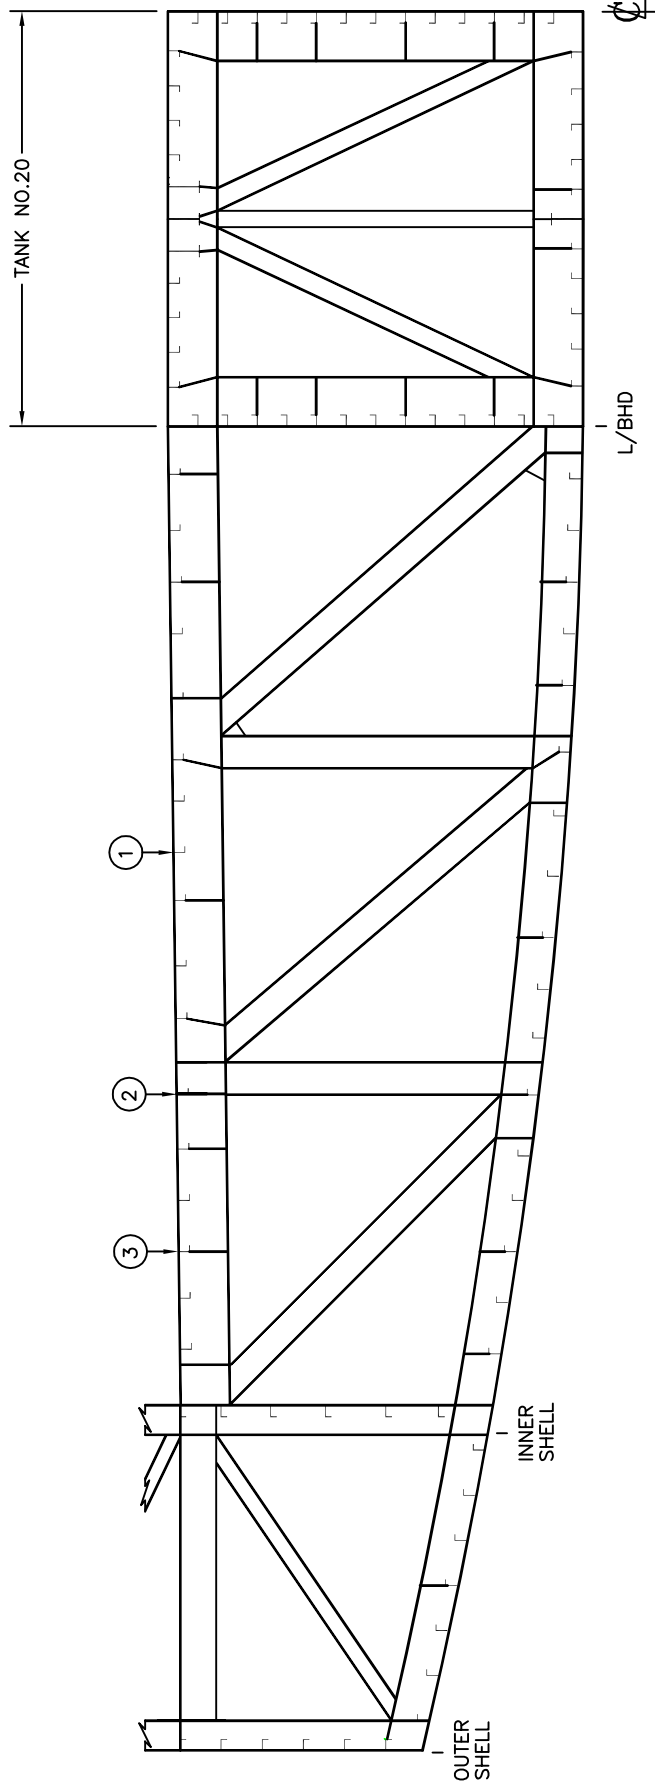
- 1.) 1" Fracture in web of longitudinal in way of channel cut-out, 17" south of frame.
- 2.) 1" Fracture in web of longitudinal in way of channel cut-out, 17" south of frame.
- 3.) 1" Fracture in web of longitudinal in way of channel cut-out, 17" north of frame.

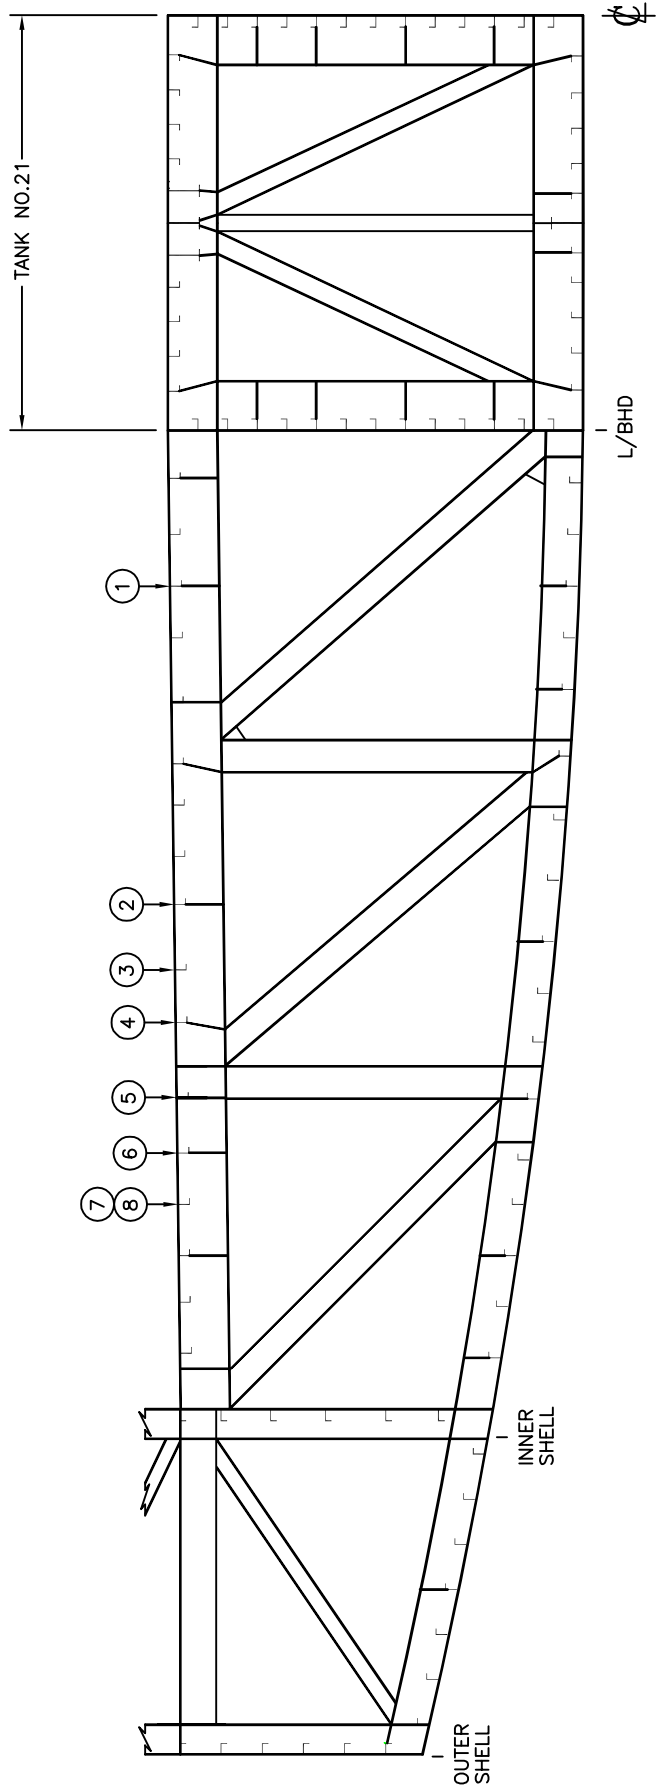
- 1.) Longitudinal stiffener missing attachment weld to deck, 6" south of frame.
- 2.) 1" Fracture in web of longitudinal in way of channel cut-out, 17" north of frame.
- 3.) 1" Fracture in web of longitudinal in way of channel cut-out, 17" north of frame.
- 4.) 1" Fracture in web of longitudinal in way of channel cut-out, 17" north of frame.
- 5.) 1" Fracture in web of longitudinal in way of channel cut-out, 17" north of frame.
- 6.) 1" Fracture in web of longitudinal in way of channel cut-out, 17" north of frame.
- 7.) 1" Fracture in web of longitudinal in way of channel cut-out, 17" north of frame.
- 8.) ½" Fracture in web of longitudinal in way of channel cut-out, 17" south of frame.

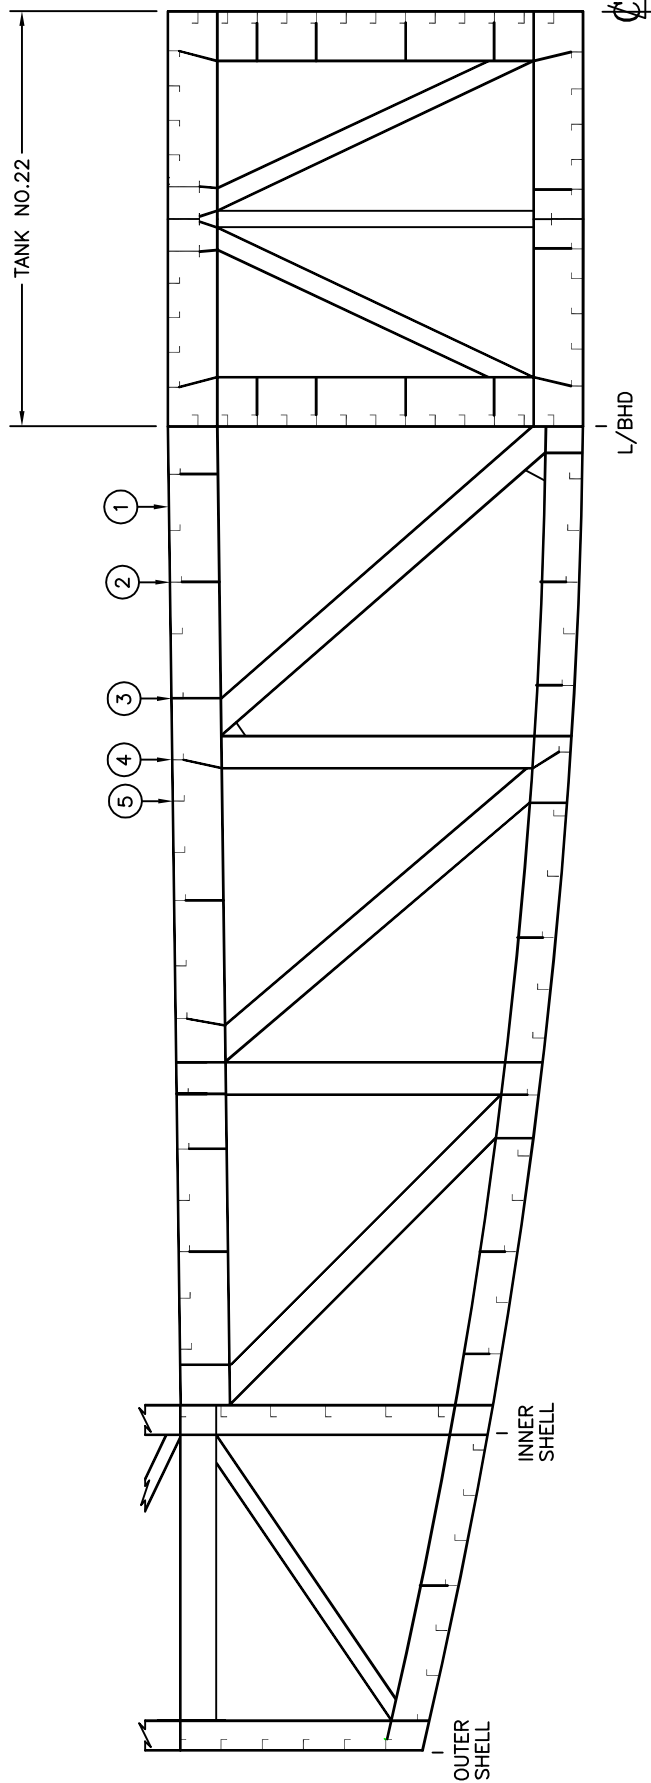
- 1.) 2" diameter hole on deck plating, 3" south of frame.
- 2.) 1" Fracture in web of longitudinal in way of channel cut-out, 24" north of frame.
- 3.) 1" Fracture in web of longitudinal in way of channel cut-out, 24" north of frame.
- 4.) 1" Fracture in web of longitudinal in way of channel cut-out, 17" north of frame.
- 5.) 1" Fracture in web of longitudinal in way of channel cut-out, 17" north of frame.

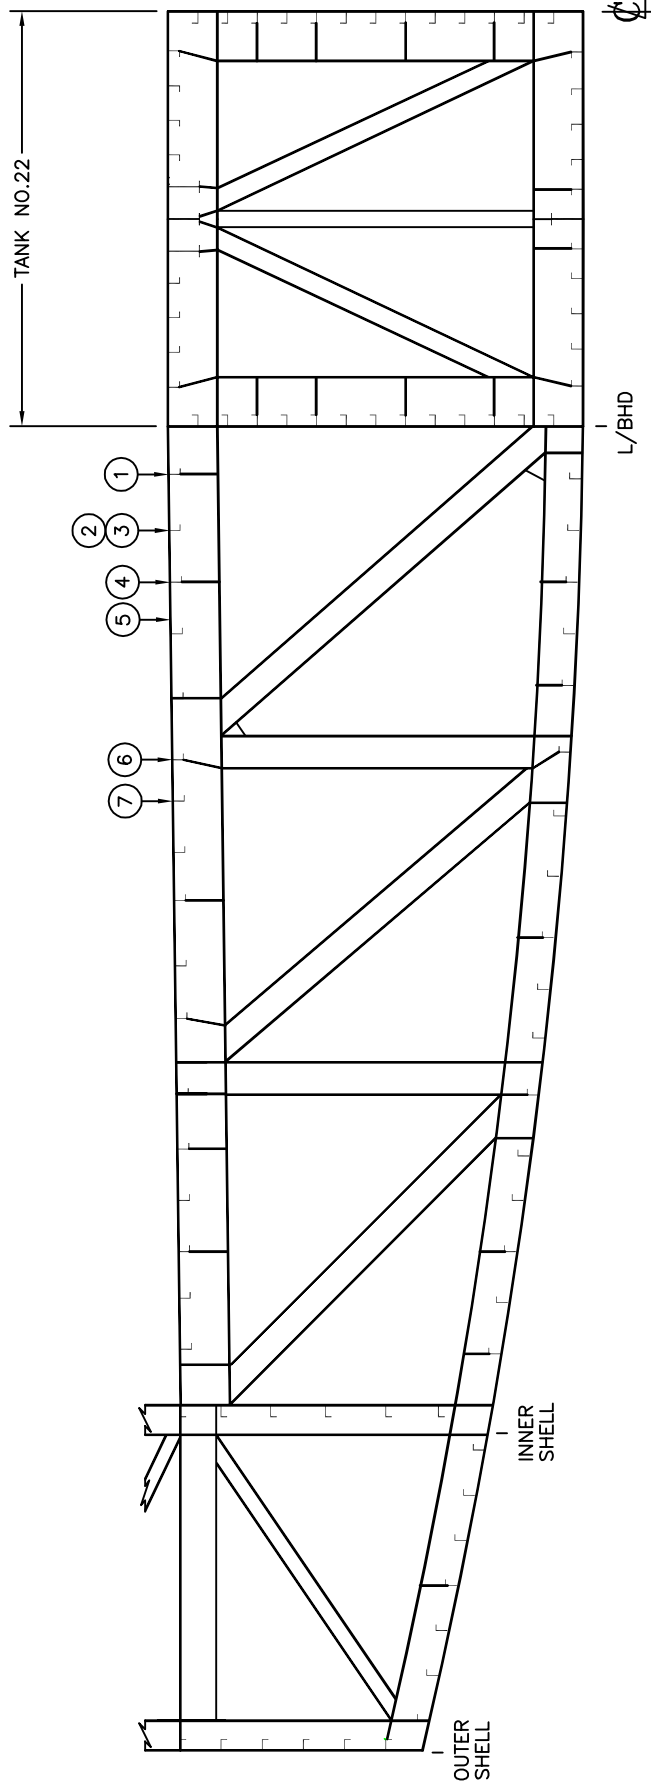
- 1.) 1" Fracture in web of longitudinal in way of channel cut-out, 17" south of frame.
- 2.) 1" Fracture in web of longitudinal in way of channel cut-out, 17" south of frame.
- 3.) 1" Fracture in web of longitudinal in way of channel cut-out, 17" north of frame.
- 4.) 1" Fracture in web of longitudinal in way of channel cut-out, 28" north of frame.
- 5.) 1" diameter hole on deck plating, 2" south of frame.
- 6.) 1" Fracture in web of longitudinal in way of channel cut-out, 17" south of frame.
- 7.) 1" Fracture in web of longitudinal in way of channel cut-out, 17" north of frame.

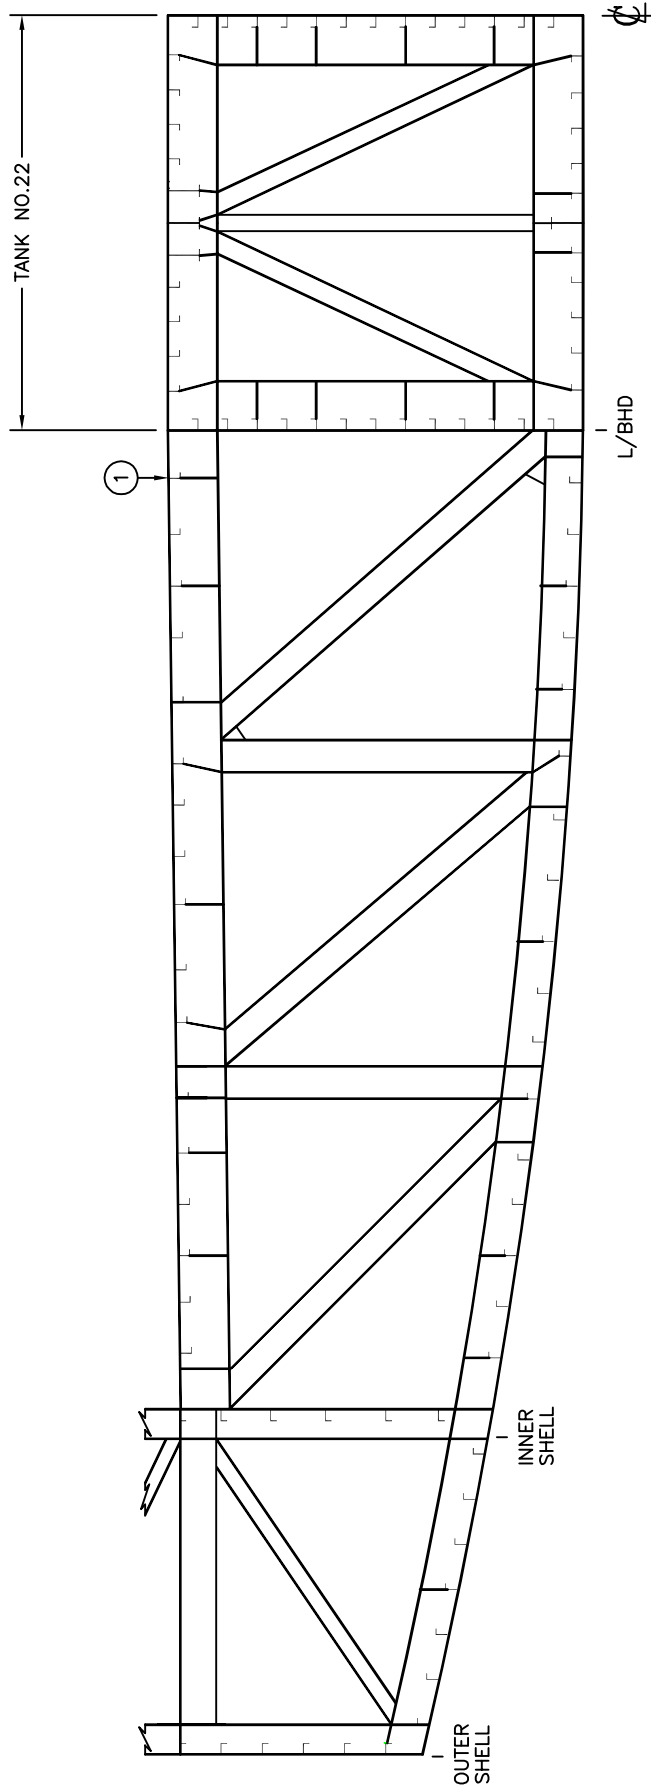
- 1.) 1" Fracture in web of longitudinal in way of channel cut-out, 17" south of frame.
