## EUREKA DRY DOCK UT /VT SURVEY MAY 2015

Ultrasonic thickness measurements and a visual survey was performed for BAE Systems of San Francisco on the Eureka Dry Dock located at BAE Shipyard in San Francisco, CA. The owners were represented by Mr. Justin Gleaton. The survey was performed by International Inspection personnel.

## EUREKA DRY DOCK VISUAL SURVEY TABLE OF CONTENTS

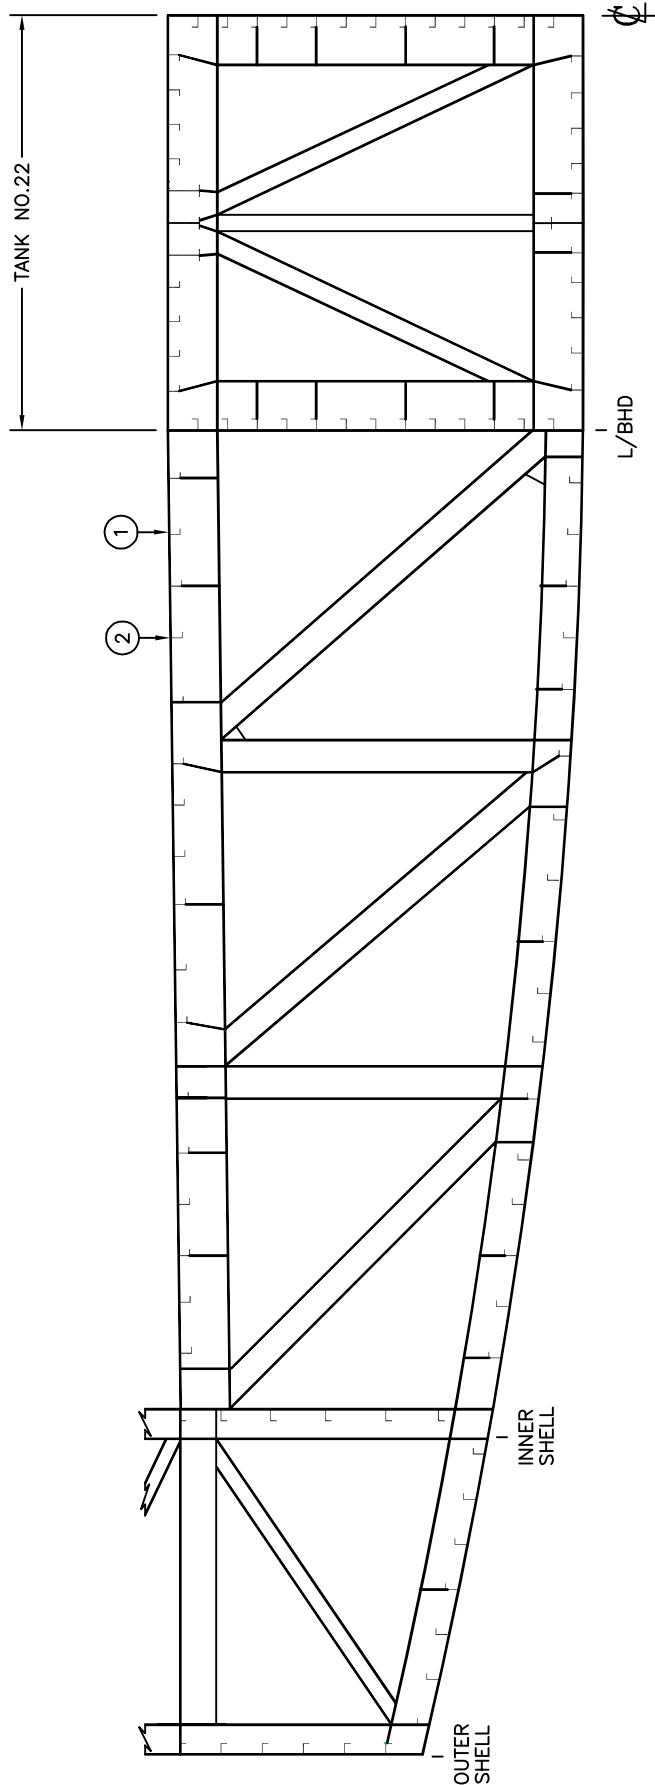
- 1.) 2" diameter hole on deck plating in way of wrap weld, 1" south of frame.
- 2.) 1" Fracture in web of longitudinal in way of channel cut-out, 7" north of frame.

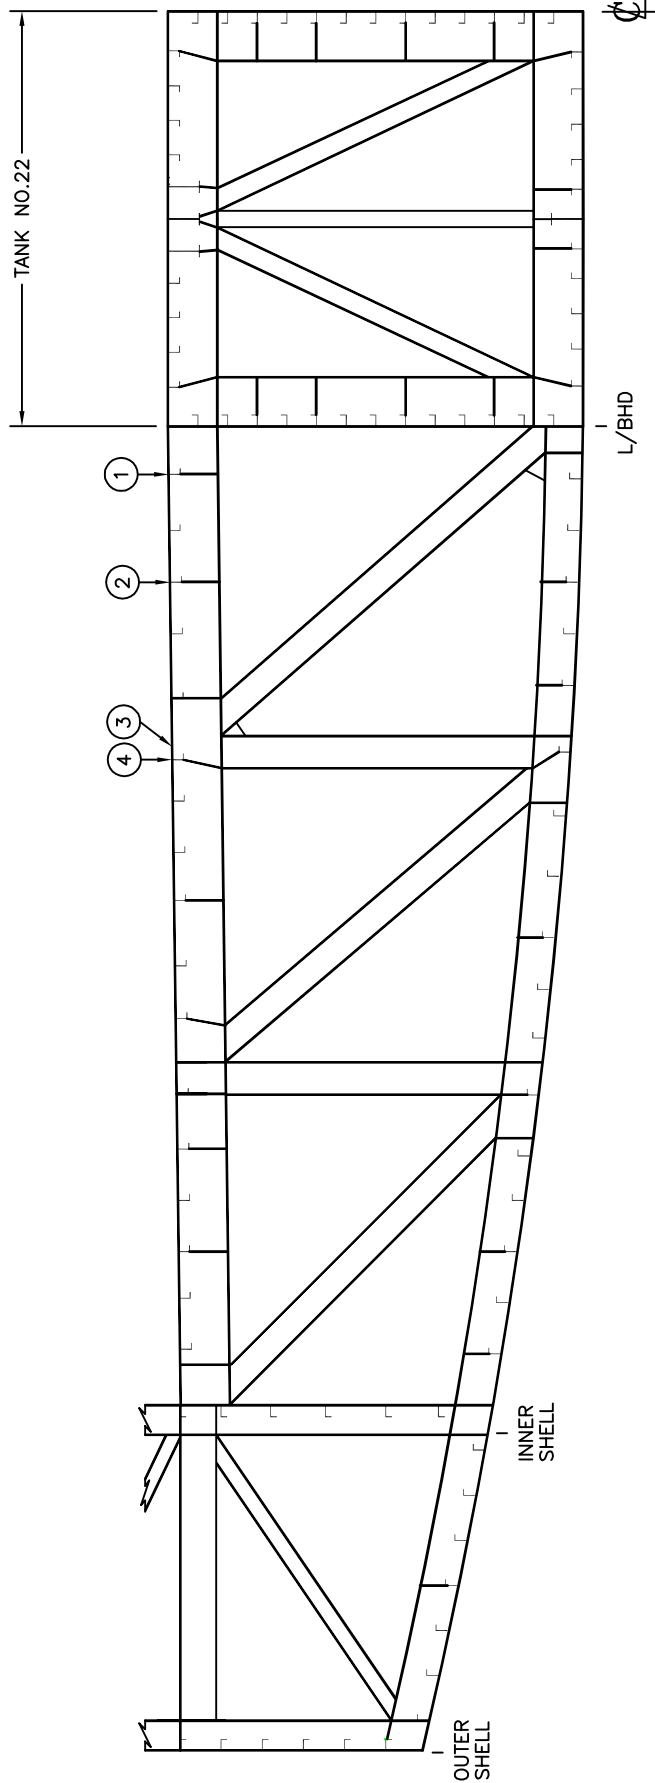
- 1.) 1" Fracture in web of longitudinal in way of channel cut-out, 17" south of frame.
- 2.) 1" Fracture in web of longitudinal in way of channel cut-out, 32" south of frame.
- 3.) 1" Fracture in web of longitudinal in way of channel cut-out, 24" north of frame.
- 4.) 1" Fracture in web of longitudinal in way of channel cut-out, 24" south of frame.

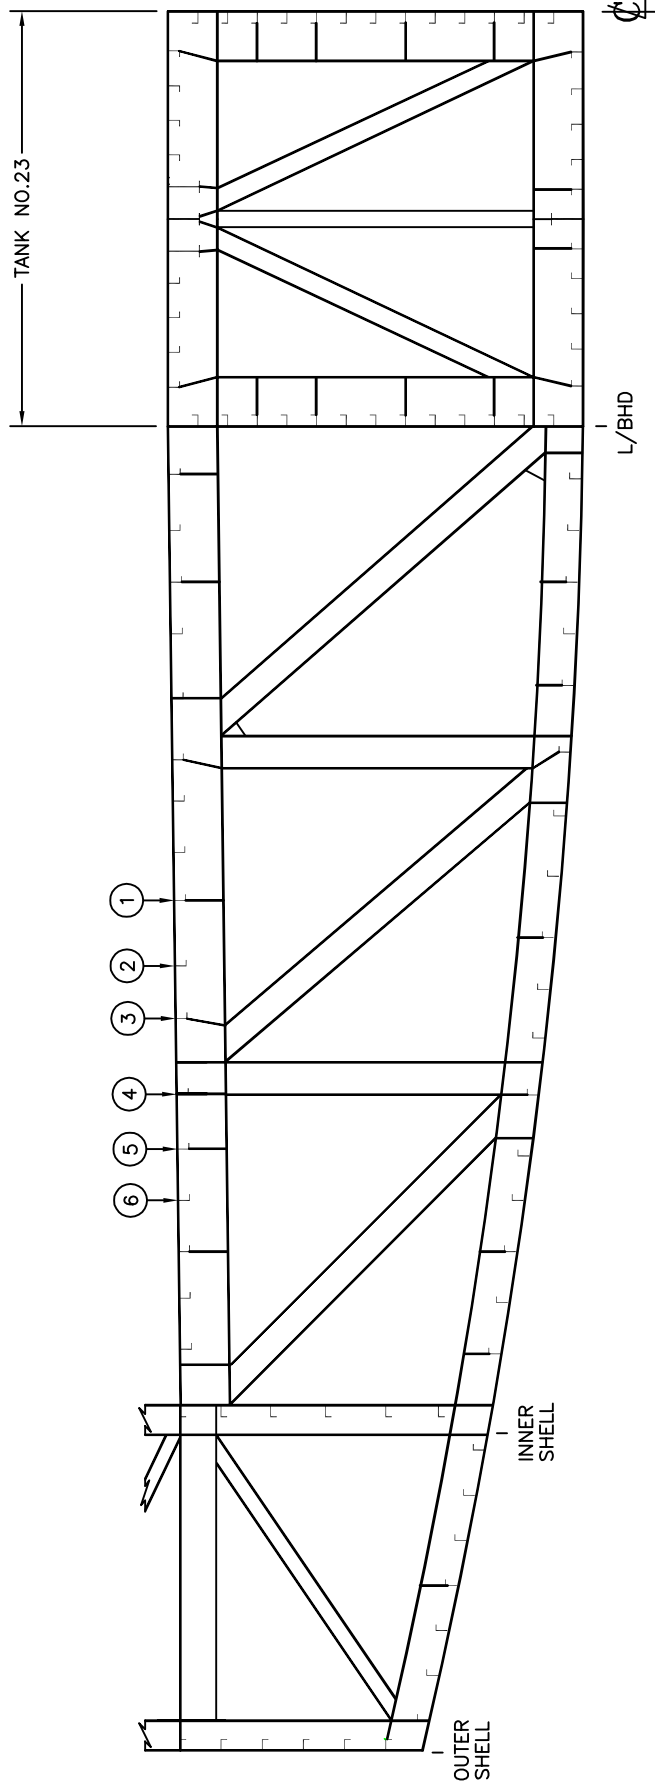
- 1.) 2" Fracture in web of longitudinal in way of channel cut-out, 17" north of frame.
- 2.) 2" Fracture in web of longitudinal in way of channel cut-out, 17" north of frame.
- 3.) 2" Fracture in web of longitudinal in way of channel cut-out, 17" north of frame.
- 4.) 2" Fracture in web of longitudinal in way of channel cut-out, 17" north of frame.
- 5.) 2" Fracture in web of longitudinal in way of channel cut-out, 17" north of frame.
- 6.) 2" Fracture in web of longitudinal in way of channel cut-out, 17" north of frame.

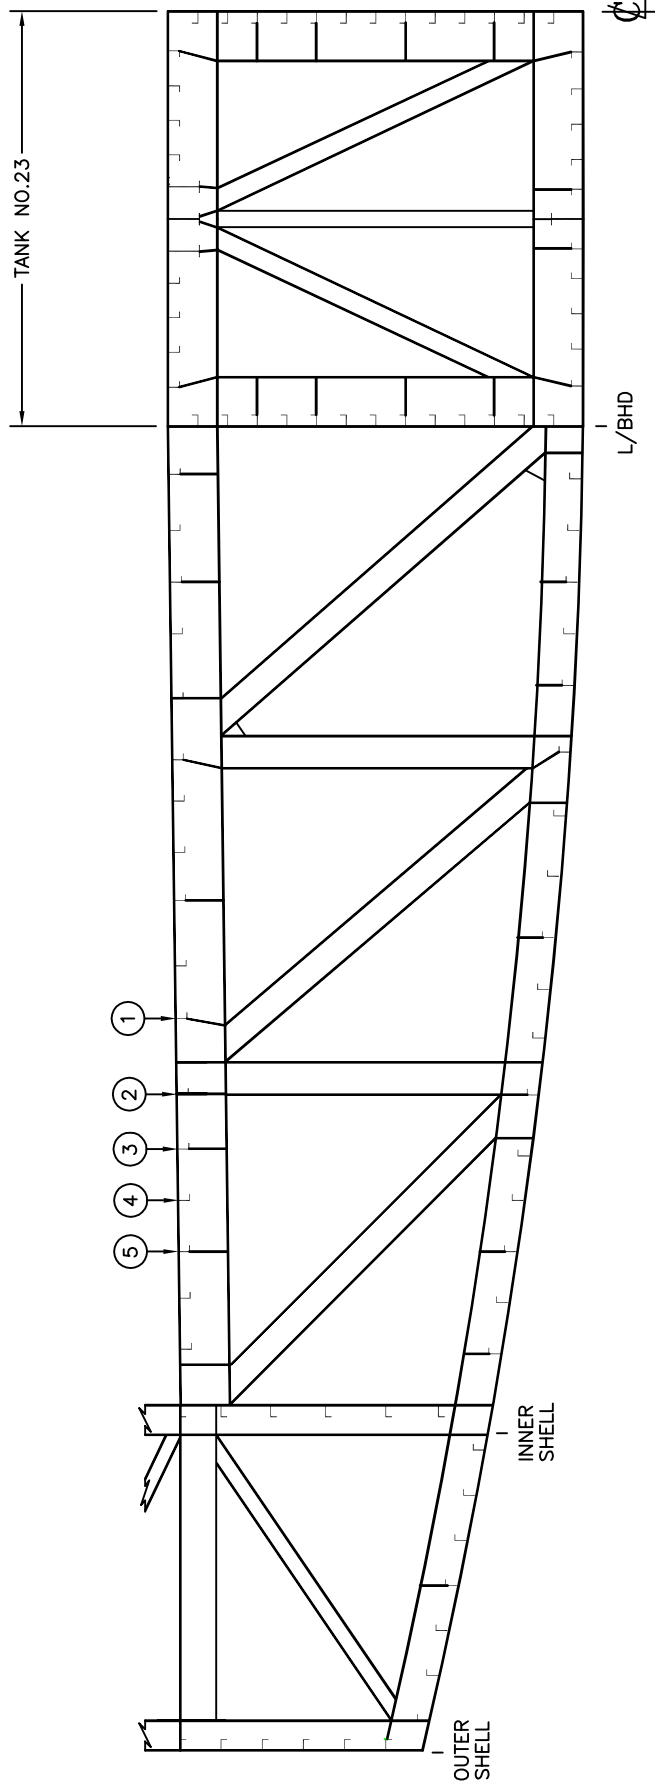
- 1.) 2" Fracture in web of longitudinal in way of channel cut-out, 17" north of frame.
- 2.) 2" Fracture in web of longitudinal in way of channel cut-out, 17" north of frame.
- 3.) 2" Fracture in web of longitudinal in way of channel cut-out, 17" north of frame.
- 4.) 2" Fracture in web of longitudinal in way of channel cut-out, 17" north of frame.
- 5.) 2" Fracture in web of longitudinal in way of channel cut-out, 17" north of frame.

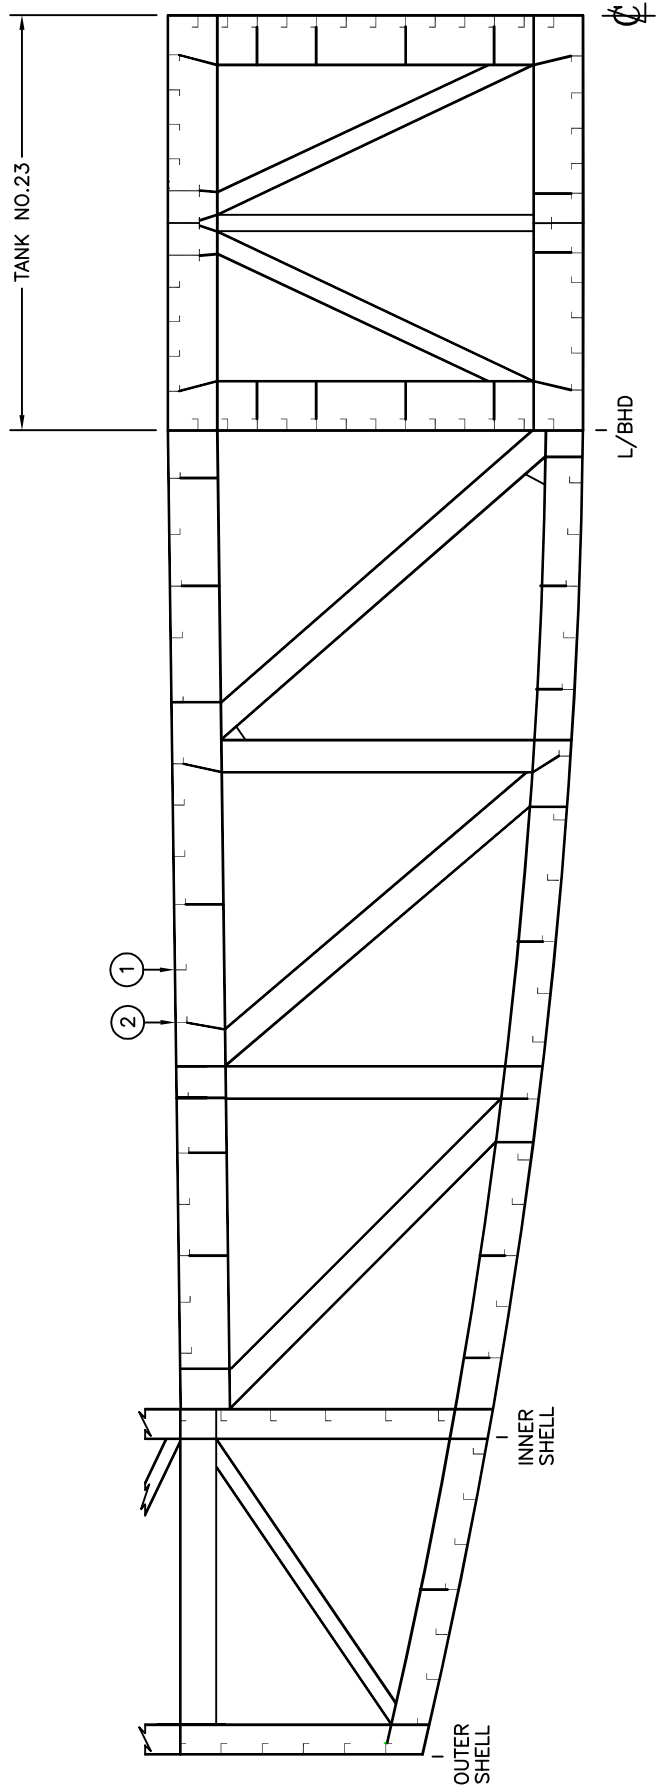
- 1.) Longitudinal web and flange fractured 100%, 12" north of frame.
- 2.) 2 ½" Fracture in web of longitudinal in way of channel cut-out, 17" north of frame.

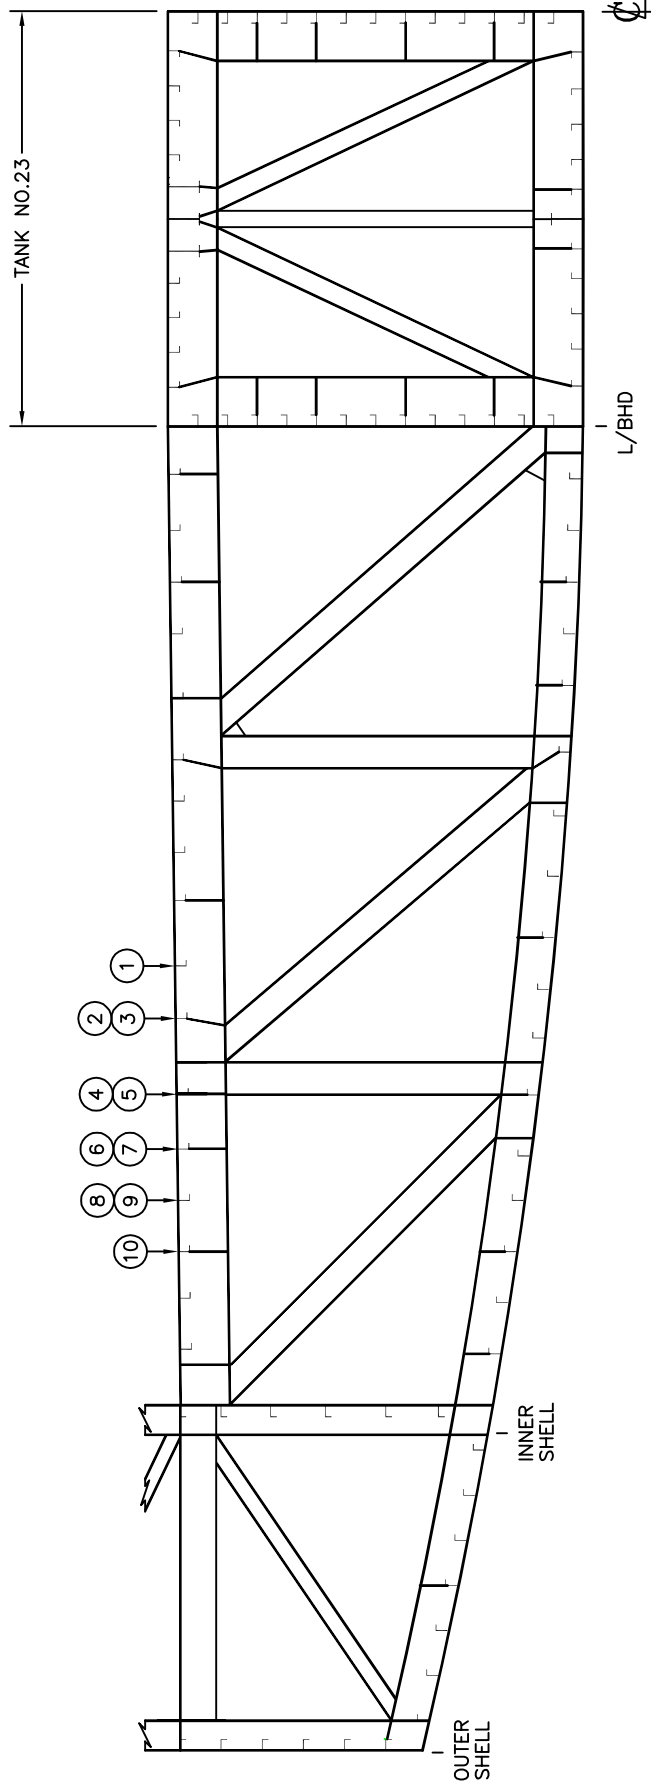
- 1.) 2" Fracture in web of longitudinal in way of channel cut-out, 17" south of frame.
- 2.) 2" Fracture in web of longitudinal in way of channel cut-out, 17" north of frame.
- 3.) 2" Fracture in web of longitudinal in way of channel cut-out, 17" south of frame.
- 4.) 2" Fracture in web of longitudinal in way of channel cut-out, 17" north of frame.
- 5.) 2" Fracture in web of longitudinal in way of channel cut-out, 17" south of frame.
- 6.) 2" Fracture in web of longitudinal in way of channel cut-out, 17" north of frame.
- 7.) 2" Fracture in web of longitudinal in way of channel cut-out, 17" south of frame.
- 8.) 2" Fracture in web of longitudinal in way of channel cut-out, 17" north of frame.
- 9.) 2" Fracture in web of longitudinal in way of channel cut-out, 17" south of frame.
- 10.) 2" Fracture in web of longitudinal in way of channel cut-out, 17" north of frame.

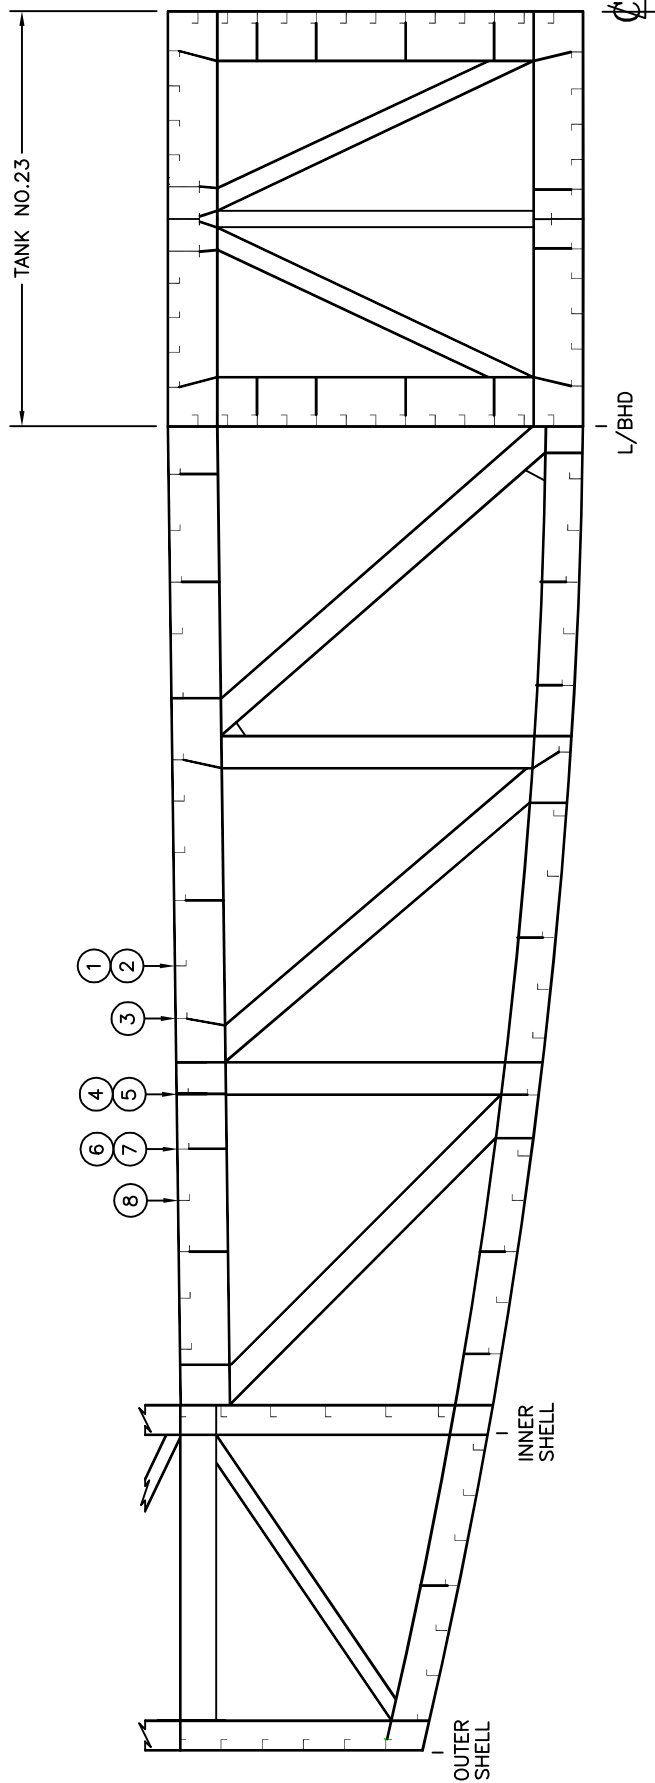
- 1.) 1 ½” Fracture in web of longitudinal in way of channel cut-out, 17” north of frame.
- 2.) Longitudinal web and flange fractured 100%, 17” south of frame.
- 3.) 1 ½” Fracture in web of longitudinal in way of channel cut-out, 17” north of frame.
- 4.) 1 ½” Fracture in web of longitudinal in way of channel cut-out, 17” north of frame.
- 5.) Longitudinal web and flange fractured 100%, 17” south of frame.
- 6.) 1 ½” Fracture in web of longitudinal in way of channel cut-out, 17” north of frame.
- 7.) Longitudinal web and flange fractured 100%, 17” south of frame.
- 8.) 1 ½” Fracture in web of longitudinal in way of channel cut-out, 17” north of frame.

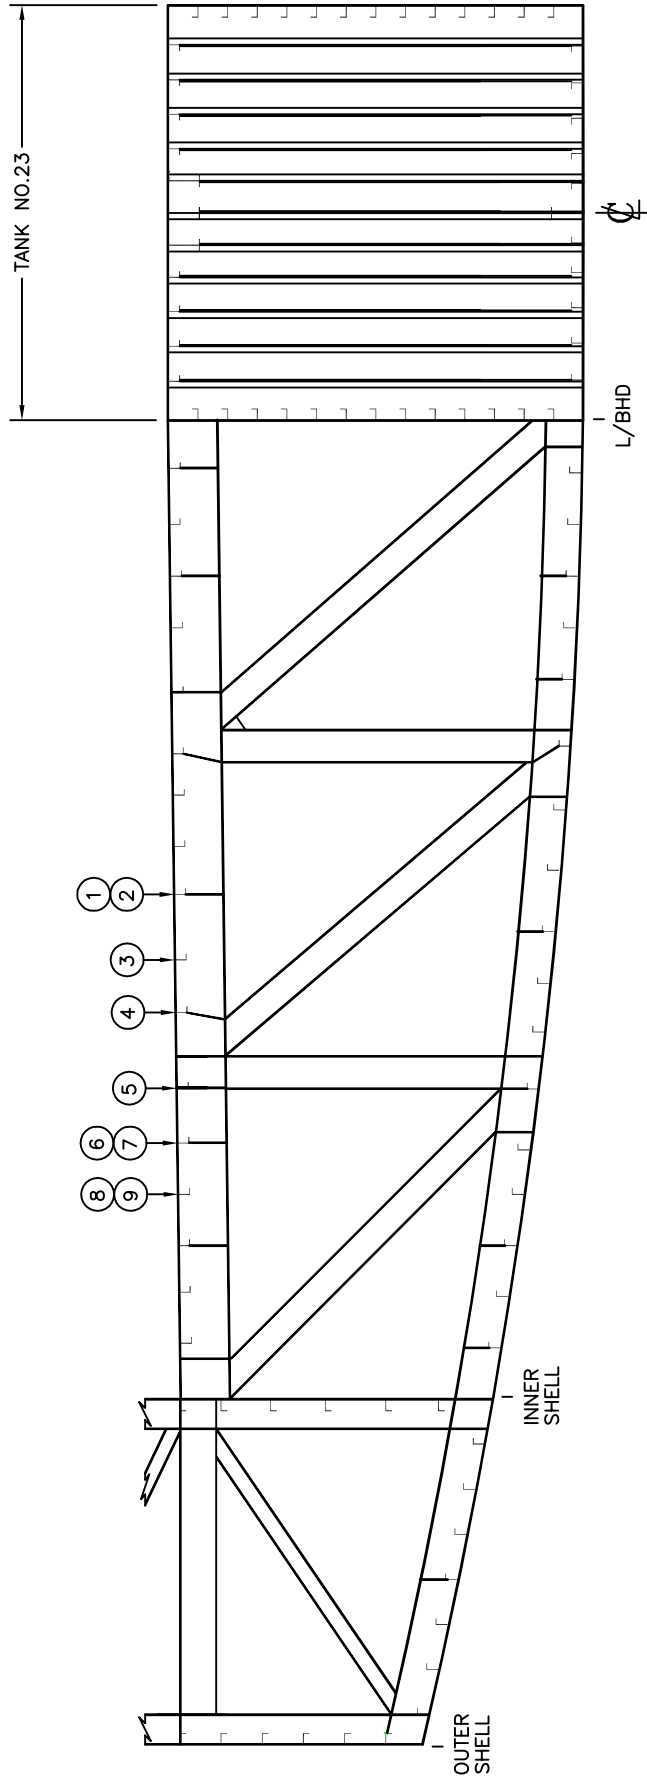
- 1.) 2 ½" Fracture in web of longitudinal in way of channel cut-out, 17" north of frame.
- 2.) 1" Fracture in web of longitudinal in way of channel cut-out, 17" south of frame.
- 3.) 2 ½" Fracture in web of longitudinal in way of channel cut-out, 17" north of frame.
- 4.) 1" Fracture in web of longitudinal in way of channel cut-out, 17" south of frame.
- 5.) 1" Fracture in web of longitudinal in way of channel cut-out, 17" south of frame
- 6.) 2 ½" Fracture in web of longitudinal in way of channel cut-out, 17" north of frame.
- 7.) 1" Fracture in web of longitudinal in way of channel cut-out, 17" south of frame.
- 8.) 2 ½" Fracture in web of longitudinal in way of channel cut-out, 17" north of frame.
- 9.) 1" Fracture in web of longitudinal in way of channel cut-out, 17" south of frame.

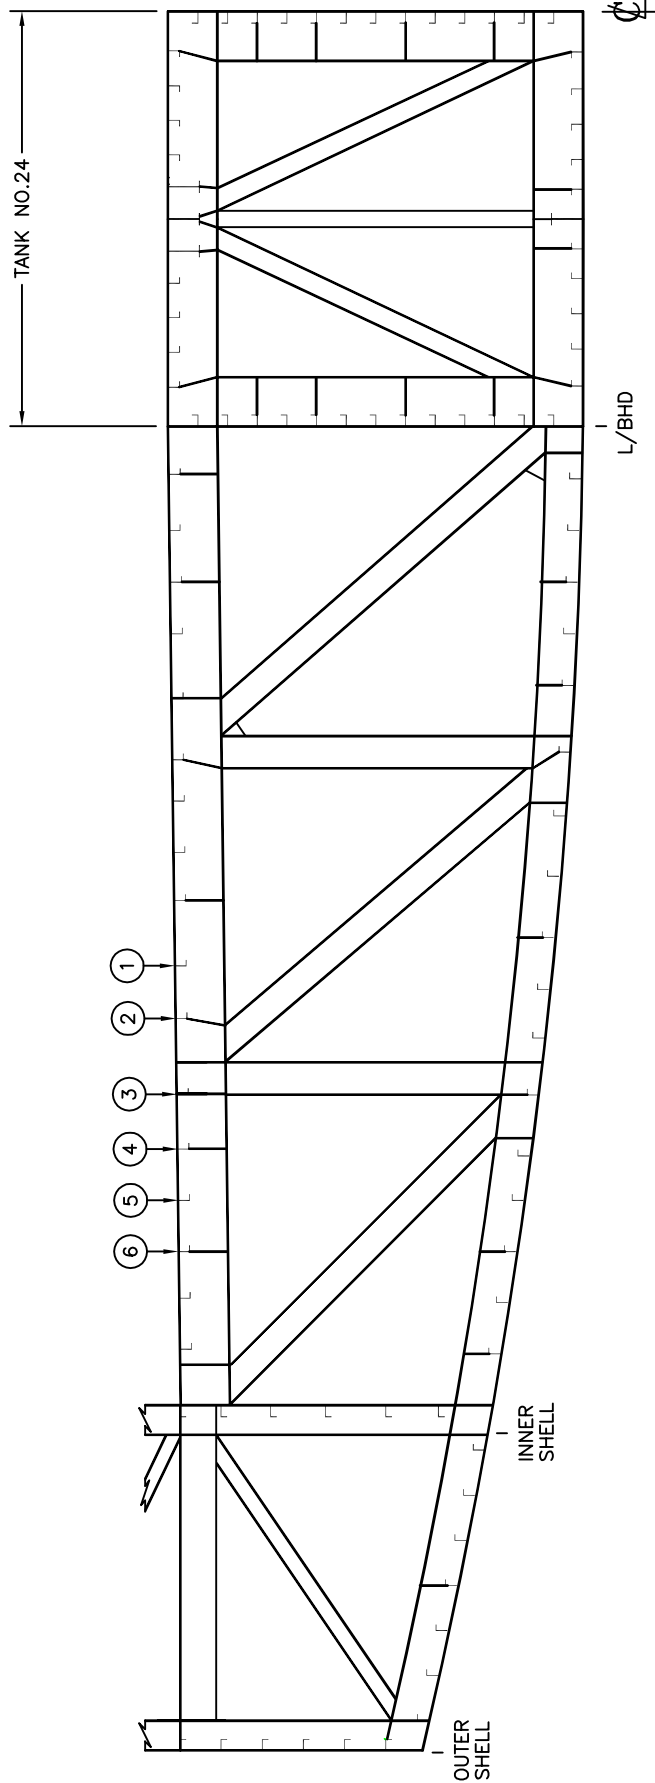
- 1.) 2” Fracture in web of longitudinal in way of channel cut-out, 17” north of frame.
- 2.) 2” Fracture in web of longitudinal in way of channel cut-out, 17” north of frame.
- 3.) 2” Fracture in web of longitudinal in way of channel cut-out, 17” north of frame.
- 4.) 2” Fracture in web of longitudinal in way of channel cut-out, 17” north of frame.
- 5.) 2” Fracture in web of longitudinal in way of channel cut-out, 17” north of frame.
- 6.) 2” Fracture in web of longitudinal in way of channel cut-out, 17” north of frame.
