# **HEGER DRY DOCK, INC**

16-87L

December 7, 2016

Re: Request for HEGER Certification of Dry Dock No. 2 located in BAE San Francisco, CA

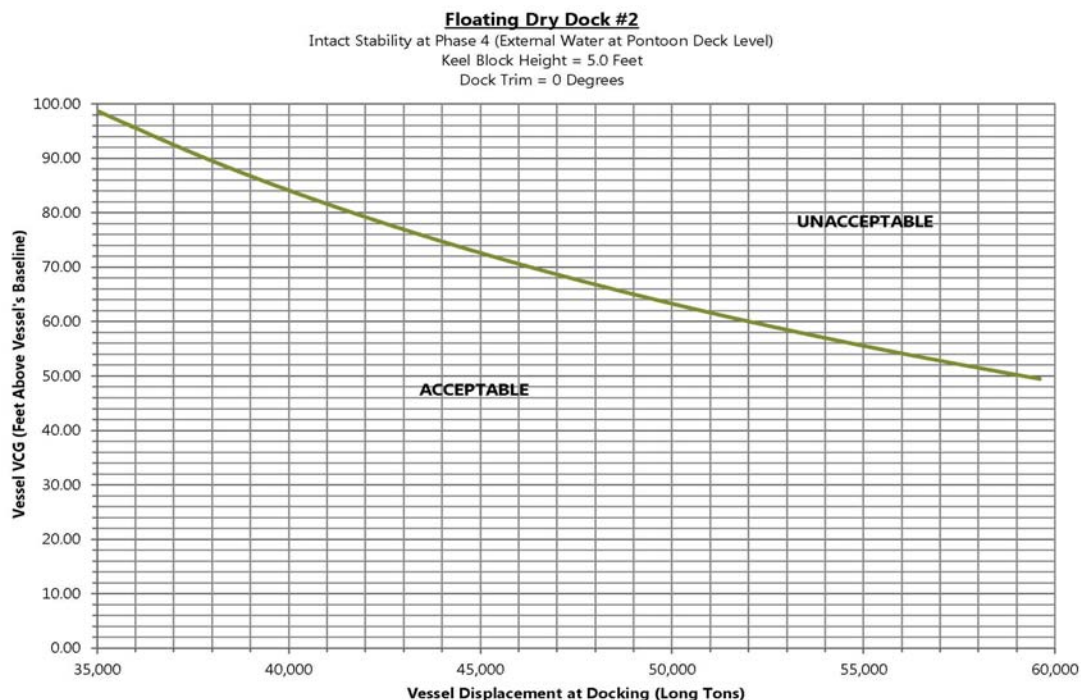
**FIGURE 1 – Intact Stability Curve**

Dry Dock No. 2 was renovated in 2008 by adding six (6) 40'x12' sponsons in order to increase its transverse intact stability for docking phases 3 and 4. HEGER has developed an allowable KG versus vessel weight curve for the floating dry dock for a minimum GM of 3.28 feet as required by ABS. The stability curve is shown Figure 1 below. Plotted points that fall on or below this line are acceptable, points above are unacceptable.

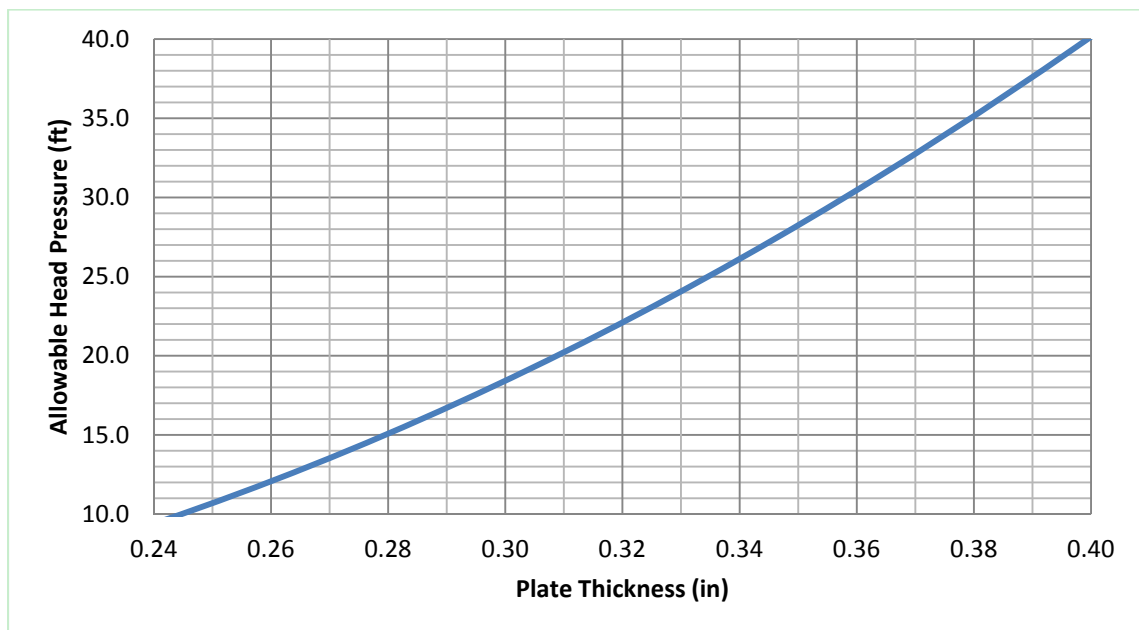
**FIGURE 2 - Allowable Head Pressure vs. Plate Thickness Curve**

The results are as follows and are shown in Figure 2:

To create the chart in Figure 2, the assumption is that the angle stiffeners welded to the shell plate have 15% corrosion or less.

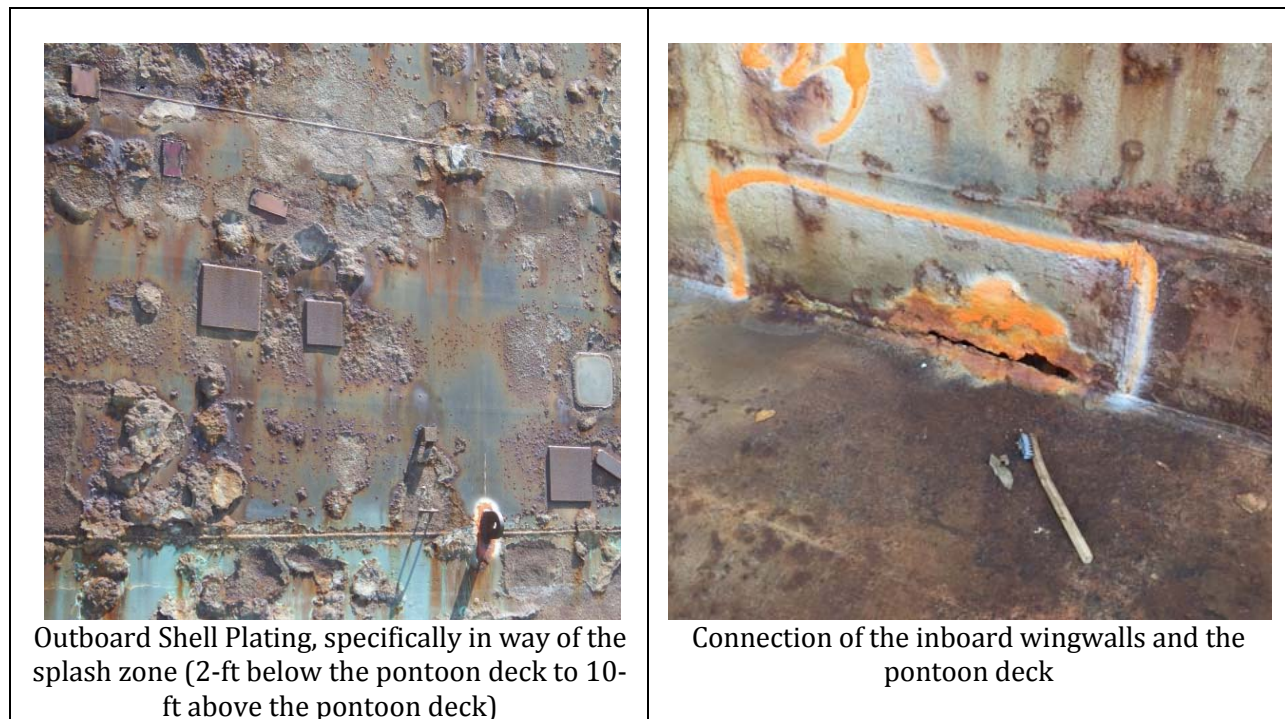
The UT survey results of the dock's external shell plating indicate areas of significant metal thickness loss. Areas of extensive corrosion were confirmed by HEGER's August 2016 visual inspection with numerous observed holes in the plating.

The most notable areas of corrosion are:

There have been ongoing repair efforts to the dock's original external plating to fix areas of extensive corrosion and holed-through plating. Some locations have been repaired by installing doubler plates over localized holes. Other areas of the external shell have been repaired by cropping and replacing 40-ft x 10-ft stiffened plate panels. The thickness of the new plate panels has been increased to 1/2" from the original 7/16".

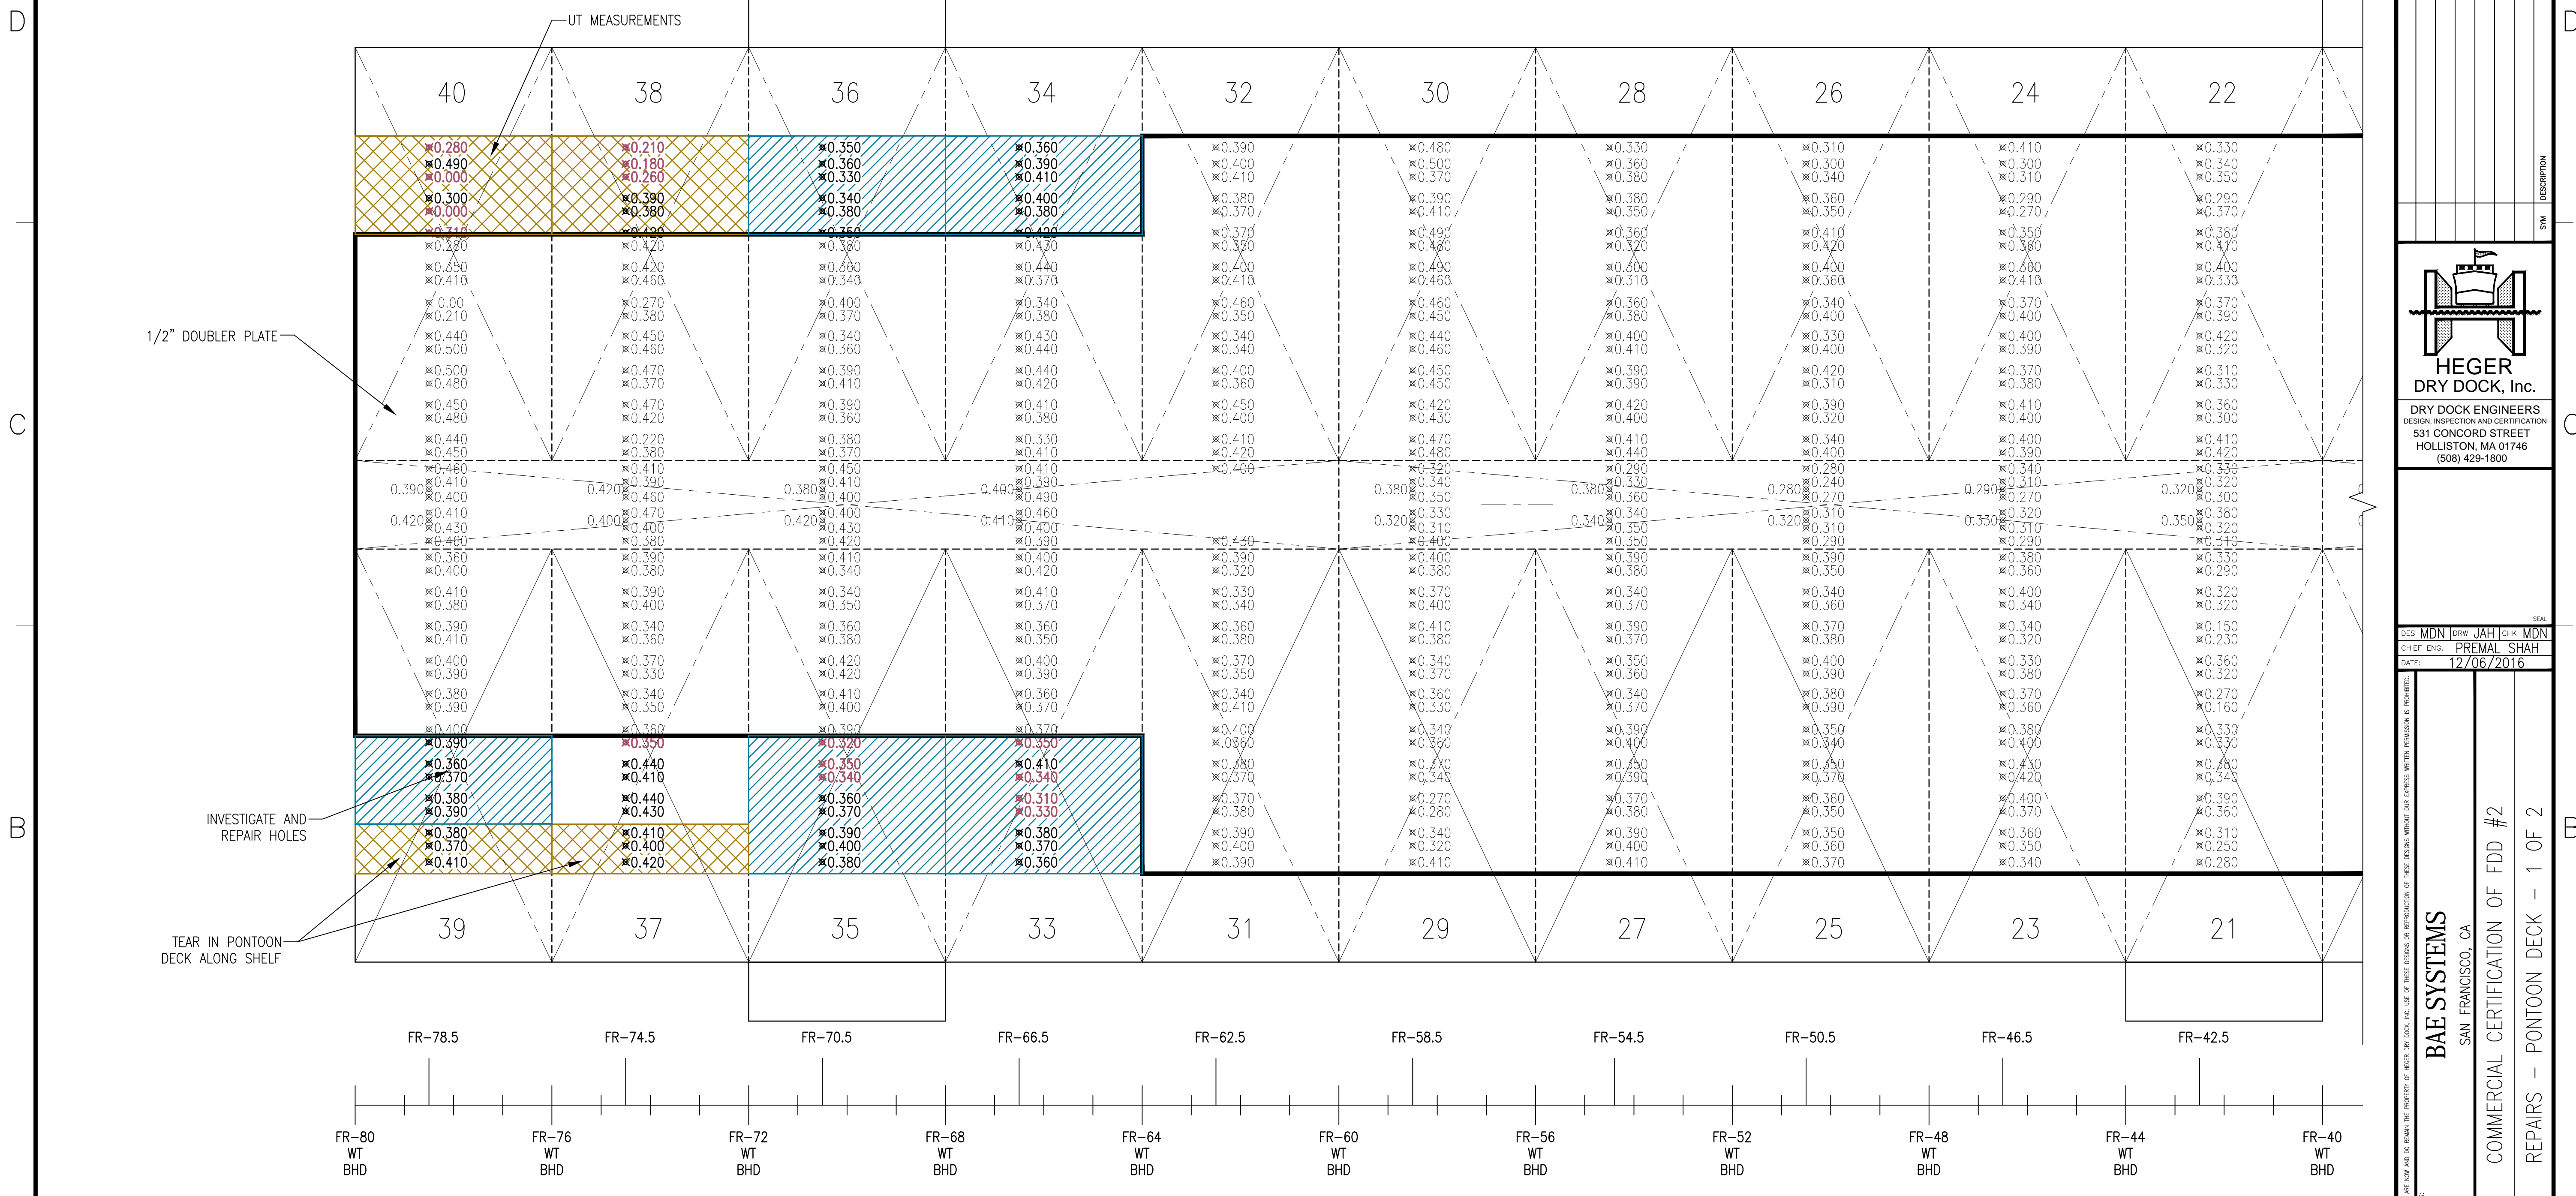
**PLAN - PONTOON DECK - UT MEASUREMENTS** A1  
SCALE: 1/16" = 1'-0"

The dock's original pontoon deck is severely corroded as reflected in the most recent ultrasonic thickness (UT) measurements surveyed by International Inspection in January 2016 (see Reference 2). UT measurements were taken internally and measured the thickness of the original deck plate only.

Doubler plates have been installed on the topside of the dry dock's original pontoon deck plate over about 65% of the surface with a concentration towards the dock's centerline. The doubler plates are 1/2" in thickness and are connected to the dock's original pontoon deck plate via 2" x 6" slot welds located along transverse and longitudinal structure. These slots welds are considered essential as they provide the doubler plates with required buckling capacity. The half-inch doubler plates were installed to fortify the original deck plate as an alternative to removing and replacing the corroded plating and stiffeners.

The majority of the pontoon deck has been covered with a 1/2" doubler plate. This is not a viable long term solution for the dock. HEGER recommends a maintenance plan be developed to properly replace the corroded deck panels with insert plates. Note that the dock was originally designed with 1/2" high strength steel (yield point of 50 ksi). HEGER recommends any pontoon deck replacements be 3/4" high strength steel. Note that this may correspond to a small reduction in the lift capacity of the dock due to an increase in dock weight, but will build in additional corrosion allowance.

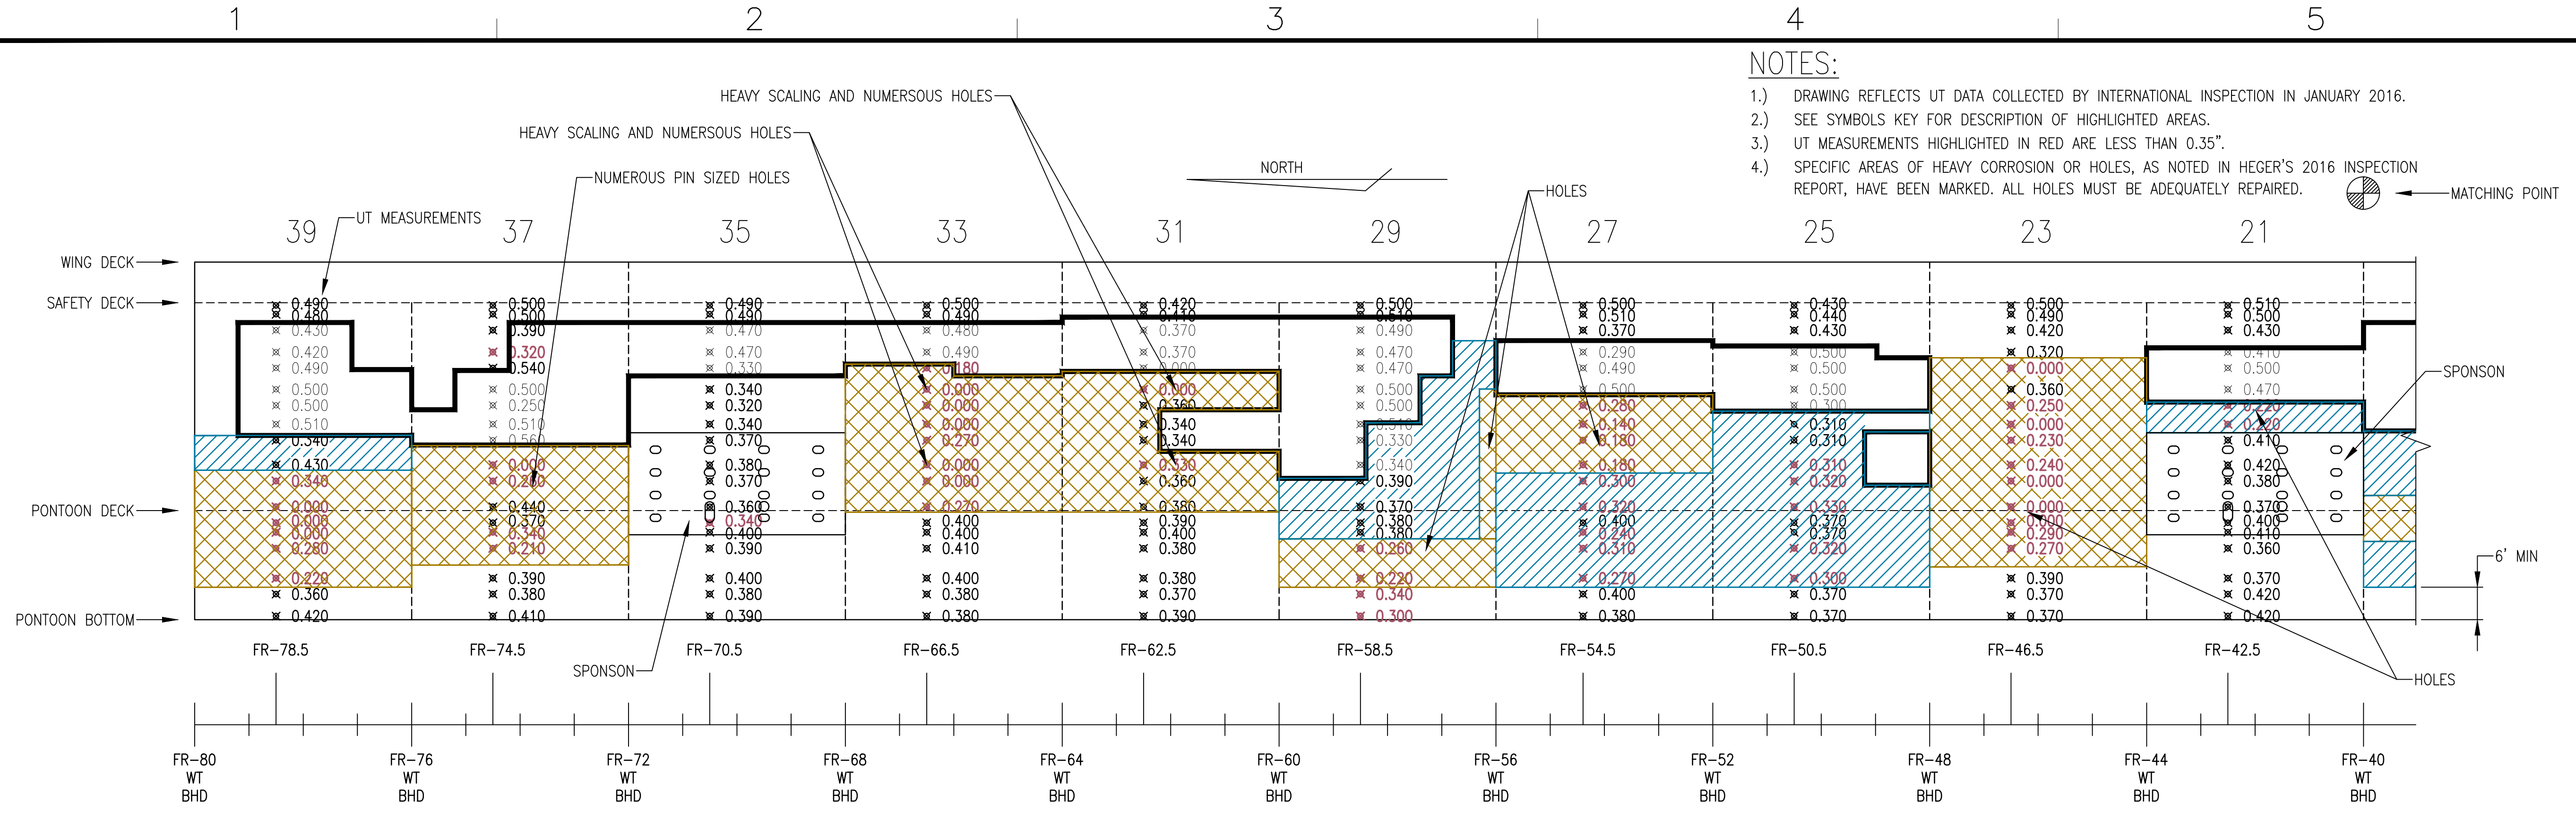
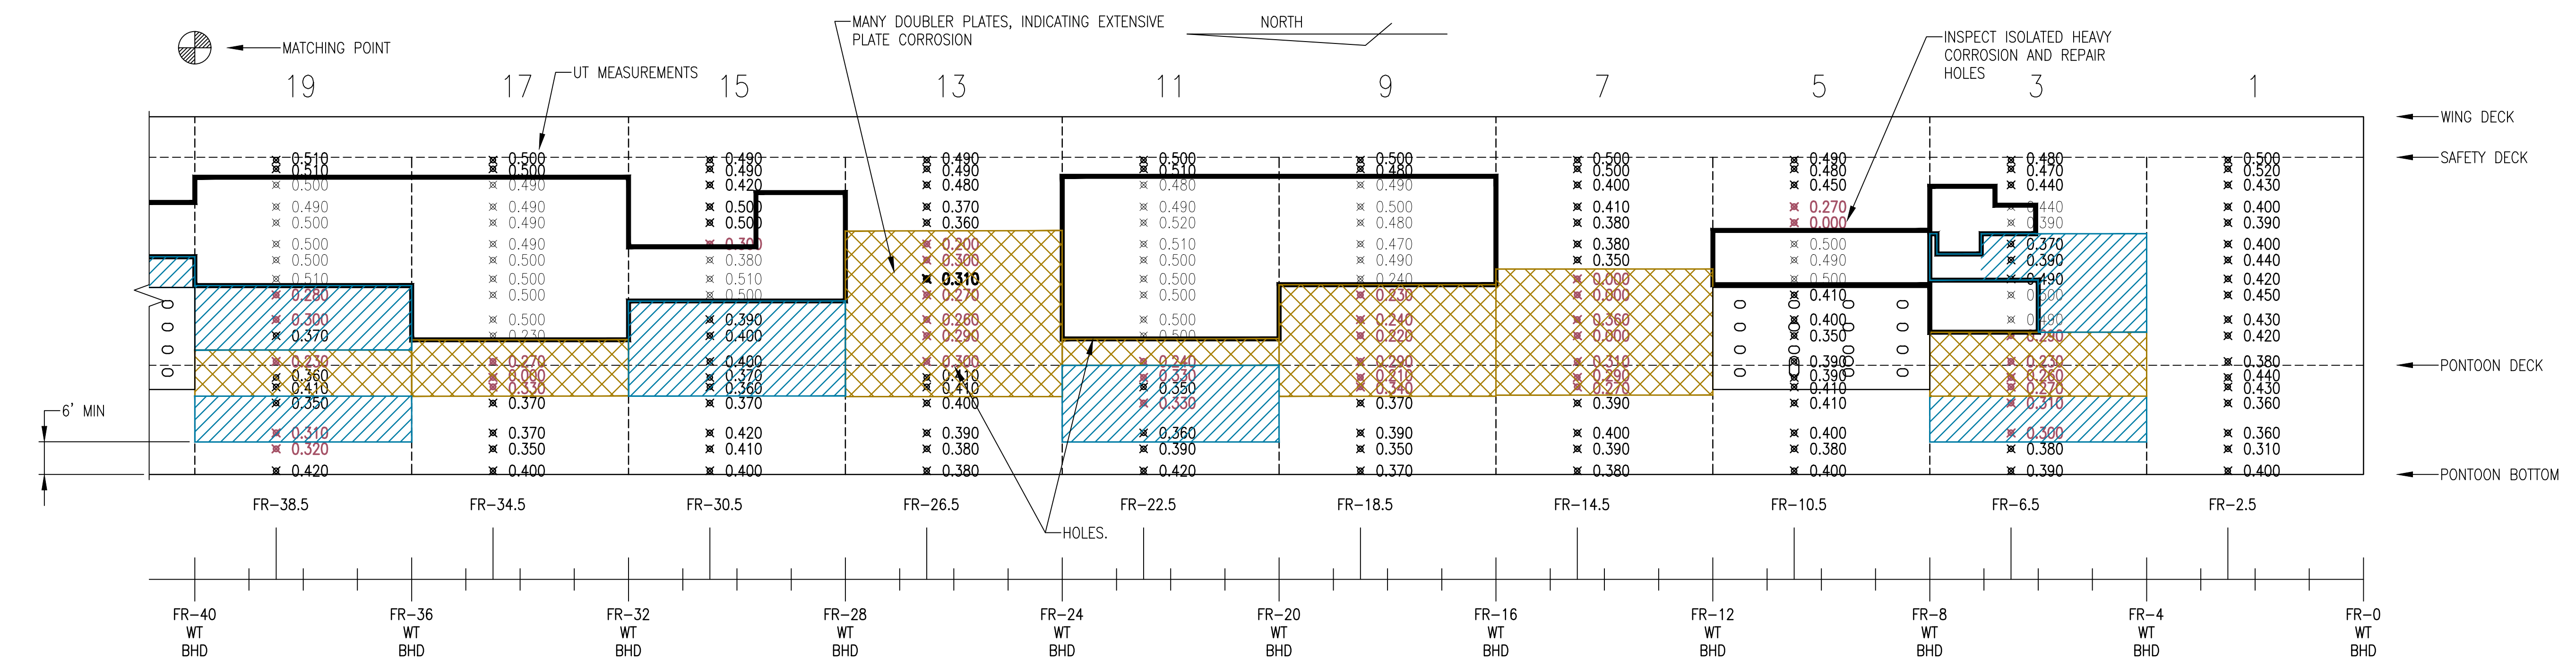
**REPAIRS - WEST OUTBOARD WINGWALL**

The majority of the external shell repairs have been made to the East and West outboard shells with about 20% of the dock's original plate panels being replaced.

In the drawings listed below, all areas are generally mapped out on a tank by tank basis. It is recommended the external shell in these areas be cropped out and replaced with a fabricated insert plate to properly repair the area. In the event of small isolated holes, a doubler plate may be installed as a temporary fix.
