HEGER DRY DOCK, INC

January 19, 2017

Re: Docking of Tandem Barges on Eureka

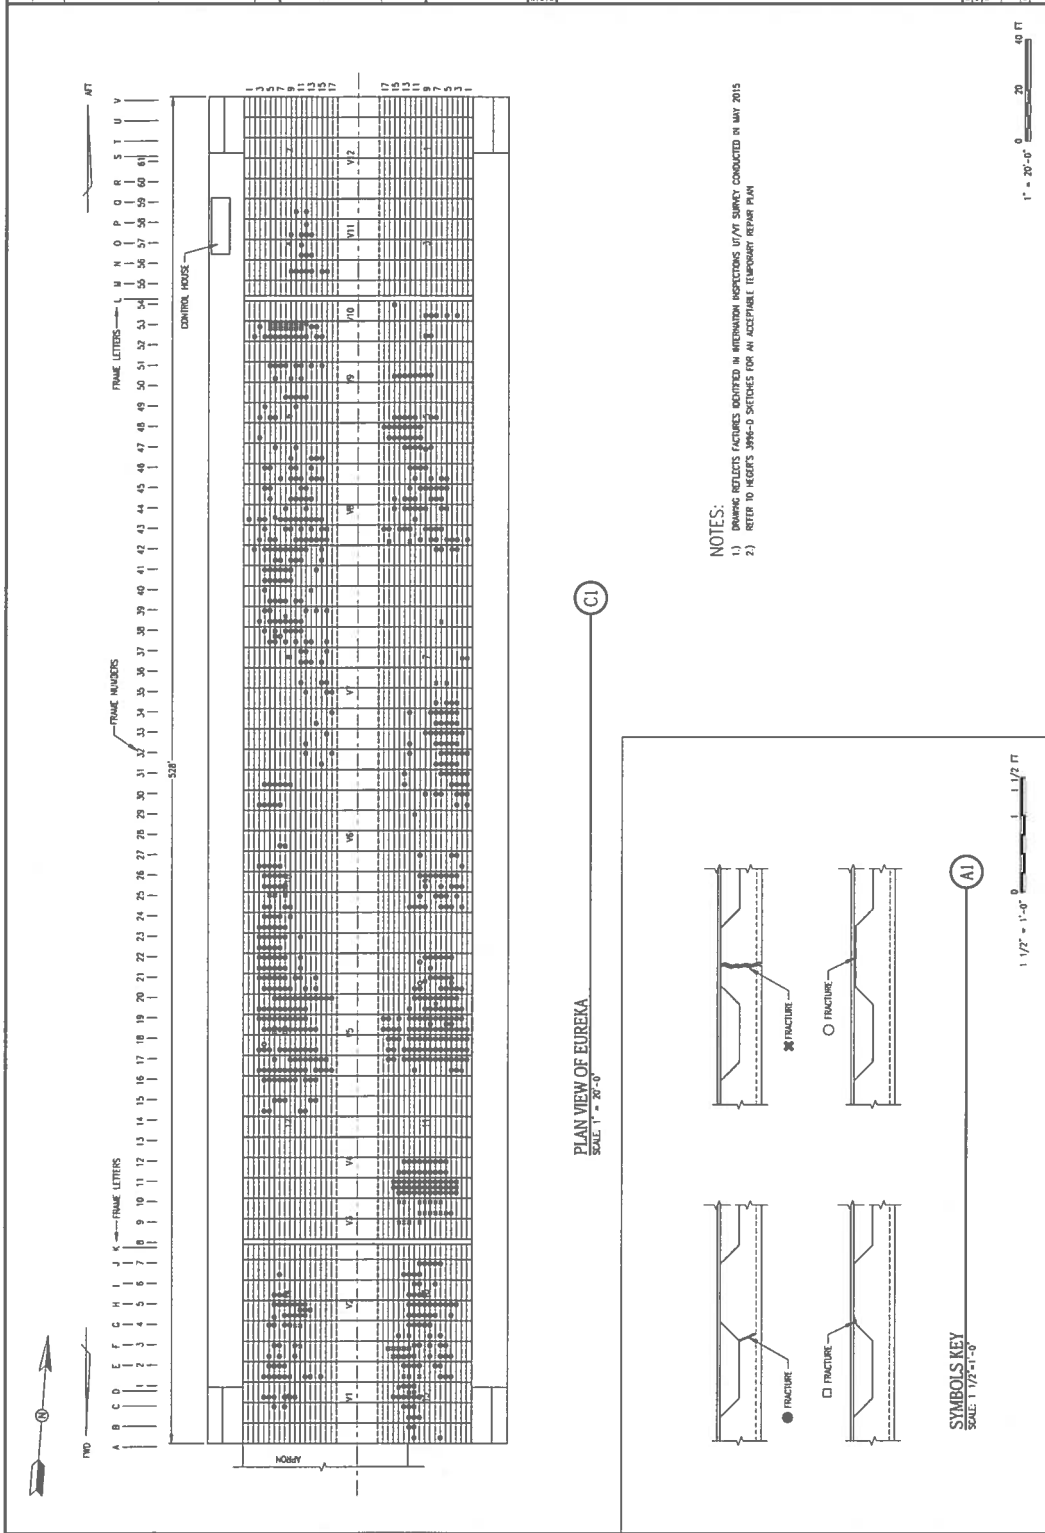
ENCLOSURE 2
Pontoon Deck Stiffener Fracture Map

The EUREKA's pontoon deck stiffeners, however, have a widespread condition of fractures to the channel stiffeners in way of the serrated notches. A fracture in the serrated channel creates a discontinuity in the flow of bending stresses and changes the boundary condition of the stiffener beam from a fixed-fixed condition to two independent cantilevered beams overhanging from the supporting transverse frame. These cantilevered beams are significantly weaker and are assumed to take no load. As a result of the failure, the hydrostatic load is redistributed to adjacent stiffeners,

The latest 2017 HEGER inspection of the EUREKA pontoon deck found that the typical condition was for multiple adjacent pontoon deck stiffeners to be fracture. This is an UNSATISFACTORY condition to resist the head pressures required of the tandem barge docking addressed in this letter.

NOTES:
 1) DRAWING REFLECTS FRACTURES IDENTIFIED IN INTERIM INSPECTIONS U/V AT SURVEY CONDUCTED IN MAY 2015
 2) REFER TO HEGER'S 3996-D SKETCHES FOR AN ACCEPTABLE TEMPORARY REPAIR PLAN

There are four(4) different types of stiffener fractures occurring on the pontoon deck stiffeners. An acceptable short term pontoon deck stiffener repair plan for each fracture type is attached in Enclosure (3). Pontoon deck stiffeners should be repaired in accordance with the repair plan to eliminate the unsatisfactory conditions stated above. If staging is erected in a tank to repair deck stiffeners, it is recommended all stiffeners in the vicinity be repaired.

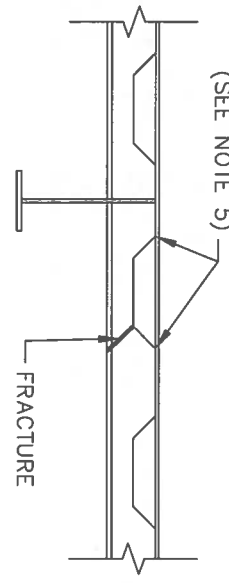
TYPE 1a
FRACTURE IN WAY OF CHANNEL CUT OUT—FLANGE DETERIORATED EXISTING CONDITION

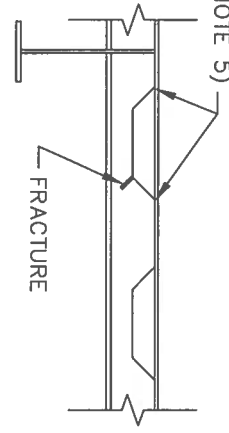
TYPE 1b
FRACTURE IN WAY OF CHANNEL CUT OUT—FLANGE OK EXISTING CONDITION

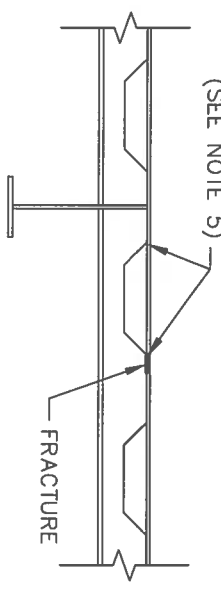
TYPE 2 FRACTURE IN WAY OF WRAP WELD EXISTING CONDITION

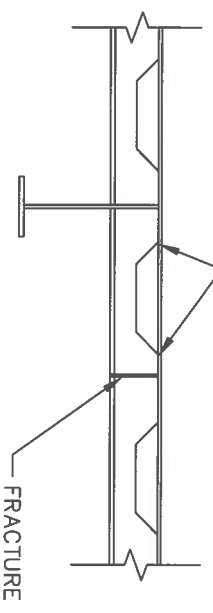
TYPE 3 FRACTURE IN WEB AND FLANGE EXISTING CONDITION

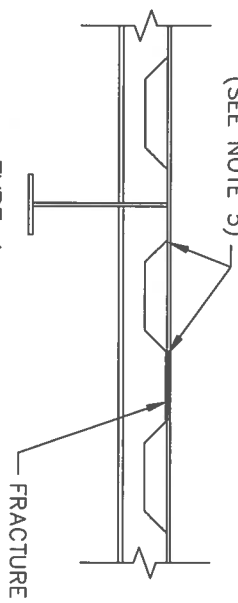
TYPE 4 FRACTURE AT ATTACHMENT WELD EXISTING CONDITION
