**COMMERCIAL INSPECTION  
for  
EUREKA FLOATING DRY DOCK  
REVISION 1**

**HEGER DRY DOCK, INC.**  
HOLLISTON, MASSACHUSETTS

**JANUARY 2017**  
Job# 3978-D

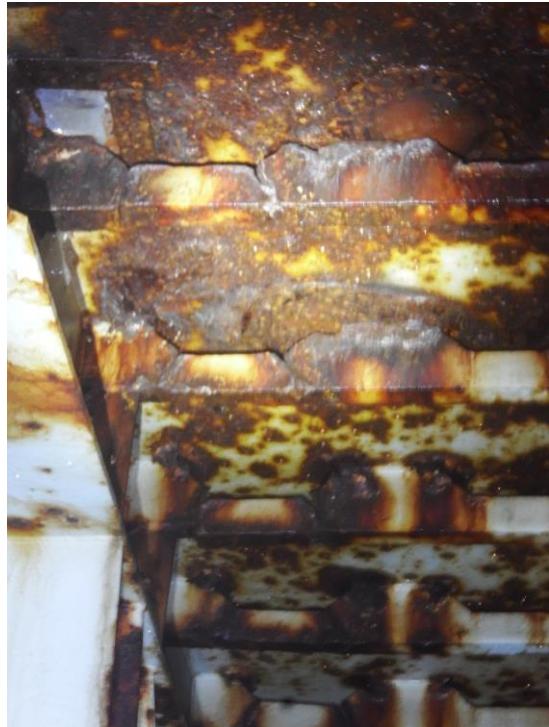
Photo 1: Multiple stiffeners in "severe condition" (as referenced in Appendix F *Material Condition Survey Deficiencies*).

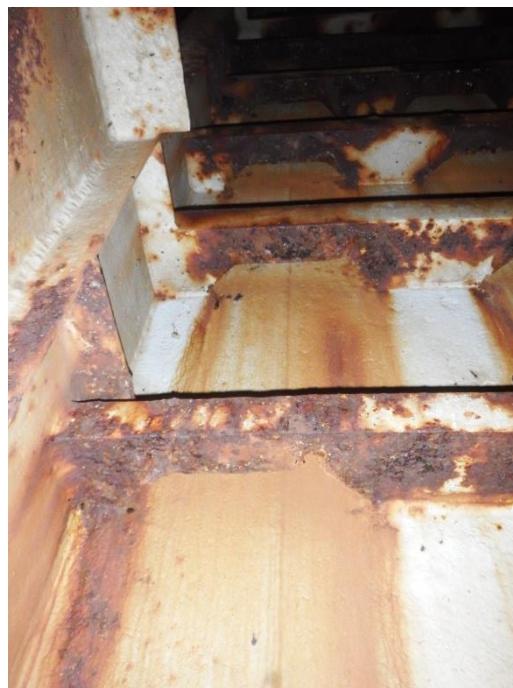
Photo 2: Typical notched condition of a stiffener.

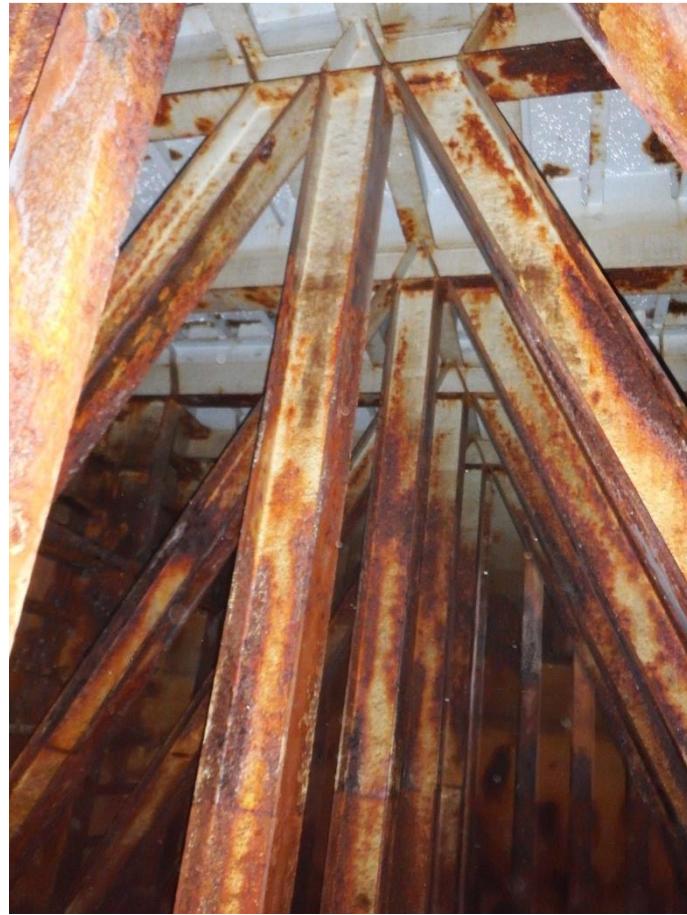
Photo 3: Condition of a corroding void tank.

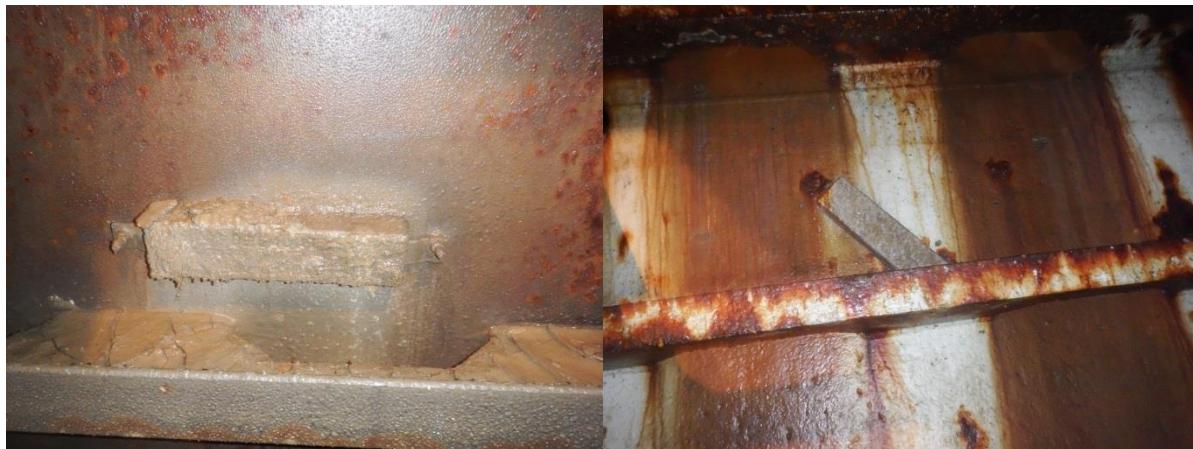
All exterior zinxs are wasted away. These should be repaired.

Photos 4 and 5: Typical condition of zinc anodes throughout the dock.

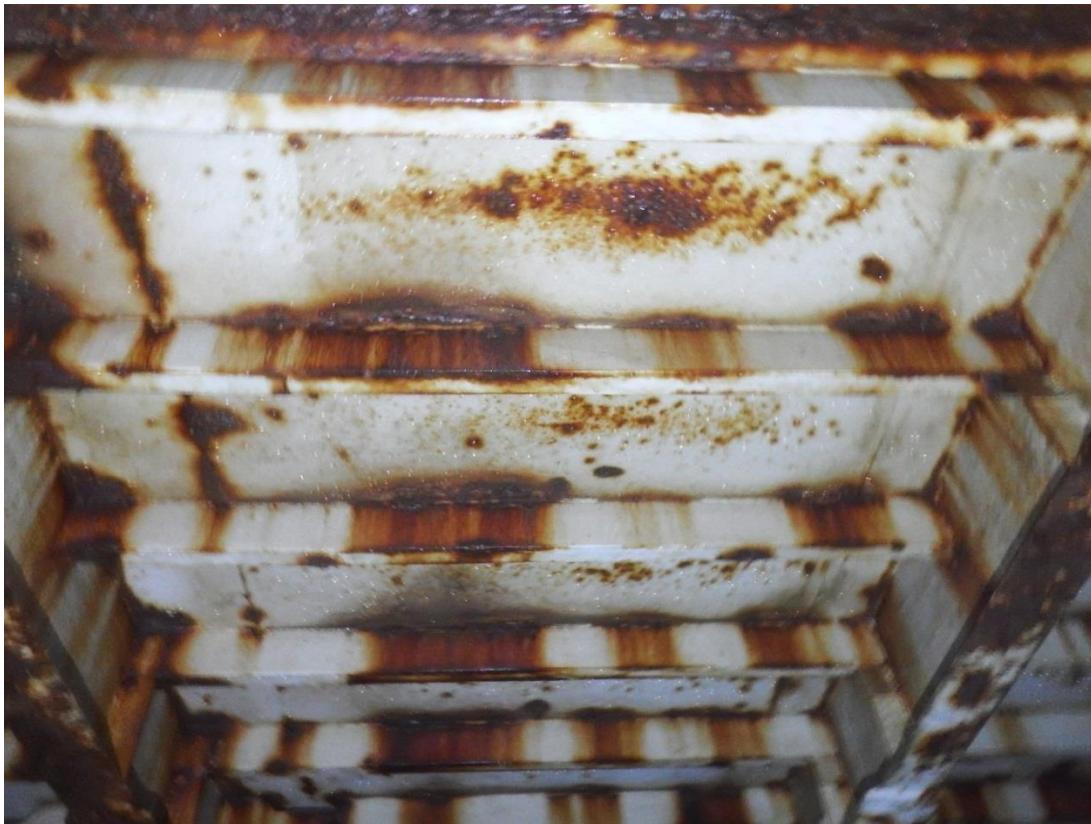
Photo 5: Typical condition of solid stiffeners. Notice skip welding and corrosion at unwelded contact between the stiffener and pontoon deck.

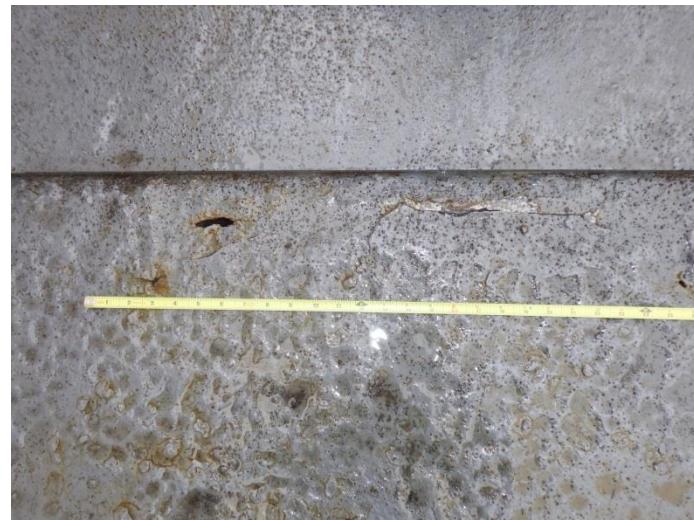
Photo 6: Tension crack over tank 9.

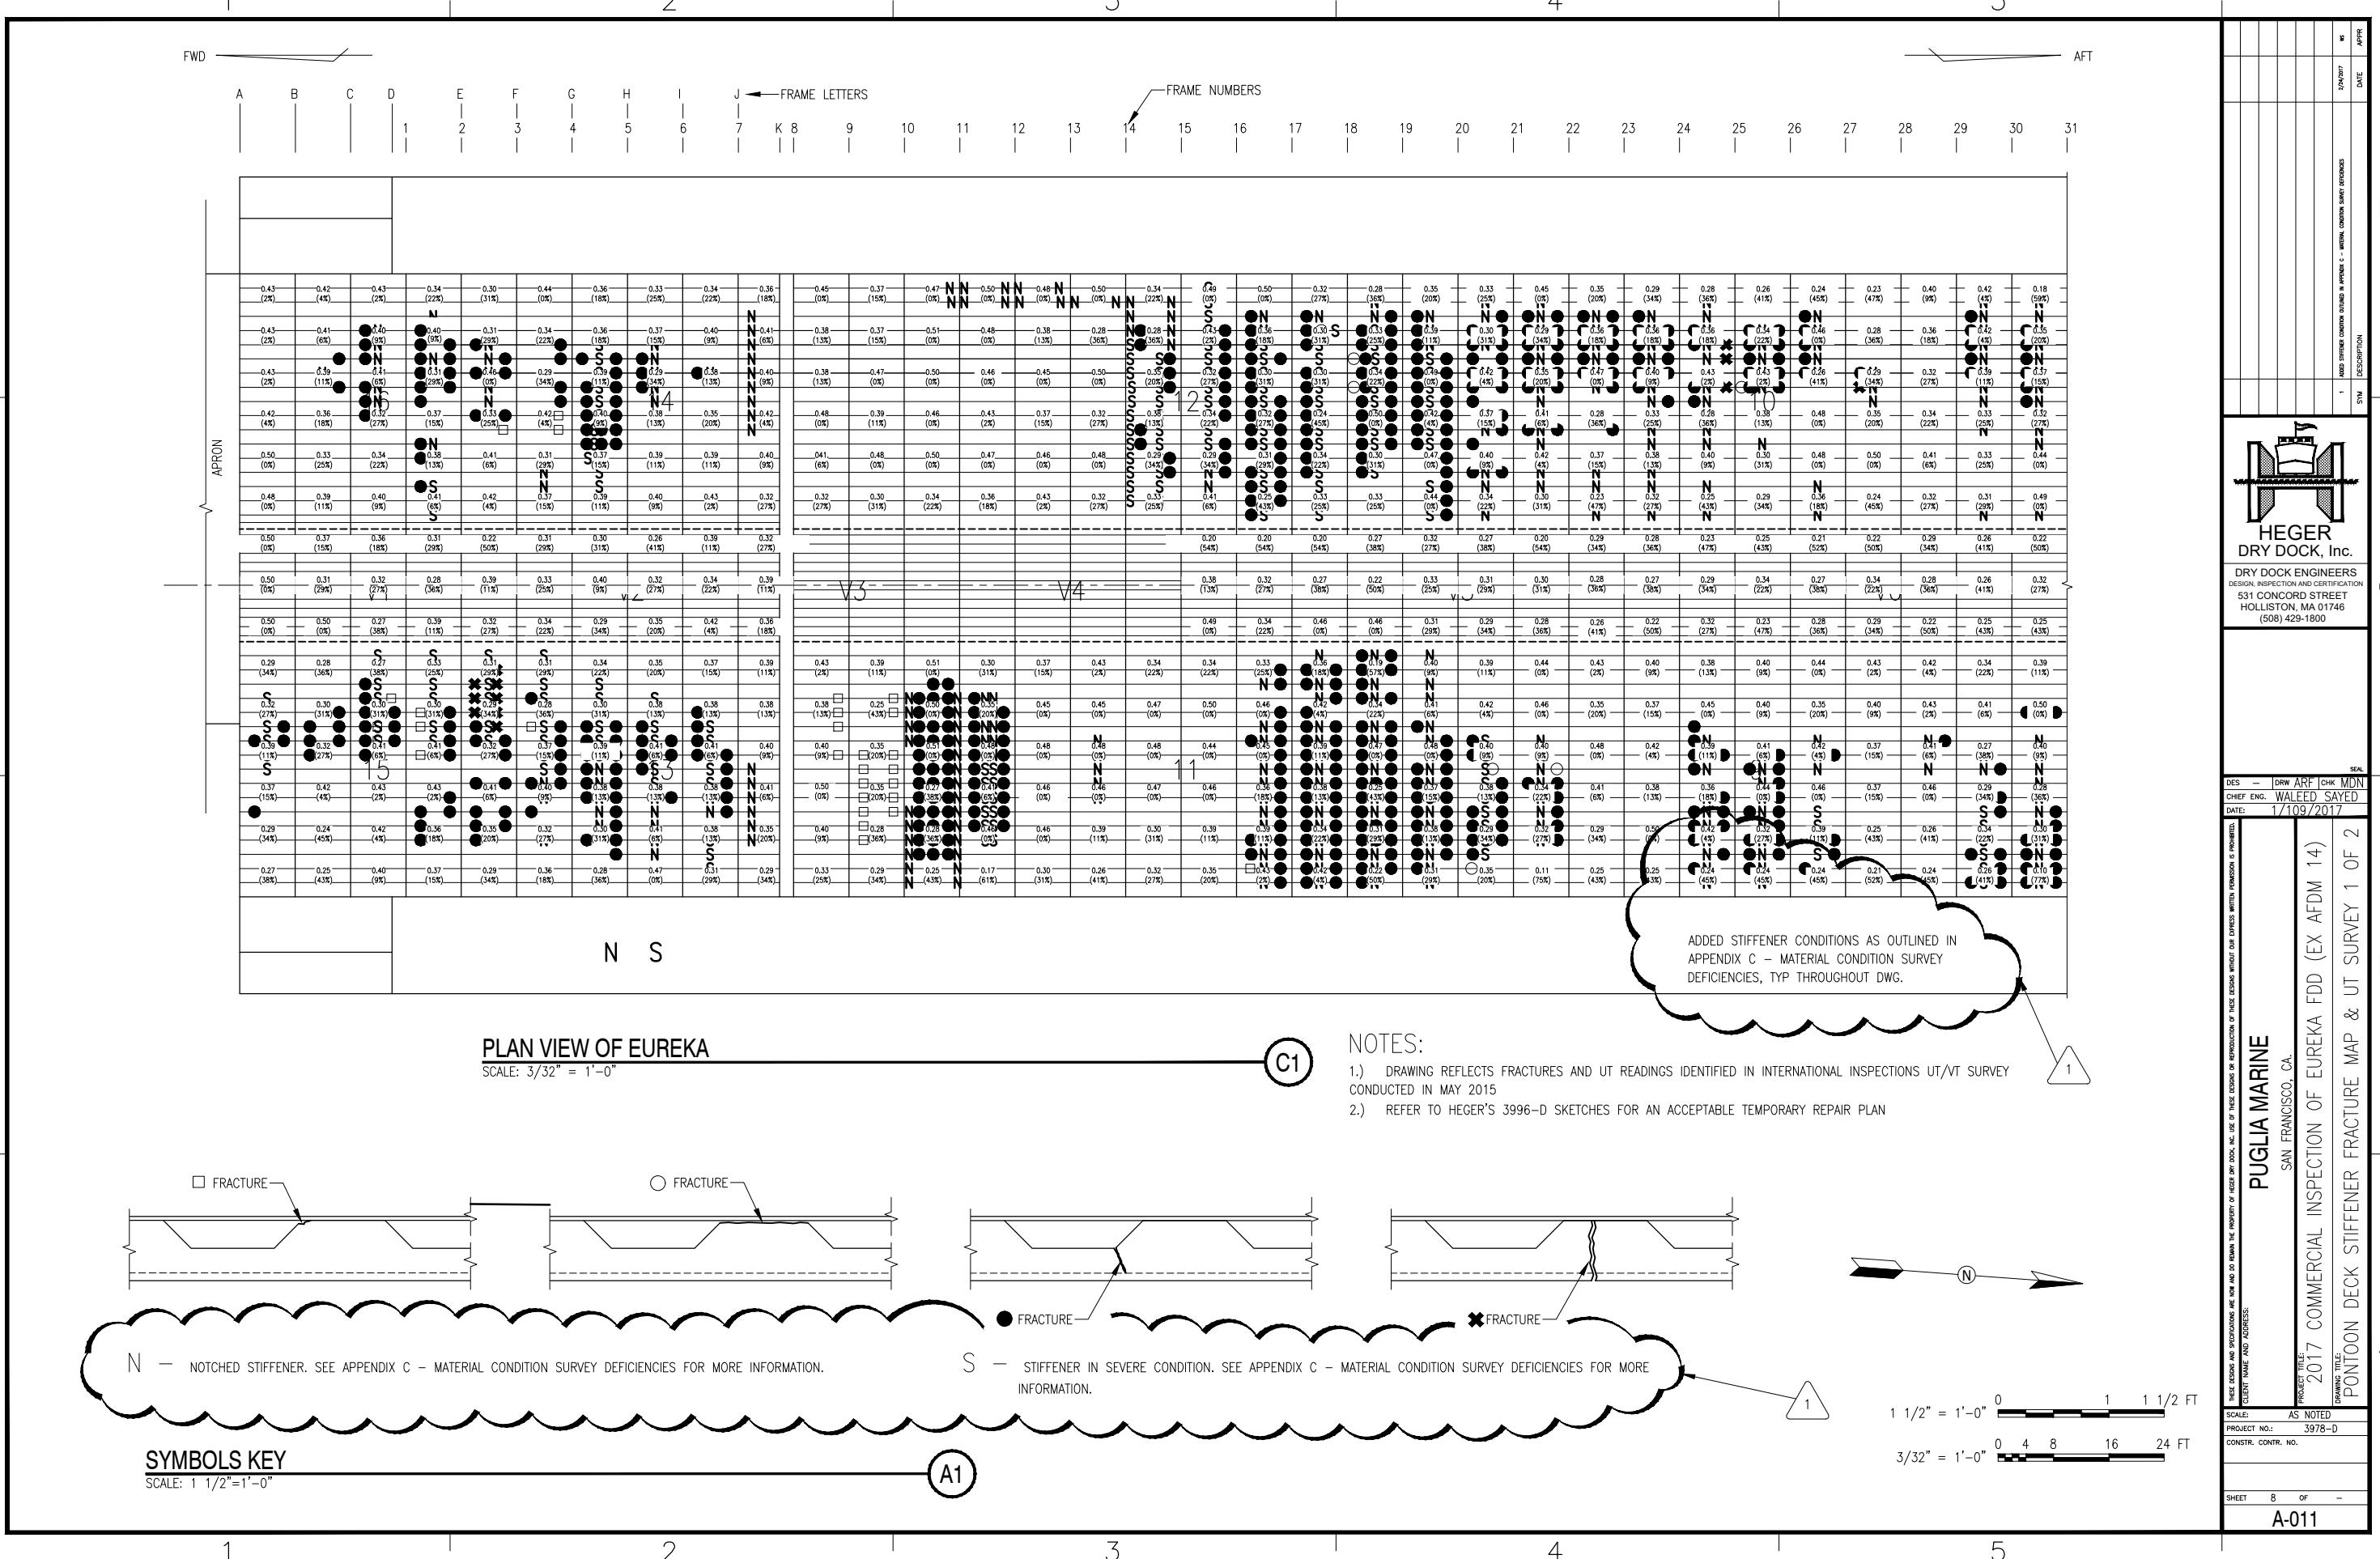
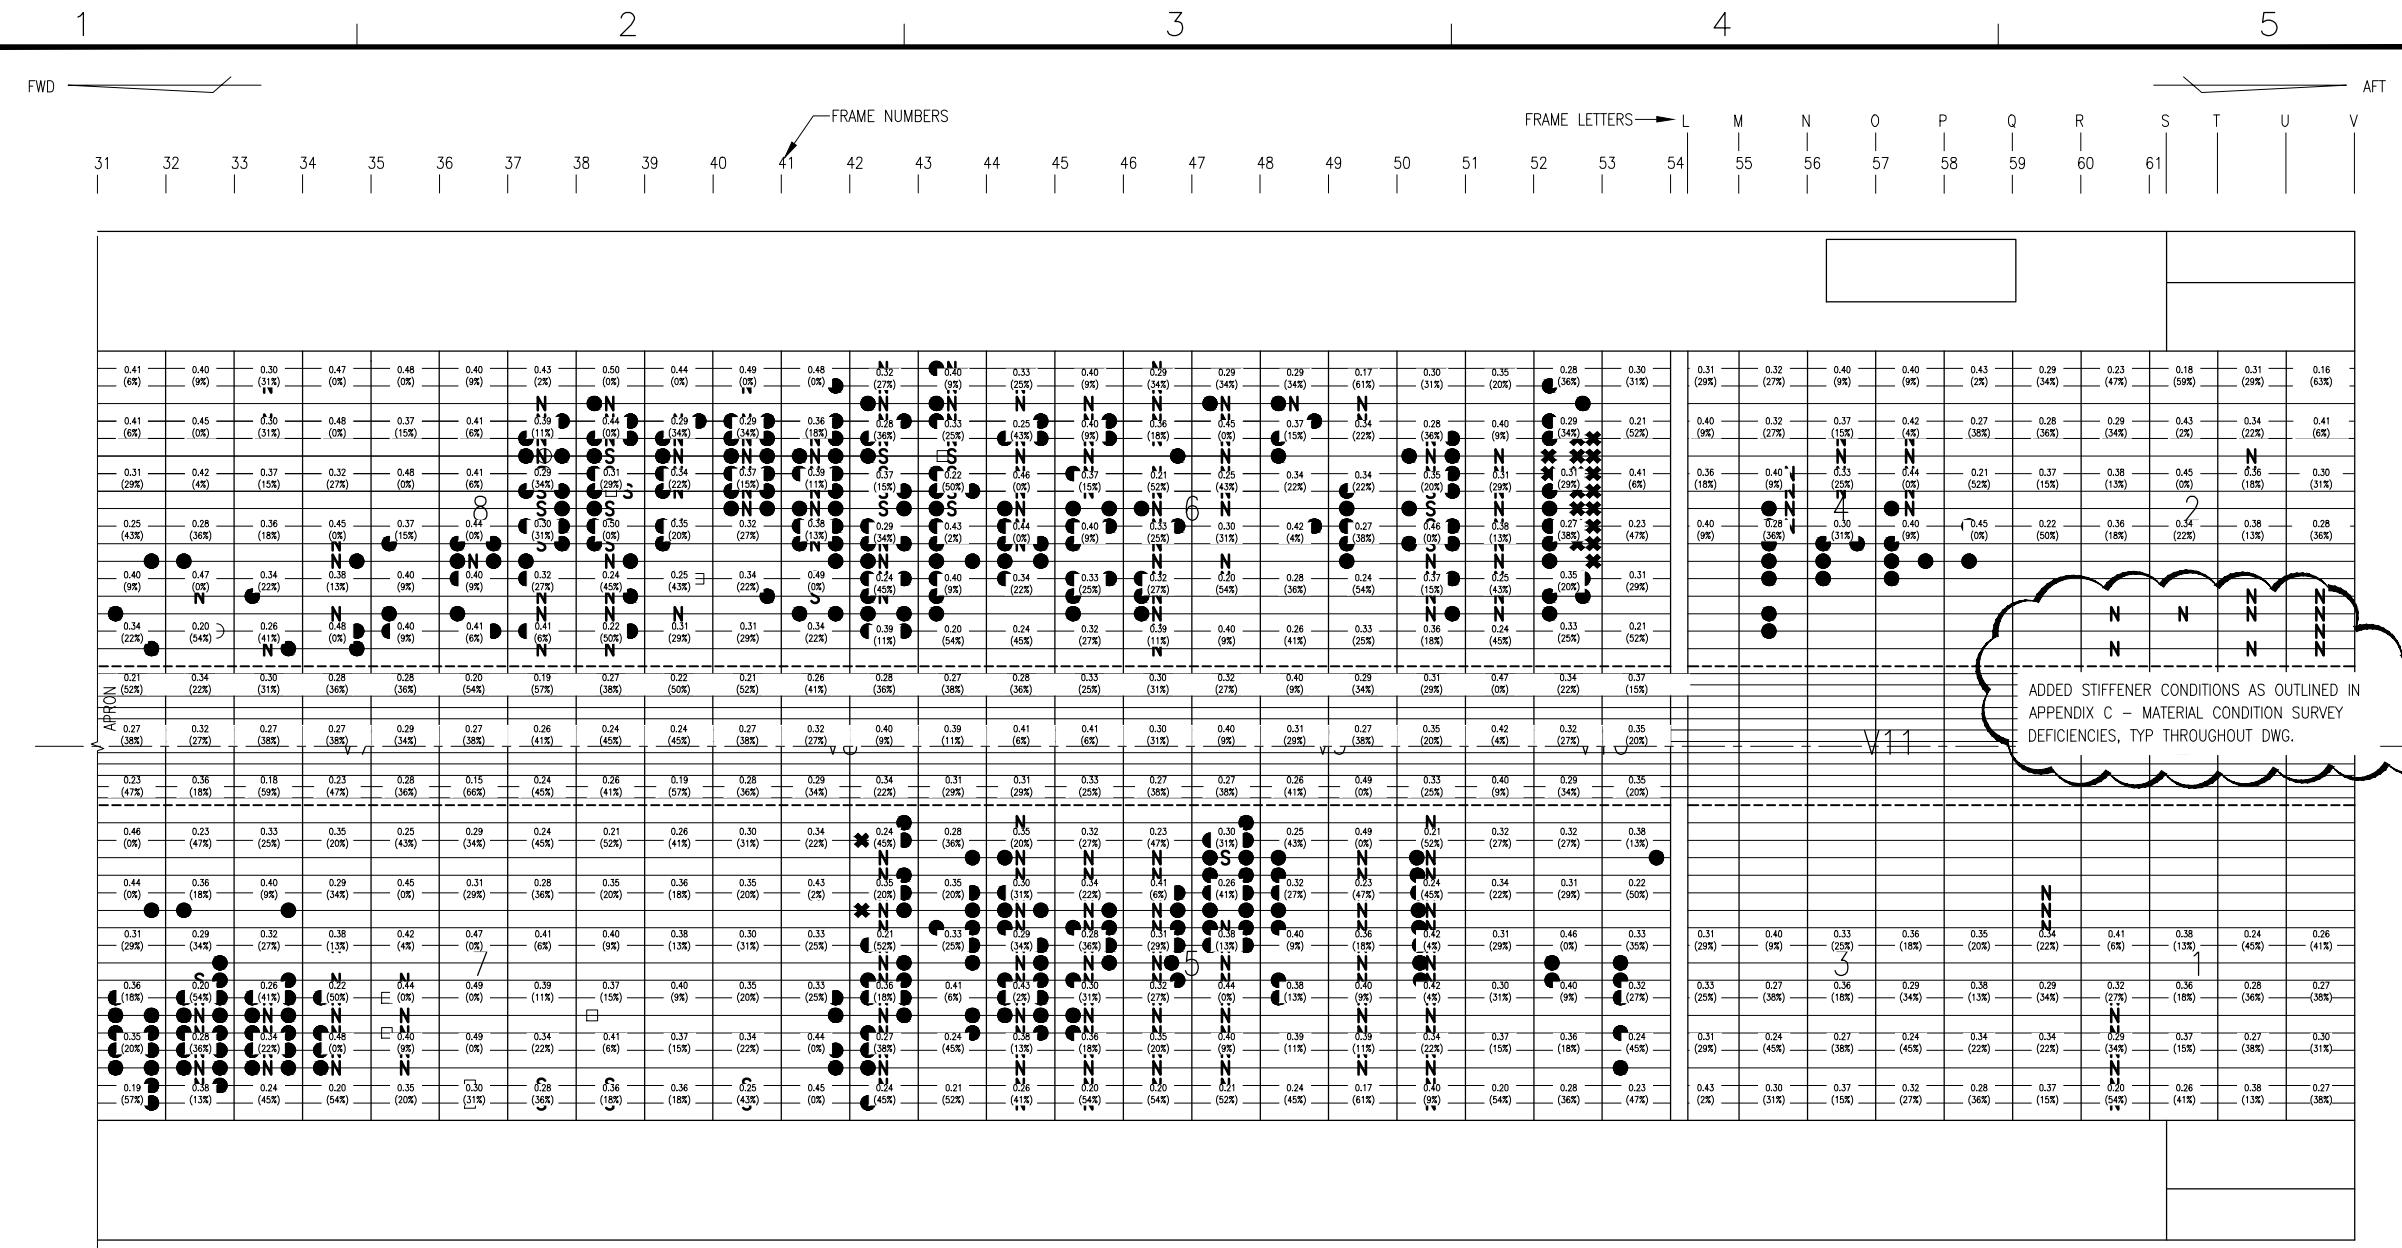
Pontoon Deck Stiffener Fracture Map and UT Report

The serrated pontoon deck stiffeners were once installed to optimize ratio of steel material to strength. However, this design is susceptible to stress concentration induced failures at the corners of the serrated notches. These stress induced failures occurred all throughout the dock,

at varying degrees as severity. The map of all pontoon deck fractures can be found on Appendix G - *Pontoon Deck Fractures Map and UT Survey*. The fatigue failures are common throughout all tanks although tanks which resist both head pressure and cyclical vehicular loading are most impacted.

Stiffener repair must be completed in accordance with Appendix I *Deck Stiffener Repairs*. Specific locations regarding fractured stiffeners can be found in Appendix G *Pontoon Deck Stiffener Fracture Map and UT Report*.

**NOTEWELL:** Vehicles may not travel over any area of the pontoon deck that has been identified to have cracked or separated stiffeners without a temporary 1" thick doubler plate. See Appendix G *Pontoon Deck Stiffener Fracture Map and UT Report*. The use of a doubler plate on the pontoon deck is intended only to facilitate access to areas in need of repair. It is not an approved method of repair.

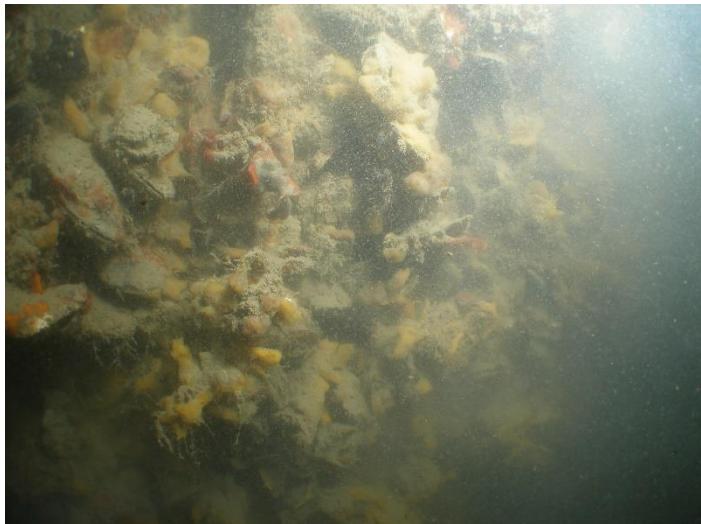
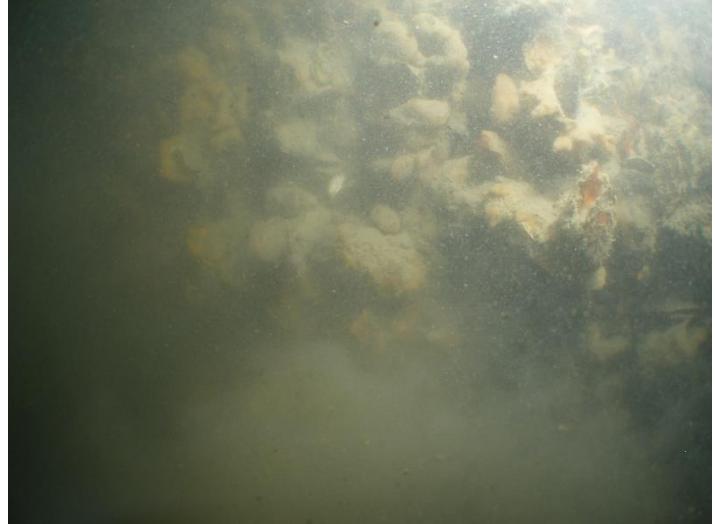
The dive crew cleaned the screens. The screens had mostly hard growth and were clogged up to 90%. All the screens were pressure washed and the marine growth was removed.

Typical condition of a screen (90% clogged with marine growth)

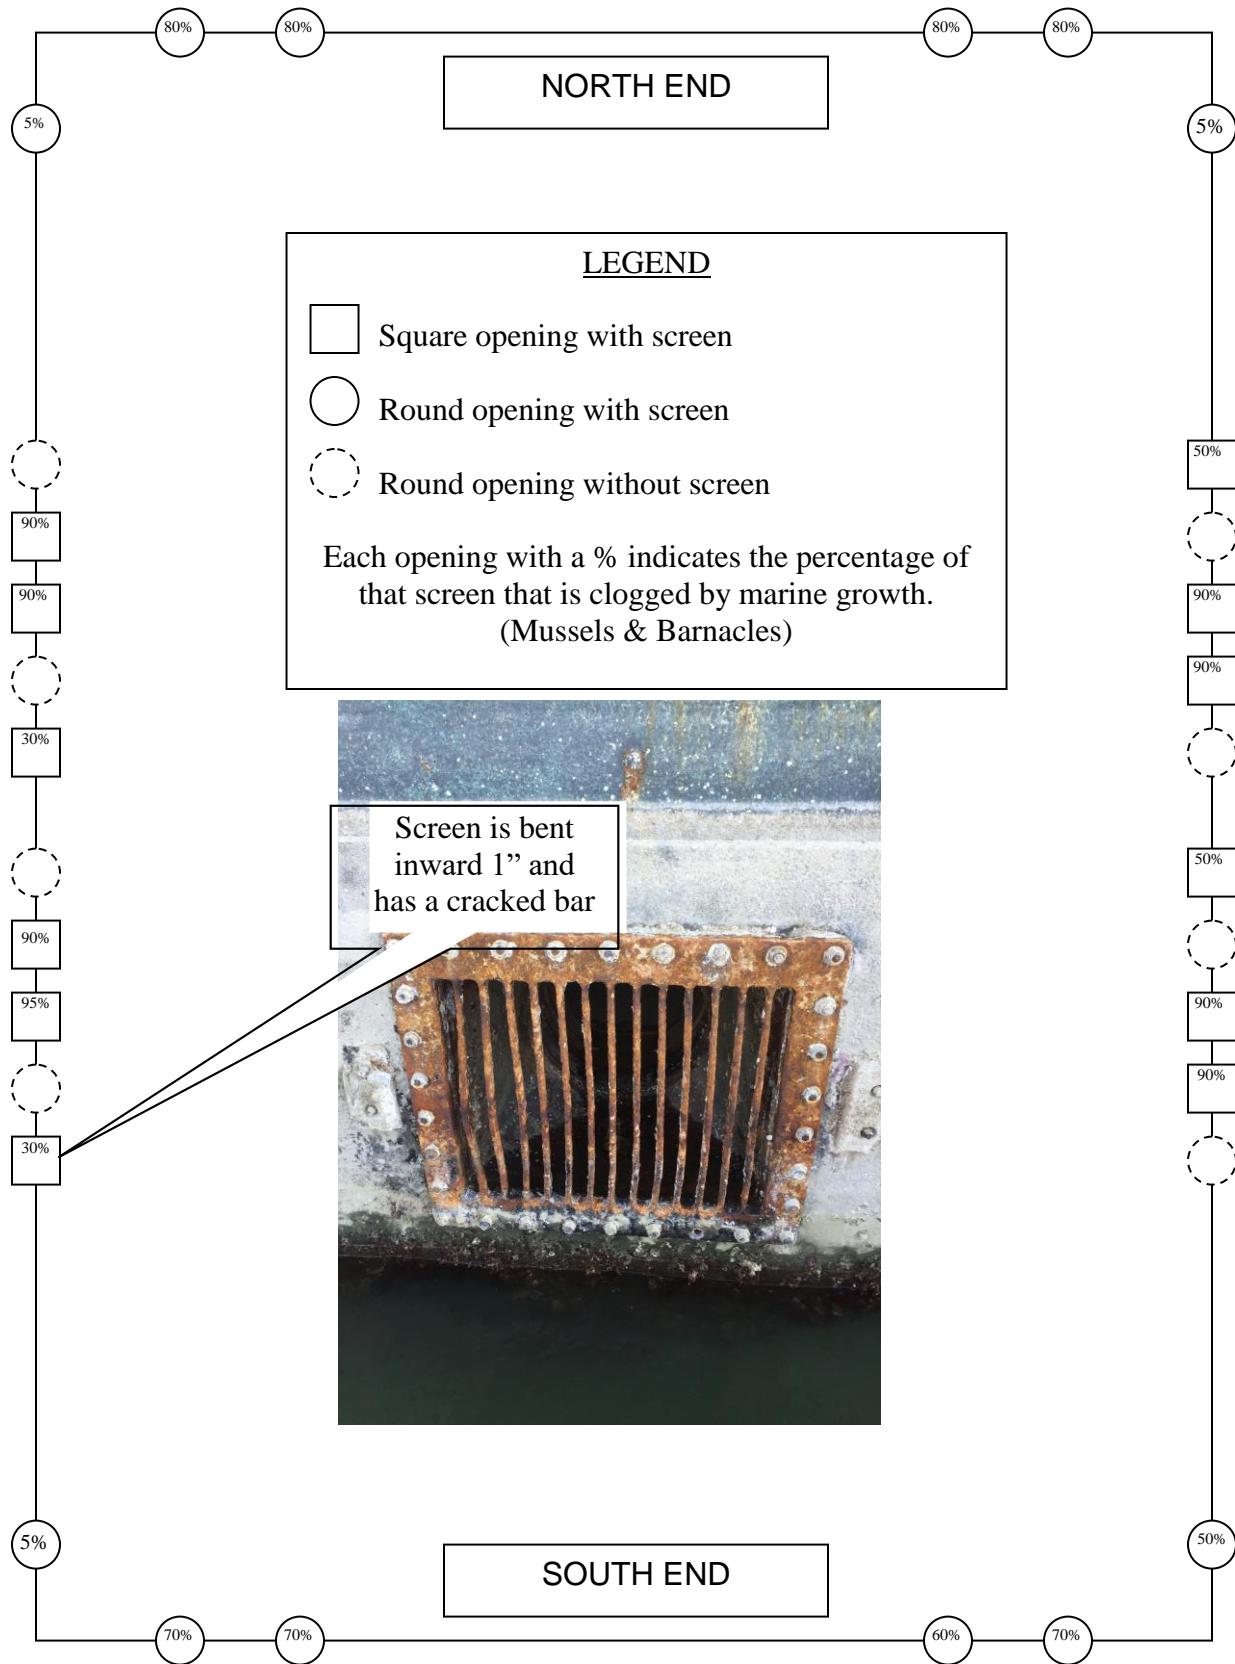
**DRAWING B % of marine growth on each screen**

Diver checked each screen again after cleaning and found one screen that has a bent bar which is identified in **Drawing B**. All other screens are securely fastened to dry dock and in good condition. Below are pictures of a few screens which are typical of all screens after cleaning.

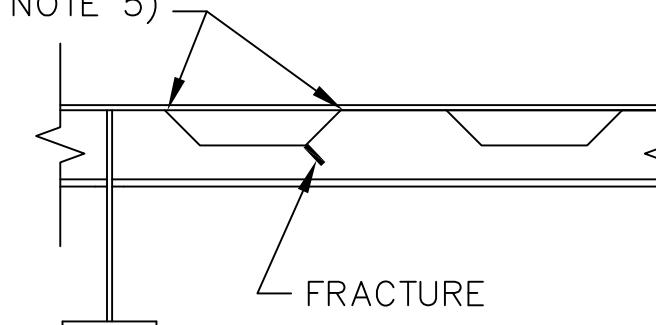
TYPE 1a  
FRACTURE IN WAY OF  
CHANNEL CUT OUT—FLANGE DETERIORATED  
EXISTING CONDITION

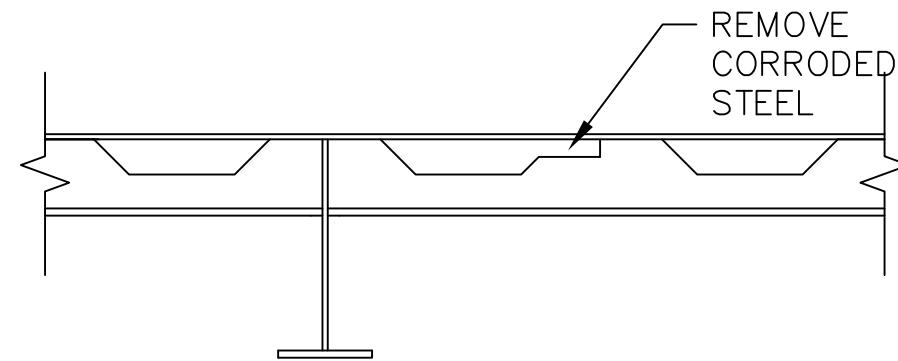
TYPE 2  
FRACTURE IN WAY OF  
WRAP WELD  
EXISTING CONDITION

TYPE 2  
FRACTURE IN WAY OF  
WRAP WELD  
REPAIR STEP 1

TYPE 2  
FRACTURE IN WAY OF  
WRAP WELD  
REPAIR STEP 2

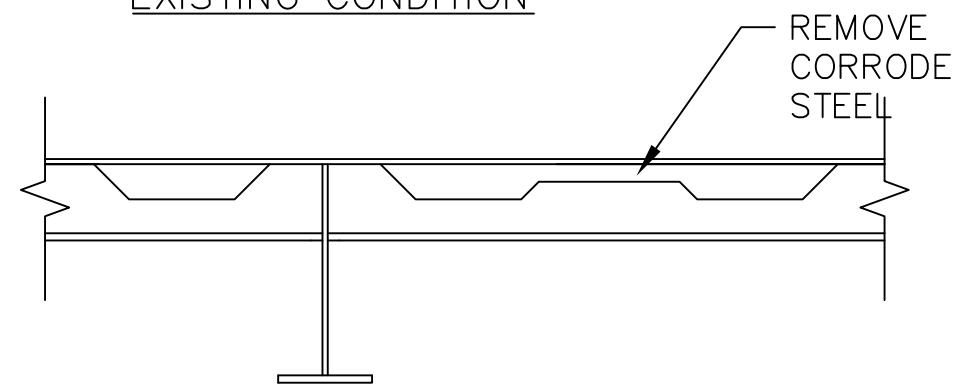
TYPE 4  
FRACTURE AT  
ATTACHMENT WELD  
EXISTING CONDITION

TYPE 4  
FRACTURE AT  
ATTACHMENT WELD  
REPAIR STEP 1

TYPE 4  
FRACTURE AT  
ATTACHMENT WELD  
REPAIR STEP 2

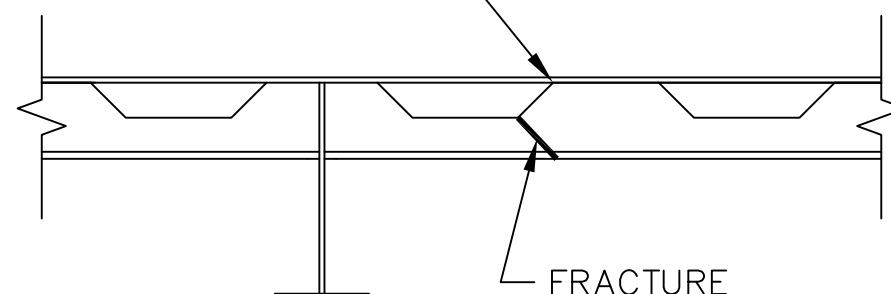
EXCESSIVE LOCAL CORROSION

ALTERNATIVE REPAIR METHOD

- 1.) REMOVE CORRODED STIFFENER STEEL BACK TO GOOD METAL – STEEL WITH LESS THAN 15% CORROSION
- 2.) REMOVE CORRODED STEEL DECK BACK TO ACCEPTABLE LIMITS – STEEL WITH LESS THAN 30% CORROSION RECOMMENDED
- 3.) REMOVE SCALE & PAINT IN REPAIRED AREA
- 4.) REPAINT REPAIRED AREA
