DRS MARINE INC.

EUREKA DRY DOCK
ULTRASONIC THICKNESS INSPECTION
PREPARED FOR

BAE SYSTEMS
SAN FRANCISCO

RE: Dry dock 2 ULTRA SONIC Thickness Gauging

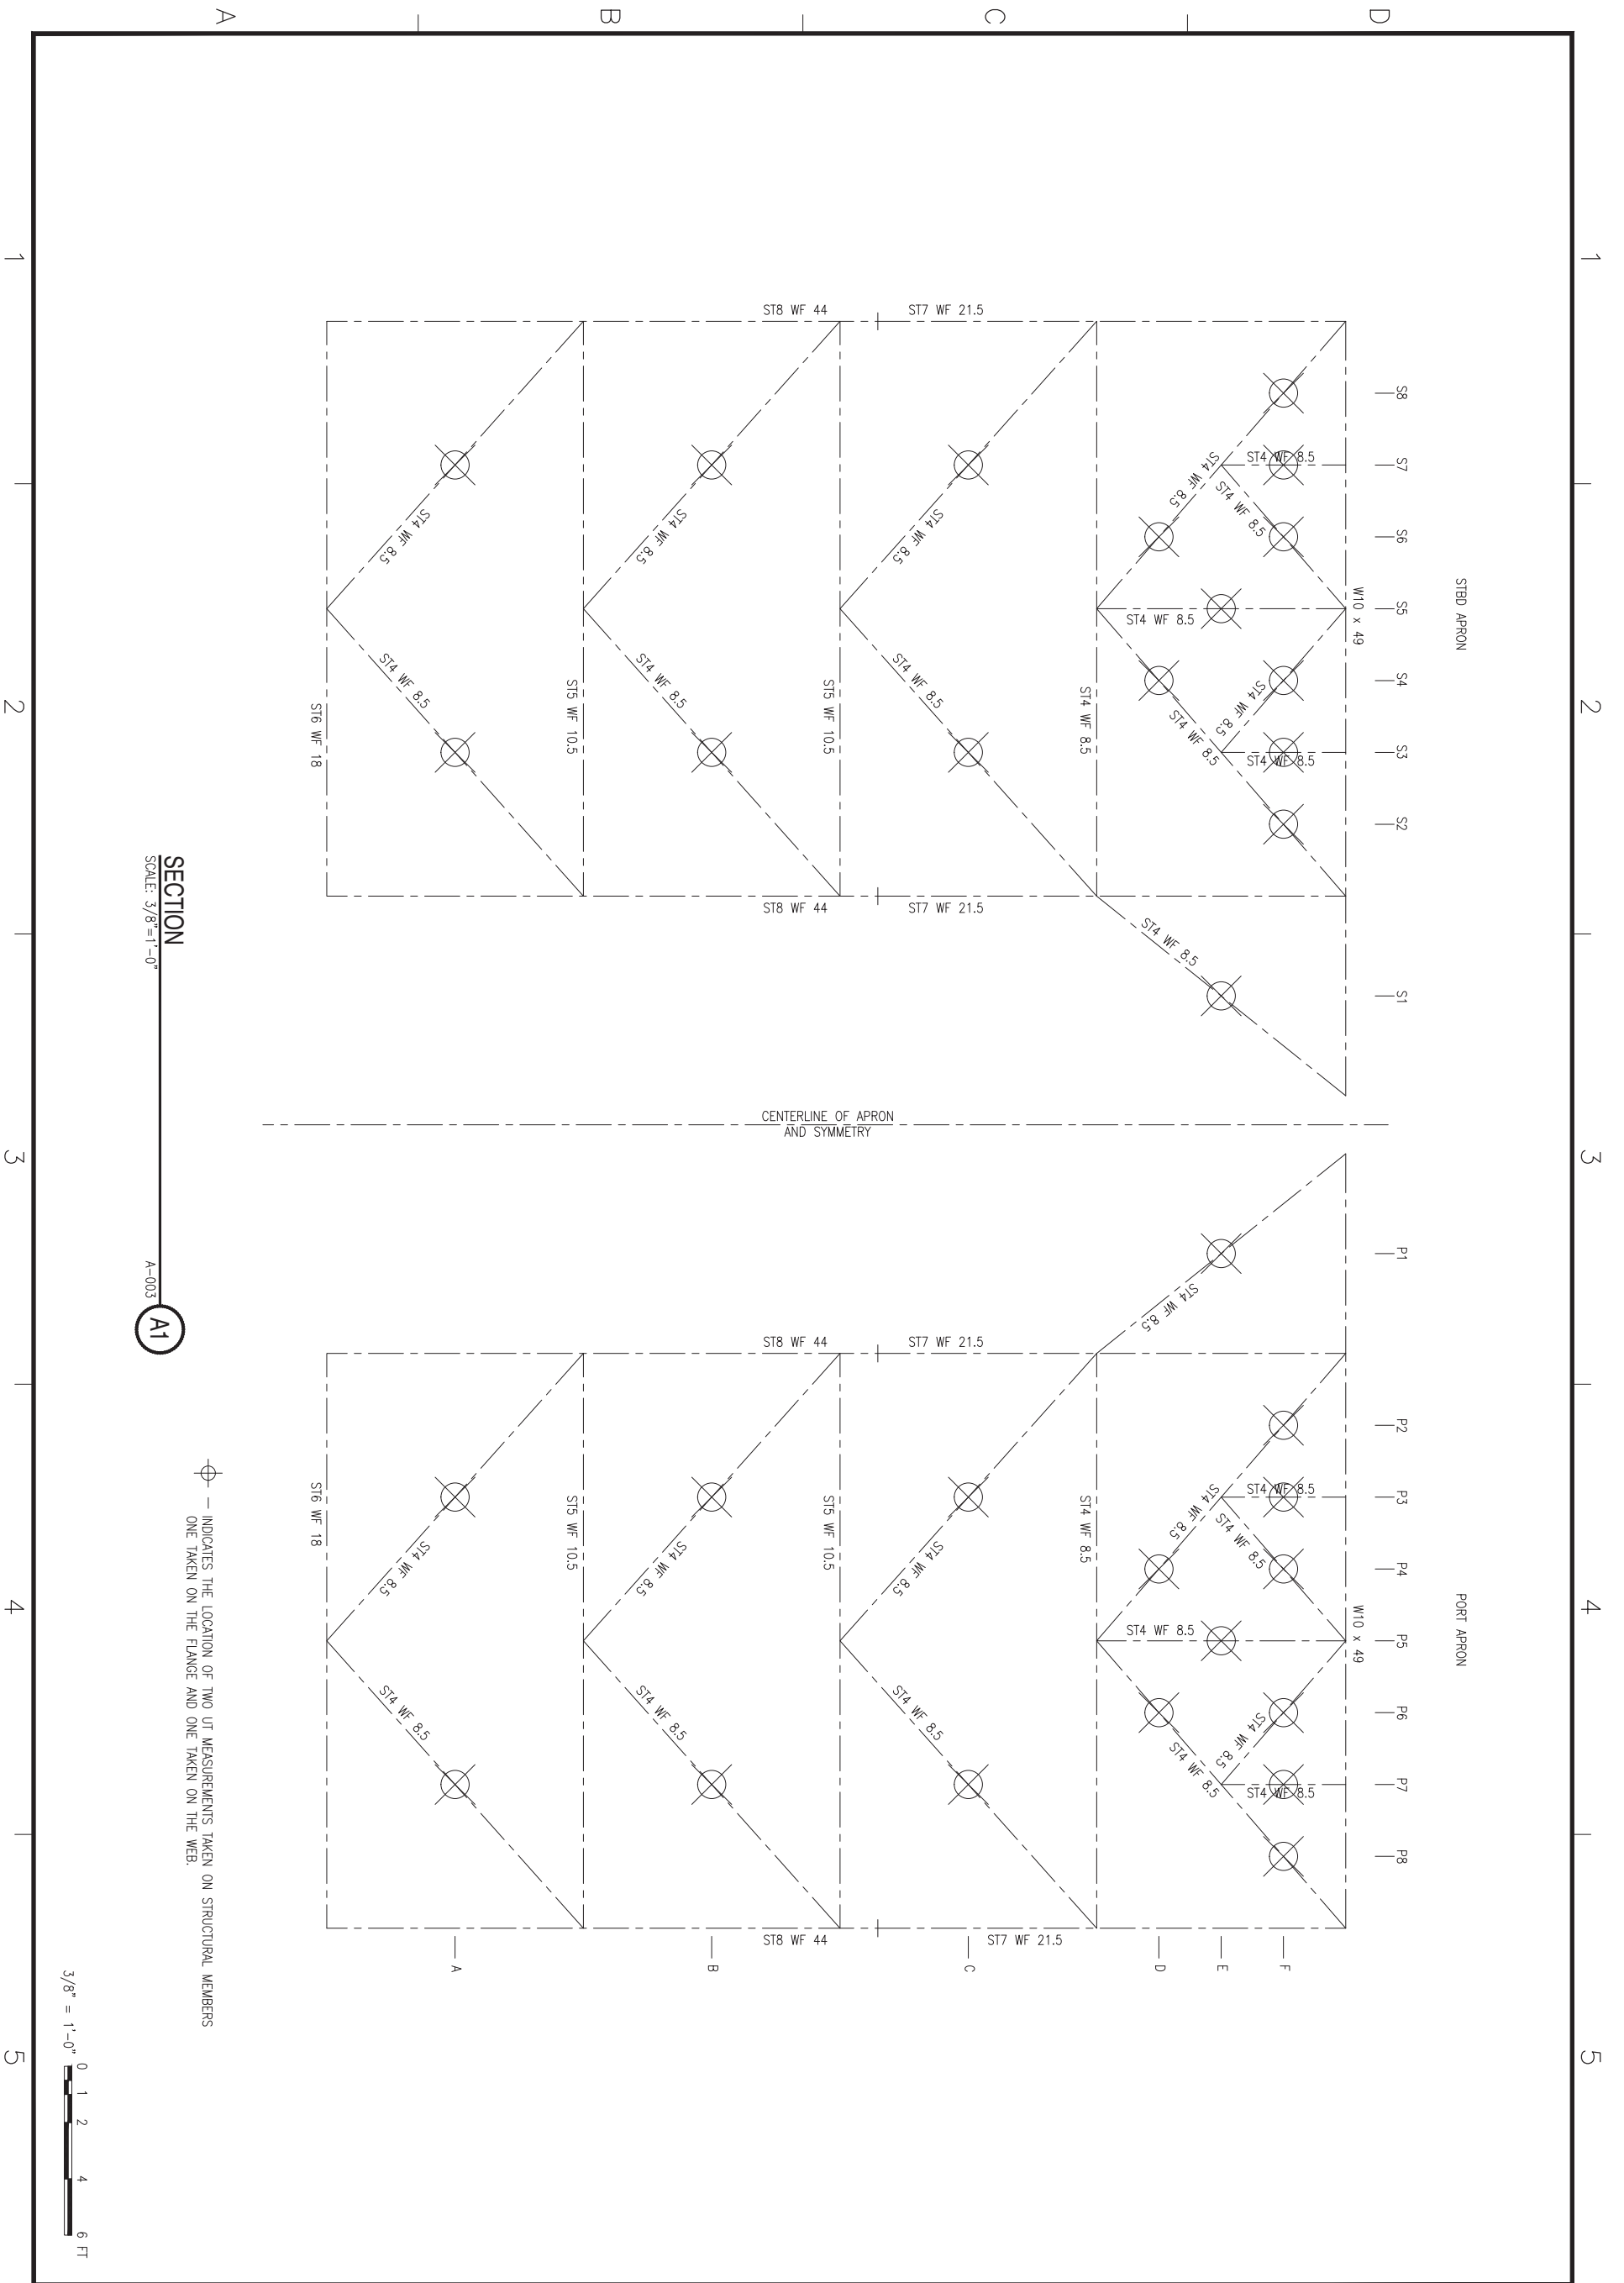
SECTION
SCALE: 3/8"=1'-0"
A-003
A1

UT
S	3	A	Web	0.542
S	3	B	Flange	0.485
S	3	C	Web	0.531
S	3	D	Flange	0.517
S	2	A	Web	0.497
S	2	B	Flange	0.217
S	2	C	Web	0.502
S	2	D	Flange	0.551
S	1	A	Web	0.505
S	1	B	Flange	0.568
S	1	C	Web	0.596
S	1	D	Flange	0.587
C	L	A	Web	0.385
C	L	B	Flange	0.389
C	L	C	Web	0.289
C	L	D	Flange	0.336

UT
P	1	A	Web	0.55
P	1	B	Flange	0.545
P	1	C	Web	0.592
P	1	D	Flange	0.581
P	2	A	Web	0.553
P	2	B	Flange	0.502
P	2	C	Web	0.494
P	2	D	Flange	0.49
P	3	A	Web	0.529
P	3	B	Flange	0.543
P	3	C	Web	0.552
P	3	D	Flange	0.427

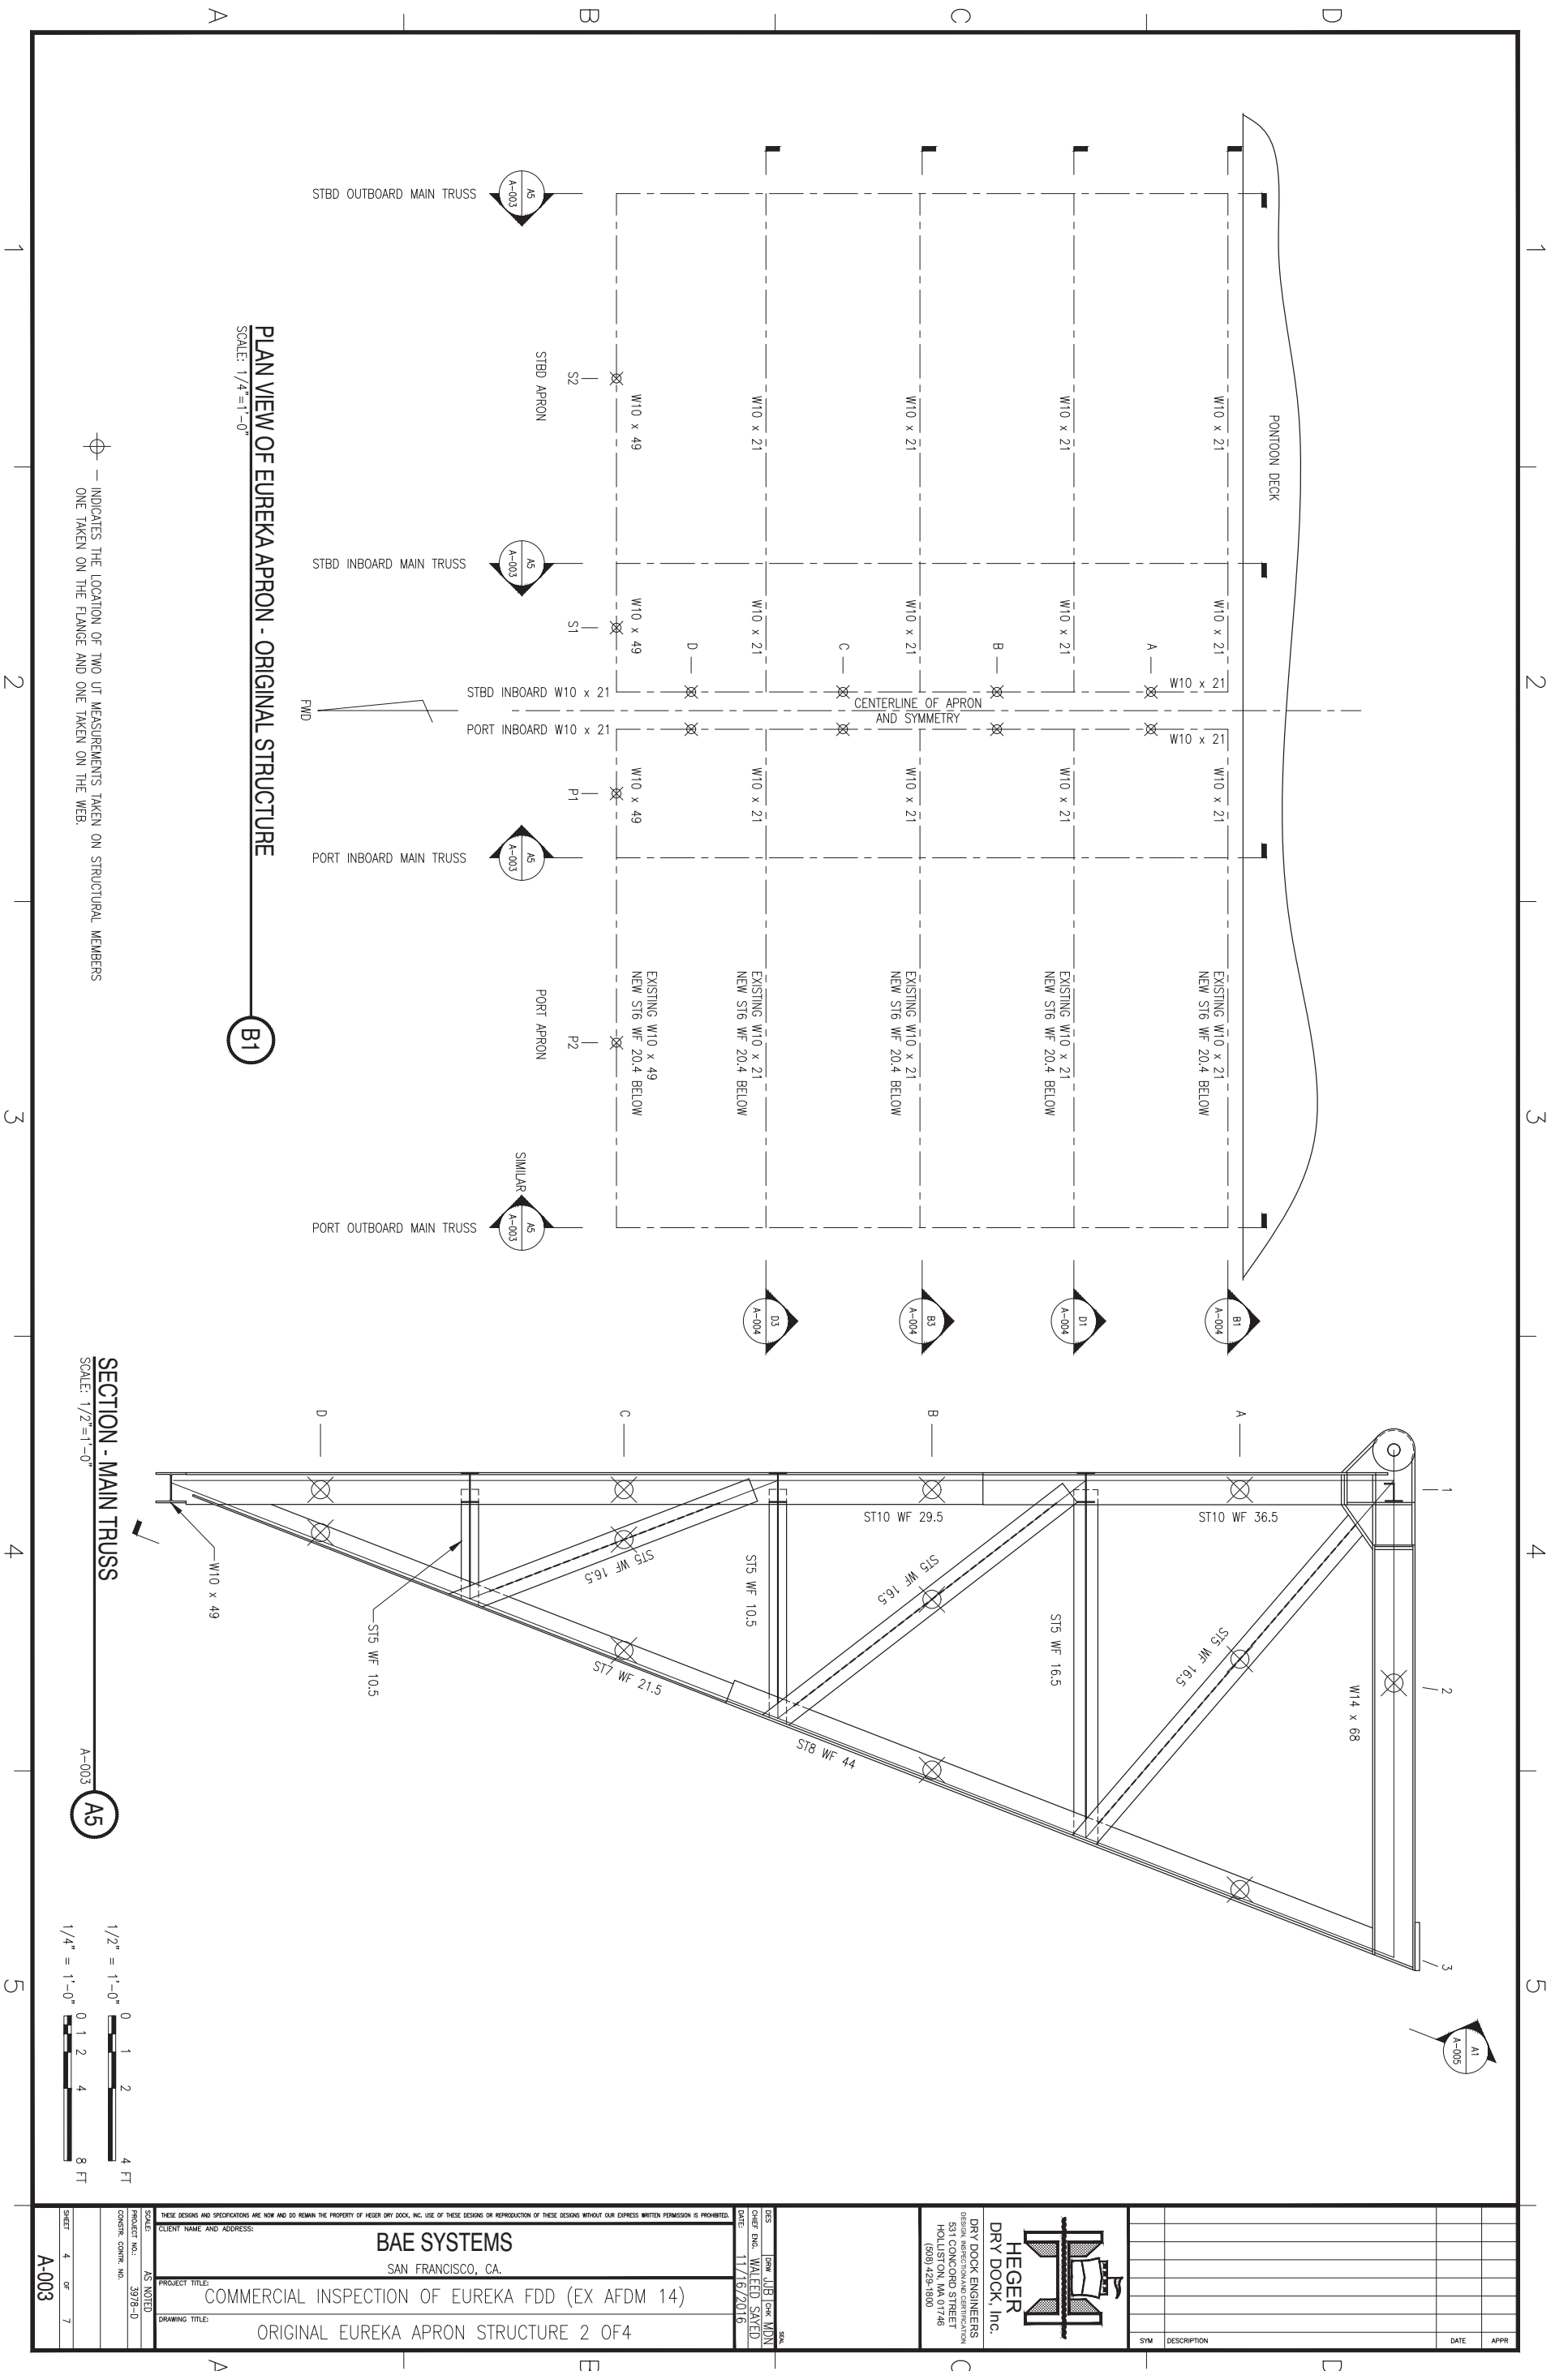
PLAN VIEW OF EUREKA APRON - ORIGINAL STRUCTURE
SCALE: 1/4"=1'-0"

UT
A 1 Web	0.412
A 1 Flange	0.462
A 2 Web	0.36
A 2 Flange	0.517
A 3 Web	0.575
A 3 Flange	0.876
B 1 Web	0.356
B 1 Flange	0.496
B 2 Web	0.403
B 2 Flange	0.589
B 3 Web	0.547
B 3 Flange	0.859
C 1 Web	0.359
C 1 Flange	0.485
C 2 Web	0.363
C 2 Flange	0.471
C 3 Web	0.377
C 3 Flange	0.58
D 1 Web	0.344
D 1 Flange	0.477
D 2 Web	0.345
D 2 Flange	0.576

UT
A 1 Web	0.4
A 1 Flange	0.5
A 2 Web	0.4
A 2 Flange	0.5
A 3 Web	0.6
A 3 Flange	0.4
B 1 Web	0.3
B 1 Flange	0.3
B 2 Web	0.3
B 2 Flange	0.4
B 3 Web	0.6
B 3 Flange	0.9
C 1 Web	0.3
C 1 Flange	0.4
C 2 Web	0.3
C 2 Flange	0.4
C 3 Web	0.3
C 3 Flange	0.6
D 1 Web	0.4
D 1 Flange	0.4
D 2 Web	0.3
D 2 Flange	0.6

UT
A Web	0.285
A Flange	0.359
B Web	0.308
B Flange	0.36
C Web	0.378
C Flange	0.298
D Web	0.305
D Flange	0.325

UT
S2 Web	0.311
S2 Flange	0.205
S1 Web	0.316
S1 Flange	0.387

UT
A Web	0.317
Flange	0.377
B Web	0.32
Flange	0.377
C Web	0.316
Flange	0.401
D Web	0.317
D Flange	0.297

UT
P1 Web	0.335
Flange	0.163
P2 Web	0.333
Flange	0.347
P2 Web	
Flange

UT
A 1 Web	0.387
A 1 Flange	0.461
A 2 Web	0.281
A 2 Flange	0.479
A 3 Web	0.623
A 3 Flange	0.875
B 1 Web	0.325
B 1 Flange	0.283
B 2 Web	0.279
B 2 Flange	0.466
B 3 Web	0.563
B 3 Flange	0.89
C 1 Web	0.351
C 1 Flange	0.323
C 2 Web	0.344
C 2 Flange	0.463
C 3 Web	0.378
C 3 Flange	0.582
D 1 Web	0.334
D 1 Flange	0.296
D 2 Web	0.375
D 2 Flange	0.553

UT
A 1 Web	0.388
A 1 Flange	0.447
A 2 Web	0.357
A 2 Flange	0.506
A 3 Web	0.604
A 3 Flange	0.852
B 1 Web	0.339
B 1 Flange	0.25
B 2 Web	0.294
B 2 Flange	0.464
B 3 Web	0.56
B 3 Flange	0.881
C 1 Web	0.291
C 1 Flange	0.307
C 2 Web	0.296
C 2 Flange	0.465
C 3 Web	0.368
C 3 Flange	0.617
D 1 Web	0.346
D 1 Flange	0.377
D 2 Web	0.371
D 2 Flange	0.595

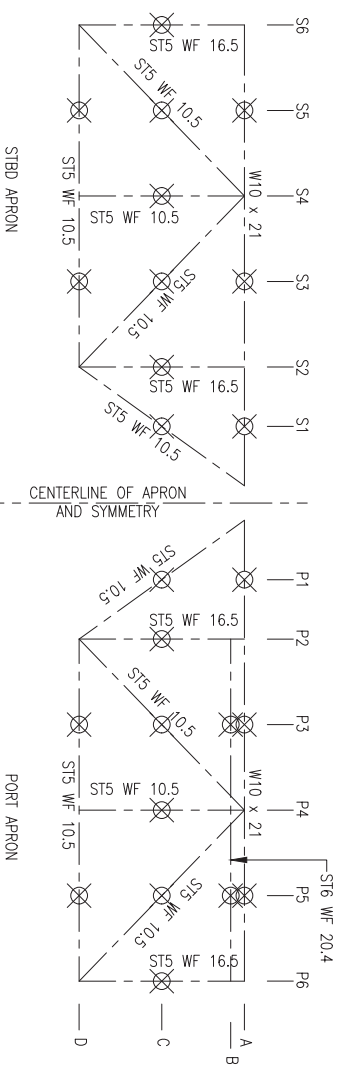
A-003
D1

UT
S	6	C	Web	0.285
S	6	C	Flange	0.52
S	5	A	Web	0.318
S	5	A	Flange	0.138
S	5	C	Web	0.209
S	5	C	Flange	0.353
S	5	D	Web	0.376
S	5	D	Flange	0.404
S	4	C	Web	0.233
S	4	C	Flange	0.366
S	3	A	Web	0.305
S	3	A	Flange	0.263
S	3	C	Web	0.29
S	3	C	Flange	0.375
S	3	D	Web	0.365
S	3	D	Flange	0.402
S	2	C	Web	0.377
S	2	C	Flange	0.604
S	1	A	Web	0.33
S	1	A	Flange	0.359
S	1	C	Web	0.262
S	1	C	Flange	0.321

UT
P	1	A	Web	0.315
P	1	A	Flange	0.319
P	1	C	Web	0.304
P	1	C	Flange	0.457
P	2	C	Web	0.356
P	2	C	Flange	0.504
P	3	A	Web	0.321
P	3	A	Flange	0.408
P	3	B	Web	0.133
P	3	B	Flange	0.55
P	3	C	Web	0.204
P	3	C	Flange	0.37
P	3	D	Web	0.335
P	3	D	Flange	0.391
P	4	C	Web	0.301
P	4	C	Flange	0.369
P	5	A	Web	0.33
P	5	A	Flange	0.358
P	5	B	Web	0.37
P	5	B	Flange	0.51
P	5	C	Web	0.328
P	5	C	Flange	0.328
P	5	D	Web	0.354
P	5	D	Flange	0.421
P	6	C	Web	0.339
P	6	C	Flange	0.585

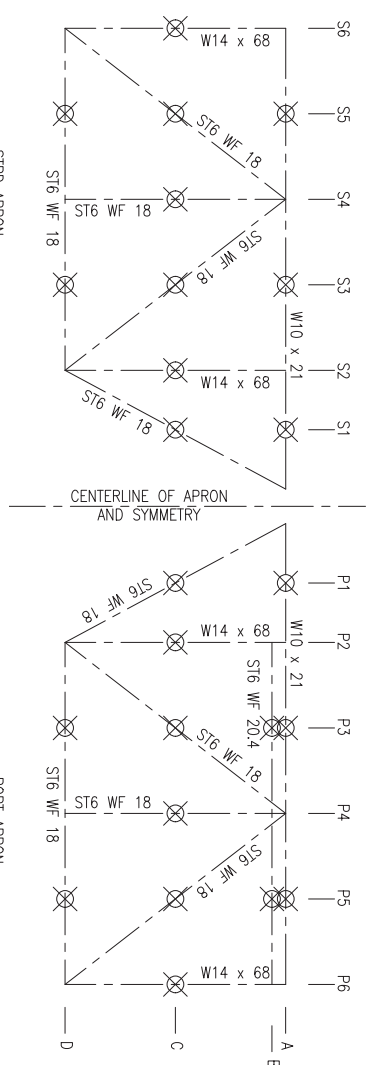
A-003
B1

UT
S	6	C	Web	0.483
S	6	C	Flange	0.742
S	5	A	Web	0.314
S	5	A	Flange	0.304
S	5	C	Web	0.314
S	5	C	Flange	0.58
S	5	D	Web	0.386
S	5	D	Flange	0.423
S	4	C	Web	0.338
S	4	C	Flange	0.526
S	3	A	Web	0.311
S	3	A	Flange	0.325
S	3	C	Web	0.362
S	3	C	Flange	0.526
S	3	D	Web	0.364
S	3	D	Flange	0.401
S	2	C	Web	0.486
S	2	C	Flange	0.723
S	1	A	Web	0.319
S	1	A	Flange	0.261
S	1	C	Web	0.31
S	1	C	Flange	0.471

UT
P	1	A	Web	0.334
P	1	A	Flange	0.255
P	1	C	Web	0.393
P	1	C	Flange	0.637
P	2	C	Web	0.505
P	2	C	Flange	0.806
P	3	A	Web	0.325
P	3	A	Flange	0.231
P	3	B	Web	0.247
P	3	B	Flange	0.54
P	3	C	Web	0.391
P	3	C	Flange	0.583
P	3	D	Web	0.337
P	3	D	Flange	0.414
P	4	C	Web	0.379
P	4	C	Flange	0.566
P	5	A	Web	0.306
P	5	A	Flange	0.388
P	5	B	Web	0.32
P	5	B	Flange	0.526
P	5	C	Web	0.42
P	5	C	Flange	0.693
P	5	D	Web	0.354
P	5	D	Flange	0.436
P	6	C	Web	0.507
P	6	C	Flange	0.797

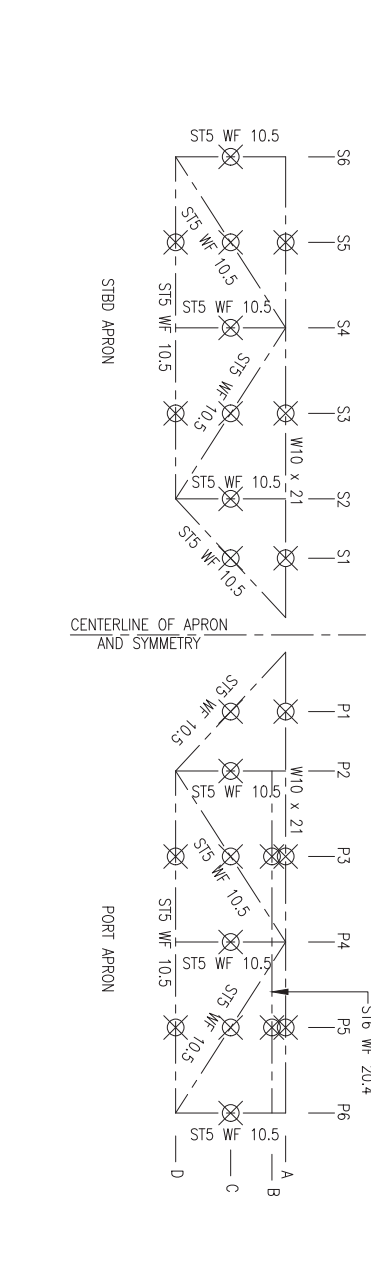
A-003
B3

UT
S	6	C	Web	0.353
S	6	C	Flange	0.613
S	5	A	Web	0.317
S	5	A	Flange	0.237
S	5	C	Web	0.28
S	5	C	Flange	0.381
S	5	D	Web	0.278
S	5	D	Flange	0.325
S	4	C	Web	0.27
S	4	C	Flange	0.439
S	3	A	Web	0.314
S	3	A	Flange	0.162
S	3	C	Web	0.295
S	3	C	Flange	0.352
S	3	D	Web	0.294
S	3	D	Flange	0.358
S	2	C	Web	0.313
S	2	C	Flange	0.46
S	1	A	Web	0.306
S	1	A	Flange	0.221
S	1	C	Web	0.276
S	1	C	Flange	0.379

UT
P	1	A	Web	0.334
P	1	A	Flange	0.152
P	1	C	Web	0.302
P	1	C	Flange	0.394
P	2	C	Web	0.363
P	2	C	Flange	0.469
P	3	A	Web	0.341
P	3	A	Flange	0.207
P	3	B	Web	0.385
P	3	B	Flange	0.52
P	3	C	Web	0.355
P	3	C	Flange	0.381
P	3	D	Web	0.245
P	3	D	Flange	0.38
P	4	C	Web	0.331
P	4	C	Flange	0.414
P	5	A	Web	0.355
P	5	A	Flange	0.311
P	5	B	Web	0.339
P	5	B	Flange	0.461
P	5	C	Web	0.23
P	5	C	Flange	0.37
P	5	D	Web	0.252
P	5	D	Flange	0.378
P	6	C	Web	0.359
P	6	C	Flange	0.49

UT
S	6	C	Web	0.33
S	6	C	Flange	0.297
S	5.5	C	Web	0.29
S	5.5	C	Flange	0.335
S	5.5	D	Web	0.282
S	5.5	D	Flange	0.328
S	5	A	Web	0.327
S	5	A	Flange	0.342
S	4.5	C	Web	0.286
S	4.5	C	Flange	0.326
S	4	D	Web	0.342
S	4	D	Flange	0.297
S	3.5	C	Web	0.264
S	3.5	C	Flange	0.354
S	3	A	Web	0.311
S	3	A	Flange	0.385
S	2.5	C	Web	0.293
S	2.5	C	Flange	0.333
S	2.5	D	Web	0.323
S	2.5	D	Flange	0.355
S	2	C	Web	0.356
S	2	C	Flange	0.525
S	1	A	Web	0.301
S	1	A	Flange	0.235
S	1	C	Web	0.298
S	1	C	Flange	0.351

UT
P	1	A	Web	0.338
P	1	A	Flange	0.356
P	1	C	Web	0.23
P	1	C	Flange	0.335
P	2	C	Web	0.342
P	2	C	Flange	0.584
P	2.5	C	Web	0.302
P	2.5	C	Flange	0.337
P	2.5	D	Web	0.254
P	2.5	D	Flange	0.36
P	3	A	Web	0.336
P	3	A	Flange	0.305
P	3	B	Web	0.148
P	3	B	Flange	0.551
P	3.5	C	Web	0.259
P	3.5	C	Flange	0.338
P	4	D	Web	0.286
P	4	D	Flange	0.367
P	4.5	C	Web	0.27
P	4.5	C	Flange	0.369
P	5	A	Web	0.367
P	5	A	Flange	0.37
P	5	B	Web	0.153
P	5	B	Flange	0.487
P	5.5	C	Web	0.273
P	5.5	C	Flange	0.342
P	5.5	D	Web	0.29
P	5.5	D	Flange	0.364
P	6	C	Web	0.346
P	6	C	Flange	0.588

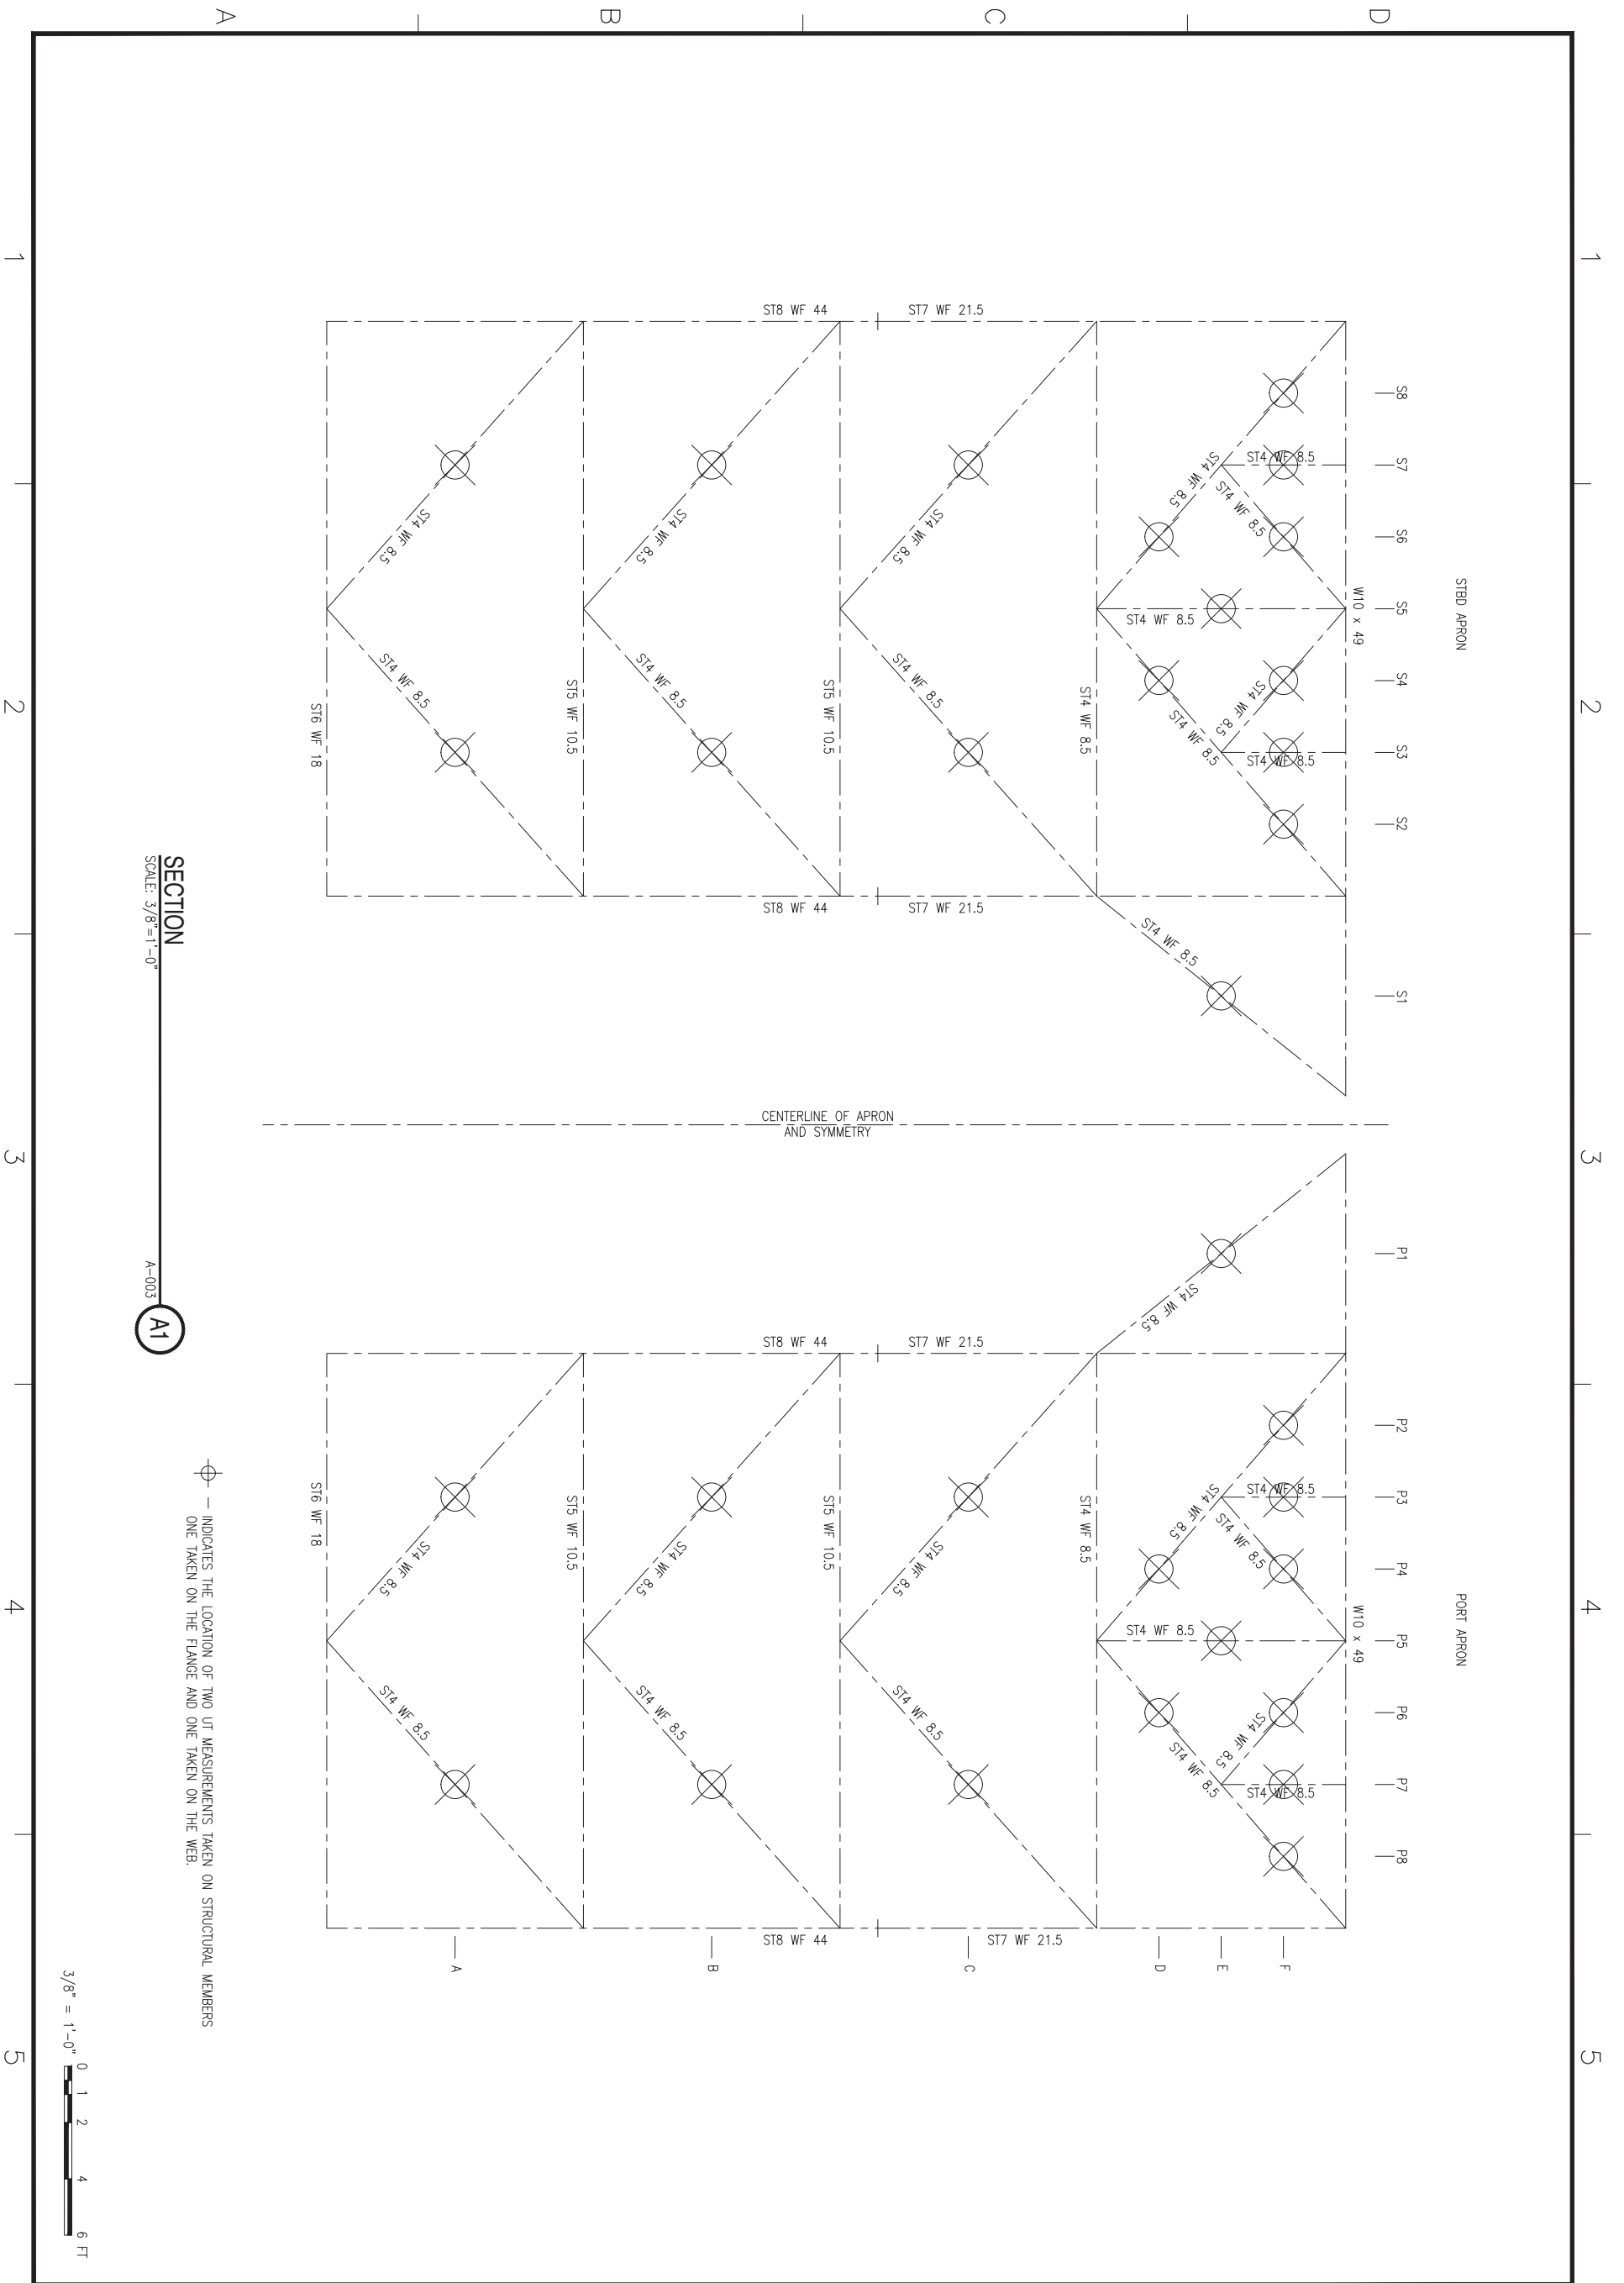
SECTION
SCALE: 3/8"=1'-0"
A-003
A1

UT
S	8	F	Web	0.316
S	8	F	Flange	0.27
S	7	F	Web	0.342
S	7	F	Flange	0.293
S	7	C	Web	0.361
S	7	C	Flange	0.307
S	7	B	Web	0.363
S	7	B	Flange	0.318
S	7	A	Web	0.319
S	7	A	Flange	0.37
S	6	F	Web	0.307
S	6	F	Flange	0.275
S	6	D	Web	0.285
S	6	D	Flange	0.271
S	5	E	Web	0.313
S	5	E	Flange	0.294
S	4	F	Web	0.266
S	4	F	Flange	0.243
S	3	F	Web	0.332
S	3	F	Flange	0.278
S	3	C	Web	0.298
S	3	C	Flange	0.296
S	3	B	Web	0.387
S	3	B	Flange	0.311
S	2	A	Web	0.351
S	2	A	Flange	0.382
S	1	E	Web	0.307
S	1	E	Flange	0.286
S	2	F	Web	0.311
S	2	F	Flange	0.284
S	4	D	Web	0.313
S	4	D	Flange	0.265

UT
P	8	F	Web	0.302
P	8	F	Flange	0.356
P	7	F	Web	0.278
P	7	F	Flange	0.29
P	7	C	Web	0.327
P	7	C	Flange	0.36
P	7	B	Web	0.326
P	7	B	Flange	0.289
P	7	A	Web	0.314
P	7	A	Flange	0.382
P	6	F	Web	0.318
P	6	F	Flange	0.226
P	6	D	Web	0.313
P	6	D	Flange	0.372
P	5	E	Web	0.288
P	5	E	Flange	0.304
P	4	F	Web	0.273
P	4	F	Flange	0.301
P	3	D	Web	0.313
P	3	D	Flange	0.384
P	3	F	Web	0.282
P	3	F	Flange	0.258
P	3	C	Web	0.316
P	3	C	Flange	0.305
P	3	B	Web	0.355
P	3	B	Flange	0.315
P	1	E	Web	0.327
P	1	E	Flange	0.359
P	2	F	Web	0.287
P	2	F	Flange	0.229
P	4	D	Web	0.312
P	4	D	Flange	0.306

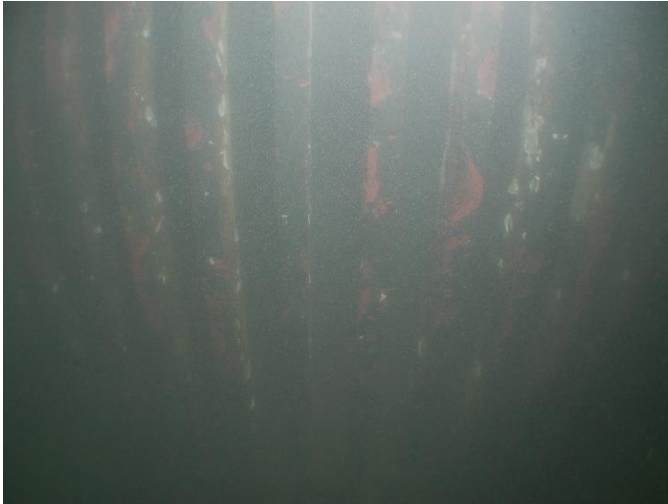
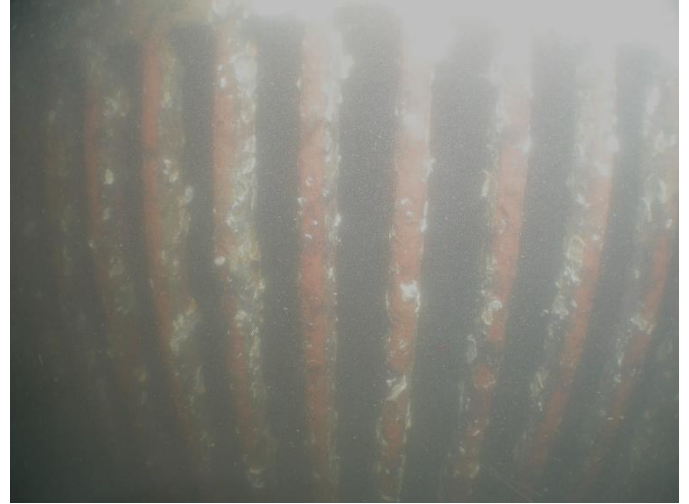
Diver checked each screen again after cleaning and found one screen that has a bent bar which is identified in ***Drawing B***. All other screens are securely fastened to dry dock and in good condition. Below are pictures of a few screens which are typical of all screens after cleaning.

Two intake screen pictures below are “typical” of all intake screens

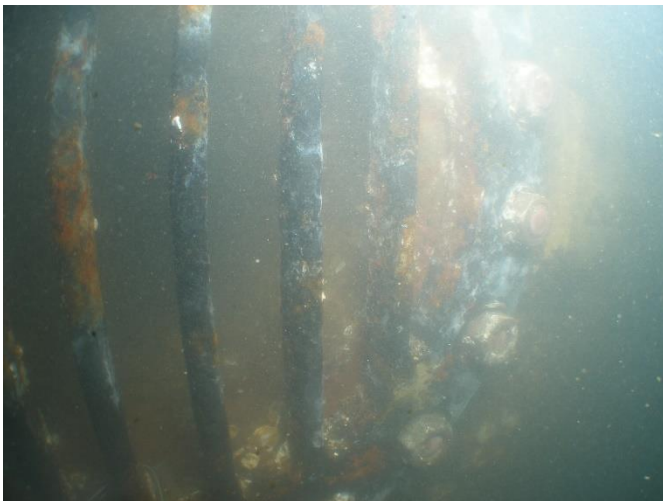
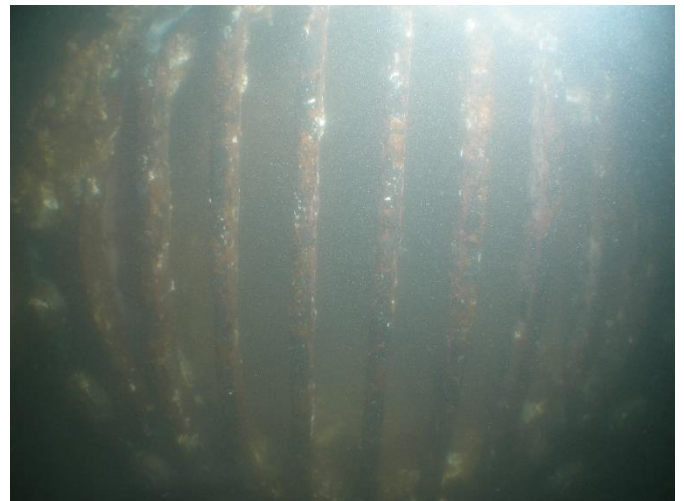
Two discharge screen pictures below are “typical” of all discharge screens
