Executive Summary Report

Seawall Earthquake Vulnerability Study

Northern Seawall

San Francisco, California

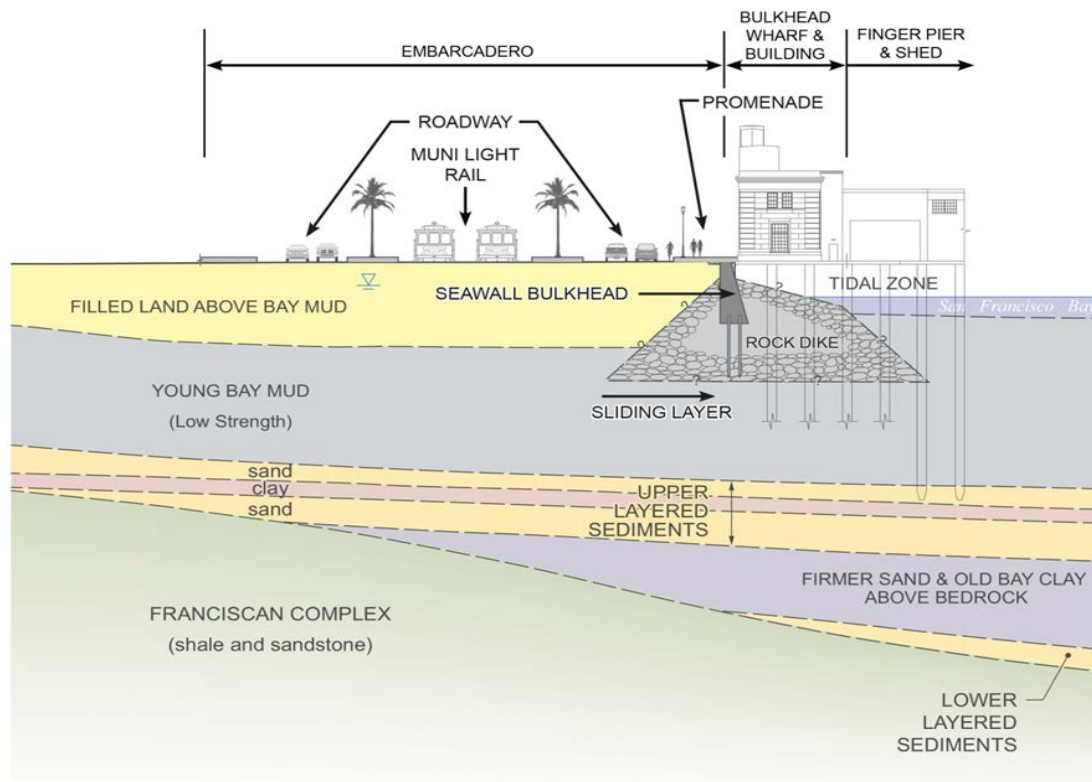
Figure 1-1: Typical Seawall Section

The Embarcadero seawall generally consists of a bulkhead wall and bulkhead wharf structure as shown in Figure 1-1 – Typical Seawall Section.

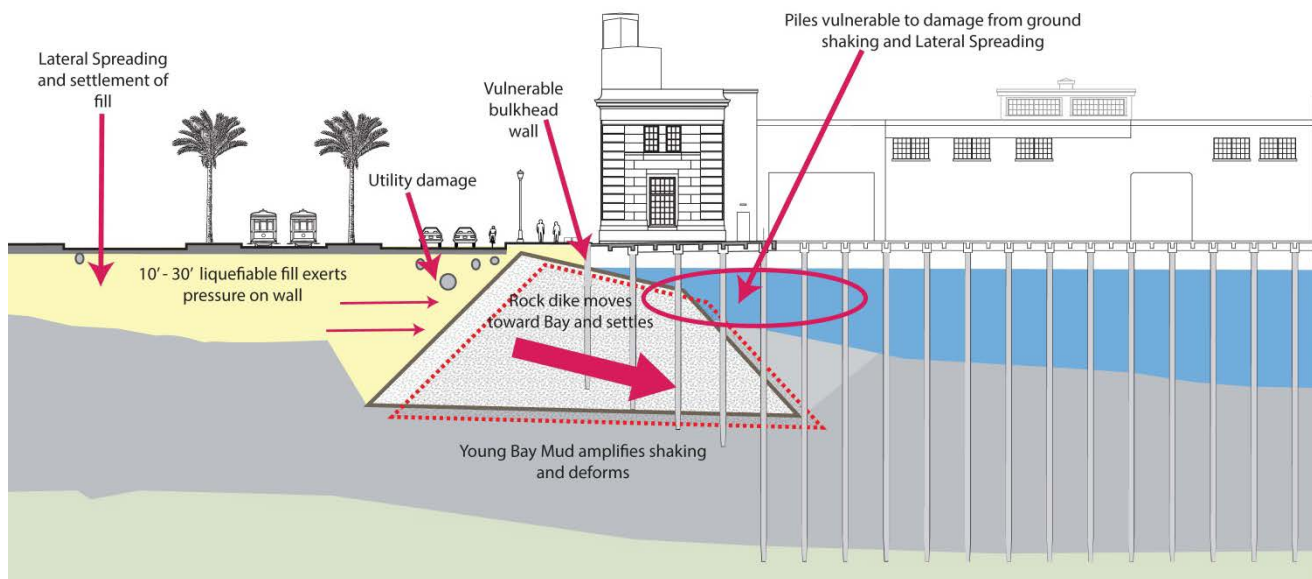
Figure 1-3: Typical Seawall Earthquake Vulnerabilities

Figure 1-3 depicts the earthquake vulnerabilities of a typical section of the Seawall. Maps showing estimated ground displacement due to lateral spreading after a major earthquake are included in Exhibits A-1 and A-2. Bulkhead wharves which support bulkhead buildings, utilities, the Embarcadero Promenade and Roadway, and Muni rail lines are particularly at risk to increased damage due to Seawall movement.

Soil lateral sliding – movement of underlying weak soil layers due to seismic shaking with accompanying significant permanent lateral displacements, most likely towards the bay. The lateral displacements associated with moderate earthquakes were found to be detrimental to the pile-supported structures along

the northern seawall and the magnitude of lateral displacement will increase with shaking intensity. The lateral displacements are expected to also cause settlement along the seawall with the combined displacement resulting in structural damage to the supporting piles and parts or all of the seawall, bulkhead wharfs, finger piers and structures located landside of the seawall.

- *Bulkhead wall to wharf connections* – Bulkhead wharves are typically supported by the bulkhead wall and one or more rows of piles located bayward. The wall/wharf connections typically consist of concrete or concrete encased steel wide flange beams seated on the bulkhead wall with little or no reinforcing crossing the joint. These connections are brittle with very little shear capacity and are expected to fail under moderate ground shaking or seawall movement, leaving the deck vulnerable to partial collapse from unseating of the beams and slab from the supporting wall. This failure will primarily impact the first structural bay.

- *Bulkhead wharf pile head to deck connections* – The pile to deck connections are typically non-ductile concrete with very little capacity to undergo cyclical overloading without substantial damage and/or failure. The brittle connections severely limit displacement capacity as compared to current code required ductile concrete structures. The difference between life safety and collapse displacement capacities for these connections also appears to be relatively small with little capacity difference between the two associated seismic events. However, there is a variation between seawall sections in the ability of bulkhead wharf structures to resist the imposed displacement demands. Some bulkhead wharf sections are expected to survive a life safety seismic event while others are expected to suffer significant damage.

- *Pile damage below ground within the rock seawall* – The rock seawall is expected to remain mostly intact as earthquake induced failure planes develop beneath and cause the rock wall to move bayward and settle. Piles that penetrate the rock are expected to fracture under ground near the failure planes leading to reduced capacity and complete failure where piles are located near the Bayward edge of the rock wall. Differential settlement and partial collapse of bulkhead wharves may result. Retrofitting existing piles to prevent below ground failure is extremely difficult and may not be possible.

- *Seismic vulnerability of finger piers* - seismic damage can be expected to occur at the transition between the finger pier and bulkhead wharf. This damage is caused by a relatively stiff structure (bulkhead wharf) behaving differently than a more flexible structure (finger pier). The two structures can be separated and a seismic joint installed at the interface to mitigate damage. Seismic evaluation of the finger piers (not part of the study) is needed to determine the appropriate seismic joint configuration as well as to assess pier performance.
