Asbestos Survey Report

Reinforced Concrete Structure
Amador Pump House

Amador Street, San Francisco California

July 15, 2016
ESI Job No.2808

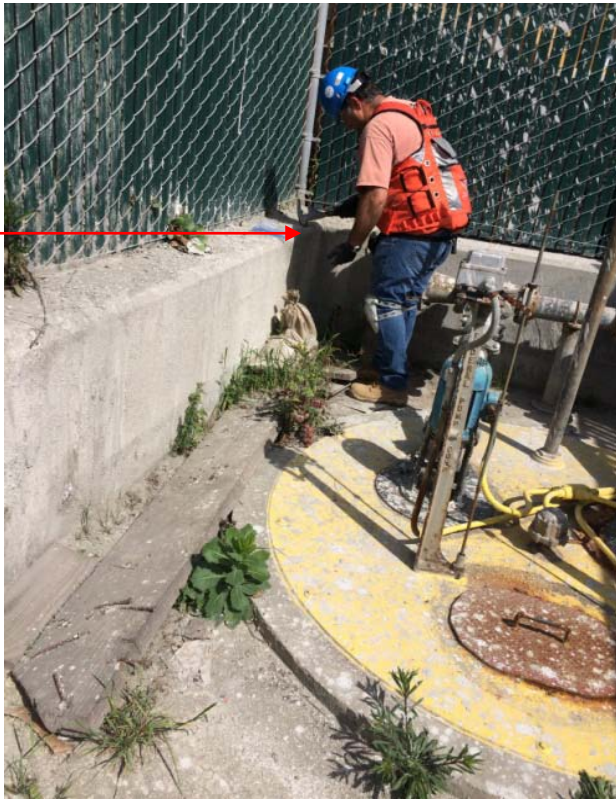
Sample Location 2808-06

Asbestos survey of the pump station consisted of collecting and analysis of six (6) bulk samples of the concrete throughout the concrete structure. Based on the analytical results, only one sample of the concrete from the west retaining wall (2808-06) contained chrysotile asbestos at a concentration of 0.25% , as confirmed by PLM (polarized Light Microscopy) and point-count analysis.

Based on the results of the asbestos survey, chrysotile asbestos is found in one of the six concrete samples in the form of naturally occurring serpentine aggregates at concentrations above 0.1 %. Considering the other 5 samples contained no asbestos, as confirmed by point count and PLM analysis, we believe the mixture of serpentine aggregate is localized along the west perimeter wall.

Photo 1. Gray Concrete – Chrys 0.25%

We recommend removal and proper disposal of the portion of the west retaining wall as asbestos containing constructions materials (ACCM < 1%). As shown in the attached diagram, the marked area long the west wall of the pump station near sample 2808-6 is estimated less than 50 ft².

Demolition of the portion of the west wall as ACCM shall be conducted under supervision of an EPA accredited supervisor, trained workers with appropriate PPE. CAL-OSHA work procedures such as wet method, regulated work areas and PEL exposure assessment will be required.

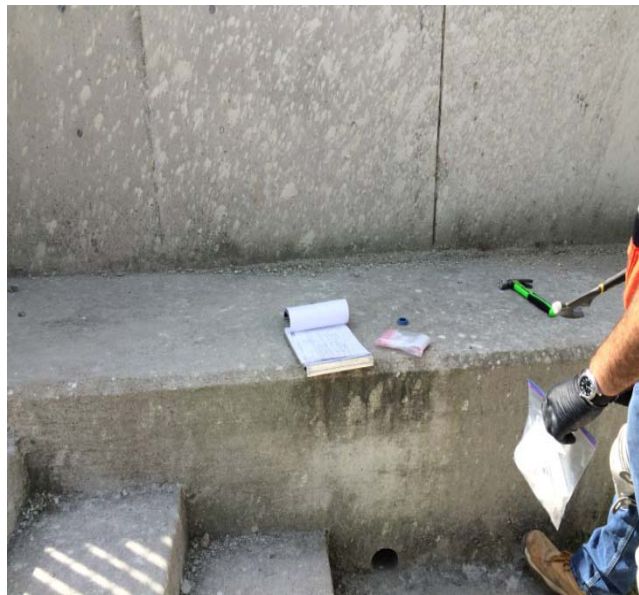
Photo 2. Entry steps Area – Gray concrete with shells

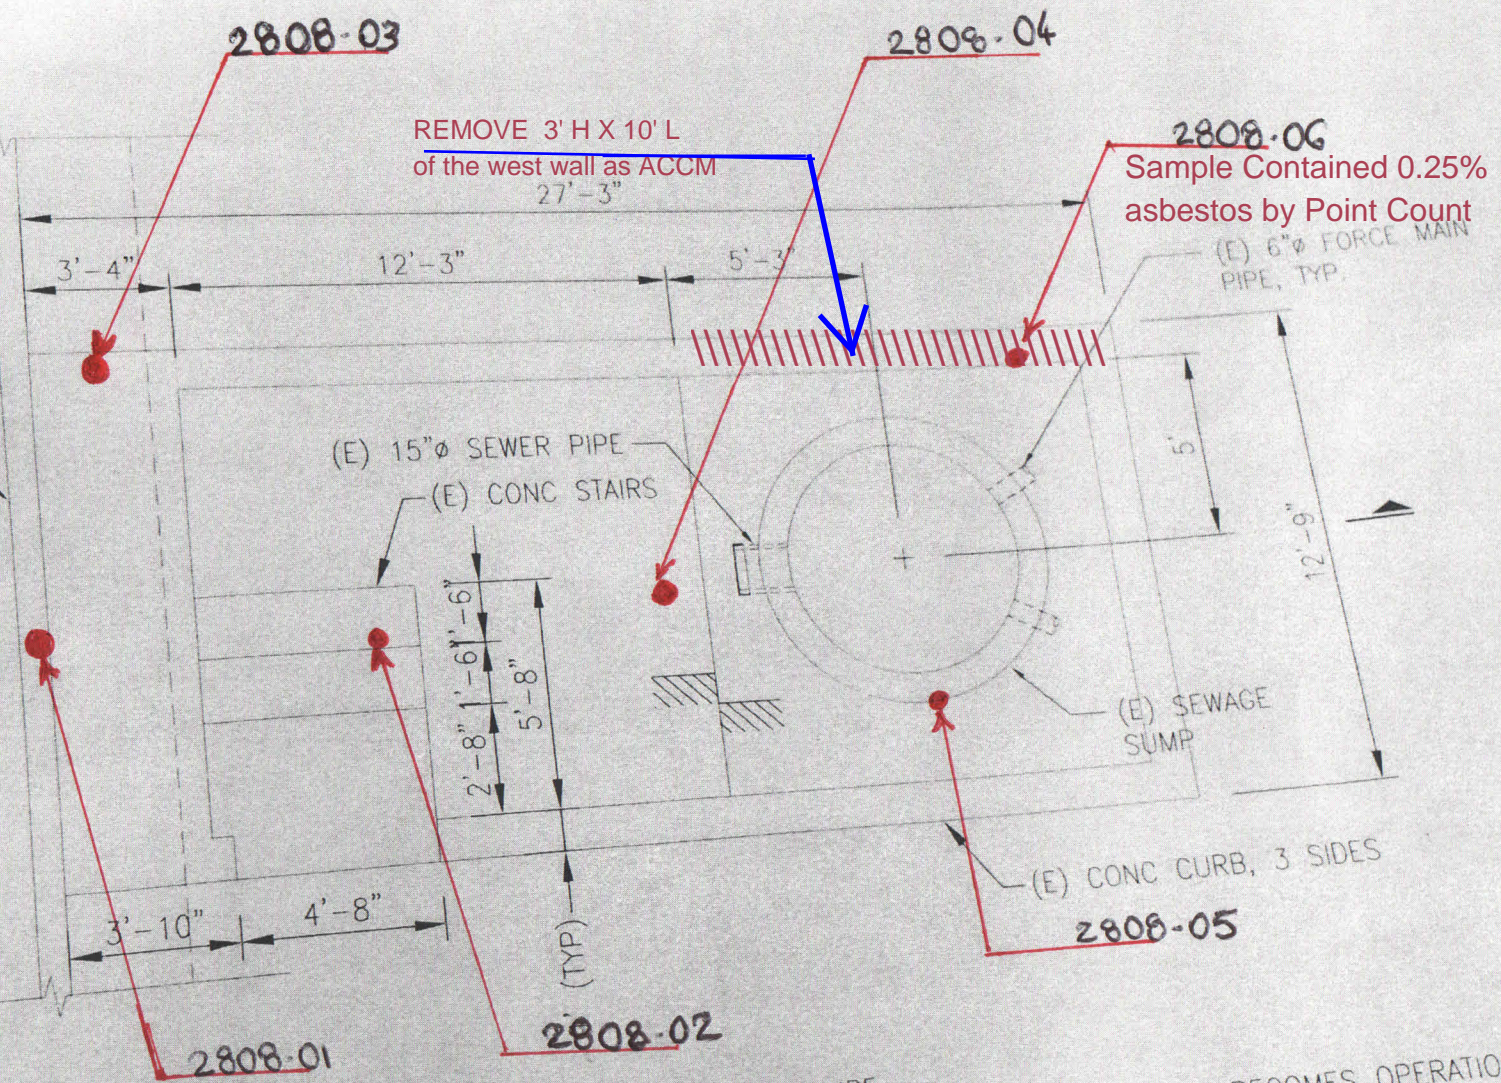
DEMOLITION PLAN - SPILL CONTAINMENT STRUCTURE
 SCALE: 1/4" = 1'-0"

PLM confirmed the presence of asbestos in one of the six (6) concrete samples at concentrations less than 1 % (< 1%) by weight. Asbestos was found in the form of serpentine aggregates in the perimeter retaining wall, Sample 2808-06, at or above the Cal/OSHA Regulatory limits of 0.1%, as shown on the attached sample location map.

● Concrete Sample location
 ///// Remove and dispose of ACCM wall
