# PIER 70 BUILDING SURVEY

HISTORIC BUILDINGS  
CONDITIONS AND ASSESSMENT  
CAREY & CO. AND OLMMA, INC  
MAY 2008

Pier 70  
San Francisco, California

Historic Building  
Conditions Survey and Assessment  
May 22, 2008

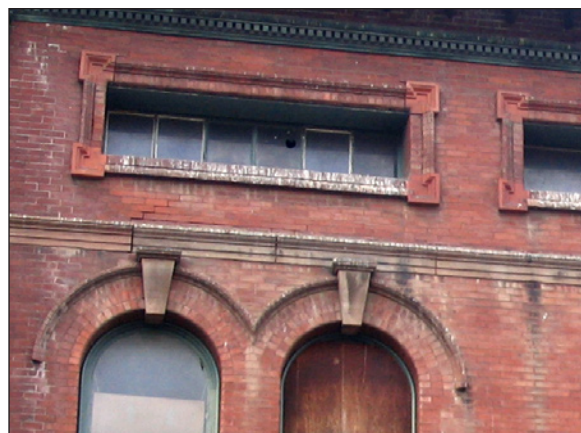
- Localized seismic cracking
- Green efflorescence from copper

- Repair 5% brick. Brick Masonry Replacement:

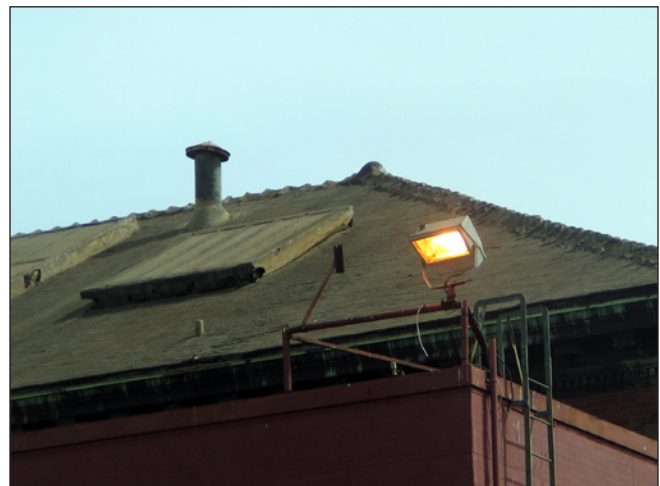
- Significant water damage around skylights

- Remove tar paper covering
- Repair roof around skylights
- Restore skylights

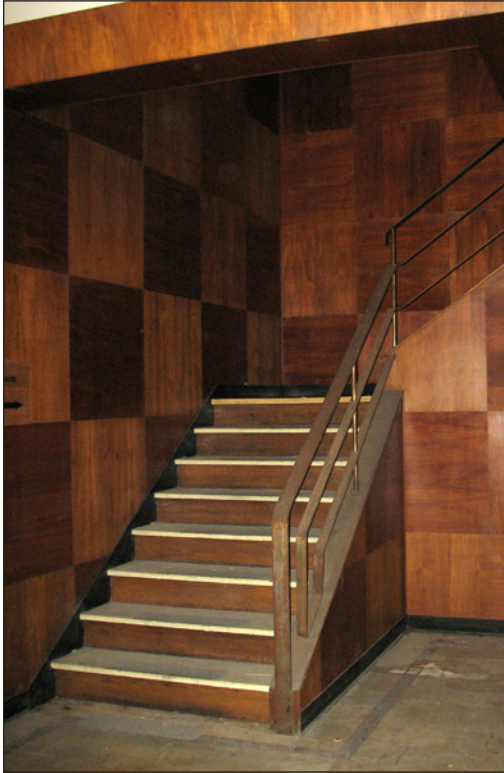
- Some rust on handrails

- Clean plywood
- Remove rust and Repaint handrails

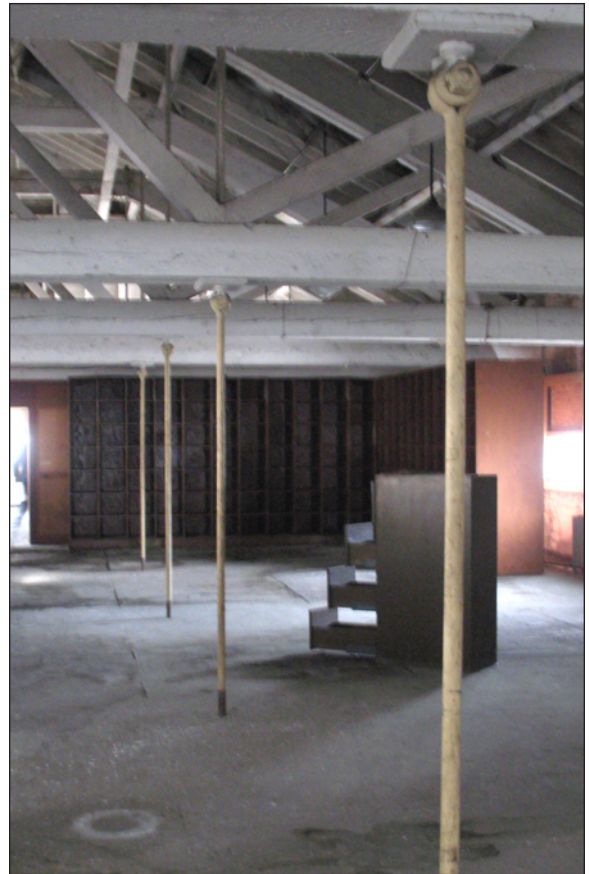
- Localized water damage
- More extensive water damage at NW wall and on second floor

- Repair 35% plaster over brick walls: Gypsum

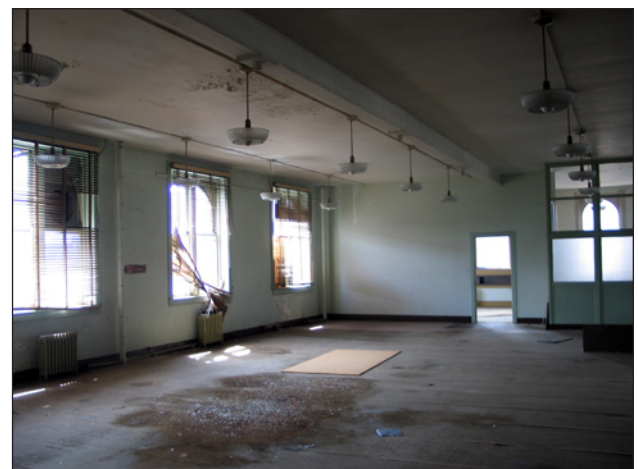
- Aged linoleum in poor condition with cracks, tears, and water damage
- Localized water damage to wood T&G floors

- Replace 100% linoleum

- Repair 10% water damaged wood floor. Wood Floor Repair:
  1. Review the survey to determine quantities of repair or replacement.
  2. Identify any sub floor deterioration and make repairs prior to making finished floor repairs.
  3. Repair materials should match the original in wood species, and dimension.
  4. Match the nailing method to the existing attachment.
  5. Sand to level the floor between repairs and existing materials.

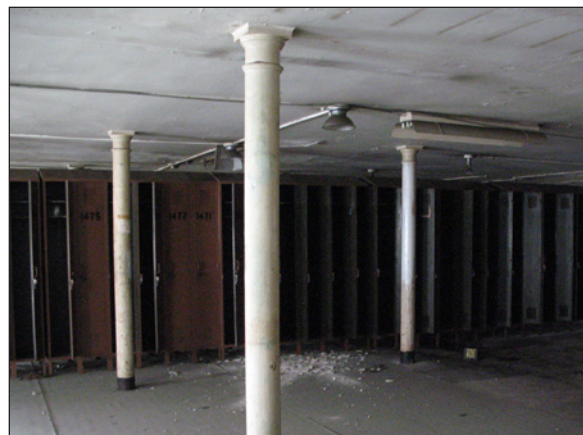
- Localized water damage

- Clean and repaint.
- Restore 20% plaster and lath ceiling. Gypsum Flat Plaster Repair:

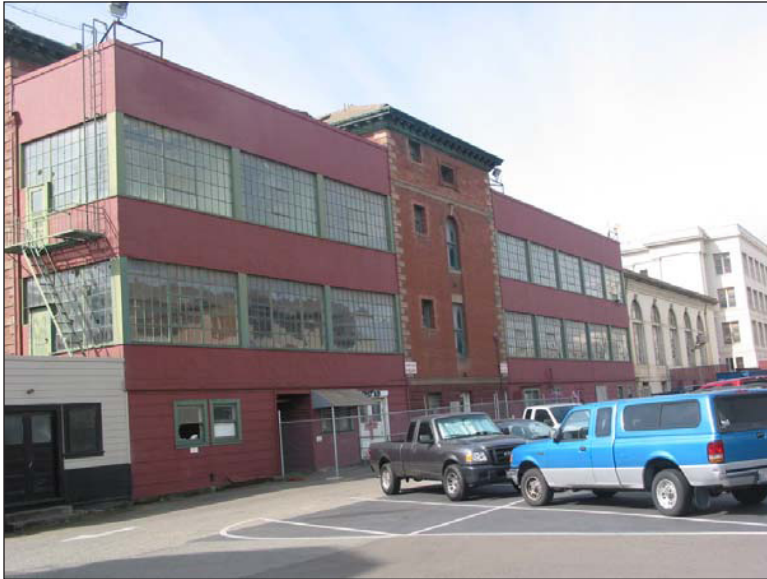
Photo 1 Above: View of North Side Showing 1941 North Annex

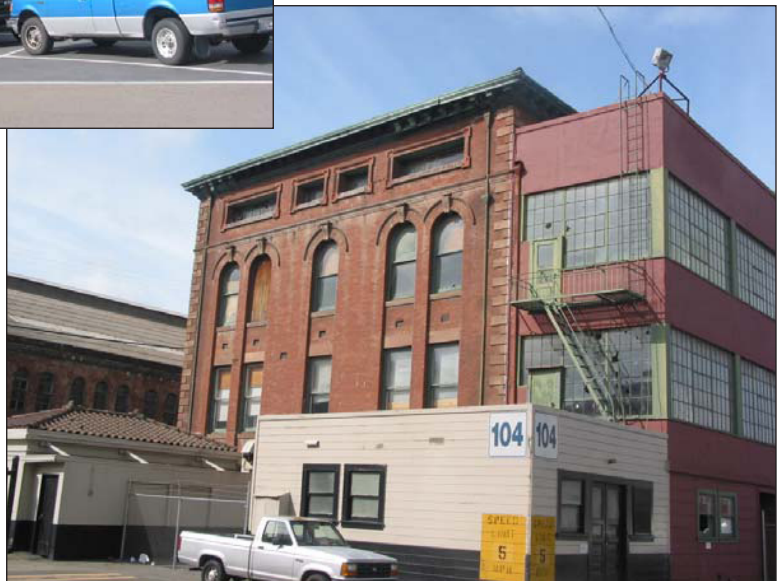
Photo 2 Below: View of East Side Showing 1941 North Annex and 1943 East Annex

Finally, the lateral load path for shear transfer between north annex and original building appears inadequate.

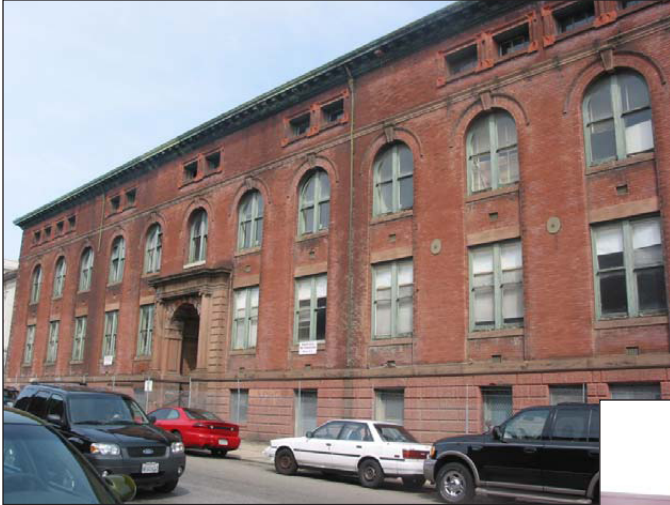
Photo 3 Above: View of South Side

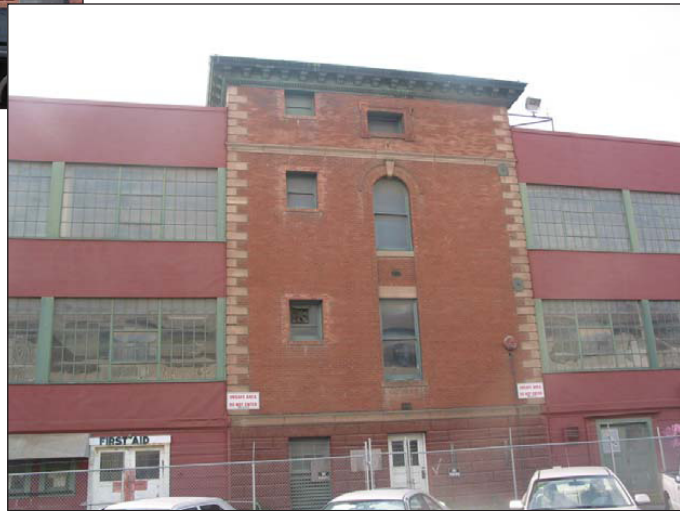
Photo 4 Below: View of North Wall Showing Stair/Restroom Area and 1941 North Annex

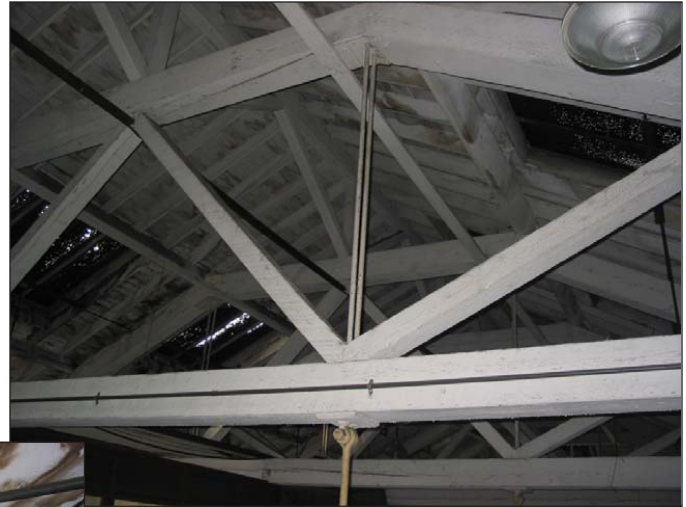
Photo 5 Above: Roof  
Truss (1896 Original

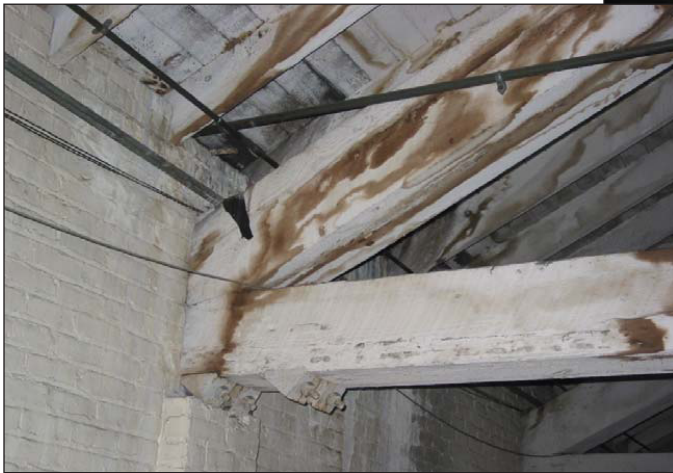
The roof vertical load carrying system of original building consists of 1x6 straight sheathing supported by 2x joists spanning between 4x10 beams, which in turn are supported on heavy wood trusses. The trusses bear on masonry pilasters. Portions of the roof sheathing have completely deteriorated and leaked rainwater onto floor, resulting in some water damage on 3<sup>rd</sup> floor finishes as shown on Photo 7. There is some significant charring and deterioration of the roof trusses as seen in Photo 5. Existing roof framing may require strengthening and/or new framing to support existing dead loads plus current code live loads. No significant additional load should be added to the roof prior to repairing the damaged structure.

Photo 6 Below: Deteriorated  
Roof Sheathing (1896 Original Building)

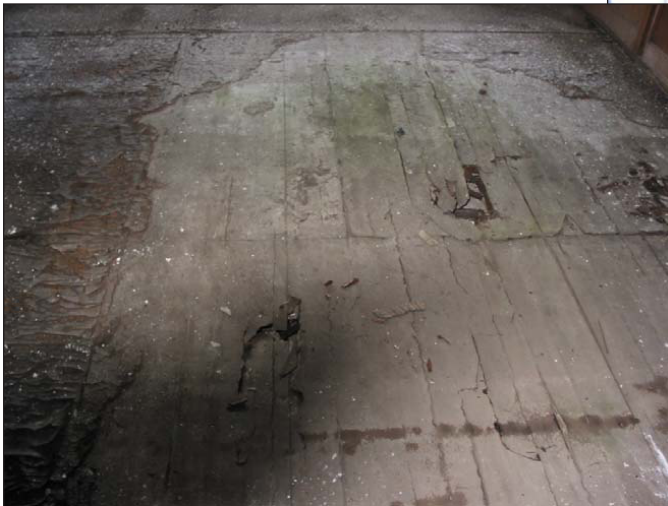
Photo 7 Below: Deteriorated  
3rd Floor Finish (1896 Original  
Building)

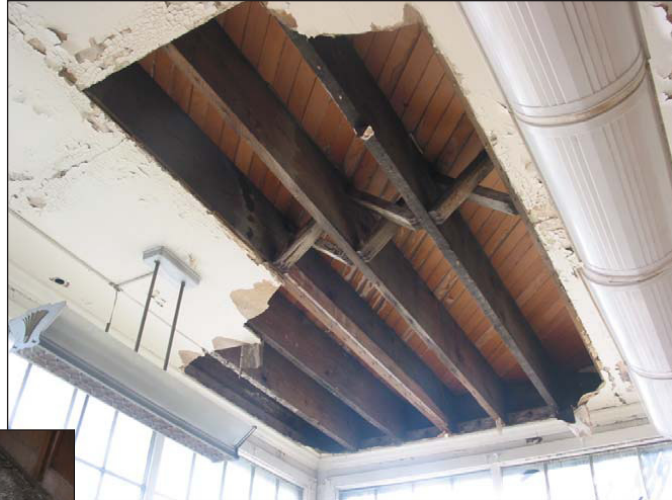
Photo 8 Above: Typical  
Framing at 2nd Floor  
(North Annex)

- Add plywood sheathing to floor and roof to increase shear strength of diaphragm.
- Strengthen the URM walls with shotcrete walls or add new steel braced frames to resist seismic forces in four sides. New shotcrete walls or steel braced frames will require new foundations to provide adequate support for seismic loads.
- Add new ties to connect roof /floor diaphragms and URM walls for out-of-plane seismic loads.
- Add new ties anchors to connect the roof trusses or floor beams and URM wall.
- Add new ties to connect the North Annex diaphragms and 1896 building. Add new anchors into existing ledgers to adequately transfer seismic loads into 1896 building
