MEMORANDUM

February 4, 2016

SUBJECT: Informational Presentation on the Port's Load Restricted (Yellow with Green Hatching-Tagged) and Fully Restricted (Red-Tagged) Facilities

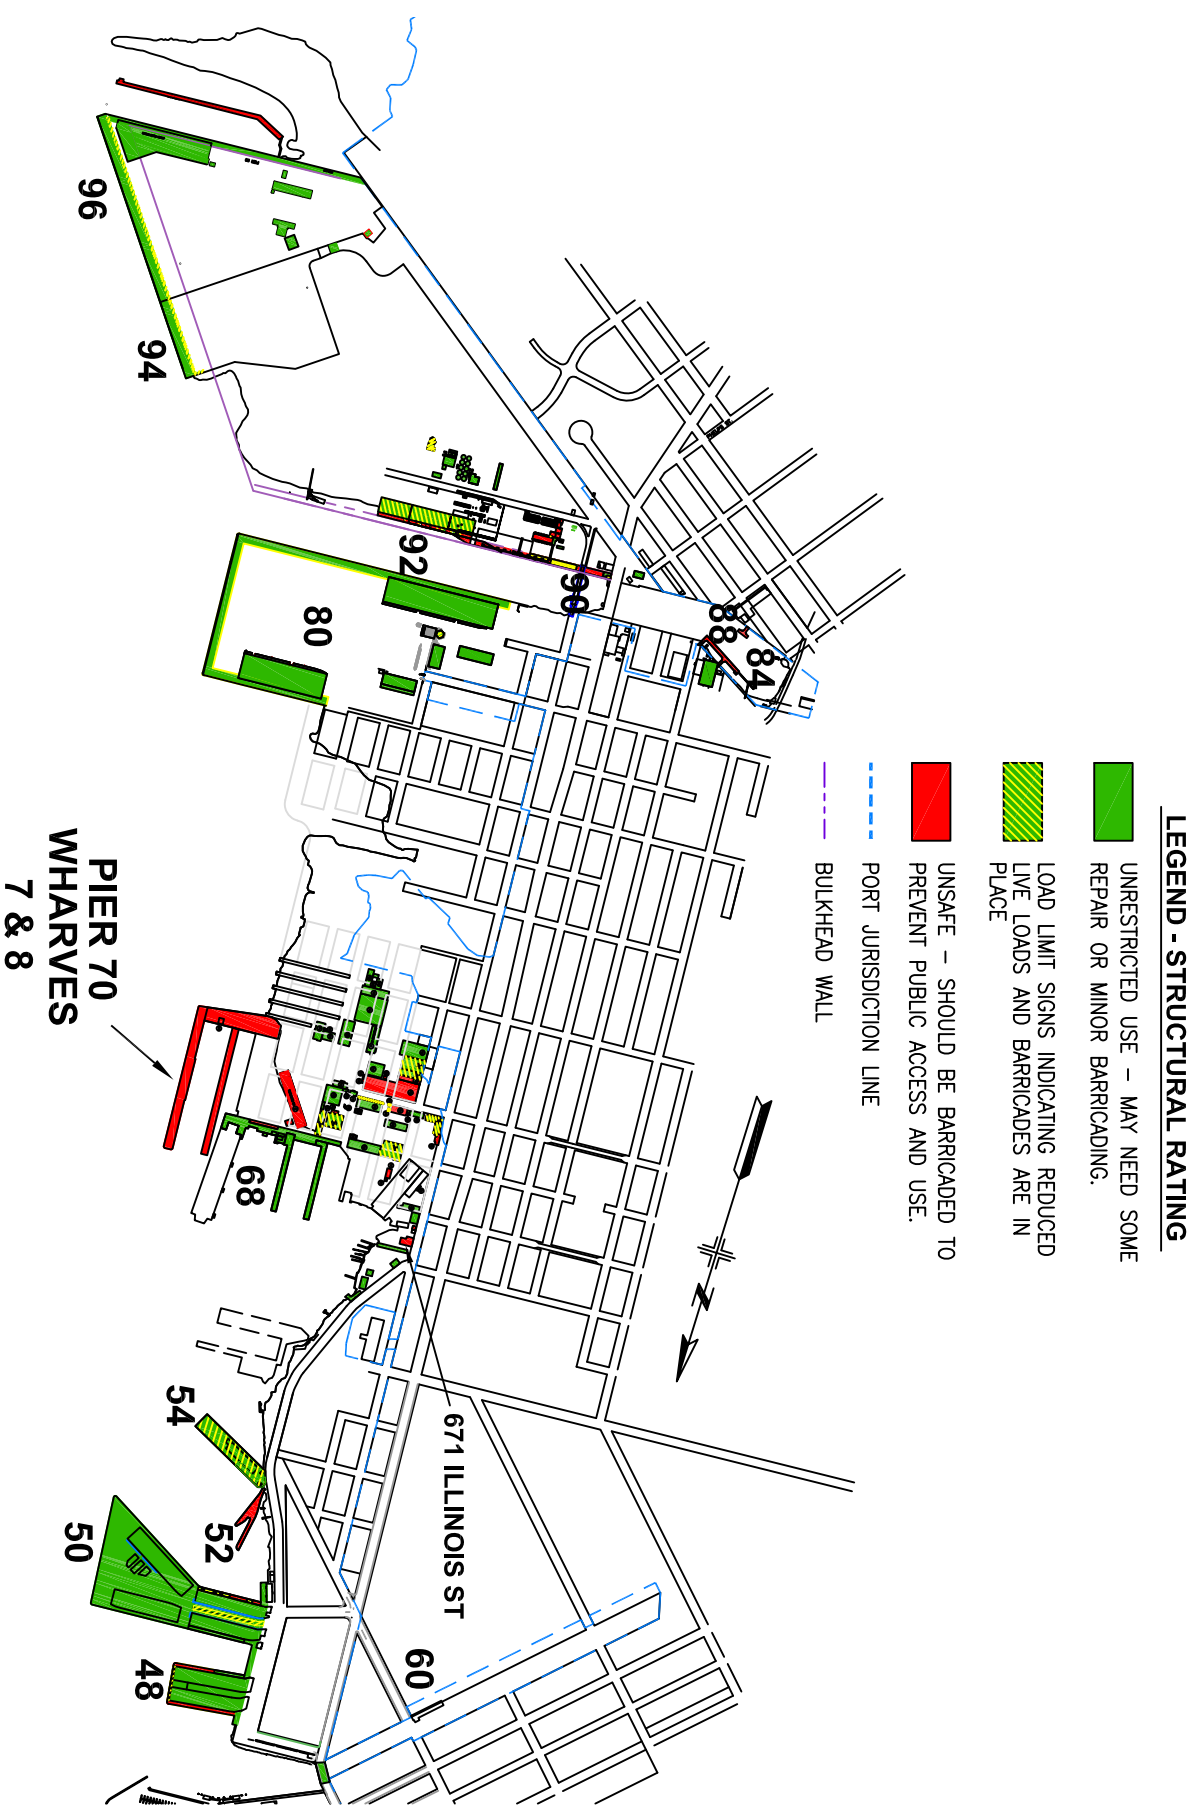
Pier 96 to Pier 48

- Pier 2 Superstructure and Substructure, Sinbad's Restaurant
The substructure includes missing and significantly damaged piles, and damaged concrete slabs and beams. The restaurant building is scheduled to be demolished as required by Port's BCDC Permit for the 34th America's Cup event. The demolition work will commence February 16, 2016. After demolition of the restaurant building is completed, Port Maintenance will install fence and barriers

- Pier 54 Substructure
Pier 54 has many damaged beams. At present, no funding source has been identified for the repairs. The estimated cost to perform the repairs is \$21 million; this includes substructure repairs and seismic strengthening.
- Pier 92 Apron Section
All of the wood piles have incurred dry rot. Port Engineering has completed the apron repair design. The project materials cost is \$2 million and the project is currently funded with Port Capital Funds, allocated in recent past. The project was on hold pending regulatory approvals. Port received the final regulatory approvals in December, 2015. Port Maintenance is scheduled to perform the work in FY 2016-17.

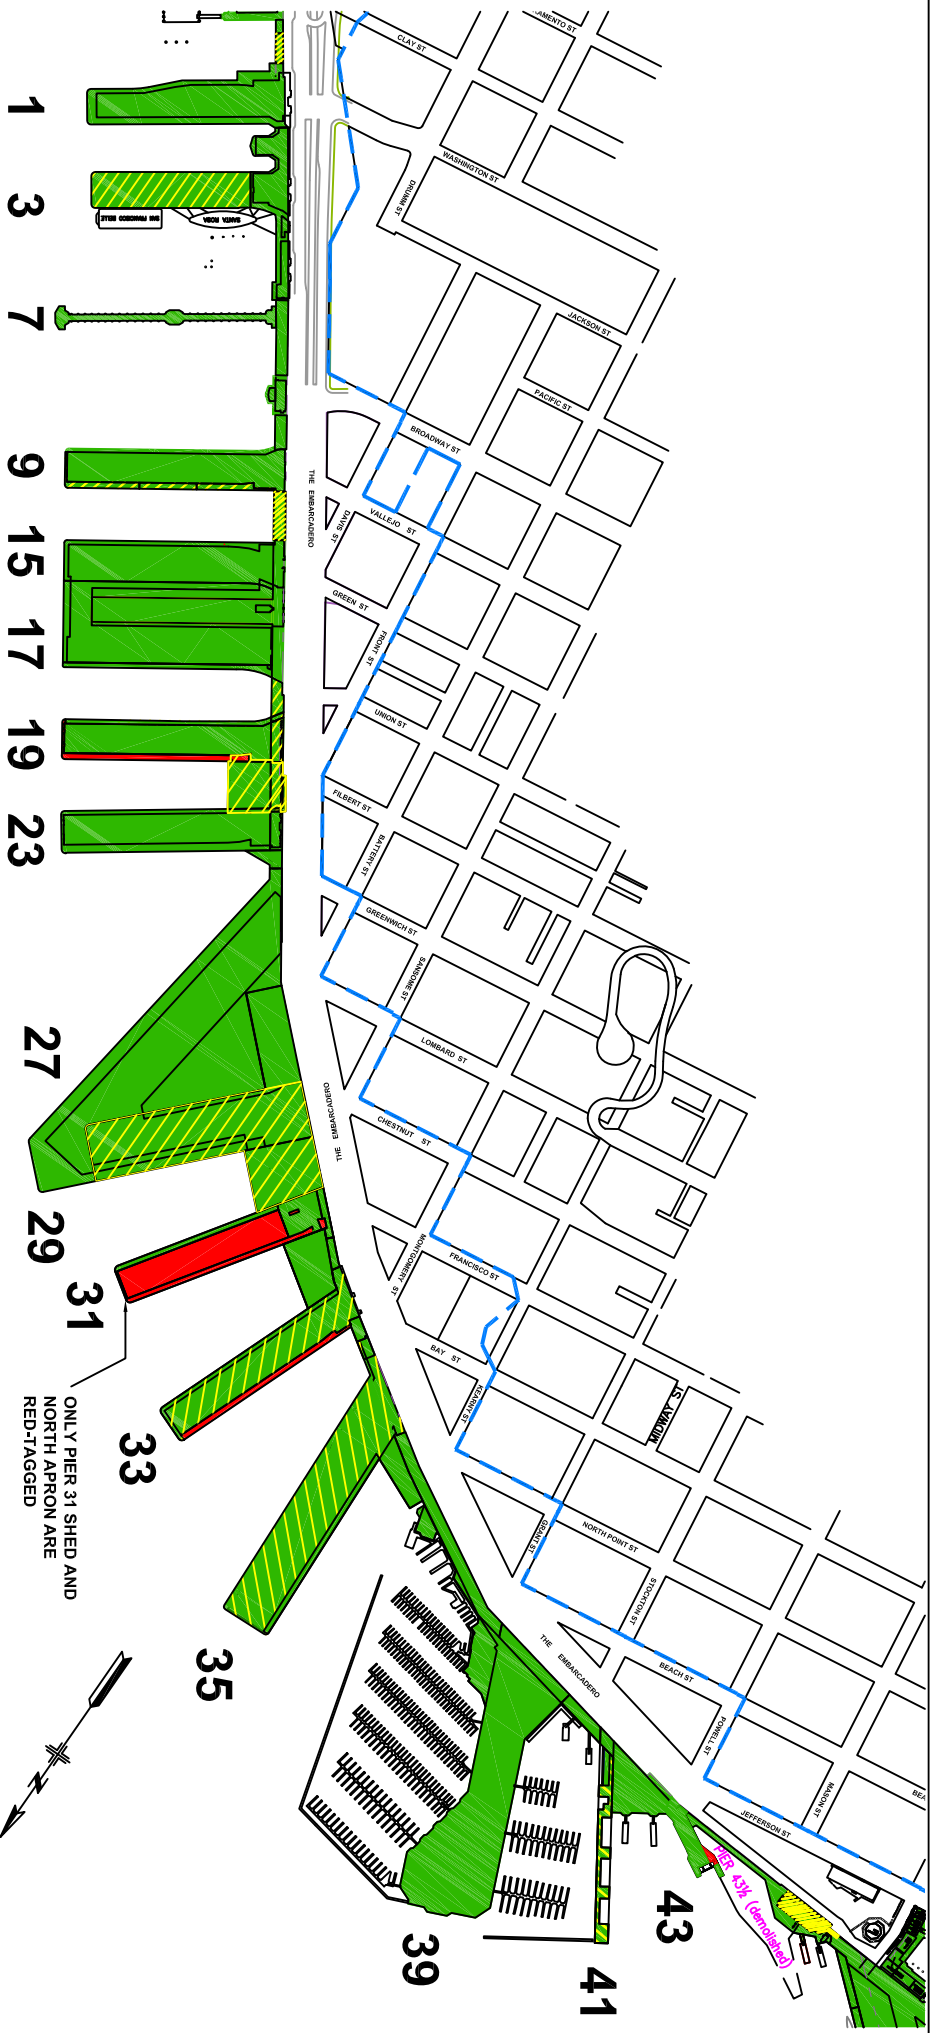
Pier 1 to Pier 43

- Pier 35 Substructure including South Apron
Structural concrete slab and beams have incurred spalling and rebar corrosion. Port Engineering has completed structural repair drawings and specifications for the 'critical' repairs. The estimated cost of the project is \$3 million, and funding for this work is already in place. The proposed FY 2016-17 budget includes staffing for a new concrete pile repair crew that would allow the Port to complete the Pier 35 substructure repairs at a significantly reduced cost compared to contracting out the work. This repair project is scheduled to commence construction in FY 2019-20.

- Pier 29 Substructure including North Apron
Inspection revealed substantial deterioration of the deck, beams, girders, and slabs. The Bulkhead substructure and a relatively small section of the Shed substructure require \$2.7 million to repair and the rest of the Shed substructure requires another \$8.3 million to repair. Port Engineering recommends that all structural members with severe and major damage be repaired. Funding for this work is already in place and Port Engineering is moving forward with the project design drawings. The proposed FY 2016-17 budget includes staffing for a new concrete pile repair crew that would allow the Port to complete the Pier 29 substructure repairs at a significantly reduced cost compared to contracting out the work. The \$2.7 million repair project is scheduled for construction in FY 2017-18.

- Agriculture Building East Apron and South Apron
As reported in the 2015 presentation, the East and South Aprons surrounding the Agriculture Building have experienced significant deterioration: slab rebar is missing in many locations due to corrosion. At present, the South and North Apron uses are restricted to light passenger vehicles while no vehicular traffic is allowed on the East Apron. No funding source has been identified for repair of the East and South Aprons yet, although efforts to identify future funding sources will continue. Currently Port staff has no plans to repair the East and South Aprons. The estimated cost of repairs is \$2 million. In the absence of these repairs, the south apron could be downgraded to pedestrian traffic only, while the east apron may be fully restricted, if future assessment reveals further substructure damage. Port Maintenance repaired the North Apron a few years ago, allowing for the continued use of the North Apron for light passenger vehicular traffic.

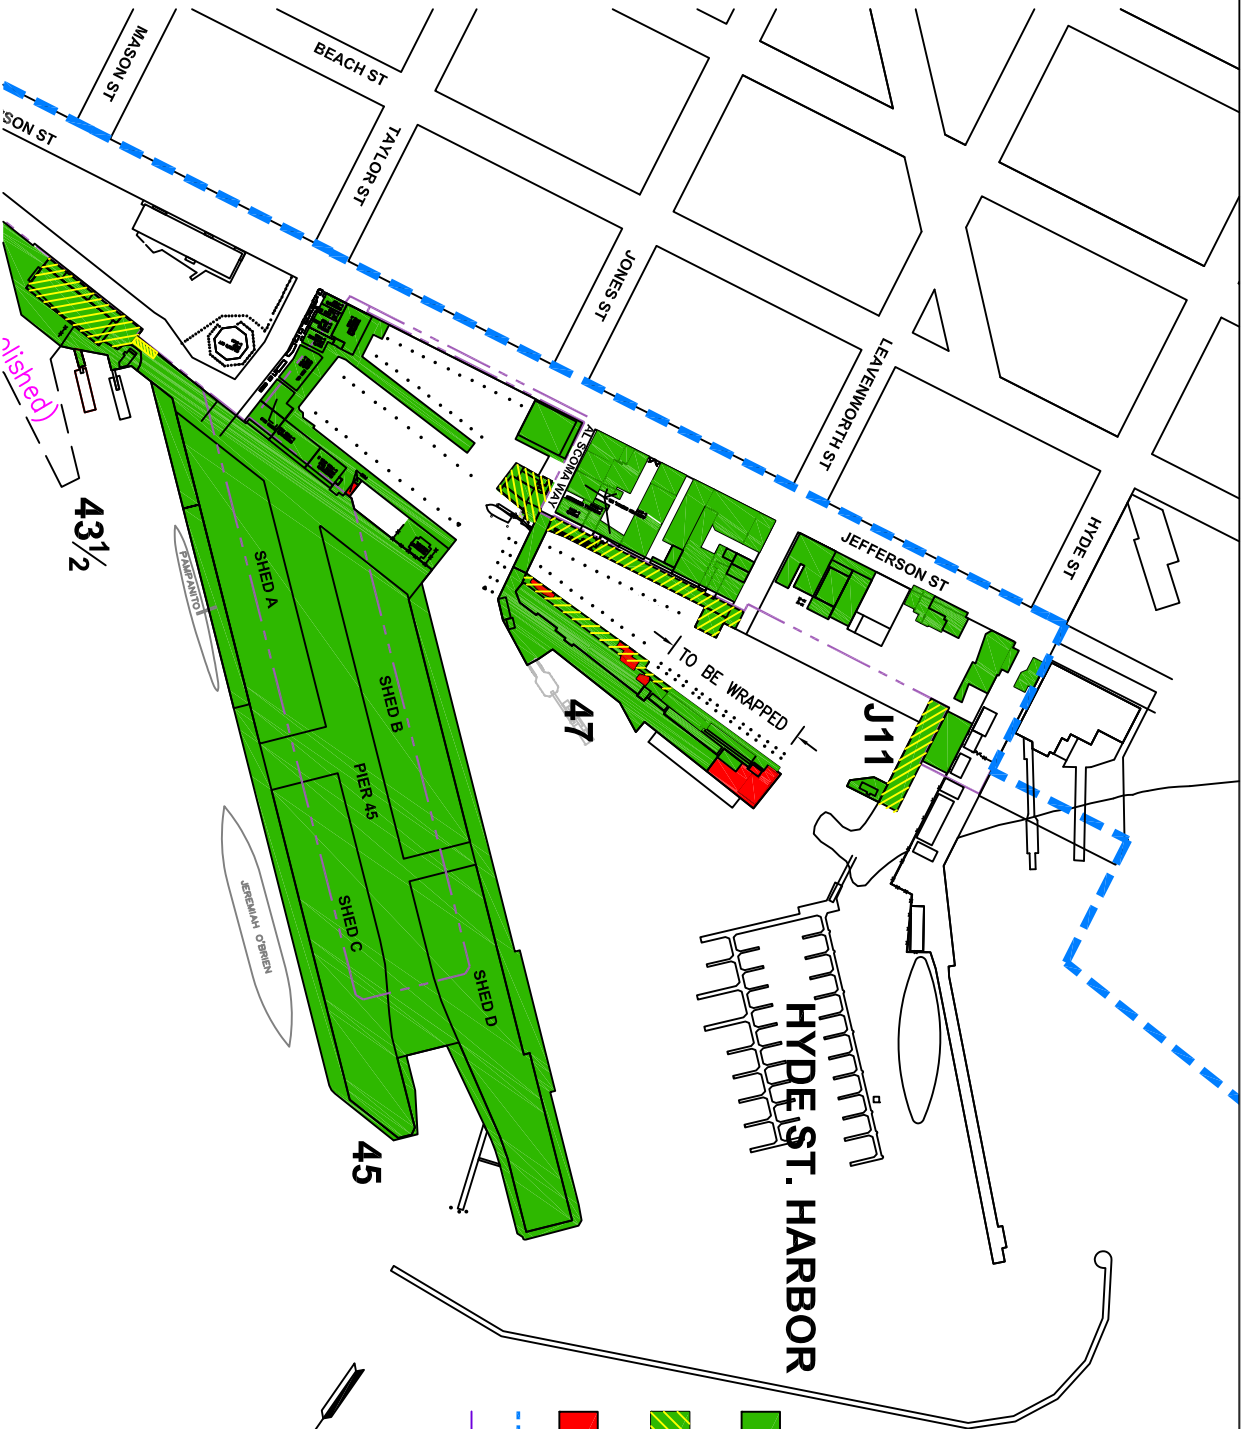
Pier 43 to Wharf J11

- Wharf J9 in Fisherman's Wharf
As reported in 2015, the wharf substructure and adjoining seawall are in deteriorated condition. The wharf substructure deck supports a roadway and the backfill behind the seawall is a critical structural support for the foundations of a number of Fisherman's Wharf buildings that exist adjacent to and south of the seawall. The Port's Consultant has completed the strengthening design. Port Maintenance is scheduled to perform the construction work in FY 2017-18. The estimated cost of materials for these repairs is \$2 million and is currently funded.

- Pier 43½ Seawall between Franciscan Restaurant and Pier 45
As reported in 2015, the Pier 43½ area has required extensive repair. The Port has substantially repaired the deck surrounding the Franciscan Restaurant. However, a small section of the Pier 43½ Seawall contains dry-rotted wood lagging which needs strengthening. The damaged wood lagging may lead to loss of backfill and ultimately create sinkholes along the Little Embarcadero. The estimated cost of repairs is \$400,000 and the project is currently funded. The

Port's Consultant has completed the design. Port Maintenance is scheduled to execute the required repair work in FY 2017-18.
