Bruce S. Rosenblatt & Associates, LLC
Naval Architects & Marine Engineers

DRY DOCK NO. 2 – ANALYSIS OF WINGWALL SHELL PLATE AS SURVEYED THICKNESSES

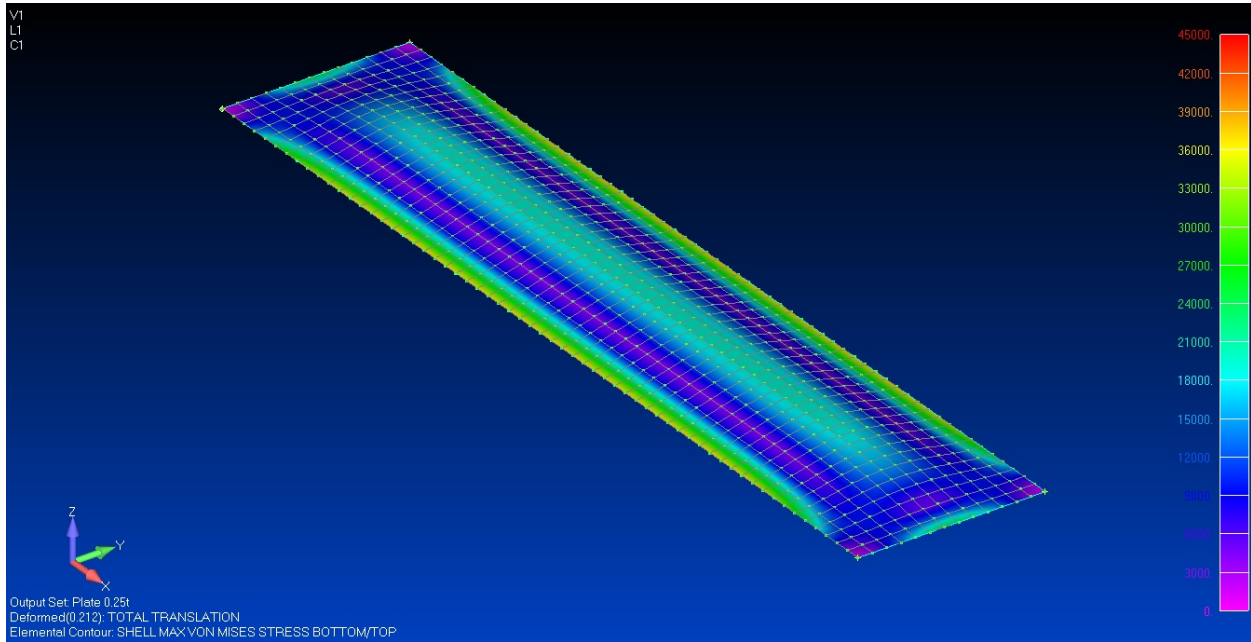
Figure 1 – 20 ft. Head – Shell Plate Panel – 45,000 psi Criteria

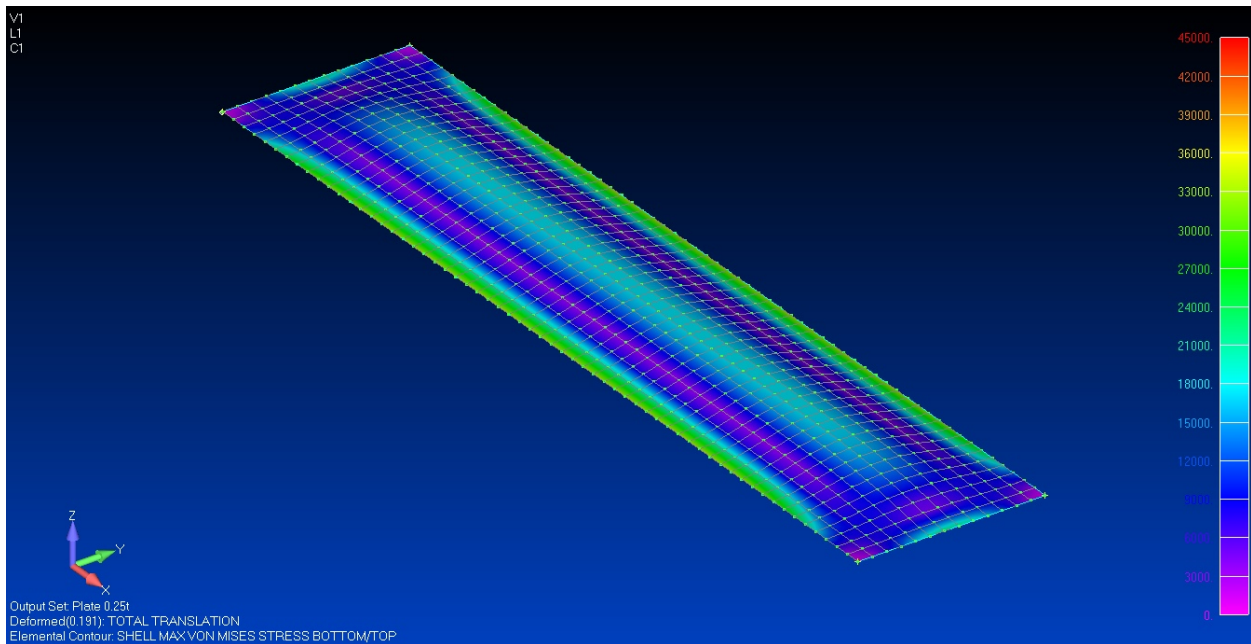
Figure 2 – 18 ft. Head – Shell Plate Panel – 45,000 psi Criteria

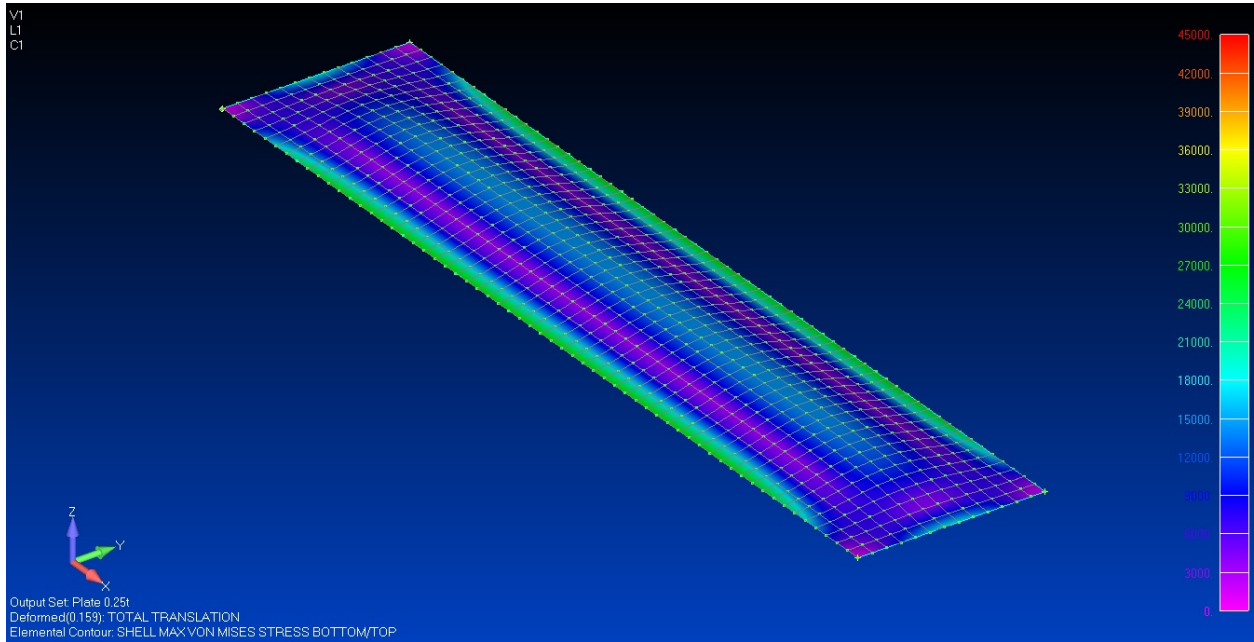
Figure 3 – 15 ft. Head – Shell Plate Panel – 45,000 psi Criteria
