Pier 70 Building Survey

Historic Buildings Conditions and Assessment Carey & Co. and OLMM, Inc May 2008

Historic Building Conditions Survey and Assessment May 22, 2008

Building 101 UIW Main Office/Administration Building

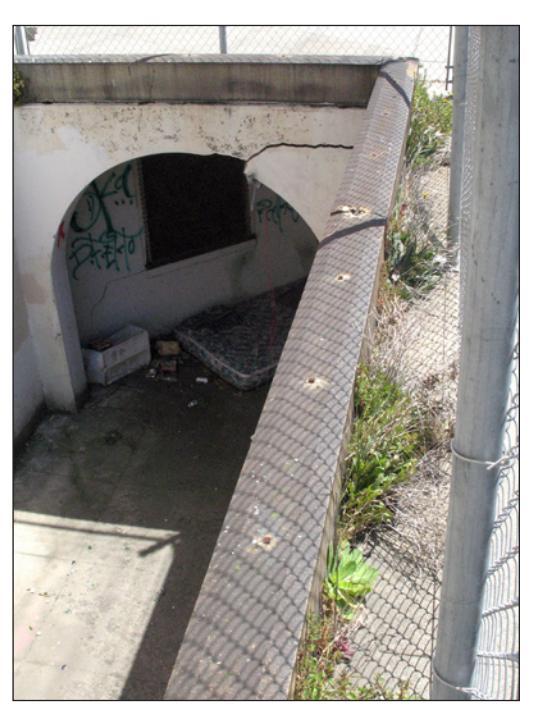
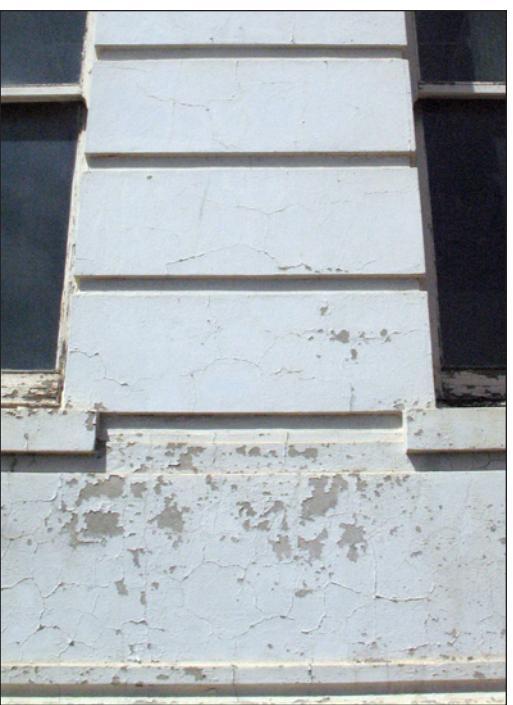
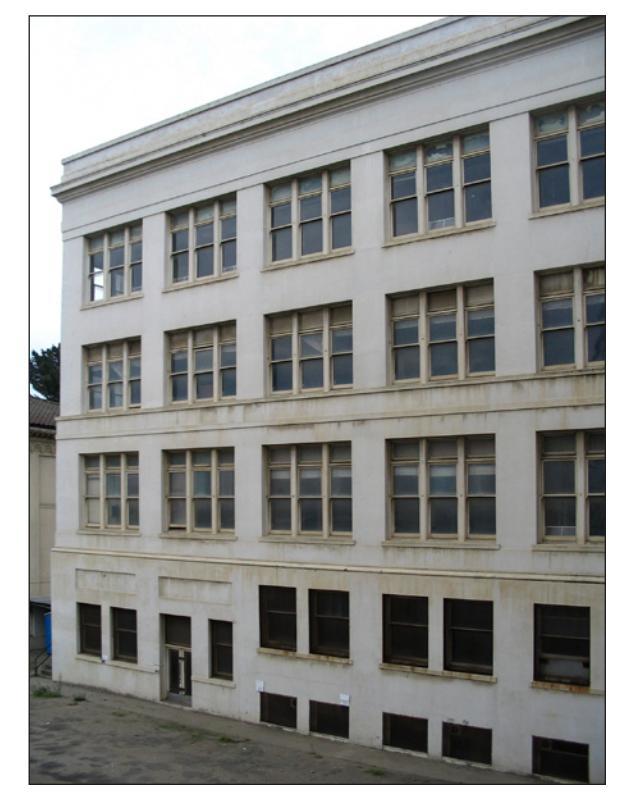
Condition:

- Some de-bonded plaster
- Dirt and staining on cement plaster walls.

- Replace 20% de-bonded cement plaster. Cement Plaster Repair
 - 1. Review laboratory reports on cement plaster to determine appropriate mix.
 - 2. Patch small cracks, less than 1/16" wide, with a thin slurry coat consisting of finish coat ingredients.
 - 3. For larger cracks, or holes, address underlying substrate deterioration problems first, then patch with new cement plaster to match surrounding material.
 - 4. Remove cement plaster as required to fully address underlying concrete or brick masonry substrate damage prior to patching.
 - 5. Undercut adjacent sound cement plaster to create a key for the new repair material.
 - 6. Following repairs, prepare and paint the building with a high-quality, non-epoxy breathable coating such as acrylic latex.

- Clean cement plaster walls. Cement Plaster Cleaning
 - 1. Determine type and source of stain. If the stain is ferrous metal corrosion, locate the metal and determine the cause of the corrosion. Staining may be the first clue that reinforcing rod within the wall is corroding. If the stain is efflorescence, determine and eliminate the source of water.
 - 2. Remove non-historic, non-functional metal attachments. Patch subsequent holes as described above under Cement Plaster Repair.
 - 3. Remove stains using the gentlest means possible. Test the area first to make sure the base material is not harmed and that significant painted materials are not affected. Begin using low pressure washing methods (100-300psi) with a fan tip and a natural bristle or nylon brush. Mild detergent or tri-sodium phosphate solutions should be tried next.

- 4. Where the cement plaster is painted, the cleaning and stripping of paint will be required to make repairs. The presence of lead-based paint will also affect the choice of removal method.
- 5. Use proprietary chemical cleaners designed for cement plaster only if necessary. For biological growth, the pressure wash may contain proprietary biocides. Non-liquid products such as "Peel-Away" may be preferred, since they have fewer environmental impacts.

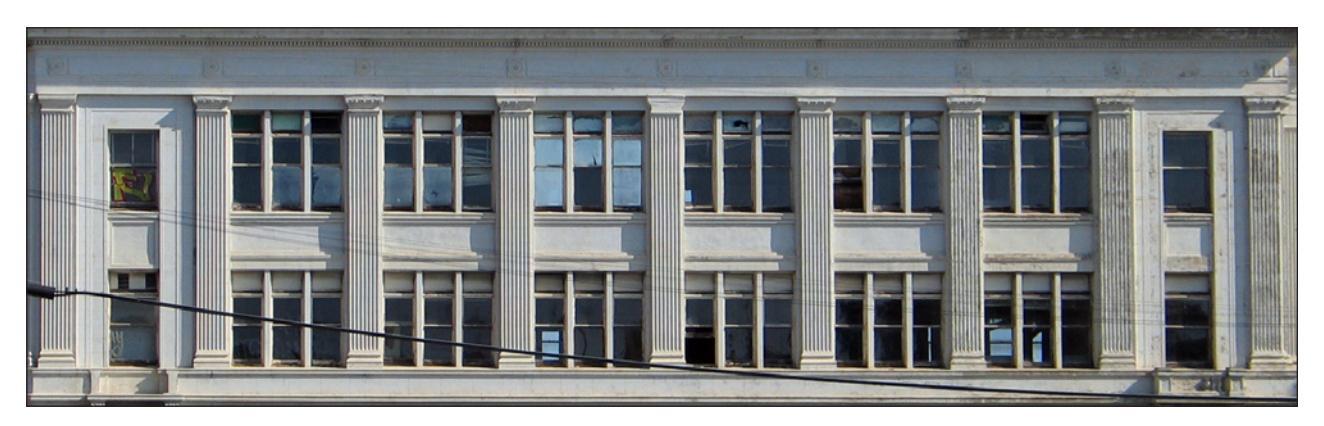
Condition:

• Ornamental elements with leading edges have suffered some cracking and chipping Recommendation:

• Repair or replace 40% damaged ornament. Ornamental Cement Plaster Repair

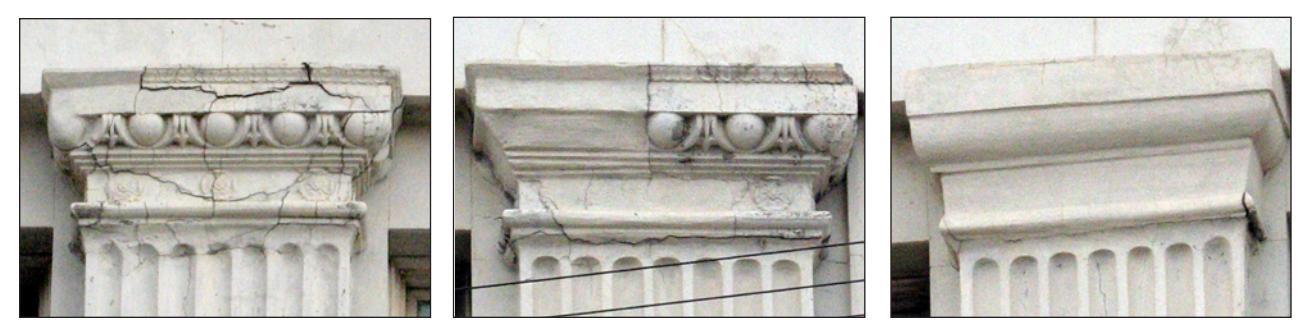
Condition:

- Cast stone chipping and spalling
- Some pilasters missing or damaged beyond recognition

- 100% rebuild 12 capitals.
- Repair non-structural cracks and spalling on remaining 18 capitals.
- Ornamental Cement Plaster Repair:
 - 1. Review laboratory reports on cement plaster to determine appropriate mix.

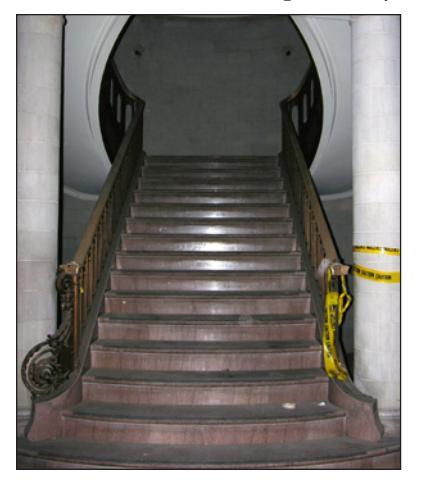
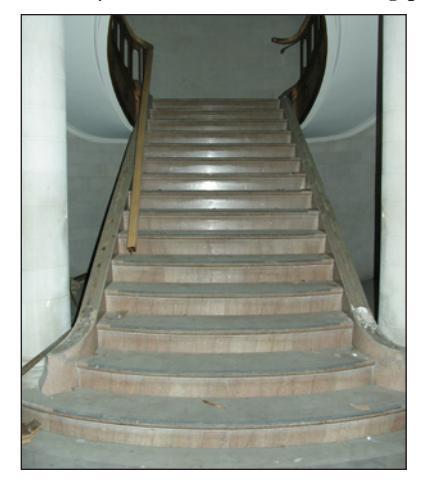
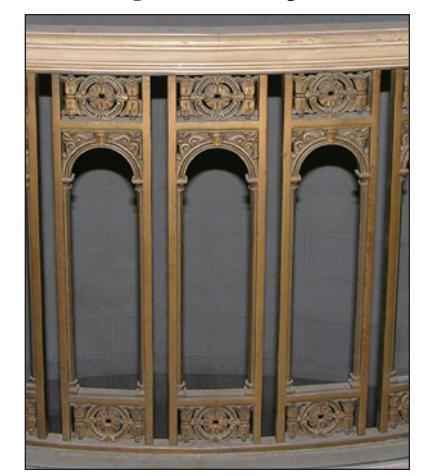
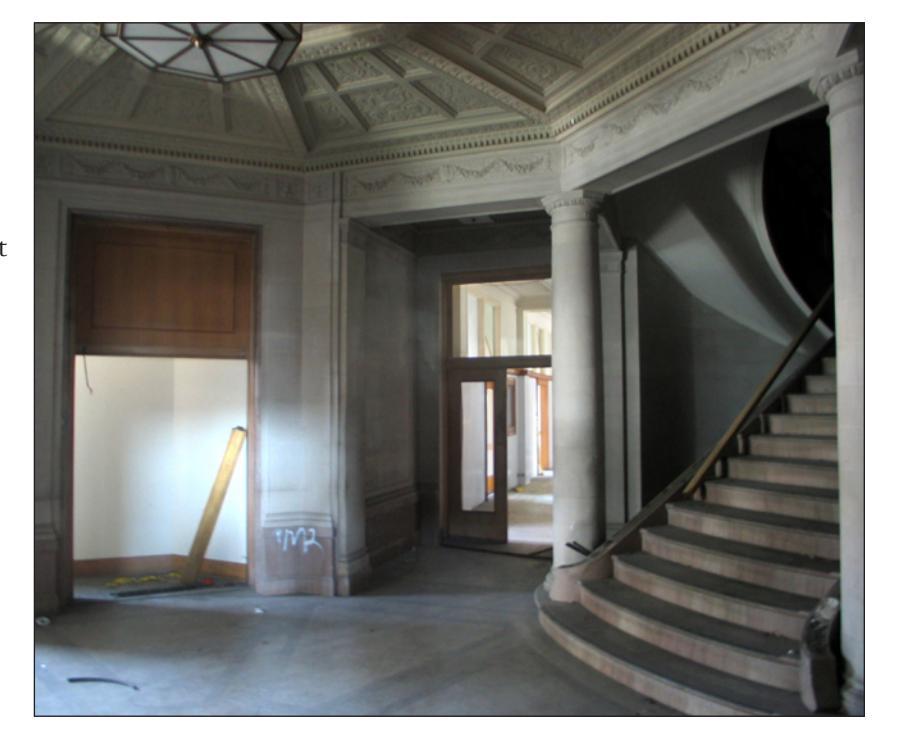
Condition:

- Significant portions of the railing have been stolen Recommendation:
 - Cast new ornamental railing components and rebuild ornamental iron railing. Ornamental Cast Metal Repair:
 - 1. Ornamental cast metal elements include the missing main stair railings
 - 2. Survey the area for missing or damaged elements. Map the quantity and location of areas to be treated on plans or interior elevations. Develop detailed drawings of existing elements, and based on existing adjacent design, reconstruct the missing elements.
 - 3. Retain the services of a foundry specializing in cast architectural ornament, to replicate missing stair railings. It may be necessary to de-mount an existing piece of railing for use as a pattern.

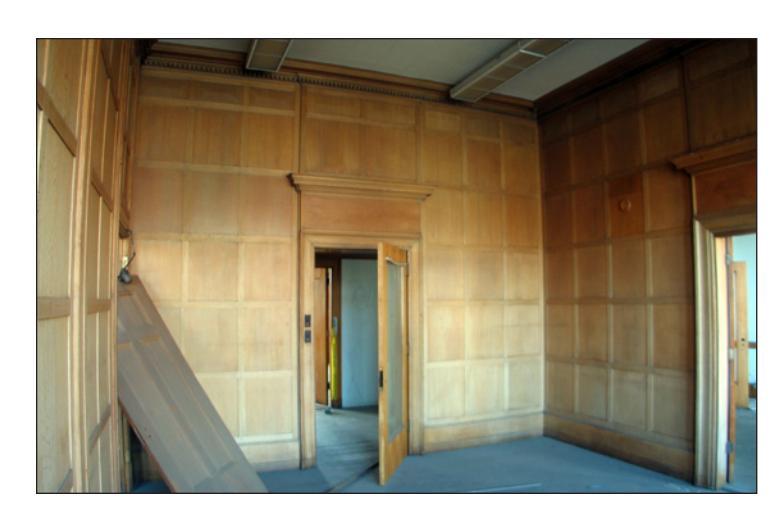
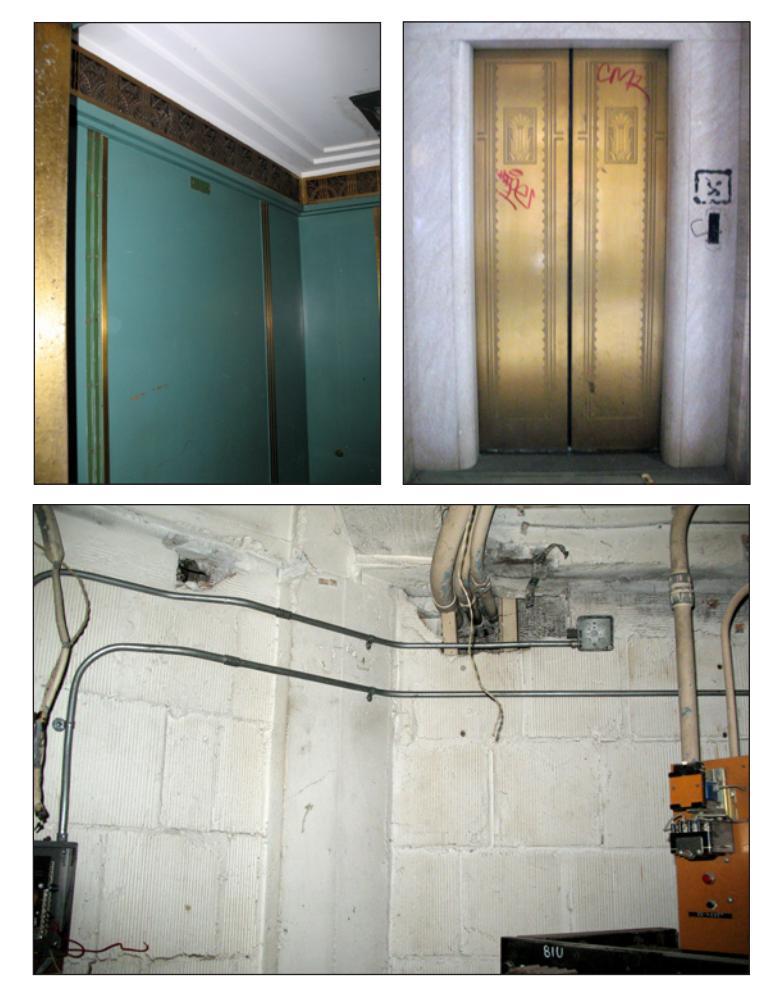
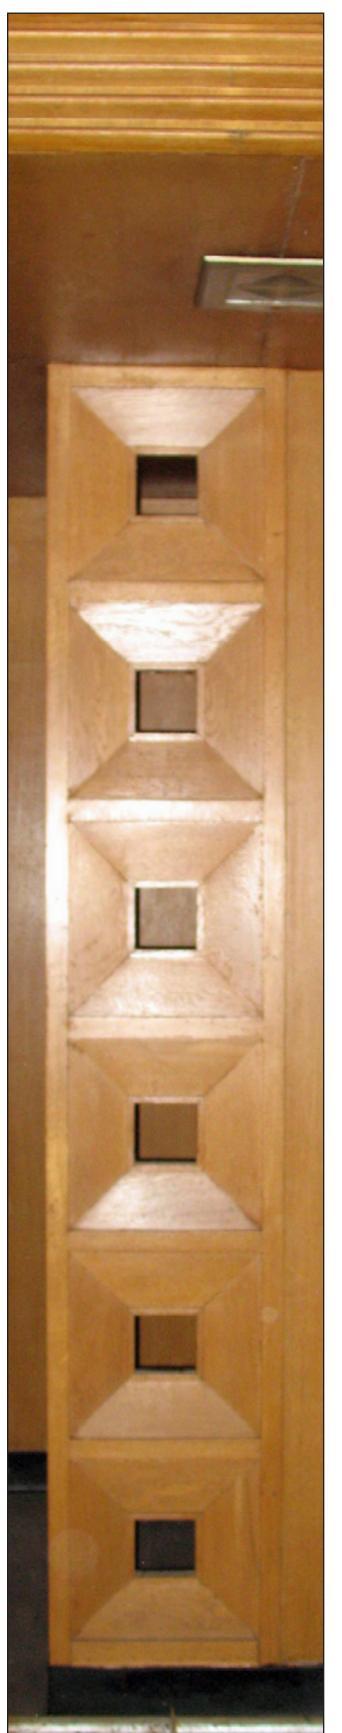
• Oak plywood wall covering Condition:

• The plywood panels have raised grain and some weathering

- Sand wood to remove raised grain
- Clean and shellac: Interior Wood Element Repair
 - Survey the interior areas for missing or damaged elements. Where the damage is the result of water intrusion, repair the water intrusion source before making wood repairs.

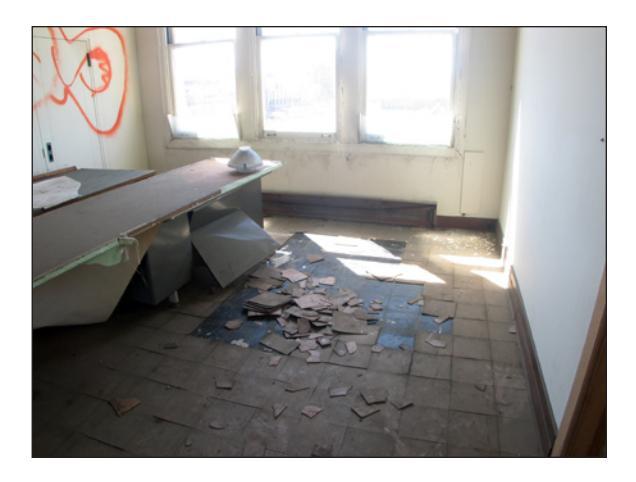
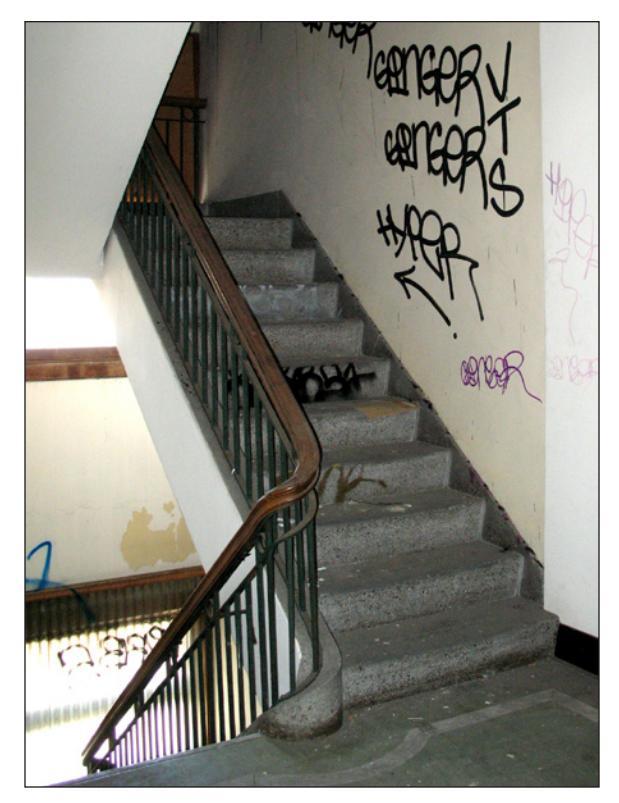
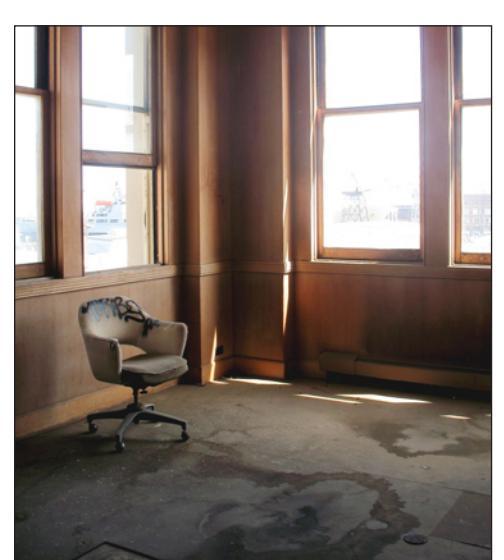
Condition:

• Dirty

- Terrazzo Floor Repair
 - 1. Survey the area for missing or damaged terrazzo floor surface. Map the quantity and location of areas to be treated on plans. or interior elevations.
 - 2. Clean terrazzo surfaces prior to making repairs.
 - 3. Repair Minor cracks and holes in marble surfaces as follows:
