Pier 70 Building Survey

Pier 70 San Francisco, California

Historic Building Conditions Survey and Assessment May 22, 2008

Building 113/114

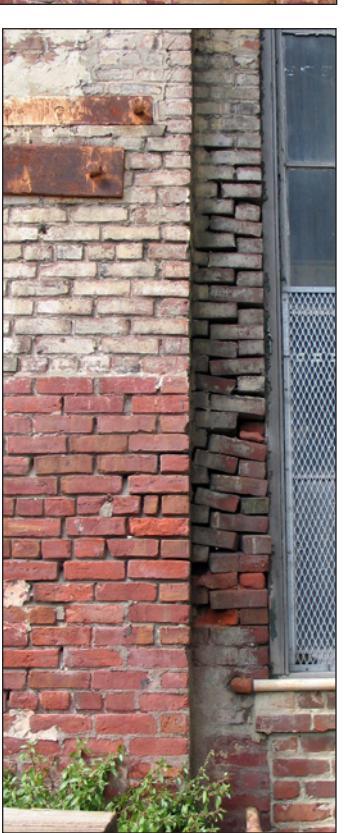
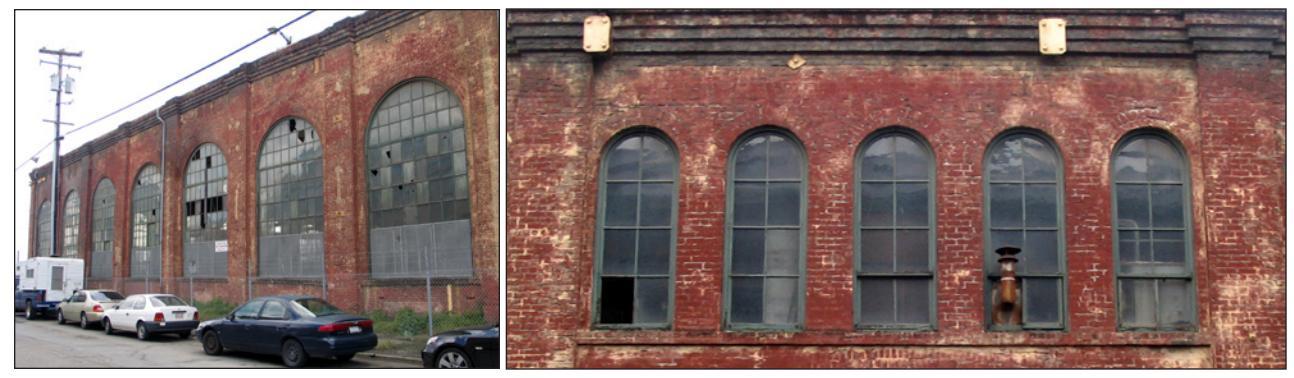
Exterior Walls - Brick Masonry

Condition: poor

• Load-bearing brick masonry with paint covering the walls Condition:

- Crumbled bricks, masonry damage
- Severely deteriorated layer of paint

- Clean Brick Masonry Walls and remove existing paint. Brick Masonry Cleaning:
 - 1. Brick masonry contains efflorescence, staining from animal deposits, staining from rust, biological growth, and grime.
 - 2. Test clean soiled brick in an unobtrusive area using the gentlest means possible
 - 3. Use low pressure water washing methods (100-300psi) with a fan tip and stiff natural bristle or nylon brush. Mild detergents may be applied next. Use proprietary chemical cleaners designed for brick masonry, only if necessary.
 - 4. Where masonry is painted, the cleaning and stripping of paint will be required to make repairs. The presence of lead-based paint will also affect the choice of removal method.
 - 5. For biological growth the pressure wash may contain proprietary biocides.

- Repoint 75% exposed mortar joints. Brick Masonry Repointing:
 - 1. Analyze mortar to establish original composition. Specify repair mortar matching original.

- Replace 5% damaged bricks on exterior. Brick Masonry Replacement:
 - 1. Remove and salvage sound brick / remove deteriorated bricks, retaining some to pulverize for color-matched patch materials. (Note that most masonry observed at Peir 70 is either load-bearing or non-veneer solid masonry. Brick replacement should be coordinated with the structural engineer regarding shoring requirements).

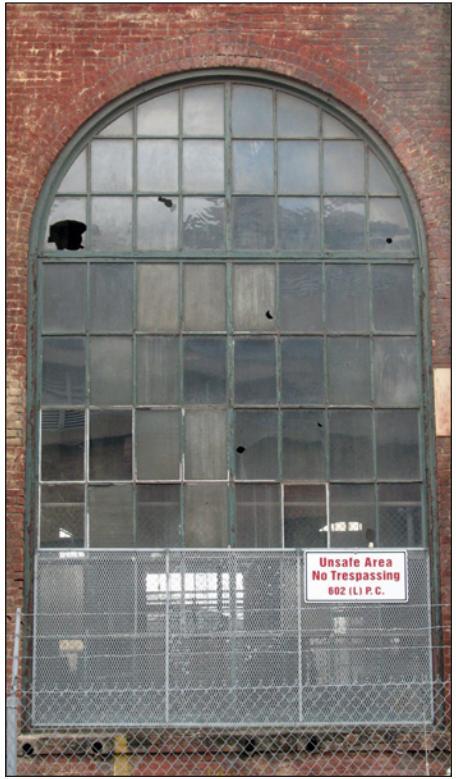
Windows:

Condition: Fair Description:

- 11' x 20' arched wood frame wood sash windows
- Top operable
- Top op
- Condition:
 - 10-15% damaged sash
- Recommendation:
 - Restore wood sash windows: Wood sash window restoration:
 - 1. Survey existing condition of all wood windows.
 - 2. Remove all dirt, debris, and miscellaneous attachments.
 - 3. Remove paint to obtain clean surface.
 - 4. Replace deteriorated wood elements in kind as required.
 - 5. Restore window to proper operation.
 - 6. Install new hardware, where missing, to match original.
 - 7. Install new glazing where cracked or missing.
 - 8. Prepare wood surfaces, prime, and paint.
 - 9. Where wood windows are deteriorated, but repairable, remove the unit to a controlled shop condition for element replacement and / or epoxy consolidation.
 - 10. Where severely deteriorated beyond repair, replace inkind with a new unit.

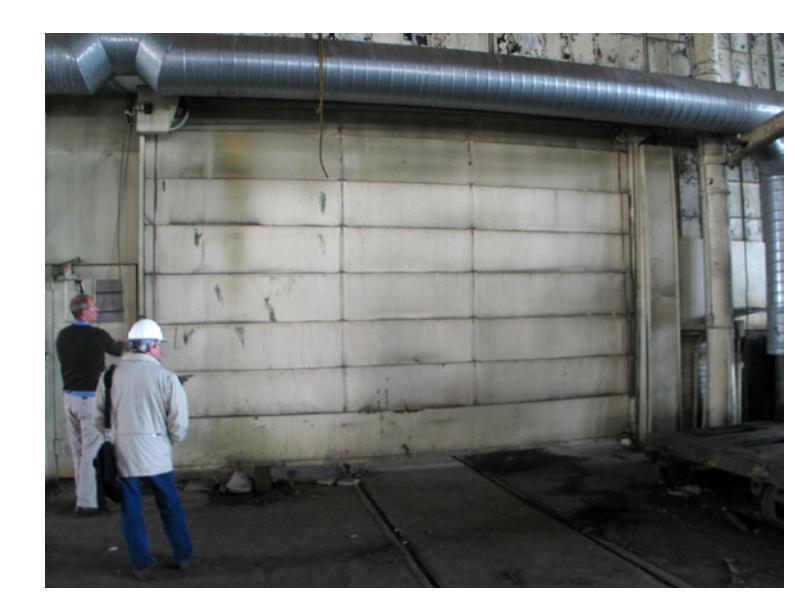
Doors

Condition: fair Description: • Several roll-up vehicle doors

• Most appear operable

- Determine if historic contributor or non-contributor
- If historic, retain roll-up vehicle doors

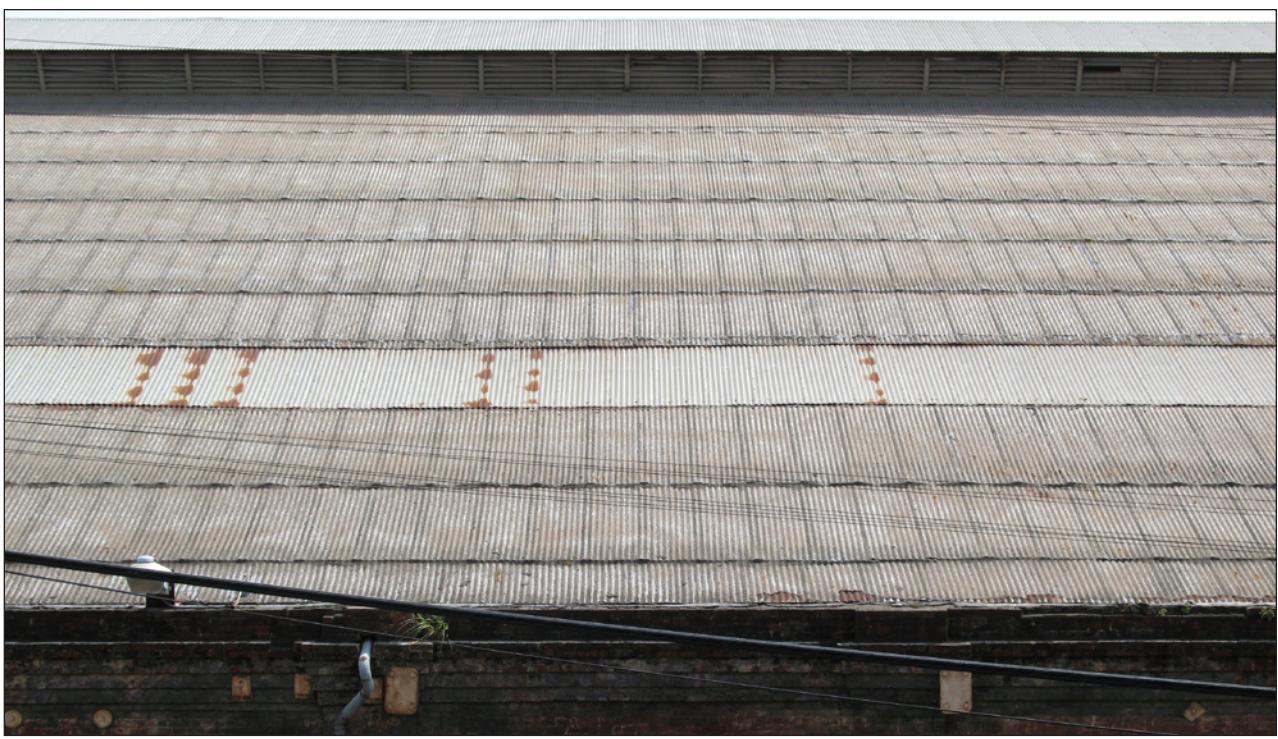
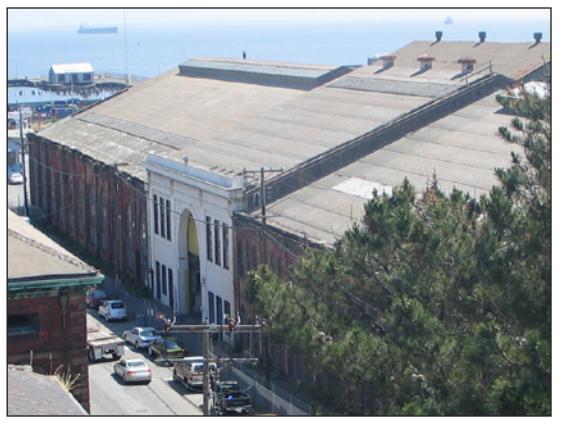
ROOF Membrane

Condition: poor Description:

• CGI Steel panels with ventilators and strip skylights Condition:

- Panels exhibit significant rust and decay
- Water penetration on floor

• 100% New CGI roof

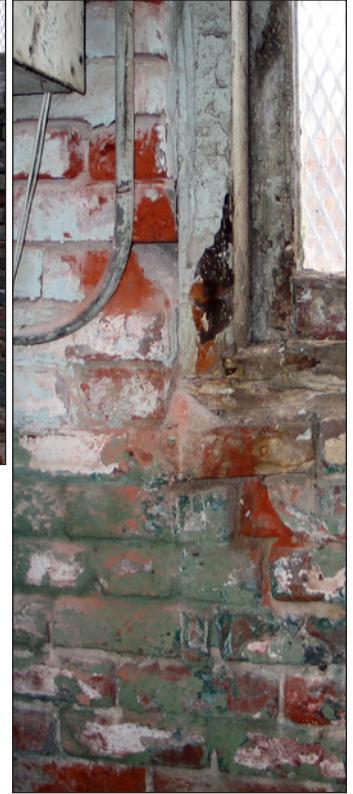
Interior walls

Condition: poor

• Load-bearing brick masonry walls

• Deteriorated mortar

Soft brick

- 75% repoint. Brick Masonry Repointing:
 - 1. Analyze mortar to establish original composition. Specify repair mortar matching original.
 - 2. Rake out all loose or deteriorated mortar. Repoint with new mortar to match original color, texture, joint profile and chemical composition.

- 3. Replace deteriorated sealant between door and window frames and other adjacent nonmasonry cladding materials.
- 15% brick replacement. Brick Masonry Replacement:

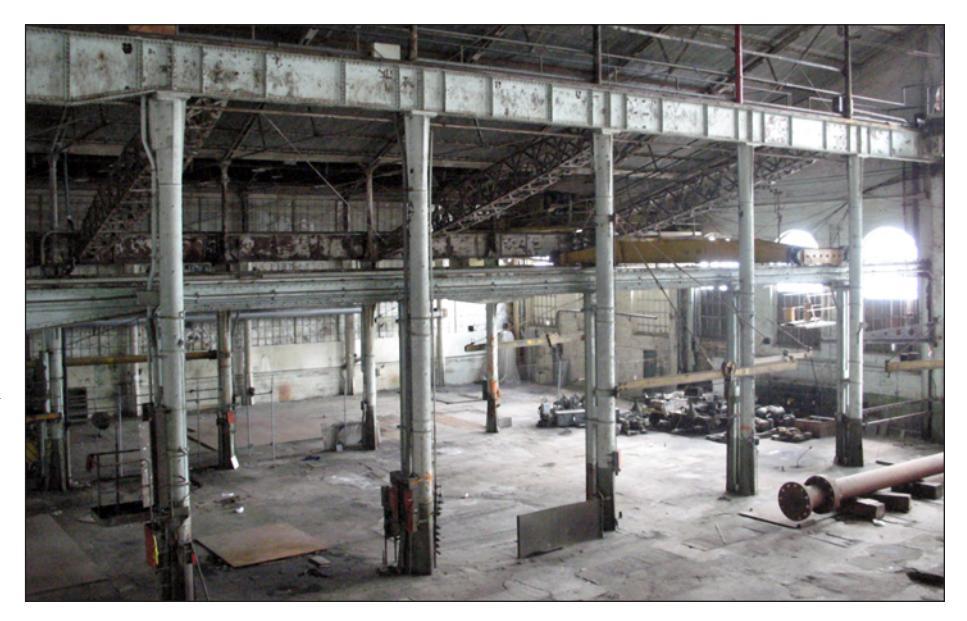
Columns & Craneways

Condition: good Description:

- Round cast-iron columns
- Multiple craneway systems

- Chipping paint
- Recommendation:
 - Repaint columns & craneways. Ferrous Metal Corrosion and Coating Treatments:
 - 1. Remove rust and most of the surrounding

- 2. Remove all loose, flaking and deteriorated paint and corrosion to bare metal.
- 3. Degrease surfaces and prime immediately.
- 4. Paint Selection:
 - Option One: spot prime with industrial corrosion-inhibiting primer, followed by two coats of oil based paint.
 - Option Two: high performance coatings, such as zinc-rich primers, and epoxy coatings should be considered to allow for longer lasting protection. Note: These coating typically require highly clean surfaces and special application conditions that can be difficult to achieve at some sites.

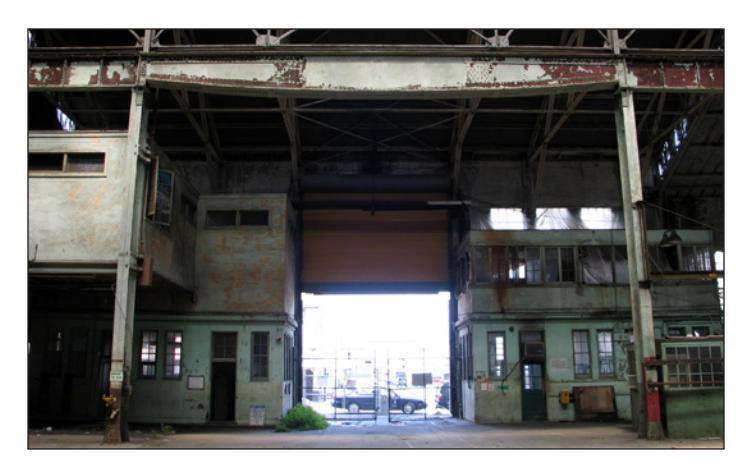
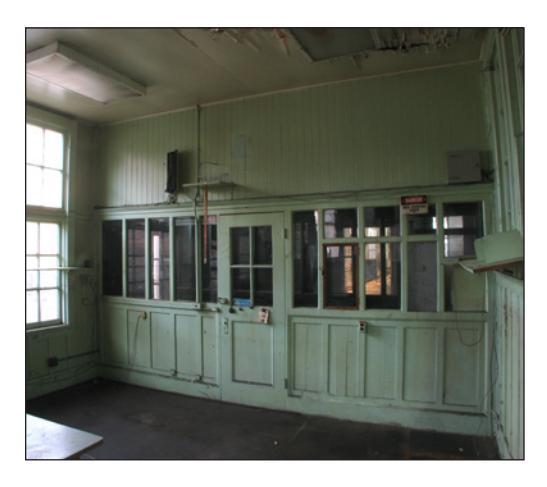
Office Space

Condition: fair Description:

- Interior offices at
 - Interior offices at concrete connector
 Detailed woodwork doors, windows, furniture

- Minor wood damage
- Chipping Paint
- Window damage

- Repaint 100% woodwork
- Re-glaze windows
- Repair 10% detail woodwork. Interior Wood Element Repair
 - 1. Survey the interior areas for missing or damaged elements. Where the damage is the result of water intrusion, repair the water intrusion source before making wood repairs.
 - 2. Where wood elements are split, splintered, or gouged, repair using a Dutchman patch of the same kind of wood with the same grain orientation. Finish to match the surrounding wood.
