# Pier 68-70 Shipyard Facility Condition Survey Electrical Power Systems

2185 North California Blvd, Suite 500 Walnut Creek, CA 94596 August 9, 2017 M&N Job Number: 9590-06 This page intentionally left blank

# 1. Executive Summary

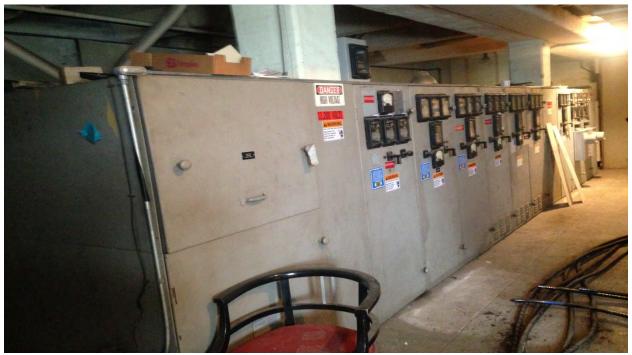
Figure 1. Building 102 first floor includes 12KV Electrical Substation #1

PG&E provides 12 KV power to 12 KV Substation #1 in Building 102 first floor. 12 KV Substation #1 provides power to 12KV/480V Substation #1 with 1500KVA PCB transformer and three 50KVA Single Phase PCB transformers in Building 102 second floor. Some temporary cables have been used in building 102 while under maintenance.

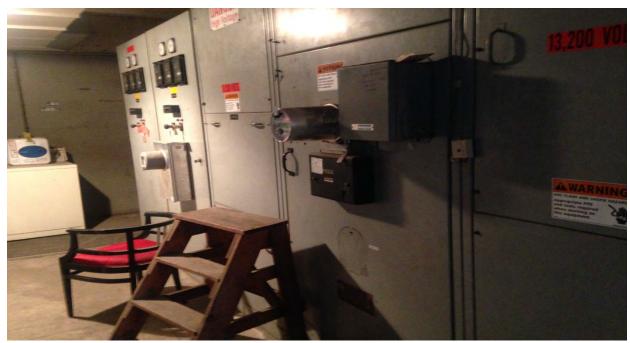
Figure 2. Building 102 first floor includes 12KV Electrical Substation #1

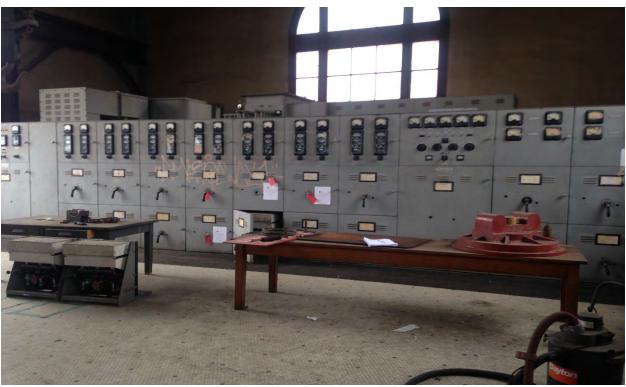
Figure 3. Building 102 second floor includes 480V Electrical Substation #1

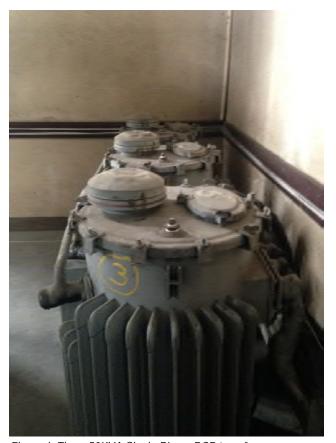
Figure 4. Three 50KVA Single-Phase PCB transformers

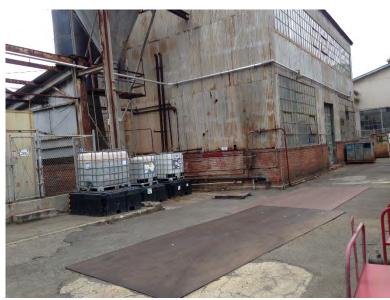
12 KV Substation # 1 (Building 102 first floor) feeds exterior Substation #11 between Buildings 103 and 107. 1500 KVA Substation #11 secondary side feeds compressors in Building 103.

Figure 6. exterior of Substation #11

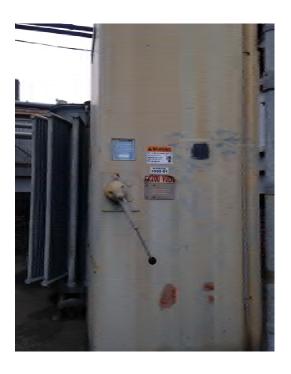
Figure 7. Substation #11 transformer - 1500KVA, 12KV-4160V

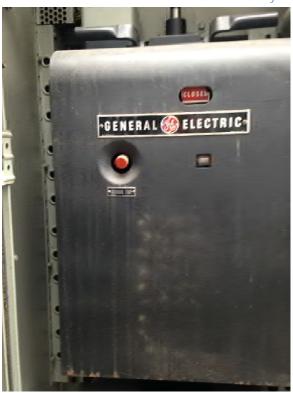
Figure 9. Substation #11 - Trip setting General Electric

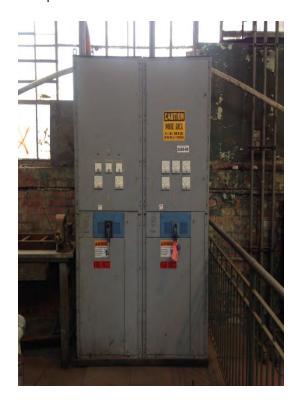
Figure 10. 4160V switchboard

Substation #11 secondary side feeds compressors in Building 103. Building 103 has a 4160V distribution board to serve the air compressors. Building 103 also has a 400A, 480/277V, 3-Phase, 4-Wire system fed from Substation #8 in Building 105. This 400A panel is currently fed from Building 108 by temporary cables.

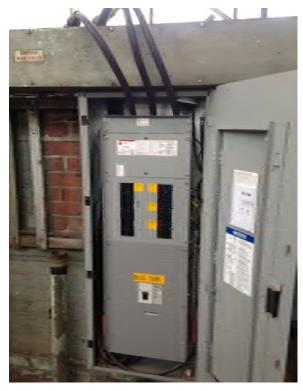
Figure 11.400A 480V panel

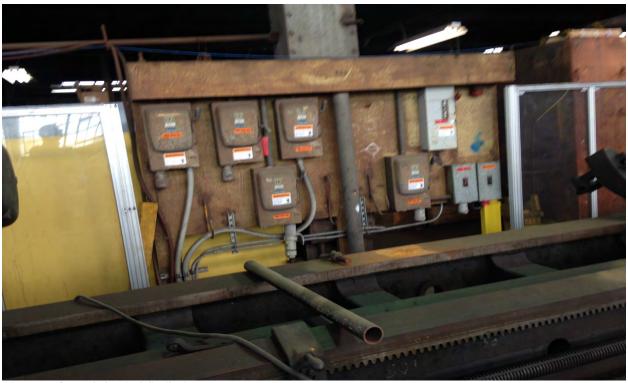
Figure 12. General-electrical distribution

Building 105 has 480/277V, 3-Phase, 4-Wire service with multiple panels fed from 480V Substation #1 in Building 102 second floor.

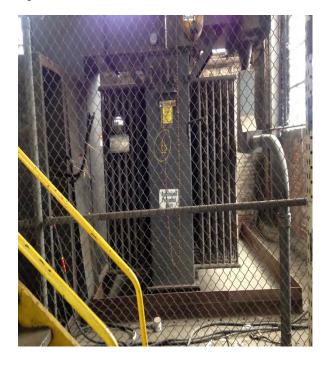
Figure 13. Substation #8 Transformer

There is an abandoned electrical Substation #8 with PCB Transformer located in the south west corner of the building. Current power service is fed with temporary cables from newer Substation east of the building.

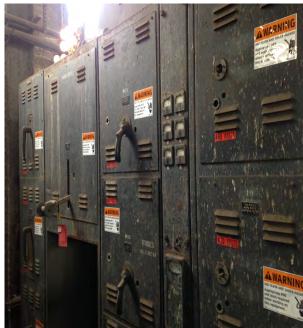
Figure 14. Substation #8 Switchgear

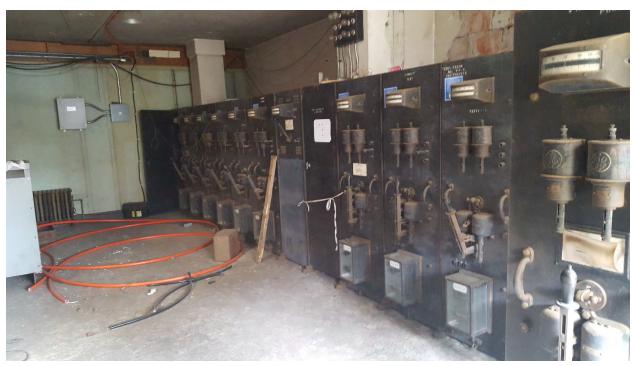
Figure 15. Substation #3 - 1000A 480 V 3P

Substation #3 with three 50KVA PCB transformers is located at the north end of the first floor. Some temporary cabling is used in the electrical room. Each floor is equipped with 120/240V panels throughout.

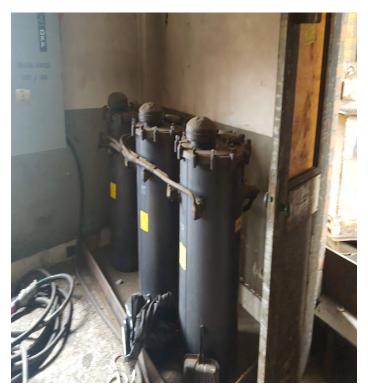
Figure 17. Nameplates for Transformers

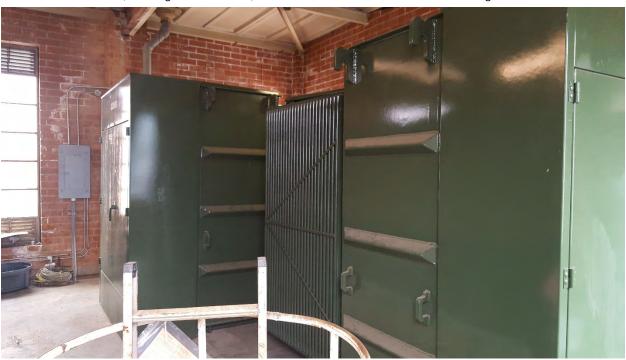
Figure 18. Substation # 7A transformers (2) 3000KVA - 12KV-480/277V

Building 68 includes Substation #7 with two 1000KVA Transformers and "Substation #7A" (HRA's designation) with two 3000KVA Transformers. Substation #7 has two PCB 1000KVA transformers from 1957 and Substation #7A has two 3000KVA transformers installed in 2012 as part of the shore power upgrade project.

Based on the observed damage to conduit, HRA recommends that Substation #7 and #7A be thoroughly tested to verify functionality. Substation #7 electrical equipment is already at or nearing its useful service life, and the transformers should be replaced due to PCBs. Other than the damaged conduit, the 2012 equipment installed for Substation #7A has an estimated useful life of 50 years. See Appendix A.

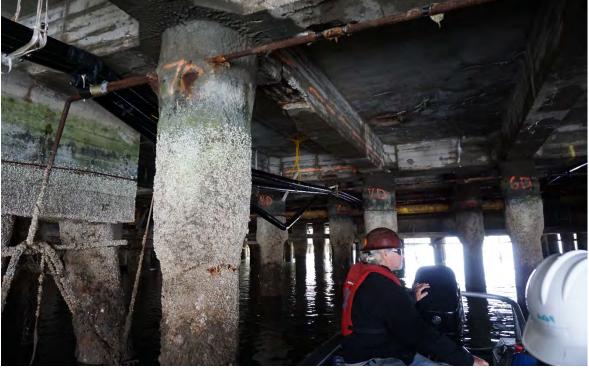
An 80' section of fiberglass conduit installed in 2012 under the High Water Platform deck between shore and Substation #7 and #7A in Building 68 was damaged by debris and currently has temporary supports (shown in Figure 21). Refer to the following Section for details and also see Appendix D.

An 80' section of fiberglass conduit installed in 2012 under the High Water Platform deck between shore and Substation #7 and #7A in Building 68 was damaged by debris and currently has temporary supports.

Figure 21. 3- 4" conduit 80' conduit run under Wharf (2 pictures)

An 80' section of fiberglass conduit installed in 2012 under the High Water Platform deck between shore and Substation #7 and #7A in Building 68 was damaged by debris and currently has temporary supports. Permanent supports should be re-installed with consideration to debris impact loading. The fiberglass conduit appears damaged and should be assessed for water-tightness. Depending on the scope of necessary repairs, re-locating this conduit run should be considered to avoid future damage.

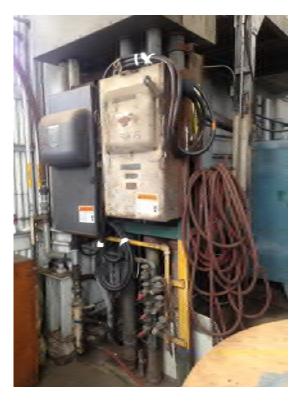
Figure 22. 400A 480V main service

Building 36 is equipped with multiple 480V and 120V panels and with a 75KW rectifier for 250VDC equipment.

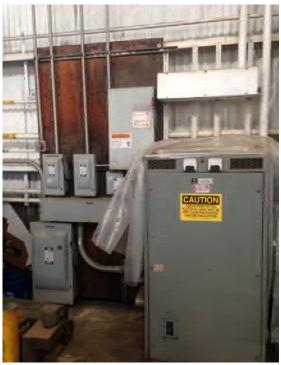
Figure 24. Rectifier

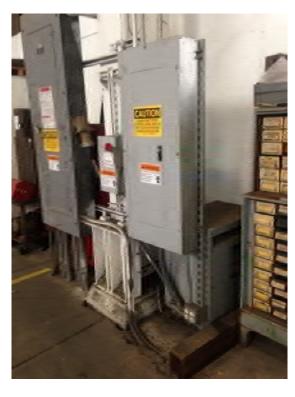
Figure 23. Interior panel boards & dry type transformer

Feeder 13 has a bad splice and currently is connected to Power Panel 1 via temporary cables.

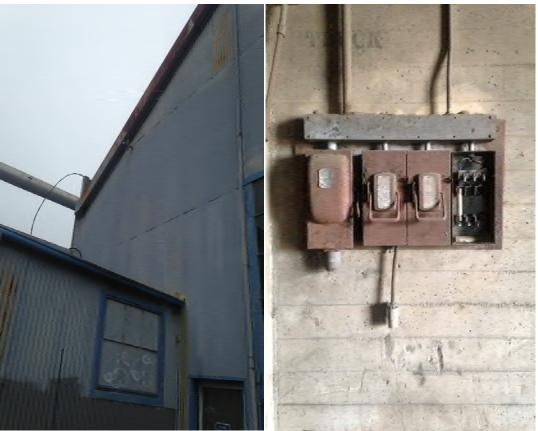
Figure 26. Overhead PG&E cut line

The equipment located in building 19 is deteriorated, non-operable and PG&E overhead electrical service is cut at the exterior of building-the building has no power.

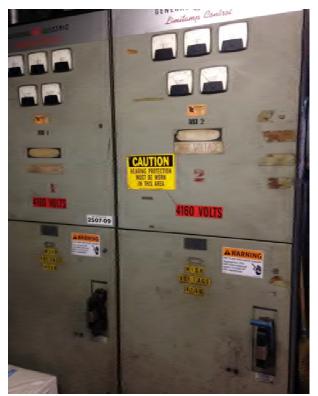
Figure 28. 4160V switchboard

Building 103 has a 4160V switchboard to serve the air compressors.

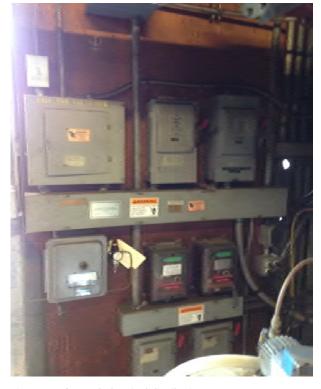
Figure 29. General-electrical distribution system

Building 107 has a 100A, 480/277V, 3-Phase, 4-Wire system fed from 480V Substation #1 in Building 108.

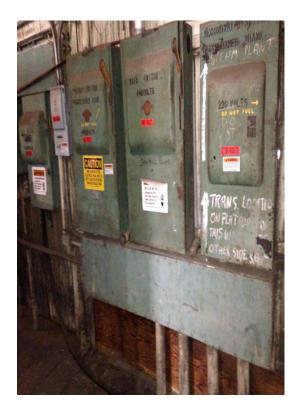
Figure 30. 400A 480V power distribution system

Building 108 has a 400A, 480/277V, 3-Phase, 4-Wire system (fed from 480V Substation #1) which feed three 50KVA single phase transformers rated at 480V-208/120V with PCB. Transformers feed the 208/120V panelboards both on first and second floors.

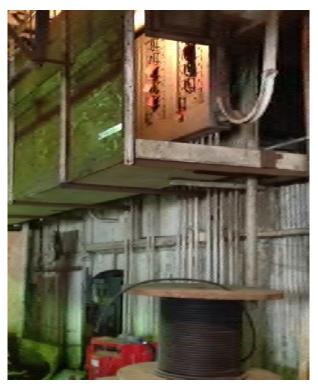
Figure 31. Power distribution system Mezzanine

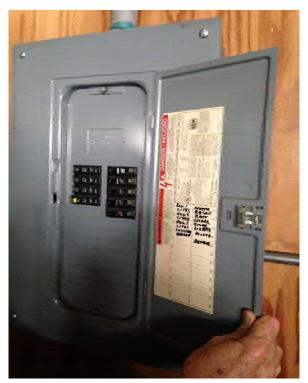
Figure 32. General electrical panel

Building 109 has 480/277V, 3-Phase, 4-Wire service with multiple panels fed from 480V Substation #1 in Building 108.

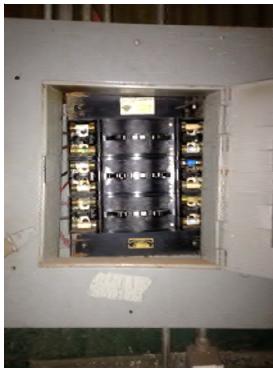
Figure 33. General electrical panel

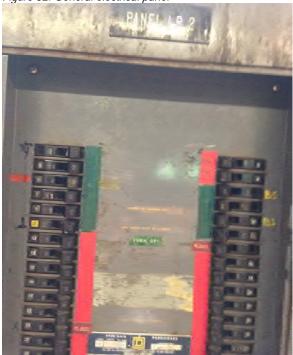
Figure 34. 100A service panel

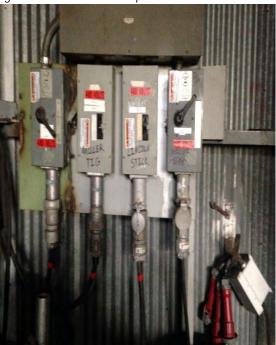
Figure 35. General-equipment electrical connections

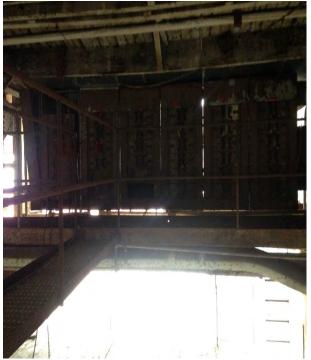
Figure 36. Electrical distribution system

Building 52 adjacent to Building 109 is abandoned and there is active electrical equipment in Building 52 which feeds Building 109. It is recommended to provide a different source of power to Building 109 since Building 52 existing power source looks deteriorated.

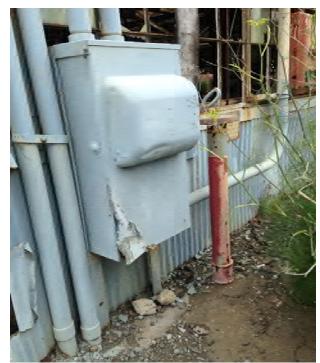
Figure 37. 400A main disconnect

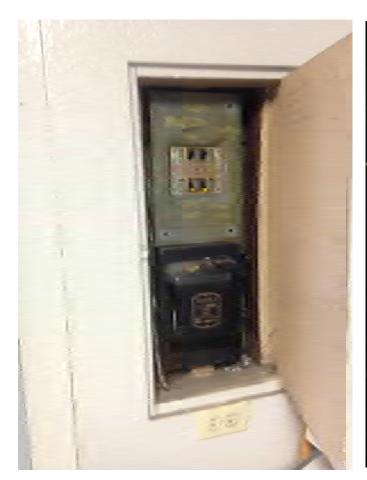
Figure 38. Power and lighting panel

Building 120 has no electrical service. Building 121 has a 60A 120V electrical panel.

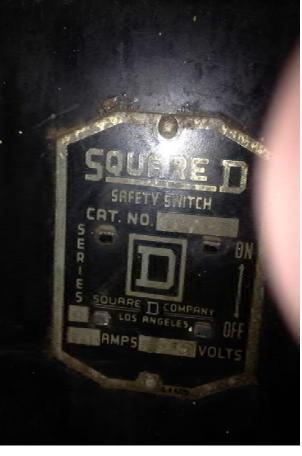
Figure 39. Power and lighting panel

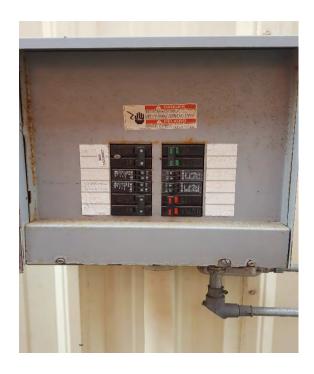
Figure 41. 100A 208V panel

Building 121 is equipped with a 225A panel rated at 480/277V, and a 30KVA transformer rated at 480V-208/120V and a 100A panel rated at 208/120V.

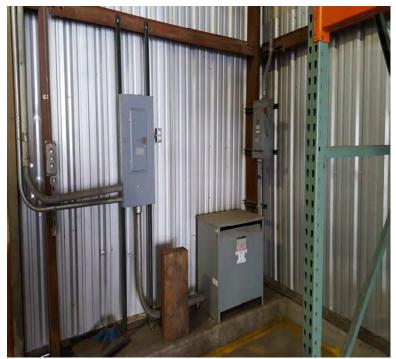
Figure 44. 100A 480V disconnect switch, 75 KVA transformer, 225A 208/120V panel

Building 250 is equipped with a 75KVA transformer rated at 480V-208/120V and a 225A panel rated at 208/120V.

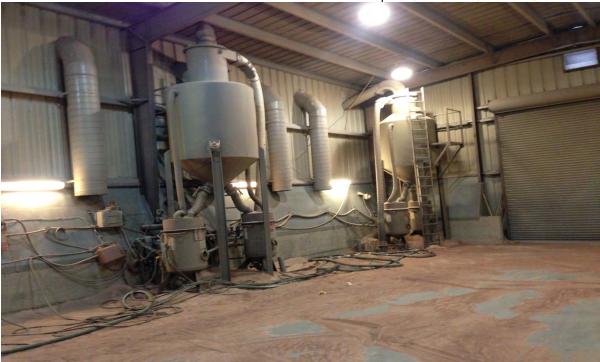
Figure 46. Interior of building 251

Building 251 has a 400A, 480/277V, 3-Phase, 4-Wire system (fed from Building 105) which feeds a 45KVA transformers rated at 480V-208/120V. Transformer feeds a 100A panel, 208/120V, 3-Phase, 4-Wire.
