### **MEMORANDUM**

**PROJECT:** Pier 70 Master Plan Area

San Francisco, California Project: 730496301

**SUBJECT:** UST Reconnaissance

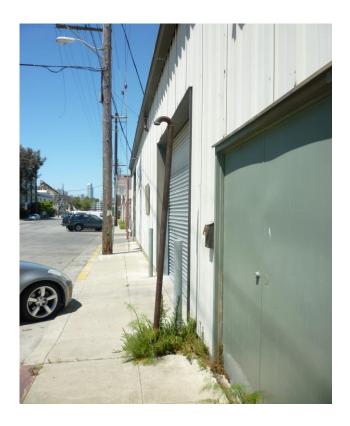
Photograph 1 - Suspected vent pipe located in sidewalk on east side of Illinois Street, in front of Building 49

The suspected vent pipe located in the sidewalk on the east side of Illinois Street was approximately two-inches in diameter and eight feet high (Photograph 1), and has a downturn at the top and a screen covering the opening to the pipe. Fill ports were not observed near the pipe.

No USTs were on record at the SFFD or SFDPH for the Port property location 699 Illinois Street, where the suspected vent pipe was observed. After further investigation it appeared that the suspect vent pipe in Illinois street adjacent to 699 Illinois Street was not associated with unknown USTs therefore further investigation was not warranted.

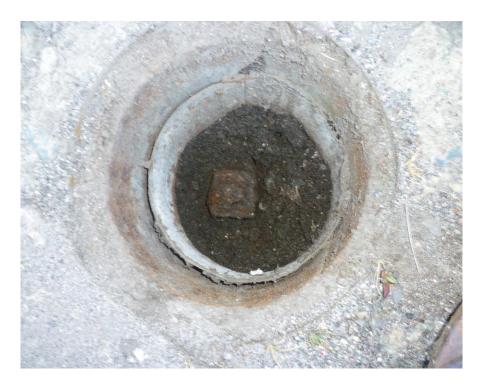
Photograph 2 – Circular metal vault with lid and square cap- located in driveway east of Building 14

An approximate ten-inch diameter round metal vault was observed east of Building 14. The inside of the vault was lined with an approximately six-inch diameter vertical open metal casing and contained an approximately 1.5-inch square cap at the bottom of the vault, buried by soil approximately 8 inches below the ground surface (Photograph 2). The cap could not be removed during the reconnaissance. No

other evidence of USTs (surface patches, vent pipes, fill ports) was observed near the east end of Buildings 14 or 113 located nearby.

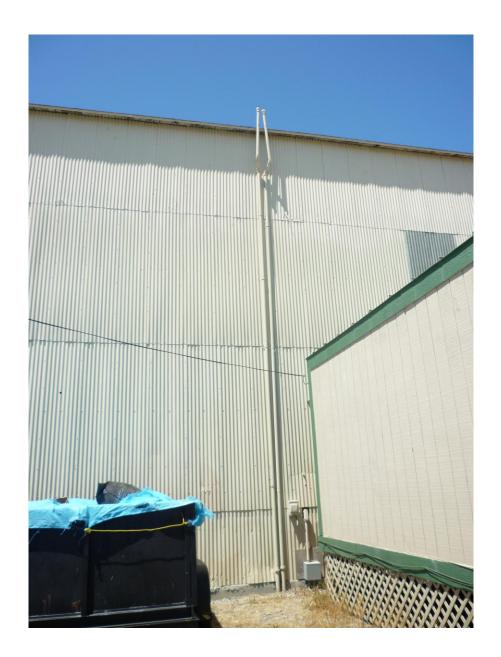
Photograph 3 - Two vertical vent pipes on south wall of Building 49

The two vertical vent pipes on the south wall of Building 49 are approximately 22 feet high and extend approximately two feet above the rooftop of the building (Photograph 3). It was unclear as to whether the vent pipes were for the sewer or UST venting though no other evidence of USTs (surface patches, vent pipes, fill ports) was observed nearby.

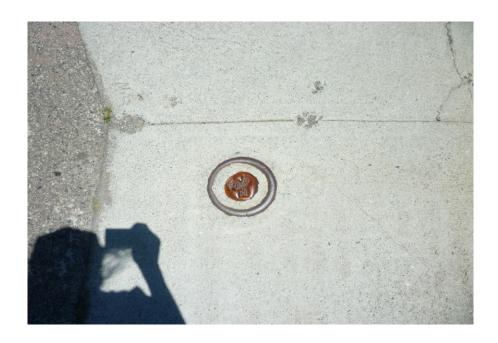
Photograph 4 - Unidentified circular metal object imbedded in concrete patch near the northeast corner of Building 11

The unidentified circular steel object near the corner of Building 11 consists of a convex steel rim of approximately six-inches diameter with a glass object imbedded in the center (Photograph 4). The object did not resemble a fill port, however it was still investigated using the air knife rig as discussed below.

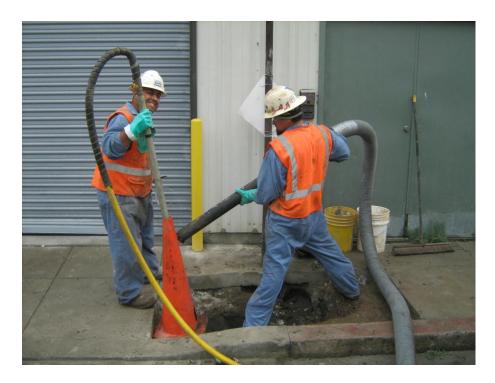
Photograph 5 - Air-knifing in sidewalk at suspect vent pipe at Building 49

Two borings were advanced in the sidewalk next to the suspected vent pipe (Photograph 5). Prior to advancing borings, Osborne cut and removed two sidewalk sections. Removal of the sidewalk sections revealed a Christy box immediately beneath (Photograph 6). Gregg hand dug to expose the Christy box and removed the lid. The inside of the Christy box was filled with soil. T&R removed the soil by hand and uncovered a closed valve, a cut (abandoned) 1-inch diameter steel pipe trending towards Building 49, and an uncut 1-inch steel line entering the box from Illinois Street. There was no evidence of contamination around the valve, pipe, or Christy box. The pipe is suspected to be an abandoned water supply line (Photograph 7). Gregg replaced the soil in the excavation around the pipe.

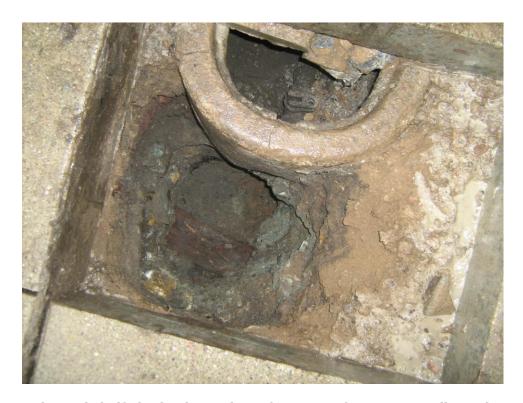
Photograph 7 - Air-knife boring located two feet west of suspect vent line. Photograph shows abandoned water valve inside valve box.

An air-knife boring was advanced approximately two feet north of the suspected water pipe (two feet west of suspect vent line). Wood debris which could not be removed by air-knifing was encountered at approximately 3 feet bgs. There was no indication of contamination in the soil at this location and it was subsequently backfilled.

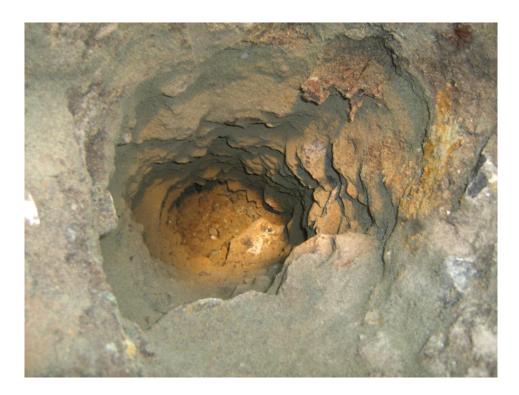
Photograph 8 - Second boring at Building 49, located approximately two feet west, one foot north of the suspect vent pipe.

An additional air knife boring was advanced approximately two feet west and one foot north of the suspect vent pipe (Photograph 8). This boring was terminated at five feet bgs. There was no indication

of USTs or contamination at this location. The subsurface materials consisted of serpentinite cobbles in a crushed serpentinite and sand matrix with wood and metal debris.

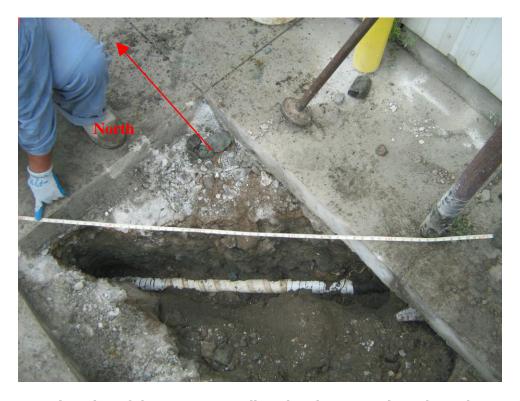
Photo 9 - Continuation of the suspect vent line plunging approximately 11 degrees in the northwest direction towards Illinois Street

T&R directed Gregg to excavate around the base of the suspect vent pipe to trace the source of the pipe. The soil was removed around the pipe, revealing a continuation of the suspect vent line trending approximately 11 degrees in the northwest direction towards Illinois Street (Photograph 9). T&R considered an additional boring to attempt to locate the pipe where it intersects Illinois Street, but this was not feasible due to proximity of marked underground utilities. Upon conclusion of investigation activities all exploratory borings and excavations were backfilled. Golden Gate Tank Removal Inc. replaced the sidewalk.

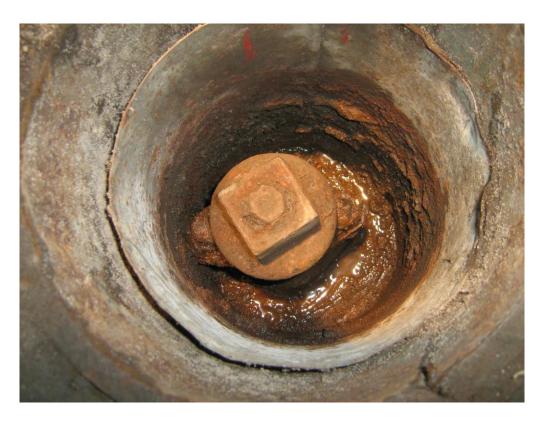
Photograph 10 - Valve inside circular steel vault east of Building 14

The inside of the metal vault located east of Building 14 was observed and contained a square cap surrounded by soil that apparently washed into and filled the vault over time (Photograph 10). Soil was removed from the cap, to the bottom of the vault approximately 1.25 feet below grade, exposing a valve. The valve was corroded seeped water, indicating it is a water valve.

Conversations with Tom Miesenbach and Jose Herrera, from the Port of San Francisco Maintenance Department confirmed that the valve is a shut off valve for the fire hydrant located directly adjacent to the metal vault.

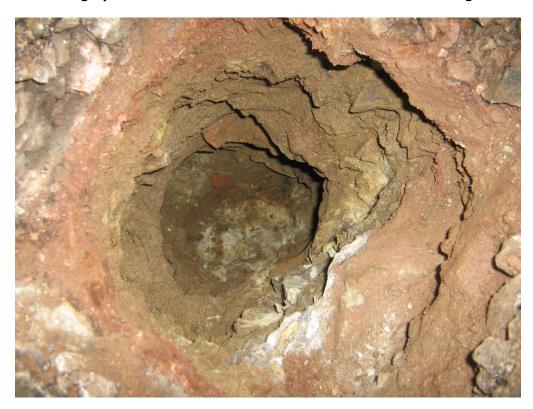
Photograph 11 – Boring located three feet southeast of circular steel vault at Building 14

One air knife boring was advanced approximately four feet east of Building 14 near the vault and met refusal at four feet bgs upon encountering a large piece of bedrock or concrete (Photograph 11). The subsurface material consisted of bedrock cobbles, sand, and brick debris. There was no evidence of USTs or contamination in this boring.

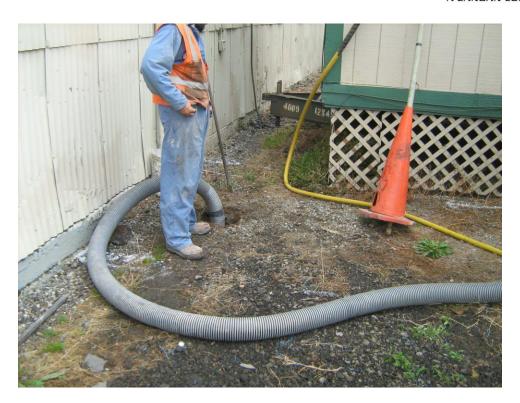
Photograph 12 – Boring area near suspect vent pipes south of Building 49

One boring was advanced approximately two feet south of the vertical vent pipes at Building 49 (Photograph 12). The boring was terminated upon reaching refusal at 4.5 feet bgs due to large pieces of debris. The subsurface material was reddish-brown sand. There was no evidence of USTs or contamination in this boring.

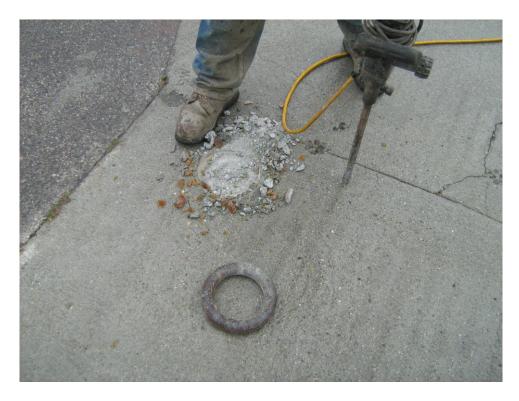
Photograph 13 – Previously unidentified metal object imbedded in concrete near Building 11 is removed and identified as a steel ring

Unidentified circular metal object imbedded in concrete patch near the northeast corner of Building 11 Osborne used a roto-hammer to break out the metal object from the concrete patch northeast of Building 11. The metal object was a one-inch thick, six-inch diameter steel ring set into the surface of the concrete patch (Photograph 13). Osborne patched the newly created void with concrete. There was no evidence of USTs or contamination.

Tom Meisenbach confirmed that the concrete patch was a result of electrical upgrades for SIMs Metals.
