BUILDING RAPID EVALUATION SAFETY ASSESSMENT FORM

Inspection Number-(1700-SUPER-006-2007-1)

<u>Building Description:</u>	<u>Overall Rating:</u>
<p>Name: Pier 70 Building #6</p> <p>Address/Location:</p> <p>Facility Code 1700 Lease No.</p> <p>No. of Stories: 1</p> <p>Construction: Wood <input type="checkbox"/> Concrete <input type="checkbox"/> Steel Masonry</p> <p style="margin-left: 40px;"><input type="checkbox"/> Combination</p> <p>Support: <input checked="" type="checkbox"/> Over Water <input type="checkbox"/> On Land</p> <p>Occupancy: Commercial Office Industrial</p> <p>Assembly Residential Emergency Serv. <input type="checkbox"/> Other</p>	<p>Green:</p> <p>Yellow:</p> <p><input checked="" type="checkbox"/> Red:</p>

PORT OF SAN FRANCISCO · PIER 70 · BUILDING 6
SEISMIC REVIEW

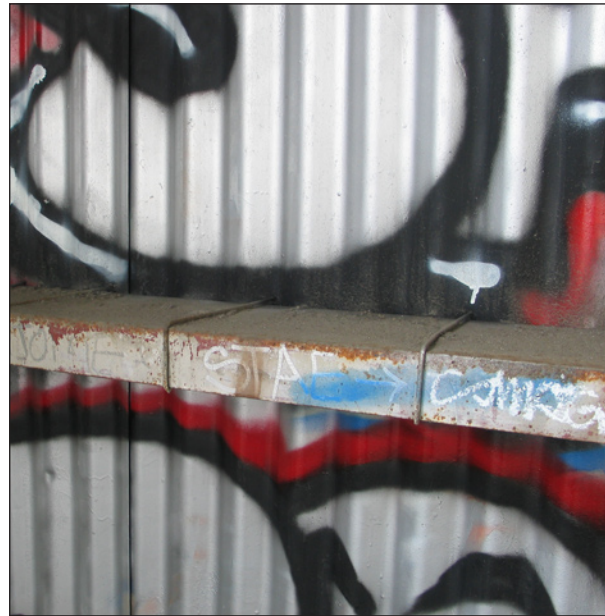
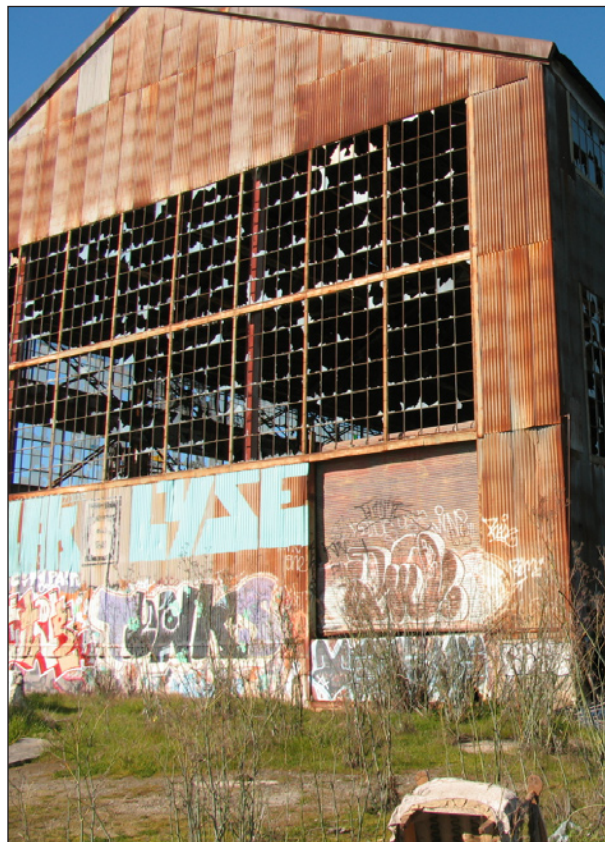
- Significant decay in CGI panels, particularly on bay side
- Heads on wire pins exhibit severe deterioration

- Replace 60% CGI wall panels.
- Restore 40% CGI wall panels. CGI restoration treatment:
 1. Survey existing condition of all galvanized metal corrugated metal panels and flashing or trim elements.

2. Clean metal of all loose paint and rust. Tight rust may remain (rust that is not flaking). Use gentlest means possible to avoid damaging metal substrate. Avoid wet-cleaning methods.

3. If substantial cross-section of panel has been lost due to rust, replace in-kind.
 4. Replace dented and damaged components in kind to match original.

5. Repair small holes by soldering, or by application of epoxy filler formulated for use on ferrous metal (i.e. auto body putty or plumbers epoxy).
 6. Wipe with mineral spirits, prime clean metal with specially formulated zinc rich, rust consolidant primer, and paint with two finish coats of compatible oil-based paint. (Note that the majority of CGI at Pier 70 has not been previously painted).

- Reattach 100% CGI wall panels with self-tapping screws. CGI reattachment treatment
 1. Identify existing interior c-channel attachment location.
 2. Using ferrous, self-tapping screws, drill through low ridge of CGI panel into c-channel flange.

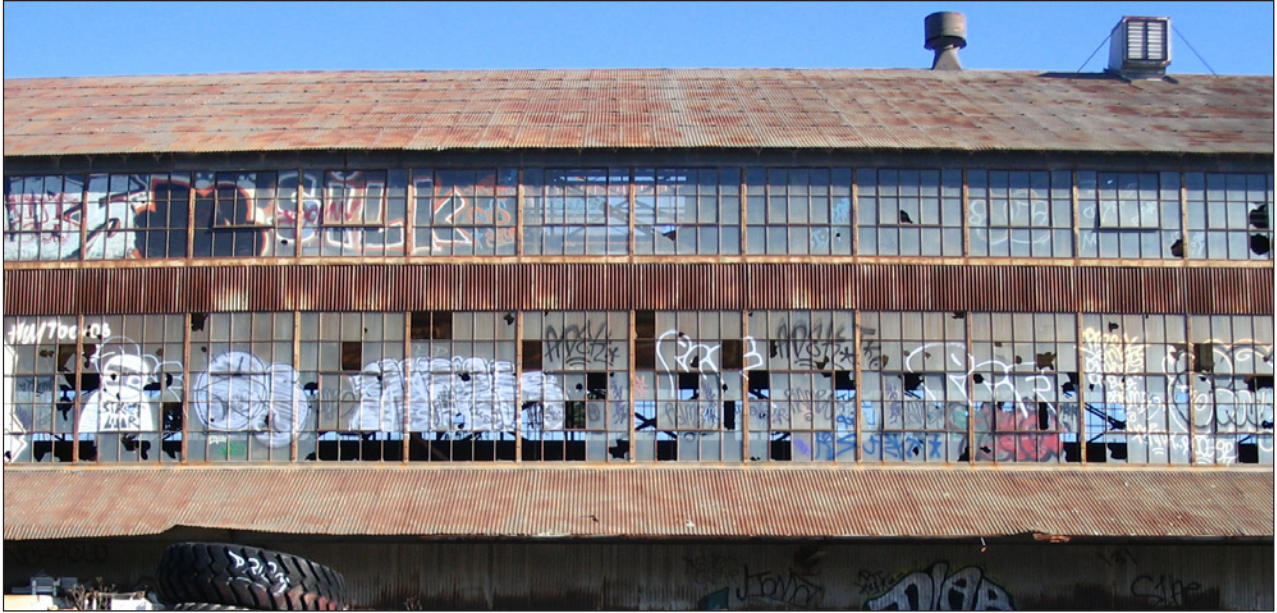
- Window panes 90% destroyed
- Steel sash exhibits surface rust but appears functional

- Replace window panes
- Restore steel sash windows: Steel sash multi-lite window – restoration:
 1. Survey existing condition of all steel sash window components.
 2. Remove dirt and deteriorated glazing putty.
 3. Wire brush steel elements to remove rust.
 4. Restore free movement to all operable units.
 5. Install new glazing putty.
 6. Clean existing hardware. Install new hardware where missing to match original.
 7. Install new glazing where required to match existing original glazing.
 8. Prepare steel surfaces, prime with rust inhibitive primer, and paint with two top coats.
 9. Where steel sash windows are bowed, remove the unit and straiten under controlled shop conditions and re-install.
 10. Where severely deteriorated from rust induced cross sectional steel loss, replace in-kind with a new unit.

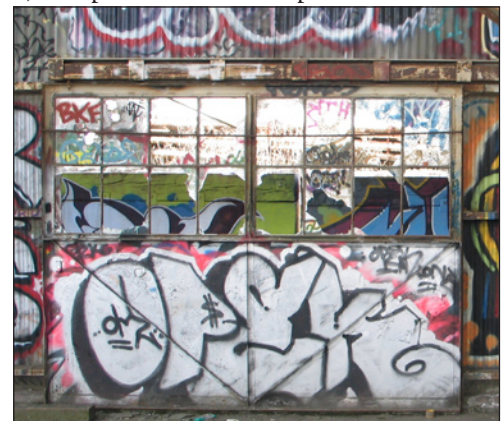
- Doors locked in position so evaluators were unable to move
- Appeared operable

- Restore to working condition. Steel door restoration:
 1. Replace missing hardware and components.
 2. Replace window panes and reglaze view windows where necessary.
 3. Clean existing hardware and kickplates.
 4. Remove existing varnish surface where worn
 5. Prepare surfaces, prime and repaint.

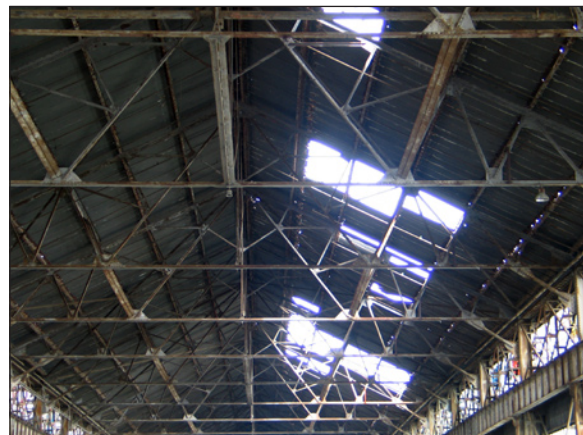
- Significant decay in CGI panels, particularly on bay side
- 5% of panels missing
- Heads on wire pins exhibit severe deterioration

- Replace 100% CGI roof panels.

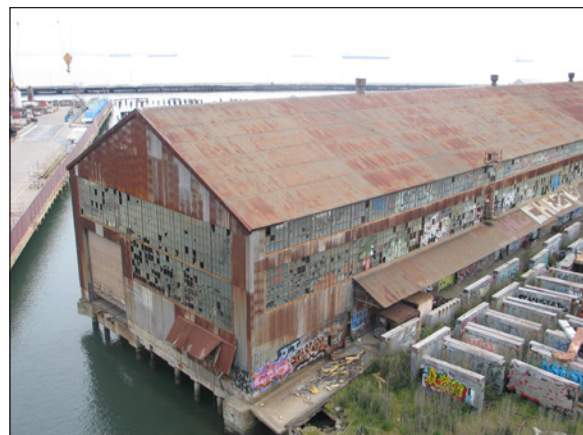
- Significant rusting
- NW gable flashing has become partially detached

- Replace 100% flashing

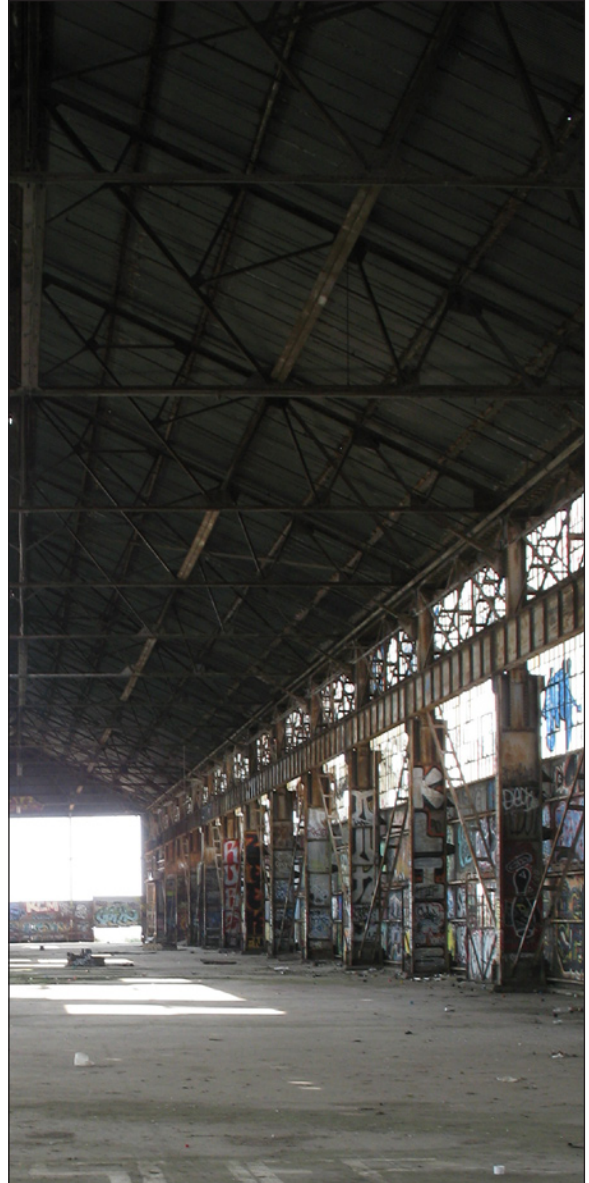
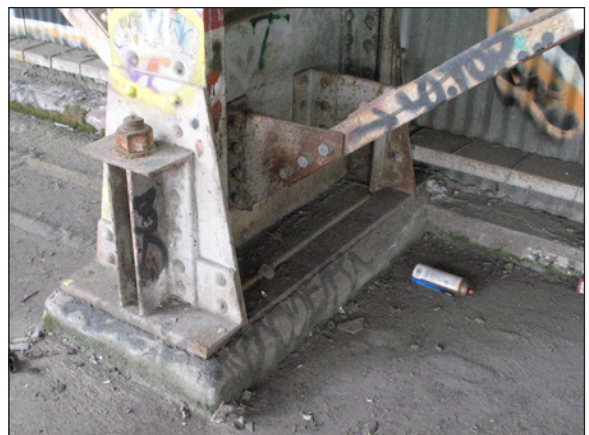
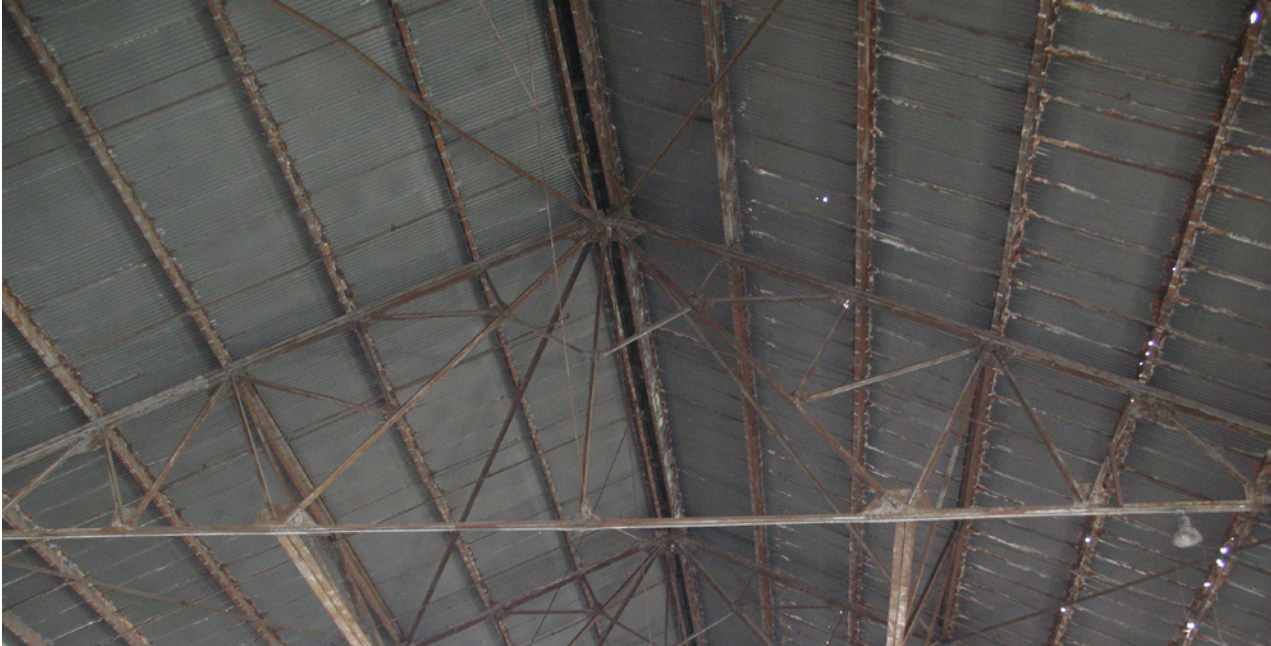
- Some surface rust
- Some trusses and cross-bracing exhibit minor bending and distortion, possibly from earthquake forces

- Use scissiors lift to determine structural integrity of trusses
- Remove surface rust. Repaint with rust consolidant. Ferrous Metal Corrosion and Coating Treatments:
 1. Remove rust and most of the surrounding paint. Determine the extent of failure, corrosion and surface detailing before determining the removal method. Potential methods include wire brushing, grit blasting, or chemical methods. The presence of lead-based paint will also affect the choice of removal method.

2. Remove all loose, flaking and deteriorated paint and corrosion to bare metal.
3. Degrease surfaces and prime immediately.
4. Paint Selection:
 - Option One: spot prime with industrial corrosion-inhibiting primer, followed by two coats of oil based paint.
 - Option Two: high performance coatings, such as zinc-rich primers, and epoxy coatings should be considered to allow for longer lasting protection. Note: These coating typically require highly clean surfaces and special application conditions that can be difficult to achieve at some sites.
