BUILDING 103 - Steam Powerhouse No. 2

ARCHITECTURAL DESCRIPTION

CONDITIONS

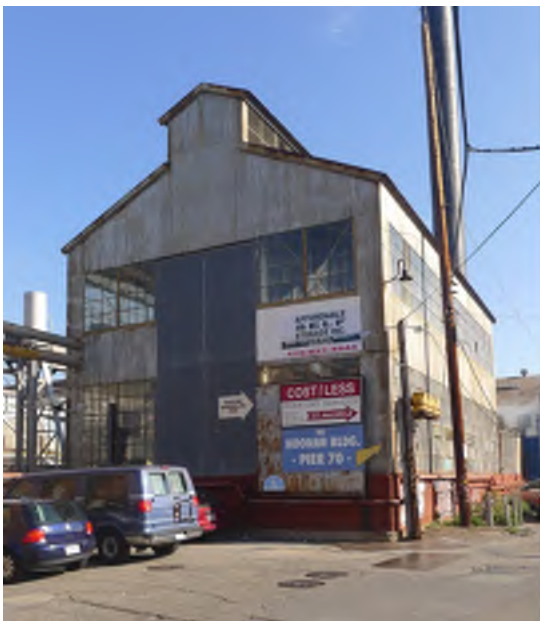
CMP. Condition: Fair

Mild rust observed throughout the CMP, heaviest at the eaves and where the panels meet the brick base. The panels exhibit multiple penetrations where I-beams, metal conduit, pipes and other appurtenances exit the building.

Figure 2 - Building 103: South Elevation

- Repair 10% CMP panels.
 1. Replace dented and damaged components in kind to match original.
 2. Install sealant at all conduit and pipe penetrations. Scrape, prime and paint rusted conduit or pipe.

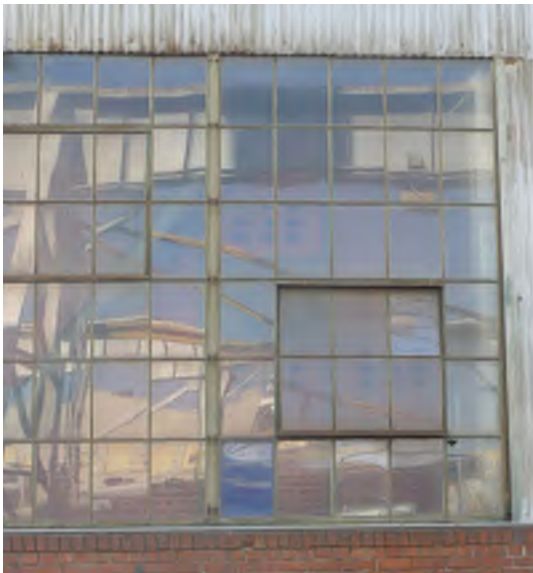
Steel sash windows. Condition: Fair (figures 7 and 8)

Steel sash multi-lite, fixed in frame with operable portions typical. Frame, mullions, and muntins are in fair condition. Window damage and broken/cracked panes have been dealt with by glueing sheet plastic panels at cracked or broken lites. Approximately 10% of the window lites are cracked or broken.

Figure 8 - Building 103: Window detail

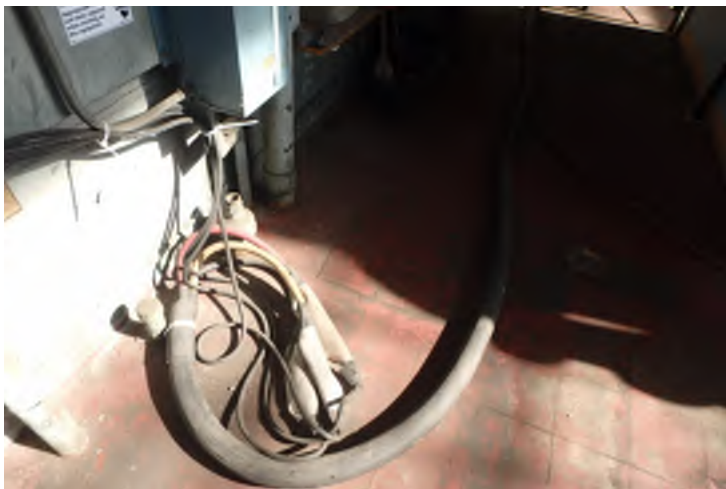
- The main electrical service to the building appears to be fed from the neighboring building 108 using flexible conductors (See figure 103-2).

Figure 103-2 – Flexible Cable Power Feed

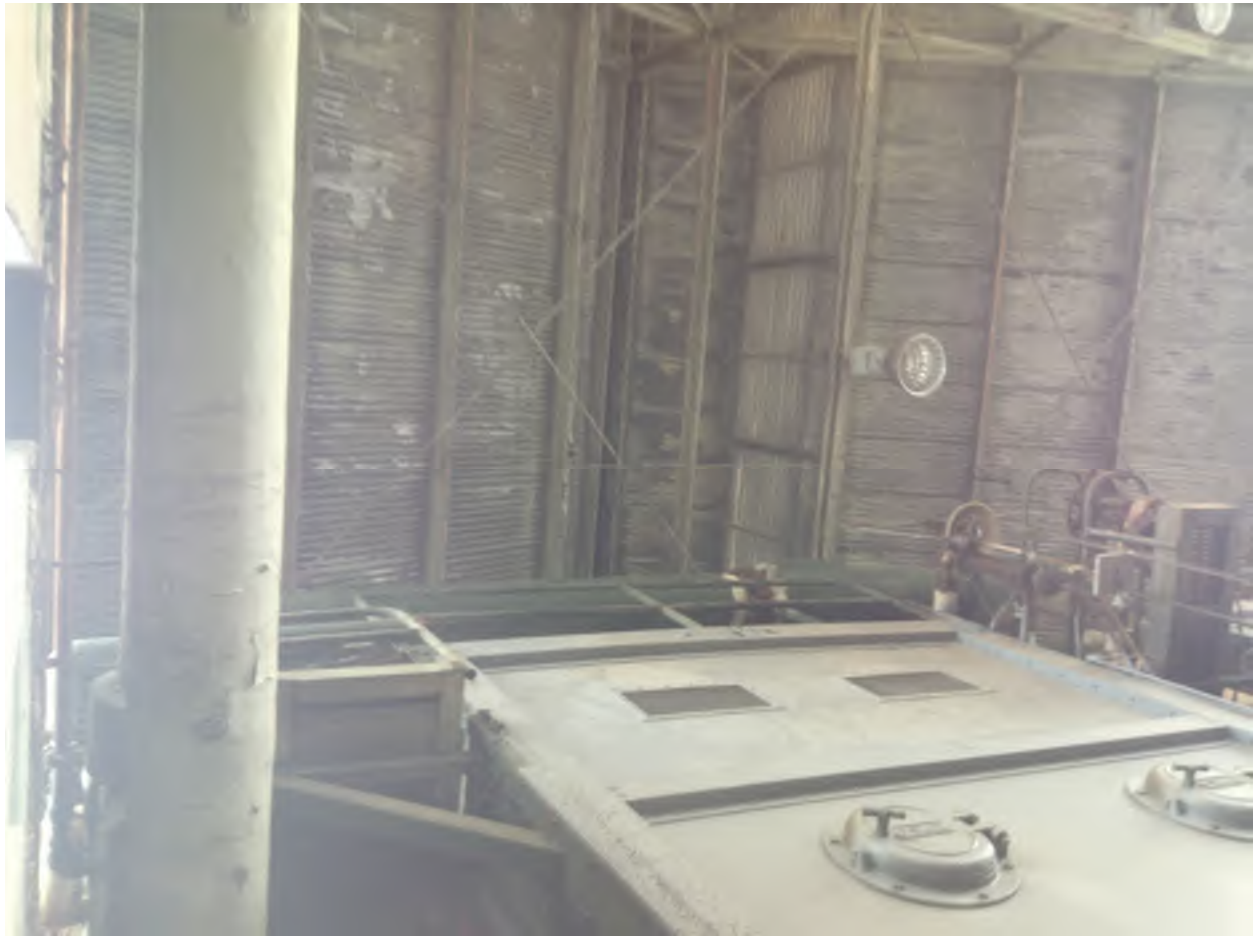
Fig. 1 - Building 103 view from fixed building ladder

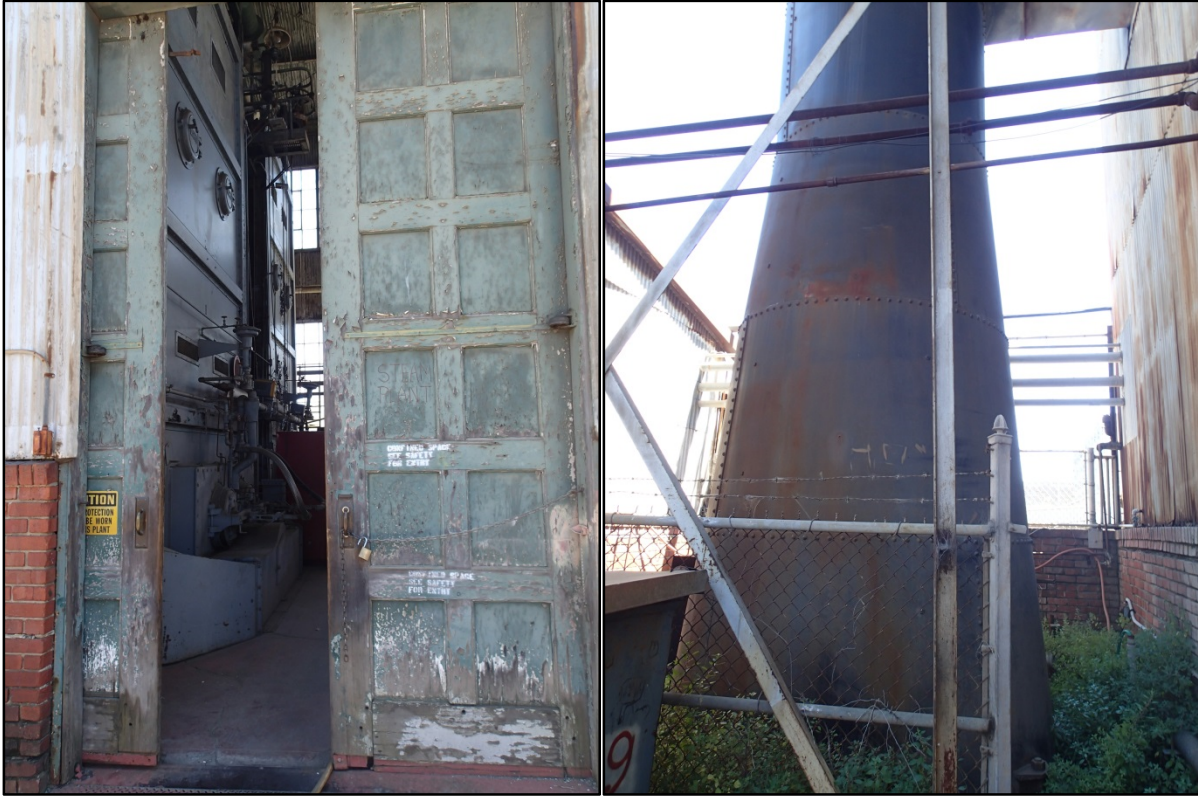
The overall condition of Building 103 has remained relatively unchanged since the previous condition assessment in 2015. The building remains as a historical steam powerhouse however is no longer in service. The recommended repairs provided in the previous condition assessment report have not been addressed. With exception to further general paint degradation on the building interior (most notably on the doors), no additional deficiencies were found.

Figure 103-4 & Figure 103-5 –View of Building 103 exterior sliding door and smokestack, respectively.

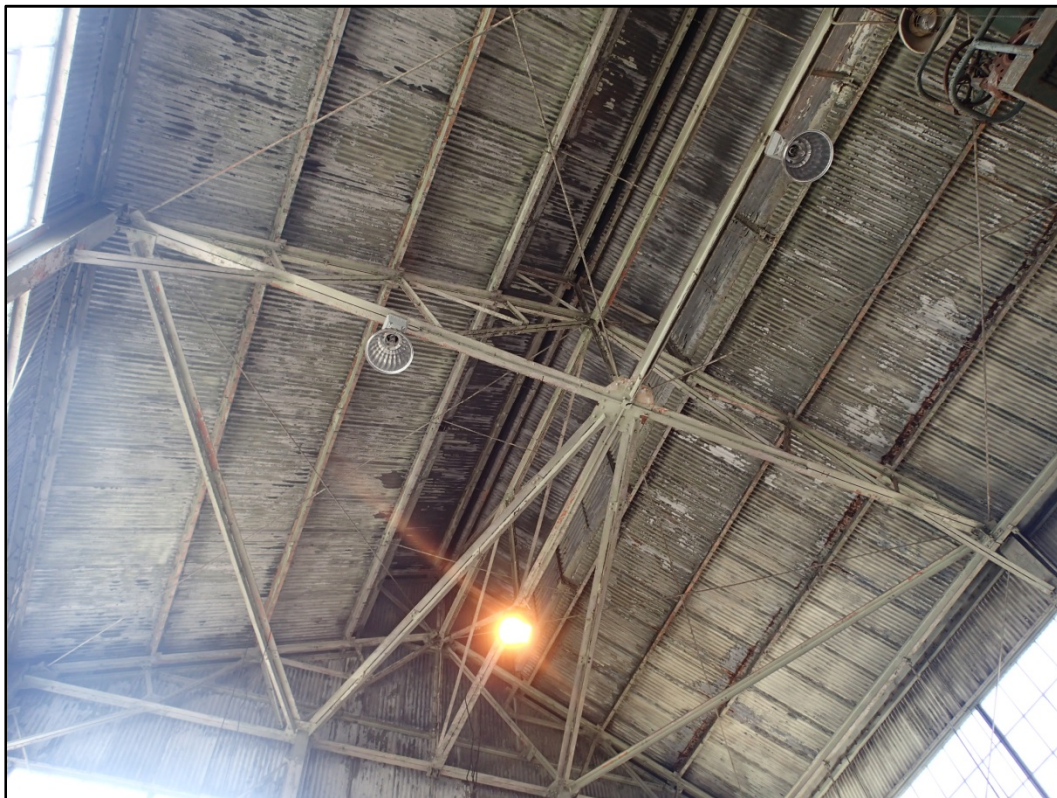
Figure 103-6 – View of Building 103 roof structure and corrugated metal panels.

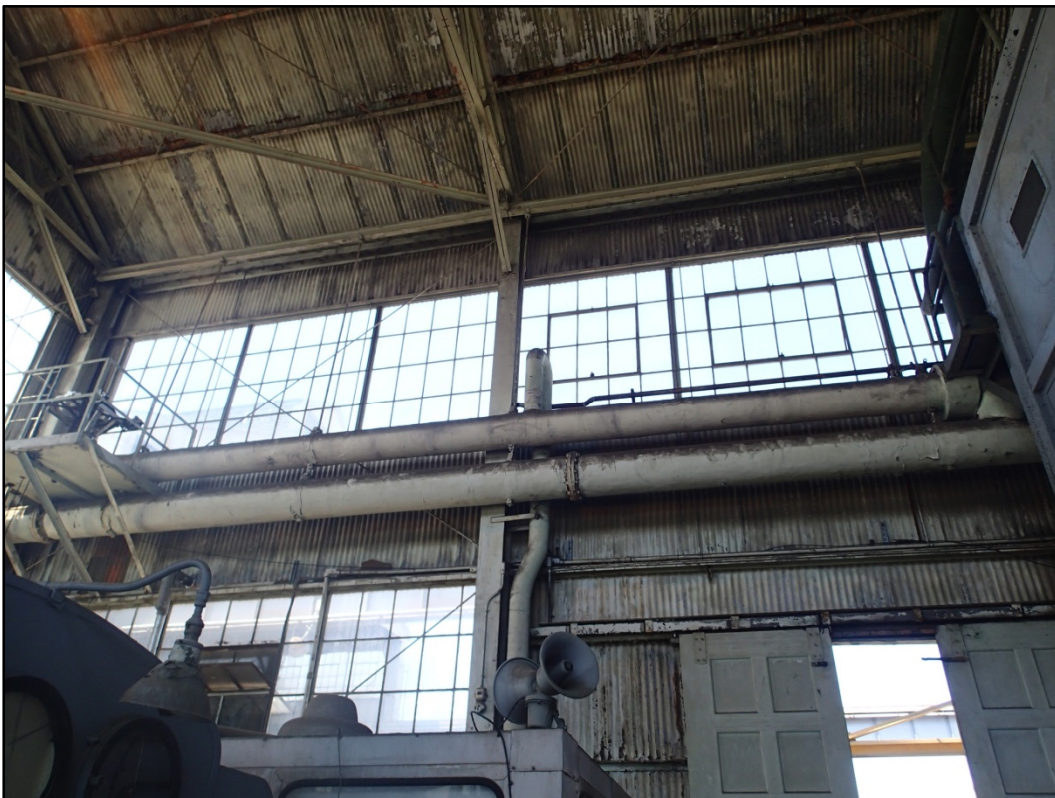
Figure 103-8 – View of Building 103 typical interior wall corrugated metal panels.

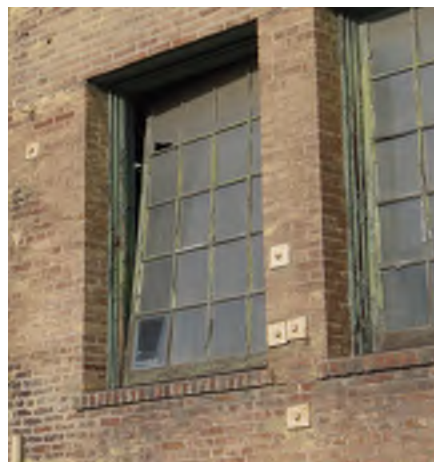
Wood Sash Windows. Condition: Good - Fair – Poor (figures 15 and 16).

There are (24) wood sash, (20) lite windows found on the south elevation. All windows operate as in swinging hoppers hinged at the bottom. The jambs, heads, sills, sash, and muntins are in fair condition. All of the paint is severely deteriorated. Approximately 15 of the window panes are currently cracked or broken. All sealant joints have failed where the wood window heads and jambs and sills meet the brick (figures 15 and 16).

Figure 16 –South wall, hopper operation

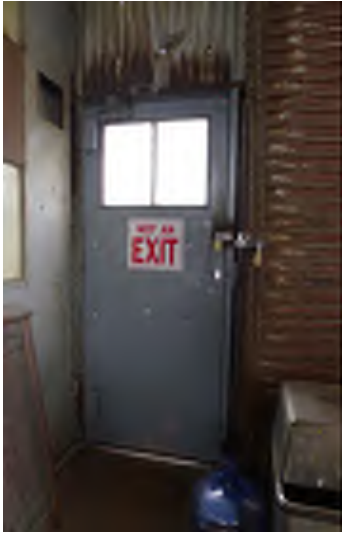
Personnel Doors. Condition: Good (figure 17).

There is one, steel personnel door in the west elevation. It is built out of angle iron and steel plate, and contains one, two lite window at the top. It is hinged, and contains a closer as well as a padlock hasp and a bent steel bar pull. It appears to be shop fabricated.

Figure 17 – West wall, steel personnel door

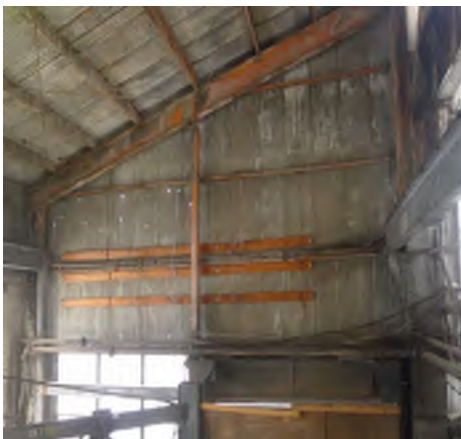
CMP. Condition: Good (figure 24).

CMP panels on the interior are found primarily on the west wall and on the east and west gable ends. The panels contain a light rust coating.

Figure. 24 - View looking west, south shed CMP

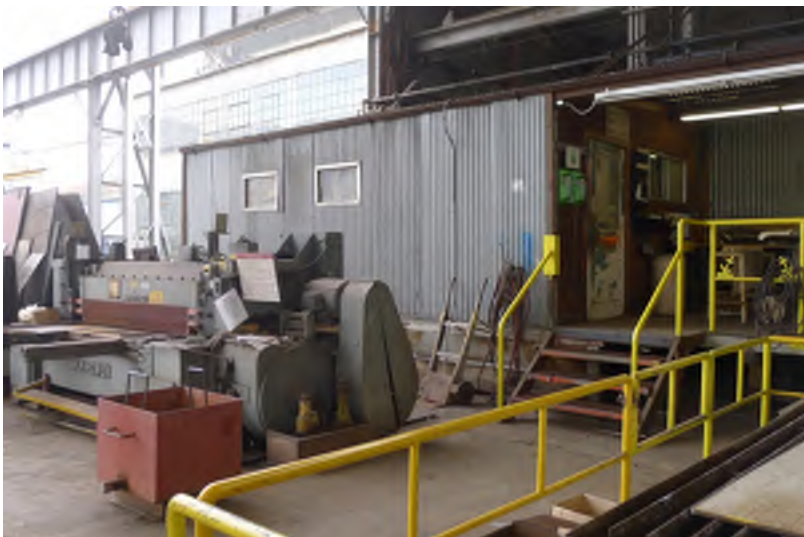
Condition: Good to fair (figures 32 and 33)

At the west elevation there are two free standing offices. One is built of plate steel with windows and the second is a shipping container built on a mezzanine over the former. At the east end is a shed on a wood platform clad in various materials. The western sheds are sheltered, and appear to be in sound condition; however the eastern shed has one exposed wall to the outside with holes that needs to be repaired.

Figure 33 – Main shed office at east end.

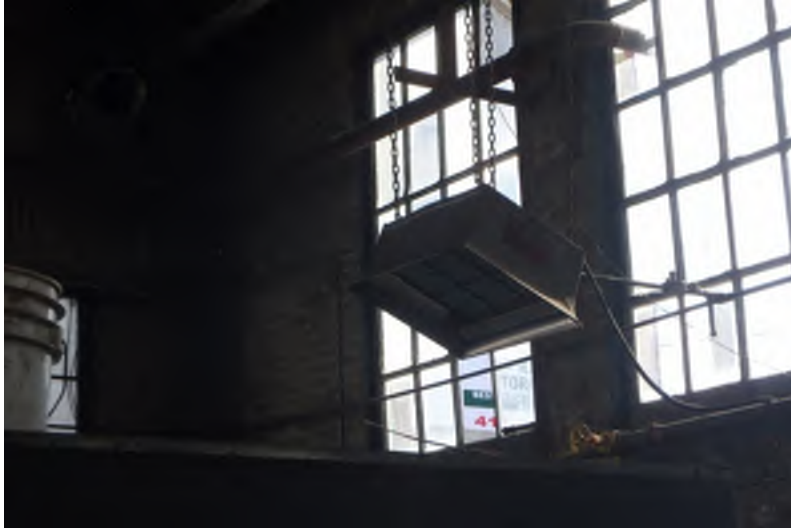
- Main machine shop area has not mechanical ventilation system. Spot heating is provided by gas-fired unit heaters without ductwork (See fig. 105-1).
- Enclosed offices within the building are generally provided with windows for natural ventilation & window-mounted DX cooling systems. 2nd floor office (shipping container) has window cooling unit but no natural ventilation (See fig. 105-2).

Figure 105-1 – Gas Radiant Heaters

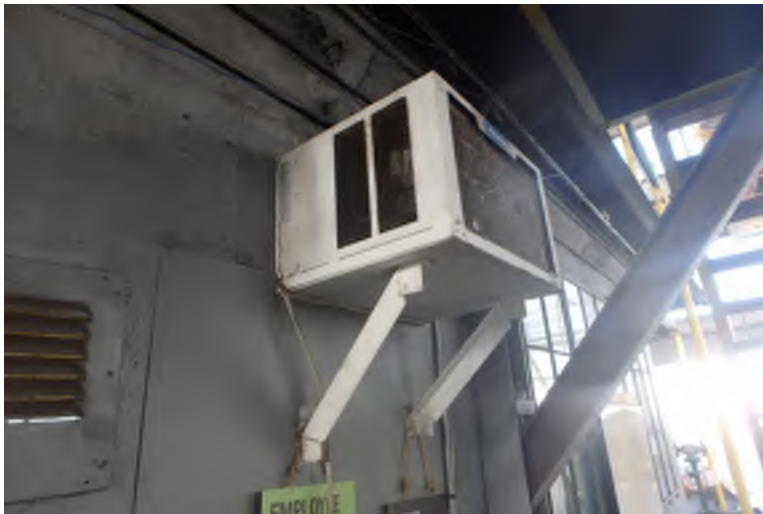
Figure 105-2 – Window-Mounted DX Cooling at Office

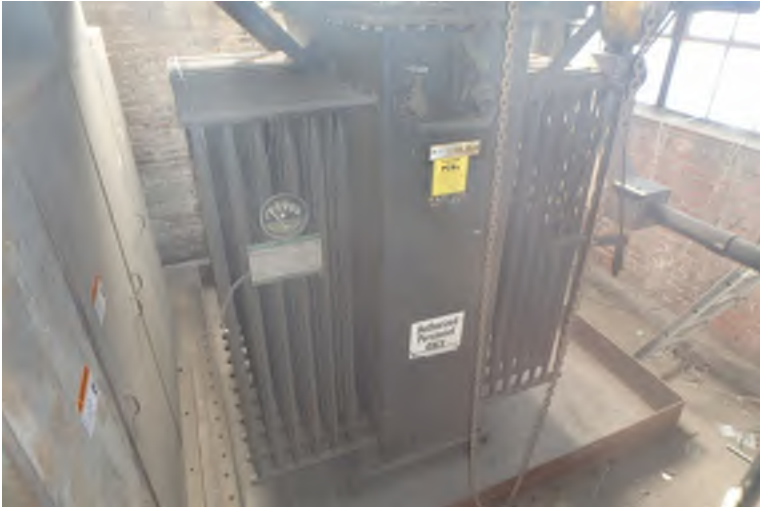
- The building has 480V service with multiple panels.
- An abandoned electrical sub-station is located in the SW corner of the building. Current power service fed from newer substation East of the building (See fig. 105-3).
- Power is fed via an underground service.

Figure 105-3 – Abandoned Sub-Station.

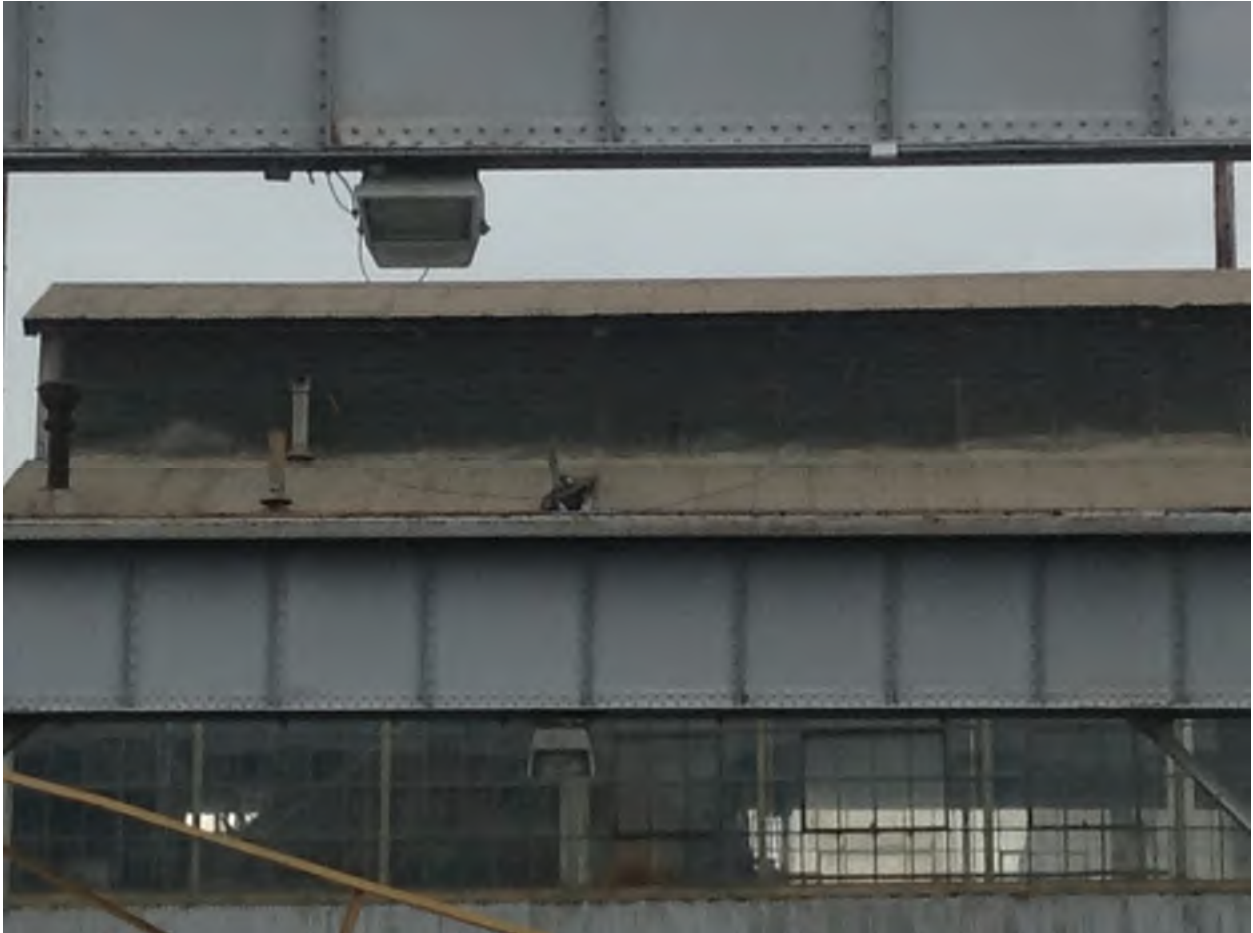
Fig. 1 - Building 103 view from N.W exterior

This building is Forging Machine Shop, this building has two roofs. One roof area is approx. 26x190 located on the South side of the main building the main Roof Area is approx. 50x190. The entire roof appears as shown in the photo in fig-1, worn and rusted with multiple pinholes throughout the entire warehouse.

GENERAL NOTES: This Building has multiple pin holes through the warehouse roof visible from the building's interior. And has what appears to be a fiberglass coated rusted corrugated metal sheathing. The smaller shed roof appears to have a recently installed corrugated metal roof.

- No new Roof or roof repairs required at this time.

- Inspect for leaks & penetrations twice a year, caulk or patch as needed.

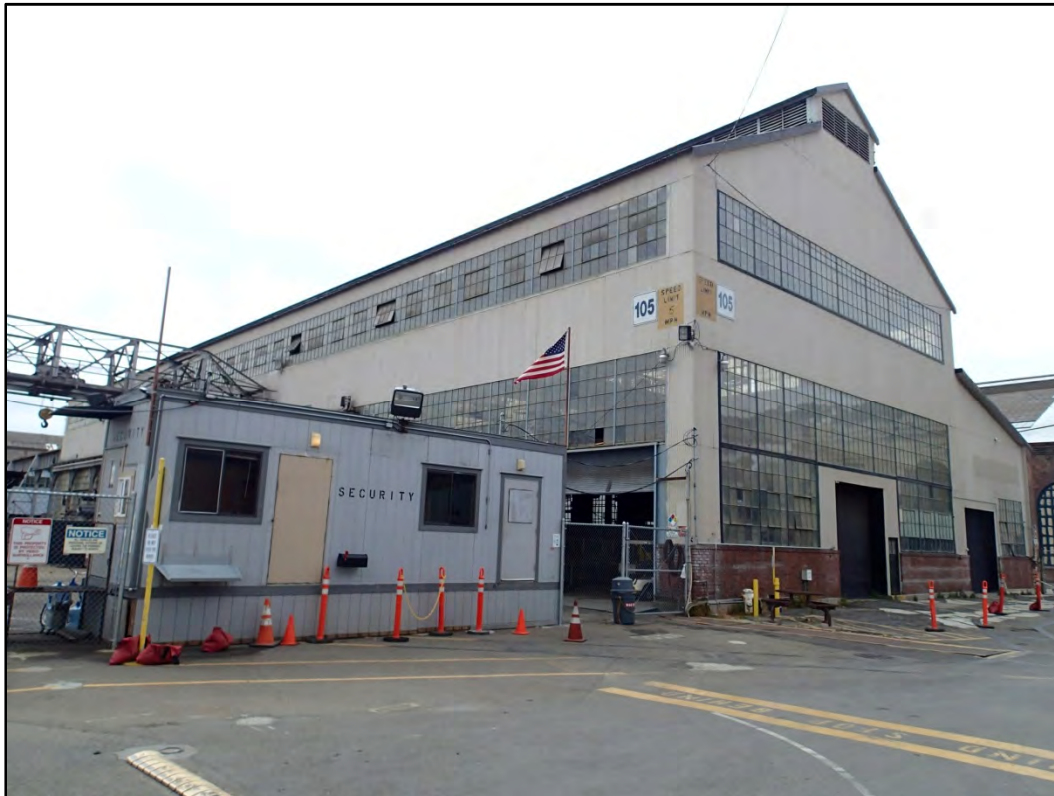
Figure 105-1 - Overall northwest view of Building 105.

The overall condition of Building 105 appears to have worsened since the previous condition assessment in 2015. The building continues to serve as a historical forge shop with a majority of the original building equipment and crane intact. The recommended repairs provided in the previous condition assessment report have not been addressed. In general, the degradation in the brick mortar joints appeared to have worsened due to continuous weathering. The steel channel support between the top and bottom rows of windows at the north side of the building has completely failed due to major corrosion. The bottom edge of the windows above the channel is no longer supported and is bulging out towards the exterior. Collapse and failure of the windows above the failed steel channel is possible in the near future. Minor to moderate surface corrosion was also identified (which was not noted in the previous condition assessment) along the interior bottom edge where the corrugated metal panels meet the top of the steel window sashes. There were originally four sets of braced frames, spaced at every third bay, along the interior column line. Three of the four sets of braced frames have been cut. The remaining braced frame located at the west end was intentionally bent and damaged, likely to provide overhead clearance.

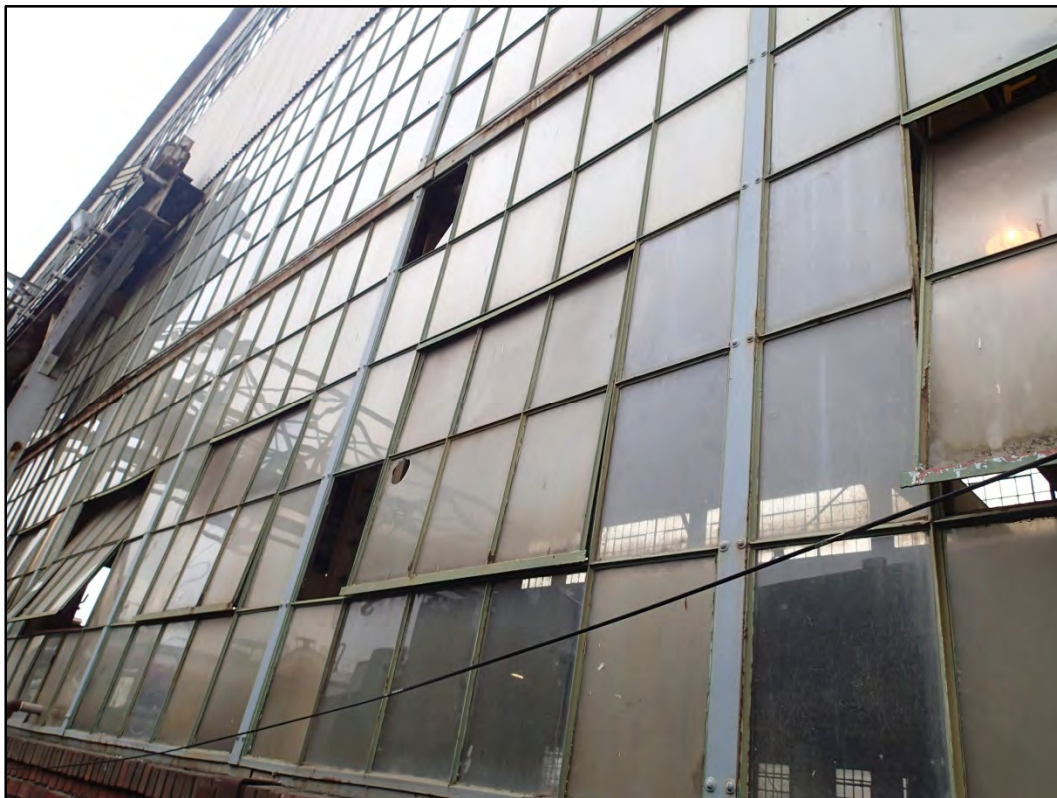
Figure 105-3 - View of Building 105 typical exterior steel window condition.

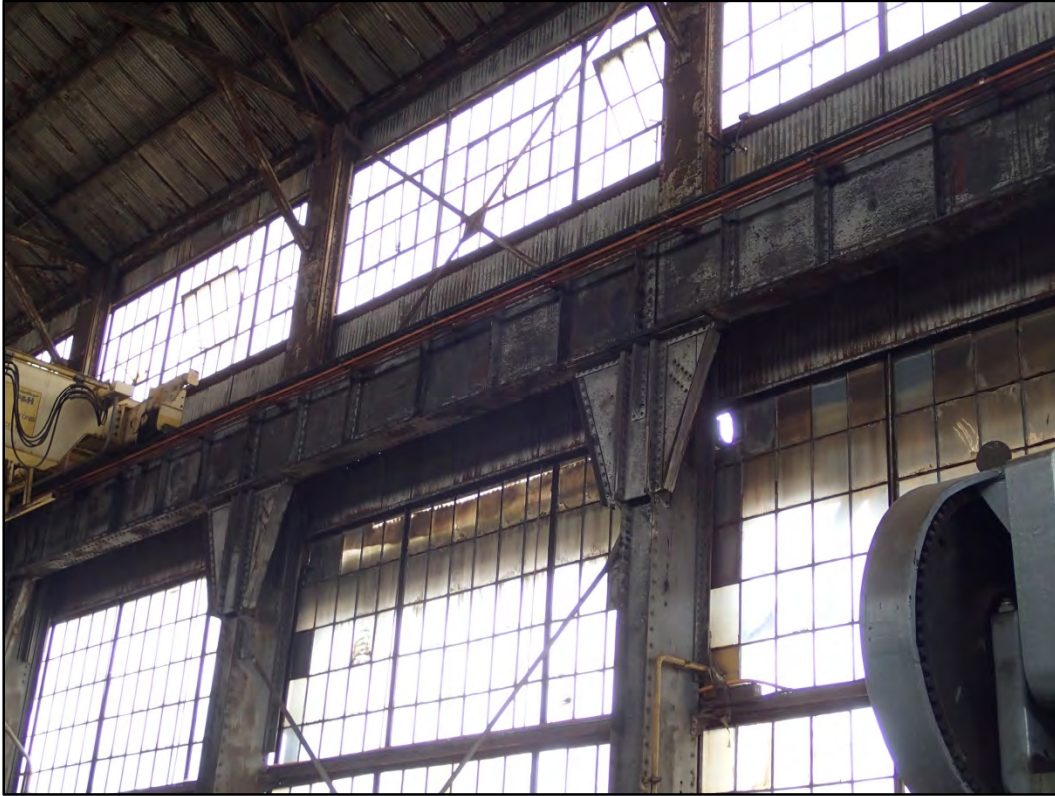
Figure 105-8 – View of Building 105 interior structure and wall corrugated metal panels.

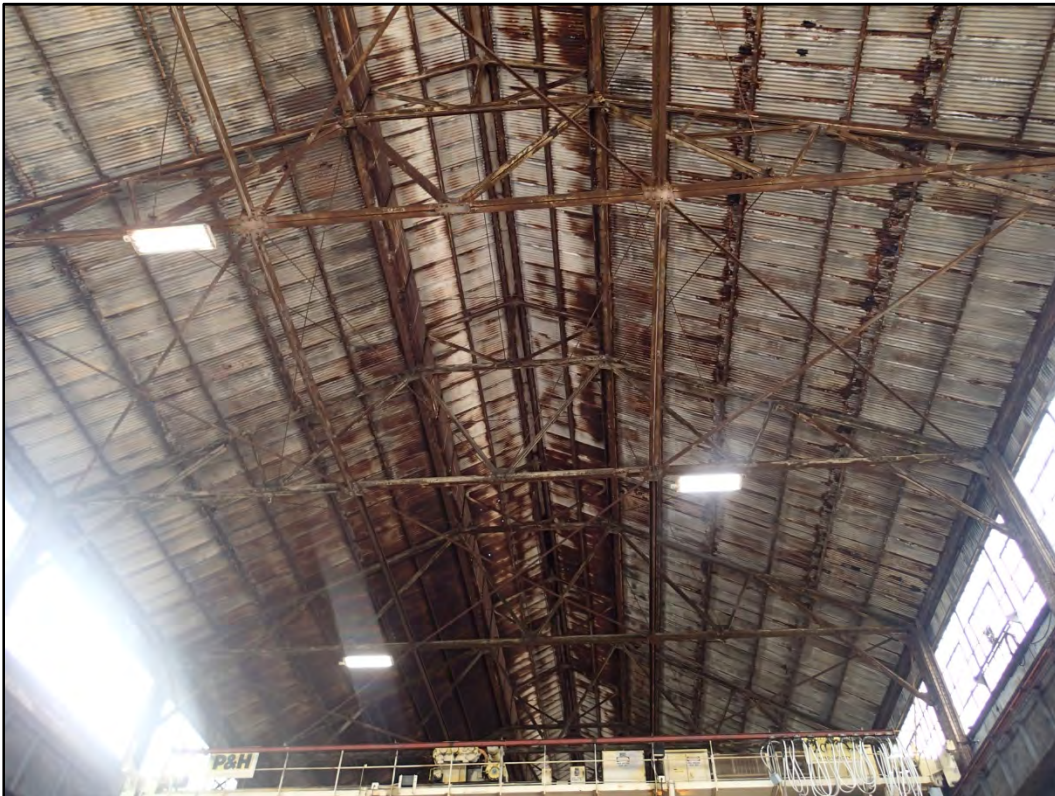
Figure 105-9 – View of Building 105 roof structure and corrugated metal panels

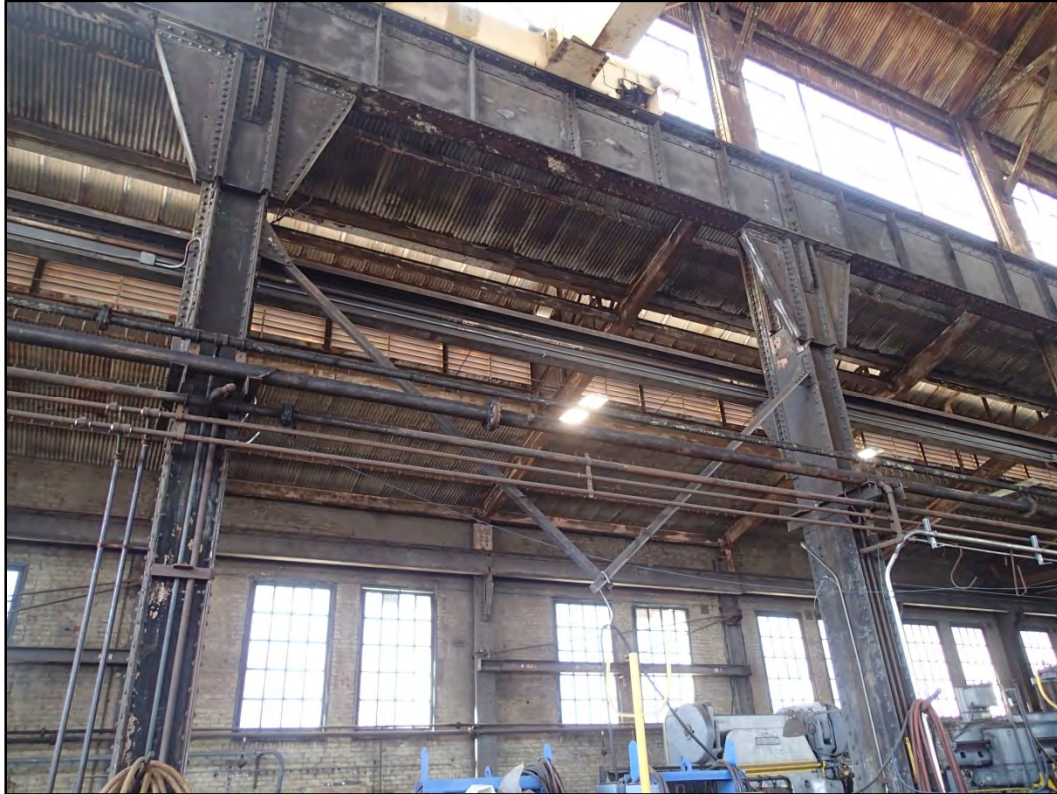
Figure 105-10 – View of Building 105 cut interior braced frames.

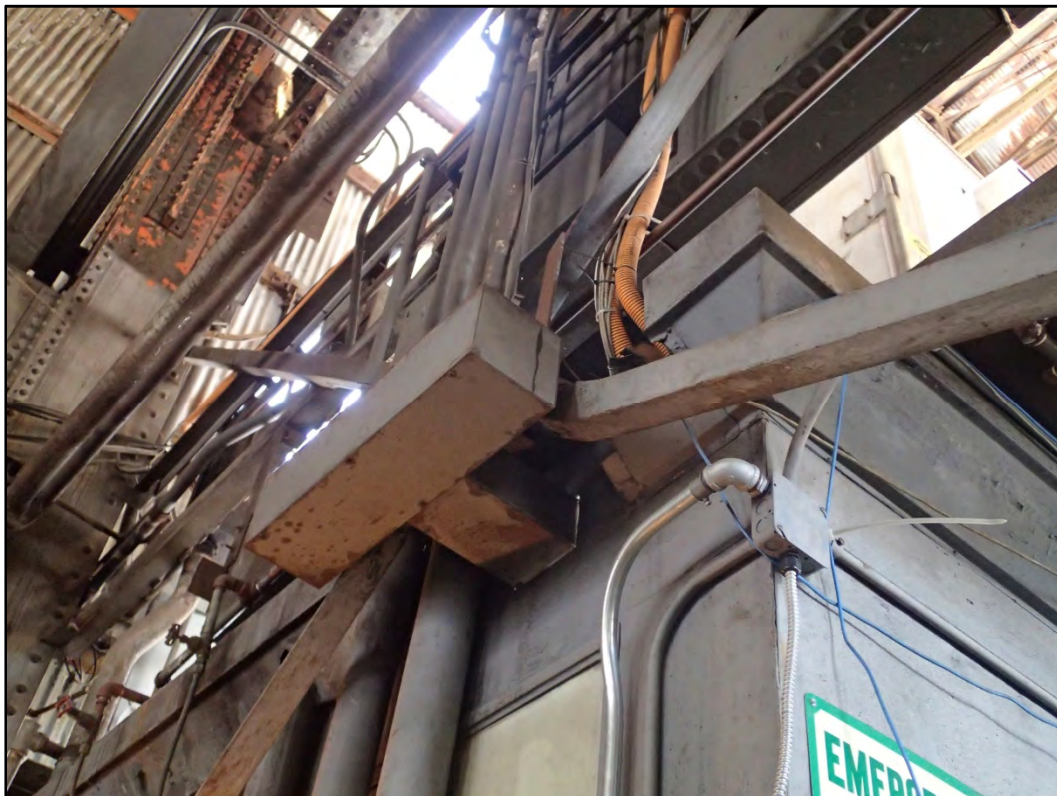
Figure 105-11 – View of the remaining bent braced frame at the west end of Building 105.

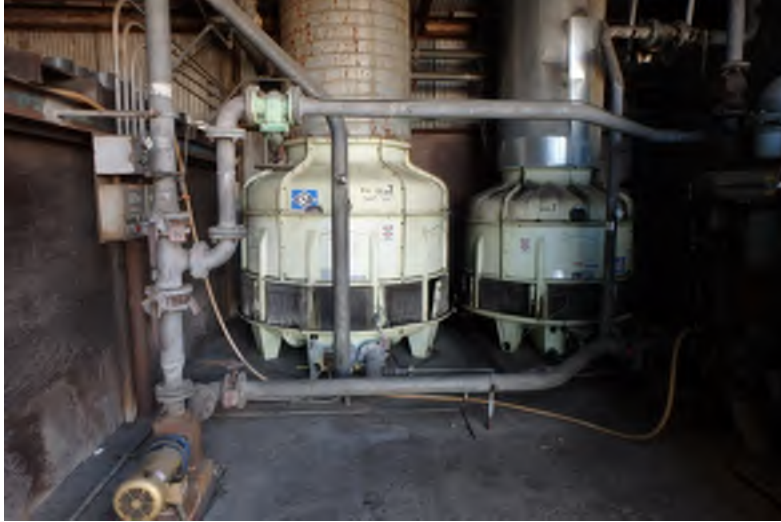
Figure 107-1 – Cooling Towers

- This building stores (2) Cooling Towers used for process equipment (see fig. 107-1).
- (2) Utility Type fans are mounted on a ledge used for sawdust collection from the neighboring woodshop (see fig. 107-2).
- A gas-fired unit heater is located for spot heating, but no gas connection is piped to the heater (see fig.107-3).
- There is no mechanical ventilation equipment, the building relies on natural ventilation.

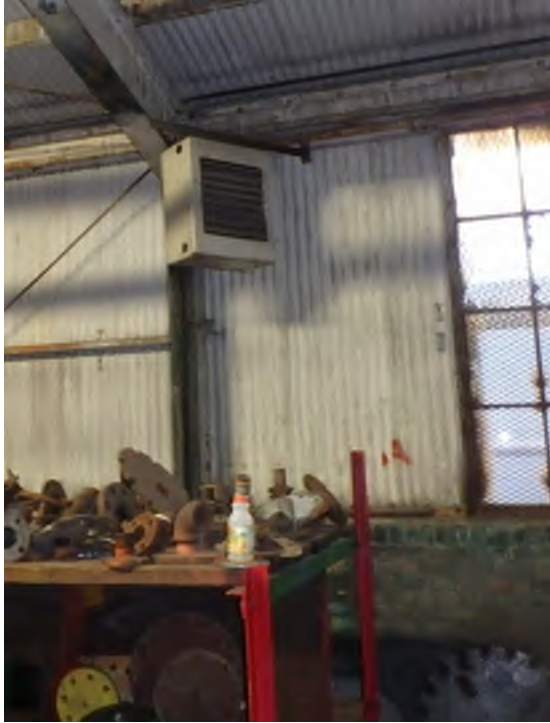
Figure 107-3 – Unit Heater without Gas Connection

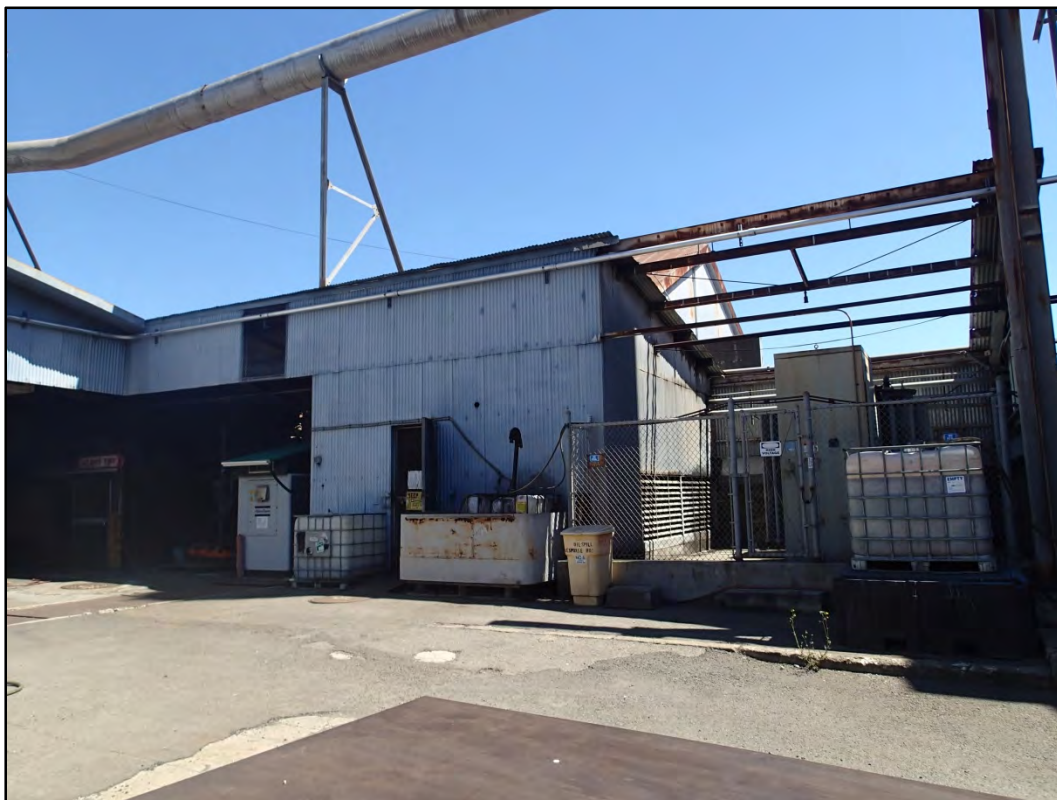
Figure 107-1 - Overall northwest view of Building 107.

The overall condition of Building 107 has remained unchanged since the previous condition assessment in 2015. The building continues to be used as a general storage facility and the recommended repairs provided in the previous condition assessment report have not been addressed. No deficiencies in addition to the deterioration identified in the previous condition assessment were found.

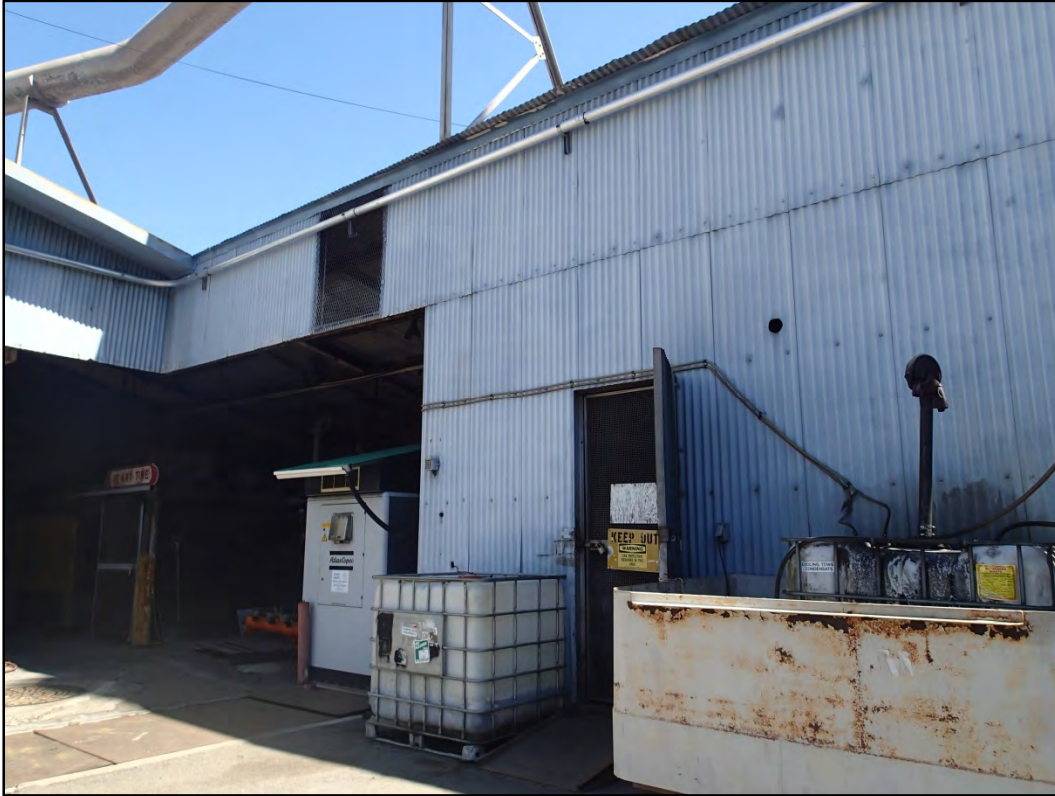
The CMP is painted on the north elevations that face the yard. The west (figure 2) and visible portions of the south elevation are unpainted and in somewhat poorer condition with corrosion and open seams especially where the panels meet the brick base. Most of the south wall was inaccessible for inspection. The narrow space between building 107 and the north wall of building 19 was boarded up with plywood. The east wall of building 107 abuts the interior of building 108.

Figure 107-2 – Typical view of Building 107 exterior corrugated metal panels.

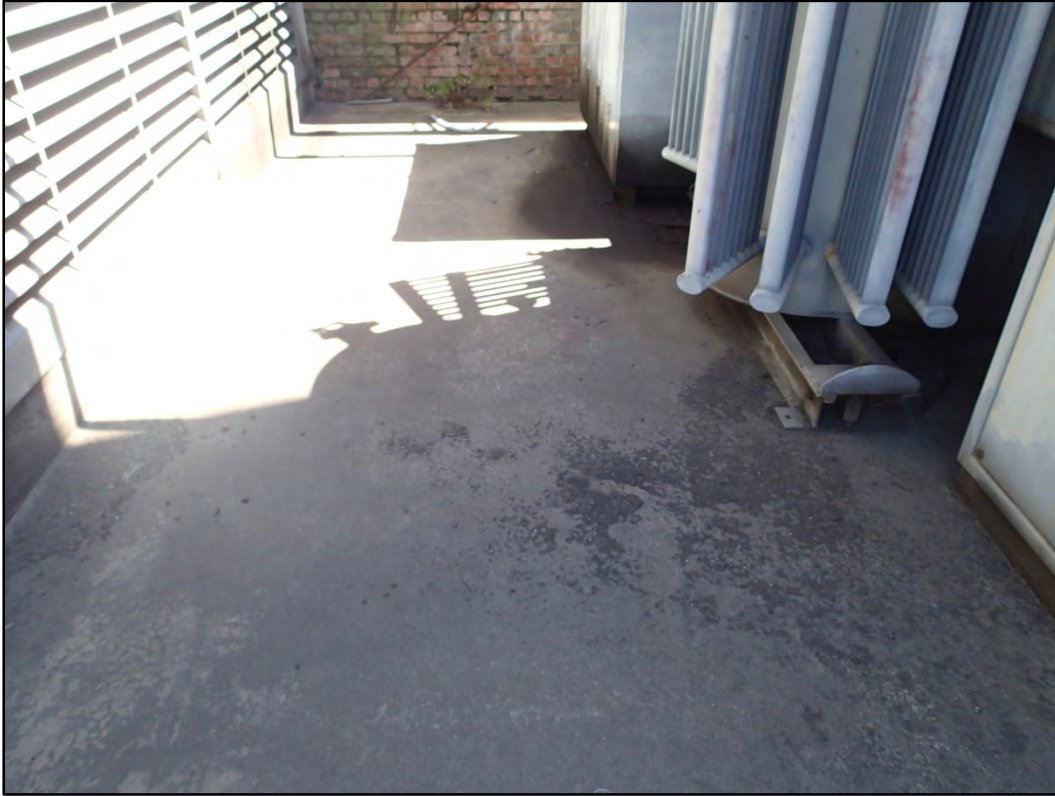
Figure 107-6 – View of Building 107 concrete slab located at the western end.
