BUILDING 108 –Carpenter’s Shop

ARCHITECTURAL DESCRIPTION

BUILDING 108 – Carpentry Shop & Storage

A condition assessment of Building 108 was performed by AGS Inc. on June 27th, 2017 based on the 2015 Pier 70 Building Condition Assessment Report by DCI+SDE Engineers. The purpose of the condition assessment and this addendum is to provide an update and field verification of the architectural and structural deficiencies found at Building 108, which was described in the aforementioned report by DCI+SDE Engineers. The condition assessment was based on a general visual observation of the exposed portions of the building from the ground level. No assessment was performed in areas that were not easily and/or safely accessible.

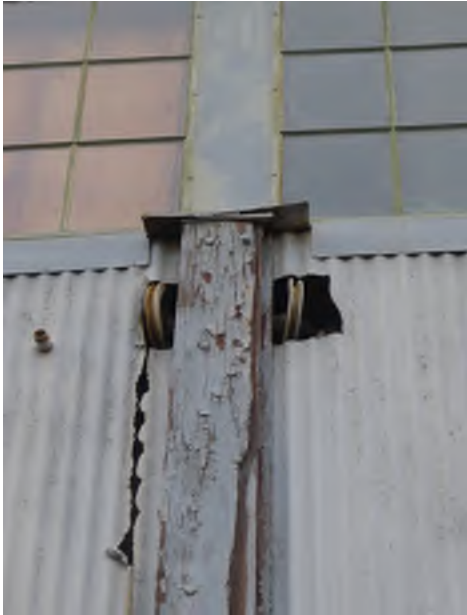
Figure 20 – North elevation, electrical equipment

Historic elements, Condition: fair, (figures 20- 23)

There are several sheaves and track door hardware elements that are remnants of the three missing vertical lift doors (also see loading door, above). The north elevation of the western half of the building contains two, wooden, wall mounted fire hose stations. This elevation also contains an alarm bell, and a single metal shaded light.

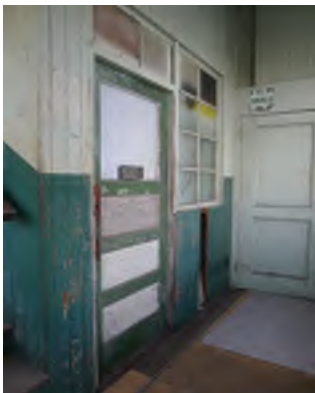
Figure. 28 – Personnel entry.

All wall partition surfaces are protected from the elements. Condition: Good (figures 28-30).

The wall partitions have been painted, and the paint is generally sound, but the painted surfaces are worn and grimy. Non-paintable plastic laminate partitions occur in the second floor break room

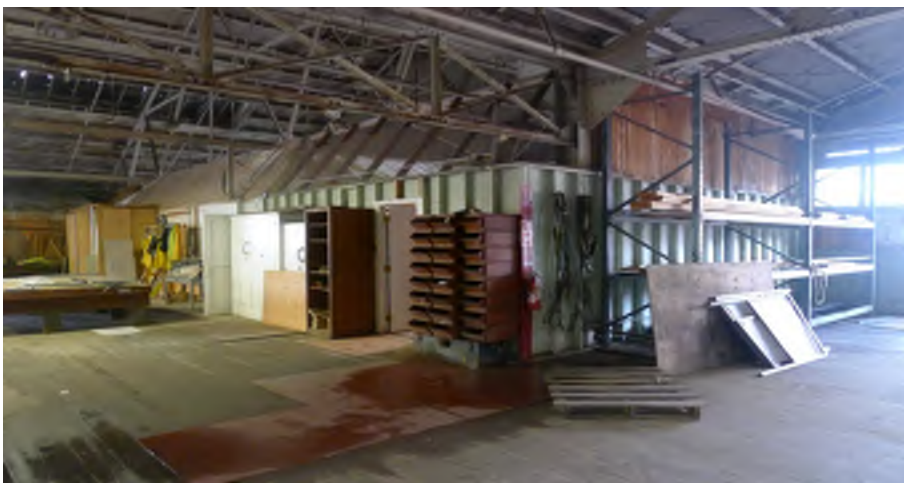
Figure 43 – Interior shed, employee area, north west side. Looking northwest.

Condition: Good to fair (figures 43 - 46)

At the north end of the west side a hallway and is a warren of rooms used as offices, break and conference room, locker room, and tool storage room and office space. It is in sound condition but worn and dirty. This area contains historic fabric (also see walls and floors above).

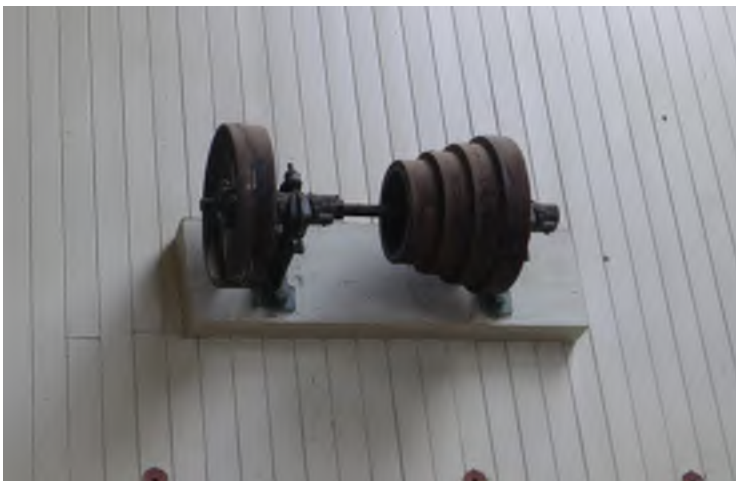
Condition: Assumed good to fair (figures 47 – 48).

Figure 47 – Second floor, historic wall mounted belt drive step pulleys, east side.

- Retain and rehabilitate historic fixtures mentioned in this report.
- Patch holes throughout the building.
- Seal CMP at all conduit and pipe penetrations.
- Replace deformed and deteriorated CMP with new galvanized corrugated steel to match the existing panels. Replace the panels from grade to the next panel above on the north, east and south elevations. Replace the deformed panels above the western loading doors. Prime and paint the new panels.
- Re-paint all existing CMP

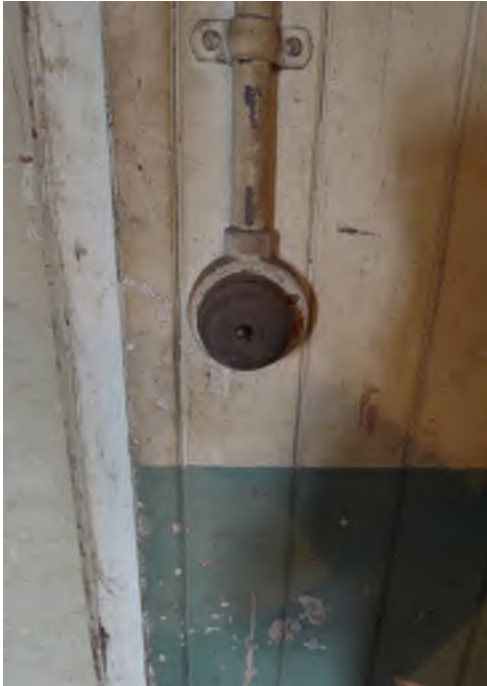
Figure 48- First floor, historic light switch.

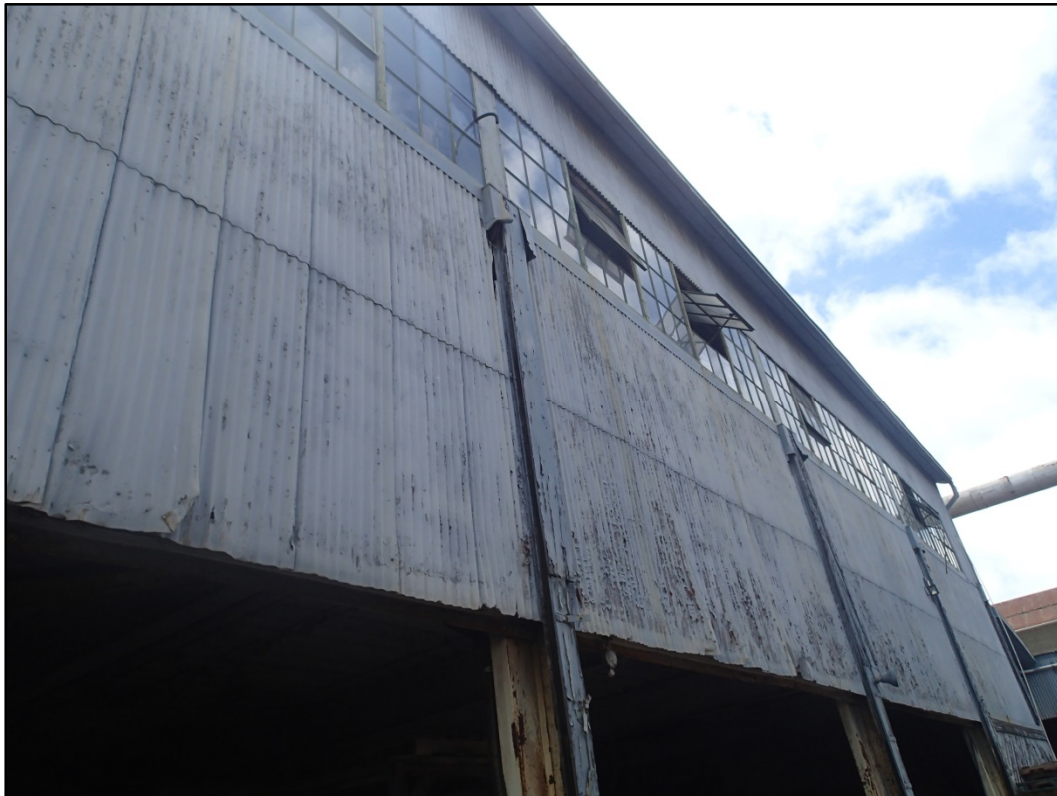
The overall condition of Building 108 has remained relatively unchanged since the previous condition assessment in 2015. The building continues to be used as general storage and as needed miscellaneous use on the first floor and as a woodworking and carpentry facility on the second floor. The recommended repairs provided in the previous condition assessment report have not been addressed. With exception to further general paint degradation on the building interior and exterior loading doors, no additional deficiencies were found.

Figure 108-3 - Typical view of Building 108 exterior corrugated metal panels.

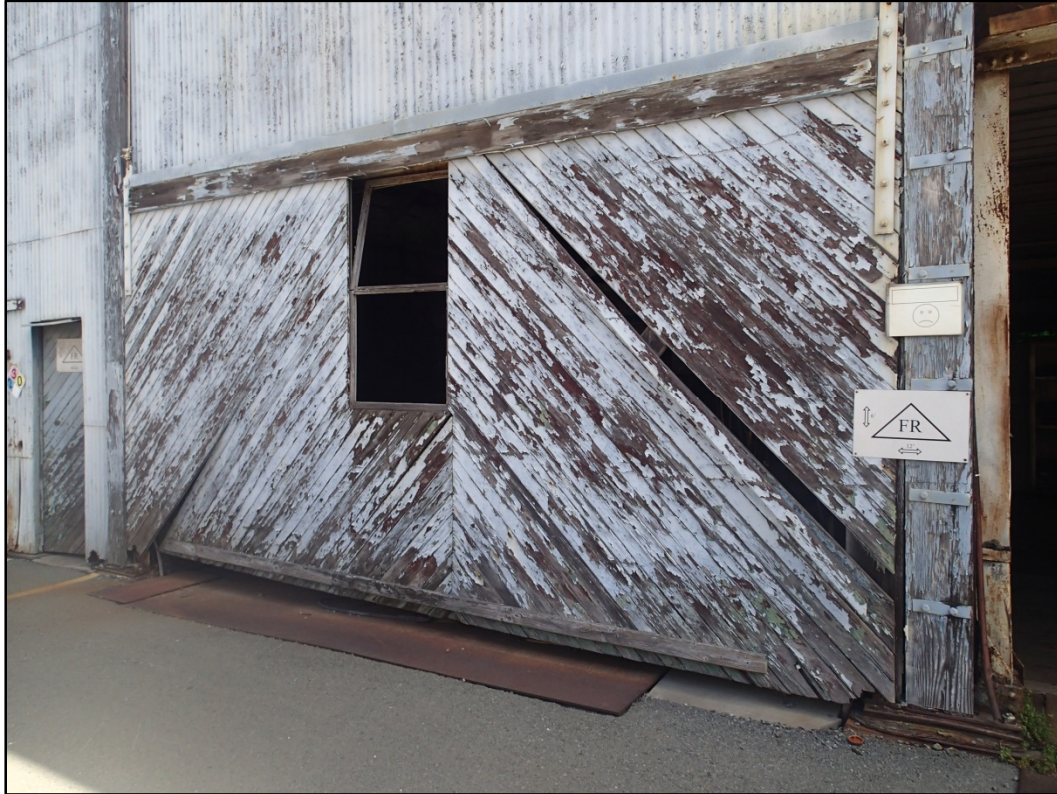
Figure 108-4 - View of Building 108 wood sliding door located on the west side.
