**BUILDING 109****Tool Room/Paint Booth/Sheet Metal & Non-UV Covered Storage**

**BUILDING 109 Tool Room**

## BUILDING 109

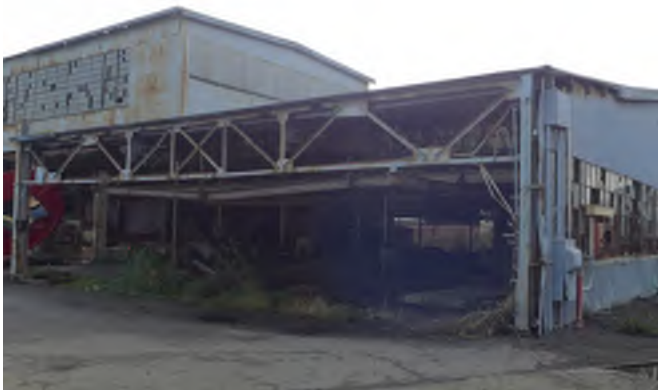
Figure 3 - Building 109, the north side of this portion of the building is open.

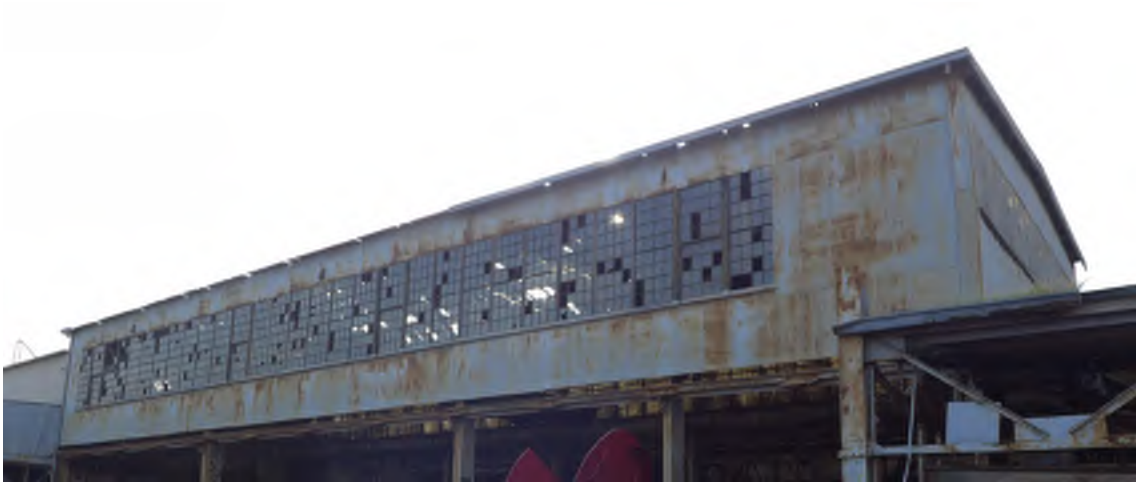
Wood Sash Multi-Lite Windows. Condition: Poor

The wood at the windows is in very poor condition. Paint is missing from much of the surface of the wood. Approximately 10% to 15% of the glass panes are missing or broken.

Figure 4 - Building 109, western section of building, north wall. Wood windows at second story.

- Replace 15% of window panes at the 2nd floor of the Non-UV Covered Storage portion of the building.
- Replace 5% of window panes at the Paint Shop/Plate Shop/Rigging-Break Room/Tool Room
- Replace 10% of window panes at the Mold Loft
- Repaint 100% of all wood frames and sash.
- Repaint 100% of all steel window sash.

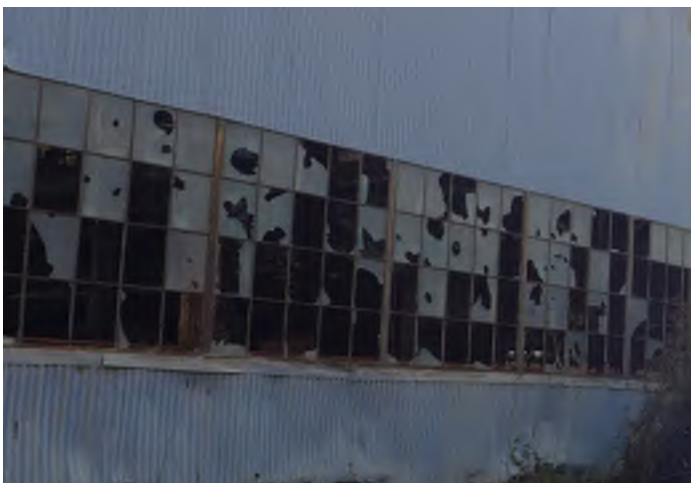
Steel Sash Multi-Light Windows. Condition: Poor

Almost 100% of the glass panes are broken or missing from this section of the building. The steel sash is heavily rusted.

Figure 5 - Building 109, steel windows

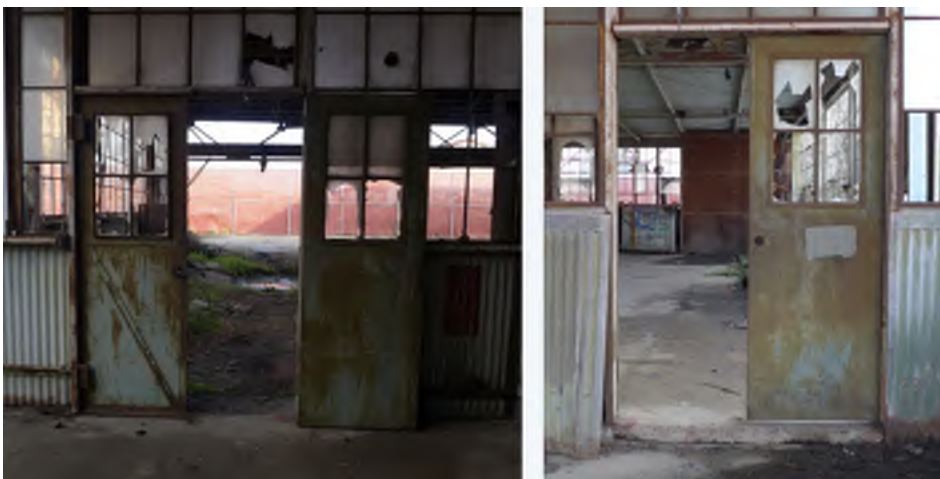
Steel frame and panel doors. Condition: Fair

Figure 8 - Building 109, interior steel frame doors

- Salvage two (2) steel doors at interior of Non-UV Covered Storage portion of the building for possible reuse in other buildings.
- Repair/paint two (2) wood panel doors at Tool Room.
  1. Repair wood elements of doors and restore operation
  2. Repair existing hardware or replace missing components
  3. Prepare surfaces, prime and paint with two top coats

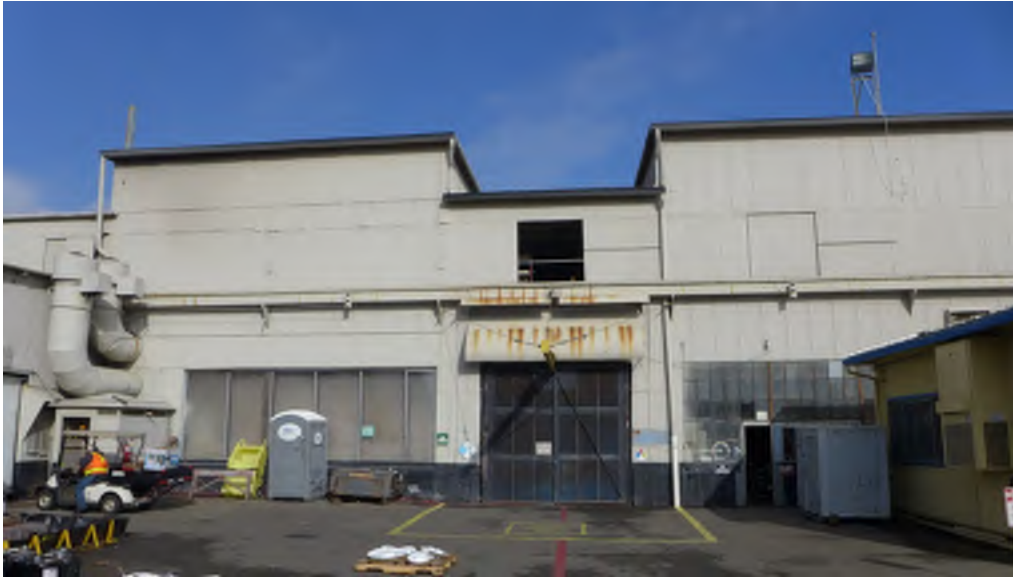
CMP (corrugated metal panels). Condition: Fair

The CMP at the Paint Shop is painted. Most areas are in fair condition with some damage at ground level and around doorways.

Figure 9 - Building 109, Paint Shop south wall.

- Repair 5% CMP panels.
  1. Replace deformed and deteriorated CMP with new galvanized corrugated steel to match the existing panels.
  2. Replace the panels from grade to the window sill level on the Non-UV Covered Storage portion of the building.
  3. Prime and paint the new panels.

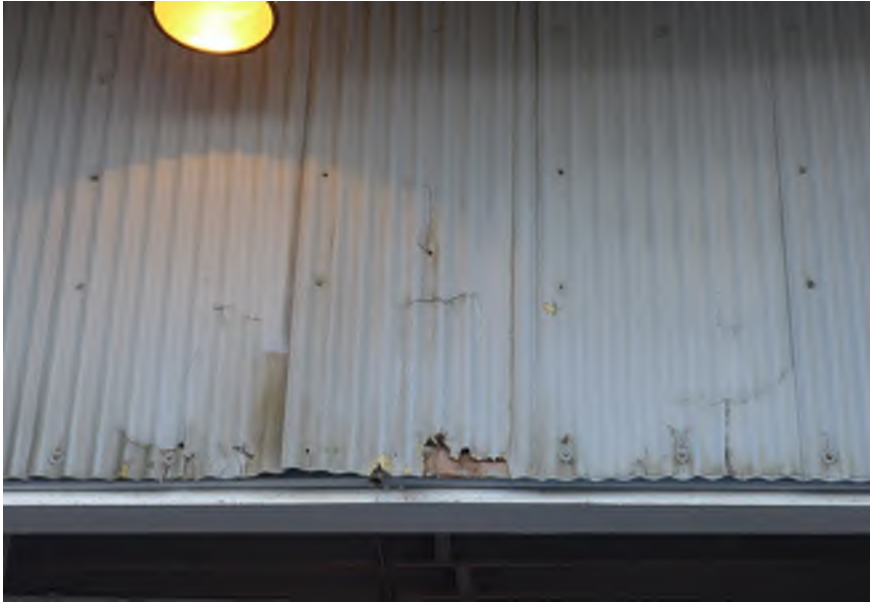
Figure 11 - Building 109, CMP damage at north elevation doorway.

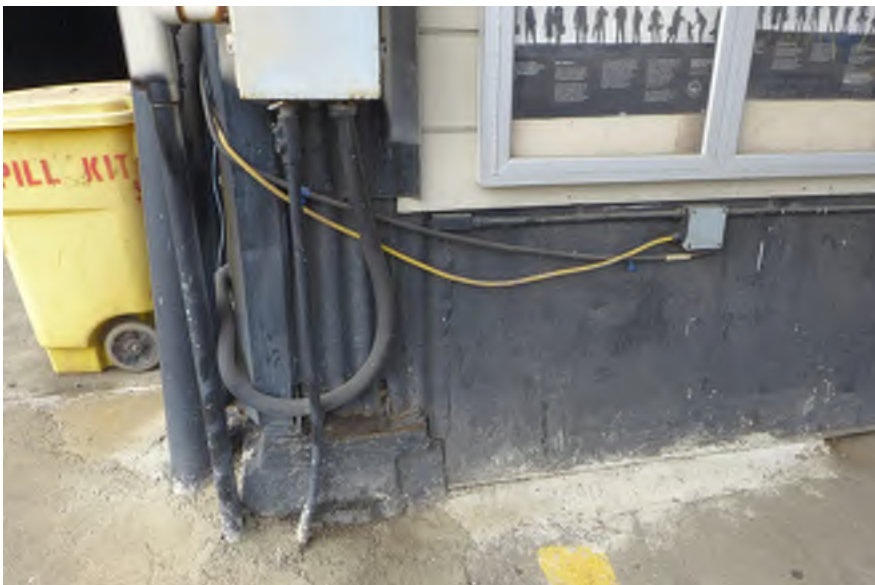
Figure 12 - Building 109, CMP damage at Tool Room, south east corner

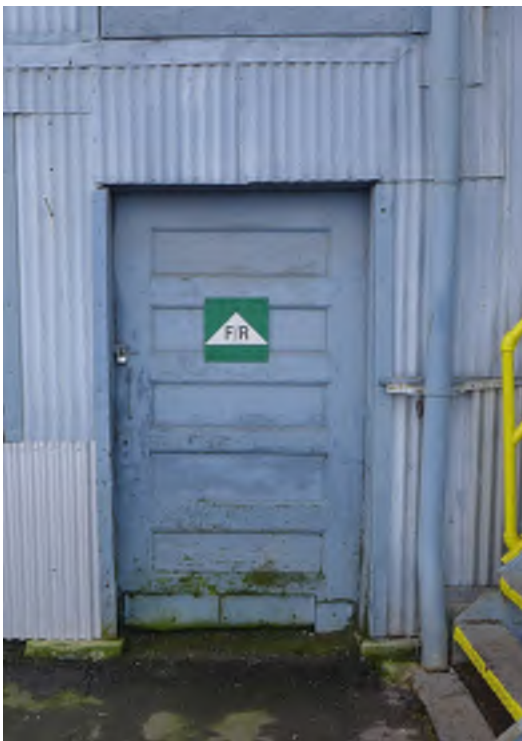
Two Wood Panel Doors. Condition: Poor

Figure 16 - Building 109, Wood panel door at north wall of Tool Room.

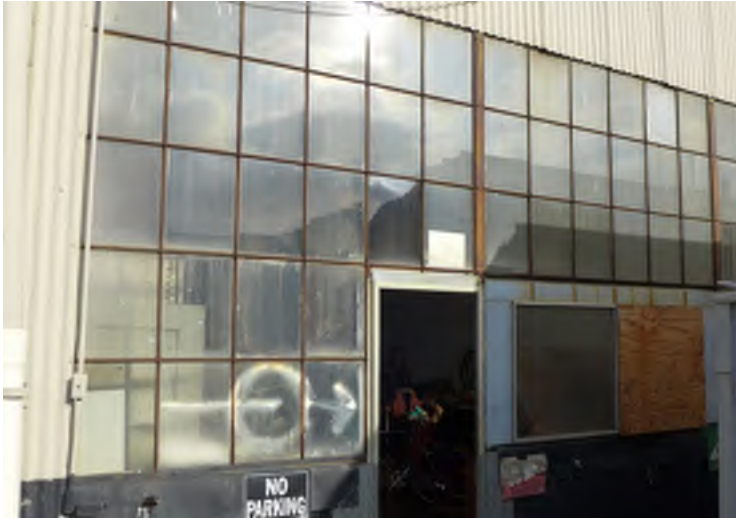
The steel windows on the south wall are rusted. The window has one missing and one broken glass pane. A section of the original window has been infilled with an aluminum window. One pane of the aluminum window is boarded up with plywood.

Figure 13 - Building 109, Paint shop south window.

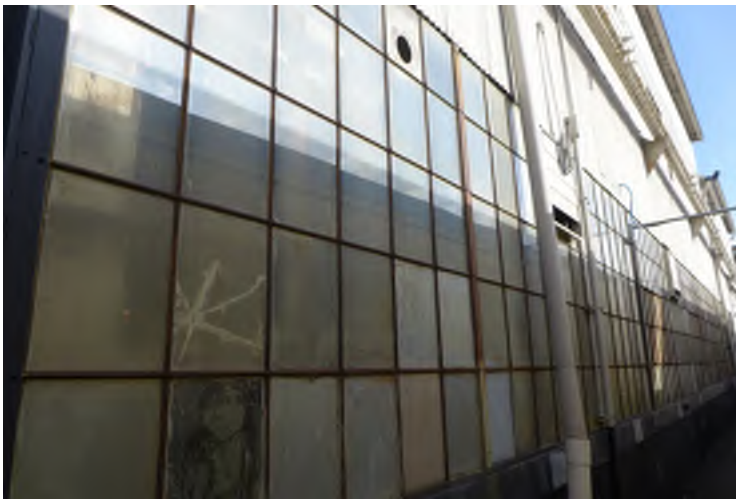
Figure 14 - Building 109, Plate shop south window.

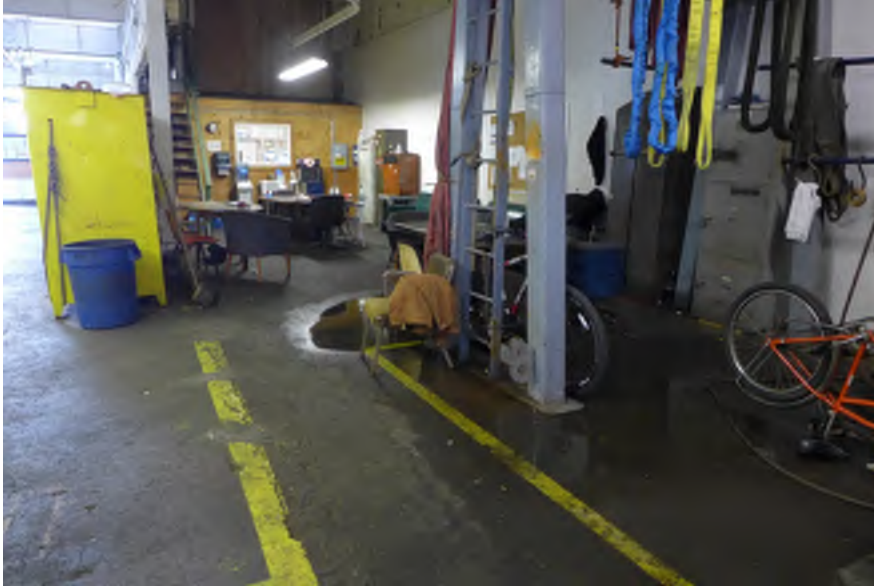
Condition: Good at Paint Shop and Plate Shop. Poor at Rigging/Break Room.

Figure 17 - Building 109, Asphalt Floor at Rigging/Break Room. Note ponding.

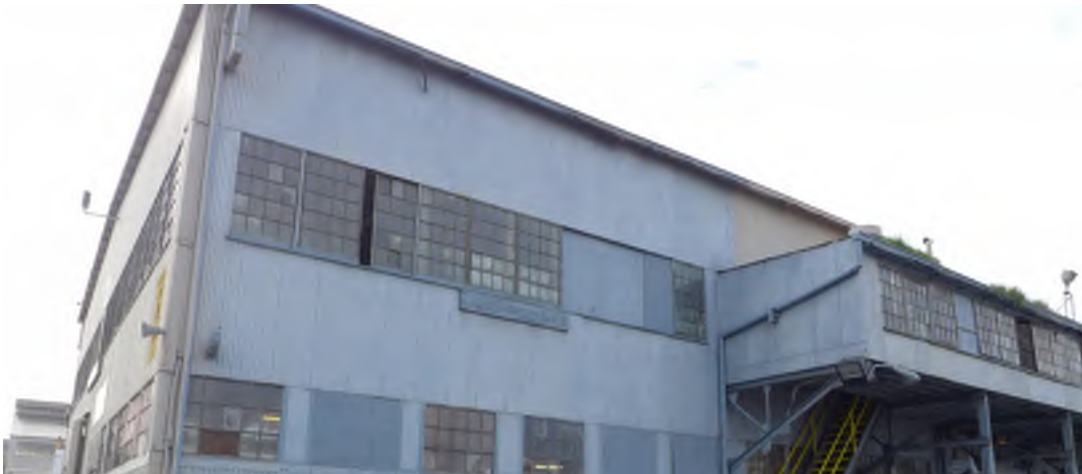
The CMP at the Mold Loft is painted. Most areas are in fair condition with some minor damage and corrosion.

Figure 20 - Building 109, Mold loft north elevation.

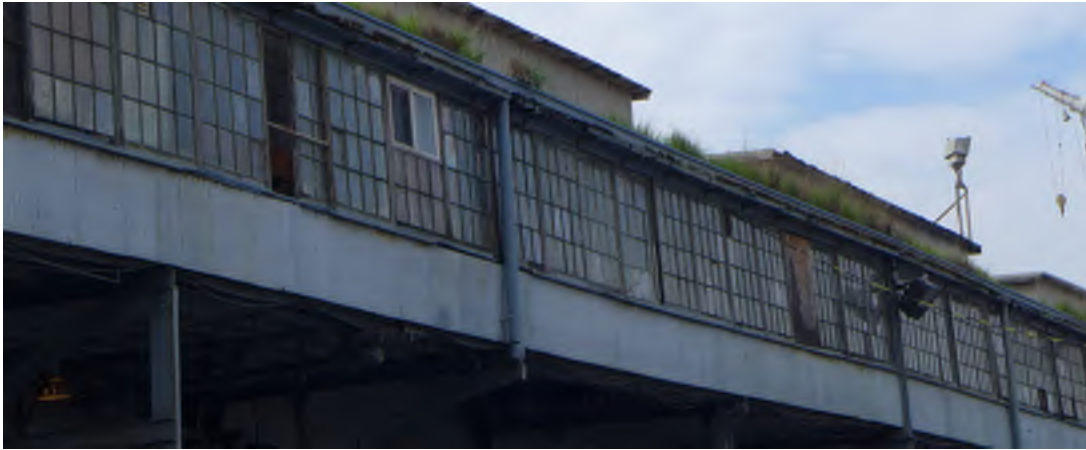
Wood Sash Multi-Lite Windows. Condition: Poor

The window sash at the Mold Loft are fixed and sliding unit. The wood at the windows is in very poor condition. Paint is missing from much of the surface of the wood. The sliding units are inoperable. Approximately 10% of the glass panes are missing or broken. The gutters above the windows are severely clogged with plant growth causing serious damage to the interior.

Figure 21 - Building 109, Mold loft windows, north elevation.

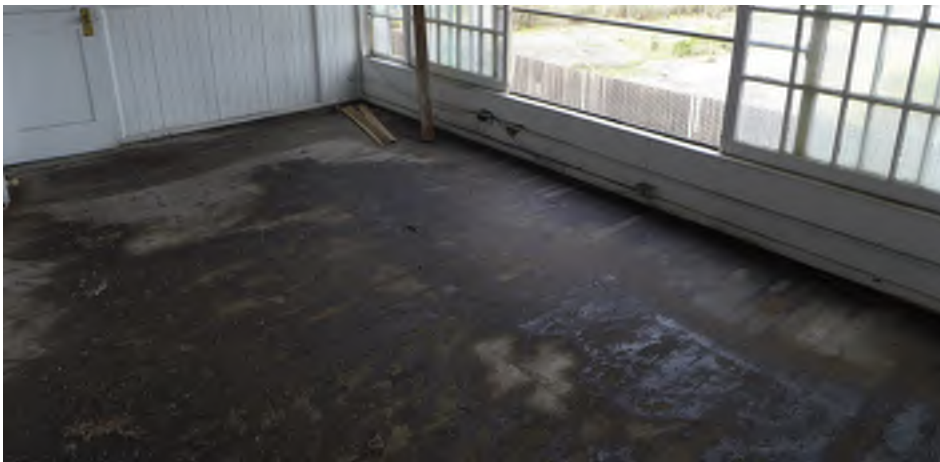
The floor areas on the northern side of the mold loft are in poor condition due to leaking of the roof at the roof/gutter interface.

Figure 24 - Building 109, wood T&G floor. Note water from deteriorated gutter condition.

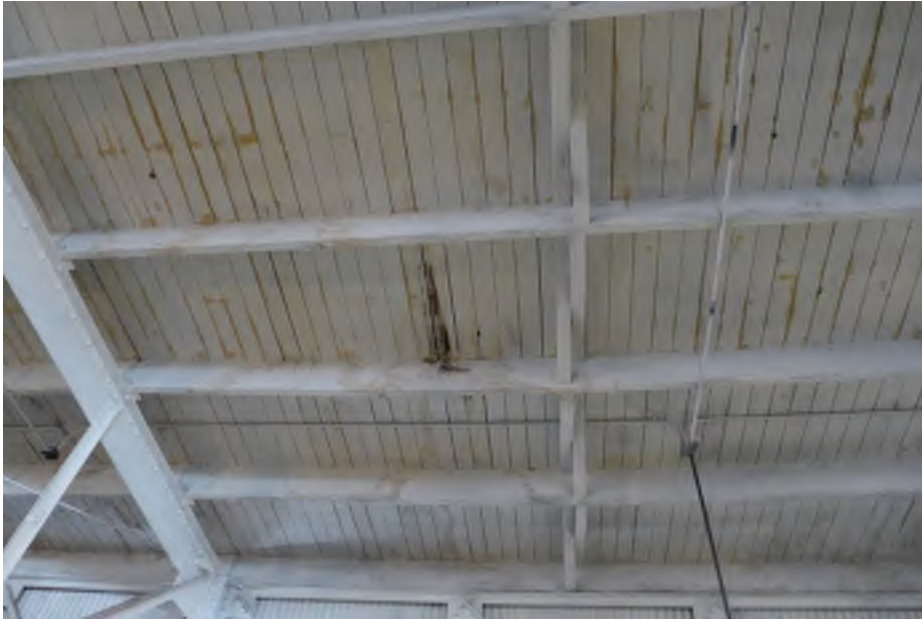
Tongue and groove wood planking. Condition: Fair. Painted with minor water damage.

Figure 25 - Building 109, Mold loft T&G ceiling.

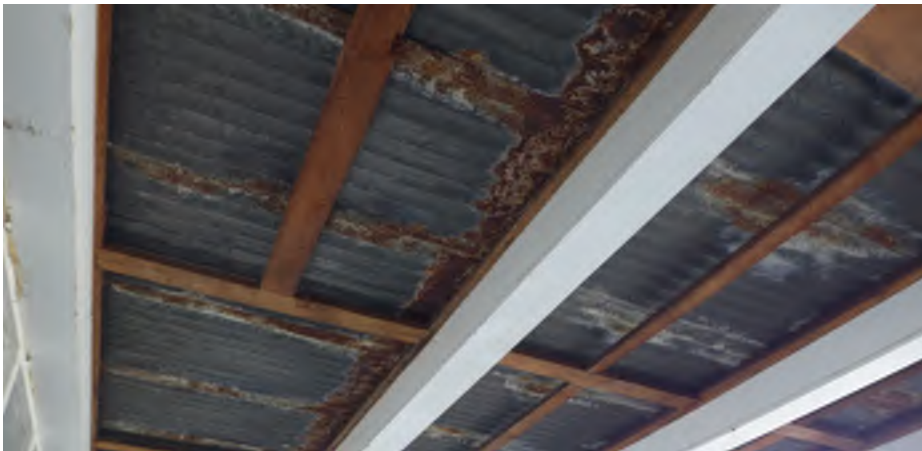
CMP ceiling. Condition: Poor. Severe deterioration due to water infiltration.

Figure 25 - Building 109, Mold loft CMP ceiling.

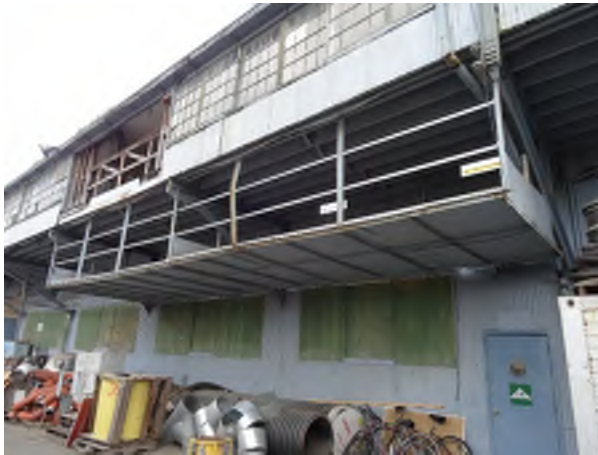
Figure 1 – Hang down frame

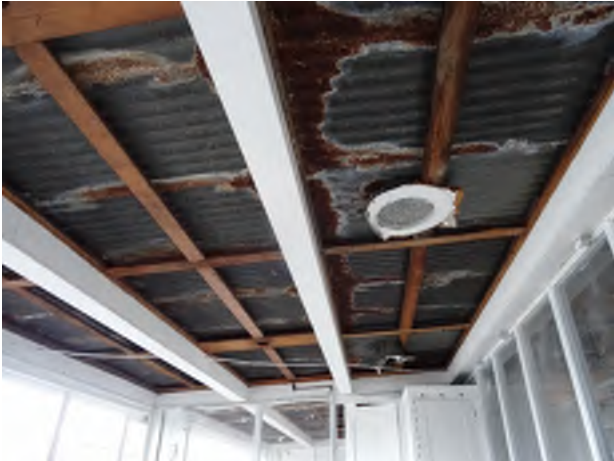
Figure 3 – Typical roof damage at 2<sup>nd</sup> floor punchout

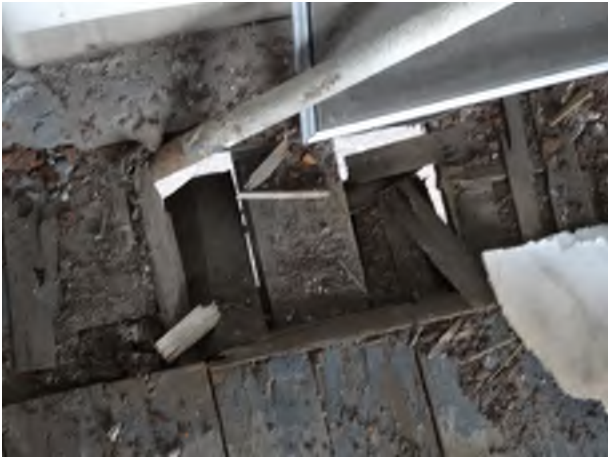
Figure 4 – Typical 2<sup>nd</sup> floor damage at 2<sup>nd</sup> floor punchout

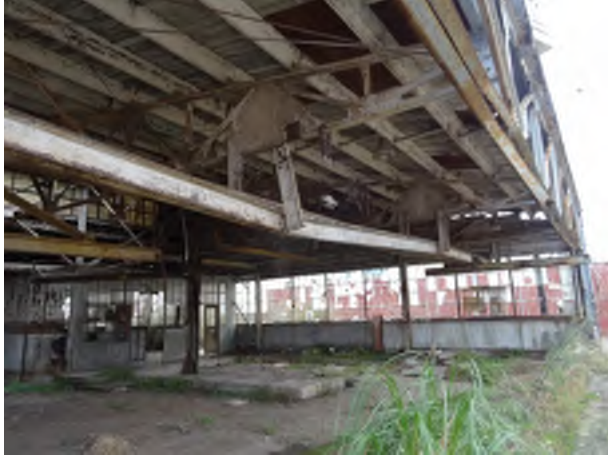
- Potential weak/soft story irregularity at the first floor.
- Potentially inadequate diaphragm strength.
- Non-ductile connections.

Figure 5 – Typical condition of west half of building 109

Given the above items noted at both the east and west portions, it is strongly recommended that a lateral analysis of the existing structure be conducted in order to accurately identify potential weaknesses and to develop a strengthening protocol if necessary.

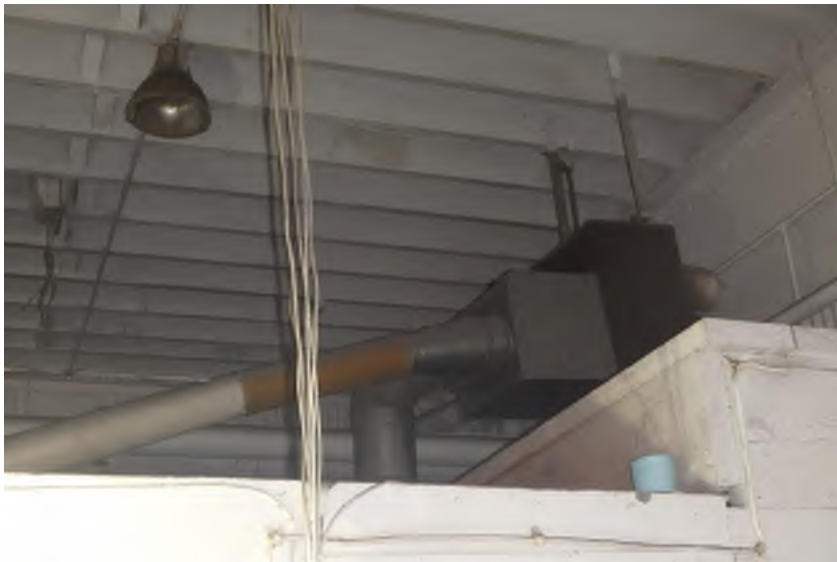
- Ground level shops provided with unit heaters supplied with gas connections.
- 2<sup>nd</sup> level provided with gas unit heaters, space appears largely abandoned.
- Small offices located within shops provided with fan-powered ventilation.
- Some spaces equipped with unit heaters retro-fitted with duct distribution. These heaters are not meant to be configured in this manner (See figure 109-1).

**Figure 109-1 – Unit heater with ducted discharge. Possible noxious gas hazard from burning fuel.**

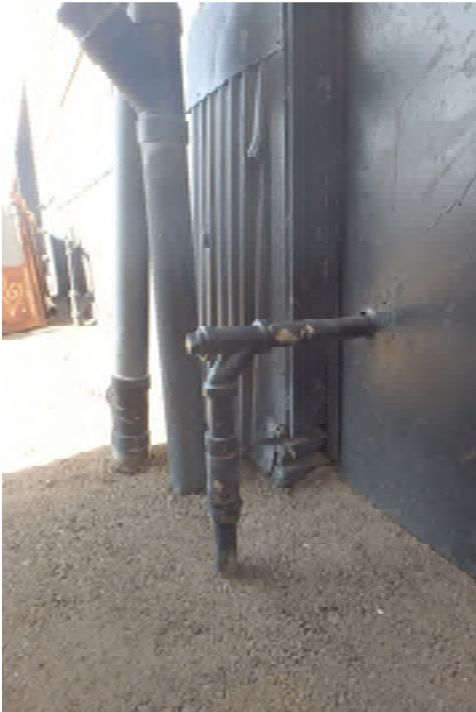
**Figure 109-2 – Cleanout on drain installed backwards.**

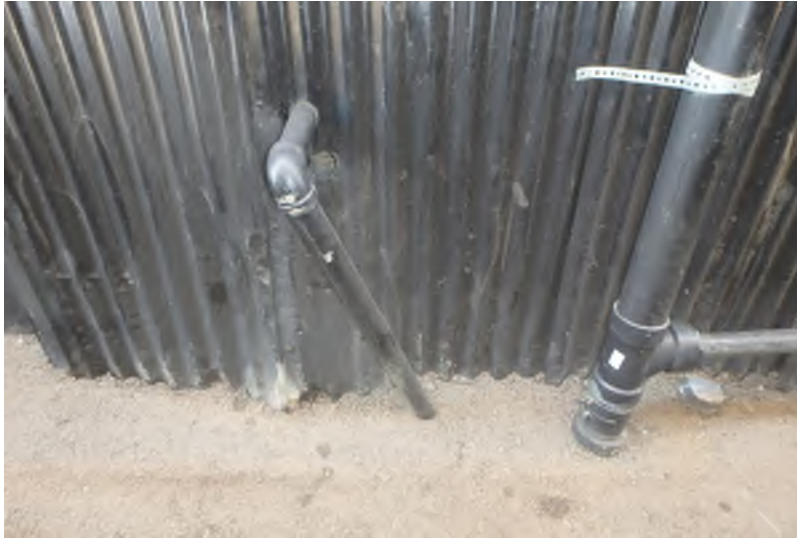
- Building is fully sprinklered with fire hoses available at the 2<sup>nd</sup> floor.
- Compressed air provided throughout building for shop use.
- Building is equipped with a restroom at the 2<sup>nd</sup> floor w/ water closet, urinal, and hand sink available. Restrooms also provided at shops with urinal and hand sink only. Restrooms provided with electric water heaters without disconnect switches on service wiring.
- Waste connection observed protruding from building with cleanout installed in the reversed position. (See fig. 109-2)
- Several CW connections fed from building 109 to nearby portable office units (See fig. 109-3).
- Many pipes at exterior of the building appear warped and bent from building settling. (See fig. 109-4).

**Figure 109-3 – Plumbing Pipe damaged from building shifting.**

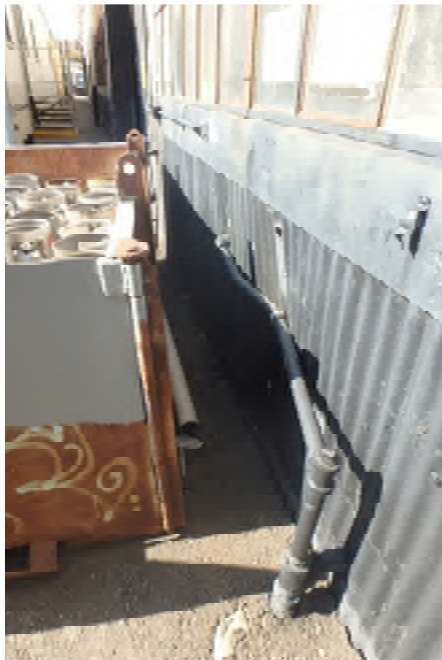
**Figure 109-4 – Waste pipe bent & damaged from collision.**

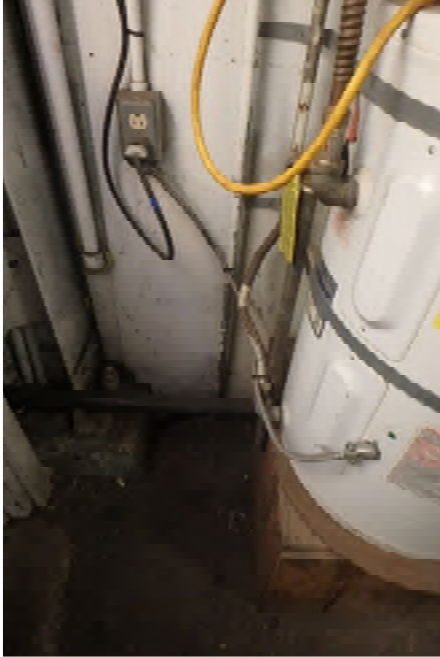
- The building has 480V service with multiple panels.
- Restrooms provided with electric water heaters without disconnect switches on service wiring (See fig. 109-5).

**Figure 109-5 – Electric Water Heater Wired without Disconnect**

- Provide local disconnect switch for electric water heaters to comply with current code.

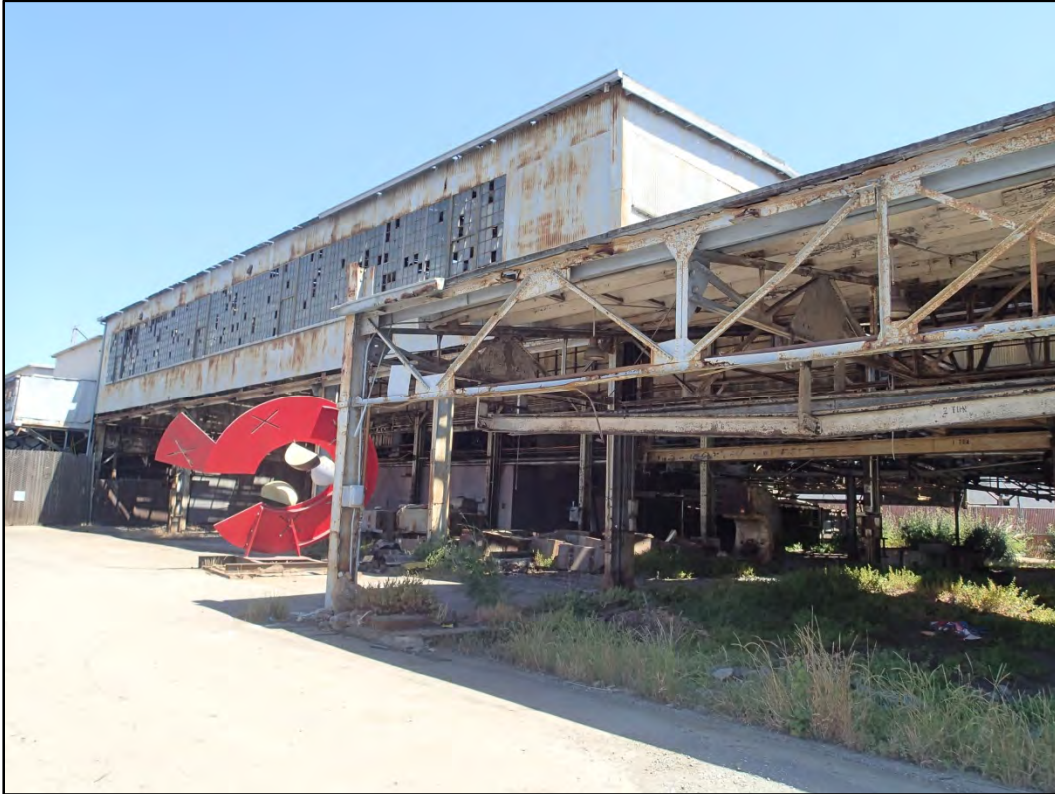
The overall condition of Building 109 has remained relatively unchanged since the previous condition assessment in 2015. The western section of Building 109 remains abandoned and unoccupied and continues to be fenced off from general use. The western section of Building 109 remains in general poor condition with no additional deficiencies found. The eastern section of Building 109 continues to be used as a paint shop, plate shop, rigging/break room, and tool room on the first floor and as a mold loft on the second floor. The recommended repairs provided in the previous condition assessment report have not been addressed. With exception to further general paint degradation on the building interior (most notably on the doors) and general advancement of the corrosion at the mold loft roof corrugated metal panels, no additional deficiencies were found at the eastern section of Building 109.

Figure 109-10 – Overall northwest view of the abandoned west section of Building 109.

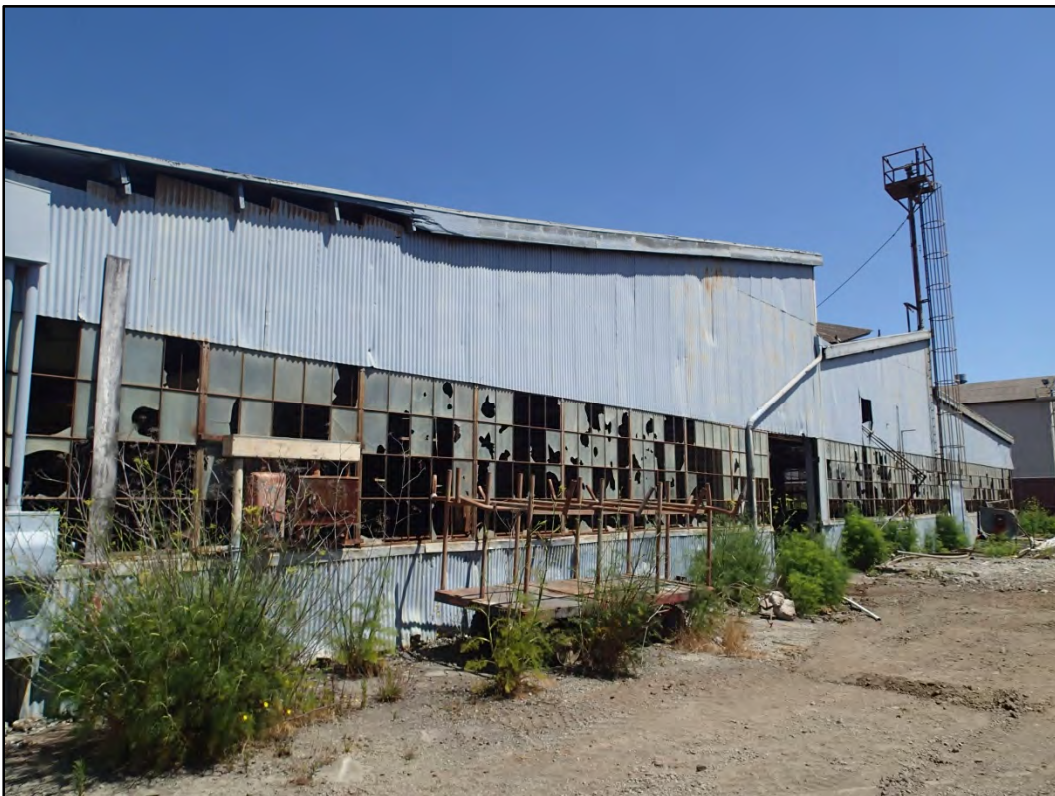
Figure 109-11 – Overall west view of the abandoned west section of Building 109.

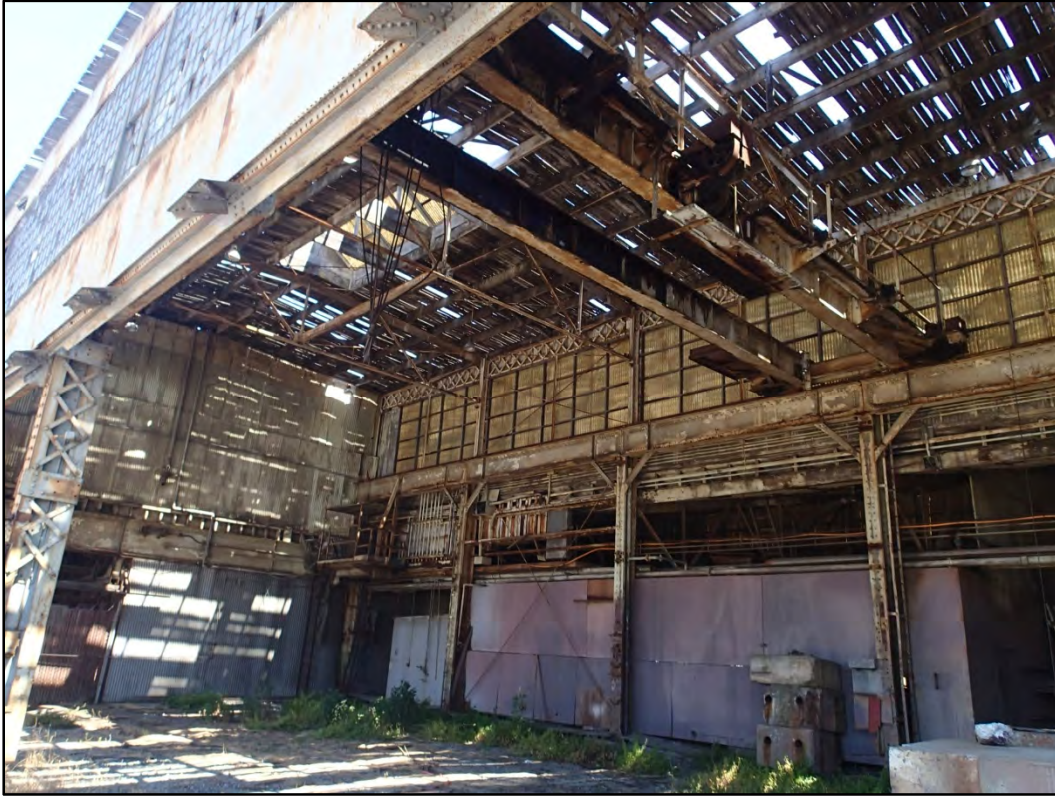
Figure 109-12 – Overall interior view of the abandoned west section of Building 109.

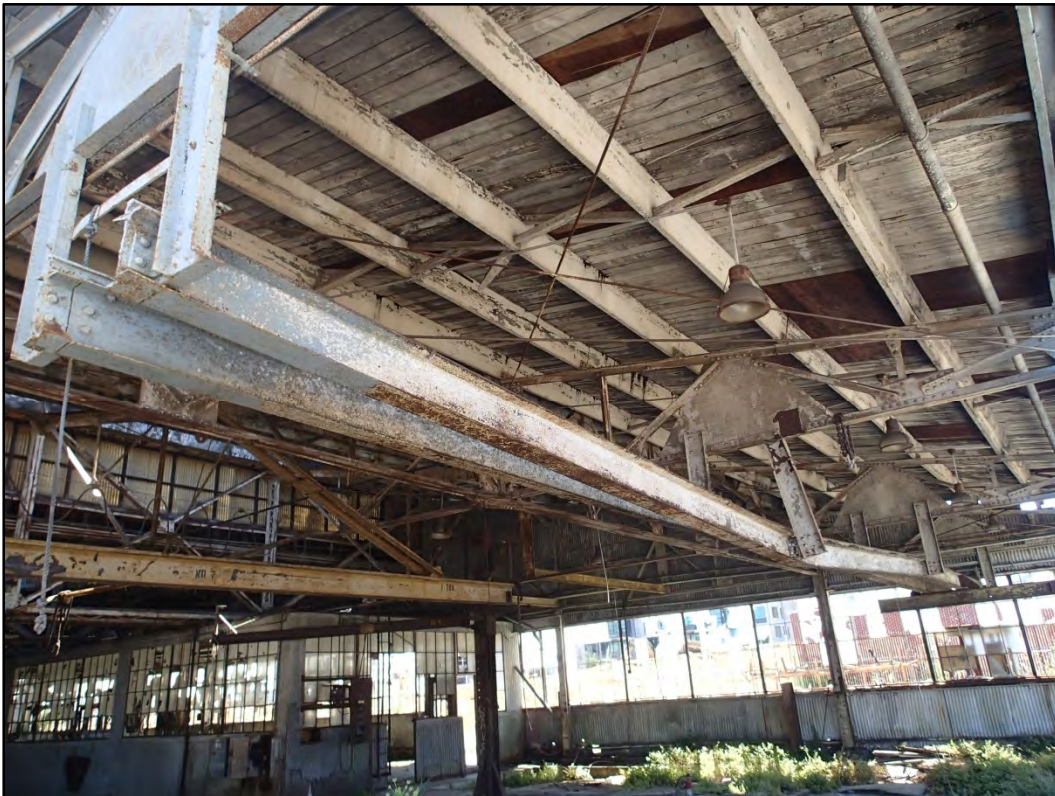
Figure 109-13 – Overall interior view of the abandoned west section of Building 109.

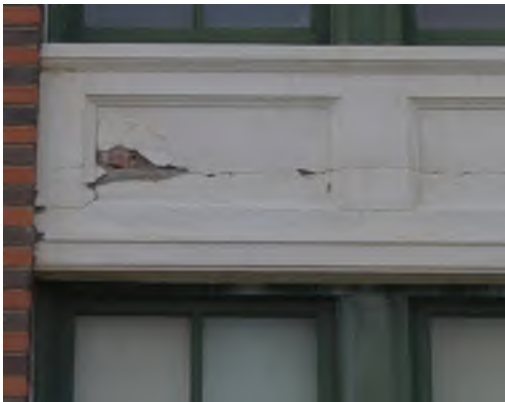
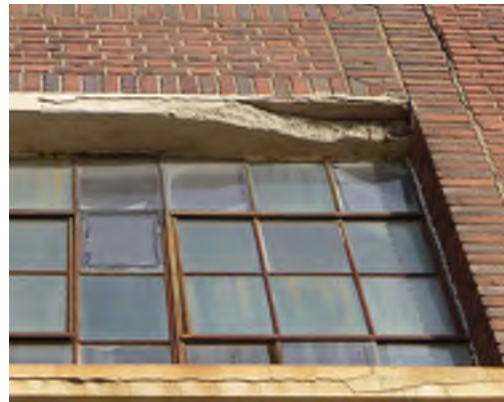
The high quality brick masonry in Building 111 contains multiple deficiencies rooted in both seismic activity and water intrusion. Over time, the cracking caused by seismic activity has allowed water intrusion to damage the fabric of the building. The failure of sealants around windows has caused water damage as well. The building contains seismic cracks, loss of brick, failed window heads and sills, and cracked ornamental parge over brick panels (figures 6 - 9).

Figure 6 - North elevation, parge failure

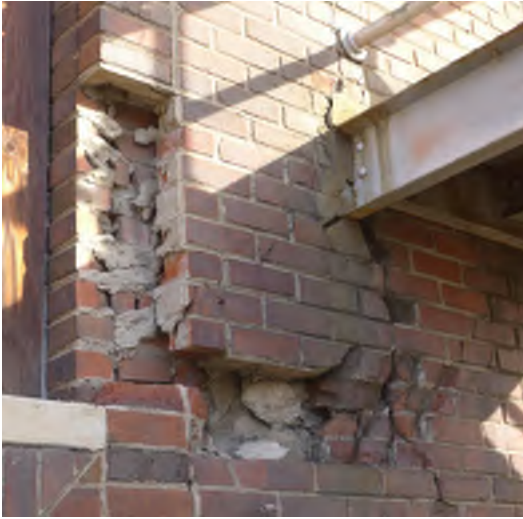
Figure 7 – West elevation, failed header and sill

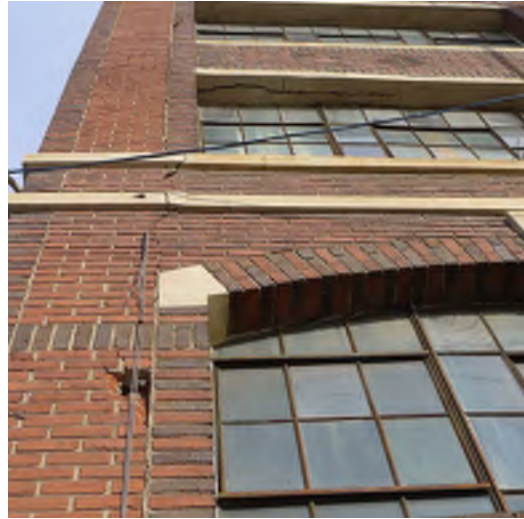
Figure 8 – Brick loss, south elevation

Figure 9 – Cracking, south elevation

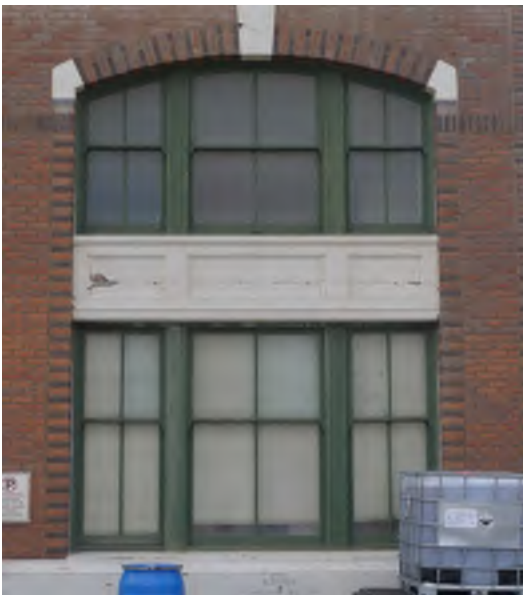
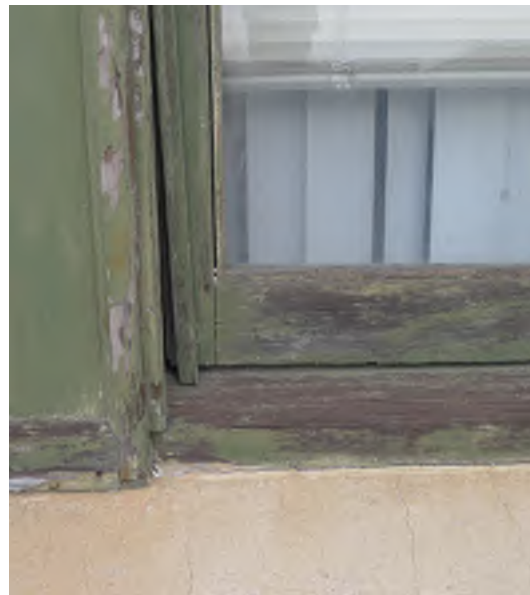
Wood windows are located in the administrative portion of the building in the northernmost three bays, and only on the first floor. All windows are two over two double hung with the upper portions having arched tops. There are no broken glazing panes (figures 6-11).

Figure 10 – Typical wood window, north elevation

Figure 11 – Wood window detail

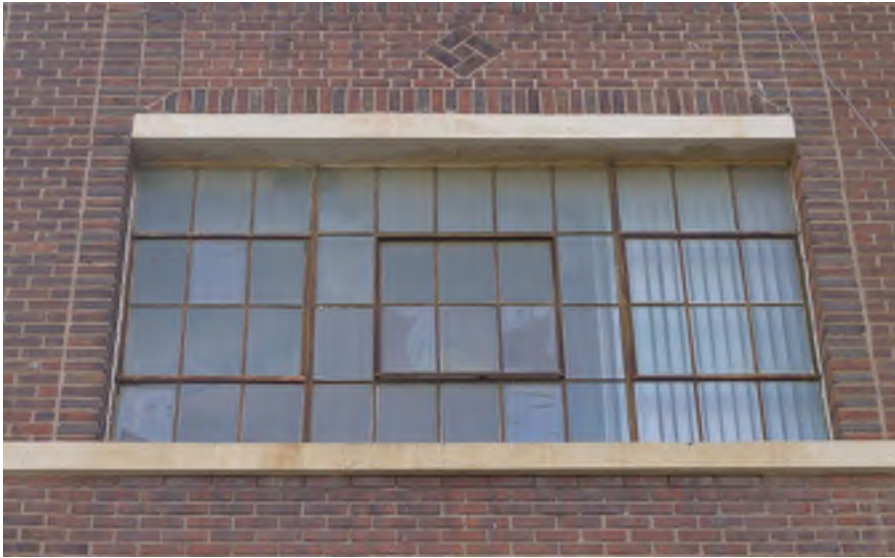
Steel sash windows are the most numerous fenestrations in the building. Typically each unit has one operable portion. All windows are moderately to severely rusted, and many operating portions are bent such that they will not close. There are approximately (75) 14”x 20” broken glass panes. The sealant at the steel sash to brick joint has failed throughout (figure 12).

Figure 12 – Typical steel window, west elevation

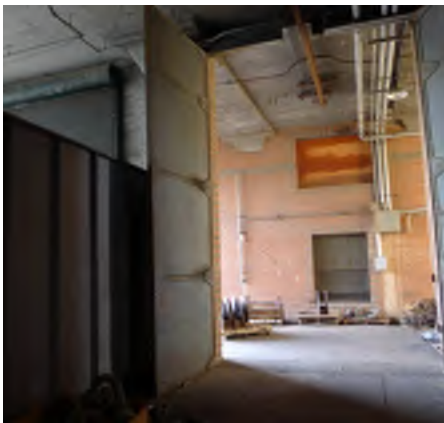
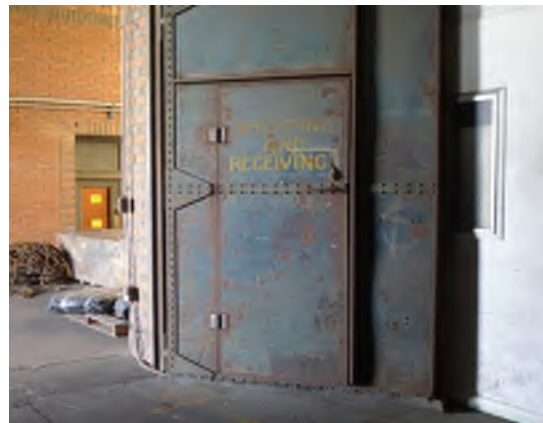
The south wall of the pass through at the fourth bay from the north contains a pair of large steel plate and angle iron loading doors on hinges. They are likely original to the building. They cover an opening 10’ wide and 17’ high. One leaf of the pair contains a personnel door. Both doors contain peeling paint and moderate rust. They operate with difficulty (figures 13 and 14).

Figure 13 – steel loading door

Figure 14 – Leaf with inset personnel door

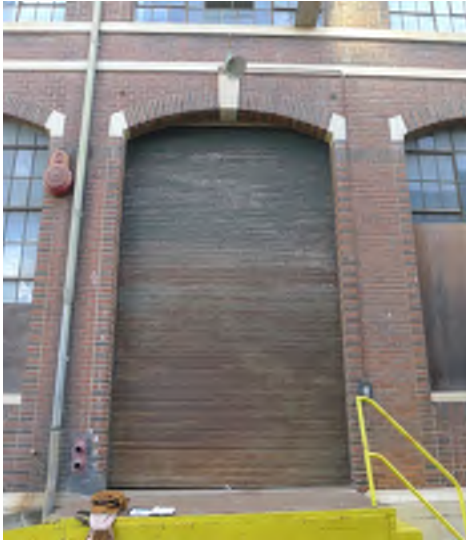
The building has four steel roll-up doors. Two are located on the south wall of the pass through and two are on the west elevation to the south of the pass through. All contain moderate rusting. It is unknown if they operate. The southernmost roll up door covers original double wood loading dock doors that are likely original (figures 15 and 16).

Figure 15 - Roll-up door, west elevation

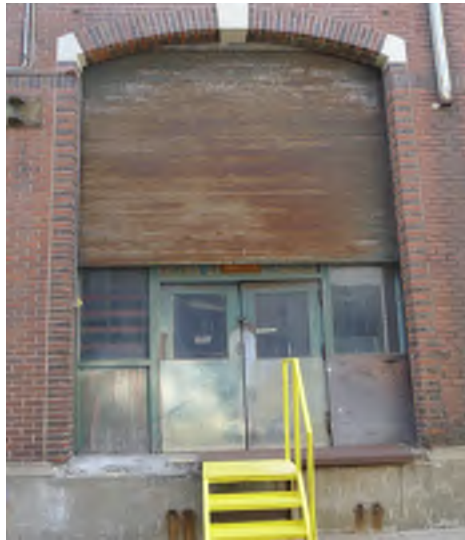
Figure 16 - Wood loading doors, west elevation

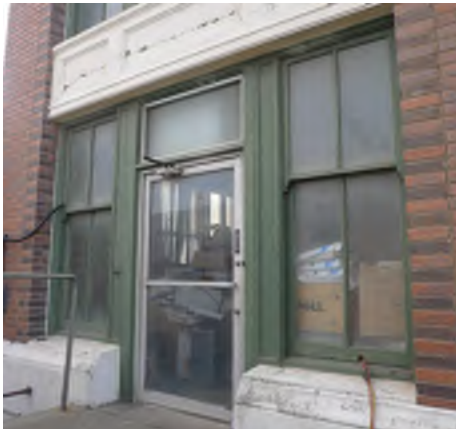
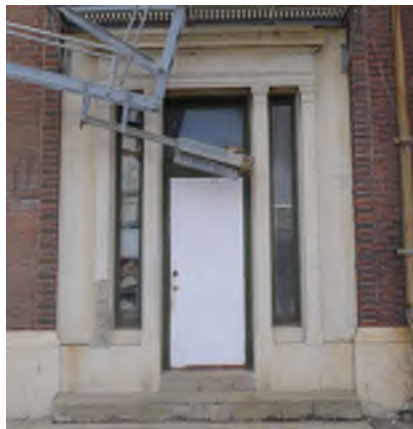
There are numerous personnel doors on the building. The south elevations contain four steel doors that exit onto the fire escape. The north elevation has an aluminum and glass entry door. The east elevation has a steel door and next to is a second entrance with a provisional wood door (figures 17 – 19).

Figure 17 - Aluminum door, north elevation

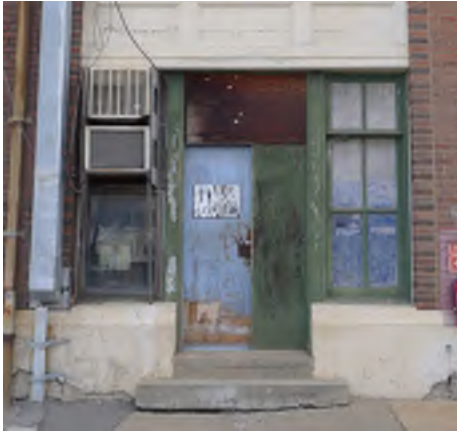
Figure 18 - Steel door, west elevation

Figure 19 – Wood door, west elevation

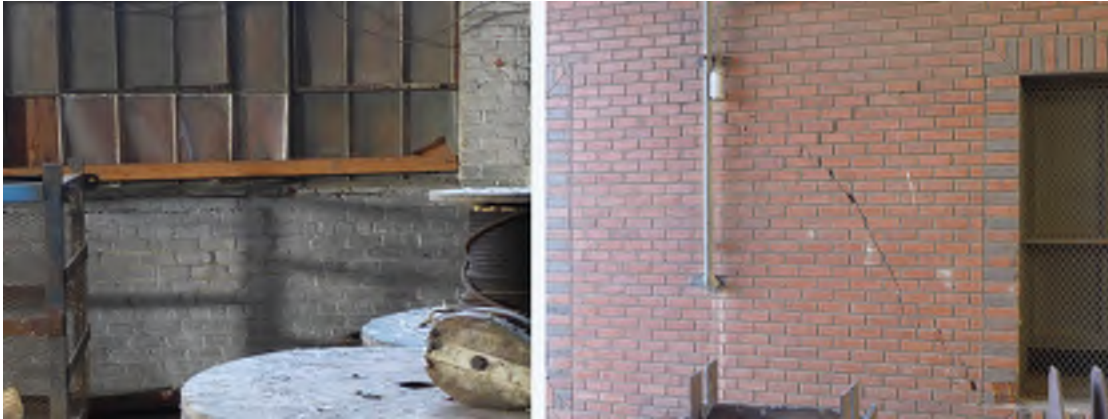
The brick on the first floor is generally in fair condition with some areas of deterioration predominantly under window sills. There are seismic cracks to brickwork in the open air loading dock.

Figure 24 - Building 111, first floor warehouse wall      Figure 25 - Building 111, first floor wall at loading dock

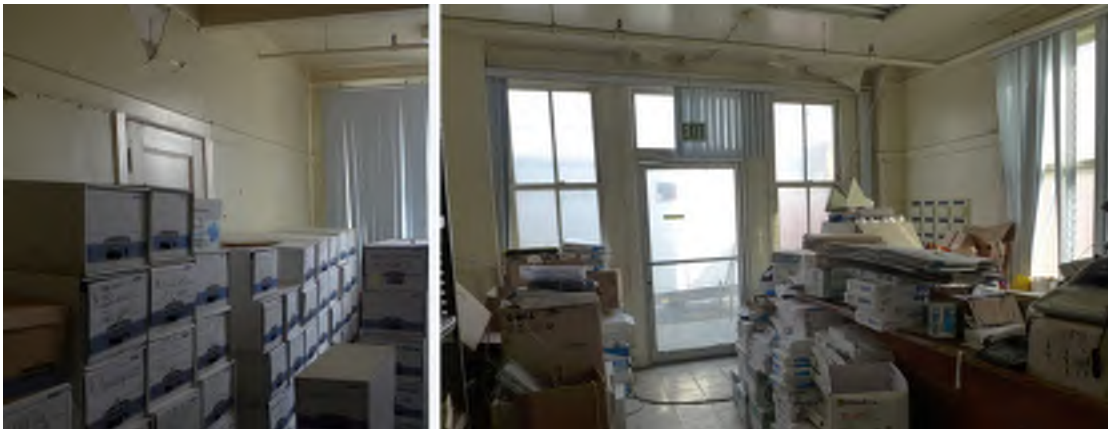
The walls in the first floor offices are cracked at all locations (figure 26). The plaster is delaminated and missing in many locations. Paint is cracked and peeling throughout.

Figure 26 - Building 111, first floor entry walls

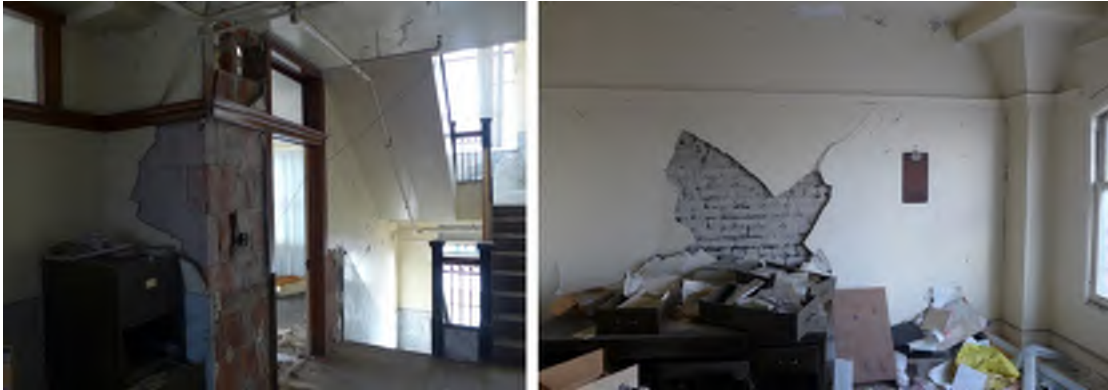
The walls in the mezzanine are cracked at all locations. The plaster is delaminated and missing in many locations. There is significant moisture damage near windows. The marble wainscot is severely damaged, missing or separated from the substrate in many locations. Paint is cracked and peeling throughout. The bathrooms contain marble walls and partitions.

Figure 27 - Building 111, mezzanine lobby and office walls

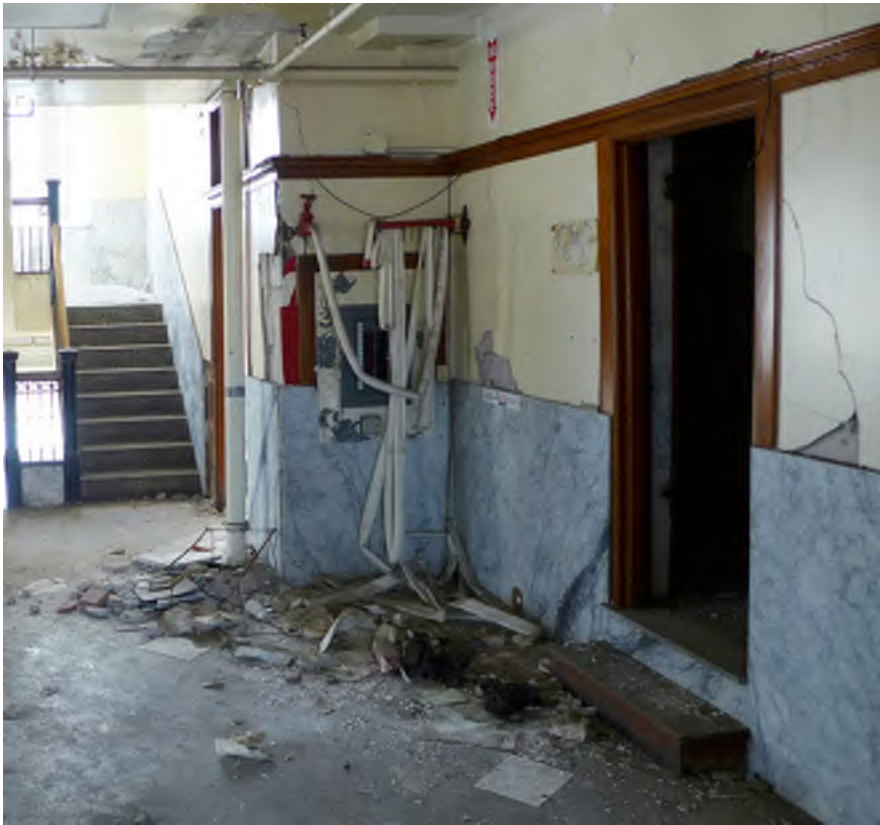
Mezzanine - Painted plaster over hollow clay tile and brick with marble wainscot  
Condition: Poor (figure 27 and 28)

Figure 28 - Building 111, mezzanine lobby and office walls, marble wainscot

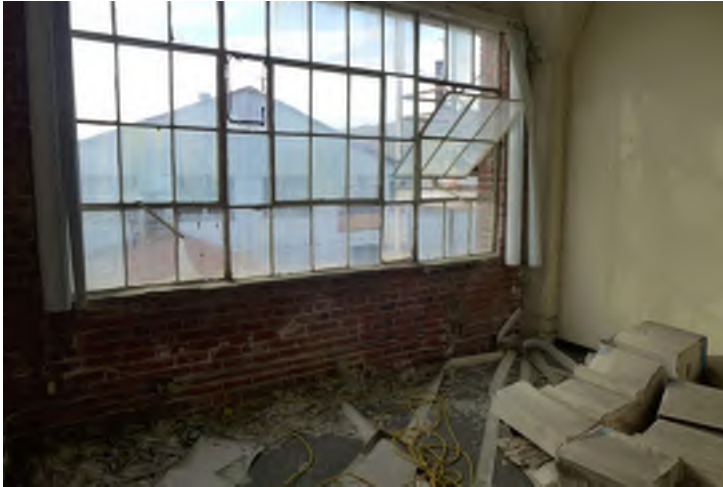
Second Floor - Brick at exterior with steel stud and gypsum board demising walls.  
Condition: Poor (figure 29)

The walls on the second floor are in poor condition. Significant moisture damage was observed around windows and where building debris remains in contact with wall surfaces. The mortar at most brick joints is heavily deteriorated. Demising walls have minor damage, predominantly at corners.

Figure 29 - Building 111, second floor exterior wall. Note moisture damage.
