**BUILDING 109****Tool Room/Paint Booth/Sheet Metal & Non-UV Covered Storage**

**BUILDING 109 Tool Room**

## BUILDING 109

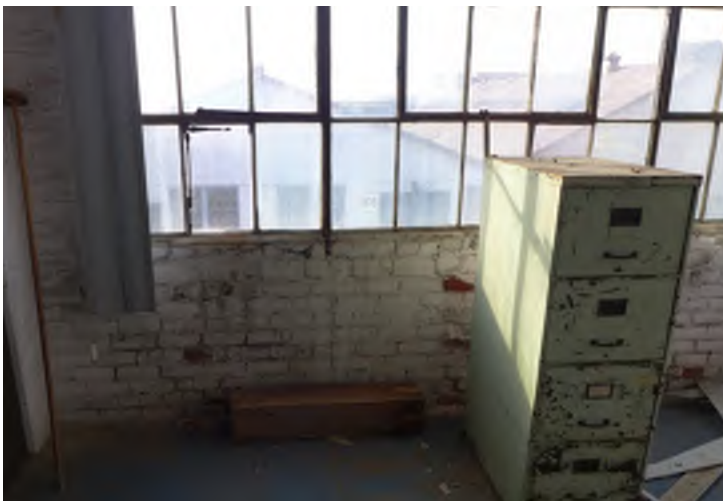
Third Floor - Brick at exterior with steel stud and gypsum board demising walls.  
Condition: Poor (figure 30)

The walls on the third floor are in poor condition. Significant moisture damage was observed around windows and where building debris remains in contact with wall surfaces. The mortar at most brick joints is heavily deteriorated. Demising walls have minor damage, predominantly at corners.

Figure 30 - Building 111, third floor exterior wall.

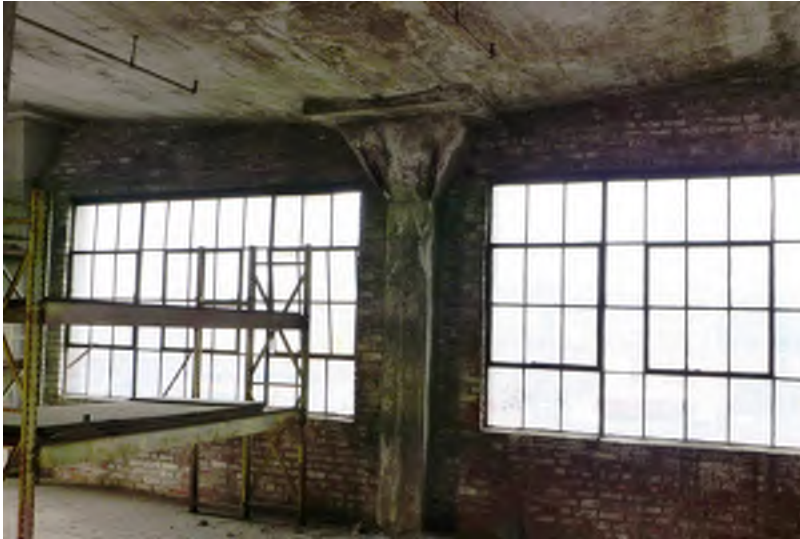
**Fourth Floor - Brick. Condition: Poor (figure 31)**

The fourth floor wall brickwork is in poor condition due to moisture damage at areas of roof leaks and around window openings.

Figure 31 - Building 111, third floor exterior wall.

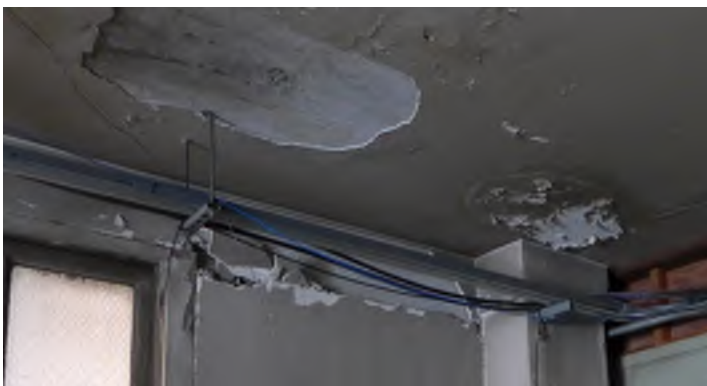
First Floor Substation #3 - Painted plaster over concrete underside of floor slab.  
Condition: Poor (figure 32)

The plaster ceiling throughout the substation exhibits cracking, spalling and peeling paint.

Figure 32 - Building 111, first floor substation # 3 ceiling

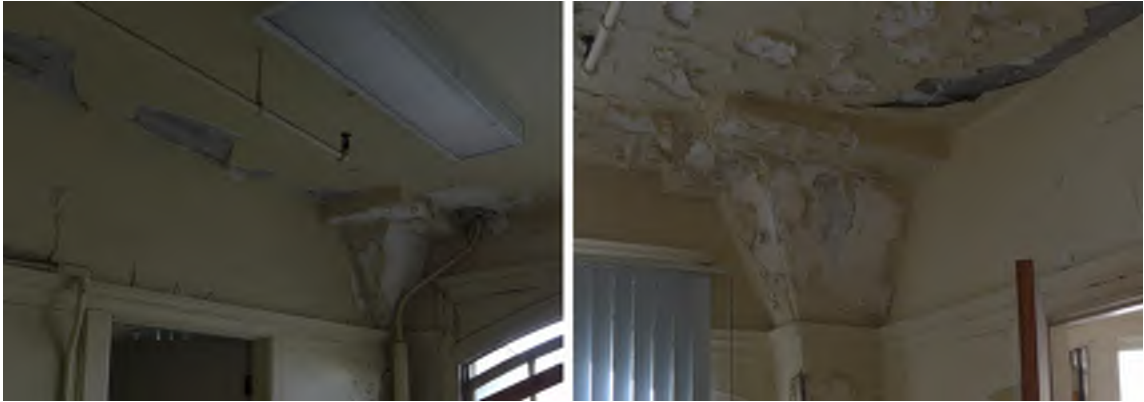
Mezzanine - Painted plaster over concrete underside of floor slab. Condition: Poor (figure 33)

The plaster ceiling throughout the mezzanine area exhibits cracking, spalling and peeling paint.

Figure 33 - Building 111, mezzanine floor ceiling

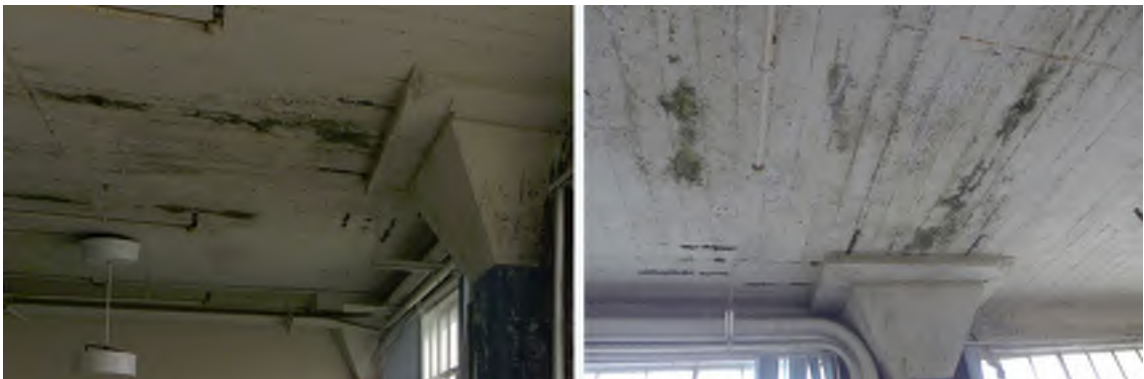
Second Floor - Painted concrete (underside of floor slab). Condition: Fair (figure 34)

Localized areas of moisture damage with biological growth, cracking, spalling and exposed, rusting rebar.

Figure 34 - Building 111, second floor ceiling

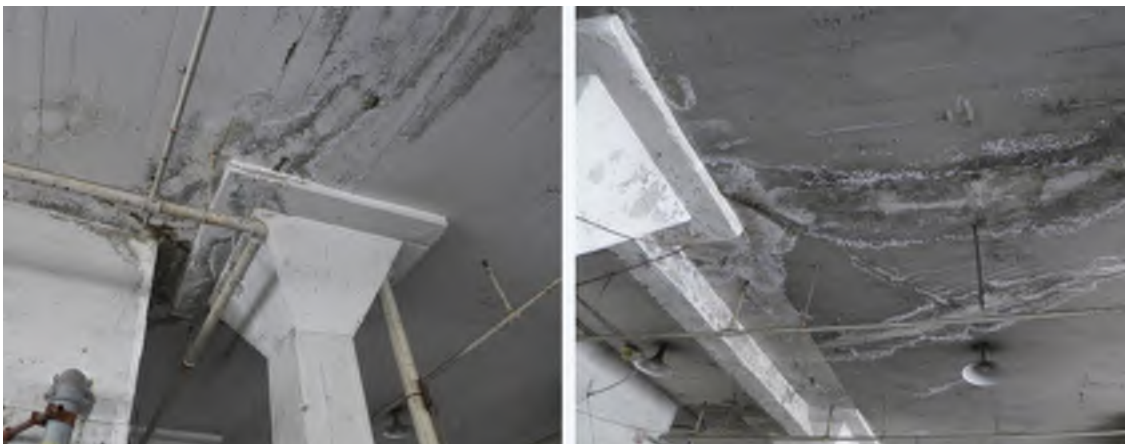
Fourth Floor - Concrete (underside of floor slab). Condition: Poor (figure 36)

Extensive cracking, spalling and exposed, rusting rebar, most pronounced at areas corresponding to roof low points. Organic growth at areas of heavy moisture.

Figure 36 - Building 111, fourth floor ceiling

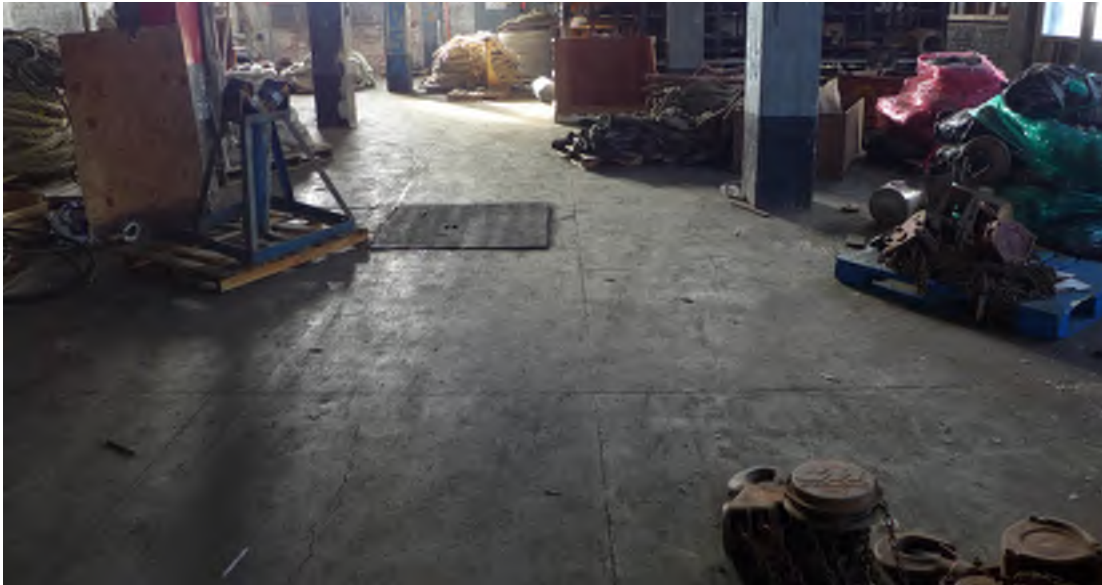
First Floor Warehouse ~ Concrete. Condition: Fair (figure 37)

Figure 37 - Building 111, fourth floor concrete floor

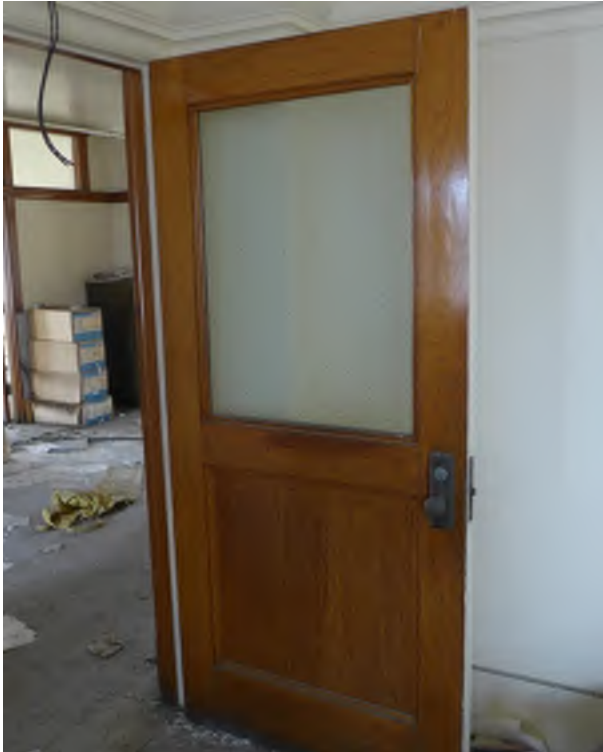
Condition: Fair

Figure 38 - Building 111, mezzanine office door

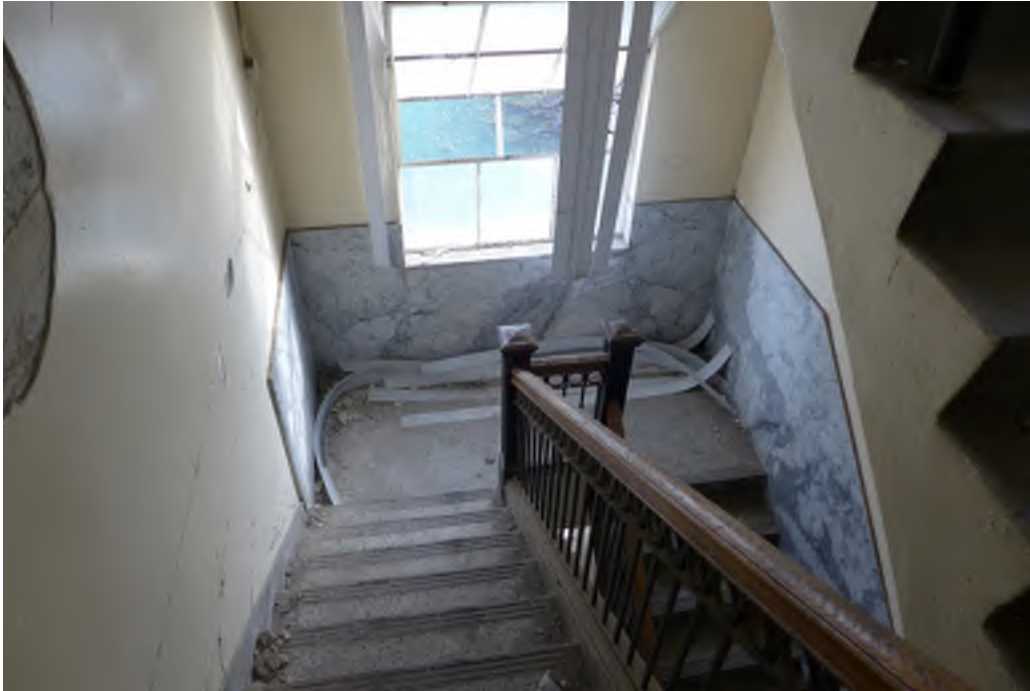
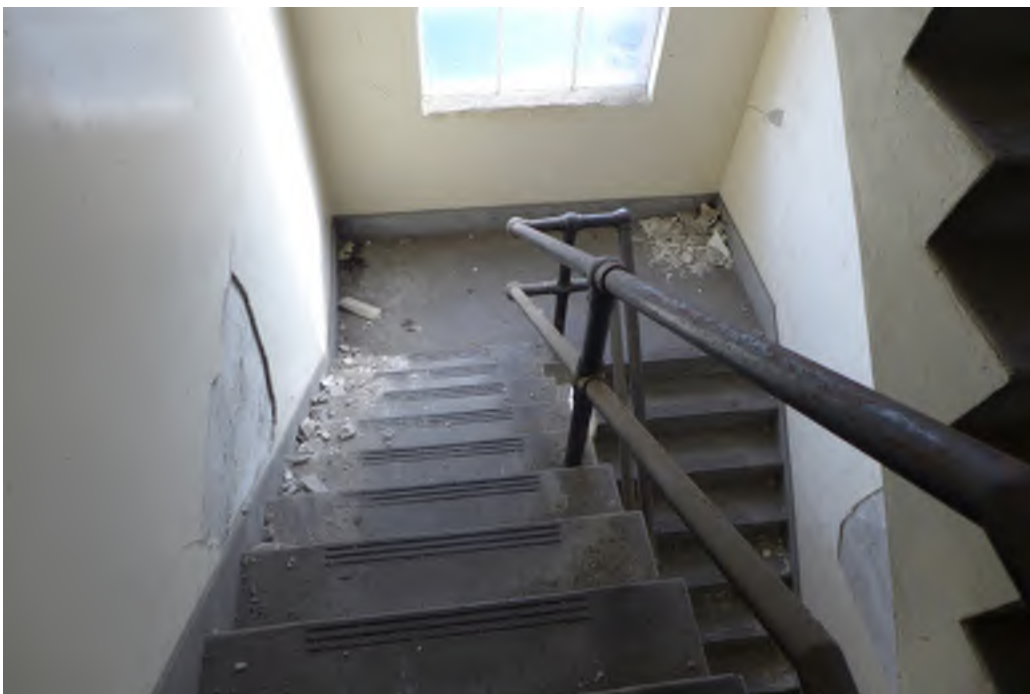
Condition: Poor

Seismic cracks were noted in the concrete structural walls. Plaster is cracked and fallen at many locations. The marble wainscot is broken, loose or completely missing at many locations. Stair areas are encumbered by debris and pigeon guano.

Figure 39 - Building 111, staircase from mezzanine to second floor level

Figure 40 - Building 111, staircase from second floor to third floor

Clear the stairwell of debris, fallen building materials and pigeon guano to provide safe passage between floor levels. Salvage and remove loose marble panels from the stairwell.

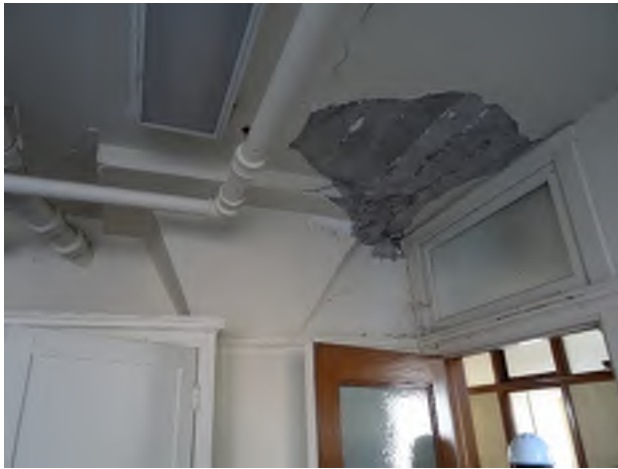
Figure 1 – Concrete capital damage

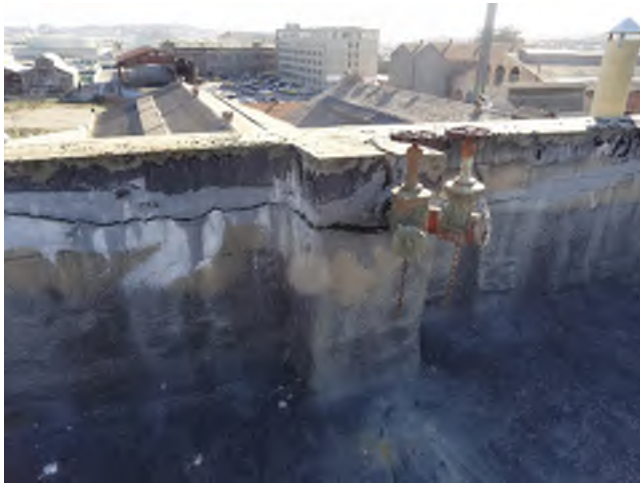
Figure 3 – Typical parapet cracking

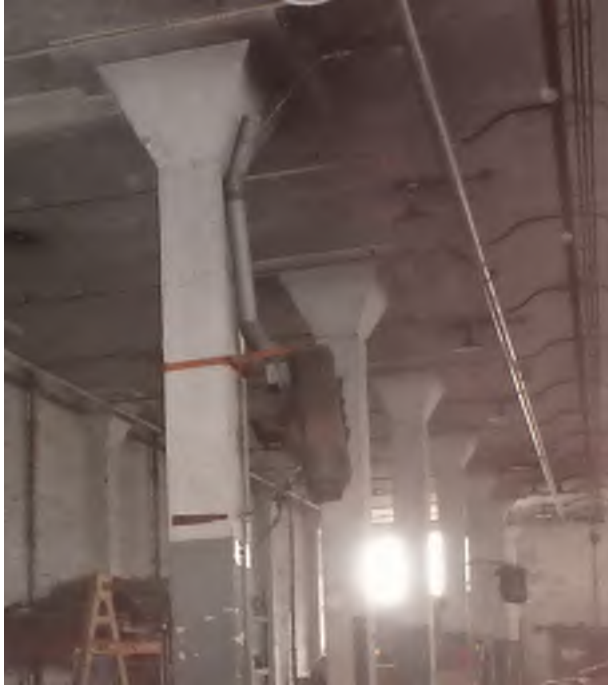
- The building is equipped with gas-fired unit heaters that are not in use. The flues connected to many of the heaters are disconnected (see fig. 111-1).
- The third floor is equipped with a ducted heating and ventilation system (see fig. 111-2).
- The building has a freight elevator that appears to still be in use.
- The roof has (3) heat pump outdoor units that appear to not be in use.

**Figure 111-1 – Disused Unit Heater with Flue Connection Broken**

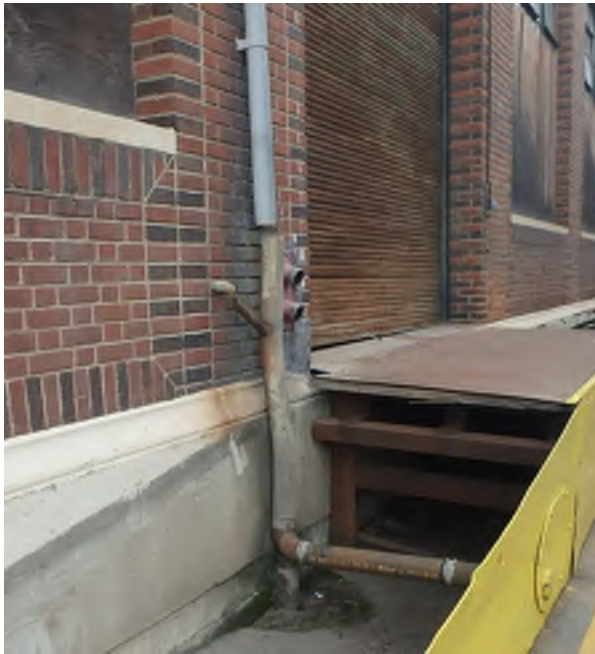
- The building is fully sprinklered with an unused water storage tank located on the roof.
- A fire water hose reels are provided at every level near the stairway.
- There are many damaged rainwater leaders from the roof (see fig. 111-3).
- The building has men's and women's restroom facilities on floors 2 and 3.

**Figure 111-3 – Damaged Rainwater Leader**

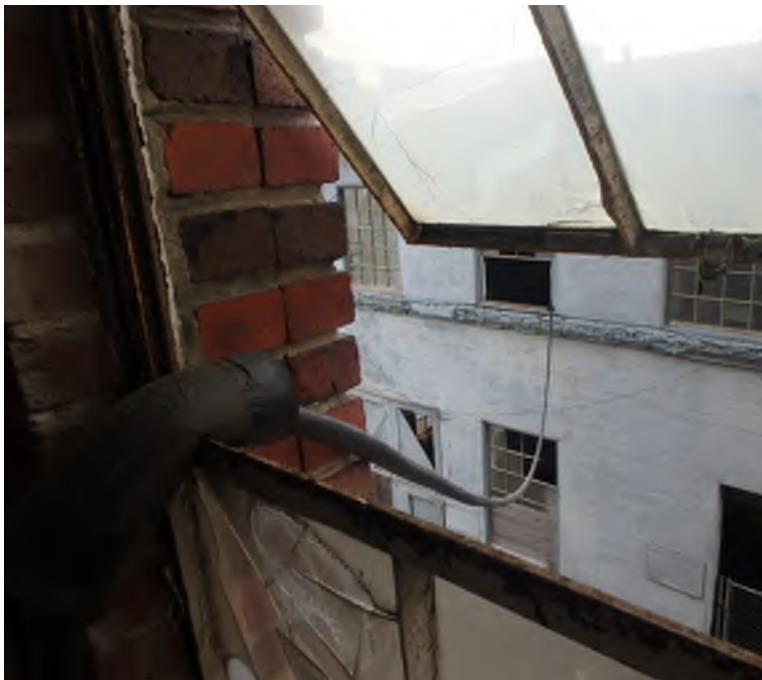
- The electrical substation is located at the north end of the 1<sup>st</sup> floor.
- Each floor is equipped with a 120/240 volt electrical panel. Many electrical panels throughout the building are not fitted with protective panel covers.
- The building has an exterior light that is being powered by a flexible cable suspended from the neighboring building (see fig. 111-4).

**Figure 111-4 – Flexible Cable Feeding Power from Neighboring Building**

- Provide safety covers at electrical panels and wiring junctions.
- Provide permanent local power supply to building exterior light currently powered by temporary flexible cable hung from neighboring building.

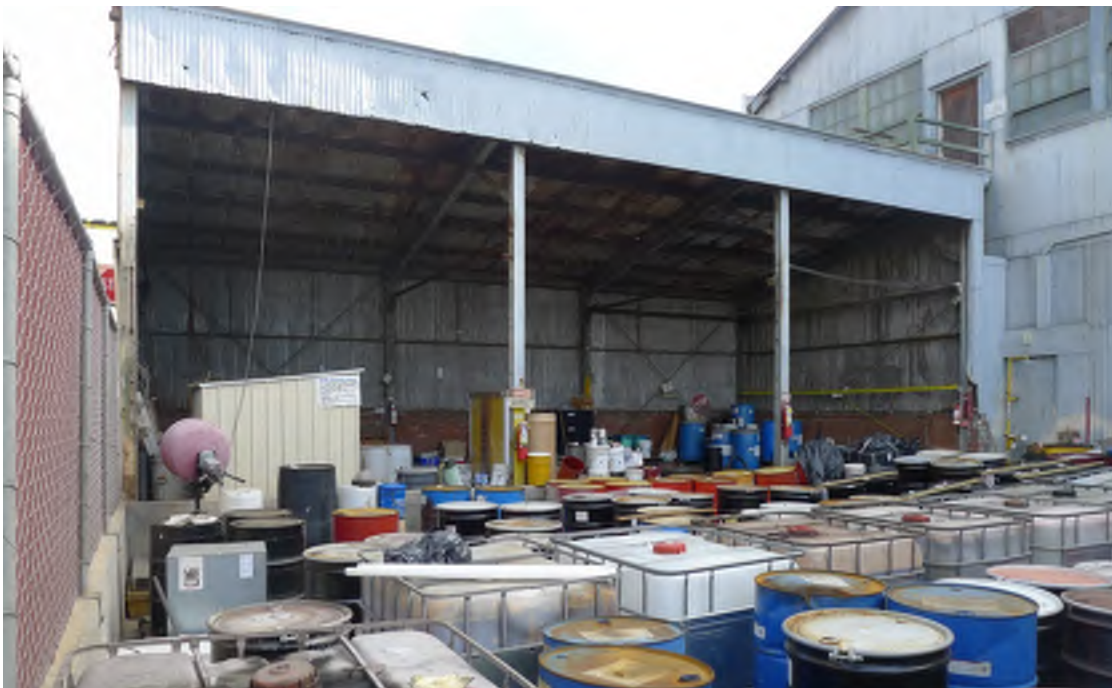
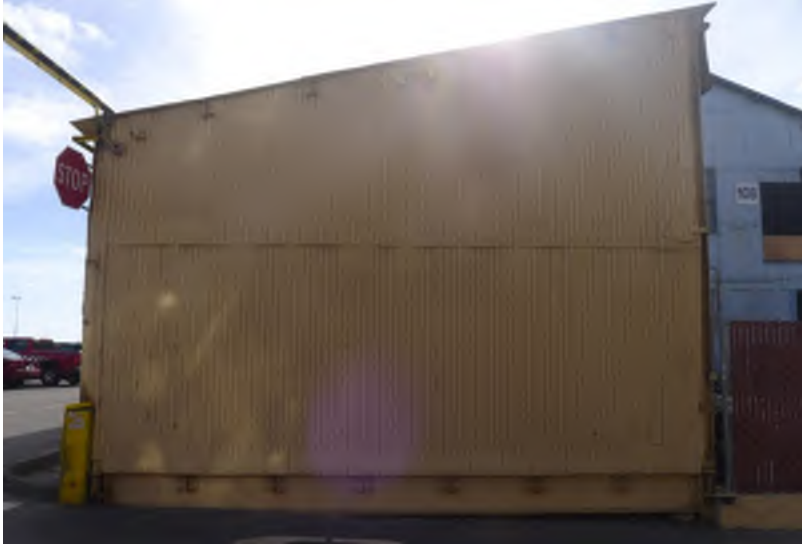
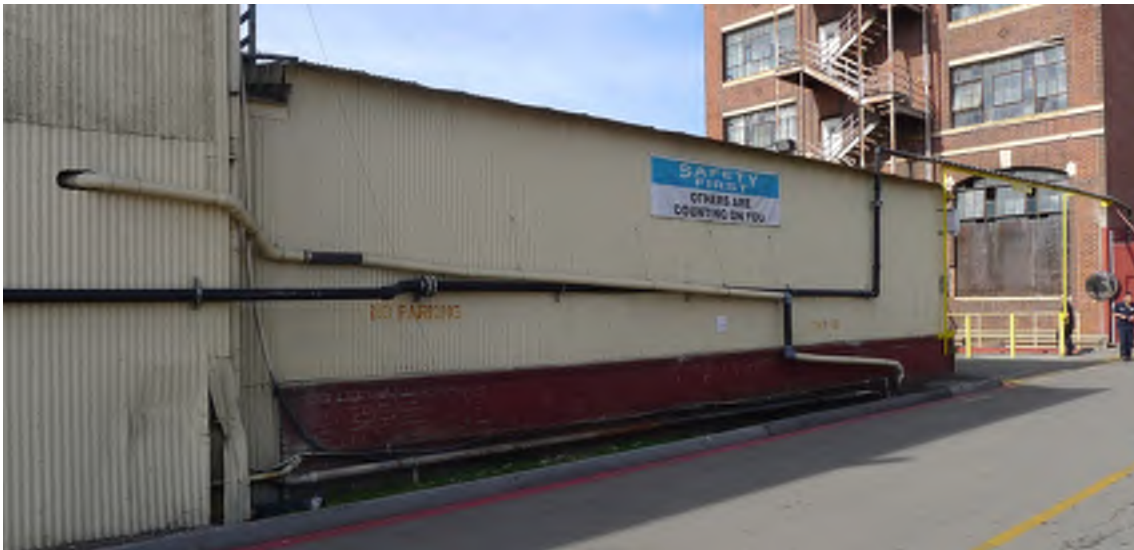
The CMP is painted on the north and east elevations of the building. The panels throughout the building are generally in fair condition with some localized denting above the opening on the west elevation. On the north elevation the panels have been cut around the structural steel roof supports which protrude from the wall. At the southeast corner the panel wrapping the steel beam has been damaged above the brick base wall. A PVC drain pipe from building 108 is poorly supported on the east wall of building 120 by wire hangers. The sheet metal corner guard at northeast corner is dented.

Figure 2 - Building 120: West Elevation

Figure 3 - Building 120: West Elevation

Figure 4 - Building 120: East Elevation

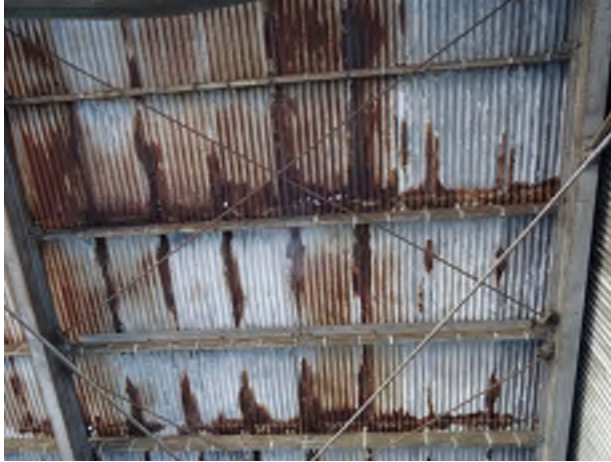
Figure 1 – Typical rusting to roof CMP

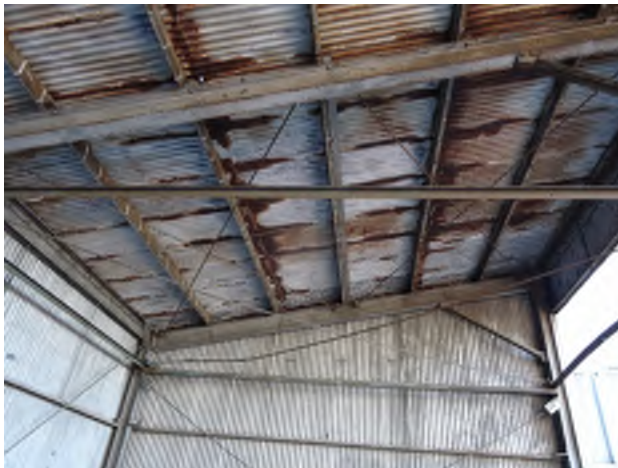
Figure 2 – Typical corrosion on steel members

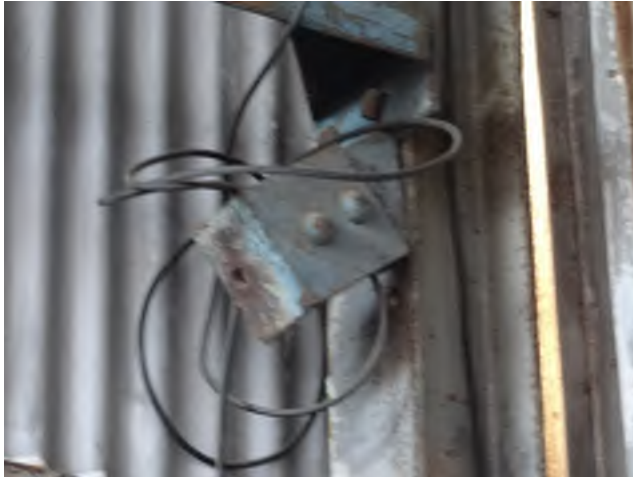
Figure 3 – Missing tension “x” brace

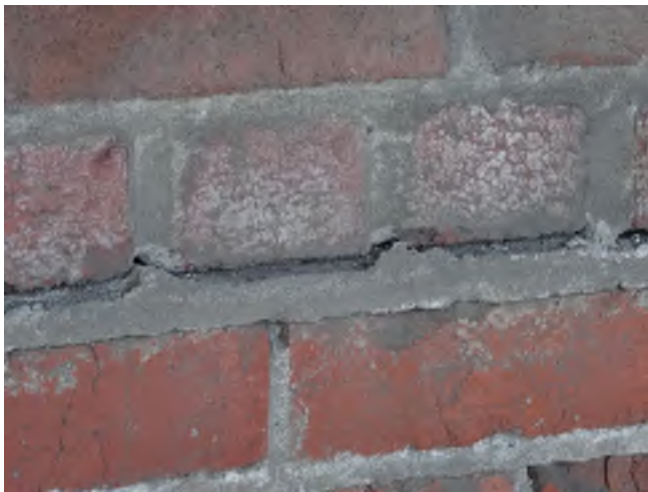
Figure 4 – Partial height masonry wall mortar damage

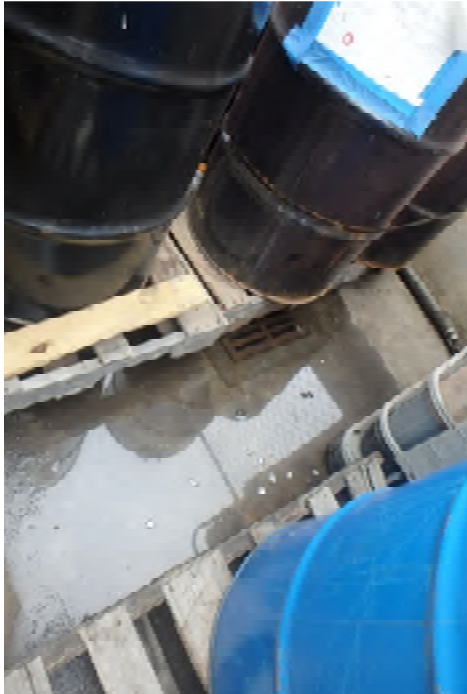
- Structure has no fire protection service.
- A fire extinguisher is provided at the East Wall.
- An eyewash station & shower is located near the entrance of the structure (see fig. 110-1).
- The hazardous materials are stored inside metal drums inside a sump just outside the structure. Standing water was observed in an area near the drain (see fig. 110-2).

**Figure 110-2 – Standing Water Inside Chemical Storage Sump at the Drain.**

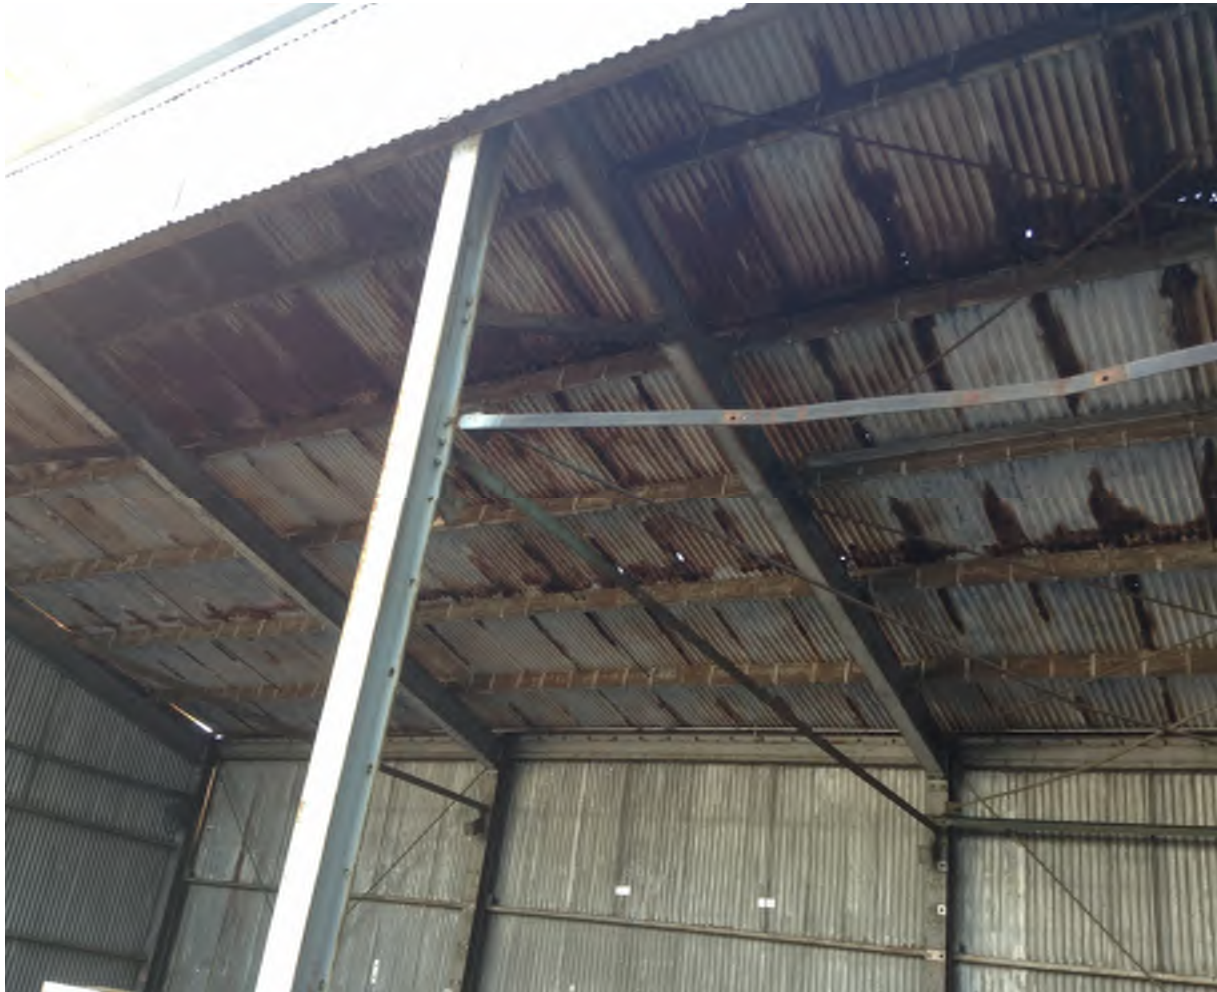
Fig. 1 - Building 120 view from Bldg. 108 2<sup>nd</sup> floor

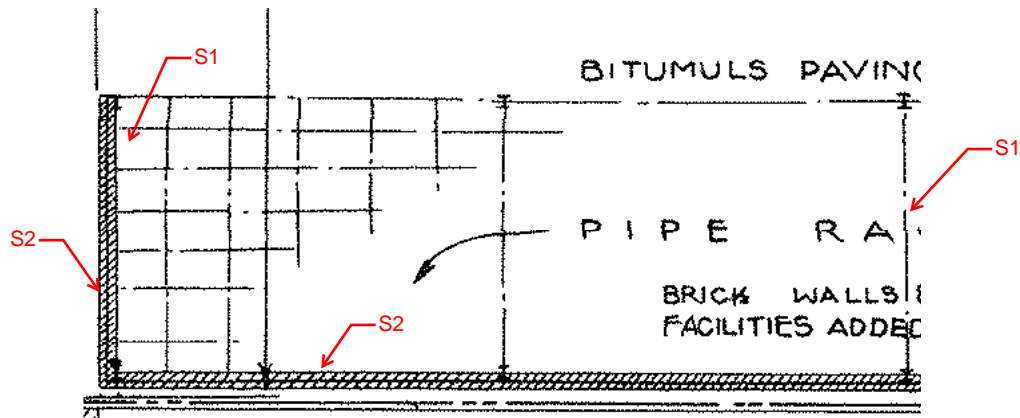
PLAN BLDG. NO. 120

S1: Steel rod "x" brace to be replaced or re-tensioned.

S2: Partial height masonry wall to be repaired per report.

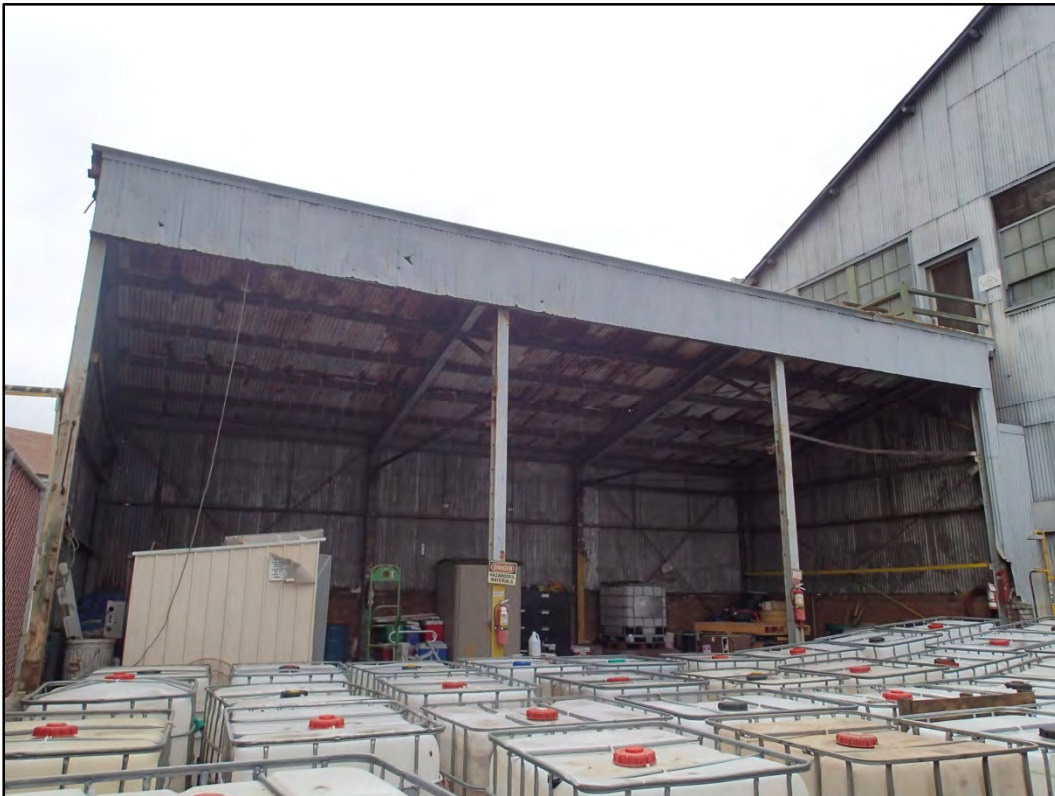
The overall condition of Building 120 has remained relatively unchanged since the previous condition assessment in 2015. The building continues to be used for hazardous material storage and the recommended repairs provided in the previous condition assessment report have not been addressed. The corrosion on the interior of the corrugated metal roof panels has worsened and there is minor to moderate corrosion typically along the bottom edge of the interior corrugated metal wall panels. No additional deficiencies were found.

Figure 120-1 - Overall west view of Building 120.

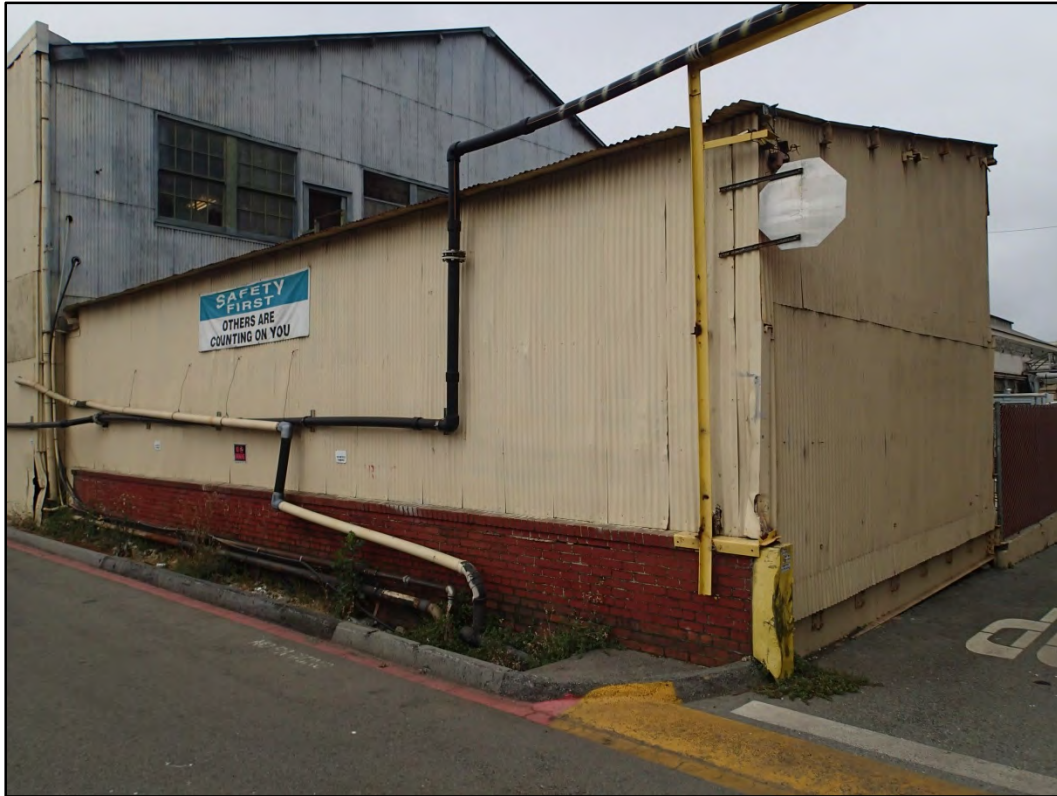
Figure 120-2 – Overall northeast view of Building 120.

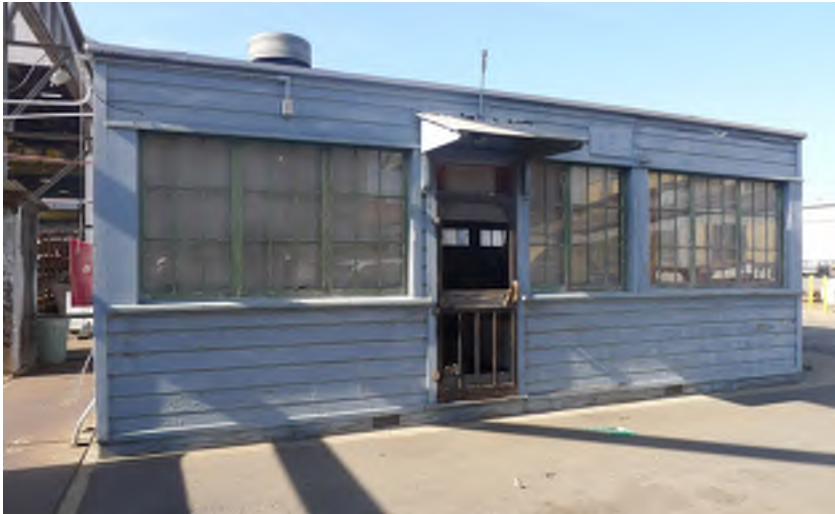
Wood Siding. Condition: Fair (figures 2 and 3)

Peeling paint throughout. Siding is patched in several locations with plywood. The 1"x4" wood trim is damaged, as are the wood skirt at the base and the siding at the parapet. Rusted nails occur throughout the walls.

Figure 2 - Building 19: East Elevation

- Replace 25% of wood trim.
- Paint 100% of wood siding.
  1. Verify that existing surfaces do not contain lead based paint.
  2. If lead based paints are suspected on the project, all removal must be done in accordance with the EPA Renovation, Repair and Painting rule and all applicable state and local regulations.

4. Replace damaged components and patched areas with new siding to match original.
  5. Remove defunct air-conditioner. Provide plywood panel at opening.

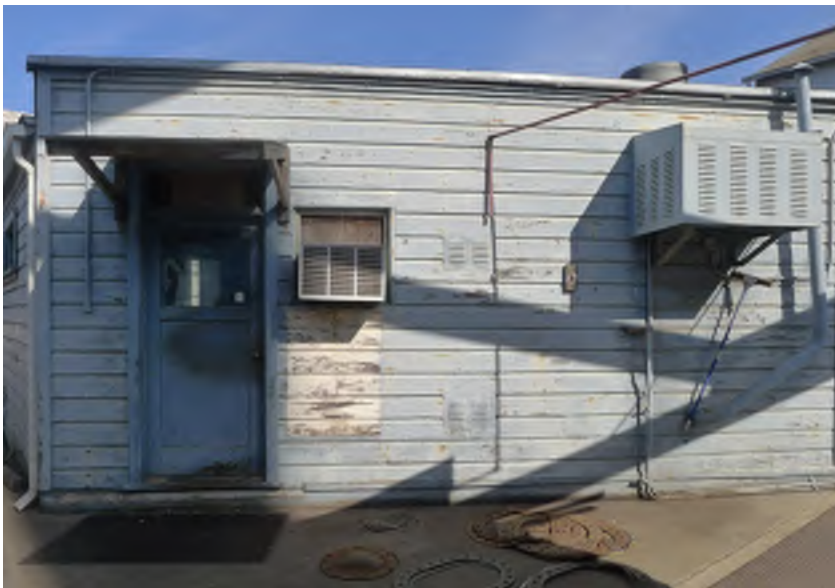
Figure 3 - Building 121: South Elevation

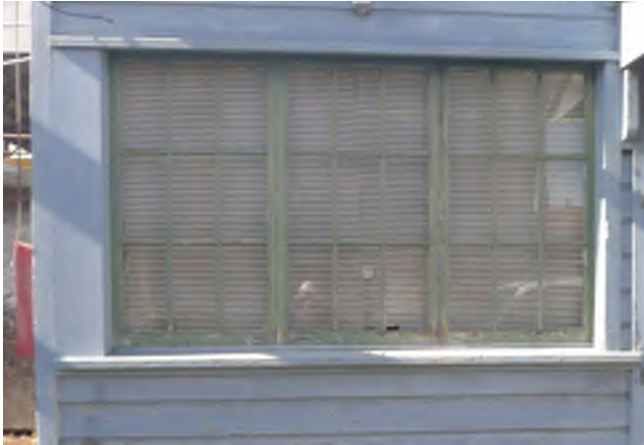
Wood Sash Windows. Condition: Poor but serviceable (figures 4 and 5)

Wood sash multi-lite, fixed in frame typical. Paint is in very poor condition throughout. There are rusted nails and holes in the wood sash. The window putty is in poor condition and missing in many locations. One sash batten is missing.

Figure 4 - Building 121: Windows at east elevation

- Replace 2% of window panes
- Restore 100% of window frame, mullion and muntins.
  1. Verify that existing surfaces do not contain lead based paint.
  2. If lead based paints are suspected on the project, all removal must be done in accordance with the EPA Renovation, Repair and Painting rules and all applicable state and local regulations.

4. Restore damaged wood window sash.
  5. Consolidate and repair deteriorated wood sills.
  6. Replace missing window trim to sound condition and existing appearance.

7. Replace cracked, broken or missing glass.
  8. Remove all deteriorated putty and replace with new.
  9. Install specified primer and two finish coats as per manufacturer's recommendations.

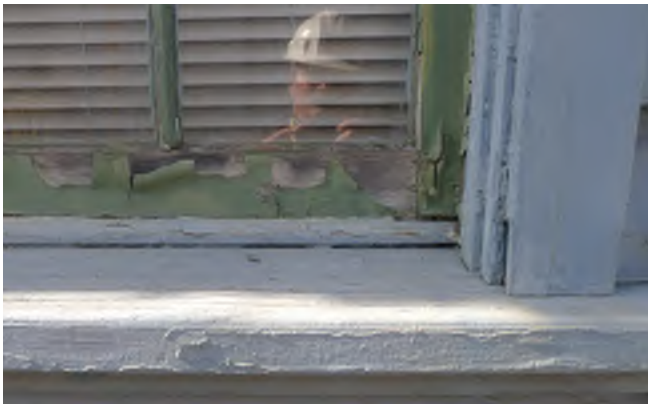
Figure 5 - Building 121: Windows detail. Poor paint and missing glazing putty.

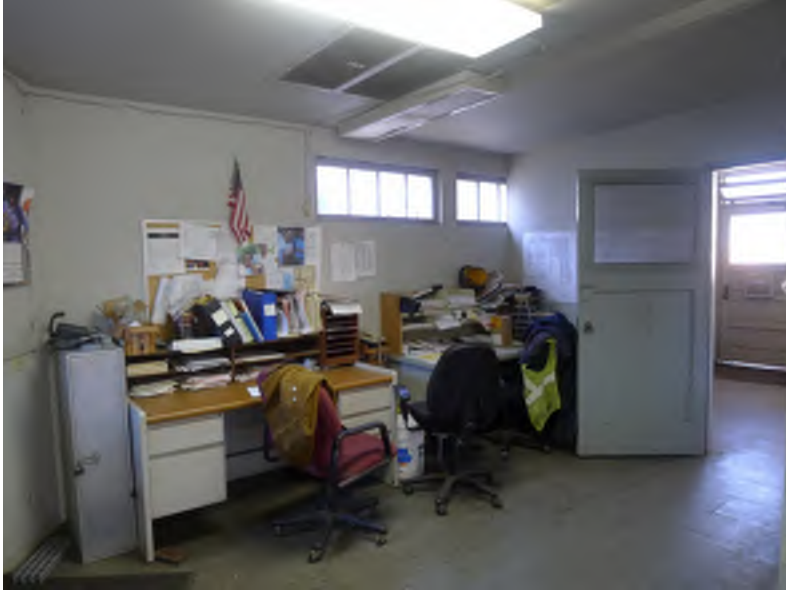
Figure 7 - Building 121: Interior view

Undetermined panel, possibly particle board, textured paint finish. Condition: Poor.

- Patch holes and repair cracks in wall surface. Prepare for paint.
- Install specified primer and two finish coats as per manufacturer's recommendations.

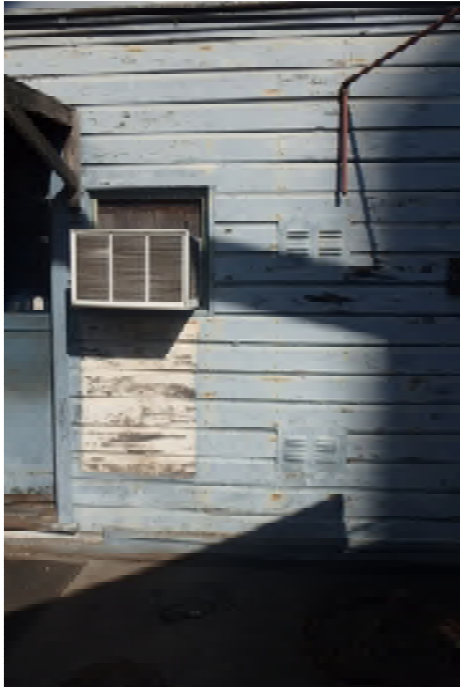
- The offices are provided with window-mounted DX units for cooling (See fig. 121-1).
- Each office has access to operable windows and ceiling vents with opening & closing controls (See fig. 121-2).

**Figure 121-1 – Window-Mounted DX Cooling Unit**

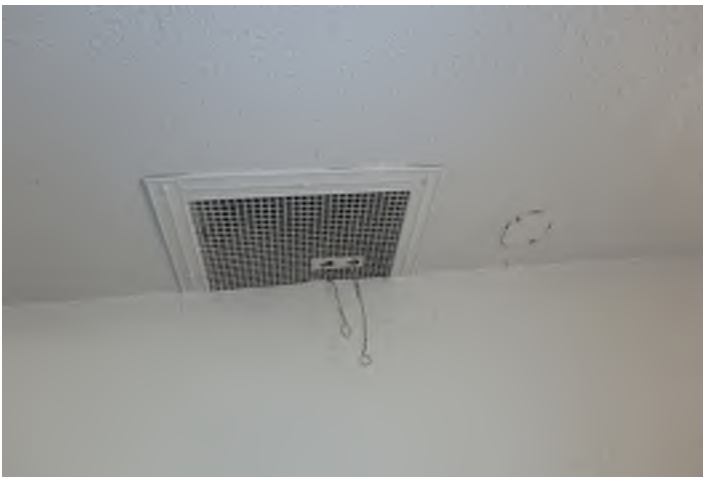
**Figure 121-2 – Operable Ceiling Vents**

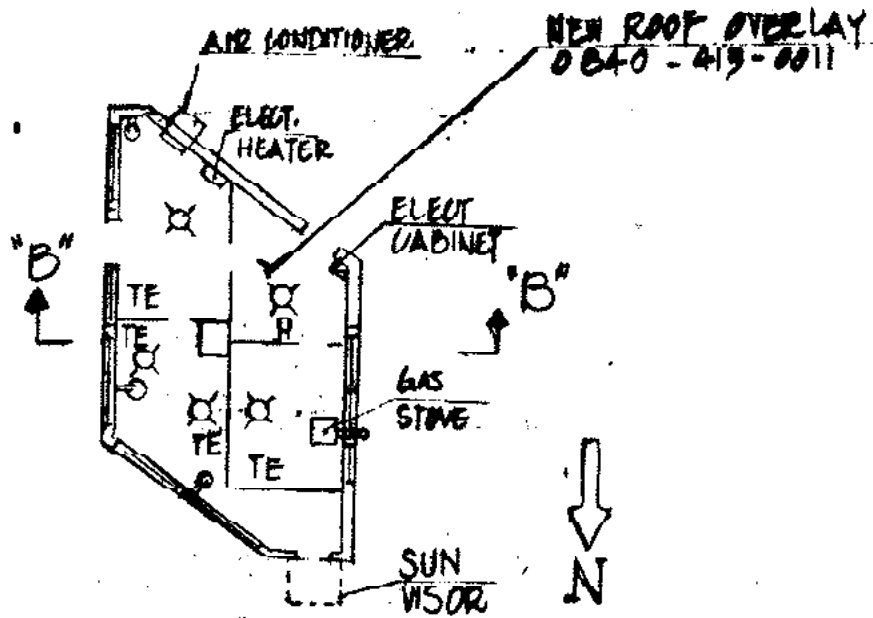
BLDG NO. (121) GEN PLAN E-4  
SCALE: 1" = 16'

NEW ROOF OVERLAY  
0840-419-0011

- Inspect roof for leaks and potential penetrations twice a year

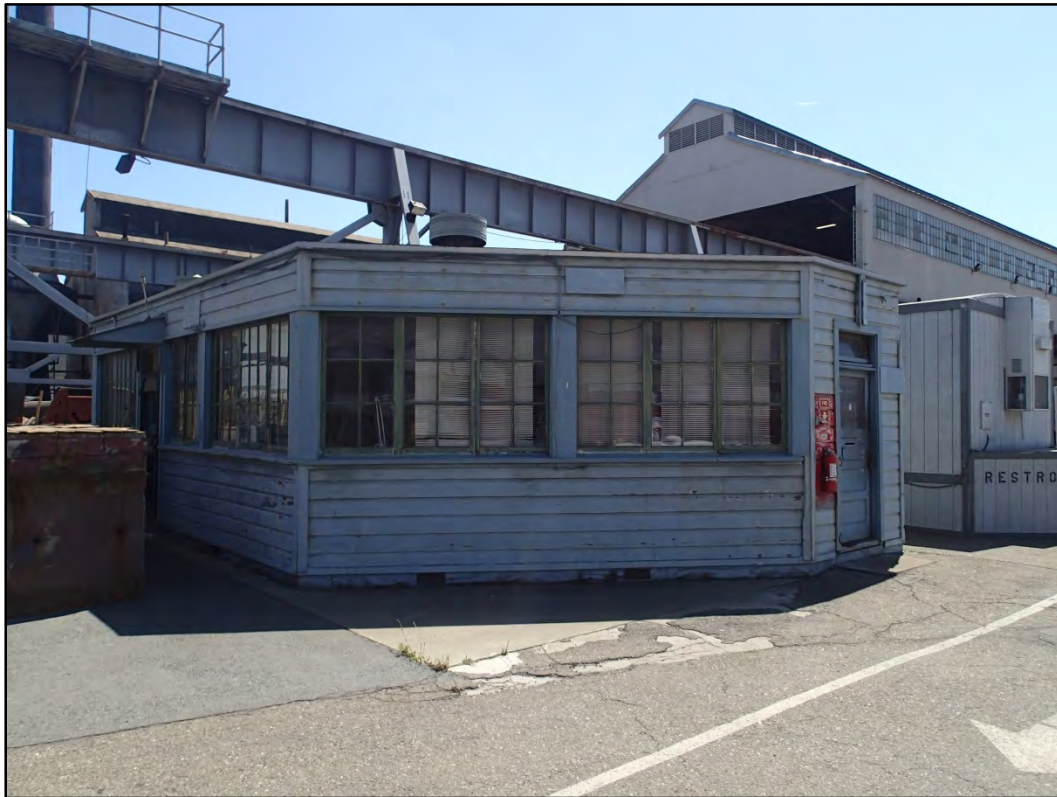
The overall condition of Building 121 has remained relatively unchanged since the previous condition assessment in 2015. The building continues to be used as a field office and the recommended repairs provided in the previous condition assessment report have not been addressed. With exception to further general paint degradation on the building interior and exterior and window glazing deterioration, no additional deficiencies were found.

Figure 121-1 - Overall northeast view of Building 121.

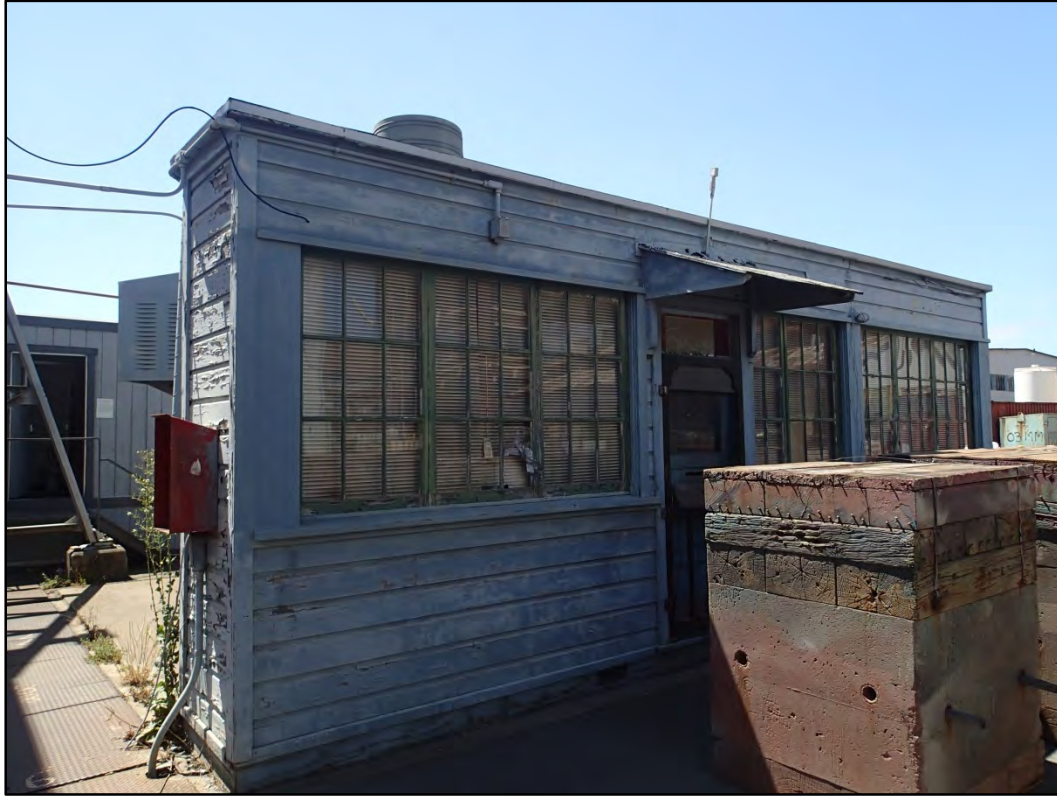
Figure 121-2 - Overall southeast view of Building 121.

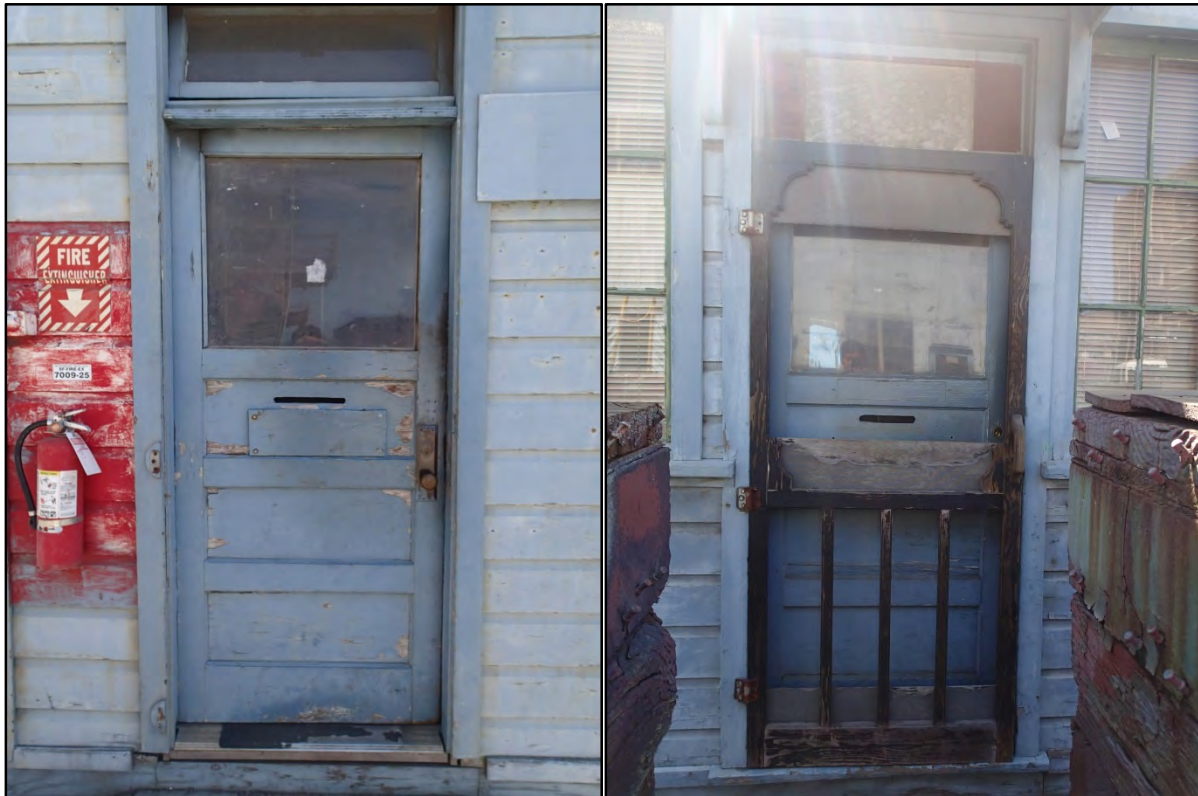
Figure 121-3 and Figure 121-4 – Typical view of the wood doors at Building 121.

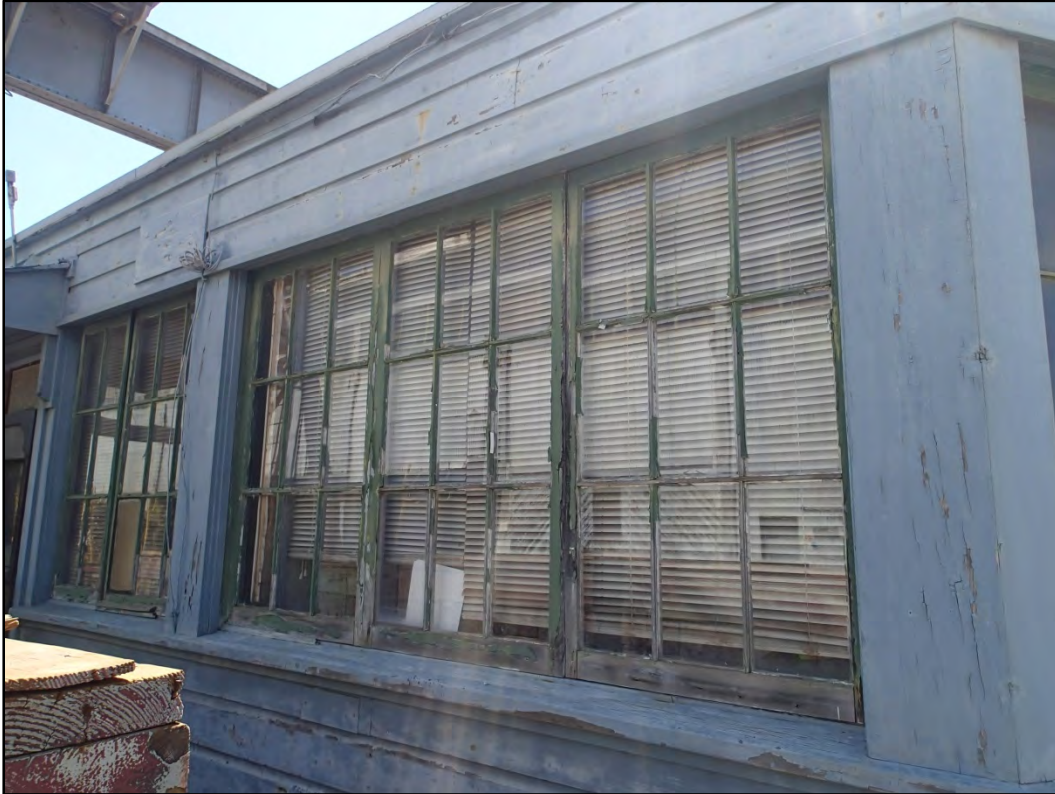
Figure 121-5 – Typical view of wood windows at Building 121.
