**BUILDING 109****Tool Room/Paint Booth/Sheet Metal & Non-UV Covered Storage**

**BUILDING 109 Tool Room**

## BUILDING 109

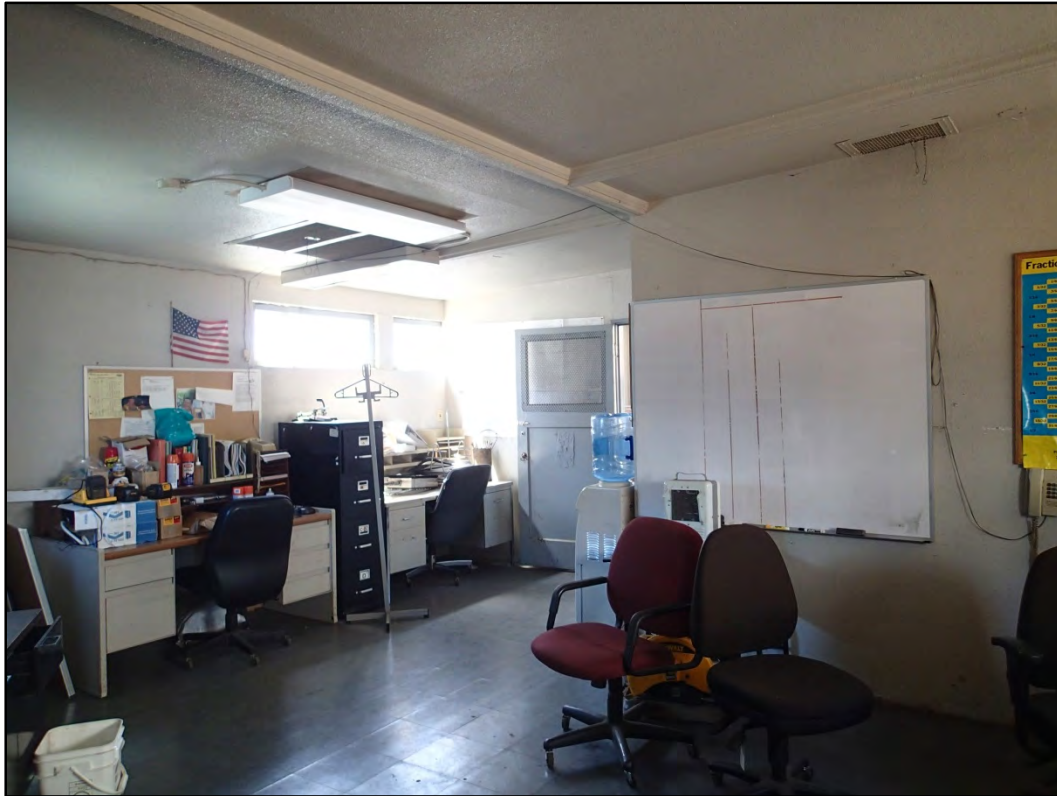
Figure 121-7 – View of typical interior condition of Building 121.

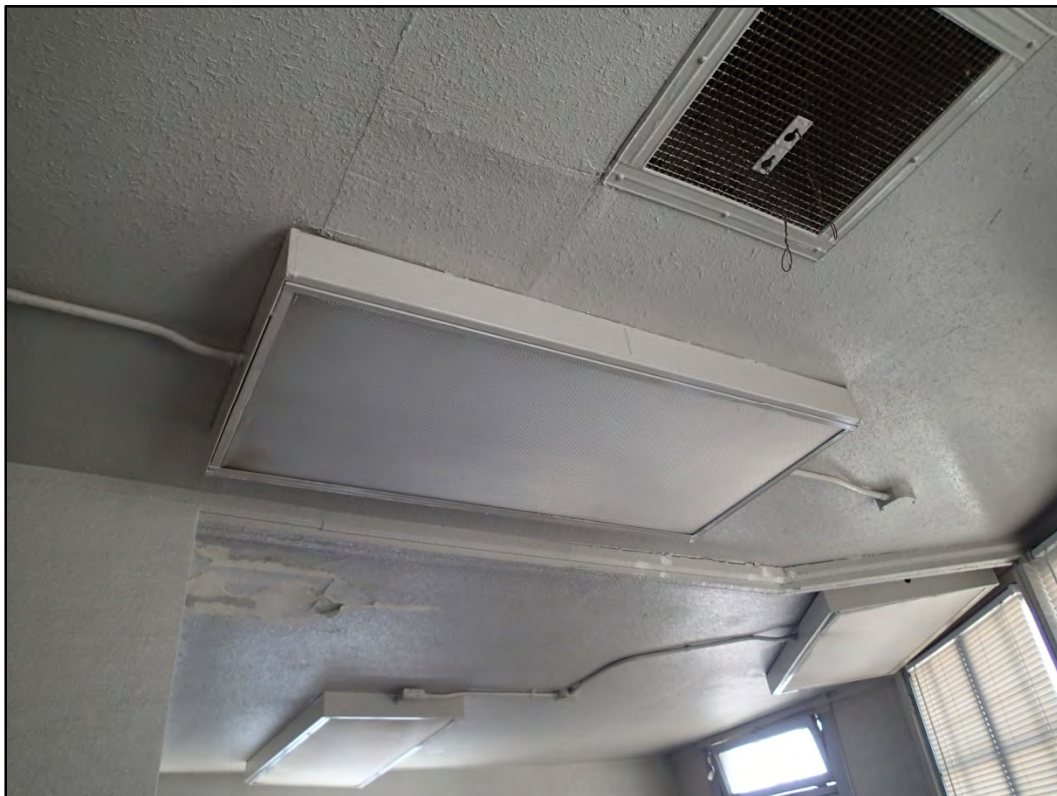
Figure 121-8 – View of typical interior ceiling condition of Building 121.

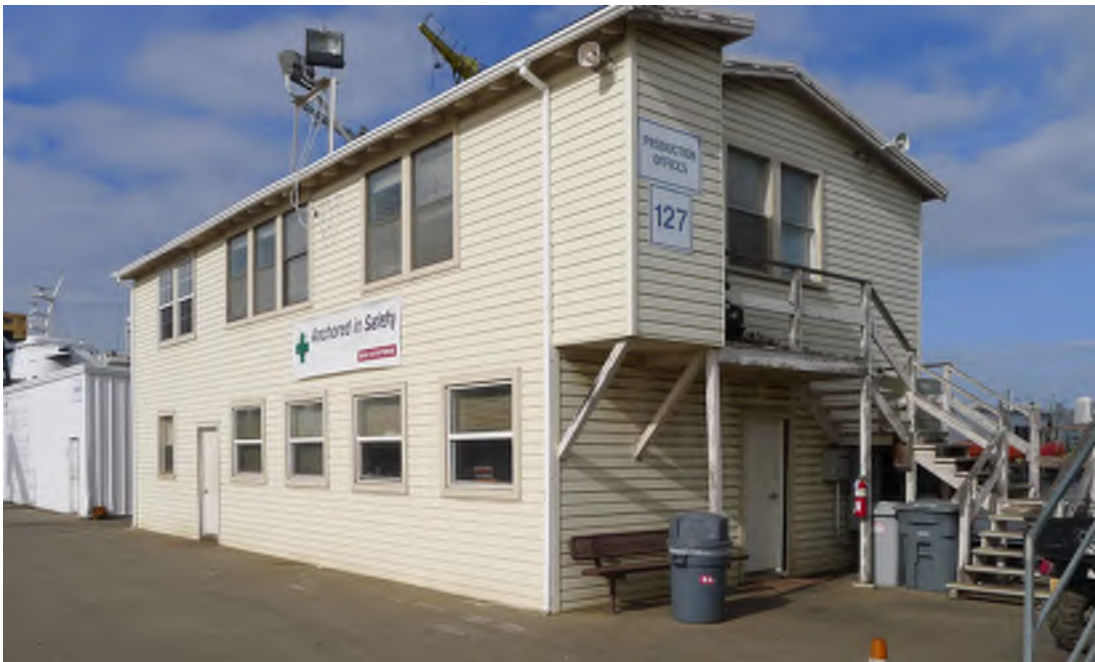
Residential grade vinyl siding. Condition: Good (figures 2 - 4)

Figure 2 - South and east elevations

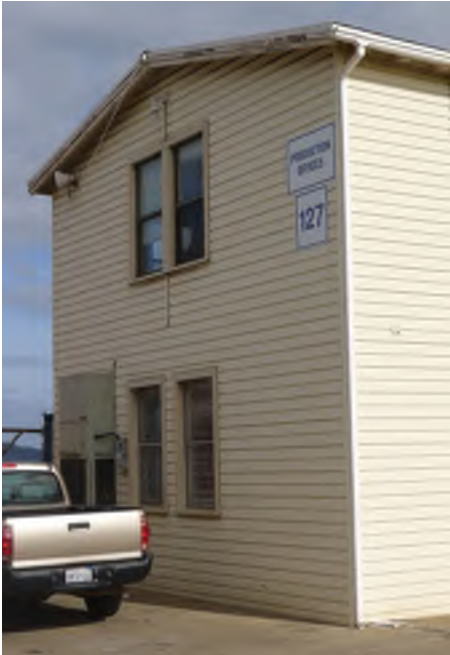
Figure 3 - West elevation

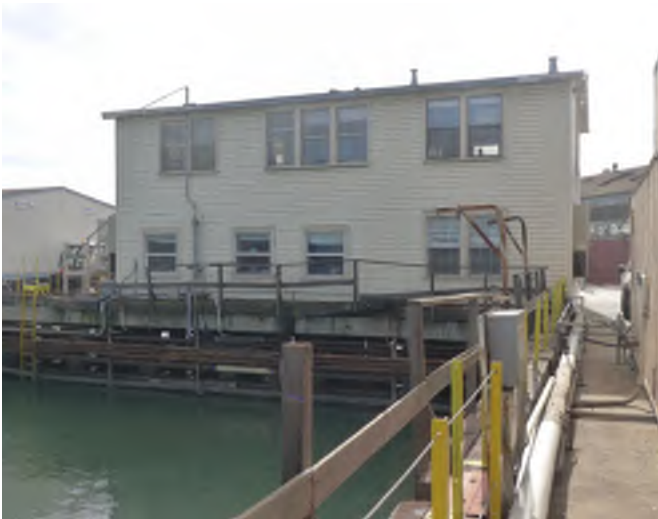
Figure 4 - North elevation

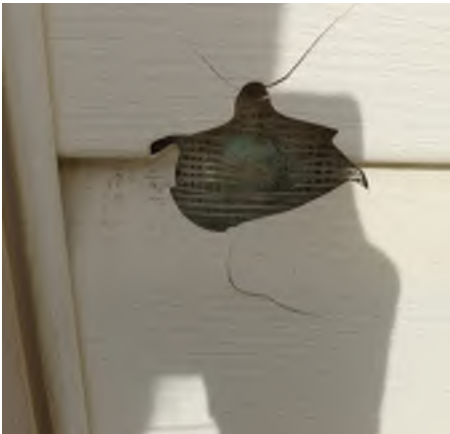
The vinyl siding is sound except for one puncture to the east side of the first floor entry door (figure 5).

Figure 5 – Puncture damage to vinyl siding

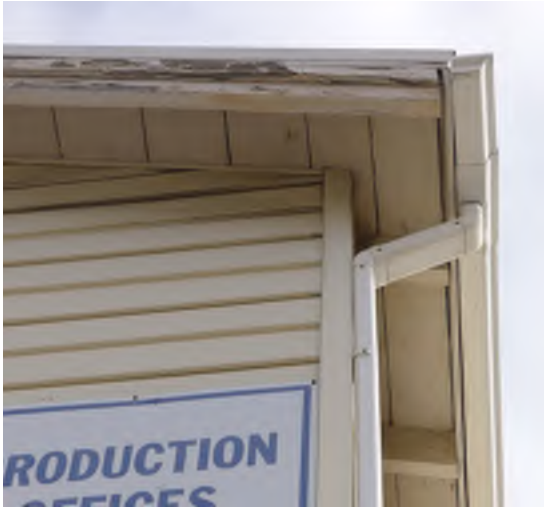
Wood stair and eave soffits and roof fascia. Condition: Fair (figures 5 and 6)

The wood stair leading to the second floor appears to be sound but the painted surfaces have failed. Similarly, the eaves, which reveal the original roof sheathing, and the fascia at the edges of the roof contain deteriorated paint.

Figure 5 - Paint deterioration at fascia and eaves.

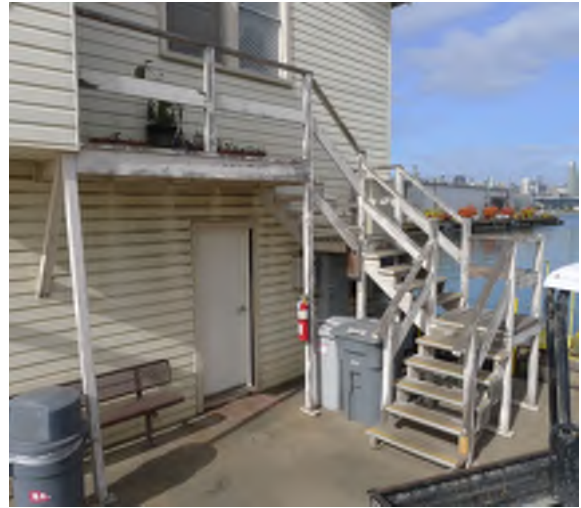
Figure 6 - Paint deterioration at second floor entry stair.

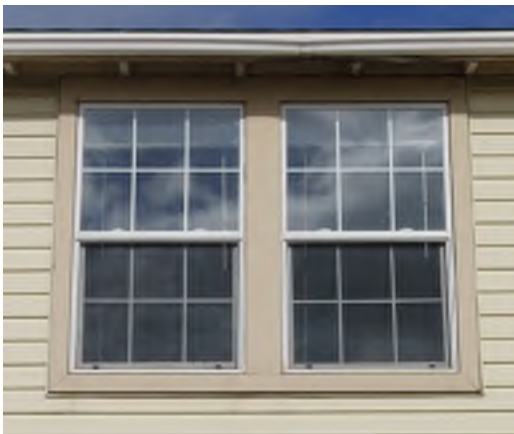
Double hung aluminum and vinyl windows. Condition: Good (figures 7 and 8)

The aluminum and vinyl double hung residential windows are sound. There is one cracked window on the first floor of the west side. Vinyl was also used for the window trim and the sills.

Figure 7 - vinyl windows with faux muntins

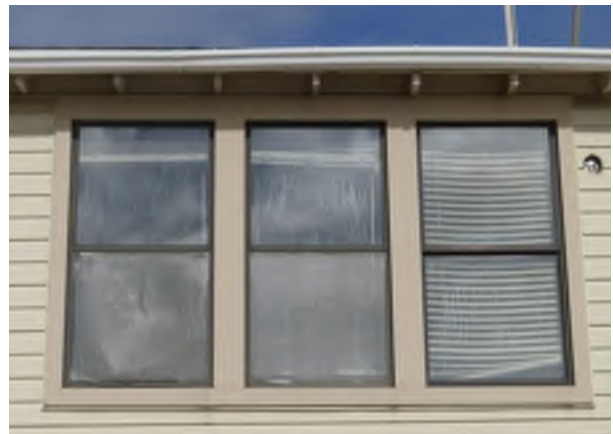
Figure 8 - Aluminum windows

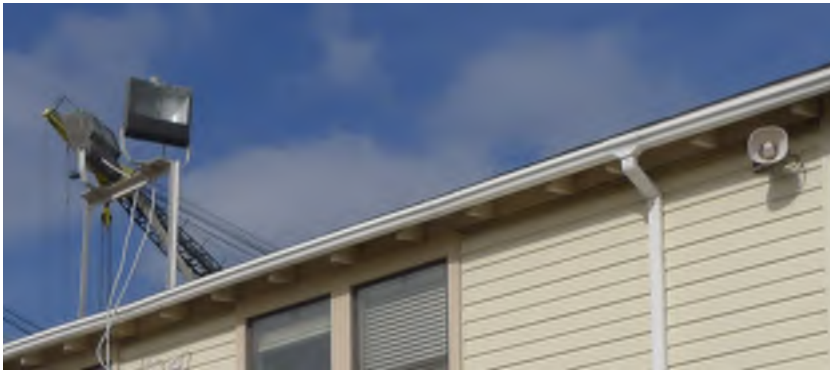
Floodlights and speakers and utility chase. Condition: Functional (figures 9 and 10)

All building mounted fixtures appear to be functional. There is a wood utility chase hung from the pier that carries pipe and conduit across the south face of the building. Access to the pipe run is apparently required because there is a wood barrier railing in disrepair.

Figure 9 - Roof mounted flood lights and speakers

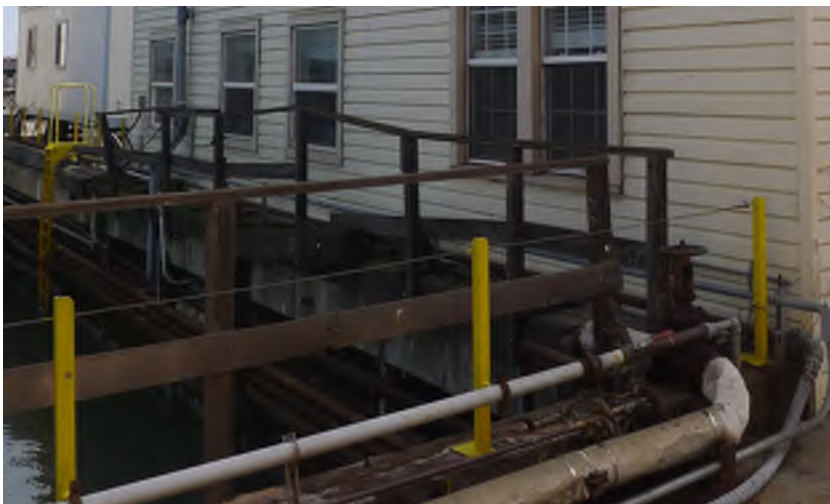
Figure 10 - Pipe chase and wood railings

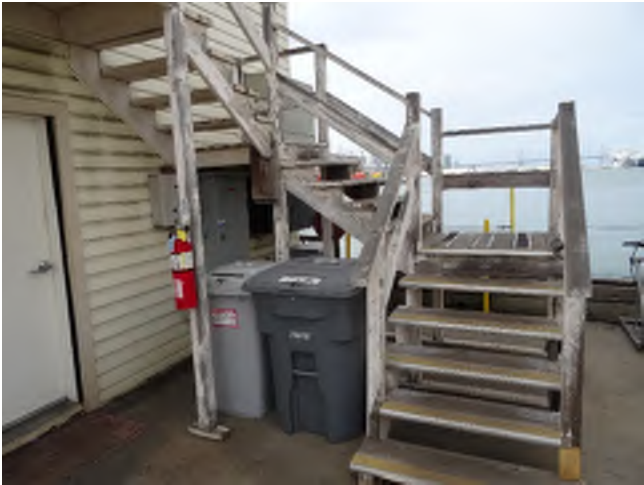
Figure 2 – Exterior stair damage

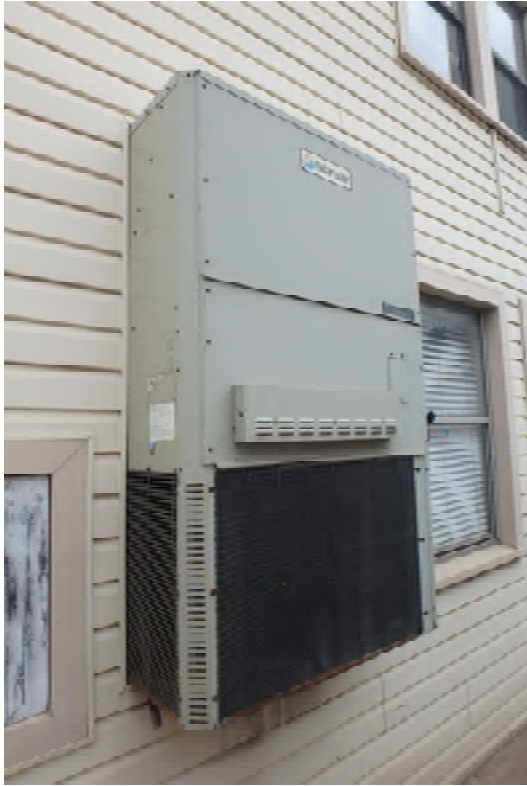
- The building is equipped with (2) wall-mounted heat pumps that are zoned separately for the 1<sup>st</sup> and 2<sup>nd</sup> floors (see fig. 127-1). The units are in good condition.

**Figure 127-1 – Wall-mounted Heat Pumps**

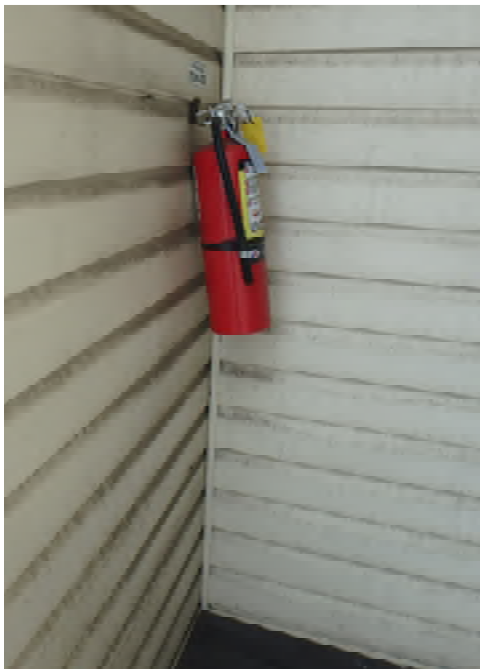
- The building has no fire protection service.
- Fire extinguishers are located on the building exterior (see fig. 127-2).
- The first floor is equipped with a kitchenette area with a sink.
- The 2<sup>nd</sup> floor is equipped with a restroom with (1) toilet and (1) lavatory.

**Figure 127-2 – Fire Extinguisher at Exterior of Building**

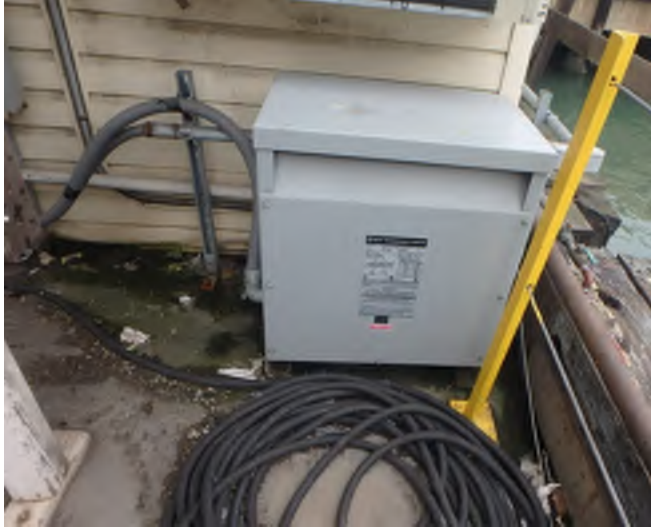
- The building is equipped with a 480/220 volt transformer (see fig. 127-3).

**Figure 127-3 – Dedicated Transformer**

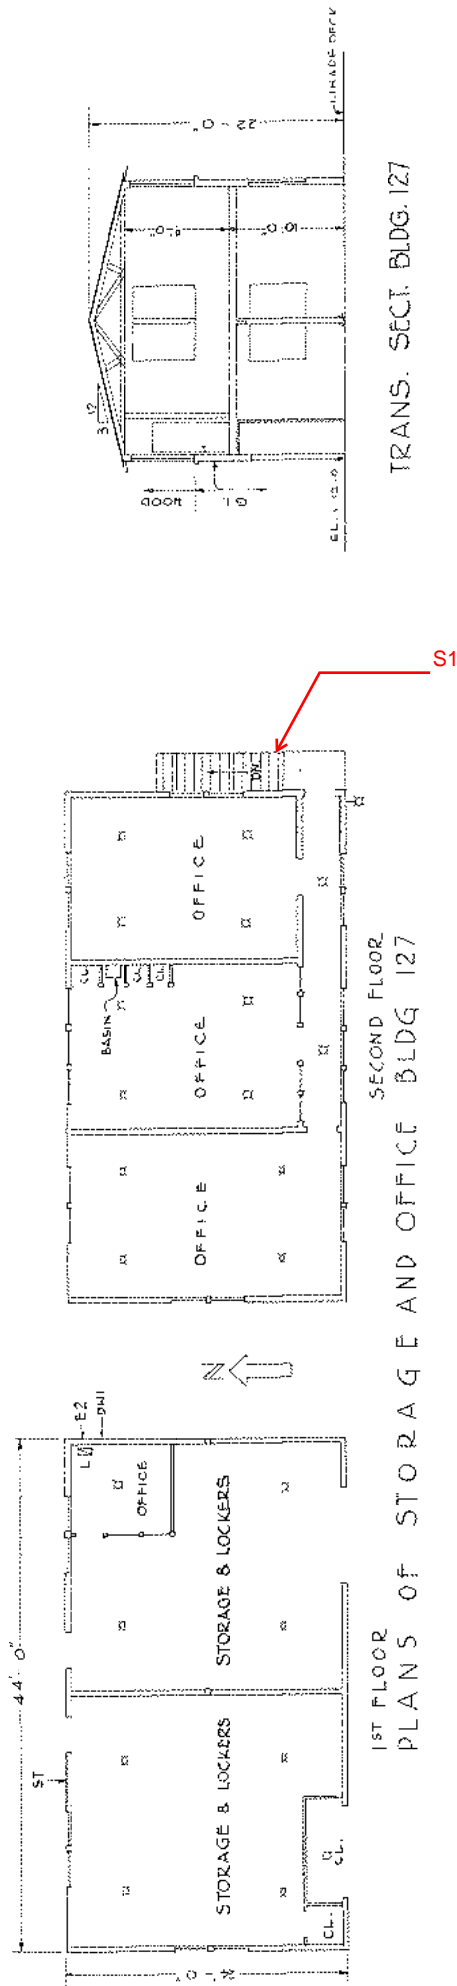
S1: Wood stair to be replaced.

- Repair dry-rot, install new shingles to the entire roof

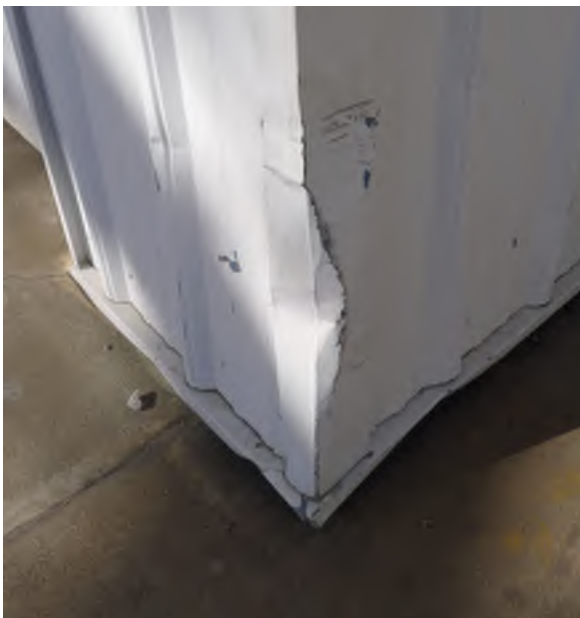
Figure 5 - Damaged southeast corner

The CMP on Building 143 is a proprietary pattern with angular bends forming the corrugations rather than the wave pattern found in generic, historic panels throughout the site. Most damage occurs at the ground level, including a crushed southeast corner (the result of impact damage) and minor scrapes and dents along the south elevation. The building appears to have been repainted within the past several years (figures 4 and 5).

- Provide maintenance and repainting on a regular schedule.
- The following conditions identified in the conditions assessment should be considered for long-term repair:
  1. Damaged southwest corner

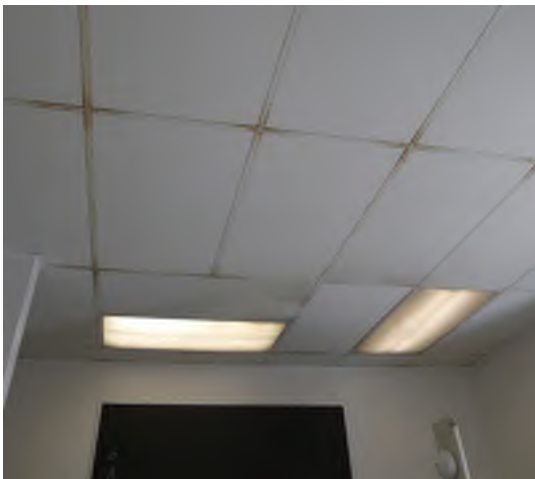
Figure 7 - Suspended ceiling, Men's Room

Suspended acoustic tile. Condition: Good to Fair (figure 7)

The T-bar metal suspension grid is lightly rusted. The tiles are stained and warped.

- Clean, re-paint, and replace acoustic tile
  1. Remove light rust from T-bar grid, prime with rust inhibiting primer and re-paint with oil based paint.
  2. Replace 100% of 2'x4' acoustic ceiling tiles.

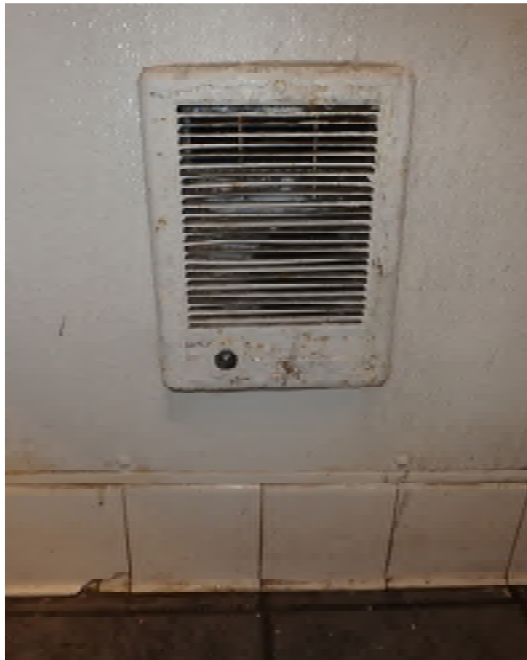
**Figure 143-1 – Wall-mounted Restroom Heater**

- The break area is an open-air space with no heating or ventilation
- The restrooms are equipped with exhaust fans and wall heaters (see fig. 143-1). The wall heaters do not appear to be operational.

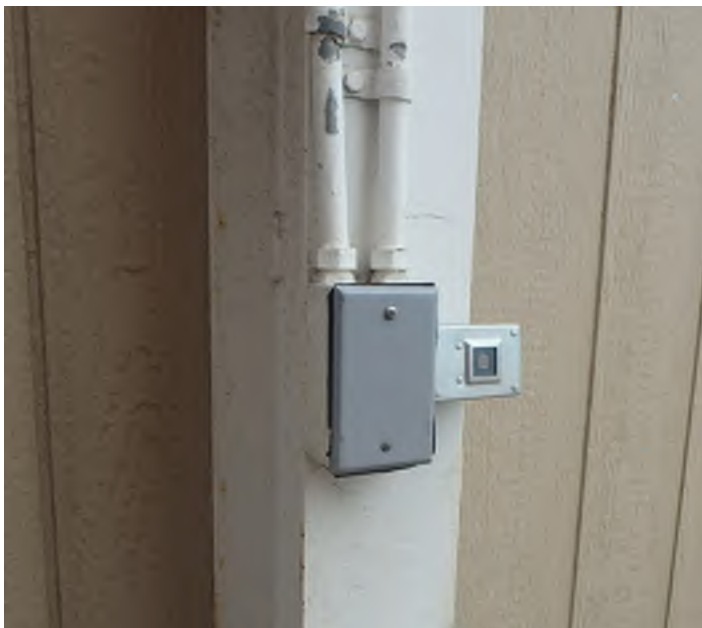
**Figure 143-2 – Exterior Lighting Photosensor Controls**

- The building is equipped with a 120/208 volt electrical panel.
- The exterior lights are equipped with photosensors (see fig. 143-2).

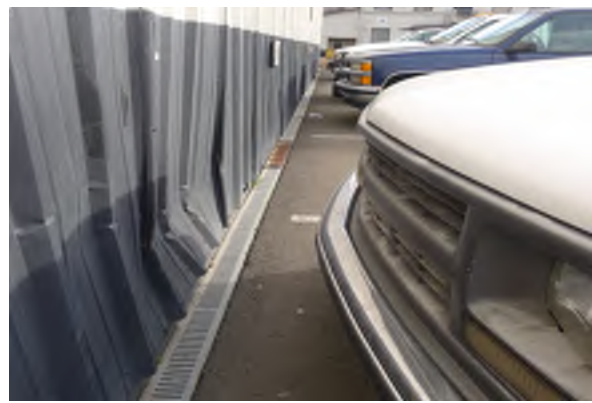
Figure 3 - Damage to the south wall caused by vehicles

The corrugated steel panels are painted and are generally in good condition with some minor localized damage at the doors and at the bottom edge of the cladding on the east and west elevations. The sealant joints around the doors are deteriorated. In particular, the corrugated steel panels along the south elevation are badly bent from being hit by vehicles in the course of parking. Sheet metal trim around personnel and vehicular doors is damaged in several locations.

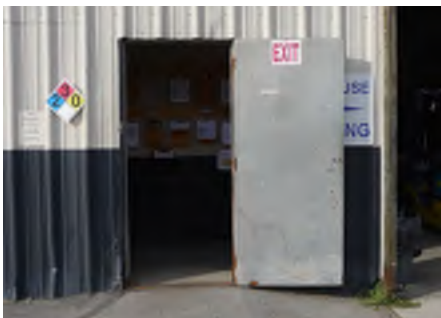
Figure 4 - East personnel door.

There are two hollow metal personnel doors. Condition: Good. There is rust at all door hinges (figure 4).

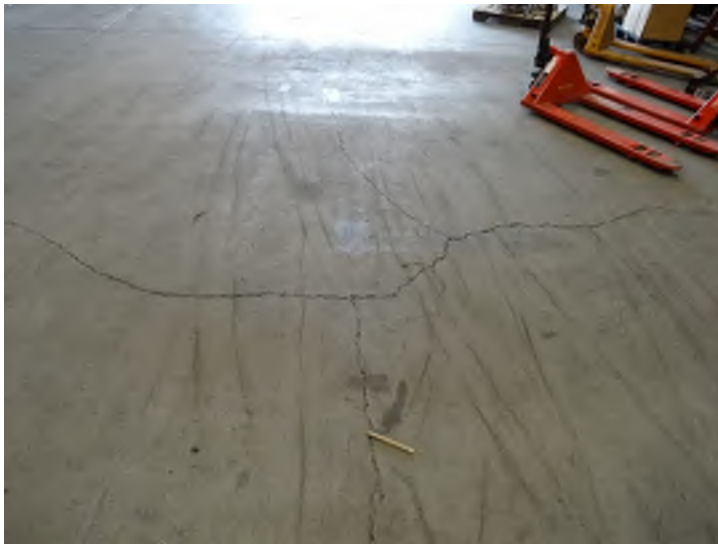
Figure 2 – Typical slab on grade cracks

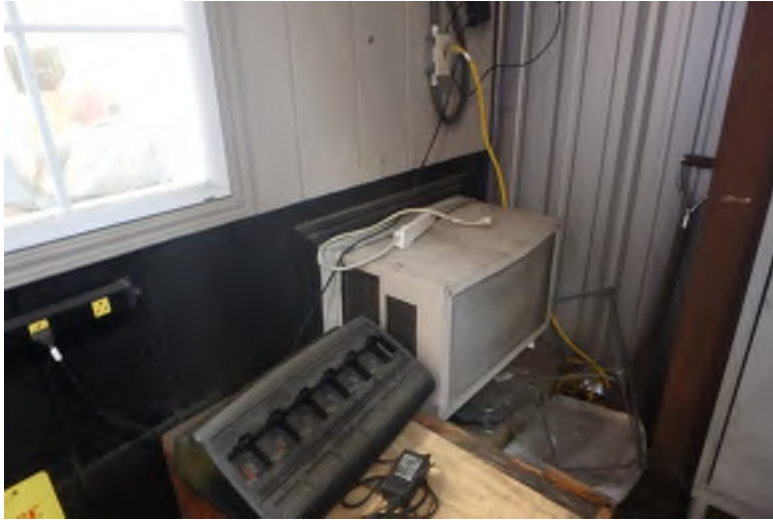
**Figure 250-1 – Window Mounted DX Unit for Office**

- No ventilation systems.
- No heating or cooling in the main warehouse area.
- Window-mounted DX unit provided at the interior office rejecting heat into the warehouse area (see fig. 250-1).
- Large louvered opening available for passive ventilation.

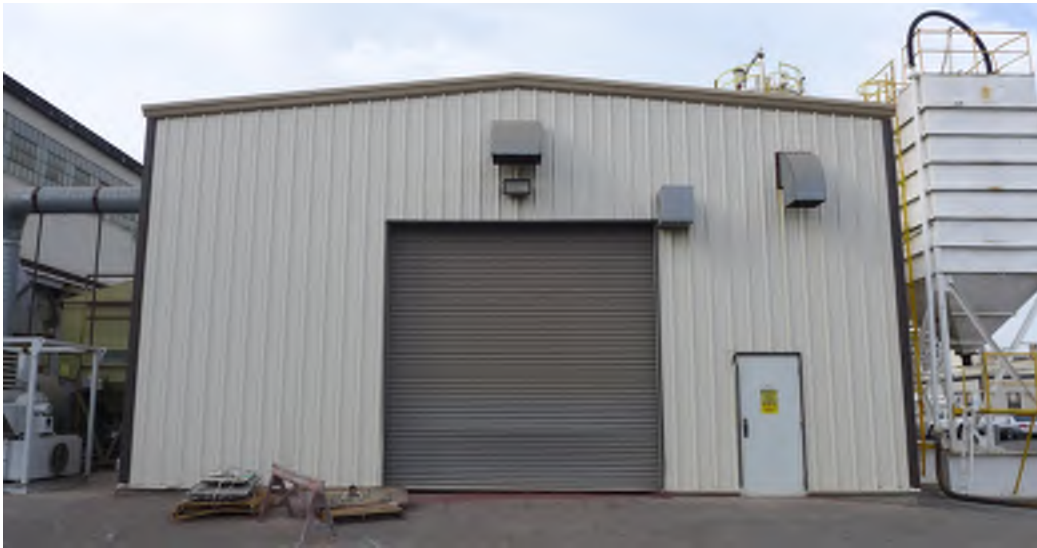
Figure 2 - Building 251: East Elevation

**WALLS** - Corrugated steel siding on concrete curb. Condition: Good (figures 2 and 3)

The corrugated steel panels are painted and are generally in good condition with some minor localized damage at the doors and at the bottom edge on the east elevation. The sealant joint at this location is deteriorated. Sheet metal trim around personnel and vehicular doors is damaged in several locations. Two vent hoods, one on the east and one on the west, have rusting metal collars.

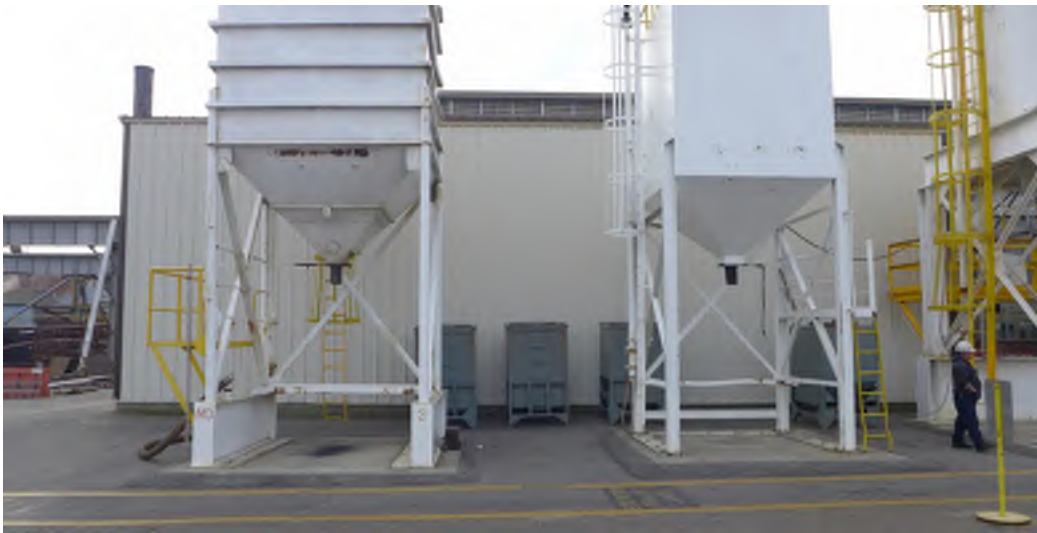
Figure. 3 - Building 251: North Elevation

- Install new sealant at bottom edge of corrugated steel panels on the east elevation.
- Paint rusted collars at two vent hoods.

- Provide maintenance and repainting on a regular schedule.
- The following conditions identified in the conditions assessment should be considered for long-term repair:
  1. Damaged sheet metal trim around doorways.

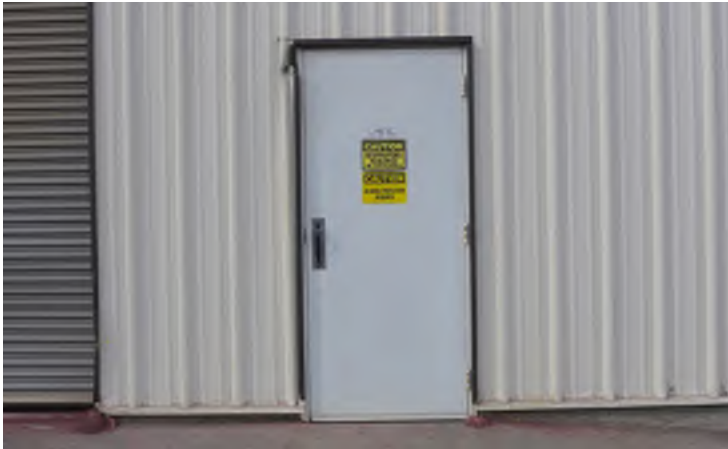
Two hollow metal personnel doors. Condition: Good. Rust at all door hinges.

Figure. 4 - Building 250: East personnel door. Note damage at door trim.

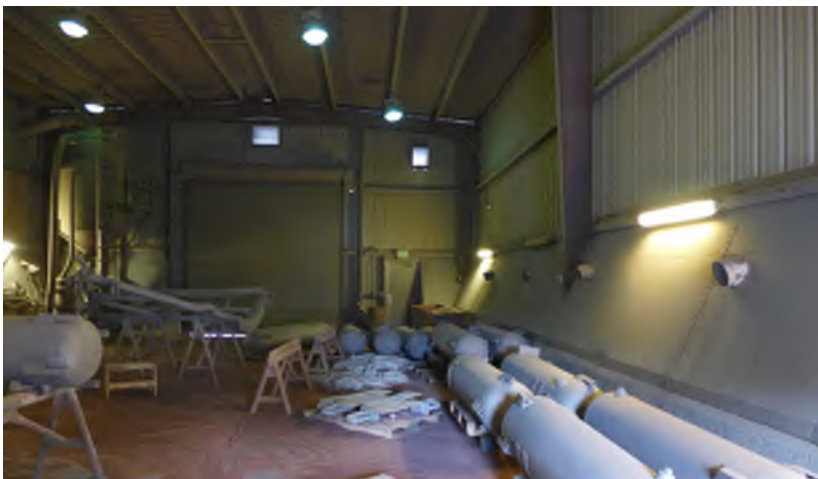
Figure. 4 - Building 250: Interior, facing west.

Corrugated steel siding. Condition: Good

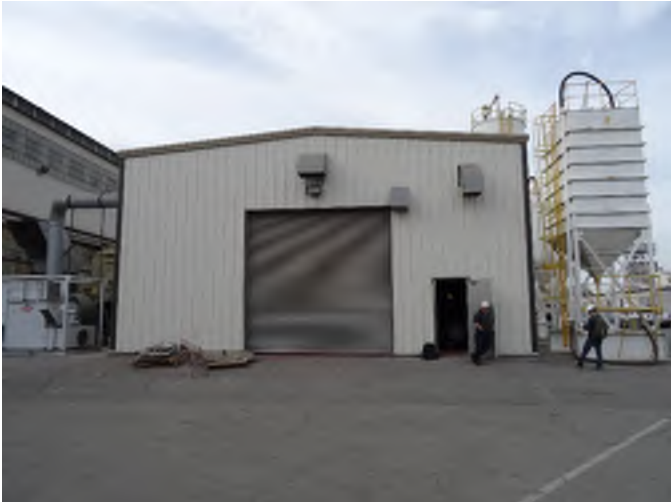
- There is minimal damage to the base of the structure near the large rollup entry door possibly due to the forklift running into it.

Figure 1 – Building 251 exterior

- No immediate repairs are required at this time.

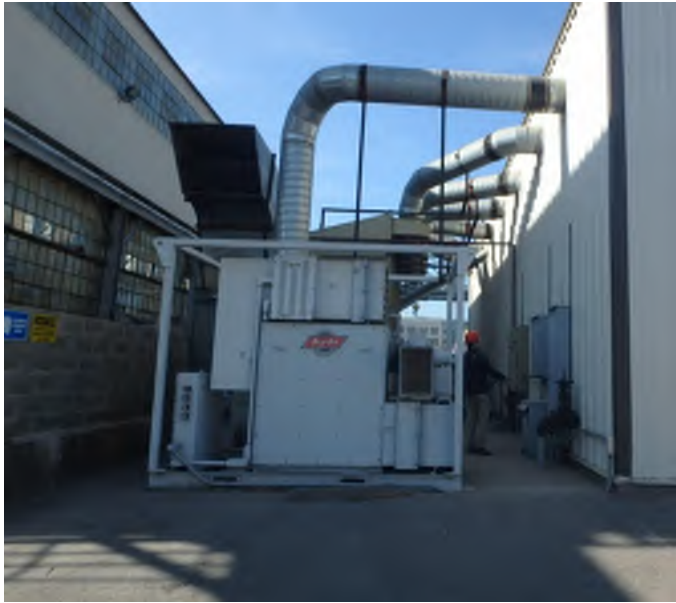
**Figure 251-1 – Industrial Dehumidifiers**

- There are multiple process fans serving the building with sand collectors.
- The building has several Bry-Air industrial dehumidifiers serving the building (see fit. 251-1).
- The building has (4) vent openings on the East and West walls of the building, each equipped with a weather cover.

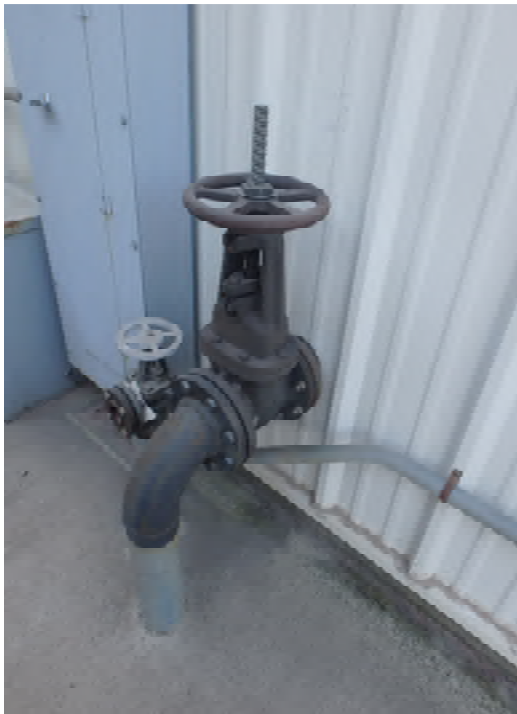
**Figure 251-2 – 3” Service Line with Gate Valve**

- The building has no fire protection service.
- Fire extinguishers are furnished at the East and West walls of the structure.
- The building has a 3” compressed air service line into the building with a rising stem gate valve (see fig. 251-2).

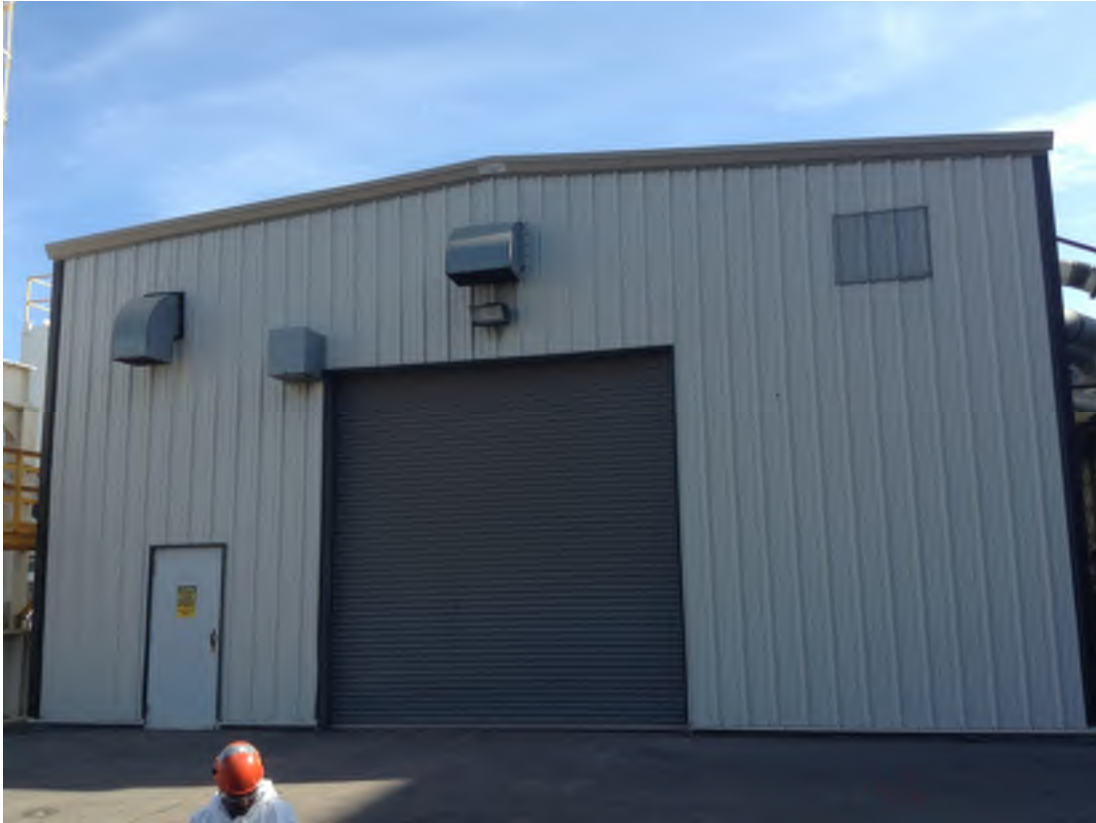
Fig. 1 - Building 251 view from front

GENERAL NOTES: This a new roof this roof appear to still be in good condition

2. Inspect roof twice a year for leaks and potential penetrations

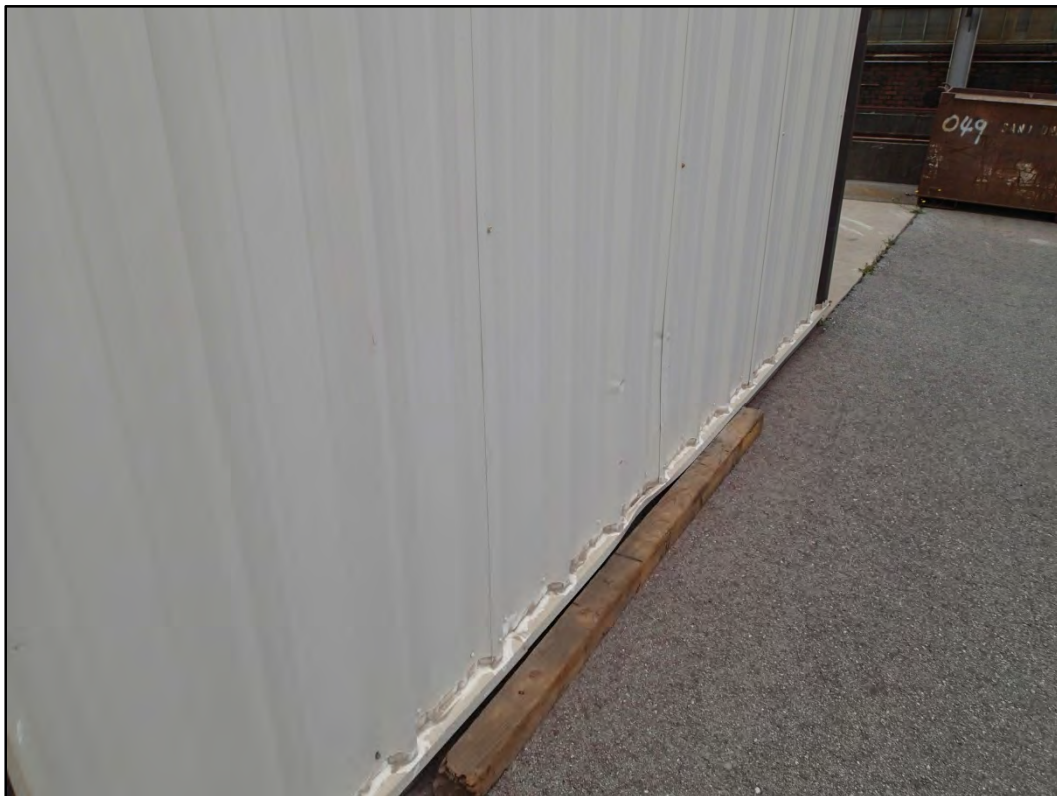
The overall condition of Building 251 has remained unchanged since the previous condition assessment in 2015. The building continues to be used as a sandblasting facility and the recommended repairs provided in the previous condition assessment report have not been addressed. The repair recommendations provided in the 2015 condition assessment were minor and of low priority. No deficiencies in addition to the deterioration identified in the previous condition assessment were found.

Figure 251-3 – View of the typical condition of the corrugated metal panels at Building 251.

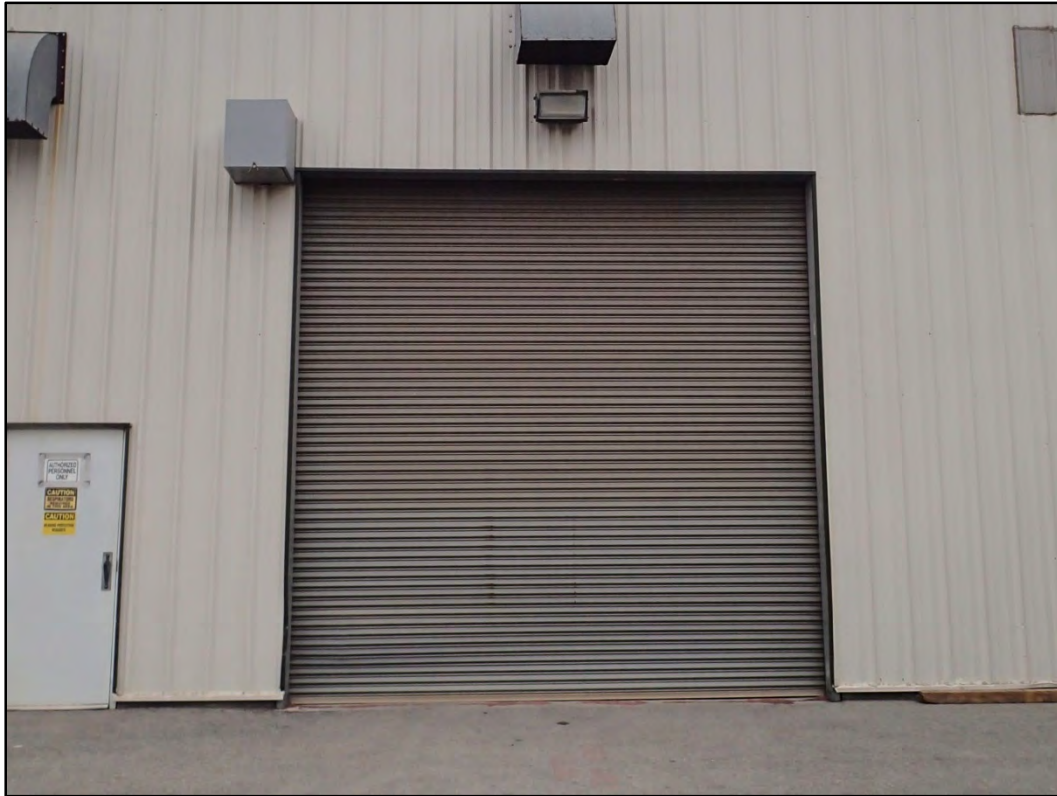
Figure 251-4 – View of steel roll-up door at Building 251.

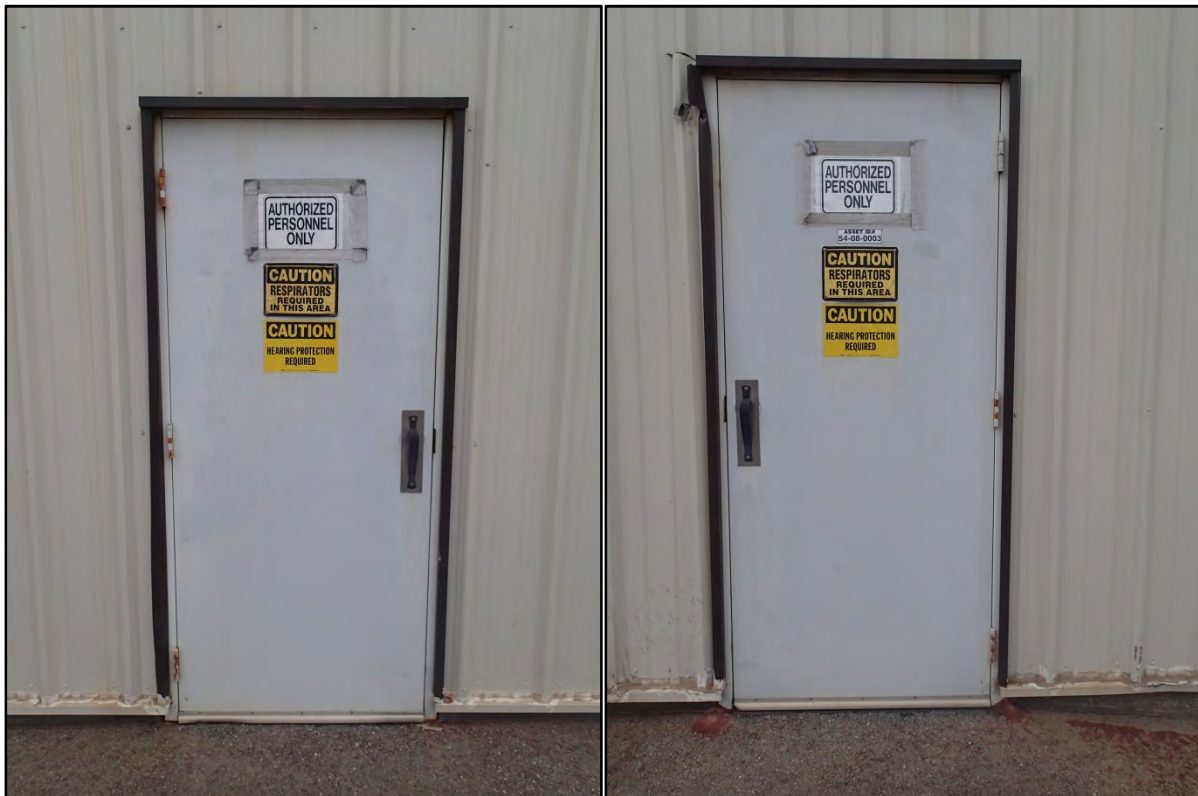
Figure 251-5 and Figure 251-6 – View two hollow metal doors at Building 251.

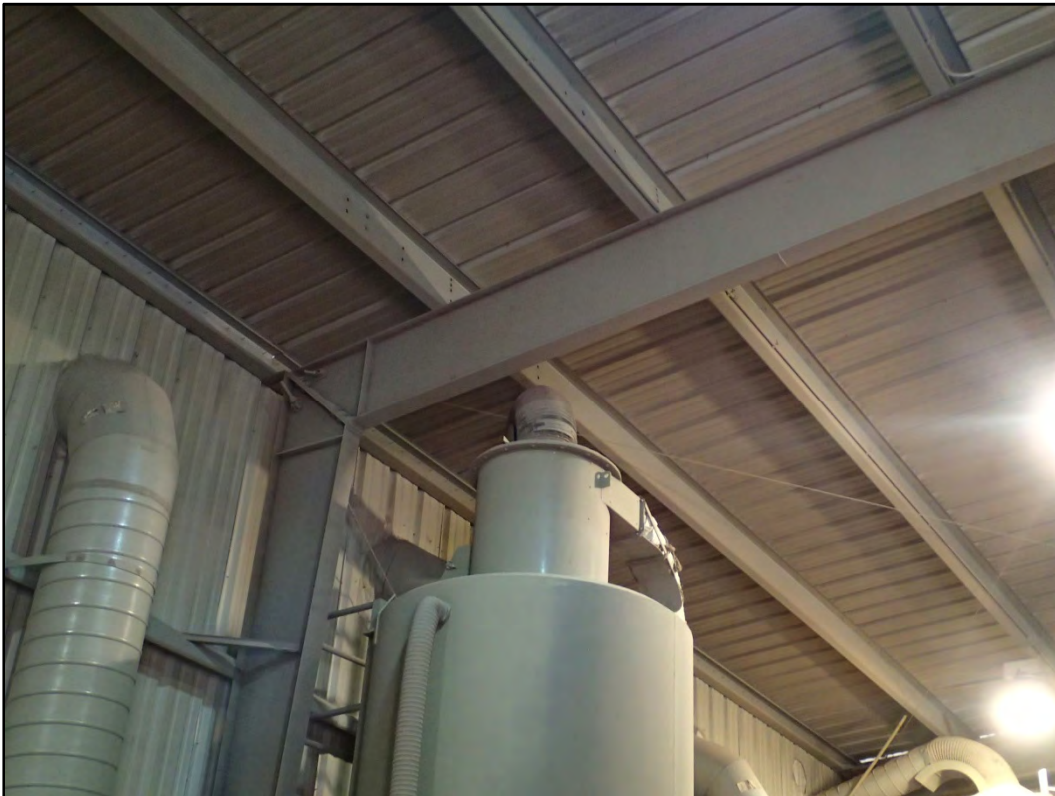
Figure 251-8 – View of the interior structural steel framing in Building 251.

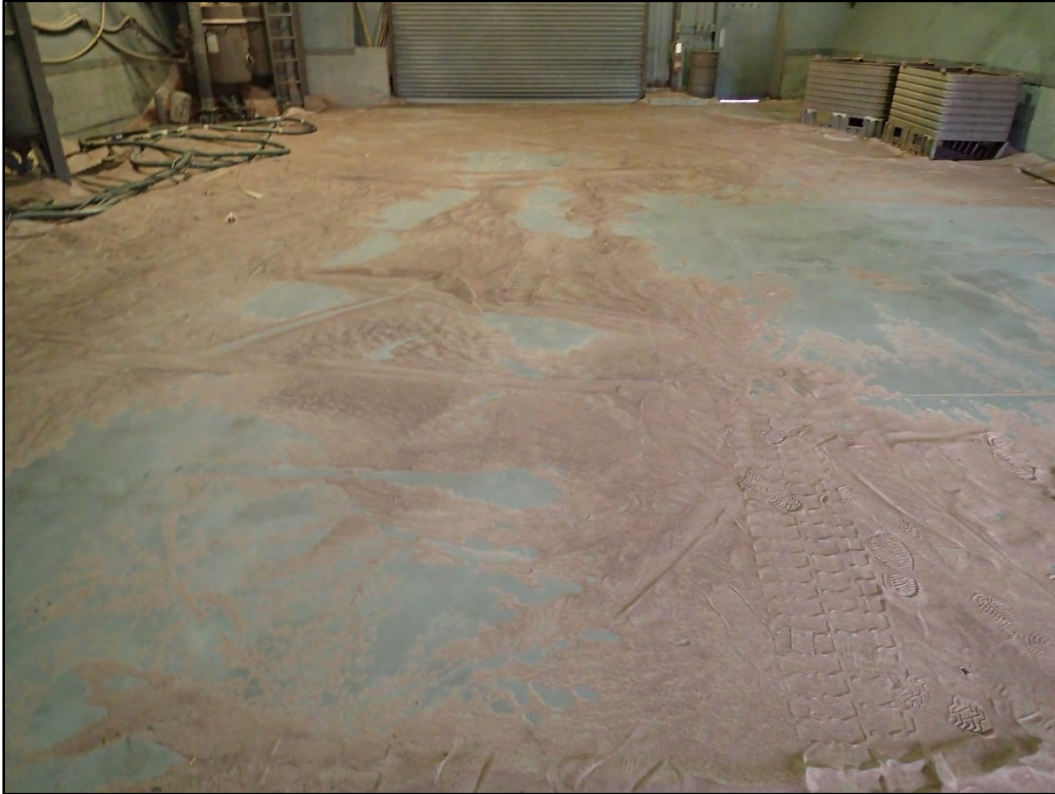
Figure 251-9 – View of the interior concrete slab in Building 251.

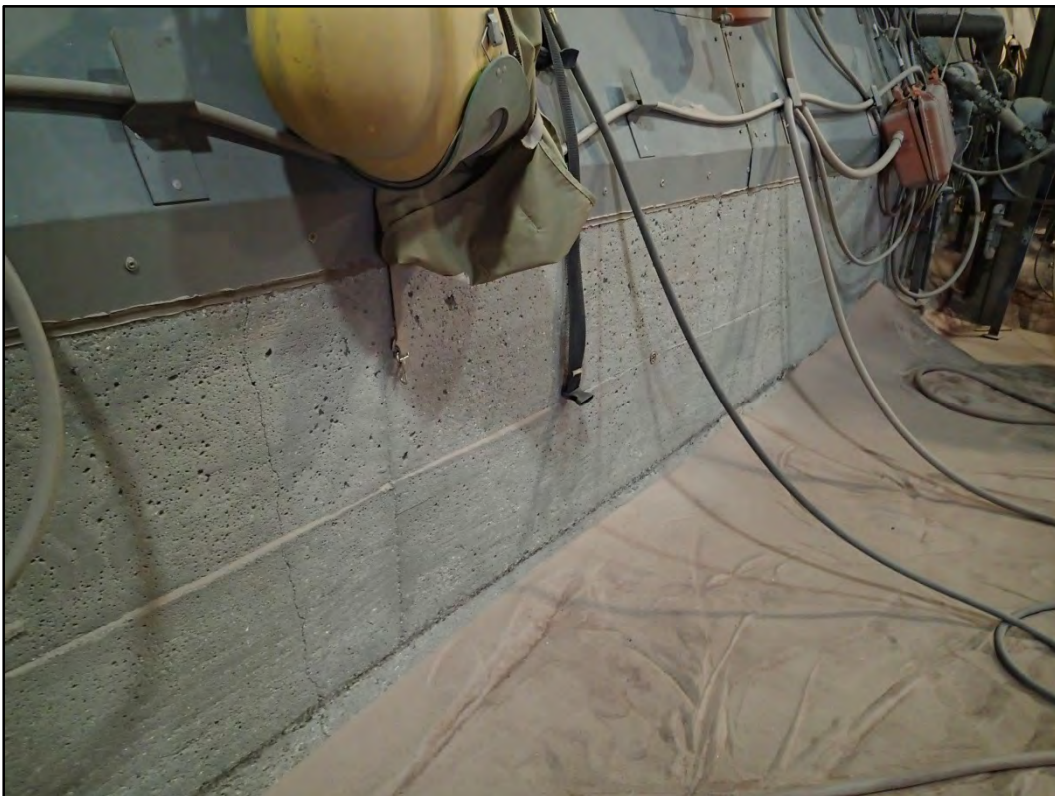
Figure 251-10 – View of the interior concrete stem wall along the north and south sides of Building 251.
