August 30, 2016

REF: 16LET019

Subject: Dry Dock No. 2 Dolphin & Stair Tower Inspection

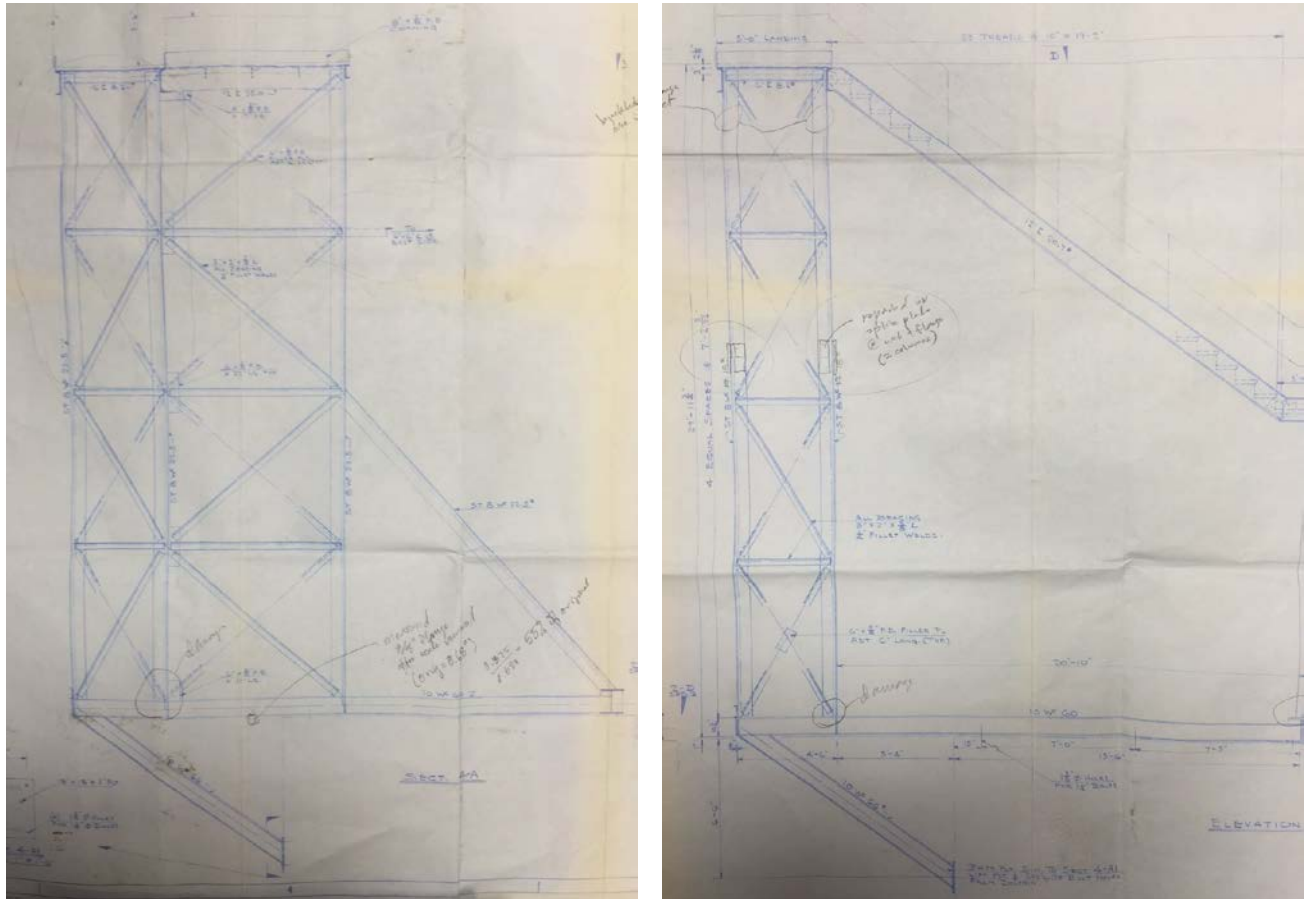
Figure 9 – Original drawing cross section of stair tower at brow (left) and stair landing (right).

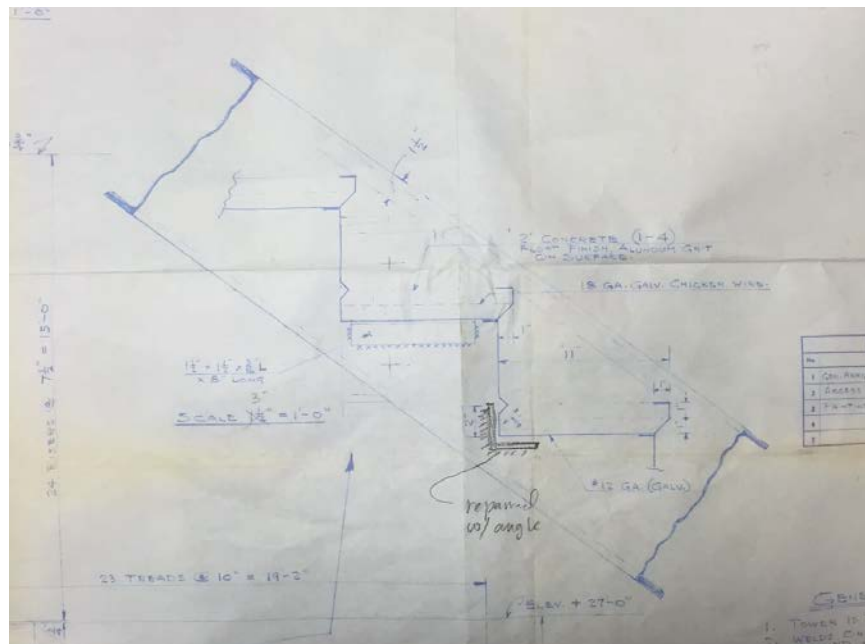
Figure 10 – Original drawing showing stair tread detail.

Numerous connections between stair treads and stringers were observed to have been previously repaired at lower regions of the stairs. Other connections will continue to fail above this region and will require similar repair as this occur.

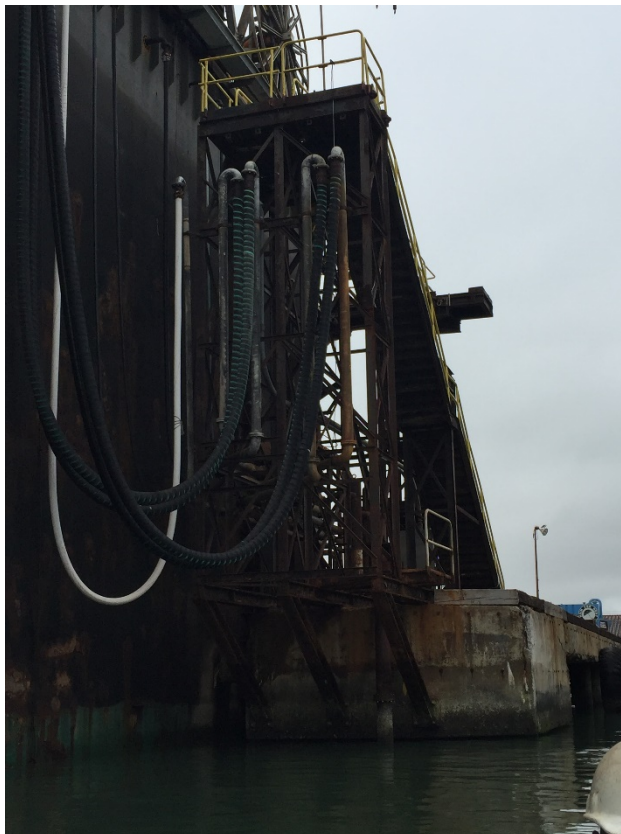
Figure 11 – Full view of stair tower framing.

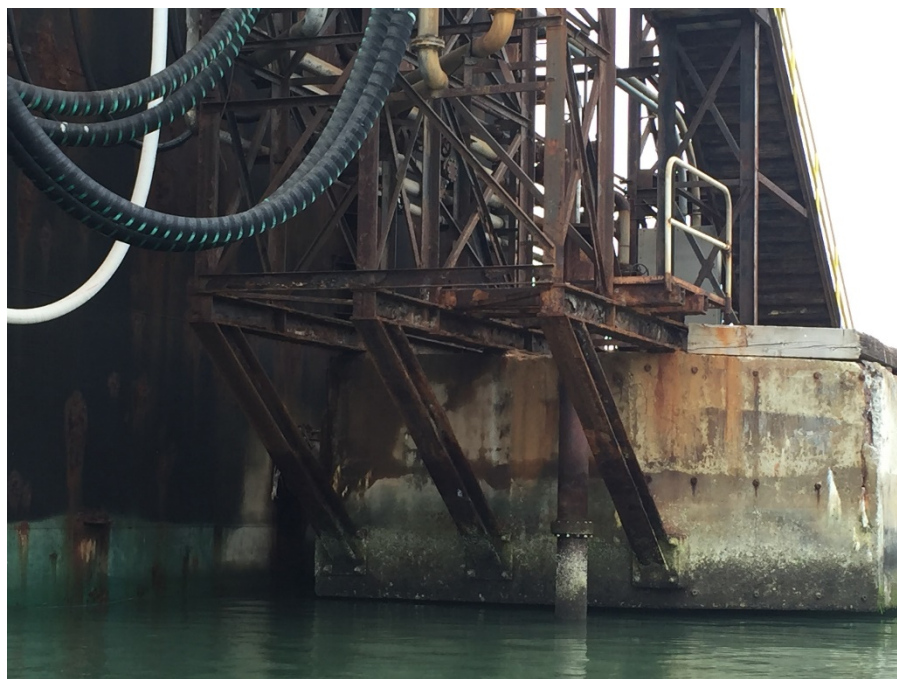
Figure 12 – View of lower frame and support framing at dolphin D1.

The heavily corroded beams and struts which support the tower at the concrete deck have lost nearly half of their original cross section and will require replacement in the next 2 to 3 years.
