Port of San Francisco Dry Dock EUREKA Structural Assessment Report

June 2017

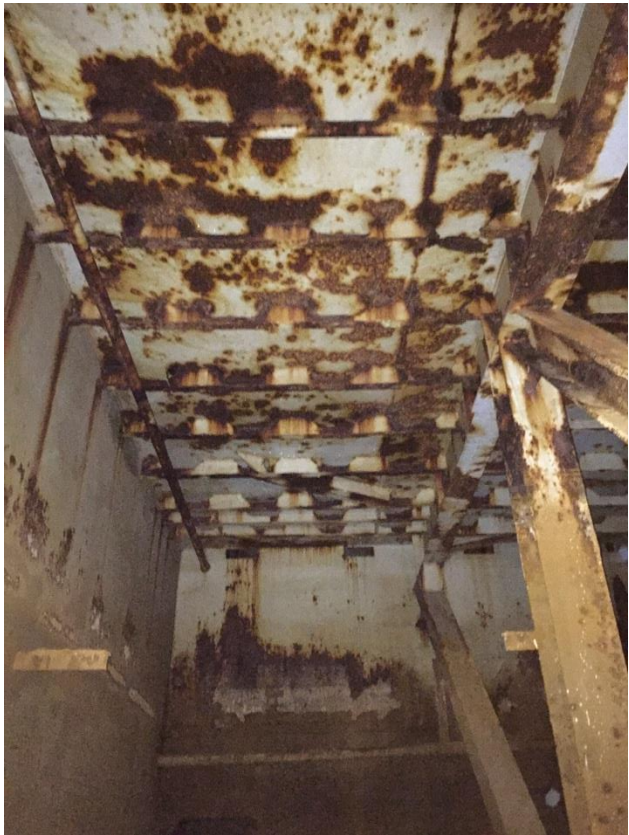
13. Roof stiffeners at Tank 6A

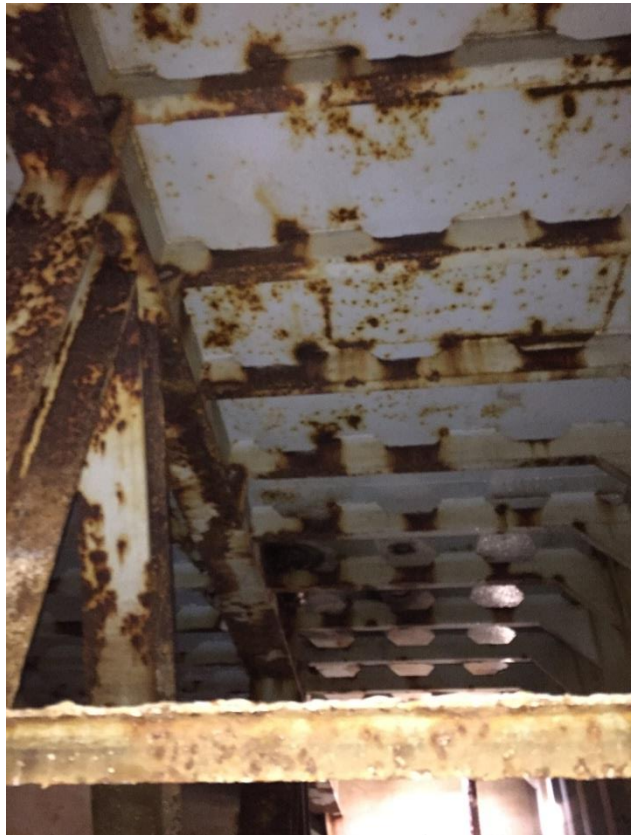
14. Roof stiffeners at Tank 6A

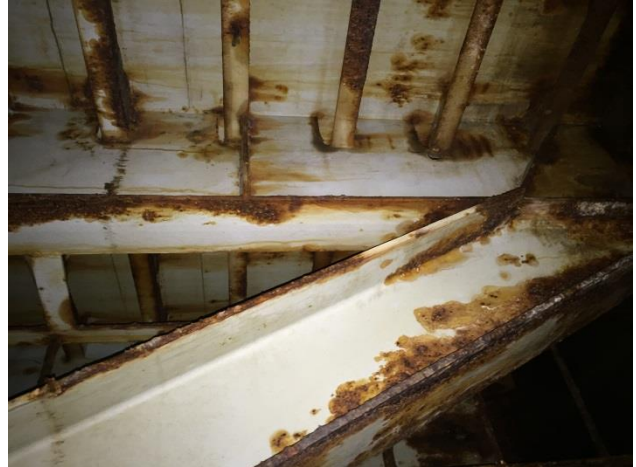
16. Roof stiffeners and braced frame at Tank 20A

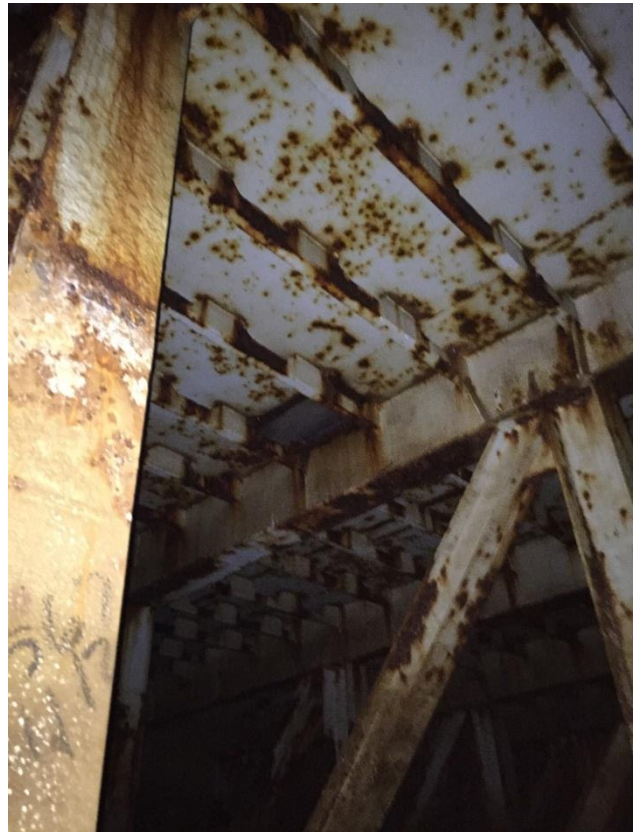
18. Roof stiffeners and braced frame at Tank 5

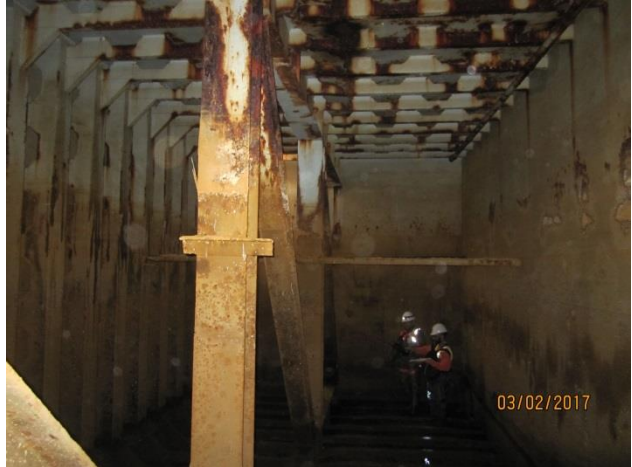
19. Ladder up wing wall at Tank 6

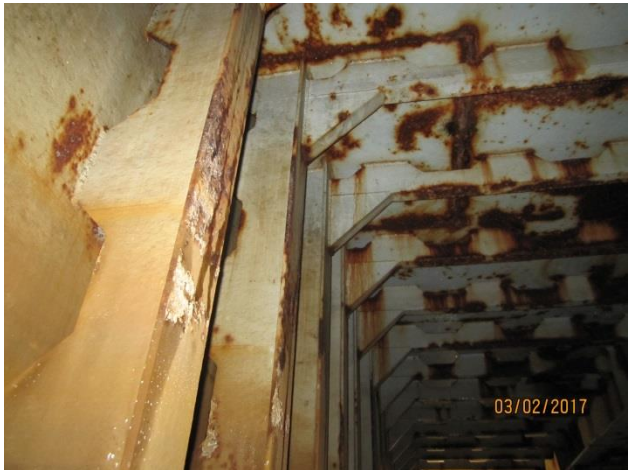
20. Roof stiffeners and braced frame at Tank 6

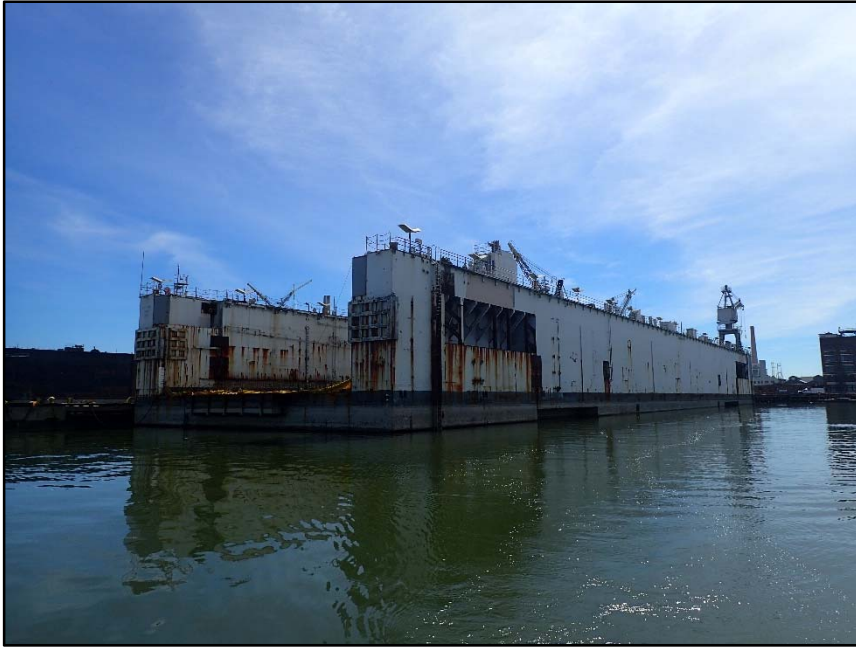
Photograph 1 : Overall view of Dry Dock EUREKA, looking southeast.
