Pier 68-70 Shipyard Facility Condition Survey Marine Structures

Pier 68-70 Shipyard Facility Condition Survey
 Marine Structures - July 2017
 (This drawing is a reproduction of available
 record drawing marked up to indicate the
 findings of the 2017 survey)

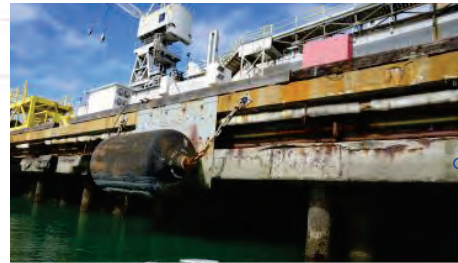
Pile Cap Spall and Crack

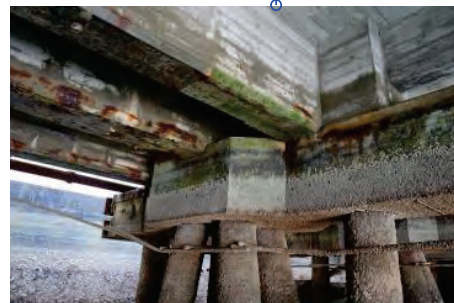
Typical Deck, Beam and Pile Cap condition

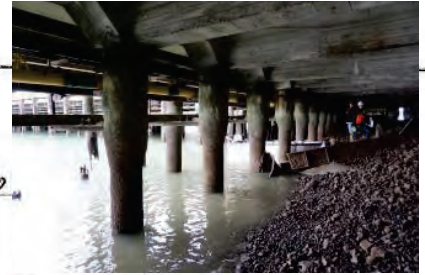
Typical Condition of Piles, Pile Caps, Decks

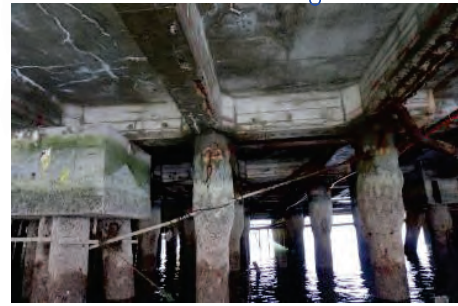
Beam, Pile Cap and Deck condition

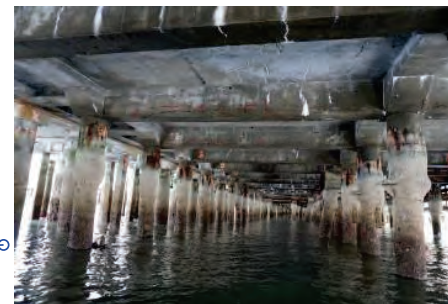
Typical Deck, Beam, Pile Cap Condition

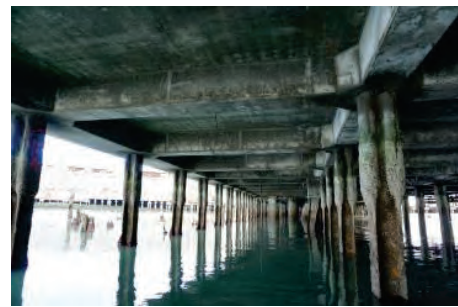
Typical Condition of Deck, Beam
 Pile
