FINAL REPORT
JUN 5, 2017

Port of San Francisco
Dry Dock EUREKA
Structural Assessment Report

June 2017

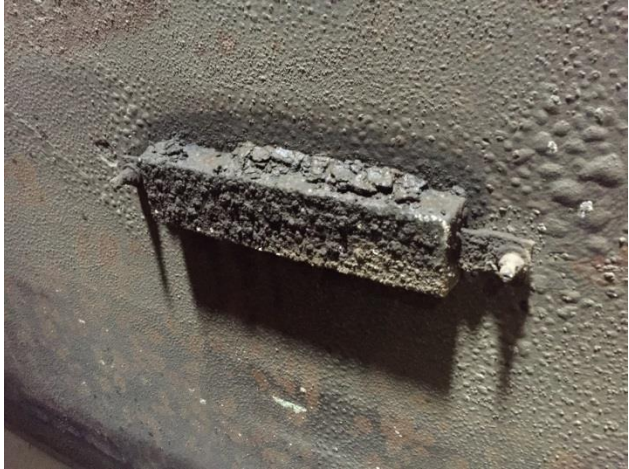
11. Sacrificial anode in Tank 9

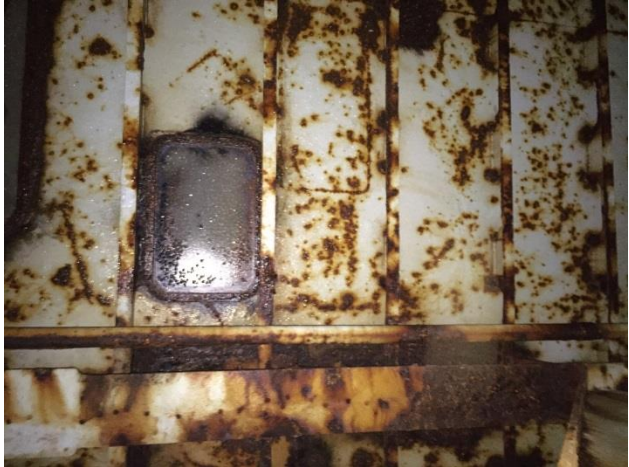
14. Roof stiffeners at Tank 6A

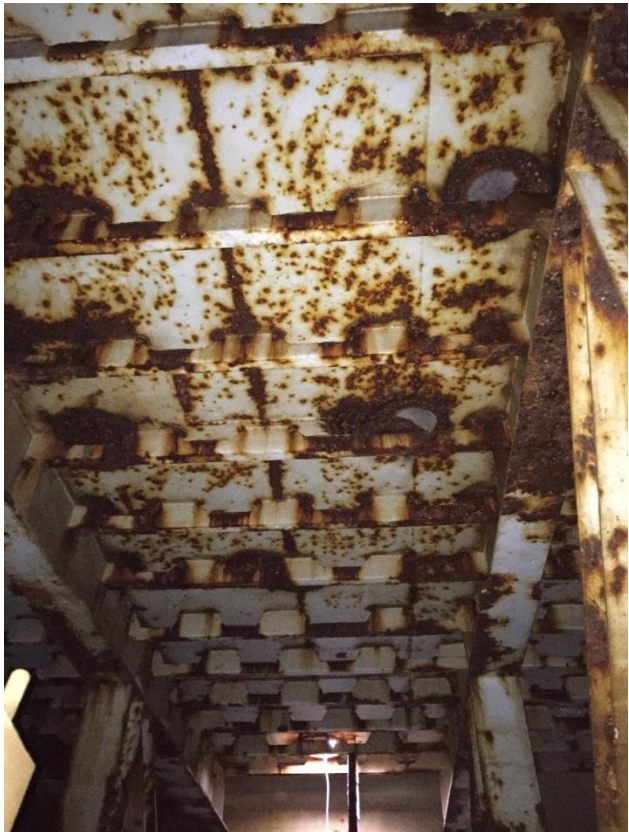
16. Roof stiffeners and braced frame at Tank 20A

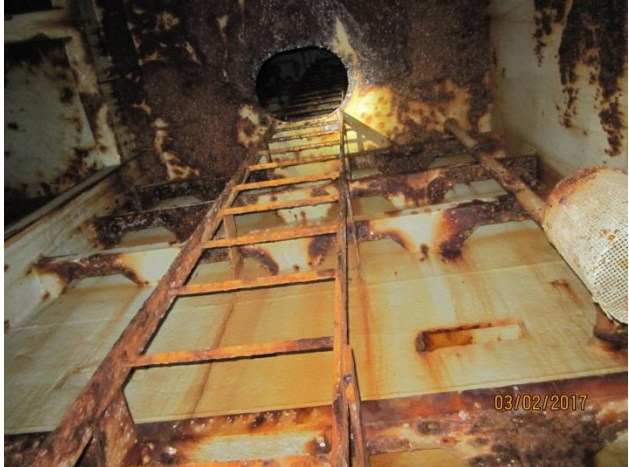
18. Roof stiffeners and braced frame at Tank 5

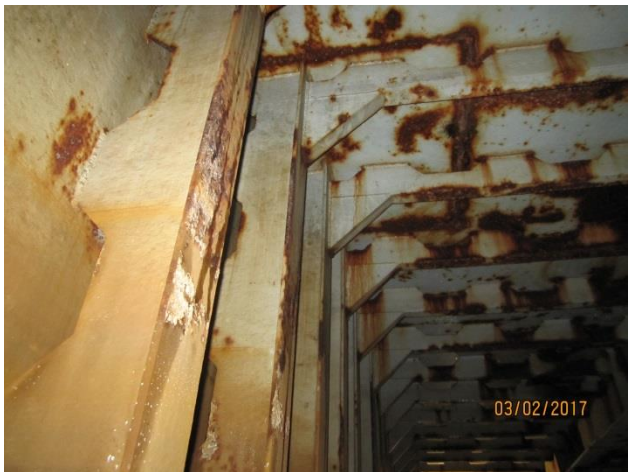
20. Roof stiffeners and braced frame at Tank 6

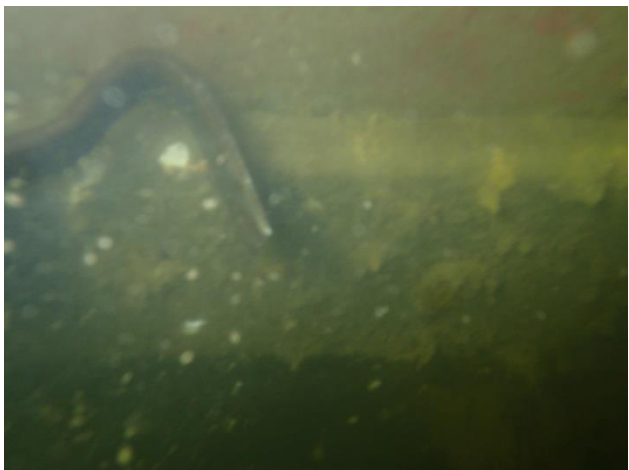
22. Typical marine growth on hull
