## EUREKA DRY DOCK UT /VT SURVEY MAY 2015

Ultrasonic thickness measurements and a visual survey was performed for BAE Systems of San Francisco on the Eureka Dry Dock located at BAE Shipyard in San Francisco, CA. The owners were represented by Mr. Justin Gleaton. The survey was performed by International Inspection personnel.

## EUREKA DRY DOCK VISUAL SURVEY TABLE OF CONTENTS

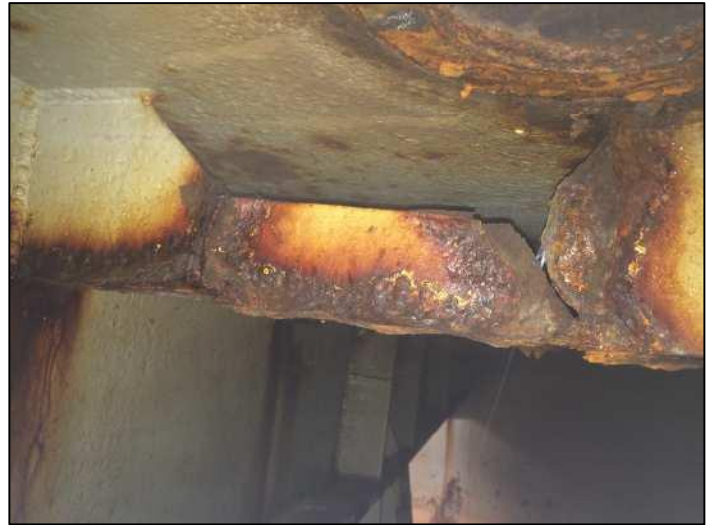
TYPICAL FRACTURE IN WAY OF CHANNEL CUT OUT SHOWN.

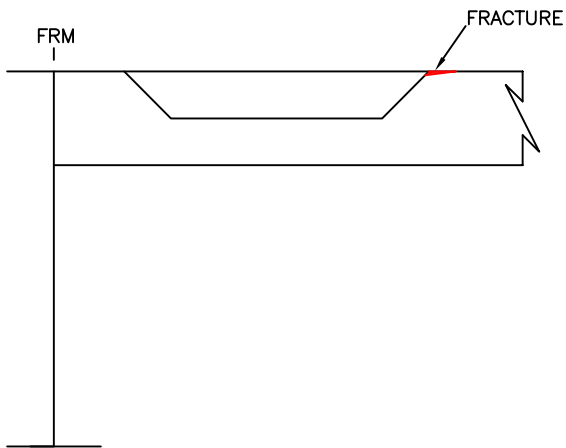
TYPICAL FRACTURE IN WAY OF WRAP WELD DECK ATTACHMENT.

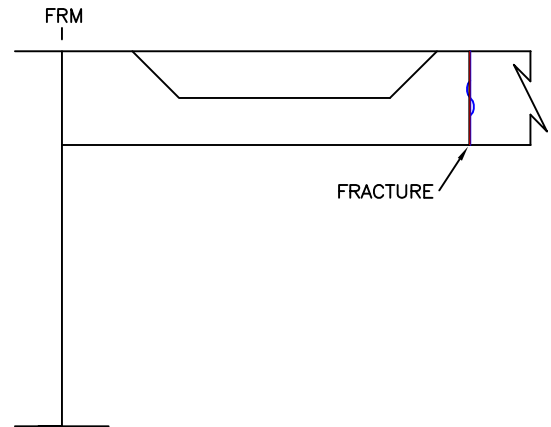
TYPICAL WEB AND FLANGE 100% FRACTURE.

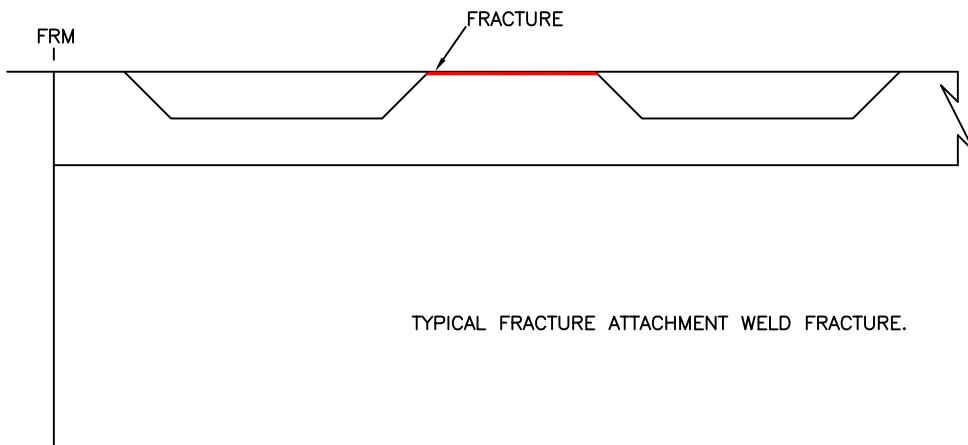
TYPICAL FRACTURE ATTACHMENT WELD FRACTURE.

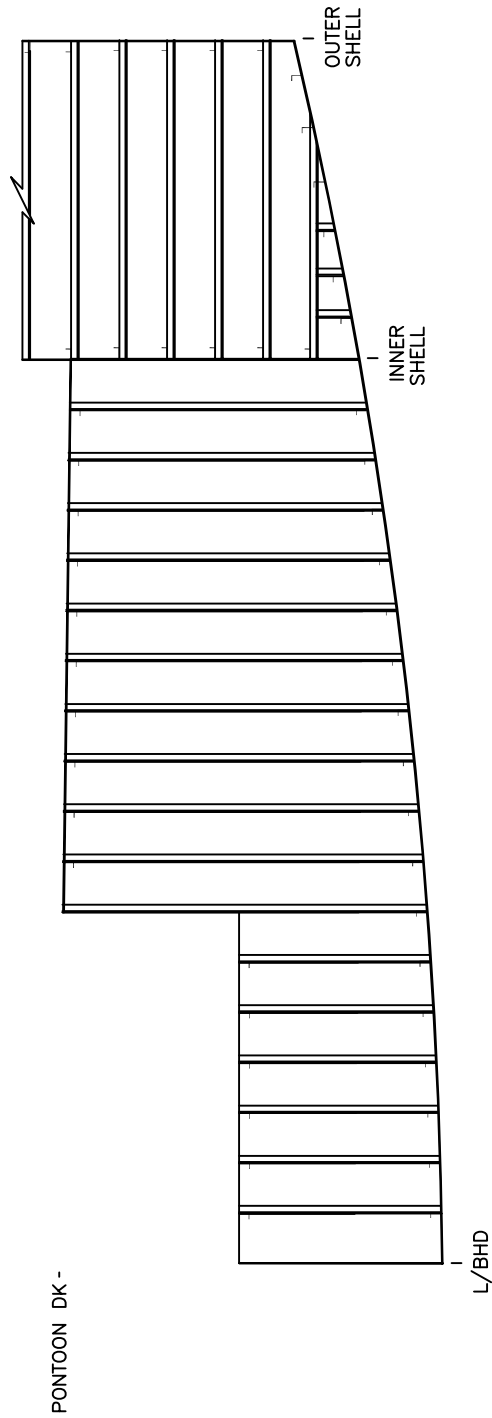
TANK No.1 - BULKHEAD V  
DESCRIPTION: LOOKING NORTH

**No visual indications found at time of survey.**

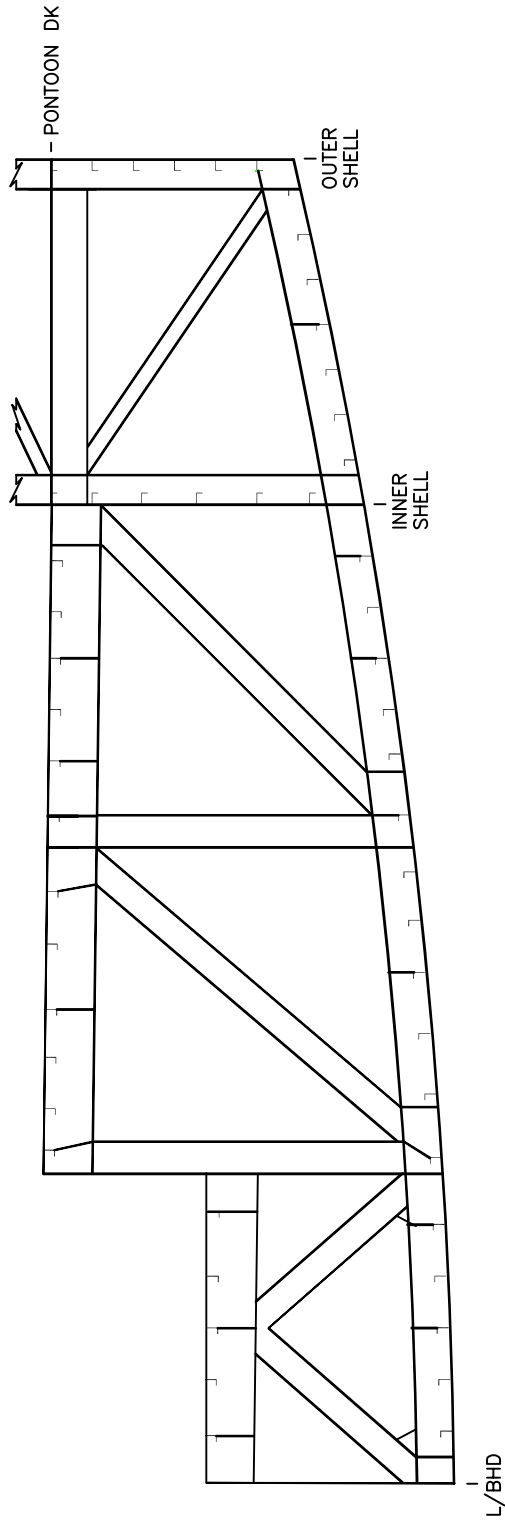
TANK No.1 - FRAME U  
DESCRIPTION: LOOKING NORTH

**No visual indications found at time of survey.**

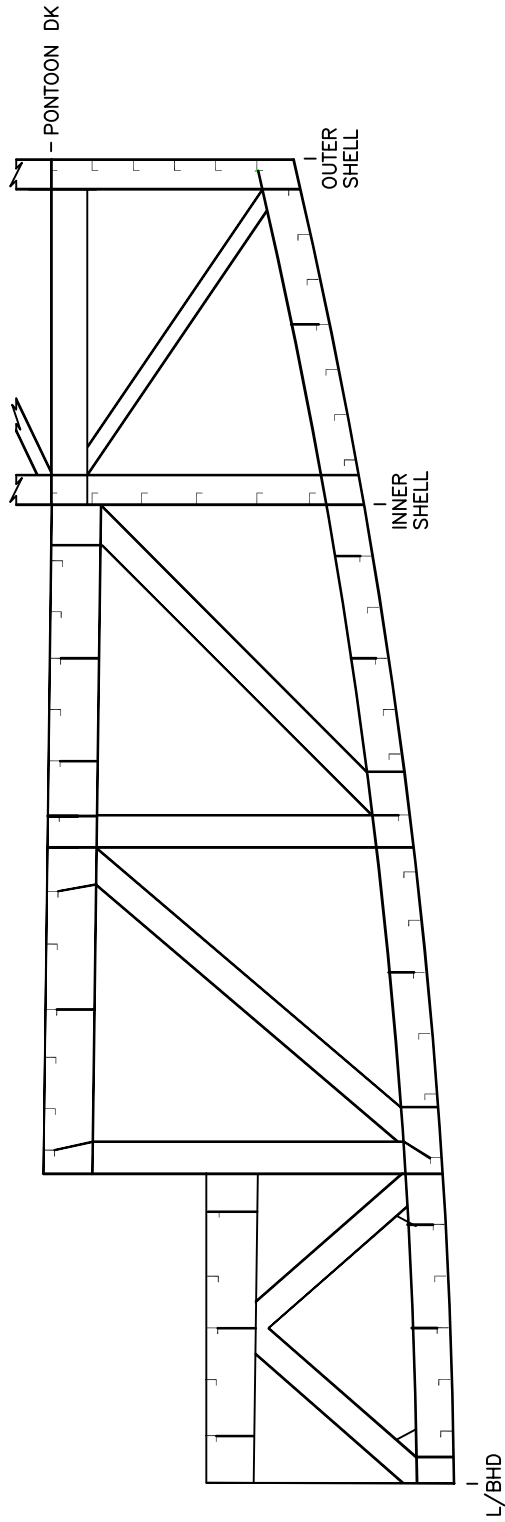
TANK No.1 - FRAME 61  
DESCRIPTION: LOOKING NORTH

**No visual indications found at time of survey.**

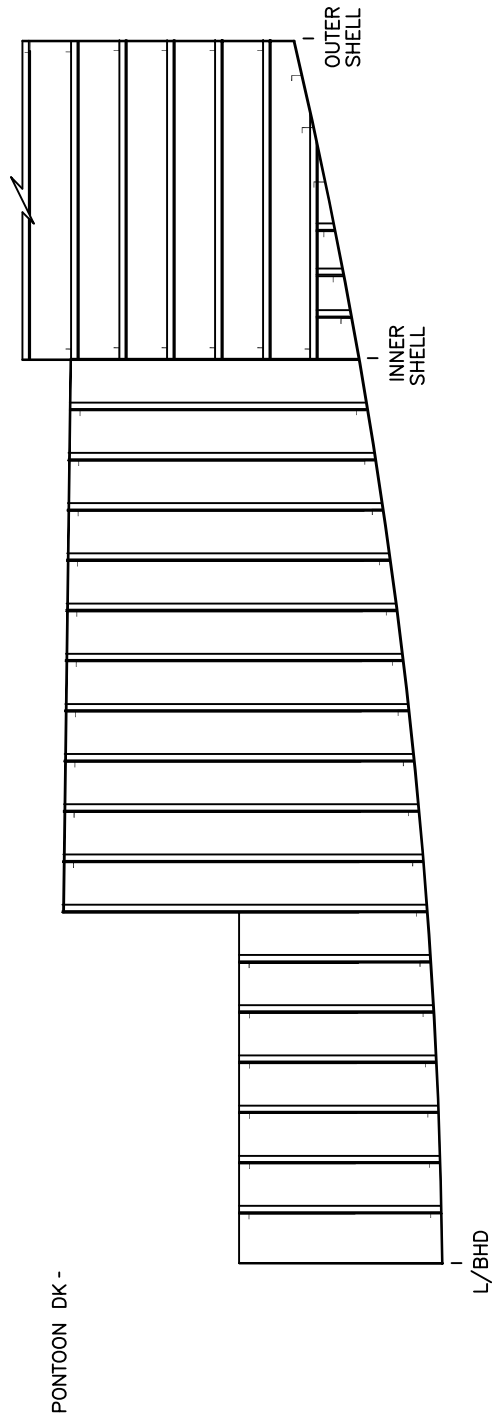
TANK No.1 - BULKHEAD 59  
DESCRIPTION: LOOKING NORTH

**No visual indications found at time of survey.**

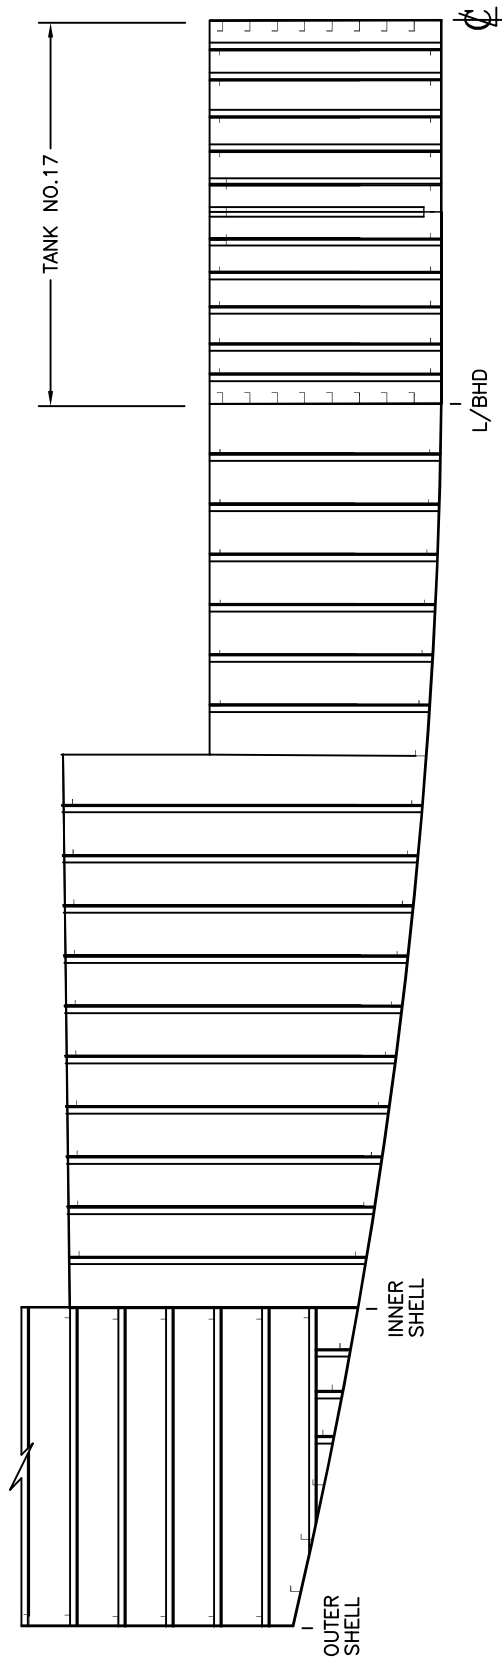
TANK No.2 & 17 - BULKHEAD V  
 DESCRIPTION: LOOKING NORTH

**No visual indications found at time of survey.**

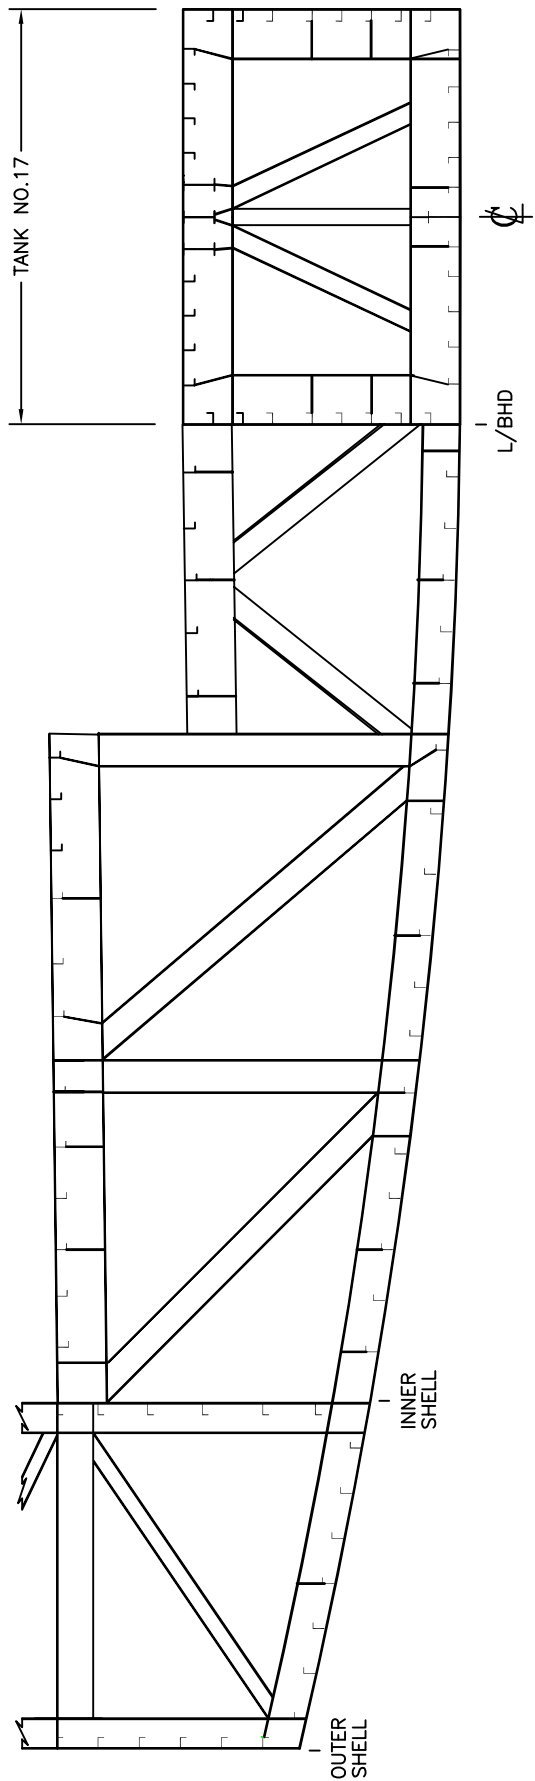
TANK No.2 & 17 - FRAME T  
DESCRIPTION: LOOKING NORTH

No visual indications found at time of survey.

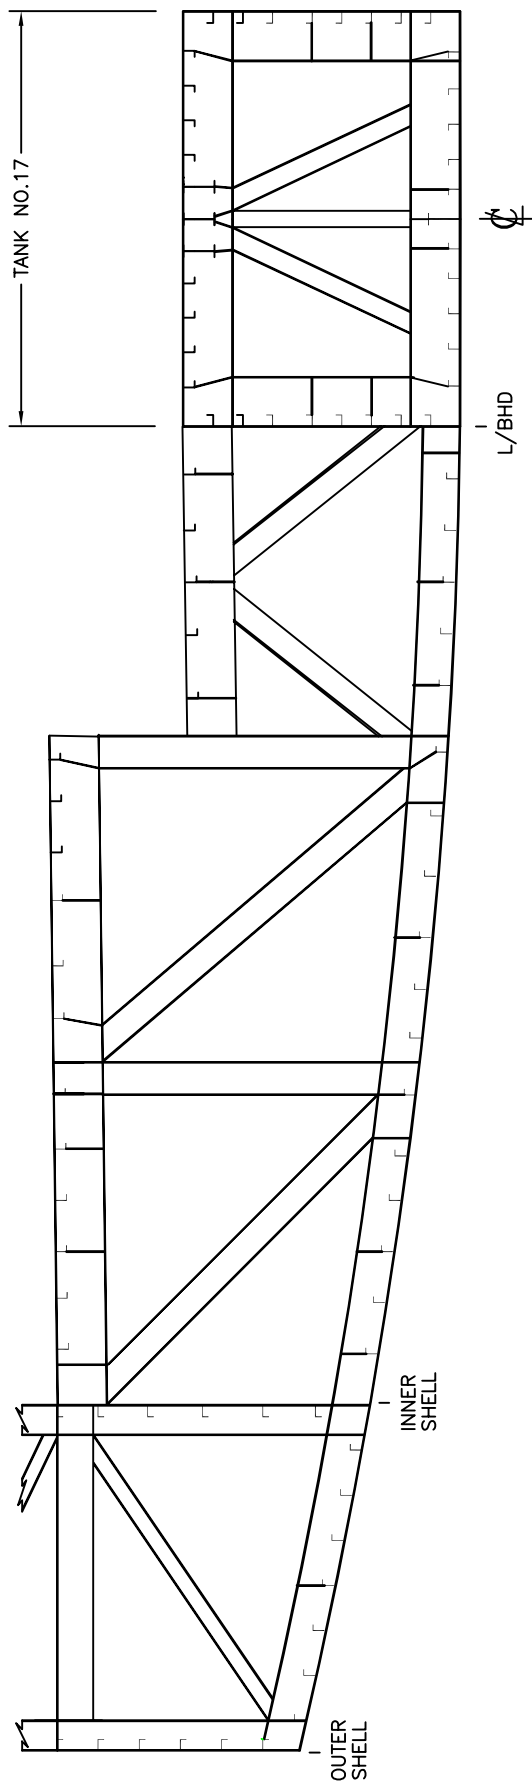
TANK No.2 & 17 - FRAME 61

No visual indications found at time of survey.

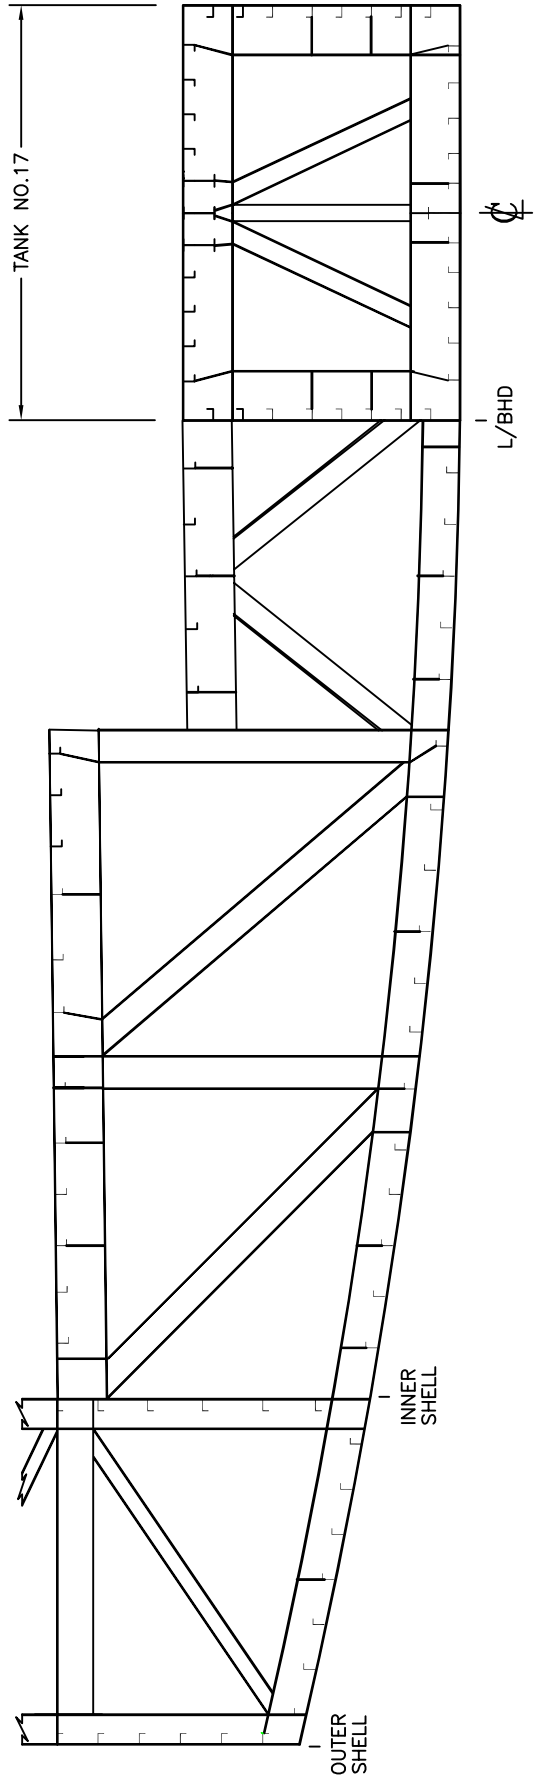
TANK No.2 & 17 - FRAME 60

No visual indications found at time of survey.

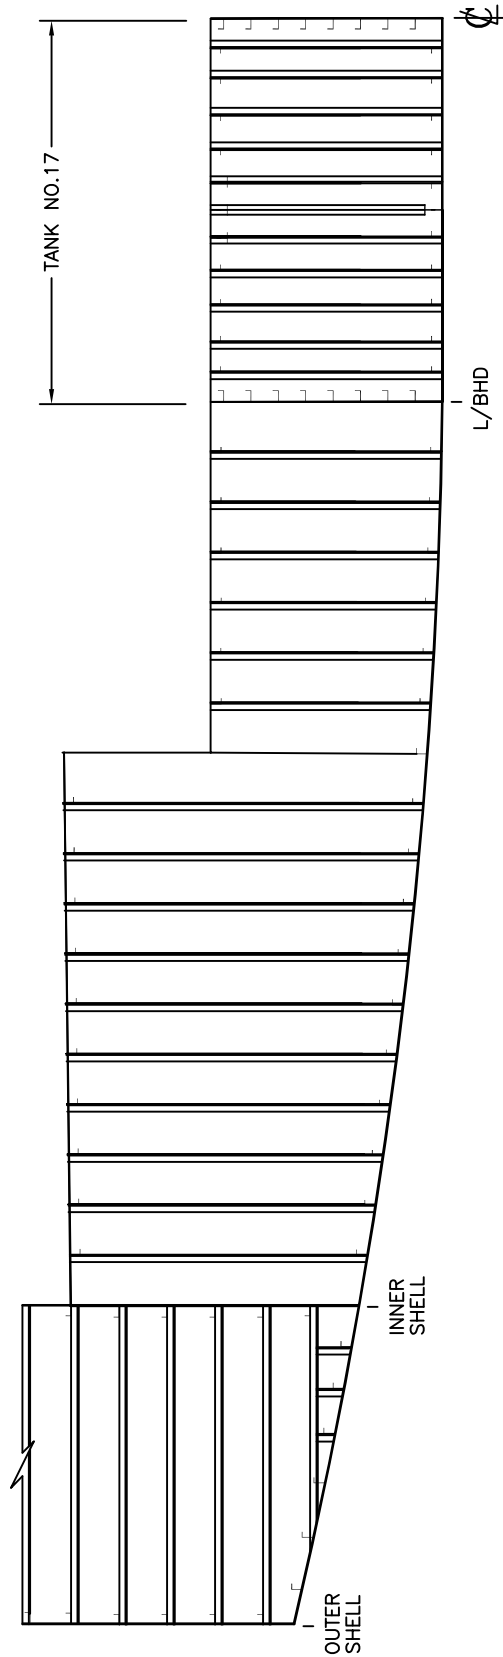
TANK No.2 & 17 - BULKHEAD 59  
DESCRIPTION: LOOKING NORTH

No visual indications found at time of survey.

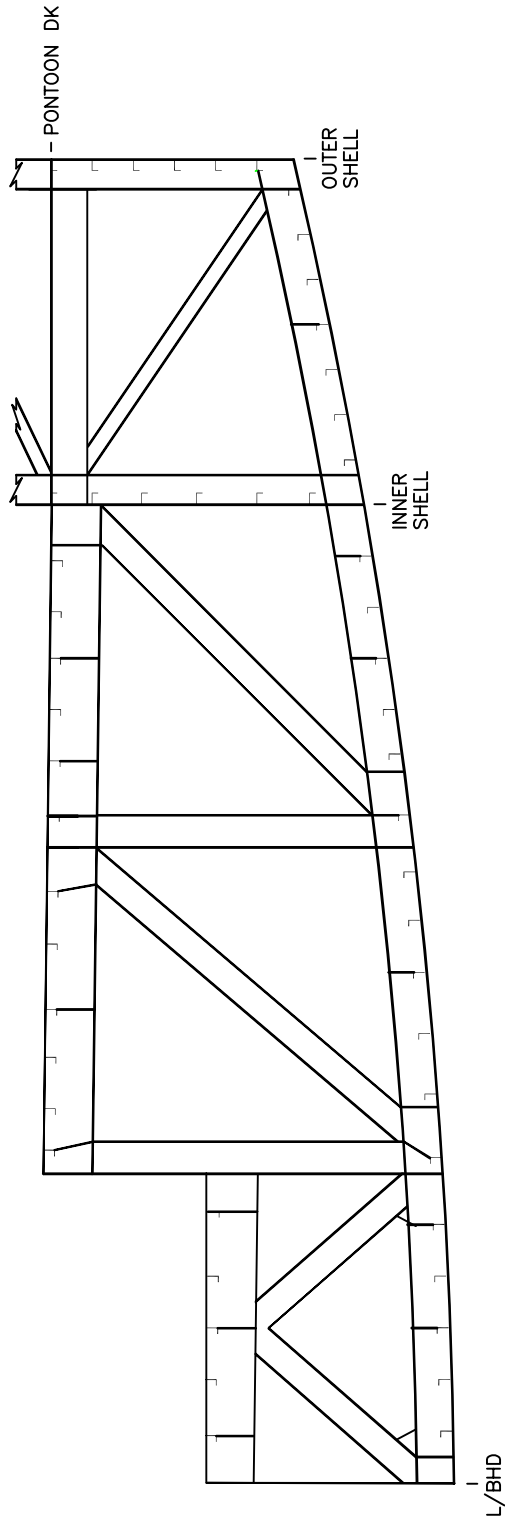
TANK No.3 - FRAME 58  
DESCRIPTION: LOOKING NORTH

**No visual indications found at time of survey.**

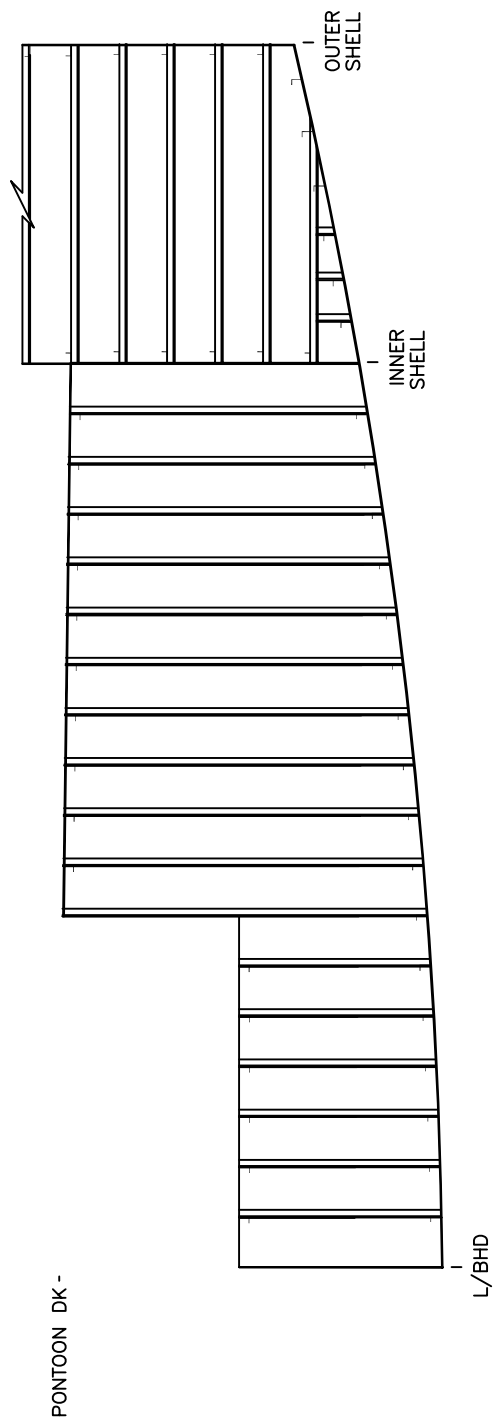
TANK No.3 - BULKHEAD 54  
DESCRIPTION: LOOKING NORTH

**No visual indications found at time of survey.**

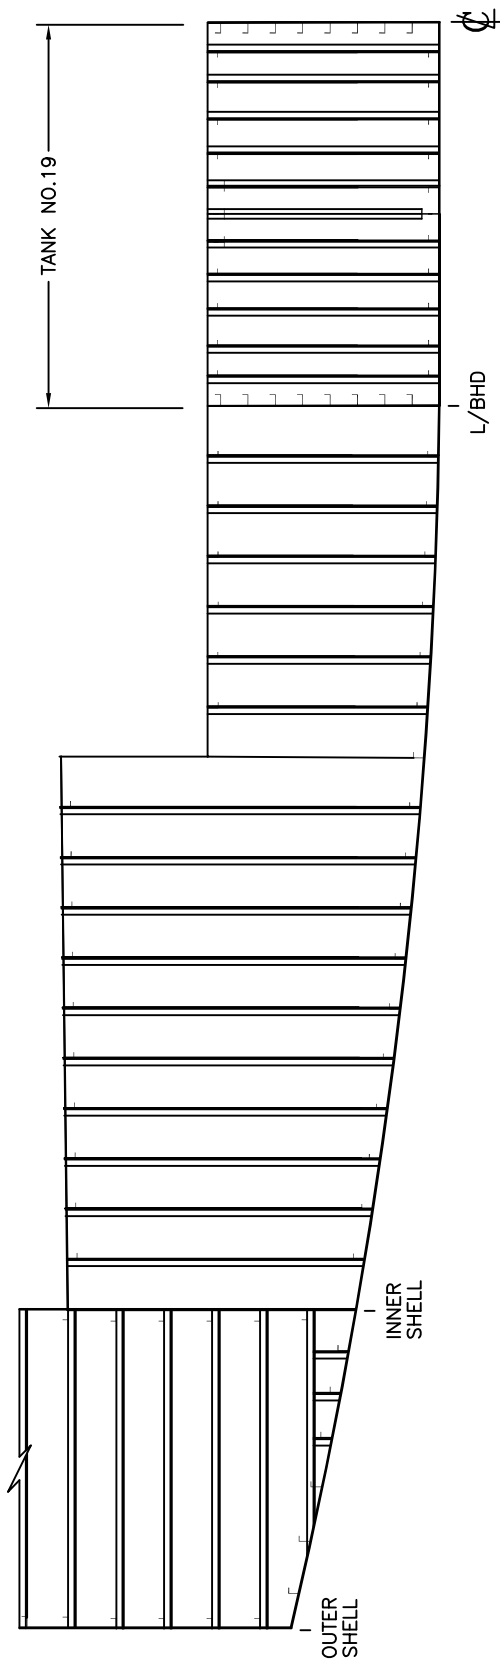
TANK No.4 & 19 - BULKHEAD 59  
DESCRIPTION: LOOKING NORTH

No visual indications found at time of survey.

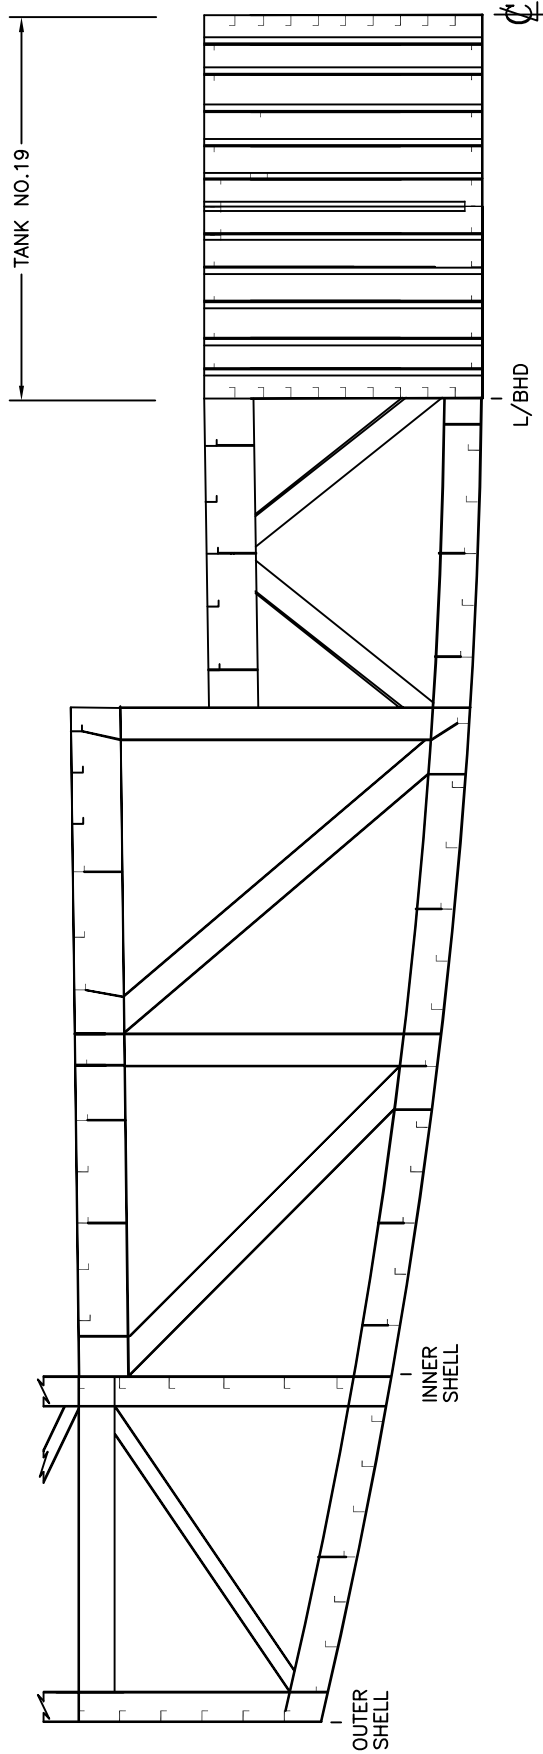
TANK No.4 & 19 - FRAME 55  
DESCRIPTION: LOOKING NORTH

No visual indications found at time of survey.

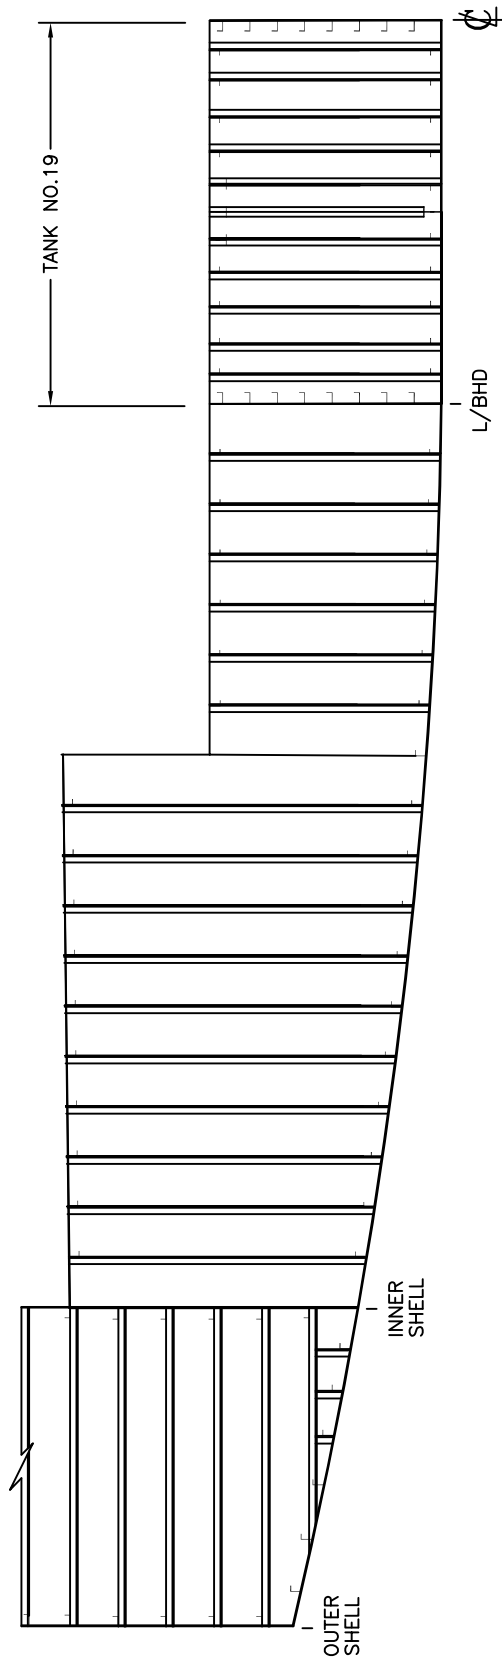
TANK No.4 & 19 - BULKHEAD 54  
 DESCRIPTION: LOOKING NORTH

No visual indications found at time of survey.

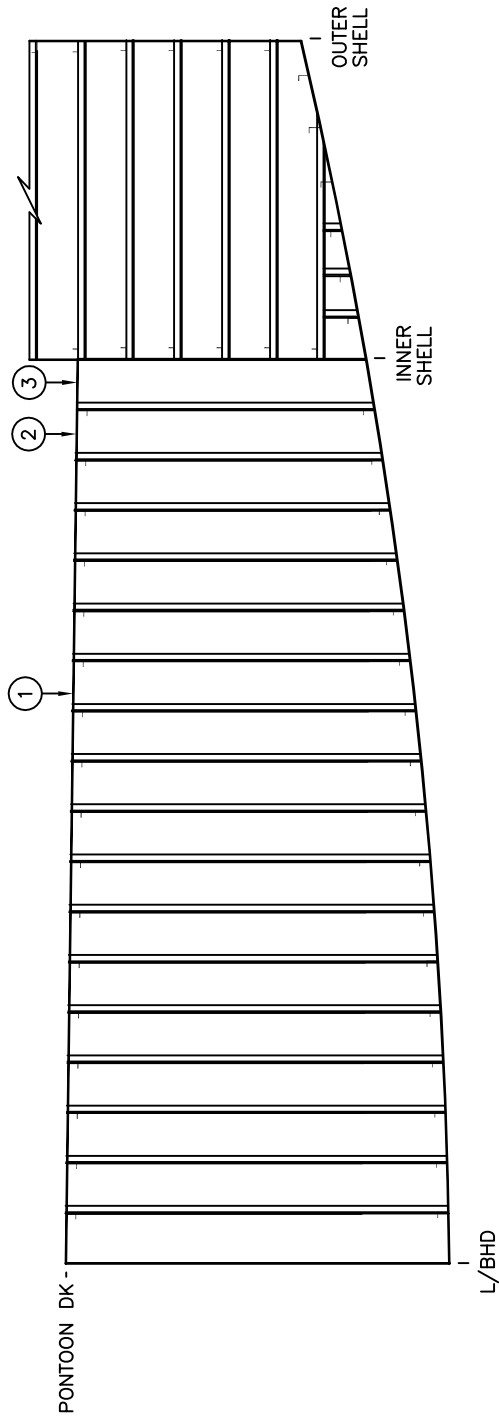
TANK No.5A - BULKHEAD 54  
DESCRIPTION: LOOKING NORTH

- 1.) Pinhole in deck plating, 10" south of bulkhead.
- 2.) 4" diameter hole, 40" south of bulkhead.
- 3.) 1" diameter hole, 33" south of bulkhead.

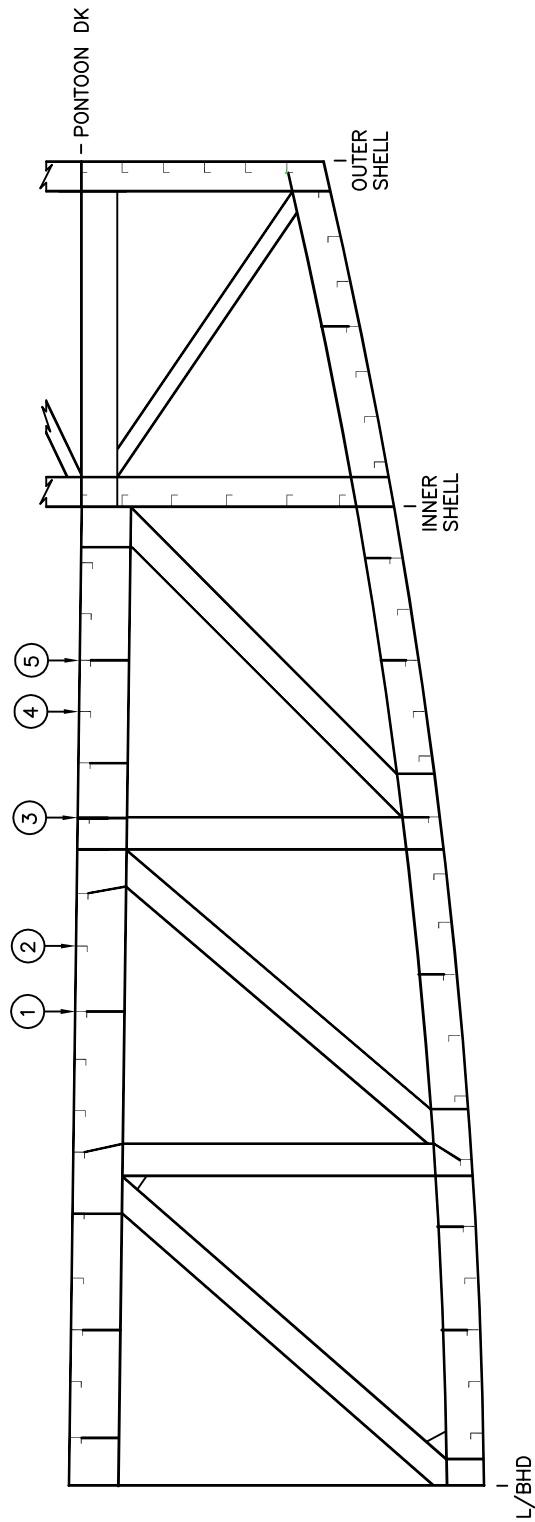
TANK No.5A - FRAME 53  
 DESCRIPTION: LOOKING NORTH

- 1.) 1" fracture at wrap weld, 20" north of frame.
- 2.) 1 ½" fracture at wrap weld, 20" north of frame.
- 3.) 3" Fracture in web of longitudinal in way of channel cut-out, 17" north of frame.
- 4.) 1 ½" Fracture in web of longitudinal in way of channel cut-out, 17" south of frame.
- 5.) 1" Fracture in web of longitudinal in way of channel cut-out, 17" north of frame.

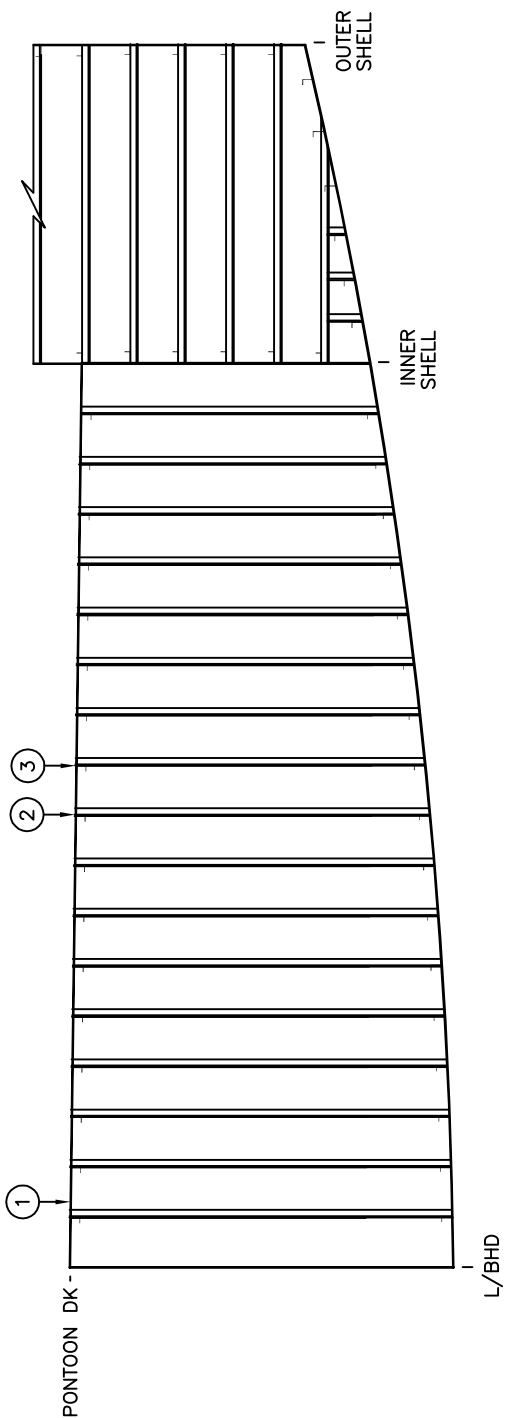
TANK No.5A - BULKHEAD 52  
DESCRIPTION: LOOKING NORTH

- 1.) 1/4" hole on deck plate, 18" north of bulkhead.
- 2.) 2" Fracture in web of longitudinal in way of channel cut-out, 17" north of bulkhead.
- 3.) 2" Fracture in web of longitudinal in way of channel cut-out, 17" north of bulkhead.

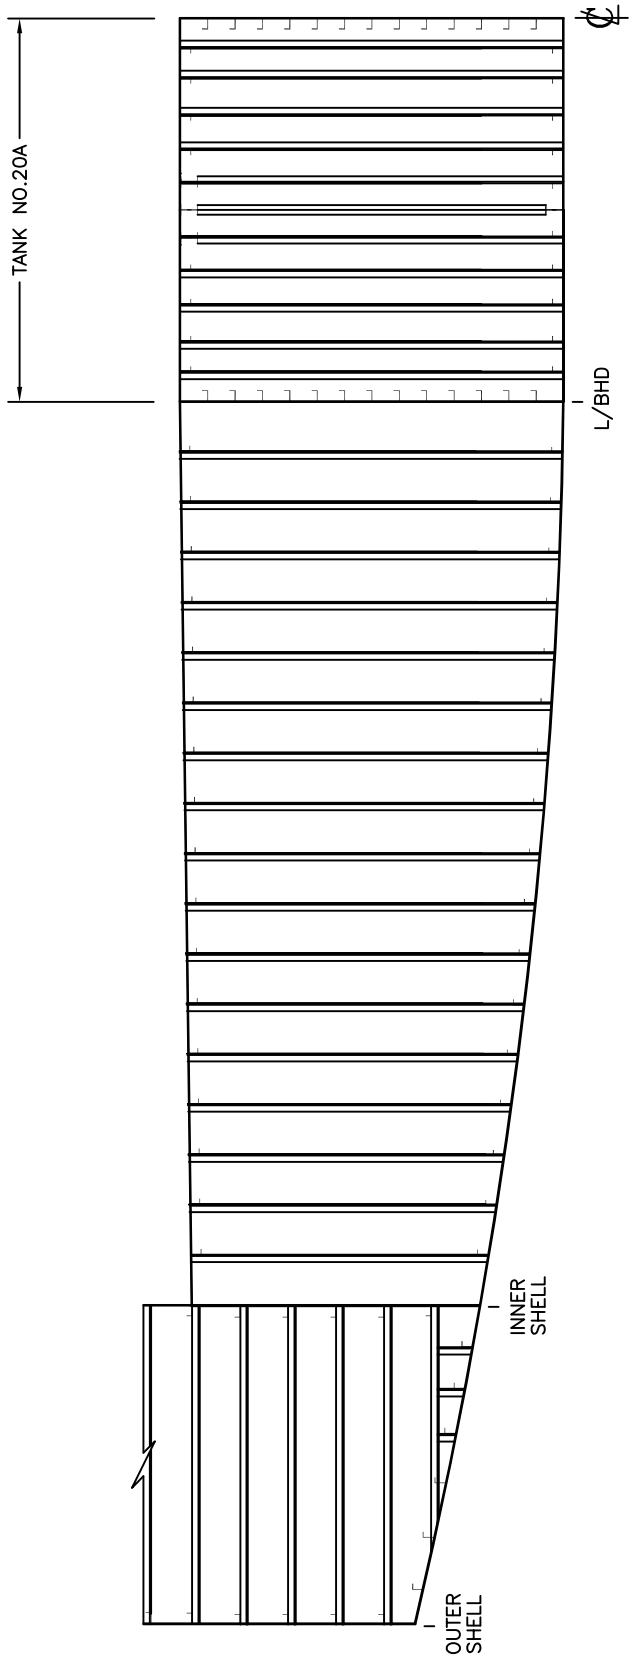
TANK NO. 6A & 20A - BULKHEAD 54  
 DESCRIPTION: LOOKING NORTH

No visual indications found at time of survey.

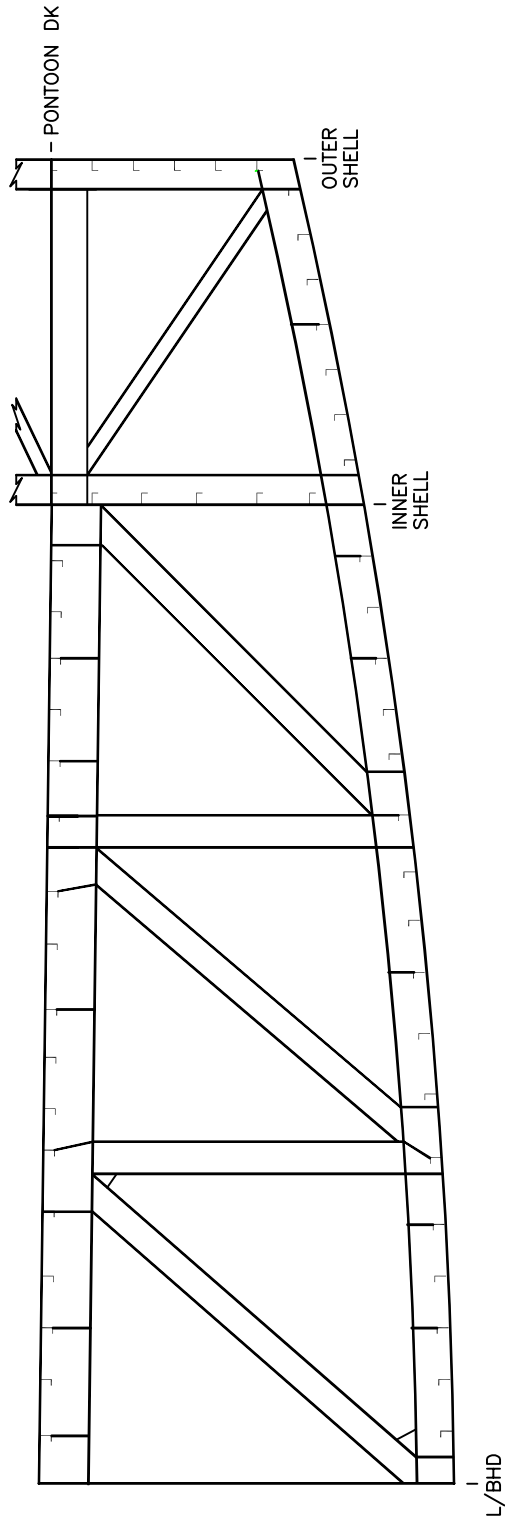
TANK No.5 - FRAME 51  
DESCRIPTION: LOOKING NORTH

**No visual indications found at time of survey.**

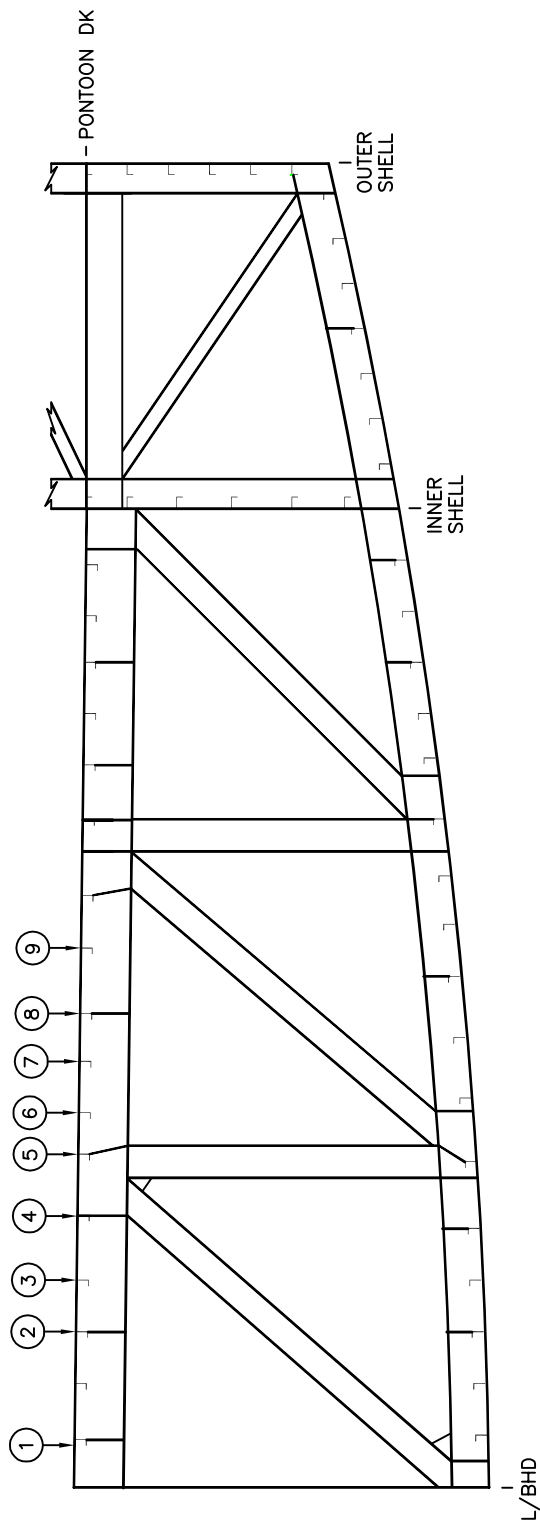
TANK No.5 - FRAME 50  
DESCRIPTION: LOOKING NORTH

- 1.) 3"Ø hole in deck plating, 6" south of frame.
- 2.) 1" Fracture in web of longitudinal in way of channel cut-out, 17" north of frame.
- 3.) 1" Fracture in web of longitudinal in way of channel cut-out, 17" north of frame.
- 4.) 1" Fracture in web of longitudinal in way of channel cut-out, 17" north of frame.
- 5.) 1" Fracture in web of longitudinal in way of channel cut-out, 17" north of frame.
- 6.) 1" Fracture in web of longitudinal in way of channel cut-out, 17" north of frame.
- 7.) 1" Fracture in web of longitudinal in way of channel cut-out, 17" north of frame.
- 8.) 1" Fracture in web of longitudinal in way of channel cut-out, 17" north of frame.
- 9.) 1" Fracture in web of longitudinal in way of channel cut-out, 17" north of frame.

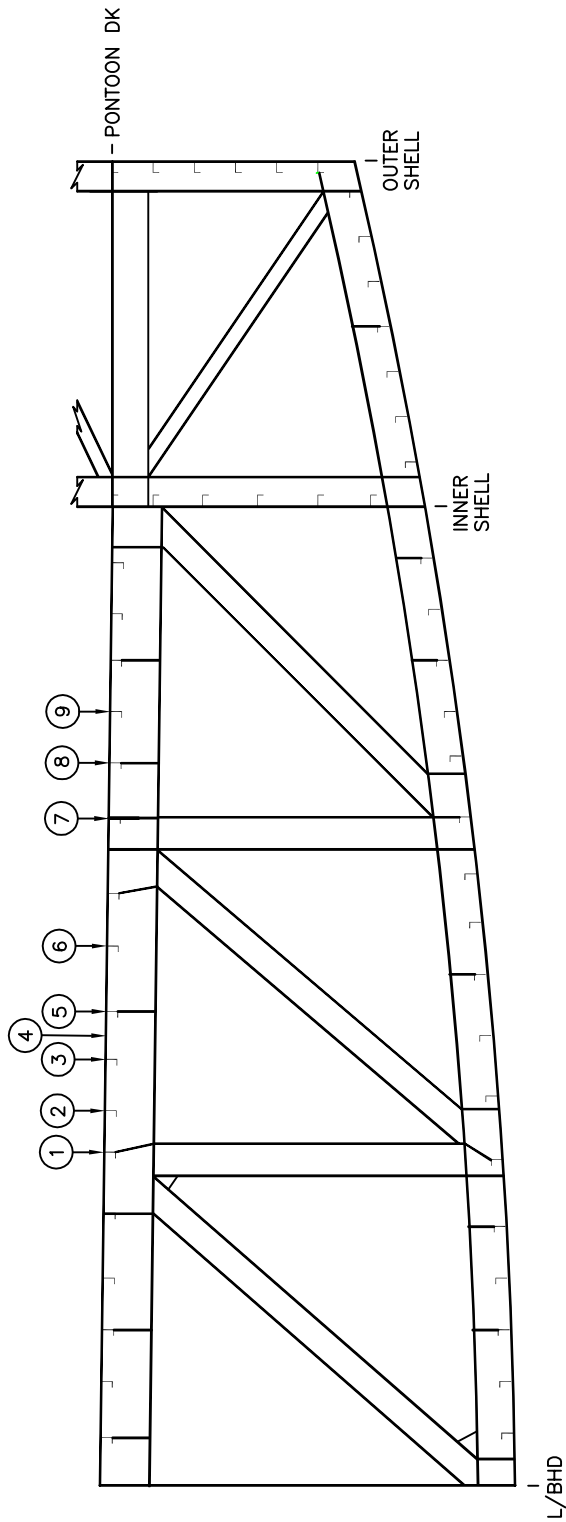
TANK No.5 - FRAME 46  
 DESCRIPTION: LOOKING NORTH

- 1.) 2" Fracture in web of longitudinal in way of channel cut-out, 17" south of frame.
- 2.) 2" Fracture in web of longitudinal in way of channel cut-out, 17" south of frame.
- 3.) 1" Fracture in web of longitudinal in way of channel cut-out, 17" south of frame.
- 4.) ½" diameter hole on deck plate, 16" south of frame.
- 5.) 2" Fracture in web of longitudinal in way of channel cut-out, 17" south of frame.
- 6.) 1" Fracture in web of longitudinal in way of channel cut-out, 17" south of frame.
- 7.) 2" Fracture in web of longitudinal in way of channel cut-out, 17" south of frame.
- 8.) 2" Fracture in web of longitudinal in way of channel cut-out, 34" south of frame.
- 9.) 2" Fracture in web of longitudinal in way of channel cut-out, 34" north of frame.

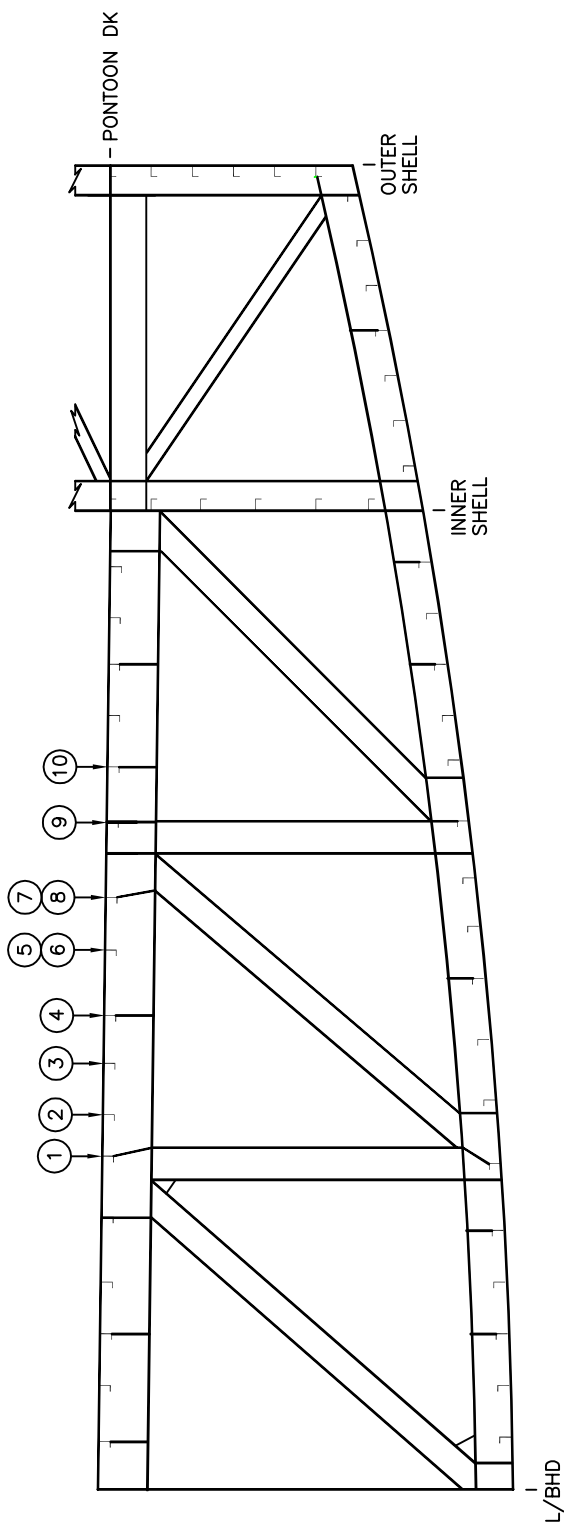
TANK No.5 - FRAME 45  
 DESCRIPTION: LOOKING NORTH

- 1.) 2" Fracture in web of longitudinal in way of channel cut-out, 17" south of frame.
- 2.) 2" Fracture in web of longitudinal in way of channel cut-out, 17" north of frame.
- 3.) 1" Fracture in web of longitudinal in way of channel cut-out, 17" south of frame.
- 4.) 1" Fracture in web of longitudinal in way of channel cut-out, 17" south of frame.
- 5.) 2" Fracture in web of longitudinal in way of channel cut-out, 17" south of frame.
- 6.) 2" Fracture in web of longitudinal in way of channel cut-out, 17" north of frame.
- 7.) ½" diameter hole on deck plate at wrap weld 6" north of frame.
- 8.) 2" Fracture in web of longitudinal in way of channel cut-out, 17" south of frame.
- 9.) 2" Fracture in web of longitudinal in way of channel cut-out, 17" south of frame.
- 10.) 2" Fracture in web of longitudinal in way of channel cut-out, 17" south of frame.

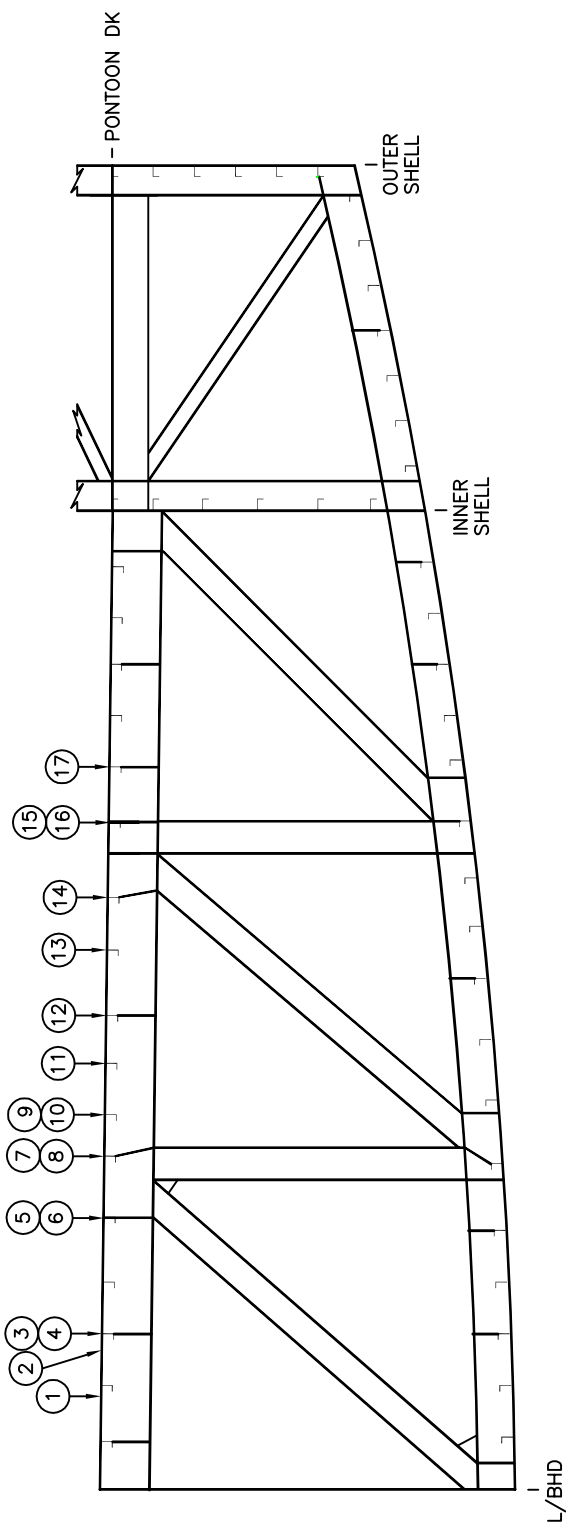
TANK No.5 - FRAME 44  
 DESCRIPTION: LOOKING NORTH

- 1.) ½” diameter hole on deck plate, 23” south of frame.
- 2.) ¼” diameter hole on deck plate, 42” south of frame.
- 3.) 1” Fracture in web of longitudinal in way of channel cut-out, 17” south of frame.

- 4.) 2” Fracture in web of longitudinal in way of channel cut-out, 17” north of frame.
- 5.) 2” Fracture in web of longitudinal in way of channel cut-out, 17” south of frame.

- 6.) 2” Fracture in web of longitudinal in way of channel cut-out, 17” north of frame.
- 7.) 2” Fracture in web of longitudinal in way of channel cut-out, 17” south of frame.

- 8.) 1” Fracture in web of longitudinal in way of channel cut-out, 17” north of frame.
- 9.) 2” Fracture in web of longitudinal in way of channel cut-out, 17” south of frame.

- 10.) 2” Fracture in web of longitudinal in way of channel cut-out, 17” north of frame.
- 11.) 2” Fracture in web of longitudinal in way of channel cut-out, 17” south of frame.

- 12.) 2” Fracture in web of longitudinal in way of channel cut-out, 17” south of frame.
- 13.) 2” Fracture in web of longitudinal in way of channel cut-out, 17” north of frame.

- 14.) 2” Fracture in web of longitudinal in way of channel cut-out, 17” north of frame.
- 15.) 1 ½” Fracture in web of longitudinal in way of channel cut-out, 17” south of frame.

- 16.) 2" Fracture in web of longitudinal in way of channel cut-out, 17" north of frame.
- 17.) 1" Fracture in web of longitudinal in way of channel cut-out, 17" south of frame.
