## EUREKA DRY DOCK UT /VT SURVEY MAY 2015

Ultrasonic thickness measurements and a visual survey was performed for BAE Systems of San Francisco on the Eureka Dry Dock located at BAE Shipyard in San Francisco, CA. The owners were represented by Mr. Justin Gleaton. The survey was performed by International Inspection personnel.

## EUREKA DRY DOCK VISUAL SURVEY TABLE OF CONTENTS

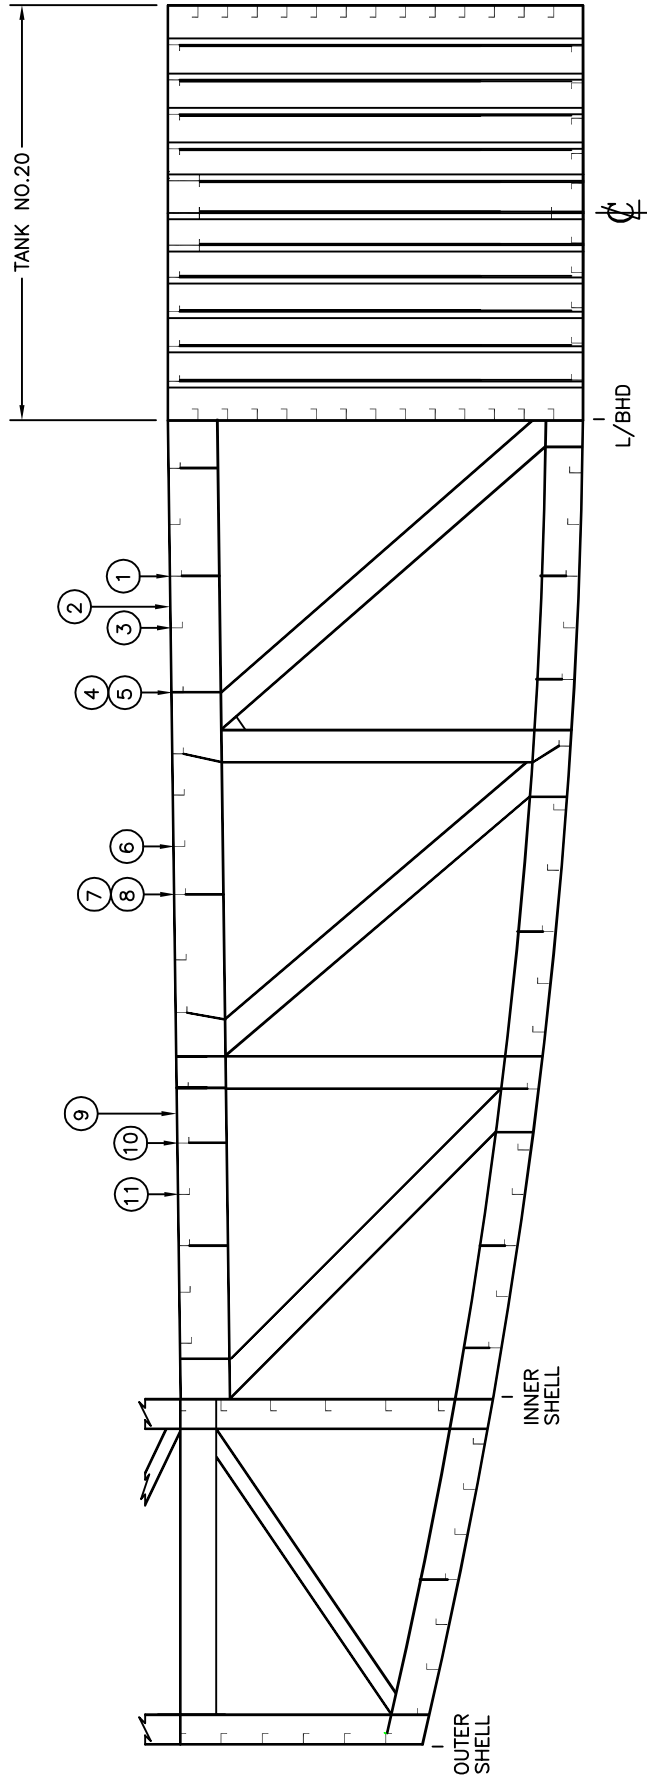
TANK No.6 & 20 - FRAME 46  
 DESCRIPTION: LOOKING NORTH

- 8.) 2” Fracture in web of longitudinal in way of channel cut-out, 17” south of frame.
- 9.) Multiple 1” $\emptyset$  holes in deck plating, 18” north of frame.

- 10.) 2” Fracture in web of longitudinal in way of channel cut-out, 17” south of frame.
- 11.) 2” Fracture in web of longitudinal in way of channel cut-out, 17” south of frame.

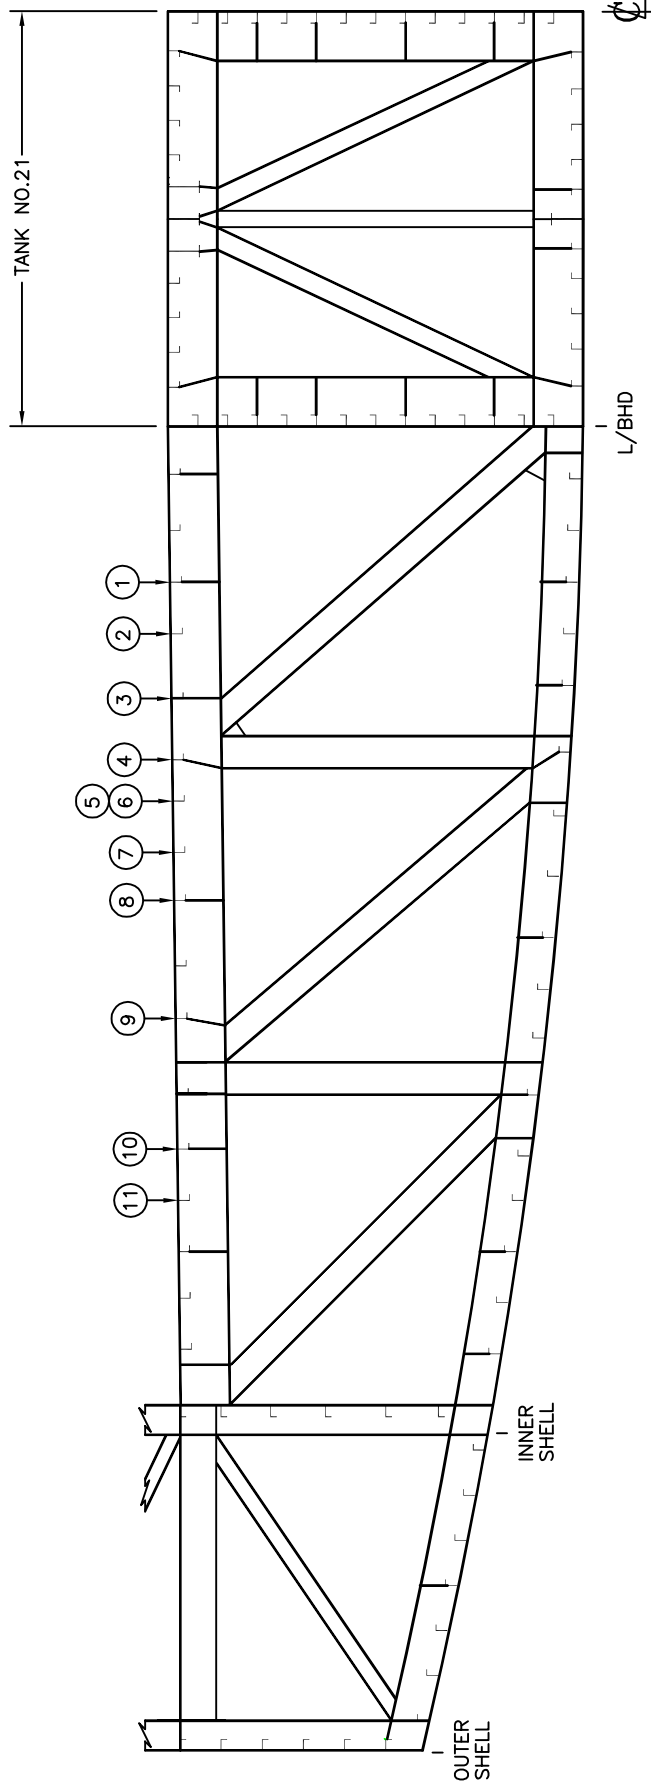
TANK NO. 6 & 21 - FRAME 45

- 9.) 2" Fracture in web of longitudinal in way of channel cut-out, 17" north of frame.
- 10.) 2" Fracture in web of longitudinal in way of channel cut-out, 17" south of frame.

- 11.) 2" Fracture in web of longitudinal in way of channel cut-out, 17" south of frame.

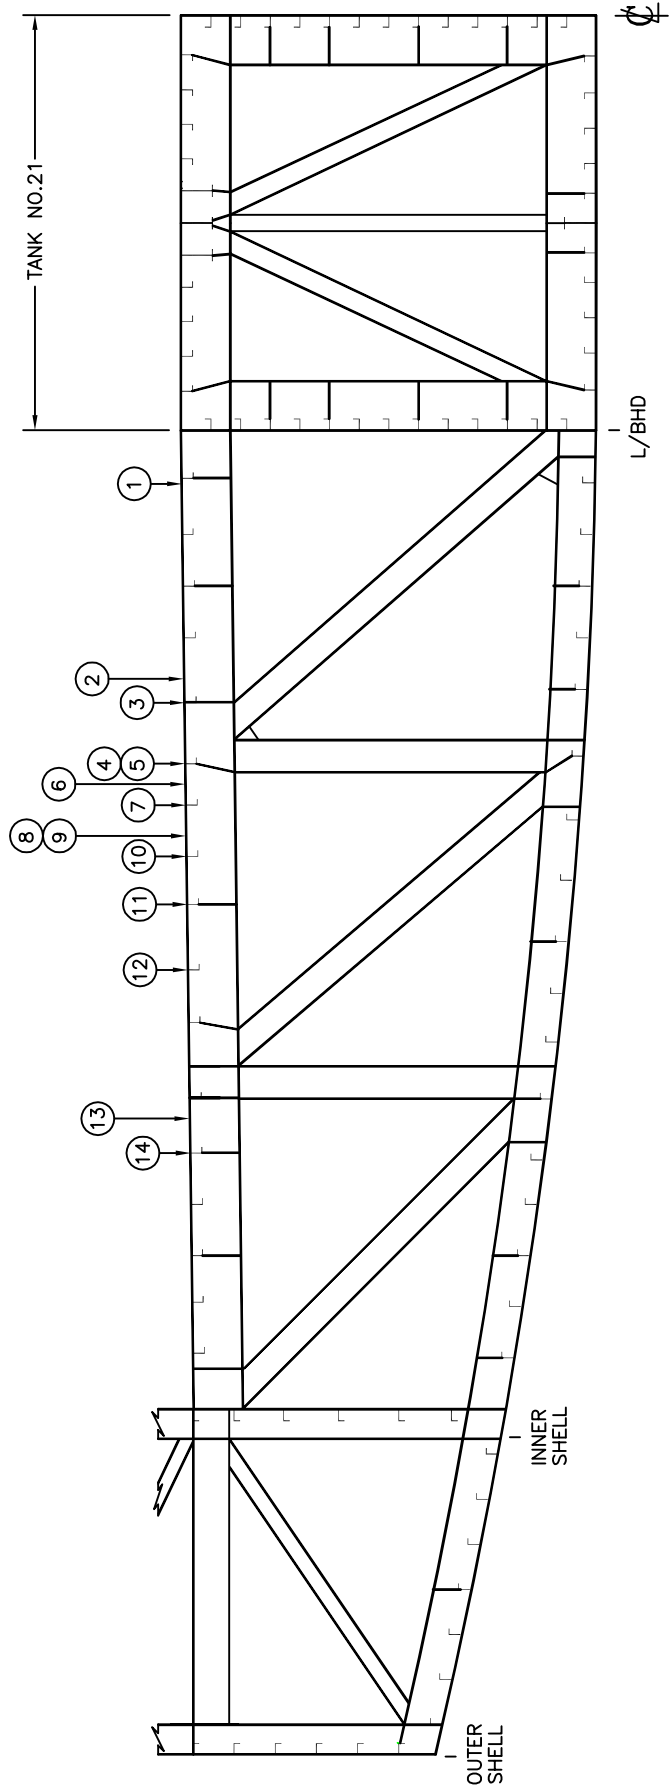
TANK NO. 6 & 21 - FRAME 44

- 9.) 1"Ø hole in deck plating, 36" south of frame.
- 10.) 2" Fracture in web of longitudinal in way of channel cut-out, 17" north of frame.
- 11.) 2" Fracture in web of longitudinal in way of channel cut-out, 17" north of frame.

- 12.) 1" Fracture in web of longitudinal in way of channel cut-out, 17" south of frame.
- 13.) 1"Ø hole in deck plating, 18" south of frame.
- 14.) 2" Fracture in web of longitudinal in way of channel cut-out, 17" north of frame.

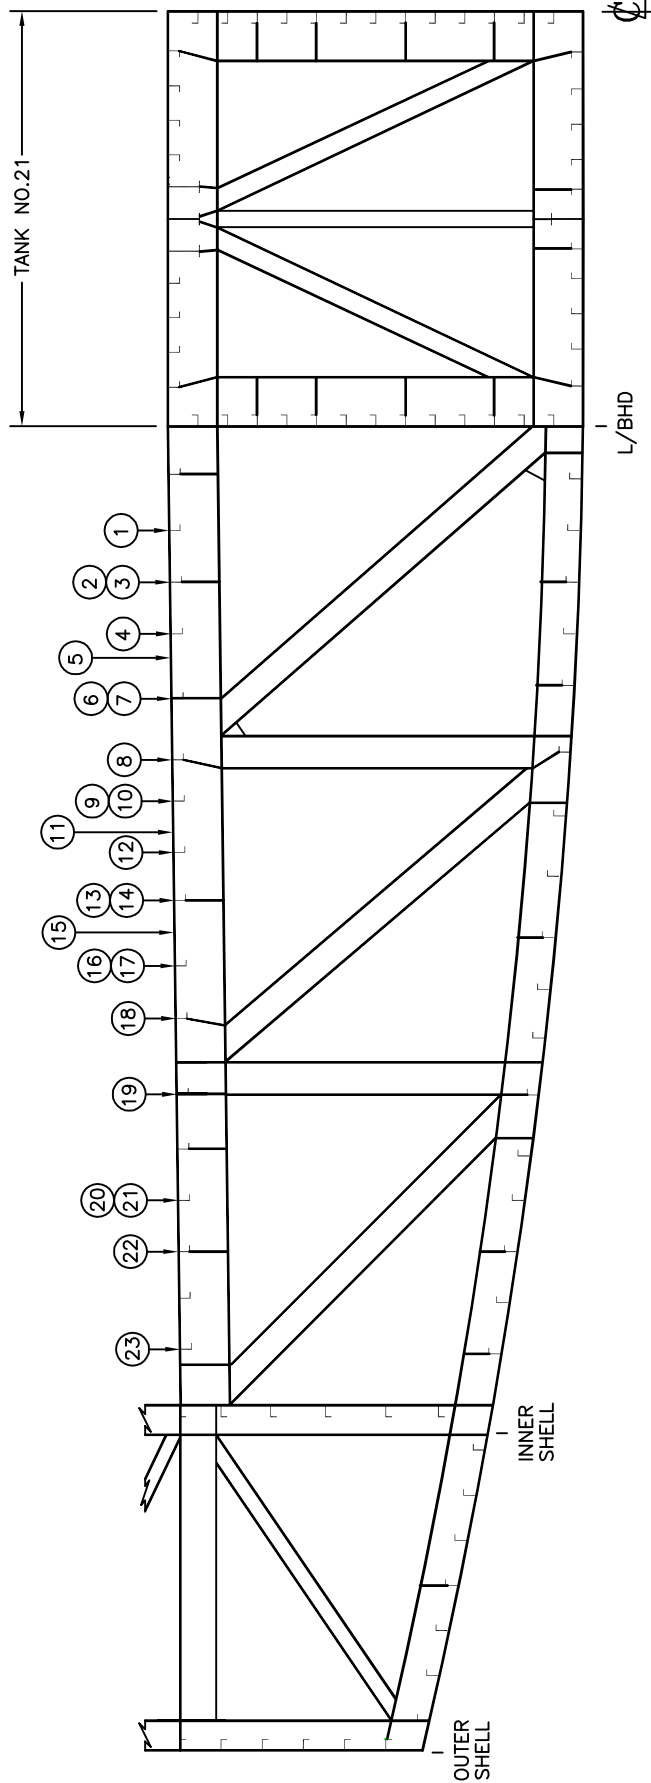
TANK NO. 6 & 21 - FRAME 43

- 16.) 1" Fracture in web of longitudinal in way of channel cut-out, 17" north of frame.
- 17.) 1" Fracture in web of longitudinal in way of channel cut-out, 17" south of frame.
- 18.) 1" Fracture in web of longitudinal in way of channel cut-out, 17" north of frame.
- 19.) 10" Fracture in attachment weld of longitudinal starting 20" north of frame.
- 20.) 1" Fracture in web of longitudinal in way of channel cut-out, 17" north of frame.
- 21.) 1" Fracture in web of longitudinal in way of channel cut-out, 17" south of frame.
- 22.) 1" Fracture in web of longitudinal in way of channel cut-out, 17" north of frame.
- 23.) 1" Fracture in web of longitudinal in way of channel cut-out, 17" north of frame.

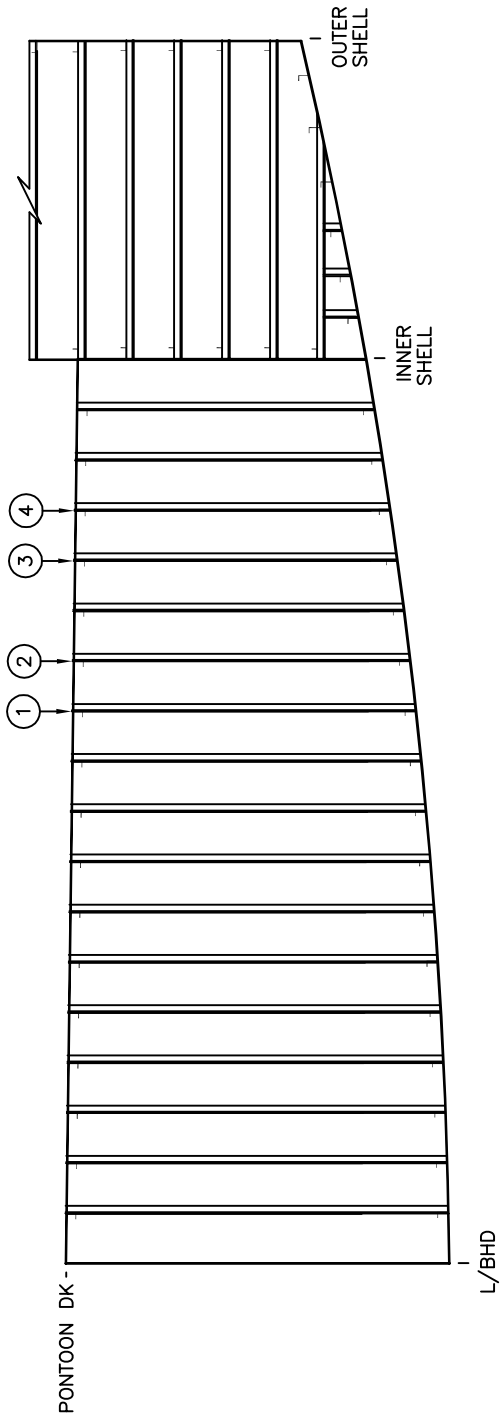
TANK No.7 - BULKHEAD 42  
DESCRIPTION: LOOKING NORTH

- 1.) 1" Fracture in web of longitudinal in way of channel cut-out, 17" south of frame.
- 2.) 1" Fracture in web of longitudinal in way of channel cut-out, 17" south of frame.
- 3.) 1" Fracture in web of longitudinal in way of channel cut-out, 17" south of frame.
- 4.) 1" Fracture in web of longitudinal in way of channel cut-out, 17" south of frame.

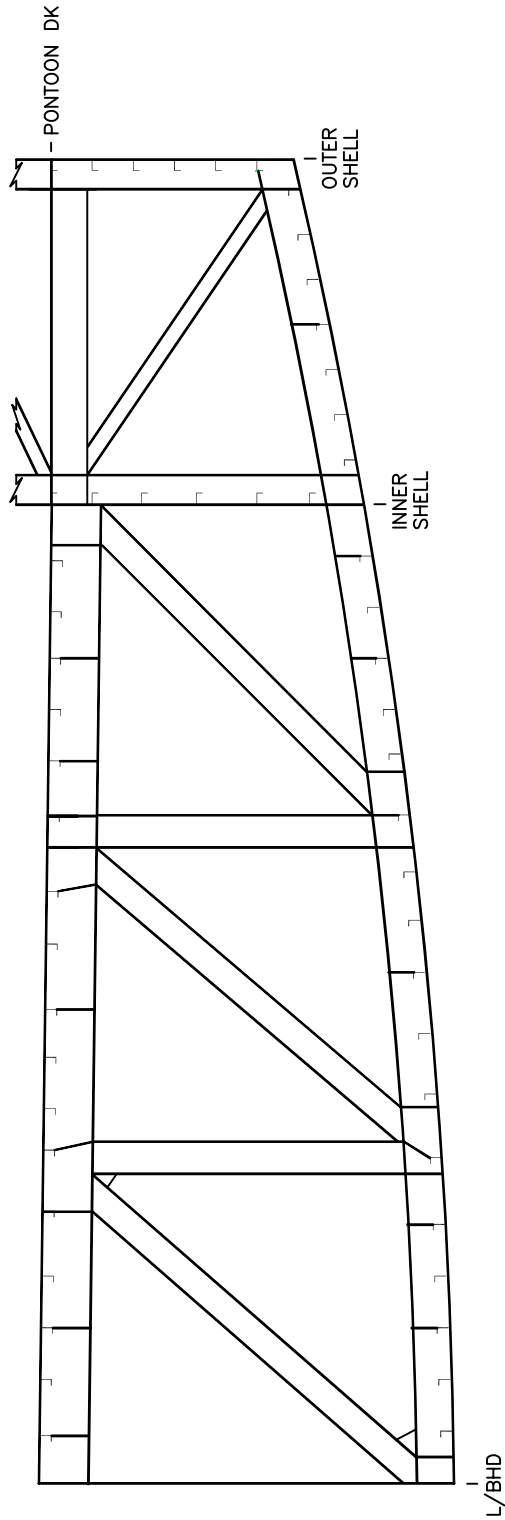
TANK No.7 - FRAME 41  
DESCRIPTION: LOOKING NORTH

No visual indications found at time of survey.

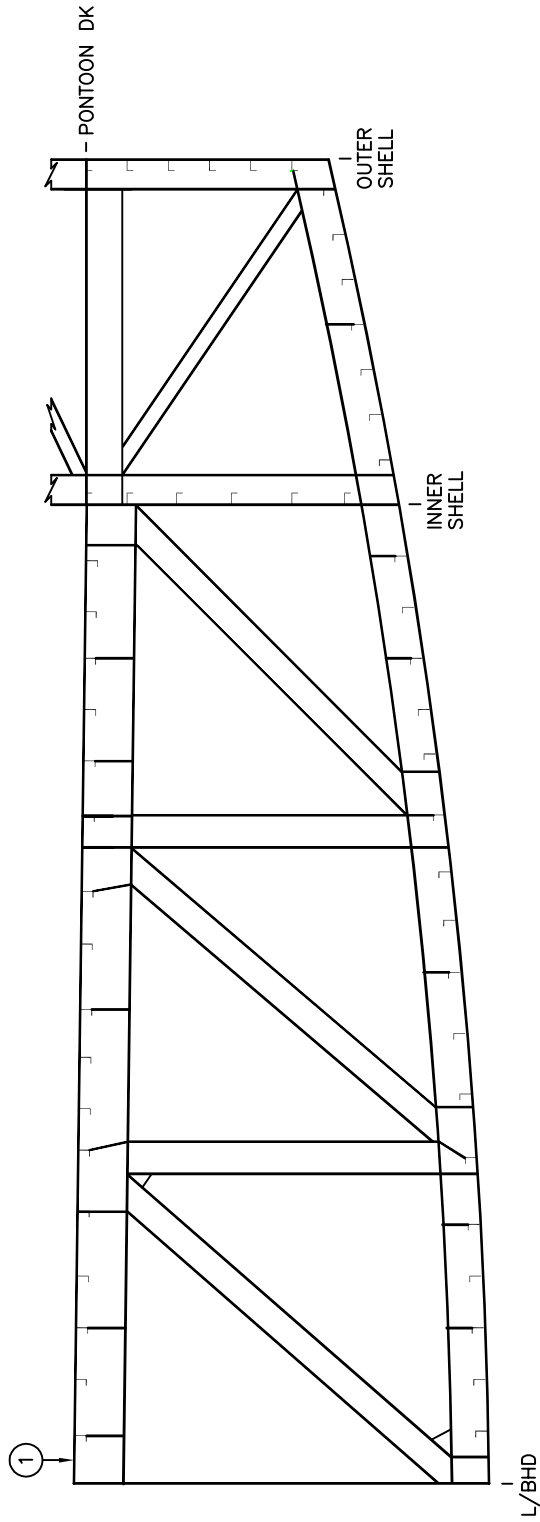
TANK No.7 - FRAME 37  
DESCRIPTION: LOOKING NORTH

**FRAME 37**

- 1.) 1"Ø hole in deck plating, 1" south of frame.

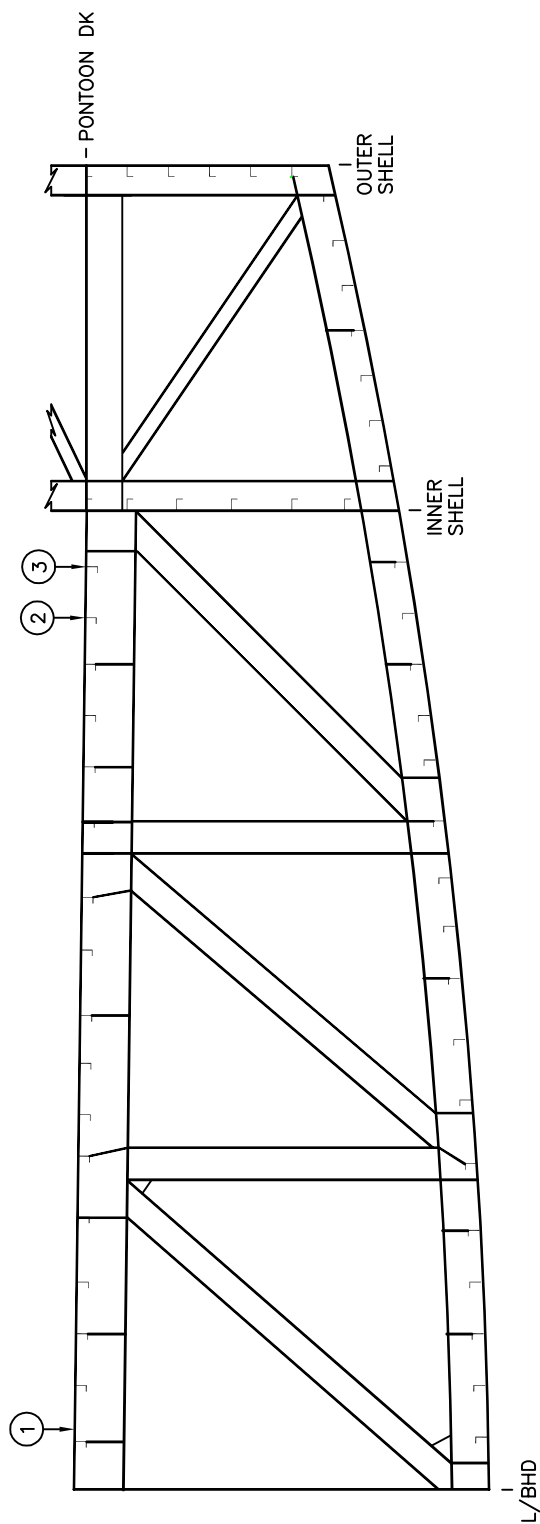
TANK No.7 - FRAME 36  
 DESCRIPTION: LOOKING NORTH

### FRAME 36

- 1.) 1" x 3" hole in deck plating, 1" north of frame.
- 2.) 10" Fracture in attachment weld of longitudinal starting 20" north of frame.
- 3.) 10" Fracture in attachment weld of longitudinal starting 20" north of frame.

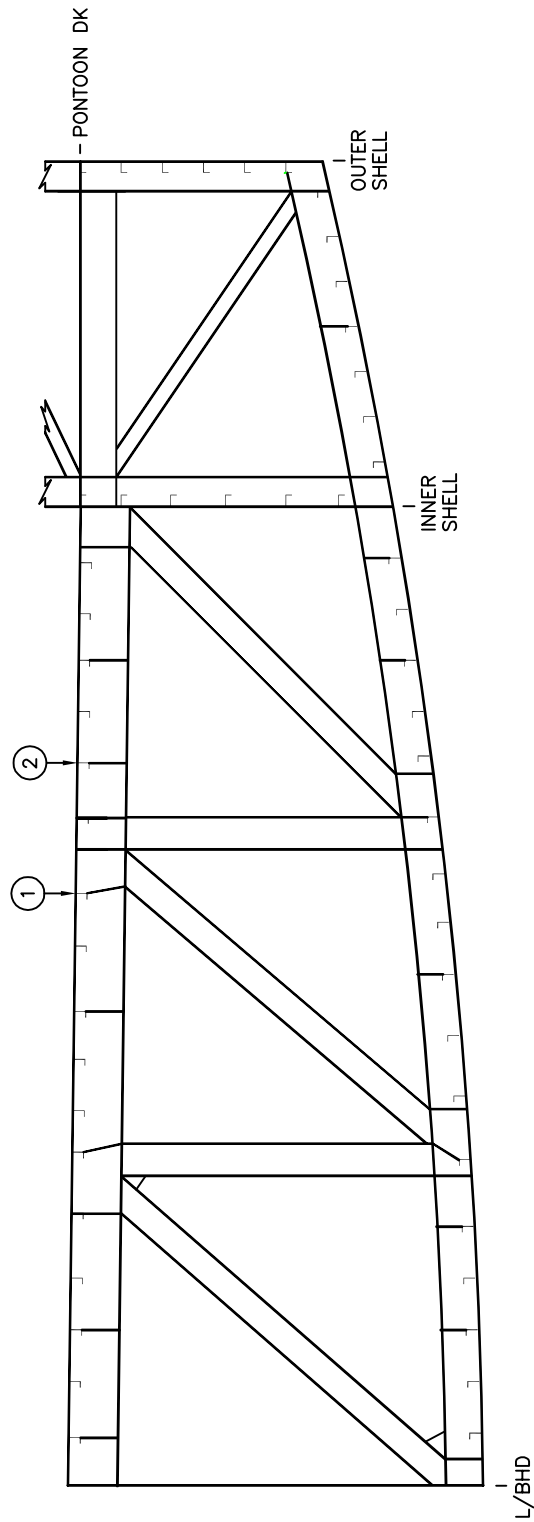
TANK No.7 - FRAME 35  
DESCRIPTION: LOOKING NORTH

### FRAME 35

- 1.) 14" Fracture in attachment weld of longitudinal starting 6" north of frame.
- 2.) 14" Fracture in attachment weld of longitudinal starting 6" north of frame.

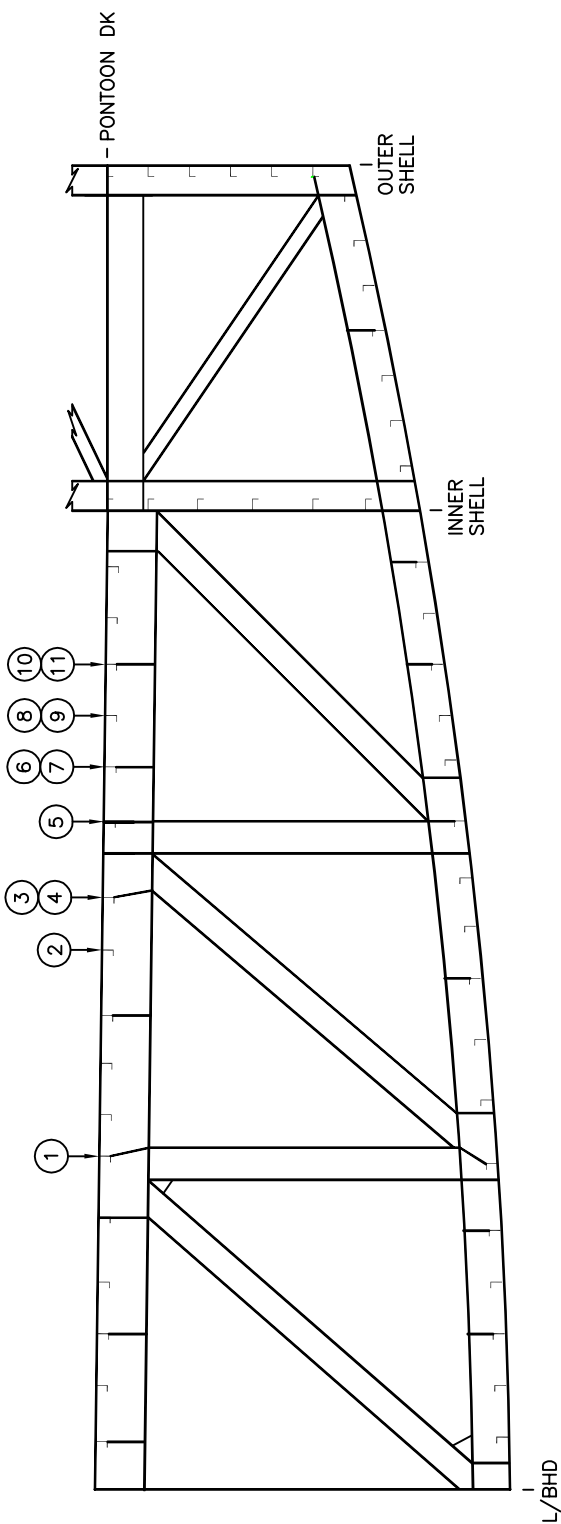
TANK No.7 - FRAME 34  
DESCRIPTION: LOOKING NORTH

- 1.) 1" Fracture in web of longitudinal in way of channel cut-out, 17" south of frame.
- 2.) 1 ½" Fracture in web of longitudinal in way of channel cut-out, 17" south of frame.

- 3.) 1" Fracture in web of longitudinal in way of channel cut-out, 17" north of frame.
- 4.) 1" Fracture in web of longitudinal in way of channel cut-out, 17" south of frame.

- 5.) 1 ½" Fracture in web of longitudinal in way of channel cut-out, 17" south of frame.
- 6.) 1" Fracture in web of longitudinal in way of channel cut-out, 17" north of frame.

- 7.) 1 ½" Fracture in web of longitudinal in way of channel cut-out, 17" south of frame.
- 8.) 1" Fracture in web of longitudinal in way of channel cut-out, 17" north of frame.

- 9.) 1" Fracture in web of longitudinal in way of channel cut-out, 17" south of frame.
- 10.) 1" Fracture in web of longitudinal in way of channel cut-out, 17" north of frame.

- 11.) 1" Fracture in web of longitudinal in way of channel cut-out, 17" south of frame.

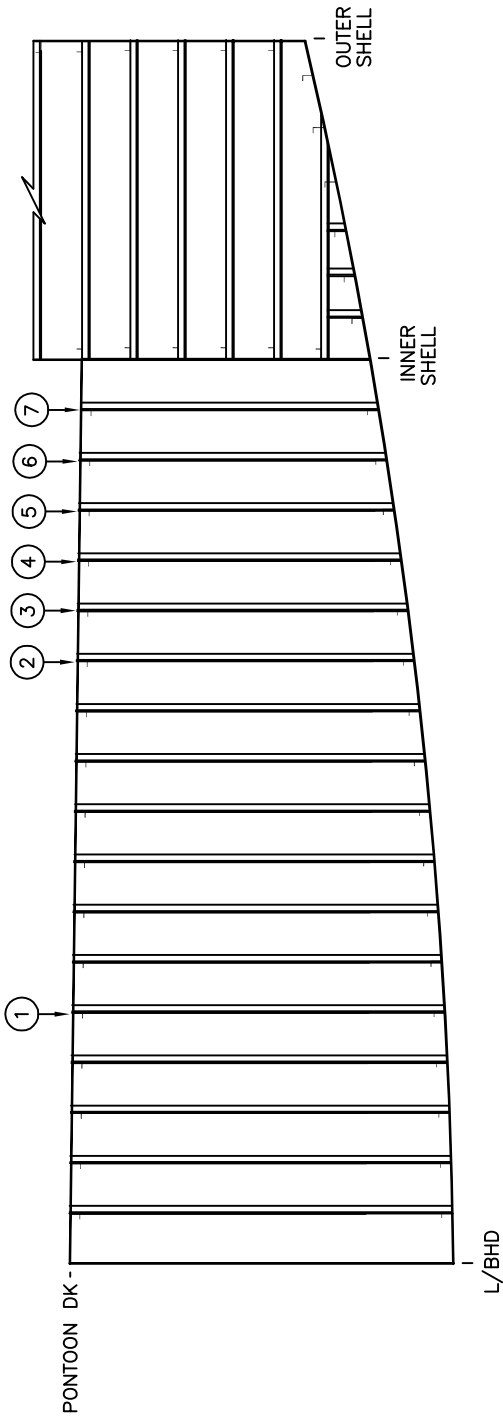
TANK No.9 - BULKHEAD 31  
DESCRIPTION: LOOKING NORTH

### **BULKHEAD 31**

- 1.) 1 ½” Fracture in web of longitudinal in way of channel cut-out, 17” south of bulkhead.
- 2.) 1 ½” Fracture in web of longitudinal in way of channel cut-out, 17” south of bulkhead.
- 3.) 1 ½” Fracture in web of longitudinal in way of channel cut-out, 17” south of bulkhead.
- 4.) 1 ½” Fracture in web of longitudinal in way of channel cut-out, 17” south of bulkhead.
- 5.) 1 ½” Fracture in web of longitudinal in way of channel cut-out, 17” south of bulkhead.
- 6.) 1 ½” Fracture in web of longitudinal in way of channel cut-out, 17” south of bulkhead.
- 7.) 1 ½” Fracture in web of longitudinal in way of channel cut-out, 17” south of bulkhead.

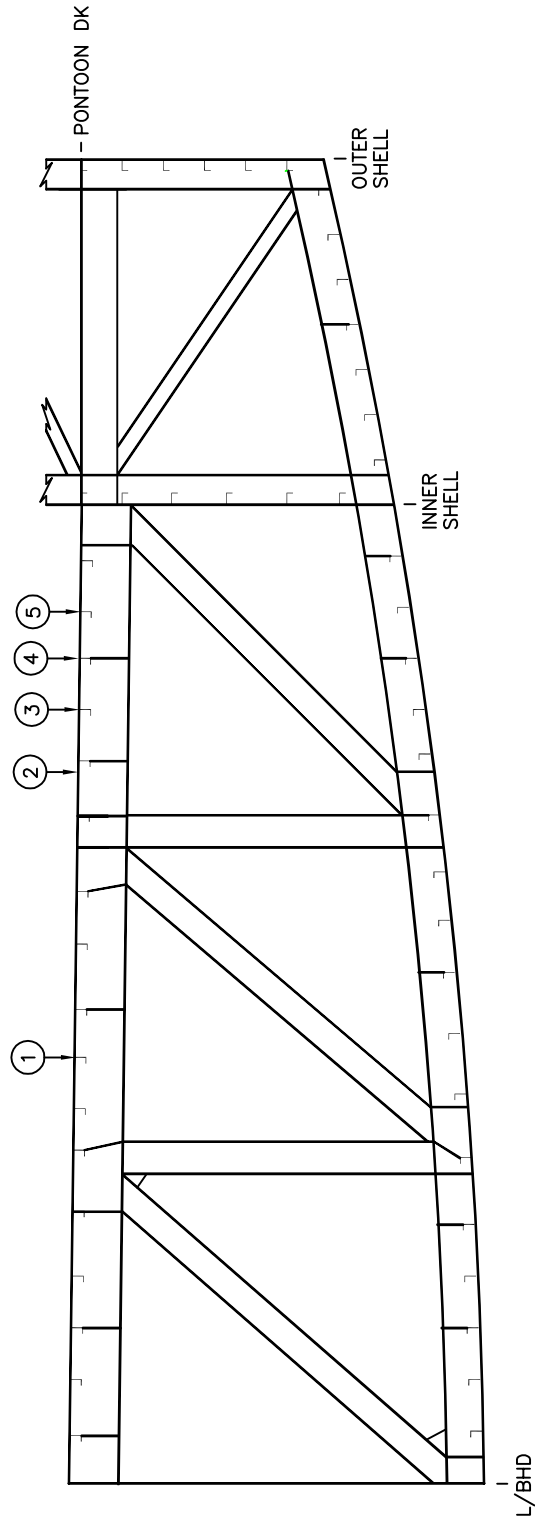
TANK No.9 - FRAME 27  
 DESCRIPTION: LOOKING NORTH

### FRAME 27

- 1.) 2" Fracture in web of longitudinal in way of channel cut-out, 17" south of frame.
- 2.) ½" diameter hole on deck plating, 6" north of frame.
- 3.) 2" Fracture in web of longitudinal in way of channel cut-out, 17" south of frame.
- 4.) 2" Fracture in web of longitudinal in way of channel cut-out, 17" south of frame.
- 5.) 1" diameter hole on deck plating, 8" south of frame.

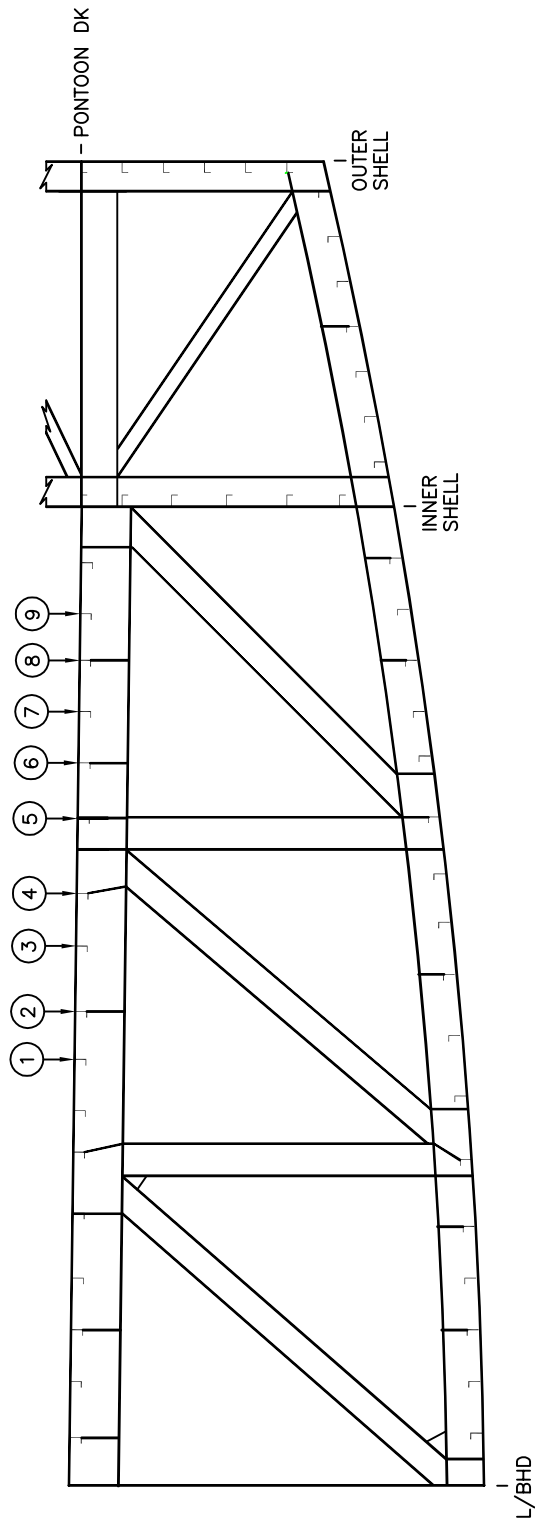
TANK No.9 - FRAME 26  
 DESCRIPTION: LOOKING NORTH

### FRAME 26

- 1.) 2" Fracture in web of longitudinal in way of channel cut-out, 17" south of frame.
- 2.) 2" Fracture in web of longitudinal in way of channel cut-out, 17" south of frame.
- 3.) 2" Fracture in web of longitudinal in way of channel cut-out, 17" south of frame.
- 4.) 2" Fracture in web of longitudinal in way of channel cut-out, 17" south of frame.
- 5.) 2" Fracture in web of longitudinal in way of channel cut-out, 17" south of frame.
- 6.) 2" Fracture in web of longitudinal in way of channel cut-out, 17" south of frame.
- 7.) 2" Fracture in web of longitudinal in way of channel cut-out, 17" south of frame.
- 8.) 2" Fracture in web of longitudinal in way of channel cut-out, 17" south of frame.
- 9.) 2" Fracture in web of longitudinal in way of channel cut-out, 17" north of frame.

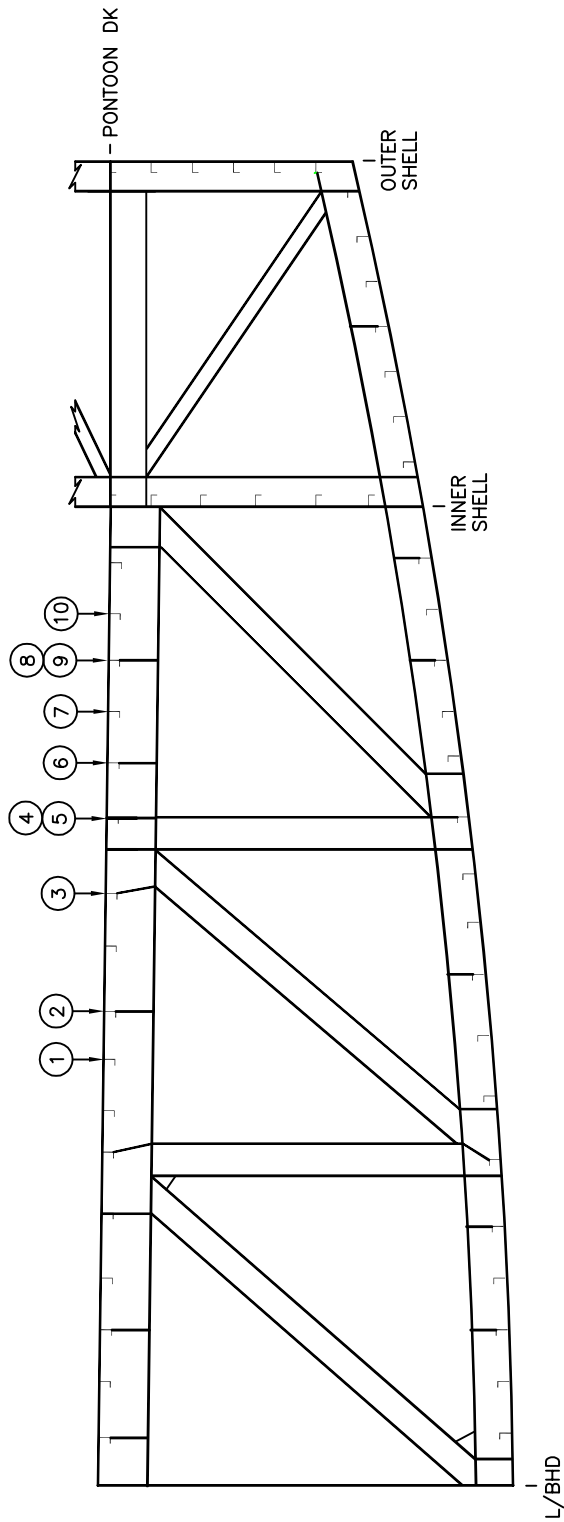
TANK No.9 - FRAME 25  
DESCRIPTION: LOOKING NORTH

### FRAME 25

- 1.) 2" Fracture in web of longitudinal in way of channel cut-out, 17" south of frame.
- 2.) 2" Fracture in web of longitudinal in way of channel cut-out, 17" north of frame.
- 3.) 2" Fracture in web of longitudinal in way of channel cut-out, 17" south of frame.
- 4.) 2" Fracture in web of longitudinal in way of channel cut-out, 17" north of frame.
- 5.) 2" Fracture in web of longitudinal in way of channel cut-out, 17" south of frame.
- 6.) 2" Fracture in web of longitudinal in way of channel cut-out, 17" south of frame.
- 7.) 2" Fracture in web of longitudinal in way of channel cut-out, 17" north of frame.
- 8.) 2" Fracture in web of longitudinal in way of channel cut-out, 17" north of frame.
- 9.) 2" Fracture in web of longitudinal in way of channel cut-out, 17" south of frame.
- 10.) 2" Fracture in web of longitudinal in way of channel cut-out, 17" north of frame.

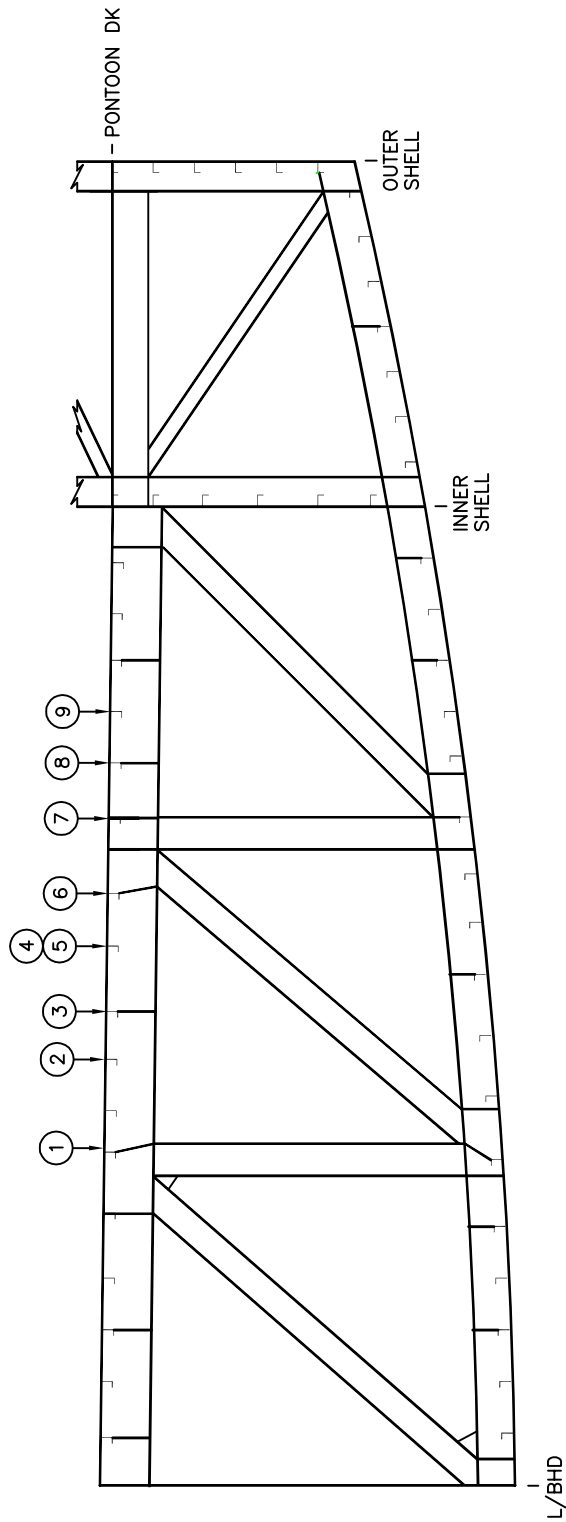
TANK No.9 - FRAME 22  
DESCRIPTION: LOOKING NORTH

### FRAME 22

- 1.) Pinhole on deck plating, 12" north of frame.
- 2.) ½" diameter hole on deck plating in way of wrap weld, 24" south of frame.
- 3.) 1" diameter hole on deck plating in way of wrap weld, 6" south of frame.
- 4.) ½" diameter hole on deck plating in way of wrap weld, 17" north of frame.
- 5.) 1" Fracture in web of longitudinal in way of channel cut-out, 17" south of frame.
- 6.) 1" Fracture in web of longitudinal in way of channel cut-out, 17" south of frame.
- 7.) 1" Fracture in web of longitudinal in way of channel cut-out, 17" south of frame.
- 8.) 1" Fracture in web of longitudinal in way of channel cut-out, 17" south of frame.
- 9.) 1" Fracture in web of longitudinal in way of channel cut-out, 17" south of frame.

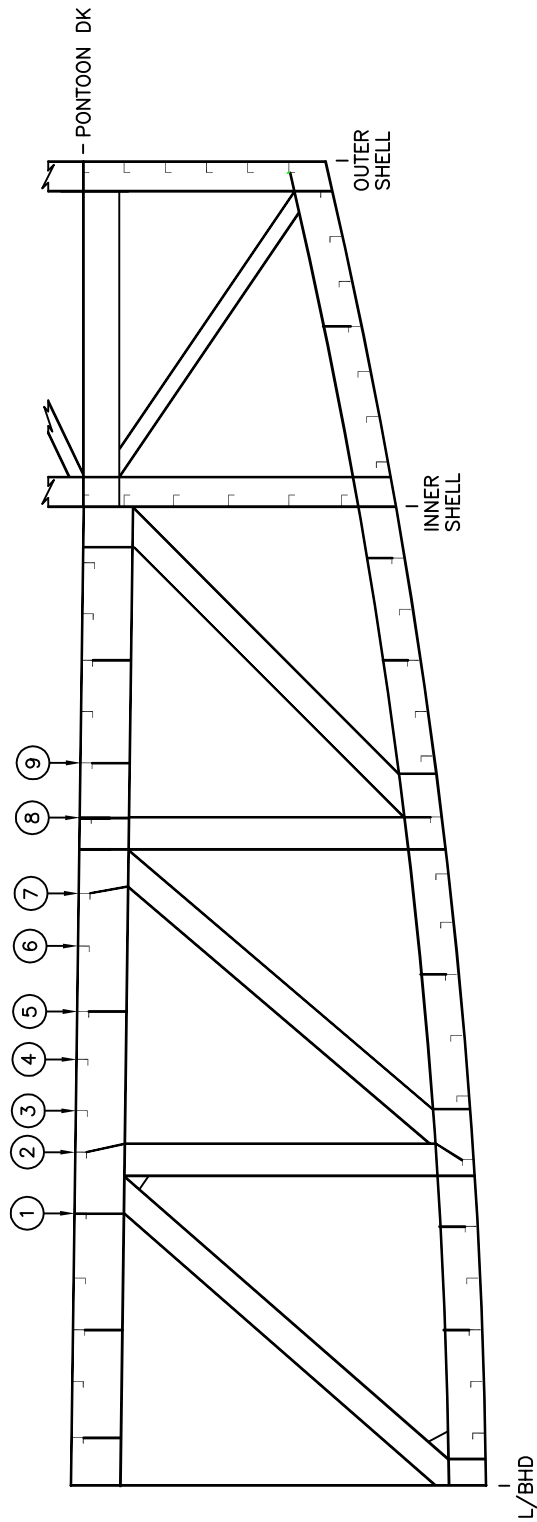
TANK No.11 - FRAME 12  
 DESCRIPTION: LOOKING NORTH

### FRAME 12

- 1.) 3” Fracture in web of longitudinal in way of channel cut-out, 17” south of frame.
- 2.) 3” Fracture in web of longitudinal in way of channel cut-out, 17” south of frame.
- 3.) 3” Fracture in web of longitudinal in way of channel cut-out, 17” south of frame.
- 4.) 3” Fracture in web of longitudinal in way of channel cut-out, 17” south of frame.
- 5.) 3” Fracture in web of longitudinal in way of channel cut-out, 17” south of frame.
- 6.) 3” Fracture in web of longitudinal in way of channel cut-out, 17” south of frame.
- 7.) 3” Fracture in web of longitudinal in way of channel cut-out, 17” south of frame.
- 8.) 3” Fracture in web of longitudinal in way of channel cut-out, 17” south of frame.
- 9.) 3” Fracture in web of longitudinal in way of channel cut-out, 17” south of frame.

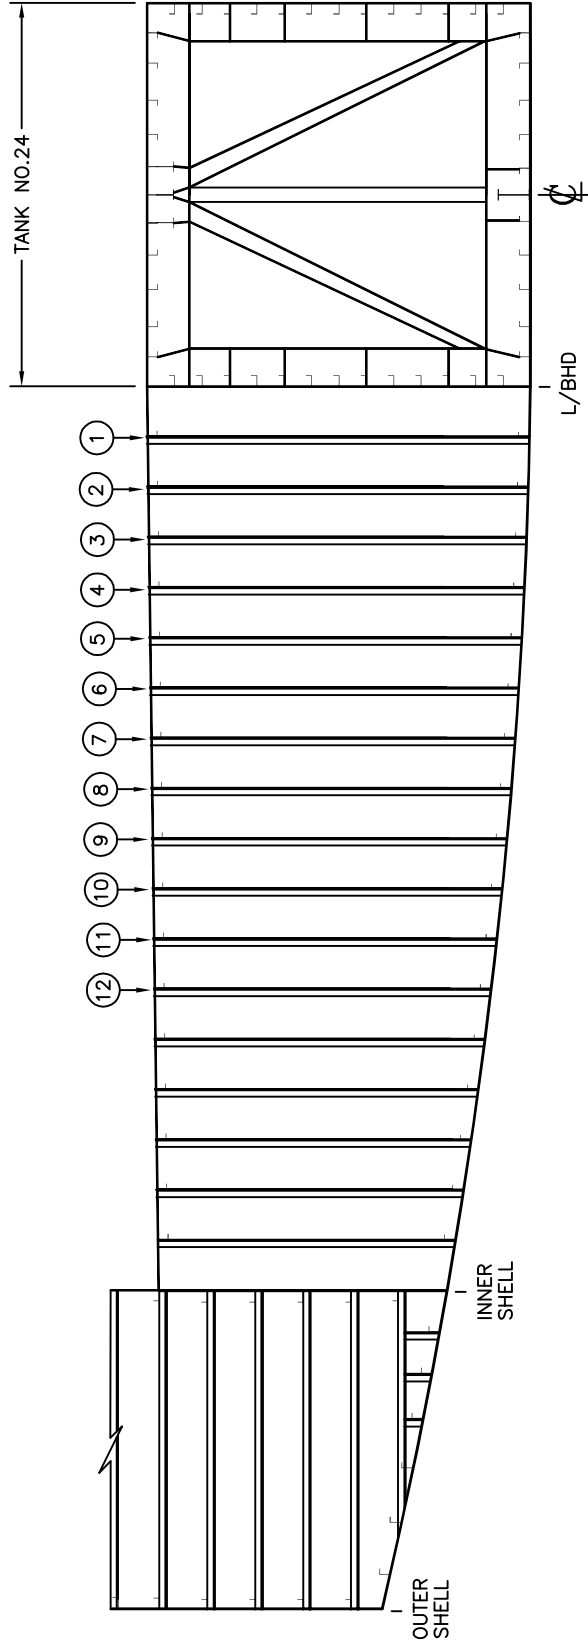
TANK NO.12 & 24 - BULKHEAD 20  
 DESCRIPTION: LOOKING NORTH

- 1.) 3” Fracture in web of longitudinal in way of channel cut-out, 17” south of frame.
- 2.) 3” Fracture in web of longitudinal in way of channel cut-out, 17” south of frame.

- 3.) 3” Fracture in web of longitudinal in way of channel cut-out, 17” south of frame.
- 4.) 3” Fracture in web of longitudinal in way of channel cut-out, 17” south of frame.

- 5.) 3” Fracture in web of longitudinal in way of channel cut-out, 17” south of frame.
- 6.) 3” Fracture in web of longitudinal in way of channel cut-out, 17” south of frame.

- 7.) 3” Fracture in web of longitudinal in way of channel cut-out, 17” south of frame.
- 8.) 3” Fracture in web of longitudinal in way of channel cut-out, 17” south of frame.

- 9.) 3” Fracture in web of longitudinal in way of channel cut-out, 17” south of frame.
- 10.) 3” Fracture in web of longitudinal in way of channel cut-out, 17” south of frame.

- 11.) 3” Fracture in web of longitudinal in way of channel cut-out, 17” south of frame.
- 12.) 3” Fracture in web of longitudinal in way of channel cut-out, 17” south of frame.

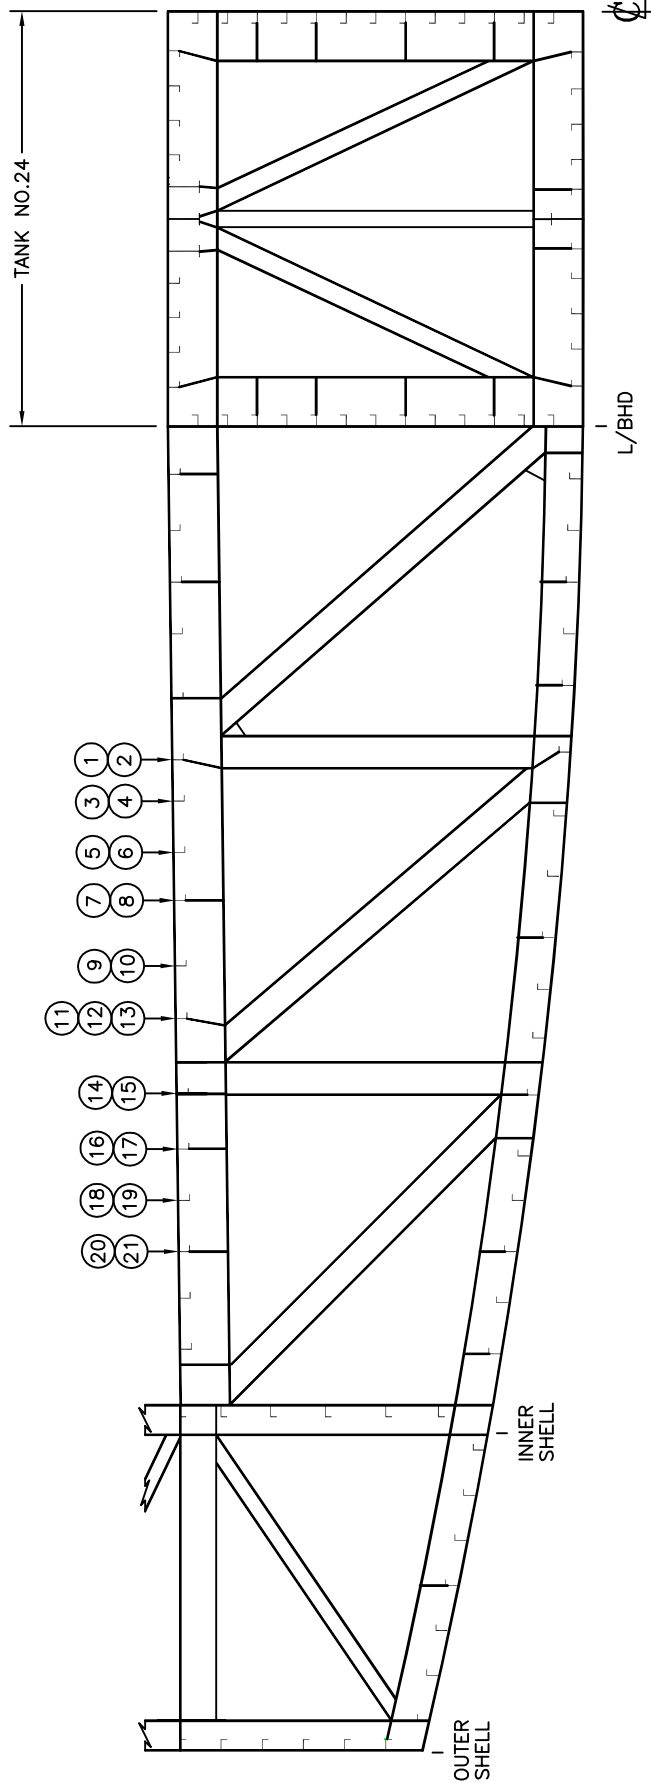
TANK NO. 12 & 24 - FRAME 19

- 1.) 3” Fracture in web of longitudinal in way of channel cut-out, 17” north of frame.
- 2.) 3” Fracture in web of longitudinal in way of channel cut-out, 17” south of frame.

- 3.) 3” Fracture in web of longitudinal in way of channel cut-out, 17” north of frame.
- 4.) 3” Fracture in web of longitudinal in way of channel cut-out, 17” south of frame.

- 5.) 3” Fracture in web of longitudinal in way of channel cut-out, 17” north of frame.
- 6.) 3” Fracture in web of longitudinal in way of channel cut-out, 17” south of frame.

- 7.) 3” Fracture in web of longitudinal in way of channel cut-out, 17” north of frame.
- 8.) 3” Fracture in web of longitudinal in way of channel cut-out, 17” south of frame.

- 9.) 3” Fracture in web of longitudinal in way of channel cut-out, 17” north of frame.
- 10.) 3” Fracture in web of longitudinal in way of channel cut-out, 17” south of frame.

- 11.) 3” Fracture in web of longitudinal in way of channel cut-out, 17” north of frame.
- 12.) 3” Fracture in web of longitudinal in way of channel cut-out, 17” south of frame.

- 13.) Pinhole on deck plating in way of wrap weld, 23” south of frame.
- 14.) 3” Fracture in web of longitudinal in way of channel cut-out, 17” north of frame.

- 15.) 3” Fracture in web of longitudinal in way of channel cut-out, 17” south of frame.

- 16.) 3" Fracture in web of longitudinal in way of channel cut-out, 17" north of frame.
- 17.) 3" Fracture in web of longitudinal in way of channel cut-out, 17" south of frame.
- 18.) 3" Fracture in web of longitudinal in way of channel cut-out, 17" north of frame.
- 19.) 3" Fracture in web of longitudinal in way of channel cut-out, 17" south of frame.
- 20.) 3" Fracture in web of longitudinal in way of channel cut-out, 17" north of frame.
- 21.) 3" Fracture in web of longitudinal in way of channel cut-out, 17" south of frame.

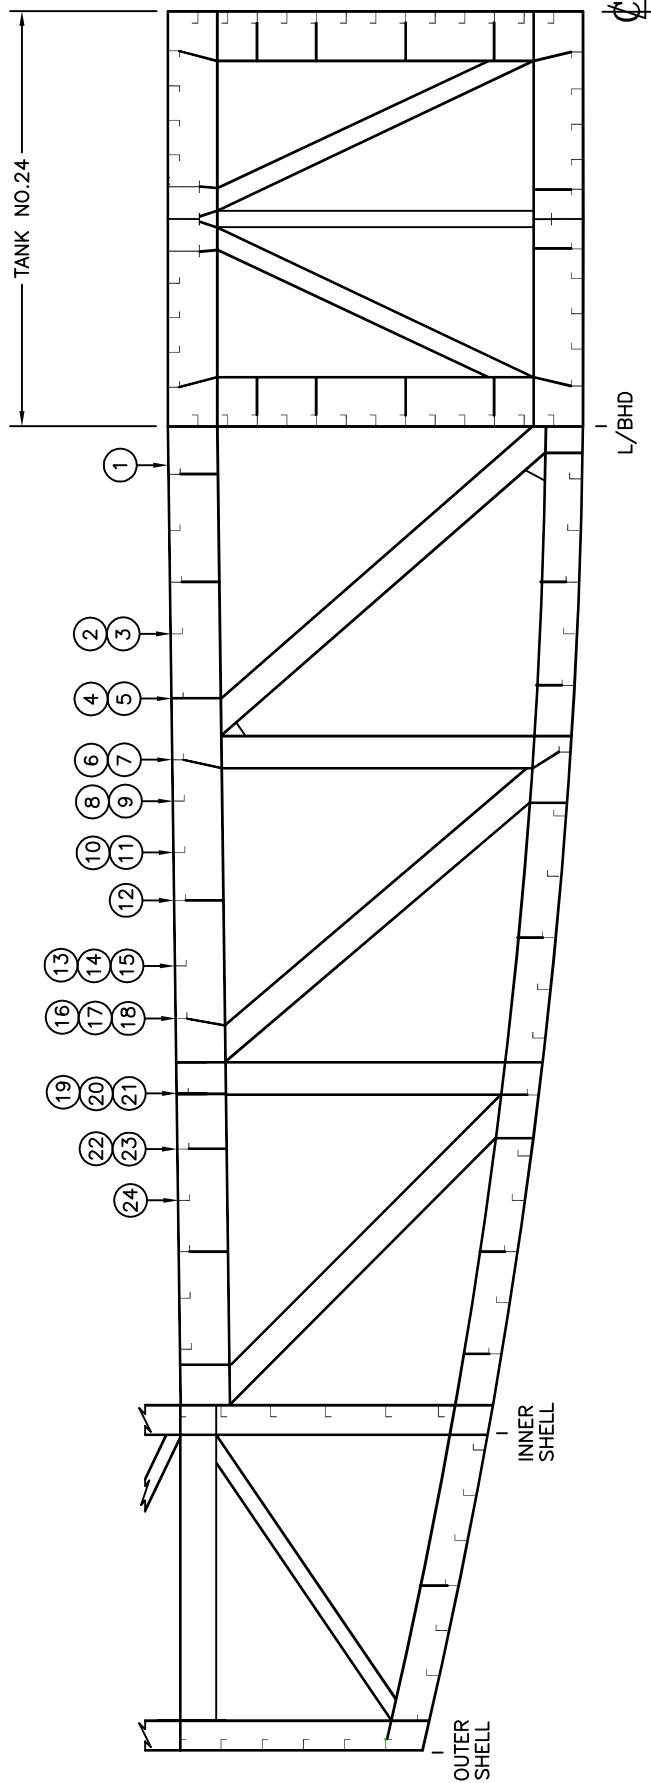
TANK NO. 12 & 24 - FRAME 18

- 1.) 2" diameter hole on deck plating, 20" south of frame.
- 2.) 3" Fracture in web of longitudinal in way of channel cut-out, 17" south of frame.
- 3.) 3" Fracture in web of longitudinal in way of channel cut-out, 17" north of frame.

- 4.) 3" Fracture in web of longitudinal in way of channel cut-out, 17" south of frame.
- 5.) 3" Fracture in web of longitudinal in way of channel cut-out, 17" north of frame.

- 6.) 3" Fracture in web of longitudinal in way of channel cut-out, 17" south of frame.
- 7.) 3" Fracture in web of longitudinal in way of channel cut-out, 17" north of frame.

- 8.) 3" Fracture in web of longitudinal in way of channel cut-out, 17" south of frame.
- 9.) 3" Fracture in web of longitudinal in way of channel cut-out, 17" north of frame.

- 10.) 3" Fracture in web of longitudinal in way of channel cut-out, 17" south of frame.
- 11.) 3" Fracture in web of longitudinal in way of channel cut-out, 17" north of frame.

- 12.) 3" Fracture in web of longitudinal in way of channel cut-out, 17" north of frame.
- 13.) 3" Fracture in web of longitudinal in way of channel cut-out, 17" south of frame.

- 14.) 3" Fracture in web of longitudinal in way of channel cut-out, 17" north of frame.
- 15.) Pinhole on deck plating in way of wrap weld, 17" north of frame.

- 16.) 3" Fracture in web of longitudinal in way of channel cut-out, 17" south of frame.
- 17.) 3" Fracture in web of longitudinal in way of channel cut-out, 17" north of frame.
- 18.) Multiple holes on deck plating, 20" south of frame.
- 19.) 3" Fracture in web of longitudinal in way of channel cut-out, 17" south of frame.
- 20.) 3" Fracture in web of longitudinal in way of channel cut-out, 17" north of frame.
- 21.) ½" hole on deck plating in way of wrap weld, 6" north of frame.
- 22.) 3" Fracture in web of longitudinal in way of channel cut-out, 17" south of frame.
- 23.) 3" Fracture in web of longitudinal in way of channel cut-out, 17" north of frame.
- 24.) 3" Fracture in web of longitudinal in way of channel cut-out, 17" north of frame.
