## EUREKA DRY DOCK UT /VT SURVEY MAY 2015

Ultrasonic thickness measurements and a visual survey was performed for BAE Systems of San Francisco on the Eureka Dry Dock located at BAE Shipyard in San Francisco, CA. The owners were represented by Mr. Justin Gleaton. The survey was performed by International Inspection personnel.

## EUREKA DRY DOCK VISUAL SURVEY TABLE OF CONTENTS

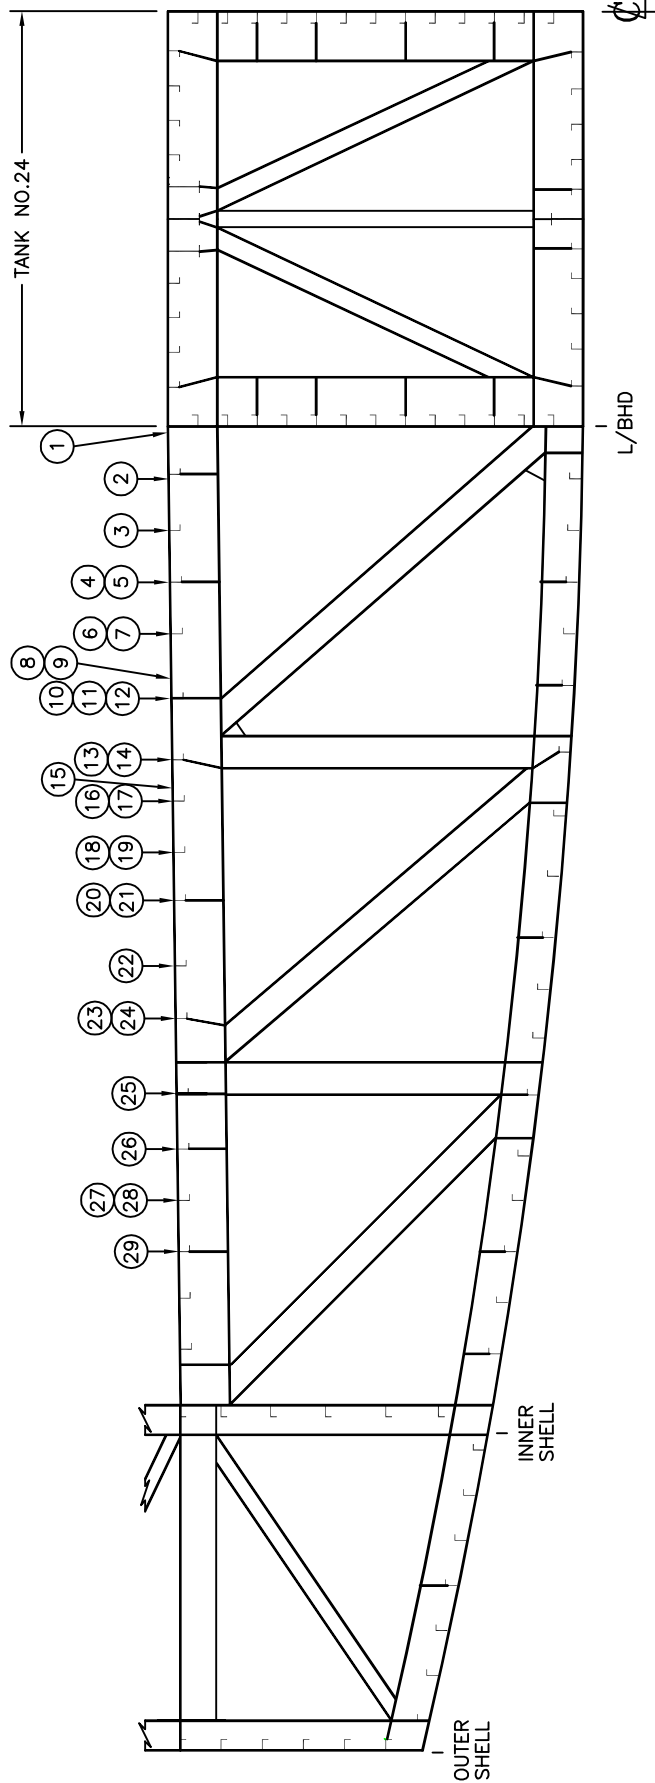
TANK NO. 12 & 24 - FRAME 17

- 4.) 2" diameter hole on deck plating in way of wrap weld, 6" south of frame.
- 5.) 2" diameter hole on deck plating, 3" north of frame.
- 6.) 2" Fracture in web of longitudinal in way of channel cut-out, 17" north of frame.

- 7.) 2" Fracture in web of longitudinal in way of channel cut-out, 17" south of frame.
- 8.) 1" diameter hole on deck plating, 23" north of frame.
- 9.) ½" diameter hole on deck plating, 17" south of frame.

- 10.) ½" diameter hole on deck plating, 6" south of frame.
- 11.) 2" Fracture in web of longitudinal in way of channel cut-out, 17" south of frame.
- 12.) 2" Fracture in web of longitudinal in way of channel cut-out, 17" north of frame.

- 13.) 2" Fracture in web of longitudinal in way of channel cut-out, 17" south of frame.
- 14.) 2" Fracture in web of longitudinal in way of channel cut-out, 17" north of frame.

- 16.) 2" Fracture in web of longitudinal in way of channel cut-out, 17" south of frame.
- 17.) 2" Fracture in web of longitudinal in way of channel cut-out, 17" north of frame.

- 18.) 2" Fracture in web of longitudinal in way of channel cut-out, 17" south of frame.
- 19.) 2" Fracture in web of longitudinal in way of channel cut-out, 17" north of frame.

- 20.) 2" Fracture in web of longitudinal in way of channel cut-out, 17" south of frame.
- 21.) 2" Fracture in web of longitudinal in way of channel cut-out, 17" north of frame.

- 22.) 2" Fracture in web of longitudinal in way of channel cut-out, 17" north of frame.
- 23.) 2" Fracture in web of longitudinal in way of channel cut-out, 17" north of frame.

- 24.) 3" diameter hole on deck plating in way of wrap weld, 6" south of frame.
- 25.) 2" Fracture in web of longitudinal in way of channel cut-out, 17" south of frame.

- 26.) 2" Fracture in web of longitudinal in way of channel cut-out, 17" north of frame.
- 27.) 2" Fracture in web of longitudinal in way of channel cut-out, 17" north of frame.

- 28.) 1" diameter hole on deck plating in way of wrap weld, 23" north of frame.
- 29.) 2" Fracture in web of longitudinal in way of channel cut-out, 17" north of frame.

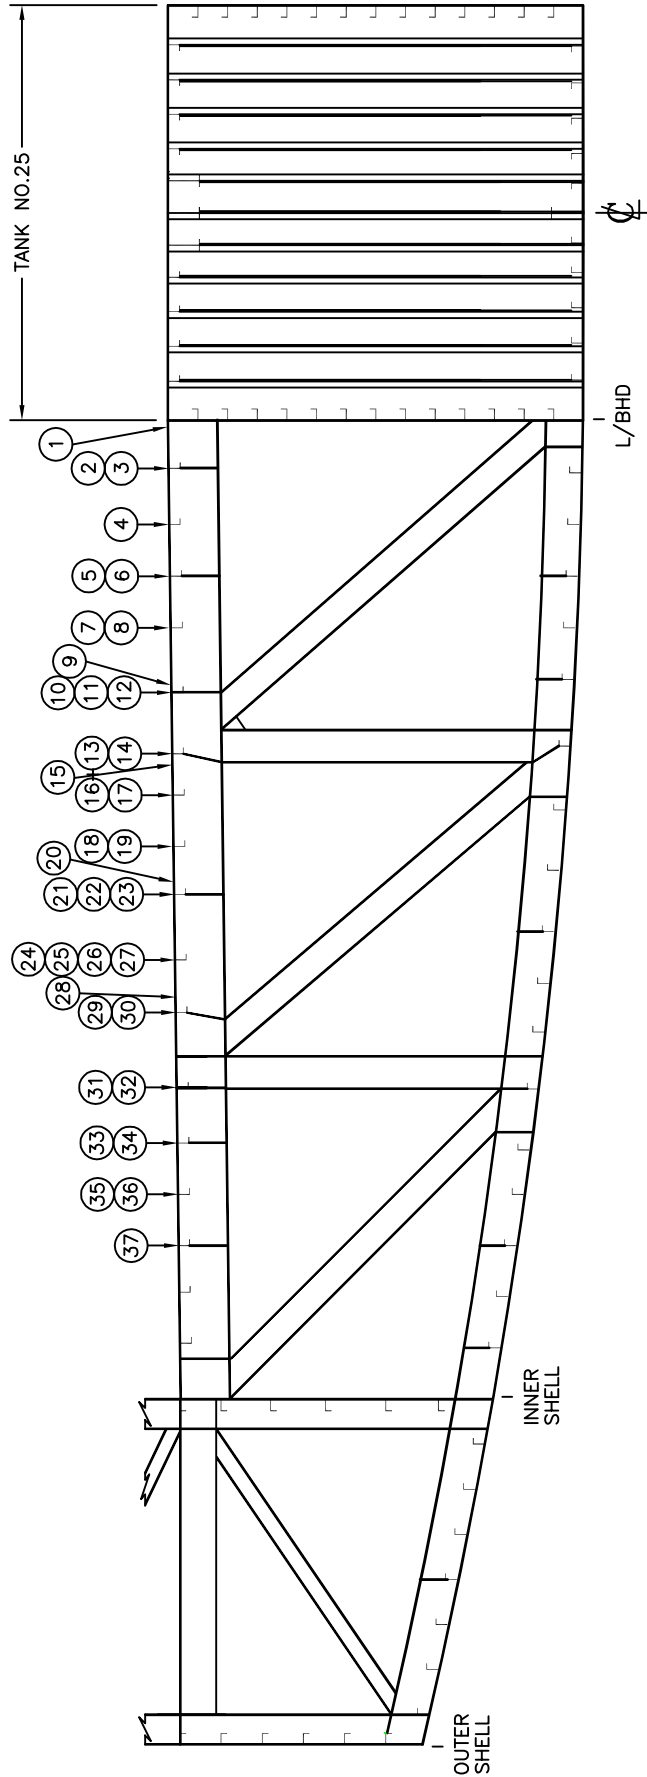
TANK No.12 & 25 - FRAME 16

- 6.) 3" Fracture in web of longitudinal in way of channel cut-out, 17" north of frame.
- 7.) 3" Fracture in web of longitudinal in way of channel cut-out, 17" north of frame.

- 8.) 2" Fracture in web of longitudinal in way of channel cut-out, 17" south of frame.
- 9.) 1" diameter hole on deck plating, 24" south of frame.
- 10.) 1" diameter hole on deck plating in way of wrap weld, 32" south of frame.

- 11.) 1" diameter hole on deck plating in way of wrap weld, 17" south of frame
- 12.) 2" Fracture in web of longitudinal in way of channel cut-out, 17" south of frame.

- 13.) 3" Fracture in web of longitudinal in way of channel cut-out, 17" north of frame.
- 14.) 2" Fracture in web of longitudinal in way of channel cut-out, 17" south of frame.

- 15.) ½" diameter hole on deck plating in way of wrap weld, 32" south of frame.
- 16.) 3" Fracture in web of longitudinal in way of channel cut-out, 17" north of frame.

- 17.) 2" Fracture in web of longitudinal in way of channel cut-out, 17" south of frame.
- 18.) 3" Fracture in web of longitudinal in way of channel cut-out, 17" north of frame.

- 19.) 2" Fracture in web of longitudinal in way of channel cut-out, 17" south of frame.
- 20.) Pinhole on deck plating, 30" north of frame.
- 21.) Pinhole on deck plating in way of wrap weld, 32" south of frame.

- 22.) 3" Fracture in web of longitudinal in way of channel cut-out, 17" north of frame.
- 23.) 2" Fracture in web of longitudinal in way of channel cut-out, 17" south of frame.

- 26.) 3" Fracture in web of longitudinal in way of channel cut-out, 17" north of frame.
- 27.) 2" Fracture in web of longitudinal in way of channel cut-out, 17" south of frame.

- 28.) 2" diameter hole on deck plating, 32" north of frame.
- 29.) 3" Fracture in web of longitudinal in way of channel cut-out, 17" north of frame.
- 30.) 2" Fracture in web of longitudinal in way of channel cut-out, 17" south of frame.

- 31.) 3" Fracture in web of longitudinal in way of channel cut-out, 17" north of frame.
- 32.) 2" Fracture in web of longitudinal in way of channel cut-out, 17" south of frame.

- 33.) 3" Fracture in web of longitudinal in way of channel cut-out, 17" north of frame.
- 34.) 2" Fracture in web of longitudinal in way of channel cut-out, 17" south of frame.
- 35.) 3" Fracture in web of longitudinal in way of channel cut-out, 17" north of frame.
- 36.) 2" Fracture in web of longitudinal in way of channel cut-out, 17" south of frame.
- 37.) 3" Fracture in web of longitudinal in way of channel cut-out, 17" north of frame.

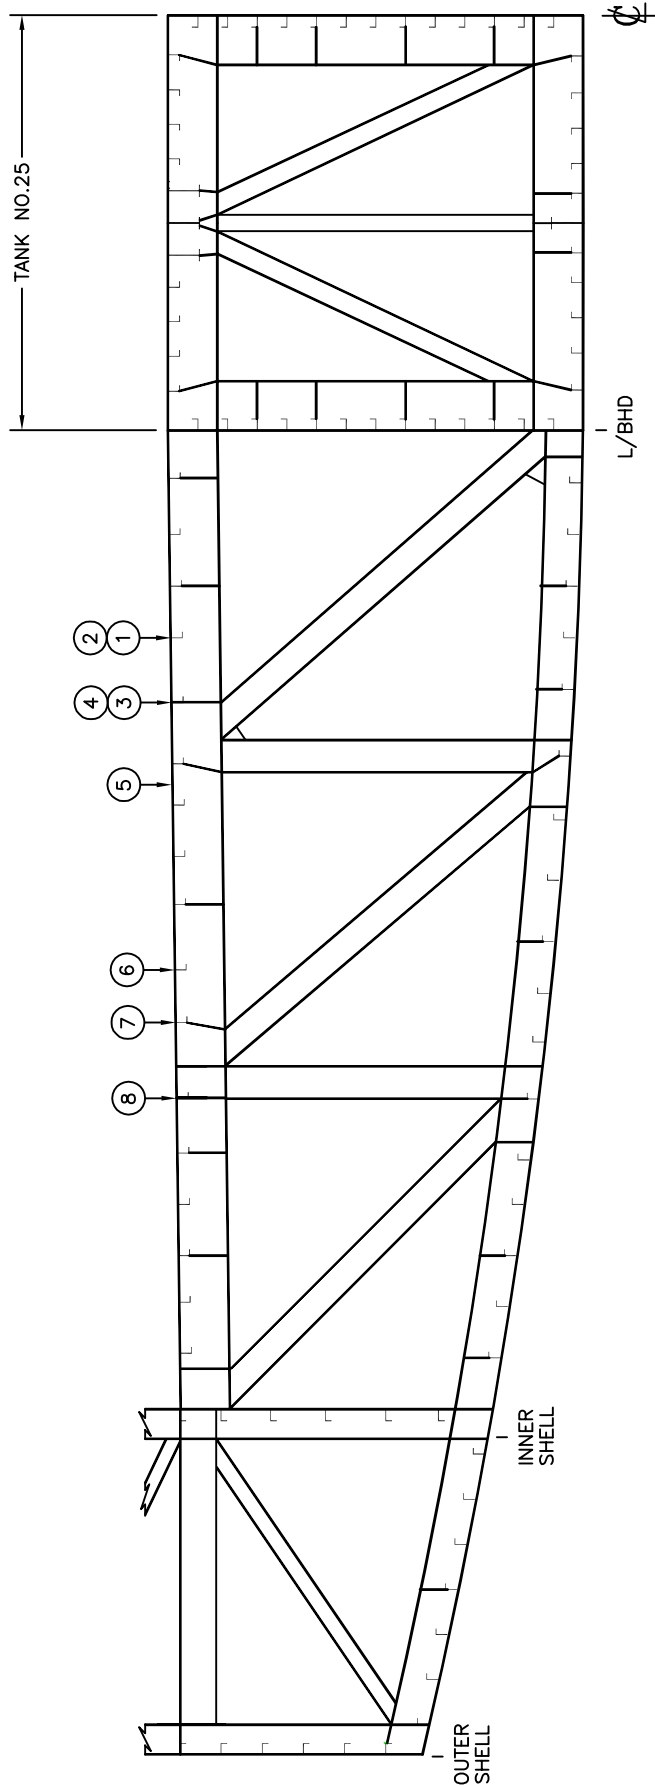
TANK NO. 12 & 25 - FRAME 15

- 1.) 2" diameter hole on deck plating, 6" north of frame.
- 2.) 4" Fracture in web of longitudinal in way of channel cut-out, 17" south of frame.
- 3.) 1" diameter hole on deck plating in way of wrap weld, 17" south of frame.
- 4.) 4" Fracture in web of longitudinal in way of channel cut-out, 17" south of frame.
- 5.) ½" diameter hole on deck plating, 30" south of frame.
- 6.) 4" Fracture in web of longitudinal in way of channel cut-out, 17" south of frame.
- 7.) 4" Fracture in web of longitudinal in way of channel cut-out, 17" south of frame.
- 8.) 4" Fracture in web of longitudinal in way of channel cut-out, 17" south of frame.

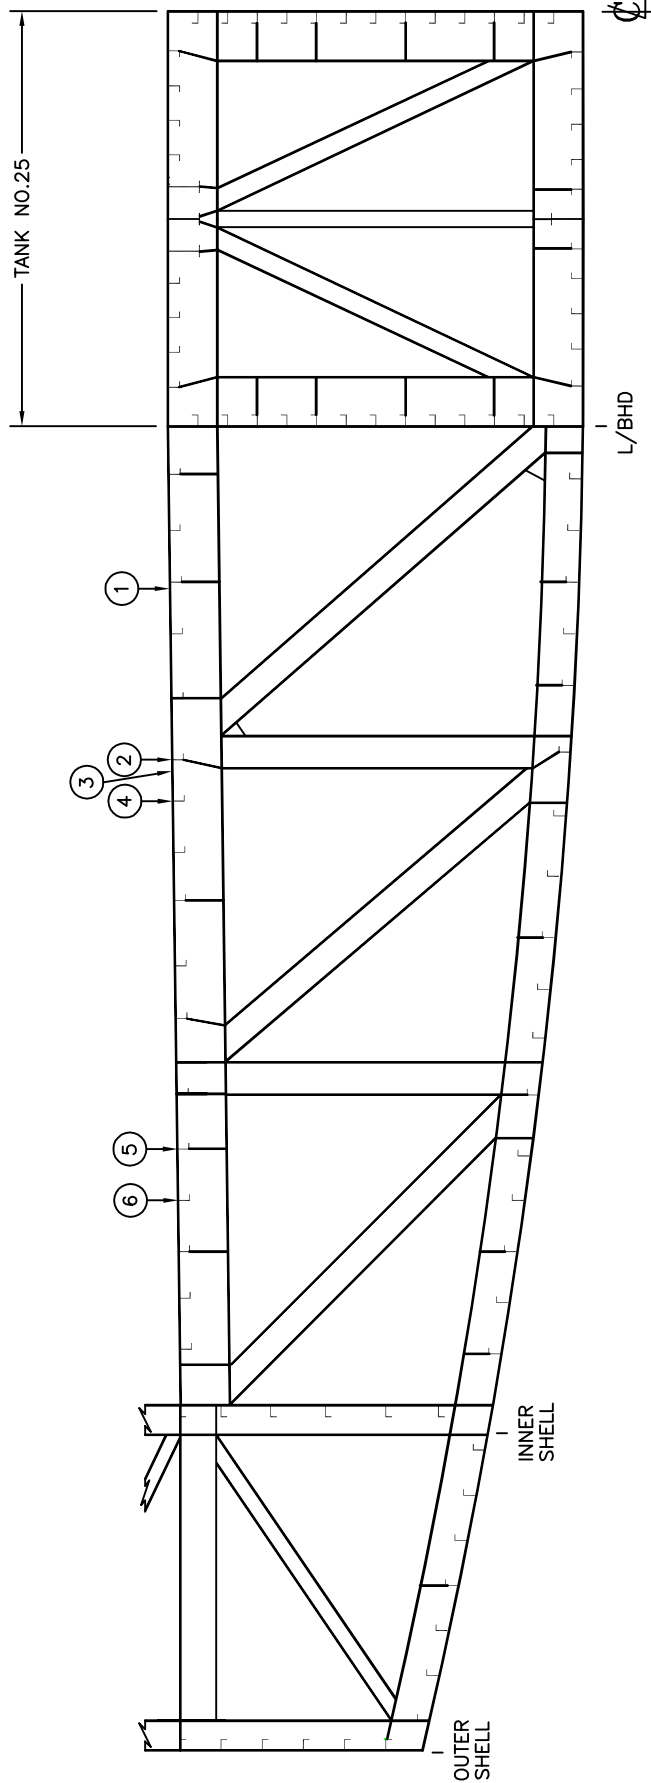
TANK NO. 12 & 25 - FRAME 14  
 DESCRIPTION: LOOKING NORTH

- 1.) 2" diameter hole on deck plating, 48" north of frame.
- 2.) 3" Fracture in web of longitudinal in way of channel cut-out, 17" north of frame.
- 3.) 1" diameter hole on deck plating, 40" north of frame.
- 4.) 3" Fracture in web of longitudinal in way of channel cut-out, 17" north of frame.
- 5.) 3" Fracture in web of longitudinal in way of channel cut-out, 17" north of frame.
- 6.) 3" Fracture in web of longitudinal in way of channel cut-out, 17" north of frame.

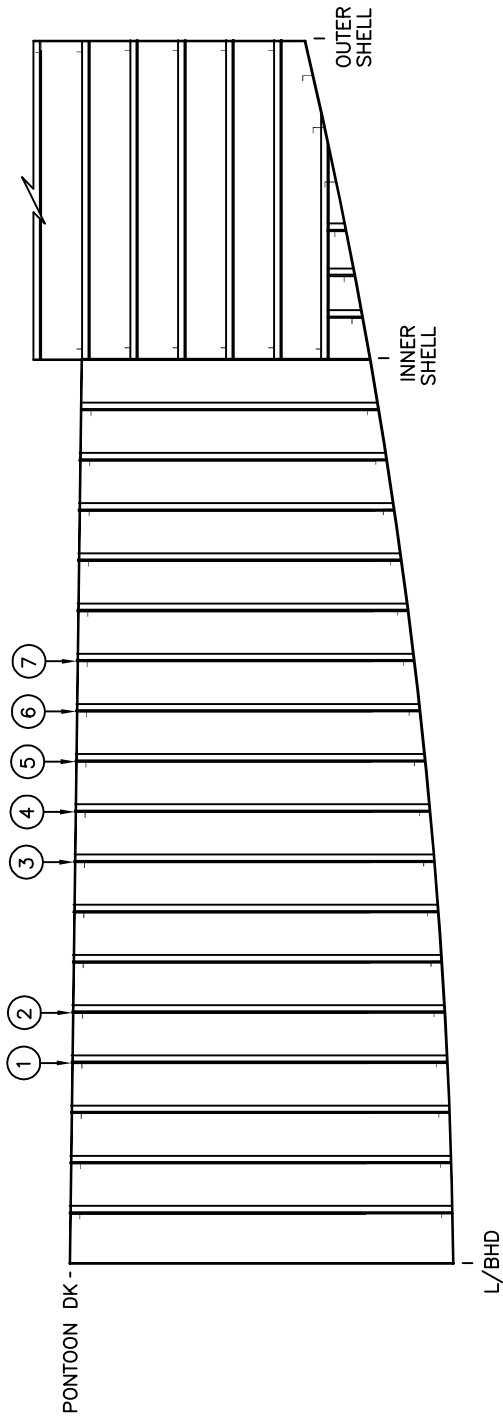
TANK No.11A - BULKHEAD 10  
DESCRIPTION: LOOKING NORTH

- 1.) 10" Fracture in attachment weld of longitudinal starting 17" south of frame.
- 2.) 10" Fracture in attachment weld of longitudinal starting 17" south of frame.
- 3.) 10" Fracture in attachment weld of longitudinal starting 17" south of frame.
- 4.) 10" Fracture in attachment weld of longitudinal starting 17" south of frame.
- 5.) 10" Fracture in attachment weld of longitudinal starting 17" south of frame.
- 6.) 10" Fracture in attachment weld of longitudinal starting 17" south of frame.
- 7.) 10" Fracture in attachment weld of longitudinal starting 17" south of frame.

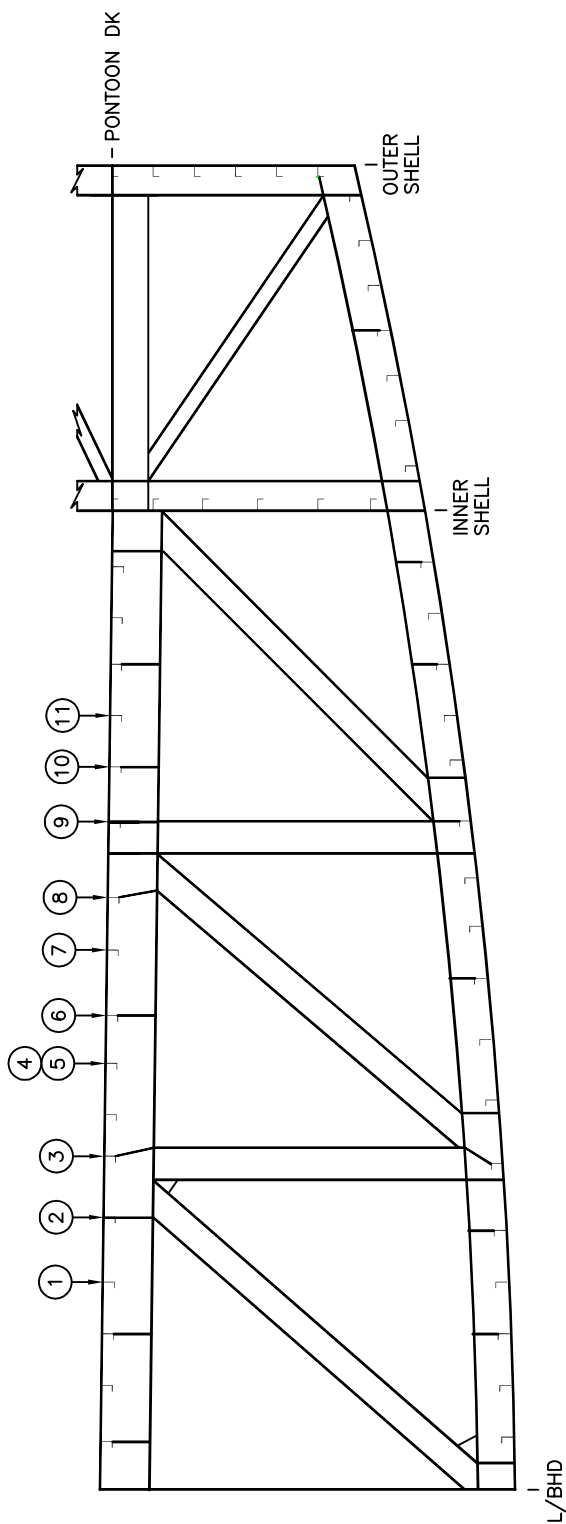
TANK No.11A - FRAME 9  
 DESCRIPTION: LOOKING NORTH

- 1.) 10” Fracture in attachment weld of longitudinal starting 17” south of frame.
- 2.) 10” Fracture in attachment weld of longitudinal starting 17” south of frame.

- 3.) 10” Fracture in attachment weld of longitudinal starting 17” south of frame.
- 4.) 10” Fracture in attachment weld of longitudinal starting 17” north of frame.

- 5.) 10” Fracture in attachment weld of longitudinal starting 17” south of frame.
- 6.) 10” Fracture in attachment weld of longitudinal starting 17” north of frame.

- 7.) 10” Fracture in attachment weld of longitudinal starting 17” north of frame.
- 8.) 10” Fracture in attachment weld of longitudinal starting 17” north of frame.

- 9.) 10” Fracture in attachment weld of longitudinal starting 17” north of frame.
- 10.) 10” Fracture in attachment weld of longitudinal starting 17” north of frame.

- 11.) 10” Fracture in attachment weld of longitudinal starting 17” north of frame.

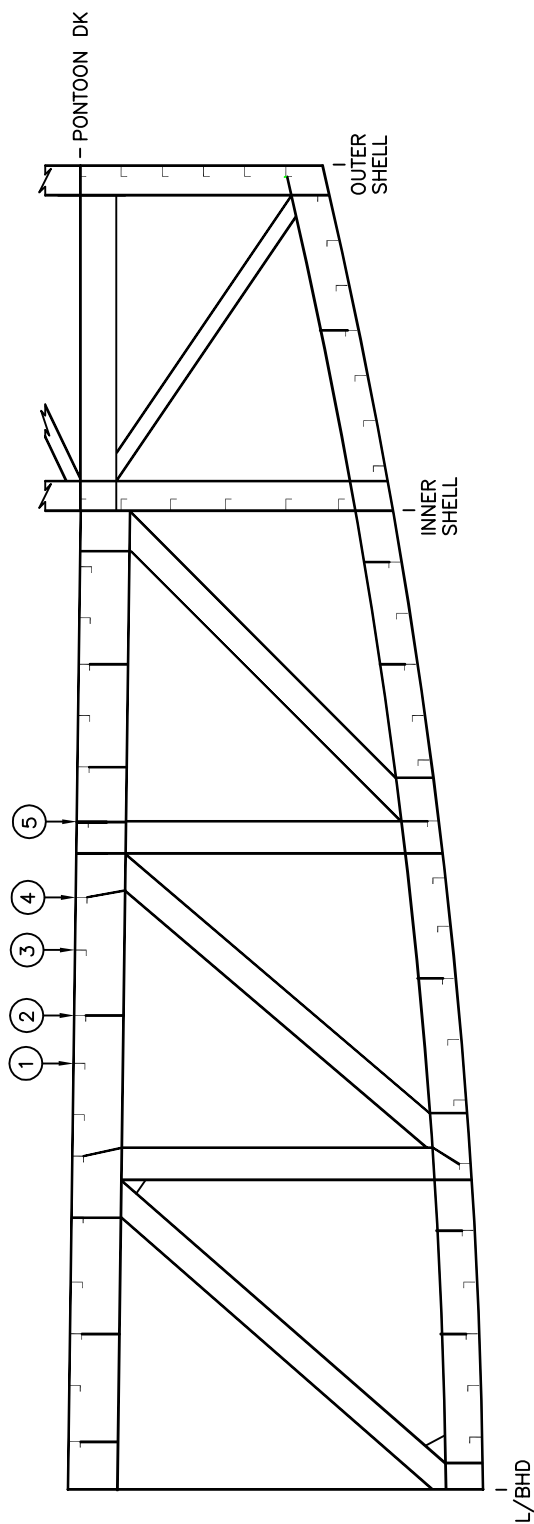
TANK No.13 - FRAME 7  
DESCRIPTION: LOOKING NORTH

- 1.) 6" Fracture in web of longitudinal in way of channel cut-out, 17" south of frame.
- 2.) 6" Fracture in web of longitudinal in way of channel cut-out, 17" south of frame.
- 3.) 6" Fracture in web of longitudinal in way of channel cut-out, 17" south of frame.
- 4.) 2" Fracture in web of longitudinal in way of channel cut-out, 17" south of frame.
- 5.) 2" Fracture in web of longitudinal in way of channel cut-out, 17" south of frame.

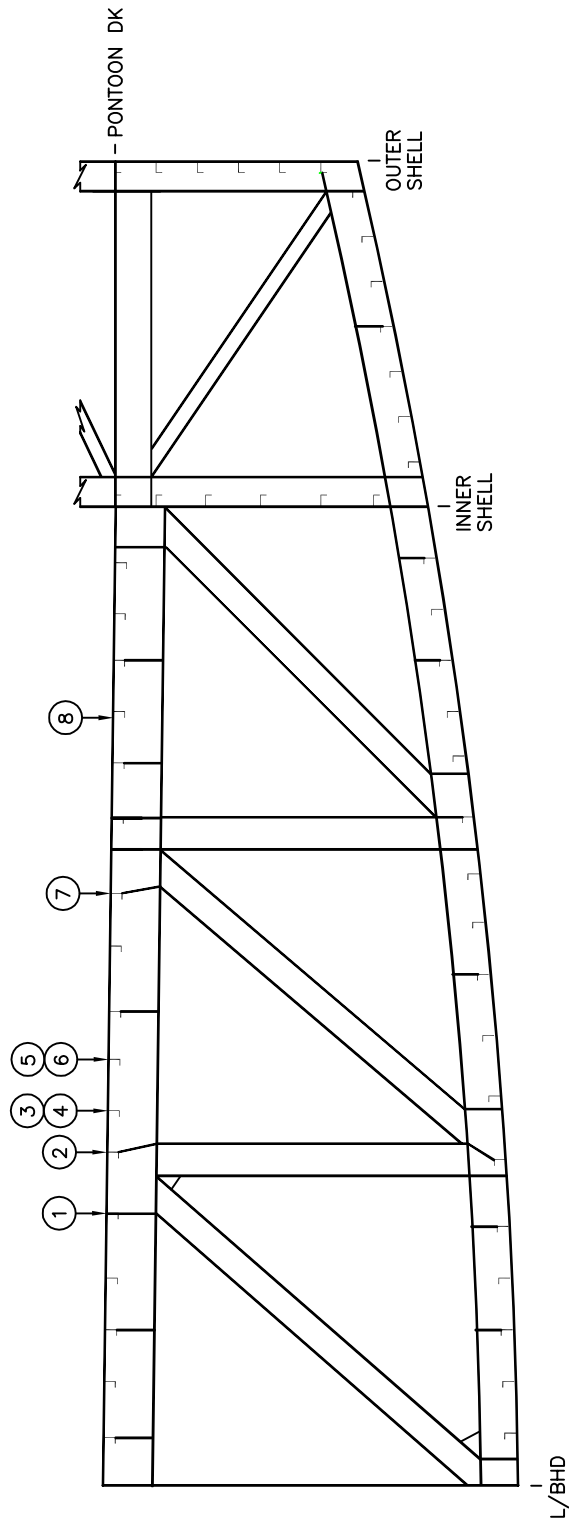
TANK No.13 - FRAME 6  
 DESCRIPTION: LOOKING NORTH

- 1.) 2" Fracture in web of longitudinal in way of channel cut-out, 17" north of frame.
- 2.) 2" Fracture in web of longitudinal in way of channel cut-out, 17" north of frame.
- 3.) 2" Fracture in web of longitudinal in way of channel cut-out, 17" north of frame.
- 4.) ½" Fracture in web of longitudinal in way of channel cut-out, 17" south of frame.
- 5.) 2" Fracture in web of longitudinal in way of channel cut-out, 17" north of frame.
- 6.) ½" Fracture in web of longitudinal in way of channel cut-out, 17" south of frame.
- 7.) 1" Fracture in web of longitudinal in way of channel cut-out, 17" south of frame.
- 8.) 1 ½"Ø hole in deck plating, 12" south of frame.

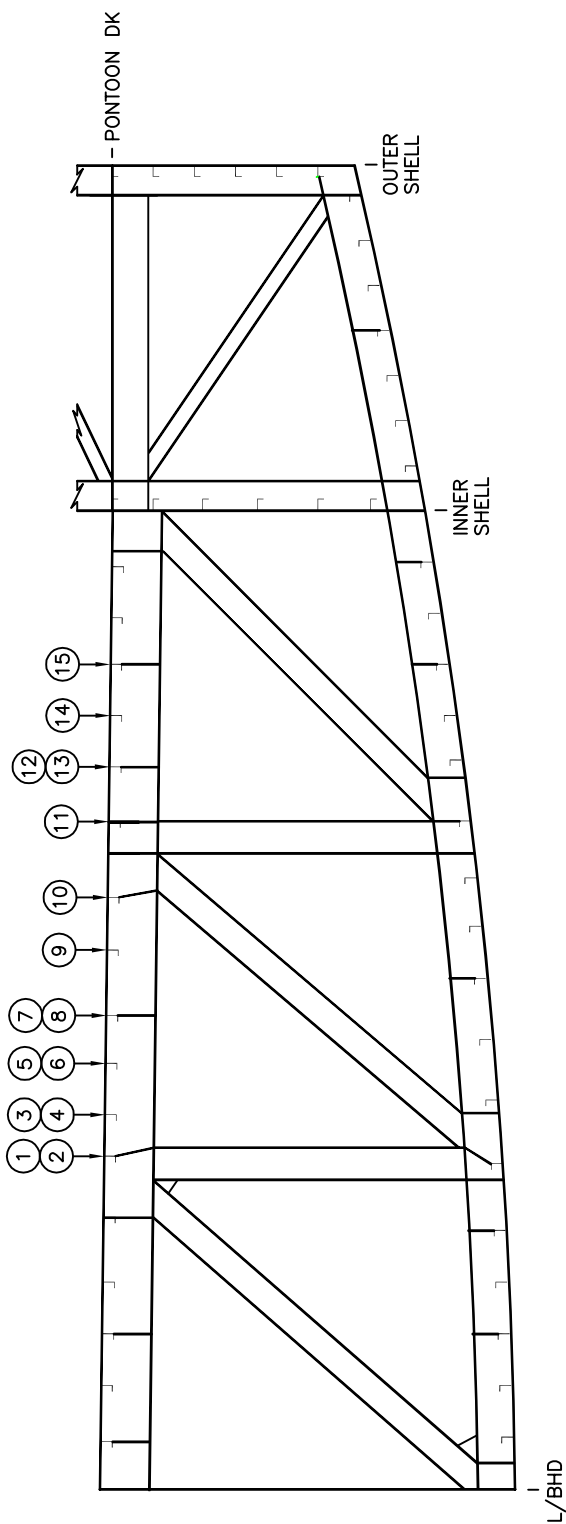
TANK No.13 - FRAME 5  
 DESCRIPTION: LOOKING NORTH

- 1.) 1" Fracture in web of longitudinal in way of channel cut-out, 17" north of frame.
- 2.) 1" Fracture in web of longitudinal in way of channel cut-out, 17" south of frame.

15.) 1" Fracture in web of longitudinal in way of channel cut-out, 17" south of frame.

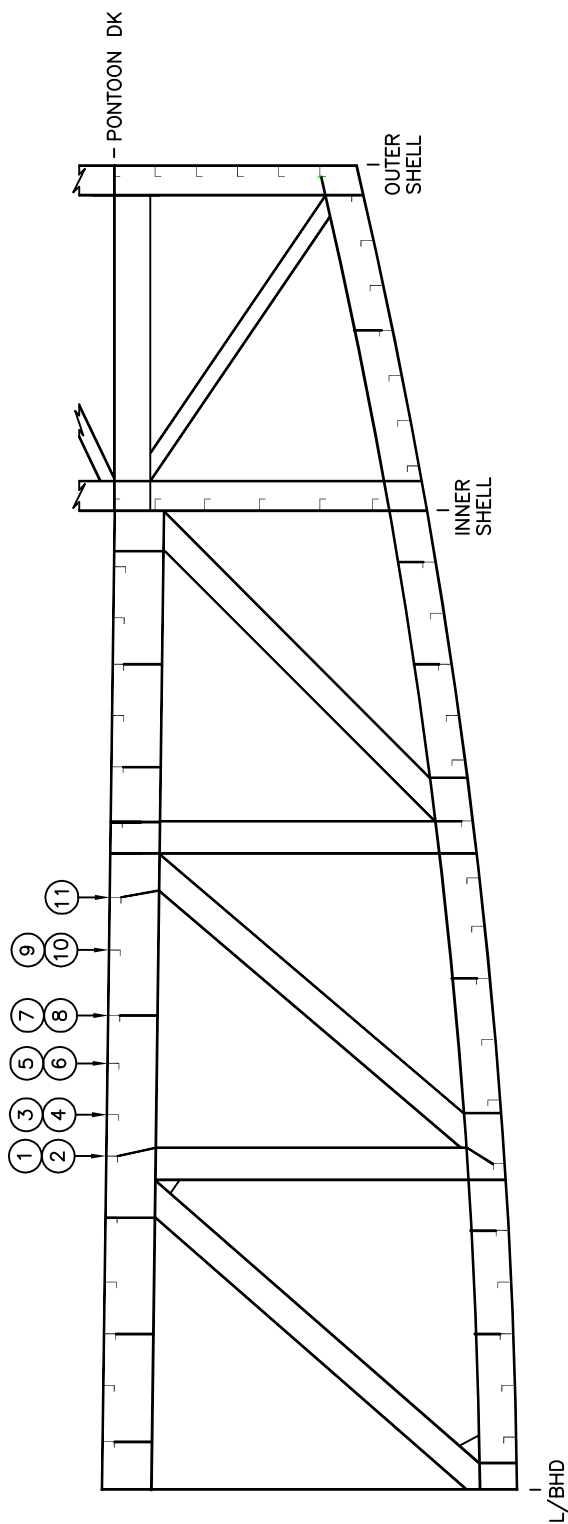
TANK No.13 - FRAME 4  
 DESCRIPTION: LOOKING NORTH

- 9.) ½” Fracture in web of longitudinal in way of channel cut-out, 17” north of frame.
- 10.) ½” Fracture in web of longitudinal in way of channel cut-out, 17” south of  
frame.

- 11.) 1 ½” Fracture in web of longitudinal in way of channel cut-out, 17” north of  
frame.

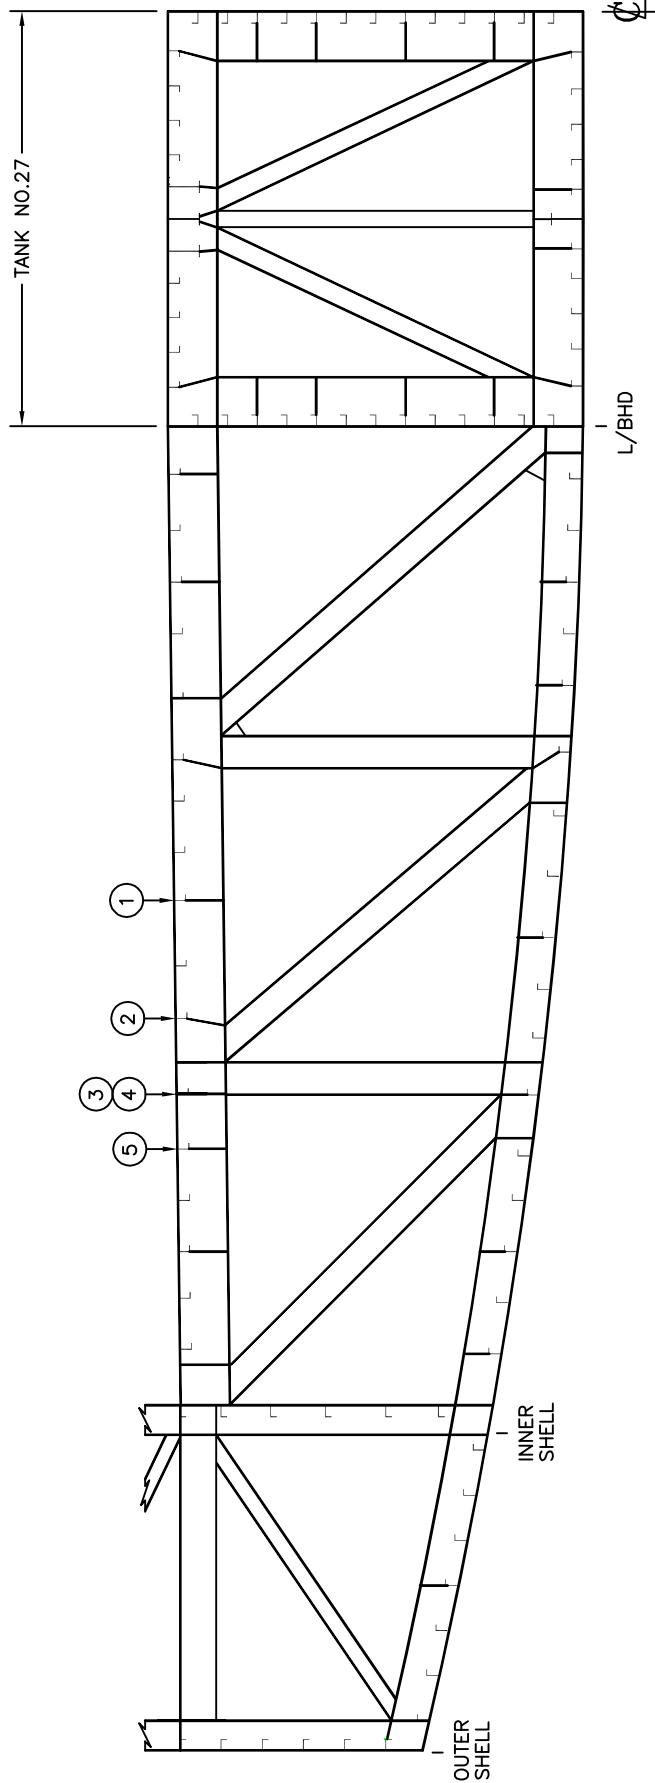
TANK NO. 14 & 27 - FRAME 6  
 DESCRIPTION: LOOKING NORTH

- 1.) ½” Fracture in web of longitudinal in way of channel cut-out, 17” south of frame.
- 2.) ½” Fracture in web of longitudinal in way of channel cut-out, 17” south of frame.
- 3.) ½” Fracture in web of longitudinal in way of channel cut-out, 17” north of frame.
- 4.) ½” Fracture in web of longitudinal in way of channel cut-out, 17” south of frame.
- 5.) ½” Fracture in web of longitudinal in way of channel cut-out, 17” south of frame.

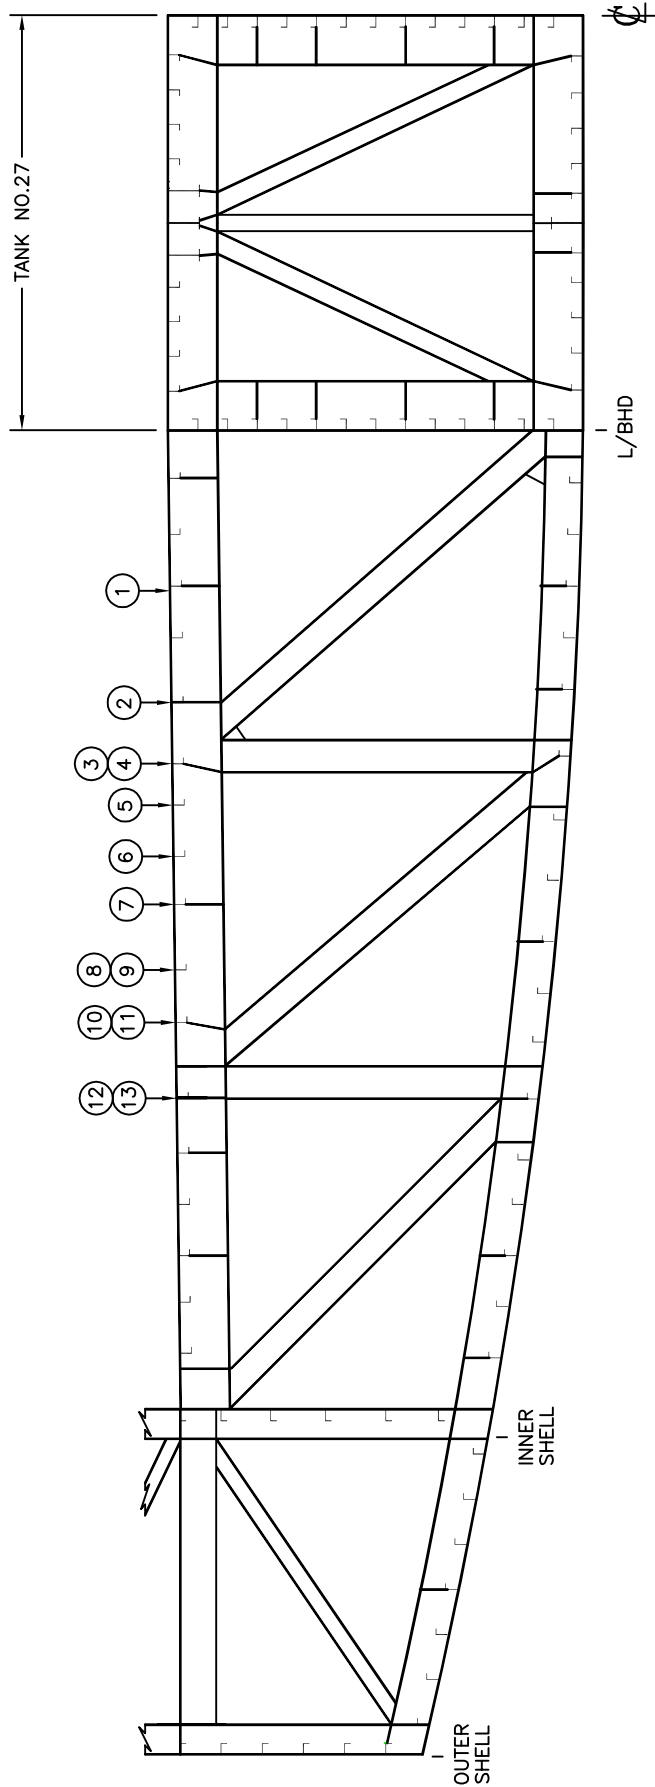
TANK NO. 14 & 27 - FRAME 5

- 11.) ½" Fracture in web of longitudinal in way of channel cut-out, 17" south of frame.
- 12.) ½" Fracture in web of longitudinal in way of channel cut-out, 17" north of frame.

- 13.) 1" Fracture in web of longitudinal in way of channel cut-out, 17" south of frame.

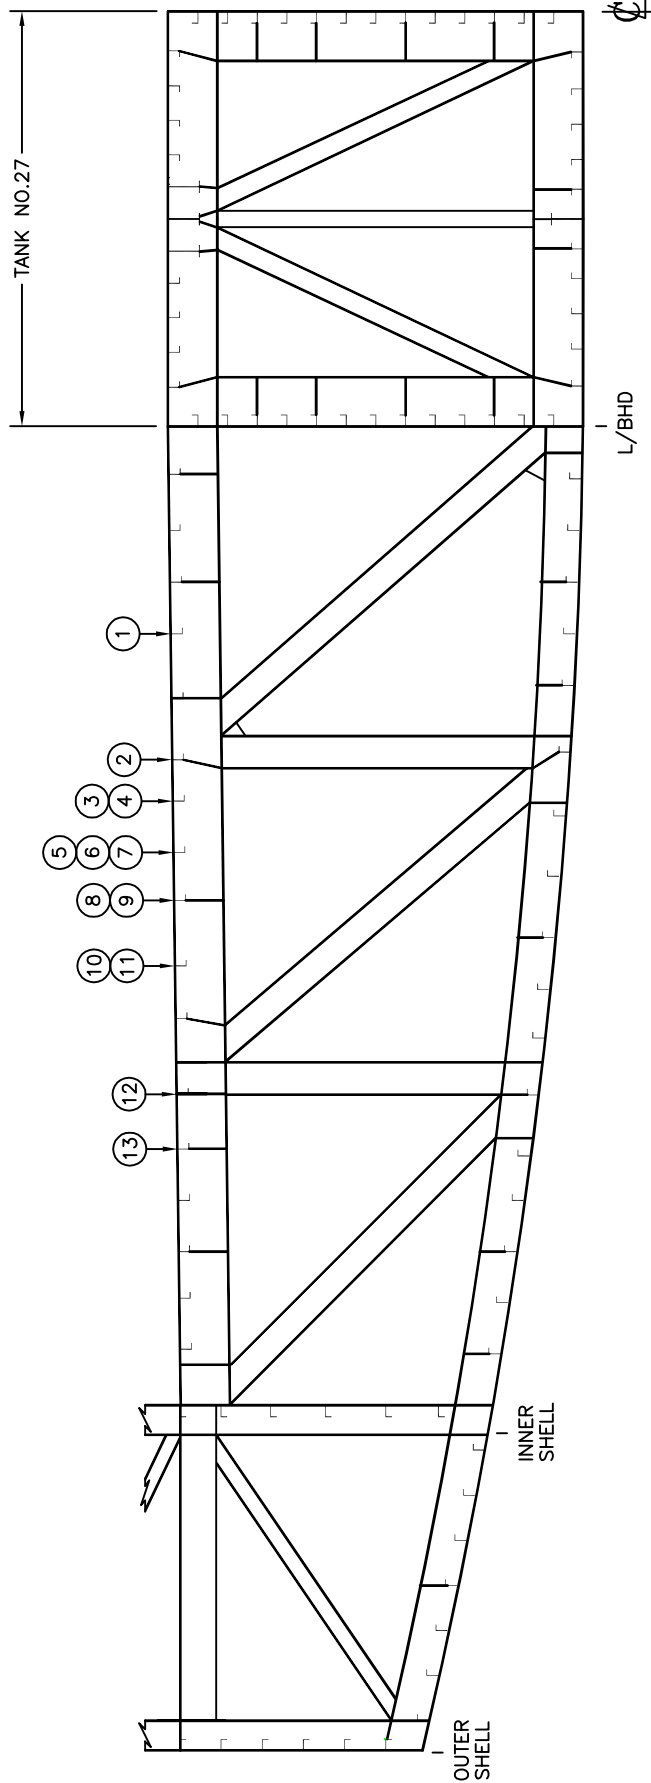
TANK NO. 14 & 27 - FRAME 4

- 10.) 1" Fracture in web of longitudinal in way of channel cut-out, 17" north of frame.
- 11.) ½" Fracture in web of longitudinal in way of channel cut-out, 17" south of frame.

- 12.) ½" Fracture in web of longitudinal in way of channel cut-out, 17" south of frame.
- 13.) ½" Fracture in web of longitudinal in way of channel cut-out, 17" south of frame.

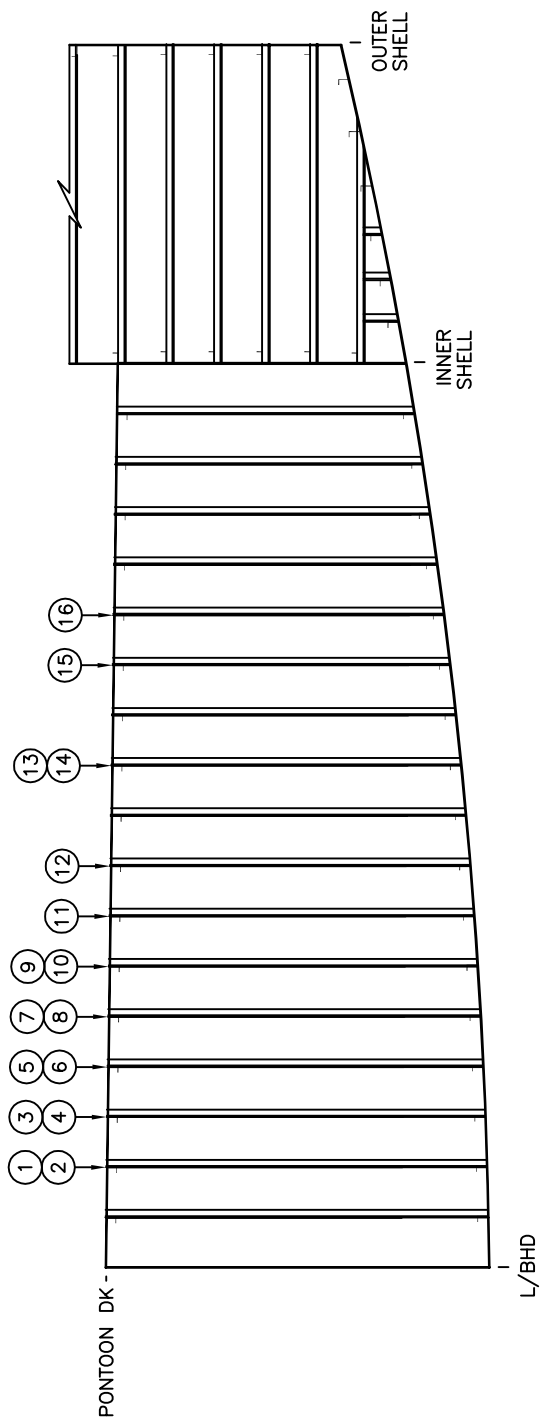
TANK No.15 - BULKHEAD 3  
 DESCRIPTION: LOOKING NORTH

- 13.) ½"Ø hole in deck plating, 26" south of bhd.
- 14.) ½" Fracture in web of longitudinal in way of channel cut-out, 17" south of bhd.
- 15.) ½" Fracture in web of longitudinal in way of channel cut-out, 17" south of bhd.

- 16.) ½" Fracture in web of longitudinal in way of channel cut-out, 17" south of bhd.

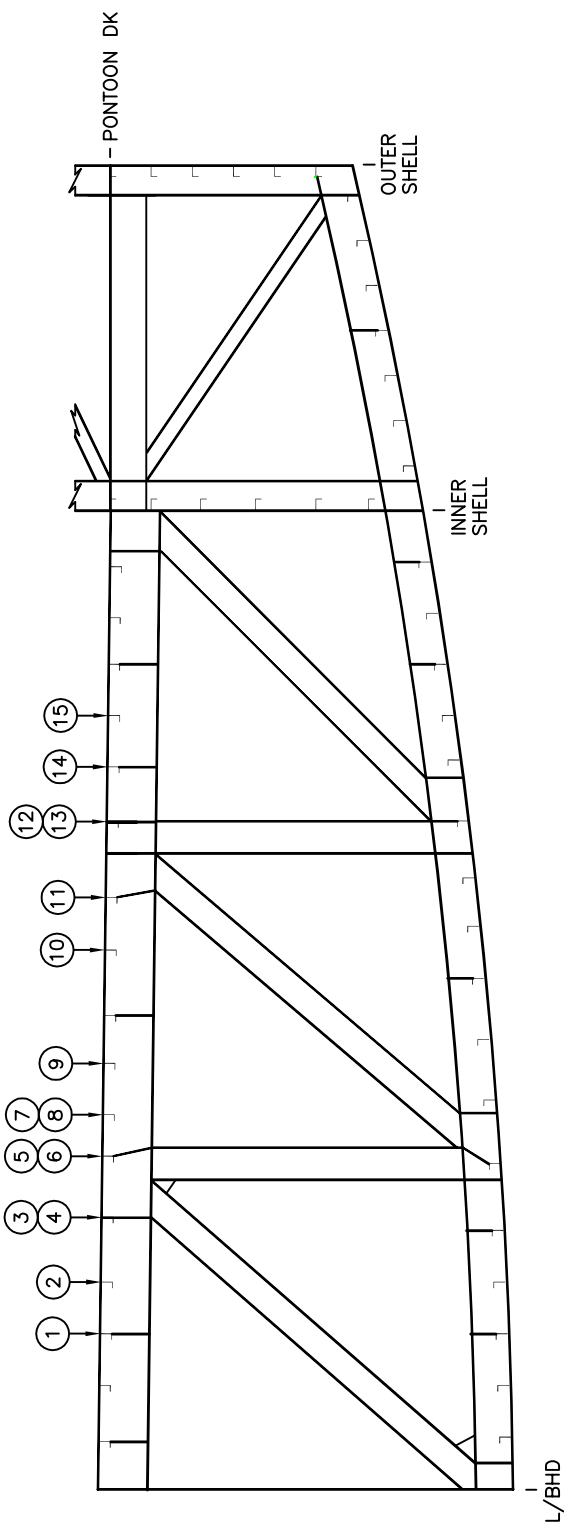
TANK No.15 - FRAME 2  
 DESCRIPTION: LOOKING NORTH

- 11.) 1” Fracture in web of longitudinal in way of channel cut-out, 17” south of frame.
- 12.) 1” Fracture in web of longitudinal in way of channel cut-out, 17” north of frame.

- 13.) 1” Fracture in web of longitudinal in way of channel cut-out, 17” south of frame.
- 14.) 1” Fracture in web of longitudinal in way of channel cut-out, 17” north of frame.

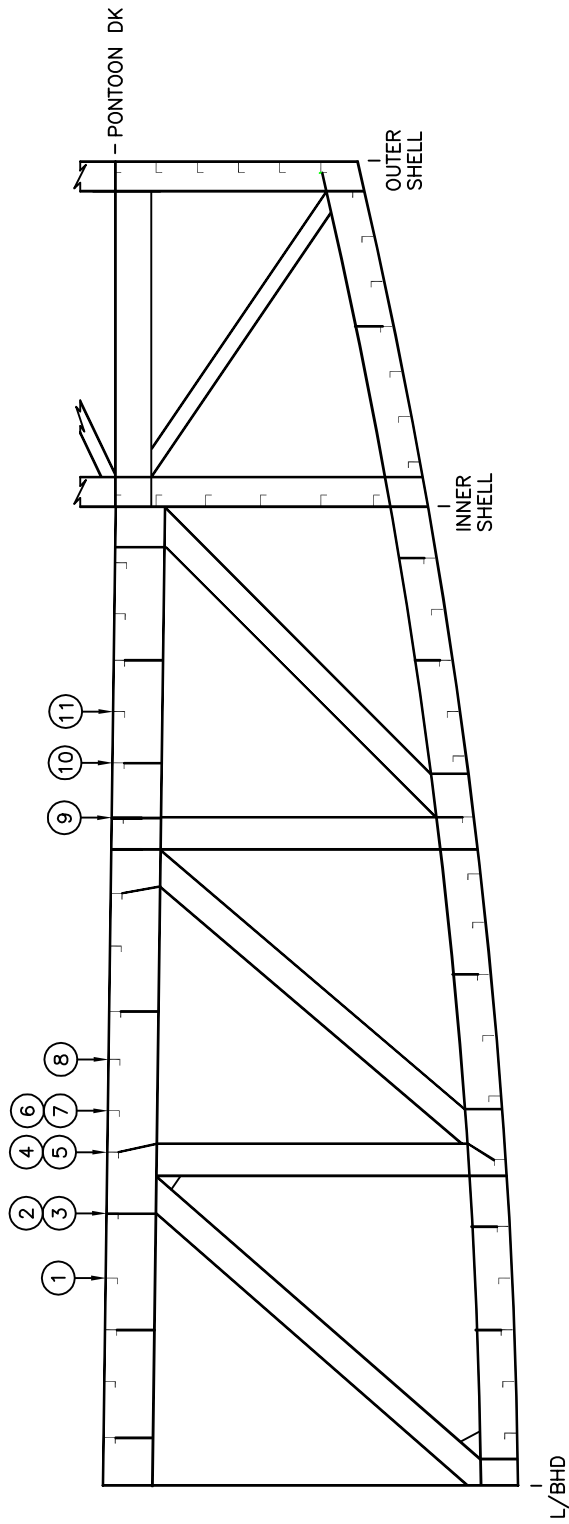
TANK No.15 - FRAME 1  
DESCRIPTION: LOOKING NORTH

15.) 1" Fracture in web of longitudinal in way of channel cut-out, 17" north of frame.

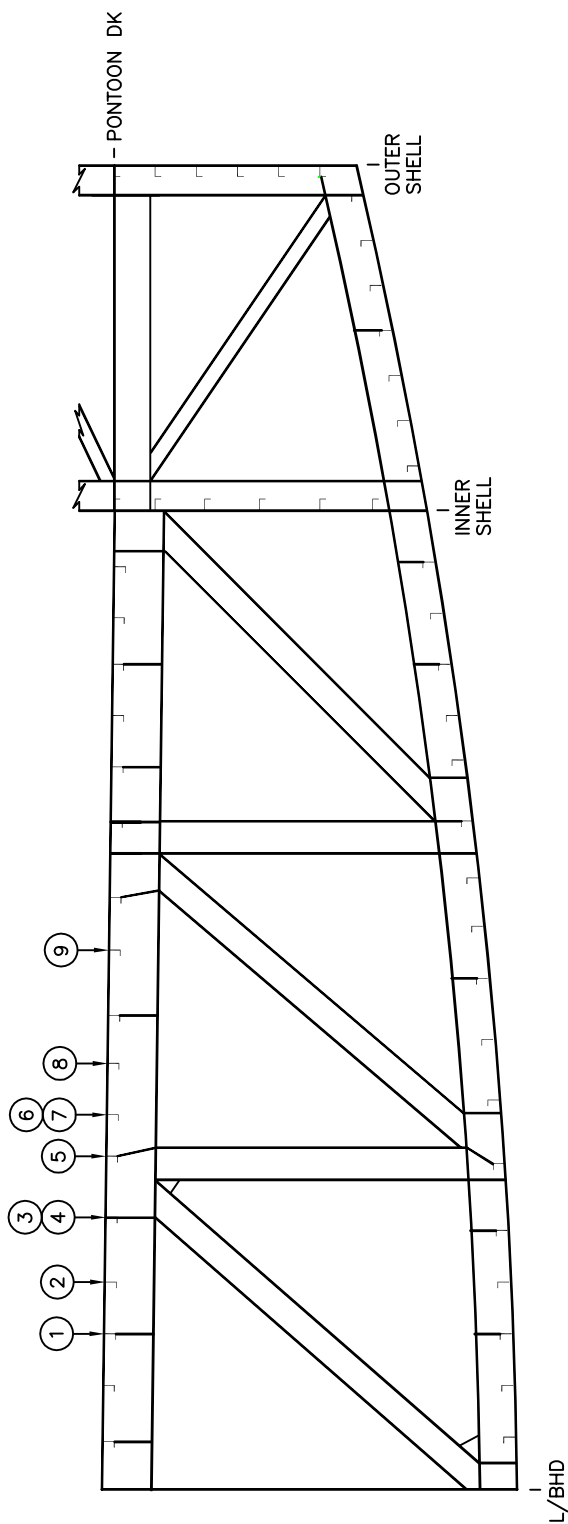
TANK No.15 - FRAME C  
DESCRIPTION: LOOKING NORTH

- 1.) 1" Fracture in web of longitudinal in way of channel cut-out, 17" north of frame.
- 2.) 1" Fracture in web of longitudinal in way of channel cut-out, 17" north of frame.
- 3.) 1" Fracture in web of longitudinal in way of channel cut-out, 17" north of frame.
- 4.) ½" Fracture in web of longitudinal in way of channel cut-out, 17" south of frame.
- 5.) 1" Fracture in web of longitudinal in way of channel cut-out, 17" north of frame.
- 6.) 1" Fracture in web of longitudinal in way of channel cut-out, 17" north of frame.
- 7.) ½" Fracture in web of longitudinal in way of channel cut-out, 17" south of frame.
- 8.) ½" Fracture in web of longitudinal in way of channel cut-out, 17" north of frame.
- 9.) 6" Fracture in flange of longitudinal in way of channel cut-out, 6" south of frame.

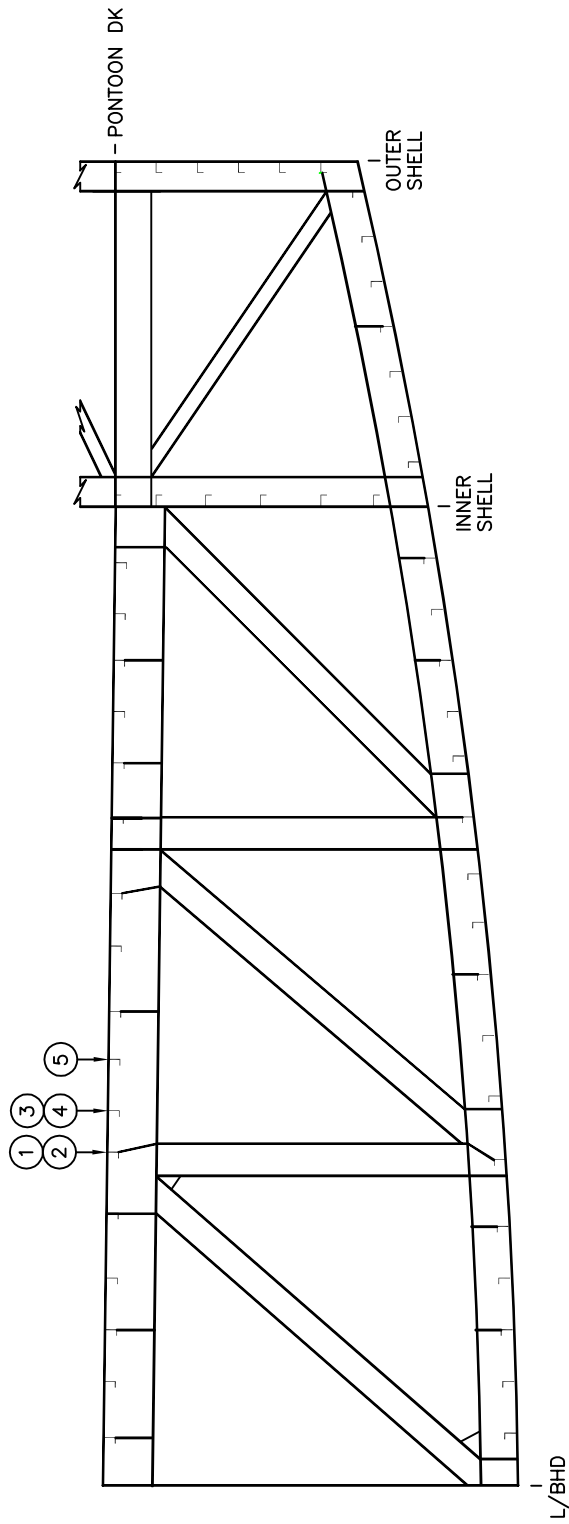
TANK No.15 - FRAME B  
DESCRIPTION: LOOKING NORTH

- 1.) ½" Fracture in web of longitudinal in way of channel cut-out, 17" north of frame.
- 2.) ½" Fracture in web of longitudinal in way of channel cut-out, 17" south of frame.
- 3.) ½" Fracture in web of longitudinal in way of channel cut-out, 17" north of frame.
- 4.) ½" Fracture in web of longitudinal in way of channel cut-out, 17" south of frame.
- 5.) ½" Fracture in web of longitudinal in way of channel cut-out, 17" north of frame.

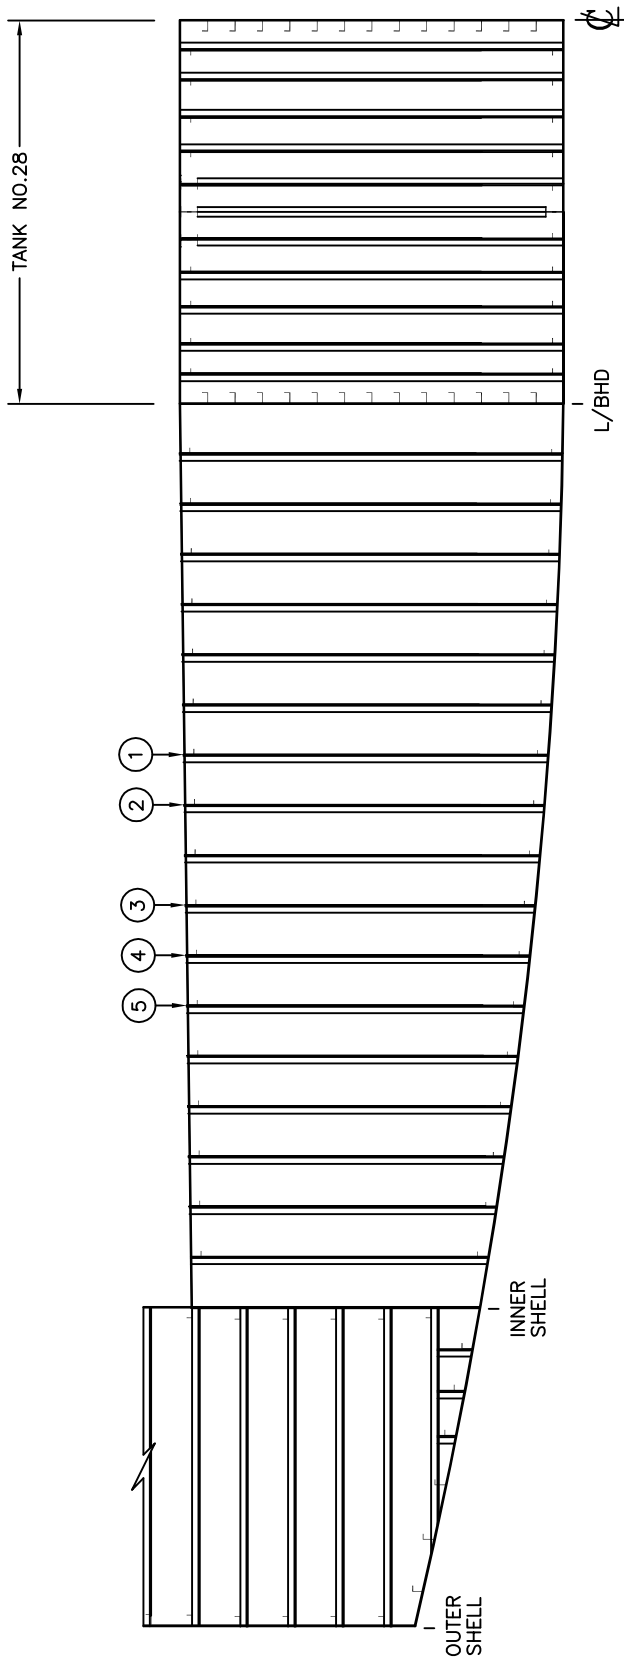
TANK NO.16 & 28 - BULKHEAD 3

- 1.) 1" Fracture in web of longitudinal in way of channel cut-out, 17" south of bhd.
- 2.) 1" Fracture in web of longitudinal in way of channel cut-out, 17" south of bhd.
- 3.) 2" diameter hole in deck plating, 6" south of bulkhead.
- 4.) 1" Fracture in web of longitudinal in way of channel cut-out, 17" south of bhd.
- 5.) 1" Fracture in web of longitudinal in way of channel cut-out, 17" south of bhd.
