## EUREKA DRY DOCK UT /VT SURVEY MAY 2015

Ultrasonic thickness measurements and a visual survey was performed for BAE Systems of San Francisco on the Eureka Dry Dock located at BAE Shipyard in San Francisco, CA. The owners were represented by Mr. Justin Gleaton. The survey was performed by International Inspection personnel.

## EUREKA DRY DOCK VISUAL SURVEY TABLE OF CONTENTS

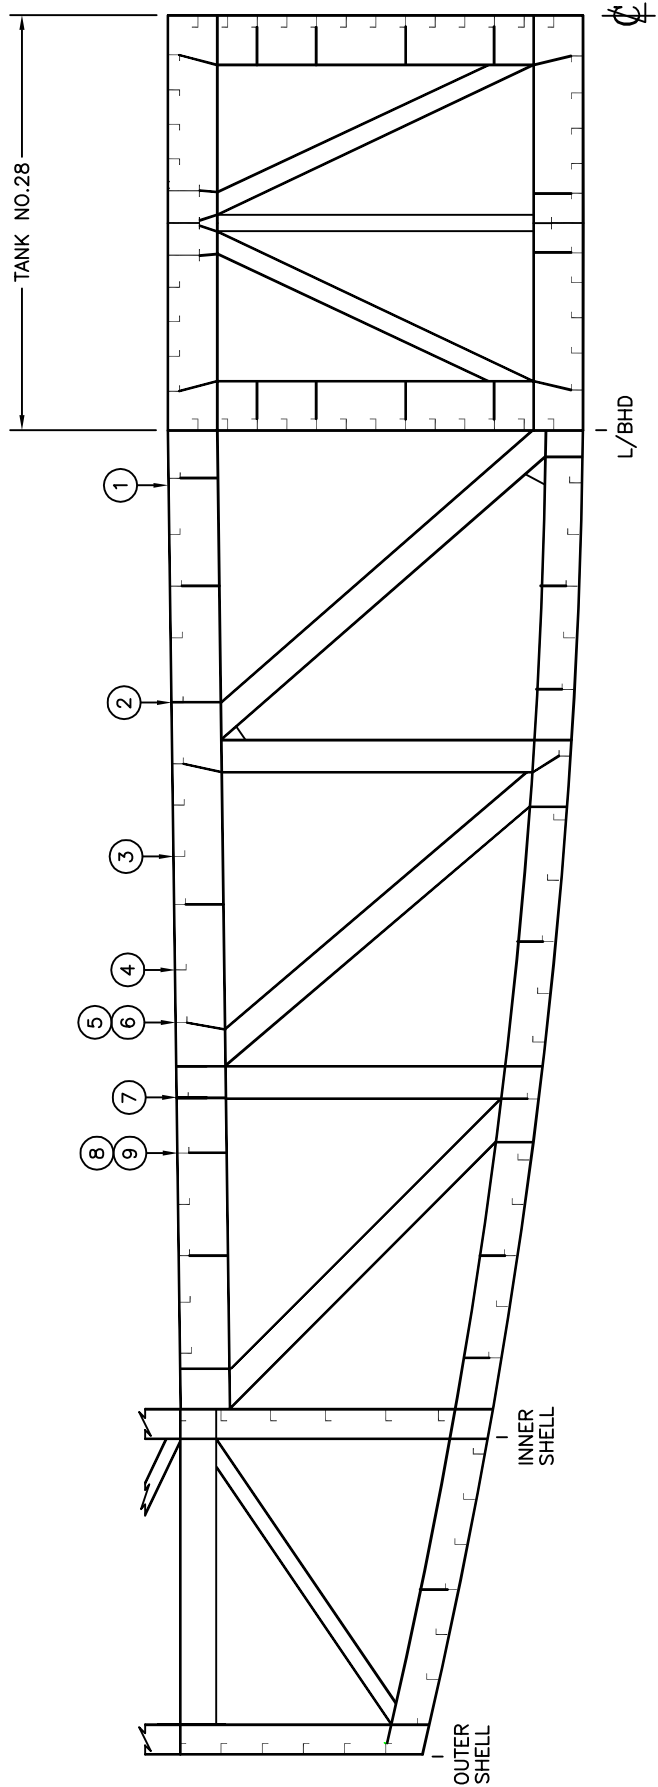
TANK NO. 16 & 28 - FRAME 2

- 1.) 3” fracture on manway attachment weld to deck, 36” north of frame.
- 2.) 1” Fracture in web of longitudinal in way of channel cut-out, 17” south of frame.
- 3.) 2” Fracture in web of longitudinal in way of channel cut-out, 17” north of frame.
- 4.) 2” Fracture in web of longitudinal in way of channel cut-out, 17” north of frame.
- 5.) 2” Fracture in web of longitudinal in way of channel cut-out, 17” north of frame.
- 6.) 1” Fracture in web of longitudinal in way of channel cut-out, 17” south of frame.
- 7.) 1” Fracture in web of longitudinal in way of channel cut-out, 17” south of frame.
- 8.) 2” Fracture in web of longitudinal in way of channel cut-out, 17” north of frame.
- 9.) 1” Fracture in web of longitudinal in way of channel cut-out, 17” south of frame.

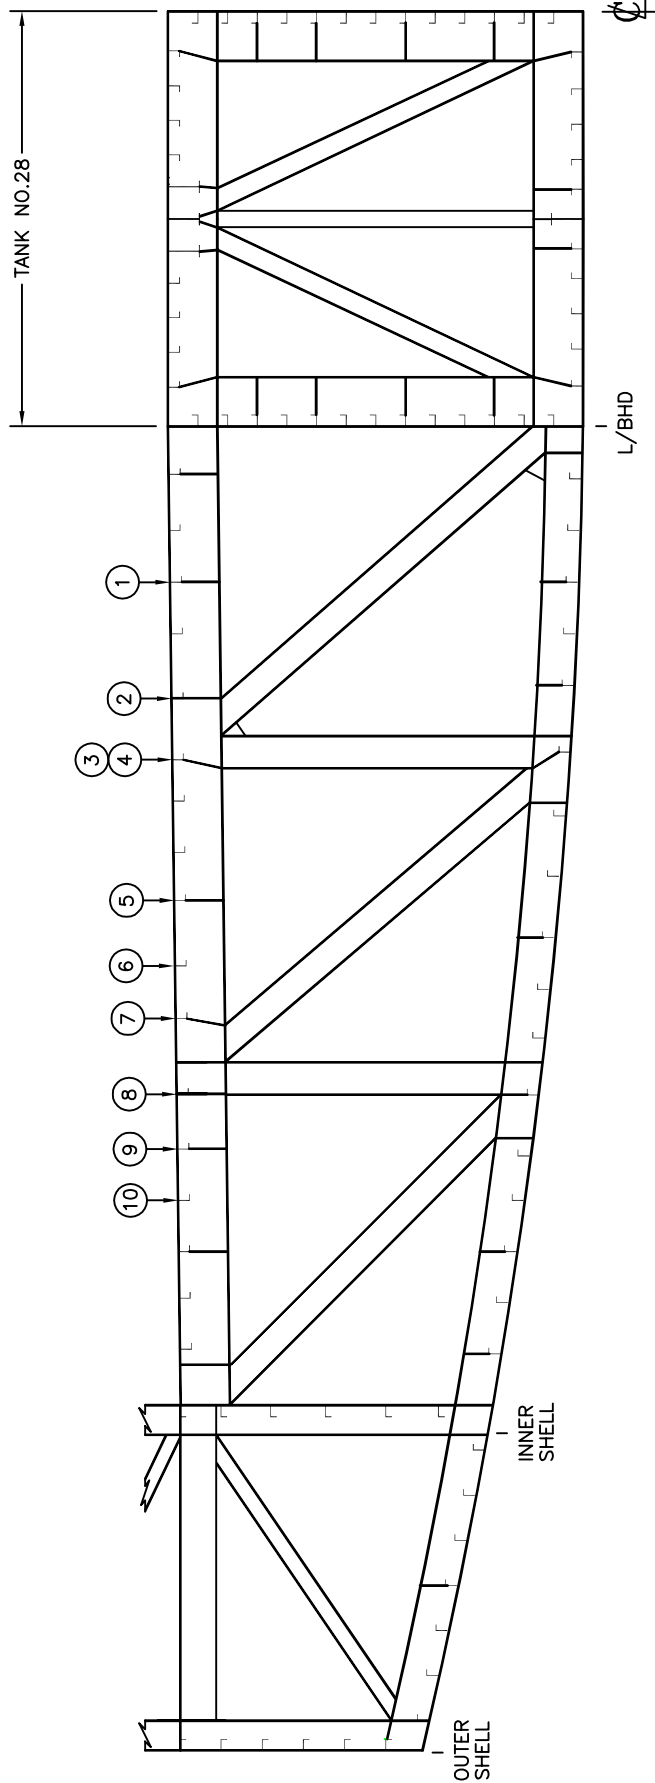
TANK NO. 16 & 28 - FRAME 1

- 1.) 1" Fracture in web of longitudinal in way of channel cut-out, 17" north of frame.
- 2.) 1" Fracture in web of longitudinal in way of channel cut-out, 17" north of frame.
- 3.) 1" Fracture in web of longitudinal in way of channel cut-out, 17" north of frame.
- 4.) 1 ½" Fracture in web of longitudinal in way of channel cut-out, 17" north of frame.
- 5.) 1" Fracture in web of longitudinal in way of channel cut-out, 17" north of frame.
- 6.) 1 ½" Fracture in web of longitudinal in way of channel cut-out, 17" north of frame.
- 7.) 1 ½" Fracture in web of longitudinal in way of channel cut-out, 17" north of frame.
- 8.) 1 ½" Fracture in web of longitudinal in way of channel cut-out, 17" north of frame.
- 9.) 1 ½" Fracture in web of longitudinal in way of channel cut-out, 17" north of frame.
- 10.) 1 ½" Fracture in web of longitudinal in way of channel cut-out, 17" north of frame.

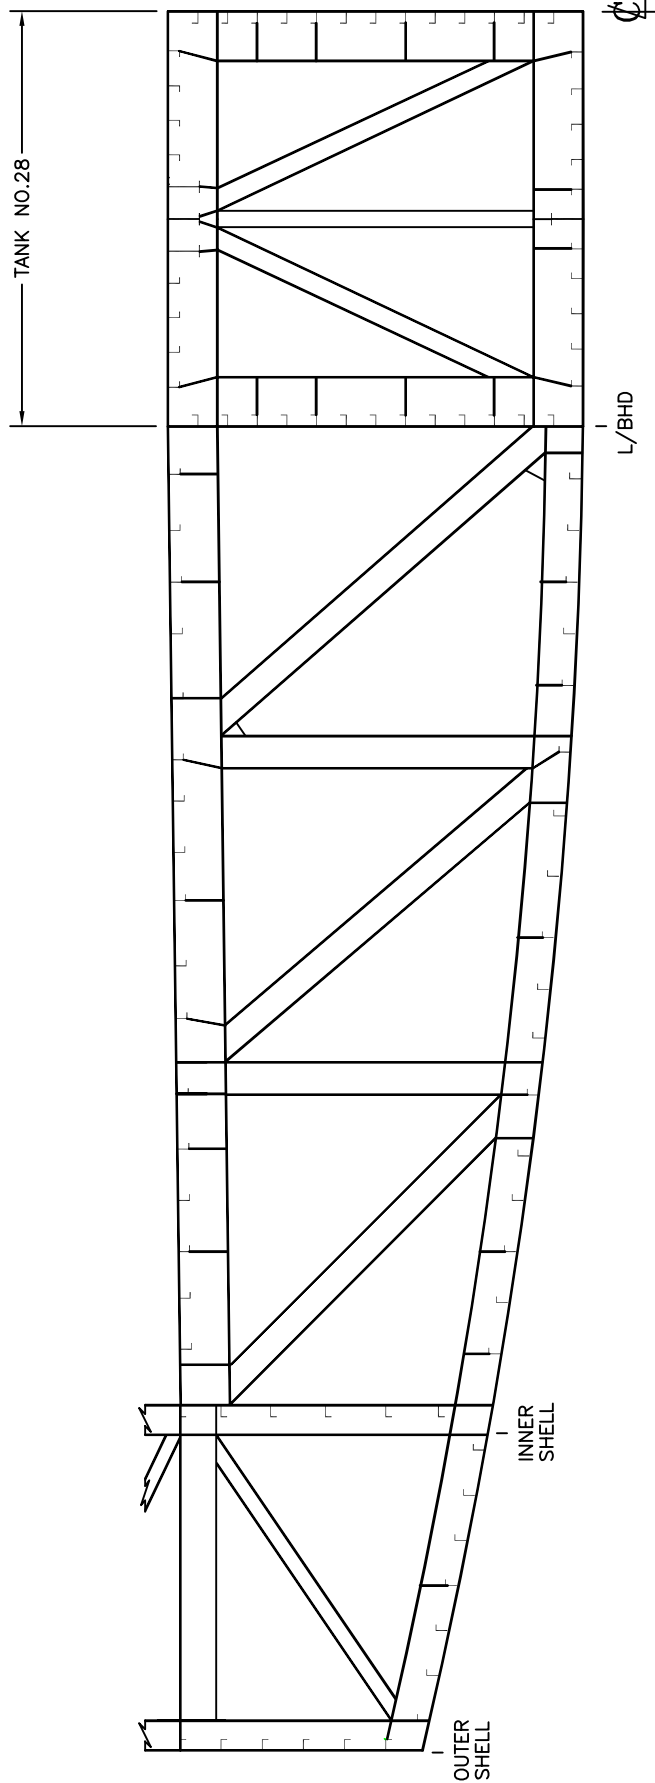
TANK NO. 16 & 28 - FRAME B

**No visual indications found at time of survey.**

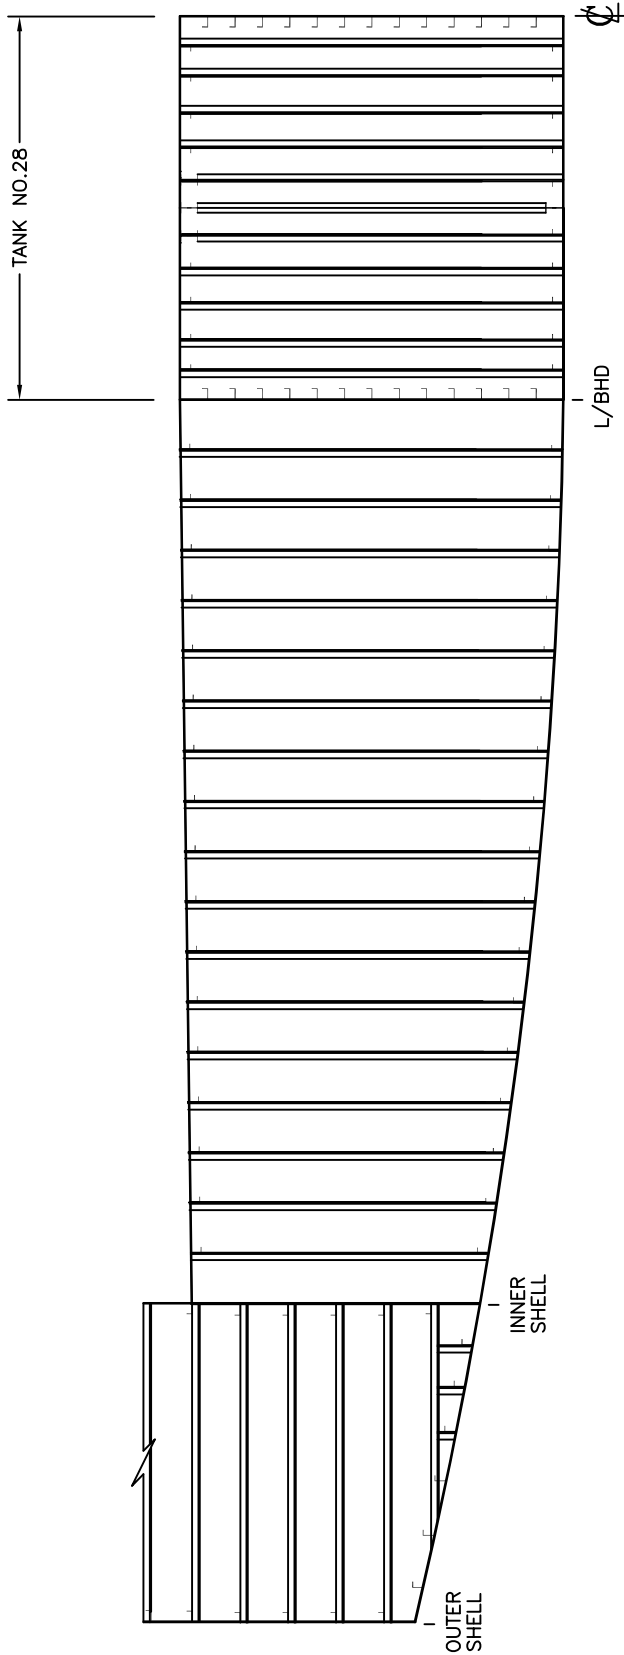
TANK NO.16 & 28 - BULKHEAD A  
 DESCRIPTION: LOOKING NORTH

**No visual indications found at time of survey.**
