# **HEGER DRY DOCK, INC**

16-87L

December 7, 2016

Re: Request for HEGER Certification of Dry Dock No. 2 located in BAE San Francisco, CA

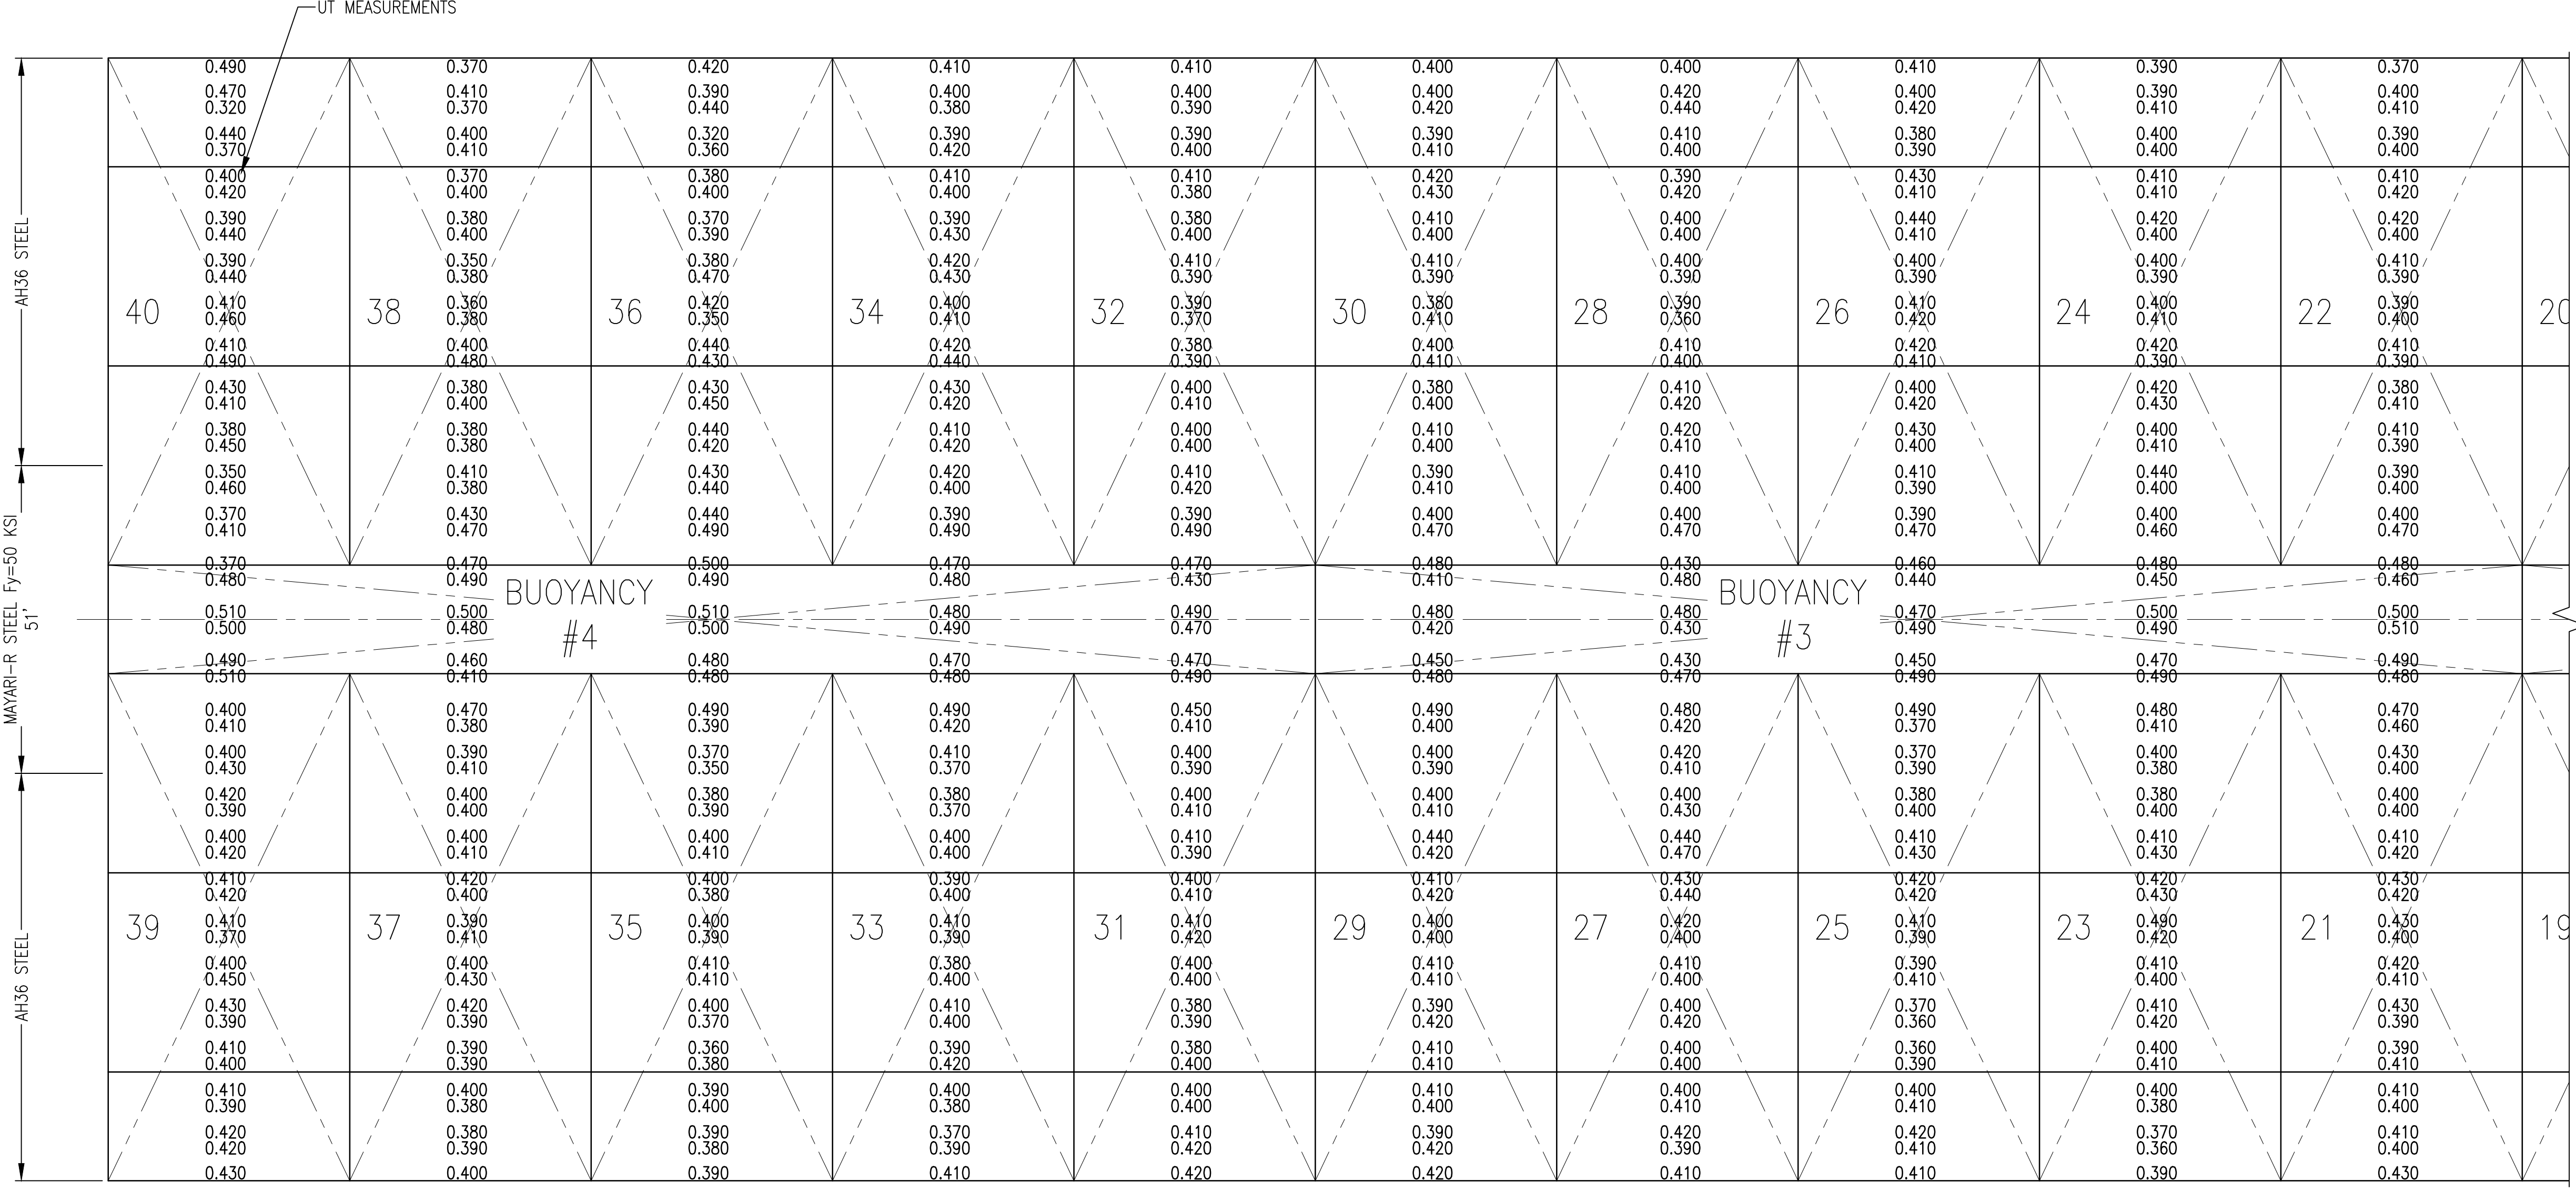
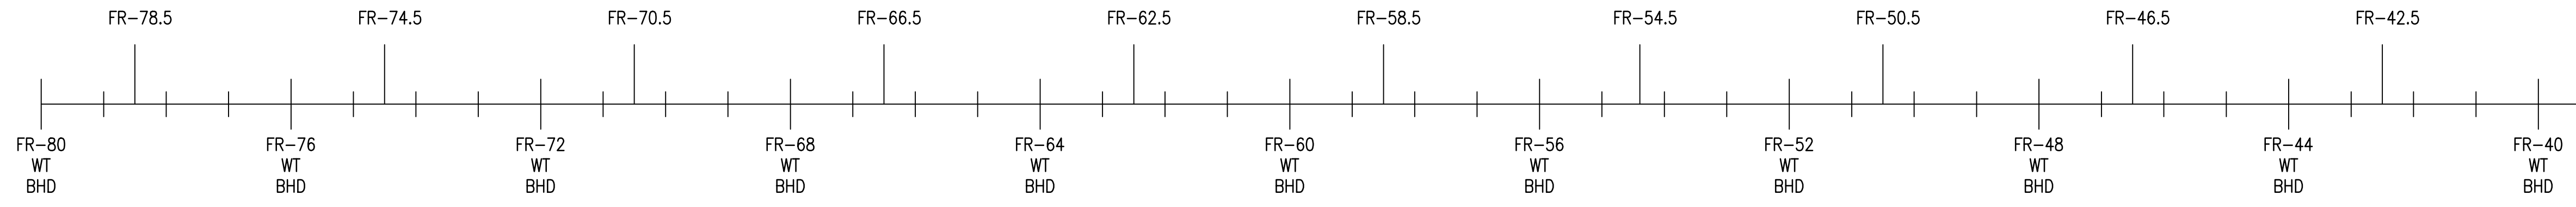
**PLAN - PONTOON BOTTOM - UT MEASUREMENTS**  
 SCALE: 1/16"=1'-0" A1

- 1.) DRAWING REFLECTS UT DATA COLLECTED BY INTERNATIONAL INSPECTION IN JANUARY 2016.
- 2.) SEE SYMBOLS KEY FOR DESCRIPTION OF HIGHLIGHTED AREAS.
- 3.) UT MEASUREMENTS HIGHLIGHTED IN RED ARE LESS THAN 0.35".

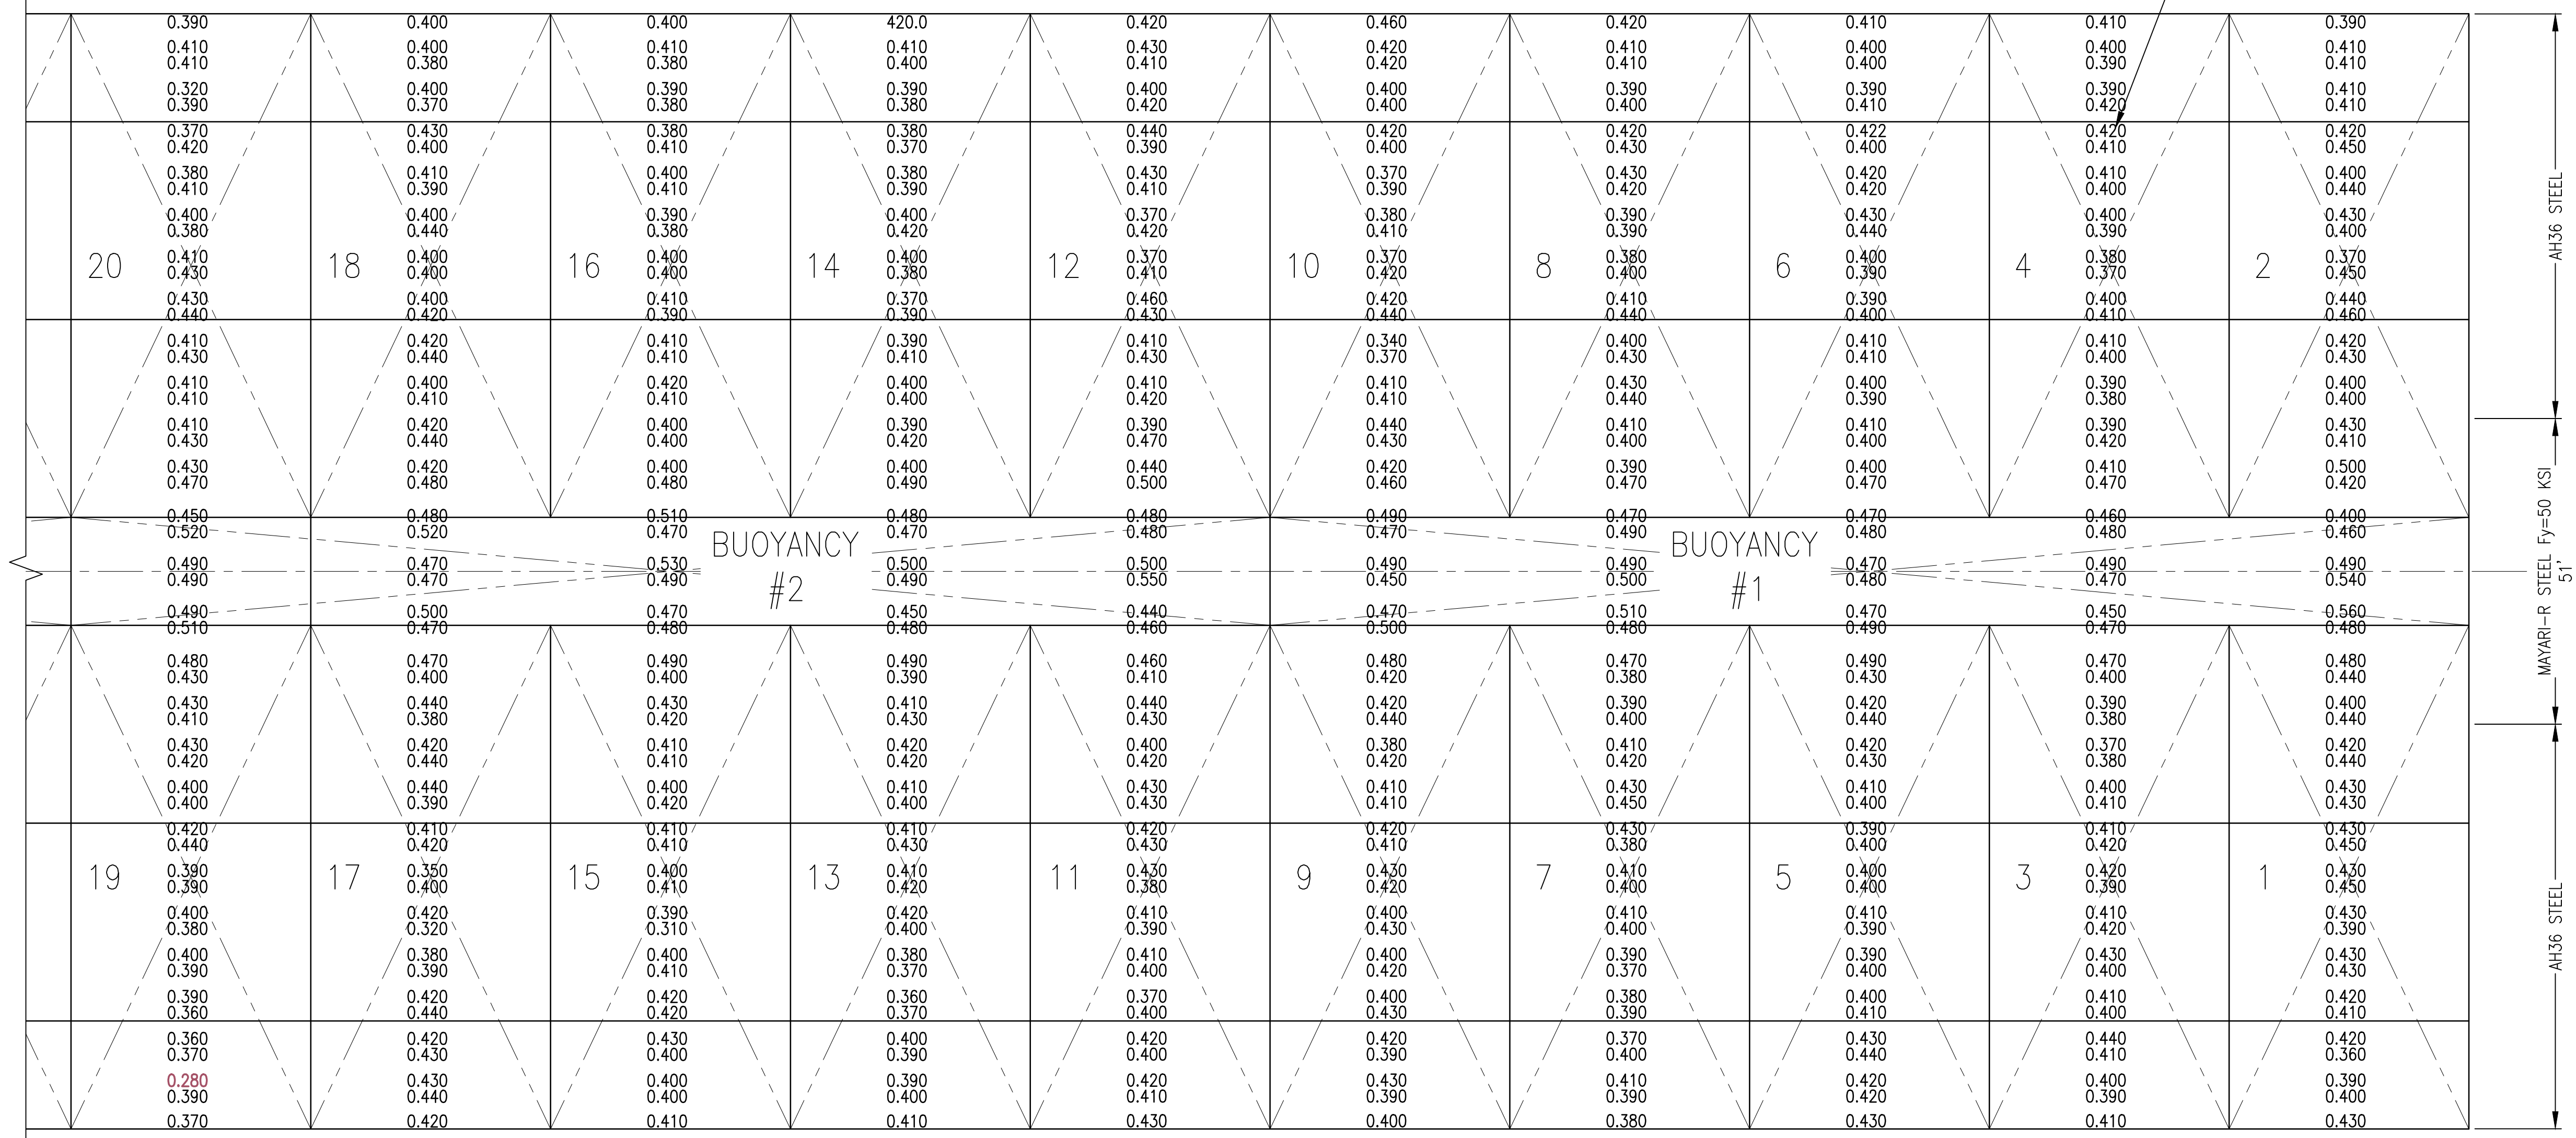
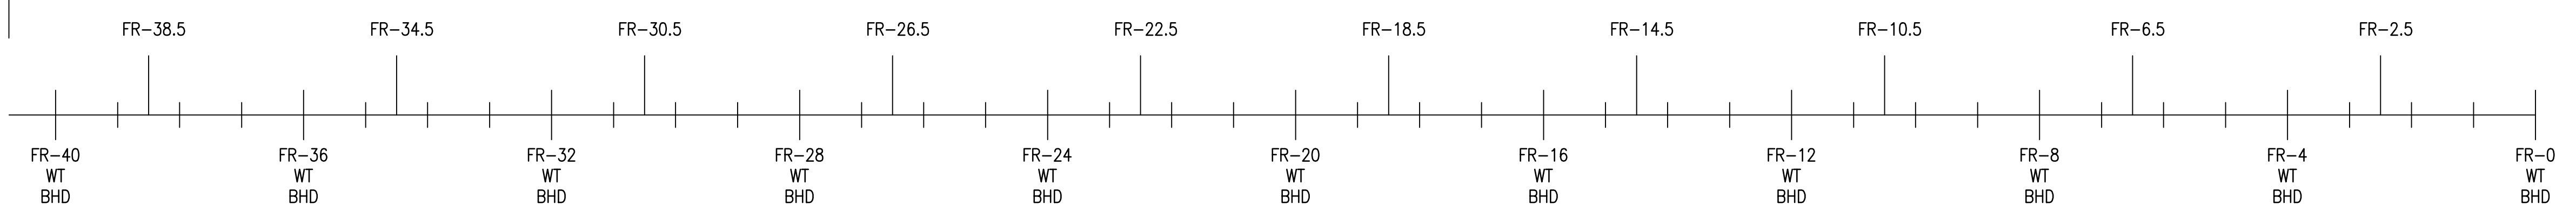
PLAN - PONTOON BOTTOM - UT MEASUREMENTS  
SCALE: 1/16"=1'-0" (A1)

NOTES:  
1.) DRAWING REFLECTS UT DATA COLLECTED BY INTERNATIONAL INSPECTION IN JANUARY 2016.  
2.) SEE SYMBOLS KEY FOR DESCRIPTION OF HIGHLIGHTED AREAS.  
3.) UT MEASUREMENTS HIGHLIGHTED IN RED ARE LESS THAN 0.35".
