HEGER DRY DOCK, INC

January 19, 2017

Re: Docking of Tandem Barges on Eureka

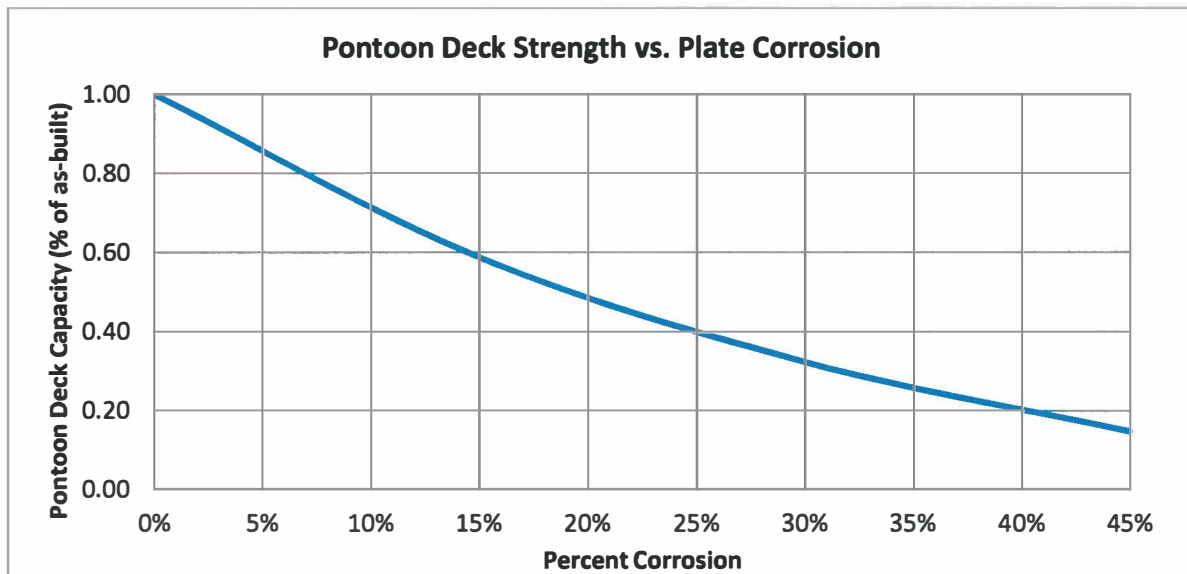
- Longitudinally stiffened panel – 96" x 24-5/8" x 7/16" (No Corrosion) = 9,360 psi
- Longitudinally stiffened panel – 96" x 24-5/8" x 0.216" (45% Corroded) = 2,520 psi

Given the coupled effects of a 45% material thickness reduction and a 75% allowable compressive stress reduction, the pontoon deck's net reduction in structural capacity is about 85% or 15% of the deck's original capacity. This reduction in pontoon deck strength drastically decreases the overall transverse bending strength of the dock.

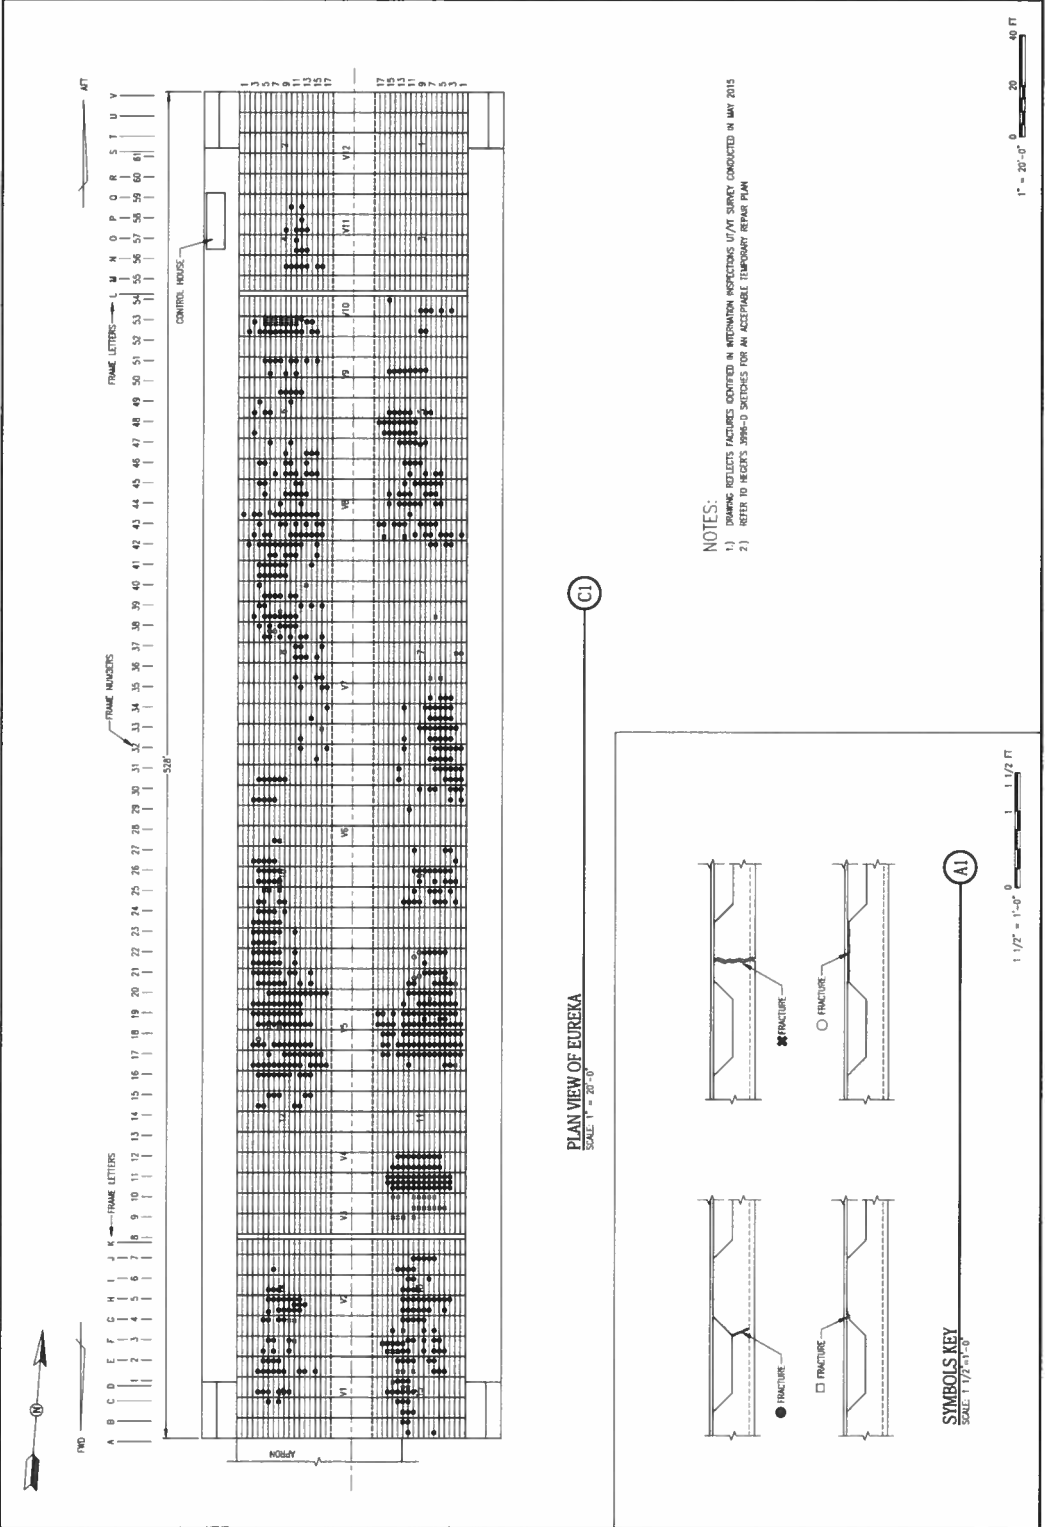
ENCLOSURE 3
Pontoon Deck Stiffener Repair Plan

The EUREKA's pontoon deck stiffeners, however, have a widespread condition of fractures to the channel stiffeners in way of the serrated notches. A fracture in the serrated channel creates a discontinuity in the flow of bending stresses and changes the boundary condition of the stiffener beam from a fixed-fixed condition to two independent cantilevered beams overhanging from the supporting transverse frame. These cantilevered beams are significantly weaker and are assumed to take no load. As a result of the failure, the hydrostatic load is redistributed to adjacent stiffeners,

The latest 2017 HEGER inspection of the EUREKA pontoon deck found that the typical condition was for multiple adjacent pontoon deck stiffeners to be fracture. This is an UNSATISFACTORY condition to resist the head pressures required of the tandem barge docking addressed in this letter.

- Fracture of any kind in two(2) adjacent pontoon deck stiffeners
- More than one(1) fracture of any kind in a single pontoon deck stiffener between transverse frames.

There are four(4) different types of stiffener fractures occurring on the pontoon deck stiffeners. An acceptable short term pontoon deck stiffener repair plan for each fracture type is attached in Enclosure (3). Pontoon deck stiffeners should be repaired in accordance with the repair plan to eliminate the unsatisfactory conditions stated above. If staging is erected in a tank to repair deck stiffeners, it is recommended all stiffeners in the vicinity be repaired.

NOTES:
 1) DRAWING REFLECTS FACTURES IDENTIFIED IN INFORMATION INSPECTIONS U/V/T SURVEY CONDUCTED IN MAY 2015
 2) REFER TO HEGER'S 3986-D SKETCHES FOR AN ACCEPTABLE TEMPORARY REPAIR PLAN
