**COMMERCIAL INSPECTION  
for  
EUREKA FLOATING DRY DOCK  
REVISION 1**

**HEGER DRY DOCK, INC.**  
HOLLISTON, MASSACHUSETTS

**JANUARY 2017**  
Job# 3978-D

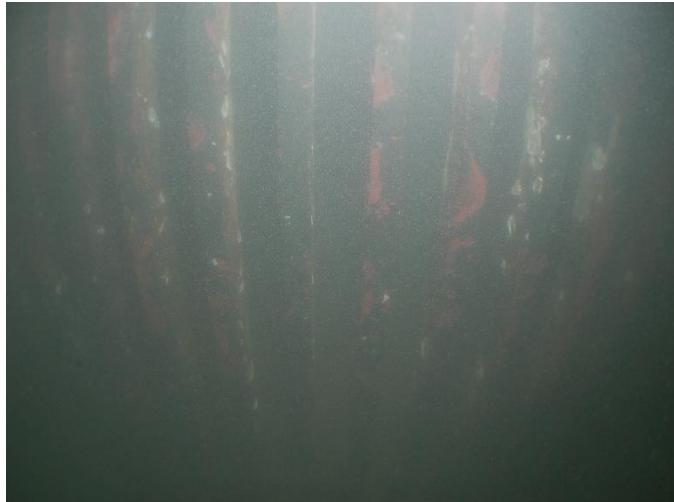
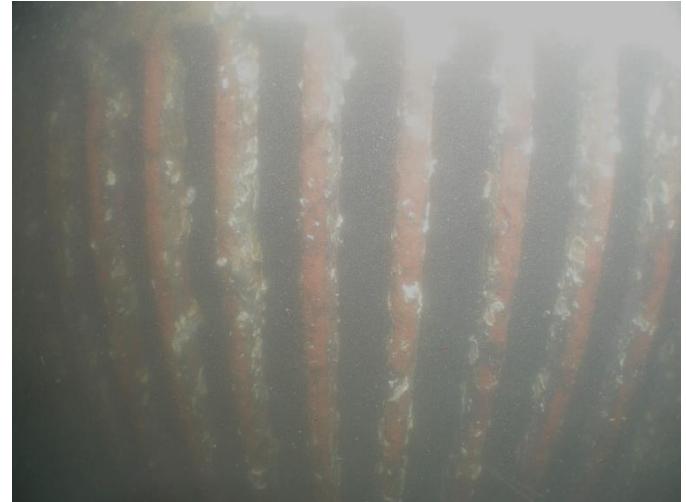
Diver checked each screen again after cleaning and found one screen that has a bent bar which is identified in **Drawing B**. All other screens are securely fastened to dry dock and in good condition. Below are pictures of a few screens which are typical of all screens after cleaning.

Two intake screen pictures below are “typical” of all intake screens

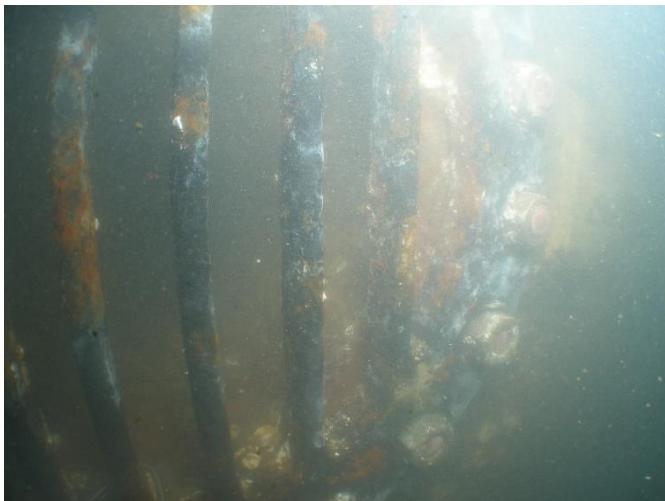
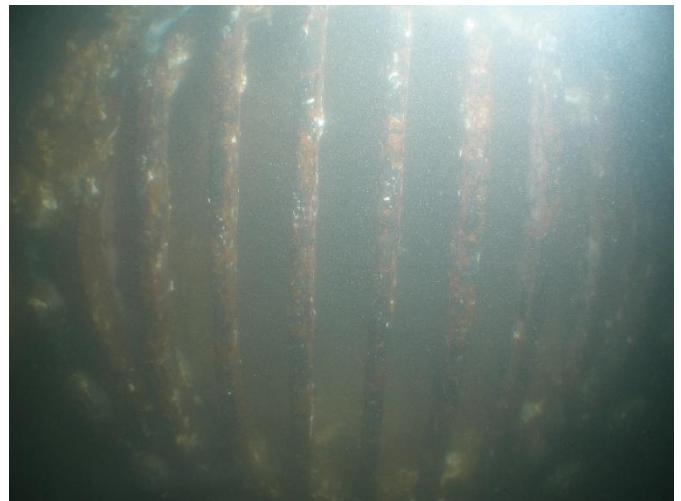
Two discharge screen pictures below are “typical” of all discharge screens

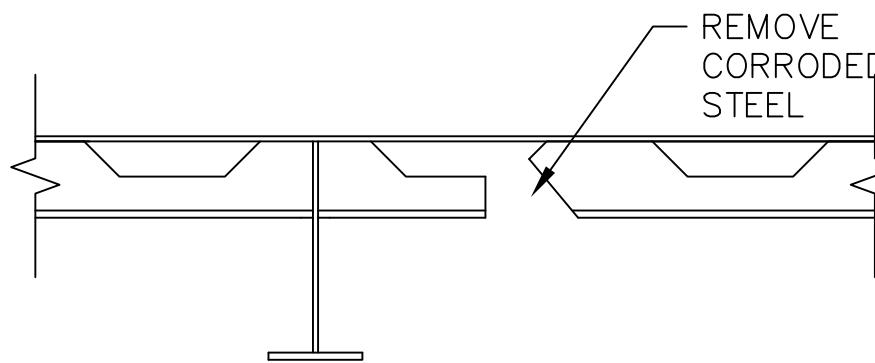
TYPE 1a  
FRACTURE IN WAY OF  
CHANNEL CUT OUT—FLANGE DETERIORATED  
EXISTING CONDITION

- 1.) REMOVE CORRODED STEEL BACK TO GOOD METAL – STEEL WITH LESS THAN 15% CORROSION
- 2.) REMOVE SCALE & PAINT IN REPAIRED AREA
- 3.) REPAINT REPAIRED AREA
- 4.) CRACK MAY BE BUTT WELDED IF SURROUNDING STEEL HAS LESS THAN 15% THICKNESS LOSS
- 5.) IF DECK PLATING HAS PIN HOLES OR CORROSION EXCEEDING LIMIT SEE SHEET SK 5-5 FOR ALTERNATIVE REPAIR METHOD

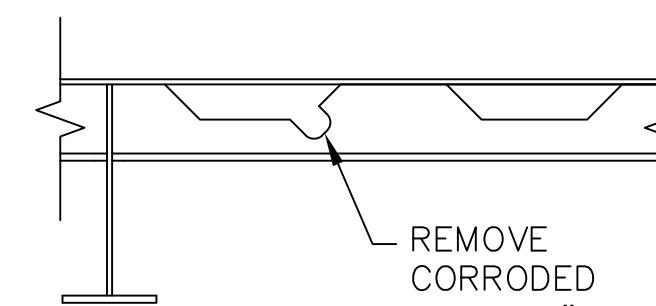
TYPE 1b  
FRACTURE IN WAY OF  
CHANNEL CUT OUT—FLANGE OK  
EXISTING CONDITION

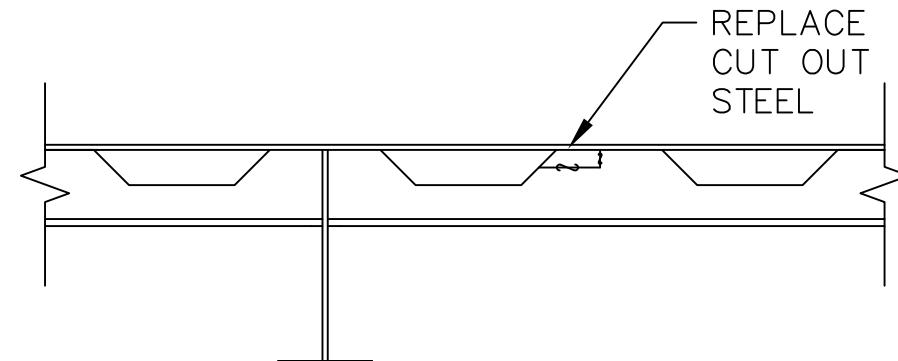
TYPE 2  
FRACTURE IN WAY OF  
WRAP WELD  
EXISTING CONDITION

TYPE 2  
FRACTURE IN WAY OF  
WRAP WELD  
REPAIR STEP 1

TYPE 2  
FRACTURE IN WAY OF  
WRAP WELD  
REPAIR STEP 2

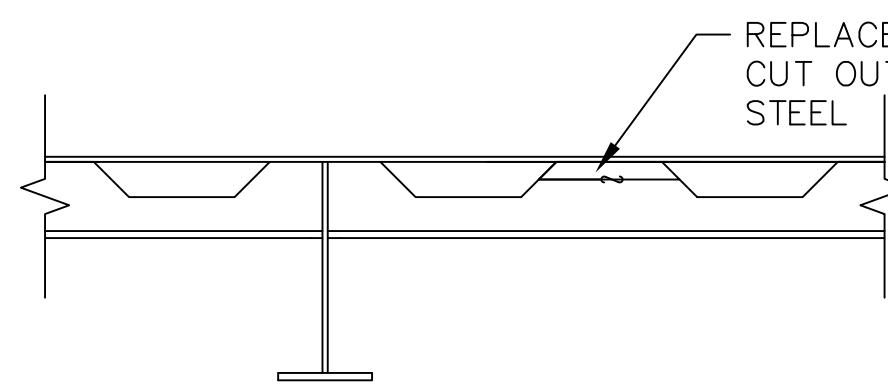
TYPE 4  
FRACTURE AT  
ATTACHMENT WELD  
EXISTING CONDITION

TYPE 4  
FRACTURE AT  
ATTACHMENT WELD  
REPAIR STEP 1

TYPE 4  
FRACTURE AT  
ATTACHMENT WELD  
REPAIR STEP 2

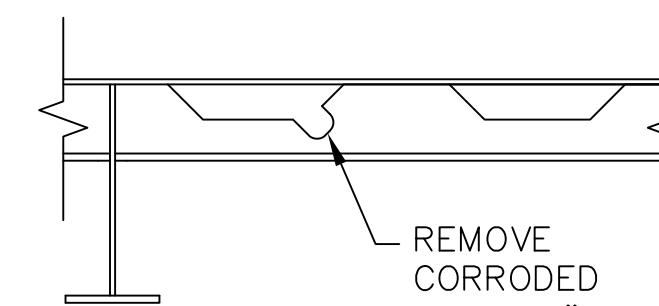
TYPE 1b  
FRACTURE IN WAY OF  
CHANNEL CUT OUT—FLANGE OK  
EXISTING CONDITION

- 1.) REMOVE CORRODED STEEL BACK TO GOOD METAL – STEEL WITH LESS THAN 15% CORROSION
- 2.) REMOVE SCALE & PAINT IN REPAIRED AREA
- 3.) REPAINT REPAIRED AREA
- 4.) CRACK MAY BE BUTT WELDED IF SURROUNDING STEEL HAS LESS THAN 15% THICKNESS LOSS
- 5.) IF DECK PLATING HAS PIN HOLES OR CORROSION EXCEEDING LIMIT SEE SHEET SK 5-5 FOR ALTERNATIVE REPAIR METHOD

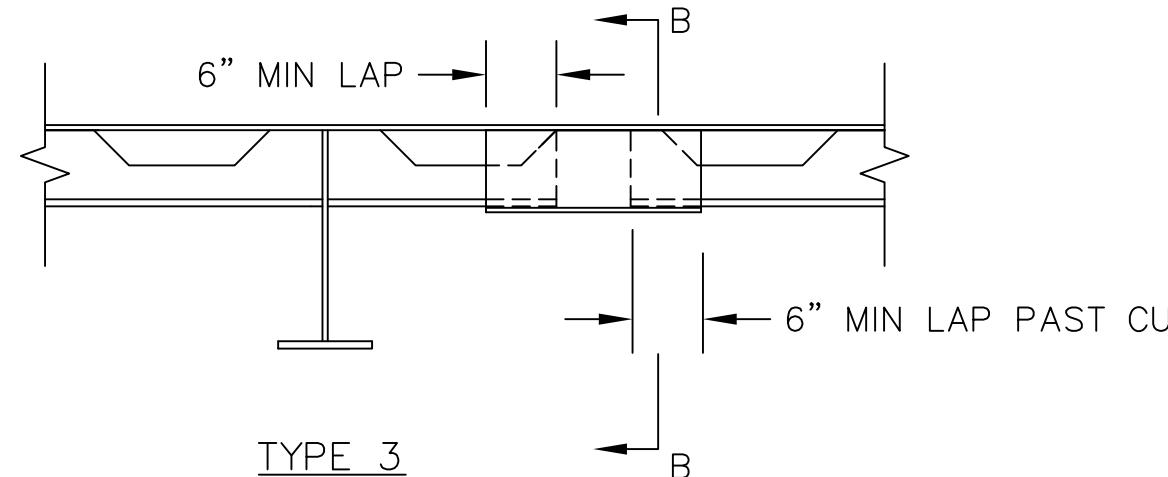
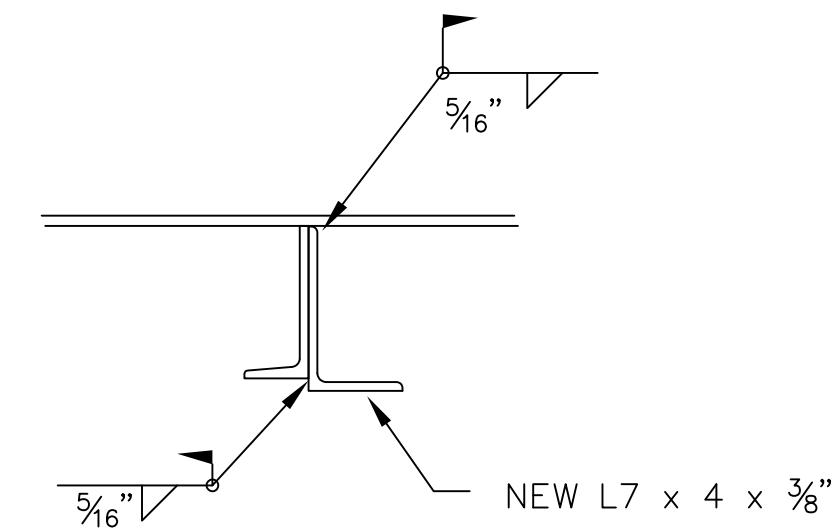
INSPECT FOR PIN  
HOLES OR CORROSION  
EXCEEDING LIMIT  
(SEE NOTE 5)

- 1.) REMOVE CORRODED STEEL BACK TO GOOD METAL  
– STEEL WITH LESS THAN 15% CORROSION
- 2.) REMOVE SCALE & PAINT IN REPAIRED AREA
- 3.) REPAINT REPAIRED AREA
- 4.) CRACK MAY BE BUTT WELDED IF SURROUNDING  
STEEL HAS LESS THAN 15% THICKNESS LOSS
- 5.) IF DECK PLATING HAS PIN HOLES OR CORROSION  
EXCEEDING LIMIT SEE SHEET SK 5-5 FOR  
ALTERNATIVE REPAIR METHOD

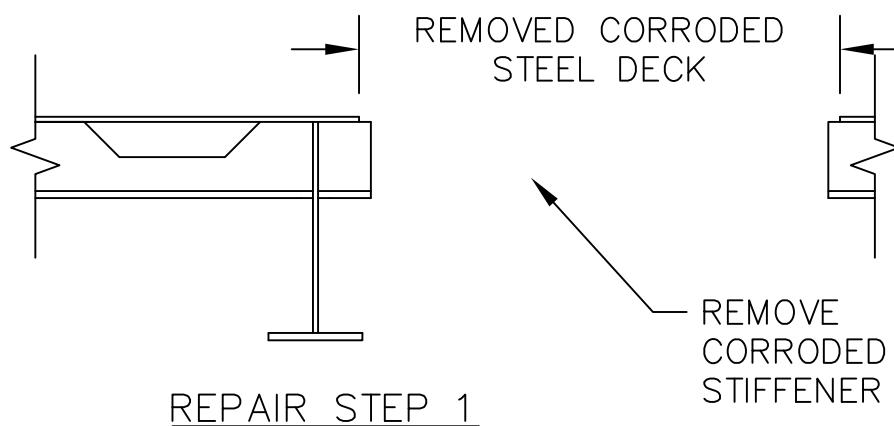
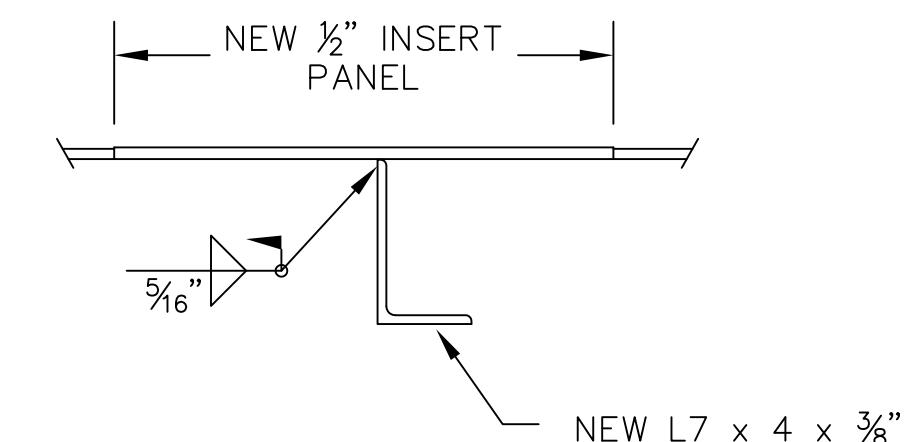
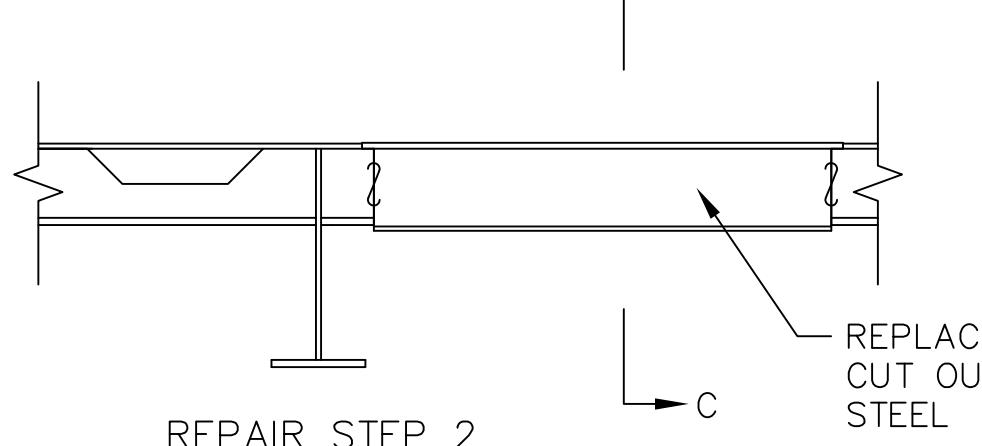
| ALTERNATIVE REPAIR METHOD | | | |

EXCESSIVE LOCAL CORROSION

- 1.) REMOVE CORRODED STIFFENER STEEL BACK TO GOOD METAL – STEEL WITH LESS THAN 15% CORROSION
- 2.) REMOVE CORRODED STEEL DECK BACK TO ACCEPTABLE LIMITS – STEEL WITH LESS THAN 30% CORROSION RECOMMENDED
- 3.) REMOVE SCALE & PAINT IN REPAIRED AREA
- 4.) REPAINT REPAIRED AREA
