Pier 70 Building Survey

Pier 70 San Francisco, California

Historic Building Conditions Survey and Assessment May 22, 2008

Building 113/114

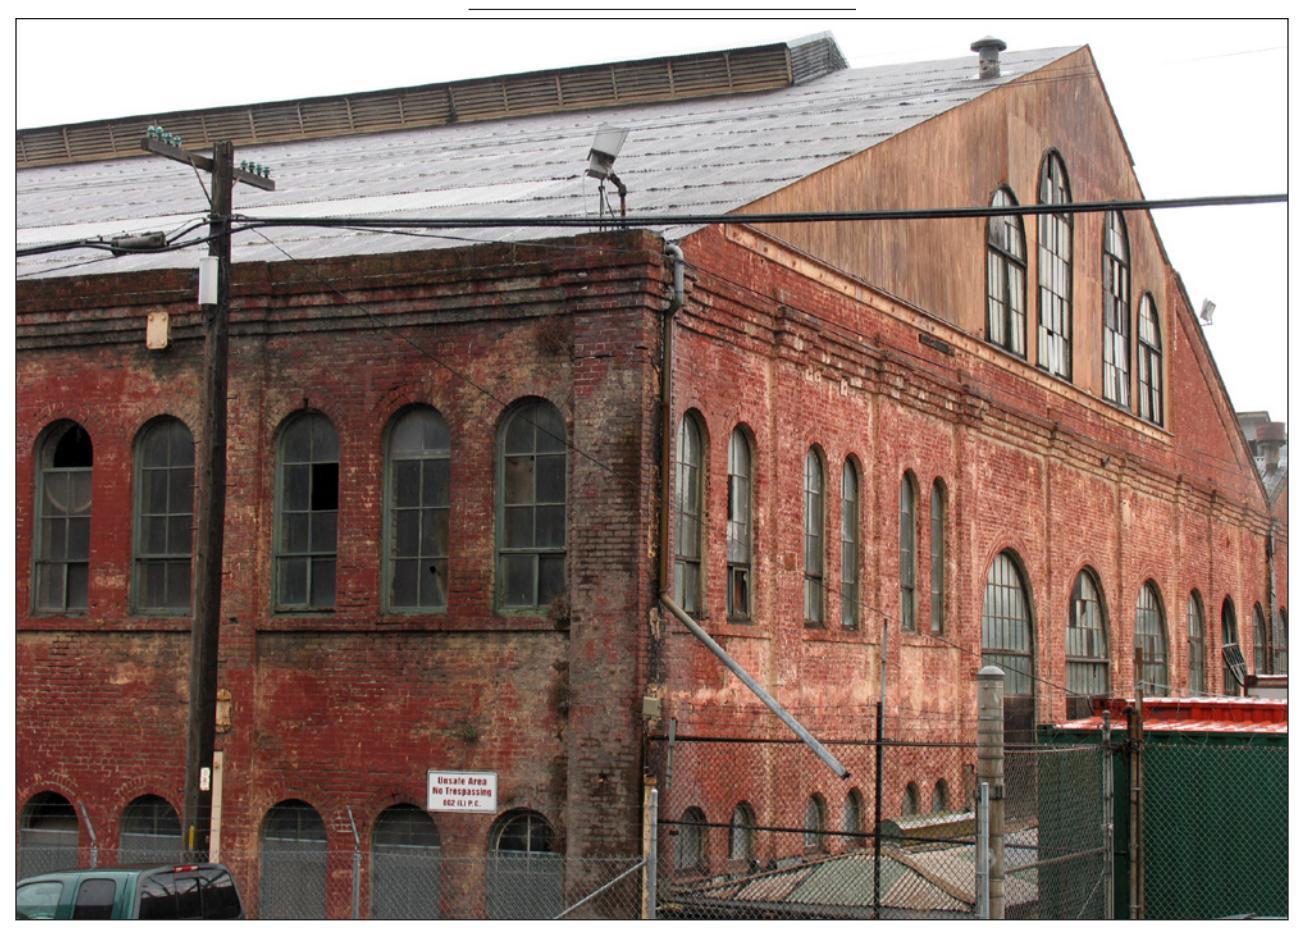
Bldg. 113 Industrial Structure: 81,864 GSF Bldg. 114 Industrial Structure: 8,000 GSF Built: 1885/1886 connector building in 1914 Construction Type: Concrete and Brick Masonry- Steel and some wood frame 492' x 175.5 and 62' tall

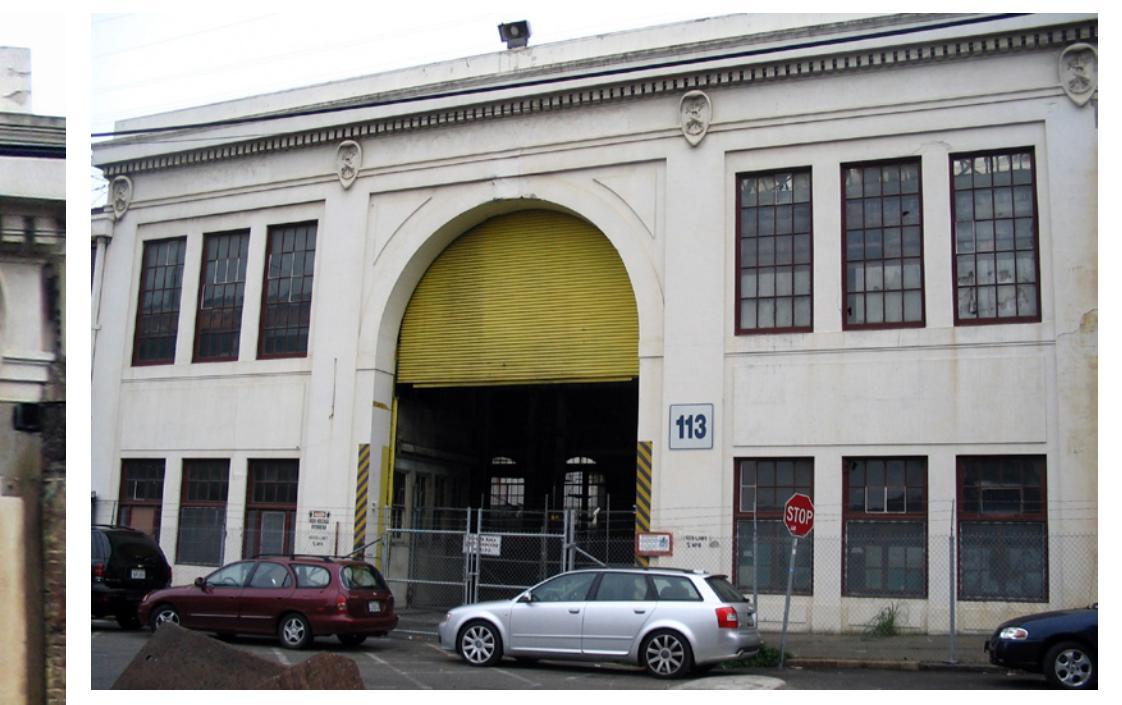
This two-block long industrial structure consists of the two original unreinforced brick buildings, and the central reinforced concrete connector (figure 49). Building 113/114 measures 492' long by 175'-6" wide by 62' tall, and contains 89,686 square feet of floor space. Both brick structures have high gable roofs with monitors, projecting piers, arched windows and simple corbelled cornices. A lower, double gable section extends the western portion south creating an "L." While the two sides of the building are similar in form, scale and materials; fenestration, bay width and rooflines differ from side to side.

Building 113 includes all of the 81,964 square foot area beneath the high, single gable as well as the northern portion of the double gable structure (including an 8,800 square foot mezzanine); Building 114 comprises only the 7,722 square foot area beneath the southern gable of the double gable portion.

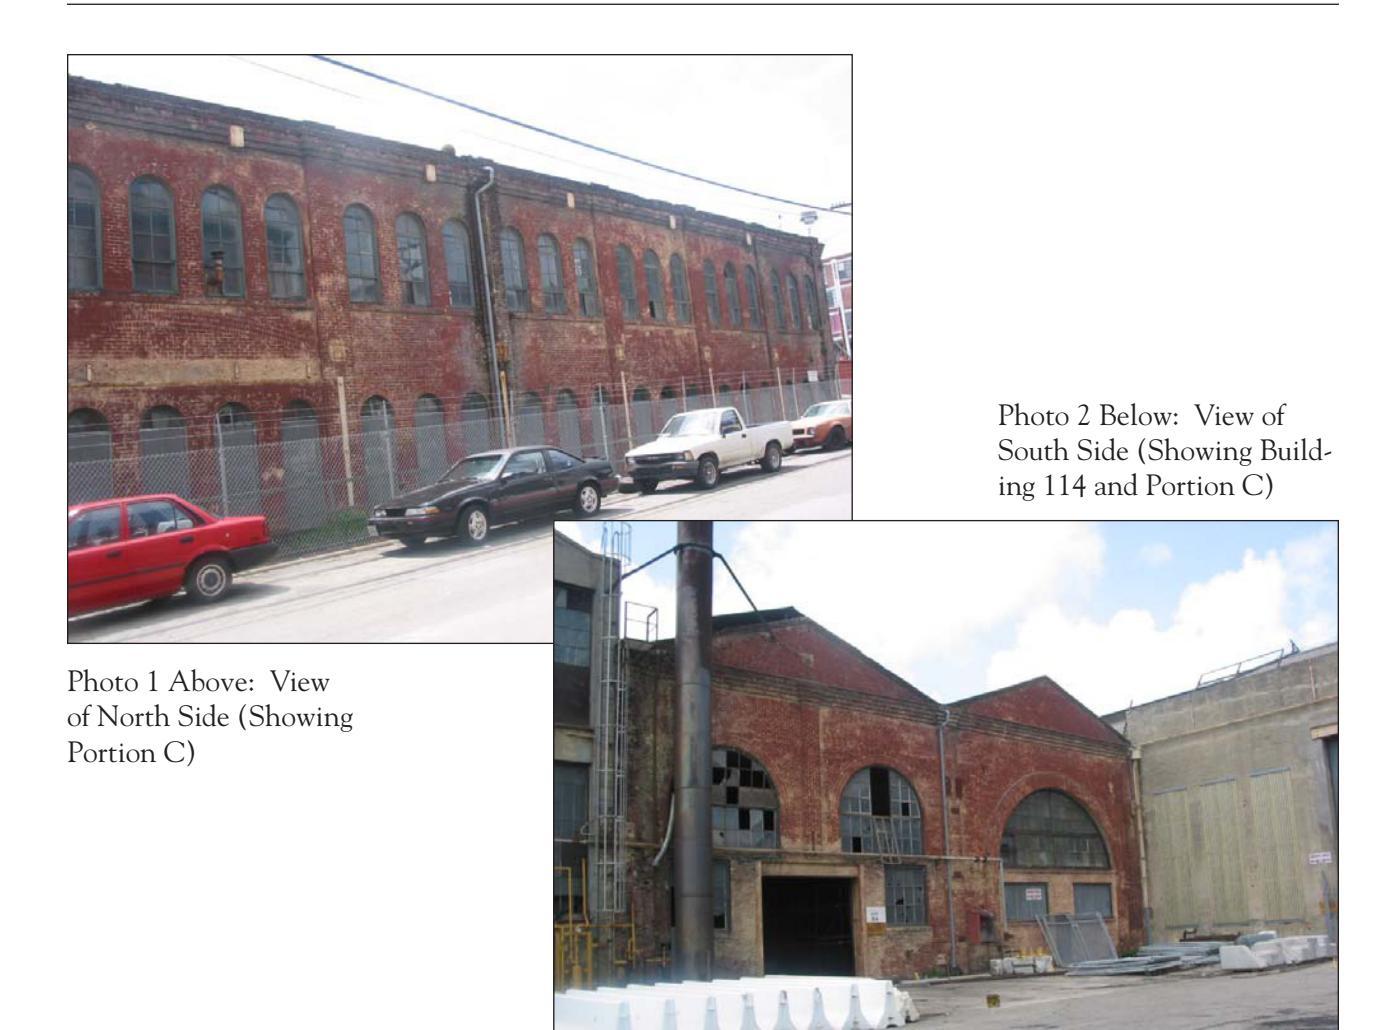
The lateral force resisting system of the building consists of roof metal deck diaphragms and URM or reinforced concrete shear walls at exterior. The existing lateral force resisting system appears to have many seismic deficiencies. The existing roof diaphragm appears inadequate for seismic lateral forces. The roof diaphragm is interrupted with continuous skylights, resulting in inadequate transfer of lateral forces. The exterior URM walls have many windows which create an inadequate seismic load resisting system. The height-to-thickness ratio of the URM wall piers exceeds that allowed by code. The flexibility of these walls can lead to excessive structural damage and / or partial collapse of the building if it is subjected to strong seismic ground motions. The exterior URM walls have some diagonal and vertical cracks in multiple locations. The URM walls do not

appear to be detailed to resist out-of-plane loads. The anchorage of the brick walls to the roof diaphragms for out-of-plane seismic loads appears inadequate. Therefore, the brick walls can pull away from the roof framing causing roof framing to lose vertical support.

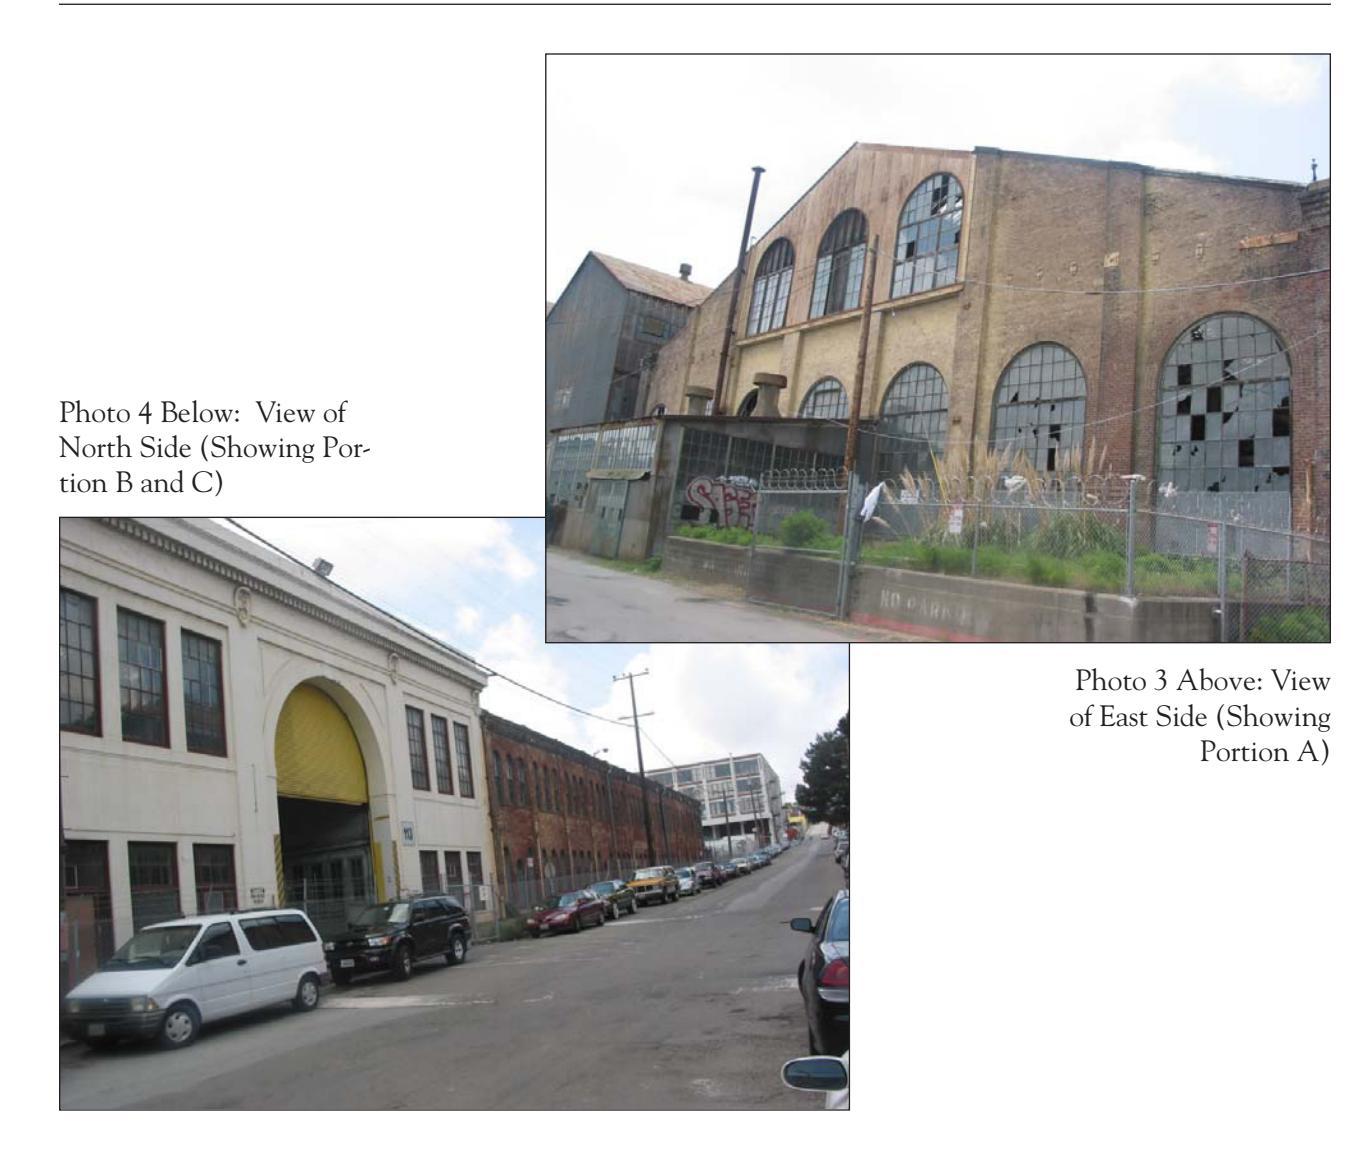
Building 113/114 was previously analyzed and evaluated in 2002 by URS. The evaluation found that the building has several specific weaknesses that would prevent the building from meeting the Life Safety Performance Level based on the requirement of Chapter 16C of the San Francisco Building Code. URS report also presented seismic strengthening concepts for the building.

Based on information contained in the geotechnical report by URS, the existing foundations consist of continuous brick/concrete and stone block footing at the perimeter walls, and concrete spread footings at the interior columns.

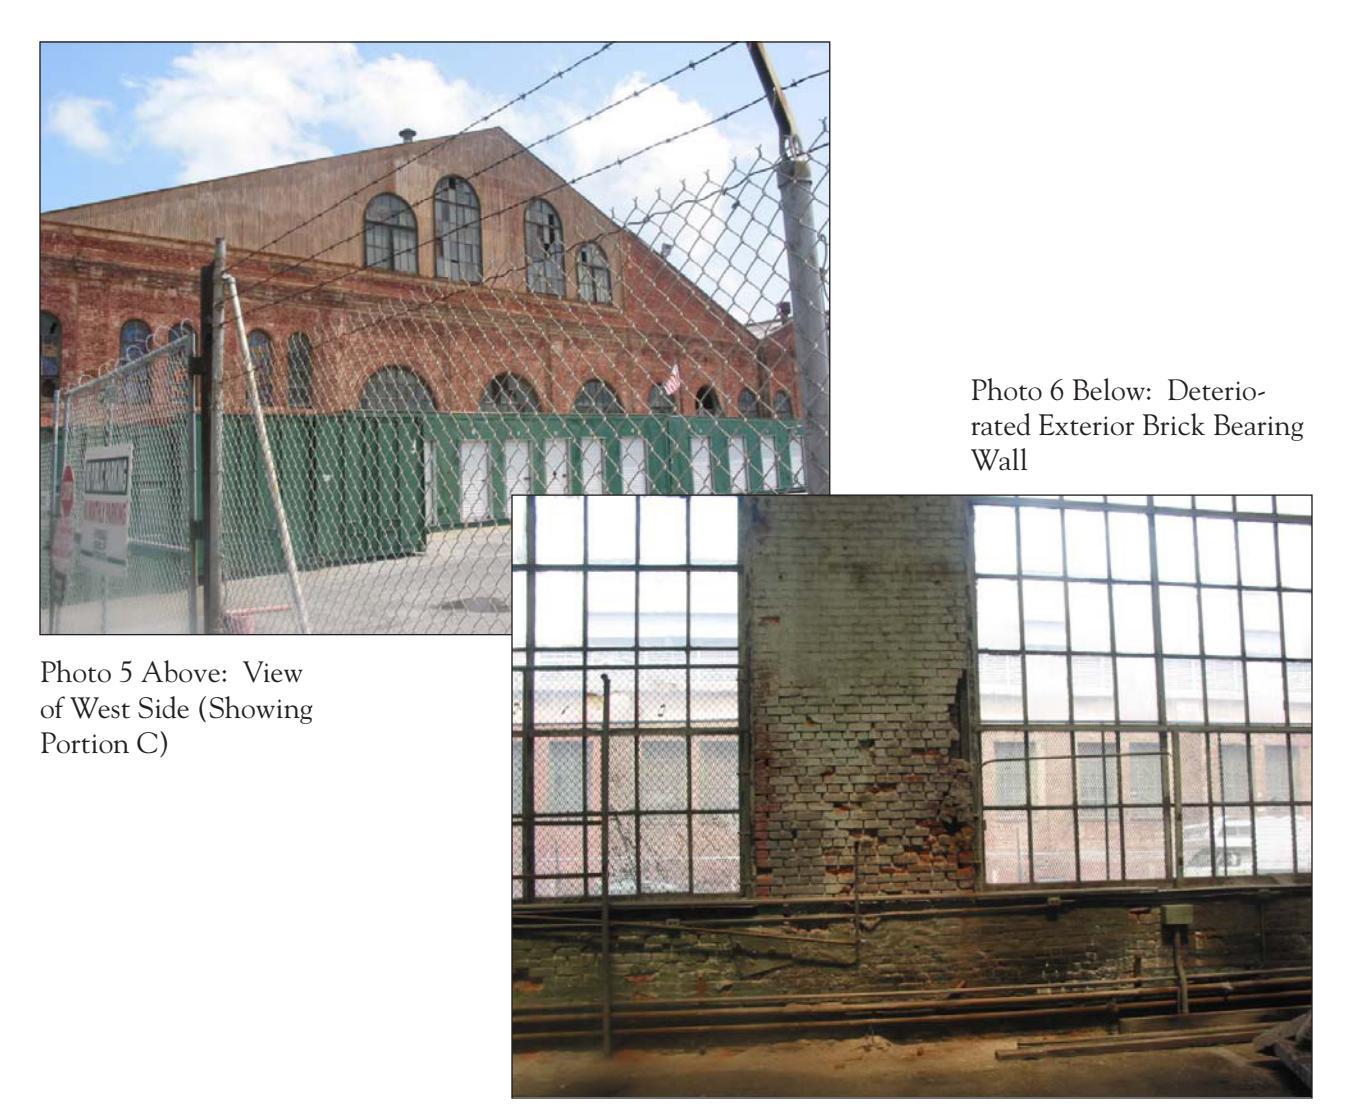
- 1. The existing diaphragm appears inadequate for seismic loads.
- 2. The roof diaphragm is interrupted with continuous skylights, resulting in inadequate transfer of lateral forces.
- 3. The exterior URM walls have many windows which create an inadequate seismic load resisting system and can lead to excessive structural damage and / or partial collapse of the building during strong seismic ground motions.
- 4. The anchorage of the URM walls to the roof diaphragms for out-of -plane load appears inadequate.

- 5. The wood frame mezzanine does not appear to have its seismic lateral resisting system nor is it anchored to the lateral-force-resisting elements of the building.
- 6. Building 115 was constructed adjoining Building 114 with a common concrete wall. Therefore, the two buildings are structurally connected and the common concrete wall shares roof dead loads as well as seismic lateral forces.

- 1. A detailed seismic evaluation of the building to quantitatively estimate the seismic deficiencies and to develop seismic retrofit measures. Since Building 113/114 and 115 are structurally connected together at south end, their seismic evaluation and retrofit may require consideration of both buildings or add seismic joint to separate Building 115 from Building 113/114.
- 2. Since structural drawings and geotechnical report for the building are not complete, the seismic evaluation would also require some site measurements and validation of geotechnical report by URS.
